Appendix I – Historical Resources Survey Report

MEMO

District: Dallas
County: Dallas, Ellis
CSJ#: 2964-10-006
Highway: SL 9, Segment A
Project Limits: US 67 to IH 34
Let Date: December 2023

SUBJECT: Internal review under the Section 106 Programmatic Agreement (Section 106 PA) among the Texas Department of Transportation, Texas State Historic Preservation Officer, Advisory Council on Historic Preservation, and Federal Highway Administration; and the Memorandum of Understanding (MOU) between the Texas Historical Commission and the Texas Department of Transportation

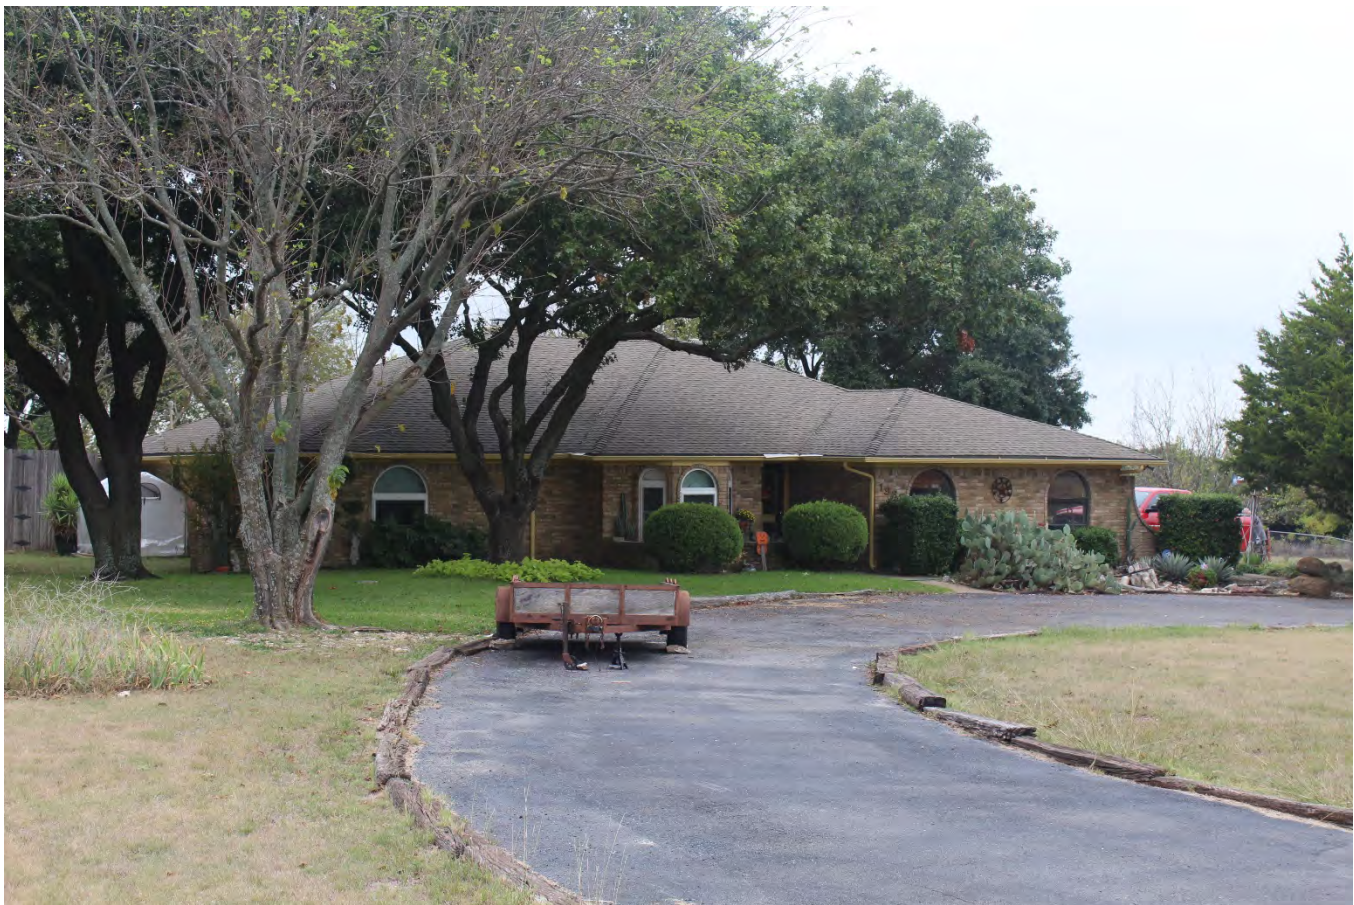
Camera facing northwest.

| Integrity/Comments: | Ranch style house with multiple hip roofs, brick siding, a recessed entry, a bay window, and replacement arched windows. Two brick half walls extend from the northeast and southeast corners of the house. |

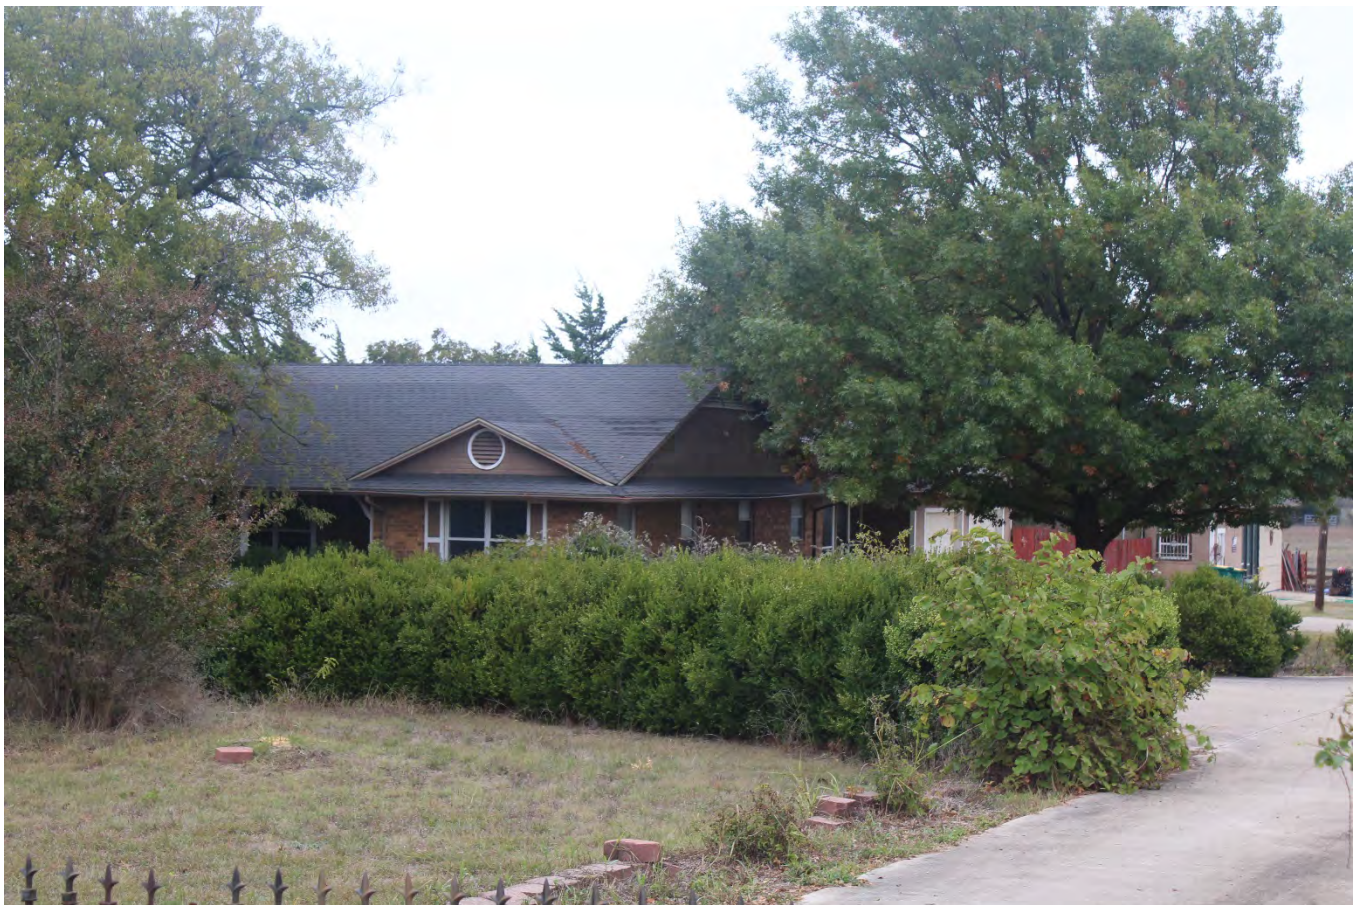
Camera facing northeast.

| Integrity/Comments: | Ranch style house with cross-gable roof, generous eaves, horizontal wood siding on gable ends, brick siding, and replacement windows. A modern addition of a garage extends from the rear (southwest) corner of the house. |

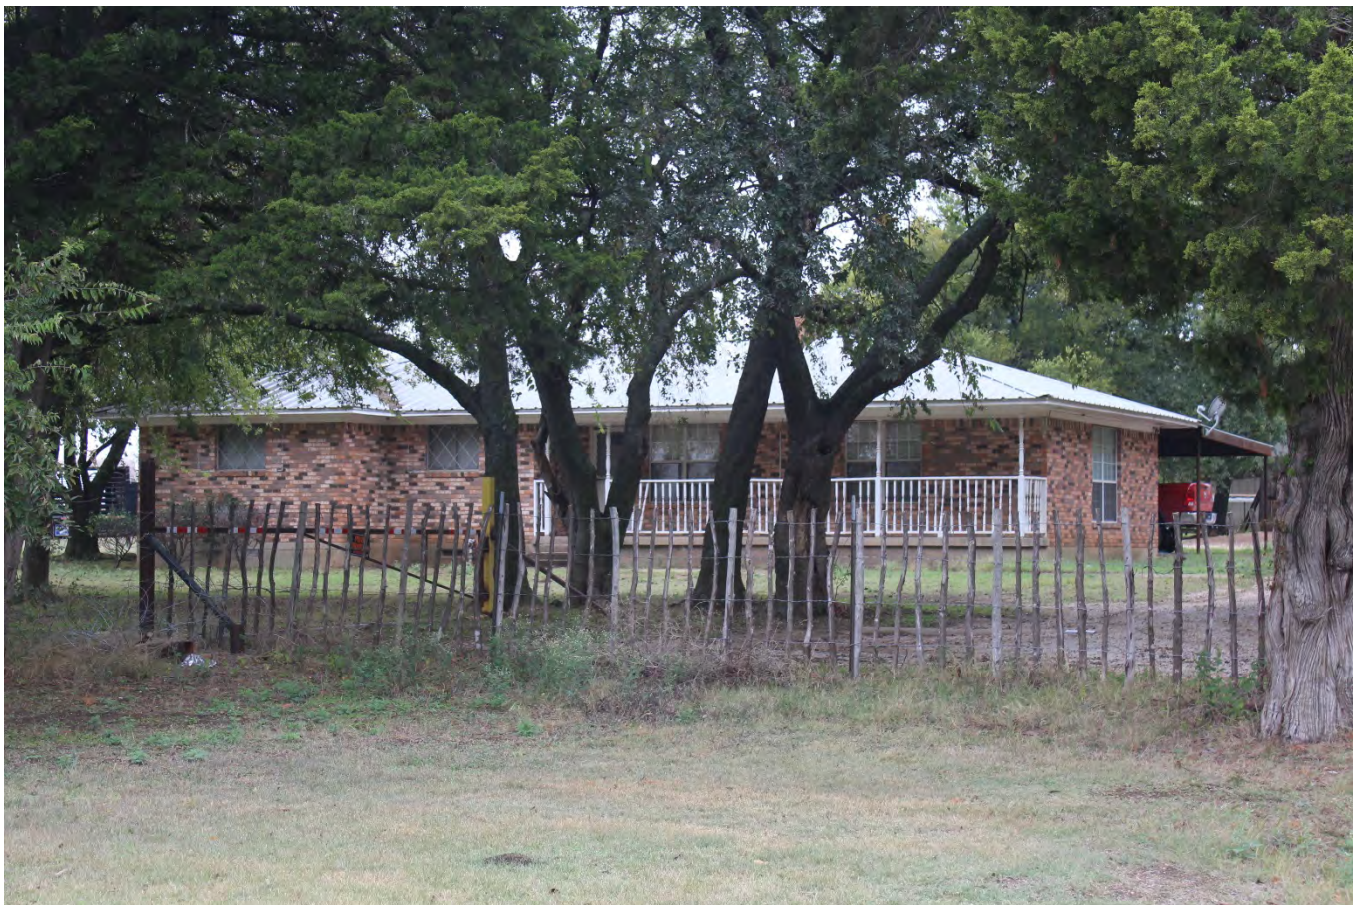
Camera facing west.

| Integrity/Comments: | Ranch style house with shallow-pitch, replacement metal hip roof, polychrome brick siding, a partial-width porch, original diamond plated windows, replacement sash windows, and a straddle ridge chimney. A carport extends from the rear (west) façade. |

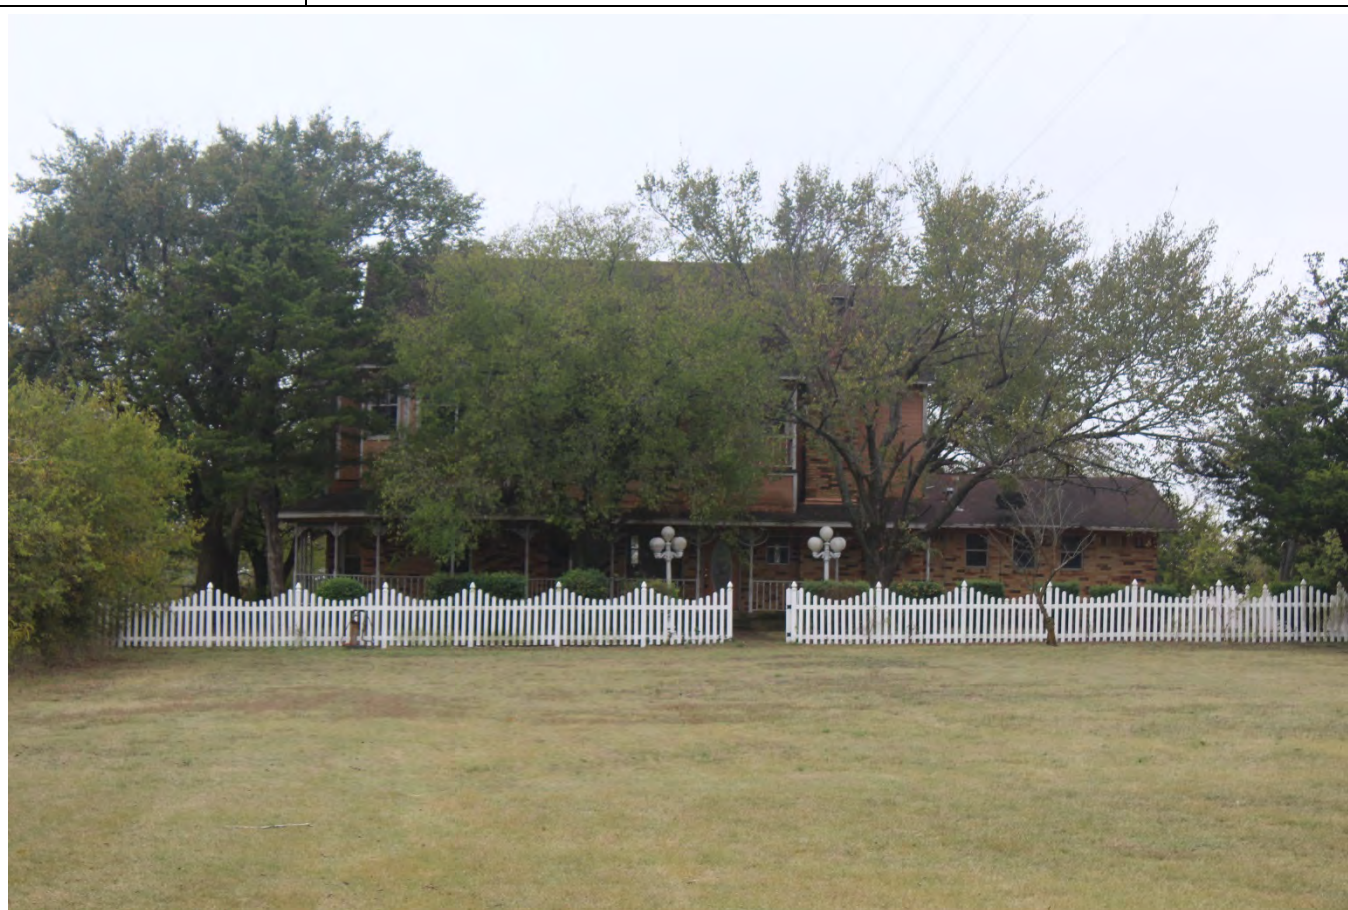
Camera facing south.

| Integrity/Comments: | Ranch style house with Victorian-style second-story addition. The house features multiple side-gable roofs, generous eaves on the ground floor, a turret, vinyl and polychrome brick siding. The ground floor has an encircling verandah, while the upper story features a partial-width deck. Both feature spindle-like ornamentation. In addition, the house features replacement windows. |

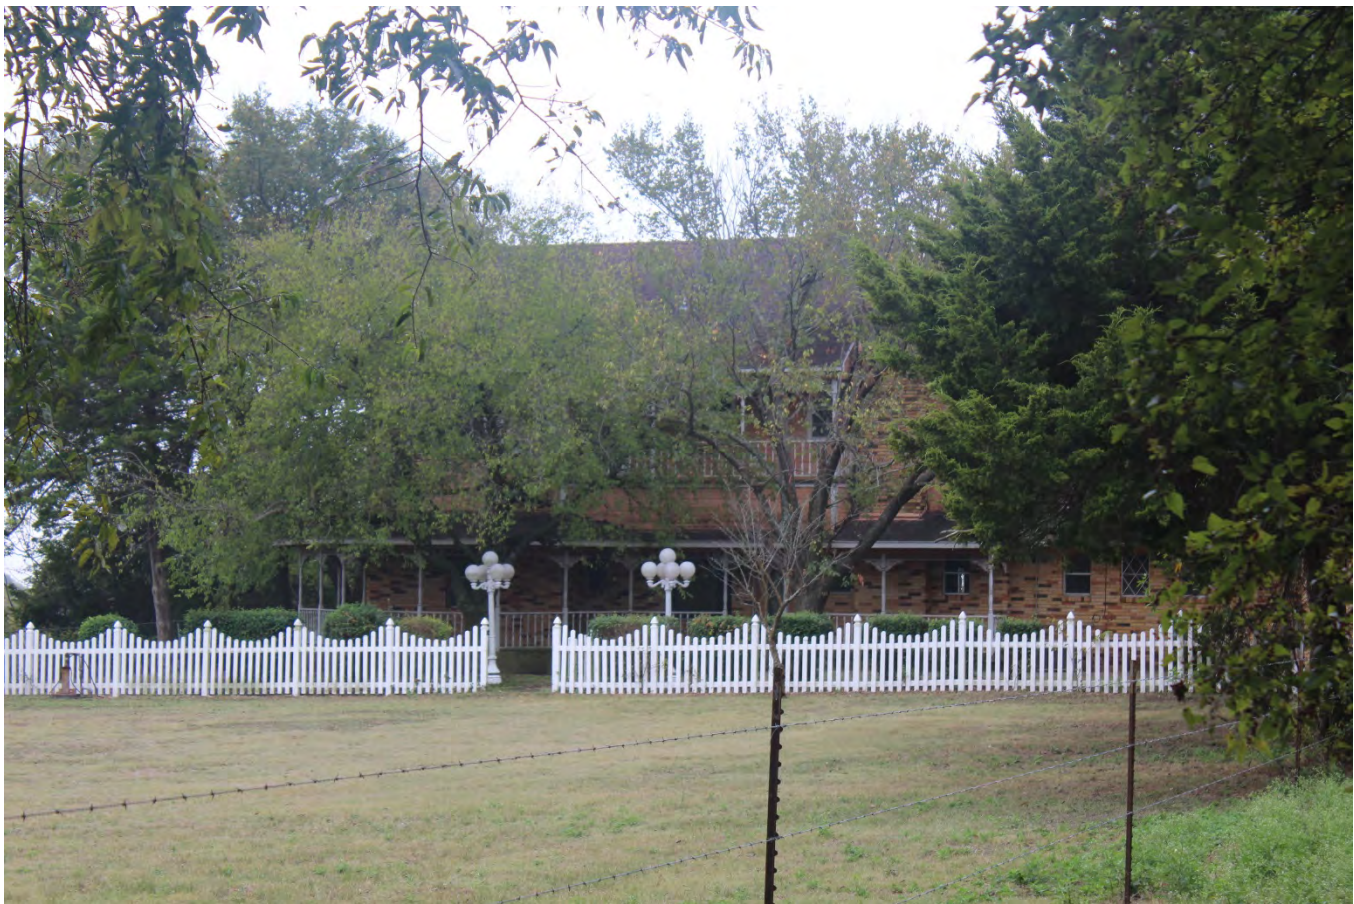
Camera facing south.

| Integrity/Comments: | Ranch style house with Victorian-style second-story addition. The house features multiple side-gable roofs, generous eaves on the ground floor, a turret, vinyl and polychrome brick siding. The ground floor has an encircling verandah, while the upper story features a partial-width deck. Both feature spindle-like ornamentation. In addition, the house features replacement windows. |

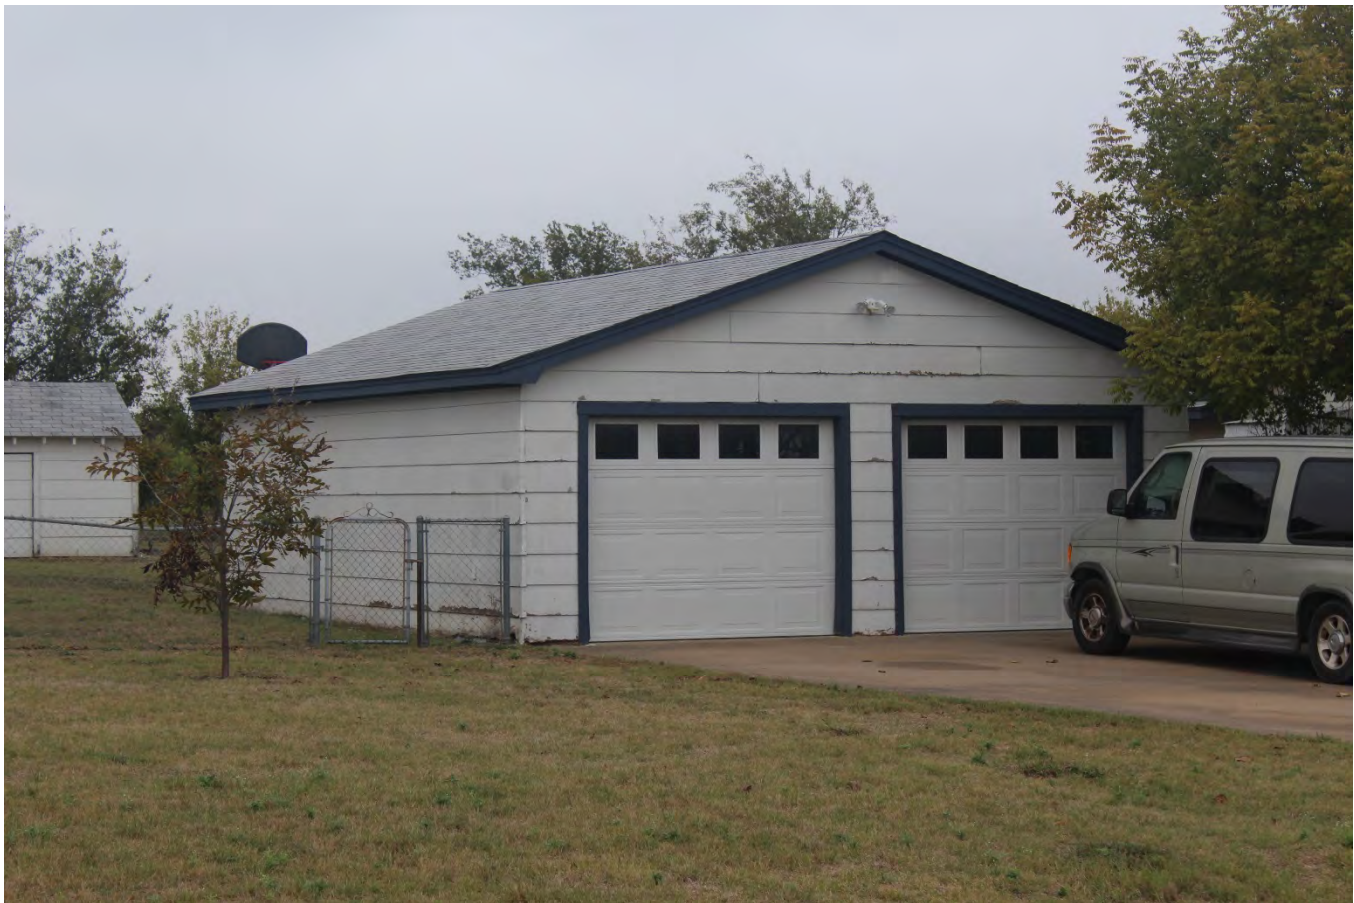
Camera facing northeast.

| Integrity/Comments: | Resource 05b is a garage with a front-gable roof, horizontal vinyl siding, and replacement sliding bay doors. |

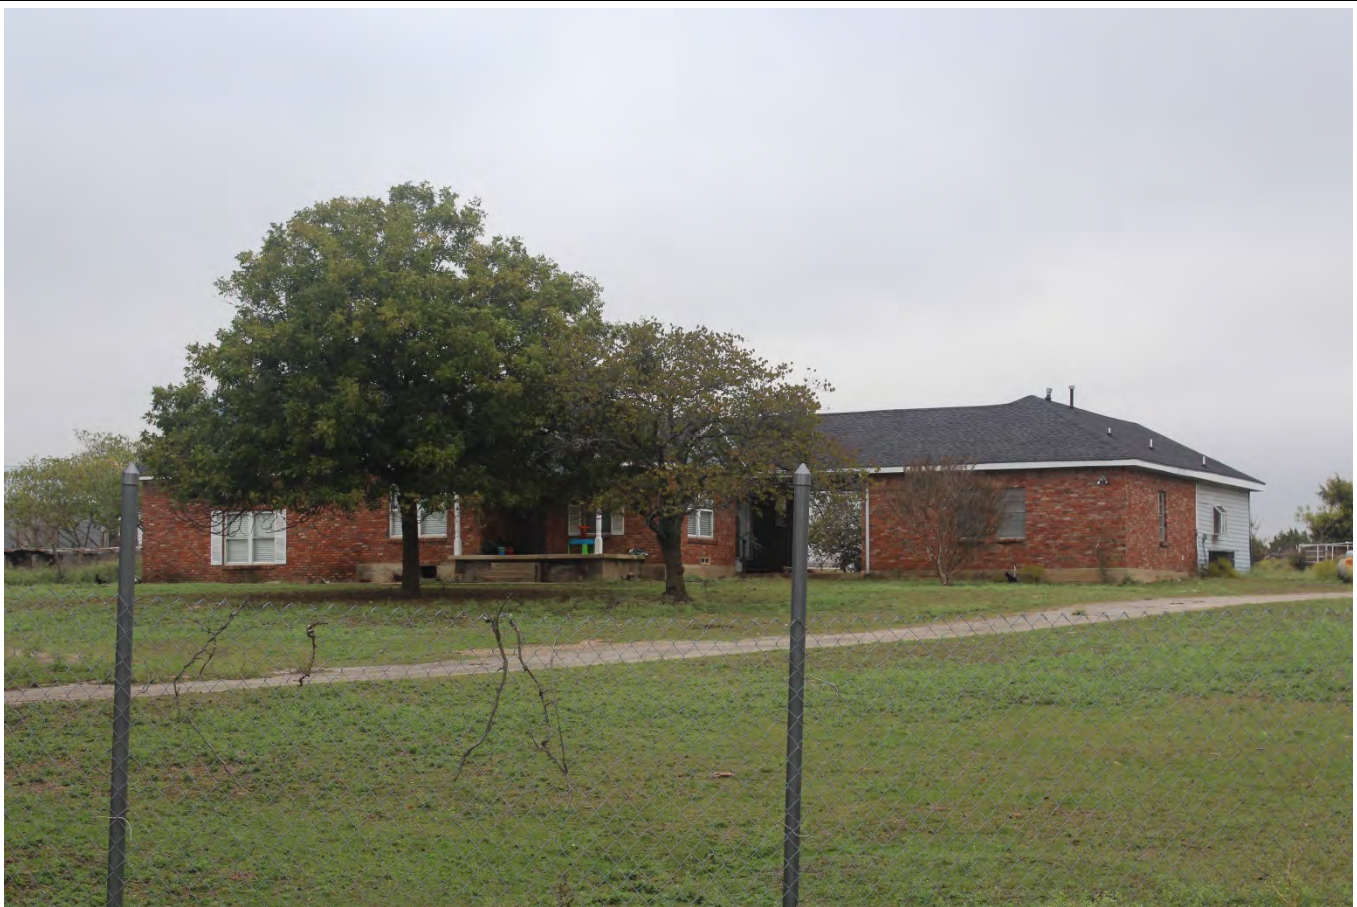
Camera facing northeast.

| Integrity/Comments: | Ranch style house with irregular footprint, cross-gable and hip roofs, dormers, brick and horizontal vinyl siding, a partial-width porch, and replacement windows with louvered shutters, a partial-width porch, and a breezeway. |

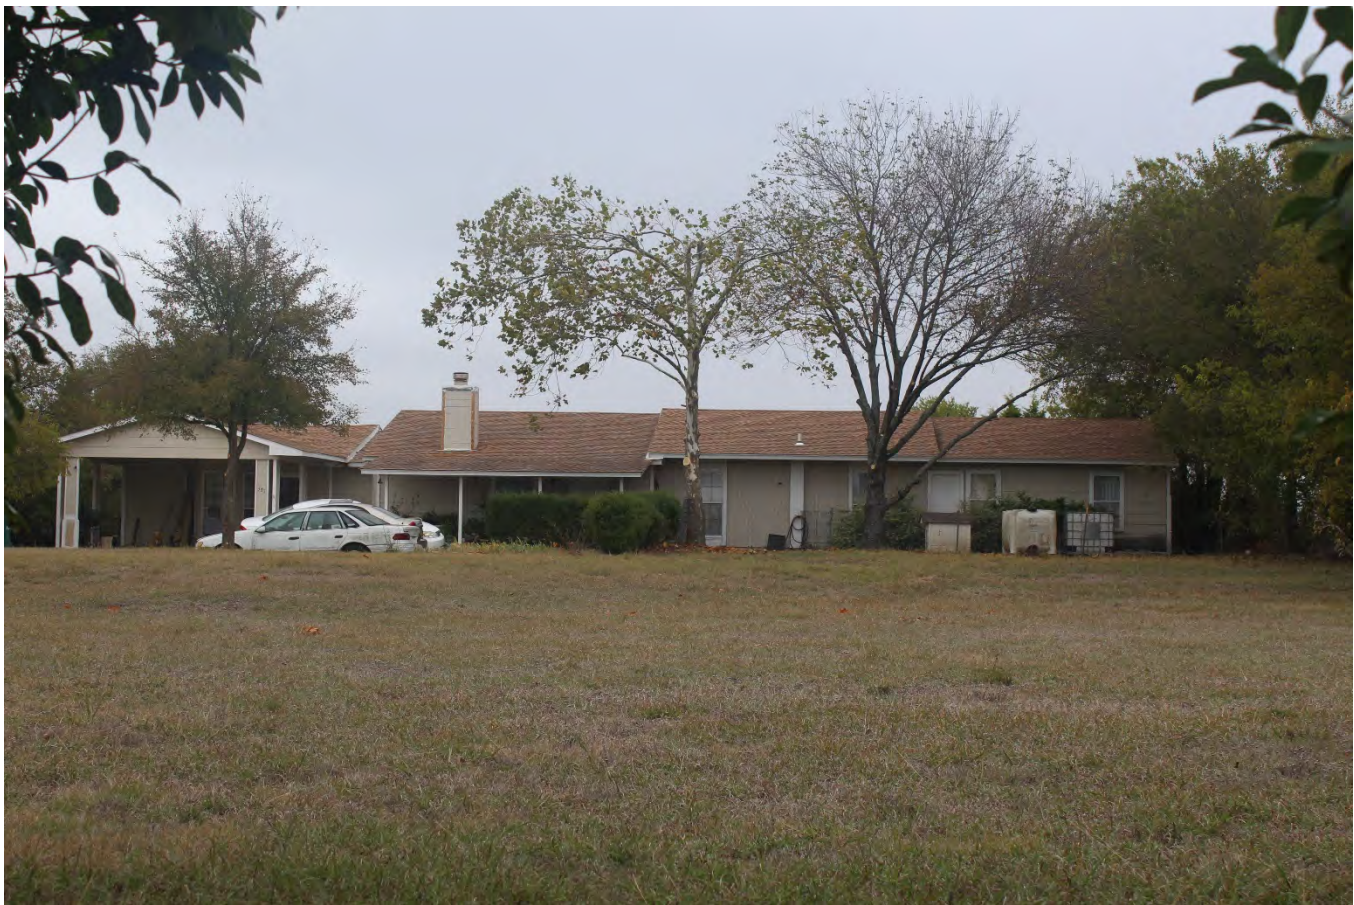
Camera facing north.

| Integrity/Comments: | Ranch style house with tiered side-gable roof and a front-gable roof over the carport. The house features horizontal vinyl siding, a partial-width porch, replacement windows, and a front slope chimney. |

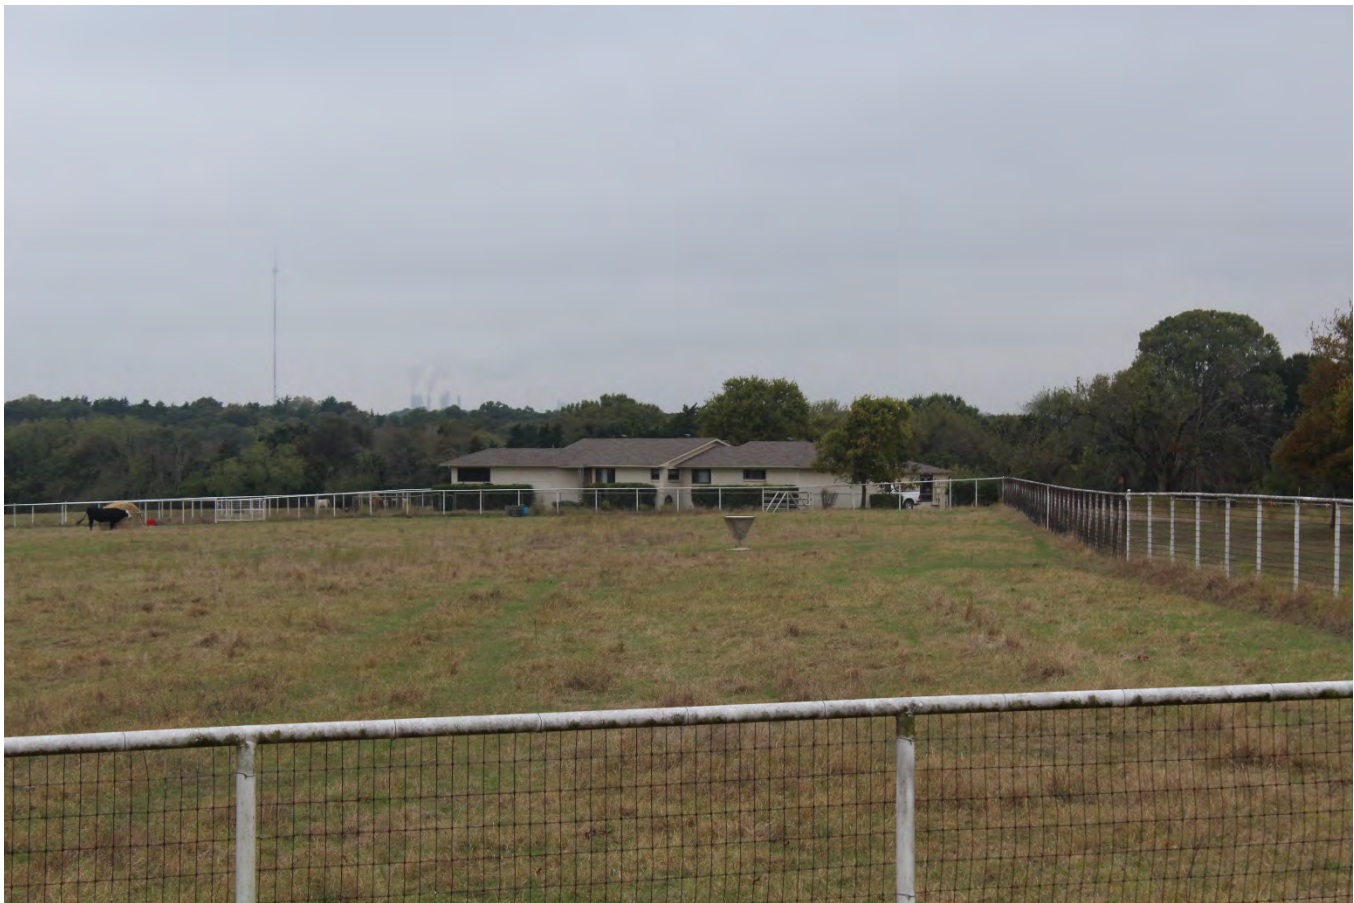
Camera facing southwest.

| Integrity/Comments: | Ranch style house with multiple tiered, shallow-pitch, side-gable roofs, brick siding, and replacement sliding windows. |

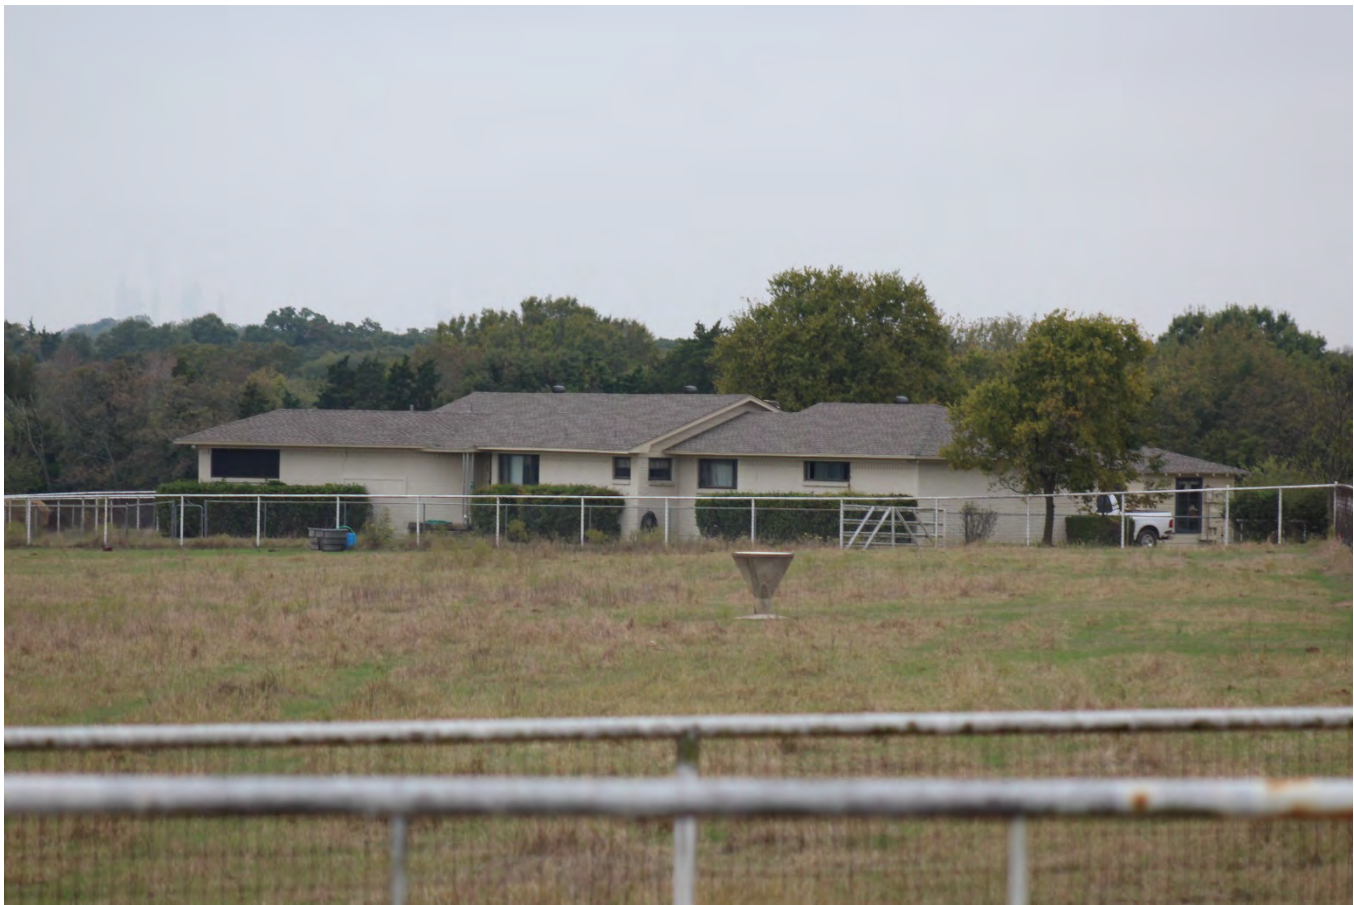
Camera facing southwest.

| Integrity/Comments: | Ranch style house with multiple tiered, shallow-pitch, side-gable roofs, brick siding, and replacement sliding windows. |

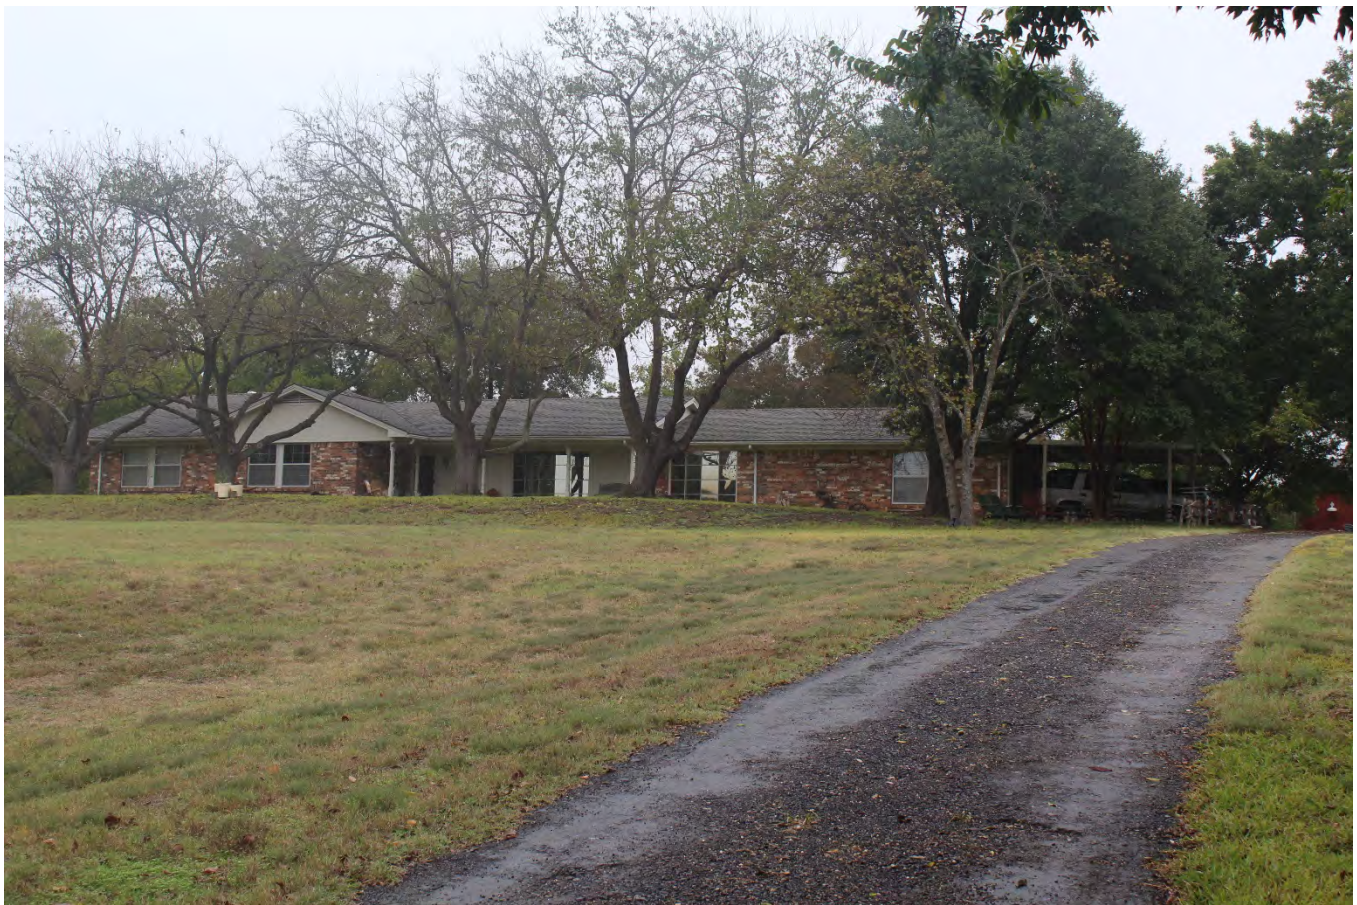
Camera facing northeast.

| Integrity/Comments: | Ranch style house with shallow-pitch, cross-gable roof, polychrome brick siding, vinyl siding on gable ends and along the recessed porch. The house features both original and replacement windows. An attached carport extends from the south façade of the house. |

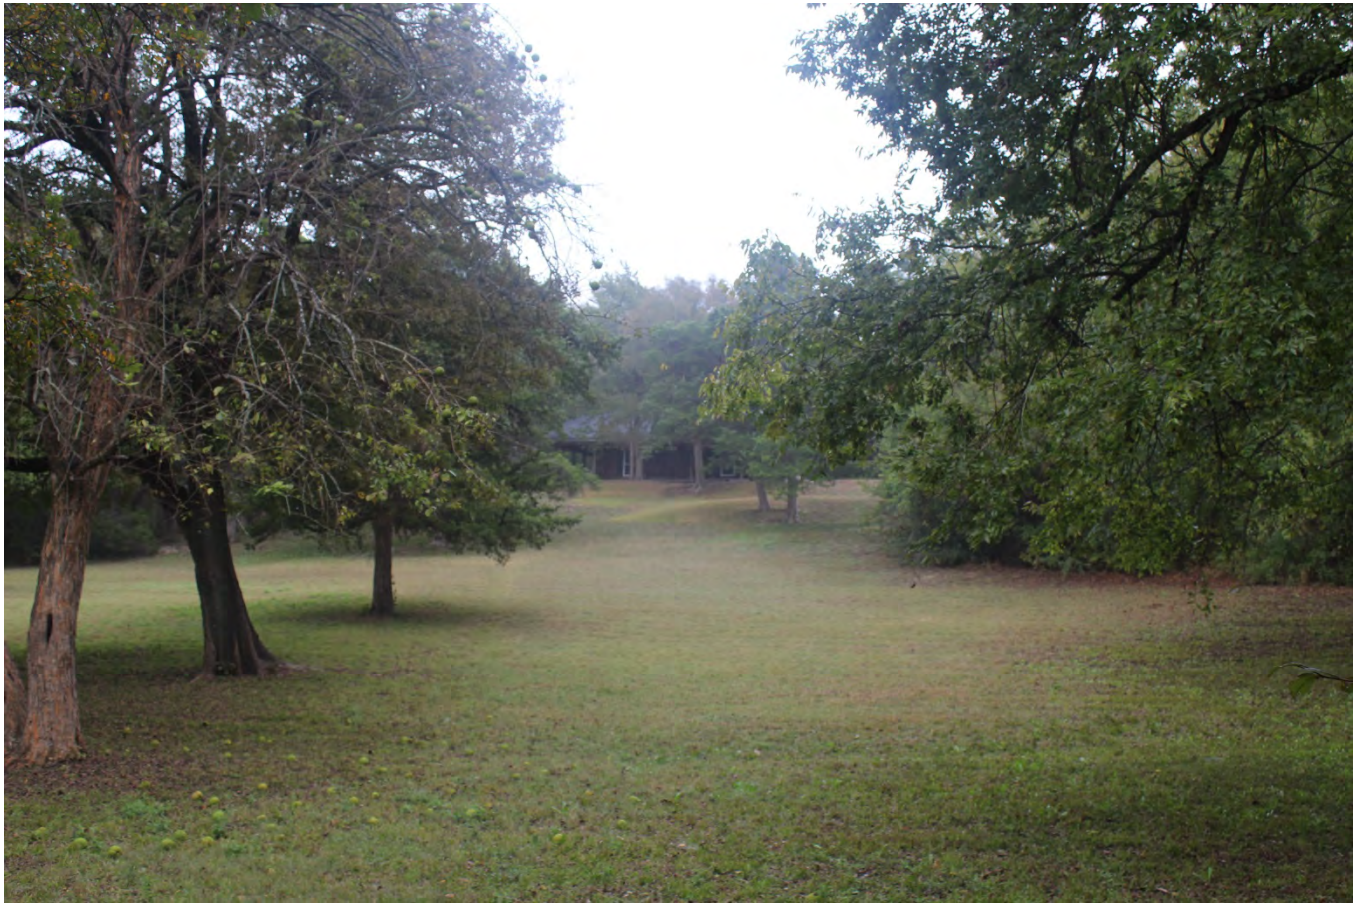
Camera facing east.

| Integrity/Comments: | Ranch style house with a gable roof, vertical wood siding, and replacement windows. An open porch extends from the south façade of the house. |

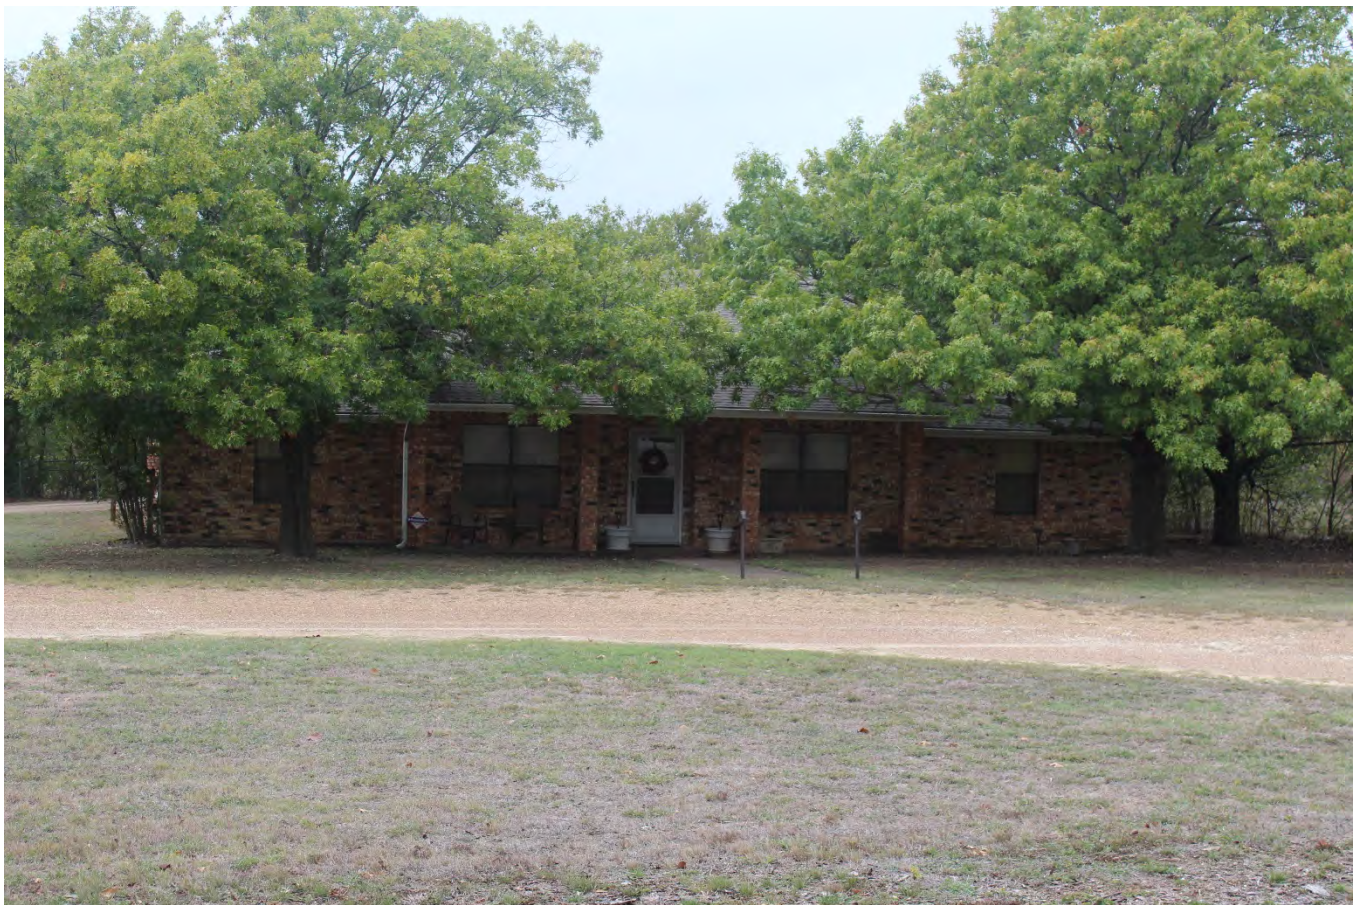
Camera facing west.

| Integrity/Comments: | Ranch style house with two-story addition at rear (west) façade of house. The house features hip and side-gable roofs, polychrome brick and horizontal vinyl siding, a partial-width porch, and replacement windows. |

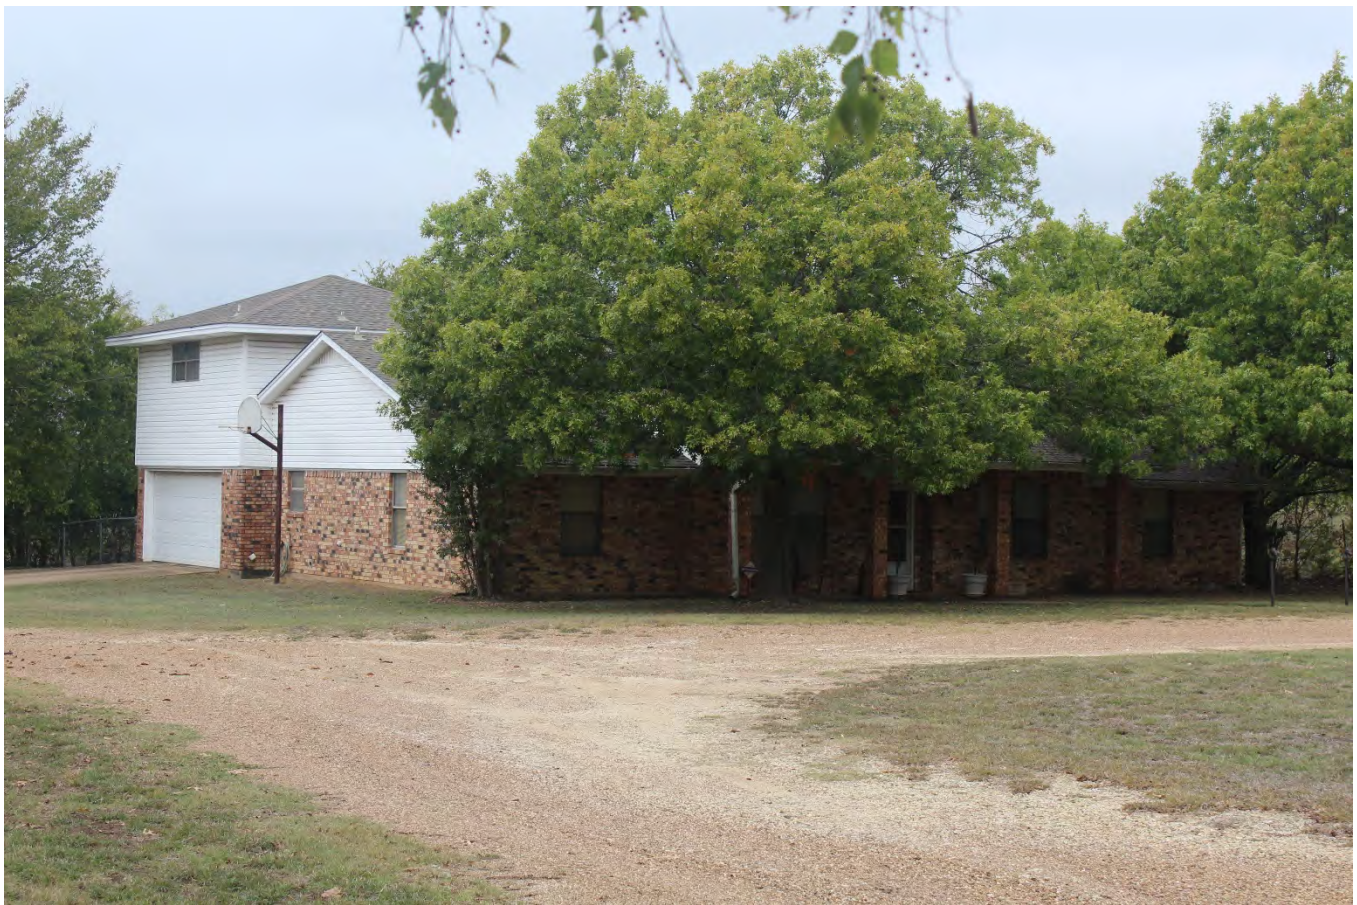
Camera facing northwest.

| Integrity/Comments: | Ranch style house with two-story addition at rear (west) façade of house. The house features hip and side-gable roofs, polychrome brick and horizontal vinyl siding, a partial-width porch, and replacement windows. |

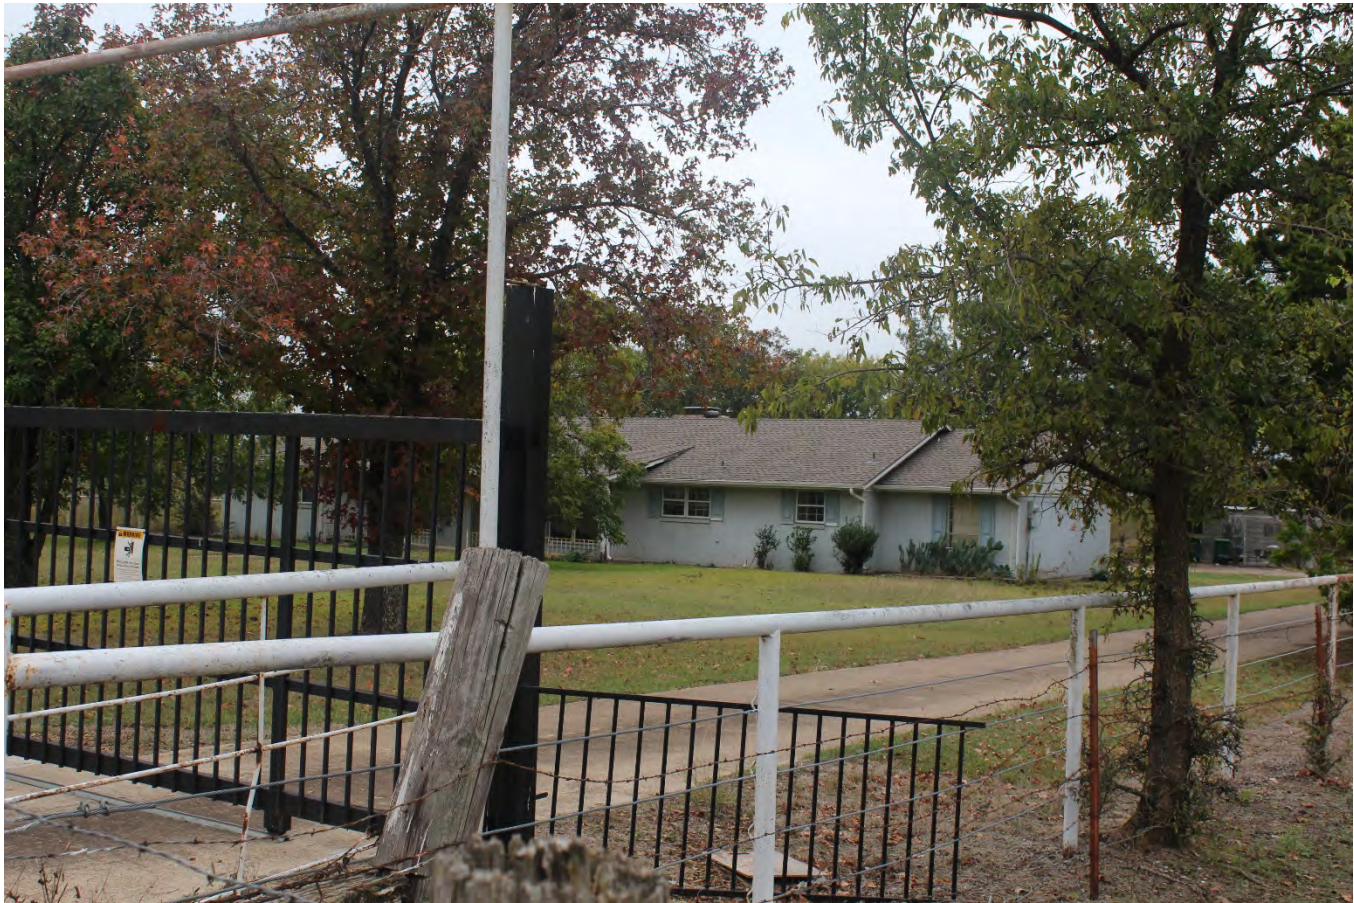
Camera facing southwest.

| Integrity/Comments: | Ranch style house with side-gable roof, brick siding, partial-width porch, replacement windows and panel and louvered shutters. |

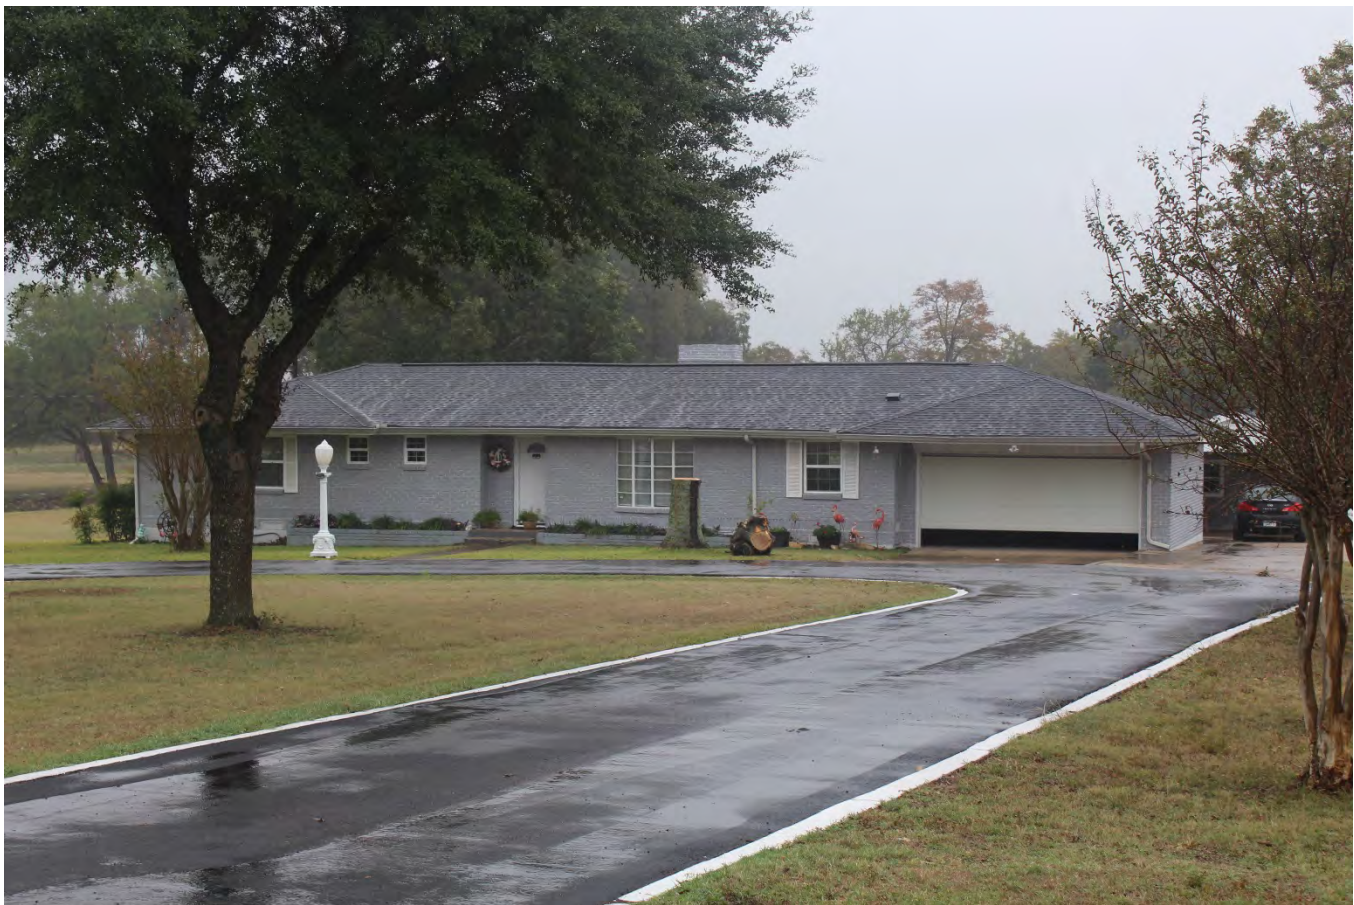
Camera facing southeast.

| Integrity/Comments: | Ranch style house with shallow-pitch, cross-hip roof, brick siding, a front stoop, both original and replacement windows, louvered shutters, an exterior chimney, and an attached garage to the west with a replacement garage door. |

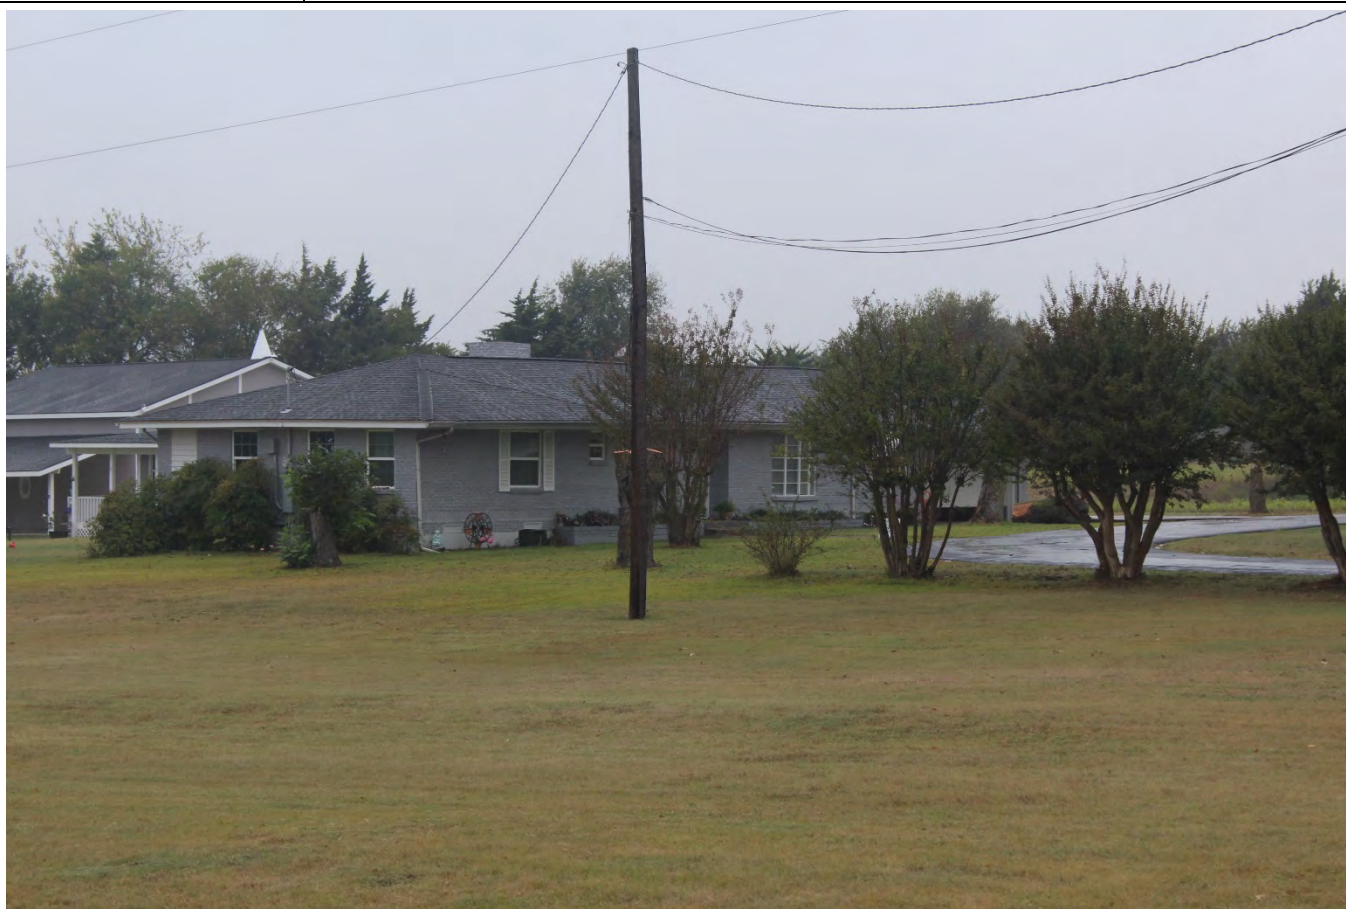
Camera facing southwest.

| Integrity/Comments: | Ranch style house with shallow-pitch, cross-hip roof, brick siding, a front stoop, both original and replacement windows, louvered shutters, an exterior chimney, and an attached garage to the west with a replacement garage door. |
