Appendix I – Historical Resources Survey Report

MEMO

District: Dallas
County: Dallas, Ellis
CSJ#: 2964-10-006
Highway: SL 9, Segment A
Project Limits: US 67 to IH 34
Let Date: December 2023

SUBJECT: Internal review under the Section 106 Programmatic Agreement (Section 106 PA) among the Texas Department of Transportation, Texas State Historic Preservation Officer, Advisory Council on Historic Preservation, and Federal Highway Administration; and the Memorandum of Understanding (MOU) between the Texas Historical Commission and the Texas Department of Transportation

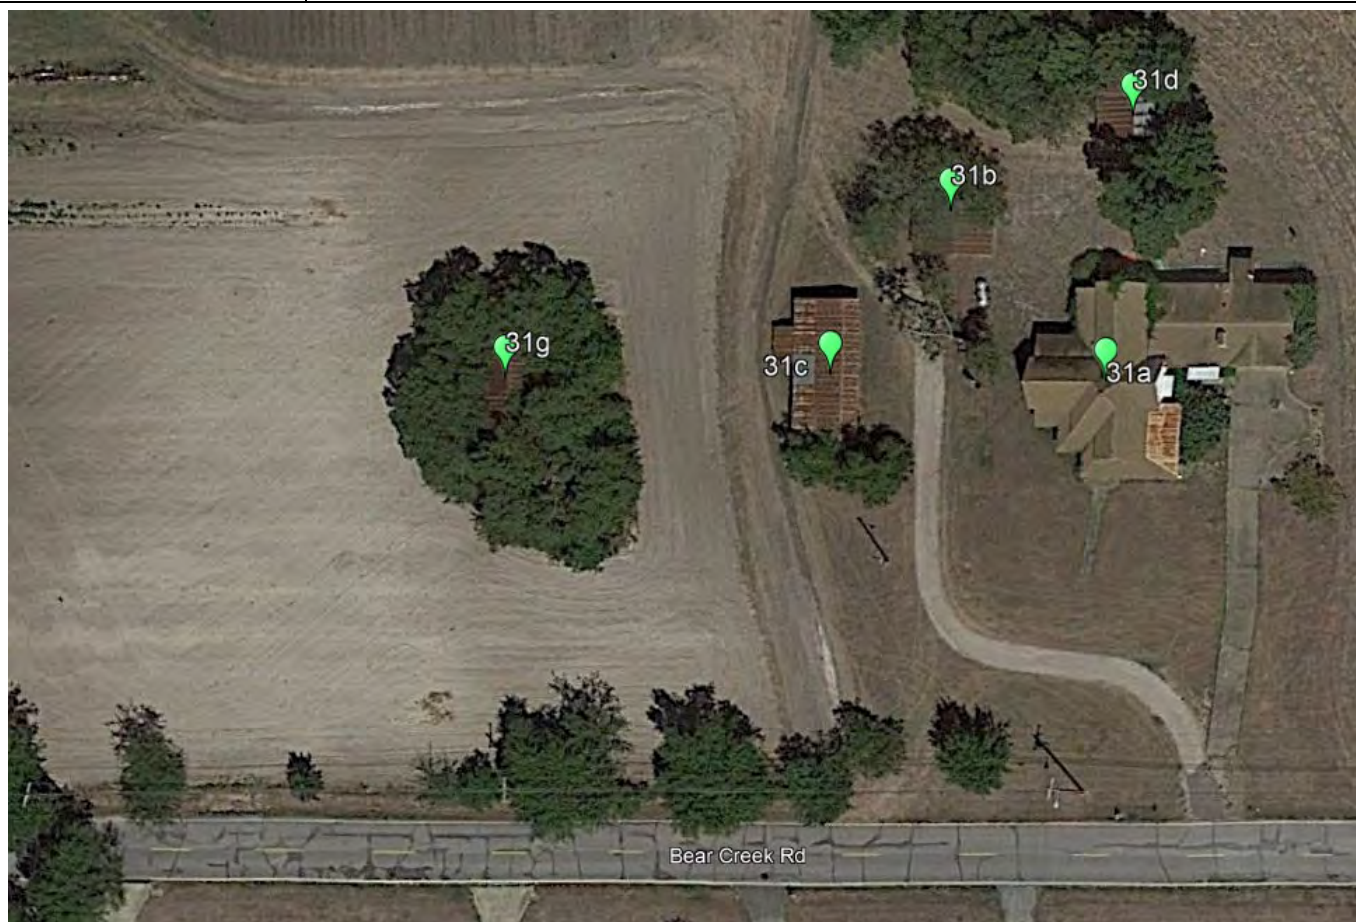
Aerial view, facing north (Google Earth 2020).

| Integrity/Comments: | Large vacant wood barn with vertical board siding, open/missing door, and front-gabled roof with metal roofing. Barn is completely obscured due to vegetation except during winter months; identified post-survey via historic aerials. |

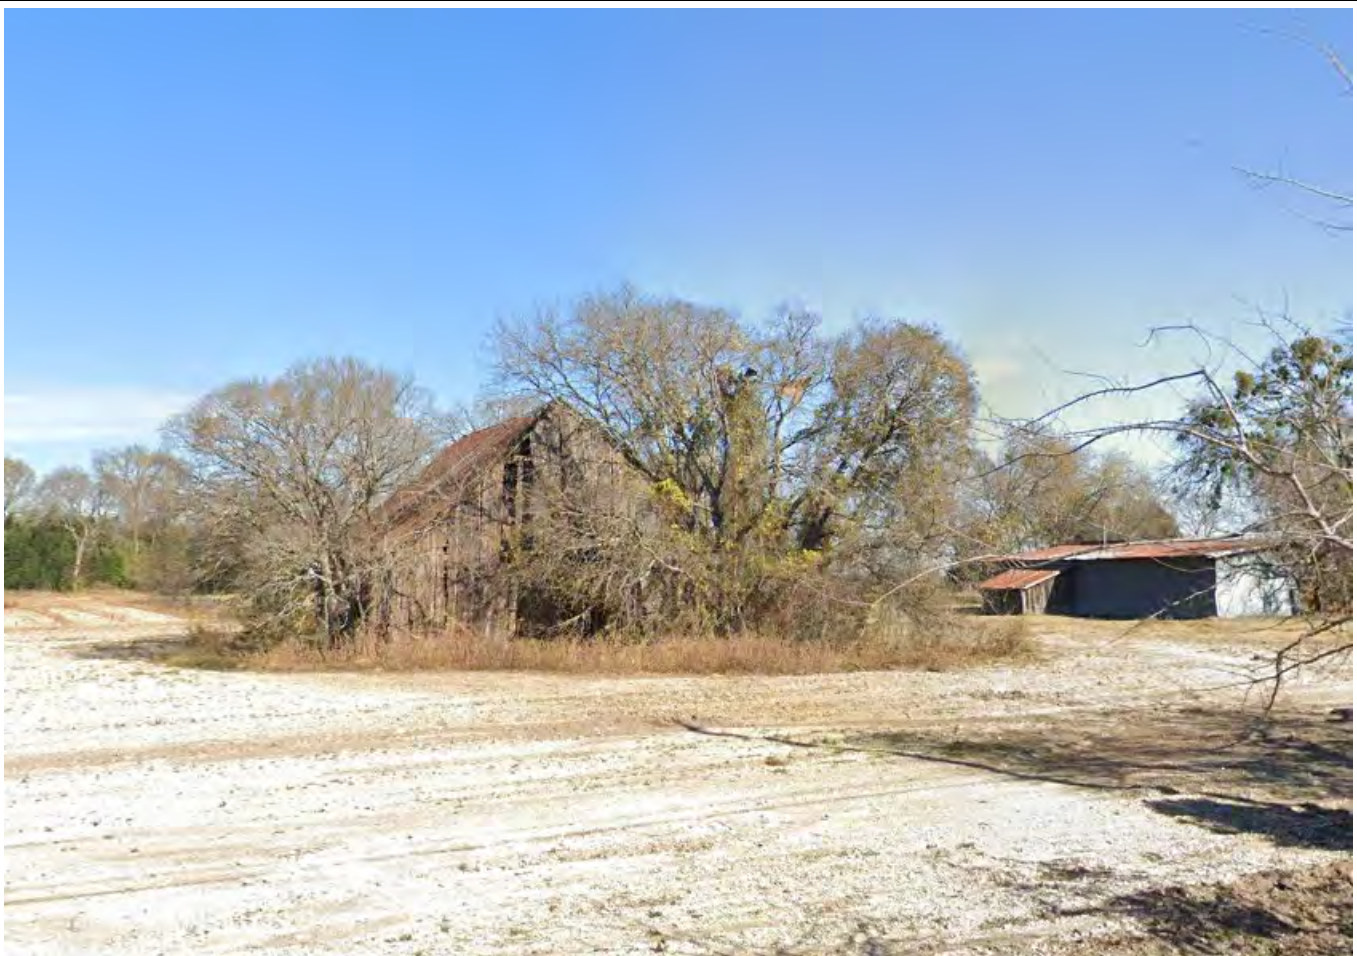
Camera facing northeast (Google Streetview revealing hidden barn, November 2018).

| Integrity/Comments: | Large vacant wood barn with vertical board siding, open/missing door, and front-gabled roof with metal roofing. Barn is completely obscured due to vegetation except during winter months; identified post-survey via historic aerials. |

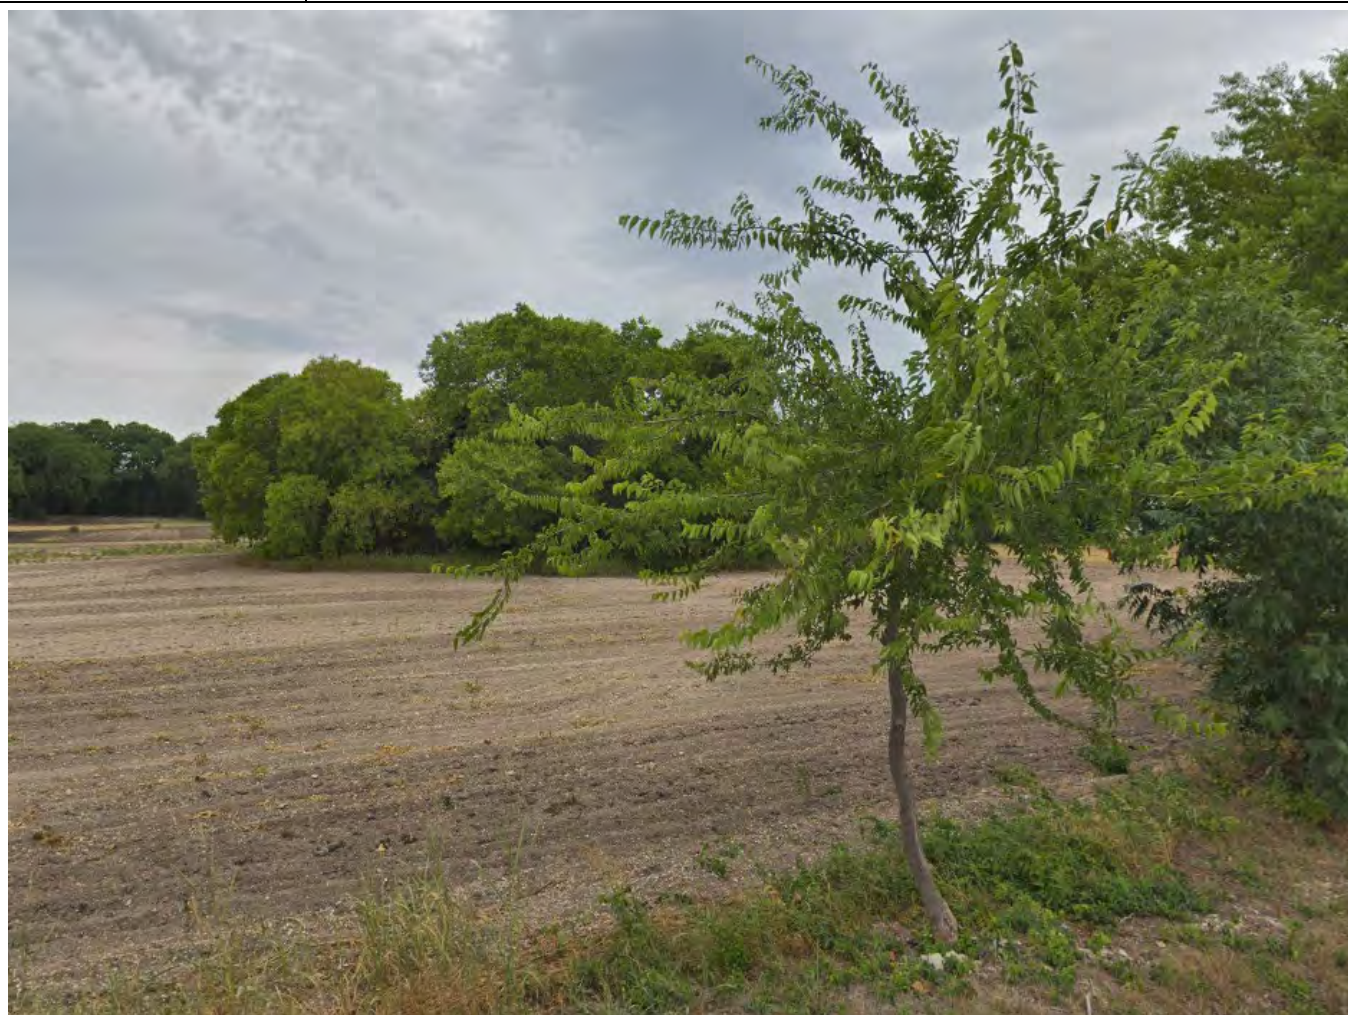
Camera facing northeast (Google Streetview showing vegetative view, July 2018).

| Integrity/Comments: | Large vacant wood barn with vertical board siding, open/missing door, and front-gabled roof with metal roofing. Barn is completely obscured due to vegetation except during winter months; identified post-survey via historic aerials. |

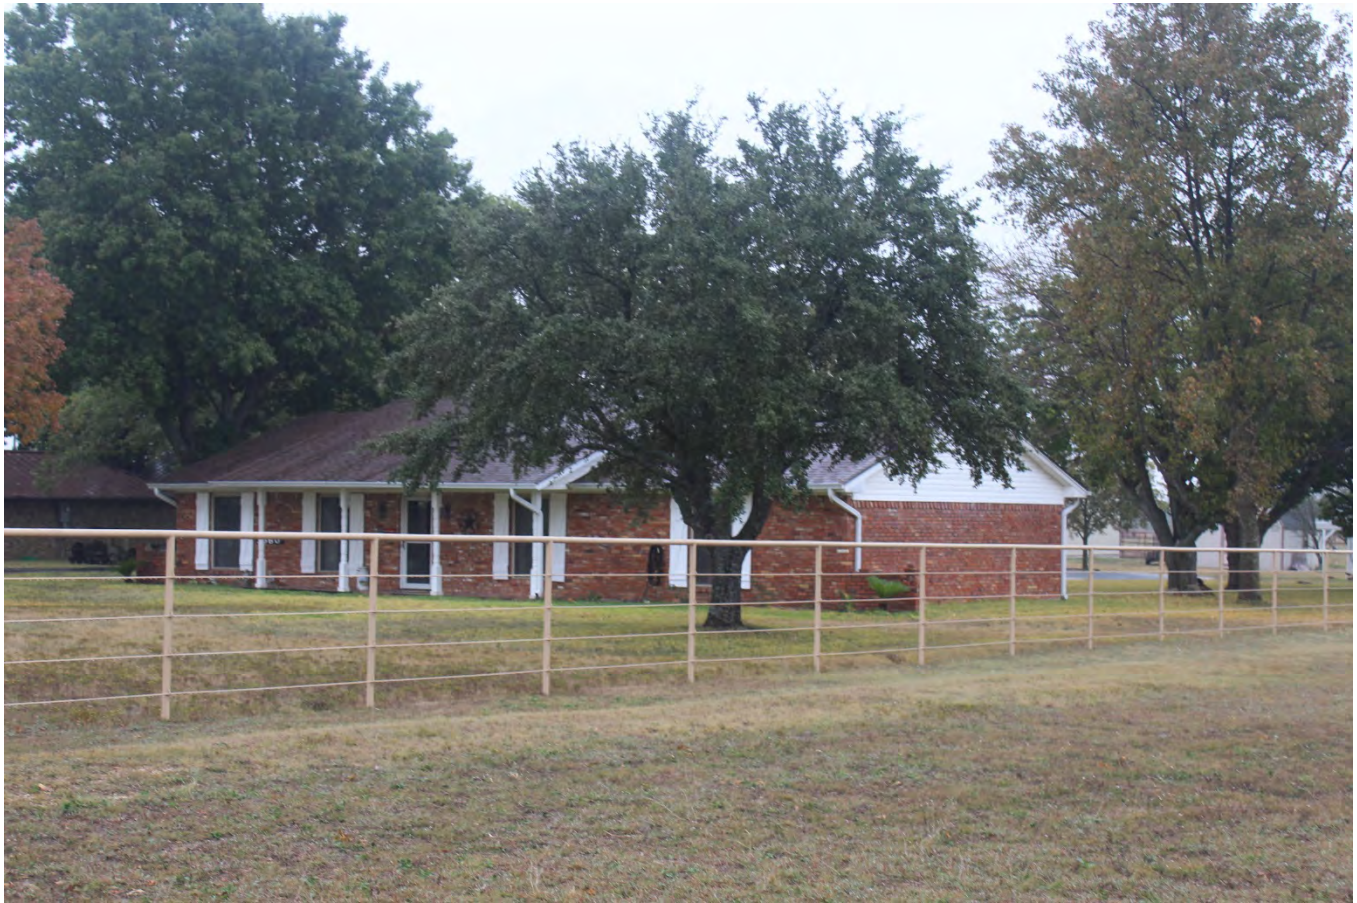
Camera facing southeast.

| Integrity/Comments: | Ranch style house with side-gable roof, brick siding, vinyl siding on gable ends, replacement windows accentuated by paneled shutters, and a partial-width porch. |

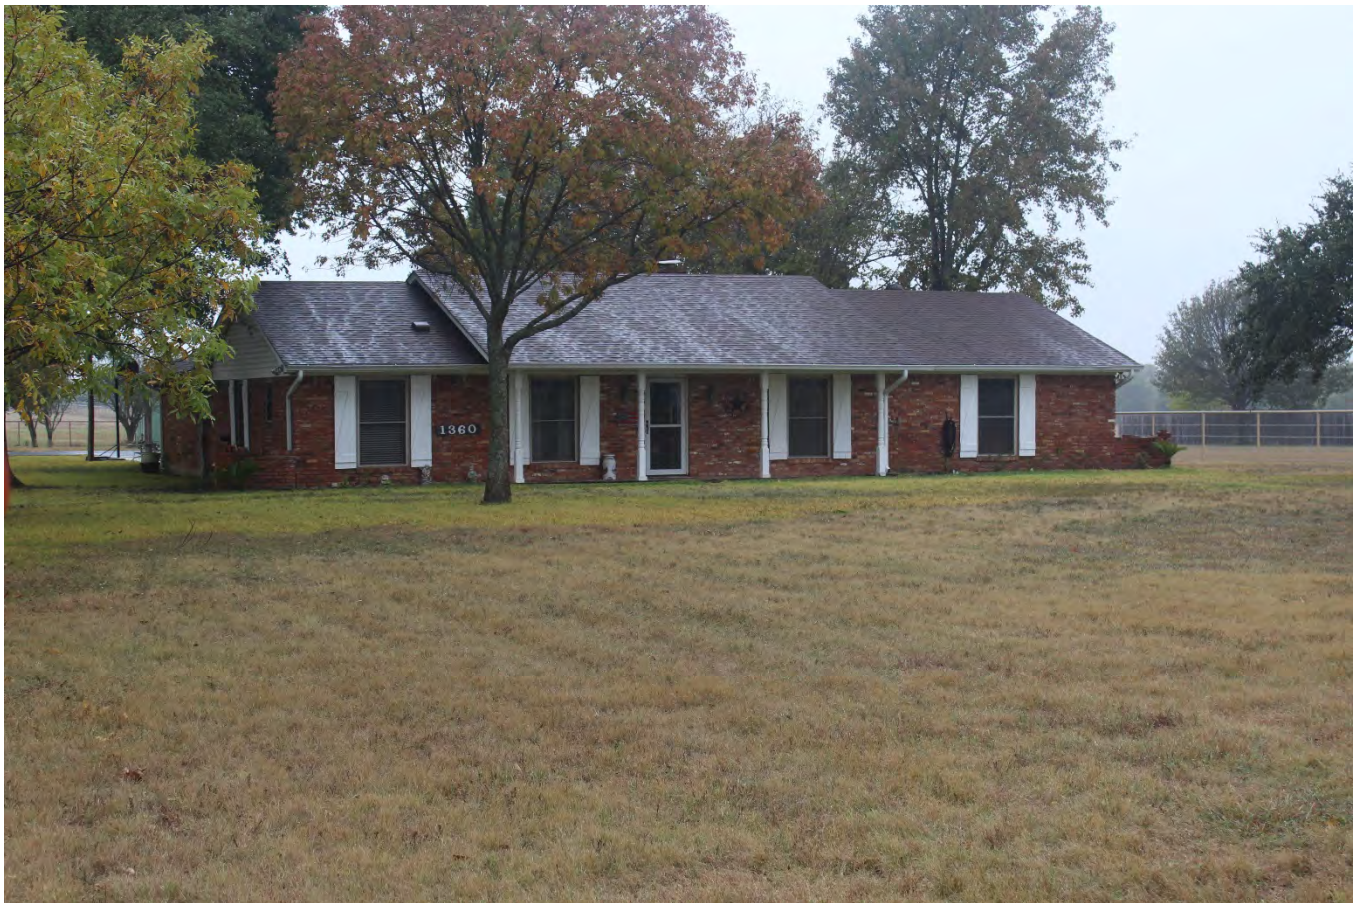
Camera facing southwest.

| Integrity/Comments: | Ranch style house with side-gable roof, brick siding, vinyl siding on gable ends, replacement windows accentuated by paneled shutters, and a partial-width porch. |

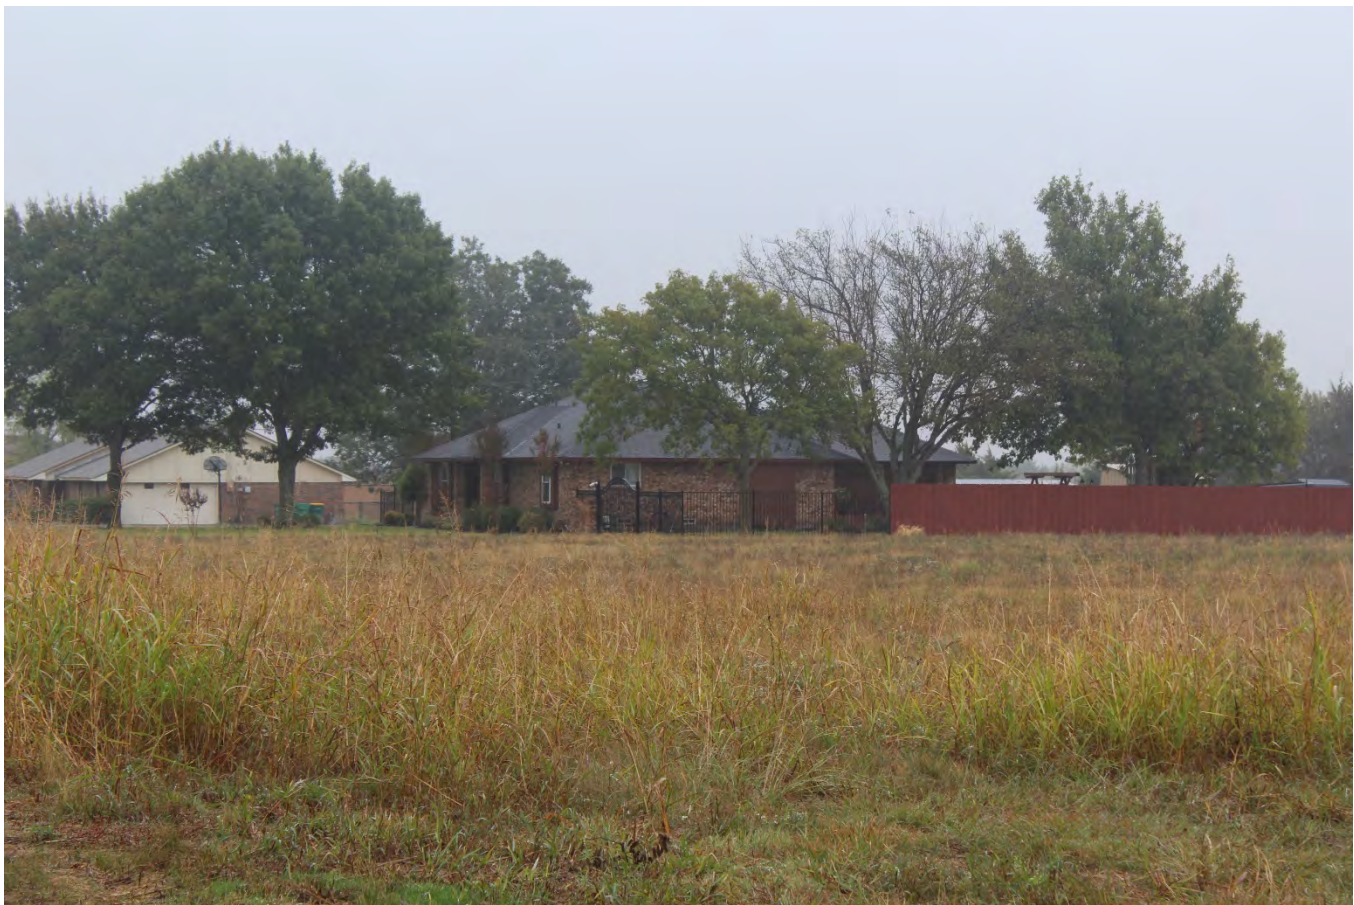
Camera facing southeast.

| Integrity/Comments: | Ranch style house with hip roof, polychrome brick siding, a recessed porch, replacement windows, a rear slope chimney, and two decorative brick half-walls extending from the northwest and northeast corners of the house. |

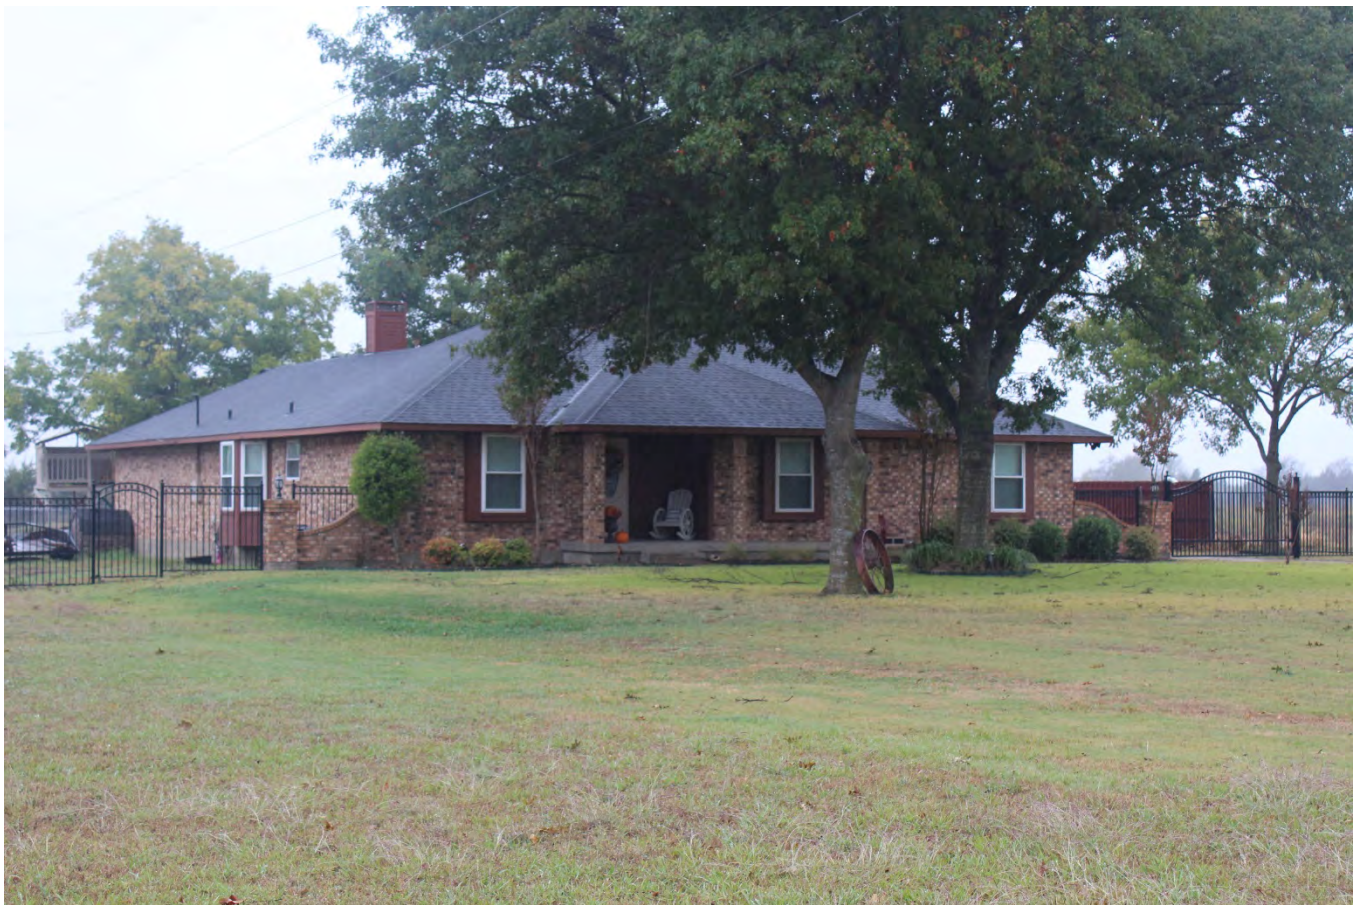
Camera facing southwest.

| Integrity/Comments: | Ranch style house with hip roof, polychrome brick siding, a recessed porch, replacement windows, a rear slope chimney, and two decorative brick half-walls extending from the northwest and northeast corners of the house. |

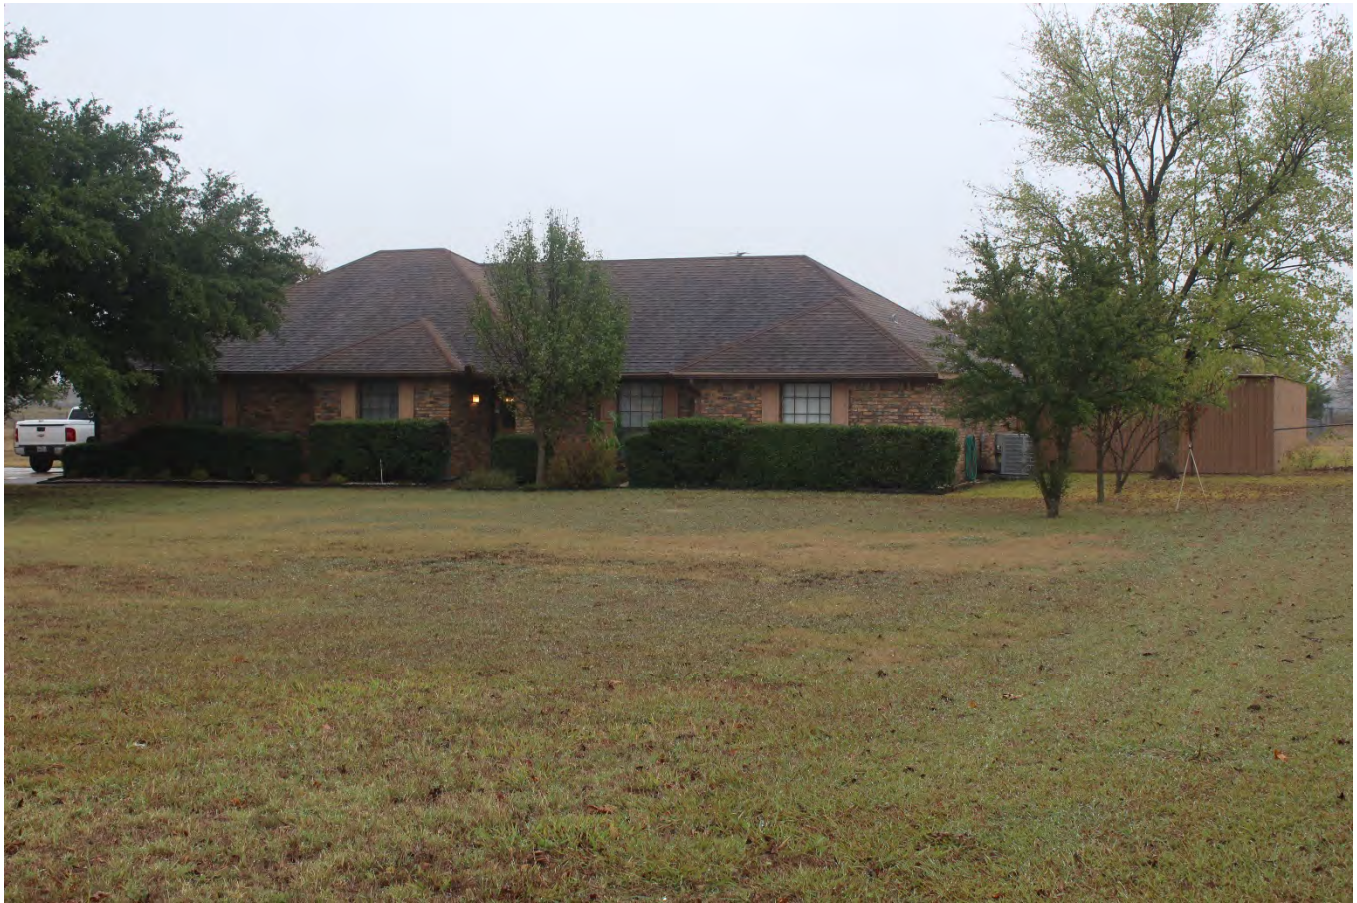
Camera facing southeast.

| Integrity/Comments: | Ranch style house with hip roof, polychrome brick siding, a recessed entry, original windows with panel shutters, and replacement garage doors. |

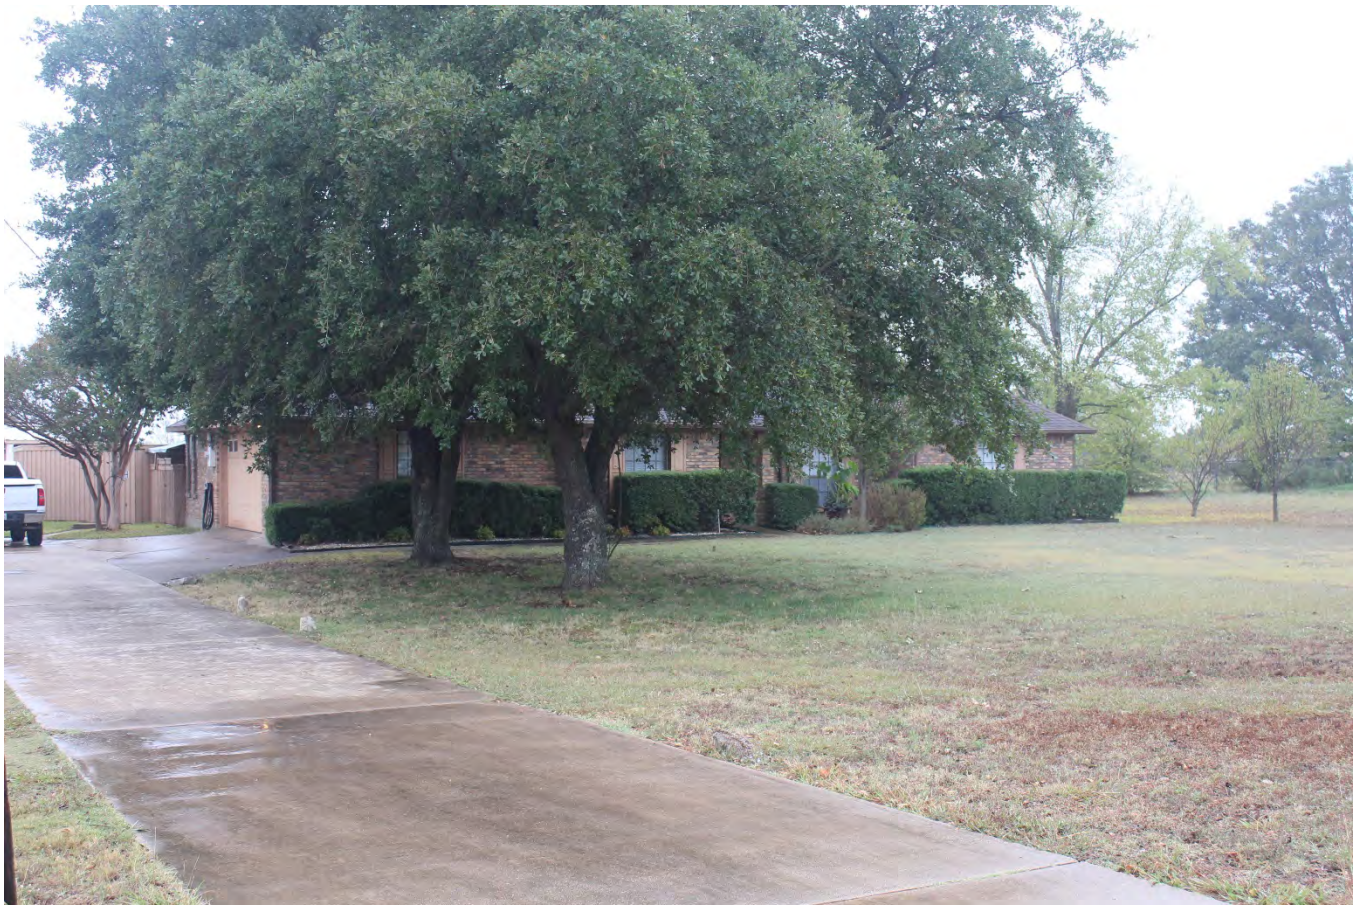
Camera facing southwest.

| Integrity/Comments: | Ranch style house with hip roof, polychrome brick siding, a recessed entry, original windows with panel shutters, and replacement garage doors. |

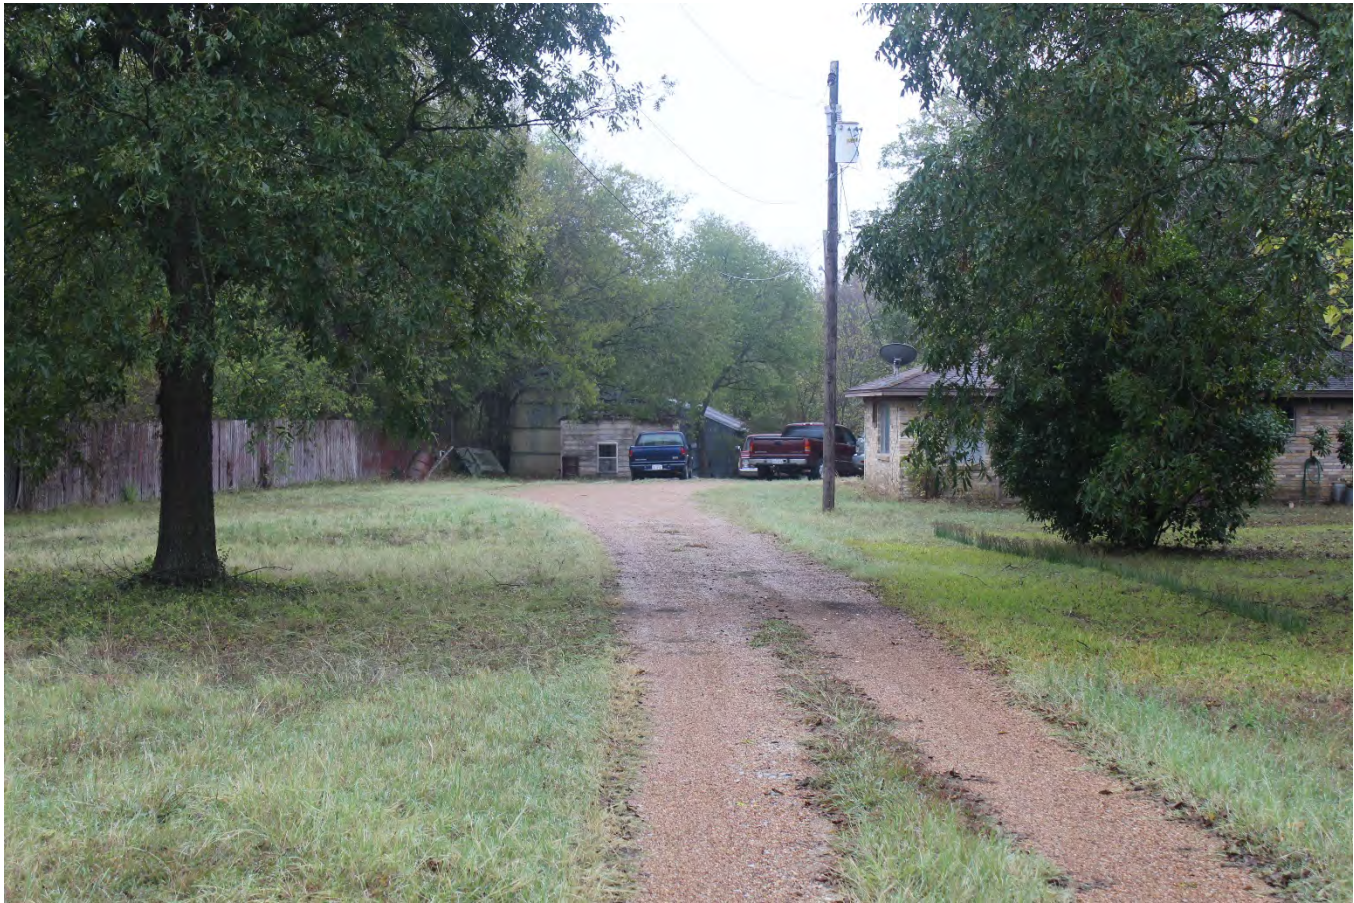
Camera facing south.

| Integrity/Comments: | Resource 36d is a shed with a wood-shingle gable roof, exposed rafter tails, horizontal wood siding, and replacement windows. The roof appears to be in poor condition. |

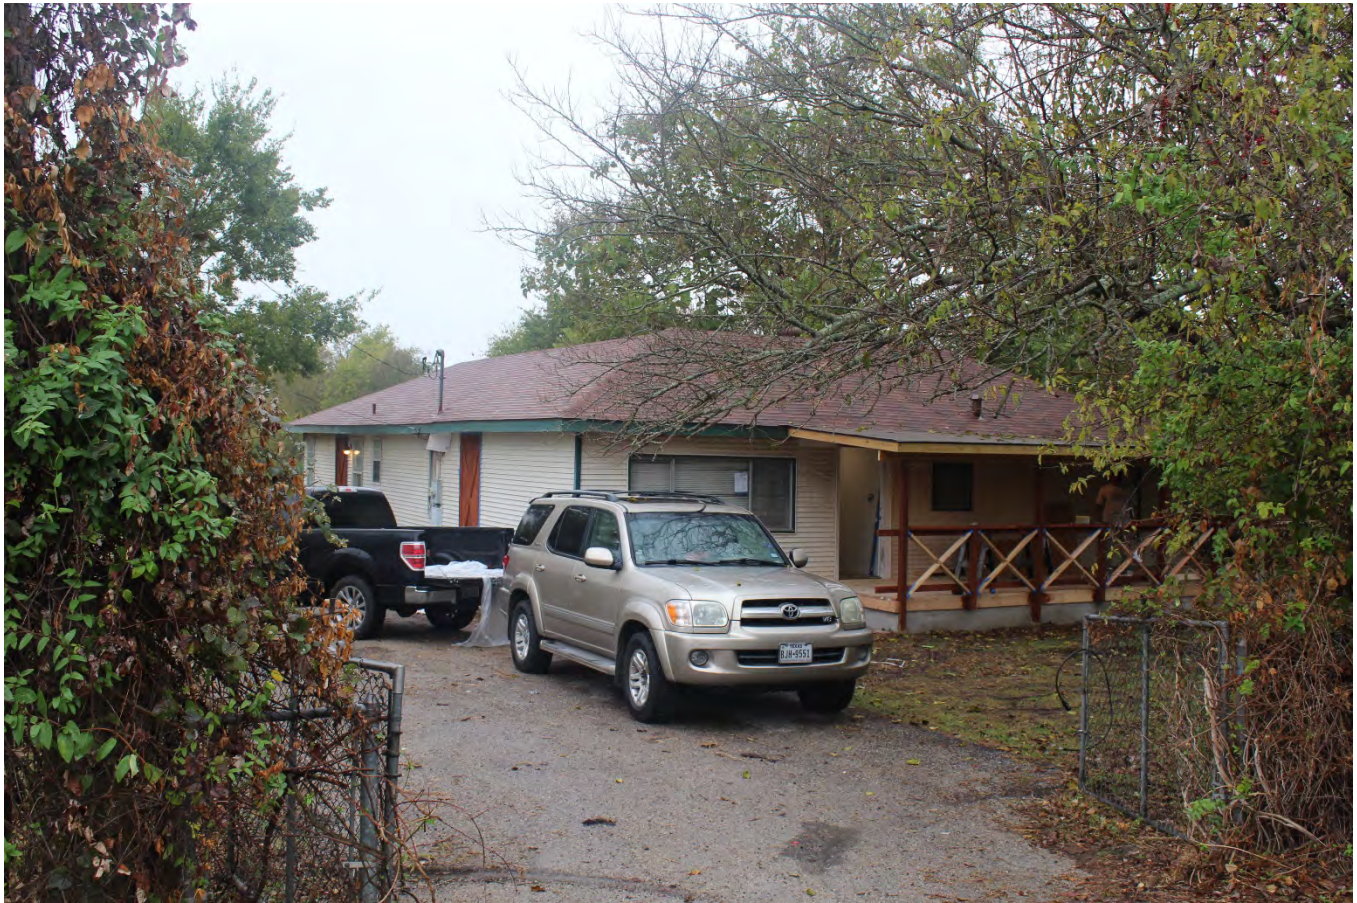
Camera facing southwest.

| Integrity/Comments: | A highly renovated Ranch style house with a hip roof, horizontal vinyl siding, a partial-width porch with decorative railings, and replacement sash and picture windows. |

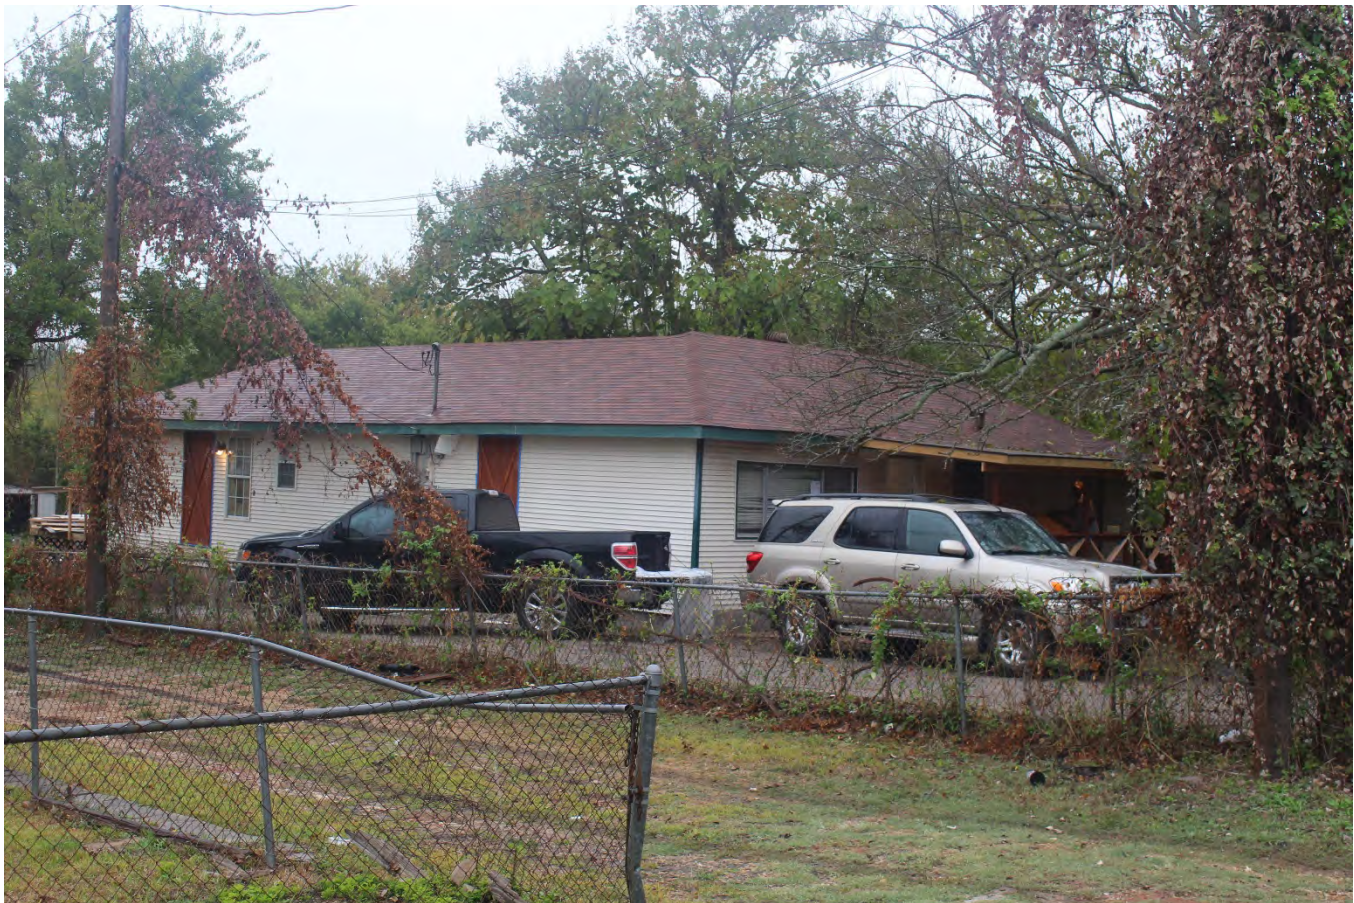
Camera facing southwest.

| Integrity/Comments: | A highly renovated Ranch style house with a hip roof, horizontal vinyl siding, a partial-width porch with decorative railings, and replacement sash and picture windows. |

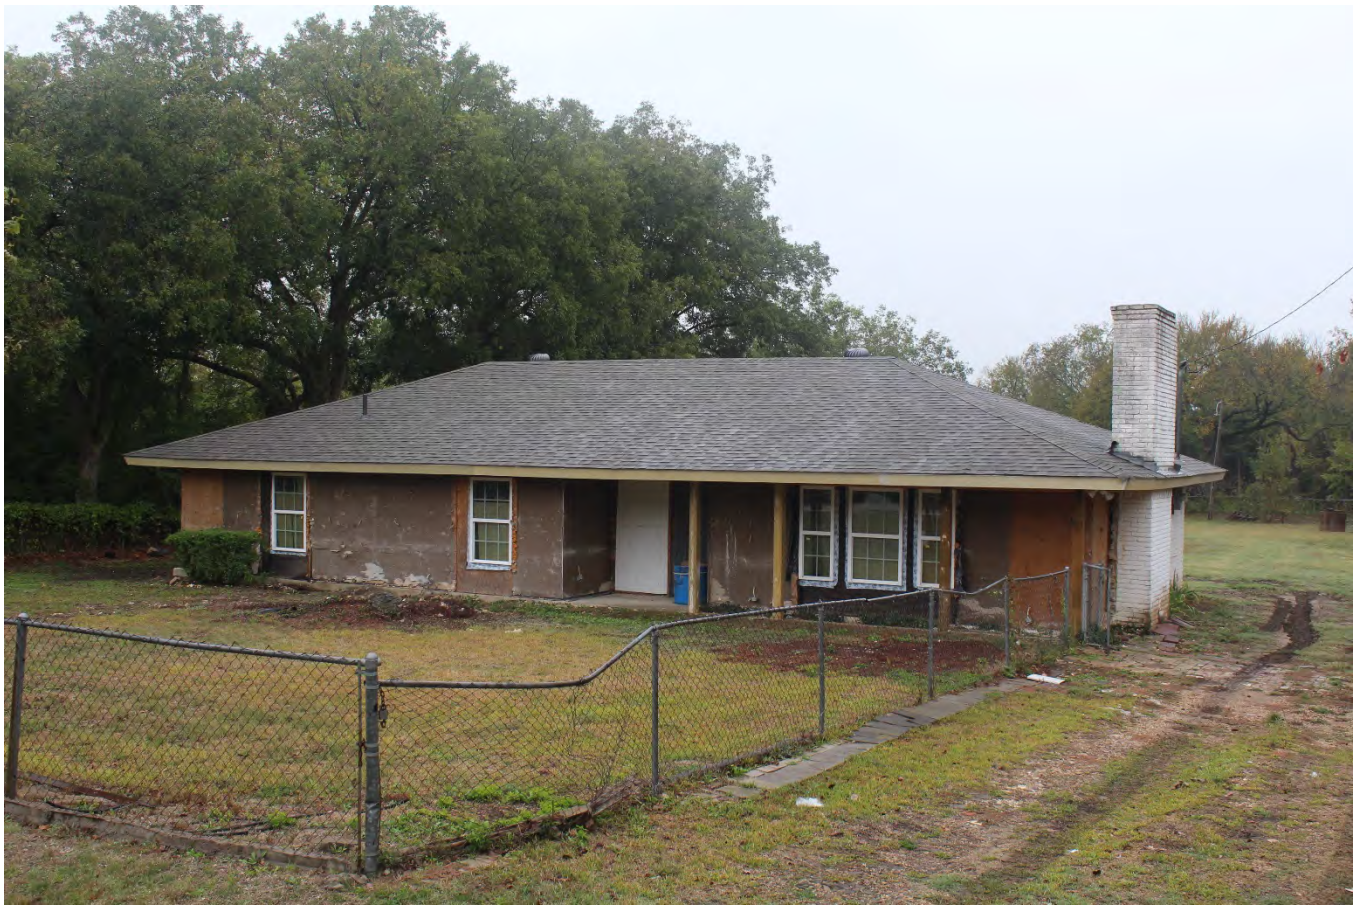
Camera facing southeast.

| Integrity/Comments: | A highly renovated Ranch style house with a shallow-pitch, hip roof with generous eaves, removed siding, a partial-width porch, replacement windows, and an exterior chimney. |

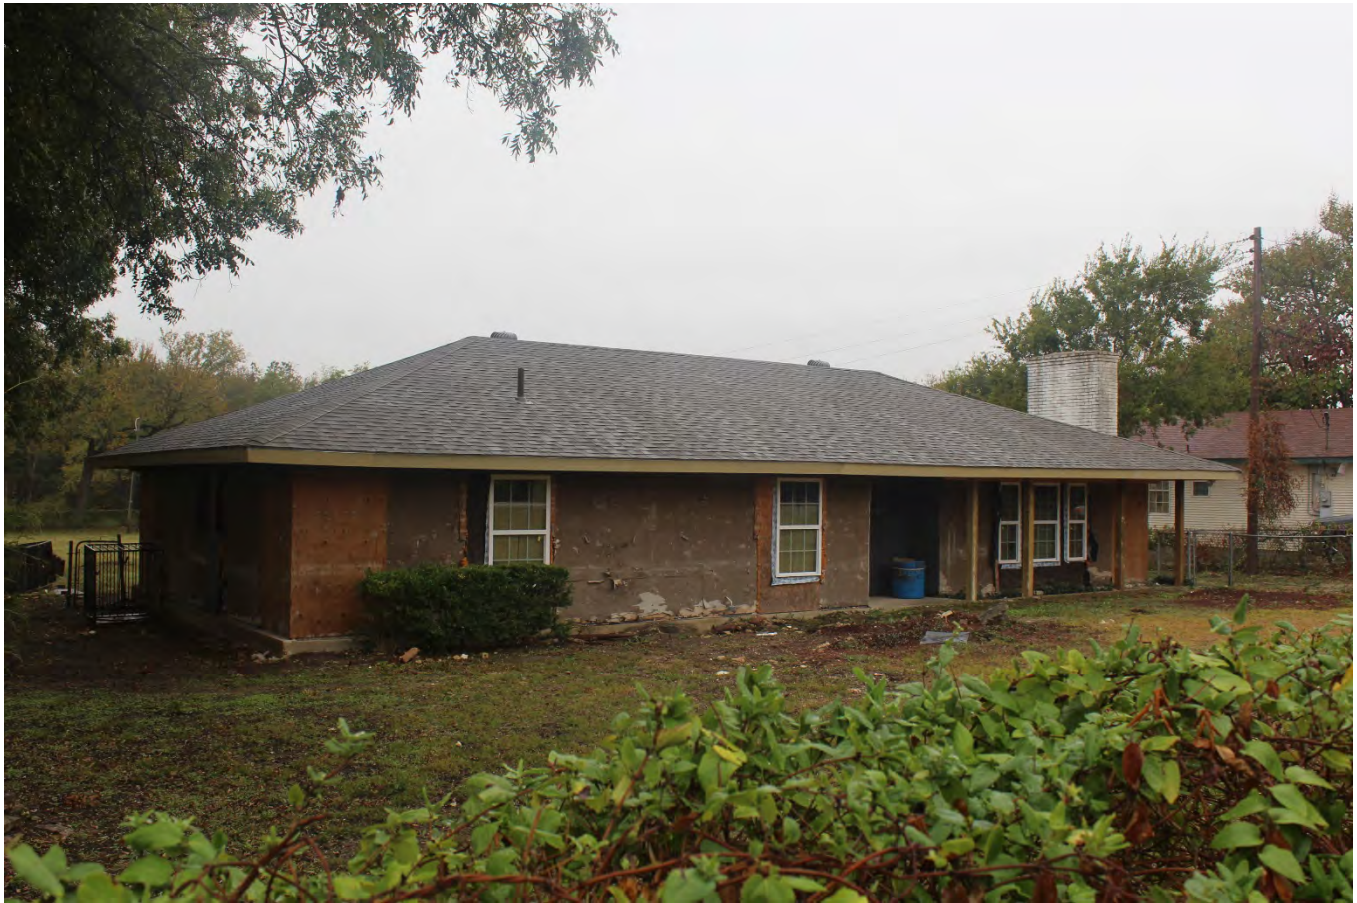
Camera facing southwest.

| Integrity/Comments: | A highly renovated Ranch style house with a shallow-pitch, hip roof with generous eaves, removed siding, a partial-width porch, replacement windows, and an exterior chimney. |

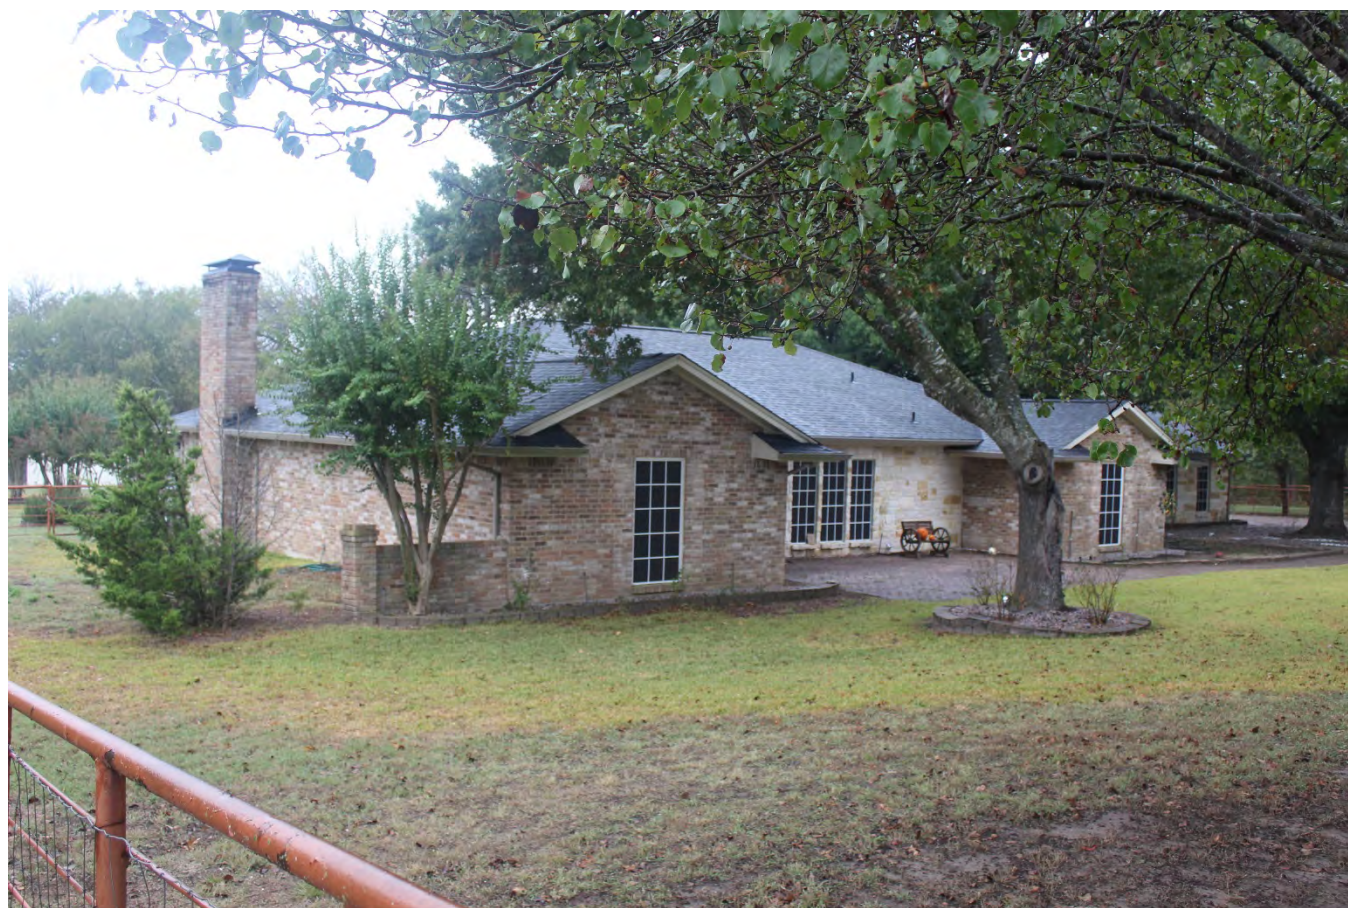
Camera facing southwest.

| Integrity/Comments: | A highly renovated Ranch style house (subtype: courtyard) with shallow-pitch, cross-gable roofs, brick and stone siding, replacement windows, a decorative brick half wall extending from the northeast corner of the house, and an exterior chimney. An addition of an integrated garage extends from the west façade of the original footprint of the house. |

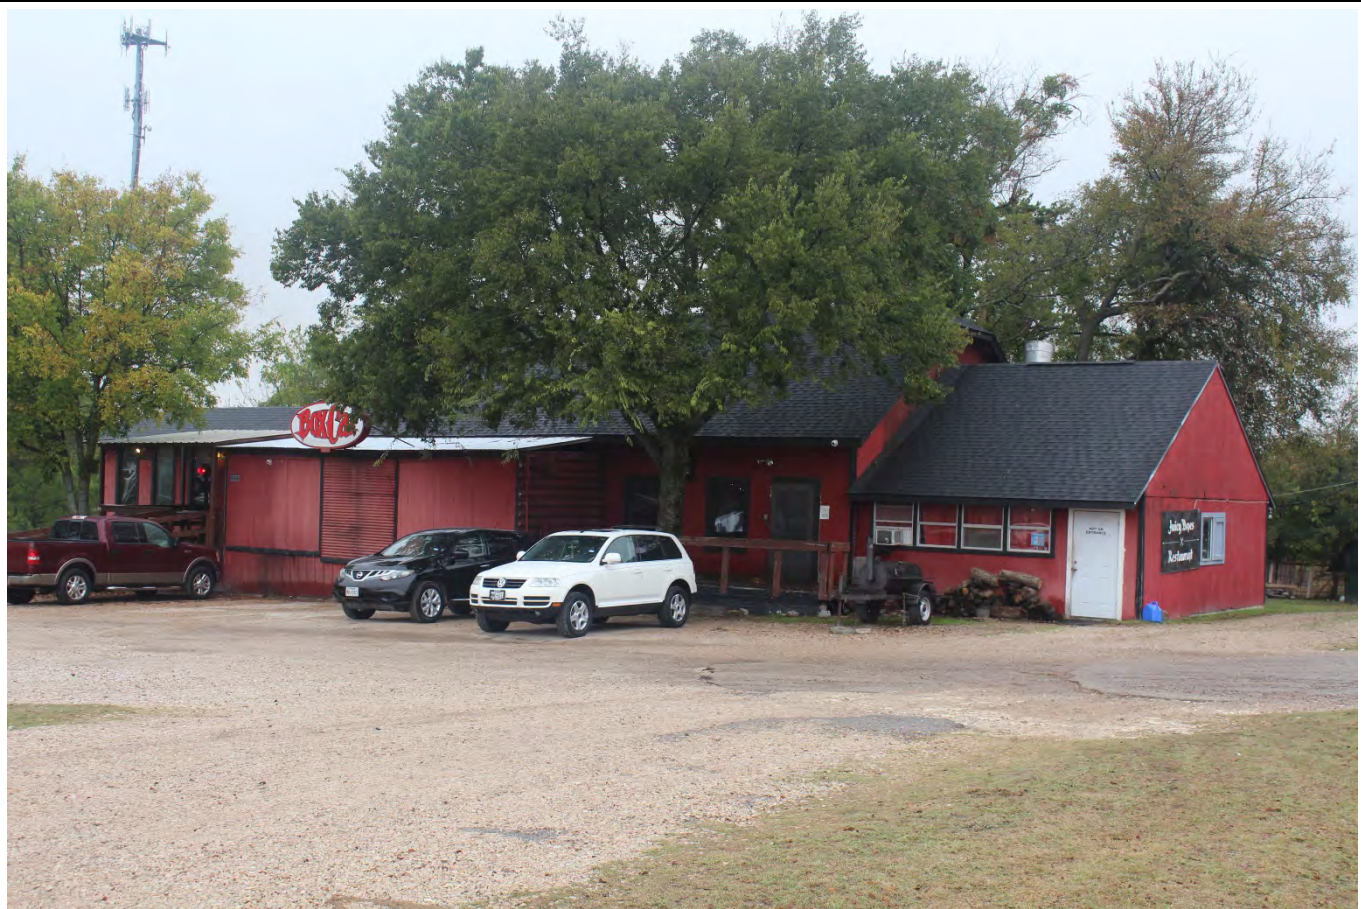
Camera facing southwest.

| Integrity/Comments: | A former ranch style house with a complex roof system consisting of steep side-gable roofs, two metal shed roofs, and a shallow-pitch, side-gable roof. The building features wood panel siding, an open porch with a metal shed roof, and replacement windows. Currently occupied by Juicy Bones Restaurant at BoxCar. |

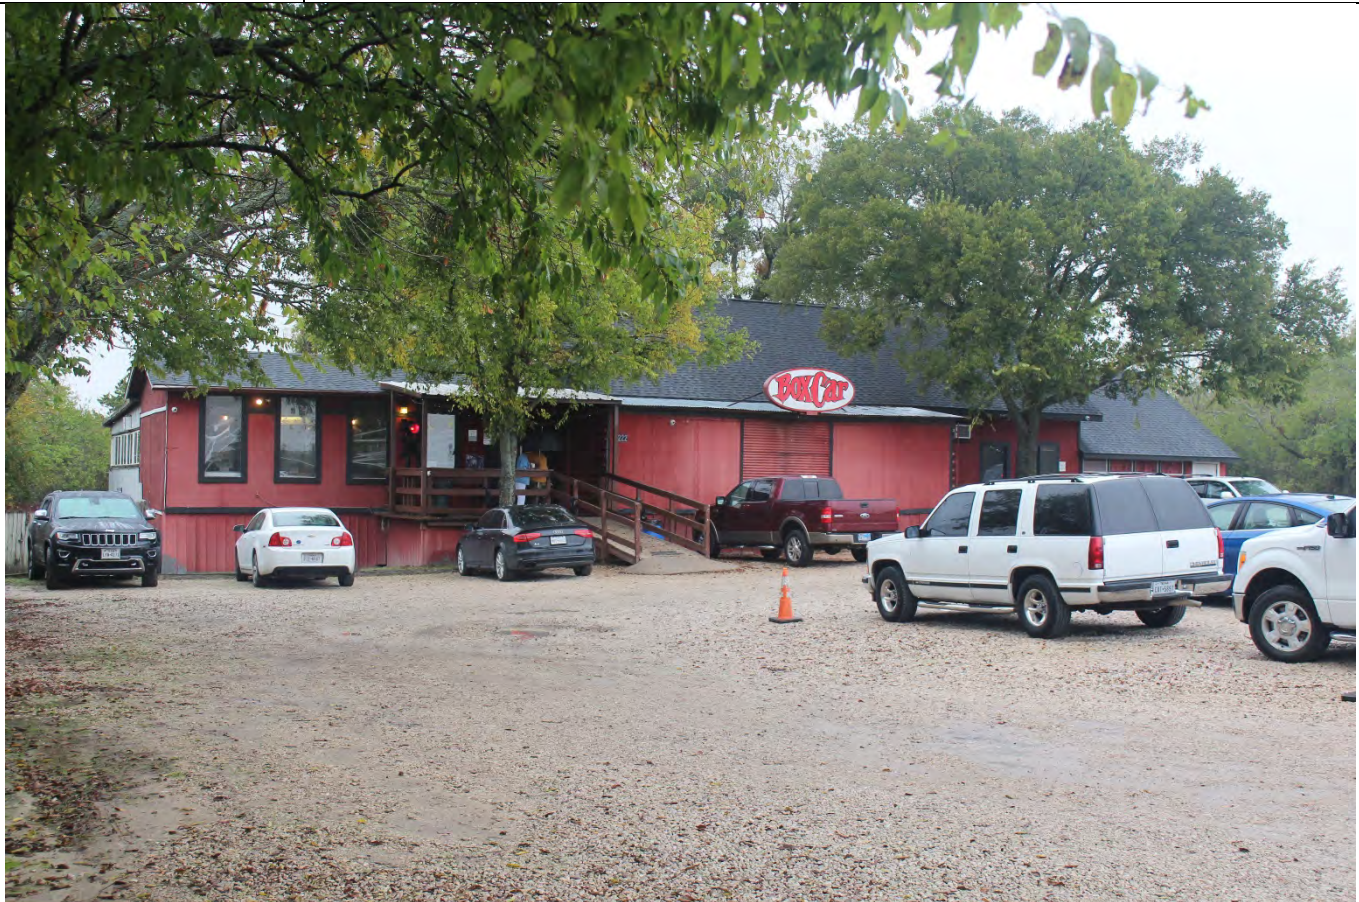
Camera facing northwest.

| Integrity/Comments: | A former ranch style house with a complex roof system consisting of steep side-gable roofs, two metal shed roofs, and a shallow-pitch, side-gable roof. The building features wood panel siding, an open porch with a metal shed roof, and replacement windows. Currently occupied by Juicy Bones Restaurant at BoxCar. |
