Appendix I – Historical Resources Survey Report

MEMO

District: Dallas
County: Dallas, Ellis
CSJ#: 2964-10-006
Highway: SL 9, Segment A
Project Limits: US 67 to IH 34
Let Date: December 2023

SUBJECT: Internal review under the Section 106 Programmatic Agreement (Section 106 PA) among the Texas Department of Transportation, Texas State Historic Preservation Officer, Advisory Council on Historic Preservation, and Federal Highway Administration; and the Memorandum of Understanding (MOU) between the Texas Historical Commission and the Texas Department of Transportation

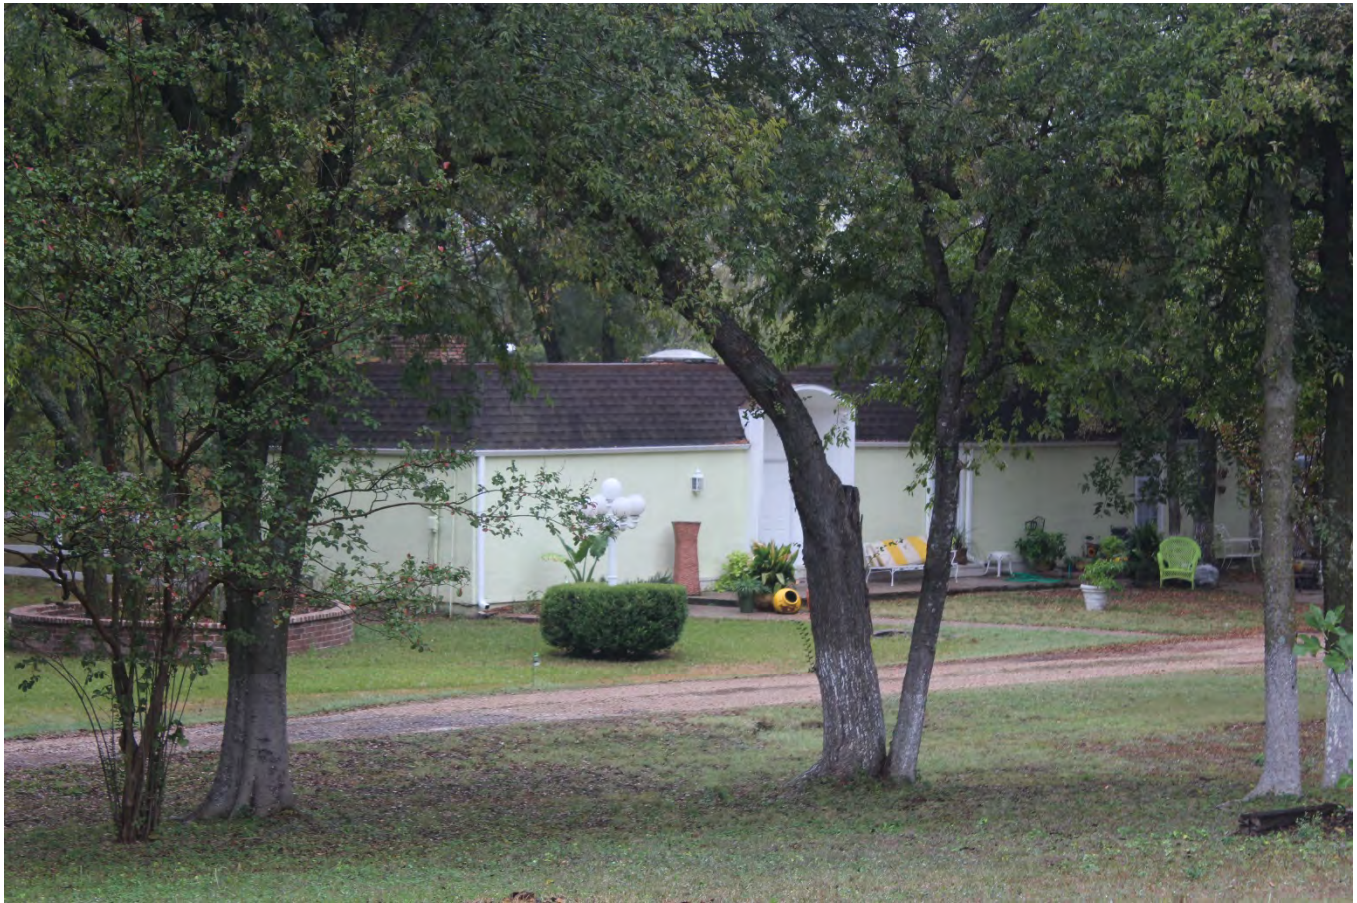
Camera facing southwest.

| Integrity/Comments: | Ranch style house with mansard roof, stucco siding, replacement windows, and an arched projection emphasizing the recessed main entry. |

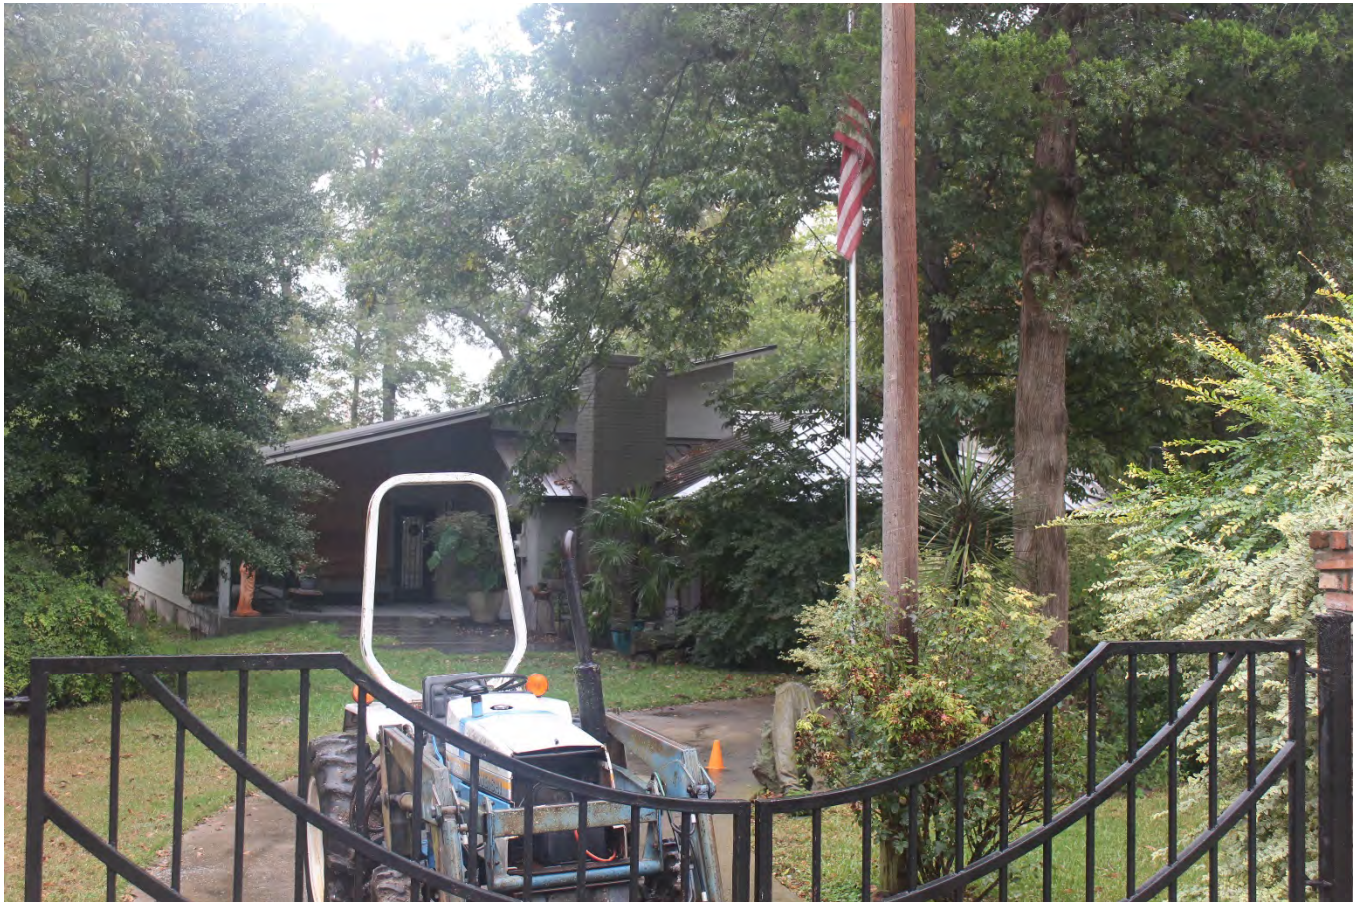
Camera facing southeast.

| Integrity/Comments: | Contemporary Ranch style house with metal shed roof, hip roof, stucco siding, replacement fixed windows, and an exterior brick chimney. |

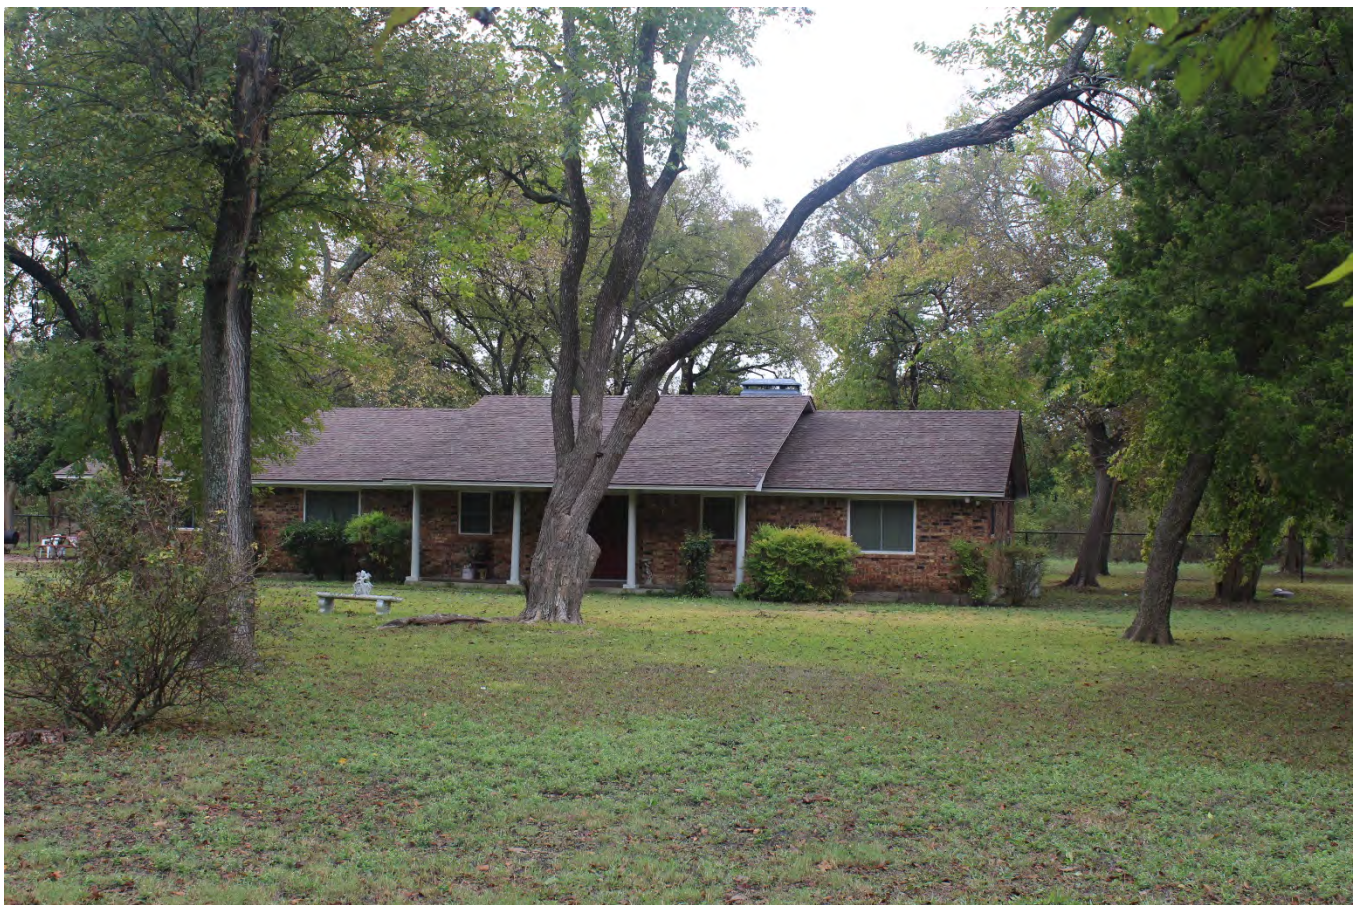
Camera facing southeast.

| Integrity/Comments: | Ranch style house with shallow-pitch, side-gable roofs with generous eaves, polychrome brick siding, cedar shake siding on gable ends, replacement windows, a partial-width porch supported by classical columns, and a rear slope chimney. An enclosed, integrated garage is located on the east façade. |

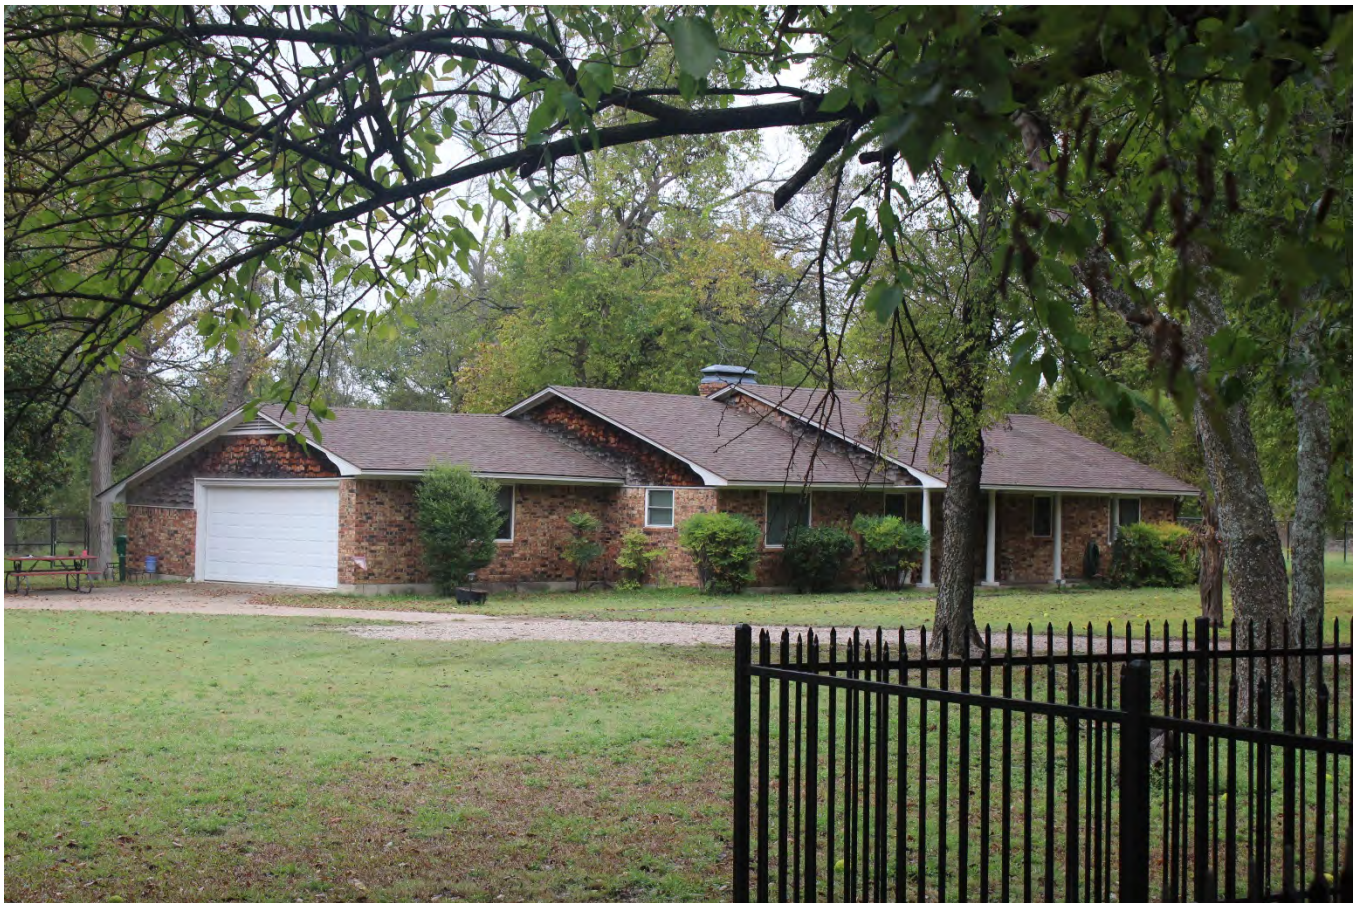
Camera facing southwest.

| Integrity/Comments: | Ranch style house with shallow-pitch, side-gable roofs with generous eaves, polychrome brick siding, cedar shake siding on gable ends, replacement windows, a partial-width porch supported by classical columns, and a rear slope chimney. An enclosed, integrated garage is located on the east façade. |

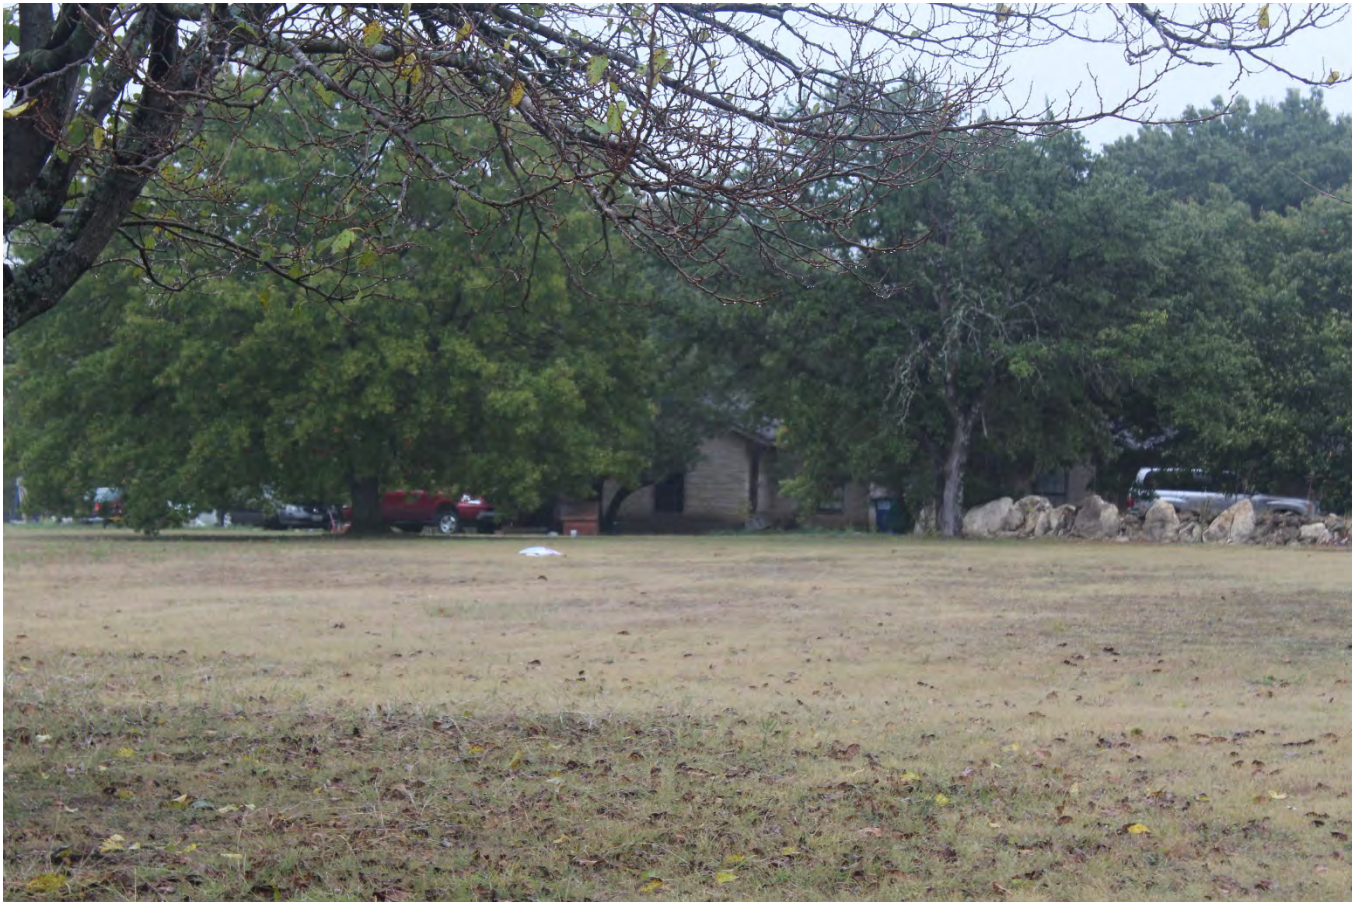
Camera facing east.

| Integrity/Comments: | Ranch style house with cross-gable roof, stone façade, and replacement windows. There appear to be decorative brick or stone quoins at the corners of the house. |

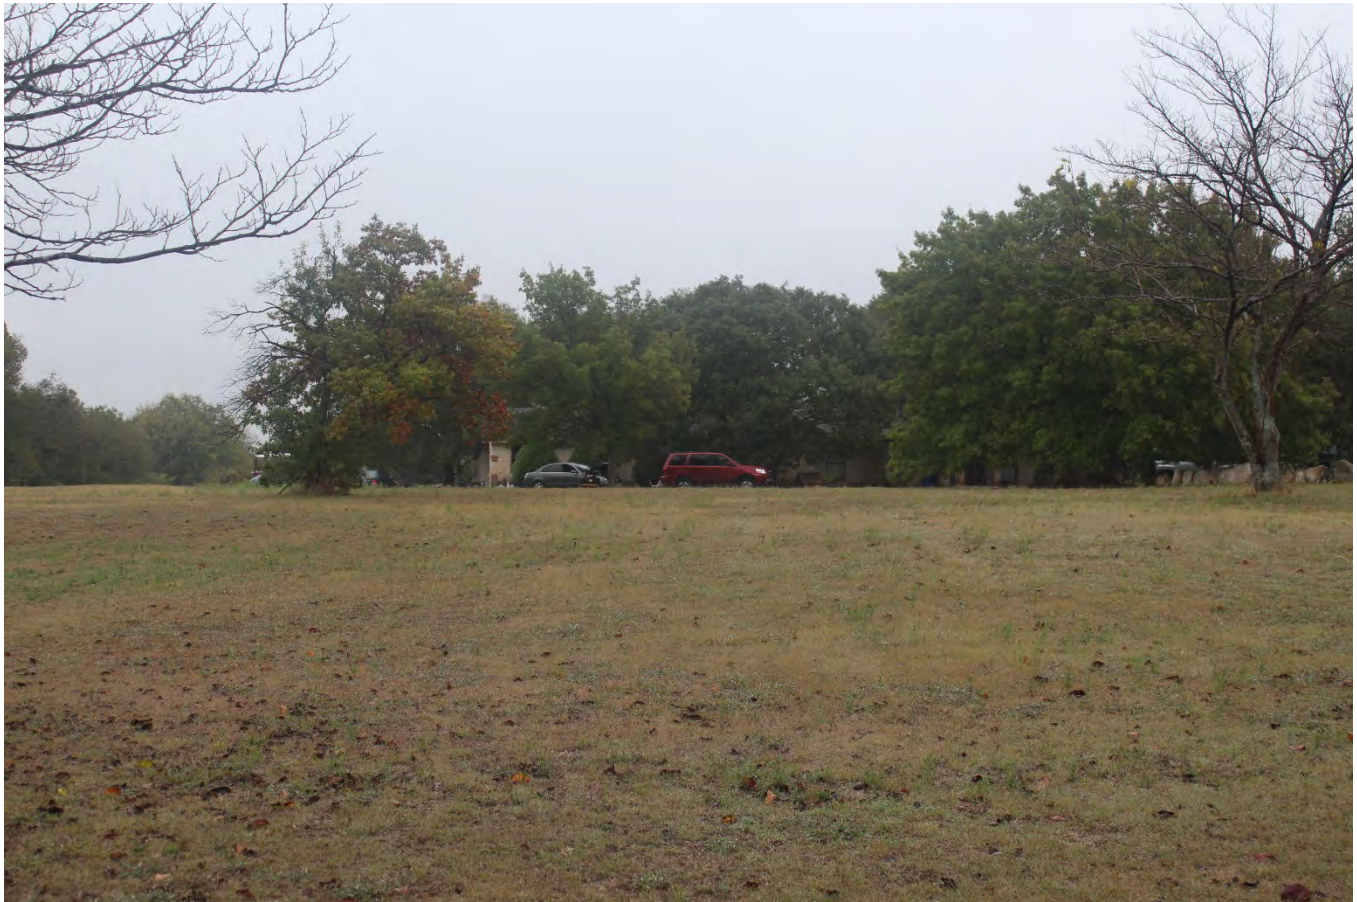
Camera facing east.

| Integrity/Comments: | Ranch style house with cross-gable roof, stone façade, and replacement windows. There appear to be decorative brick or stone quoins at the corners of the house. |

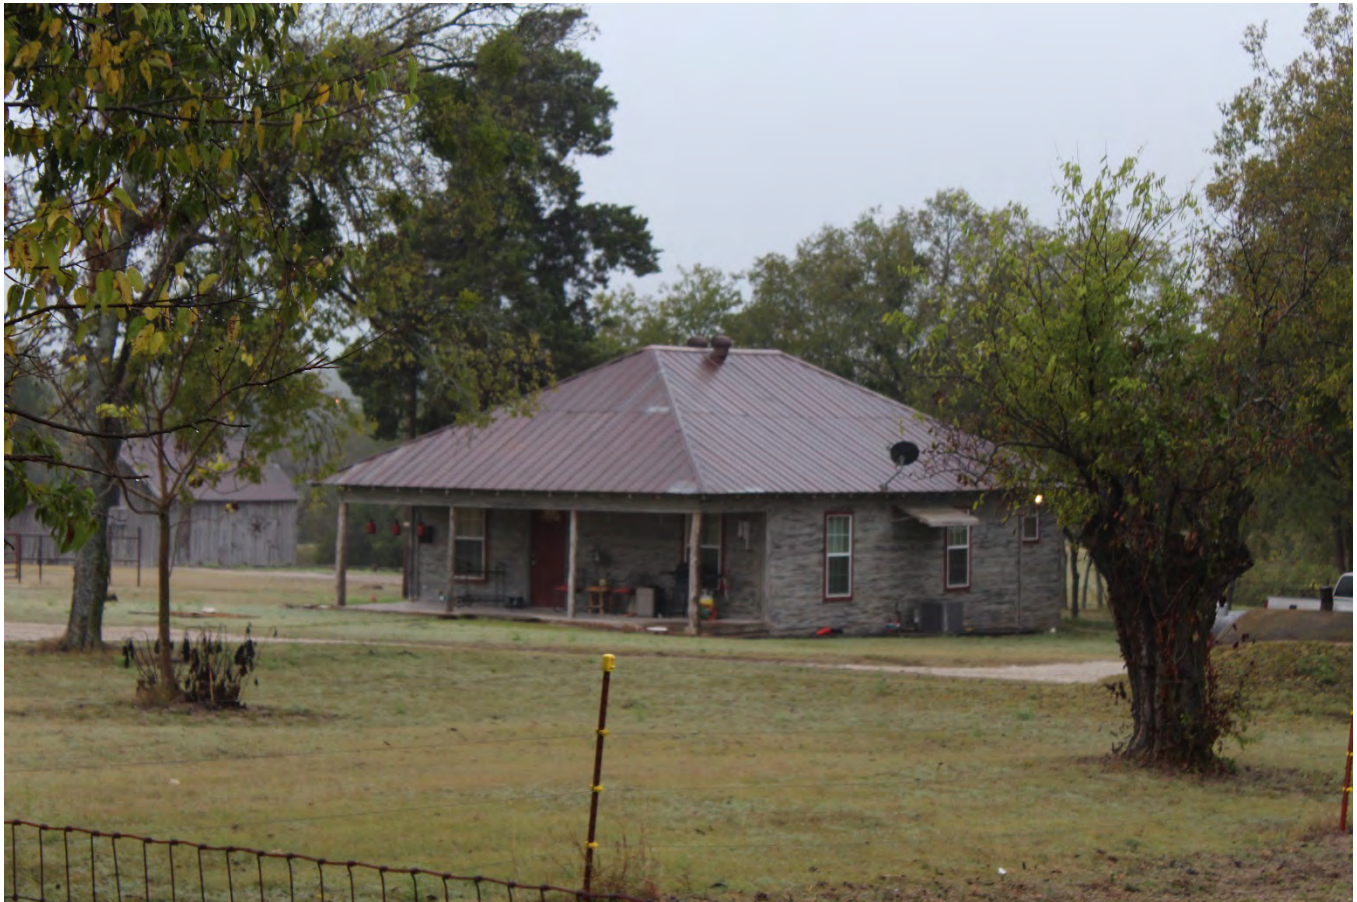
Camera facing southwest.

| Integrity/Comments: | Craftsman style house with a metal hip roof, exposed rafter tails, replacement siding, a full-width porch featuring rustic wood supports, and replacement windows. |

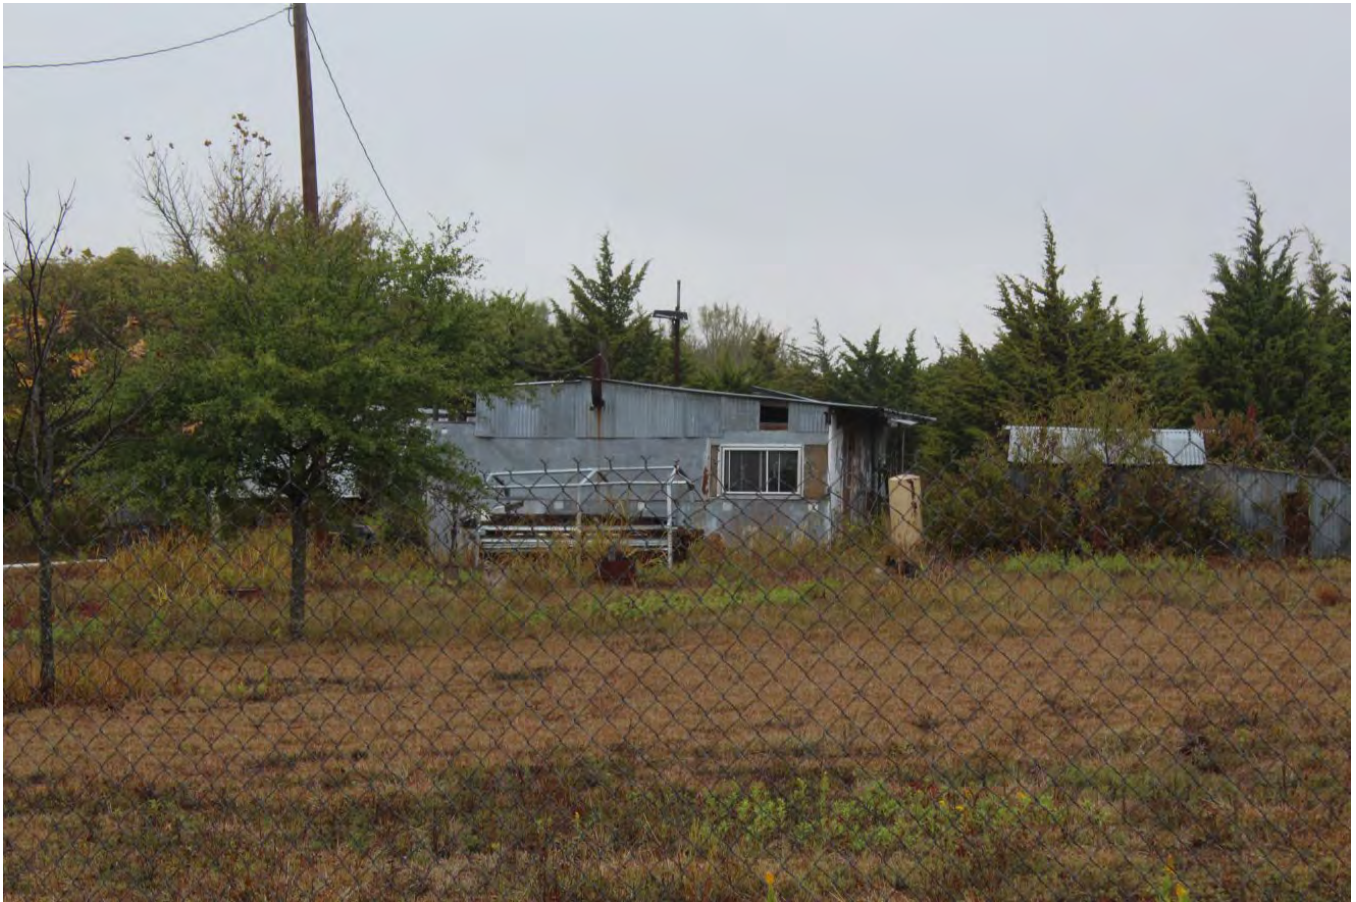
Camera facing west.

| Integrity/Comments: | Resource 70a is a metal building with a shallow-pitch, side-gable metal roof, metal siding, and replacement windows. |
