APPENDIX L: Cultural Resources

APPENDIX L – CULTURAL RESOURCES – FEIS Preferred Alternative/Blue Alternative

US 380 MCKINNEY – Coit Road to FM 1827, Collin County CSJs 0135-02-065 and 0135-15-002; Dallas District

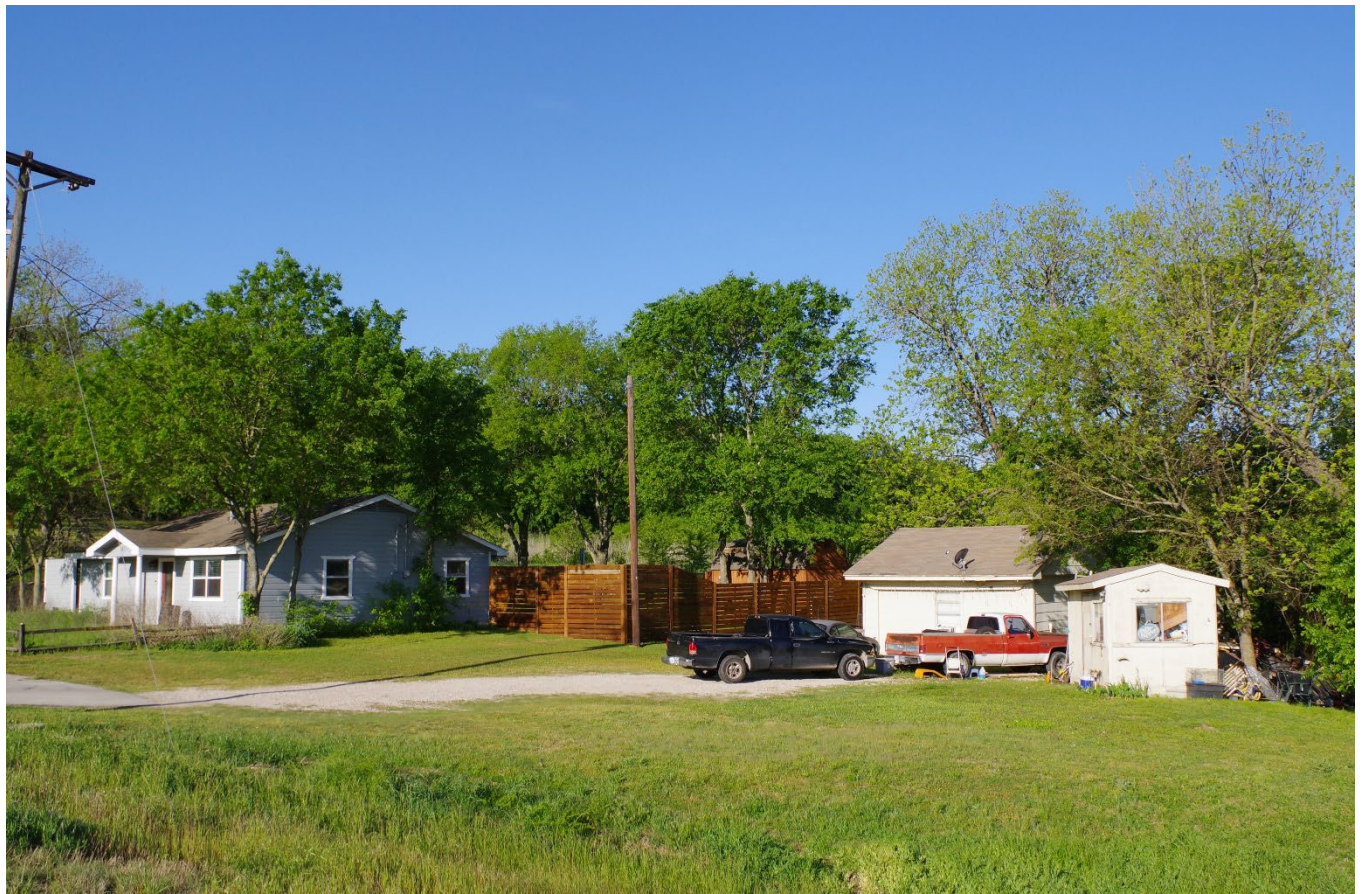
4177 N. McDonald Street - The residential property at 4177 N. McDonald Street includes a ca. 1965 Minimal Traditional-style dwelling, a ca. 1975 former garage outbuilding, and a small ca. 1980 gabled outbuilding or shed (Attachment A: Figure 1; Attachment B; Attachment C: Photographs 1-3). Historic period aerial imagery depicts the dwelling on site by 1968, and although not entirely clear, imagery appears to depict the garage and outbuilding by 1981 (NETR 2023). The dwelling features a side-gabled asphalt shingle roof, wood siding, replacement vinyl windows, and a small gabled front stoop with simple column supports. The former garage features a side-gabled asphalt shingle roof, asbestos siding, and enclosure of the two-car garage bay with wood siding and an aluminum window. The adjacent shed features a side-gabled roof, plywood siding, and aluminum horizontal sash windows.

Alterations in the form of replacement vinyl windows on the dwelling and enclosure of the former garage with wood siding and a window have undermined the resources' integrity of materials, workmanship, and feeling. Although the shed outbuilding retains fair integrity, all of the resources lack design distinction, architectural merit, or known associations of historical significance. Therefore, the property is recommended not eligible for NRHP inclusion due to lack of integrity or significance.

Overview of dwelling, former garage, and outbuilding/shed, camera facing southwest (May 2021)

The updated schematic indicates an area of newly proposed ROW acquisition for proposed improvements to N. McDonald Street at its junction with the proposed US 380 McKinney Project. A small portion of the ROW acquisition includes an undeveloped section of the subject parcel at the northeast edge of the property. No physical effects to the individual resources are anticipated, and as the resources are recommended not-eligible for NRHP inclusion, no further consideration of effects to the resources is recommended in relation to the proposed Project.

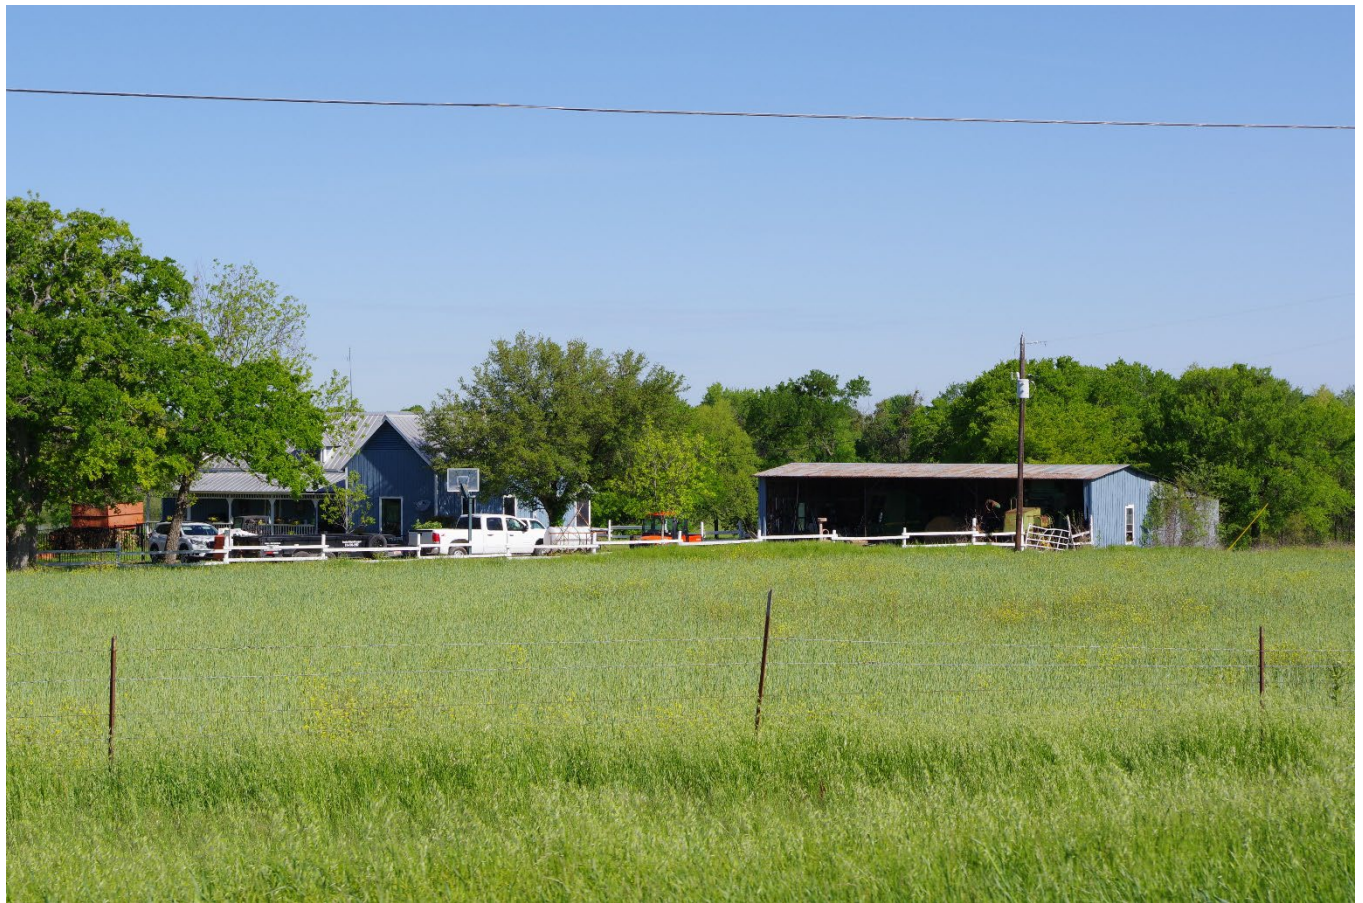
The L-shaped dwelling features a cross-gabled replacement metal roof with a small dormer addition; replacement vertical wood siding; and a shed-roof porch across the façade with chamfered square supports, decorative brackets, and a simple railing. Windows appear to be modern replacements, and the projecting front ell includes a former window opening that has been converted into an entrance. Additional details were not discernable from the ROW due to setback and intervening vegetation. The barn, located south of the dwelling, features a front-gabled corrugated metal roof, vertical wood siding, a large central entrance bay, and shed-roof side additions of open stalls and an equipment bay that are of historic-age. The west side of the barn includes a non-historic-age open, flat-roofed projection enclosed with a metal fence. A non-historic-age metal fenced corral adjoins the east side of the barn. A wood rail fence spans both sides of the entrance drive near the dwelling. The property appears to remain in active agricultural use as pasturage.

Extensive alterations to the dwelling in the form of replacement roofing, siding, and windows, and the incorporation of an entrance from a former window on the façade have undermined the integrity of original design, materials, workmanship, and feeling. The non-historic-age westside projection and eastside corral additions to the barn have undermined its integrity of design, materials, and workmanship. The resources lack design distinction or known associations of historical significance, and the loss of former agricultural outbuildings visible in 1956 aerial imagery has further undermined the integrity of the property as an intact historic-age agricultural complex. Therefore, the property is recommended not eligible for NRHP inclusion due to lack of integrity or significance.

Overview of dwelling and non-historic-age shed outbuilding, camera facing northwest (April 2023).

The updated schematic indicates the need for additional proposed ROW and improvements to a portion of FM 2933 immediately south of the subject property. Although no ROW acquisition is currently proposed of the variable non-physical or visual APE. The property and individual historic-age resources would not be physically affected by the proposed Project, effects to the resources is recommended in relation to the proposed Project.

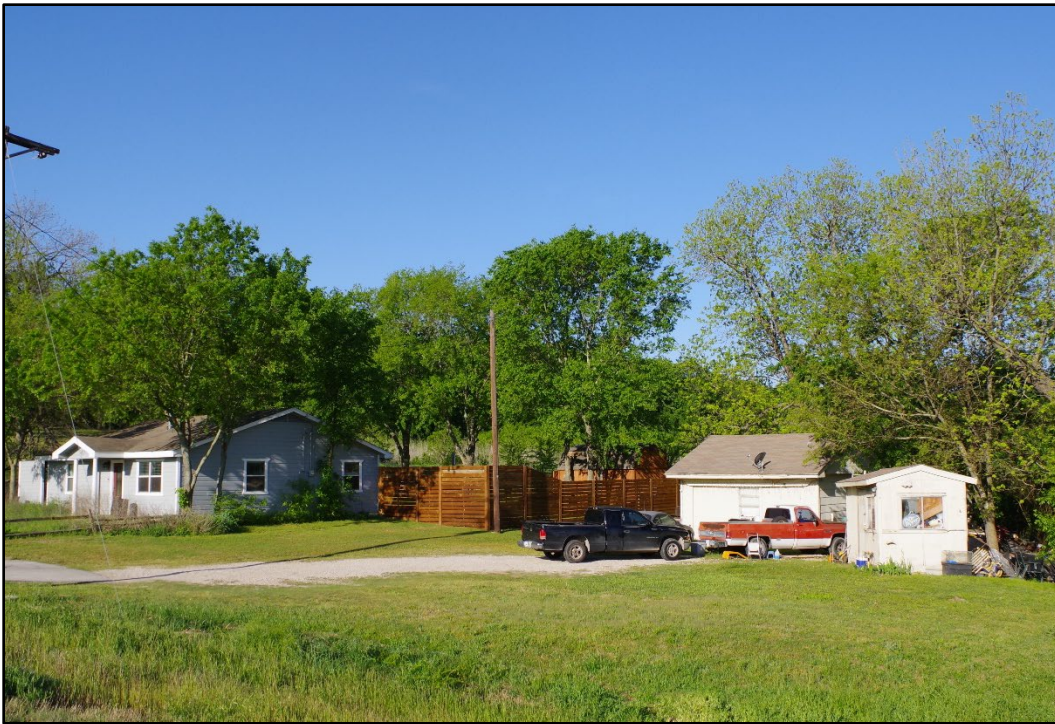
Photograph 1: Overview of 4177 N. McDonald St., camera facing southwest (May 2021).

Survey Date:	04/19/2023
Project Location:	McKinney, Collin County, Texas
Project Name and CSJ:	US 380 from Coit Road to FM 1827; CSJs: 0135-02-065, 0135-15-002, 0135-03-053
Address, Lat/Long:	4177 N. McDonald Street, McKinney, Texas; 33.24085/-96.61033
Function/Sub-function:	Residential
Construction Date:	ca. 1965
NRHP Eligibility:	Not eligible
Integrity/Comments:	Residential property with a ca. 1965 Minimal Traditional-style dwelling, a ca. 1975 former garage outbuilding, and a small ca. 1980 gabled outbuilding or shed. Alterations to the dwelling include replacement vinyl windows. Alterations to the garage include enclosure of the former two-car bay. The resources lack integrity, design distinction, architectural merit, or known associations of historical significance.

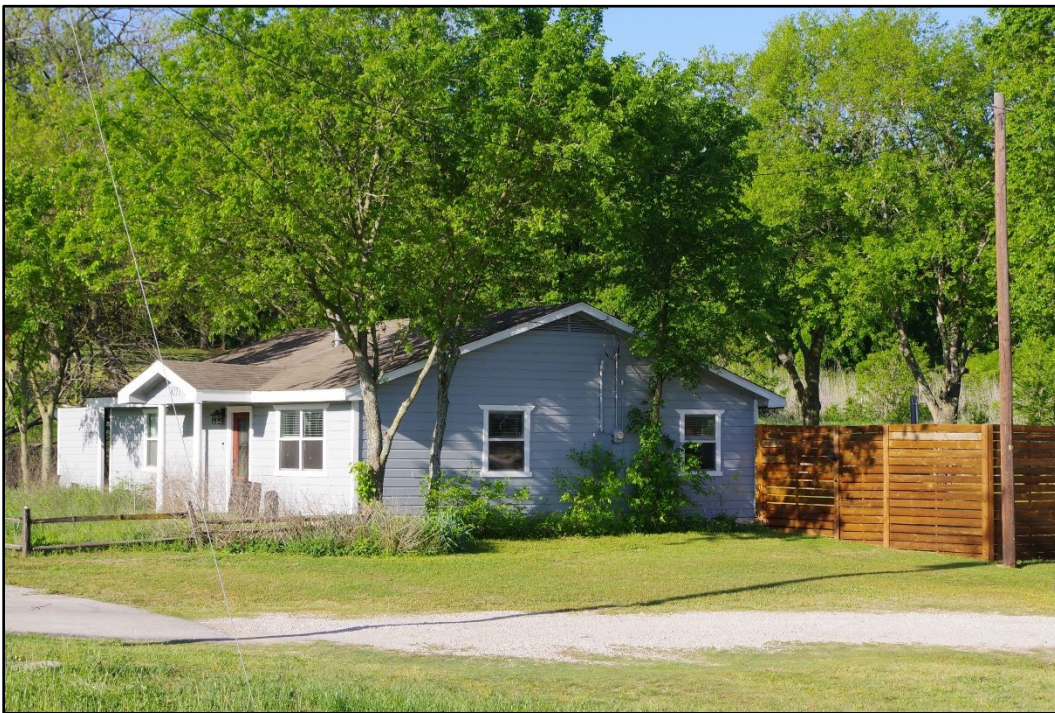
Photograph 2: View of 4177 N. McDonald St. dwelling, camera facing southwest (May 2021).

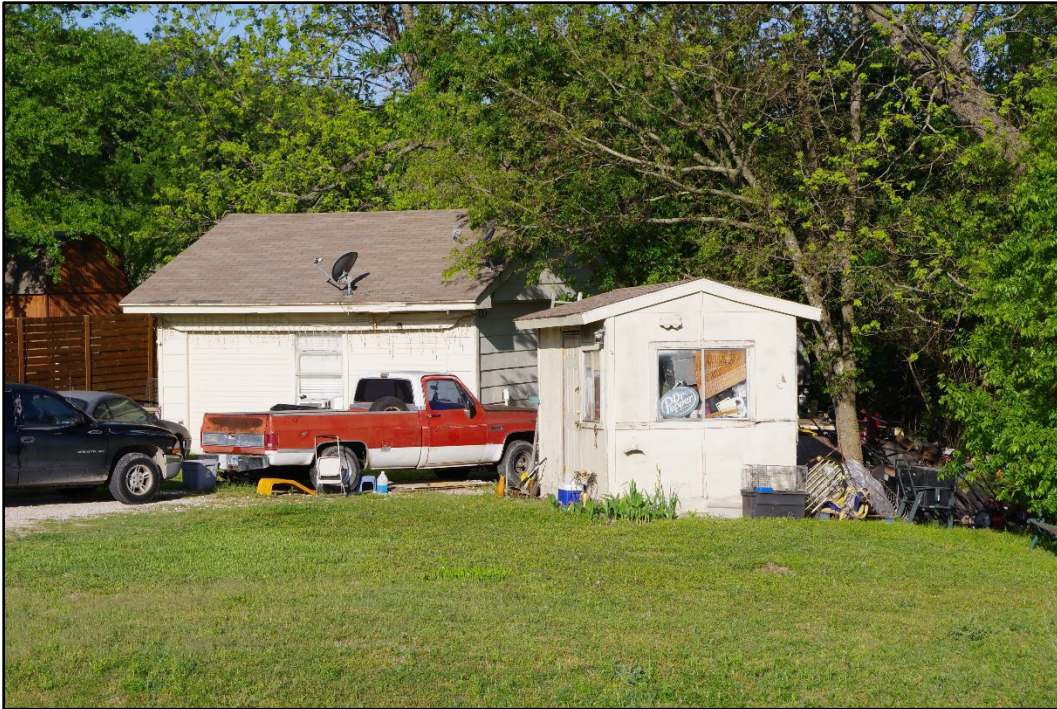
Photograph 3: View of 4177 N. McDonald St. former garage and outbuilding/shed, camera facing west (May 2021).

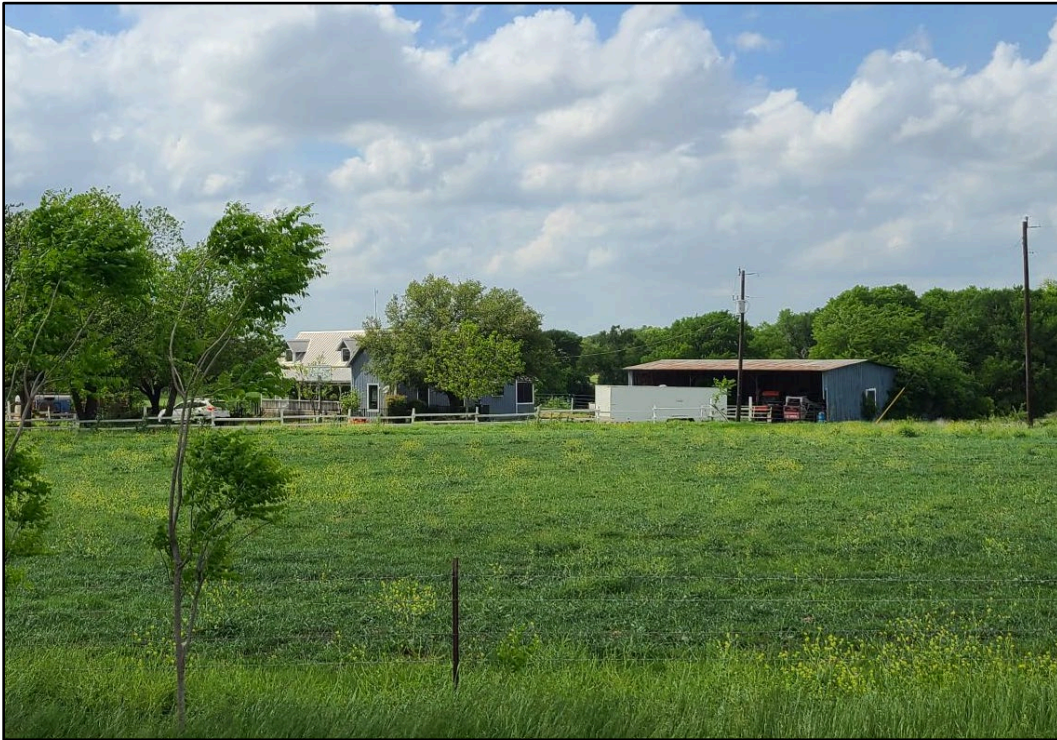
Photograph 4: Overview of 3187 FM 2933, dwelling and non-historic-age shed outbuilding, camera facing west (April 2023).

Survey Date:	04/19/2023
Project Location:	McKinney, Collin County, Texas
Project Name and CSJ:	US 380 from Coit Road to FM 1827; CSJs: 0135-02-065, 0135-15-002, 0135-03-053
Address, Lat/Long:	3187 FM 2933, McKinney, Texas; 33.23120/-96.57865
Function/Sub-function:	Residential/agricultural
Construction Date:	ca. 1900 / ca. 1960
NRHP Eligibility:	Not eligible
Integrity/Comments:	Agricultural property includes a highly-altered ca. 1900 Folk Victorian-style dwelling, a ca. 1960 barn, and a non-historic-age shed outbuilding. Alterations to the dwelling include replacement roofing, siding, and windows, and the incorporation of an entrance from a former window on the façade. Alterations to the barn include a non-historic-age westside projection and eastside corral additions. The resources no longer retain integrity of design, materials, workmanship, or feeling and lack design distinction or known associations of historical significance. The loss of former agricultural outbuildings visible in 1956 aerial imagery has further undermined the integrity of the property as an intact historic-age agricultural complex.

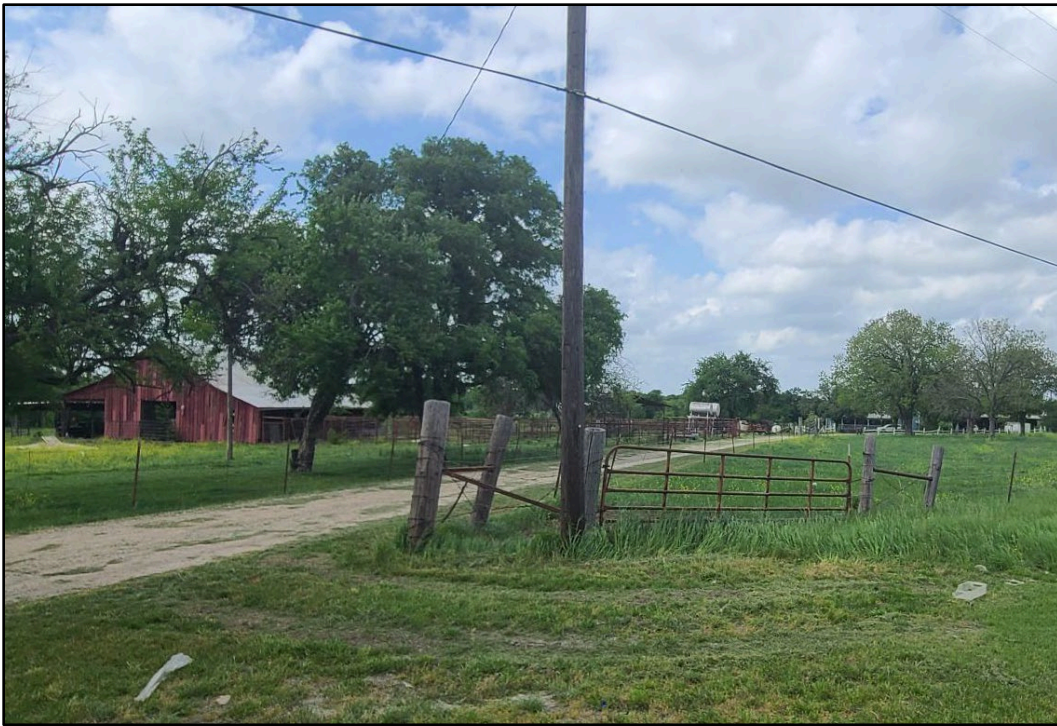
Photograph 5: Overview of 3187 FM 2933 barn (left) and obstructed view of dwelling and non-historic-age shed outbuilding (background, right), camera facing north (April 2023).

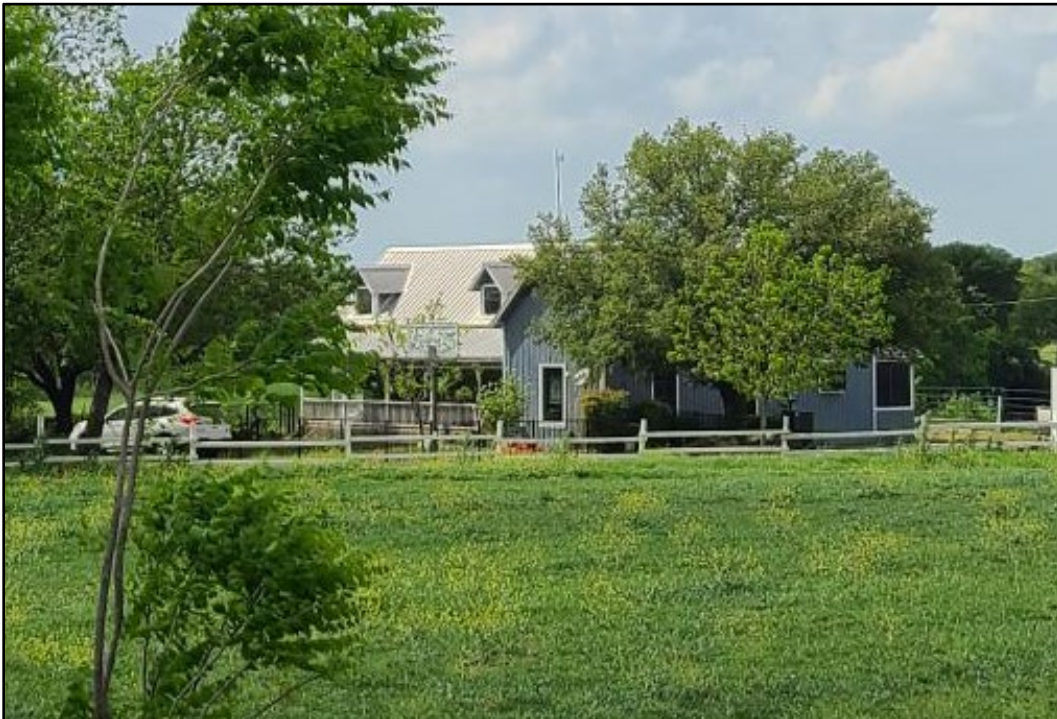
Photograph 6: Obstructed view of 3187 FM 2933 dwelling, camera facing west (April 2023).

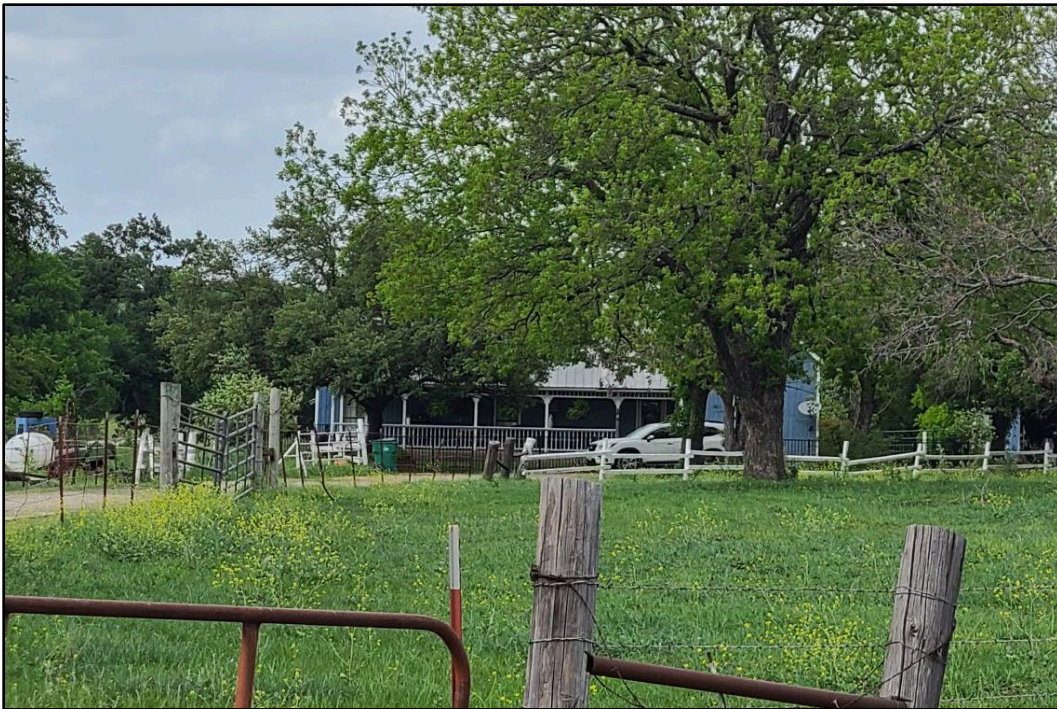
Photograph 7: Obstructed view of 3187 FM 2933 dwelling, camera facing north (April 2023).

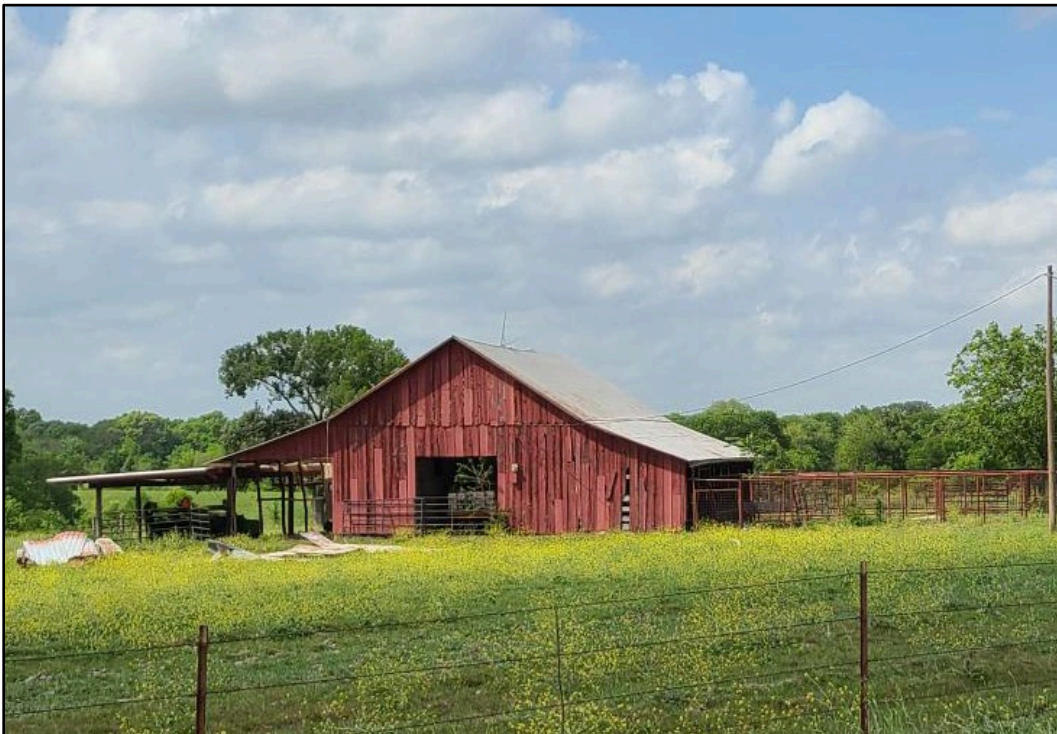
Photograph 8: View of 3187 FM 2933 barn, camera facing north (April 2023).

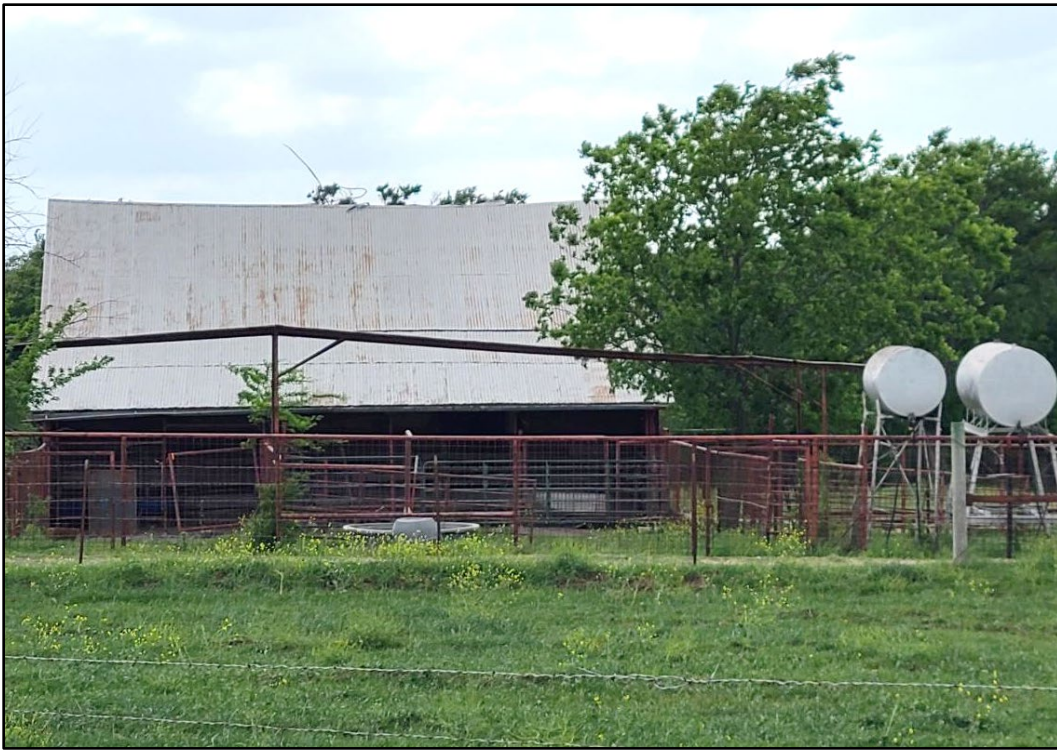
Photograph 9: View of 3187 FM 2933 barn, camera facing west (April 2023).

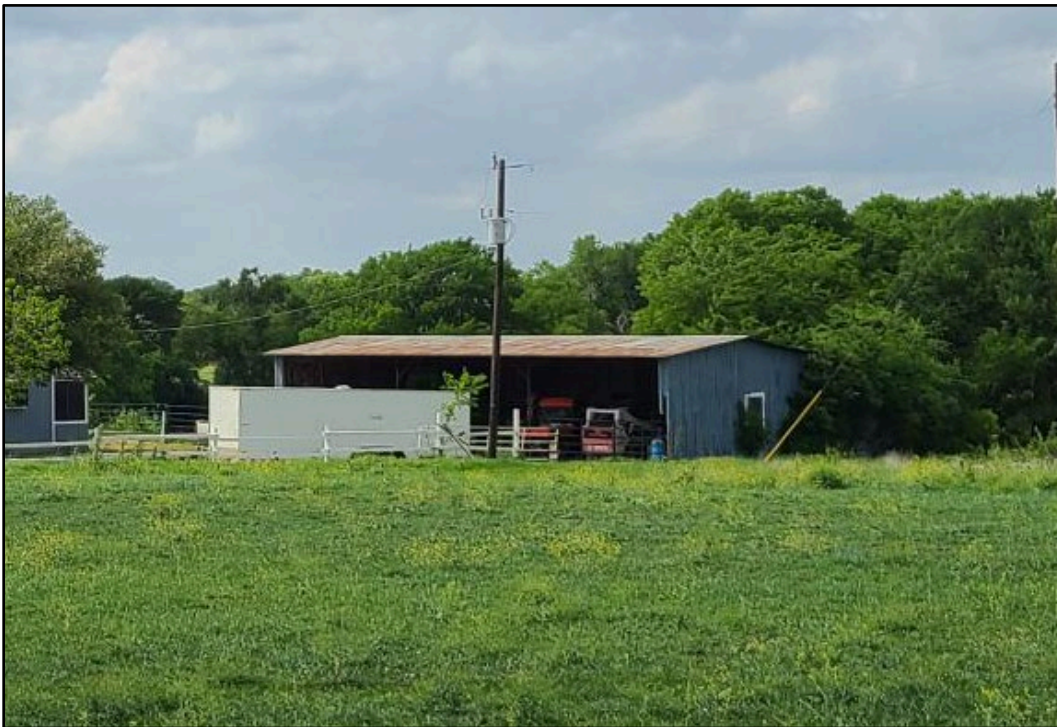
Photograph 10: View of 3187 FM 2933 non-historic-age shed outbuilding, camera facing northwest (April 2023).

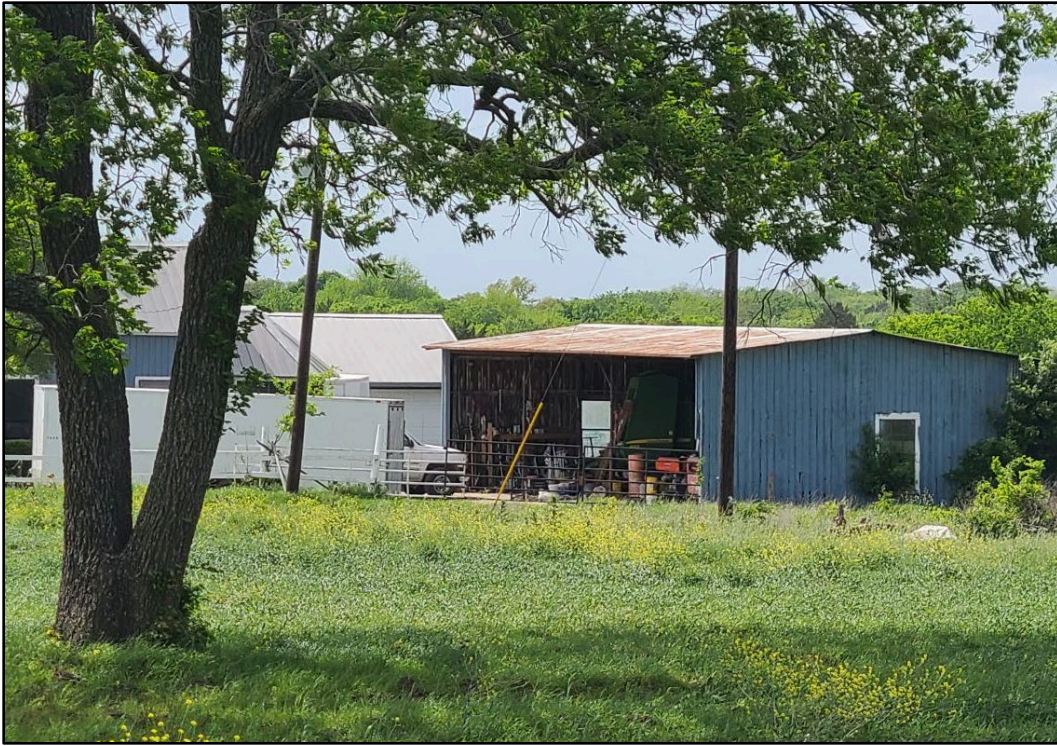
Photograph 11: View of 3187 FM 2933 non-historic-age shed outbuilding, camera facing southwest (April 2023).

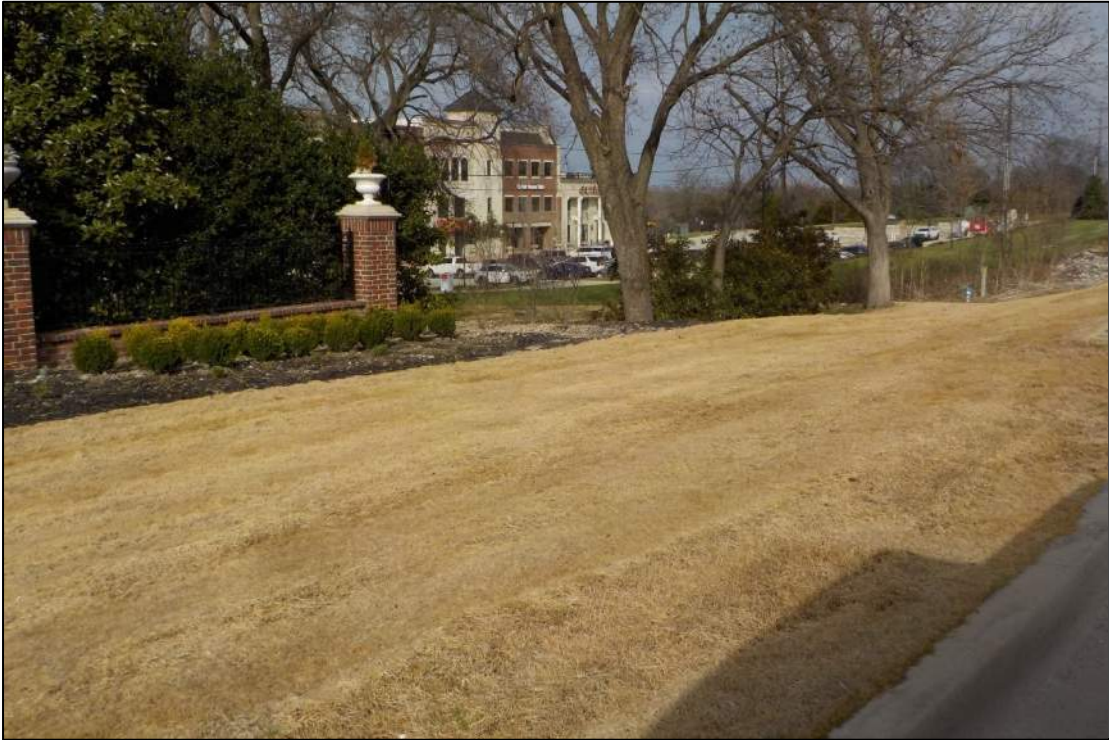
Attachment 15b. Developed ROW along US 380, facing east-at parcel 974271.

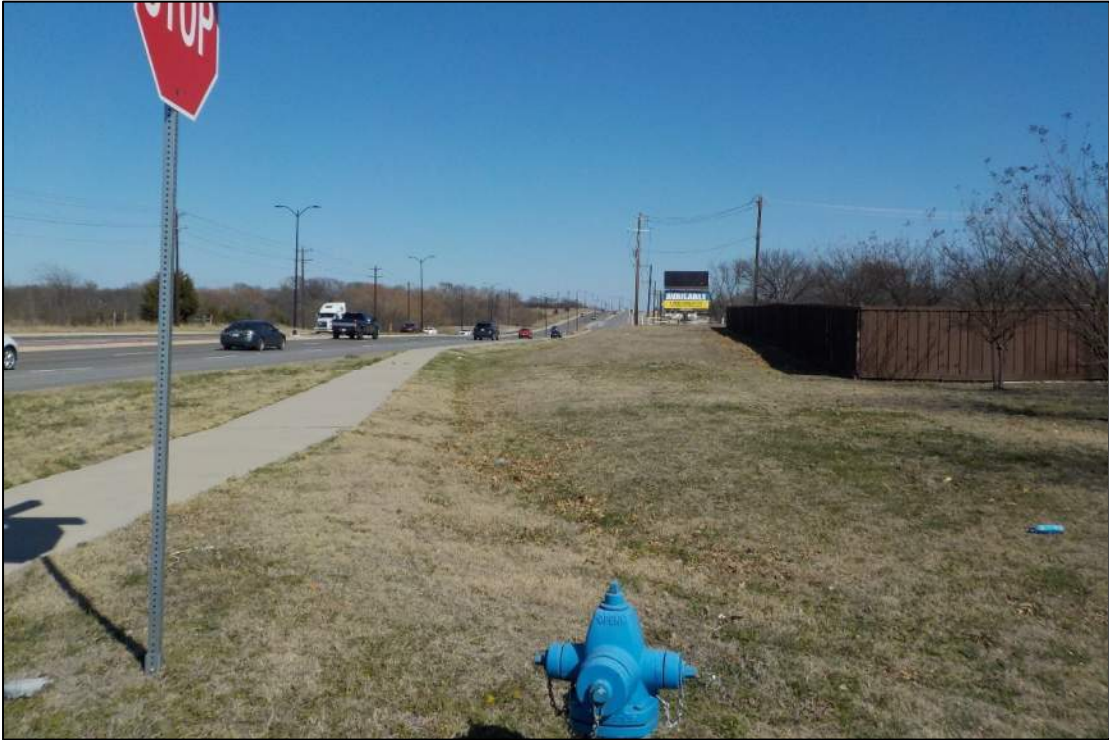
Attachment 15c. Report figures–parcel 1061969 inaccessible due to wetland flooding.

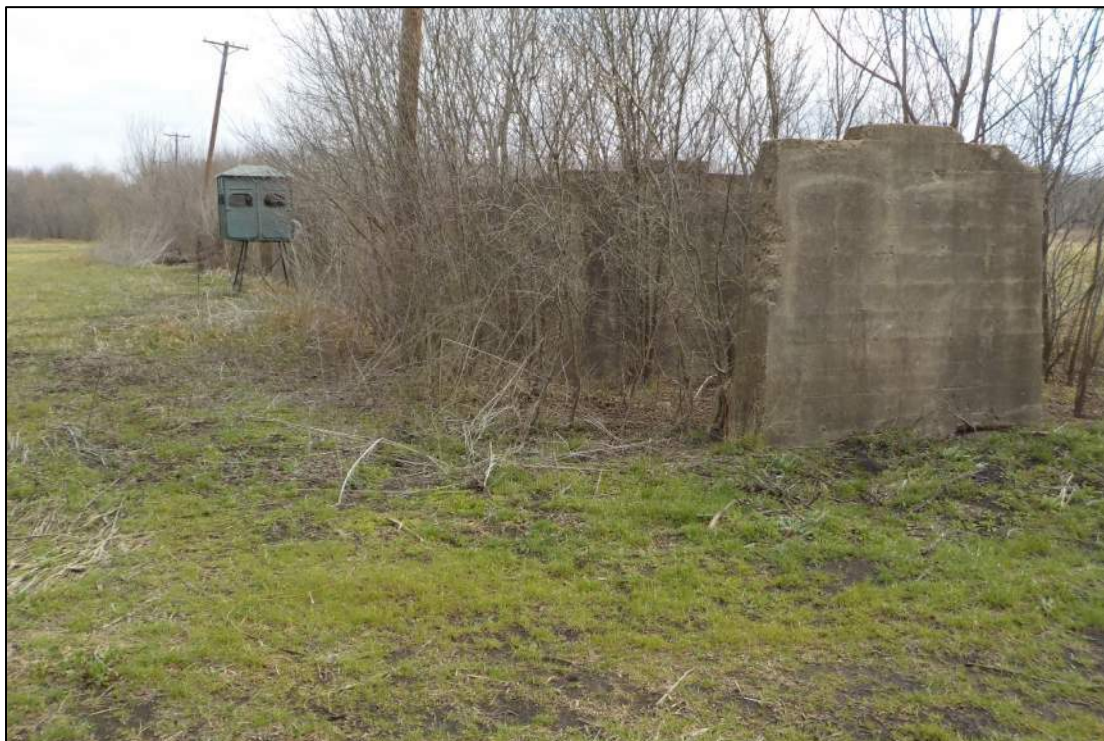
Attachment 15e. Report figures–railroad berm remnants.

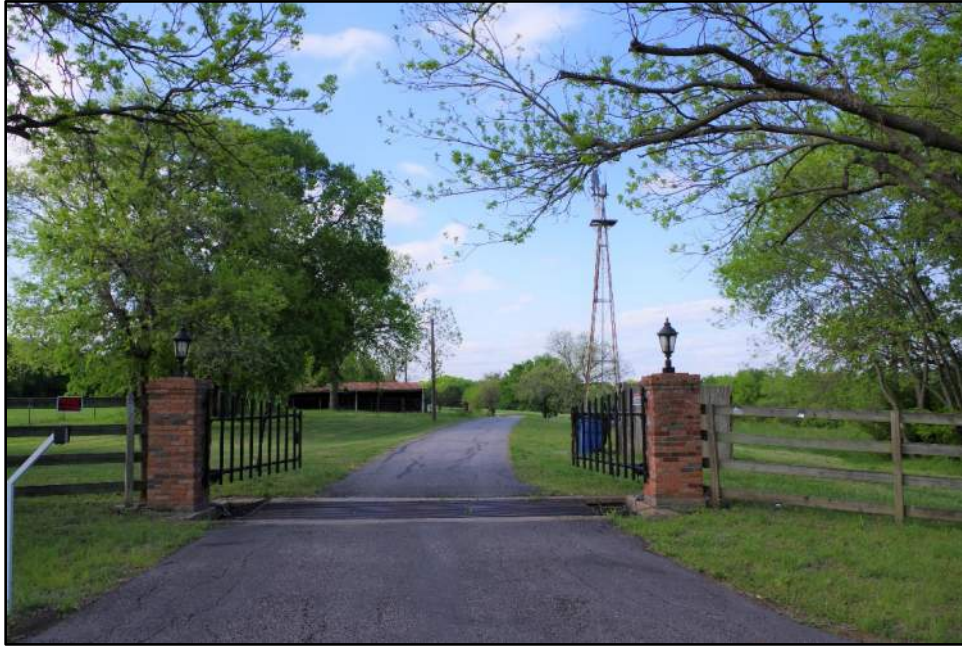
Photograph 1: View of historic-age property on County Road 1124 (CR 1124), camera facing north.

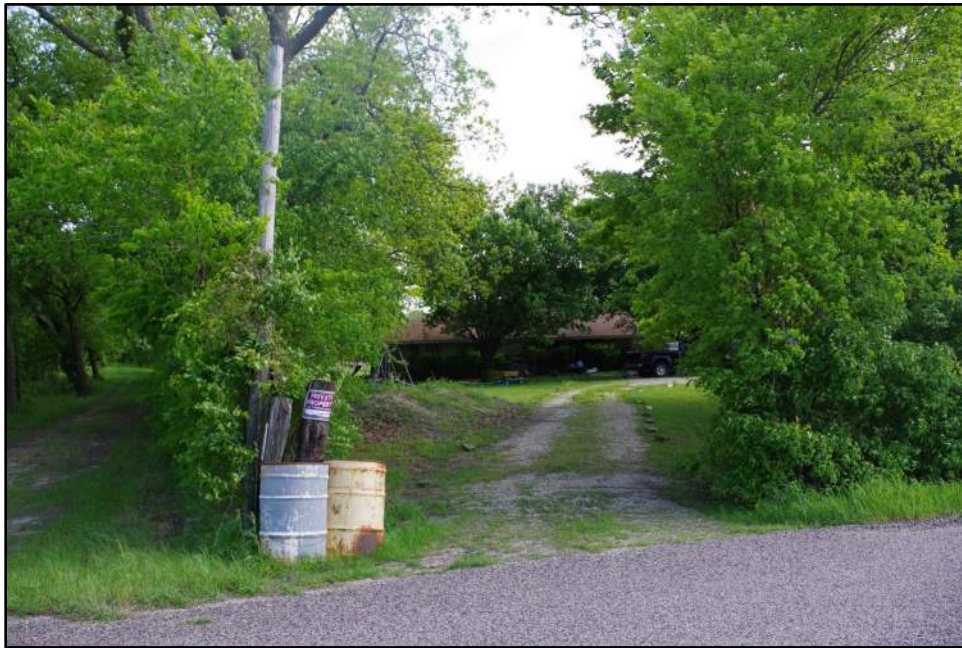
Photograph 4: View of historic-age dwelling on CR 1124, camera facing southeast.

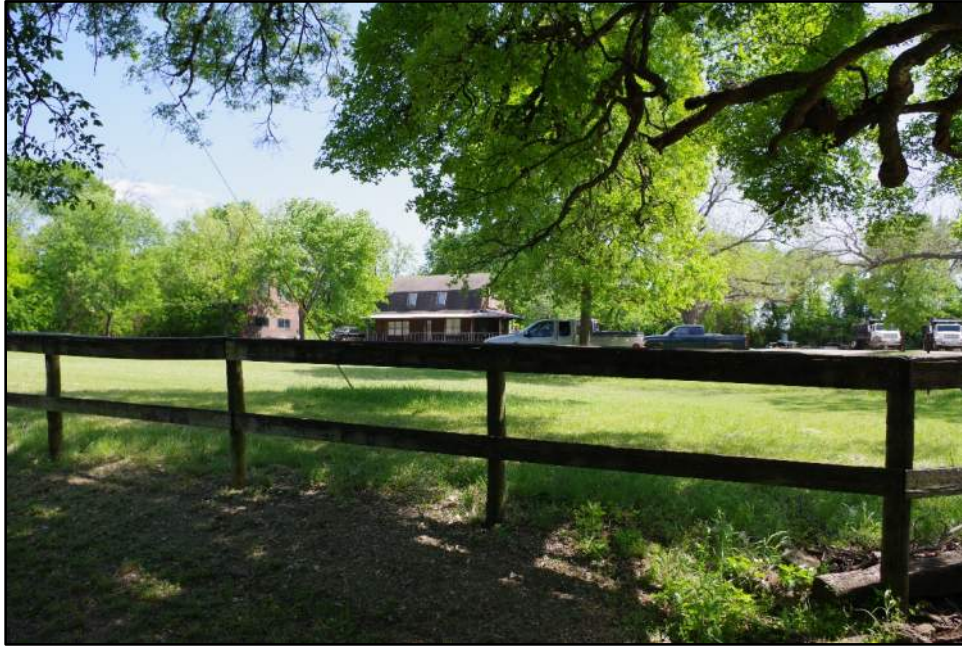
Photograph 6: View of non-historic-age property on County Road 933 (CR 933), camera facing southeast.

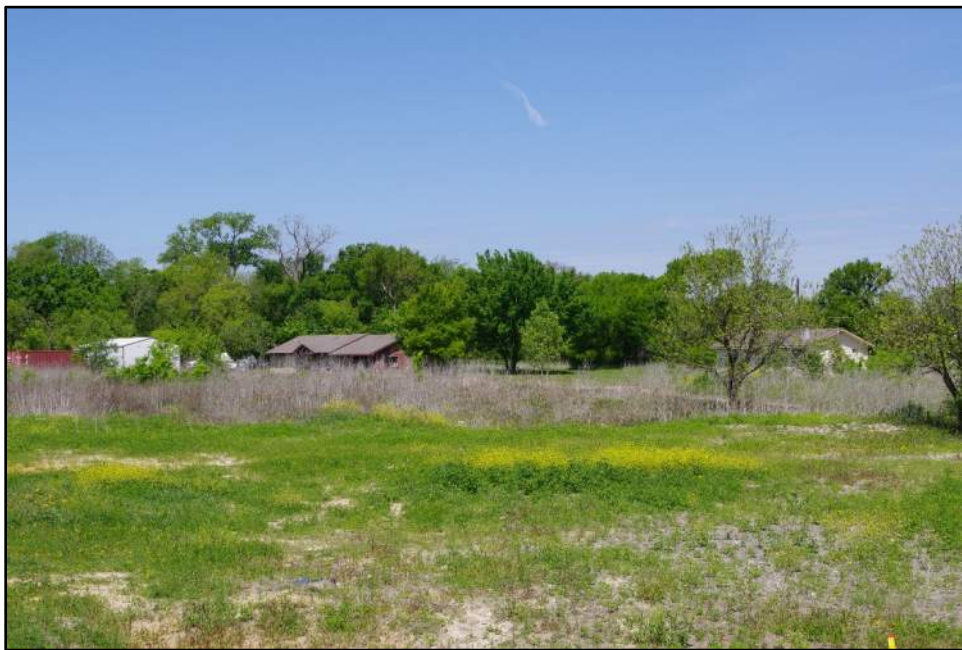
Photograph 56: Overview of historic-age property on North Central Expressway, camera facing southwest.

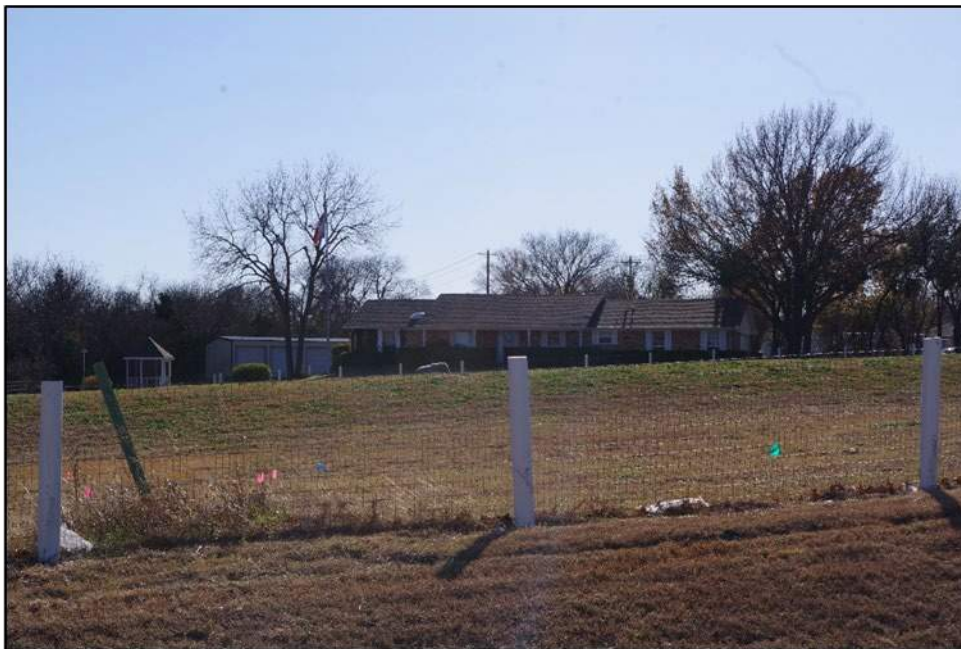
Survey Date:	December 6-9, 2021
Resource No:	01
Project Location:	Coit Road to FM 1827
Project Name and CSJ:	0135-02-065, 0135-15-002, 0135-03-053
Address, Lat/Long:	10753 W. University Dr. (US 380) 33.217910 / -96.750070
Function/Sub-function:	Domestic / Single Dwelling
Construction Date:	ca. 1975
NRHP Eligibility:	Not eligible
Integrity/Comments:	Side-gabled Ranch-style dwelling with brick cladding, replacement vinyl windows, inset front porch, and integral garage; on parcel with a non-historic-age garage outbuilding and gazebo (see additional Photographs in Appendix F); retains fair integrity but is not a significant example of resource type or style.

Overview of Resource 01, camera facing southwest

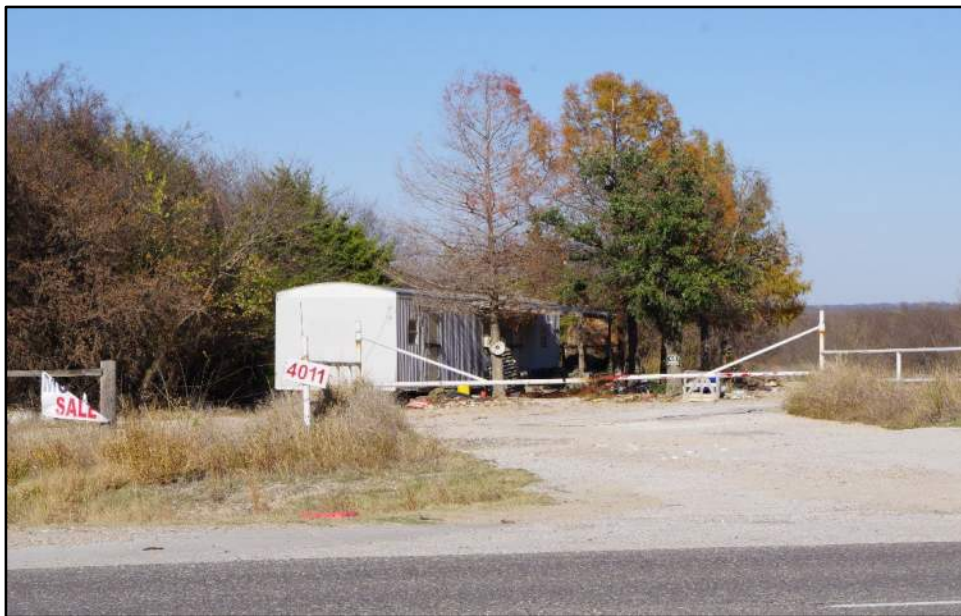
Survey Date:	December 6-9, 2021
Resource No:	02
Project Location:	Coit Road to FM 1827
Project Name and CSJ:	0135-02-065, 0135-15-002, 0135-03-053
Address, Lat/Long:	Located on the northwest side of E. University Dr., approximately 0.13 mi southwest of the intersection with University Business Dr. 33.220006 / -96.746241
Function/Sub-function:	Domestic / Single Dwelling
Construction Date:	ca. 1980
NRHP Eligibility:	Not eligible
Integrity/Comments:	Manufactured dwelling with vinyl siding, aluminum windows, and shed-roof porch addition (see additional Photographs in Appendix F); not a significant example of resource type.

View of Resource 02, camera facing north.

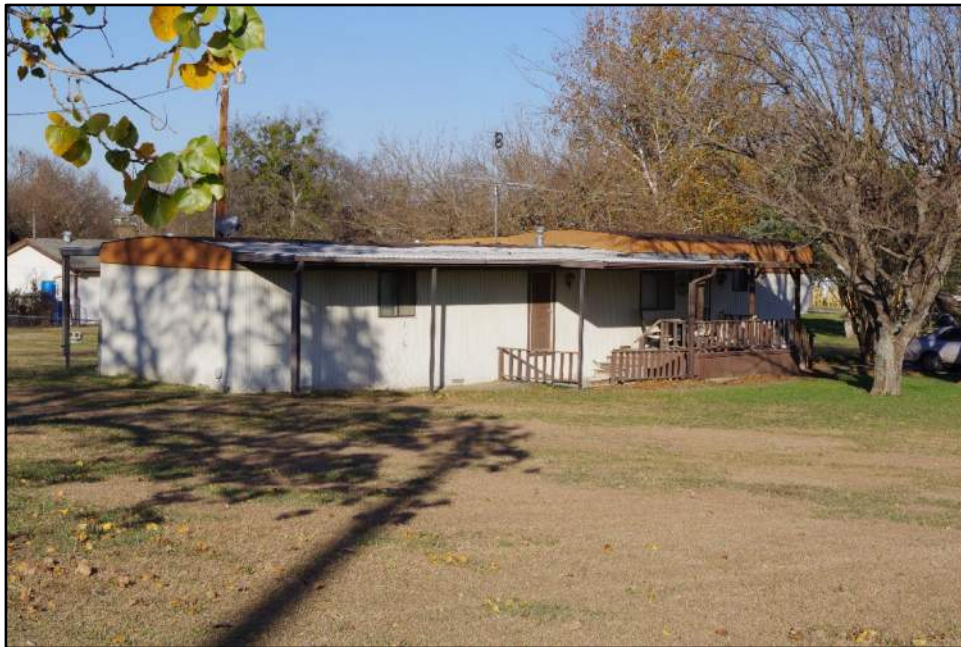
Survey Date:	December 6-9, 2021
Resource No:	03
Project Location:	Coit Road to FM 1827
Project Name and CSJ:	0135-02-065, 0135-15-002, 0135-03-053
Address, Lat/Long:	8888 Easy Ln. 33.237140 / -96.731050
Function/Sub-function:	Domestic / Single Dwelling
Construction Date:	ca. 1980
NRHP Eligibility:	Not eligible
Integrity/Comments:	Manufactured dwelling with vinyl siding, vinyl windows, rear addition, and shed-roof porch addition; on parcel with non-historic-age outbuilding (see additional Photographs in Appendix F); lacks integrity and is not a significant example of resource type.

View of Resource 03, camera facing northeast.

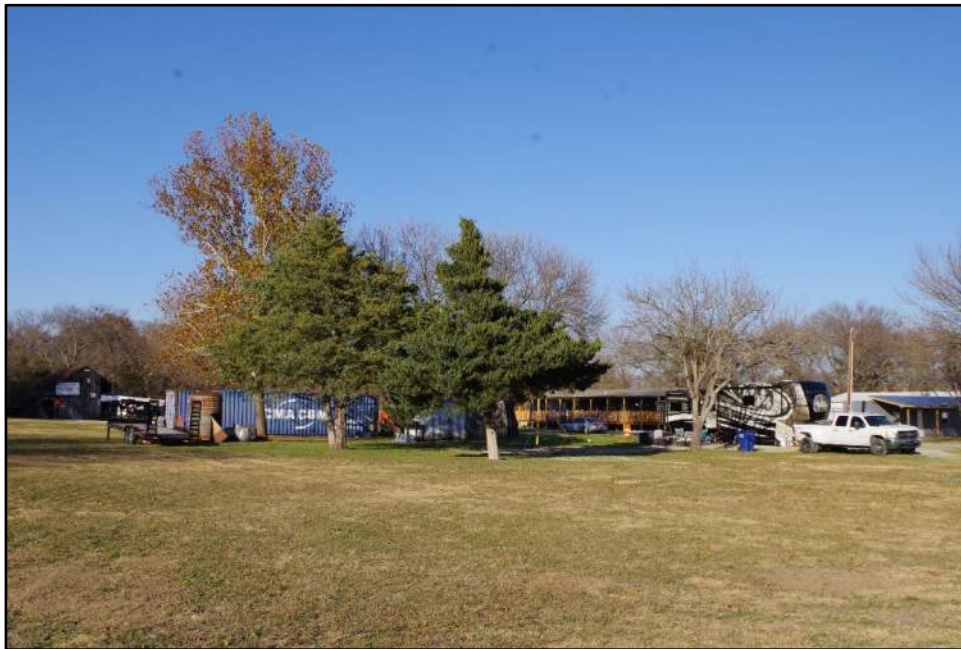
Survey Date:	December 6-9, 2021
Resource No:	04
Project Location:	Coit Road to FM 1827
Project Name and CSJ:	0135-02-065, 0135-15-002, 0135-03-053
Address, Lat/Long:	8848 Easy Ln. 33.237247 / -96.730385
Function/Sub-function:	Agriculture / Animal Facility (former)
Construction Date:	ca. 1960
NRHP Eligibility:	Not eligible
Integrity/Comments:	Front-gabled barn with metal roof, vertical wood siding, animal stalls, and hayloft; on parcel with non-historic-age manufactured dwelling and outbuildings (see additional Photographs in Appendix F); no longer associated with agricultural buildings or in agricultural use and is not a significant example of resource type.

Overview of Resource 04, camera facing northeast.

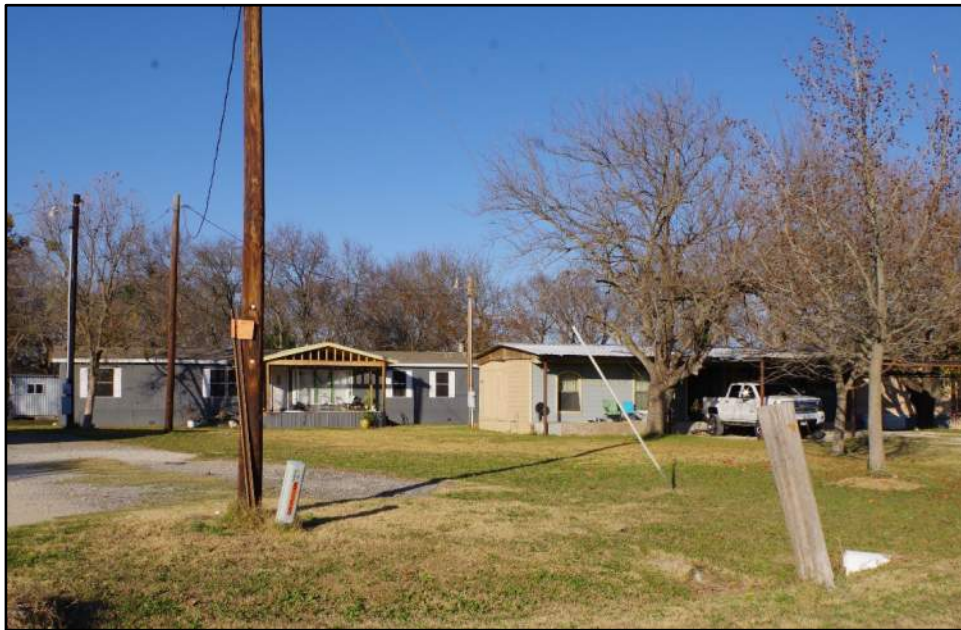
Survey Date:	December 6-9, 2021
Resource No:	05
Project Location:	Coit Road to FM 1827
Project Name and CSJ:	0135-02-065, 0135-15-002, 0135-03-053
Address, Lat/Long:	8728 Easy Ln. 33.237568 / -96.728950
Function/Sub-function:	Domestic / Single Dwelling
Construction Date:	ca. 1980
NRHP Eligibility:	Not eligible
Integrity/Comments:	Manufactured dwelling with a replacement metal roof, replacement hardiplank siding, replacement vinyl windows, and shed-roof carport addition; on parcel with secondary non-historic-age dwelling (see additional Photographs in Appendix F); lacks integrity and is not a significant example of resource type.

Overview of Resource 05, camera facing northeast.

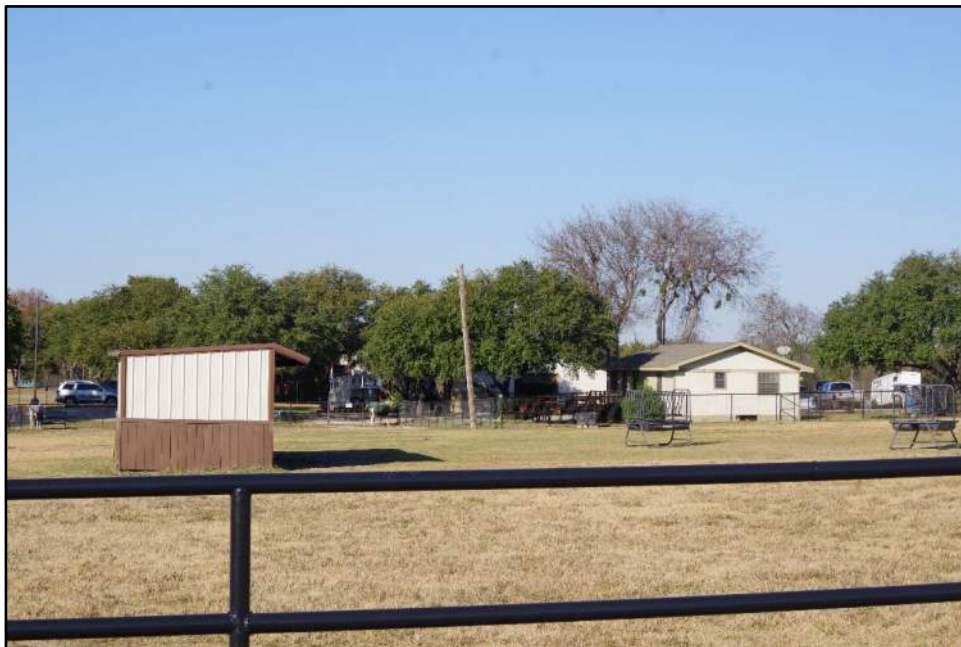
Survey Date:	December 6-9, 2021
Resource No:	07a
Project Location:	Coit Road to FM 1827
Project Name and CSJ:	0135-02-065, 0135-15-002, 0135-03-053
Address, Lat/Long:	3154 N. Custer Rd. 33.232212 / -96.730815
Function/Sub-function:	Domestic / Single Dwelling
Construction Date:	ca. 1975
NRHP Eligibility:	Not eligible
Integrity/Comments:	Side-gabled dwelling with vertical plyboard siding, aluminum windows, shed-roof porch, and uncovered deck additions; on parcel with Resources 07b-07d and non-historic-age outbuildings; resources comprise the ManeGait Therapeutic Horsemanship organization (see additional Photographs in Appendix F); retains fair integrity but is not a significant example of resource type/style.

View of Resource 07a and non-historic-age pole barn, camera facing north.
