APPENDIX L: Cultural Resources

APPENDIX L – CULTURAL RESOURCES – FEIS Preferred Alternative/Blue Alternative

US 380 MCKINNEY – Coit Road to FM 1827, Collin County CSJs 0135-02-065 and 0135-15-002; Dallas District

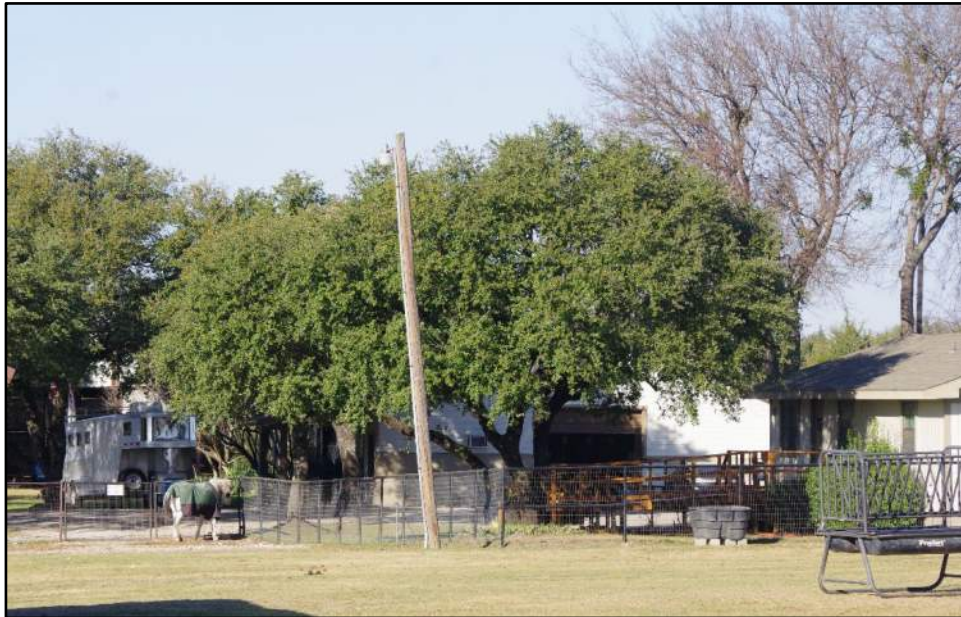
Survey Date:	December 6-9, 2021
Resource No:	07b
Project Location:	Coit Road to FM 1827
Project Name and CSJ:	0135-02-065, 0135-15-002, 0135-03-053
Address, Lat/Long:	3154 N. Custer Rd. 33.232212 / -96.730815
Function/Sub-function:	Agriculture / Animal Facility
Construction Date:	ca. 1980
NRHP Eligibility:	Not eligible
Integrity/Comments:	Side-gabled barn with vinyl siding, concrete masonry unit (CMU) foundation wall, metal overhead garage door, shed roof addition, and attached fenced animal pens; on parcel with Resource 07a, Resources 07c and d, and non-historic-age outbuildings (see additional Photographs in Appendix F); lacks integrity of materials and is not a significant example of resource type.

Obstructed view of Resource 07b, camera facing north.

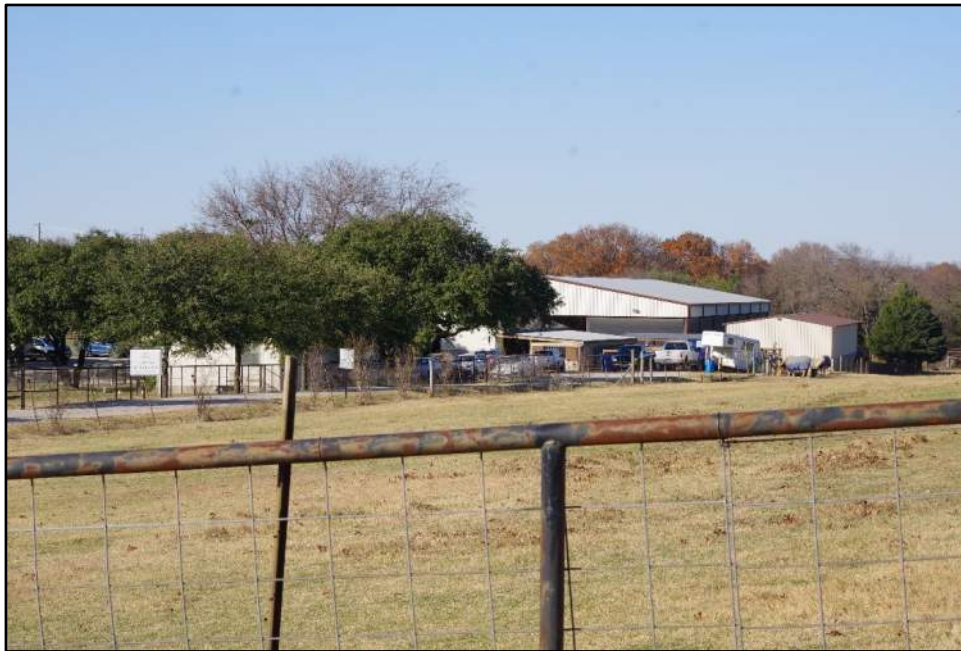
Survey Date:	December 6-9, 2021
Resource No:	07c
Project Location:	Coit Road to FM 1827
Project Name and CSJ:	0135-02-065, 0135-15-002, 0135-03-053
Address, Lat/Long:	3154 N. Custer Rd. 33.232212 / -96.730815
Function/Sub-function:	Agriculture / Animal Facility
Construction Date:	ca. 1980
NRHP Eligibility:	Not eligible
Integrity/Comments:	Front-gabled barn with metal roof, metal siding and, and metal sliding doors on the gabled end; on parcel with Resources 07a, 07b, and 07d and non-historic-age outbuildings (see additional Photographs in Appendix F); not a significant example of resource type.

View of Resource 07c (center, left) and Resource 07d (right), camera facing northwest.

Survey Date:	December 6-9, 2021
Resource No:	07d
Project Location:	Coit Road to FM 1827
Project Name and CSJ:	0135-02-065, 0135-15-002, 0135-03-053
Address, Lat/Long:	3154 N. Custer Rd. 33.232212 / -96.730815
Function/Sub-function:	Agriculture / Outbuilding
Construction Date:	ca. 1980
NRHP Eligibility:	Not eligible
Integrity/Comments:	Side-gabled storage barn with metal roof, metal siding, and CMU foundation wall; on parcel with Resources 07a-07c and non-historic-age outbuildings (see additional Photographs in Appendix F); not a significant example of resource type.

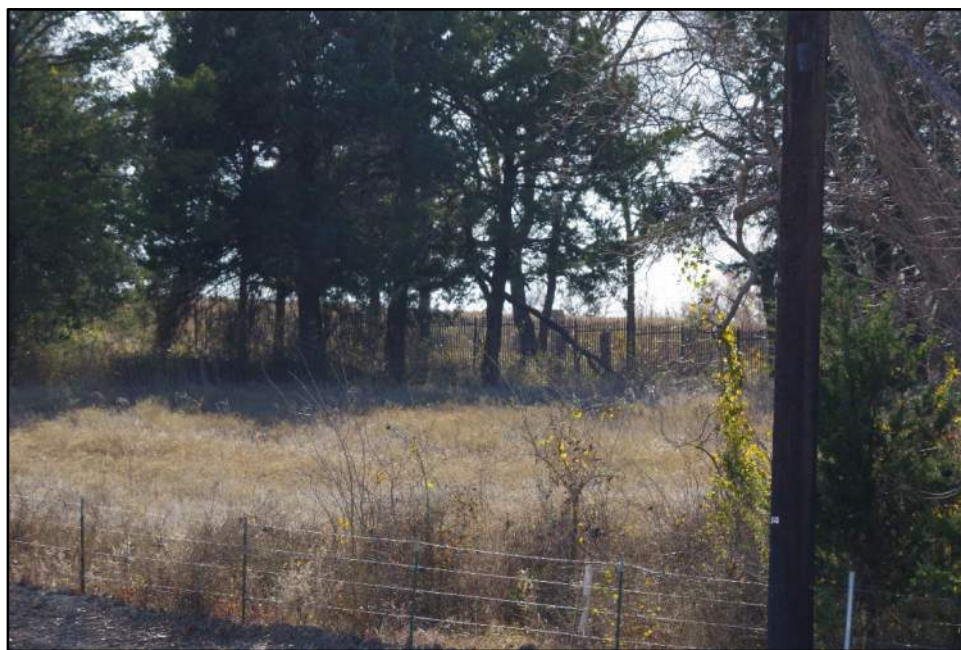
Survey Date:	December 6-9, 2021
Resource No:	08 (Hunt Cemetery)
Project Location:	Coit Road to FM 1827
Project Name and CSJ:	0135-02-065, 0135-15-002, 0135-03-053
Address, Lat/Long:	Located on the west side of N. Custer Rd., approximately 0.09 mi southwest of the intersection with County Rd. 858 33.229619 / -96.733628
Function/Sub-function:	Funerary / Cemetery
Construction Date:	ca. 1861
NRHP Eligibility:	Not eligible
Integrity/Comments:	Hunt Cemetery, also known by the names of Jeramiah Horn, Reverend Horn, and Horn Family; small cemetery enclosed with non-original decorative iron fence surrounded by trees; located on large undeveloped parcel on west side of N. Custer Road that was not accessible during the field survey; small number of upright markers visible; largely overgrown and unmaintained; contains approximately 16 burials ranging from ca. 1861-1900, with additional unmarked graves outside cemetery fence (THC Atlas) (see additional Photographs in Appendix F); no known associations of historic significance at local, state, or national level and does not reflect distinctive mortuary or landscape design characteristics.

View of Resource 08, camera facing southwest.

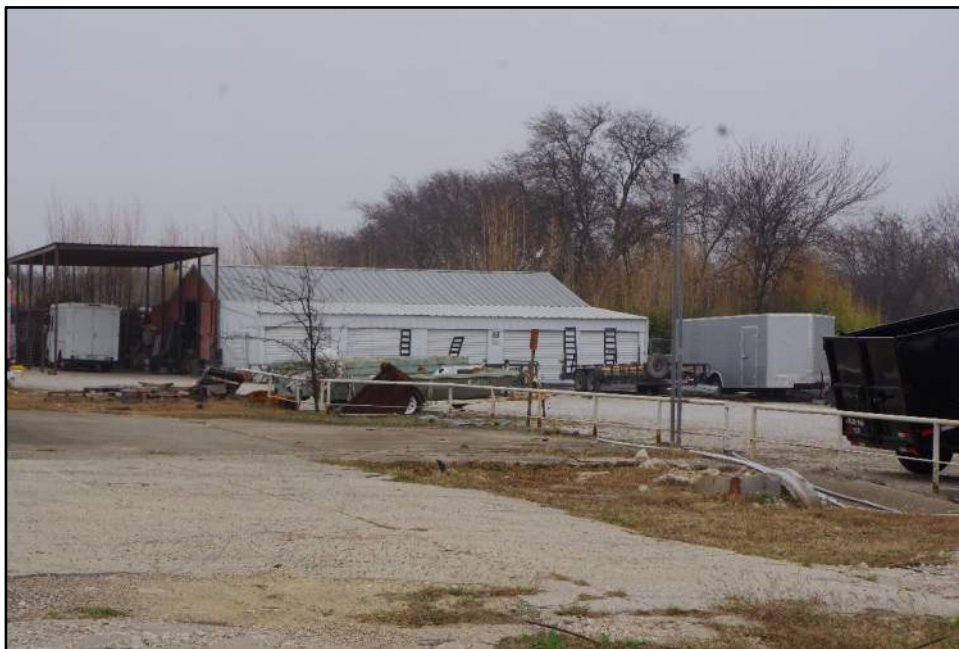
Survey Date:	December 6-9, 2021
Resource No:	09
Project Location:	Coit Road to FM 1827
Project Name and CSJ:	0135-02-065, 0135-15-002, 0135-03-053
Address, Lat/Long:	8734 W. University Dr. (US 380) 33.219306 / -96.730085
Function/Sub-function:	Commerce / Warehouse
Construction Date:	ca. 1980
NRHP Eligibility:	Not eligible
Integrity/Comments:	Side-gabled outbuilding/equipment shed with metal roof, metal siding, and five-bay shed roof side addition with five metal overhead garage doors; associated with a non-historic-age commercial building and adjacent carport (see additional Photographs in Appendix F); not a significant example of resource type.

View of Resource 09, camera facing northwest.

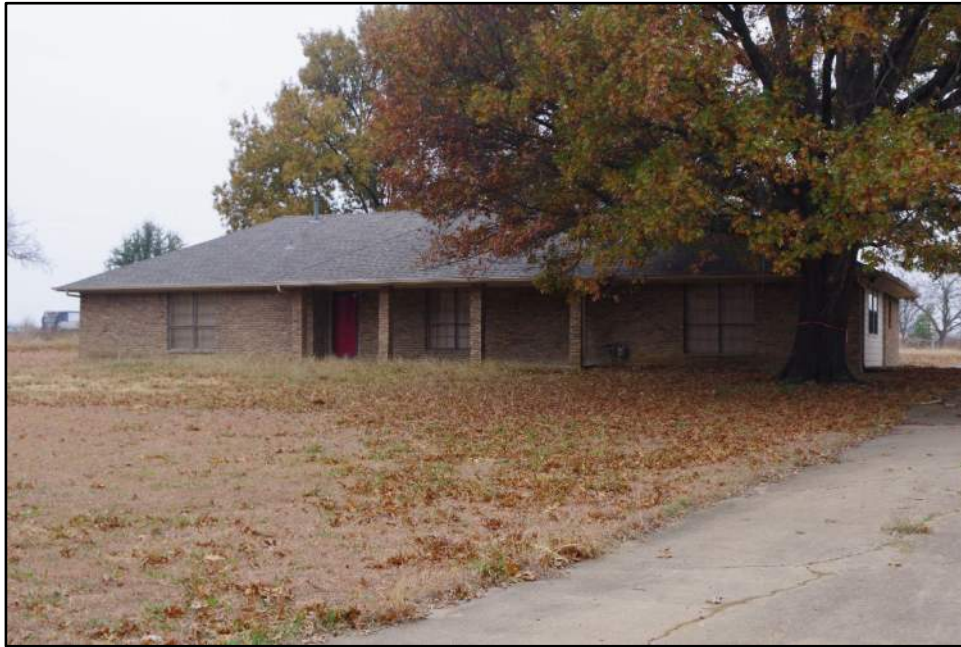
Survey Date:	December 6-9, 2021
Resource No:	10a
Project Location:	Coit Road to FM 1827
Project Name and CSJ:	0135-02-065, 0135-15-002, 0135-03-053
Address, Lat/Long:	2099 County Rd. 856 33.219791 / -96.724792
Function/Sub-function:	Domestic / Single Dwelling
Construction Date:	ca. 1975
NRHP Eligibility:	Not eligible
Integrity/Comments:	Hipped-roof Ranch-style dwelling with brick cladding, vinyl windows, an inset front porch, and an enclosed integral garage; on parcel with Resource 10b and non-historic-age pole barn (see additional Photographs in Appendix F); retains fair integrity but is not a significant example of resource type.

View of Resource 10a, camera facing southwest.

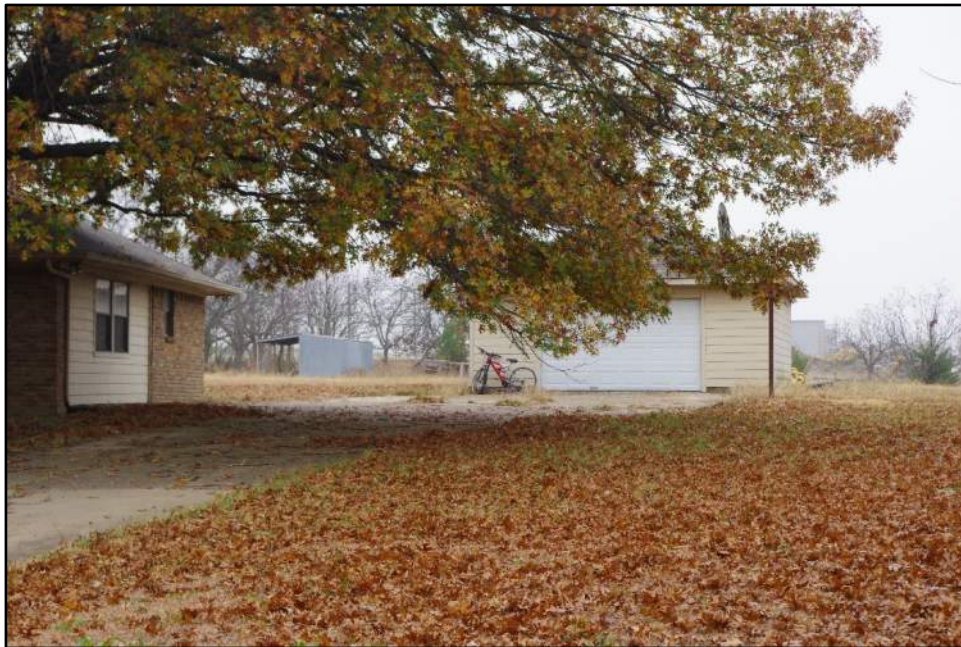
Survey Date:	December 6-9, 2021
Resource No:	10b
Project Location:	Coit Road to FM 1827
Project Name and CSJ:	0135-02-065, 0135-15-002, 0135-03-053
Address, Lat/Long:	2099 County Rd. 856 33.219791 / -96.724792
Function/Sub-function:	Domestic / Secondary Structure
Construction Date:	ca. 1975
NRHP Eligibility:	Not eligible
Integrity/Comments:	Hipped-roof garage with vinyl siding and metal garage door; on parcel with Resource 10a and non-historic-age pole barn (see additional Photographs in Appendix F); not a significant example of resource type.

View of Resource 10b and non-historic-age pole barn, camera facing west.

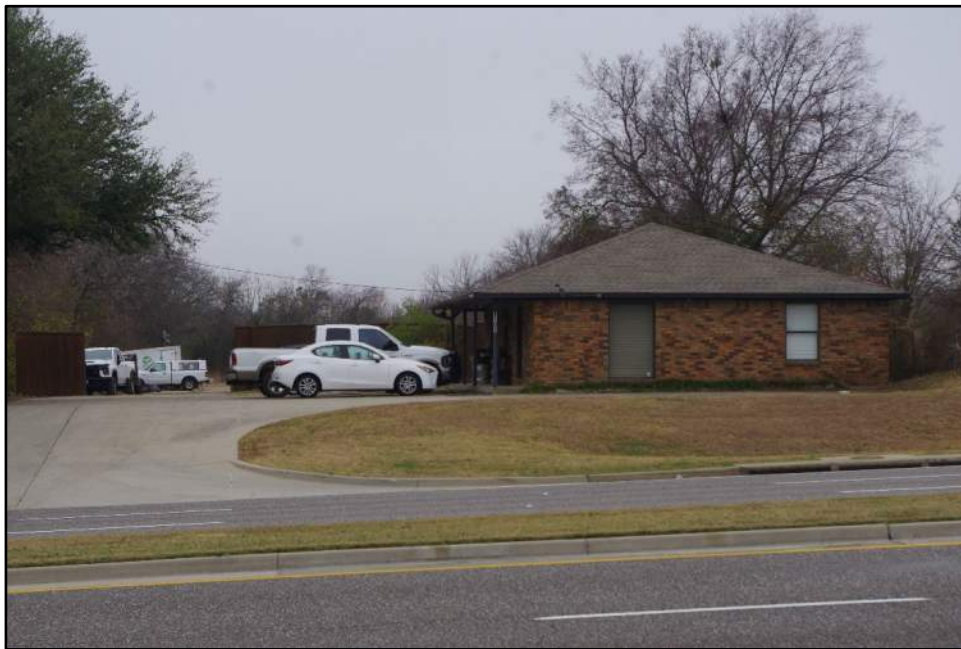
Survey Date:	December 6-9, 2021
Resource No:	11
Project Location:	Coit Road to FM 1827
Project Name and CSJ:	0135-02-065, 0135-15-002, 0135-03-053
Address, Lat/Long:	8301 W. University Dr. (US 380) 33.218525 / -96.724255
Function/Sub-function:	Domestic / Single Dwelling
Construction Date:	ca. 1975
NRHP Eligibility:	Not eligible
Integrity/Comments:	Hipped-roof ranch-style dwelling with brick cladding, replacement vinyl windows, and an inset front porch (see additional Photographs in Appendix F); not a significant example of resource type or style.

View of Resource 11, camera facing south.

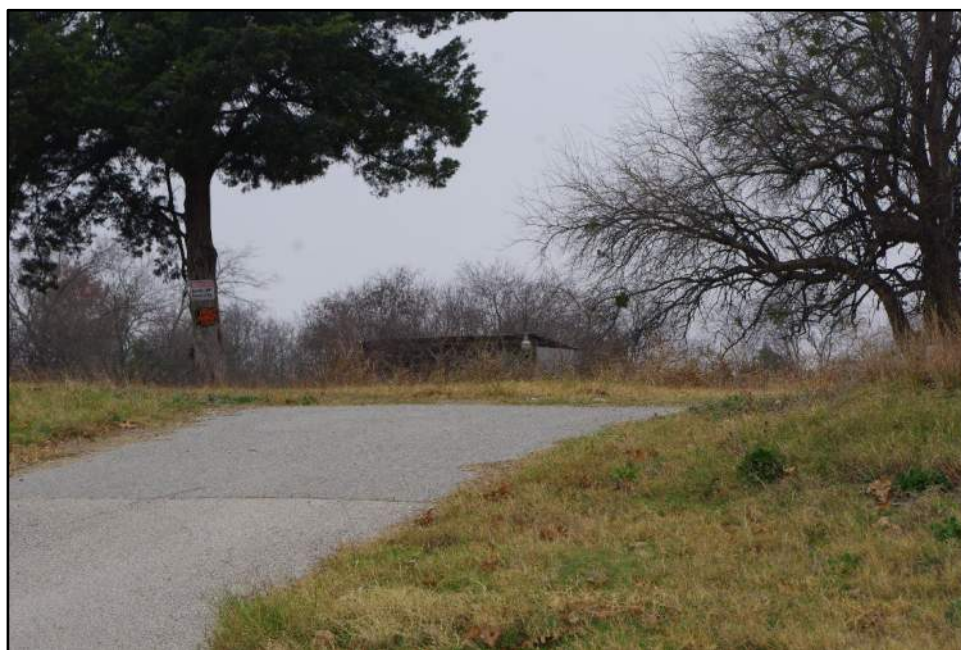
Survey Date:	December 6-9, 2021
Resource No:	12
Project Location:	Coit Road to FM 1827
Project Name and CSJ:	0135-02-065, 0135-15-002, 0135-03-053
Address, Lat/Long:	Located on the north side of W. University Dr., approximately 0.11 mi from the intersection with County Rd. 856 33.219647 / -96.721647
Function/Sub-function:	Vacant / Not in Use
Construction Date:	ca. 1965
NRHP Eligibility:	Not eligible
Integrity/Comments:	Partially obscured pole barn with metal siding; no additional details were visible from the public ROW (see additional Photographs in Appendix F); not associated with any additional historic-age building; appears vacant; not a significant example of resource type.

Obstructed view of Resource 12, camera facing northwest.

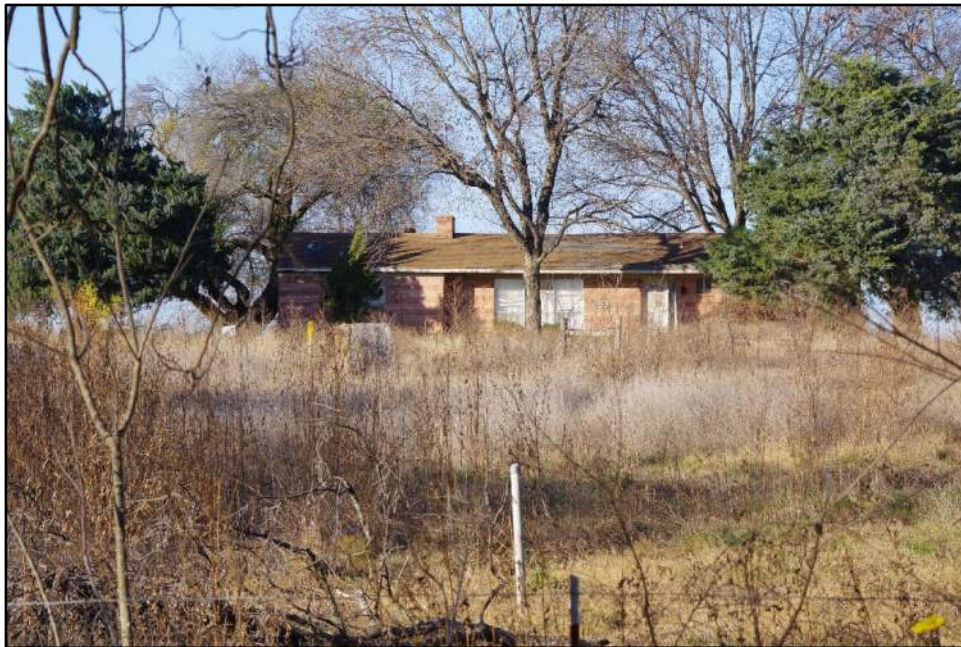
Survey Date:	December 6-9, 2021
Resource No:	13a
Project Location:	Coit Road to FM 1827
Project Name and CSJ:	0135-02-065, 0135-15-002, 0135-03-053
Address, Lat/Long:	7520 County Rd. 124 33.238550 / -96.717840
Function/Sub-function:	Domestic / Single Dwelling
Construction Date:	ca. 1965
NRHP Eligibility:	Not eligible
Integrity/Comments:	Side-gabled Ranch-style dwelling with brick cladding, replacement vinyl windows, and interior chimney; on parcel with Resource 13b (see additional Photographs in Appendix F); retains fair integrity but is not a significant example of resource type or style.

View of Resource 13a, camera facing north.

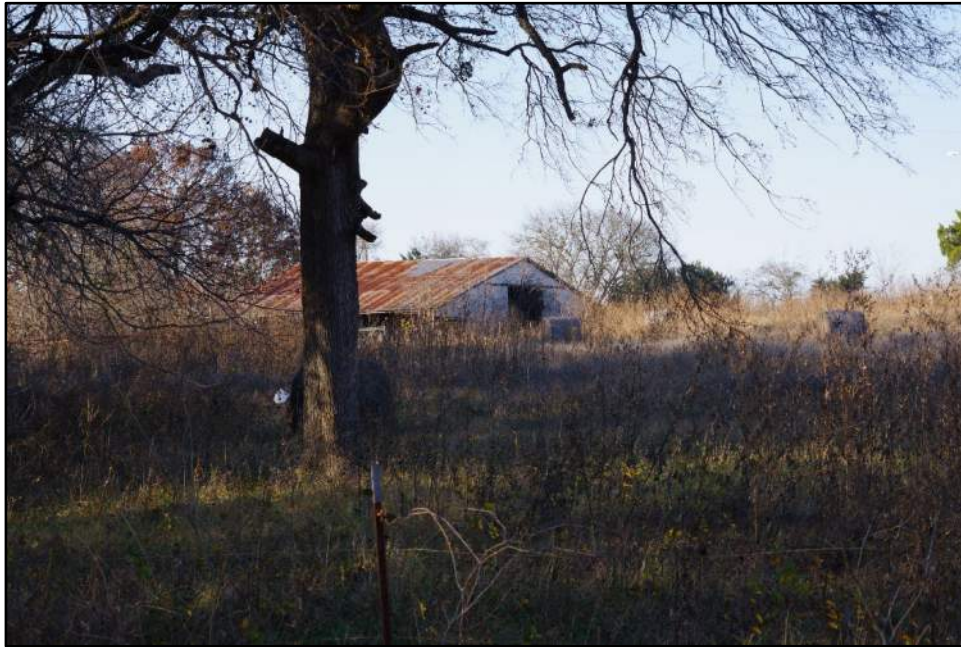
Survey Date:	December 6-9, 2021
Resource No:	13b
Project Location:	Coit Road to FM 1827
Project Name and CSJ:	0135-02-065, 0135-15-002, 0135-03-053
Address, Lat/Long:	7520 County Rd. 124 33.238550 / -96.717840
Function/Sub-function:	Agricultural / Outbuilding
Construction Date:	ca. 1950
NRHP Eligibility:	Not eligible
Integrity/Comments:	Front-gabled barn with metal roof, metal siding, and sliding metal doors at the gable end; visible in aerial imagery in 1956 prior to extant dwelling (Resource 13a); on parcel with Resource 13a (see additional Photographs in Appendix F; not a significant example of resource type.

View of Resource 13b, camera facing northwest.

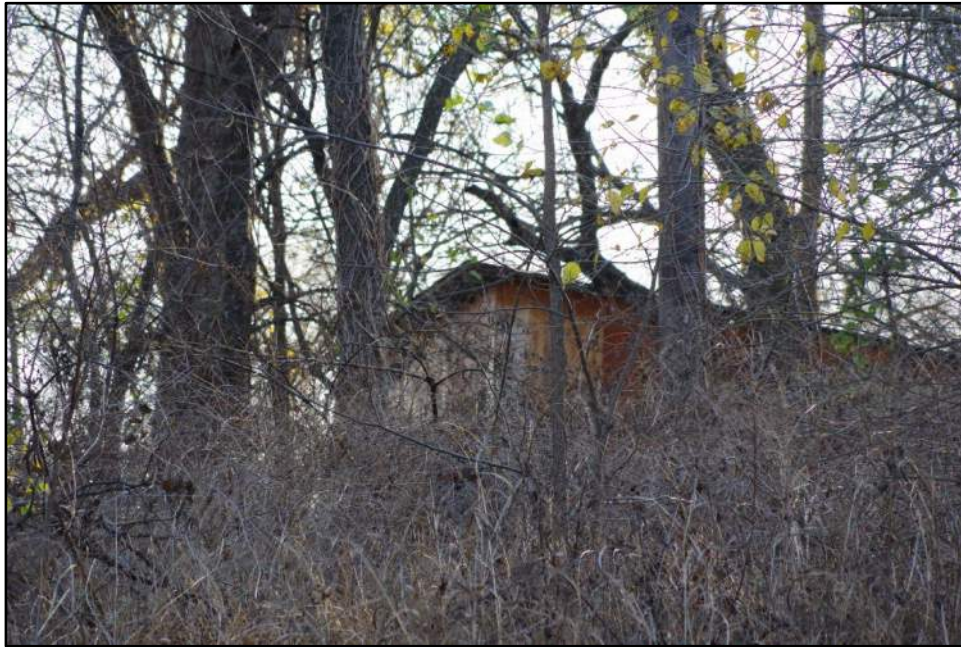
Survey Date:	December 6-9, 2021
Resource No:	14
Project Location:	Coit Road to FM 1827
Project Name and CSJ:	0135-02-065, 0135-15-002, 0135-03-053
Address, Lat/Long:	South of County Rd. 124, approximately 0.31 mi from the intersection with Private Road 5343 33.236404 / -96.716179
Function/Sub-function:	Agricultural / Outbuilding
Construction Date:	ca. 1950
NRHP Eligibility:	Not eligible
Integrity/Comments:	Front-gabled barn with wide eave overhang and metal siding; not associated with additional historic-age buildings; no additional details were visible from the public ROW (see additional Photographs in Appendix F); appears vacant; not a significant example of resource type.

Obstructed view of Resource 14, camera facing south-southwest.

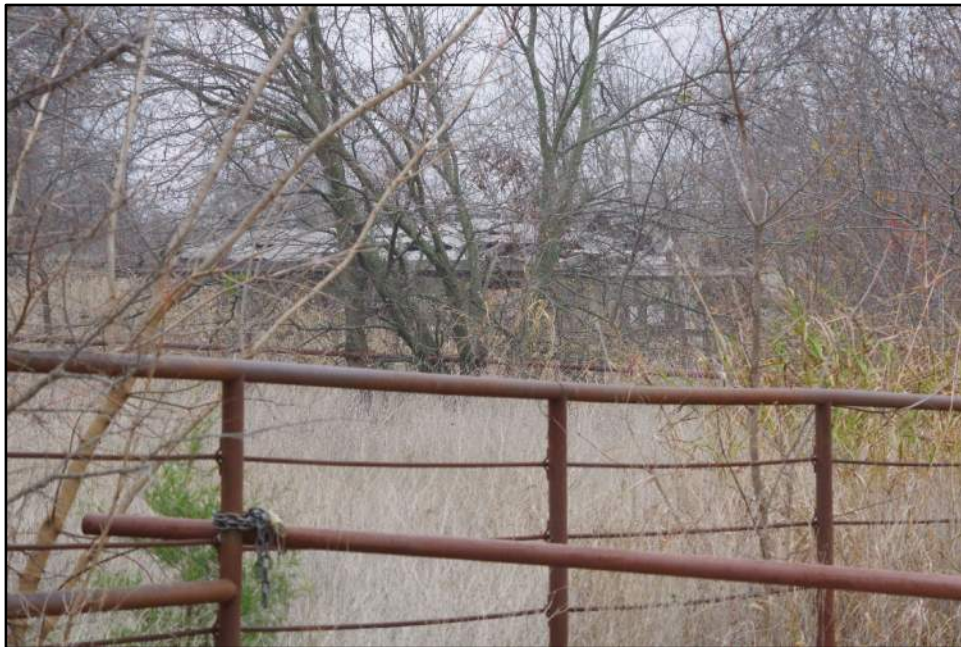
Survey Date:	December 6-9, 2021
Resource No:	15
Project Location:	Coit Road to FM 1827
Project Name and CSJ:	0135-02-065, 0135-15-002, 0135-03-053
Address, Lat/Long:	Northeast of the intersection of W. University Dr. and Grassmere Ln. 33.219759 / 33.219759
Function/Sub-function:	Vacant / Not in Use
Construction Date:	ca. 1980
NRHP Eligibility:	Not eligible
Integrity/Comments:	Abandoned and partially obscured manufactured dwelling with vinyl siding, carport addition, and stone entry gate; no additional details were visible from the public ROW (see additional Photographs in Appendix F); appears vacant; not a significant example of resource type.

Obstructed view of Resource 15, camera facing northwest.

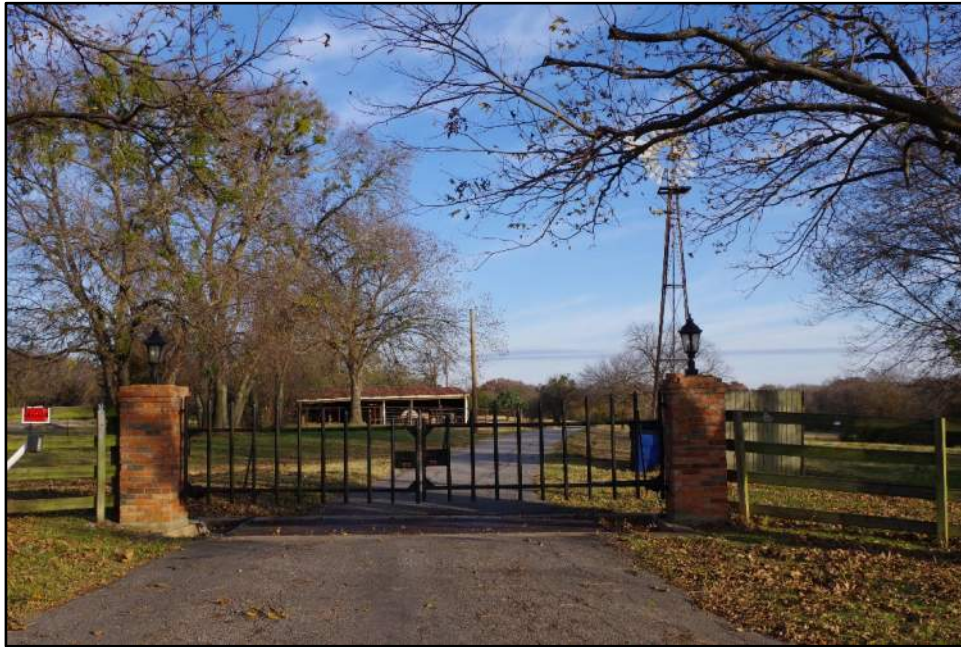
Survey Date:	December 6-9, 2021
Resource No:	16a
Project Location:	Coit Road to FM 1827
Project Name and CSJ:	0135-02-065, 0135-15-002, 0135-03-053
Address, Lat/Long:	6400 County Rd. 124 33.233113 / -96.703356
Function/Sub-function:	Agriculture / Storage
Construction Date:	ca. 1965
NRHP Eligibility:	Not eligible
Integrity/Comments:	Side-gabled pole barn with metal roof and multiple open bays; associated with windmill (Resource 16b), a historic-age outbuilding not visible from the public ROW, and a non-historic-age dwelling (see additional Photographs in Appendix F); not a significant example of resource type.

View of Resource 16a (center, left) and Resource 16b (right), camera facing north.

Survey Date:	December 6-9, 2021
Resource No:	16b
Project Location:	Coit Road to FM 1827
Project Name and CSJ:	0135-02-065, 0135-15-002, 0135-03-053
Address, Lat/Long:	6400 County Rd. 124 33.233113 / -96.703356
Function/Sub-function:	Industrial / Energy facility
Construction Date:	ca. 1965
NRHP Eligibility:	Not eligible
Integrity/Comments:	Metal-framed windmill and associated concrete water trough located on parcel with Resource 16a, a historic-age outbuilding not visible from the public ROW, and a non-historic-age dwelling (see additional Photographs in Appendix F); not a significant example of resource type.

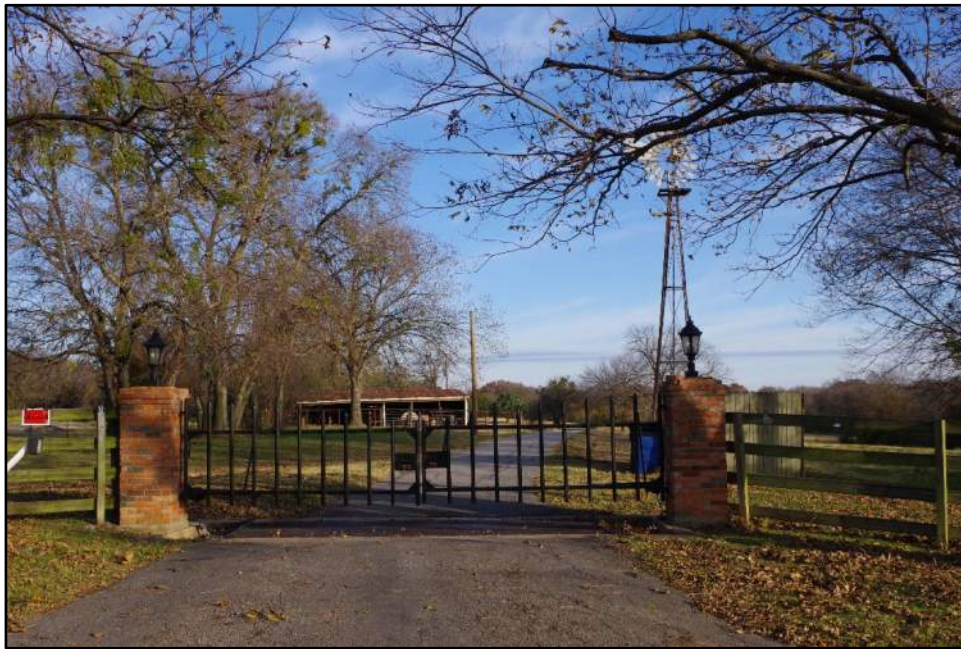
View of Resource 16a (center, left) and Resource 16b (right), camera facing north.

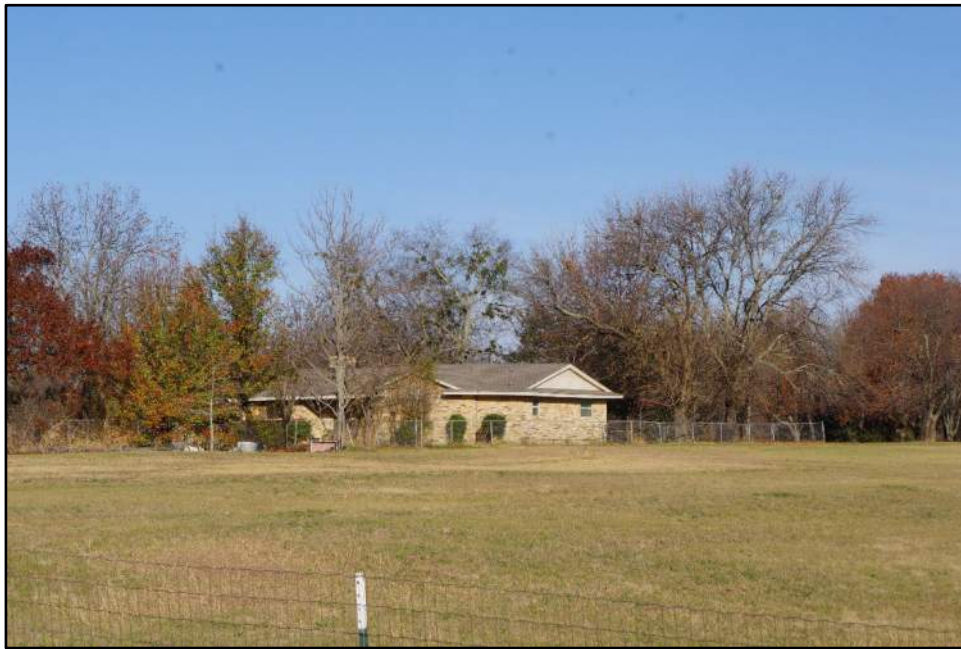
Survey Date:	December 6-9, 2021
Resource No:	17a
Project Location:	Coit Road to FM 1827
Project Name and CSJ:	0135-02-065, 0135-15-002, 0135-03-053
Address, Lat/Long:	6008 County Rd. 123 33.248095 / -96.685487
Function/Sub-function:	Domestic / Single Dwelling
Construction Date:	ca. 1975
NRHP Eligibility:	Not eligible
Integrity/Comments:	Ranch-style dwelling with gable-on-hip roof, brick cladding, replacement vinyl windows, interior brick chimney, and inset front porch; on parcel with Resources 17b,17c, and non-historic-age garage (see additional Photographs in Appendix F); retains fair integrity but is not a significant example of resource type or style.

View of Resource 17a, camera facing northwest.

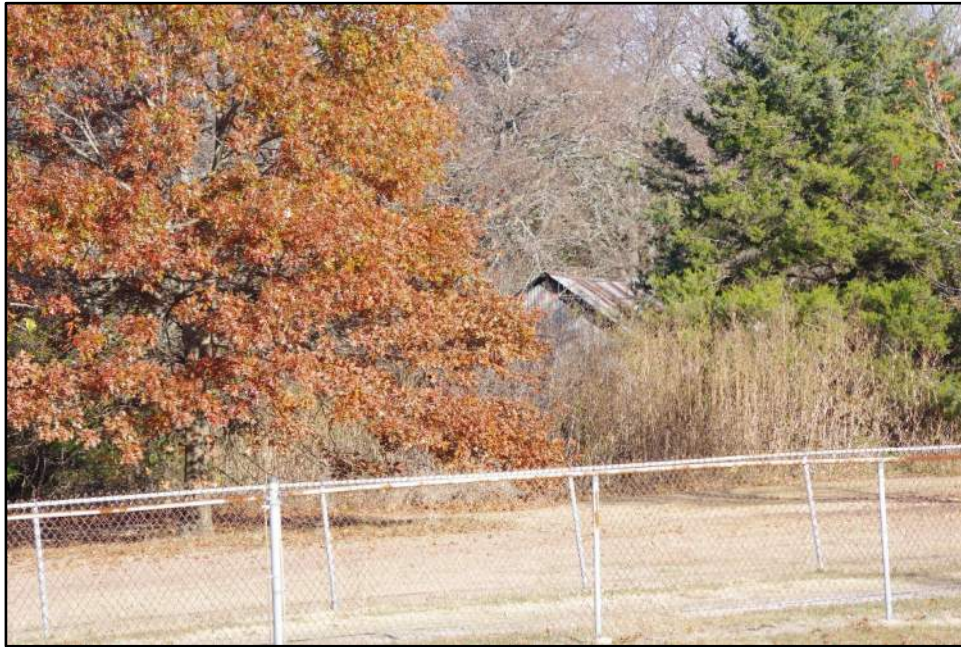
Survey Date:	December 6-9, 2021
Resource No:	17b
Project Location:	Coit Road to FM 1827
Project Name and CSJ:	0135-02-065, 0135-15-002, 0135-03-053
Address, Lat/Long:	6008 County Rd. 123 33.248095 / -96.685487
Function/Sub-function:	Agricultural / Outbuilding
Construction Date:	ca. 1975
NRHP Eligibility:	Not eligible
Integrity/Comments:	Front-gabled barn with metal roof and metal siding; no additional details were visible from the public ROW; on parcel with Resources 17a and 17c and non-historic-age shed and garage (see additional Photographs in Appendix F); retains fair integrity but is not a significant example of resource type.

View of Resource 17b, camera facing northwest.

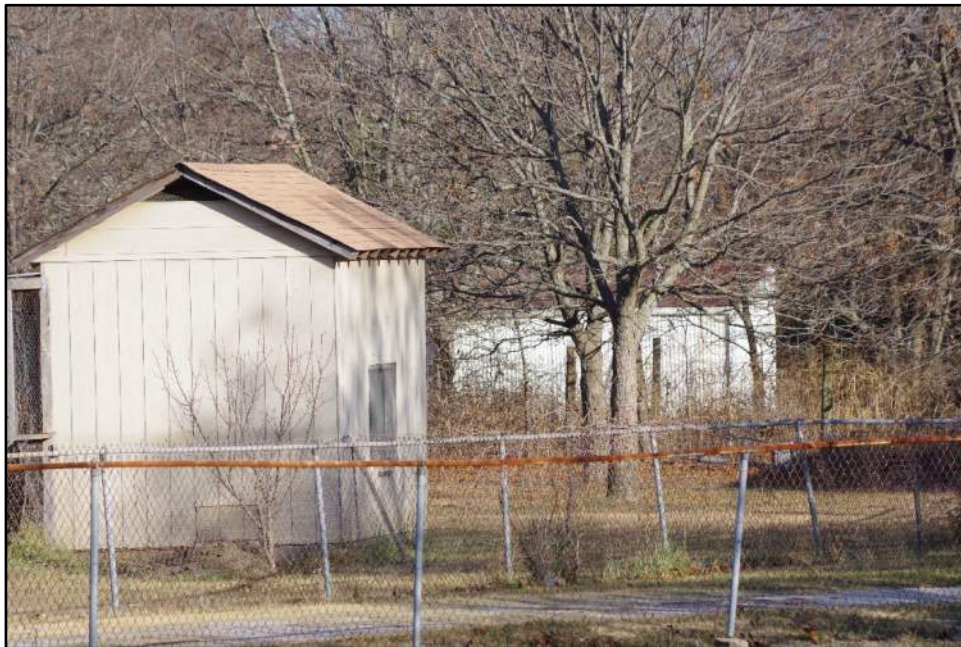
Survey Date:	December 6-9, 2021
Resource No:	17c
Project Location:	Coit Road to FM 1827
Project Name and CSJ:	0135-02-065, 0135-15-002, 0135-03-053
Address, Lat/Long:	6008 County Rd. 123 33.248095 / -96.685487
Function/Sub-function:	Agricultural / Outbuilding
Construction Date:	ca. 1975
NRHP Eligibility:	Not eligible
Integrity/Comments:	Side-gabled outbuilding with metal roof and metal siding; no additional details were visible from the public ROW; on parcel with Resources 17a and 17b and non-historic-age shed and garage (see additional Photographs in Appendix F); retains fair integrity but is not a significant example of resource type.

View of Resource 17c and non-historic-age shed, camera facing north-northwest.

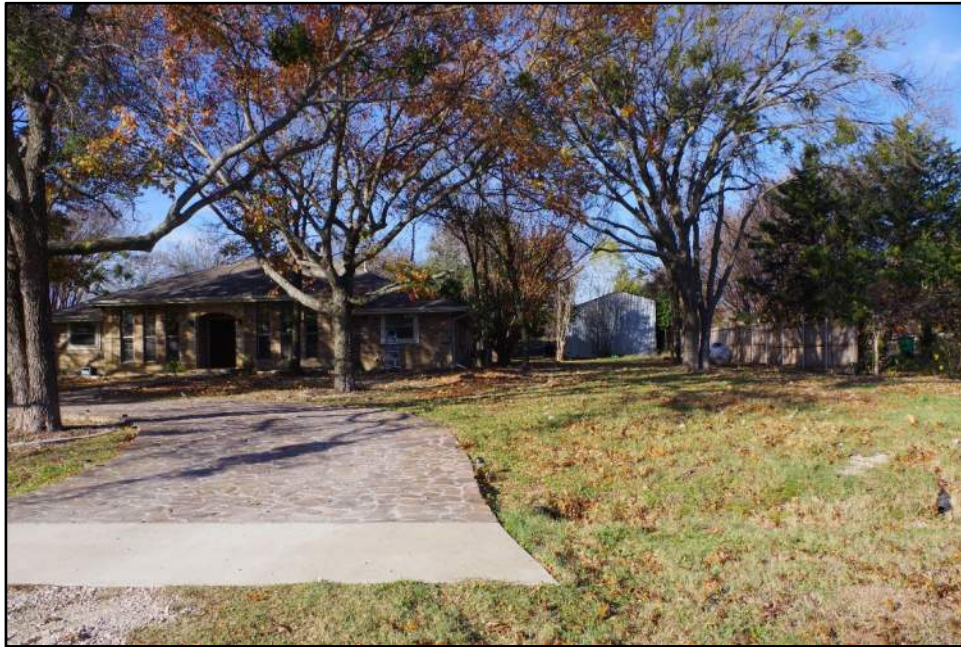
Survey Date:	December 6-9, 2021
Resource No:	18
Project Location:	Coit Road to FM 1827
Project Name and CSJ:	0135-02-065, 0135-15-002, 0135-03-053
Address, Lat/Long:	4023 Akela Way (Private Rd. 5157) 33.247449 / -96.683898
Function/Sub-function:	Domestic / Single Dwelling
Construction Date:	ca. 1975
NRHP Eligibility:	Not eligible
Integrity/Comments:	Ranch-style dwelling with hipped roof, brick cladding, and replacement vinyl windows; on parcel with non-historic-age outbuilding (see additional Photographs in Appendix F); dwelling is visible in 1981 aerial imagery but façade with arched entrance and narrow windows may be a later alteration (NETR 1981); not a significant example of resource type or style.

Overview of Resource 18, camera facing west.

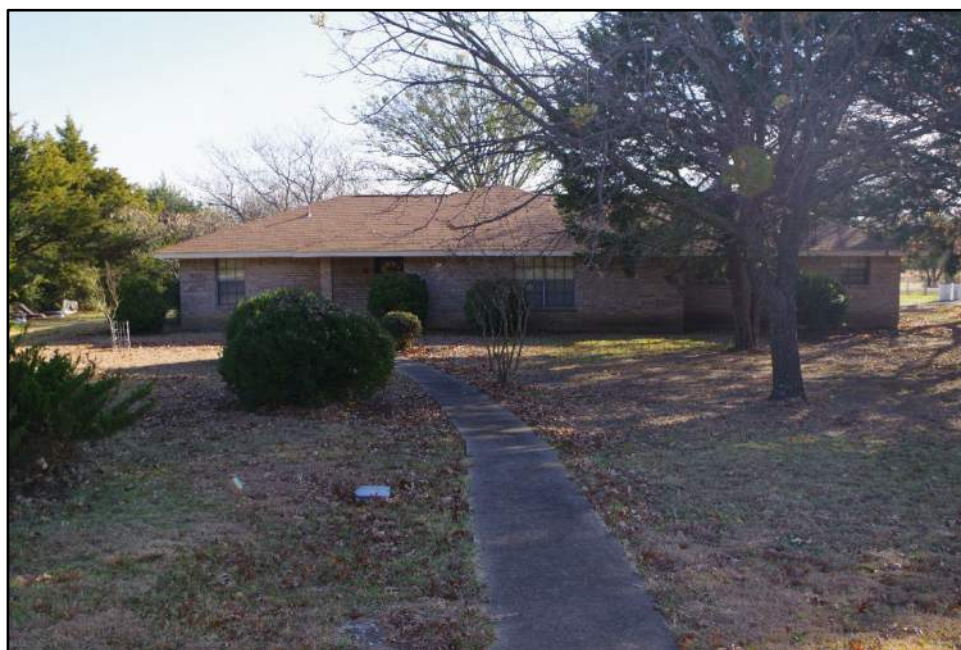
Survey Date:	December 6-9, 2021
Resource No:	19a
Project Location:	Coit Road to FM 1827
Project Name and CSJ:	0135-02-065, 0135-15-002, 0135-03-053
Address, Lat/Long:	5764 County Rd. 123 33.247252 / -96.682942
Function/Sub-function:	Domestic / Single Dwelling
Construction Date:	ca. 1975
NRHP Eligibility:	Not eligible
Integrity/Comments:	Ranch-style dwelling with hipped-roof, brick cladding, aluminum windows, and an enclosed rear porch addition; on parcel with Resources 19b and 19c and non-historic-age garage (see additional Photographs in Appendix F); not a significant example of resource type or style.

View of Resource 19a, camera facing east.

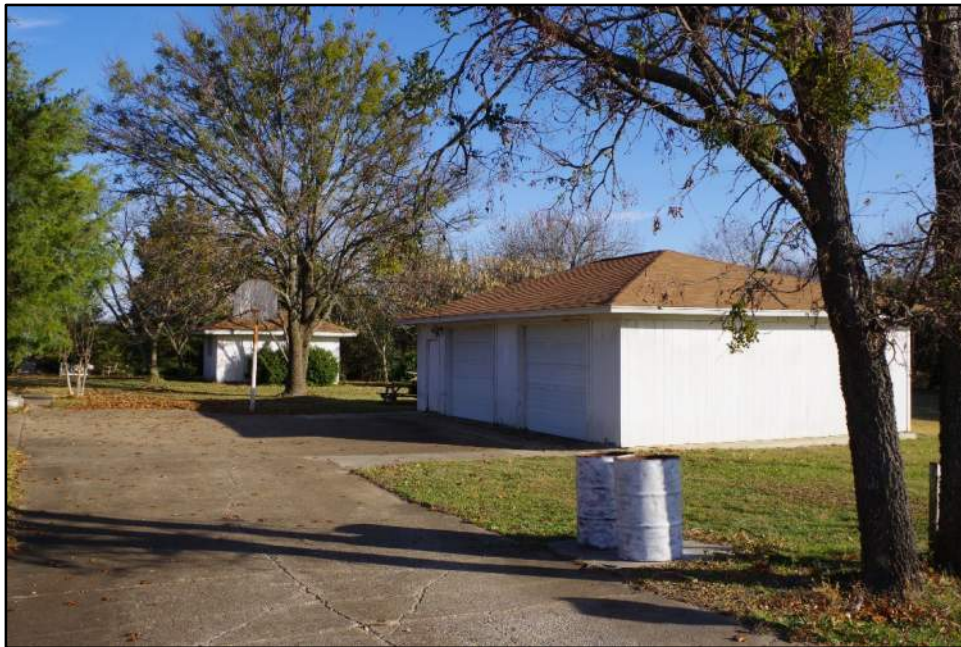
Survey Date:	December 6-9, 2021
Resource No:	19b
Project Location:	Coit Road to FM 1827
Project Name and CSJ:	0135-02-065, 0135-15-002, 0135-03-053
Address, Lat/Long:	5764 County Rd. 123 33.247252 / -96.682942
Function/Sub-function:	Domestic / Secondary Structure
Construction Date:	ca. 1975
NRHP Eligibility:	Not eligible
Integrity/Comments:	Pyramidal-roof outbuilding with vertical wood siding and a single window and door; on parcel with Resources 19a and 19c and non-historic-age garage (see additional Photographs in Appendix F); not a significant example of resource type.

View of Resource 19b (rear) and non-historic-age garage, camera facing northeast.

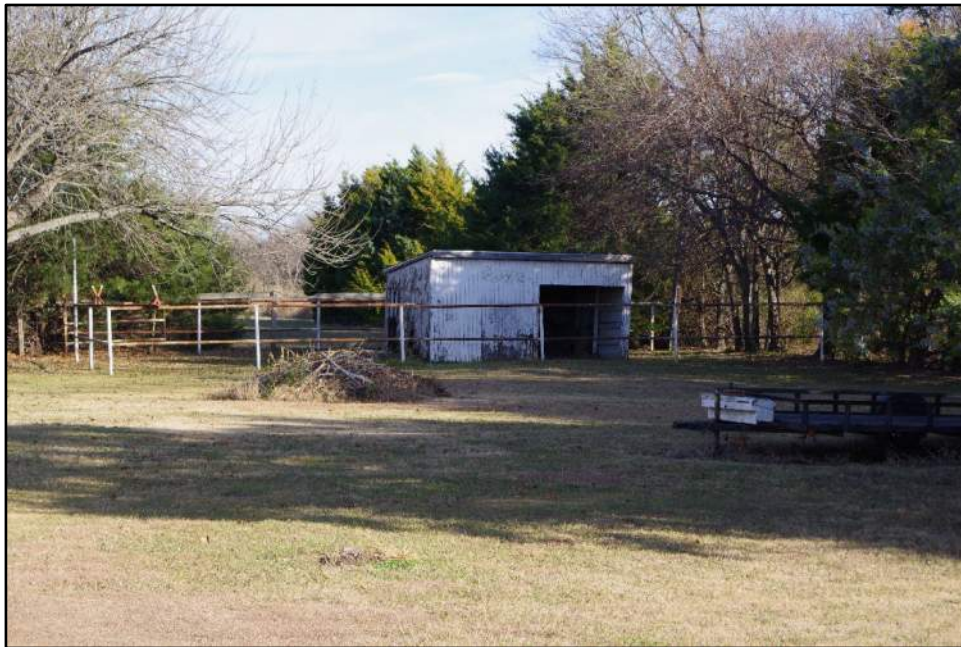
Survey Date:	December 6-9, 2021
Resource No:	19c
Project Location:	Coit Road to FM 1827
Project Name and CSJ:	0135-02-065, 0135-15-002, 0135-03-053
Address, Lat/Long:	5764 County Rd. 123 33.247252 / -96.682942
Function/Sub-function:	Agricultural/ Animal Facility
Construction Date:	ca. 1975
NRHP Eligibility:	Not eligible
Integrity/Comments:	Animal pen with shed-roof, vertical wood siding, and single-bay surrounded by metal corral fencing; on parcel with Resources 19a and 19b and non-historic-age garage (see additional Photographs in Appendix F); not a significant example of resource type.

View of Resource 19c, camera facing northeast.

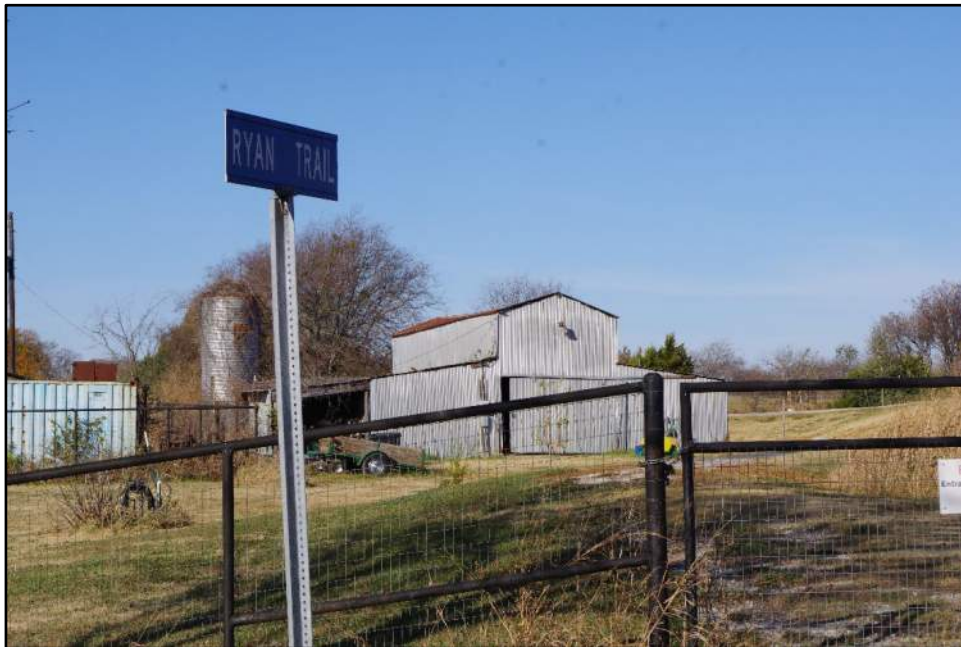
Survey Date:	December 6-9, 2021
Resource No:	20a
Project Location:	Coit Road to FM 1827
Project Name and CSJ:	0135-02-065, 0135-15-002, 0135-03-053
Address, Lat/Long:	3355 Ryan Trl. 33.248095 / -96.681181
Function/Sub-function:	Agricultural / Outbuilding
Construction Date:	ca. 1975
NRHP Eligibility:	Not eligible
Integrity/Comments:	Front-gabled monitor barn/outbuilding with shed-roof side additions, metal roof, and vertical metal siding; not visible in aerial imagery until after 1968 (NETR 1968); on parcel with Resource 20b and non-historic-age dwelling and outbuildings (see additional Photographs in Appendix F); not a significant example of resource type.

View of Resource 20a, camera facing west.

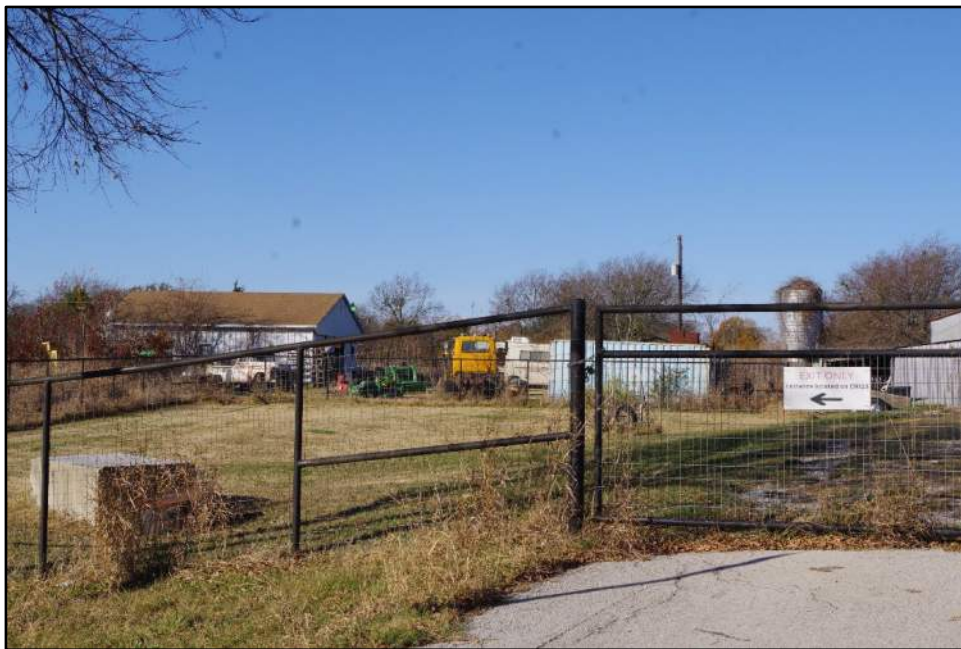
Survey Date:	December 6-9, 2021
Resource No:	20b
Project Location:	Coit Road to FM 1827
Project Name and CSJ:	0135-02-065, 0135-15-002, 0135-03-053
Address, Lat/Long:	3355 Ryan Trl. 33.248095 / -96.681181
Function/Sub-function:	Agricultural / Storage
Construction Date:	ca. 1975
NRHP Eligibility:	Not eligible
Integrity/Comments:	Metal silo; appears to not be in use; not visible in aerial imagery until after 1968 (NETR 1968); on parcel with Resource 20a and non-historic-age dwelling and outbuildings (see additional Photographs in Appendix F); not a significant example of resource type.

View of Resource 20b (right) and non-historic-age shed (left), camera facing west.

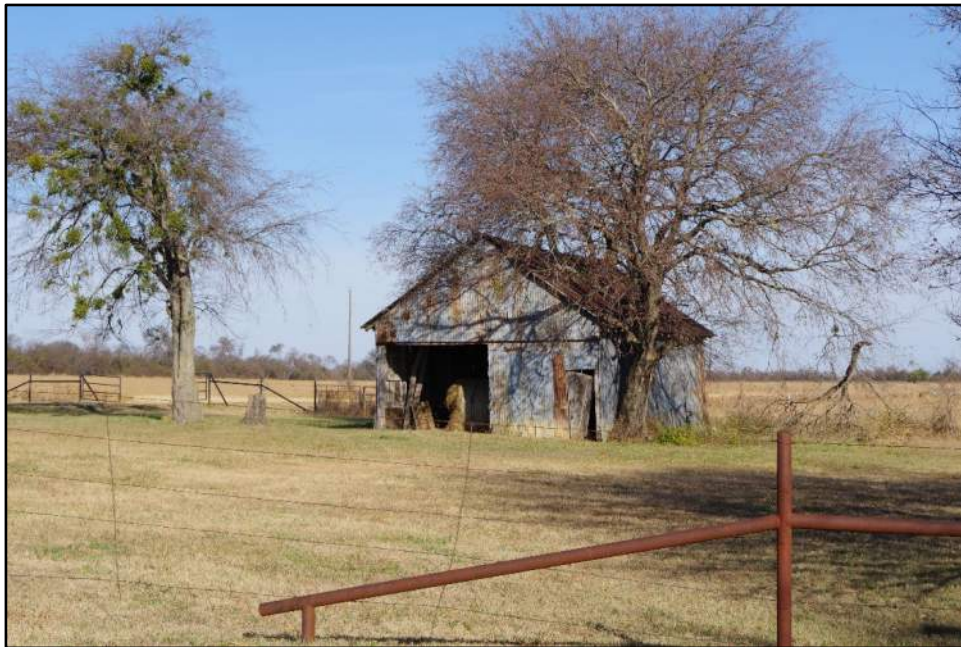
Survey Date:	December 6-9, 2021
Resource No:	21
Project Location:	Coit Road to FM 1827
Project Name and CSJ:	0135-02-065, 0135-15-002, 0135-03-053
Address, Lat/Long:	4366 County Rd. 164 33.252860 / -96.669520
Function/Sub-function:	Agricultural / Outbuilding
Construction Date:	ca. 1950
NRHP Eligibility:	Not eligible
Integrity/Comments:	Front-gabled barn with metal roof, metal siding, and single-bay; associated with a non-historic-age dwelling and outbuildings (see additional Photographs in Appendix F); not a significant example of resource type.

View of Resource 21, camera facing northwest.

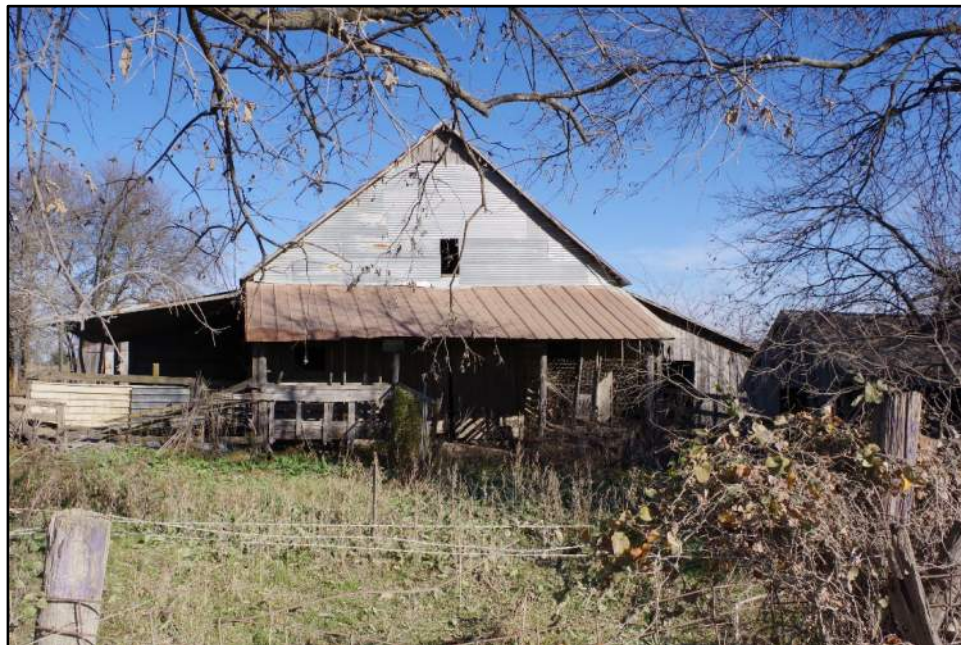
Survey Date:	December 6-9, 2021
Resource No:	22b
Project Location:	Coit Road to FM 1827
Project Name and CSJ:	0135-02-065, 0135-15-002, 0135-03-053
Address, Lat/Long:	3734 County Rd. 164 33.247366 / -96.662309
Function/Sub-function:	Vacant / Not in use
Construction Date:	ca. 1920
NRHP Eligibility:	Not eligible
Integrity/Comments:	Front-gabled barn with metal roof, a mix of wooden board-and-batten and corrugated metal siding, an enclosed shed-roof east side addition, and open shed-roof projections on the west side and south front elevations; no additional details were visible from the public ROW; on parcel with Resource 22a and Resources 22c-22j (see additional Photographs in Appendix F); retains fair integrity despite incorporation of additions and replacement metal siding on portions of the exterior but does not represent a significant example resource type; property as a whole no longer represents an intact or significant example of an early-twentieth-century agricultural complex.

View of Resource 22b, camera facing north.

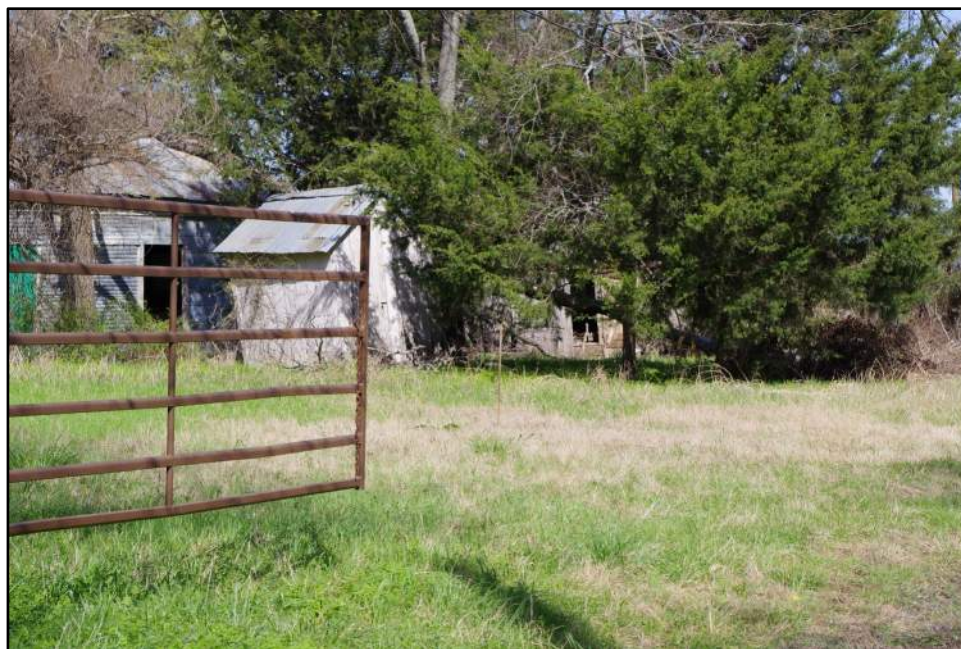
Survey Date:	December 6-9, 2021
Resource No:	22d
Project Location:	Coit Road to FM 1827
Project Name and CSJ:	0135-02-065, 0135-15-002, 0135-03-053
Address, Lat/Long:	3734 County Rd. 164 33.247366 / -96.662309
Function/Sub-function:	Vacant / Not in use
Construction Date:	ca. 1920
NRHP Eligibility:	Not eligible
Integrity/Comments:	Gabled outbuilding with vertical wood siding that was largely obscured from view due to setback; no additional details were visible from the public ROW; on parcel with Resources 22a-22c and Resources 22e-22j (see additional Photographs in Appendix F); does not appear to represent a significant example of a particular resource type; property as a whole no longer represents an intact or significant example of an early-twentieth-century agricultural complex.

View of Resource 22d, camera facing, camera facing northwest.

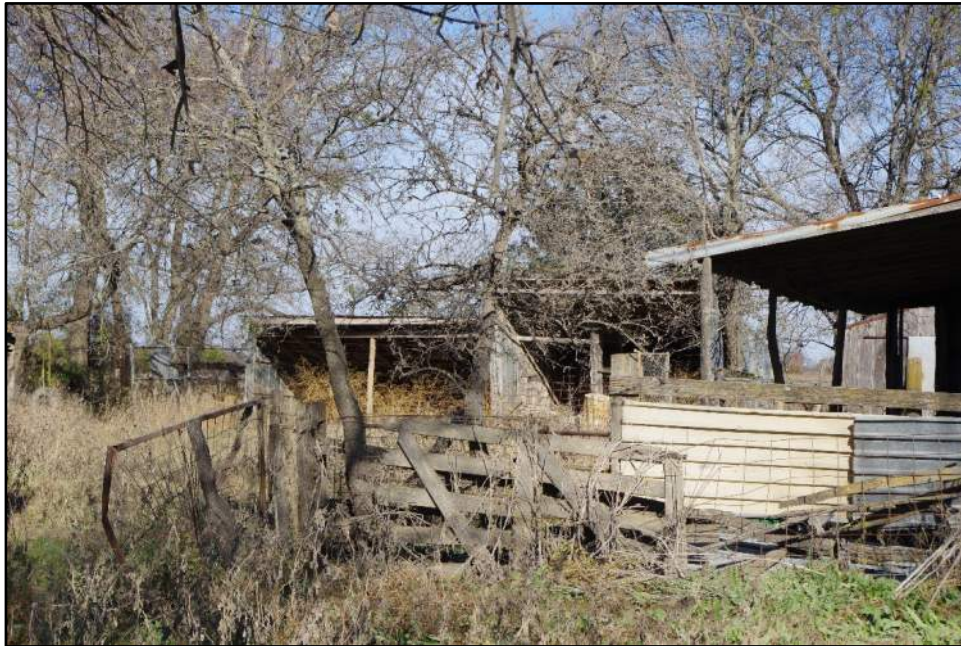
Survey Date:	December 6-9, 2021
Resource No:	22e
Project Location:	Coit Road to FM 1827
Project Name and CSJ:	0135-02-065, 0135-15-002, 0135-03-053
Address, Lat/Long:	3734 County Rd. 164 33.247366 / -96.662309
Function/Sub-function:	Vacant / Not in use
Construction Date:	ca. 1940
NRHP Eligibility:	Not eligible
Integrity/Comments:	Open two-bay hay shed with a metal shed roof, wood framing, and vertical wood siding; on parcel with Resources 22a-22d and Resources 22f-22j (see additional Photographs in Appendix F); retains fair integrity but not a significant example of a resource type; property as a whole no longer represents an intact or significant example of an early-twentieth-century agricultural complex.

View of Resource 22e, camera facing north.
