APPENDIX L: Cultural Resources

APPENDIX L – CULTURAL RESOURCES – FEIS Preferred Alternative/Blue Alternative

US 380 MCKINNEY – Coit Road to FM 1827, Collin County CSJs 0135-02-065 and 0135-15-002; Dallas District

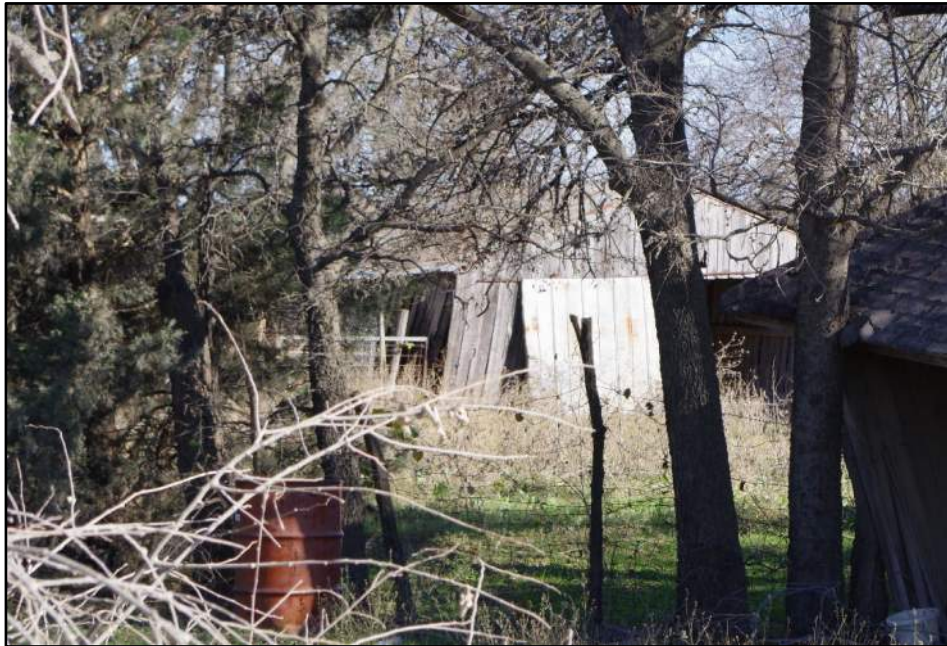
Survey Date:	December 6-9, 2021
Resource No:	22f
Project Location:	Coit Road to FM 1827
Project Name and CSJ:	0135-02-065, 0135-15-002, 0135-03-053
Address, Lat/Long:	3734 County Rd. 164 33.247366 / -96.662309
Function/Sub-function:	Vacant / Not in use
Construction Date:	ca. 1940
NRHP Eligibility:	Not eligible
Integrity/Comments:	Front-gabled equipment shed with a metal roof, vertical wood siding, and a sliding wooden door; on parcel with Resources 22a-22e and Resources 22g-22j (see additional Photographs in Appendix F); retains fair integrity but does not represent a significant example of resource type; property as a whole no longer represents an intact or significant example of an early-twentieth-century agricultural complex.

Obstructed view of Resource 22f, camera facing northeast.

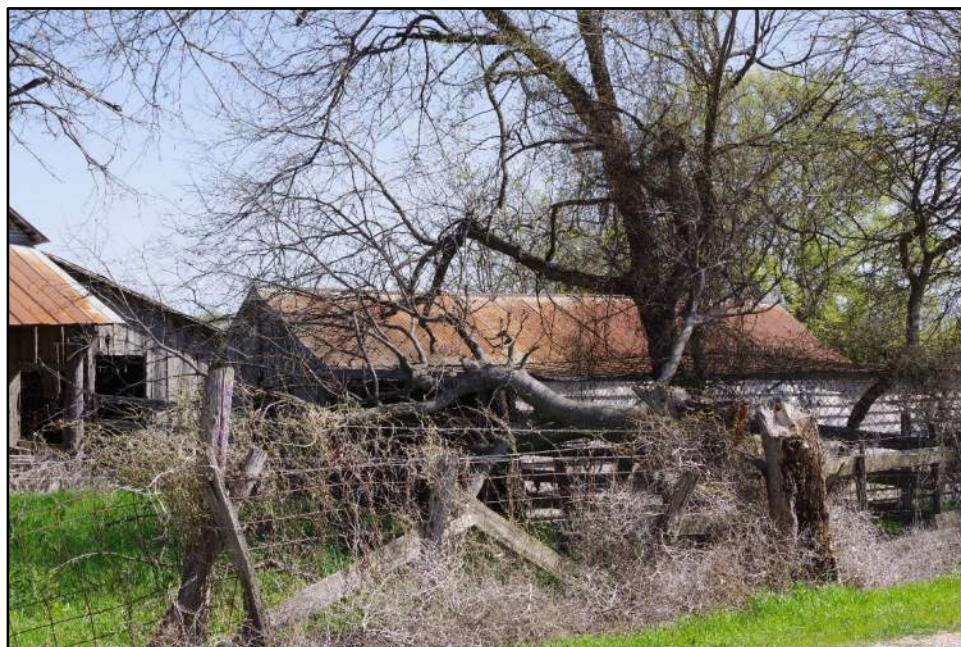
Survey Date:	December 6-9, 2021
Resource No:	22g
Project Location:	Coit Road to FM 1827
Project Name and CSJ:	0135-02-065, 0135-15-002, 0135-03-053
Address, Lat/Long:	3734 County Rd. 164 33.247366 / -96.662309
Function/Sub-function:	Vacant / Not in use
Construction Date:	ca. 1940
NRHP Eligibility:	Not eligible
Integrity/Comments:	Front-gabled outbuilding includes a metal roof, vertical wood siding, and a shed-roof side addition with metal siding; on parcel with Resources 22a-22f and Resources 22h-22j (see additional Photographs in Appendix F); retains fair integrity but does not represent a significant example of resource type; property as a whole no longer represents an intact or significant example of an early-twentieth-century agricultural complex.

View of Resource 22g, camera facing northeast.

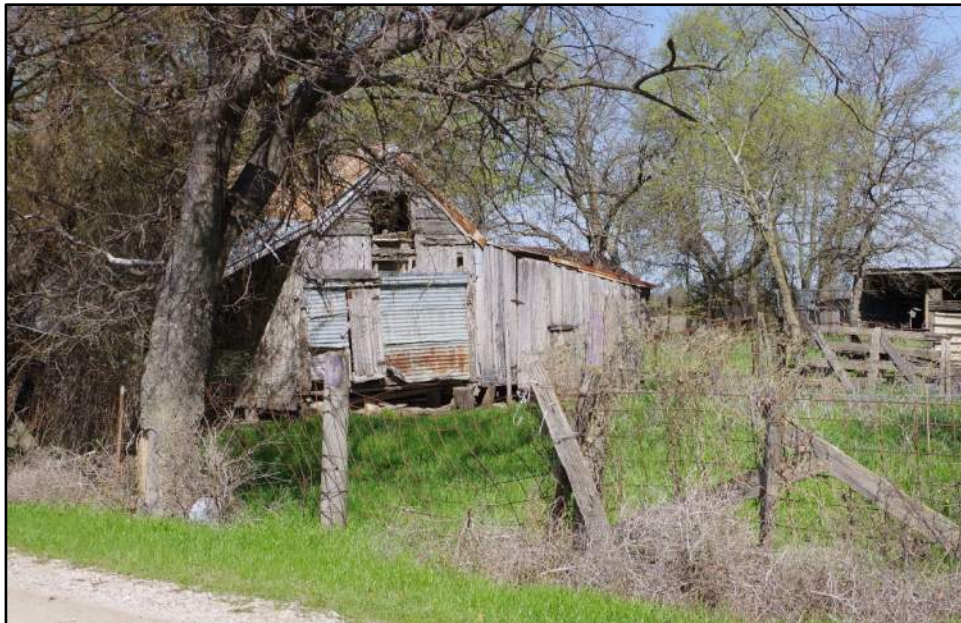
Survey Date:	December 6-9, 2021
Resource No:	22h
Project Location:	Coit Road to FM 1827
Project Name and CSJ:	0135-02-065, 0135-15-002, 0135-03-053
Address, Lat/Long:	3734 County Rd. 164 33.247366 / -96.662309
Function/Sub-function:	Vacant / Not in use
Construction Date:	ca. 1920
NRHP Eligibility:	Not eligible
Integrity/Comments:	Front-gabled outbuilding features a metal roof, vertical wood siding, a hayloft opening over the central bay, and shed-roof north and south side additions; on parcel with Resources 22a-22g and Resources 22i-22j (see additional Photographs in Appendix F); deterioration due to neglect has reduced its integrity, and it does not represent a significant example of resource type; property as a whole no longer represents an intact or significant example of an early-twentieth-century agricultural complex.

View of Resource 22h, camera facing northwest.

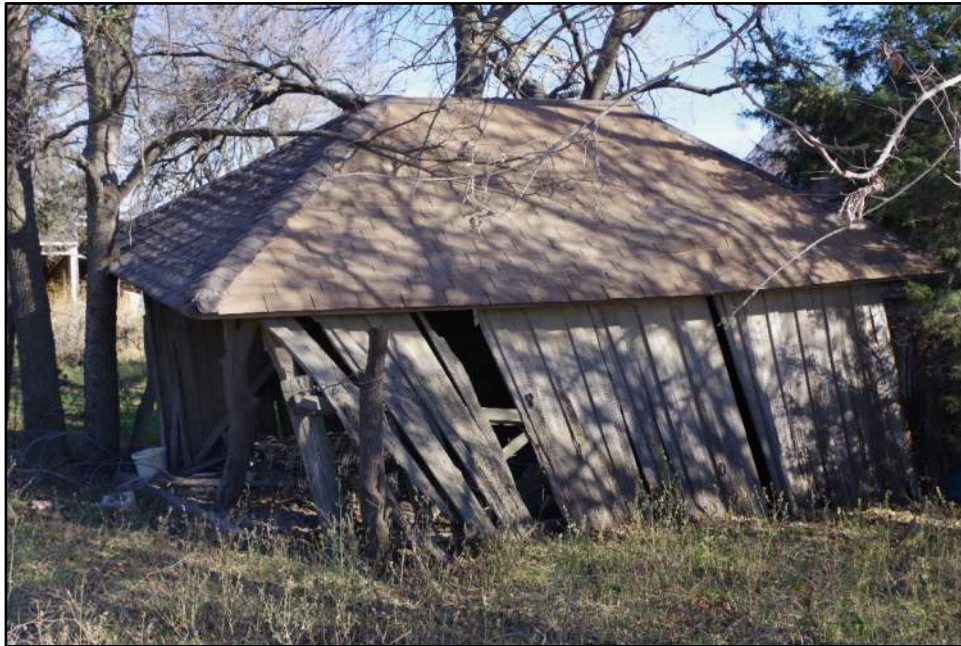
Survey Date:	December 6-9, 2021
Resource No:	22i
Project Location:	Coit Road to FM 1827
Project Name and CSJ:	0135-02-065, 0135-15-002, 0135-03-053
Address, Lat/Long:	3734 County Rd. 164 33.247366 / -96.662309
Function/Sub-function:	Vacant / Not in use
Construction Date:	ca. 1920
NRHP Eligibility:	Not eligible
Integrity/Comments:	Partially-collapsed garage with a hipped roof and vertical wood siding; in poor structural condition; on parcel with Resources 22a-22h and Resource 22j (see additional Photographs in Appendix F); deterioration due to neglect has reduced its integrity, and it does not represent a significant example of resource type; property as a whole no longer represents an intact or significant example of an early-twentieth-century agricultural complex.

View of Resource 22i, camera facing northeast.

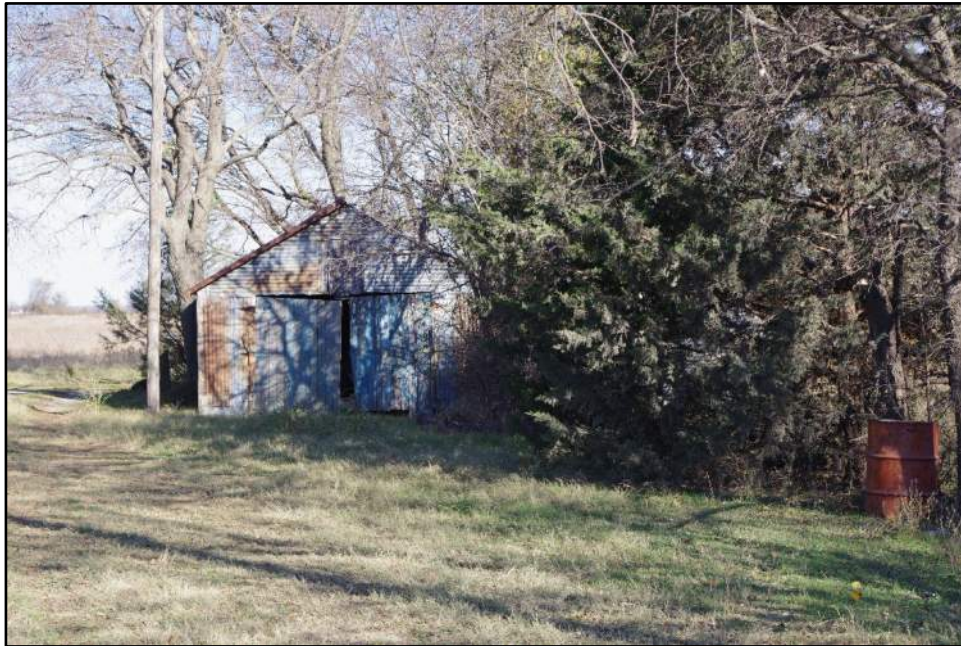
Survey Date:	December 6-9, 2021
Resource No:	22j
Project Location:	Coit Road to FM 1827
Project Name and CSJ:	0135-02-065, 0135-15-002, 0135-03-053
Address, Lat/Long:	3734 County Rd. 164 33.247366 / -96.662309
Function/Sub-function:	Vacant / Not in use
Construction Date:	ca. 1940
NRHP Eligibility:	Not eligible
Integrity/Comments:	Front-gabled equipment shed/garage features a metal roof, vertical metal cladding, hinged wooden doors, and a hayloft opening with a wooden door; on parcel with Resources 22a-22i (see additional Photographs in Appendix F); retains fair integrity but does not represent a significant example of resource type; property as a whole no longer represents an intact or significant example of an early-twentieth-century agricultural complex.

View of Resource 22j, camera facing north.

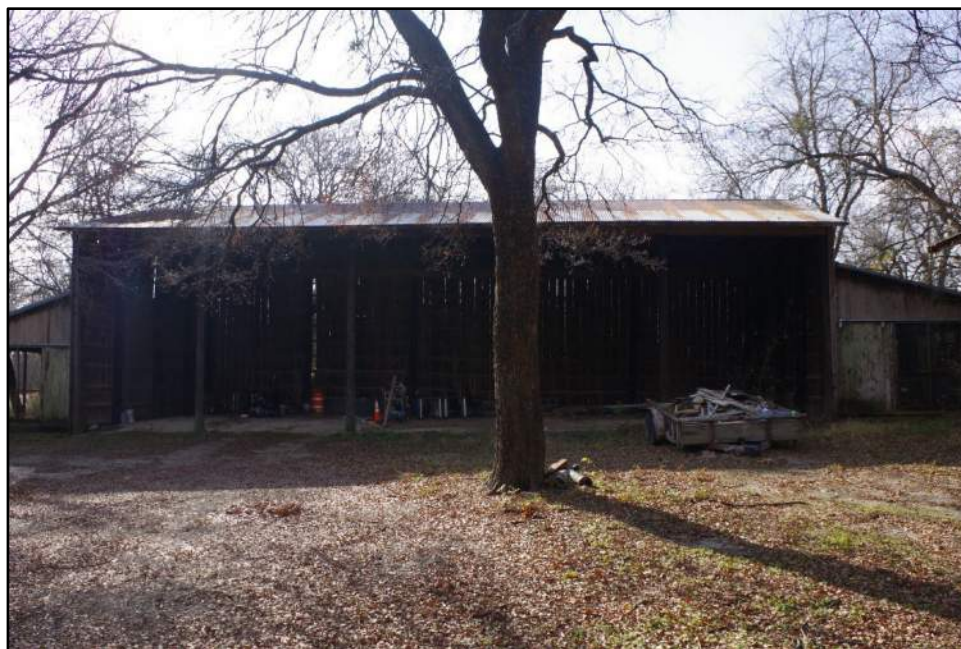
Survey Date:	December 6-9, 2021
Resource No:	23a
Project Location:	Coit Road to FM 1827
Project Name and CSJ:	0135-02-065, 0135-15-002, 0135-03-053
Address, Lat/Long:	North side of County Rd. 164, approximately 0.41 mi from the intersection with Limousine Pkwy. 33.247632 / -96.648300
Function/Sub-function:	Agricultural / Outbuilding
Construction Date:	ca. 1975
NRHP Eligibility:	Not eligible
Integrity/Comments:	Large, side-gabled, five-bay pole barn with metal roof, vertical wood siding, and two shed-roof side additions (chicken coops) with wooden sliding doors; on parcel with Resources 23b-23g and non-historic-age dwelling (see additional Photographs in Appendix F); not visible in aerial imagery until after 1968 (NETR 1968); retains fair integrity but is not a significant example of resource type.

Photograph 23: View of Resource 23a, camera facing south.

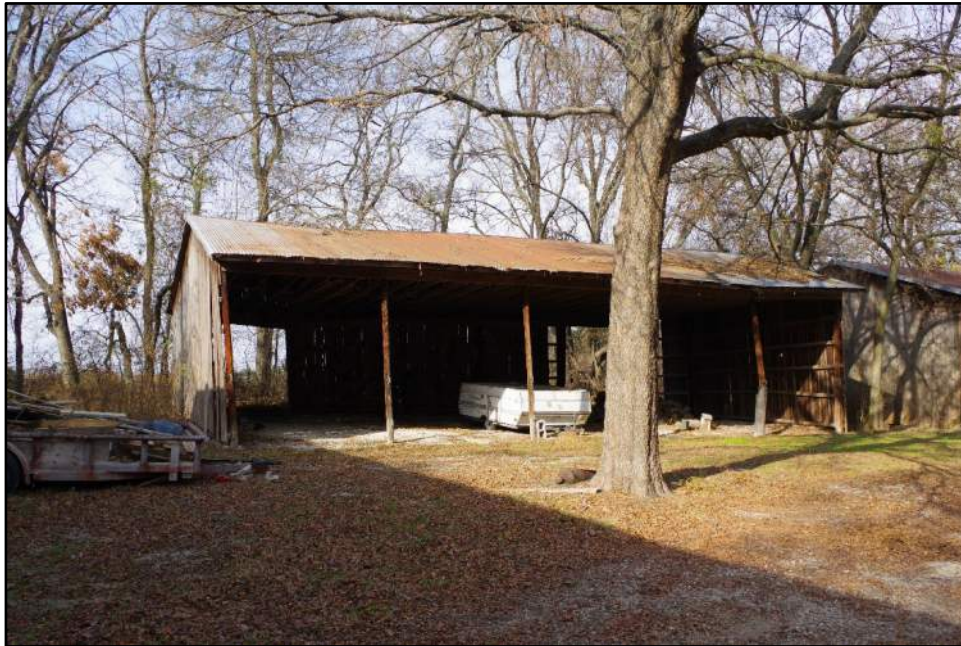
Survey Date:	December 6-9, 2021
Resource No:	23b
Project Location:	Coit Road to FM 1827
Project Name and CSJ:	0135-02-065, 0135-15-002, 0135-03-053
Address, Lat/Long:	North side of County Rd. 164, approximately 0.41 mi from the intersection with Limousine Pkwy. 33.247632 / -96.648300
Function/Sub-function:	Agricultural / Outbuilding
Construction Date:	ca. 1975
NRHP Eligibility:	Not eligible
Integrity/Comments:	Large side-gabled pole barn with metal roof, vertical wood siding, and a large open bay with central wooden supports; on parcel with Resource 23a and 23c-23g and non-historic-age dwelling (see additional Photographs in Appendix F); not visible in aerial imagery until after 1968 (NETR 1968); retains fair integrity but is not a significant example of resource type.

View of Resource 23b, camera facing northwest.

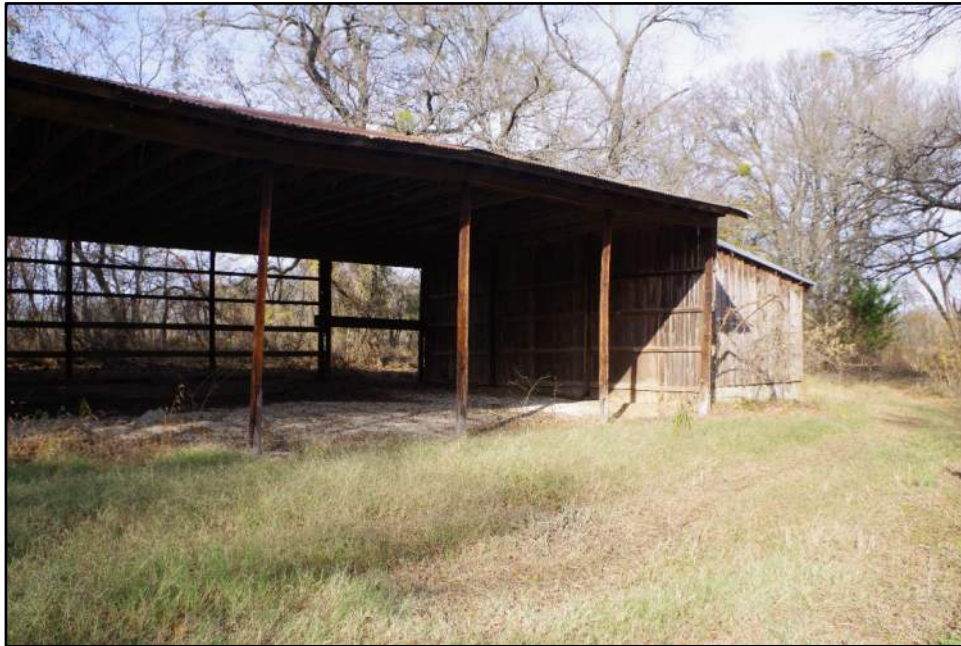
Survey Date:	December 6-9, 2021
Resource No:	23c
Project Location:	Coit Road to FM 1827
Project Name and CSJ:	0135-02-065, 0135-15-002, 0135-03-053
Address, Lat/Long:	North side of County Rd. 164, approximately 0.41 mi from the intersection with Limousine Pkwy. 33.247632 / -96.648300
Function/Sub-function:	Agricultural / Outbuilding
Construction Date:	ca. 1975
NRHP Eligibility:	Not eligible
Integrity/Comments:	Large side-gabled pole barn with metal roof, vertical wood cladding, and large open bay; on parcel with Resources 23a, 23b, 23d-23g, and non-historic-age dwelling (see additional Photographs in Appendix F); not visible in aerial imagery until after 1968 (NETR 1968); not a significant example of resource type.

View of Resource 23c, camera facing north-northwest.

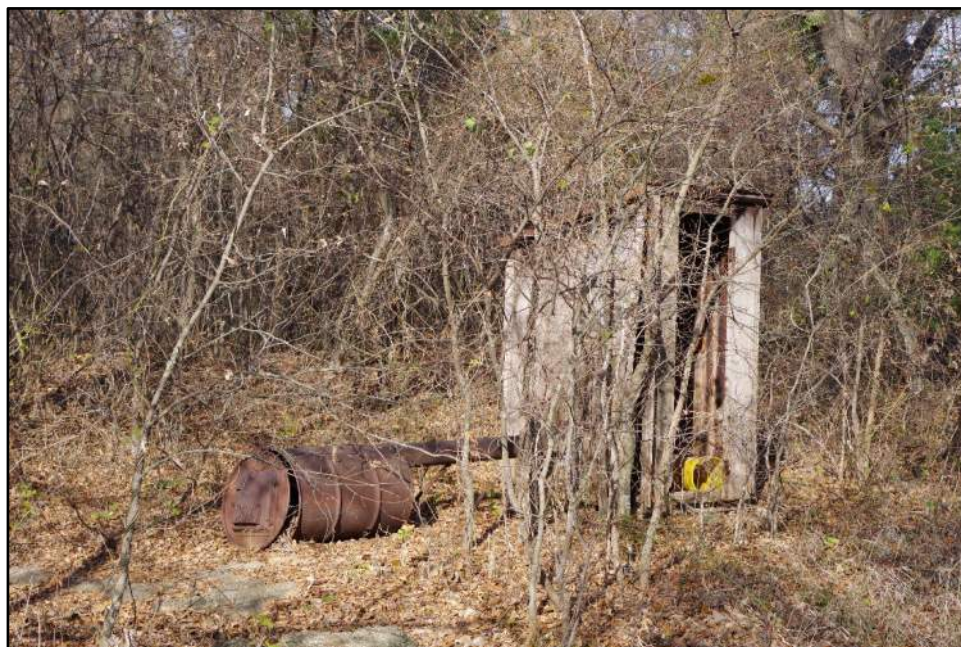
Survey Date:	December 6-9, 2021
Resource No:	23d
Project Location:	Coit Road to FM 1827
Project Name and CSJ:	0135-02-065, 0135-15-002, 0135-03-053
Address, Lat/Long:	North side of County Rd. 164, approximately 0.41 mi from the intersection with Limousine Pkwy. 33.247632 / -96.648300
Function/Sub-function:	Vacant / Not in use
Construction Date:	1975
NRHP Eligibility:	Not eligible
Integrity/Comments:	Small smokehouse (per property owner) with a shed-roof, wood siding, and a metal smoker on the western side; on parcel with Resources 23a-23c and 23e-23g and non-historic-age dwelling (see additional Photographs in Appendix F); retains fair integrity but is not a significant example of resource type.

View of Resource 23d, camera facing north.

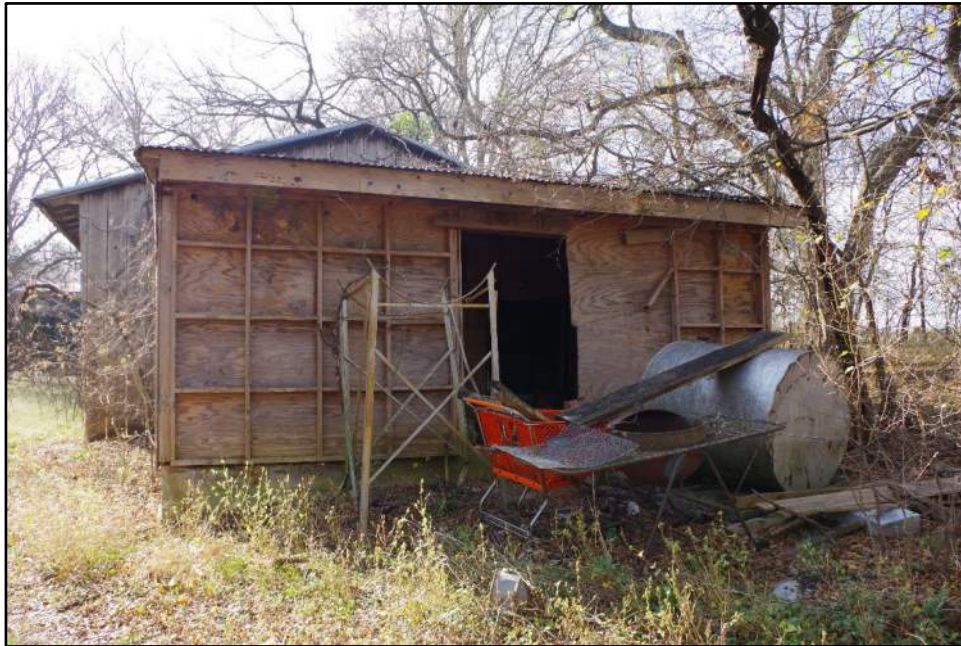
Survey Date:	December 6-9, 2021
Resource No:	23e
Project Location:	Coit Road to FM 1827
Project Name and CSJ:	0135-02-065, 0135-15-002, 0135-03-053
Address, Lat/Long:	North side of County Rd. 164, approximately 0.41 mi from the intersection with Limousine Pkwy. 33.247632 / -96.648300
Function/Sub-function:	Vacant / Not in use
Construction Date:	1975
NRHP Eligibility:	Not eligible
Integrity/Comments:	Shed-roof "cold storage" building (adjacent to Resource 23d) with plywood and vertical wood siding and central front entrance; on parcel with Resources 23a-23d and 23f-23g and non-historic-age dwelling (see additional Photographs in Appendix F); not a significant example of resource type.

View of Resource 23e, camera facing south.

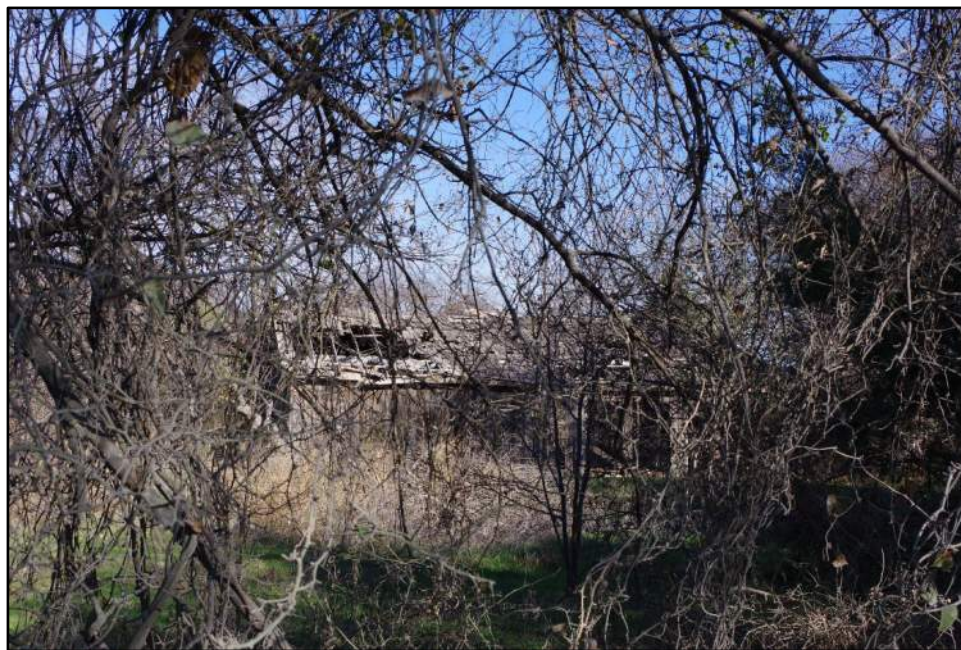
Survey Date:	December 6-9, 2021
Resource No:	23f
Project Location:	Coit Road to FM 1827
Project Name and CSJ:	0135-02-065, 0135-15-002, 0135-03-053
Address, Lat/Long:	North side of County Rd. 164, approximately 0.41 mi from the intersection with Limousine Pkwy. 33.247632 / -96.648300
Function/Sub-function:	Vacant / Not in use
Construction Date:	ca. 1925
NRHP Eligibility:	Not eligible
Integrity/Comments:	Side-gabled barn with remnants of wood shingle roof and vertical wood siding; vacant and in poor structural condition; no additional details were visible from the public ROW; visible in aerial imagery in 1956 as part of former farmstead (no longer extant); on parcel with Resources 23a-23e and 23g and non-historic-age dwelling (see additional Photographs in Appendix F); no longer in agricultural use; deterioration due to neglect has reduced its integrity; not a significant example of resource type.

Obstructed view of Resource 23f, camera facing north.

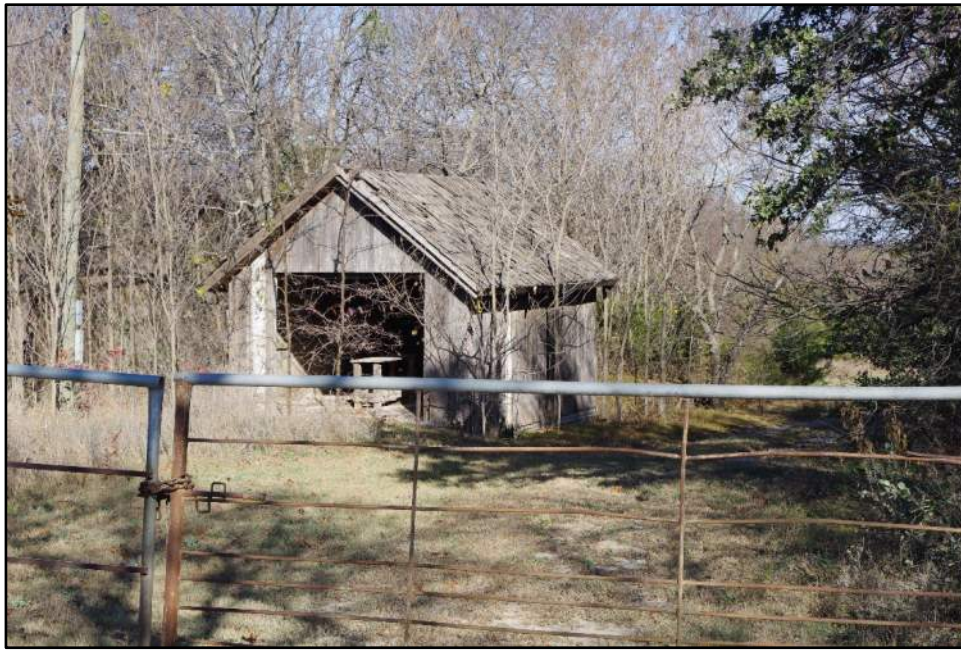
Survey Date:	December 6-9, 2021
Resource No:	23g
Project Location:	Coit Road to FM 1827
Project Name and CSJ:	0135-02-065, 0135-15-002, 0135-03-053
Address, Lat/Long:	North side of County Rd. 164, approximately 0.41 mi from the intersection with Limousine Pkwy. 33.247632 / -96.648300
Function/Sub-function:	Vacant / Not in use
Construction Date:	1940
NRHP Eligibility:	Not eligible
Integrity/Comments:	Front-gabled garage with wood shingle roof, vertical wood siding, and central open bay; currently vacant; visible in aerial imagery in 1956 as part of former farmstead (no longer extant); on parcel with Resources 23a-23f and non-historic-age dwelling (see additional Photographs in Appendix F); retains fair integrity but is not a significant example of resource type.

View of Resource 23g, camera facing northwest.

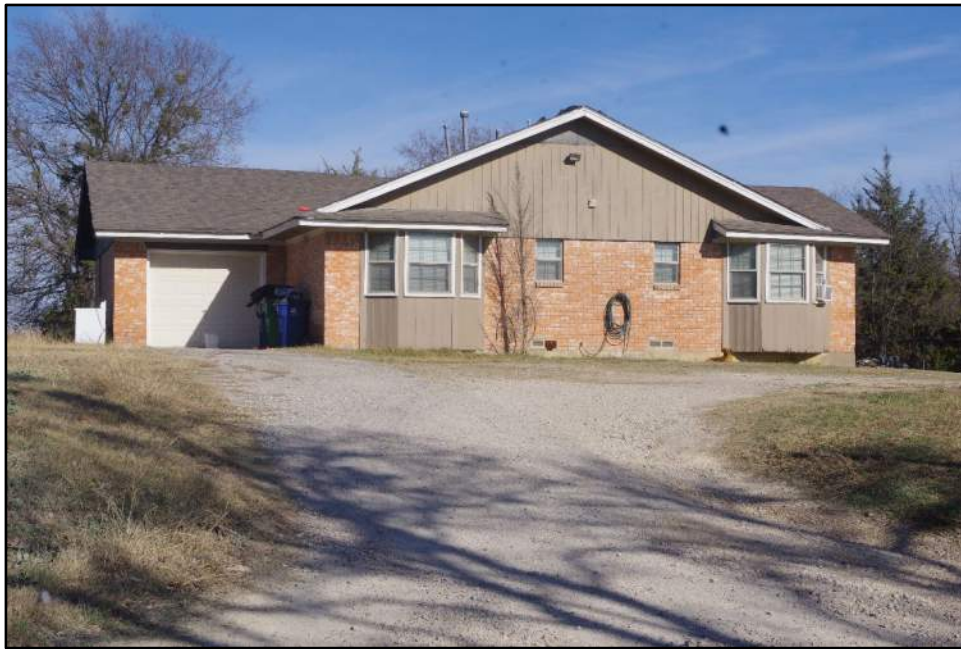
Survey Date:	December 6-9, 2021
Resource No:	24
Project Location:	Coit Road to FM 1827
Project Name and CSJ:	0135-02-065, 0135-15-002, 0135-03-053
Address, Lat/Long:	5764 Co. Road 201 33.252118 / -96.643281
Function/Sub-function:	Domestic / Single Dwelling
Construction Date:	ca. 1965
NRHP Eligibility:	Not eligible
Integrity/Comments:	Cross-gabled Ranch-style dwelling with brick cladding, aluminum multi-light and bay windows, and a single-bay garage (see additional Photographs in Appendix F); retains fair integrity but is not a significant example of resource type or style.

View of Resource 24, camera facing north.

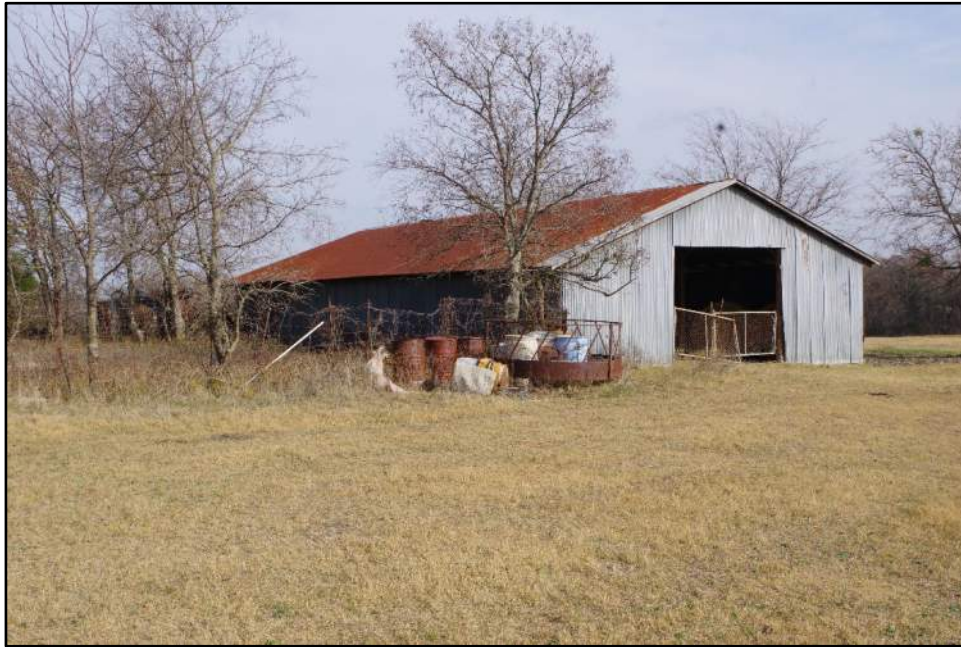
Survey Date:	December 6-9, 2021
Resource No:	25a
Project Location:	Coit Road to FM 1827
Project Name and CSJ:	0135-02-065, 0135-15-002, 0135-03-053
Address, Lat/Long:	Southeast corner of County Rd. 201 and County Rd. 164 33.250180 / -96.643022
Function/Sub-function:	Agricultural / Outbuilding
Construction Date:	ca. 1975
NRHP Eligibility:	Not eligible
Integrity/Comments:	Front-gabled barn with metal roof, metal siding, and central bay; on parcel with Resource 25b, remains of two collapsed outbuildings, and a non-historic-age shed (see additional Photographs in Appendix F); not visible in aerial imagery in 1968 but on site by 1981 (NETR 1968, 1981); retains fair integrity but is not a significant example of resource type.

View of Resource 25a, camera facing northeast.

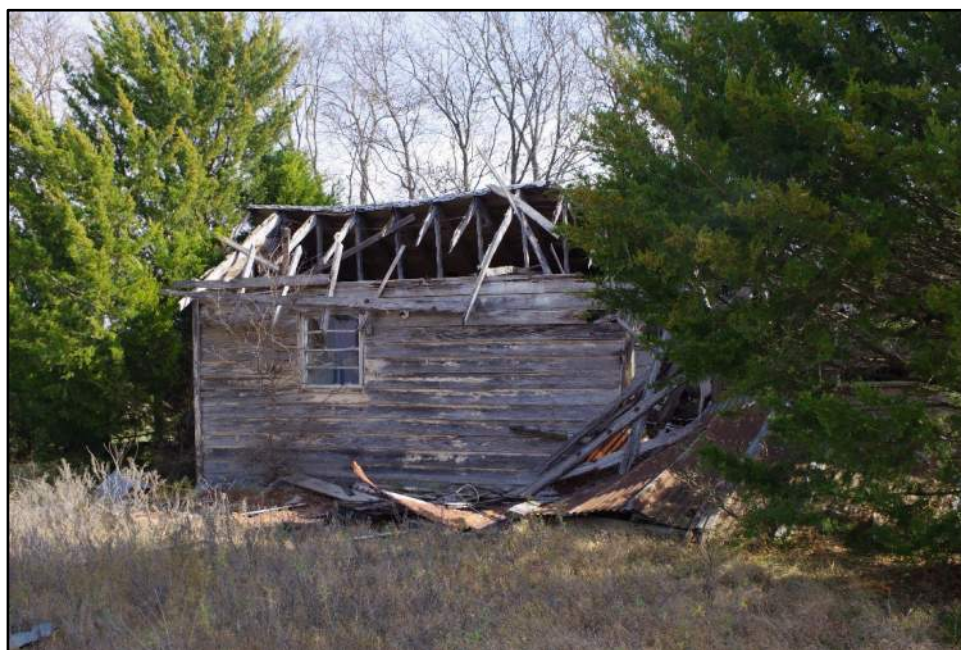
Survey Date:	December 6-9, 2021
Resource No:	25b
Project Location:	Coit Road to FM 1827
Project Name and CSJ:	0135-02-065, 0135-15-002, 0135-03-053
Address, Lat/Long:	Southeast corner of County Rd. 201 and County Rd. 164 33.250180 / -96.643022
Function/Sub-function:	Vacant / Not in use
Construction Date:	ca. 1965
NRHP Eligibility:	Not eligible
Integrity/Comments:	Side-gabled partially collapsed building (possible small dwelling) with vertical wood siding and aluminum windows; on parcel with Resource 25a, remains of two collapsed outbuildings, and a non-historic-age shed (see additional Photographs in Appendix F); not a significant example of resource type.

View of Resource 25b, camera facing east.

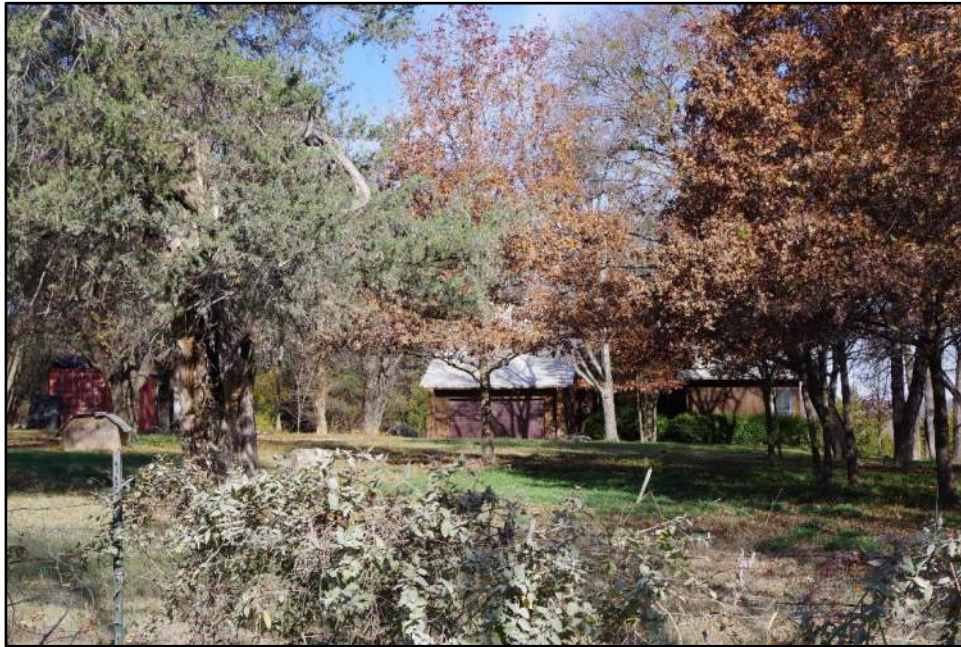
Survey Date:	December 6-9, 2021
Resource No:	26
Project Location:	Coit Road to FM 1827
Project Name and CSJ:	0135-02-065, 0135-15-002, 0135-03-053
Address, Lat/Long:	5378 County Rd. 201 33.252262 / -96.637162
Function/Sub-function:	Domestic / Single Dwelling
Construction Date:	ca. 1980
NRHP Eligibility:	Not eligible
Integrity/Comments:	Contemporary-style dwelling with steeply-pitched metal roof, wood siding, aluminum windows, and an integral two-bay garage with a vinyl overhead garage door; on parcel with two non-historic-age outbuildings (see additional Photographs in Appendix F); retains fair integrity but is not a significant example of resource type or style.

Obstructed overview of Resource 26, camera facing north.

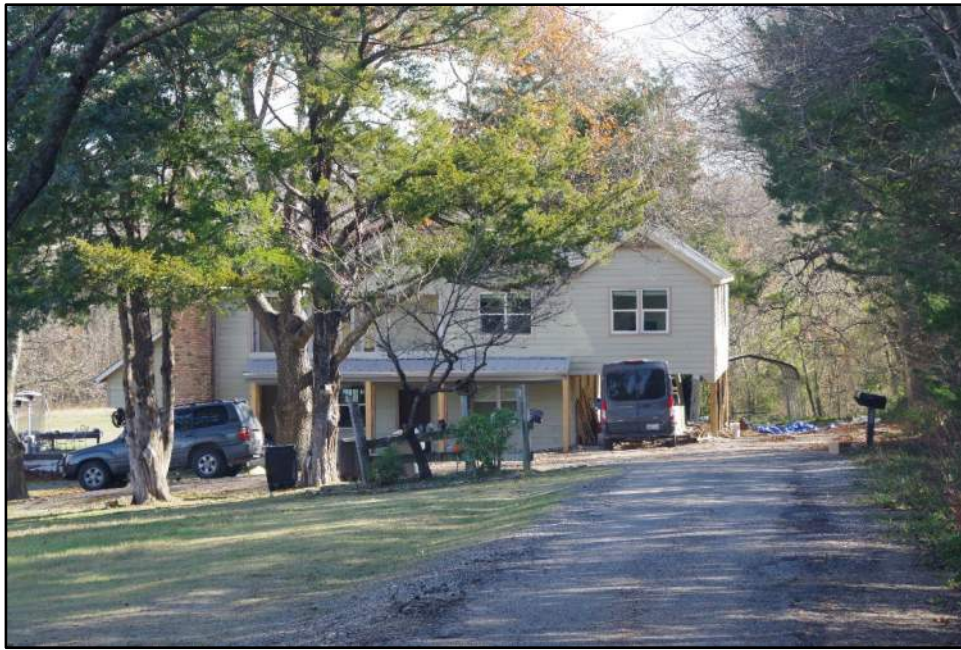
Survey Date:	December 6-9, 2021
Resource No:	27
Project Location:	Coit Road to FM 1827
Project Name and CSJ:	0135-02-065, 0135-15-002, 0135-03-053
Address, Lat/Long:	800 County Rd. 1200 33.251549 / -96.632482
Function/Sub-function:	Domestic / Single Dwelling
Construction Date:	ca. 1965
NRHP Eligibility:	Not eligible
Integrity/Comments:	Highly altered dwelling (possible former ranch-style dwelling) with front-gabled metal roof, vinyl cladding, replacement vinyl windows, shed-roof porch addition, and two-story gabled side addition; appears to be undergoing current exterior renovations (see additional Photographs in Appendix F); visible on 1968 aerial imagery (NETR 1968); lacks integrity of design, materials, and workmanship and is not a significant example of resource type or style.

View of Resource 27, camera facing east.

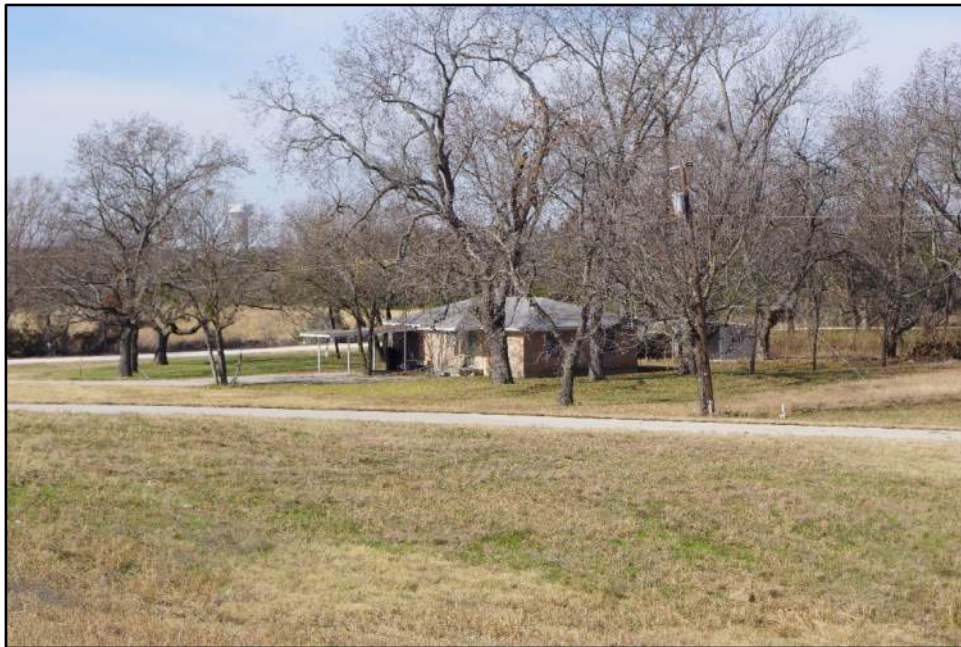
Survey Date:	December 6-9, 2021
Resource No:	28
Project Location:	Coit Road to FM 1827
Project Name and CSJ:	0135-02-065, 0135-15-002, 0135-03-053
Address, Lat/Long:	1300 Central Expy. 33.265882 / -96.601832
Function/Sub-function:	Domestic / Single Dwelling
Construction Date:	ca. 1975
NRHP Eligibility:	Not eligible
Integrity/Comments:	Simplified Ranch-style dwelling with hipped roof, brick cladding, aluminum windows, enclosed integral garage, and shed-roof carport addition (see additional Photographs in Appendix F); retains fair integrity but is not a significant example of resource type or style.

View of Resource 28 and non-historic-age shed, camera facing northwest.

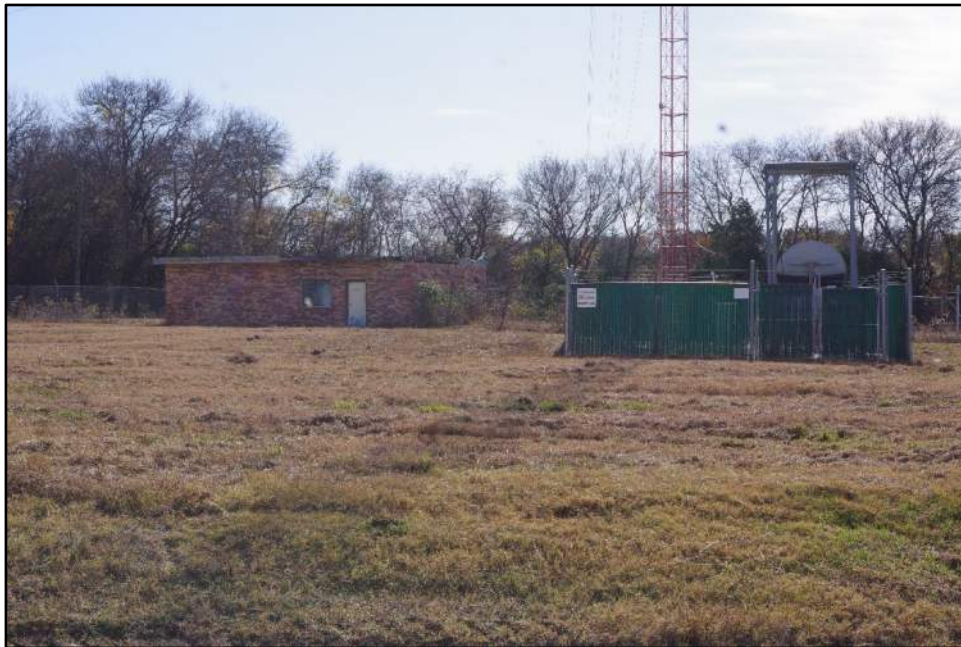
Survey Date:	December 6-9, 2021
Resource No:	29
Project Location:	Coit Road to FM 1827
Project Name and CSJ:	0135-02-065, 0135-15-002, 0135-03-053
Address, Lat/Long:	822 Central Expy. 33.263756 / -96.598175
Function/Sub-function:	Industry / Communication Facility
Construction Date:	ca. 1975
NRHP Eligibility:	Not eligible
Integrity/Comments:	Utility building for telephone communication with flat roof, brick cladding, single fixed window, and entry door (see additional Photographs in Appendix F); not a significant example of resource type.

Overview of Resource 29, camera facing south.

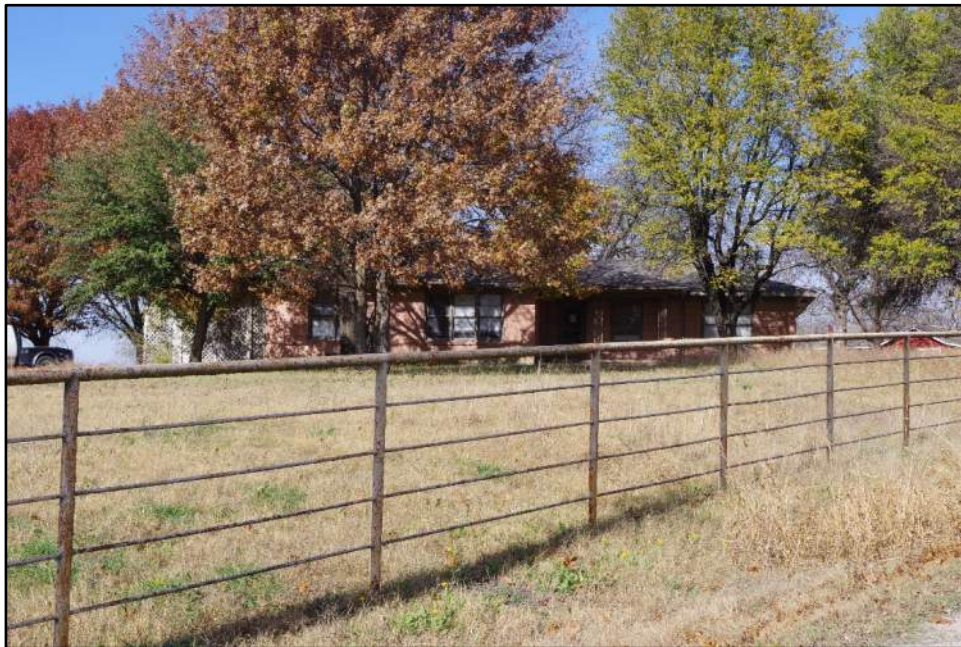
Survey Date:	December 6-9, 2021
Resource No:	30a
Project Location:	Coit Road to FM 1827
Project Name and CSJ:	0135-02-065, 0135-15-002, 0135-03-053
Address, Lat/Long:	3807 County Rd. 276 33.263473 / -96.605607
Function/Sub-function:	Domestic / Single Dwelling
Construction Date:	ca. 1965
NRHP Eligibility:	Not eligible
Integrity/Comments:	Hipped-roof Ranch-style dwelling with brick cladding, original painted metal windows, and integral front porch; on parcel with secondary dwellings and outbuildings (Resources 30b-30f) (see additional Photographs in Appendix F); retains integrity but is not a significant example of resource type or style.

View of Resource 30a, camera facing northwest.

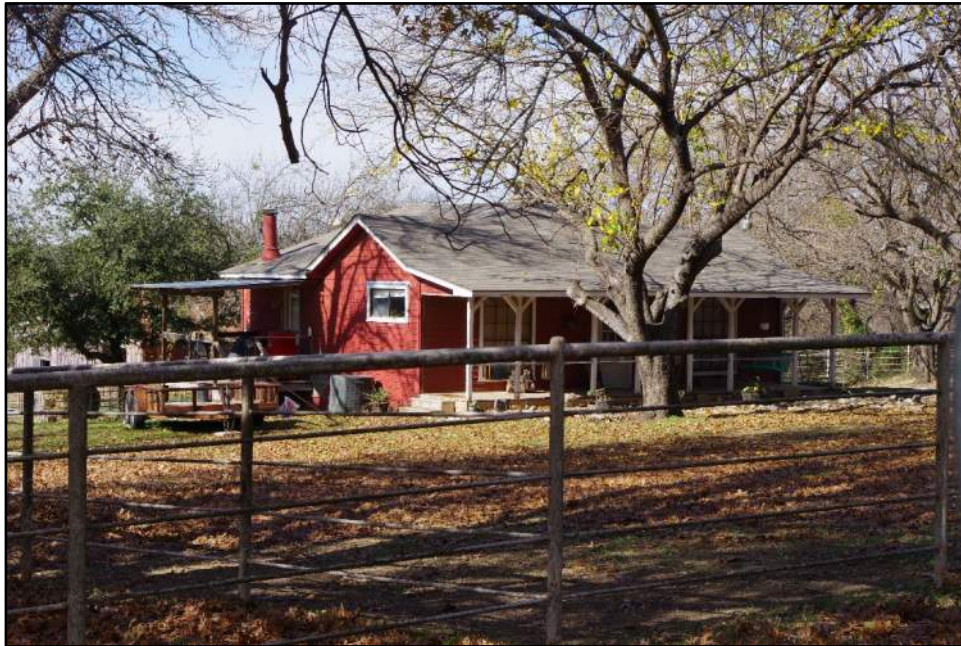
Survey Date:	December 6-9, 2021
Resource No:	30b
Project Location:	Coit Road to FM 1827
Project Name and CSJ:	0135-02-065, 0135-15-002, 0135-03-053
Address, Lat/Long:	3807 County Rd. 276 33.263473 / -96.605607
Function/Sub-function:	Domestic / Single Dwelling
Construction Date:	ca. 1960
NRHP Eligibility:	Not eligible
Integrity/Comments:	Side-gabled simplified ranch-style secondary dwelling with wood siding, wood windows, shed-roof front porch, and a large, hipped roof rear addition with side porches; on parcel with Resources 30a and 30c-30f (see additional Photographs in Appendix F); dwelling is not visible on site in 1956 aerial imagery (NETR 1956); lacks integrity of design and workmanship and is not a significant example of resource type.

View of Resource 30b, camera facing west-northwest.

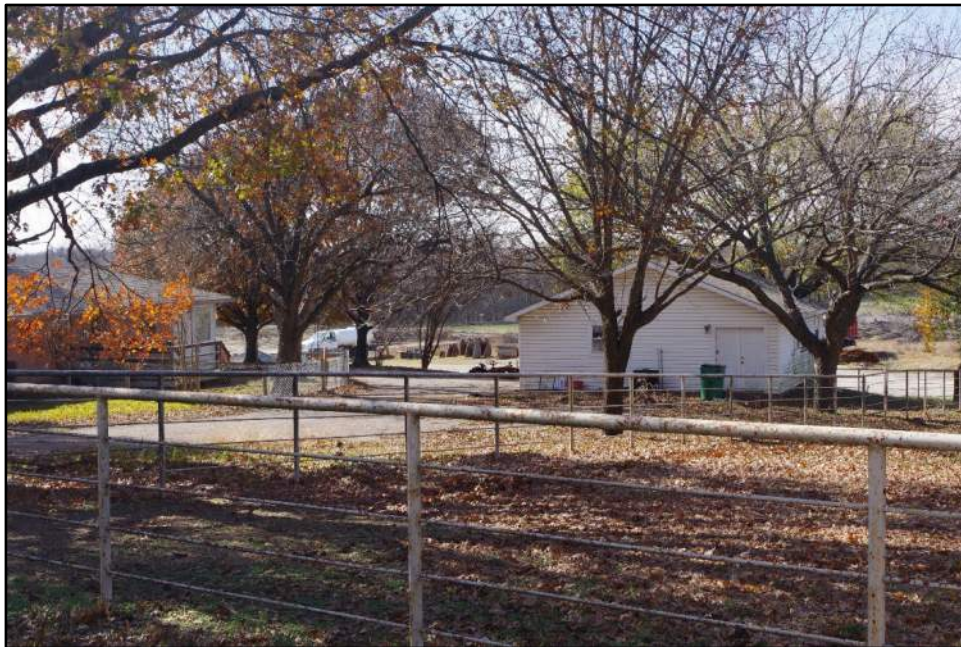
Survey Date:	December 6-9, 2021
Resource No:	30c
Project Location:	Coit Road to FM 1827
Project Name and CSJ:	0135-02-065, 0135-15-002, 0135-03-053
Address, Lat/Long:	3807 County Rd. 276 33.263473 / -96.605607
Function/Sub-function:	Domestic / Secondary Structure
Construction Date:	ca. 1975
NRHP Eligibility:	Not eligible
Integrity/Comments:	Front-gabled outbuilding or shop with vinyl cladding, vinyl windows, and paired entrance doors; on parcel with Resources 30a-30b and 30d-30f (see additional Photographs in Appendix F); not a significant example of resource type.

View of Resource 30c, camera facing northwest.

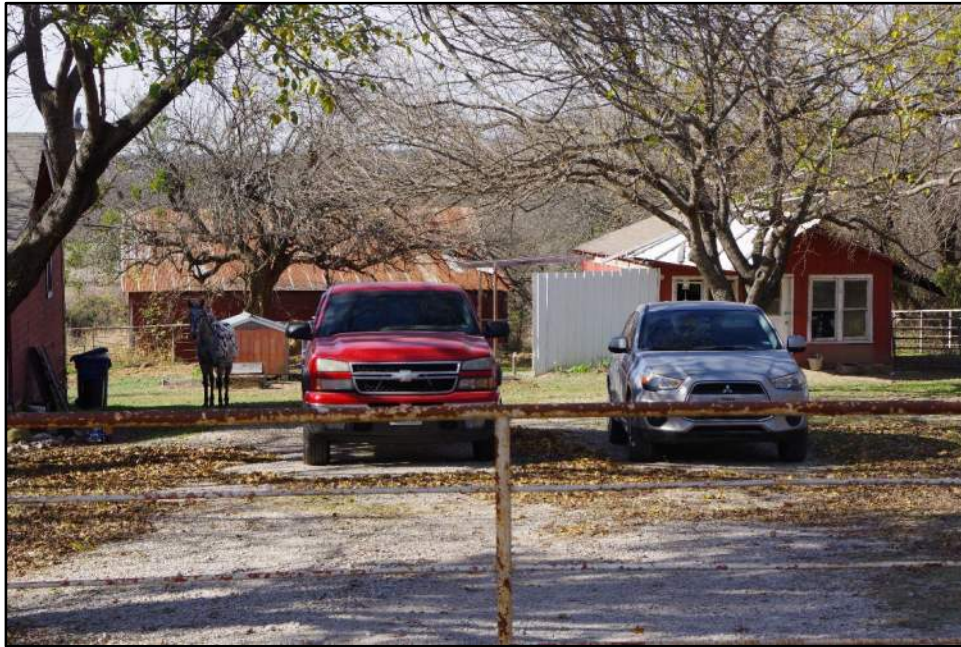
Survey Date:	December 6-9, 2021
Resource No:	30d
Project Location:	Coit Road to FM 1827
Project Name and CSJ:	0135-02-065, 0135-15-002, 0135-03-053
Address, Lat/Long:	3807 County Rd. 276 33.263473 / -96.605607
Function/Sub-function:	Domestic / Secondary Structure
Construction Date:	ca. 1960
NRHP Eligibility:	Not eligible
Integrity/Comments:	Front-gabled secondary dwelling with replacement metal roof (currently under construction), vertical wood siding, and original wood windows; not visible in aerial imagery in 1956; on parcel with Resources 30a-30c and 30e-30f (see additional Photographs in Appendix F); not a significant example of resource type.

View of Resource 30d (right) and Resource 30e (left), camera facing west.

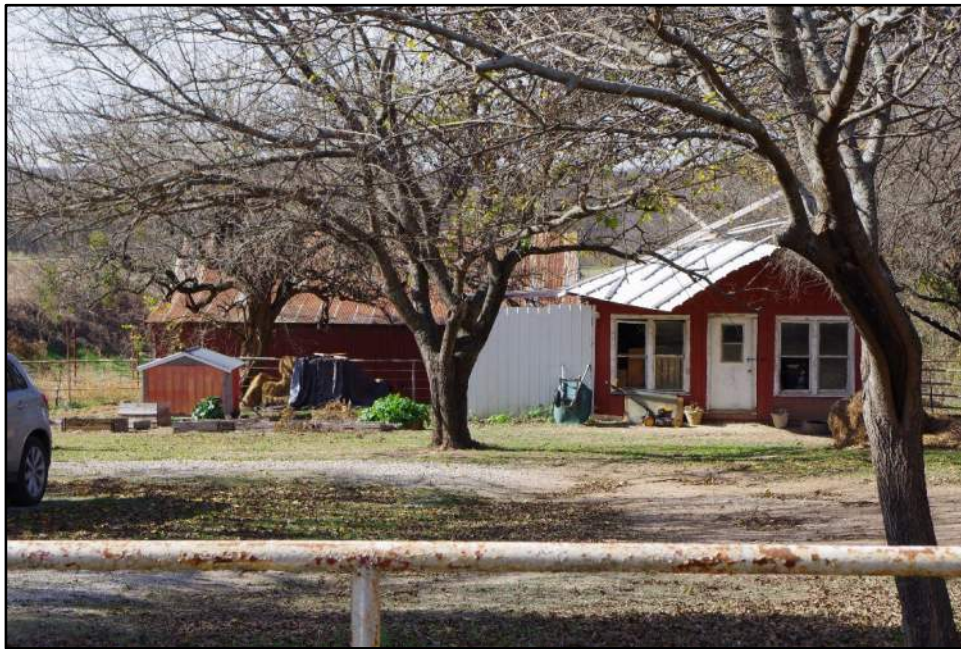
Survey Date:	December 6-9, 2021
Resource No:	30e
Project Location:	Coit Road to FM 1827
Project Name and CSJ:	0135-02-065, 0135-15-002, 0135-03-053
Address, Lat/Long:	3807 County Rd. 276 33.263473 / -96.605607
Function/Sub-function:	Agricultural / Outbuilding
Construction Date:	ca. 1960
NRHP Eligibility:	Not eligible
Integrity/Comments:	Metal clad barn with broken-gabled metal roof, metal siding, and shed-roof side addition; no additional details were visible from the public ROW; not visible in aerial imagery in 1956; on parcel with Resources 30a-30d and Resource 30f (see additional Photographs in Appendix F); not a significant example of resource type.

View of Resource 30d (right) and Resource 30e (left), camera facing west.

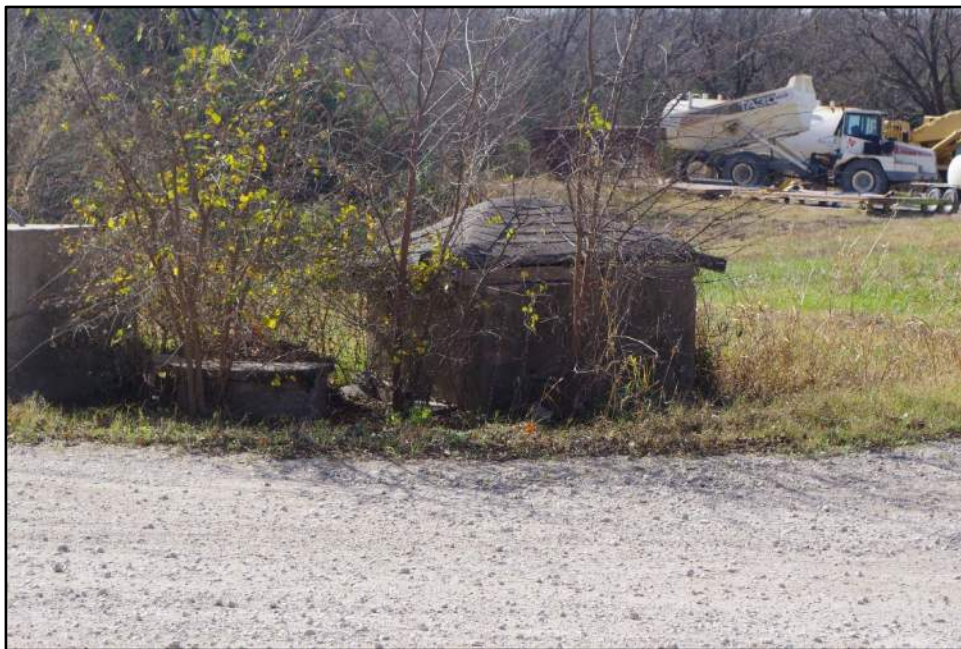
Survey Date:	December 6-9, 2021
Resource No:	30f
Project Location:	Coit Road to FM 1827
Project Name and CSJ:	0135-02-065, 0135-15-002, 0135-03-053
Address, Lat/Long:	3807 County Rd. 276 33.263473 / -96.605607
Function/Sub-function:	Domestic / Secondary Structure
Construction Date:	ca. 1960
NRHP Eligibility:	Not eligible
Integrity/Comments:	Concrete wellhouse with a pyramidal roof; no additional details were visible from the public ROW; on parcel with Resources 30a-30e (see additional Photographs in Appendix F); not a significant example of resource type.

View of Resource 30f, camera facing northwest.

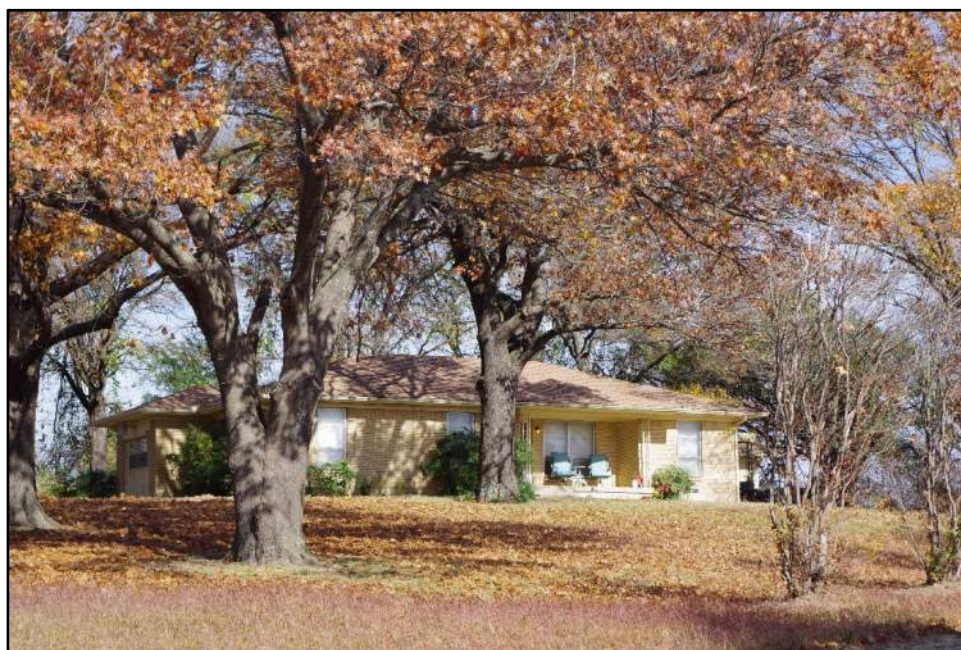
Survey Date:	December 6-9, 2021
Resource No:	31a
Project Location:	Coit Road to FM 1827
Project Name and CSJ:	0135-02-065, 0135-15-002, 0135-03-053
Address, Lat/Long:	3822 County Rd. 276 33.263419 / -96.605102
Function/Sub-function:	Domestic / Single Dwelling
Construction Date:	ca. 1960
NRHP Eligibility:	Not eligible
Integrity/Comments:	Ranch-style dwelling with hipped-roof, brick cladding, replacement vinyl windows, enclosed garage, and integral front entrance; on parcel with Resources 31b-31c (see additional Photographs in Appendix F); retains fair integrity but is not a significant example of resource type or style.

View of Resource 31a, camera facing north.

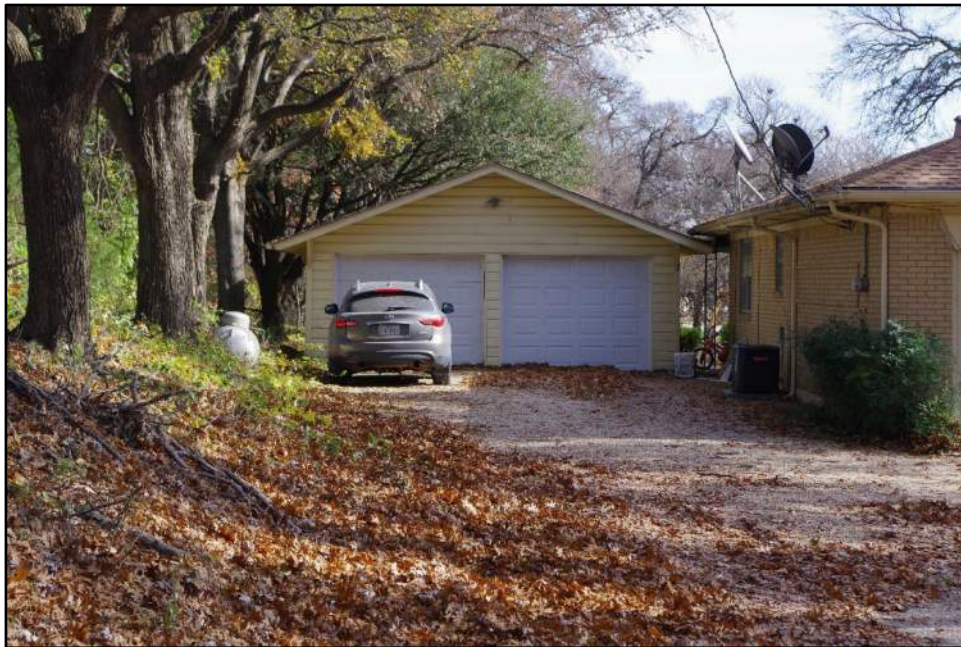
Survey Date:	December 6-9, 2021
Resource No:	31b
Project Location:	Coit Road to FM 1827
Project Name and CSJ:	0135-02-065, 0135-15-002, 0135-03-053
Address, Lat/Long:	3822 County Rd. 276 33.263419 / -96.605102
Function/Sub-function:	Domestic / Secondary Structure
Construction Date:	ca. 1975
NRHP Eligibility:	Not eligible
Integrity/Comments:	Front-gabled garage with vinyl siding and two metal or vinyl overhead garage doors; on parcel with Resources 31a and 31c (see additional Photographs in Appendix F); not a significant example of resource type.

View of Resource 31b, camera facing east.
