APPENDIX L: Cultural Resources

APPENDIX L – CULTURAL RESOURCES – FEIS Preferred Alternative/Blue Alternative

US 380 MCKINNEY – Coit Road to FM 1827, Collin County CSJs 0135-02-065 and 0135-15-002; Dallas District

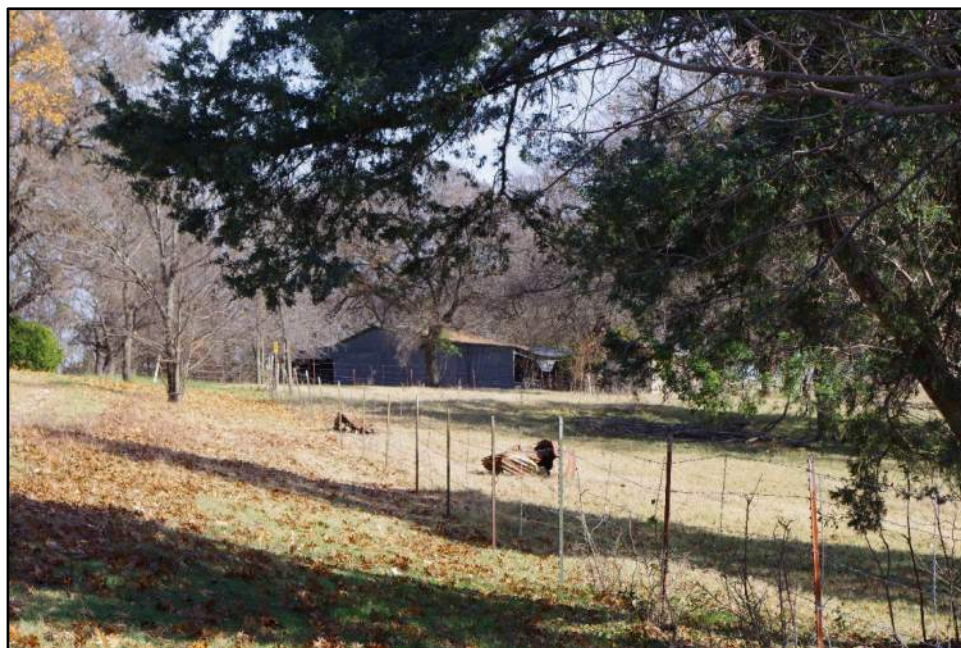
Survey Date:	December 6-9, 2021
Resource No:	31c
Project Location:	Coit Road to FM 1827
Project Name and CSJ:	0135-02-065, 0135-15-002, 0135-03-053
Address, Lat/Long:	3822 County Rd. 276 33.263419 / -96.605102
Function/Sub-function:	Agricultural / Outbuilding
Construction Date:	ca. 1960
NRHP Eligibility:	Not eligible
Integrity/Comments:	Gabled pole barn with metal roof and metal siding; on parcel with Resources 31a-31b (see additional Photographs in Appendix F); not a significant example of resource type.

View of Resource 31c, camera facing northeast.

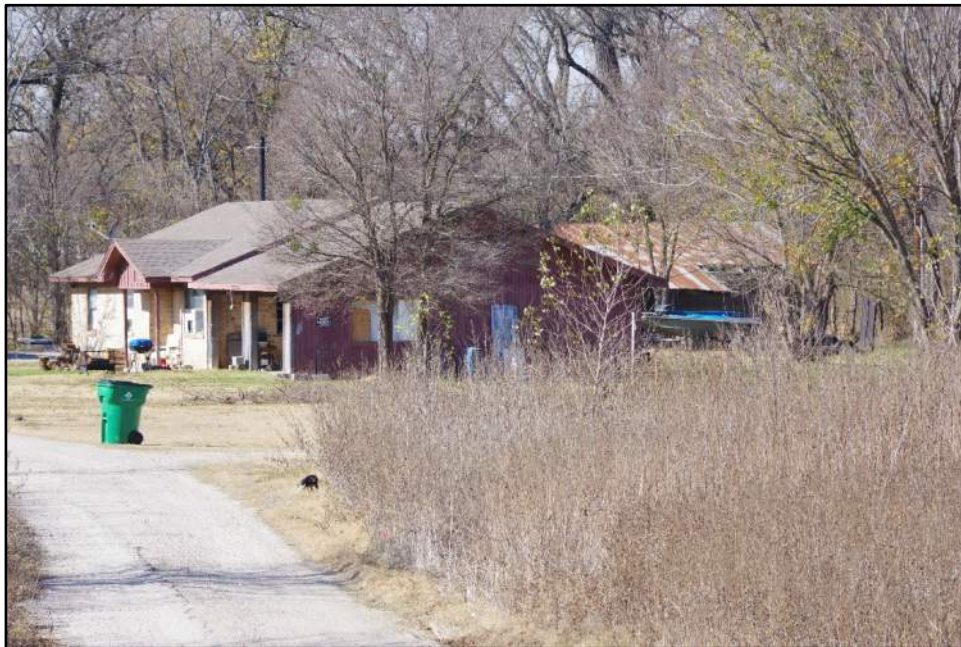
Survey Date:	December 6-9, 2021
Resource No:	32a
Project Location:	Coit Road to FM 1827
Project Name and CSJ:	0135-02-065, 0135-15-002, 0135-03-053
Address, Lat/Long:	North side of N. Central Expy. S., approximately 0.25 mi from the intersection with Laud Howell Pkwy. 33.248386 / -96.622295
Function/Sub-function:	Domestic / Single Dwelling
Construction Date:	ca. 1965
NRHP Eligibility:	Not eligible
Integrity/Comments:	Side-gabled Ranch-style dwelling with brick cladding, aluminum windows, and garage addition; on parcel with Resources 32b-32c (see additional Photographs in Appendix F); retains fair integrity but is not a significant example of resource type.

View of Resource 32a and Resource 32c (background), camera facing northwest.

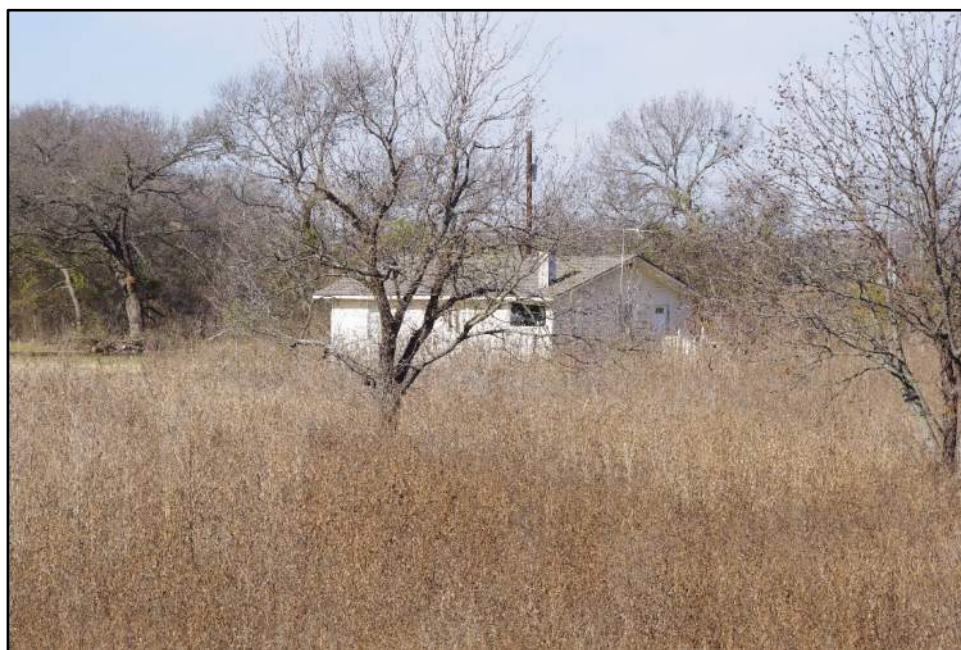
Survey Date:	December 6-9, 2021
Resource No:	32b
Project Location:	Coit Road to FM 1827
Project Name and CSJ:	0135-02-065, 0135-15-002, 0135-03-053
Address, Lat/Long:	North side of N. Central Expy. S., approximately 0.25 mi from the intersection with Laud Howell Pkwy. 33.248386 / -96.622295
Function/Sub-function:	Domestic / Secondary Dwelling or Structure
Construction Date:	ca. 1975
NRHP Eligibility:	Not eligible
Integrity/Comments:	Side-gabled secondary dwelling or outbuilding with wood siding, apparent metal windows, an interior chimney, and two replacement doors; on parcel with Resources 32a and 32c (see additional Photographs in Appendix F); not a significant example of resource type.

View of Resource 32b, camera facing northwest.

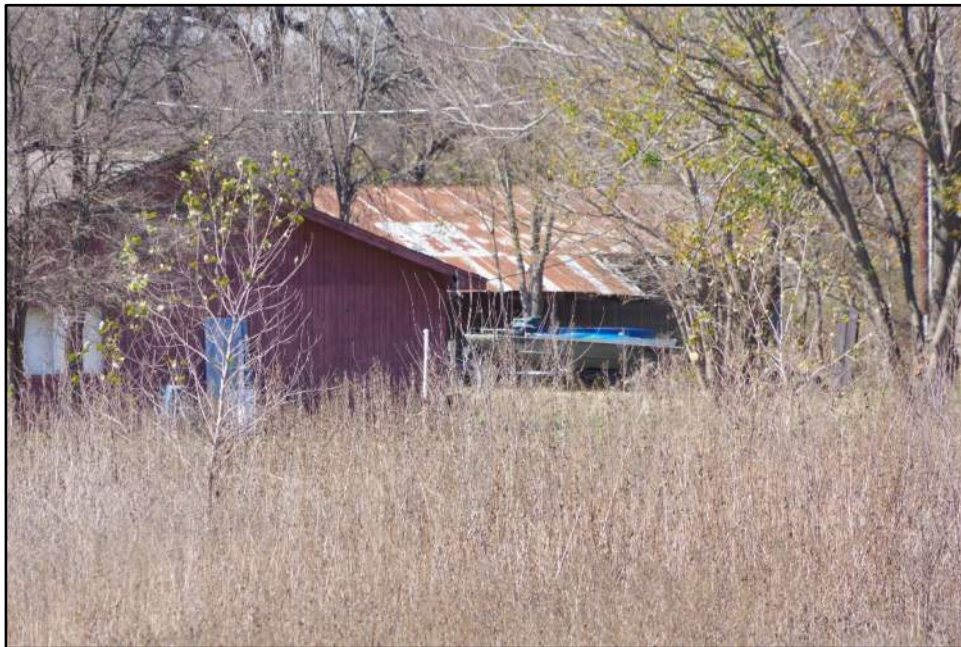
Survey Date:	December 6-9, 2021
Resource No:	32c
Project Location:	Coit Road to FM 1827
Project Name and CSJ:	0135-02-065, 0135-15-002, 0135-03-053
Address, Lat/Long:	North side of N. Central Expy. S., approximately 0.25 mi from the intersection with Laud Howell Pkwy. 33.248386 / -96.622295
Function/Sub-function:	Agricultural / Outbuilding
Construction Date:	ca. 1965
NRHP Eligibility:	Not eligible
Integrity/Comments:	Front-gabled barn clad with metal roof and metal cladding; no additional details were visible from the public ROW; on parcel with Resources 32a-32b (see additional Photographs in Appendix F); does not appear to be a significant example of resource type.

Obstructed view of Resource 32c, camera facing northwest.

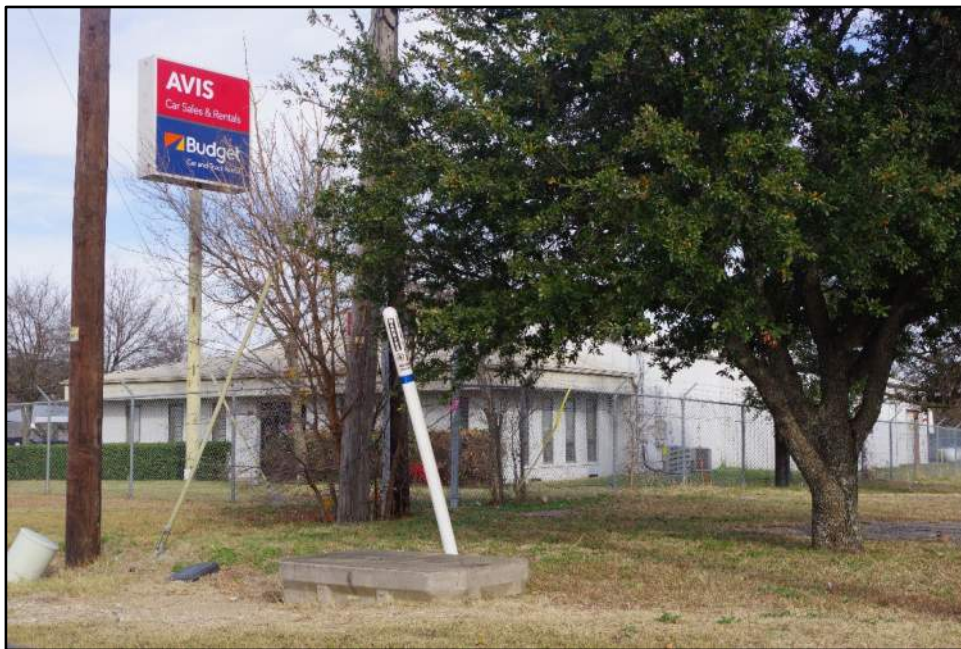
Survey Date:	December 6-9, 2021
Resource No:	33
Project Location:	Coit Road to FM 1827
Project Name and CSJ:	0135-02-065, 0135-15-002, 0135-03-053
Address, Lat/Long:	3512 N US 75-Central Expy 1000 33.233347 / -96.630819
Function/Sub-function:	Commerce / Business
Construction Date:	ca. 1975
NRHP Eligibility:	Not eligible
Integrity/Comments:	Front-gabled commercial building with vinyl siding and windows and hipped-roof front addition (see additional Photographs in Appendix F); not a significant example of resource type.

Obstructed view of Resource 33, camera facing northeast.

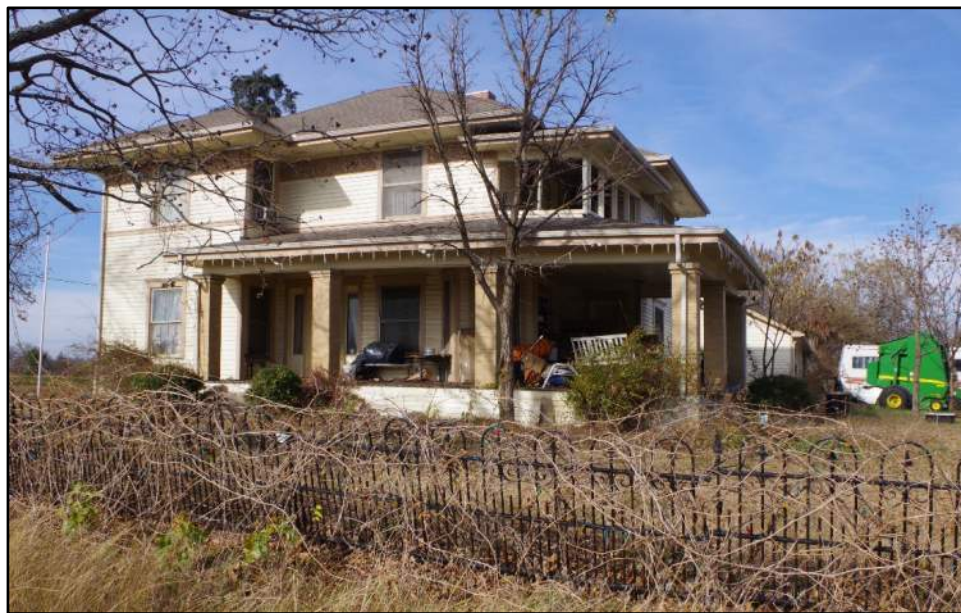
Survey Date:	December 6-9, 2021
Resource No:	34a
Project Location:	Coit Road to FM 1827
Project Name and CSJ:	0135-02-065, 0135-15-002, 0135-03-053
Address, Lat/Long:	551 McIntyre Rd. 33.226896 / -96.604478
Function/Sub-function:	Domestic / Single Dwelling
Construction Date:	ca. 1910
NRHP Eligibility:	NRHP Eligible: Criterion C
Integrity/Comments:	Simplified Queen Anne-style dwelling with Classical and Prairie influences; features hipped roof, two exterior brick chimneys, original wood siding, original single and multi-light wood windows, a Classical frieze below the eave, a wraparound front porch with square brick supports, a second-floor side porch, and an original front door; on parcel with Resources 34b-32c and two large non-historic-age outbuildings (see additional Photographs in Appendix F); research indicates dwelling constructed ca. 1910 for early are resident T.B. Wilson; property remained within Wilson-McEntire family through at least 1994; would require additional research to determine significance under Criterion B; associated with adjacent large agricultural parcel but not a significant example of an historic-age farm under Criterion A, in the area of agriculture. However, dwelling is recommended NRHP eligible under Criterion C, in the area of architecture.

View of Resource 34a, camera facing north.

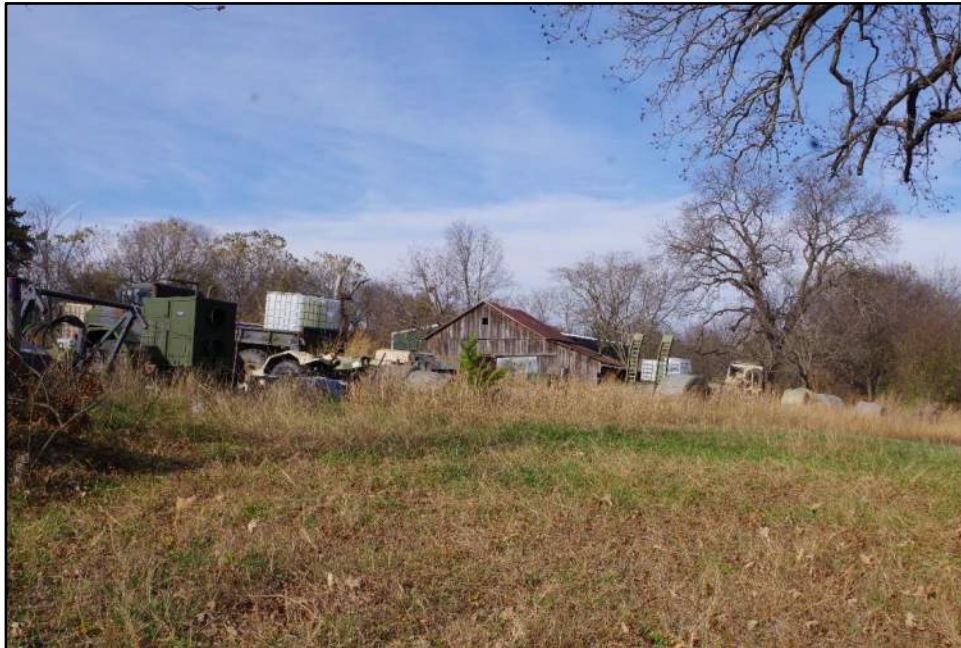
Survey Date:	December 6-9, 2021
Resource No:	34b
Project Location:	Coit Road to FM 1827
Project Name and CSJ:	0135-02-065, 0135-15-002, 0135-03-053
Address, Lat/Long:	551 McIntyre Rd. 33.226896 / -96.604478
Function/Sub-function:	Agricultural / Storage
Construction Date:	ca. 1925
NRHP Eligibility:	NRHP Eligible: Criterion C (contributing resource)
Integrity/Comments:	A front-gabled barn with metal roof, vertical board-and-batten wood siding, a central bay, and a shed-roof side addition of historic age; the barn is located on a separate parcel historically and currently associated by ownership with the parcel containing the dwelling (see additional Photographs in Appendix F); contributing resource to the property recommended NRHP eligible under Criterion C, in the area of architecture.

View of Resource 34b, camera facing north.

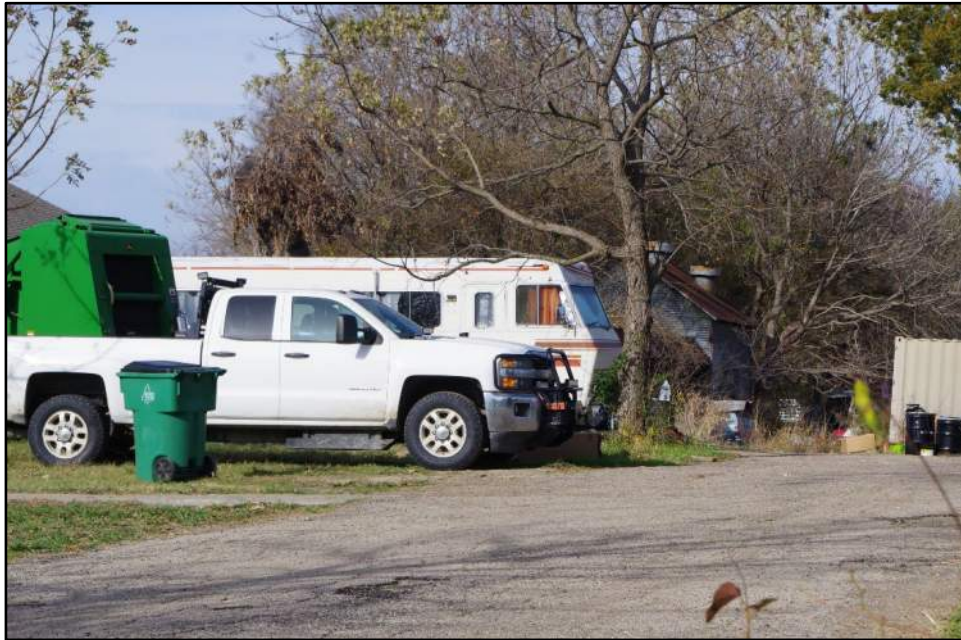
Survey Date:	December 6-9, 2021
Resource No:	34c
Project Location:	Coit Road to FM 1827
Project Name and CSJ:	0135-02-065, 0135-15-002, 0135-03-053
Address, Lat/Long:	551 McIntyre Rd. 33.226896 / -96.604478
Function/Sub-function:	Agricultural / Outbuilding
Construction Date:	ca. 1945
NRHP Eligibility:	NRHP Eligible: Criterion C (contributing resource)
Integrity/Comments:	A front-gabled barn of undetermined function with metal roof, metal ventilators at the roof ridge, metal siding, and a small gabled, metal-clad front addition; (see additional Photographs in Appendix F); located on same parcel as dwelling; contributing resource to the property recommended NRHP eligible under Criterion C, in the area of architecture

Obstructed view of Resource 34c, camera facing northwest.

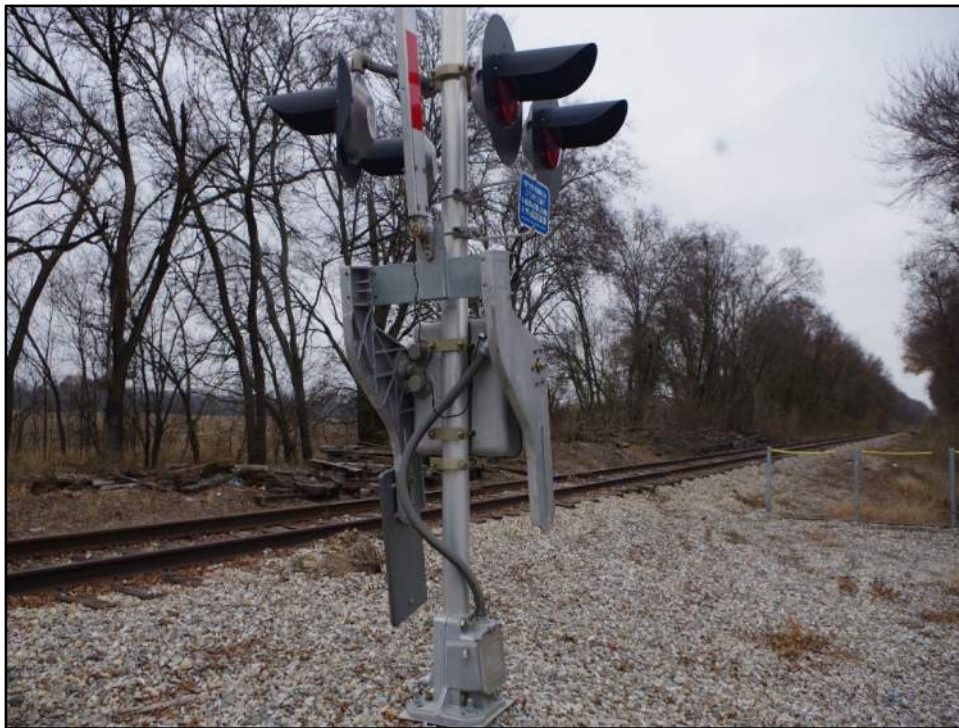
Survey Date:	December 6-9, 2021
Resource No:	35a
Project Location:	Coit Road to FM 1827
Project Name and CSJ:	0135-02-065, 0135-15-002, 0135-03-053
Address, Lat/Long:	Segment of railroad crosses McIntyre Rd., approximately 0.58 mi east from the intersection of N. McDonald St. 33.22668 / -96.602461
Function/Sub-function:	Transportation / Rail Related
Construction Date:	ca. 1880
NRHP Eligibility:	Not eligible
Integrity/Comments:	The railroad segment includes at grade or slightly elevated tracks with gravel ballast; currently part of Dallas Area Rapid Transit (DART) rail line; historically part of the Houston and Texas Central Railway, Southern Pacific, and Texas and New Orleans; the ballast, tracks, and operational components of the railroad have been repaired, maintained, and replaced over the years to enable the system to maintain functionality (see additional Photographs in Appendix F); the resource lacks physical integrity.

View of Resource 35a, camera facing north.

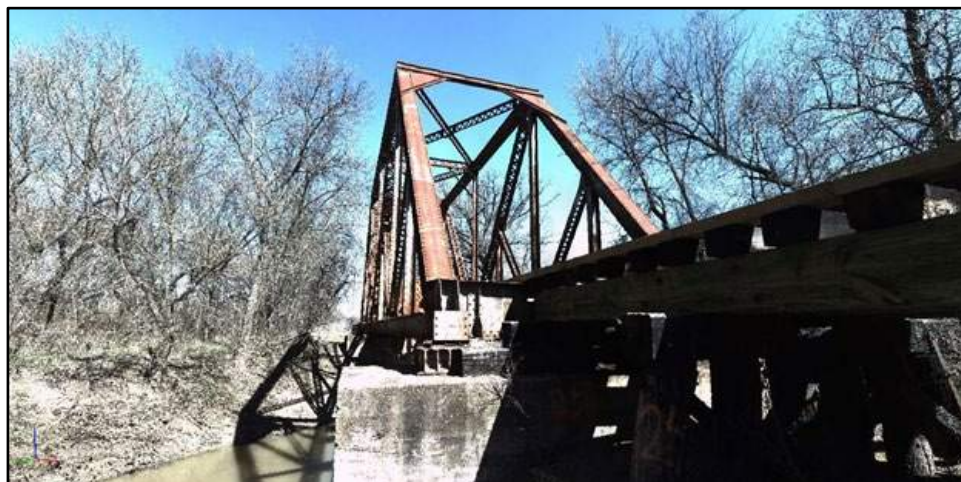
Survey Date:	December 6-9, 2021
Resource No:	35b
Project Location:	Coit Road to FM 1827
Project Name and CSJ:	0135-02-065, 0135-15-002, 0135-03-053
Address, Lat/Long:	Railroad truss bridge over East Fork Trinity River; approximately 0.96 mi northeast of the intersection of McIntyre Road and N. McDonald St. (SH 5) 33.22668 / -96.602461
Function/Sub-function:	Transportation / Rail Related
Construction Date:	ca. 1900
NRHP Eligibility:	NRHP eligible: A and C
Integrity/Comments:	Metal Pratt truss bridge with concrete abutments within the channel and wooden abutments below the approaches; as an active rail line bridge (on current DART line), resource retains integrity of setting, location, design, materials, workmanship, feeling, and association; significant for its continued role in rail transportation through McKinney and Collin County and as a less common type of truss bridge remaining in Texas (see additional Photographs in Appendix F); recommended NRHP eligible under Criterion A and Criterion C, in the areas of transportation and engineering.

View of Resource 35b, camera facing north.

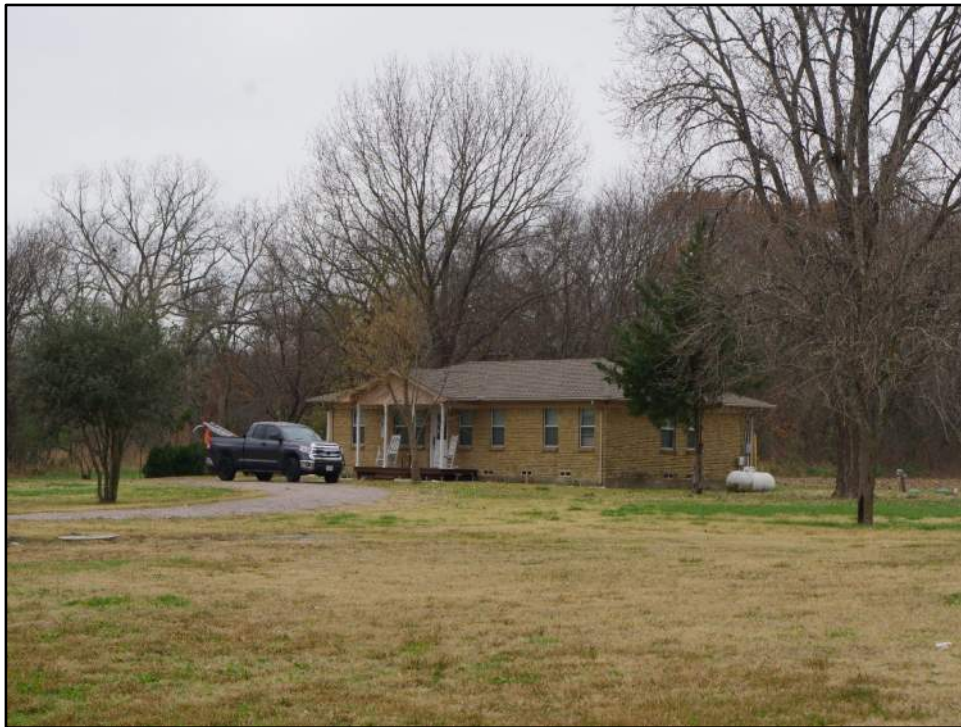
Survey Date:	December 6-9, 2021
Resource No:	36
Project Location:	Coit Road to FM 1827
Project Name and CSJ:	0135-02-065, 0135-15-002, 0135-03-053
Address, Lat/Long:	3001 Woodlawn Rd. 33.219913 / -96.600197
Function/Sub-function:	Domestic / Single Dwelling
Construction Date:	ca. 1960
NRHP Eligibility:	Not eligible
Integrity/Comments:	Hipped-roof Ranch-style dwelling with brick cladding, vinyl windows, and central entrance with a gabled front porch (see additional Photographs in Appendix F); not a significant example of resource type or style.

View of Resource 36, camera facing northwest.

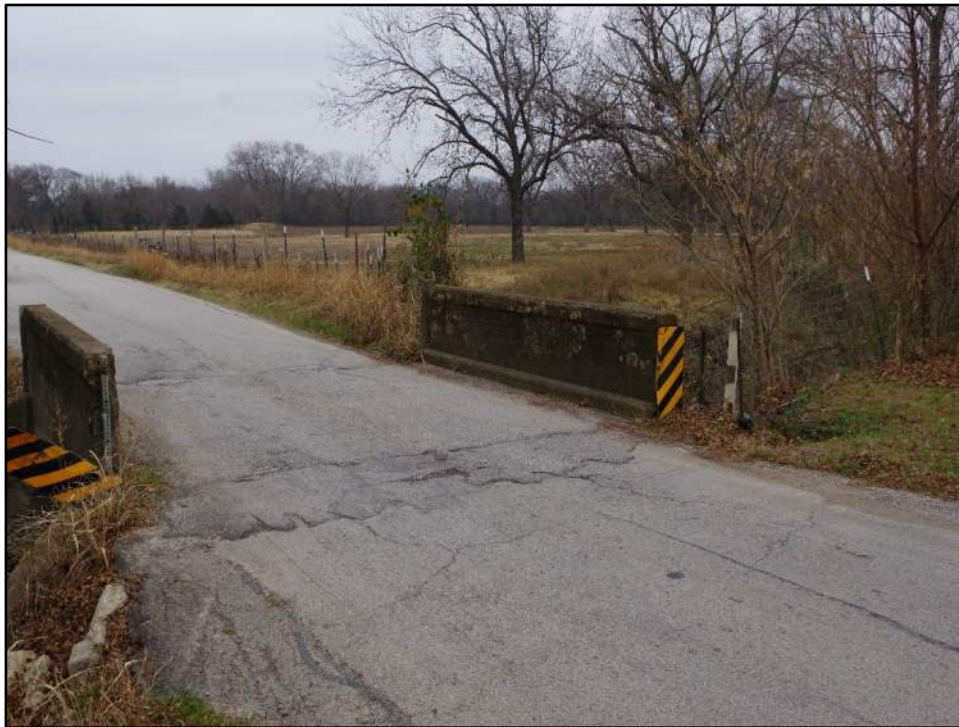
Survey Date:	December 6-9, 2021
Resource No:	37
Project Location:	Coit Road to FM 1827
Project Name and CSJ:	0135-02-065, 0135-15-002, 0135-03-053
Address, Lat/Long:	Bridge located over Powerhouse Creek on Woodlawn Rd. 33.219123 / -96.600369
Function/Sub-function:	Transportation / Rail-related
Construction Date:	ca. 1950
NRHP Eligibility:	Not eligible
Integrity/Comments:	Concrete culvert bridge constructed ca. 1950 with concrete parapet walls; located over Powerhouse Creek on Woodlawn Rd. (see additional Photographs in Appendix F); not a significant example of resource type.

View of Resource 37, camera facing southwest.

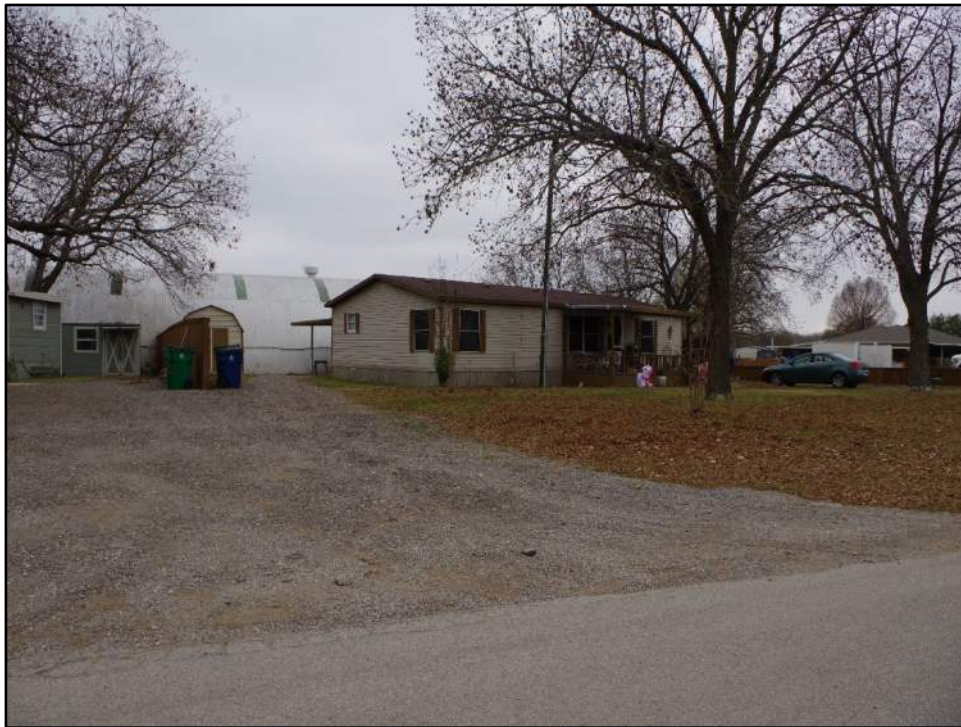
Survey Date:	December 6-9, 2021
Resource No:	38a
Project Location:	Coit Road to FM 1827
Project Name and CSJ:	0135-02-065, 0135-15-002, 0135-03-053
Address, Lat/Long:	2908 Woodlawn Rd. 33.219096 / -96.600058
Function/Sub-function:	Domestic / Single Dwelling
Construction Date:	ca. 1980
NRHP Eligibility:	Not eligible
Integrity/Comments:	Manufactured dwelling with vinyl cladding, vinyl windows, and shed-roof front porch addition; on parcel with Resource 38b (see additional Photographs in Appendix F); not a significant example of resource type.

View of Resource 38a, camera facing east.

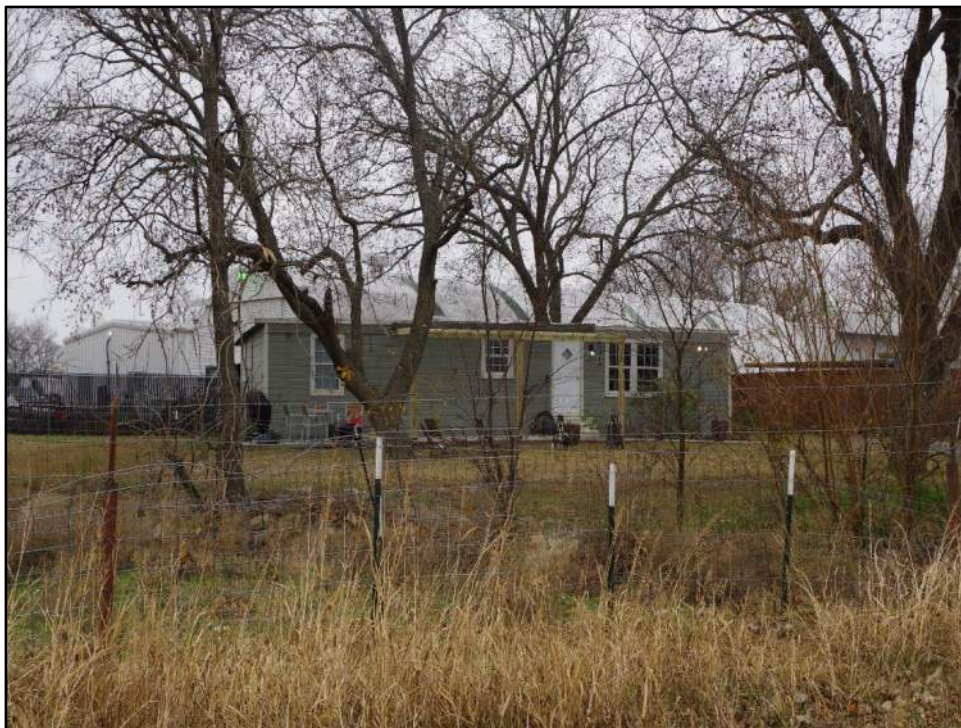
Survey Date:	December 6-9, 2021
Resource No:	38b
Project Location:	Coit Road to FM 1827
Project Name and CSJ:	0135-02-065, 0135-15-002, 0135-03-053
Address, Lat/Long:	2908 Woodlawn Rd. 33.219096 / -96.600058
Function/Sub-function:	Domestic / Single Dwelling
Construction Date:	ca. 1980
NRHP Eligibility:	Not eligible
Integrity/Comments:	Manufactured dwelling with synthetic cladding and replacement vinyl windows; on parcel with Resource 38a (see additional Photographs in Appendix F); not a significant example of resource type.

View of Resource 38b, camera facing southeast.

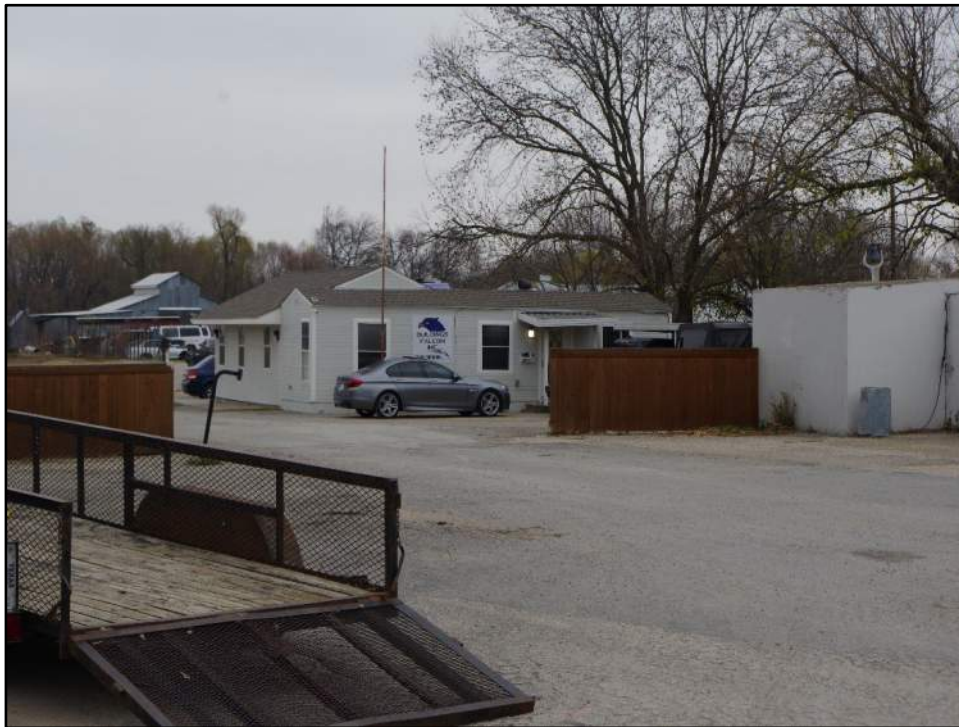
Survey Date:	December 6-9, 2021
Resource No:	39a
Project Location:	Coit Road to FM 1827
Project Name and CSJ:	0135-02-065, 0135-15-002, 0135-03-053
Address, Lat/Long:	2906 Woodlawn Rd. 33.218683 / -96.600203
Function/Sub-function:	Commercial / Business
Construction Date:	ca. 1980
NRHP Eligibility:	Not eligible
Integrity/Comments:	Front-gabled commercial building with manufactured building addition on façade; features vinyl siding and replacement vinyl windows; on parcel with Resources 39b-39c and non-historic-age outbuildings (see additional Photographs in Appendix F); lacks integrity and is not a significant example of resource type.

View of Resource 39a, camera facing southeast.

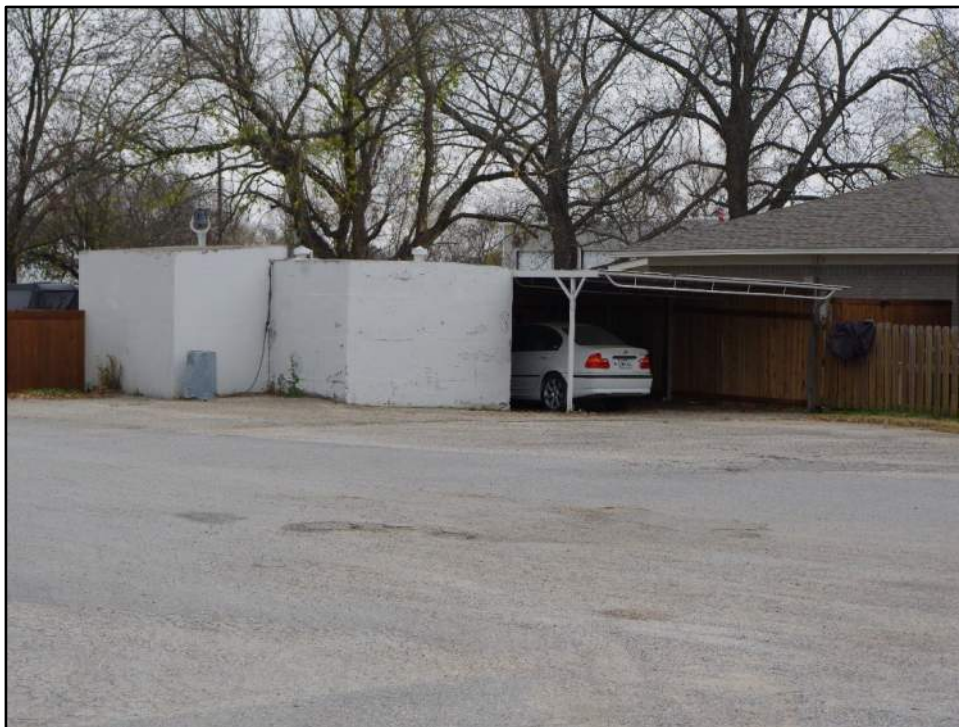
Survey Date:	December 6-9, 2021
Resource No:	39b
Project Location:	Coit Road to FM 1827
Project Name and CSJ:	0135-02-065, 0135-15-002, 0135-03-053
Address, Lat/Long:	2906 Woodlawn Rd. 33.218683 / -96.600203
Function/Sub-function:	Commercial / Business
Construction Date:	ca. 1980
NRHP Eligibility:	Not eligible
Integrity/Comments:	Outbuilding of concrete block construction with non-historic-age carport addition; on parcel with Resources 39a and 39c and non-historic-age outbuildings (see additional Photographs in Appendix F); not a significant example of resource type.

View of Resource 39b carport, camera facing southeast.

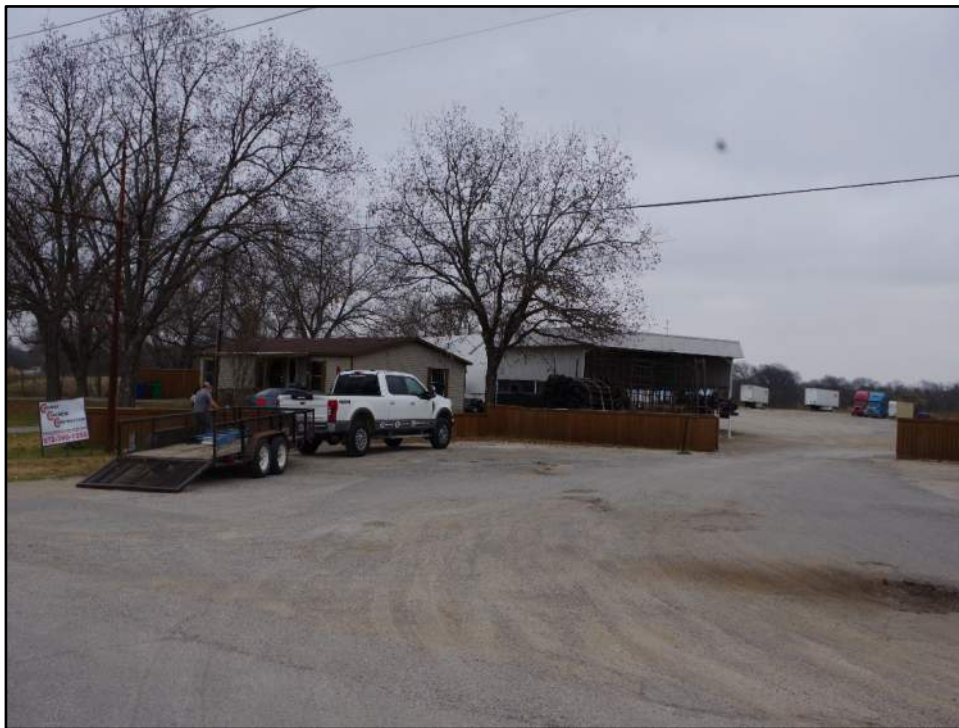
Survey Date:	December 6-9, 2021
Resource No:	39c
Project Location:	Coit Road to FM 1827
Project Name and CSJ:	0135-02-065, 0135-15-002, 0135-03-053
Address, Lat/Long:	2906 Woodlawn Rd. 33.218683 / -96.600203
Function/Sub-function:	Commercial / Business
Construction Date:	ca. 1965
NRHP Eligibility:	Not eligible
Integrity/Comments:	Large outbuilding with flat-roof, metal siding, and large central bay; no additional details were visible from the public ROW; on parcel with Resources 39b-39c and non-historic-age outbuildings (see additional Photographs in Appendix F); visible in 1968 aerial imagery prior to associated resources currently on site (NETR 1968); not a significant example of resource type.

View of Resource 39c (right), camera facing northeast.

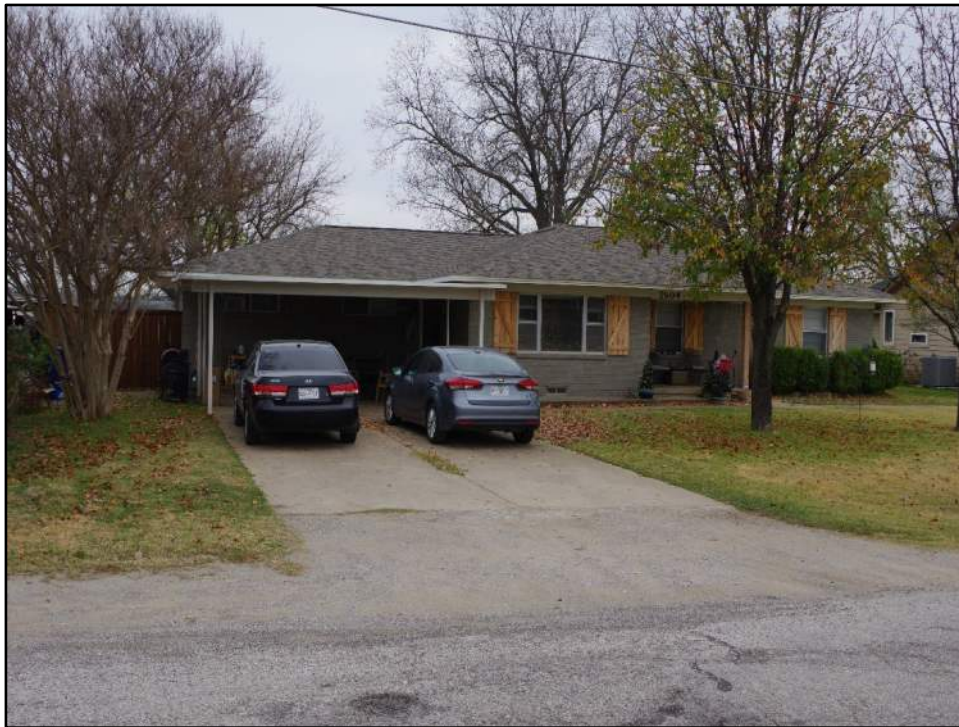
Survey Date:	December 6-9, 2021
Resource No:	40
Project Location:	Coit Road to FM 1827
Project Name and CSJ:	0135-02-065, 0135-15-002, 0135-03-053
Address, Lat/Long:	2904 Woodlawn Rd. 33.218549 / -96.600192
Function/Sub-function:	Domestic / Single Dwelling
Construction Date:	ca. 1965
NRHP Eligibility:	Not eligible
Integrity/Comments:	Hipped-roof Ranch-style dwelling with brick cladding, apparent original metal windows with vinyl exterior storm windows, enclosed garage, and carport addition; lacks integrity due to garage enclosure and is not a significant example of resource type or style.

View of Resource 40, camera facing southeast.

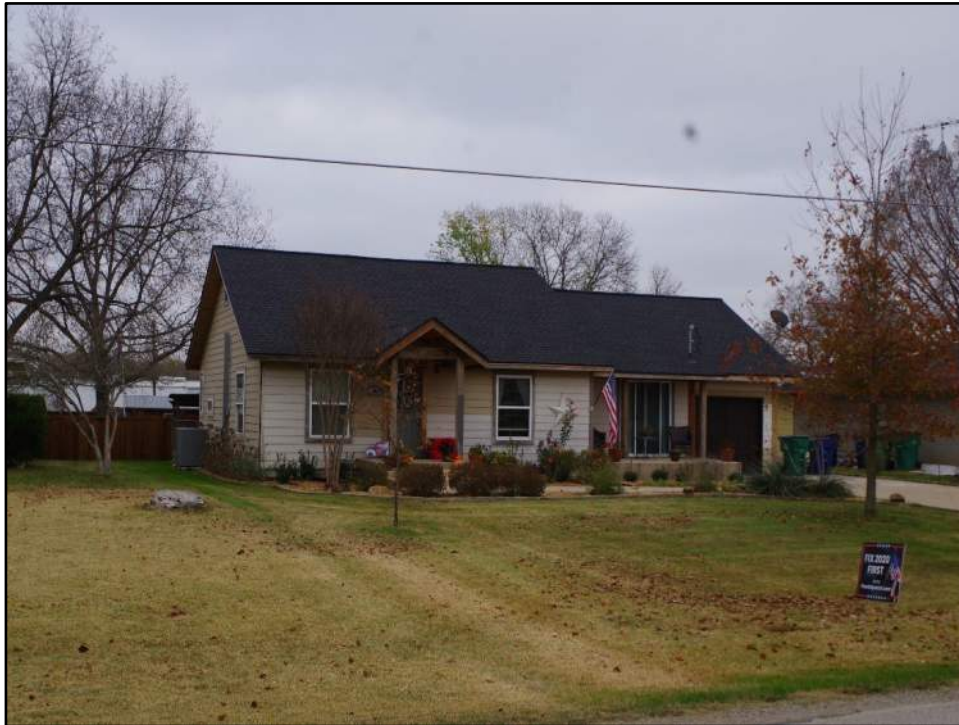
Survey Date:	December 6-9, 2021
Resource No:	41a
Project Location:	Coit Road to FM 1827
Project Name and CSJ:	0135-02-065, 0135-15-002, 0135-03-053
Address, Lat/Long:	2902 Woodlawn Rd. 33.218338 / -96.60016
Function/Sub-function:	Domestic / Single Dwelling
Construction Date:	ca. 1965
NRHP Eligibility:	Not eligible
Integrity/Comments:	Side-gabled Simplified Ranch-style dwelling with synthetic siding, replacement vinyl windows, and garage addition; on parcel with Resource 41b and non-historic-age greenhouse (see additional Photographs in Appendix F); not visible in aerial imagery in 1956 but onsite in 1968 (NETR 1956, 1968); lacks integrity of materials and is not a significant example of resource type or style.

View of Resource 41a, camera facing southeast.

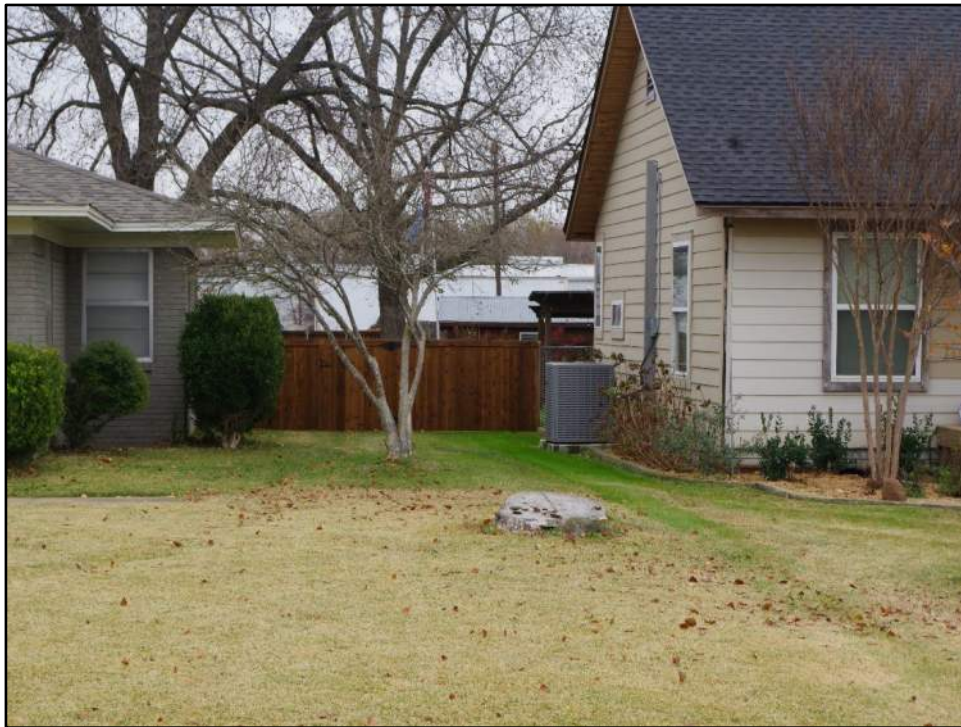
Survey Date:	December 6-9, 2021
Resource No:	41b
Project Location:	Coit Road to FM 1827
Project Name and CSJ:	0135-02-065, 0135-15-002, 0135-03-053
Address, Lat/Long:	2902 Woodlawn Rd. 33.218338 / -96.60016
Function/Sub-function:	Domestic / Secondary Structure
Construction Date:	ca. 1980
NRHP Eligibility:	Not eligible
Integrity/Comments:	Side-gabled shed with metal roof and wood siding; no additional details were visible from the public ROW; on parcel with Resource 41a and non-historic-age greenhouse (see additional Photographs in Appendix F); not a significant example of resource type.

View of Resource 41b (background), camera facing east.

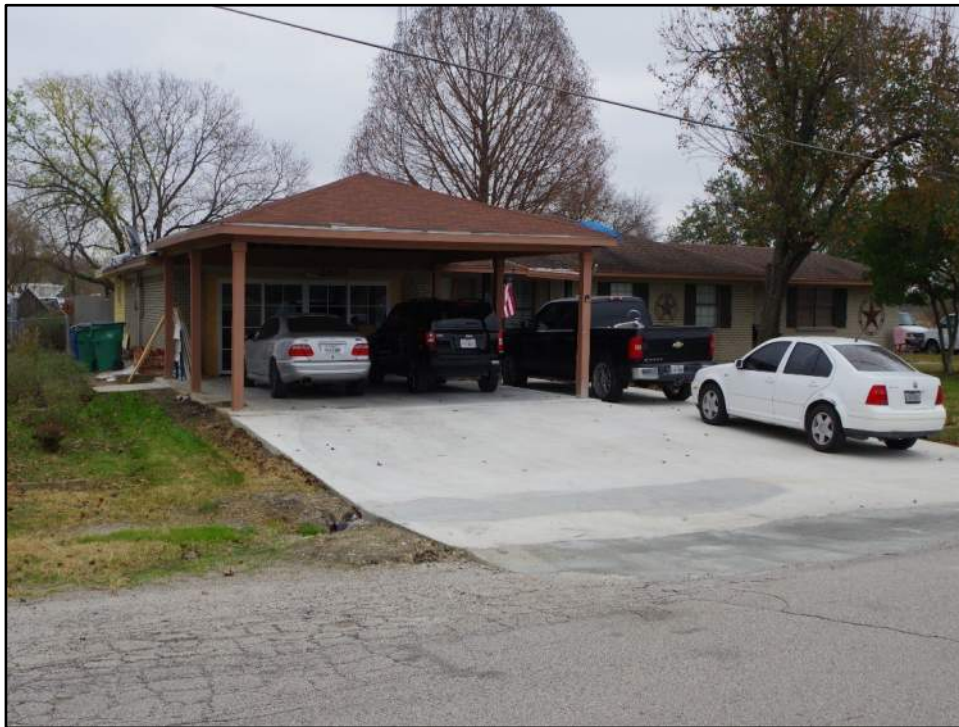
Survey Date:	December 6-9, 2021
Resource No:	42
Project Location:	Coit Road to FM 1827
Project Name and CSJ:	0135-02-065, 0135-15-002, 0135-03-053
Address, Lat/Long:	2900 Woodlawn Rd. 33.218095 / -96.600214
Function/Sub-function:	Domestic / Single Dwelling
Construction Date:	ca. 1975
NRHP Eligibility:	Not eligible
Integrity/Comments:	Hipped-roof Ranch-style dwelling with brick cladding, aluminum and replacement vinyl windows, an enclosed garage, and carport addition; on parcel with non-historic-age outbuilding (see additional Photographs in Appendix F); lacks integrity and is not a significant example of resource type or style.

View of Resource 42, camera facing east.

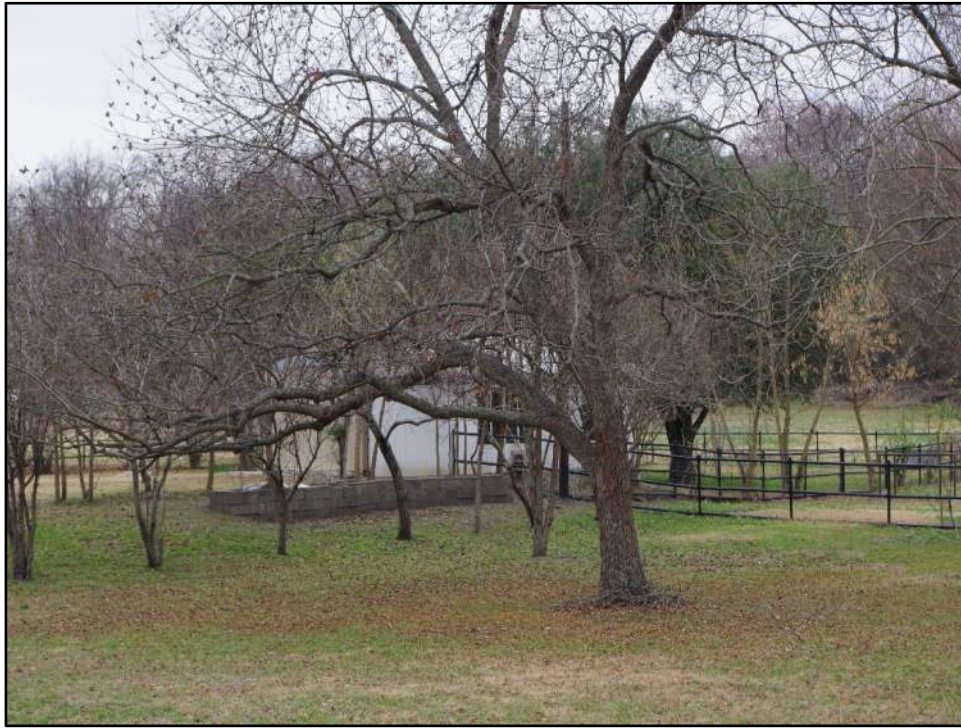
Survey Date:	December 6-9, 2021
Resource No:	43
Project Location:	Coit Road to FM 1827
Project Name and CSJ:	0135-02-065, 0135-15-002, 0135-03-053
Address, Lat/Long:	2605 Woodlawn Rd. 33.21442 / -96.601141
Function/Sub-function:	Domestic / Single Dwelling
Construction Date:	ca. 1980
NRHP Eligibility:	Not eligible
Integrity/Comments:	Simplified Ranch-style dwelling or possible manufactured dwelling with side-gabled roof, and undetermined siding material; no additional details were visible from the public ROW due to intervening vegetation; on parcel with two non-historic-age outbuildings (see additional Photographs in Appendix F); not a significant example of resource type or style.

Obstructed view of Resource 43, camera facing southwest.

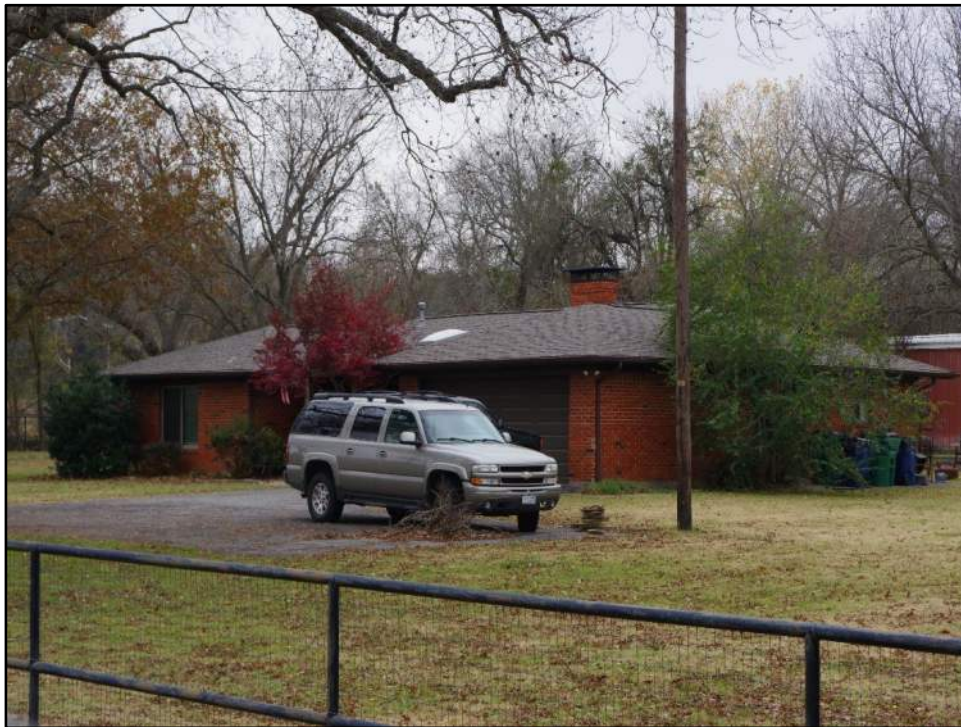
Survey Date:	December 6-9, 2021
Resource No:	44a
Project Location:	Coit Road to FM 1827
Project Name and CSJ:	0135-02-065, 0135-15-002, 0135-03-053
Address, Lat/Long:	2601 Woodlawn Rd. 33.213872 / -96.601227
Function/Sub-function:	Domestic / Single Dwelling
Construction Date:	ca. 1975
NRHP Eligibility:	Not eligible
Integrity/Comments:	Hipped-roof Ranch-style dwelling with brick cladding, replacement vinyl windows, and integral garage with vinyl overhead garage door; on parcel with Resource 44b and non-historic-age outbuilding (see additional Photographs in Appendix F); not a significant example of resource type or style.

View of Resource 44a, camera facing southwest.

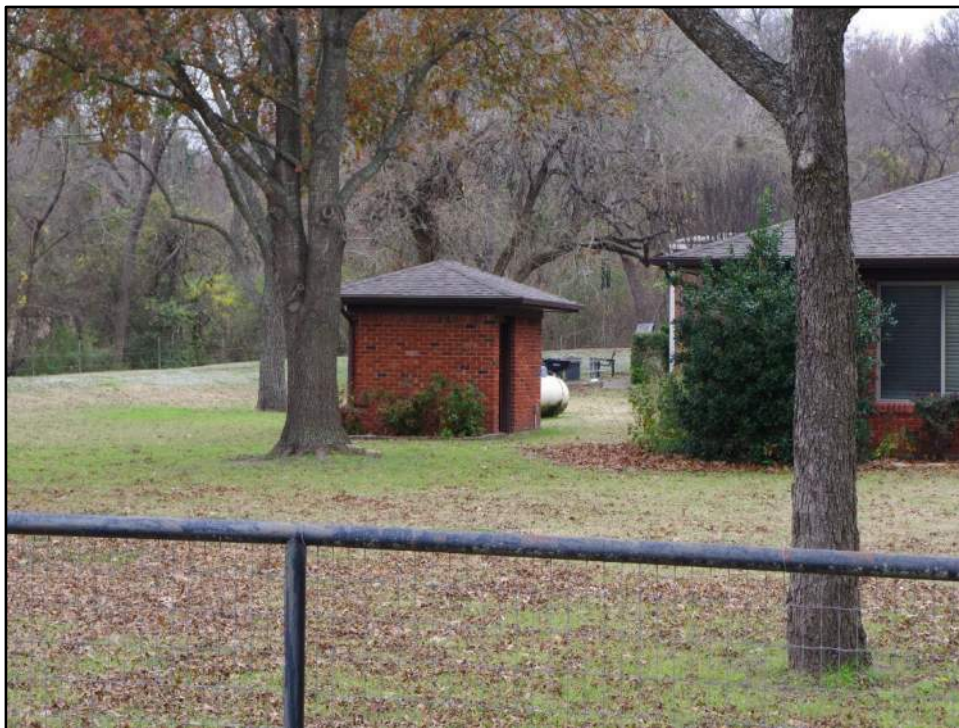
Survey Date:	December 6-9, 2021
Resource No:	44b
Project Location:	Coit Road to FM 1827
Project Name and CSJ:	0135-02-065, 0135-15-002, 0135-03-053
Address, Lat/Long:	2601 Woodlawn Rd. 33.213872 / -96.601227
Function/Sub-function:	Domestic / Secondary Structure
Construction Date:	ca. 1975
NRHP Eligibility:	Not eligible
Integrity/Comments:	Small outbuilding with pyramidal roof and brick cladding, on parcel with Resource 44a and non-historic-age outbuilding (see additional Photographs in Appendix F); not a significant example of resource type.

View of Resource 44b, camera facing west.

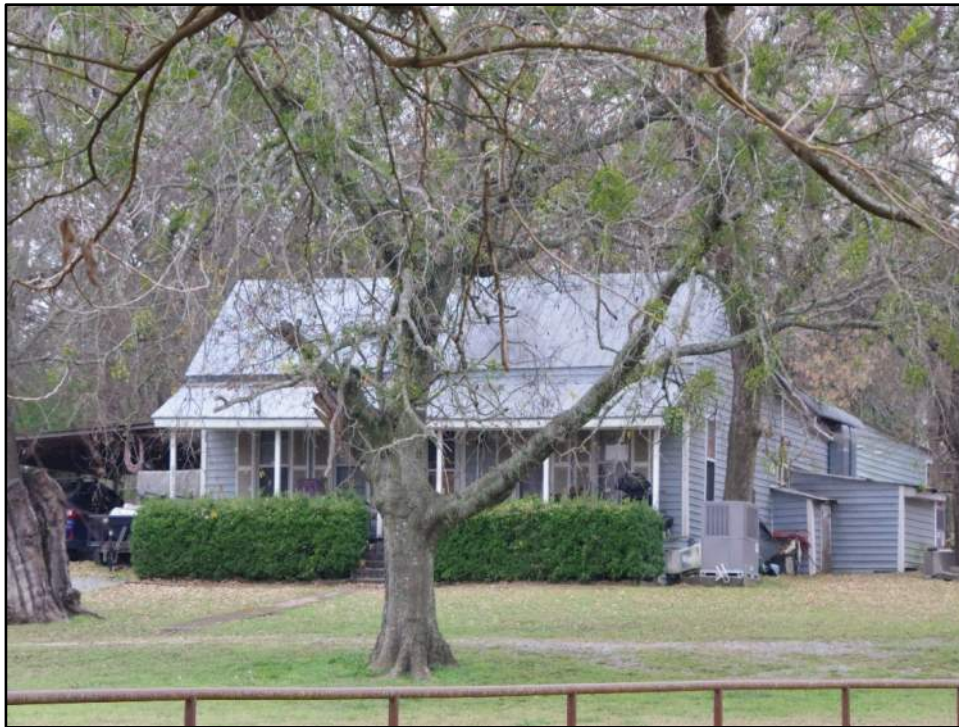
Survey Date:	December 6-9, 2021
Resource No:	45
Project Location:	Coit Road to FM 1827
Project Name and CSJ:	0135-02-065, 0135-15-002, 0135-03-053
Address, Lat/Long:	2503 Woodlawn Rd. 33.212705 / -96.601646
Function/Sub-function:	Domestic / Single Dwelling
Construction Date:	ca. 1920
NRHP Eligibility:	Not eligible
Integrity/Comments:	National Folk/Hall-and-Parlor-style dwelling with a side-gabled replacement metal roof, replacement vinyl siding and vinyl windows, a full shed-roof front porch with simple wooden supports, a shed-roof carport addition, and multiple rear, shed-roof additions; on parcel with non-historic-age outbuildings (see additional Photographs in Appendix F); lacks integrity of design, materials, workmanship, and feeling, and is not a significant example of resource type or style.

View of Resource 45, camera facing west-southwest.
