APPENDIX L: Cultural Resources

APPENDIX L – CULTURAL RESOURCES – FEIS Preferred Alternative/Blue Alternative

US 380 MCKINNEY – Coit Road to FM 1827, Collin County CSJs 0135-02-065 and 0135-15-002; Dallas District

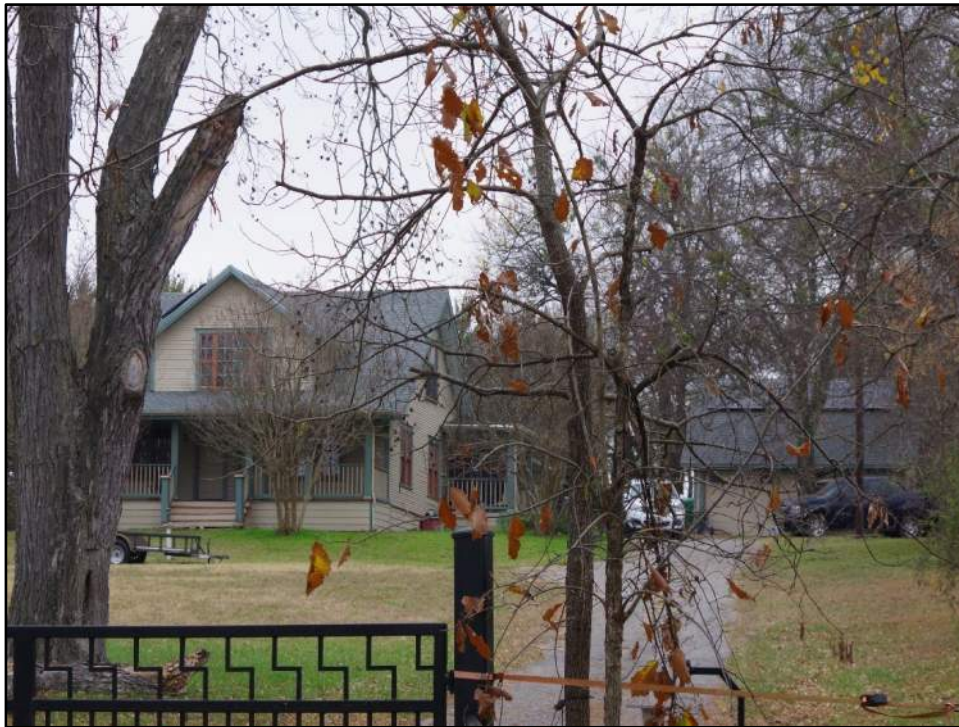
Survey Date:	December 6-9, 2021
Resource No:	46
Project Location:	Coit Road to FM 1827
Project Name and CSJ:	0135-02-065, 0135-15-002, 0135-03-053
Address, Lat/Long:	2501 Woodlawn Rd. 33.212346 / -96.601796
Function/Sub-function:	Domestic / Single Dwelling
Construction Date:	ca. 1925
NRHP Eligibility:	Not eligible
Integrity/Comments:	Side-gabled Craftsman-style bungalow and possible former duplex with original wood siding, replacement wood and vinyl windows, a large gabled front dormer, a hipped-roof front porch; paired front entrances, hipped roof side porches, and a large rear addition that more than doubles the original footprint of the dwelling; on parcel with non-historic-age garage (see additional Photographs in Appendix F); resources are not visible on site in earlier aerial imagery but are depicted on 1981 aerial (NETR 1956, 1968, 1981); dwelling appears to have been relocated to the property at that time; Collin CAD notes construction date of ca. 1925; lacks integrity of design, materials, workmanship, location, feeling, and setting due to replacement windows, large rear addition, and relocation; research revealed no additional information or known associations of historic significance.

Overview of Resource 46, camera facing southwest.

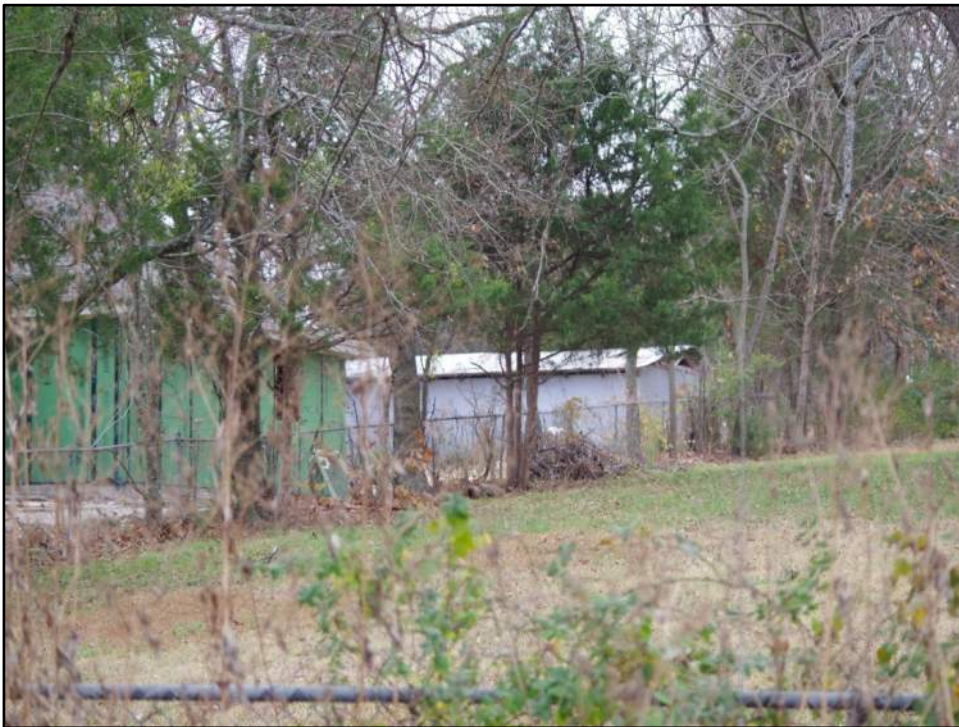
Survey Date:	December 6-9, 2021
Resource No:	47
Project Location:	Coit Road to FM 1827
Project Name and CSJ:	0135-02-065, 0135-15-002, 0135-03-053
Address, Lat/Long:	2415 Woodlawn Rd.
Function/Sub-function:	Domestic / Secondary Structure
Construction Date:	ca. 1975
NRHP Eligibility:	Not eligible
Integrity/Comments:	Side-gabled outbuilding with metal roof and metal siding; on parcel with non-historic-age dwelling under construction (see additional Photographs in Appendix F); not a significant example of resource type.

View of Resource 47, camera facing southwest.

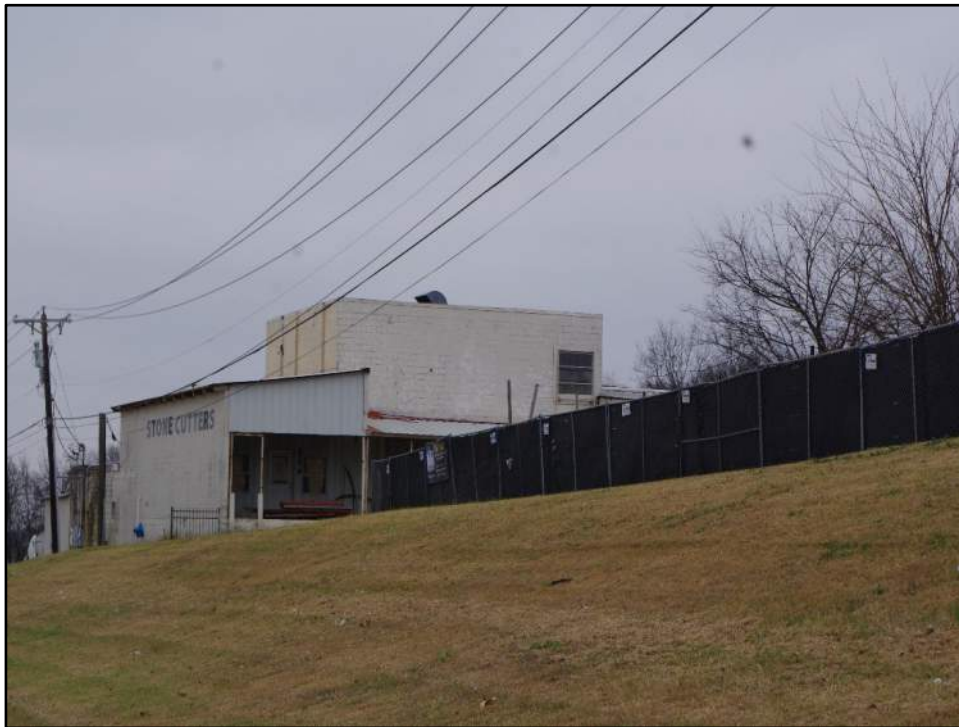
Survey Date:	December 6-9, 2021
Resource No:	48
Project Location:	Coit Road to FM 1827
Project Name and CSJ:	0135-02-065, 0135-15-002, 0135-03-053
Address, Lat/Long:	900 E. University Dr. 33.205605 / -96.603459
Function/Sub-function:	Commercial / Business
Construction Date:	ca. 1950
NRHP Eligibility:	Not eligible
Integrity/Comments:	Flat-roof commercial/industrial building of concrete block construction with metal siding, aluminum windows, and multiple shed-roof additions (see additional Photographs in Appendix F); "Stone Cutters" signage painted on façade; not a significant example of resource type.

View of Resource 48, camera facing southeast.

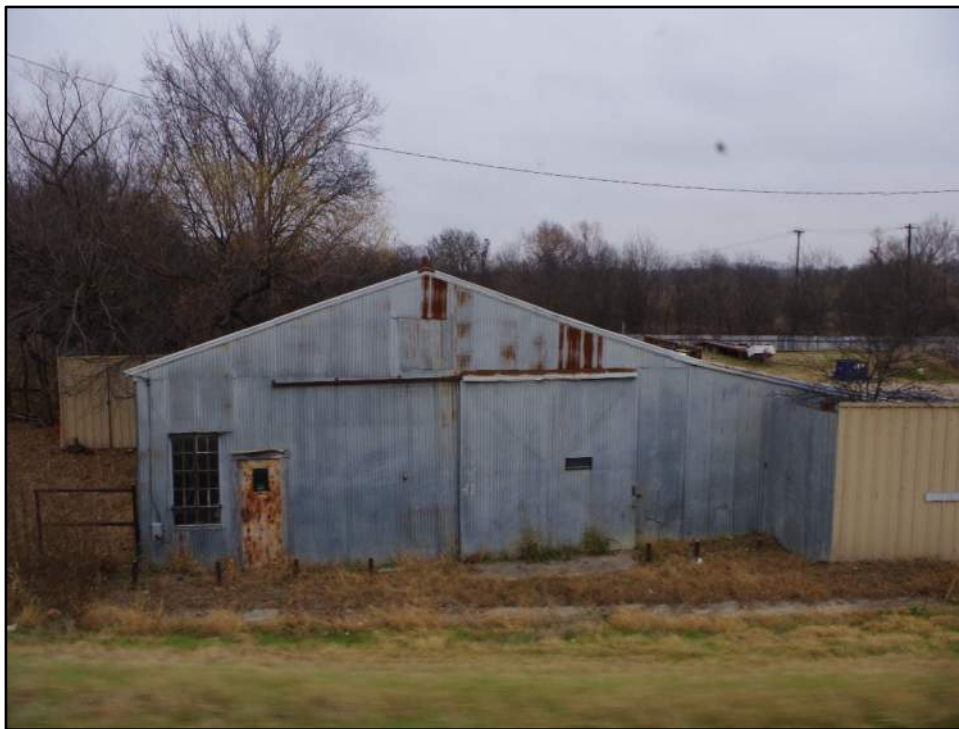
Survey Date:	December 6-9, 2021
Resource No:	49
Project Location:	Coit Road to FM 1827
Project Name and CSJ:	0135-02-065, 0135-15-002, 0135-03-053
Address, Lat/Long:	832 E. University Dr. 33.205856 / -96.601914
Function/Sub-function:	Commercial / Business
Construction Date:	ca. 1960
NRHP Eligibility:	Not eligible
Integrity/Comments:	Front-gabled commercial building (possible former barn) with metal roof, metal siding, and paired metal doors at the gable end; on parcel with non-historic-age shed (see additional Photographs in Appendix F); not a significant example of resource type.

View of Resource 49, camera facing north.

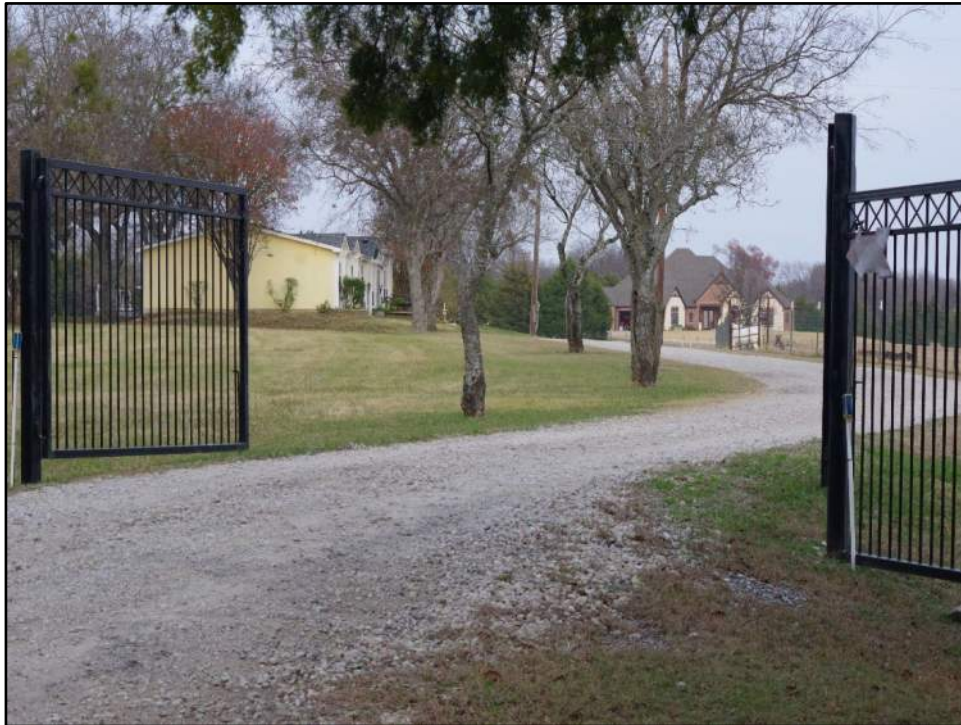
Survey Date:	December 6-9, 2021
Resource No:	50a
Project Location:	Coit Road to FM 1827
Project Name and CSJ:	0135-02-065, 0135-15-002, 0135-03-053
Address, Lat/Long:	2172 County Rd. 338 33.233815 / -96.586561
Function/Sub-function:	Domestic / Single Dwelling
Construction Date:	ca. 1965
NRHP Eligibility:	Not eligible
Integrity/Comments:	Highly altered side-gabled Ranch-style dwelling with stucco cladding, replacement vinyl windows, large side addition, and non-historic-age pilasters on façade; on parcel with Resource 50b and non-historic-age shed (see additional Photographs in Appendix F); lacks integrity of design, materials, workmanship, and feeling due to extent of alterations; not a significant example of resource type or style.

View of Resource 50a (left) and non-historic building (right), camera facing northeast.

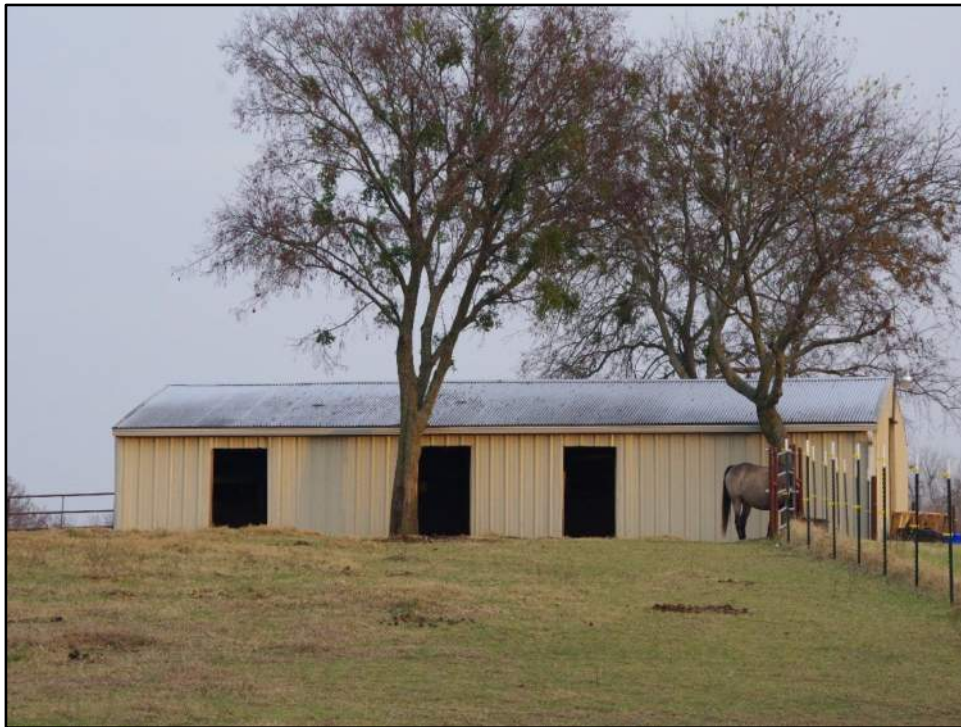
Survey Date:	December 6-9, 2021
Resource No:	50b
Project Location:	Coit Road to FM 1827
Project Name and CSJ:	0135-02-065, 0135-15-002, 0135-03-053
Address, Lat/Long:	2172 County Rd. 338 33.233815 / -96.586561
Function/Sub-function:	Agricultural / Outbuilding
Construction Date:	ca. 1980
NRHP Eligibility:	Not eligible
Integrity/Comments:	Front-gabled outbuilding/horse barn with metal roof, metal siding, and three entrance bays on side elevation; on parcel with Resource 50a and non-historic-age shed (see additional Photographs in Appendix F); not a significant example of resource type.

View of Resource 50b, camera facing northeast.

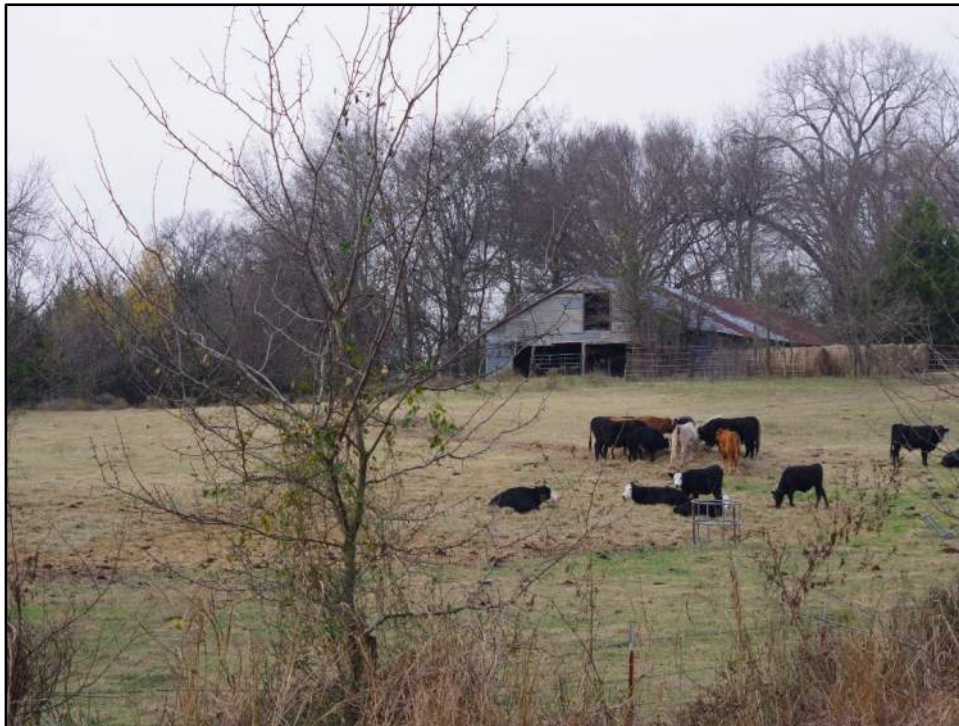
Survey Date:	December 6-9, 2021
Resource No:	51b
Project Location:	Coit Road to FM 1827
Project Name and CSJ:	0135-02-065, 0135-15-002, 0135-03-053
Address, Lat/Long:	2149 County Rd. 338 33.233779 / -96.588846
Function/Sub-function:	Agricultural / Storage
Construction Date:	ca. 1940
NRHP Eligibility:	Not eligible
Integrity/Comments:	Large front-gabled barn with metal roof, metal siding, and hayloft; on parcel with Resource 51a (see additional Photographs in Appendix F); not a significant example of resource type.

View of Resource 51b, camera facing north-northwest.

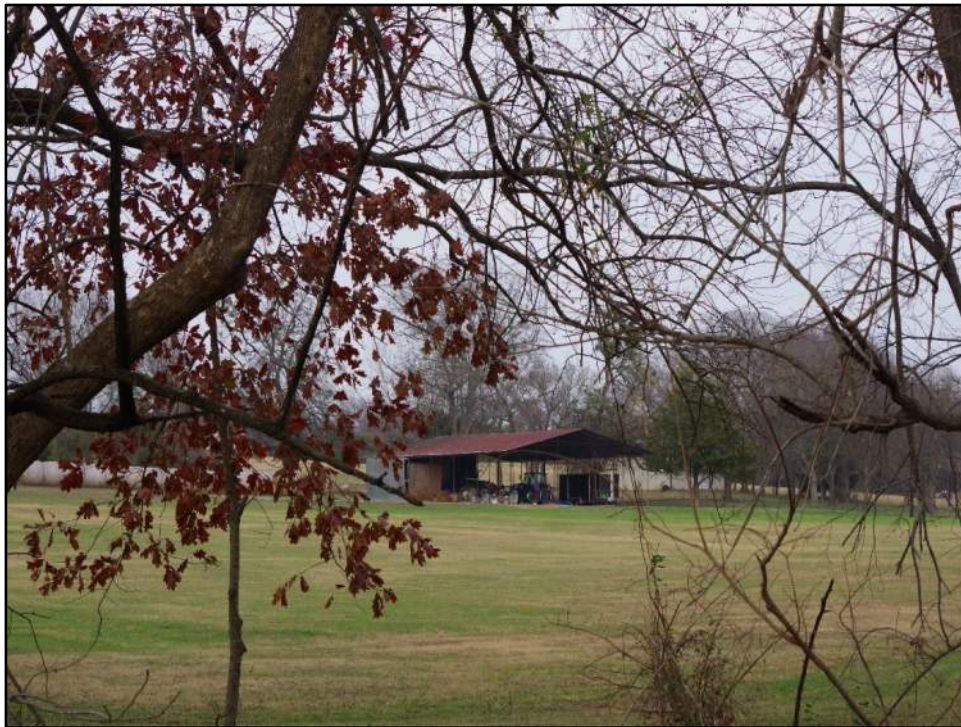
Survey Date:	December 6-9, 2021
Resource No:	52
Project Location:	Coit Road to FM 1827
Project Name and CSJ:	0135-02-065, 0135-15-002, 0135-03-053
Address, Lat/Long:	2118 County Rd. 338 33.232469 / -96.586454
Function/Sub-function:	Agricultural / Storage
Construction Date:	ca. 1965
NRHP Eligibility:	Not eligible
Integrity/Comments:	Side-gabled pole barn/open shed with a metal roof and enclosed rear portion with metal siding (see additional Photographs in Appendix F); not associated with additional historic-age resources; not a significant example of resource type.

View of Resource 52 pole barn/open shed, camera facing northeast.

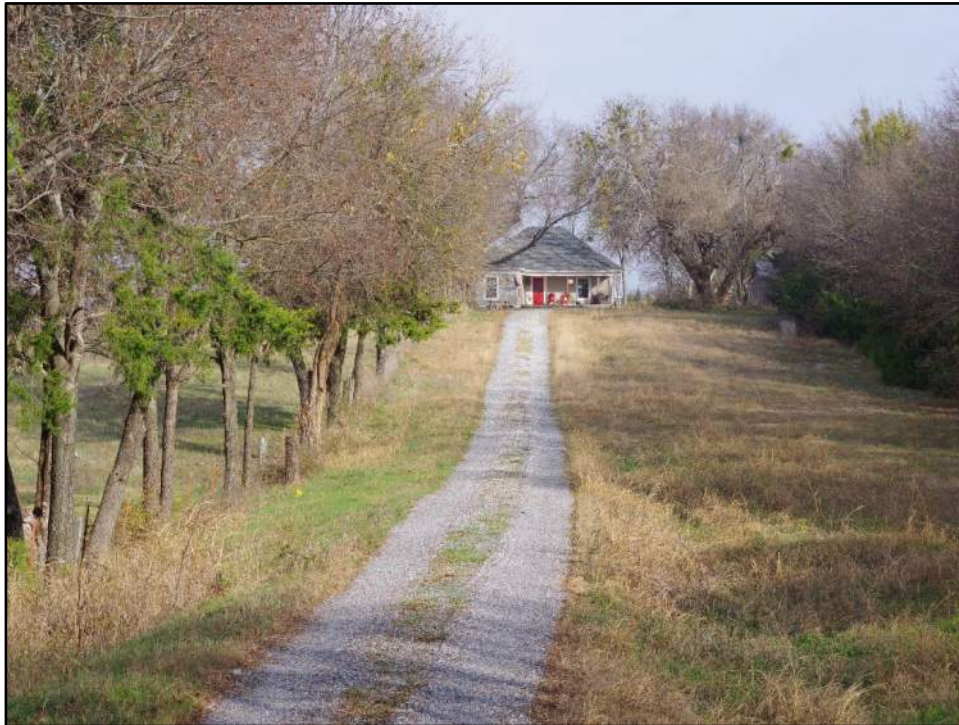
Survey Date:	December 6-9, 2021
Resource No:	53a
Project Location:	Coit Road to FM 1827
Project Name and CSJ:	0135-02-065, 0135-15-002, 0135-03-053
Address, Lat/Long:	3983 County Rd. 331 33.228116 / -96.588149
Function/Sub-function:	Domestic / Single Dwelling
Construction Date:	ca. 1910
NRHP Eligibility:	Not eligible
Integrity/Comments:	National Folk pyramidal-style dwelling with a steeply pitched roof, wood siding, replacement vinyl windows, and a small, hipped roof projecting front ell with replacement components; on parcel with Resources 53b-53c (see additional Photographs in Appendix F); lacks integrity of materials, workmanship, and feeling and no longer represents a significant example of resource type.

View of Resource 53a, camera facing north.

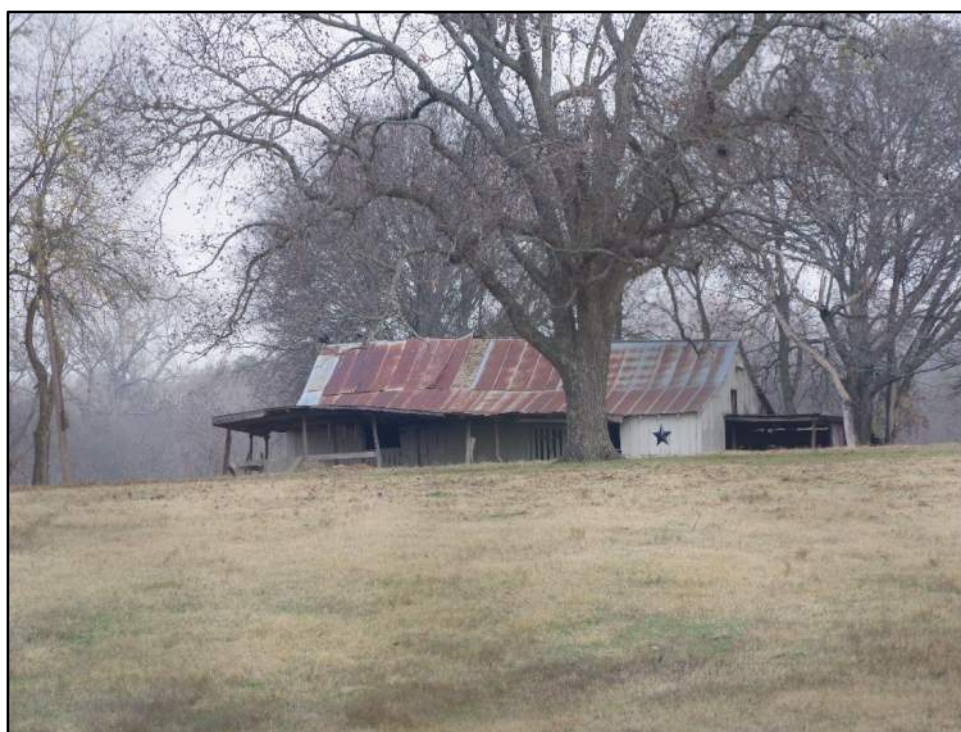
Survey Date:	December 6-9, 2021
Resource No:	53b
Project Location:	Coit Road to FM 1827
Project Name and CSJ:	0135-02-065, 0135-15-002, 0135-03-053
Address, Lat/Long:	3983 County Rd. 331 33.228116 / -96.588149
Function/Sub-function:	Agricultural / Outbuilding
Construction Date:	ca. 1940
NRHP Eligibility:	Not eligible
Integrity/Comments:	Side-gabled barn with metal roof, vertical wood siding, hayloft at gable end. and a shed-roof projection on the façade over an animal pen; on parcel with Resources 53a and 53c (see additional Photographs in Appendix F); not a significant example of resource type.

View of Resource 53b, camera facing north.

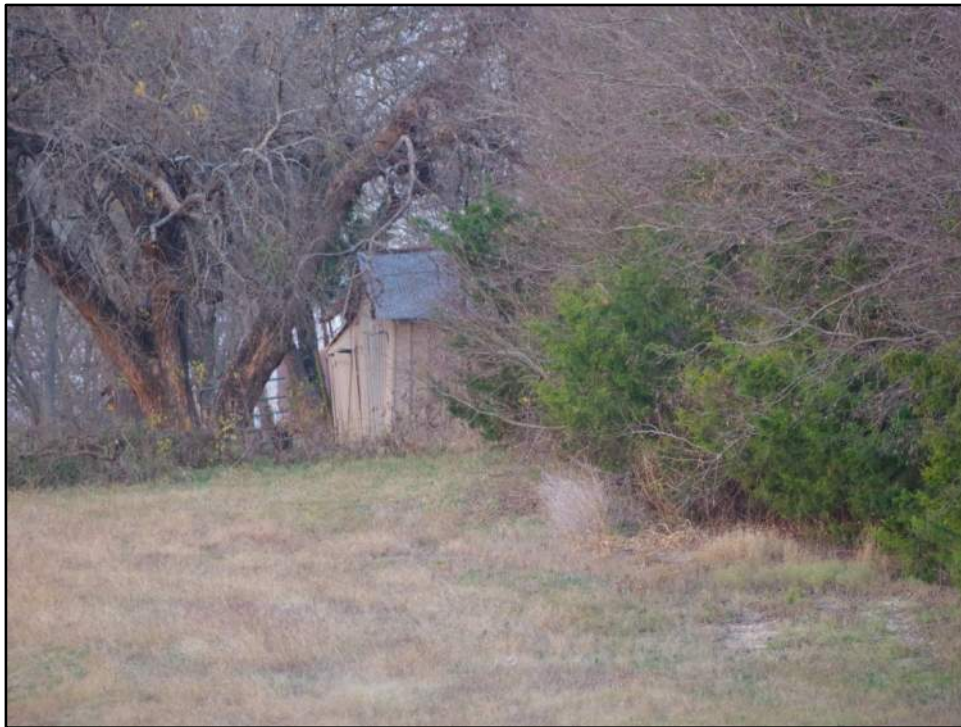
Survey Date:	December 6-9, 2021
Resource No:	53c
Project Location:	Coit Road to FM 1827
Project Name and CSJ:	0135-02-065, 0135-15-002, 0135-03-053
Address, Lat/Long:	3983 County Rd. 331 33.228116 / -96.588149
Function/Sub-function:	3983 County Rd. 331
Construction Date:	ca. 1940
NRHP Eligibility:	Not eligible
Integrity/Comments:	Front-gabled shed with shed-roof addition, metal roof, wood siding, and two hinged doors; on parcel with Resources 53a-53b (see additional Photographs in Appendix F); not a significant example of resource type.

View of Resource 53c, camera facing northeast.

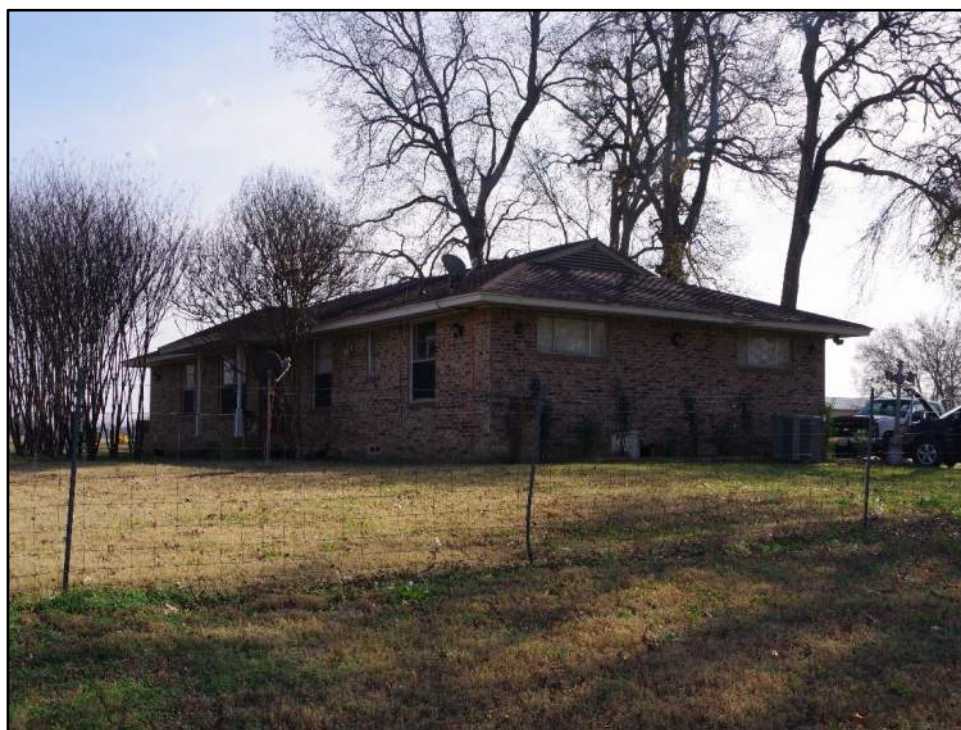
Survey Date:	December 6-9, 2021
Resource No:	54a
Project Location:	Coit Road to FM 1827
Project Name and CSJ:	0135-02-065, 0135-15-002, 0135-03-053
Address, Lat/Long:	4022 County Rd. 33.225926 / -96.58787
Function/Sub-function:	Domestic / Single Dwelling
Construction Date:	ca. 1965
NRHP Eligibility:	Not eligible
Integrity/Comments:	Ranch-style dwelling with gable-on-hip roof, brick cladding, a mix of vinyl and aluminum windows, and a hipped-roof rear addition; on parcel with Resources 54b-54c (see additional Photographs in Appendix F); retains fair integrity but is not a significant example of resource type or style.

View of Resource 54a, camera facing southeast.

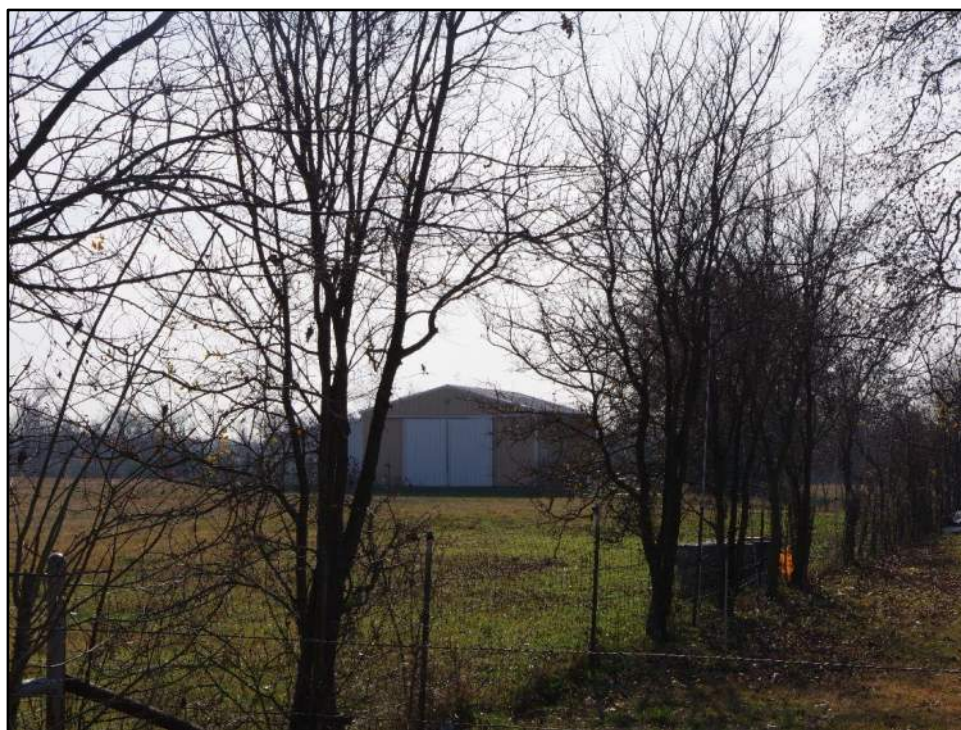
Survey Date:	December 6-9, 2021
Resource No:	54b
Project Location:	Coit Road to FM 1827
Project Name and CSJ:	0135-02-065, 0135-15-002, 0135-03-053
Address, Lat/Long:	4022 County Rd. 33.225926 / -96.58787
Function/Sub-function:	Domestic / Secondary Structure
Construction Date:	ca. 1980
NRHP Eligibility:	Not eligible
Integrity/Comments:	Front-gabled utility building with a metal roof, metal siding, paired sliding doors at the gabled end, and an open shed-roof projection; on parcel with Resources 54a and 54c (see additional Photographs in Appendix F); not a significant example of resource type.

View of Resource 54b, camera facing south.

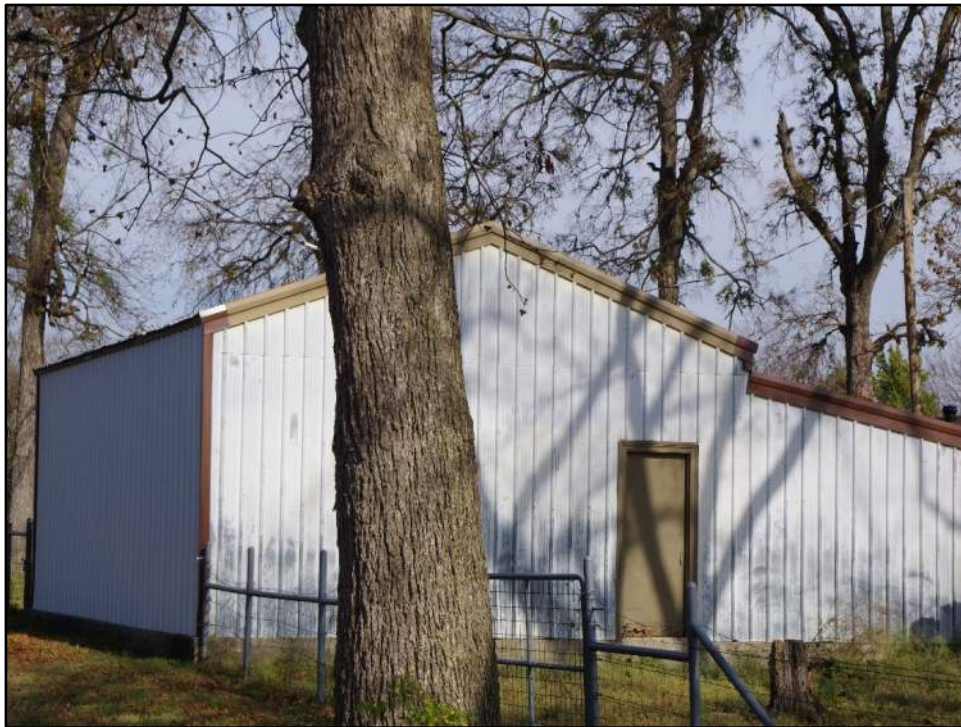
Survey Date:	December 6-9, 2021
Resource No:	54c
Project Location:	Coit Road to FM 1827
Project Name and CSJ:	0135-02-065, 0135-15-002, 0135-03-053
Address, Lat/Long:	4022 County Rd. 33.225926 / -96.58787
Function/Sub-function:	Domestic / Secondary Structure
Construction Date:	ca. 1965
NRHP Eligibility:	Not eligible
Integrity/Comments:	Front-gabled outbuilding with metal roof, metal siding, and a shed-roof side addition; on parcel with Resources 54a-54b (see additional Photographs in Appendix F); not a significant example of resource type.

View of Resource 54c, camera facing north-northeast.

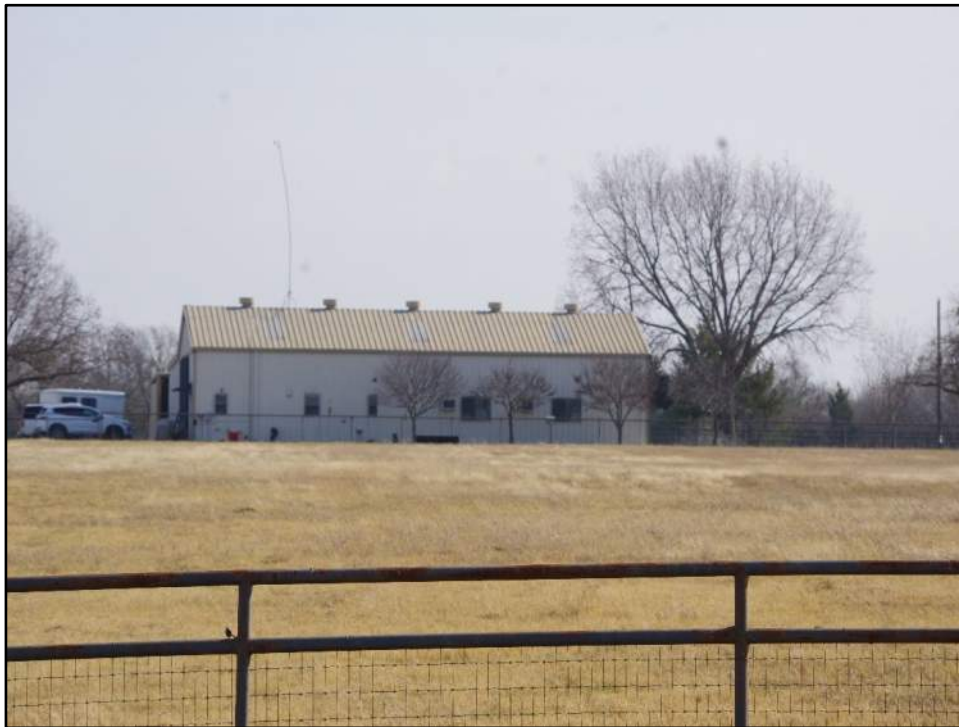
Survey Date:	December 6-9, 2021
Resource No:	55a
Project Location:	Coit Road to FM 1827
Project Name and CSJ:	0135-02-065, 0135-15-002, 0135-03-053
Address, Lat/Long:	1974 Bellemeade Ln. 33.224024 / -96.580703
Function/Sub-function:	Agricultural / Storage
Construction Date:	ca. 1975
NRHP Eligibility:	Not eligible
Integrity/Comments:	Front-gabled barn with metal roof, metal ventilators at the roof ridge, metal siding, and a large shed-roof side projection; on parcel with Resource 55b and non-historic-age dwelling and outbuilding (see additional Photographs in Appendix F); not a significant example of resource type.

View of Resource 55a, camera facing east.

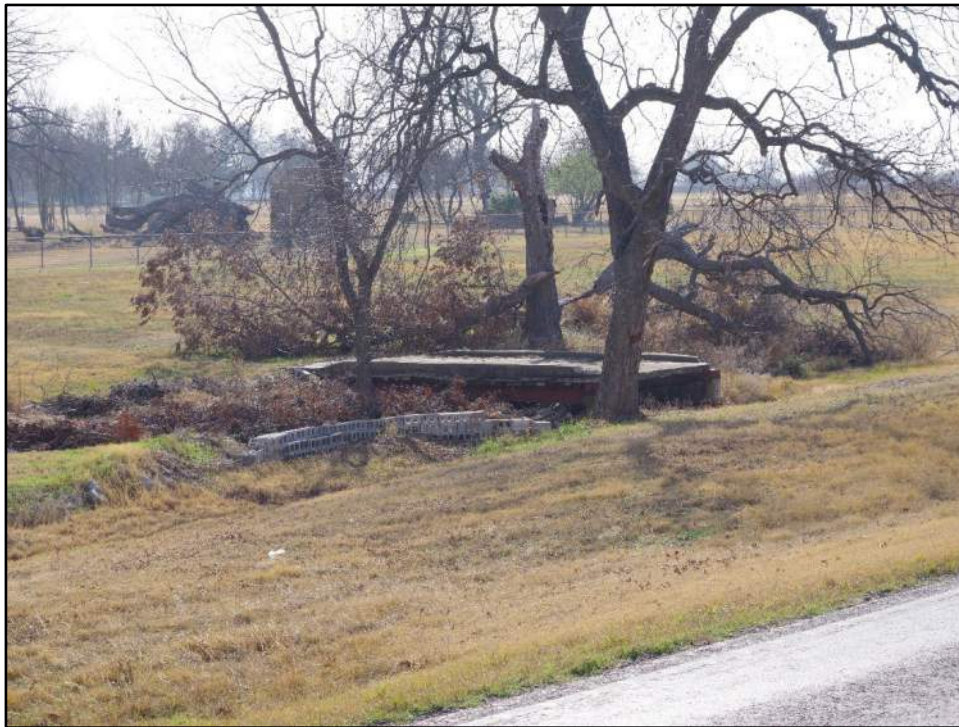
Survey Date:	December 6-9, 2021
Resource No:	55b
Project Location:	Coit Road to FM 1827
Project Name and CSJ:	0135-02-065, 0135-15-002, 0135-03-053
Address, Lat/Long:	1974 Bellemeade Ln. 33.224024 / -96.580703
Function/Sub-function:	Transportation / Road Related
Construction Date:	ca. 1950
NRHP Eligibility:	Not eligible
Integrity/Comments:	Abandoned concrete and steel bridge; on parcel with Resource 55a and non-historic-age dwelling and outbuilding (see additional Photographs in Appendix F); not associated with current road system; not a significant example of resource type.

View of Resource 55b, camera facing southeast.

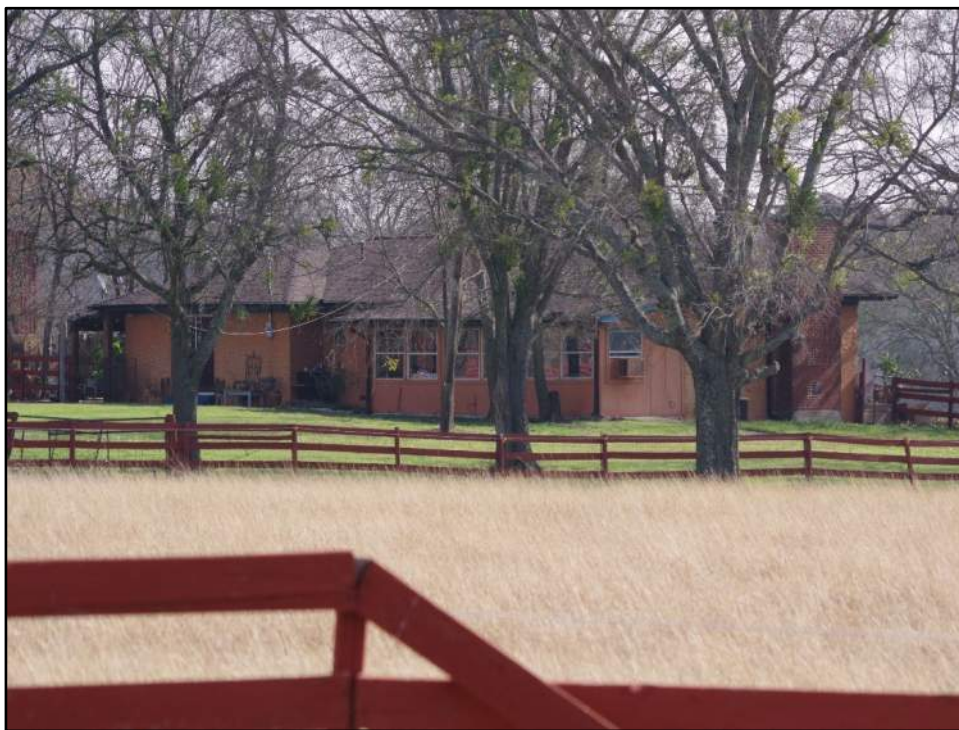
Survey Date:	December 6-9, 2021
Resource No:	56a
Project Location:	Coit Road to FM 1827
Project Name and CSJ:	0135-02-065, 0135-15-002, 0135-03-053
Address, Lat/Long:	East side of FM 2933, approximately 0.3 mi from the intersection with Wayside Rd. 33.219787 / -96.581604
Function/Sub-function:	Domestic / Single Dwelling
Construction Date:	ca. 1975
NRHP Eligibility:	Not eligible
Integrity/Comments:	Hipped-roof Ranch-style dwelling with stucco and plywood cladding, replacement vinyl windows, exterior brick chimney, and shed-roof side porch; on parcel with Resource 56b and non-historic-age outbuilding (see additional Photographs in Appendix F); not a significant example of resource type or style.

View of Resource 56a, camera facing southeast.

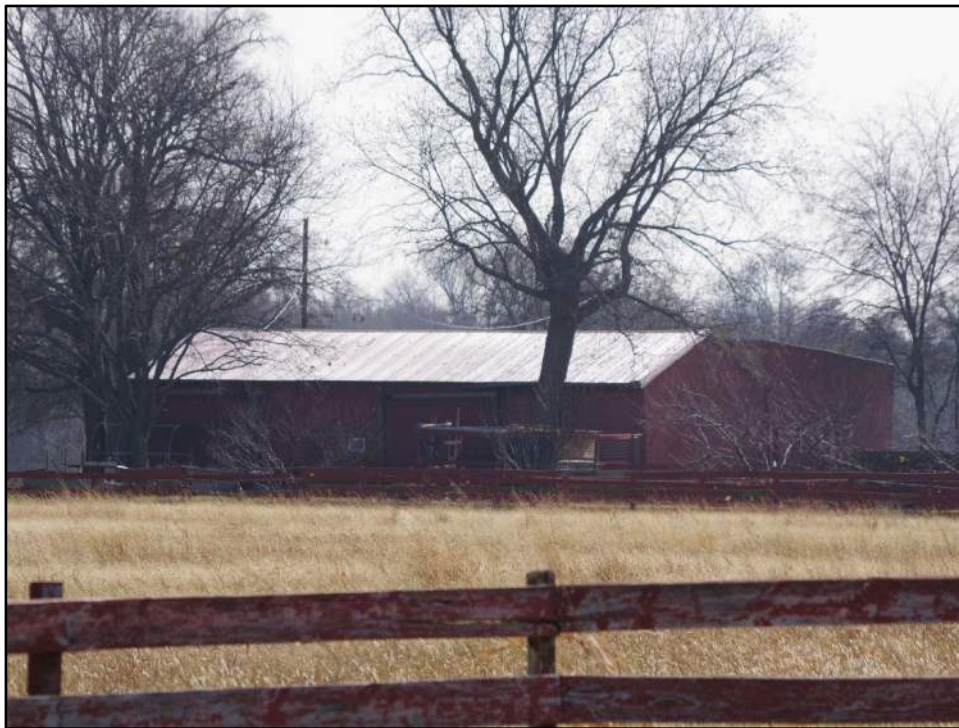
Survey Date:	December 6-9, 2021
Resource No:	56b
Project Location:	Coit Road to FM 1827
Project Name and CSJ:	0135-02-065, 0135-15-002, 0135-03-053
Address, Lat/Long:	East side of FM 2933, approximately 0.3 mi from the intersection with Wayside Rd. 33.219787 / -96.581604
Function/Sub-function:	Agricultural / Outbuilding
Construction Date:	ca. 1980
NRHP Eligibility:	Not eligible
Integrity/Comments:	Side-gabled barn with metal roof, metal siding, and paired sliding metal doors; on parcel with Resource 56a and non-historic-age outbuilding (see additional Photographs in Appendix F); not a significant example of resource type.

View of Resource 56b, camera facing southeast.

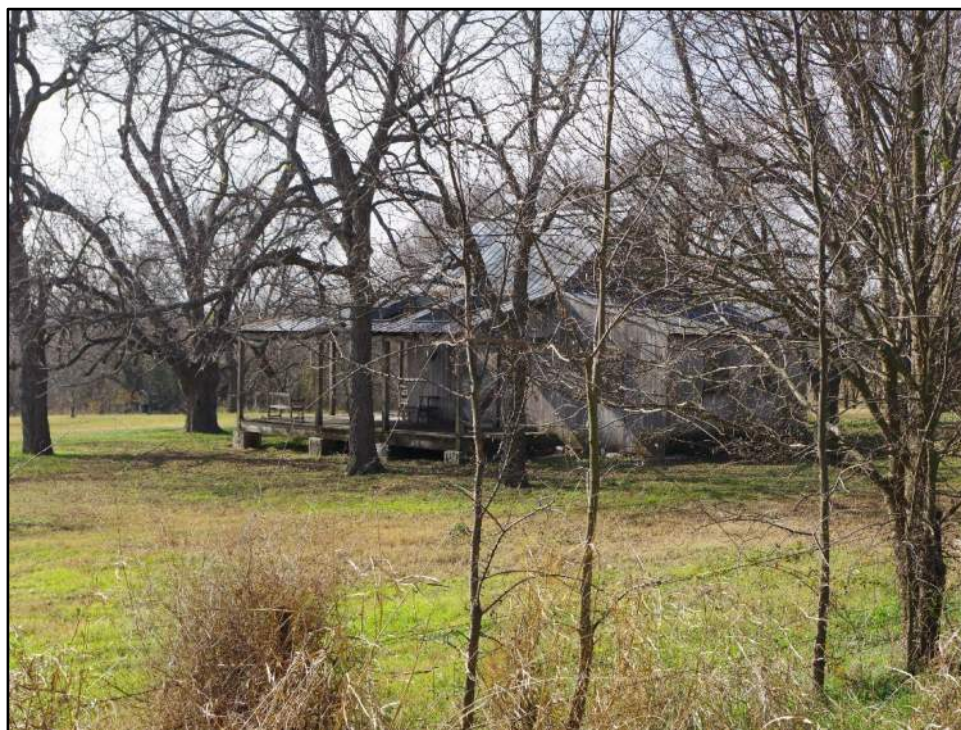
Survey Date:	December 6-9, 2021
Resource No:	57a
Project Location:	Coit Road to FM 1827
Project Name and CSJ:	0135-02-065, 0135-15-002, 0135-03-053
Address, Lat/Long:	2343 County Rd. 335 33.218782 / -96.586153
Function/Sub-function:	Domestic / Single Dwelling
Construction Date:	ca. 1910
NRHP Eligibility:	No eligible
Integrity/Comments:	Highly altered front-gabled outbuilding converted into a residence; reoriented with entrances on side elevations; features metal roof, vertical wood siding, wood windows at the gable end and over both entrances; sliding wooden barn doors on the side elevations, an interior stone chimney, a non-historic-age shed-roof wraparound porch addition, and a shed-roof addition on the former front façade with hinged wooden doors over the window openings; on parcel with Resources 57b-57c and two non-historic-age outbuildings (see additional Photographs in Appendix F); a dwelling is depicted at this location on a 1939 Collin County highway map and dwelling and outbuildings are visible on site in 1956 aerial imagery (TSHD 1939; NETR 1956); extant resource appears to be a remnant outbuilding; lacks integrity of design, materials, workmanship, and feeling due to extent of alterations; no known associations of historic significance; no longer represents an intact or significant example of resource type or style.

View of Resource 57a, camera facing northeast.

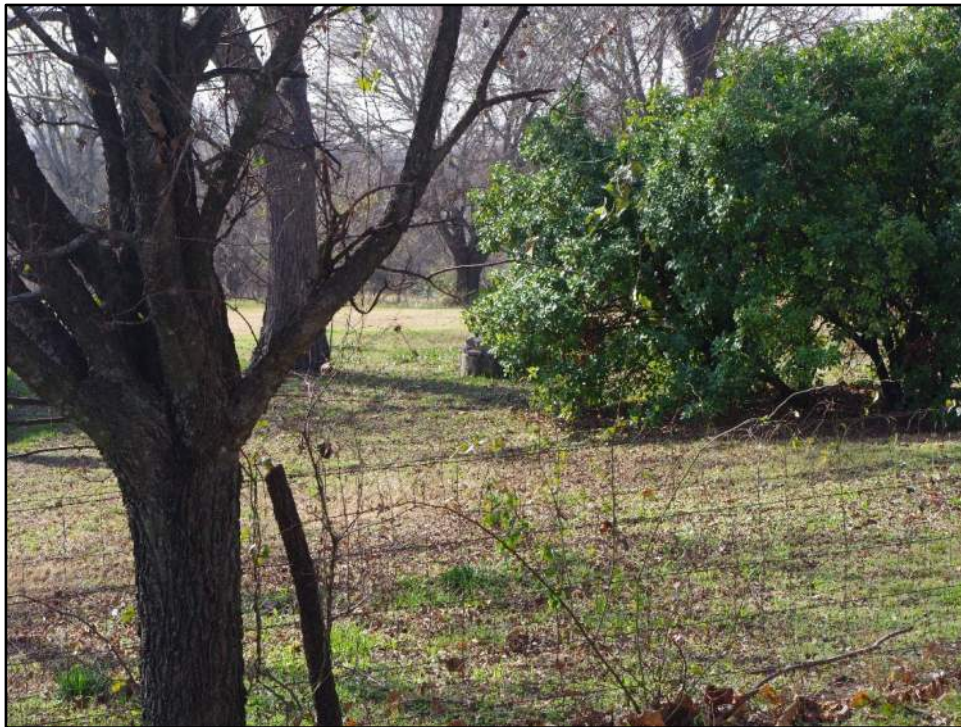
Survey Date:	December 6-9, 2021
Resource No:	57b
Project Location:	Coit Road to FM 1827
Project Name and CSJ:	0135-02-065, 0135-15-002, 0135-03-053
Address, Lat/Long:	2343 County Rd. 335 33.218782 / -96.586153
Function/Sub-function:	Domestic / Secondary Structure
Construction Date:	ca. 1910
NRHP Eligibility:	No eligible
Integrity/Comments:	Concrete well; on parcel with Resources 57a and Resource 57c and two-non-historic-age outbuildings (see additional Photographs in Appendix F); not a significant example of resource type.

View of Resource 57b, camera facing south.

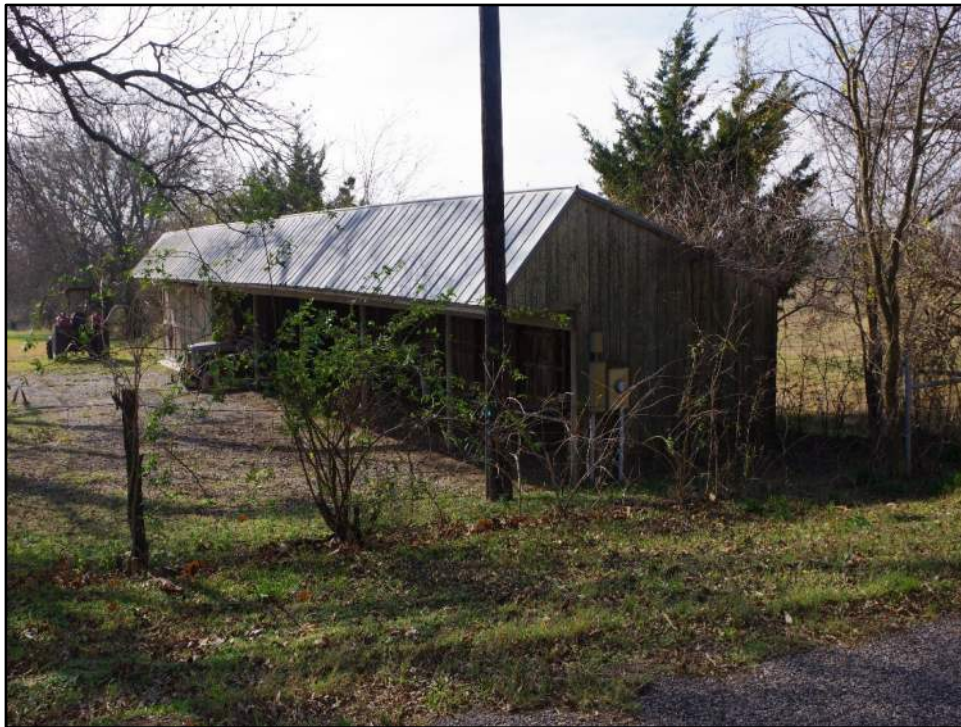
Survey Date:	December 6-9, 2021
Resource No:	57c
Project Location:	Coit Road to FM 1827
Project Name and CSJ:	0135-02-065, 0135-15-002, 0135-03-053
Address, Lat/Long:	2343 County Rd. 335 33.218782 / -96.586153
Function/Sub-function:	Agricultural / Outbuilding
Construction Date:	ca. 1975
NRHP Eligibility:	No eligible
Integrity/Comments:	Side-gabled four bay pole barn with asymmetrical metal roof, wood siding, and hinged doors over one bay; on parcel with Resources 57a-57b and two-non-historic-age outbuildings (see additional Photographs in Appendix F); not a significant example of resource type.

View of Resource 57c, camera facing southwest.

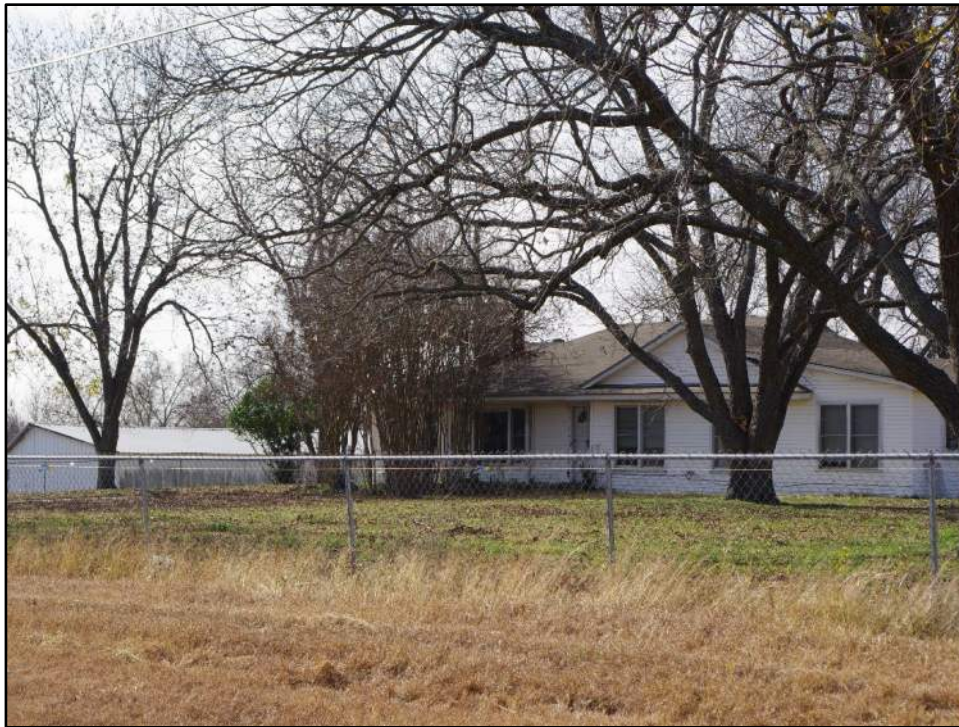
Survey Date:	December 6-9, 2021
Resource No:	58a
Project Location:	Coit Road to FM 1827
Project Name and CSJ:	0135-02-065, 0135-15-002, 0135-03-053
Address, Lat/Long:	2047 FM 2933 33.212624 / -96.584286
Function/Sub-function:	Domestic / Single Dwelling
Construction Date:	ca. 1950
NRHP Eligibility:	Not eligible
Integrity/Comments:	Hipped-roof Ranch-style dwelling with projecting front gable, replacement vinyl siding, aluminum windows, and a large shed-roof side addition; on parcel with Resources 58b-58f and small, non-historic-age outbuilding (see additional Photographs in Appendix F); lacks integrity of design, materials, and workmanship and is not a significant example of resource type or style; property as a whole retains fair integrity but does not represent a significant example of a mid-twentieth-century agricultural complex.

View of Resource 58a, camera facing southwest.

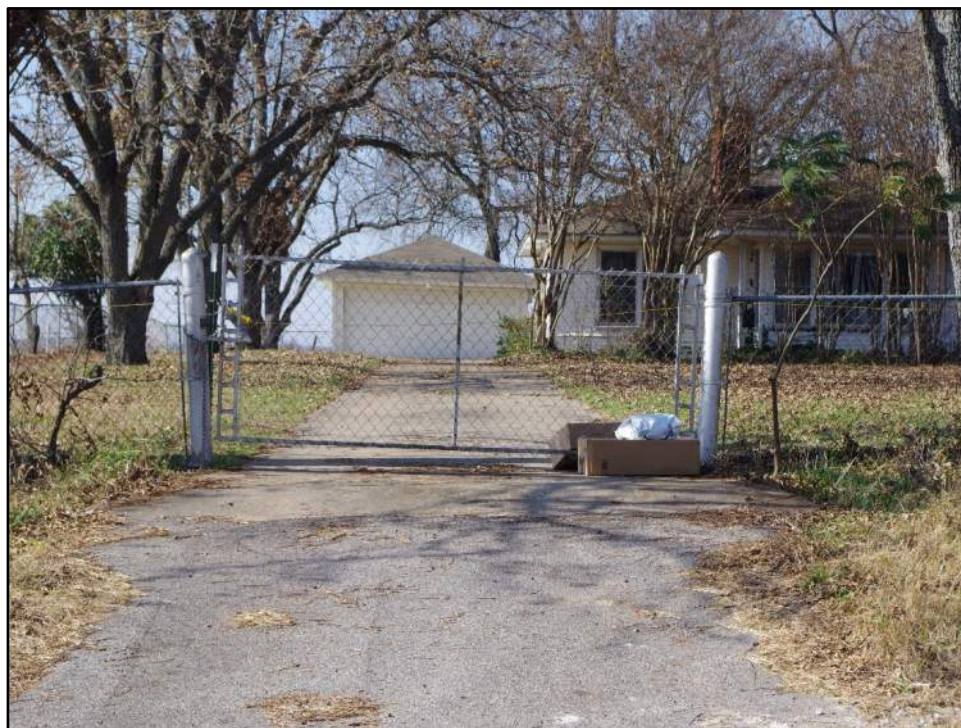
Survey Date:	December 6-9, 2021
Resource No:	58b
Project Location:	Coit Road to FM 1827
Project Name and CSJ:	0135-02-065, 0135-15-002, 0135-03-053
Address, Lat/Long:	2047 FM 2933 33.212624 / -96.584286
Function/Sub-function:	Domestic / Secondary Structure
Construction Date:	ca. 1950
NRHP Eligibility:	Not eligible
Integrity/Comments:	Pyramidal-roof garage with replacement vinyl siding and vinyl garage door; on parcel with Resource 58a, Resources 58c-58f, and small, non-historic-age outbuilding (see additional Photographs in Appendix F); not a significant example of resource type; property as a whole retains fair integrity but does not represent a significant example of a mid-twentieth-century agricultural complex.

View of Resource 58b, camera facing west.

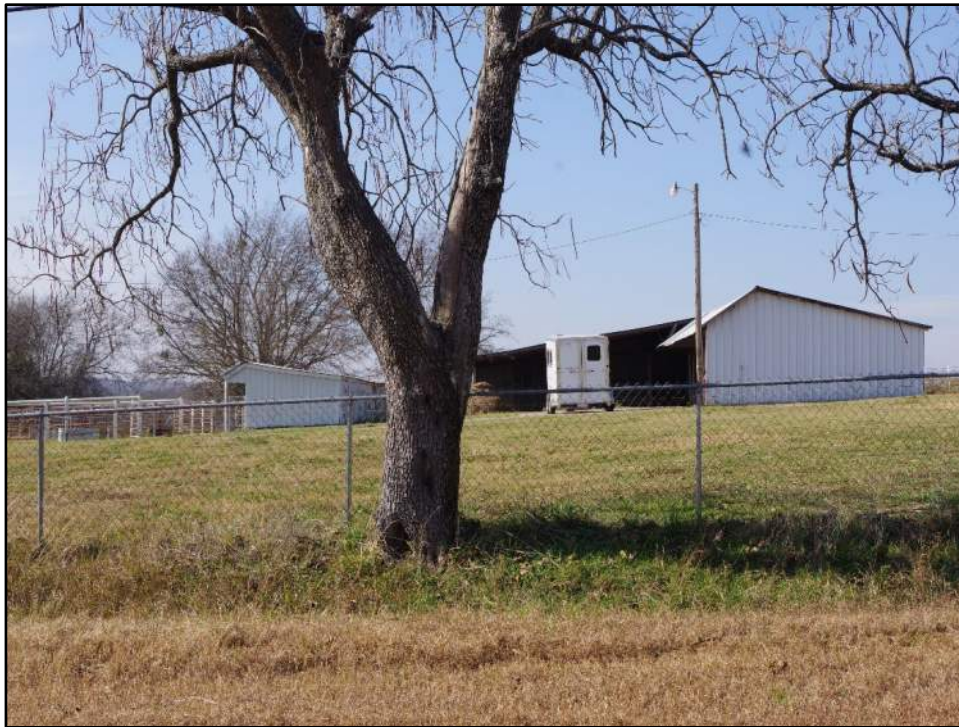
Survey Date:	December 6-9, 2021
Resource No:	58c
Project Location:	Coit Road to FM 1827
Project Name and CSJ:	0135-02-065, 0135-15-002, 0135-03-053
Address, Lat/Long:	2047 FM 2933 33.212624 / -96.584286
Function/Sub-function:	Agricultural / Outbuilding
Construction Date:	ca. 1950
NRHP Eligibility:	Not eligible
Integrity/Comments:	Side-gabled pole barn with metal roof, metal siding, and a ca. 1980 shed-roof addition (NETR 1981); on parcel with Resources 58a-58b, Resources 58d-58f, and small, non-historic-age outbuilding (see additional Photographs in Appendix F); original portion of barn visible in 1956 aerial imagery (NETR 1956); not a significant example of resource type; property as a whole retains fair integrity but does not represent a significant example of a mid-twentieth-century agricultural complex

View of Resource 58c (right) and non-historic-age pole barn (left), camera facing west.

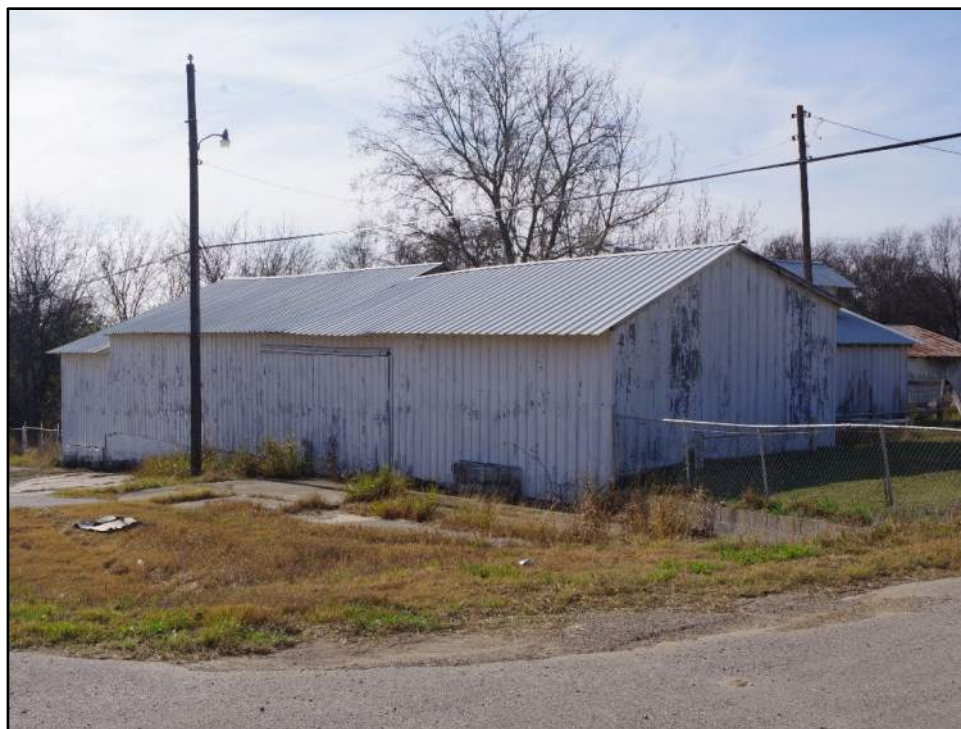
Survey Date:	December 6-9, 2021
Resource No:	58d
Project Location:	Coit Road to FM 1827
Project Name and CSJ:	0135-02-065, 0135-15-002, 0135-03-053
Address, Lat/Long:	2047 FM 2933 33.212624 / -96.584286
Function/Sub-function:	Agricultural / Outbuilding
Construction Date:	ca. 1950
NRHP Eligibility:	Not eligible
Integrity/Comments:	Side-gabled barn/equipment building with metal roof, metal siding, a gabled side addition, a concrete block foundation, and paired sliding doors; on parcel with Resources 58a-58c, Resources 58e-58f, and small, non-historic-age outbuilding (see additional Photographs in Appendix F); not a significant example of resource type; property as a whole retains fair integrity but does not represent a significant example of a mid-twentieth-century agricultural complex

View of Resource 58d, camera facing southwest.
