APPENDIX L: Cultural Resources

APPENDIX L – CULTURAL RESOURCES – FEIS Preferred Alternative/Blue Alternative

US 380 MCKINNEY – Coit Road to FM 1827, Collin County CSJs 0135-02-065 and 0135-15-002; Dallas District

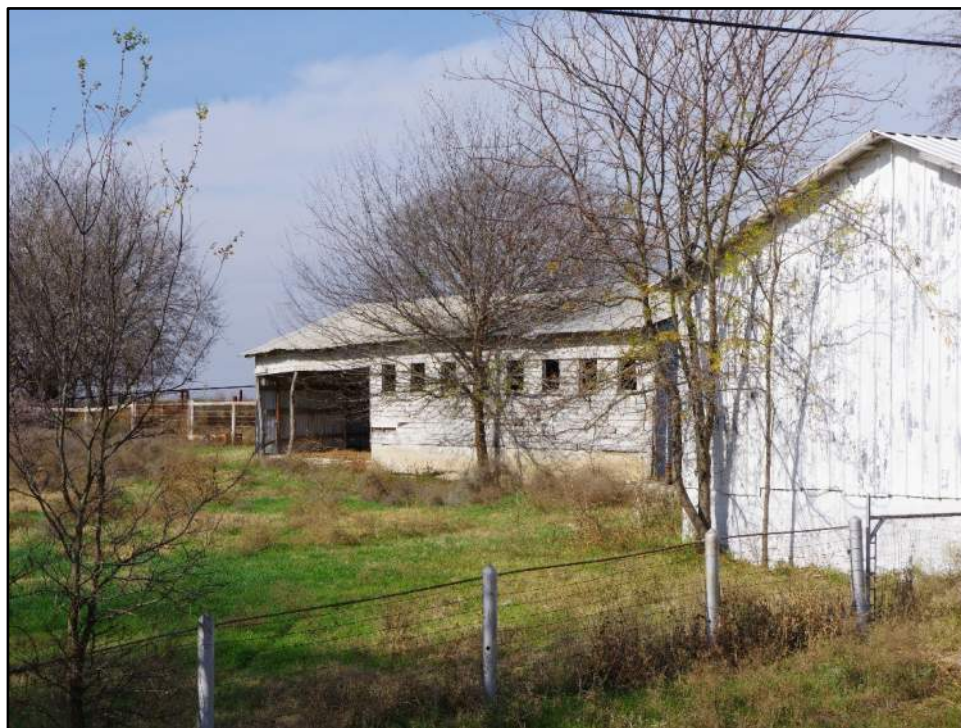
Survey Date:	December 6-9, 2021
Resource No:	58e
Project Location:	Coit Road to FM 1827
Project Name and CSJ:	0135-02-065, 0135-15-002, 0135-03-053
Address, Lat/Long:	2047 FM 2933 33.212624 / -96.584286
Function/Sub-function:	Agricultural / Outbuilding
Construction Date:	ca. 1950
NRHP Eligibility:	Not eligible
Integrity/Comments:	Side-gabled barn with metal roof, metal siding, and small rectangular window openings with no glazing; on parcel with Resources 58a-58d, Resource 58f, and small, non-historic-age outbuilding (see additional Photographs in Appendix F); not a significant example of resource type; property as a whole retains fair integrity but does not represent a significant example of a mid-twentieth-century agricultural complex

View of Resource 58e, camera facing northwest.

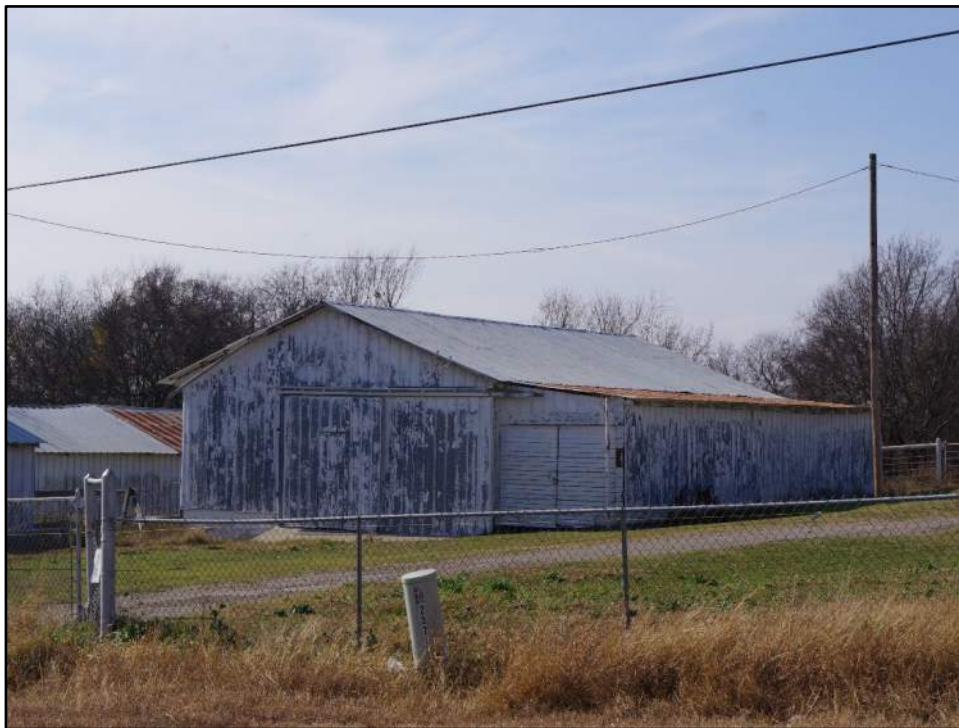
Survey Date:	December 6-9, 2021
Resource No:	58f
Project Location:	Coit Road to FM 1827
Project Name and CSJ:	0135-02-065, 0135-15-002, 0135-03-053
Address, Lat/Long:	2047 FM 2933 33.212624 / -96.584286
Function/Sub-function:	Agricultural / Outbuilding
Construction Date:	ca. 1950
NRHP Eligibility:	Not eligible
Integrity/Comments:	Front-gabled barn/equipment shed with metal roof, metal siding, and a shed-roof side addition; on parcel with Resources 58a-58e and a small, non-historic-age outbuilding (see additional Photographs in Appendix F); not a significant example of resource type; property as a whole retains fair integrity but does not represent a significant example of a mid-twentieth-century agricultural complex

View of Resource 58f, camera facing southwest.

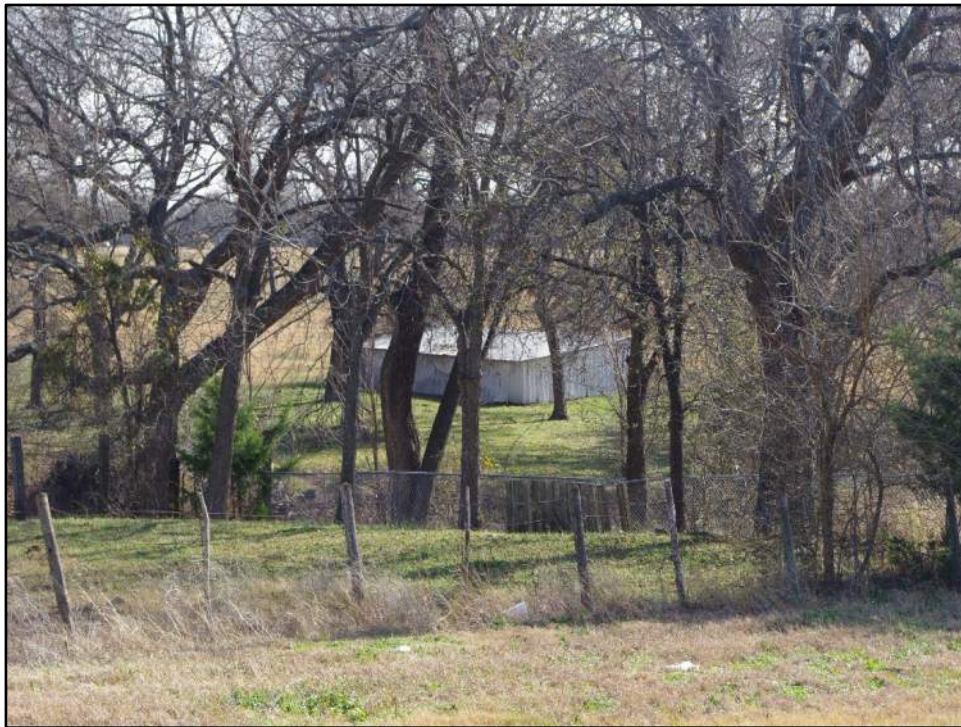
Survey Date:	December 6-9, 2021
Resource No:	59
Project Location:	Coit Road to FM 1827
Project Name and CSJ:	0135-02-065, 0135-15-002, 0135-03-053
Address, Lat/Long:	Southeast corner of the intersection with FM 2933 and County Rd 332 33.212212 / -96.583235
Function/Sub-function:	Agricultural / Outbuilding
Construction Date:	ca. 1975
NRHP Eligibility:	Not eligible
Integrity/Comments:	Pole barn with metal shed roof and metal siding (see additional Photographs in Appendix F); no longer associated with other agricultural or historic-age buildings; not a significant example of resource type.

View of Resource 59, camera facing southeast.

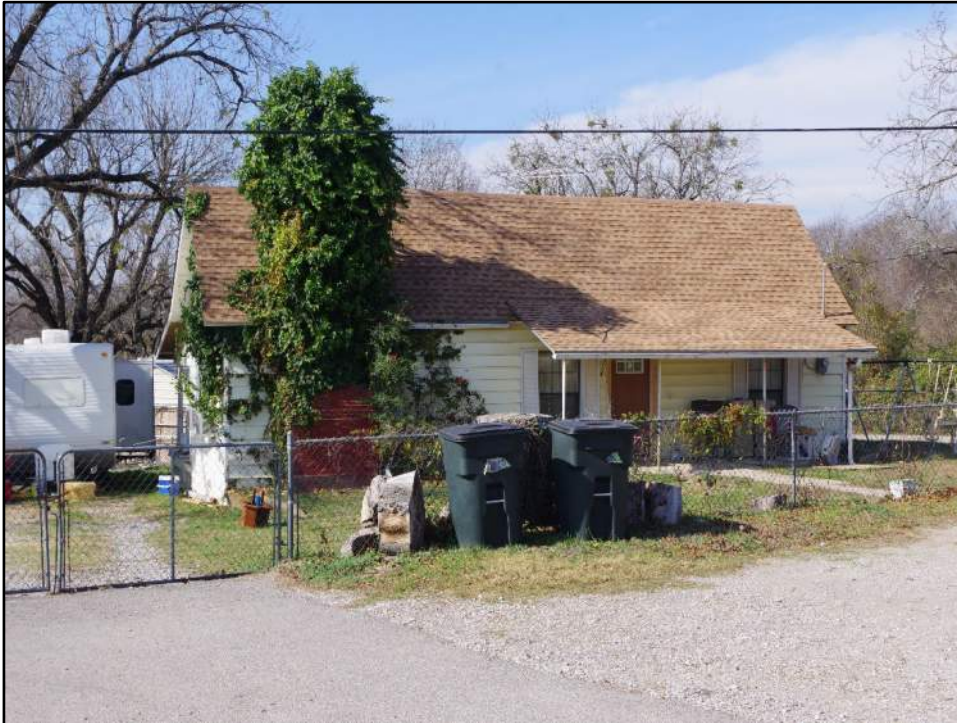
Survey Date:	December 6-9, 2021
Resource No:	60a
Project Location:	Coit Road to FM 1827
Project Name and CSJ:	0135-02-065, 0135-15-002, 0135-03-053
Address, Lat/Long:	1789 FM 2933 33.210632 / -96.584308
Function/Sub-function:	Domestic / Single Dwelling
Construction Date:	ca. 1910
NRHP Eligibility:	Not eligible
Integrity/Comments:	Highly altered National Folk Hall-and-Parlor-style dwelling with a side-gabled roof, replacement vinyl siding, replacement aluminum windows, a, shed-roof front porch addition, and a large gabled rear addition; on parcel with Resource 60b and non-historic-age outbuildings and stables (see additional Photographs in Appendix F); dwelling depicted in this location on the 1939 Collin County highway map and in 1956 aerial imagery (TSHD 1939; NETR 1956); lacks integrity of design, materials, workmanship, and feeling due to extent of alterations and no longer represents an intact or significant example of resource type or style.

View of Resource 60a, camera facing west.

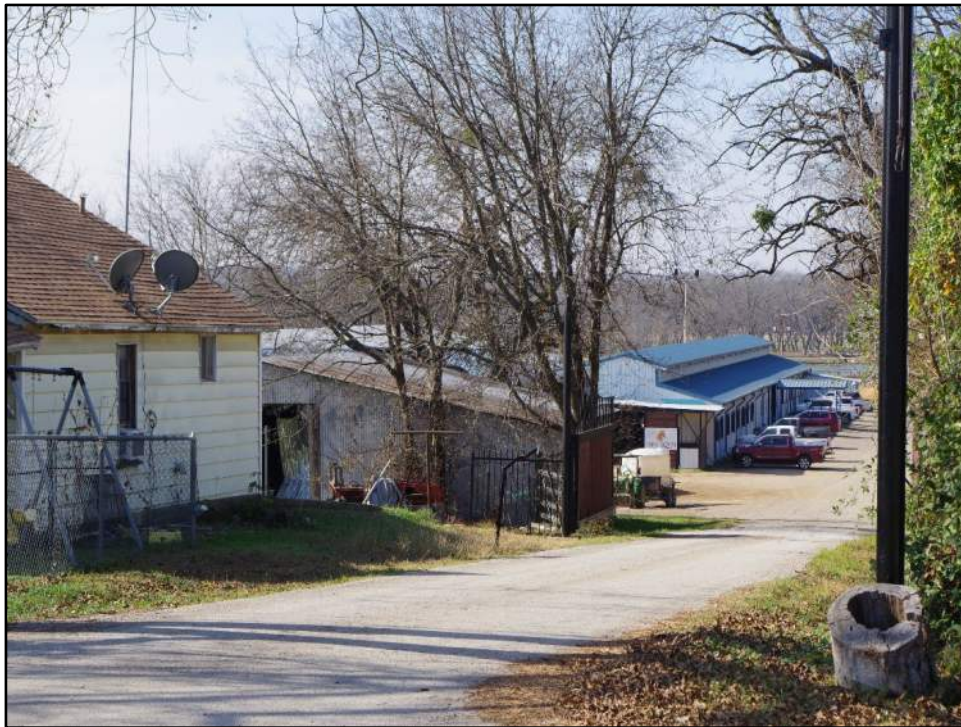
Survey Date:	December 6-9, 2021
Resource No:	60b
Project Location:	Coit Road to FM 1827
Project Name and CSJ:	0135-02-065, 0135-15-002, 0135-03-053
Address, Lat/Long:	1789 FM 2933 33.210632 / -96.584308
Function/Sub-function:	Agricultural / Outbuilding
Construction Date:	ca. 1965
NRHP Eligibility:	Not eligible
Integrity/Comments:	Front-gabled barn/utility building with metal roof, metal siding, and central bay; on parcel with Resource 60a and non-historic-age outbuildings and stables (see additional Photographs in Appendix F); not a significant example of resource type.

View of Resource 60b (center), and non-historic-age stables, camera facing west-southwest.

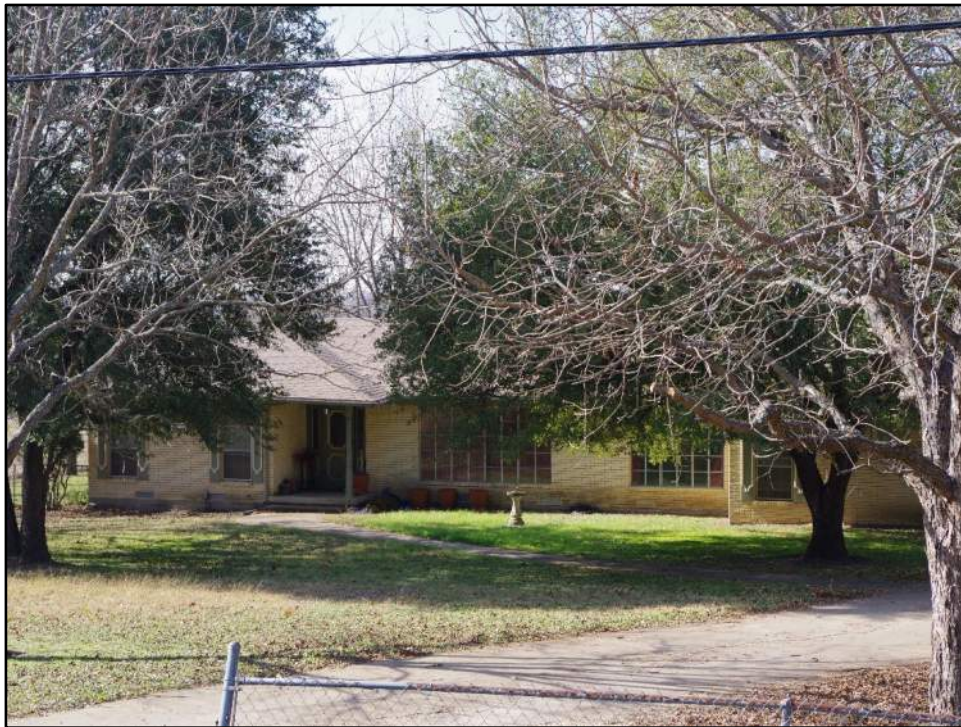
Survey Date:	December 6-9, 2021
Resource No:	61a
Project Location:	Coit Road to FM 1827
Project Name and CSJ:	0135-02-065, 0135-15-002, 0135-03-053
Address, Lat/Long:	2663 County Rd. 332 33.20977 / -96.584394
Function/Sub-function:	Domestic / Single Dwelling
Construction Date:	ca. 1975
NRHP Eligibility:	Not eligible
Integrity/Comments:	Hipped-roof Ranch-style dwelling with brick cladding and aluminum windows; on parcel with Resource 61b and non-historic-age outbuilding (see additional Photographs in Appendix F); not a significant example of resource type or style.

View of Resource 61a, camera facing west.

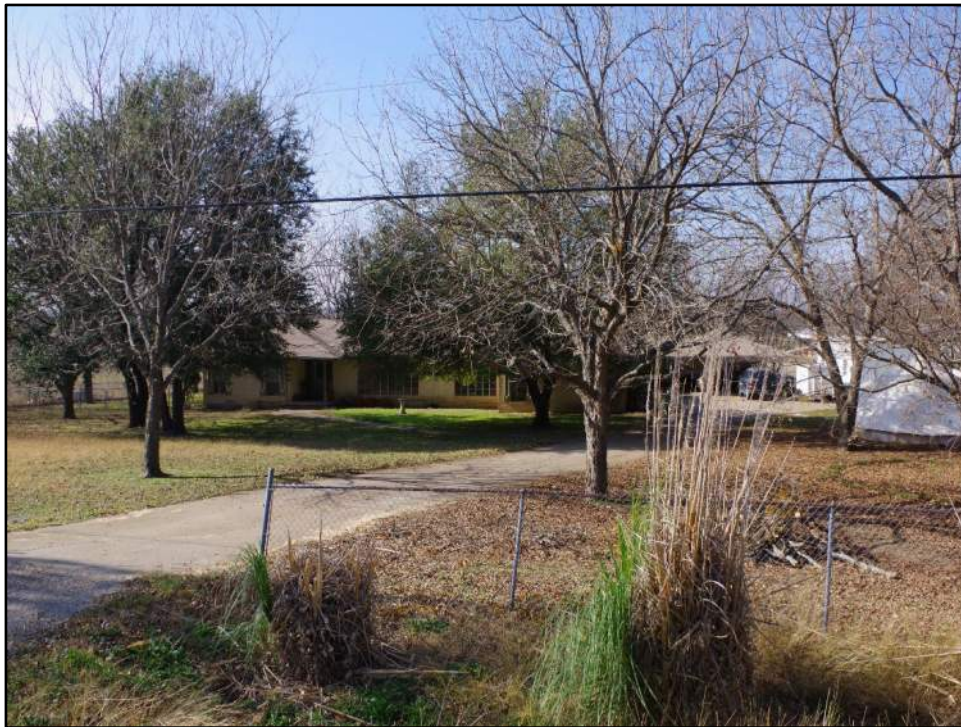
Survey Date:	December 6-9, 2021
Resource No:	61b
Project Location:	Coit Road to FM 1827
Project Name and CSJ:	0135-02-065, 0135-15-002, 0135-03-053
Address, Lat/Long:	2663 County Rd. 332 33.20977 / -96.584394
Function/Sub-function:	Domestic / Secondary Structure
Construction Date:	ca. 1975
NRHP Eligibility:	Not eligible
Integrity/Comments:	Hipped-roof garage; other details were not visible from the public ROW; on parcel with Resource 61a and non-historic-age outbuilding (see additional Photographs in Appendix F); not a significant example of resource type.

View of Resource 61a and Resource 61b (right, background), non-historic-age outbuildings, camera facing west.

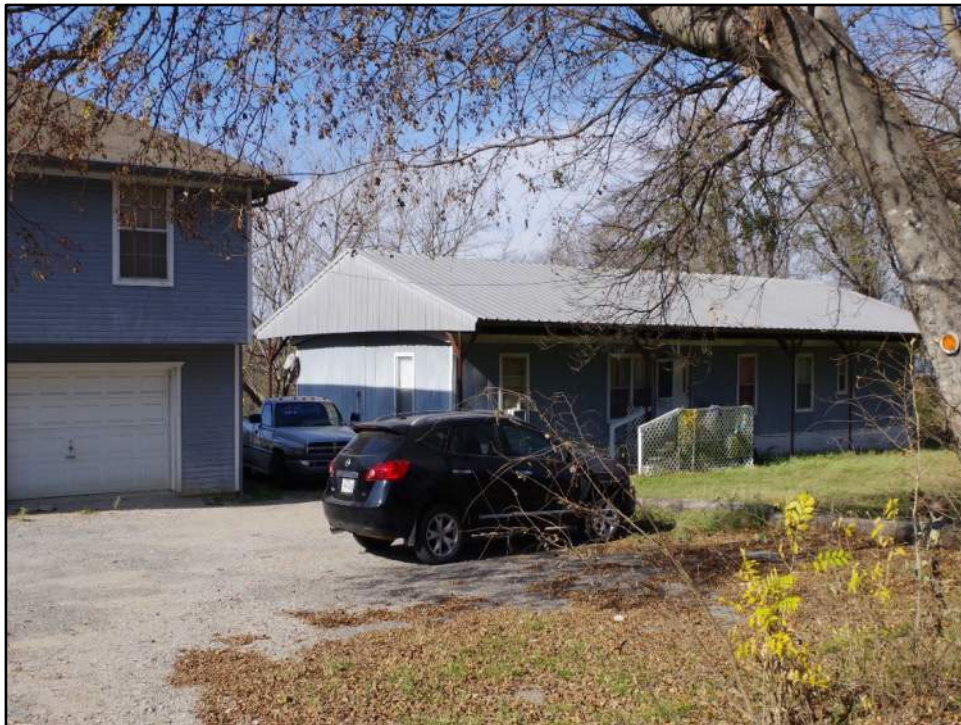
Survey Date:	December 6-9, 2021
Resource No:	62a
Project Location:	Coit Road to FM 1827
Project Name and CSJ:	0135-02-065, 0135-15-002, 0135-03-053
Address, Lat/Long:	2571 County Rd. 332 33.208334 / -96.584448
Function/Sub-function:	Domestic / Single Dwelling
Construction Date:	ca. 1975
NRHP Eligibility:	Not eligible
Integrity/Comments:	Manufactured dwelling with metal pavilion over dwelling, vinyl siding, vinyl windows, and vinyl skirting; on parcel with Resource 62b (see additional Photographs in Appendix F); not a significant example of resource type.

View of Resource 62a, camera facing west.

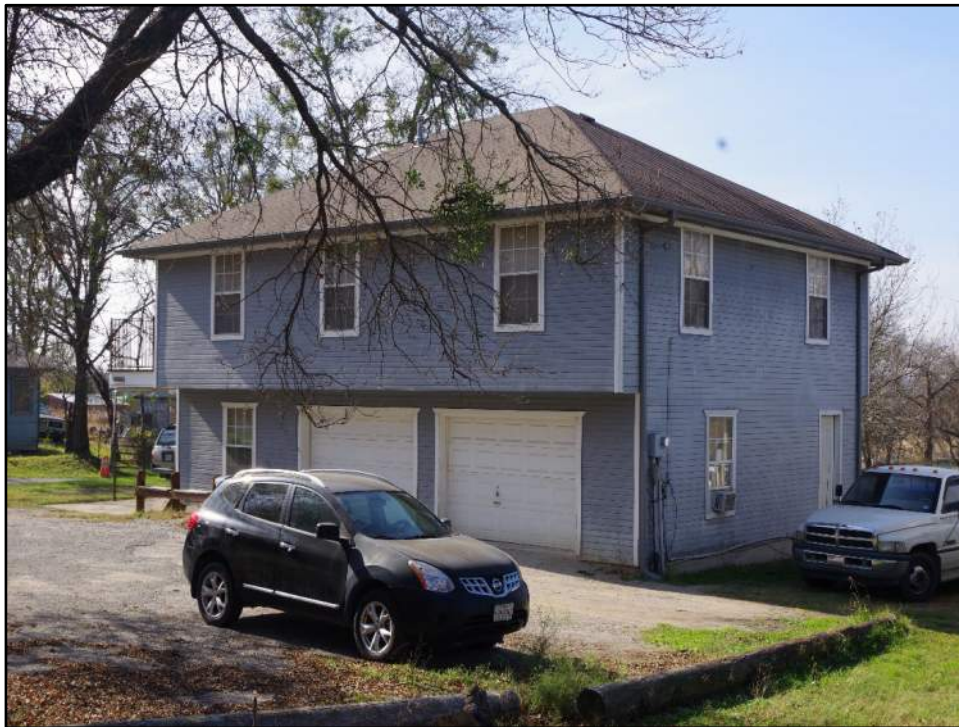
Survey Date:	December 6-9, 2021
Resource No:	62b
Project Location:	Coit Road to FM 1827
Project Name and CSJ:	0135-02-065, 0135-15-002, 0135-03-053
Address, Lat/Long:	2571 County Rd. 332 33.208334 / -96.584448
Function/Sub-function:	Domestic / Single Dwelling
Construction Date:	ca. 1975
NRHP Eligibility:	Not eligible
Integrity/Comments:	Hipped-roof, two-story secondary dwelling/garage includes hardiplank siding, vinyl windows, two garage bays with vinyl overhead garage doors, and carport with upper-level porch; on parcel with Resource 62a (see additional Photographs in Appendix F); not a significant example of resource type.

View of Resource 62b, camera facing southwest.

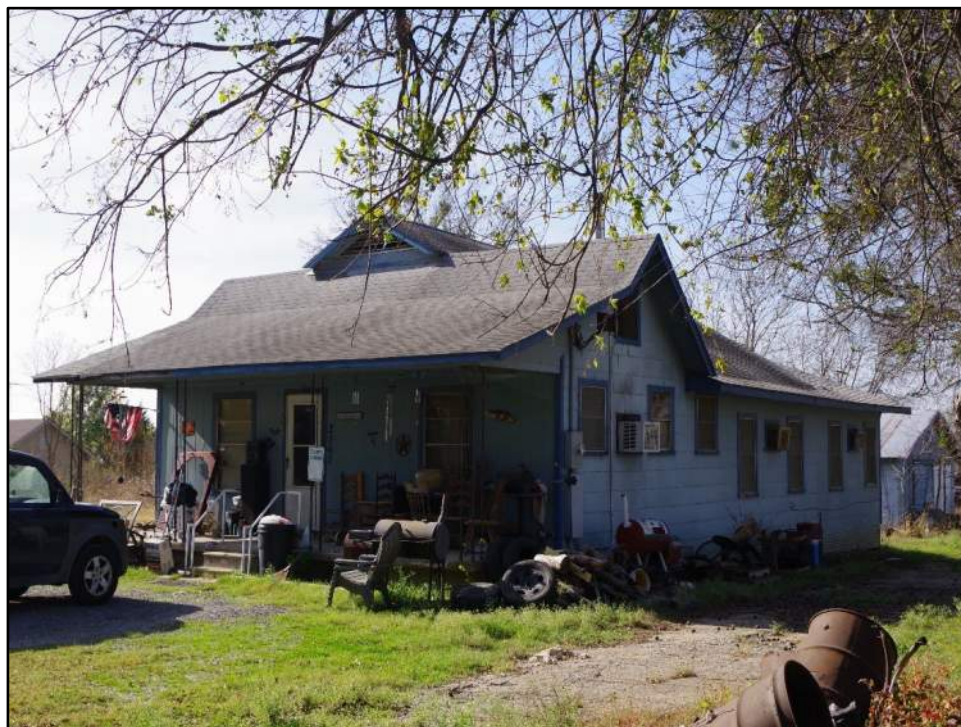
Survey Date:	December 6-9, 2021
Resource No:	63a
Project Location:	Coit Road to FM 1827
Project Name and CSJ:	0135-02-065, 0135-15-002, 0135-03-053
Address, Lat/Long:	2563 County Rd. 332 33.207827 / -96.584437
Function/Sub-function:	Domestic / Single Dwelling
Construction Date:	ca. 1940
NRHP Eligibility:	Not eligible
Integrity/Comments:	Appears to be a highly altered, side-gabled Minimal Traditional-style dwelling with a large gabled rear addition that extends above the original roof ridge; features asbestos siding, aluminum windows, and an integral shed-roof porch; original side-gabled dwelling visible on site in 1956, with gabled rear addition first visible in 1968 (NETR 1956, 1968); on parcel with Resource 63b and two metal outbuildings of historic age that were not visible from the ROW (see additional Photographs in Appendix F); lacks integrity of design, materials, workmanship, and feeling and is not an intact or significant example of resource type or style.

View of Resource 63a, camera facing southwest.

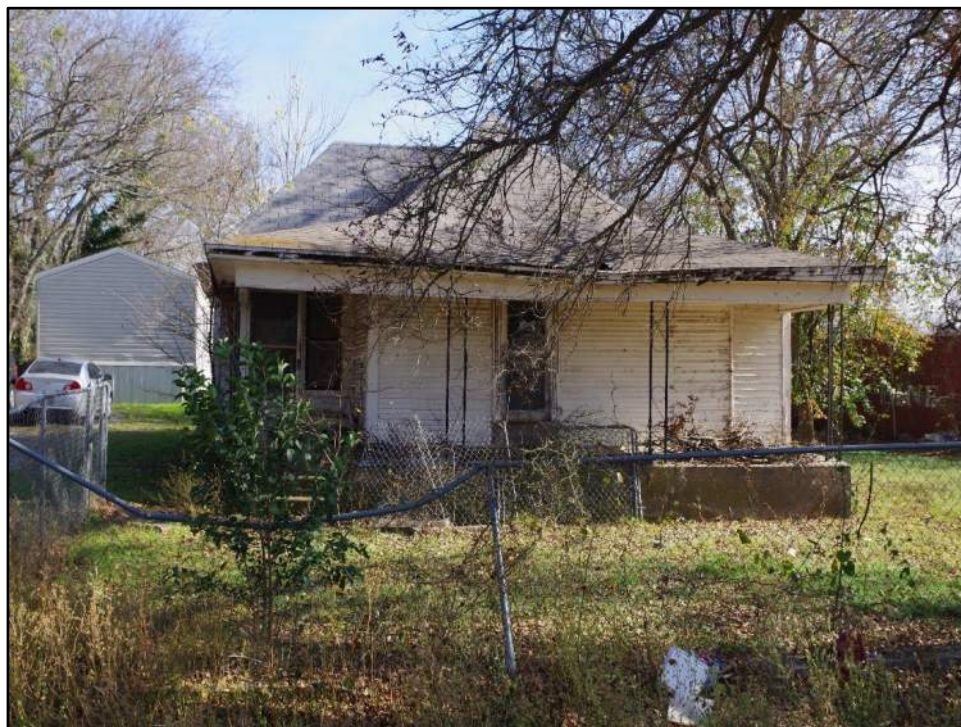
Survey Date:	December 6-9, 2021
Resource No:	64
Project Location:	Coit Road to FM 1827
Project Name and CSJ:	0135-02-065, 0135-15-002, 0135-03-053
Address, Lat/Long:	2550 County Rd. 332 33.207827 / -96.583938
Function/Sub-function:	Domestic / Single Dwelling
Construction Date:	ca. 1915
NRHP Eligibility:	Not eligible
Integrity/Comments:	National Folk-style dwelling with cross-hipped roof, wood siding, original wood windows, wraparound inset front porch with ca. 1950s decorative iron supports, and rear shed-roof greenhouse addition; on parcel with a non-historic-age manufactured dwelling and small shed (see additional Photographs in Appendix F); does not appear on site in 1956 aerial imagery but is visible in 1968 (NETR 1956, 1968); appears to have been relocated to the property at that time; lacks integrity of original location and setting and retains no known associations of historic significance; retains fair integrity but is not a significant example of resource type or style

View of Resource 64, camera facing east.

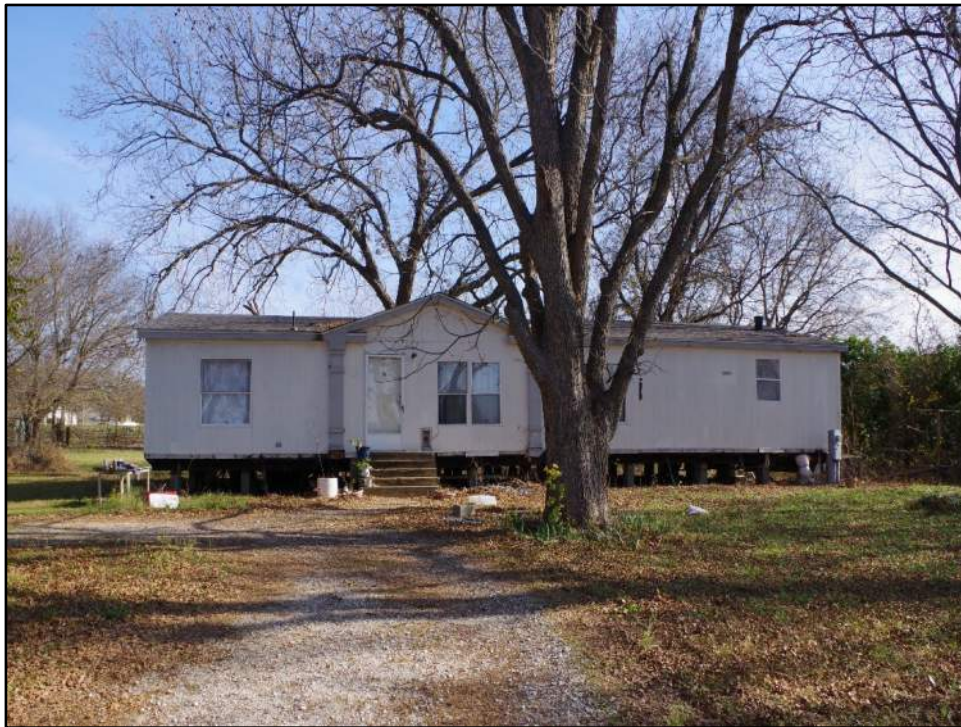
Survey Date:	December 6-9, 2021
Resource No:	65
Project Location:	Coit Road to FM 1827
Project Name and CSJ:	0135-02-065, 0135-15-002, 0135-03-053
Address, Lat/Long:	2550 County Rd. 332 33.207665 / -96.58389
Function/Sub-function:	Domestic / Single Dwelling
Construction Date:	ca. 1975
NRHP Eligibility:	Not eligible
Integrity/Comments:	Side-gabled manufactured dwelling with synthetic siding, vinyl windows, a central gabled roof over the entrance (see additional Photographs in Appendix F); visible on site in 1981 aerial imagery (NETR 1981); not a significant example of resource type.

View of Resource 65, camera facing east.

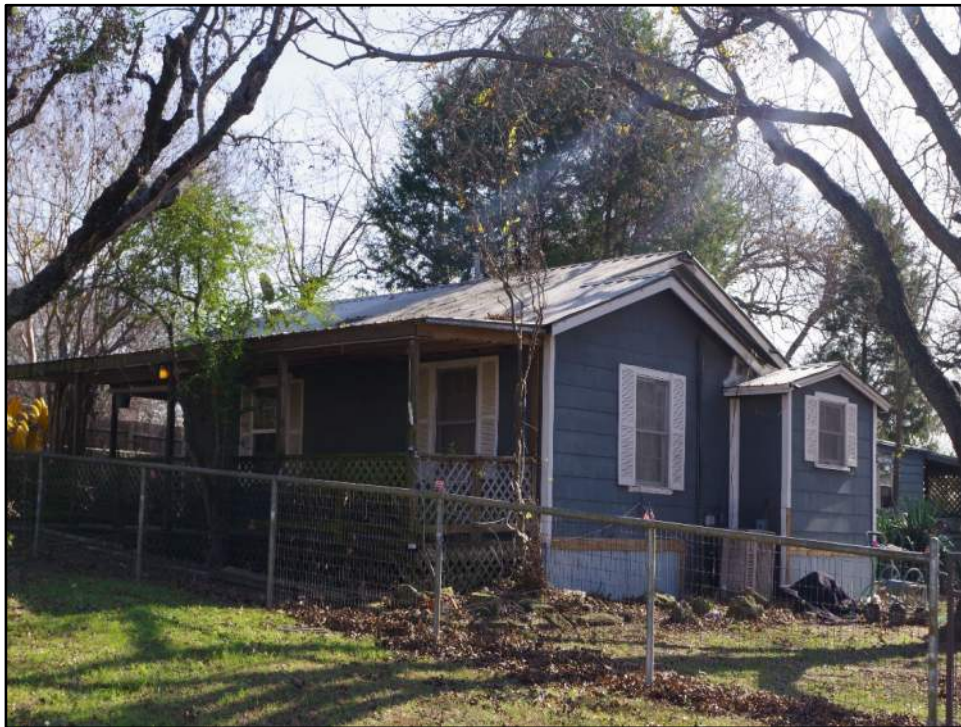
Survey Date:	December 6-9, 2021
Resource No:	66
Project Location:	Coit Road to FM 1827
Project Name and CSJ:	0135-02-065, 0135-15-002, 0135-03-053
Address, Lat/Long:	1834 County Rd. 329 33.208419 / -96.583461
Function/Sub-function:	Domestic / Single Dwelling
Construction Date:	ca. 1940
NRHP Eligibility:	Not eligible
Integrity/Comments:	Side-gabled Minimal Traditional-style dwelling with metal roof, asbestos siding, original wood windows, a shed-roof front porch addition, multiple rear shed-roof additions, and a rear carport; on parcel with non-historic-age sheds (see additional Photographs in Appendix F); retains fair integrity but is not a significant example of resource type or style.

View of Resource 66, camera facing southeast.

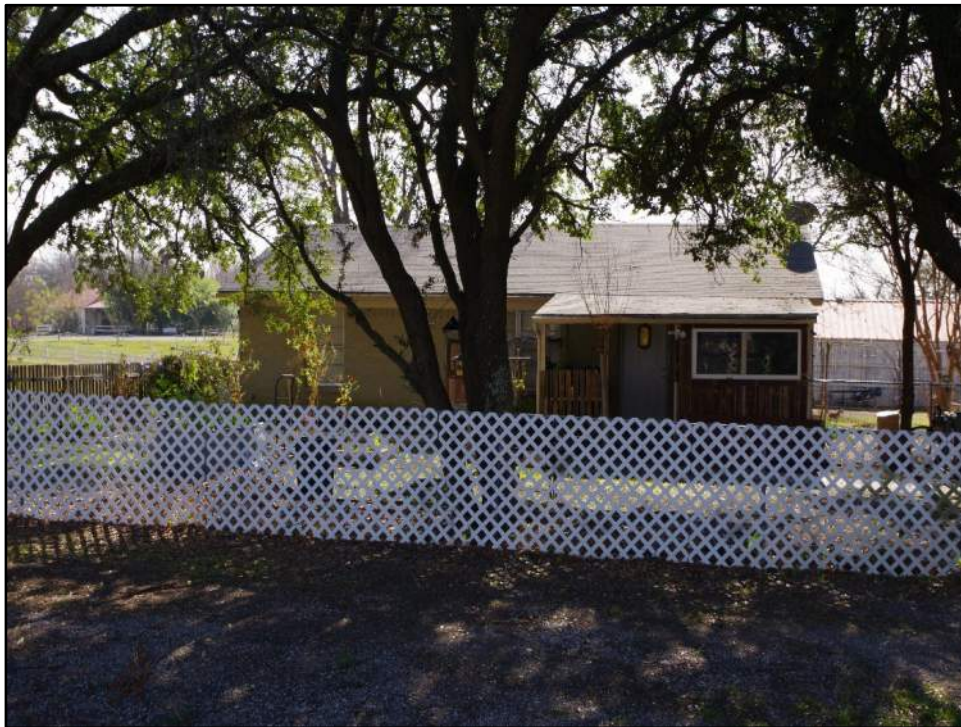
Survey Date:	December 6-9, 2021
Resource No:	67a
Project Location:	Coit Road to FM 1827
Project Name and CSJ:	0135-02-065, 0135-15-002, 0135-03-053
Address, Lat/Long:	1872 County Rd. 329 33.208365 / -96.582468
Function/Sub-function:	Domestic / Single Dwelling
Construction Date:	ca. 1965
NRHP Eligibility:	Not eligible
Integrity/Comments:	Side-gabled Simplified Ranch-style dwelling with brick cladding, aluminum and vinyl windows, and a shed-roof front porch; on parcel with Resource 67b and non-historic-age shed (see additional Photographs in Appendix F); not a significant example of resource type or style.

View of Resource 67a, camera facing south

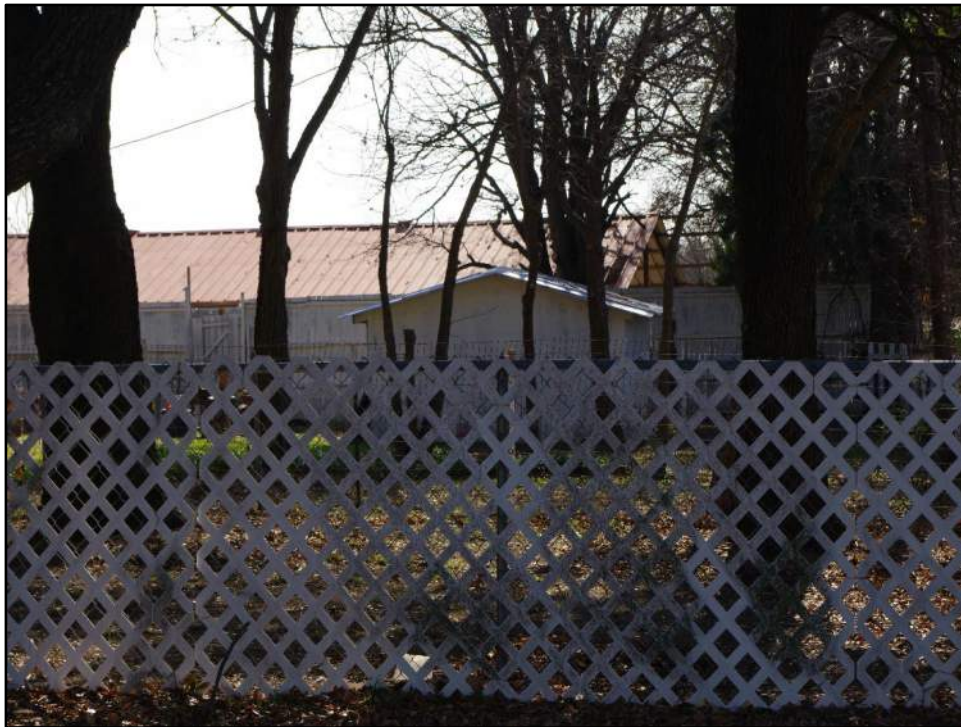
Survey Date:	December 6-9, 2021
Resource No:	67b
Project Location:	Coit Road to FM 1827
Project Name and CSJ:	0135-02-065, 0135-15-002, 0135-03-053
Address, Lat/Long:	1872 County Rd. 329 33.208365 / -96.582468
Function/Sub-function:	Domestic / Secondary Structure
Construction Date:	ca. 1975
NRHP Eligibility:	Not eligible
Integrity/Comments:	Side-gabled outbuilding with metal roof and plywood siding; on parcel with Resource 67a and non-historic-age shed (see additional Photographs in Appendix F); not a significant example of resource type.

View of Resource 67b, camera facing south.

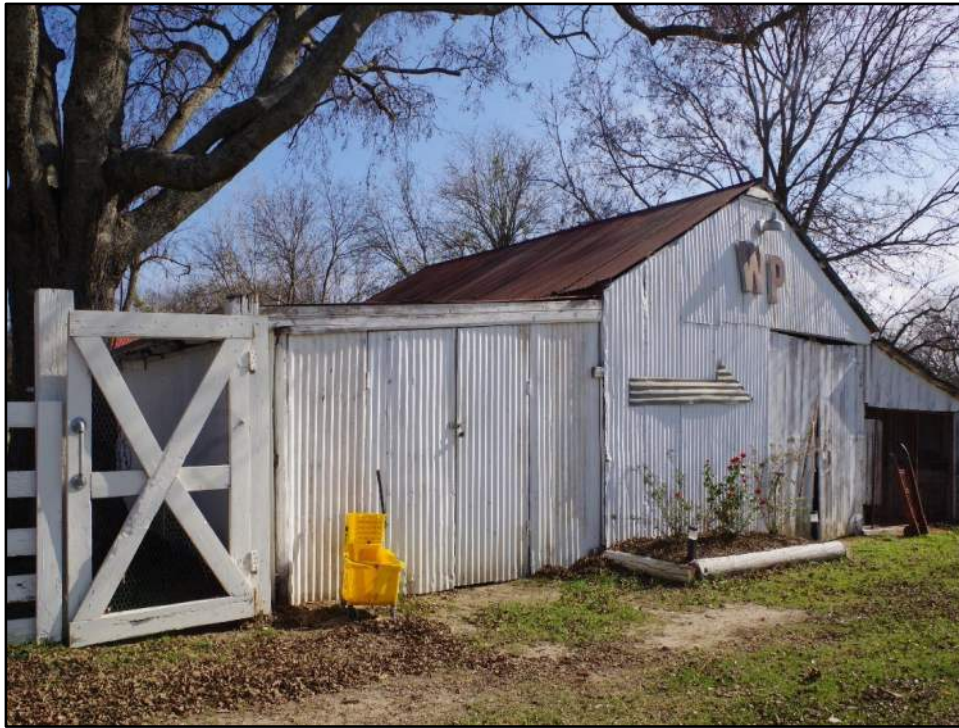
Survey Date:	December 6-9, 2021
Resource No:	68a
Project Location:	Coit Road to FM 1827
Project Name and CSJ:	0135-02-065, 0135-15-002, 0135-03-053
Address, Lat/Long:	South side of FM 2933, approximately 0.01 mi southeast of the intersection with County Rd. 329 33.207674 / -96.581728
Function/Sub-function:	Commerce /Business
Construction Date:	ca. 1960
NRHP Eligibility:	Not eligible
Integrity/Comments:	Front-gabled barn with metal roof, metal siding, paired metal doors at the gabled end, and two shed-roof additions; on parcel with Resources 68b-68c and non-historic-age outbuilding and events building (see additional Photographs in Appendix F); former agricultural property currently serves as a wedding venue; no longer associated with agricultural buildings or in agricultural use and is not a significant example of resource type or historic-age agricultural complex.

View of Resource 68a, camera facing southwest.

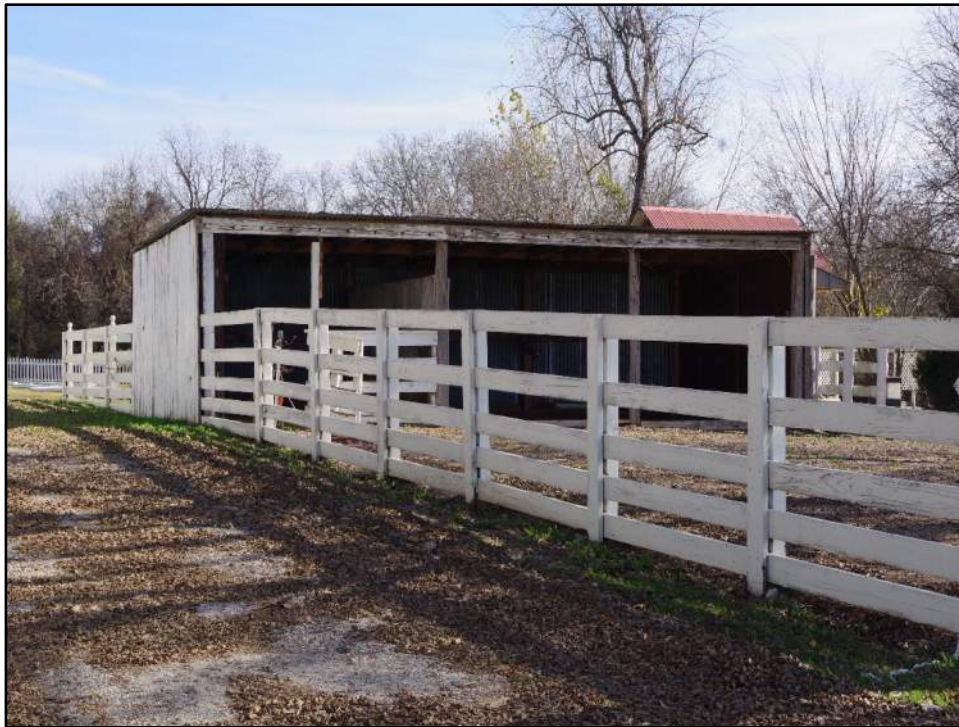
Survey Date:	December 6-9, 2021
Resource No:	68b
Project Location:	Coit Road to FM 1827
Project Name and CSJ:	0135-02-065, 0135-15-002, 0135-03-053
Address, Lat/Long:	South side of FM 2933, approximately 0.01 mi southeast of the intersection with County Rd. 329 33.207674 / -96.581728
Function/Sub-function:	Commerce / Business
Construction Date:	ca. 1975
NRHP Eligibility:	Not eligible
Integrity/Comments:	Flat-roof animal shelter with metal roof, wood siding, and three bays; on parcel with Resources 68a and 68c and non-historic-age outbuilding and event building (see additional Photographs in Appendix F); not a significant example of resource type; no longer associated with agricultural buildings or in agricultural use and is not a significant example of resource type or historic-age agricultural complex.

View of Resource 68b, camera facing south.

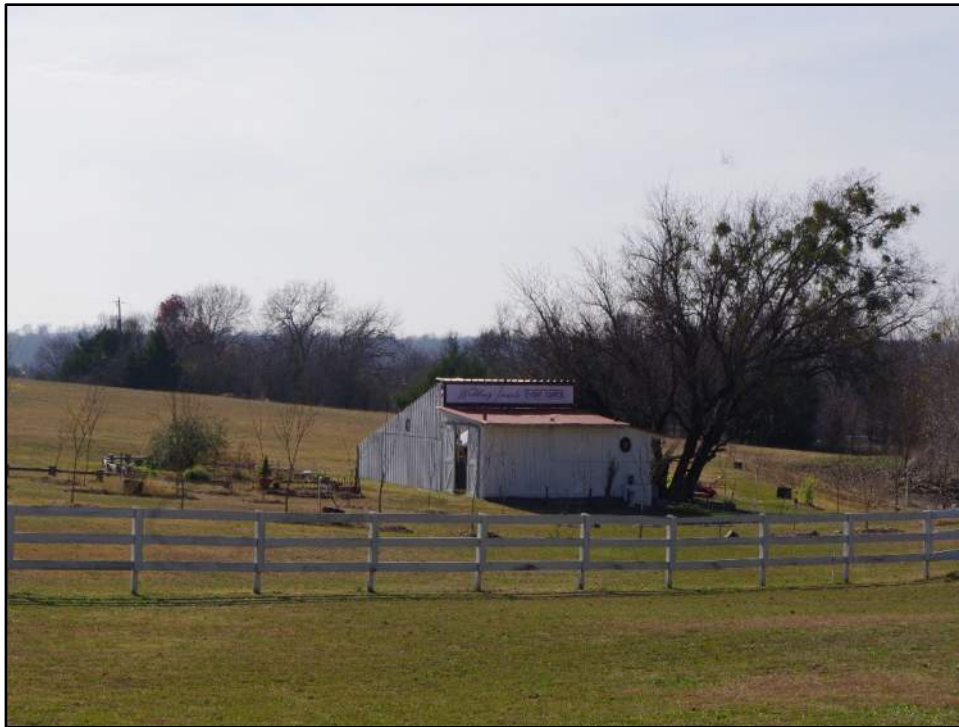
Survey Date:	December 6-9, 2021
Resource No:	68c
Project Location:	Coit Road to FM 1827
Project Name and CSJ:	0135-02-065, 0135-15-002, 0135-03-053
Address, Lat/Long:	South side of FM 2933, approximately 0.01 mi southeast of the intersection with County Rd. 329 33.207674 / -96.581728
Function/Sub-function:	Commerce / Business
Construction Date:	ca. 1975
NRHP Eligibility:	Not eligible
Integrity/Comments:	Front-gabled barn with metal roof, metal and vertical wood siding, and paired sliding wooden doors; on parcel with Resources 68a-68b and non-historic-age outbuilding and event building (see additional Photographs in Appendix F); no longer associated with agricultural buildings or in agricultural use and is not a significant example of resource type or historic-age agricultural complex.

View of Resource 68c, camera facing southwest.

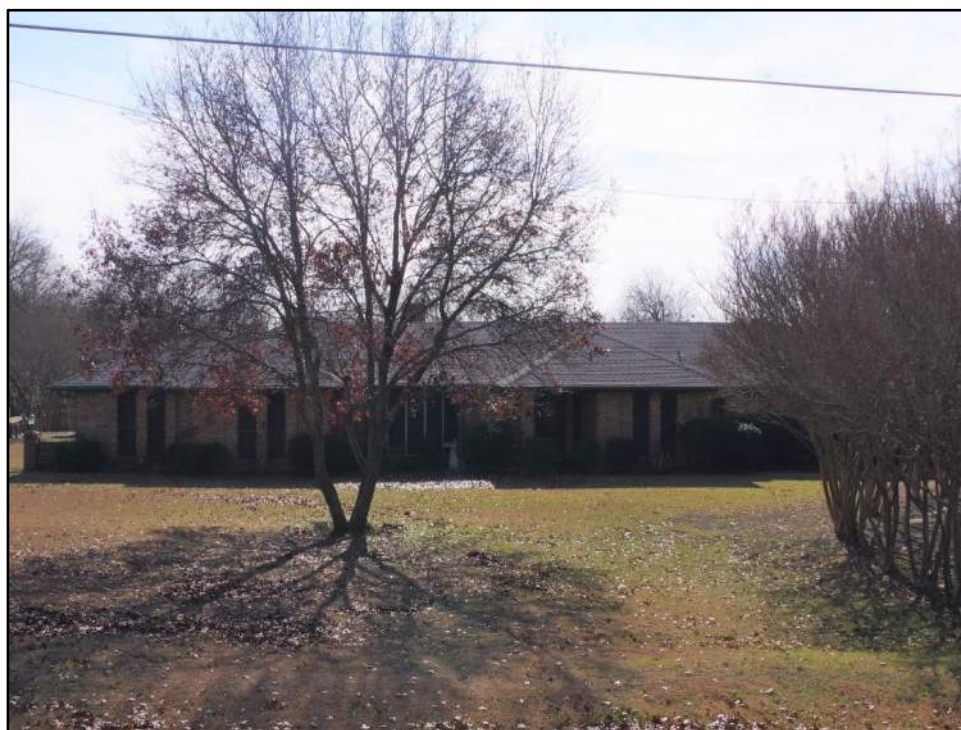
Survey Date:	December 6-9, 2021
Resource No:	69
Project Location:	Coit Road to FM 1827
Project Name and CSJ:	0135-02-065, 0135-15-002, 0135-03-053
Address, Lat/Long:	1675FM 2933 33.208213 / -96.581224
Function/Sub-function:	Domestic / Single Dwelling
Construction Date:	ca. 1975
NRHP Eligibility:	Not eligible
Integrity/Comments:	Hipped-roof Ranch-style dwelling with brick cladding, replacement vinyl windows, interior brick chimney, and recessed front entry; on parcel with non-historic-age outbuildings (see additional Photographs in Appendix F); retains fair integrity but is not a significant example of resource type or style.

View of Resource 69, camera facing south.

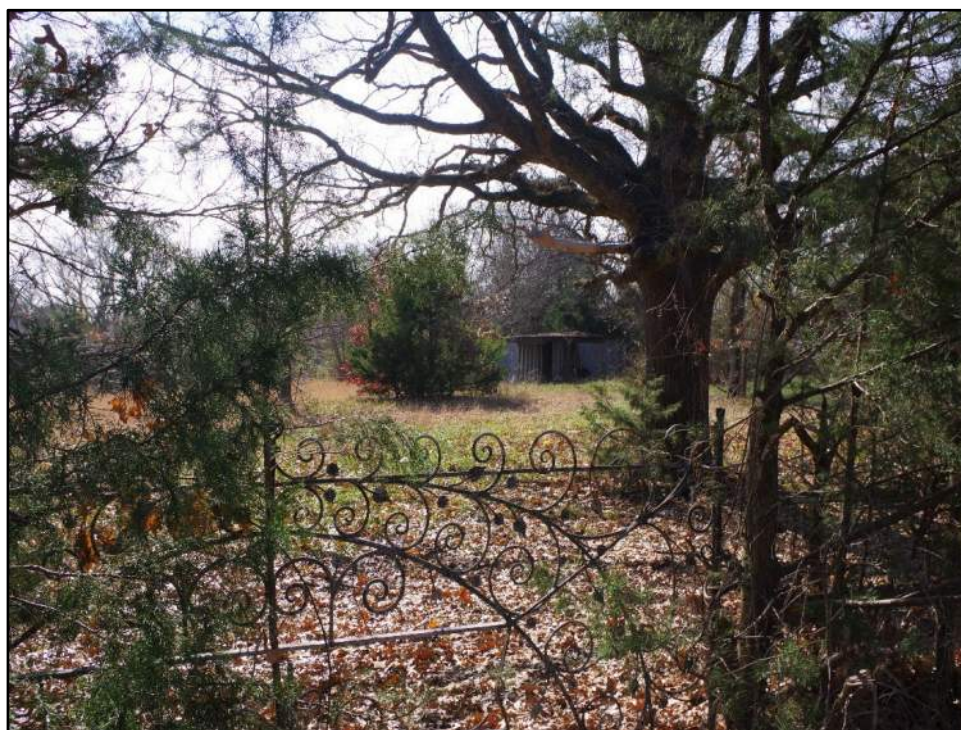
Survey Date:	December 6-9, 2021
Resource No:	70
Project Location:	Coit Road to FM 1827
Project Name and CSJ:	0135-02-065, 0135-15-002, 0135-03-053
Address, Lat/Long:	South side of FM 2933, approximately 0.05 mi southeast of the intersection with County Rd. 329 33.208284 / -96.58036
Function/Sub-function:	Vacant / Not in Use
Construction Date:	ca. 1975
NRHP Eligibility:	Not eligible
Integrity/Comments:	Flat-roof outbuilding with metal roof and siding; vacant and no longer associated with a dwelling or other outbuildings; no other details visible from the public ROW (see additional Photographs in Appendix F); not a significant example of resource type.

View of Resource 70, camera facing southwest.

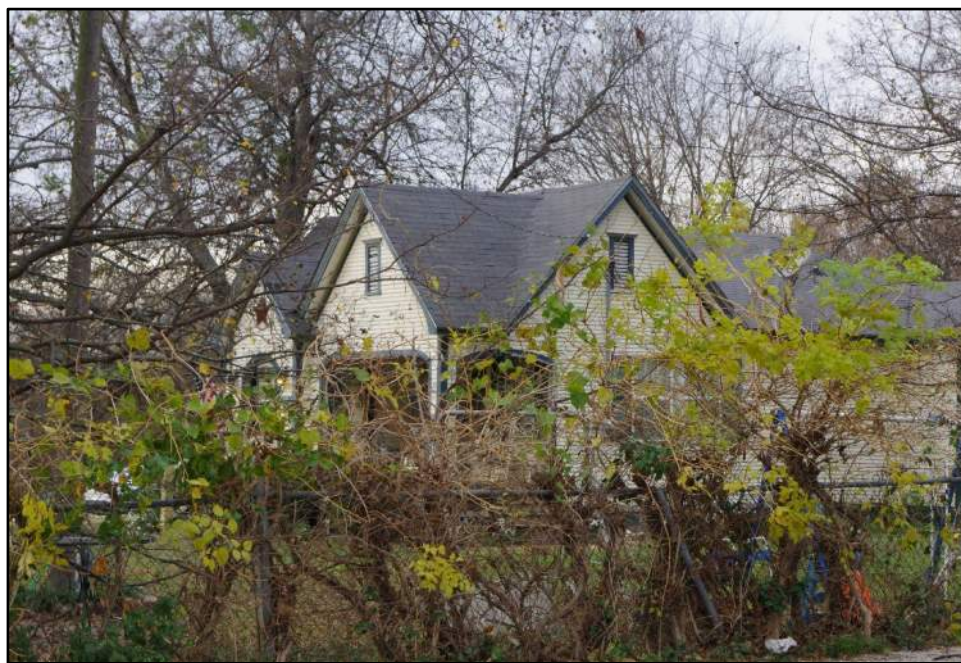
Survey Date:	December 6-9, 2021
Resource No:	71a
Project Location:	Coit Road to FM 1827
Project Name and CSJ:	0135-02-065, 0135-15-002, 0135-03-053
Address, Lat/Long:	160 Fisher Rd 33.203993 / -96.57837
Function/Sub-function:	Domestic / Single Dwelling
Construction Date:	ca. 1935
NRHP Eligibility:	Not eligible
Integrity/Comments:	Cross-gabled Tudor Revival-style dwelling with original wood siding, replacement multi-light vinyl windows, an inset front porch, and a large, non-historic-age rear addition (visible in aerial imagery after 2001) that more than doubles the original footprint of the dwelling (NETR 2001) (see additional Photographs in Appendix F); on parcel with a garage/outbuilding (Resource 71b) and additional resources not visible from the public ROW including a ca. 1965 Ranch-style dwelling, two ca. 1975 outbuildings, two additional small outbuildings of undetermined age, and a non-historic-age manufactured dwelling; property associated with Fisher family members since at least the 1940s but does not possess associations of historic significance; dwelling lacks integrity of design, materials, and workmanship due to the large non-historic-age rear addition and replacement vinyl windows; property no longer in agricultural use and no longer represents an intact example of an early-twentieth-century farm.

View of Resource 71a, camera facing northwest.

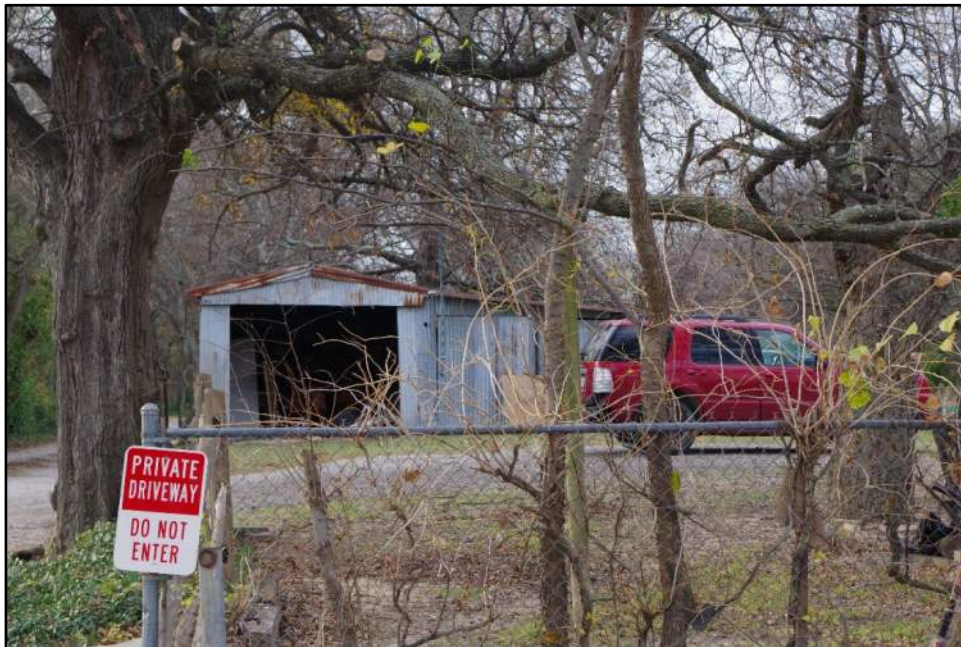
Survey Date:	December 6-9, 2021
Resource No:	71b
Project Location:	Coit Road to FM 1827
Project Name and CSJ:	0135-02-065, 0135-15-002, 0135-03-053
Address, Lat/Long:	160 Fisher Rd 33.203993 / -96.57837
Function/Sub-function:	Domestic / Secondary Structure
Construction Date:	Ca. 1960
NRHP Eligibility:	Not eligible
Integrity/Comments:	Front-gabled shed/small garage with metal roof, vertical metal siding, and a shed-roof side addition with metal siding and hinged metal doors; on parcel with Resource 71a and other resources not visible from the public ROW (see additional Photographs in Appendix F); not a significant example of resource type or style.

View of Resource 71b, camera facing west.

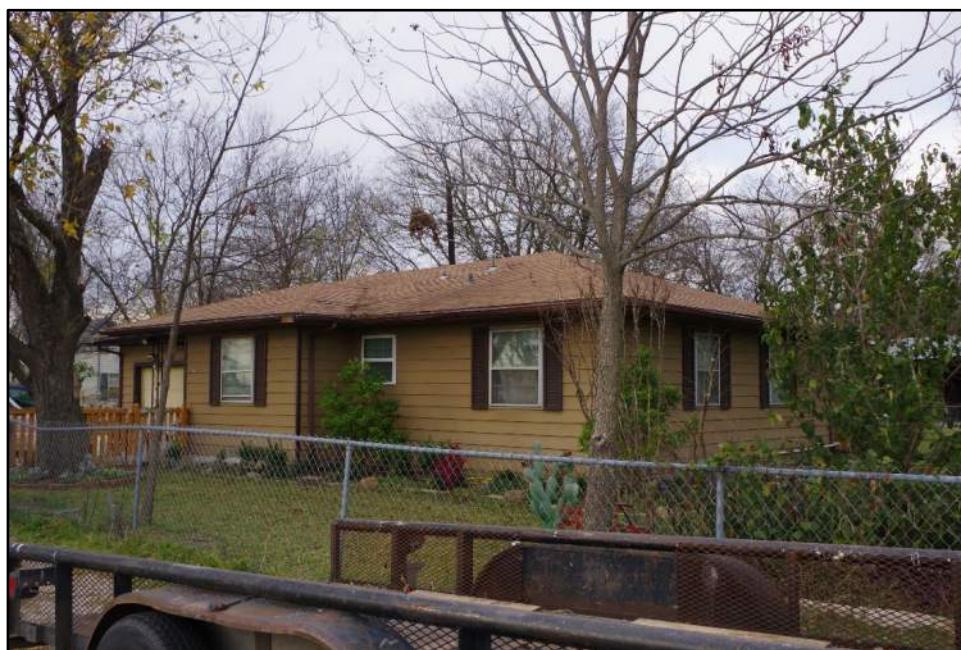
Survey Date:	December 6-9, 2021
Resource No:	72a
Project Location:	Coit Road to FM 1827
Project Name and CSJ:	0135-02-065, 0135-15-002, 0135-03-053
Address, Lat/Long:	120 Fisher Rd 33.203998 / -96.577189
Function/Sub-function:	Domestic / Single Dwelling
Construction Date:	ca. 1960
NRHP Eligibility:	Not eligible
Integrity/Comments:	Hipped-roof Simplified Ranch-style dwelling with hardiplank siding, replacement vinyl windows, and single bay garage with overhead vinyl door; on parcel with Resource 72b (see additional Photographs in Appendix F); lacks integrity and is not a significant example of resource type or style.

View of Resource 72a, camera facing northwest.

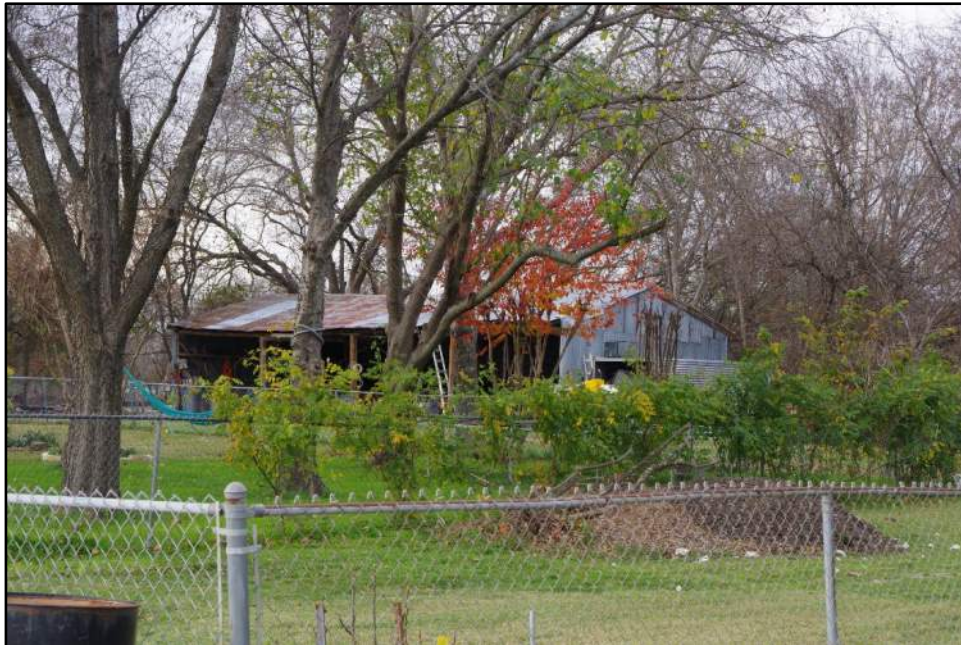
Survey Date:	December 6-9, 2021
Resource No:	72b
Project Location:	Coit Road to FM 1827
Project Name and CSJ:	0135-02-065, 0135-15-002, 0135-03-053
Address, Lat/Long:	120 Fisher Rd 33.203998 / -96.577189
Function/Sub-function:	Agricultural / Storage
Construction Date:	ca. 1980
NRHP Eligibility:	Not eligible
Integrity/Comments:	Side-gabled pole barn with metal roof and metal siding; on parcel with Resource 72a (see additional Photographs in Appendix F); not a significant example of resource type.

View of Resource 72b, camera facing northwest.

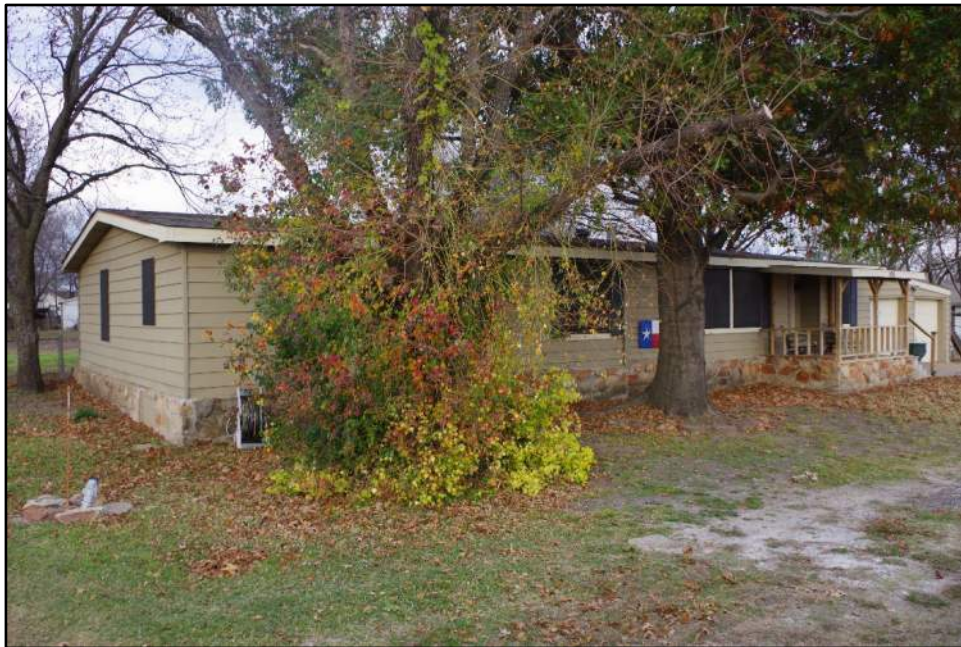
Survey Date:	December 6-9, 2021
Resource No:	73
Project Location:	Coit Road to FM 1827
Project Name and CSJ:	0135-02-065, 0135-15-002, 0135-03-053
Address, Lat/Long:	100 Fisher Rd 33.204002 / -96.576562
Function/Sub-function:	Domestic / Single Dwelling
Construction Date:	ca. 1975
NRHP Eligibility:	Not eligible
Integrity/Comments:	Side-gabled manufactured dwelling with hardiplank siding, vinyl windows, stone skirting, and a shed-roof garage addition (see additional Photographs in Appendix F); not a significant example of resource type.

View of Resource 73, camera facing northeast.
