APPENDIX L: Cultural Resources

APPENDIX L – CULTURAL RESOURCES – FEIS Preferred Alternative/Blue Alternative

US 380 MCKINNEY – Coit Road to FM 1827, Collin County CSJs 0135-02-065 and 0135-15-002; Dallas District

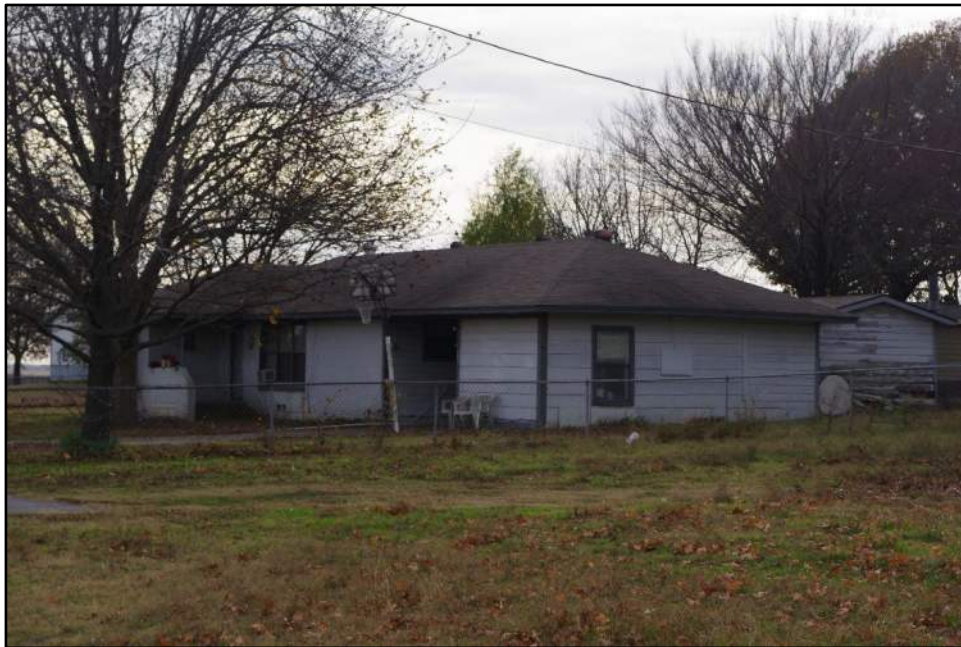
Survey Date:	December 6-9, 2021
Resource No:	74
Project Location:	Coit Road to FM 1827
Project Name and CSJ:	0135-02-065, 0135-15-002, 0135-03-053
Address, Lat/Long:	680 New Hope Rd. W. 33.204137 / -96.576219
Function/Sub-function:	Domestic / Single Dwelling
Construction Date:	ca. 1950
NRHP Eligibility:	Not eligible
Integrity/Comments:	Hipped-roof Ranch-style dwelling with a mix of brick cladding and asbestos siding, vinyl windows, and a partially enclosed integral carport (see additional Photographs in Appendix F); not a significant example of resource type or style.

View of Resource 74, camera facing southwest.

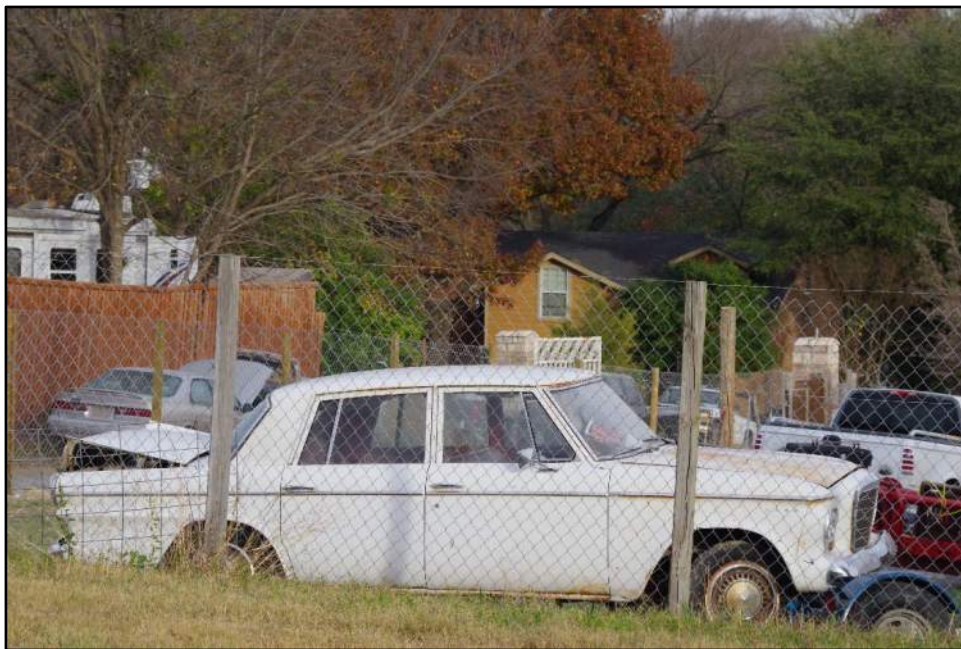
Survey Date:	December 6-9, 2021
Resource No:	75
Project Location:	Coit Road to FM 1827
Project Name and CSJ:	0135-02-065, 0135-15-002, 0135-03-053
Address, Lat/Long:	190 FM 1827 33.203621 / -96.57477
Function/Sub-function:	Domestic / Single Dwelling
Construction Date:	ca. 1975
NRHP Eligibility:	Not eligible
Integrity/Comments:	Cross-gabled dwelling with hardiplank siding and vinyl windows; other details were not visible from the public ROW (see additional Photographs in Appendix F); not a significant example of resource type or style.

Obstructed view of Resource 75, camera facing east.

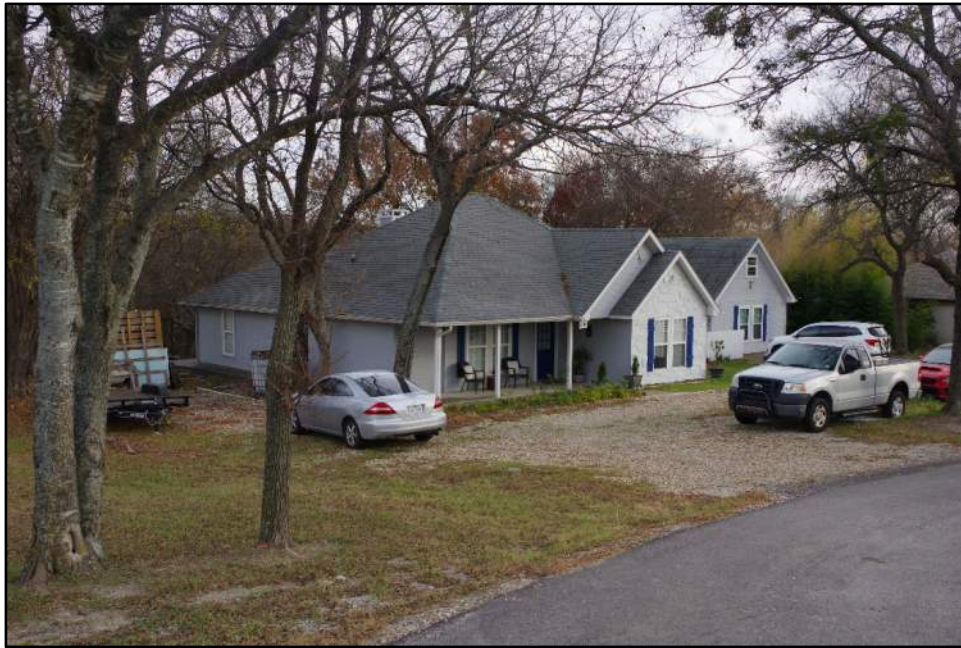
Survey Date:	December 6-9, 2021
Resource No:	76
Project Location:	Coit Road to FM 1827
Project Name and CSJ:	0135-02-065, 0135-15-002, 0135-03-053
Address, Lat/Long:	1134 FM 1827 33.202131 / -96.575747
Function/Sub-function:	Domestic / Single Dwelling
Construction Date:	ca. 1975
NRHP Eligibility:	Not eligible
Integrity/Comments:	Appears to be a highly altered dwelling; a dwelling or small outbuilding is visible on site in 1968 and 1981 (NETR 1968, 1981); original portion of current dwelling may be reflected in current garage ell at southern end; larger northern portion of dwelling is not historic age; dwelling features a hipped and cross-gabled roof, a mix of vinyl siding and stone veneer cladding, vinyl windows, and an inset front porch (see additional Photographs in Appendix F); lacks integrity due to extent of alterations and is not a significant example of resource type or style.

View of Resource 76, camera facing southeast.

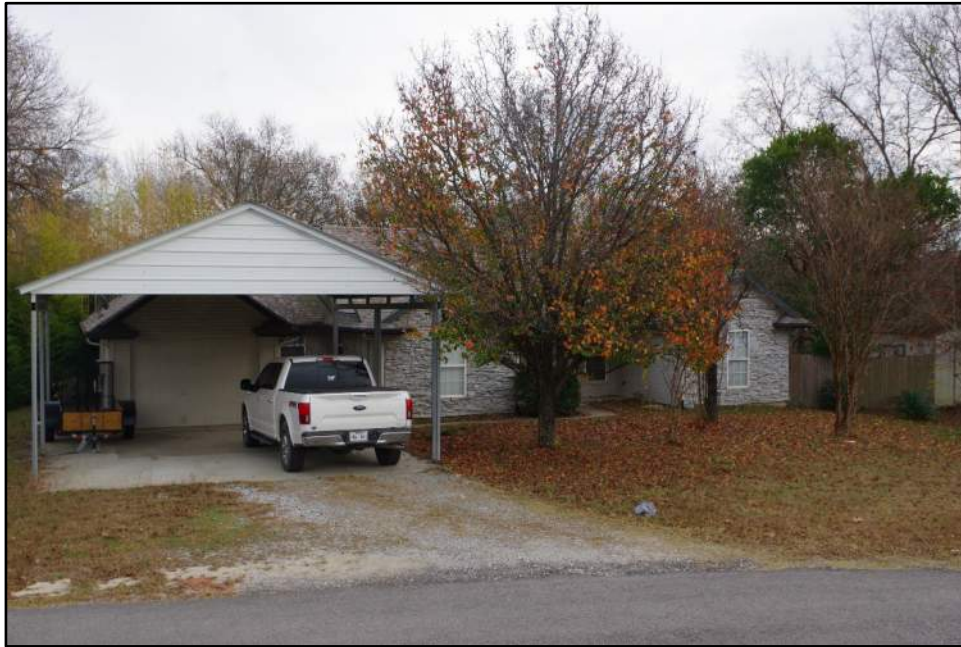
Survey Date:	December 6-9, 2021
Resource No:	77
Project Location:	Coit Road to FM 1827
Project Name and CSJ:	0135-02-065, 0135-15-002, 0135-03-053
Address, Lat/Long:	1128 FM 1827 33.201825 / -96.575881
Function/Sub-function:	Domestic / Single Dwelling
Construction Date:	ca. 1975
NRHP Eligibility:	Not eligible
Integrity/Comments:	Altered cross-gabled Ranch-style dwelling with mix of vinyl siding and stone veneer cladding, vinyl windows, integrated single bay garage, and non-historic-age carport (see additional Photographs in Appendix F); lacks integrity and is not a significant example of resource type or style.

Overview of Resource 77, camera facing southeast.

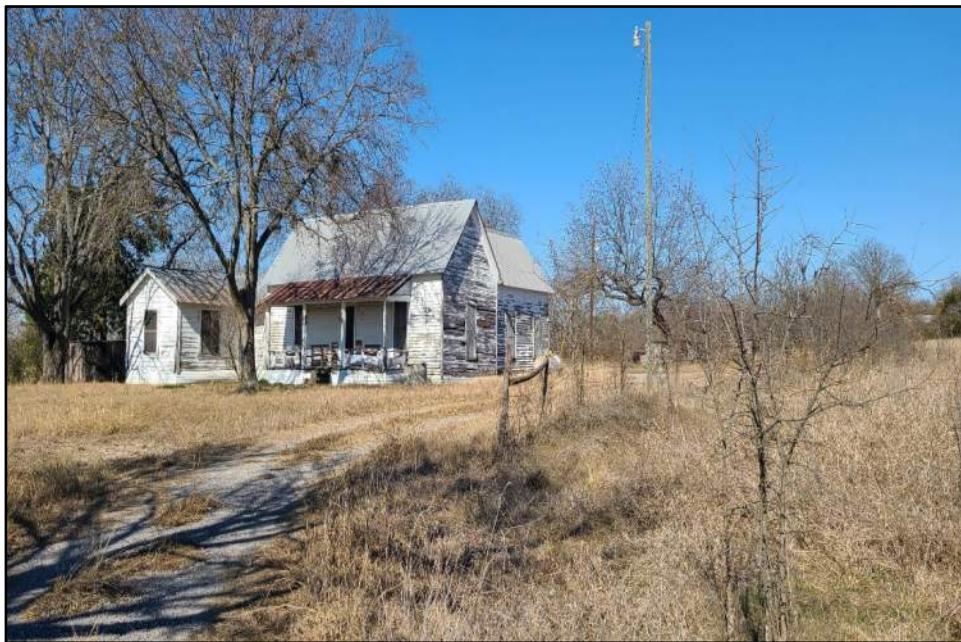
Survey Date:	December 6-9, 2021
Resource No:	78a
Project Location:	Coit Road to FM 1827
Project Name and CSJ:	0135-02-065, 0135-15-002, 0135-03-053
Address, Lat/Long:	2163 E. Dave Brown Rd. 33.201278 / -96.579427
Function/Sub-function:	Domestic / Single Dwelling
Construction Date:	ca. 1900
NRHP Eligibility:	NRHP Eligible: Criterion C
Integrity/Comments:	National Folk-style dwelling with a side-gabled, replacement metal roof, an original gabled rear ell, two ca. 1940 shed-roof rear additions, two small, ca. 1940 side and front-gabled additions on the west side elevation, an original shed-roof front porch with simple wooden supports, an original central entrance door, and a variety of original wood windows including two-over- two-light sashes on the main block and one-over-one and multi-light wood sashes on the rear and side additions; on parcel with Resources 78b-78e (see additional Photographs in Appendix F); property associated with Brown family members for over a century (ca. 1900-2016) but would require additional research to determine significance under Criterion B; former agricultural property is vacant, no longer in active agricultural, and no longer represents an intact or significant historic-age farm under Criterion A; under Criterion C, however, the dwelling (Resource 78a) retains a high degree of integrity of design, materials, workmanship, and feeling as an intact and significant example of ca. 1900 National Folk-style dwelling; recommended NRHP boundary is the footprint of the dwelling.

View of Resource 78a, camera facing northwest.

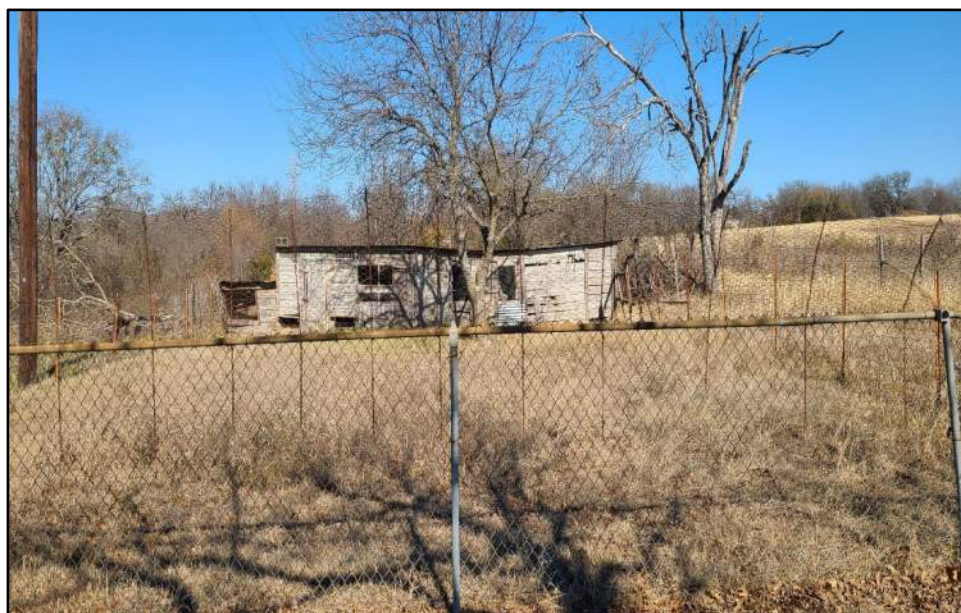
Survey Date:	December 6-9, 2021
Resource No:	78c
Project Location:	Coit Road to FM 1827
Project Name and CSJ:	0135-02-065, 0135-15-002, 0135-03-053
Address, Lat/Long:	2163 E. Dave Brown Rd. 33.201278 / -96.579427
Function/Sub-function:	Agricultural / Outbuilding
Construction Date:	ca. 1940
NRHP Eligibility:	Not eligible
Integrity/Comments:	Outbuilding (former chicken coop) features a metal roof, wood siding, vertical wood-plank doors, and several small, screened window openings; on parcel with Resources 78a-78b and Resources 78d-78e (see additional Photographs in Appendix F); under Criterion A, former agricultural property is vacant, no longer in active agricultural, and no longer represents an intact or significant historic-age farm; would require additional research to determine significance under Criterion B; not a significant example of resource type/non-contributing under Criterion C.

View of Resource 78c, camera facing north.

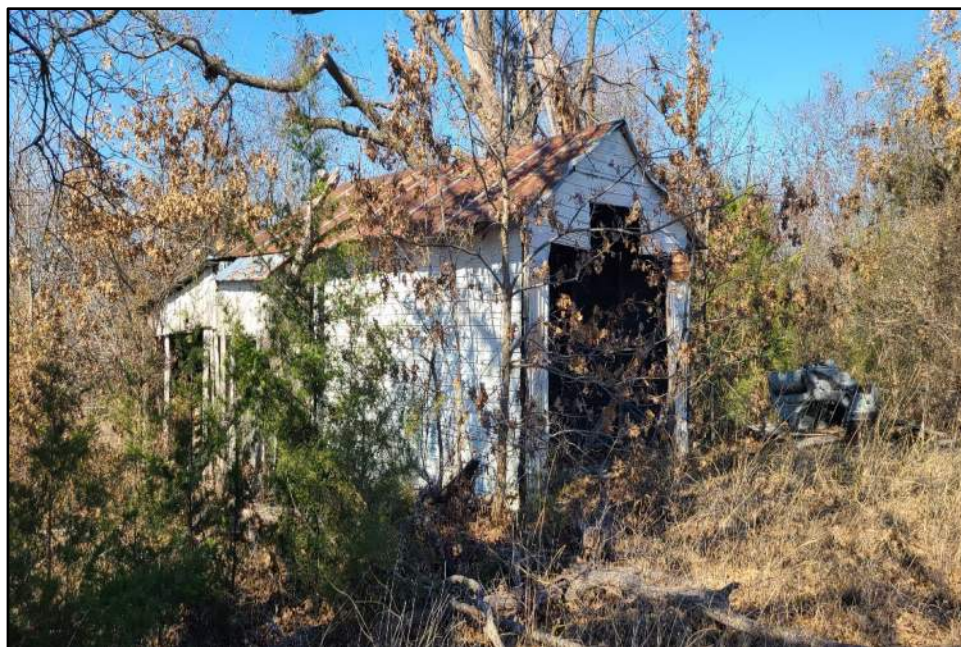
Survey Date:	December 6-9, 2021
Resource No:	78d
Project Location:	Coit Road to FM 1827
Project Name and CSJ:	0135-02-065, 0135-15-002, 0135-03-053
Address, Lat/Long:	2163 E. Dave Brown Rd. 33.201278 / -96.579427
Function/Sub-function:	Domestic / Secondary Structure
Construction Date:	ca. 1940
NRHP Eligibility:	Not eligible
Integrity/Comments:	Single-bay garage features a front-gabled metal roof, wood and metal siding, and a shed-roof rear addition of an open equipment shed; on parcel with Resources 78a-78c (see additional Photographs in Appendix F); under Criterion A, former agricultural property is vacant, no longer in active agricultural, and no longer represents an intact or significant historic-age farm; would require additional research to determine significance under Criterion B; not a significant example of resource type/non-contributing under Criterion C.

Obstructed view of Resource 78d, camera facing northeast.

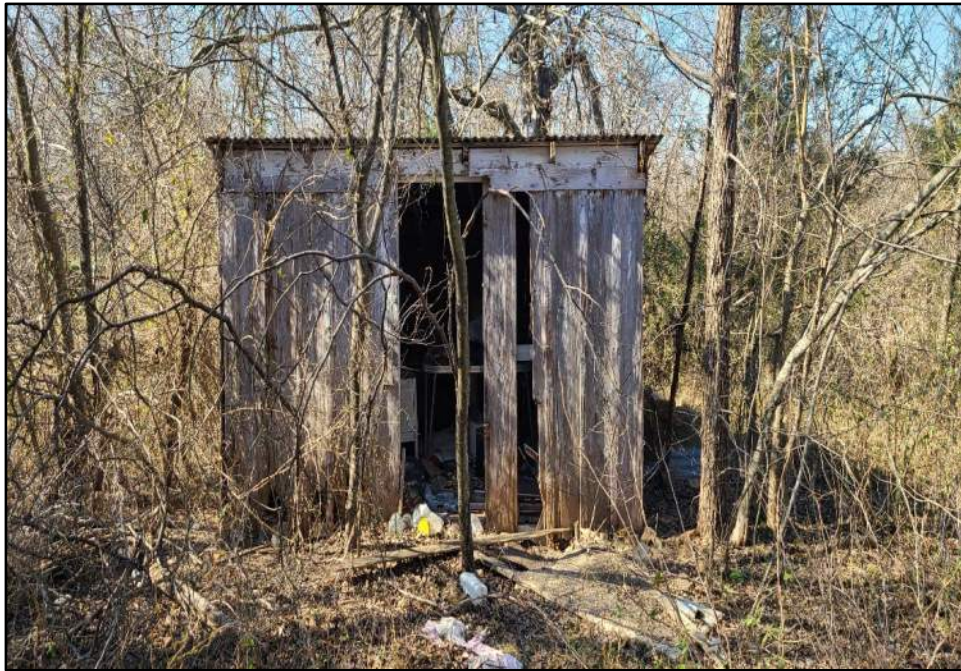
Survey Date:	December 6-9, 2021
Resource No:	78e
Project Location:	Coit Road to FM 1827
Project Name and CSJ:	0135-02-065, 0135-15-002, 0135-03-053
Address, Lat/Long:	2163 E. Dave Brown Rd. 33.201278 / -96.579427
Function/Sub-function:	Domestic / Secondary Structure
Construction Date:	1940
NRHP Eligibility:	Not eligible
Integrity/Comments:	Small outbuilding with corrugated metal shed roof and vertical wood plank cladding, much of which is missing; associated with a collection of several small wood-framed chicken coops with wood siding and screened openings; on parcel with Resources 78a-78d (see additional Photographs in Appendix F); under Criterion A, former agricultural property is vacant, no longer in active agricultural, and no longer represents an intact or significant historic-age farm; would require additional research to determine significance under Criterion B; not a significant example of resource type/non-contributing under Criterion C.

Obstructed view of Resource 78e, camera facing west.

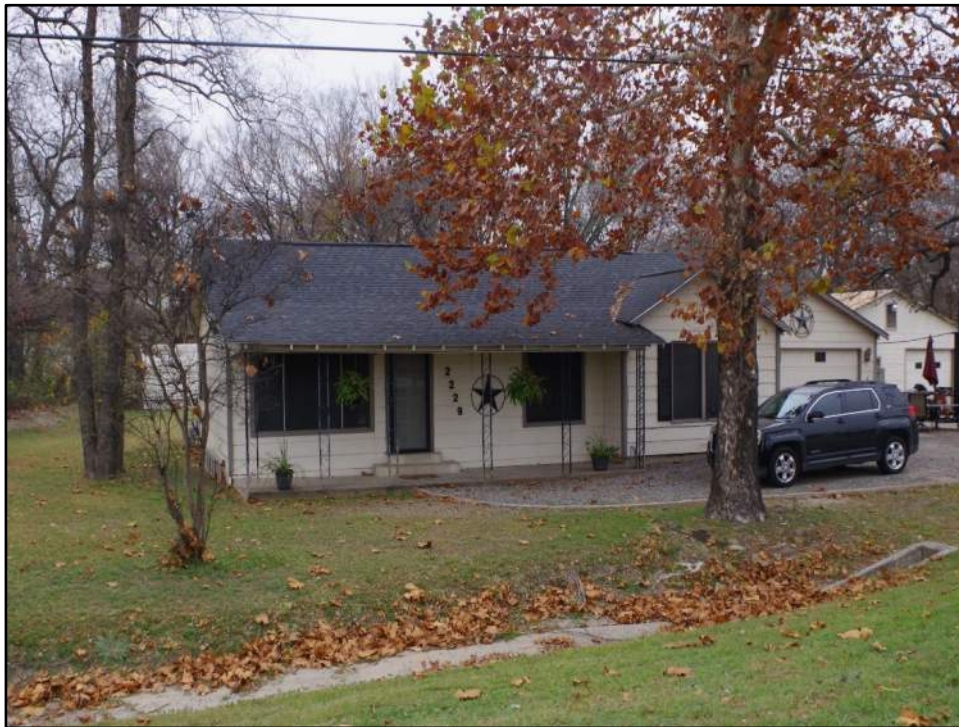
Survey Date:	December 6-9, 2021
Resource No:	79a
Project Location:	Coit Road to FM 1827
Project Name and CSJ:	0135-02-065, 0135-15-002, 0135-03-053
Address, Lat/Long:	2229 E. University Dr. 33.199114 / -96.577688
Function/Sub-function:	Domestic / Single Dwelling
Construction Date:	ca. 1950
NRHP Eligibility:	Not eligible
Integrity/Comments:	Minimal Traditional-style dwelling with side-gabled roof, asbestos siding, exterior solar screens over all windows, a small, integral front porch, and gabled rear ell; on parcel with Resources 79b-79d and non-historic-age garage (see additional Photographs in Appendix F); retains fair integrity but is not a significant example of resource type or style.

View of Resource 79a, camera facing northeast.

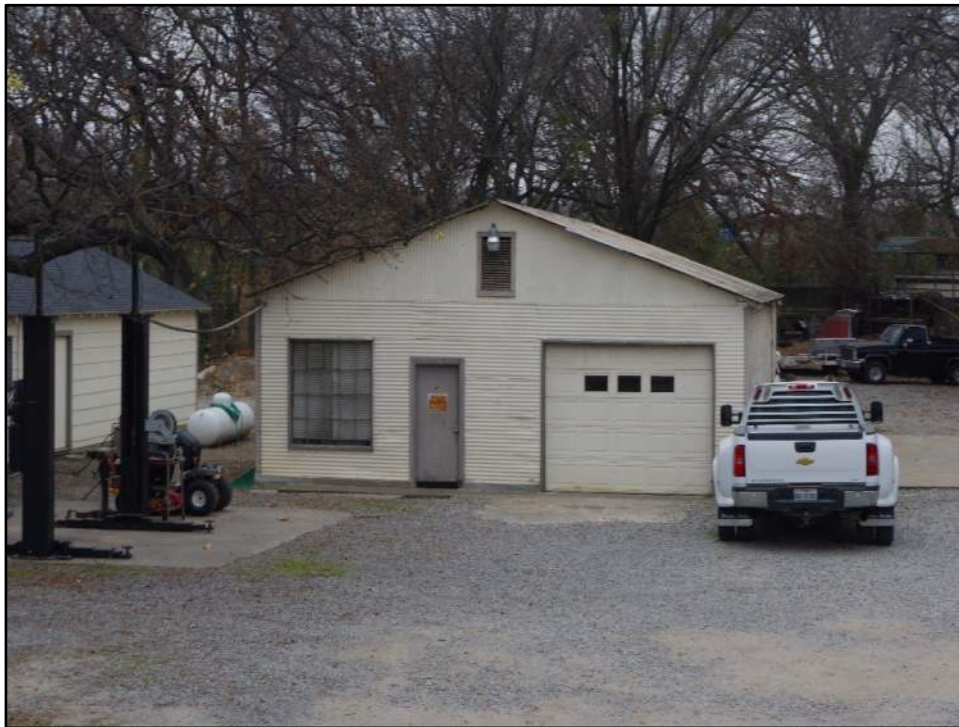
Survey Date:	December 6-9, 2021
Resource No:	79b
Project Location:	Coit Road to FM 1827
Project Name and CSJ:	0135-02-065, 0135-15-002, 0135-03-053
Address, Lat/Long:	2229 E. University Dr. 33.199114 / -96.577688
Function/Sub-function:	Domestic / Secondary Structure
Construction Date:	ca. 1975
NRHP Eligibility:	Not eligible
Integrity/Comments:	Front gabled garage/outbuilding with metal siding, fixed metal windows, a single entrance door, and a vinyl garage door; on parcel with Resources 79a, 79c- 79d, and non-historic-age garage (see additional Photographs in Appendix F); not a significant example of resource type.

Photograph C-40: View of Resource 79b, camera facing northwest.

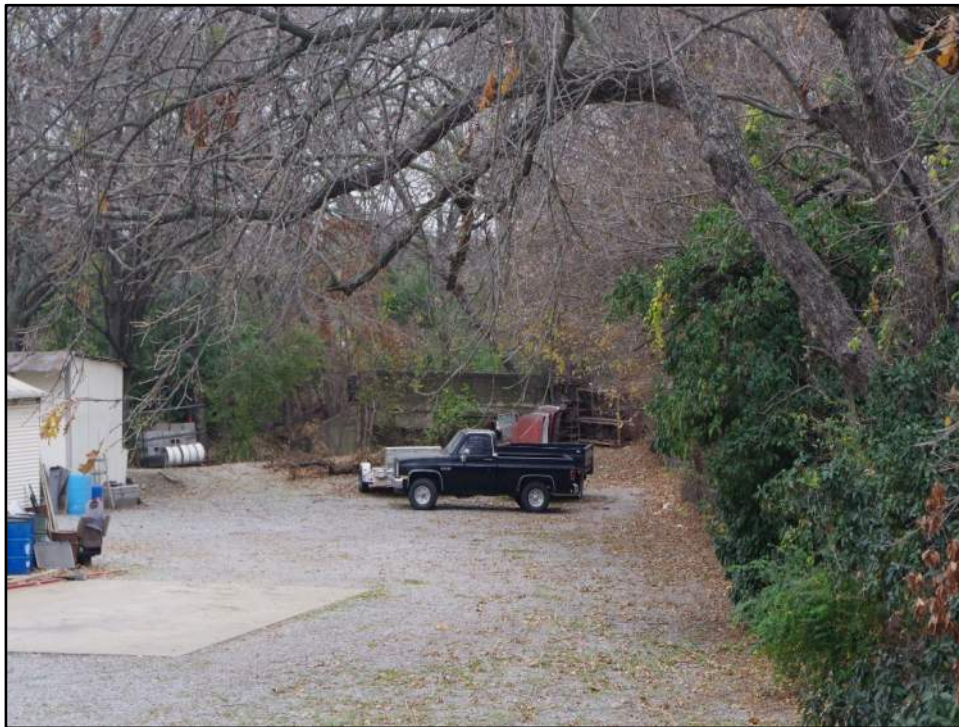
Survey Date:	December 6-9, 2021
Resource No:	79c
Project Location:	Coit Road to FM 1827
Project Name and CSJ:	0135-02-065, 0135-15-002, 0135-03-053
Address, Lat/Long:	2229 E. University Dr. 33.199114 / -96.577688
Function/Sub-function:	Domestic / Secondary Structure
Construction Date:	ca. 1975
NRHP Eligibility:	Not eligible
Integrity/Comments:	Side-gabled outbuilding/shed with metal roof and vertical wood siding; located behind dwelling and not entirely visible from public ROW; on parcel with Resources 79a-79b, 79d, and non-historic-age garage (see additional Photographs in Appendix F); not a significant example of resource type.

Obstructed view of Resource 79c (left) and Resource 79d (center, background), camera facing north.

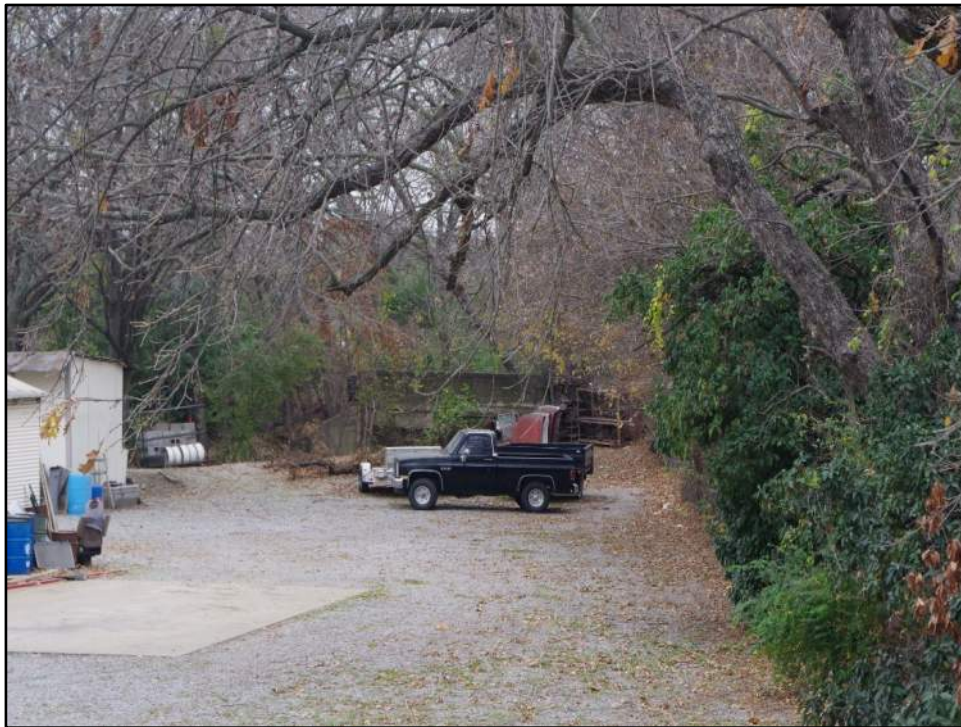
Survey Date:	December 6-9, 2021
Resource No:	79d
Project Location:	Coit Road to FM 1827
Project Name and CSJ:	0135-02-065, 0135-15-002, 0135-03-053
Address, Lat/Long:	2229 E. University Dr. 33.199114 / -96.577688
Function/Sub-function:	Transportation / Road Related
Construction Date:	ca. 1950
NRHP Eligibility:	Not eligible
Integrity/Comments:	Abandoned concrete bridge with parapet walls; no longer in use; on parcel with Resources 79a-79c and non-historic-age garage (see additional Photographs in Appendix F); lacks integrity of location and setting and is not a significant example of resource type.

Obstructed view of Resource 79c (left) and Resource 79d (center, background), camera facing north.

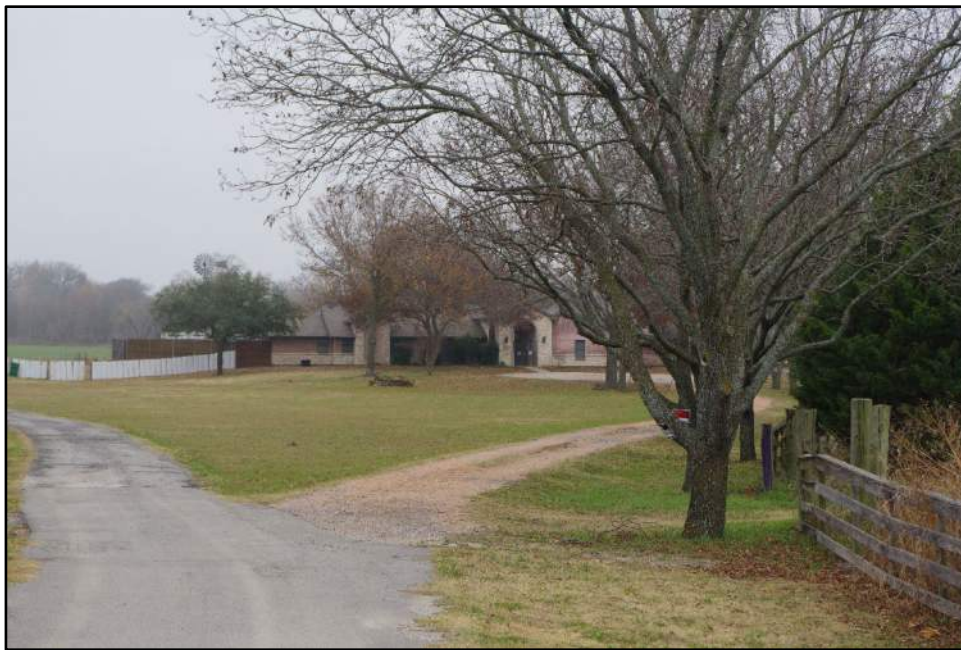
Survey Date:	December 6-9, 2021
Resource No:	80
Project Location:	Coit Road to FM 1827
Project Name and CSJ:	0135-02-065, 0135-15-002, 0135-03-053
Address, Lat/Long:	2236 E. University Dr. 33.197256 / -96.578944
Function/Sub-function:	Domestic / Single Dwelling
Construction Date:	ca. 1975
NRHP Eligibility:	Not eligible
Integrity/Comments:	Highly altered hipped-roof Ranch-style dwelling with brick and replacement stone cladding, arched entrance addition, and replacement vinyl windows; other details were not visible from the public ROW; on parcel with non-historic-age outbuilding (see additional Photographs in Appendix F); dwelling with same footprint visible at this location on 1981 aerial (NETR 1981); lacks integrity of design, materials, workmanship, and feeling and is not a significant example of resource type or style.

Obstructed view of Resource 80, camera facing southwest.

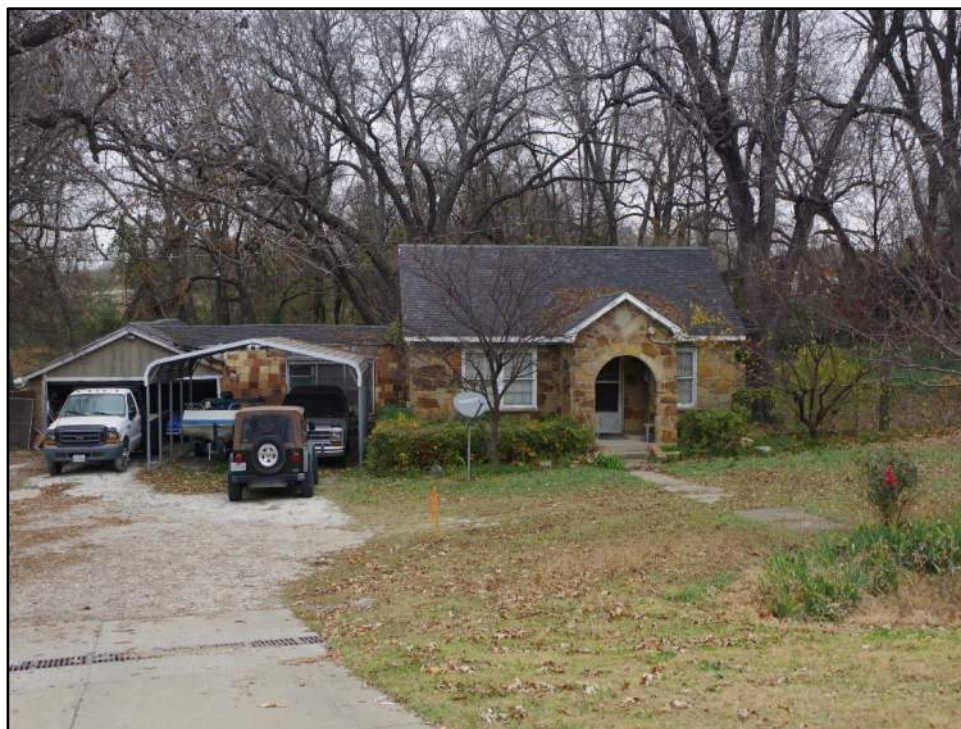
Survey Date:	December 6-9, 2021
Resource No:	81a
Project Location:	Coit Road to FM 1827
Project Name and CSJ:	0135-02-065, 0135-15-002, 0135-03-053
Address, Lat/Long:	2273 E. University Dr. 33.199024 / -96.57742
Function/Sub-function:	Domestic / Single Dwelling
Construction Date:	ca. 1940
NRHP Eligibility:	Not eligible
Integrity/Comments:	Side-gabled Minimal Traditional-style dwelling with Tudor Revival influences; features fieldstone cladding, original multi-light wood sash windows, arched entry porch, original central front door, and side and front-gabled garage additions clad in clay tile and plywood paneling; on parcel with Resource 81b (see additional Photographs in Appendix F); lacks integrity of design and feeling due to the additions and is not a significant example of resource type or style.

View of Resource 81a and non-historic-age carport, camera facing north.

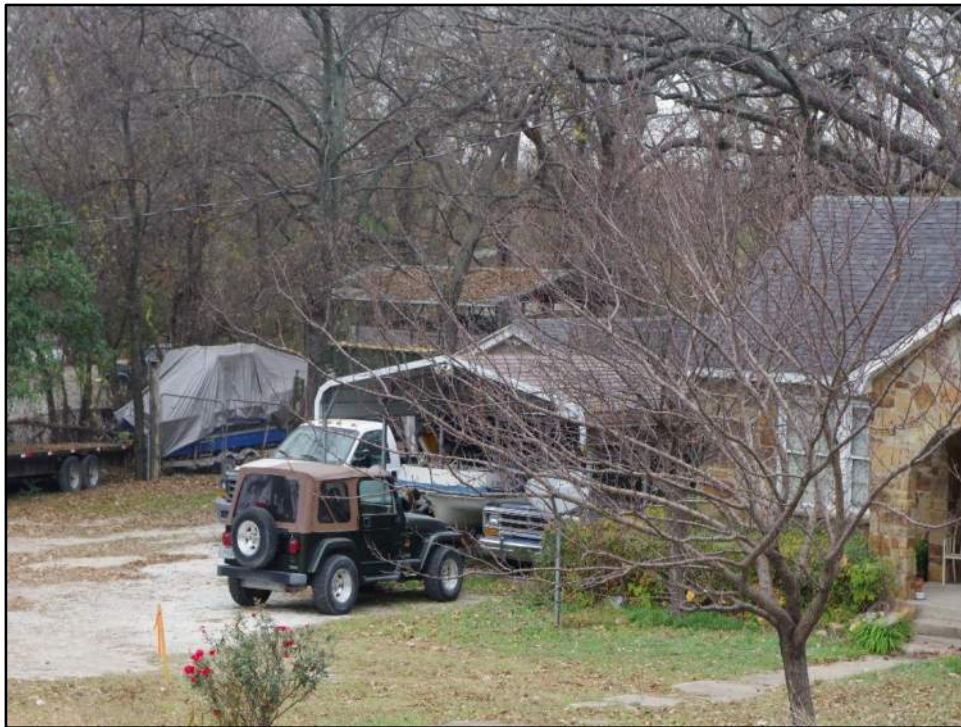
Survey Date:	December 6-9, 2021
Resource No:	81b
Project Location:	Coit Road to FM 1827
Project Name and CSJ:	0135-02-065, 0135-15-002, 0135-03-053
Address, Lat/Long:	2273 E. University Dr. 33.199024 / -96.57742
Function/Sub-function:	Domestic / Secondary Structure
Construction Date:	ca. 1975
NRHP Eligibility:	Not eligible
Integrity/Comments:	Gabled rear outbuilding with metal roof; other details were not visible from the public ROW; on parcel with Resource 81a (see additional Photographs in Appendix F); not a significant example of resource type.

View of Resource 81b (rear) and non-historic-age carport, camera facing northwest.

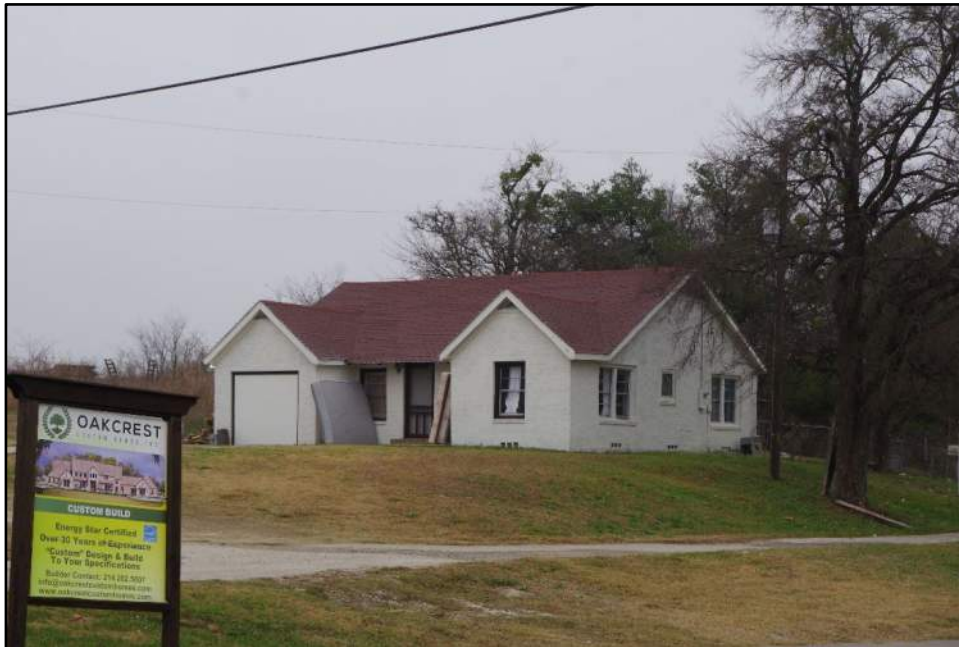
Survey Date:	December 6-9, 2021
Resource No:	82
Project Location:	Coit Road to FM 1827
Project Name and CSJ:	0135-02-065, 0135-15-002, 0135-03-053
Address, Lat/Long:	2274 E. University Dr. 33.198243 / -96.577624
Function/Sub-function:	Commercial / Professional
Construction Date:	ca. 1950
NRHP Eligibility:	Not eligible
Integrity/Comments:	Side-gabled former dwelling now in commercial use with two projecting front gables (one converted to a garage opening), brick cladding, a mix of original multilight wood and replacement metal windows, and a replacement garage door (see additional Photographs in Appendix F); lacks integrity of materials, workmanship, and association and is not a significant example of resource type or style.

View of Resource 82, camera facing southeast.

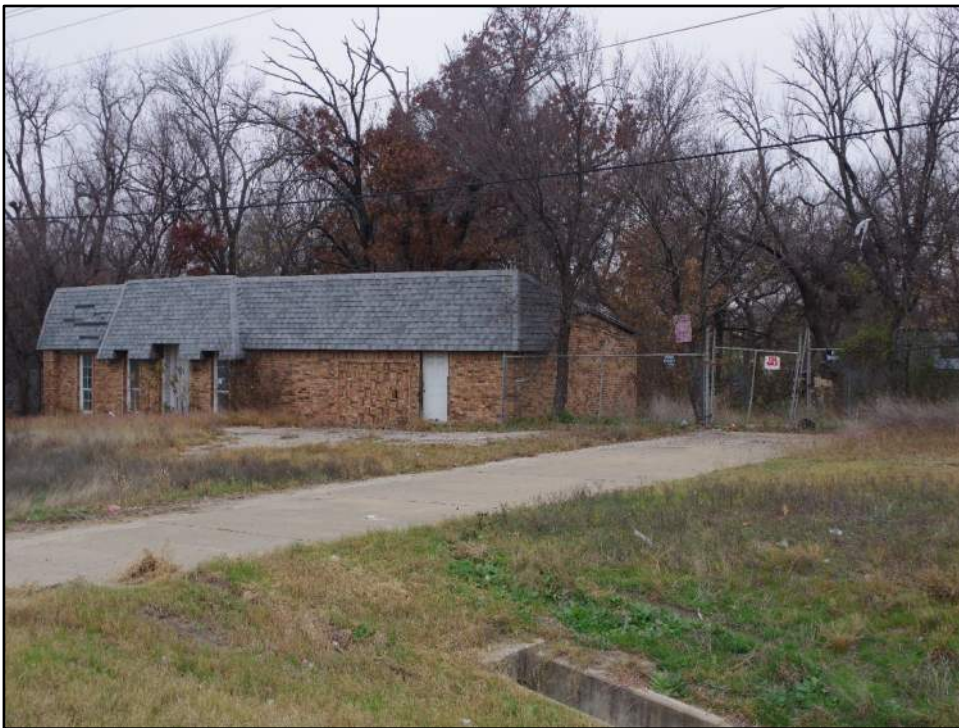
Survey Date:	December 6-9, 2021
Resource No:	83
Project Location:	Coit Road to FM 1827
Project Name and CSJ:	0135-02-065, 0135-15-002, 0135-03-053
Address, Lat/Long:	2321 E. University Dr. 33.198935 / -96.576927
Function/Sub-function:	Vacant / Not in Use
Construction Date:	ca. 1980
NRHP Eligibility:	Not eligible
Integrity/Comments:	One-story brick-clad building with faux mansard roof, replacement vinyl windows, and two entrance doors; currently vacant (see additional Photographs in Appendix F); not a significant example of resource type.

View of Resource 83, abandoned, camera facing northwest.

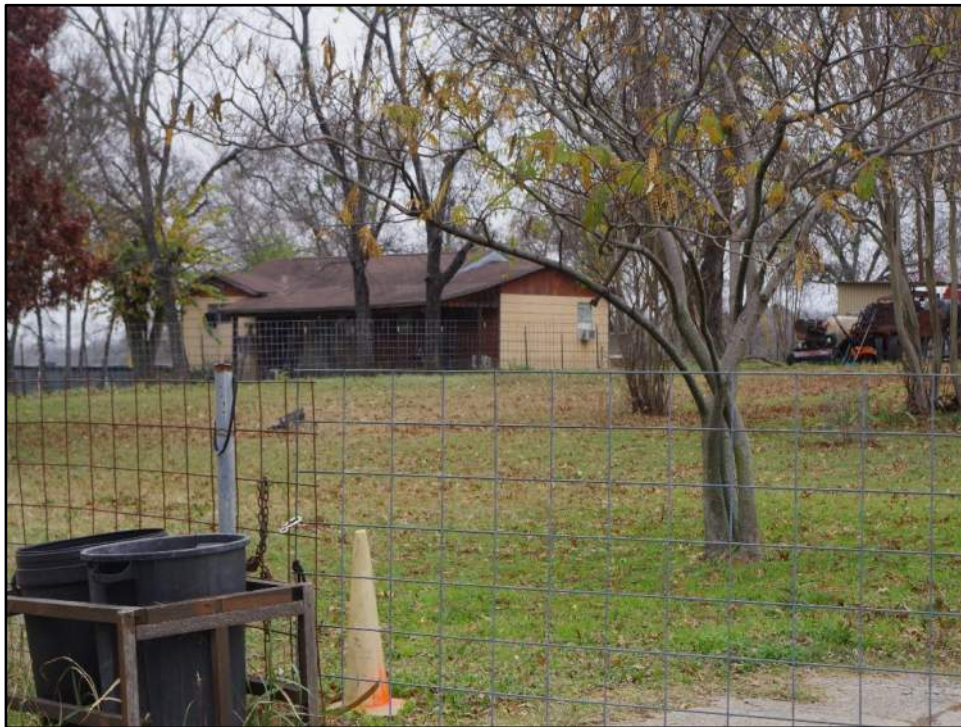
Survey Date:	December 6-9, 2021
Resource No:	84a
Project Location:	Coit Road to FM 1827
Project Name and CSJ:	0135-02-065, 0135-15-002, 0135-03-053
Address, Lat/Long:	2411 County Rd. 330 33.198674 / -96.573998
Function/Sub-function:	Domestic / Single Dwelling
Construction Date:	ca. 1965
NRHP Eligibility:	Not eligible
Integrity/Comments:	Cross-gabled ranch-style dwelling with wood and asbestos siding, shed-roof porch, and rear addition; partially obscured from view of public ROW; on parcel with Resource 84b (see additional Photographs in Appendix F); lacks integrity of design and feeling due to rear addition and is not a significant example of resource type or style.

View of Resource 84a, camera facing north.

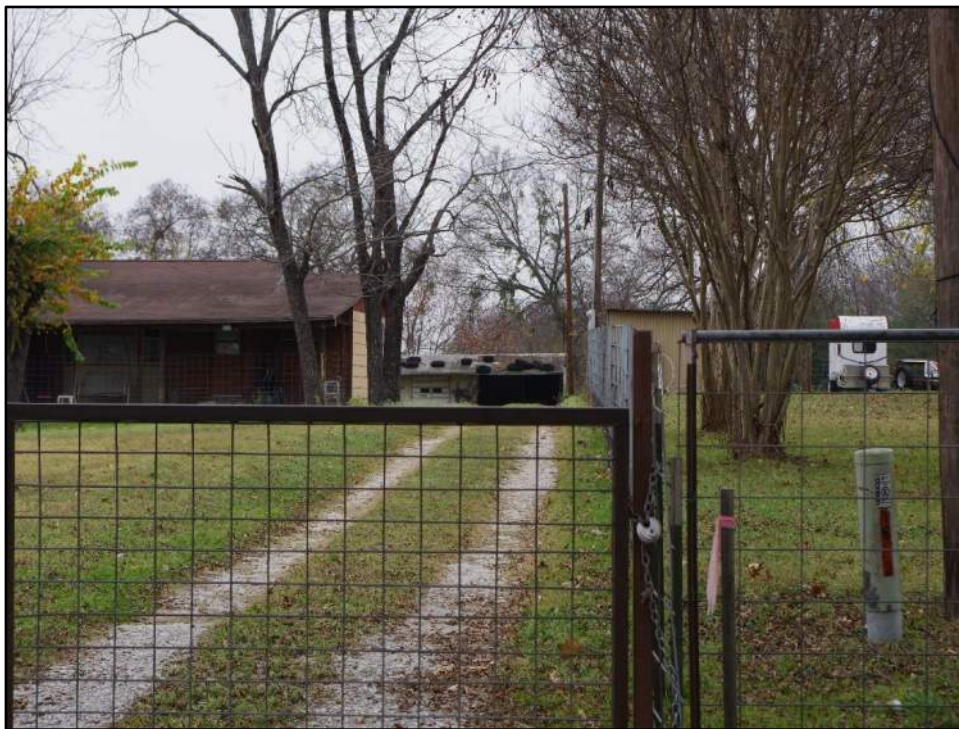
Survey Date:	December 6-9, 2021
Resource No:	84b
Project Location:	Coit Road to FM 1827
Project Name and CSJ:	0135-02-065, 0135-15-002, 0135-03-053
Address, Lat/Long:	2411 County Rd. 330 33.198674 / -96.573998
Function/Sub-function:	Domestic / Secondary Structure
Construction Date:	ca. 1975
NRHP Eligibility:	Not eligible
Integrity/Comments:	Side-gabled metal-clad garage; other details were not visible from the public ROW; on parcel with Resource 84a (see additional Photographs in Appendix F); not a significant example of resource type.

View of Resource 84a (left) and 84b (right), camera facing north.

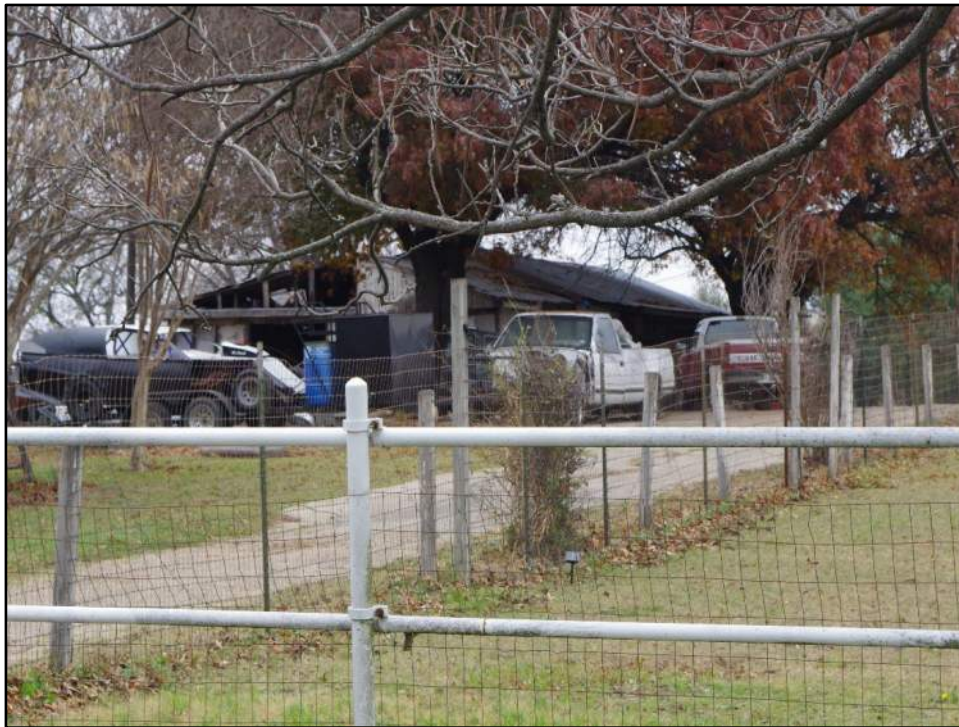
Survey Date:	December 6-9, 2021
Resource No:	85
Project Location:	Coit Road to FM 1827
Project Name and CSJ:	0135-02-065, 0135-15-002, 0135-03-053
Address, Lat/Long:	2461 County Rd. 330 33.198818 / -96.573665
Function/Sub-function:	Domestic / Single Dwelling
Construction Date:	ca. 1975
NRHP Eligibility:	Not eligible
Integrity/Comments:	Side-gabled dwelling with metal roof, vertical wood siding, and large gabled garage/carport side addition; (see additional Photographs in Appendix F); additional details were not visible from the public ROW; not a significant example of resource type.

Obstructed view of Resource 85, camera facing northwest.

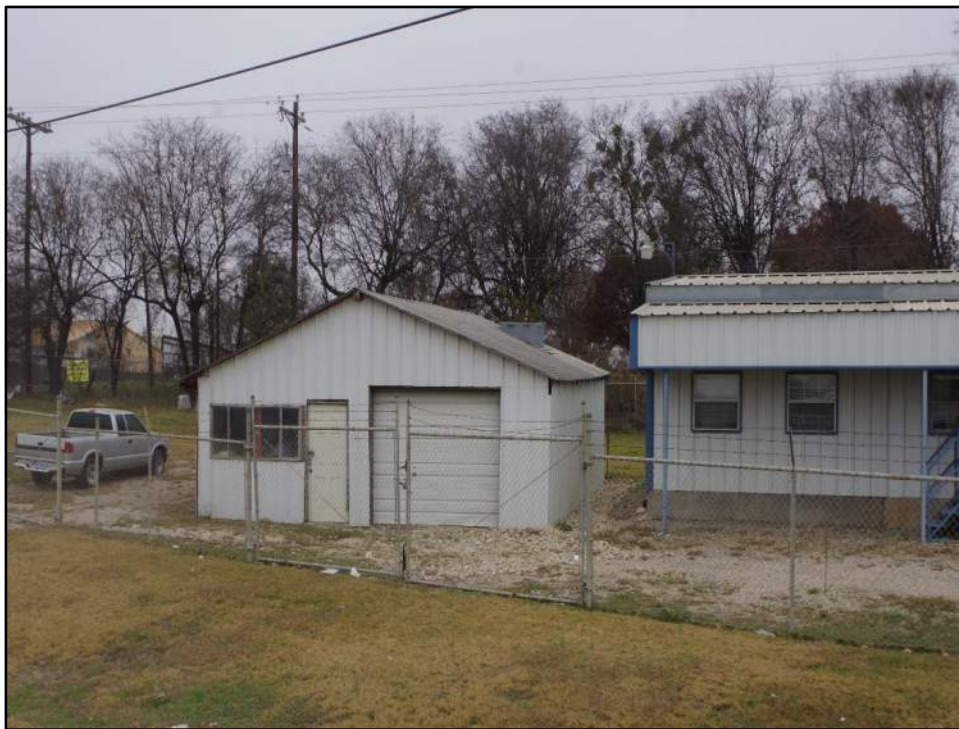
Survey Date:	December 6-9, 2021
Resource No:	86
Project Location:	Coit Road to FM 1827
Project Name and CSJ:	0135-02-065, 0135-15-002, 0135-03-053
Address, Lat/Long:	2535 E. University Dr. 33.197983 / -96.573729
Function/Sub-function:	Industry / Waterworks
Construction Date:	ca. 1975
NRHP Eligibility:	Not eligible
Integrity/Comments:	Front-gabled accessory building associated with non-historic-age commercial warehouse complex; features metal siding, aluminum windows, and overhead garage door; (see additional Photographs in Appendix F); not a significant example of resource type.

View of Resource 86, camera facing northwest.

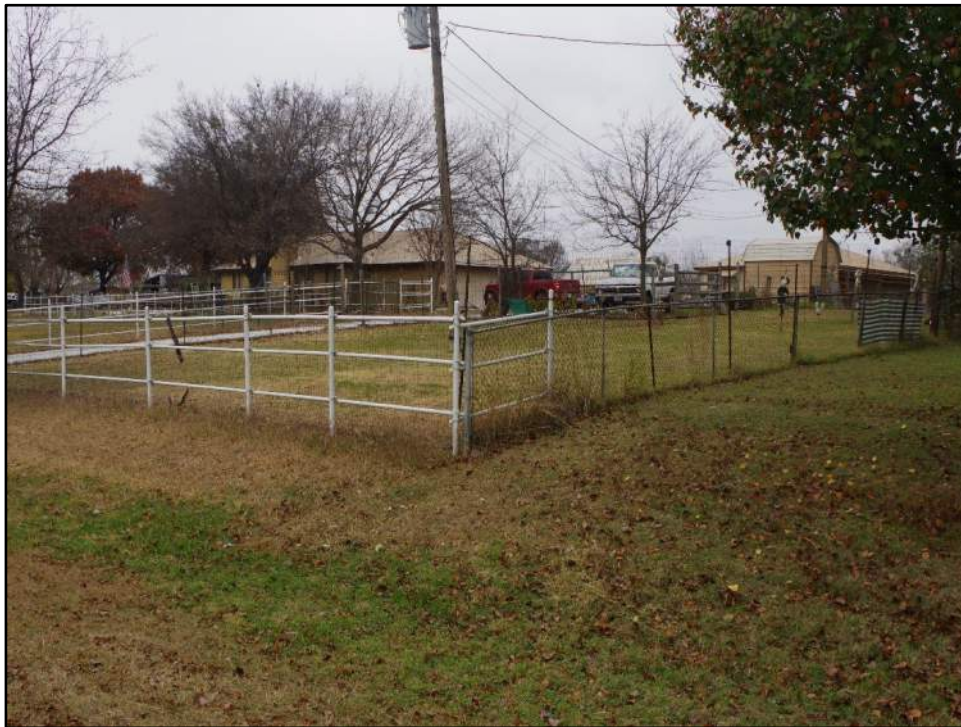
Survey Date:	December 6-9, 2021
Resource No:	87
Project Location:	Coit Road to FM 1827
Project Name and CSJ:	0135-02-065, 0135-15-002, 0135-03-053
Address, Lat/Long:	2495 County Rd. 330 33.19862 / -96.573129
Function/Sub-function:	Domestic / Single Dwelling
Construction Date:	ca. 1975
NRHP Eligibility:	Not eligible
Integrity/Comments:	Hipped-roof Ranch-style dwelling partially obscured from view of public ROW; features replacement metal roof, brick cladding, replacement vinyl windows, and exterior brick chimney; on parcel with non-historic-age outbuilding, greenhouse, and two sheds (see additional Photographs in Appendix F); not a significant example of resource type or style.

Overview of Resource 87, camera facing northwest.

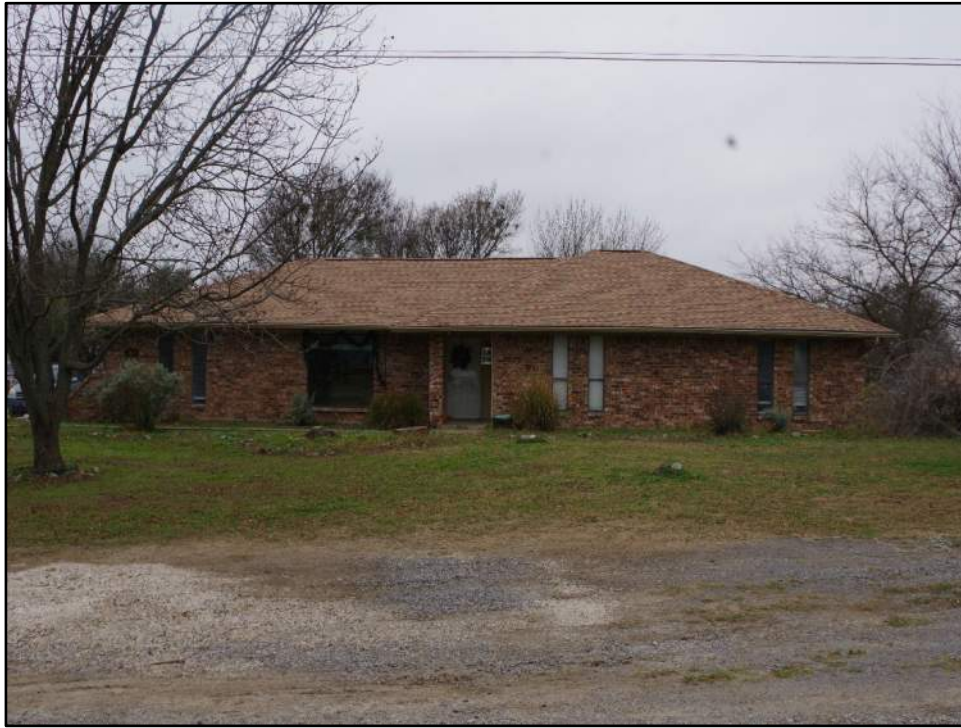
Survey Date:	December 6-9, 2021
Resource No:	88
Project Location:	Coit Road to FM 1827
Project Name and CSJ:	0135-02-065, 0135-15-002, 0135-03-053
Address, Lat/Long:	2115 Privat Rd. 5076 33.198558 / -96.57183
Function/Sub-function:	Domestic / Single Dwelling
Construction Date:	ca. 1975
NRHP Eligibility:	Not eligible
Integrity/Comments:	Hipped-roof Ranch-style dwelling with brick cladding, vinyl or aluminum windows, and recessed front entrance; on parcel with non-historic-age pavilion (see additional Photographs in Appendix F); retains integrity but is not a significant example of resource type or style.

View of Resource 88, camera facing west.

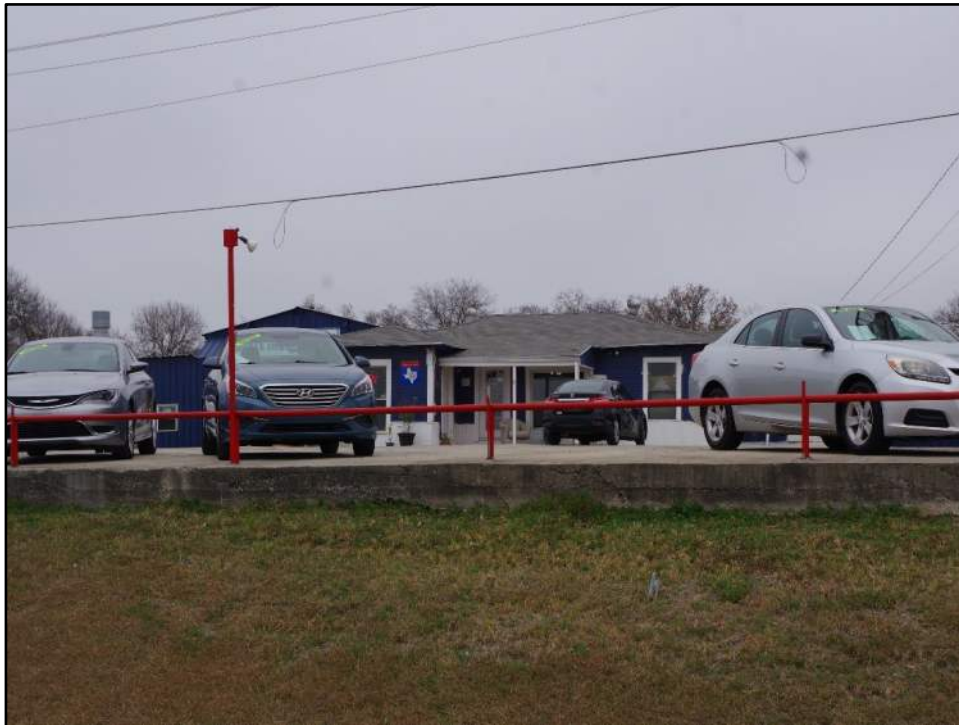
Survey Date:	December 6-9, 2021
Resource No:	89
Project Location:	Coit Road to FM 1827
Project Name and CSJ:	0135-02-065, 0135-15-002, 0135-03-053
Address, Lat/Long:	2675 E. University Dr. 33.197364 / -96.570983
Function/Sub-function:	Commercial / Specialty Store
Construction Date:	ca. 1950
NRHP Eligibility:	Not eligible
Integrity/Comments:	Hipped-roof former Minimal Traditional-style dwelling now in commercial use with replacement vinyl siding, metal skirting, and replacement vinyl windows in altered openings; on parcel with a non-historic-age garage outbuilding (see additional Photographs in Appendix F); lacks integrity of design, materials, workmanship, and feeling and is not a significant example of resource type or style.

View of Resource 89, camera facing northwest.

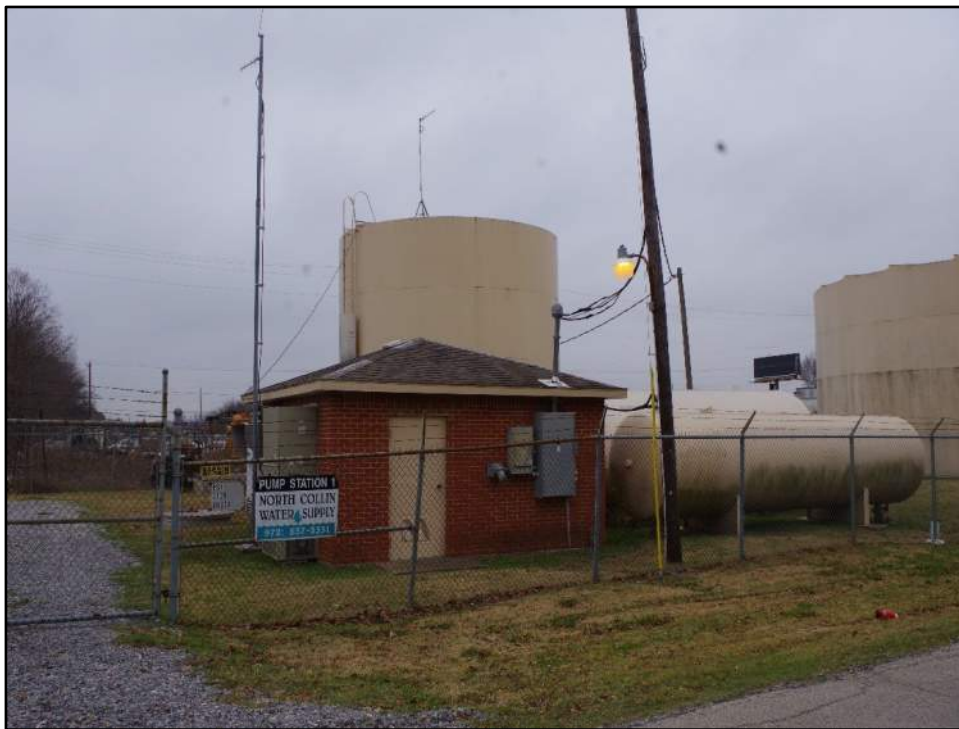
Survey Date:	December 6-9, 2021
Resource No:	90a
Project Location:	Coit Road to FM 1827
Project Name and CSJ:	0135-02-065, 0135-15-002, 0135-03-053
Address, Lat/Long:	2710 County Rd. 330 33.198019 / -96.569567
Function/Sub-function:	Industry / Waterworks
Construction Date:	ca. 1975
NRHP Eligibility:	Not eligible
Integrity/Comments:	Pyramidal, brick-clad building with single entry and shuttered window opening; on parcel with Resource 90b and non-historic-age water tower (see additional Photographs in Appendix F); not a significant example of resource type.

View of Resource 90a and Resource 90b (rear), camera facing southwest.
