APPENDIX L: Cultural Resources

APPENDIX L – CULTURAL RESOURCES – FEIS Preferred Alternative/Blue Alternative

US 380 MCKINNEY – Coit Road to FM 1827, Collin County CSJs 0135-02-065 and 0135-15-002; Dallas District

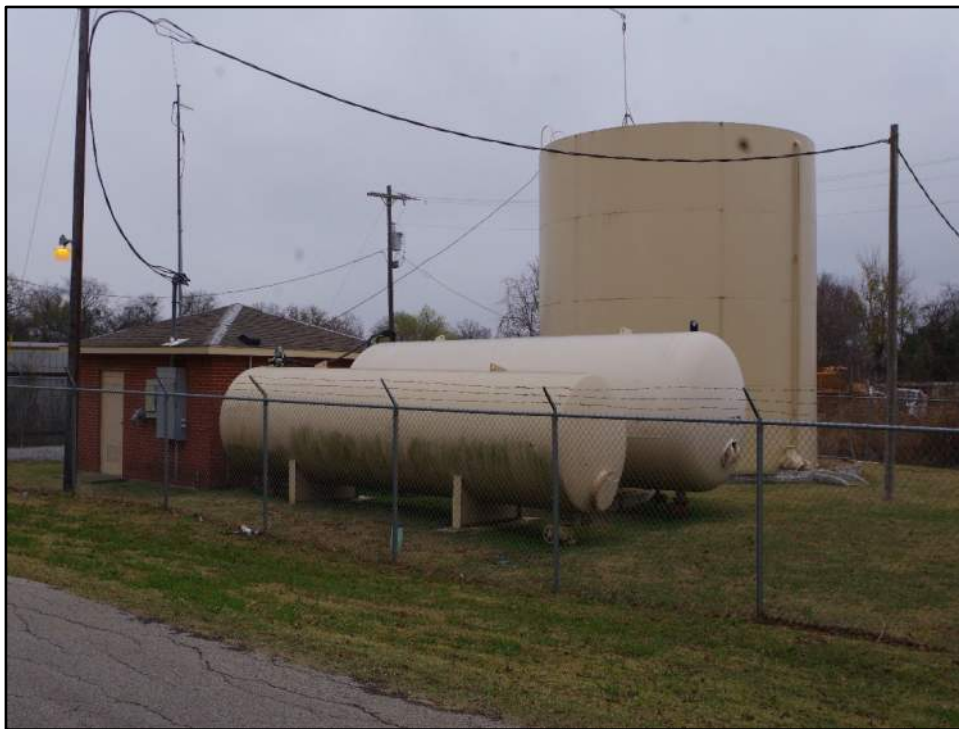
Survey Date:	December 6-9, 2021
Resource No:	90b
Project Location:	Coit Road to FM 1827
Project Name and CSJ:	0135-02-065, 0135-15-002, 0135-03-053
Address, Lat/Long:	2710 County Rd. 330 33.198019 / -96.569567
Function/Sub-function:	Industry / Waterworks
Construction Date:	ca. 1975
NRHP Eligibility:	Not eligible
Integrity/Comments:	Round concrete water tower with full height ladder; on parcel with Resource 90a and additional non-historic-age water tower (see additional Photographs in Appendix F); not a significant example of resource type.

View of Resource 90a (left) and Resource 90b (rear), camera facing southeast.

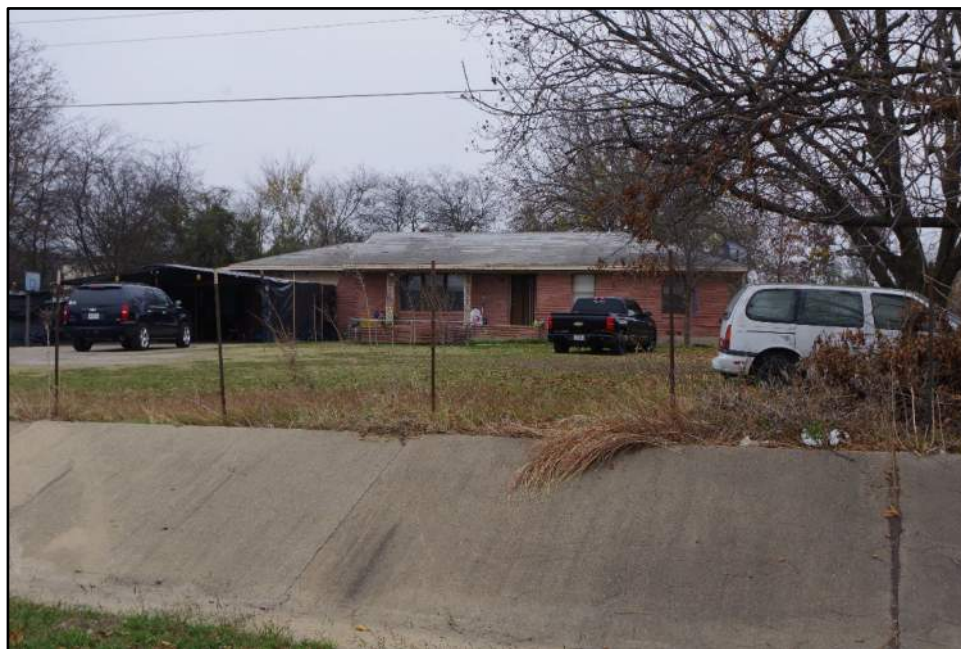
Survey Date:	December 6-9, 2021
Resource No:	91a
Project Location:	Coit Road to FM 1827
Project Name and CSJ:	0135-02-065, 0135-15-002, 0135-03-053
Address, Lat/Long:	2805 E. University Dr. 33.196888 / -96.569213
Function/Sub-function:	Domestic / Single Dwelling
Construction Date:	ca. 1965
NRHP Eligibility:	Not eligible
Integrity/Comments:	Side-gabled/hipped-roof Ranch-style dwelling with Roman brick cladding, aluminum windows, a hipped-roof garage addition, a shed-roof carport addition, and a carport addition; associated with Resources 91b-91c and non-historic-age shed and manufactured dwelling (see additional Photographs in Appendix F); lacks integrity of design and feeling and is not a significant example of resource type or style.

View of Resource 91a, camera facing north.

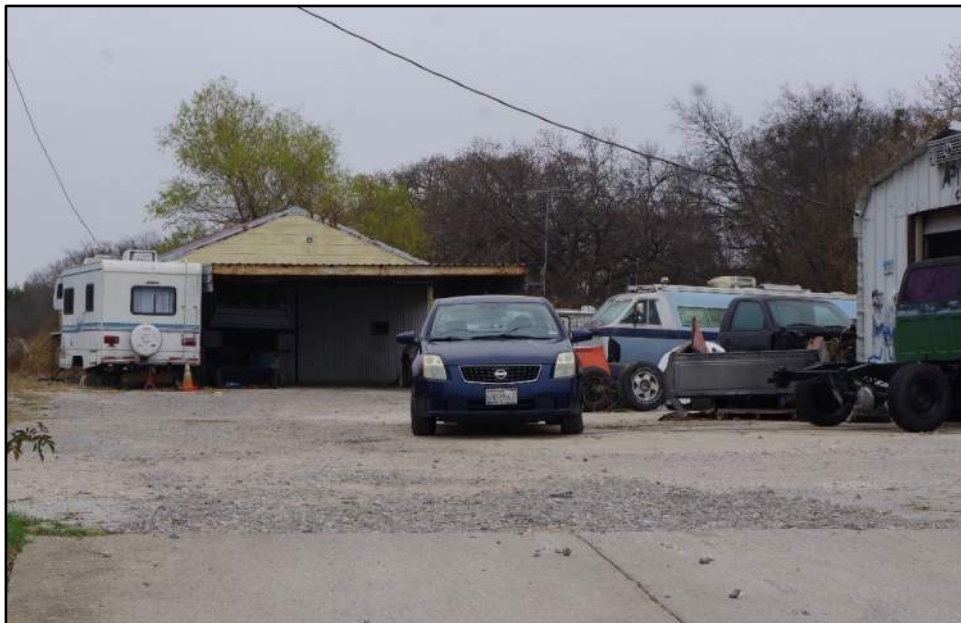
Survey Date:	December 6-9, 2021
Resource No:	91b
Project Location:	Coit Road to FM 1827
Project Name and CSJ:	0135-02-065, 0135-15-002, 0135-03-053
Address, Lat/Long:	2805 E. University Dr. 33.196888 / -96.569213
Function/Sub-function:	Commercial / Business
Construction Date:	ca. 1975
NRHP Eligibility:	Not eligible
Integrity/Comments:	Front-gabled garage with metal roof and metal siding; associated with Resource 91b, 91c, and non-historic-age shed and manufactured dwelling (see additional Photographs in Appendix F); not a significant example of resource type.

View of Resource 91b, camera facing north.

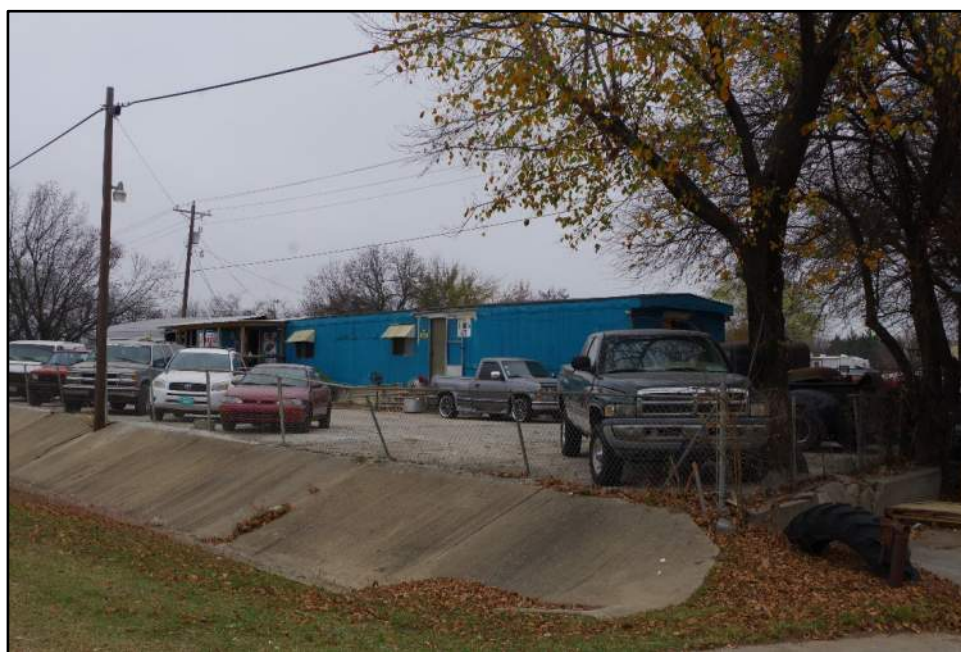
Survey Date:	December 6-9, 2021
Resource No:	91c
Project Location:	Coit Road to FM 1827
Project Name and CSJ:	0135-02-065, 0135-15-002, 0135-03-053
Address, Lat/Long:	2805 E. University Dr. 33.196888 / -96.569213
Function/Sub-function:	Commercial / Business
Construction Date:	ca. 1975
NRHP Eligibility:	Not eligible
Integrity/Comments:	Side-gabled former manufactured dwelling with metal cladding, metal windows some with awnings, and shed-roof porch; associated with Resource 91b, 91c, and non-historic-age shed and manufactured dwelling (see additional Photographs in Appendix F); not a significant example of resource type.

View of Resource 91c, camera facing northwest.

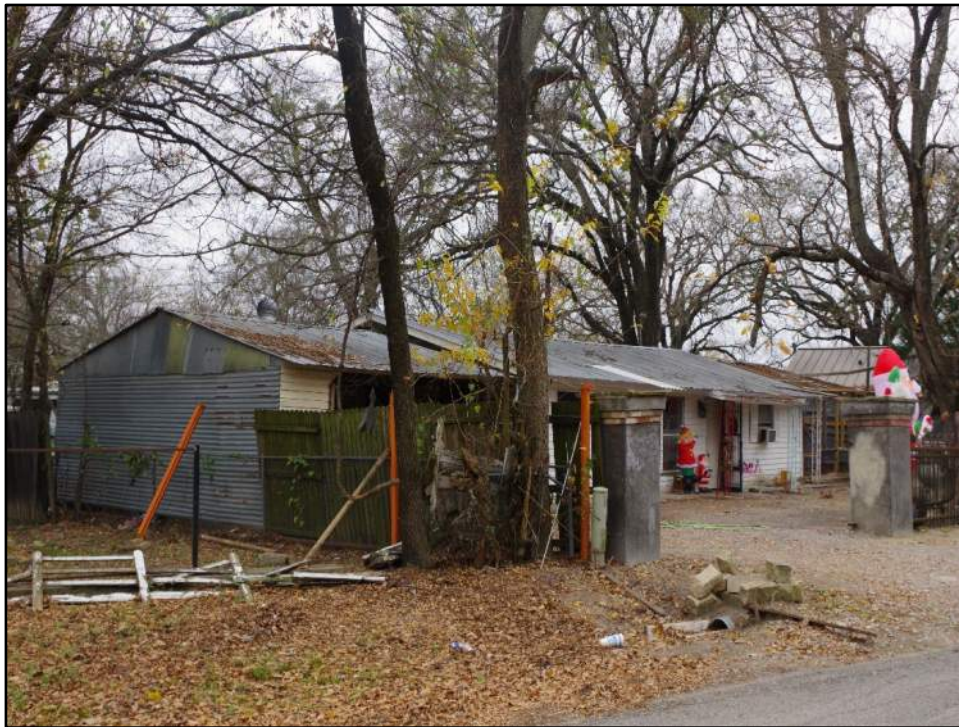
Survey Date:	December 6-9, 2021
Resource No:	92
Project Location:	Coit Road to FM 1827
Project Name and CSJ:	0135-02-065, 0135-15-002, 0135-03-053
Address, Lat/Long:	2804 County Rd. 330 33.197543 / -96.568022
Function/Sub-function:	Domestic / Single Dwelling
Construction Date:	ca. 1965
NRHP Eligibility:	Not eligible
Integrity/Comments:	Side-gabled Simplified Ranch-style dwelling with metal roof, replacement vinyl cladding, aluminum windows, and gabled carport addition (see additional Photographs in Appendix F); not a significant example of resource type or style.

View of Resource 92, camera facing southwest.

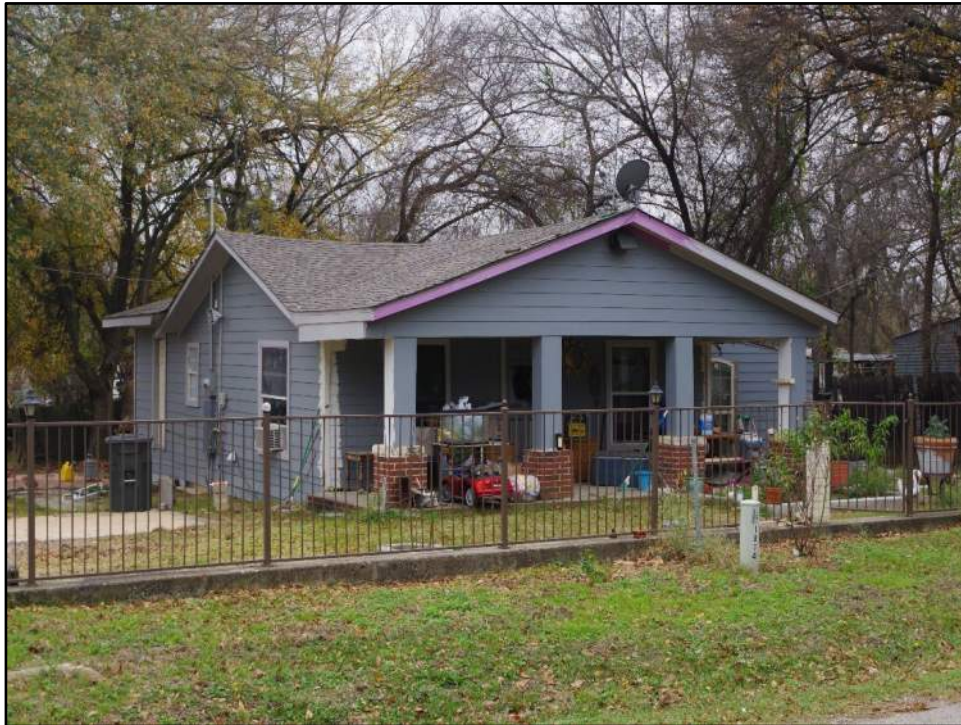
Survey Date:	December 6-9, 2021
Resource No:	93a
Project Location:	Coit Road to FM 1827
Project Name and CSJ:	0135-02-065, 0135-15-002, 0135-03-053
Address, Lat/Long:	2814 County Rd. 330 33.197373 / -96.567839
Function/Sub-function:	Domestic / Single Dwelling
Construction Date:	ca. 1950
NRHP Eligibility:	Not eligible
Integrity/Comments:	Highly altered Minimal Traditional-style dwelling with hardiplank/synthetic siding, replacement vinyl windows, a gabled full front porch addition with faux Craftsman-style supports, and a shed-roof side addition; on parcel with Resource 93b and non-historic-age shed (see additional Photographs in Appendix F); lacks integrity and is not a significant example of resource type or style.

View of Resource 93a, camera facing southwest.

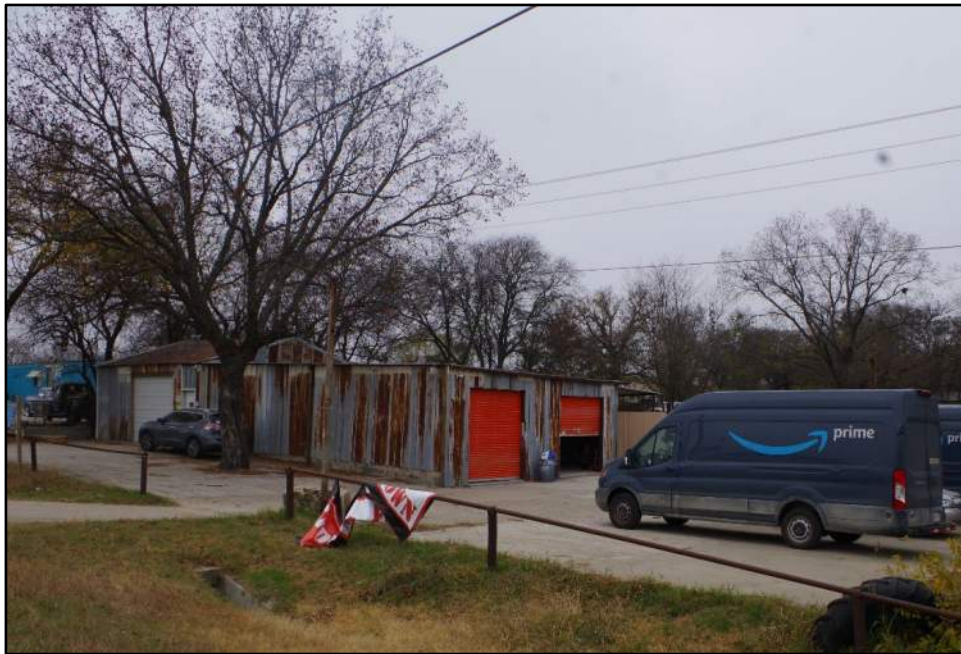
Survey Date:	December 6-9, 2021
Resource No:	94
Project Location:	Coit Road to FM 1827
Project Name and CSJ:	0135-02-065, 0135-15-002, 0135-03-053
Address, Lat/Long:	2861 E. University Dr. 33.196223 / -96.567711
Function/Sub-function:	Commercial / Business
Construction Date:	ca. 1950
NRHP Eligibility:	Not eligible
Integrity/Comments:	Shed-roof building with side-gabled garage addition, metal roof, metal siding, and replacement garage doors (see additional Photographs in Appendix F); not a significant example of resource type.

Overview of Resource 94, camera facing northwest.

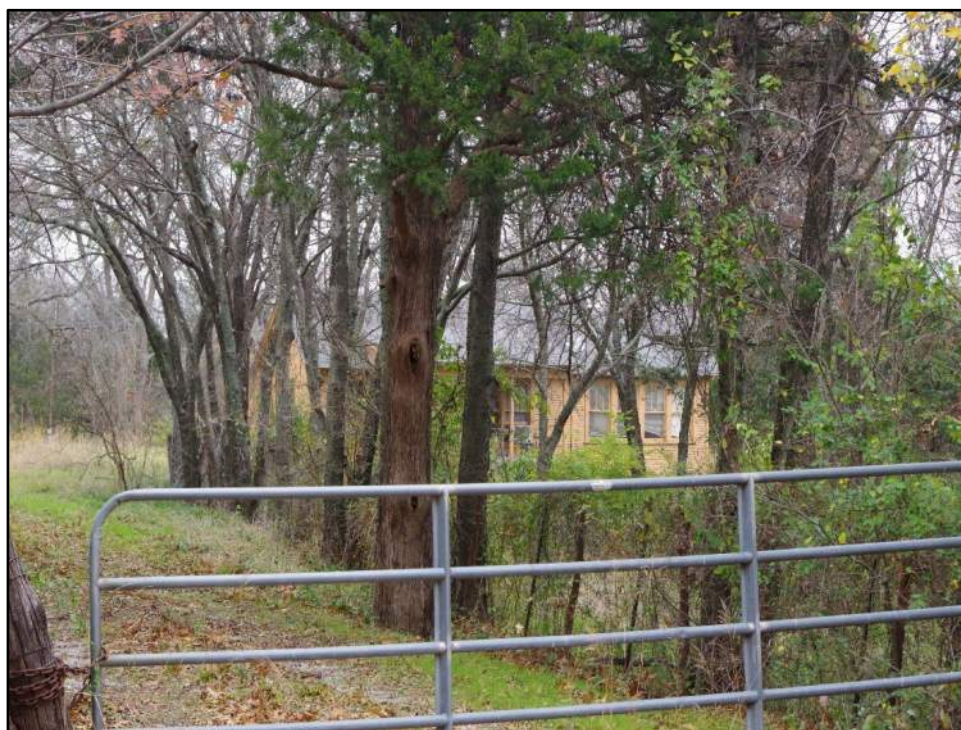
Survey Date:	December 6-9, 2021
Resource No:	95a
Project Location:	Coit Road to FM 1827
Project Name and CSJ:	0135-02-065, 0135-15-002, 0135-03-053
Address, Lat/Long:	2911 County Rd. 330 33.197337 / -96.566176
Function/Sub-function:	Domestic / Single Dwelling
Construction Date:	ca. 1925
NRHP Eligibility:	Not eligible
Integrity/Comments:	Side-gabled Bungalow-style dwelling with wood siding, original 3/1 wood windows, and shed-roof porch; on parcel with Resource 95b (see additional Photographs in Appendix F); partially obstructed from view of ROW due to setback and intervening vegetation; retains integrity but is not a significant example of resource type or style.

Obscured view of Resource 95a, camera facing northwest.

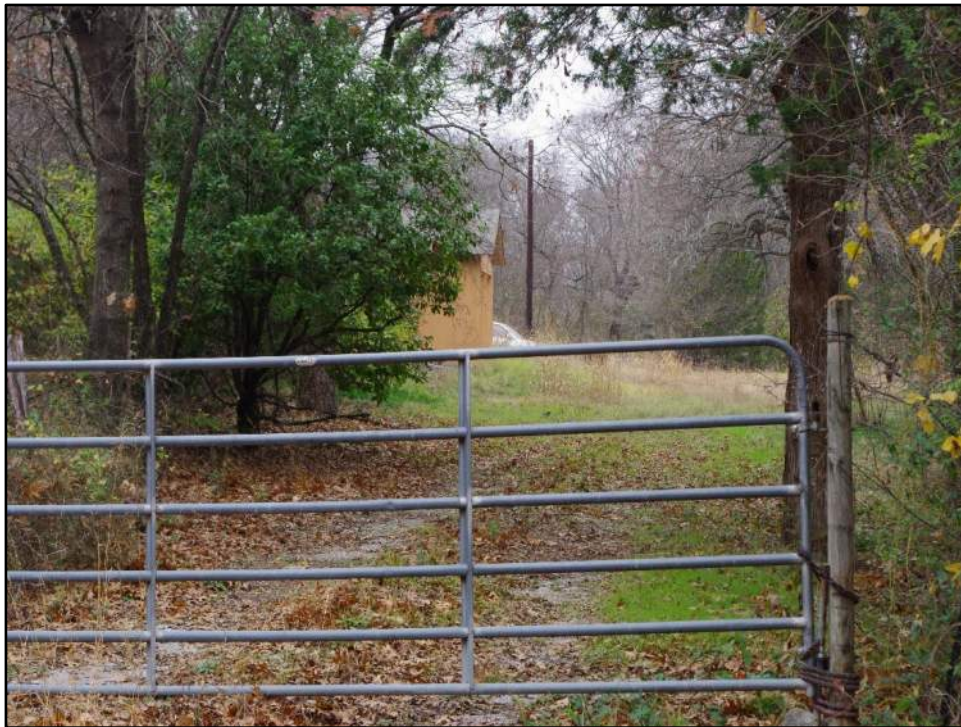
Survey Date:	December 6-9, 2021
Resource No:	95b
Project Location:	Coit Road to FM 1827
Project Name and CSJ:	0135-02-065, 0135-15-002, 0135-03-053
Address, Lat/Long:	2911 County Rd. 330 33.197337 / -96.566176
Function/Sub-function:	Domestic / Single Dwelling
Construction Date:	ca. 1940
NRHP Eligibility:	Not eligible
Integrity/Comments:	Front-gabled garage with vertical wood siding and two garage bays; no other details were discernable from the public ROW; on parcel with Resource 95a (see additional Photographs in Appendix F); not is not a significant example of resource type.

Obscured view of Resource 95b, camera facing southwest.

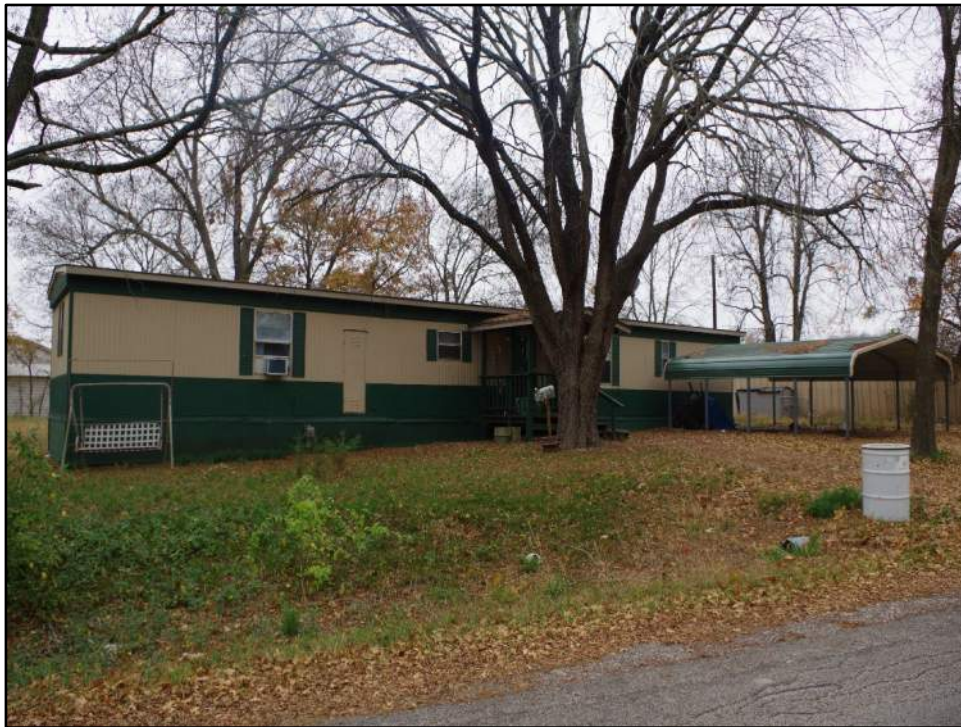
Survey Date:	December 6-9, 2021
Resource No:	96
Project Location:	Coit Road to FM 1827
Project Name and CSJ:	0135-02-065, 0135-15-002, 0135-03-053
Address, Lat/Long:	3910 County Rd. 33.196672 / -96.566509
Function/Sub-function:	Domestic / Single Dwelling
Construction Date:	ca. 1975
NRHP Eligibility:	Not eligible
Integrity/Comments:	Side-gabled manufactured dwelling with a mix of vinyl and metal panel siding, aluminum windows, gabled front entry porch, and non-historic-age carport (see additional Photographs in Appendix F); not a significant example of resource type.

View of Resource 96, camera facing southwest.

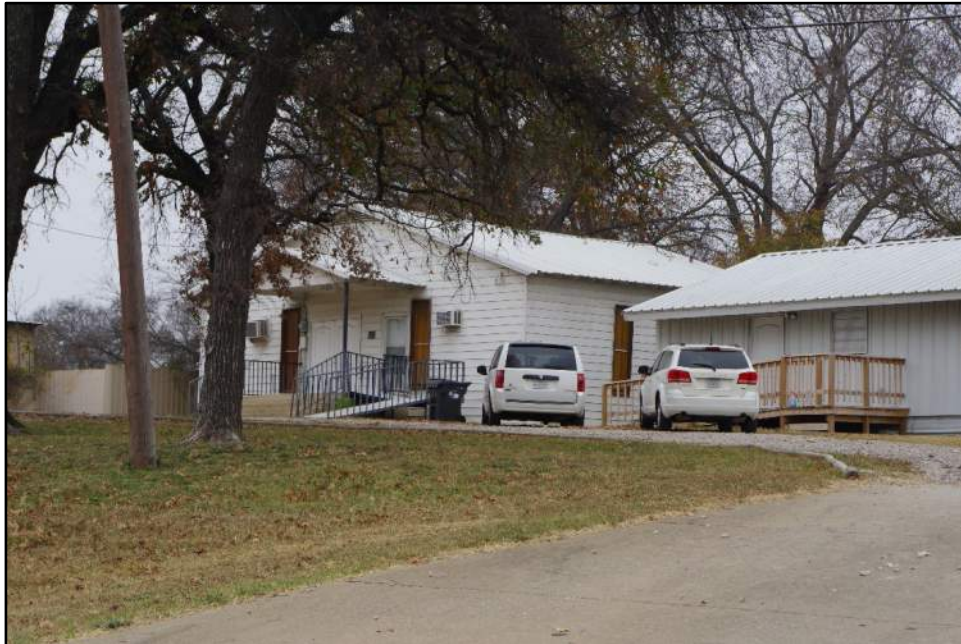
Survey Date:	December 6-9, 2021
Resource No:	97a
Project Location:	Coit Road to FM 1827
Project Name and CSJ:	0135-02-065, 0135-15-002, 0135-03-053
Address, Lat/Long:	2987 E. University Dr, 33.196241 / -96.566648
Function/Sub-function:	Religious/Apostolic Church of Jesus Christ
Construction Date:	ca. 1950
NRHP Eligibility:	Not eligible
Integrity/Comments:	Front-gabled church building with metal roof, vinyl siding, aluminum windows, a gabled front porch, and replacement vinyl double doors; on parcel with Resources 97b-97c (see additional Photographs in Appendix F); lacks integrity of materials, workmanship, or known associations of historical significance; not a significant example of resource type.

Obstructed view of Resource 97a, camera facing northwest.

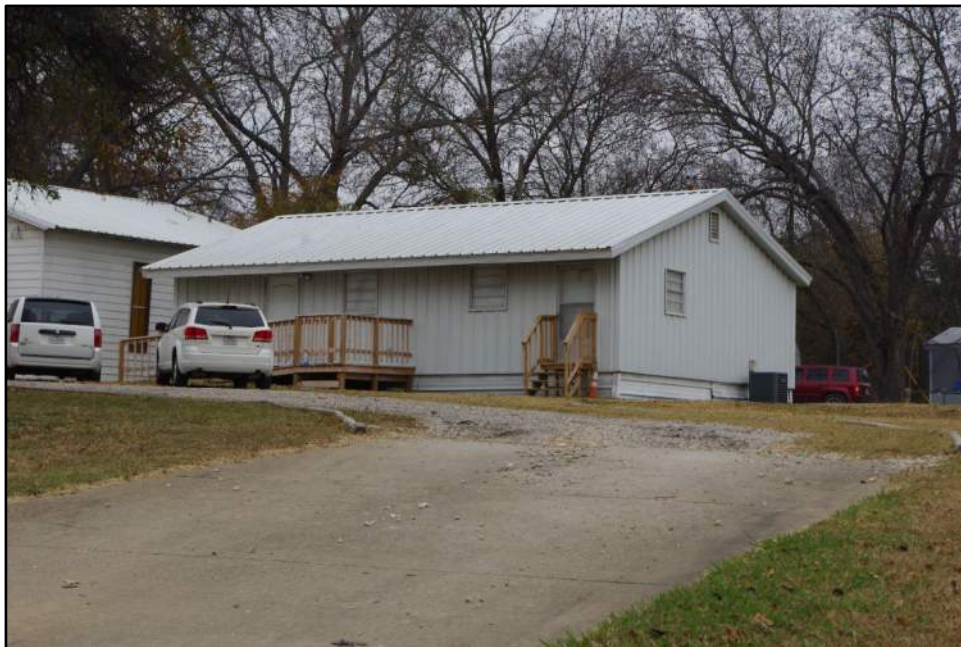
Survey Date:	December 6-9, 2021
Resource No:	97b
Project Location:	Coit Road to FM 1827
Project Name and CSJ:	0135-02-065, 0135-15-002, 0135-03-053
Address, Lat/Long:	2987 E. University Dr, 33.196241 / -96.566648
Function/Sub-function:	Religious/Apostolic Church of Jesus Christ
Construction Date:	ca. 1980
NRHP Eligibility:	Not eligible
Integrity/Comments:	Manufactured building with metal roof, metal siding, and aluminum windows; on parcel with Resources 97a and 97c (see additional Photographs in Appendix F); not a significant example of resource type.

View of Resource 97b, camera facing northwest.

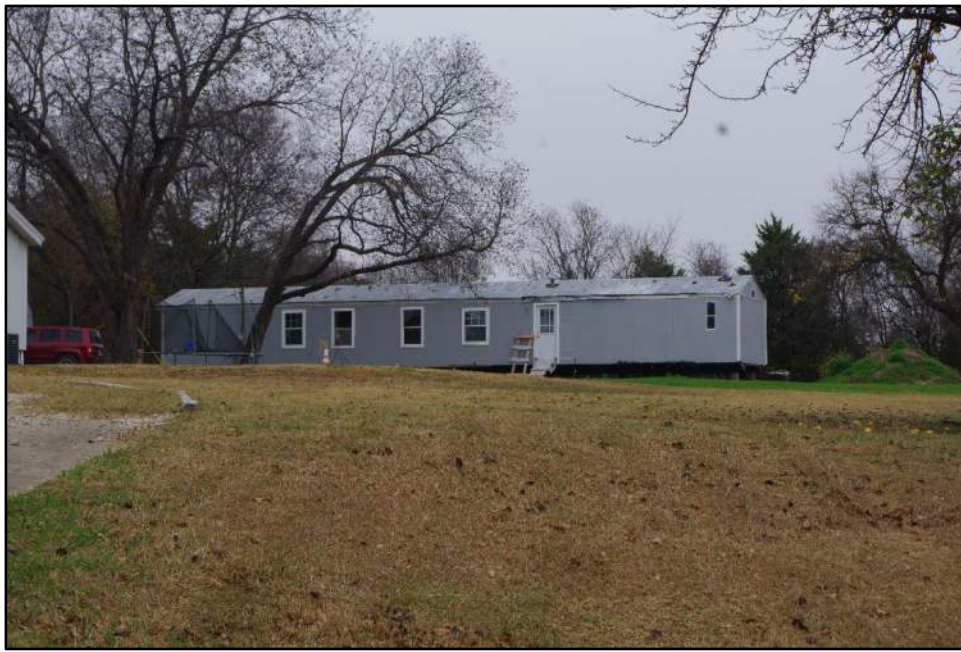
Survey Date:	December 6-9, 2021
Resource No:	97c
Project Location:	Coit Road to FM 1827
Project Name and CSJ:	0135-02-065, 0135-15-002, 0135-03-053
Address, Lat/Long:	2987 E. University Dr, 33.196241 / -96.566648
Function/Sub-function:	Religious/Apostolic Church of Jesus Christ
Construction Date:	ca. 1980
NRHP Eligibility:	Not eligible
Integrity/Comments:	Manufactured dwelling with plywood siding and replacement vinyl windows; on parcel with Resource 97a and 97b (see additional Photographs in Appendix F); not significant example of resource type.

View of Resource 97c, camera facing northwest.

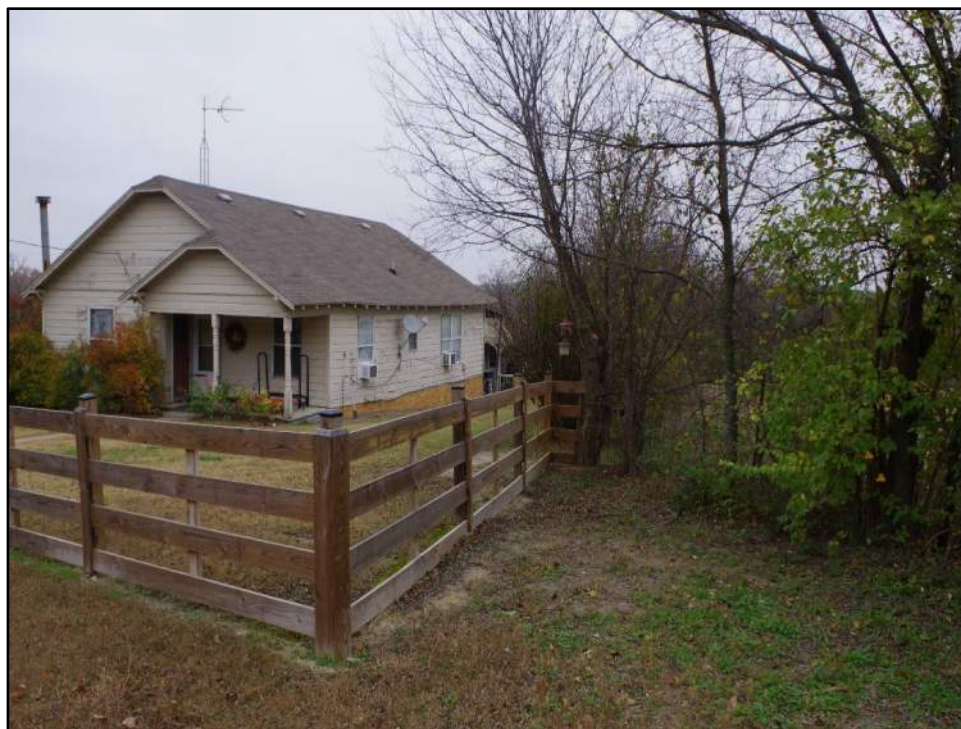
Survey Date:	December 6-9, 2021
Resource No:	98a
Project Location:	Coit Road to FM 1827
Project Name and CSJ:	0135-02-065, 0135-15-002, 0135-03-053
Address, Lat/Long:	2150 County Rd. 1084 33.196969 / -96.565254
Function/Sub-function:	Domestic / Single Dwelling
Construction Date:	1910
NRHP Eligibility:	Not eligible
Integrity/Comments:	Front-gabled bungalow-style dwelling with clipped gable ends, exposed rafter tails, replacement wood plank siding, replacement vinyl windows units, and an inset front porch with replacement faux turned wooden supports; on parcel with Resources 98b-98c and non-historic-age out building (see additional Photographs in Appendix F); lacks integrity of materials, workmanship, and feeling and is not a significant example of resource type or style; property is not an intact or significant example of an historic-age agricultural complex.

View of Resource 98a, camera facing northeast.

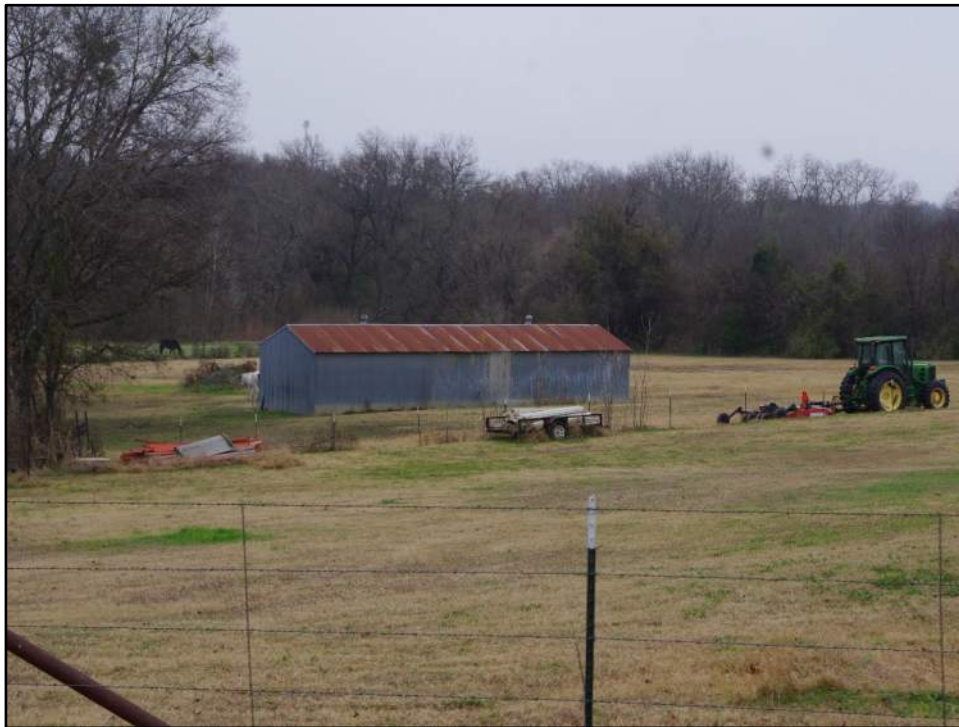
Survey Date:	December 6-9, 2021
Resource No:	98b
Project Location:	Coit Road to FM 1827
Project Name and CSJ:	0135-02-065, 0135-15-002, 0135-03-053
Address, Lat/Long:	2150 County Rd. 1084 33.196969 / -96.565254
Function/Sub-function:	Agriculture / Outbuilding
Construction Date:	ca. 1975
NRHP Eligibility:	Not eligible
Integrity/Comments:	Side-gabled utility barn with metal roof, metal vents at the roof ridge, and metal siding; on parcel with Resources 98a and 98c and non-historic-age outbuilding (see additional Photographs in Appendix F); not a significant example of resource type; property is not an intact or significant example of an historic-age agricultural complex.

View of Resource 98b, camera facing northeast.

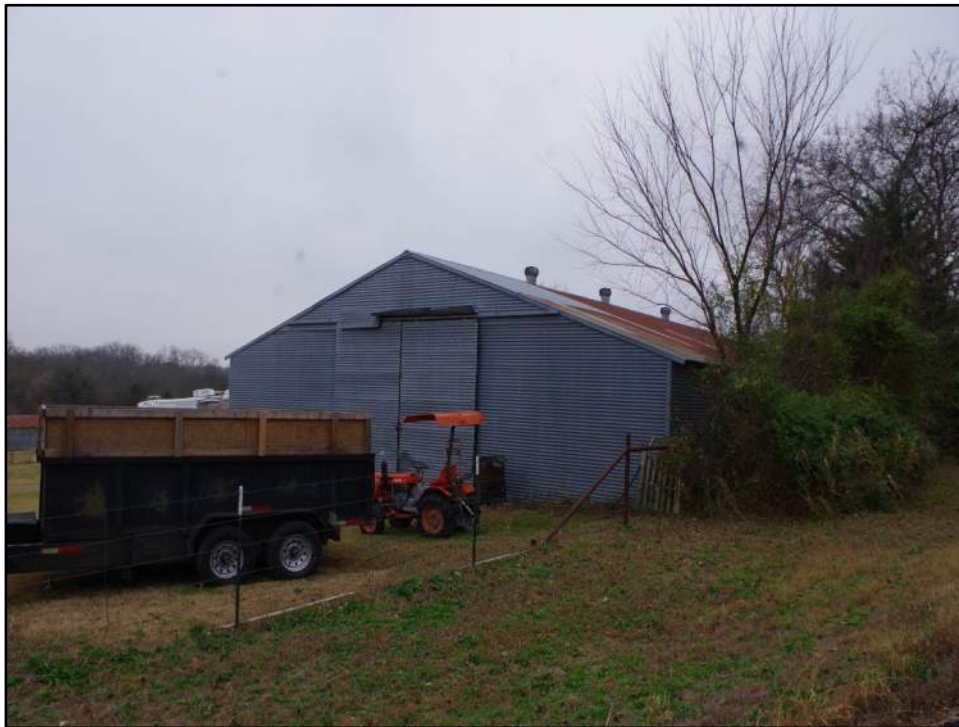
Survey Date:	December 6-9, 2021
Resource No:	98c
Project Location:	Coit Road to FM 1827
Project Name and CSJ:	0135-02-065, 0135-15-002, 0135-03-053
Address, Lat/Long:	2150 County Rd. 1084 33.196969 / -96.565254
Function/Sub-function:	Agriculture / Outbuilding
Construction Date:	ca. 1950
NRHP Eligibility:	Not eligible
Integrity/Comments:	Front-gabled barn with metal roof, metal siding, and paired metal sliding doors at the gabled end; on parcel with Resources 98a-98b and non-historic-age outbuilding (see additional Photographs in Appendix F); not a significant example of resource type; property is not an intact or significant example of an historic-age agricultural complex.

View of Resource 98c, camera facing east.

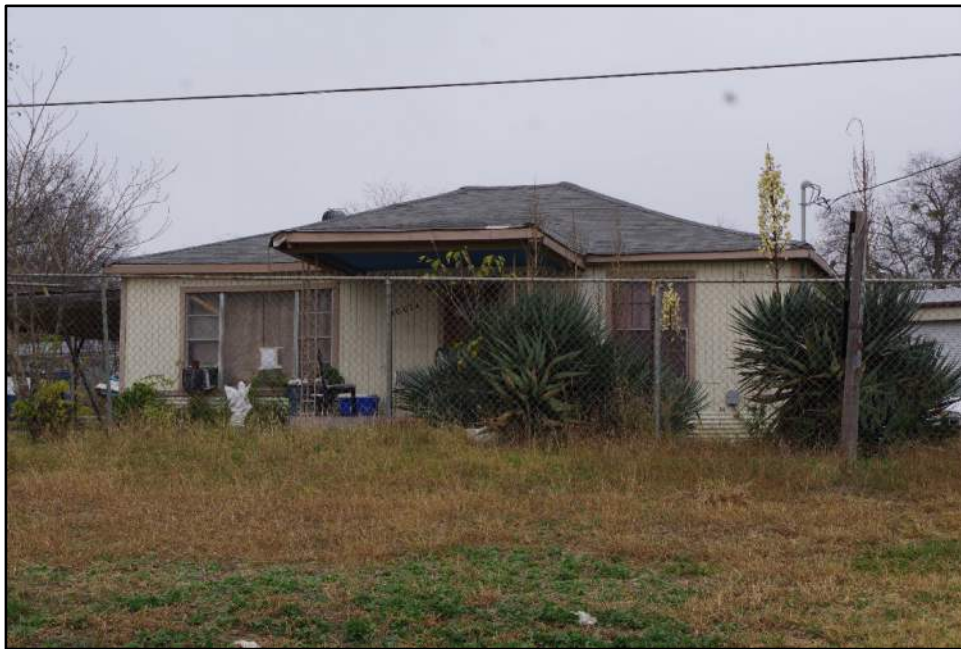
Survey Date:	December 6-9, 2021
Resource No:	99a
Project Location:	Coit Road to FM 1827
Project Name and CSJ:	0135-02-065, 0135-15-002, 0135-03-053
Address, Lat/Long:	3007 E. University Dr. 33.195909 / -96.566091
Function/Sub-function:	Domestic / Single Dwelling
Construction Date:	ca. 1965
NRHP Eligibility:	Not eligible
Integrity/Comments:	Hipped roof Minimal Traditional-style dwelling with vertical plywood siding, aluminum windows, and shed-roof carport; on parcel with Resource 99b and non-historic-age outbuildings (see additional Photographs in Appendix F); lacks integrity and is not a significant example of resource type or style.

View of Resource 99a, camera facing north.

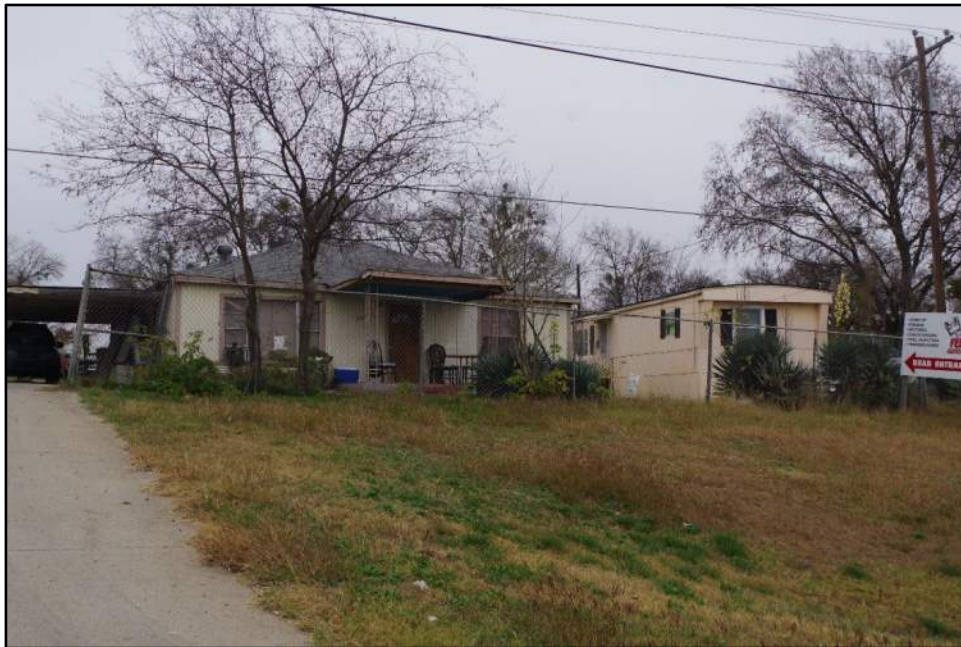
Survey Date:	December 6-9, 2021
Resource No:	99b
Project Location:	Coit Road to FM 1827
Project Name and CSJ:	0135-02-065, 0135-15-002, 0135-03-053
Address, Lat/Long:	3007 E. University Dr. 33.195909 / -96.566091
Function/Sub-function:	Domestic / Single Dwelling
Construction Date:	ca. 1975
NRHP Eligibility:	Not eligible
Integrity/Comments:	Manufactured dwelling with synthetic siding and vinyl windows; on parcel with Resource 99a and non-historic-age outbuilding (see additional Photographs in Appendix F); not a significant example of resource type.

View of Resource 99a and Resource 99b, camera facing northeast.

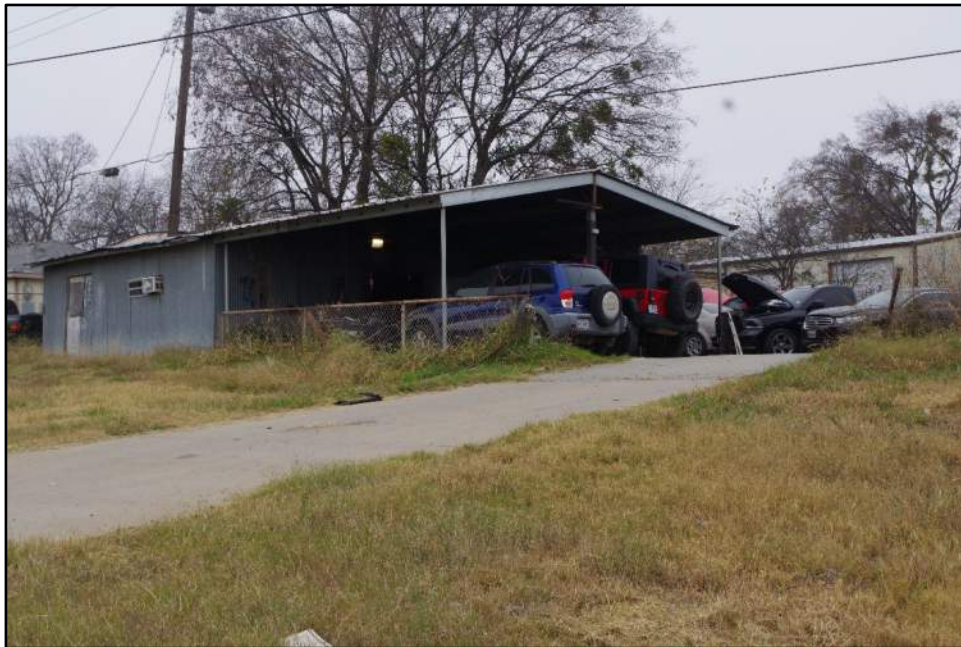
Survey Date:	December 6-9, 2021
Resource No:	100a
Project Location:	Coit Road to FM 1827
Project Name and CSJ:	0135-02-065, 0135-15-002, 0135-03-053
Address, Lat/Long:	3038 E. University Dr. 33.195694 / -96.565833
Function/Sub-function:	Commerce / Business
Construction Date:	ca. 1975
NRHP Eligibility:	Not eligible
Integrity/Comments:	Side-gabled building with metal roof and siding and open pavilion at one end; on parcel with Resource 100b (see additional Photographs in Appendix F); not a significant example of resource type.

View of Resource 100a, camera facing northwest.

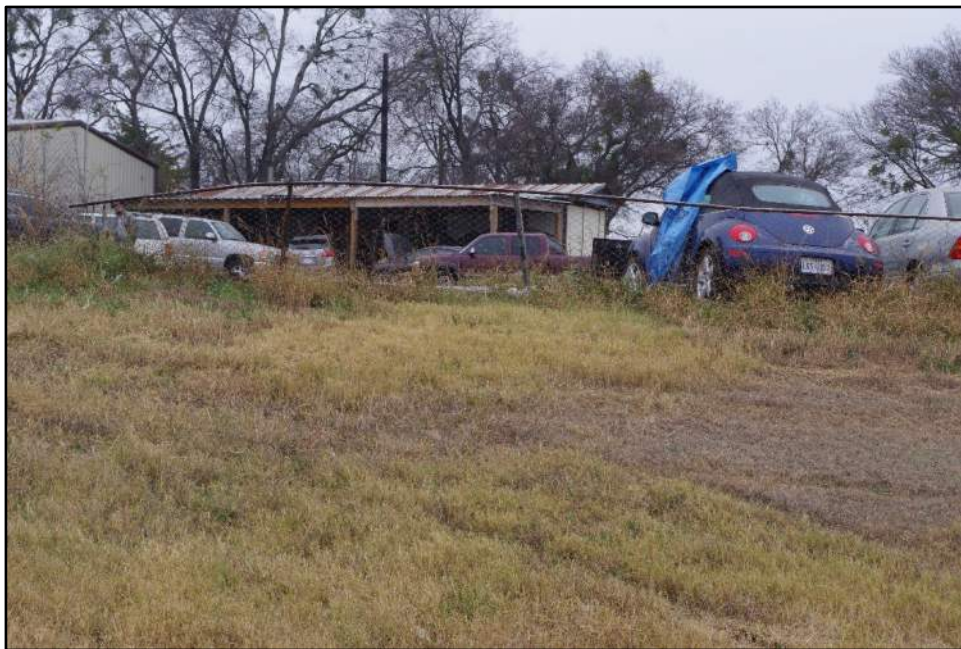
Survey Date:	December 6-9, 2021
Resource No:	100b
Project Location:	Coit Road to FM 1827
Project Name and CSJ:	0135-02-065, 0135-15-002, 0135-03-053
Address, Lat/Long:	3038 E. University Dr. 33.195694 / -96.565833
Function/Sub-function:	Domestic / Secondary Structure
Construction Date:	ca. 1975
NRHP Eligibility:	Not eligible
Integrity/Comments:	Side-gabled building with metal roof, a mix of metal and vinyl siding, and shed-roof addition; other details were not discernable from the public ROW; on parcel with Resource 100a (see additional Photographs in Appendix F); not a significant example of resource type.

View of Resource 100b, camera facing northwest.

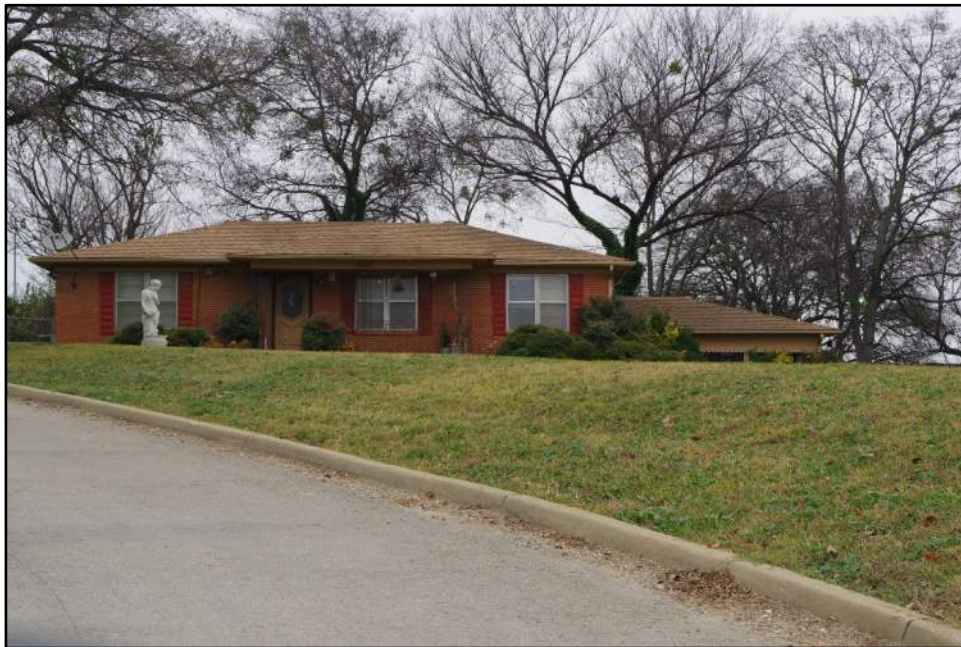
Survey Date:	December 6-9, 2021
Resource No:	101a
Project Location:	Coit Road to FM 1827
Project Name and CSJ:	0135-02-065, 0135-15-002, 0135-03-053
Address, Lat/Long:	3067 County Rd. 330 33.195918 / -96.564824
Function/Sub-function:	Domestic / Single Dwelling
Construction Date:	ca. 1965
NRHP Eligibility:	Not eligible
Integrity/Comments:	Hipped-roof Ranch-style dwelling with brick cladding, aluminum windows, and large garage/carport addition; on parcel with Resources 101b-101c and non-historic-age shed (see additional Photographs in Appendix F); retains a degree of integrity but is not a significant example of resource type.

View of Resource 101a, camera facing northwest.

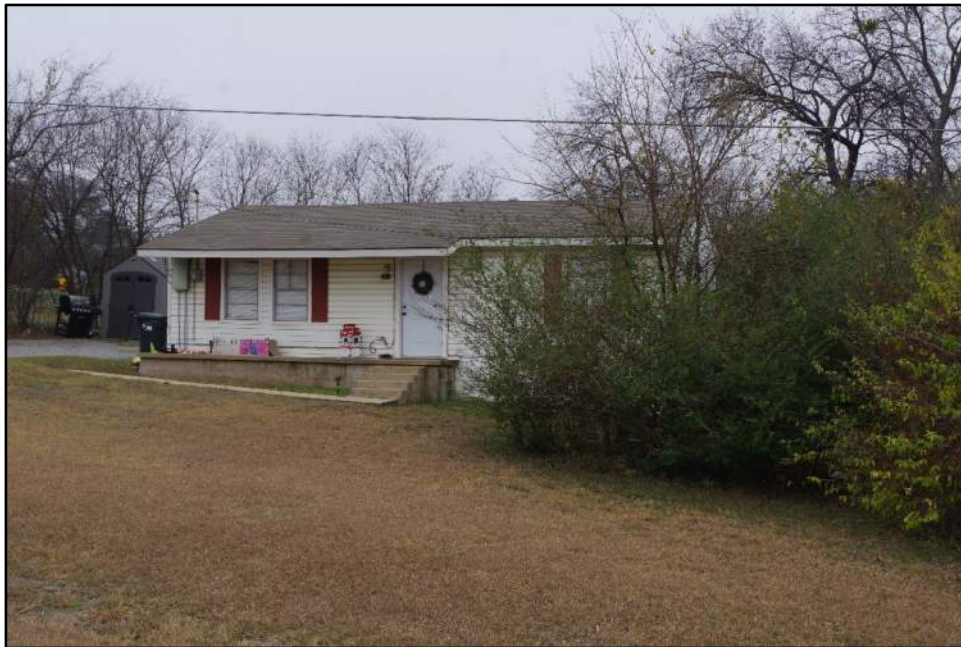
Survey Date:	December 6-9, 2021
Resource No:	101b
Project Location:	Coit Road to FM 1827
Project Name and CSJ:	0135-02-065, 0135-15-002, 0135-03-053
Address, Lat/Long:	3067 County Rd. 330 33.195918 / -96.564824
Function/Sub-function:	Domestic / Single Dwelling
Construction Date:	ca. 1970
NRHP Eligibility:	Not eligible
Integrity/Comments:	Side-gabled Simplified Ranch-style dwelling with vinyl siding and aluminum windows; on parcel with Resources 101a and 101c and non-historic-age shed (see additional Photographs in Appendix F); not a significant example of resource type.

View of Resource 101b, camera facing northwest.

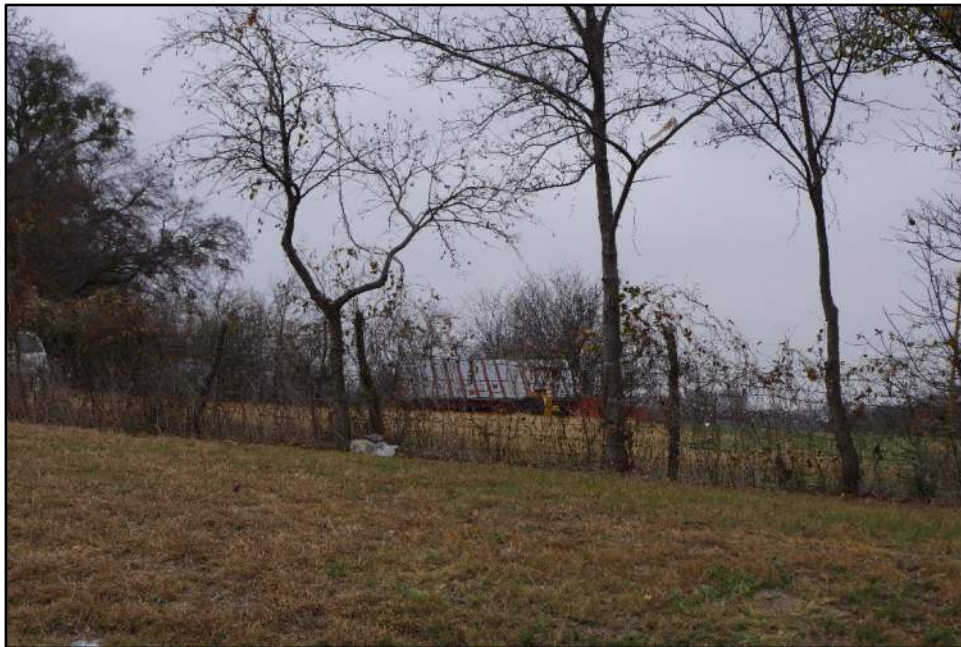
Survey Date:	December 6-9, 2021
Resource No:	101c
Project Location:	Coit Road to FM 1827
Project Name and CSJ:	0135-02-065, 0135-15-002, 0135-03-053
Address, Lat/Long:	3067 County Rd. 330 33.195918 / -96.564824
Function/Sub-function:	Domestic / Single Dwelling
Construction Date:	ca. 1965
NRHP Eligibility:	Not eligible
Integrity/Comments:	Side-gabled barn with metal roof and wood siding; other details were not visible from the public ROW; on parcel with Resources 101a-101b and non-historic-age shed (see additional Photographs in Appendix F); not a significant example of resource type.

View of Resource 101c, camera facing north.

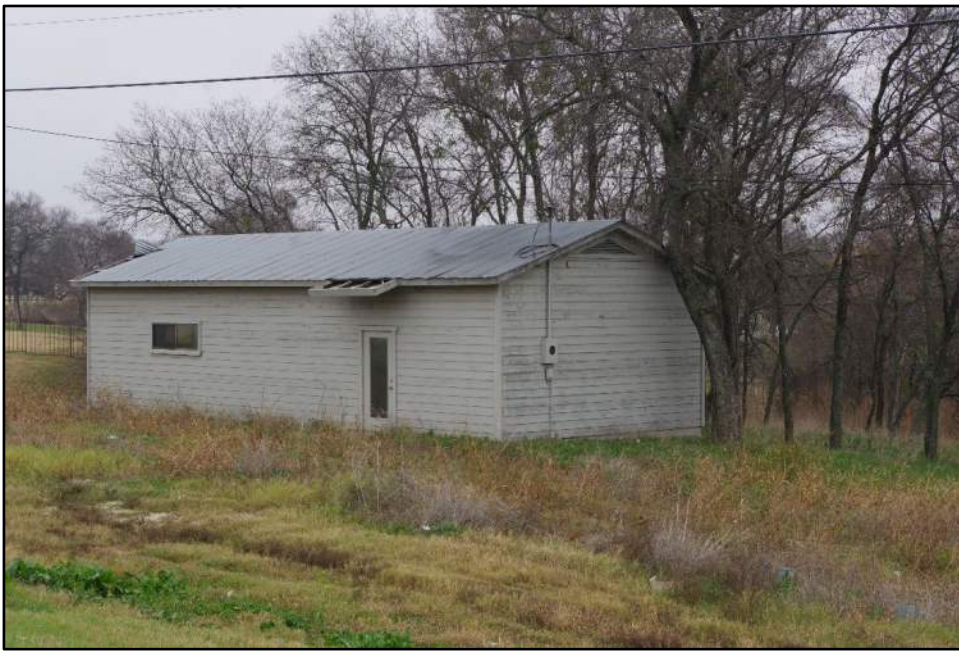
Survey Date:	December 6-9, 2021
Resource No:	102
Project Location:	Coit Road to FM 1827
Project Name and CSJ:	0135-02-065, 0135-15-002, 0135-03-053
Address, Lat/Long:	2452 E. University Dr. 33.197435 / -96.574127
Function/Sub-function:	Commercial / Professional
Construction Date:	ca. 1980
NRHP Eligibility:	Not eligible
Integrity/Comments:	Side-gabled building with replacement metal roof, wood siding, and a single vinyl window and door on the primary façade (see additional Photographs in Appendix F); undetermined use; not a significant example of resource type.

View of Resource 102, camera facing southeast.

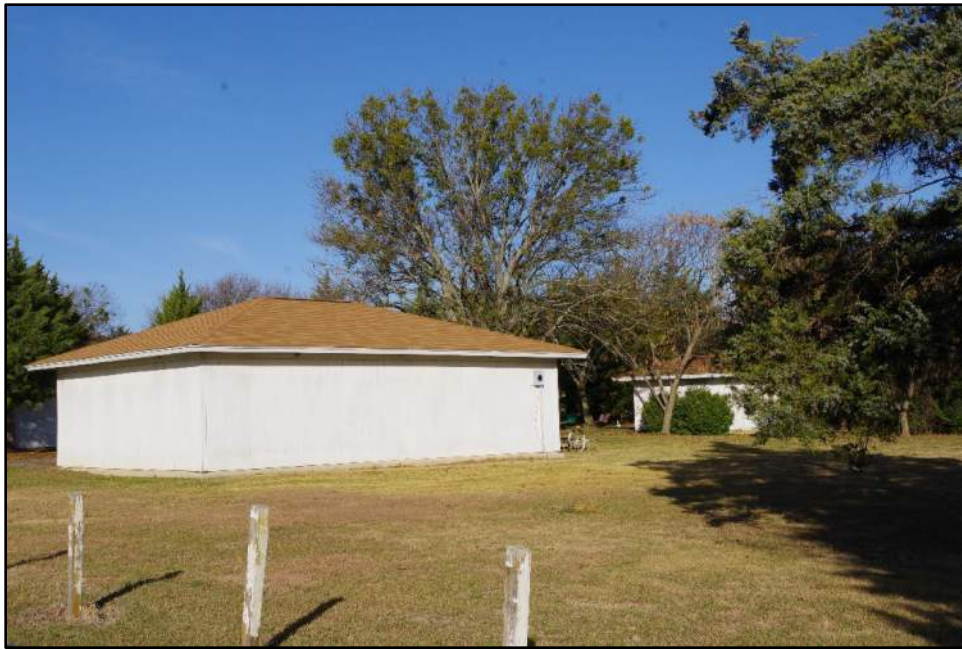
Photograph F-71: View of Resource 19b (background) and non-historic-age garage, camera facing northwest.

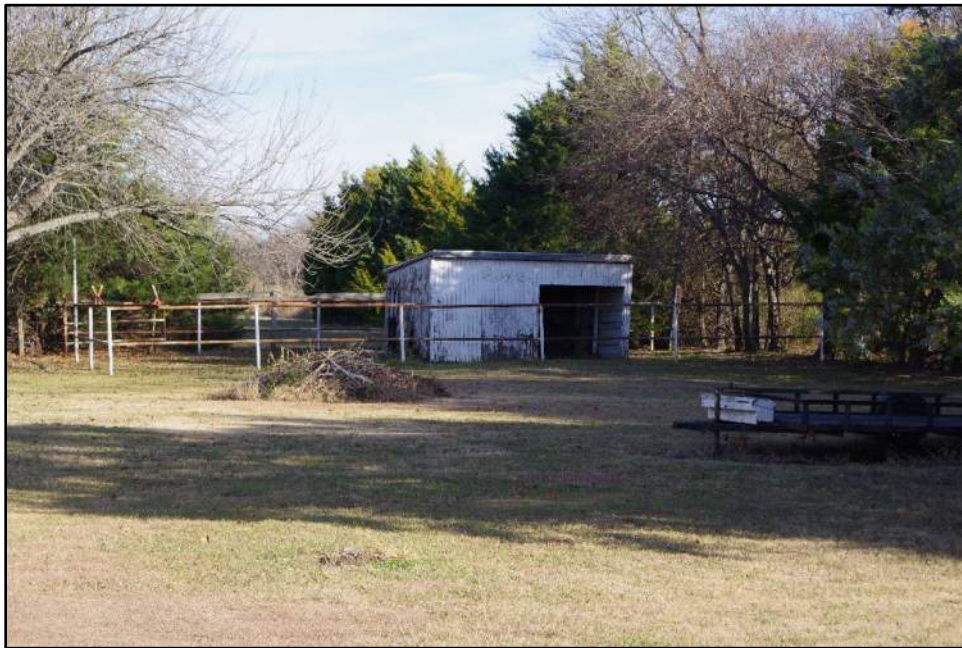
Photograph F-72: View of Resource 19c, camera facing northeast.

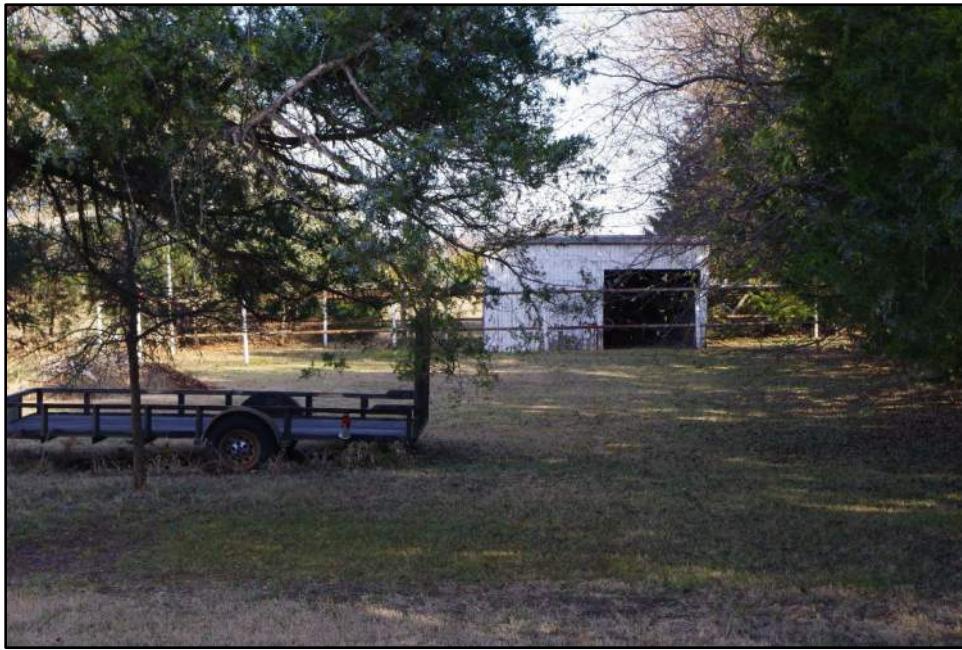
Photograph F-73: View of Resource 19c, camera facing north.

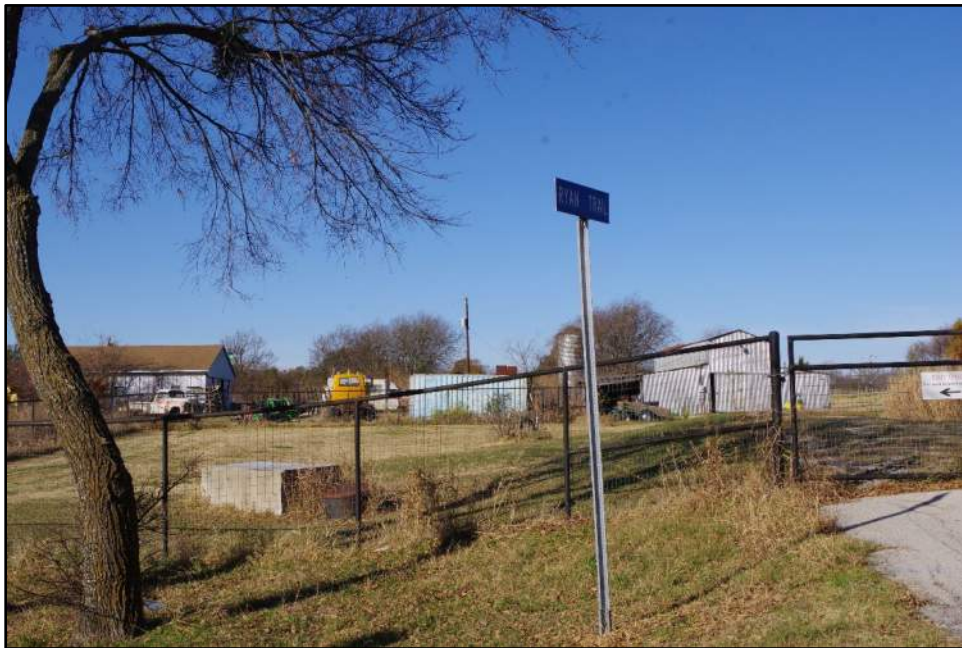
Photograph F-74: Overview of Resource 20, camera facing west.
