APPENDIX L: Cultural Resources

APPENDIX L – CULTURAL RESOURCES – FEIS Preferred Alternative/Blue Alternative

US 380 MCKINNEY – Coit Road to FM 1827, Collin County CSJs 0135-02-065 and 0135-15-002; Dallas District

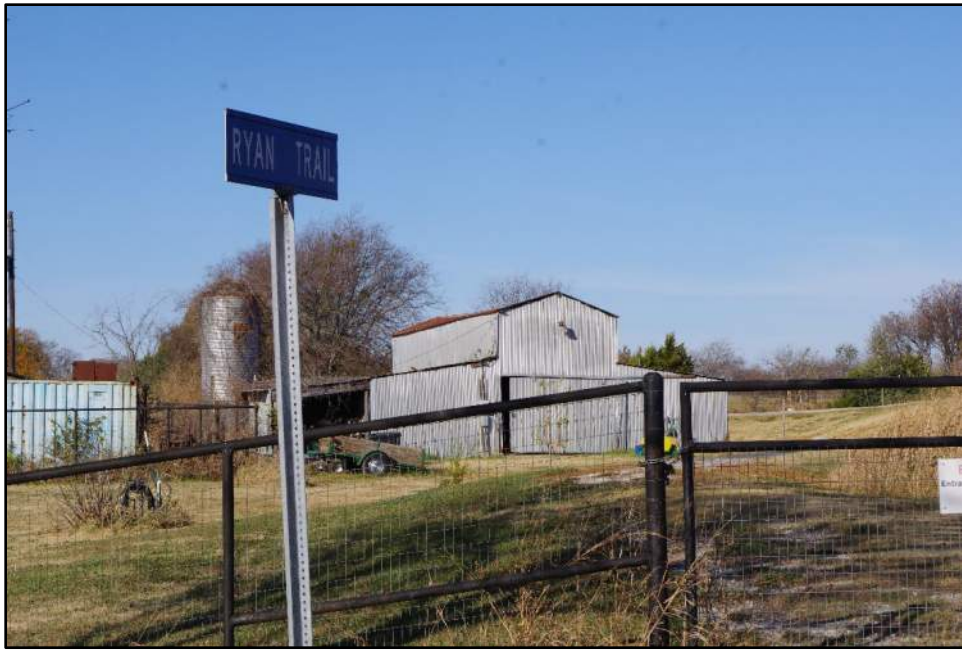
Photograph F-75: View of Resource 20a, camera facing west.

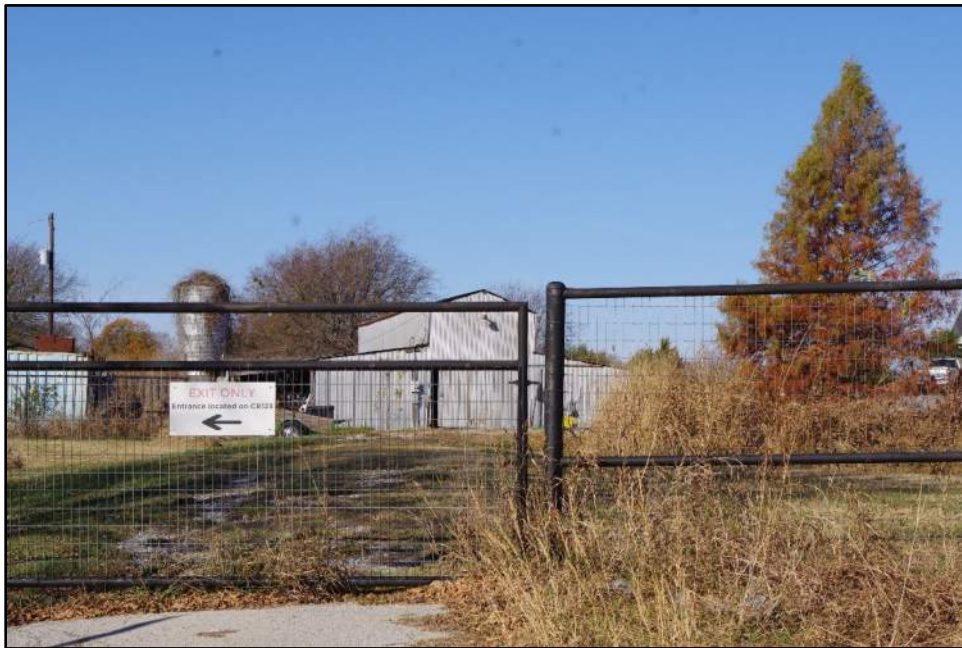
Photograph F-76: Obstructed view of Resource 20a and Resource 20b, camera facing west.

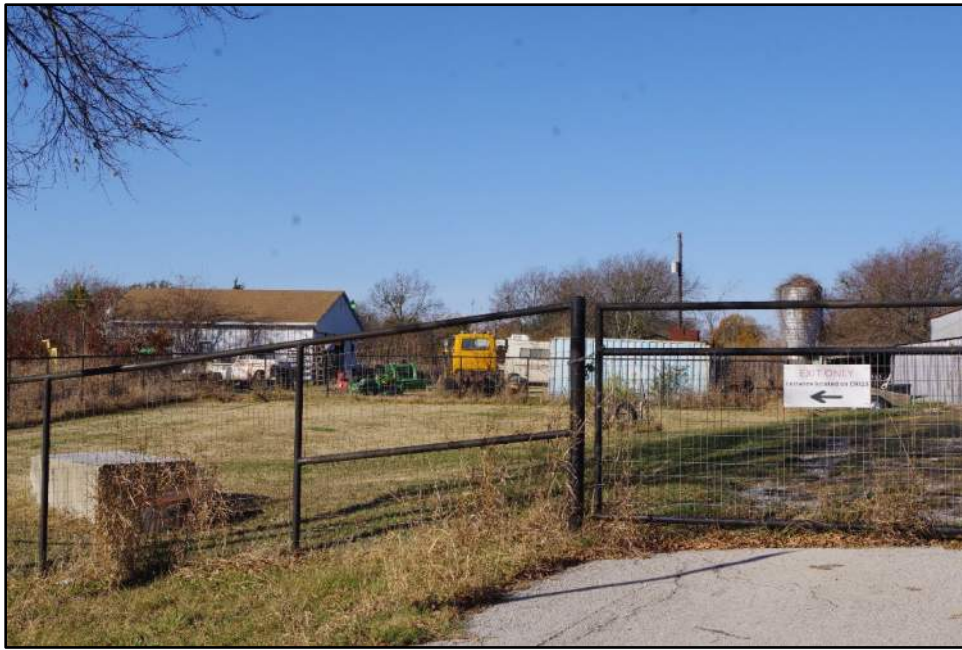
Photograph F-77: View of Resource 20b (right) and non-historic-age shed (left), camera facing west.

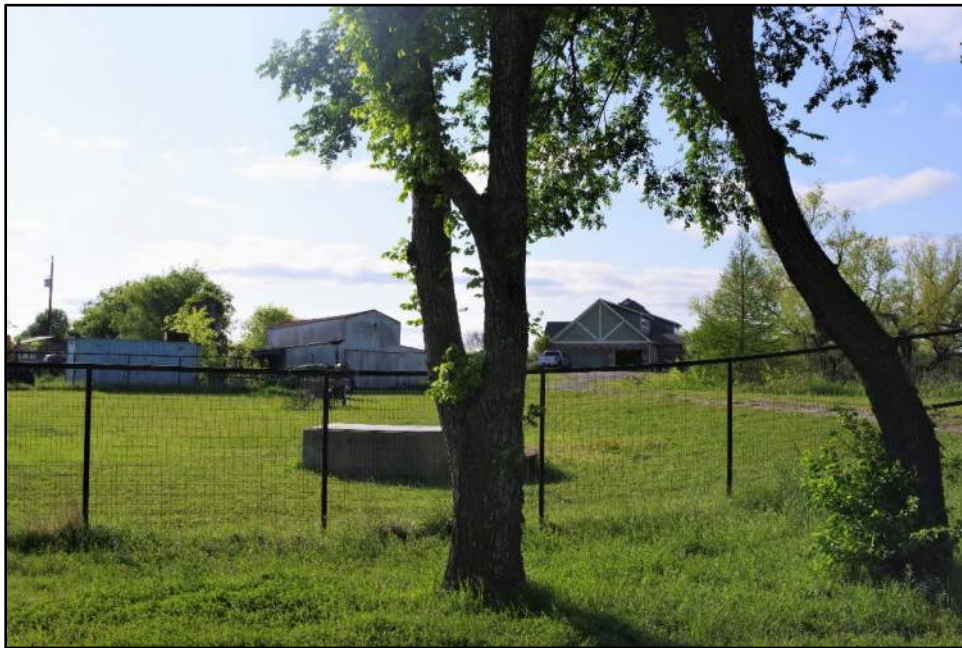
Photograph F-78: View of Resource 20a (left) and non-historic-age dwelling (right), camera facing west.

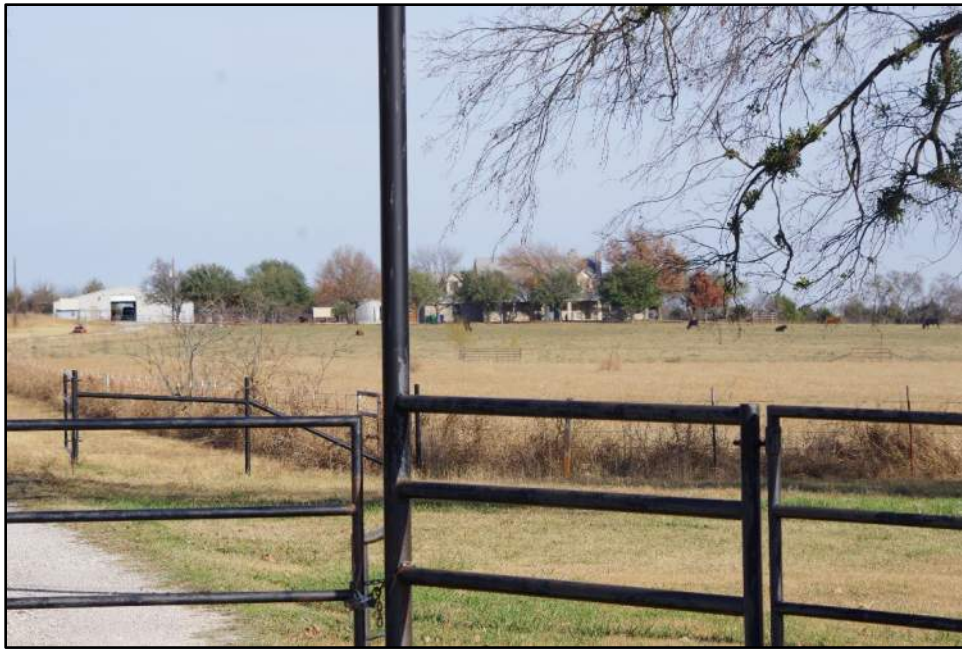
Photograph F-79: Overview of Resource 21, camera facing north.

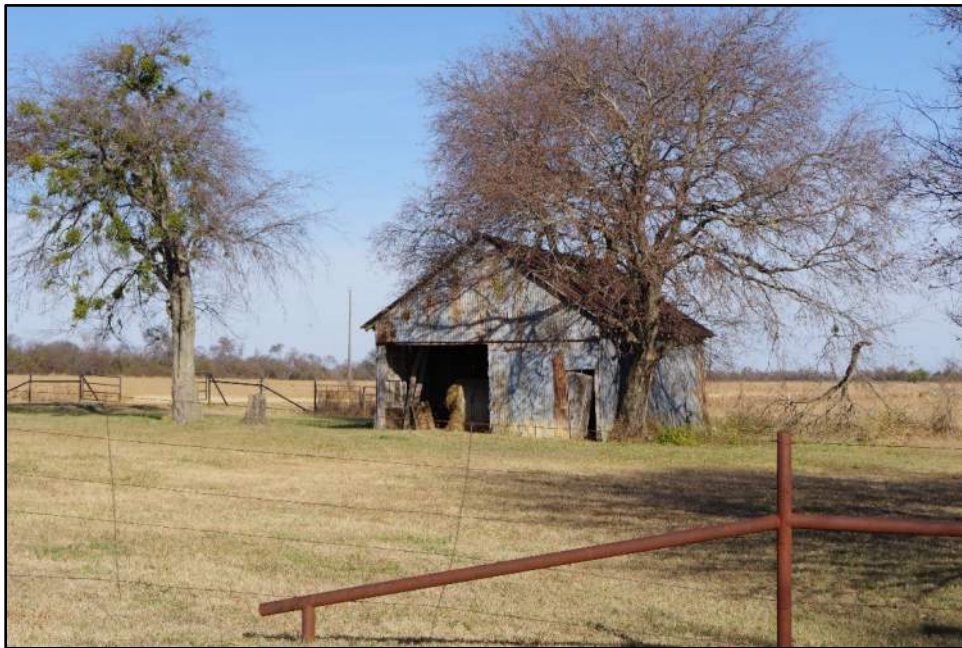
Photograph F-80: View of Resource 21, camera facing northwest.

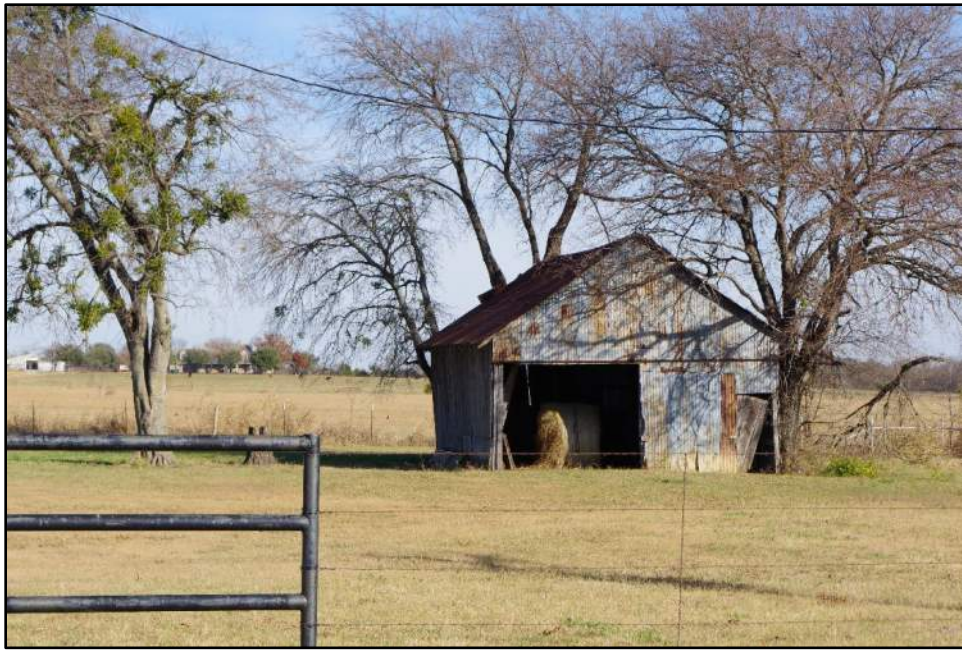
Photograph F-81: View of Resource 21, camera facing northwest.

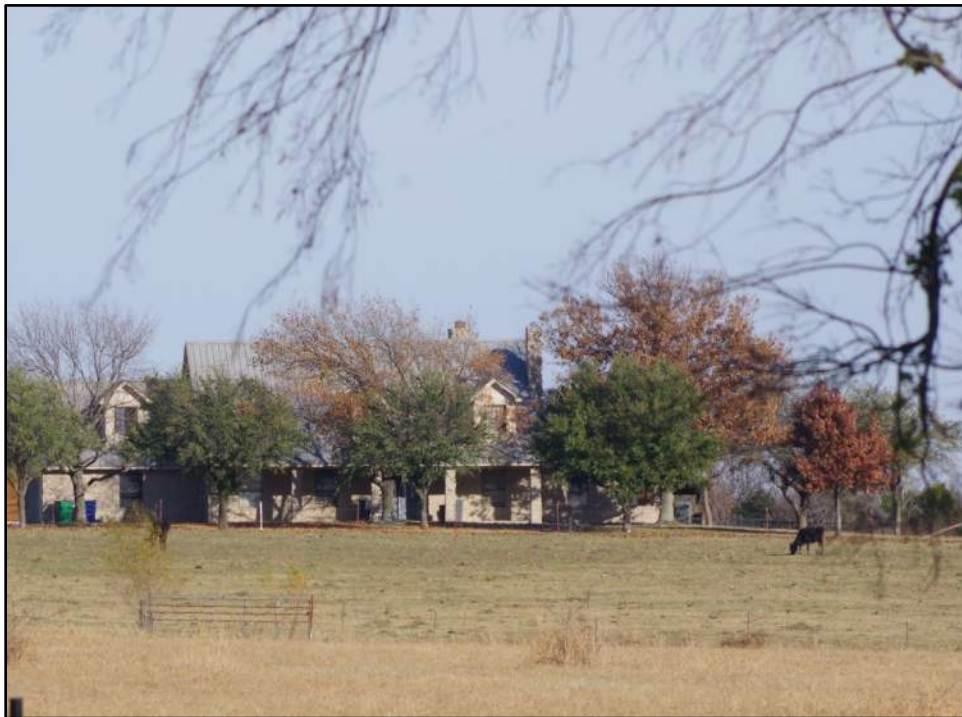
Photograph F-82: View of non-historic-age dwelling associated with Resource 21, camera facing north.

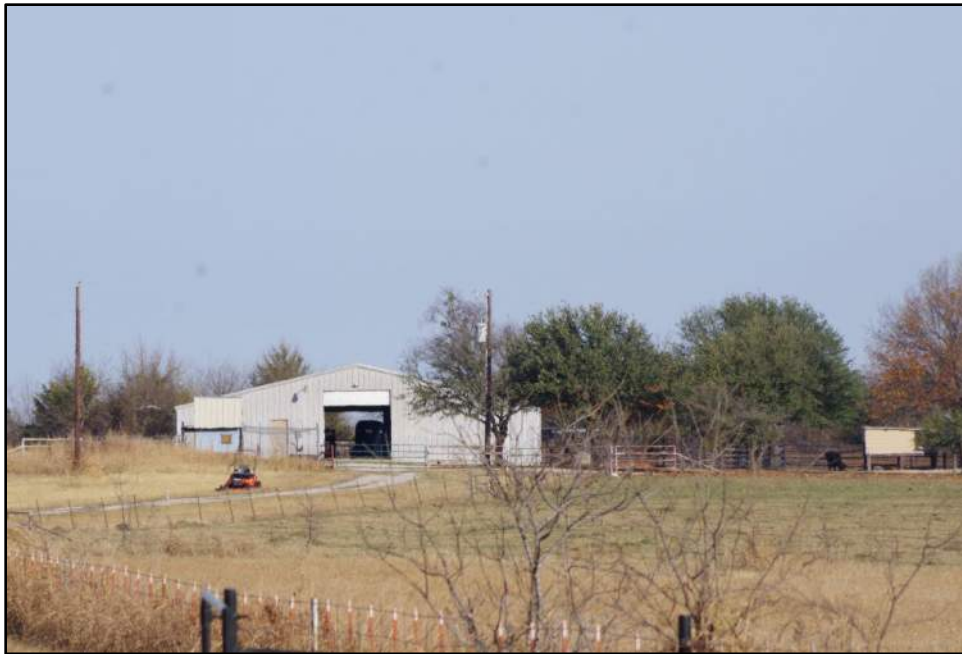
Photograph F-83: View of non-historic-age garage associated with Resource 21, camera facing northwest.

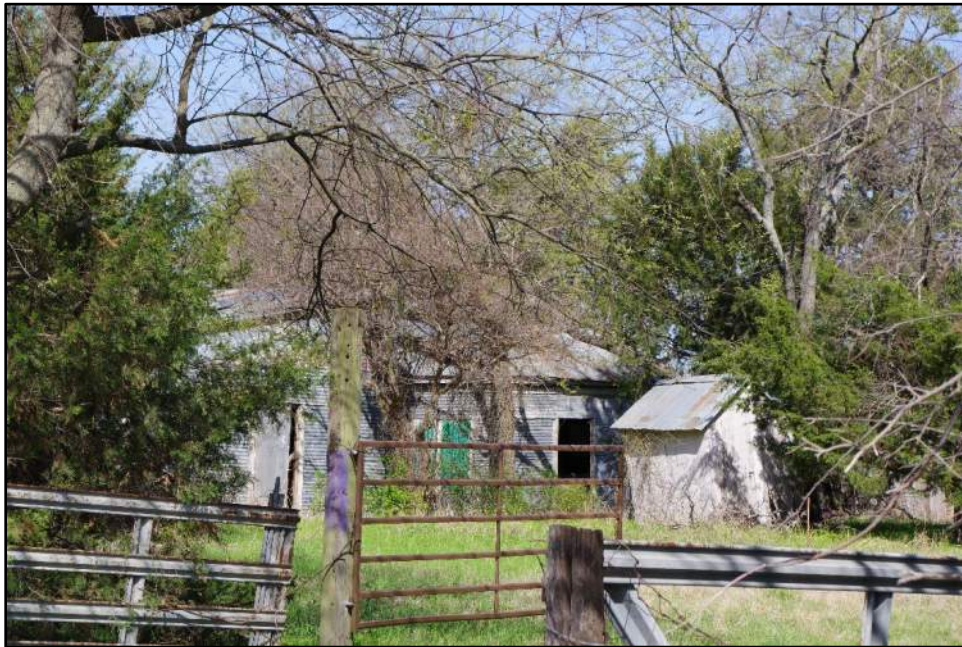
Photograph F-84: Obstructed view of Resource 22a (left) and Resource 22c (center, foreground), camera facing northwest.

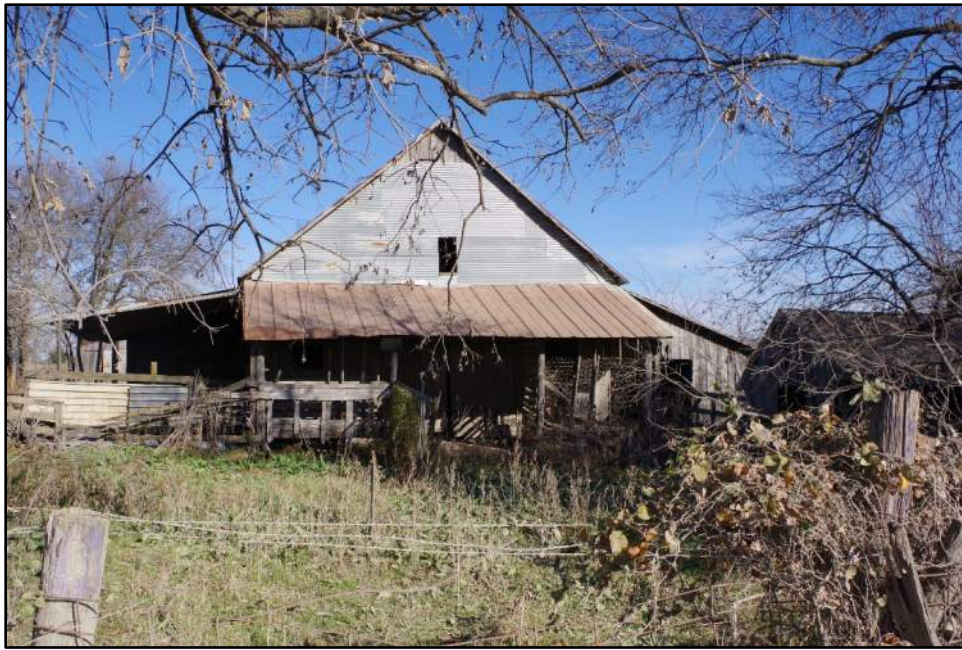
Photograph F-85: View of Resource 22b, camera facing north.

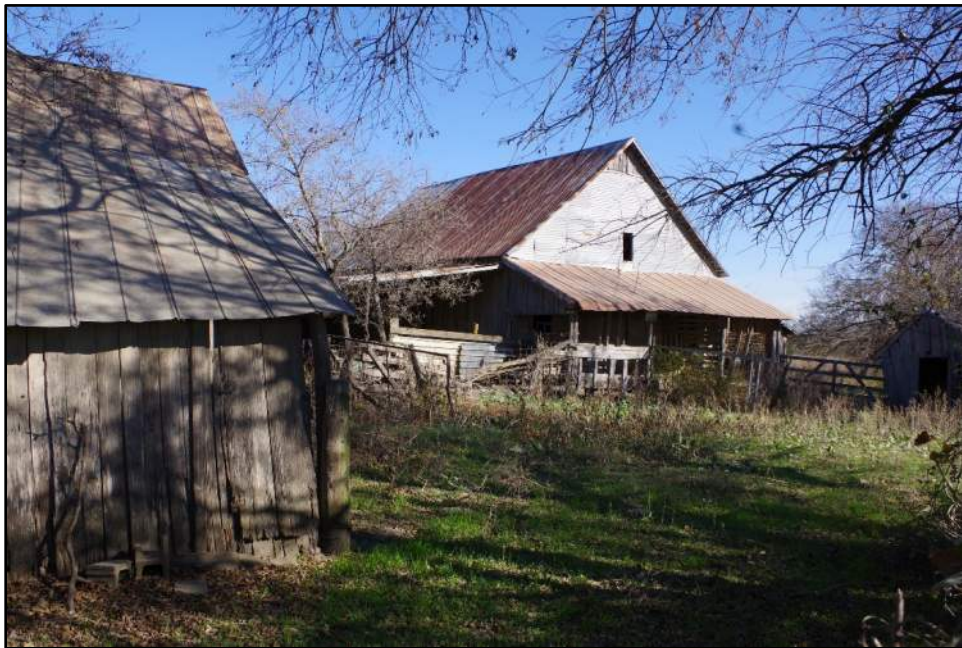
Photograph F-86: View of Resource 22b, camera facing northeast.

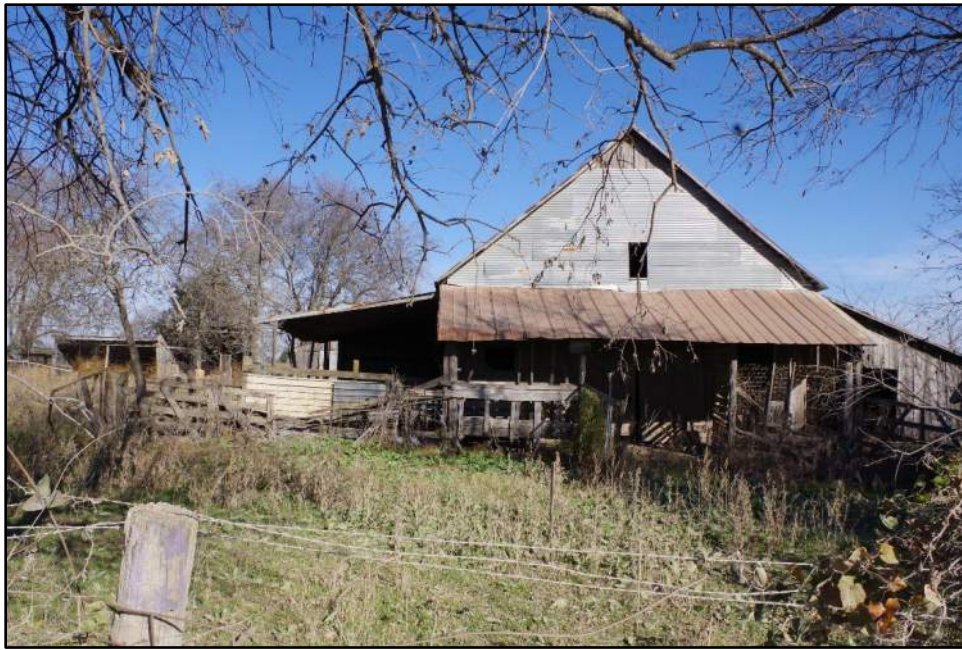
Photograph F-87: View of Resource 22b (center) and Resource 22e (left), camera facing north.

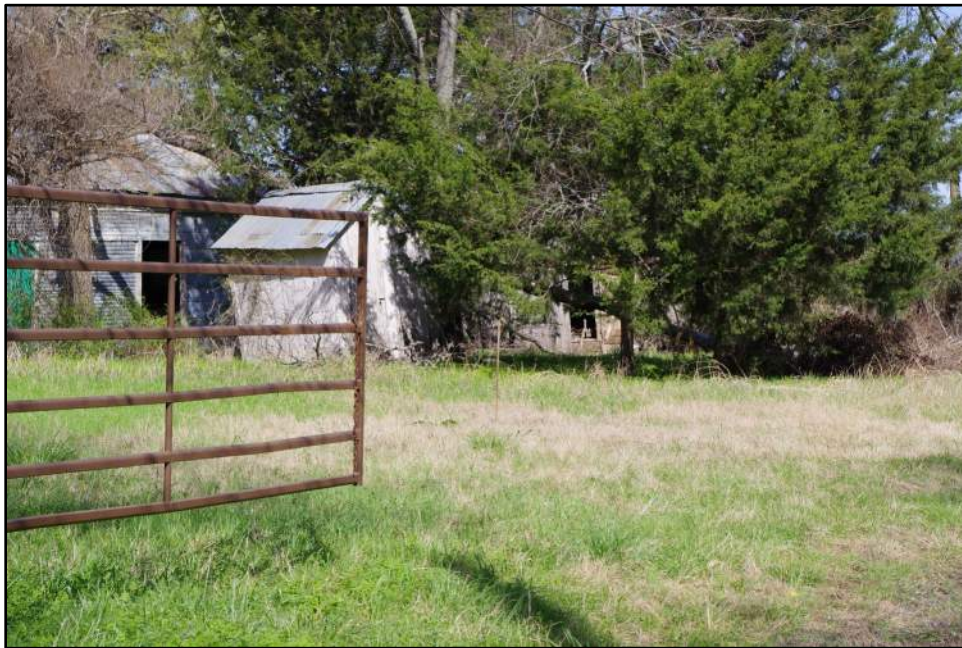
Photograph F-88: View of Resource 22d, camera facing, camera facing northwest.

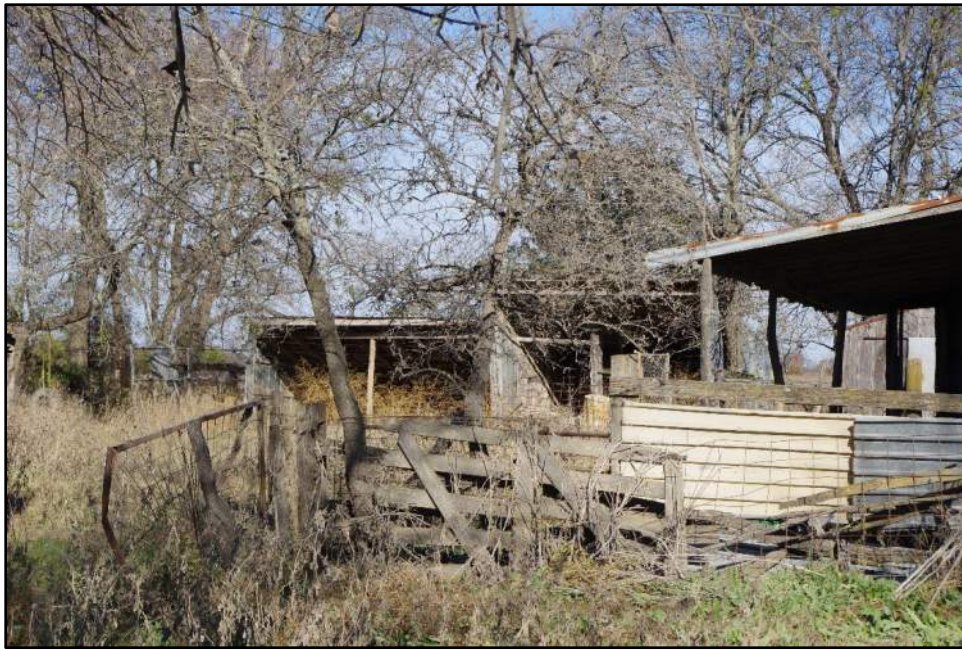
Photograph F-89: View of Resource 22e, camera facing north.

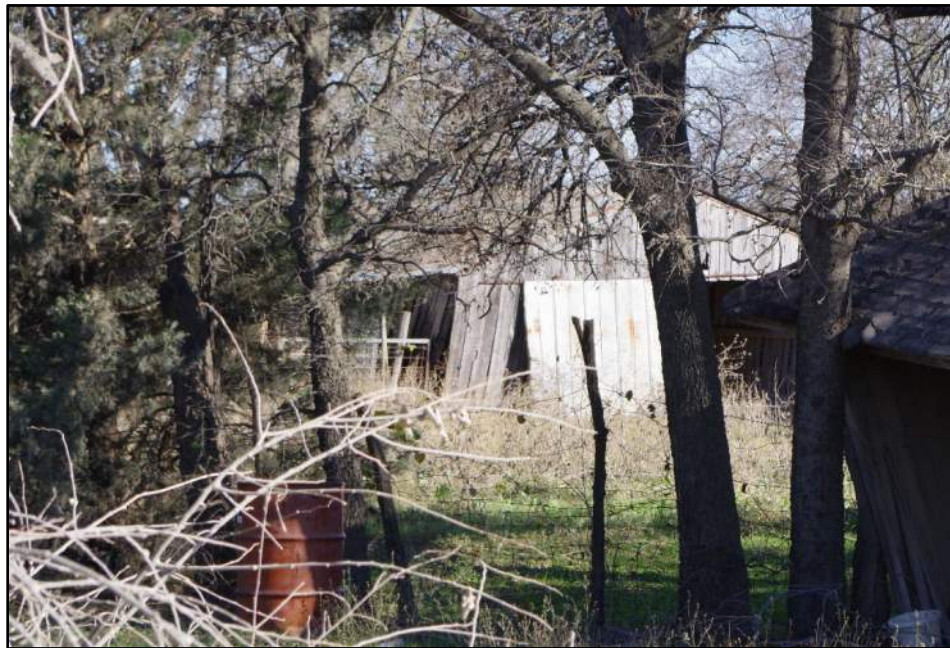
Photograph F-90: Obstructed view of Resource 22f, camera facing northeast.

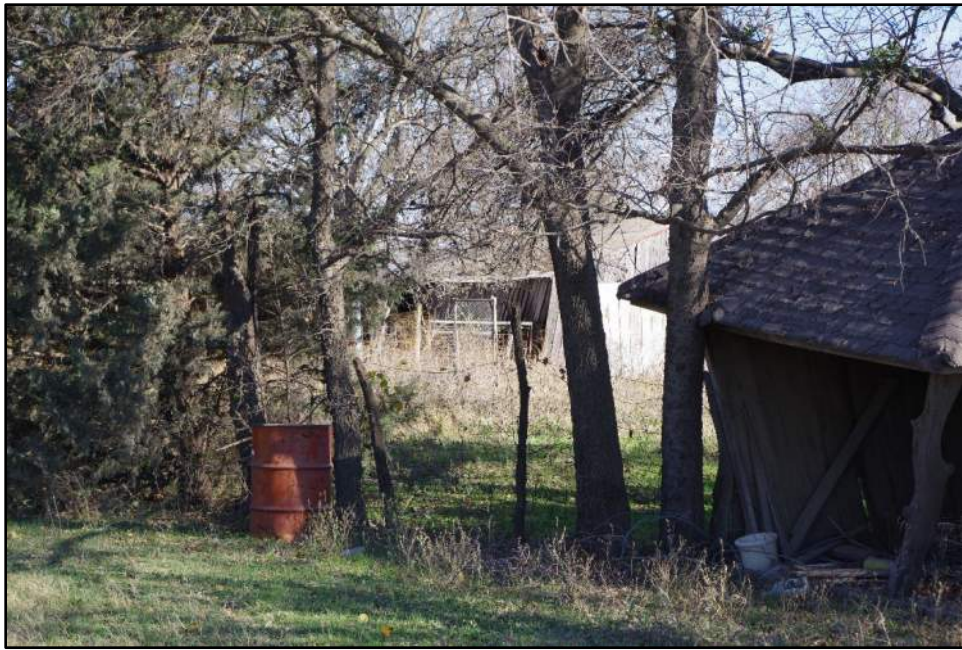
Photograph F-91: Obstructed view of Resource 22f (center, background) and Resource 22i (right), camera facing northeast.

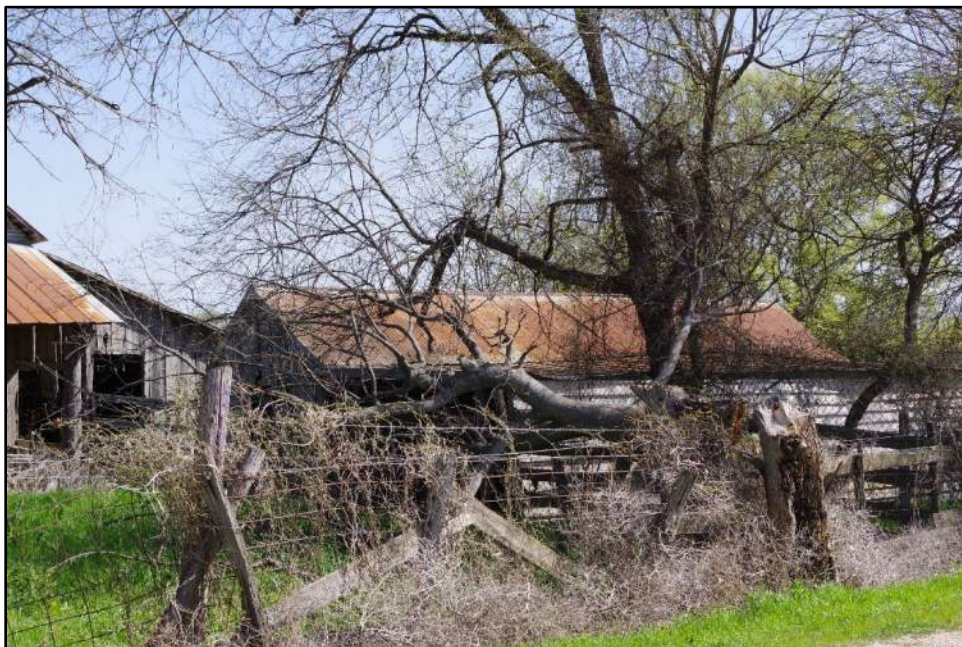
Photograph F-92: View of Resource 22g, camera facing northeast.

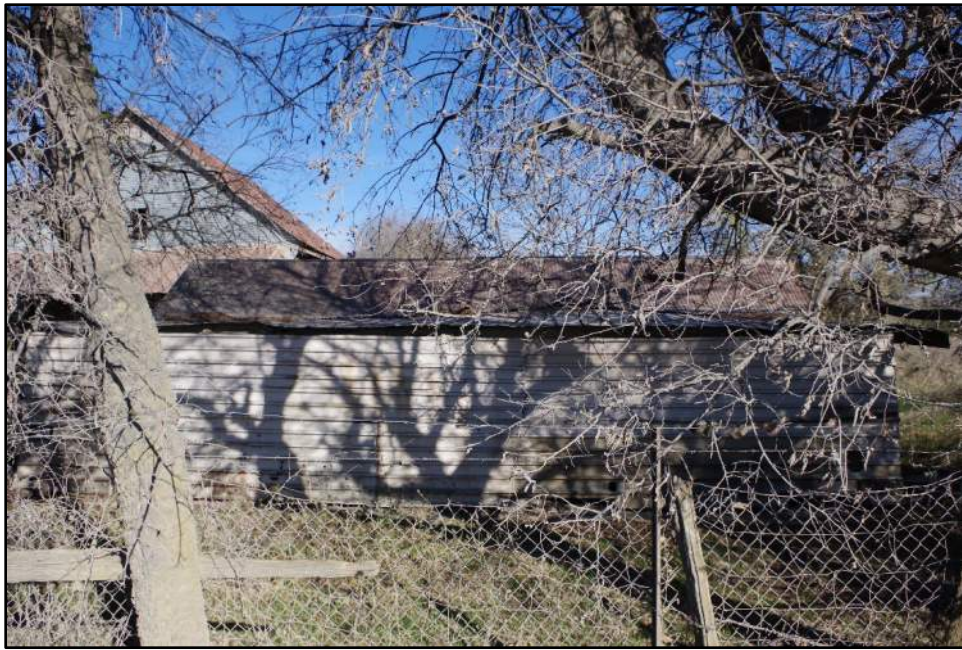
Photograph F-93: View of Resource 22g, camera facing north.

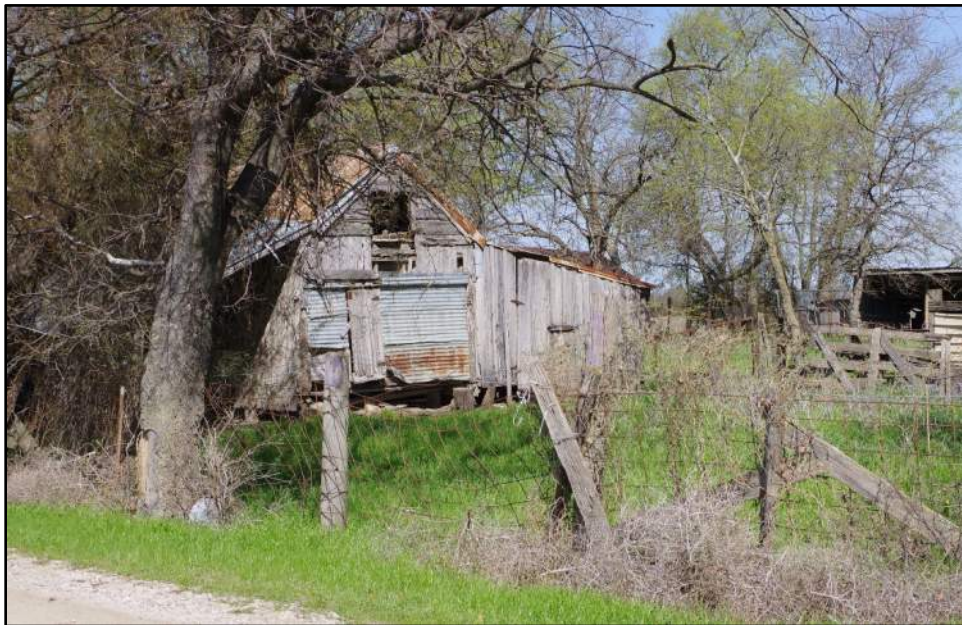
Photograph F-94: View of Resource 22h, camera facing northwest.

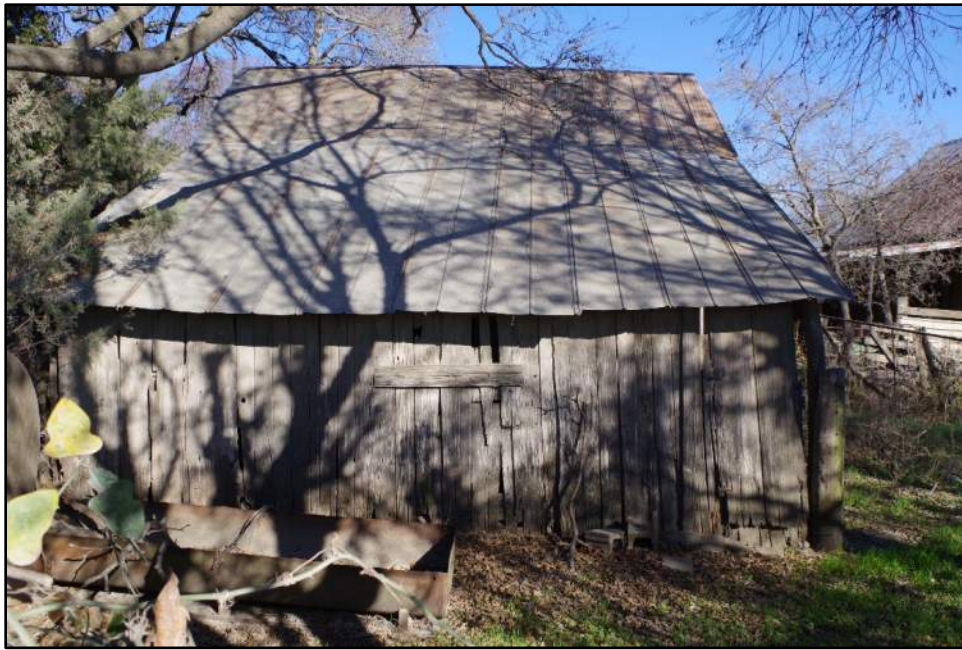
Photograph F-95: View of Resource 22h, camera facing north.

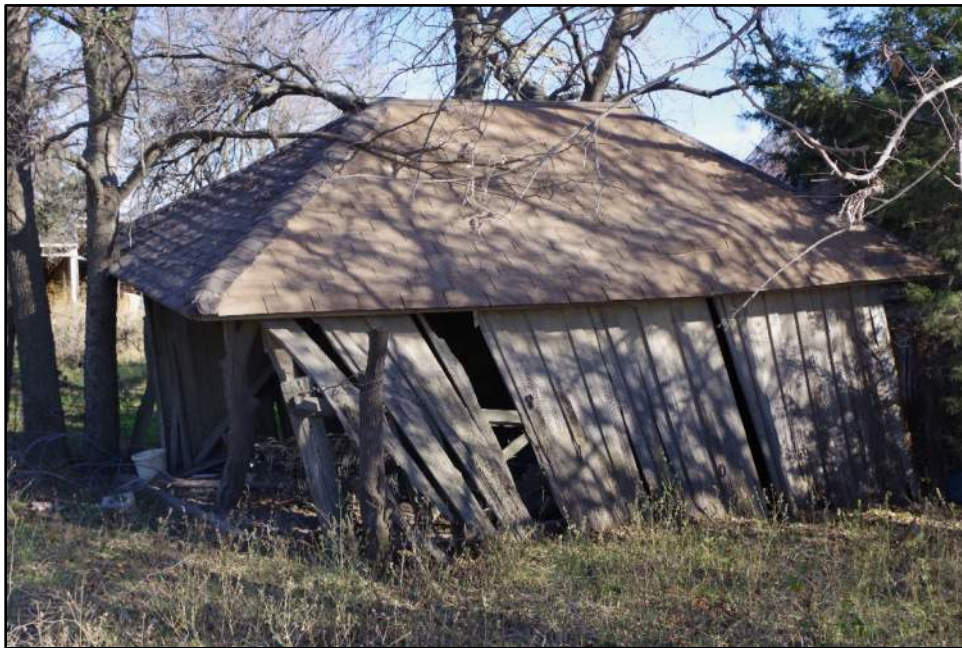
Photograph F-96: View of Resource 22i, camera facing northeast.

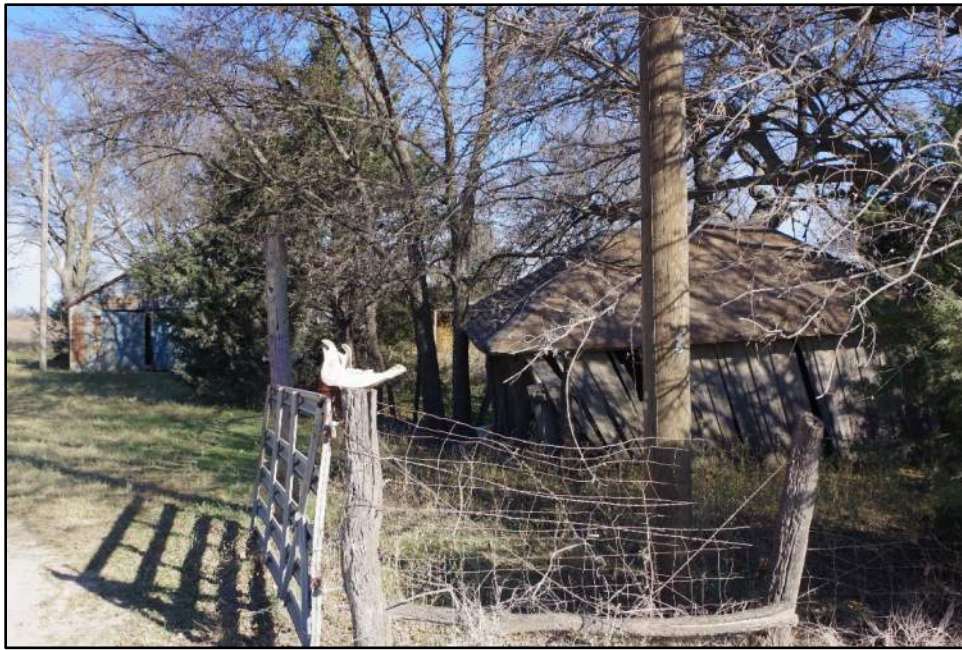
Photograph F-97: Obstructed view of Resource 22i (right) and Resource 22j (left), camera facing north.

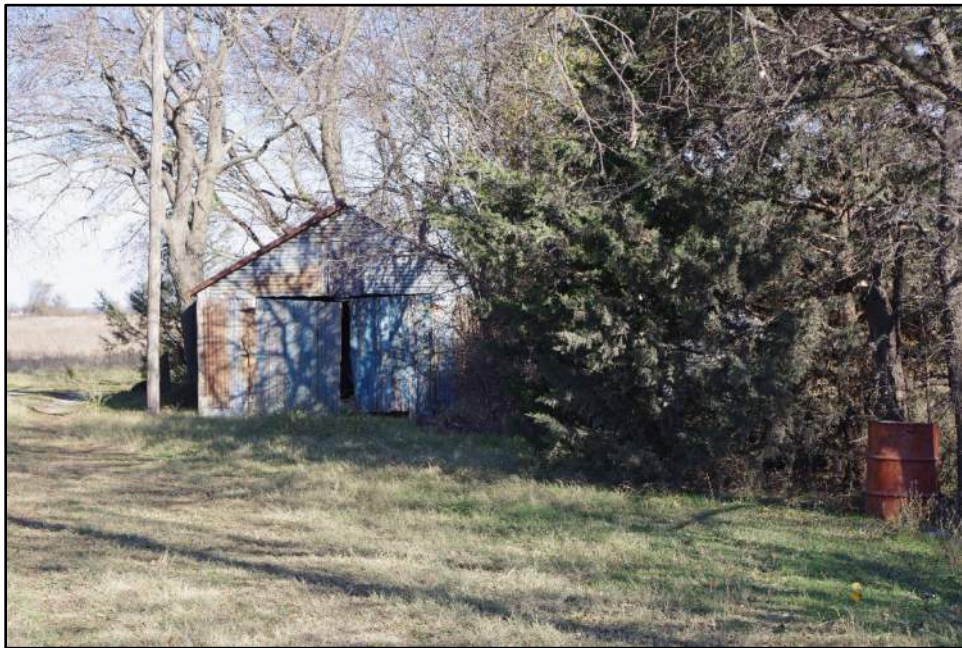
Photograph F-98: View of Resource 22j, camera facing north.

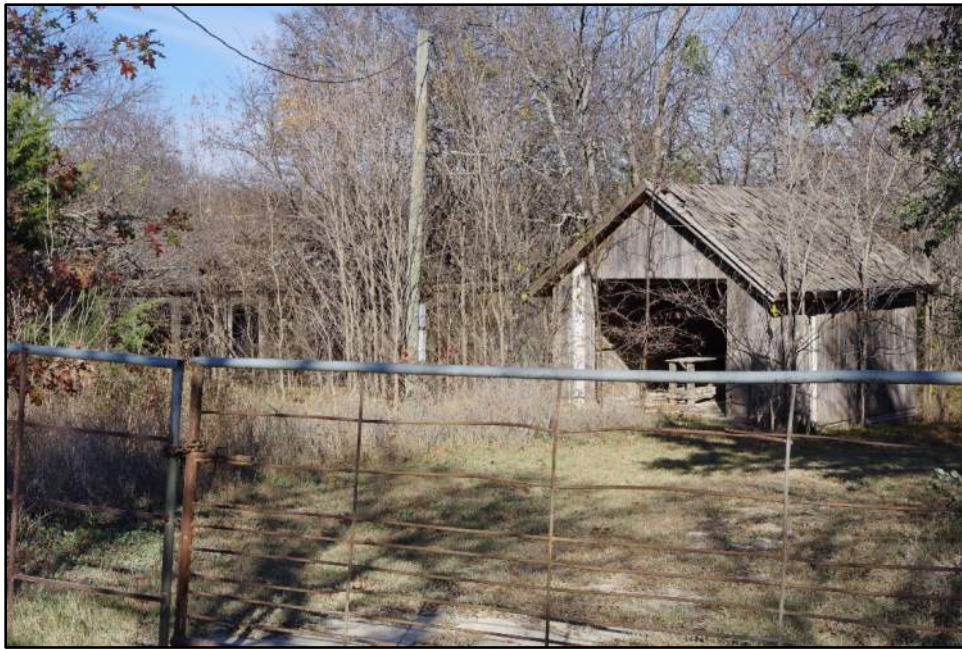
Photograph F-99: Overview of Resource 23, camera facing northwest.

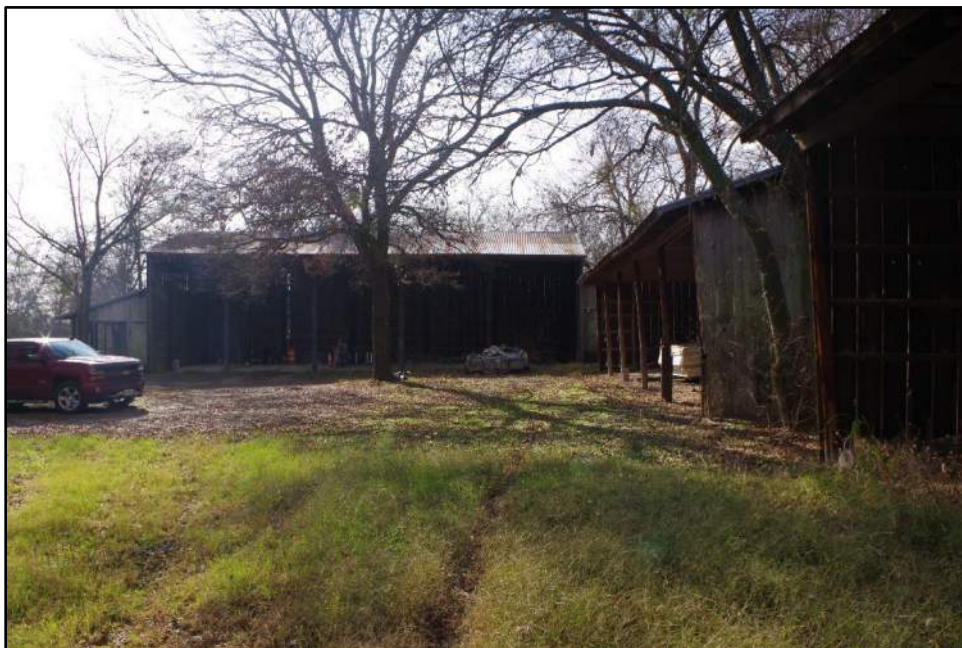
Photograph F-100: View of Resource 23, camera facing south.

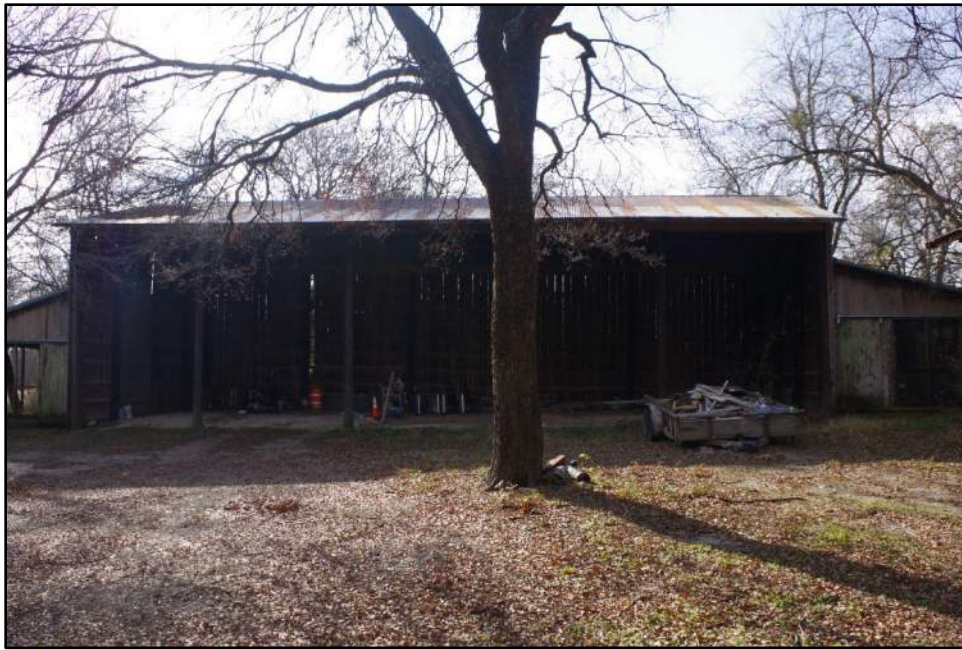
Photograph F-101: View of Resource 23a, camera facing south.

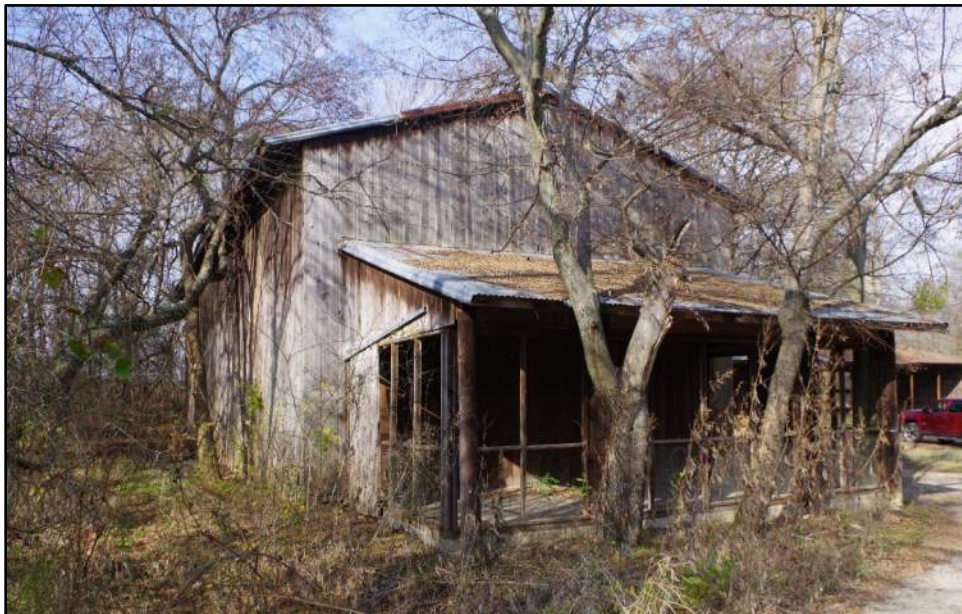
Photograph F-102: View of Resource 23a, camera facing northwest.

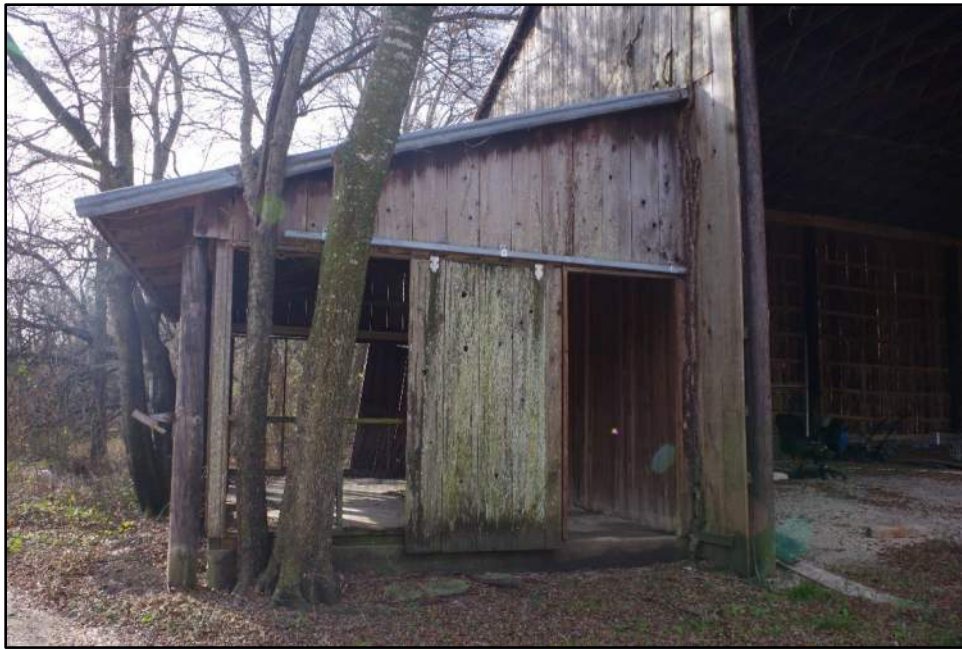
Photograph F-103: View of Resource 23a, camera facing south.

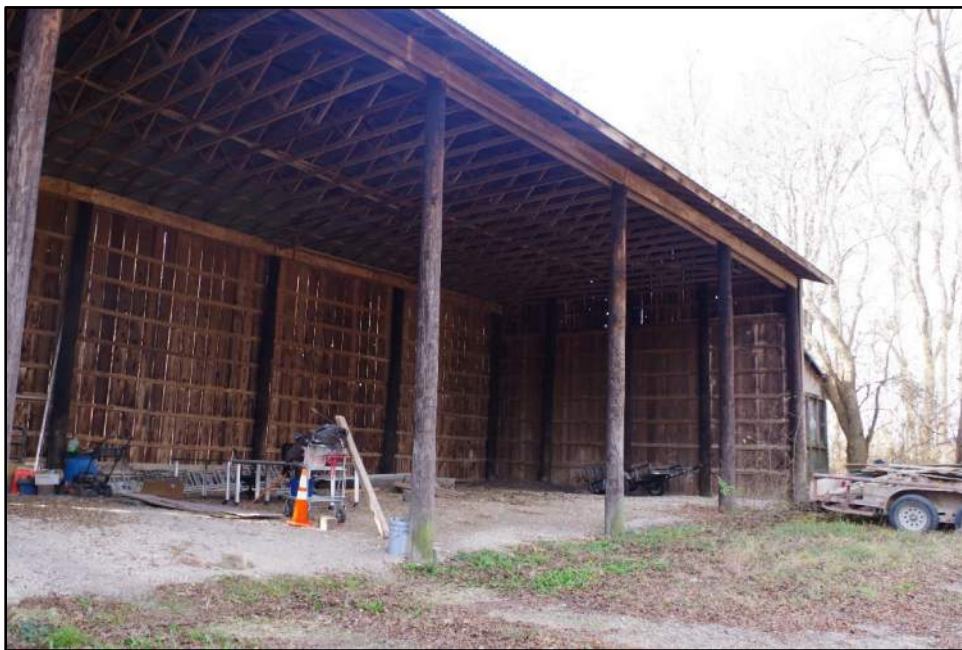
Photograph F-104: View of Resource 23a, camera facing southwest.

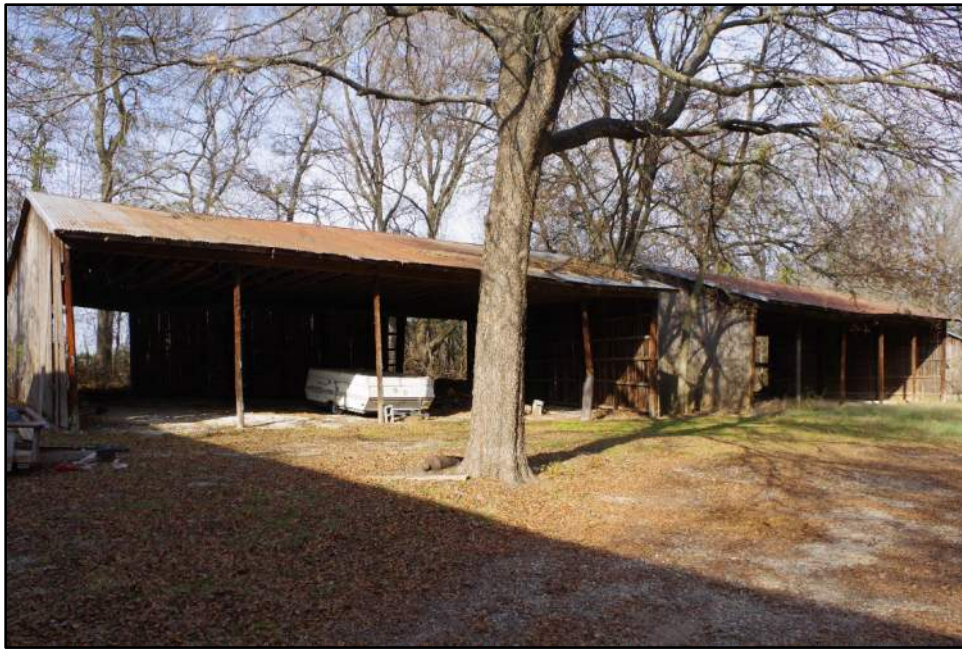
Photograph F-105: View of Resource 23b (left) and Resource 23c (right), camera facing northwest.

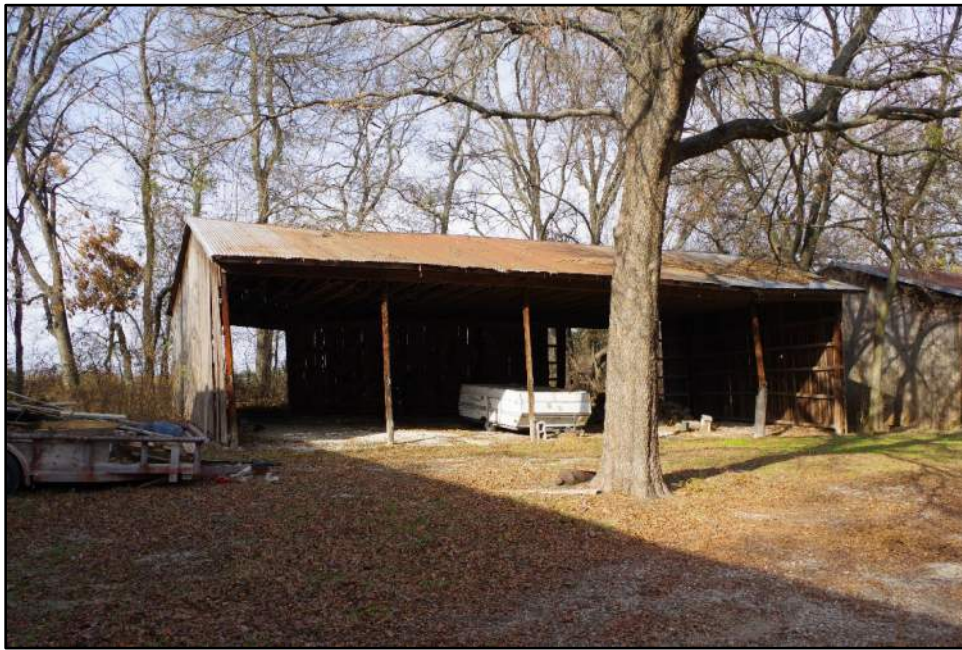
Photograph F-106: View of Resource 23b, camera facing northwest.

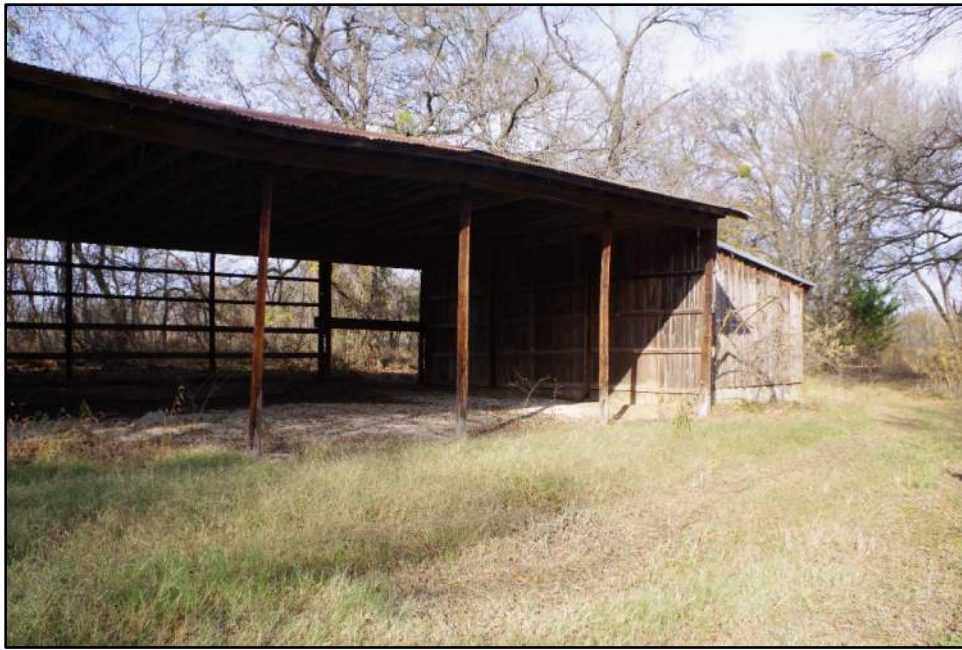
Photograph F-107: View of Resource 23c, camera facing north-northwest.

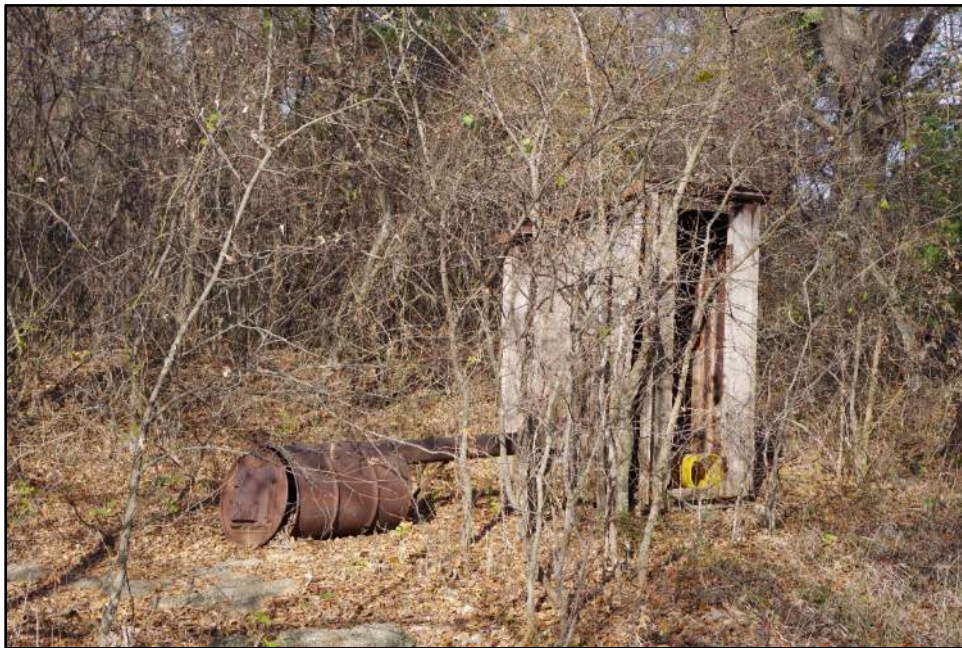
Photograph F-108: View of Resource 23d, camera facing north.

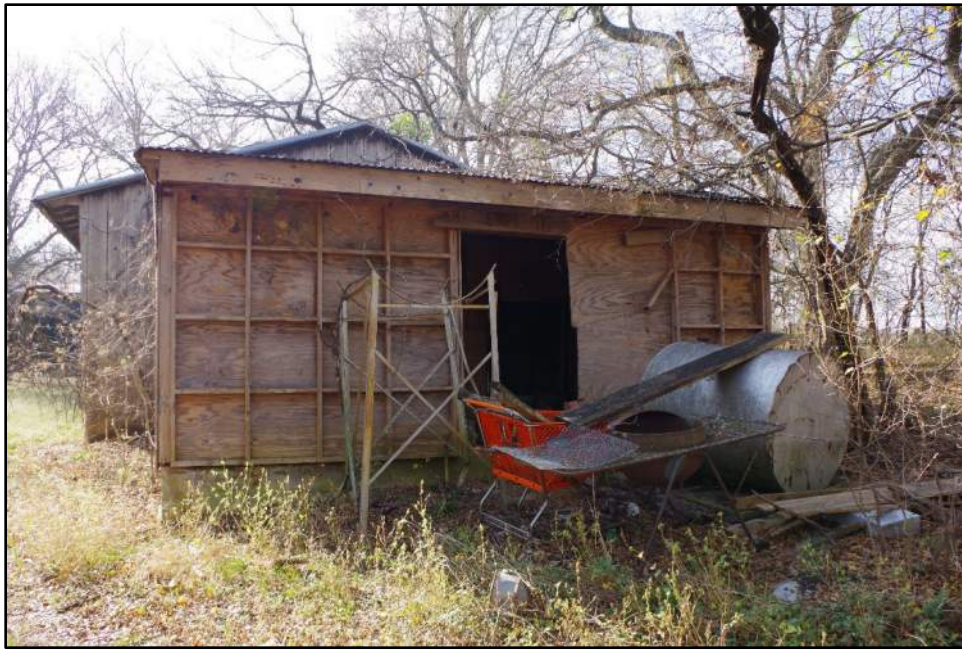
Photograph F-109: View of Resource 23e, camera facing south.

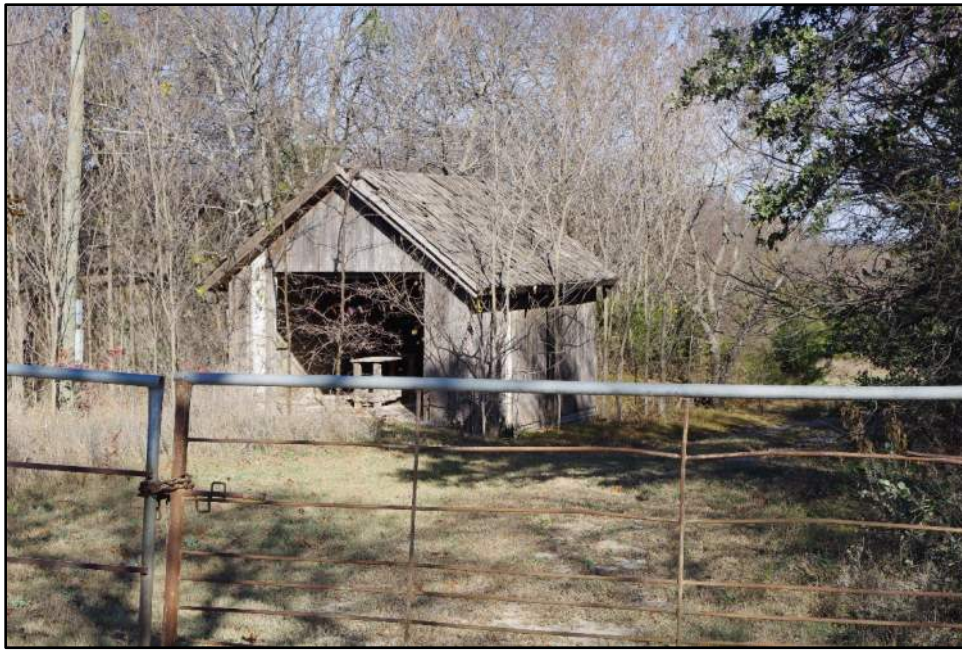
Photograph F-111: View of Resource 23g, camera facing northwest.
