APPENDIX L: Cultural Resources

APPENDIX L – CULTURAL RESOURCES – FEIS Preferred Alternative/Blue Alternative

US 380 MCKINNEY – Coit Road to FM 1827, Collin County CSJs 0135-02-065 and 0135-15-002; Dallas District

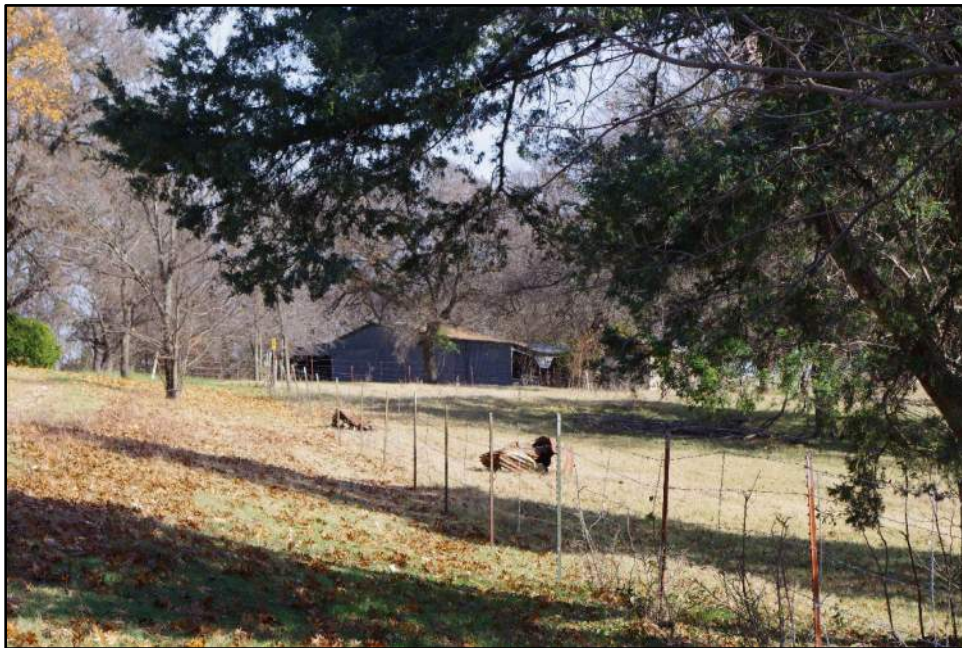
Photograph F-152: View of Resource 31c, camera facing northeast.

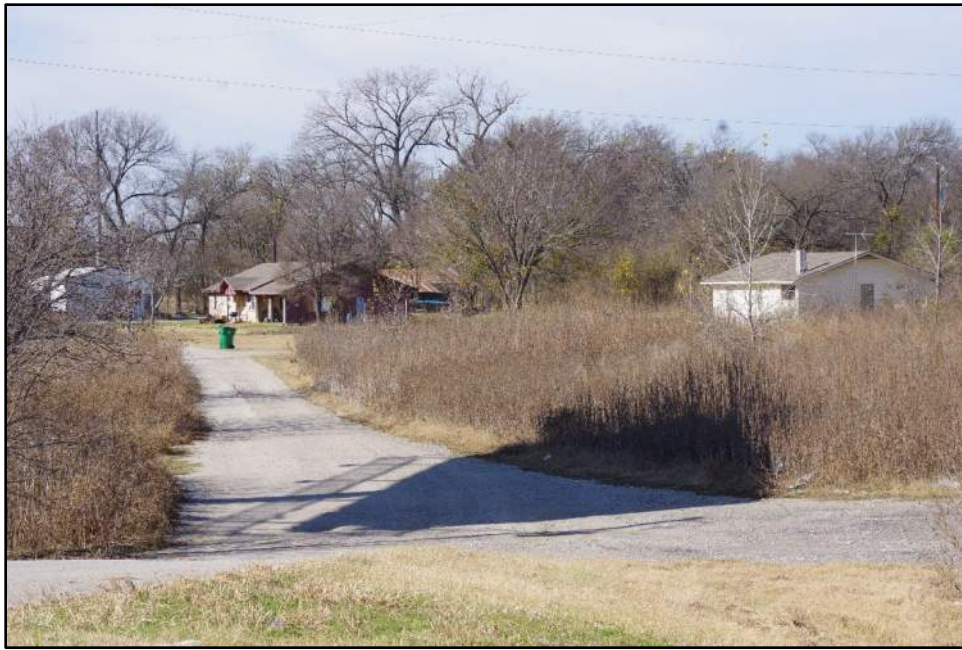
Photograph F-153: Overview of Resource 32, camera facing northwest.

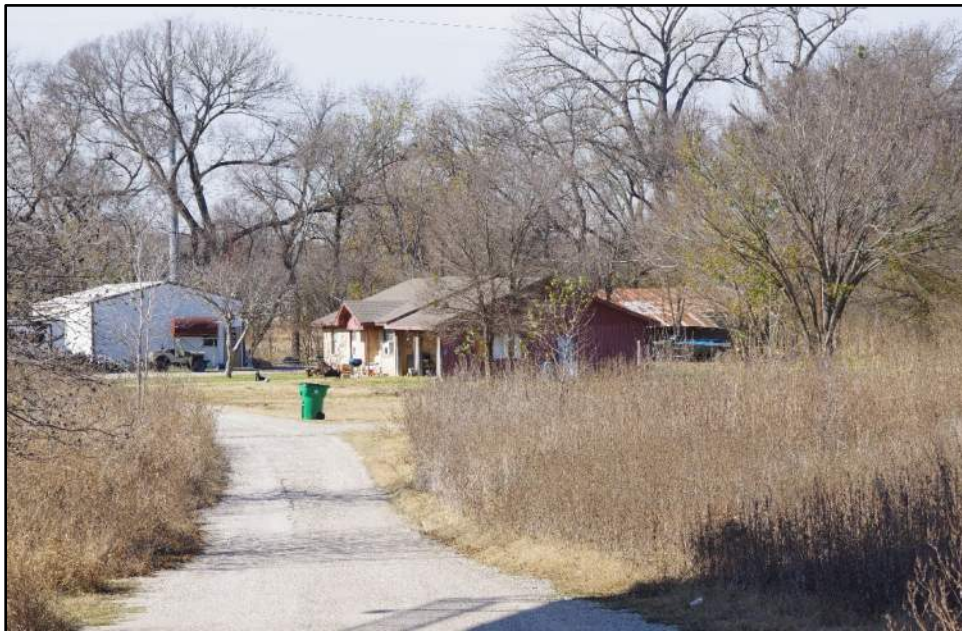
Photograph F-154: View of Resource 32a (center), Resource 32c (right, background), and non-historic-age outbuilding (left), camera facing northwest.

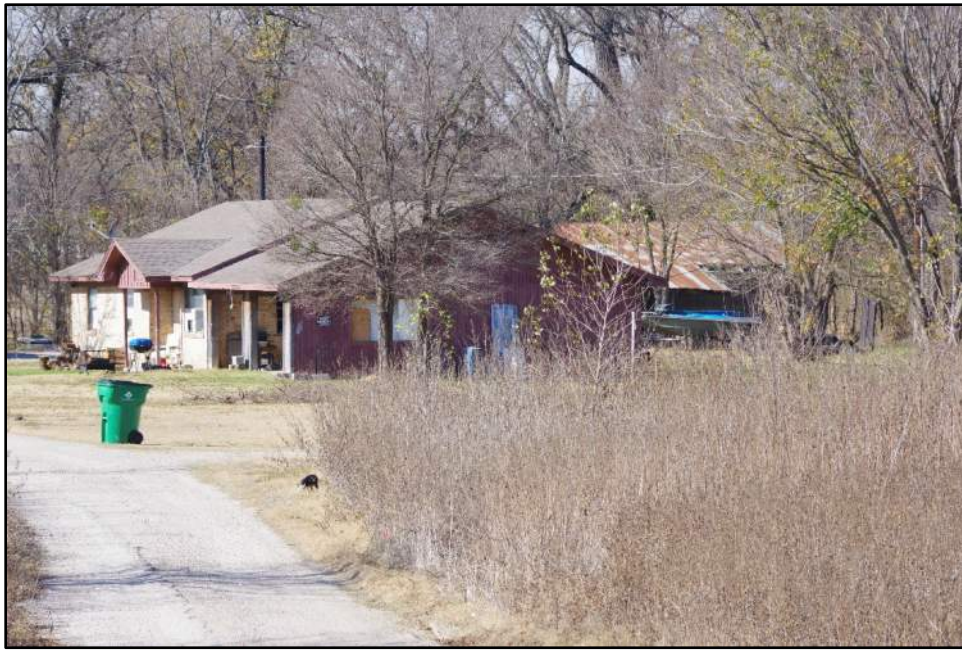
Photograph F-155: View of Resource 32a and Resource 32c (background), camera facing northwest.

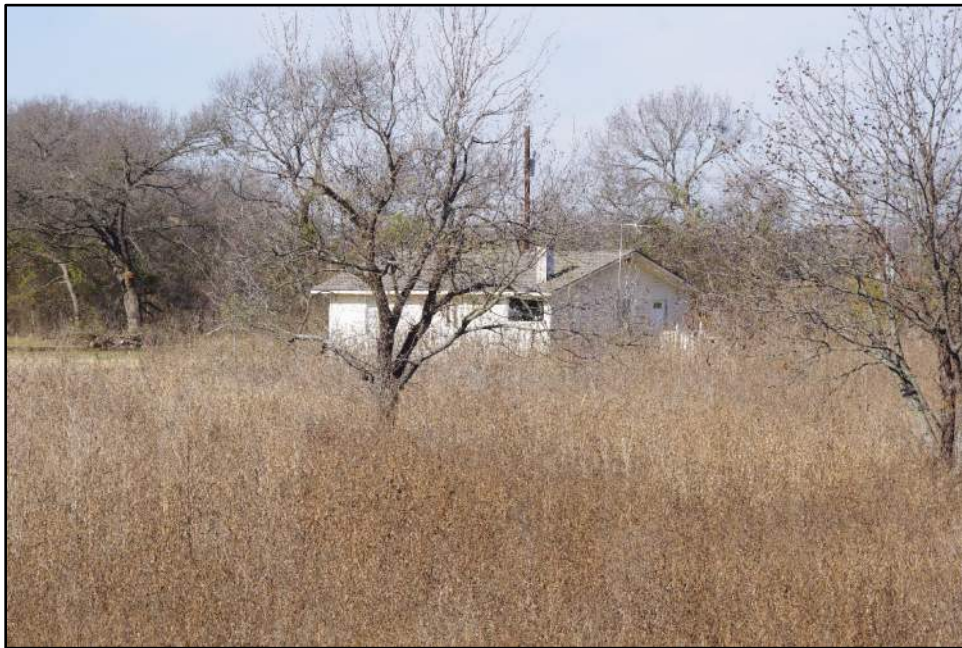
Photograph F-156: View of Resource 32b, camera facing northwest.

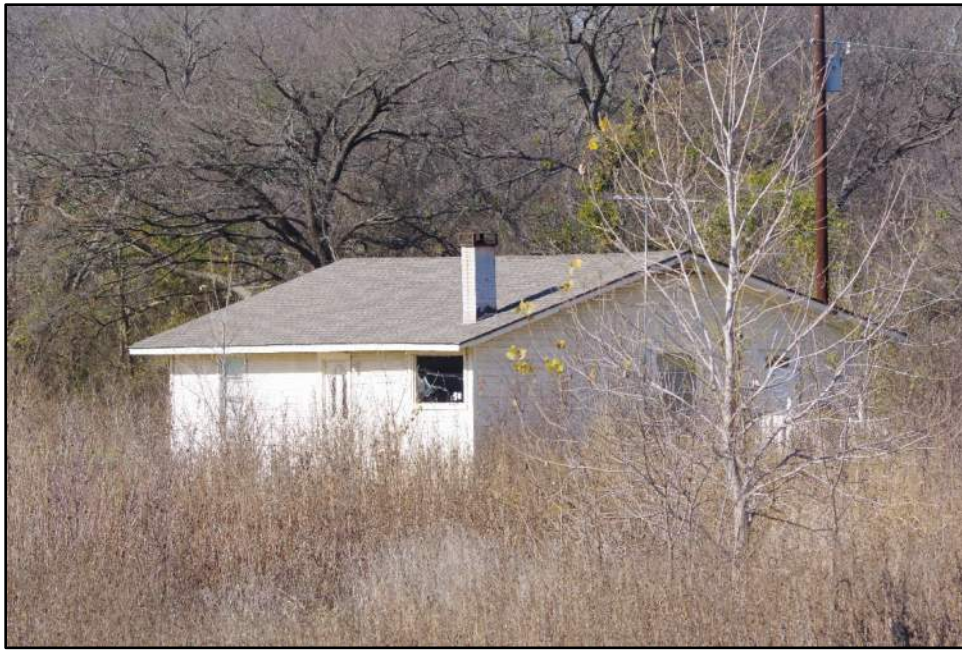
Photograph F-157: View of Resource 32b, camera facing northwest.

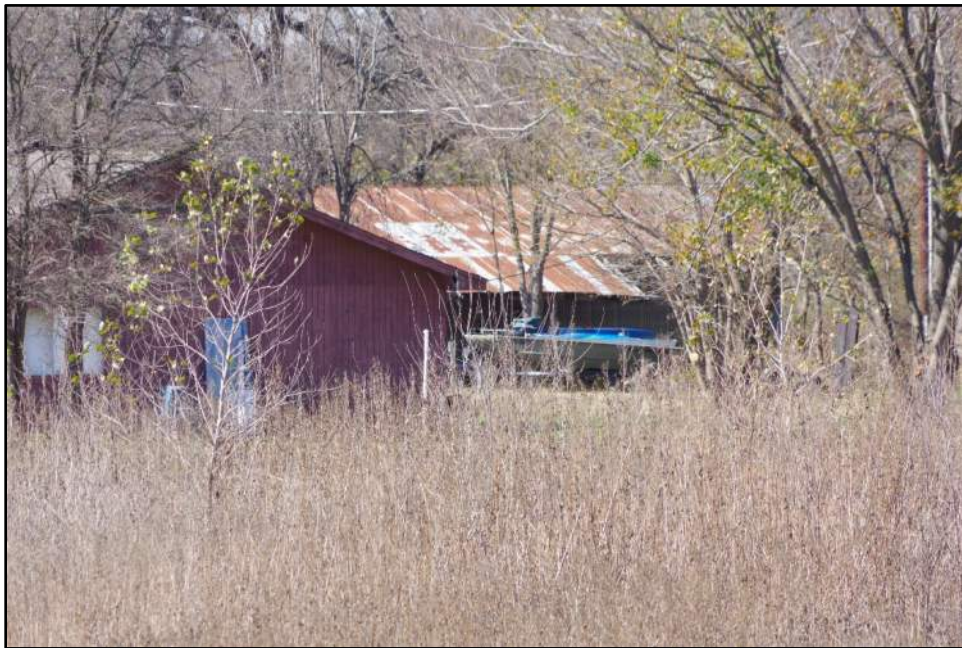
Photograph F-158: Obstructed view of Resource 32c, camera facing northwest.

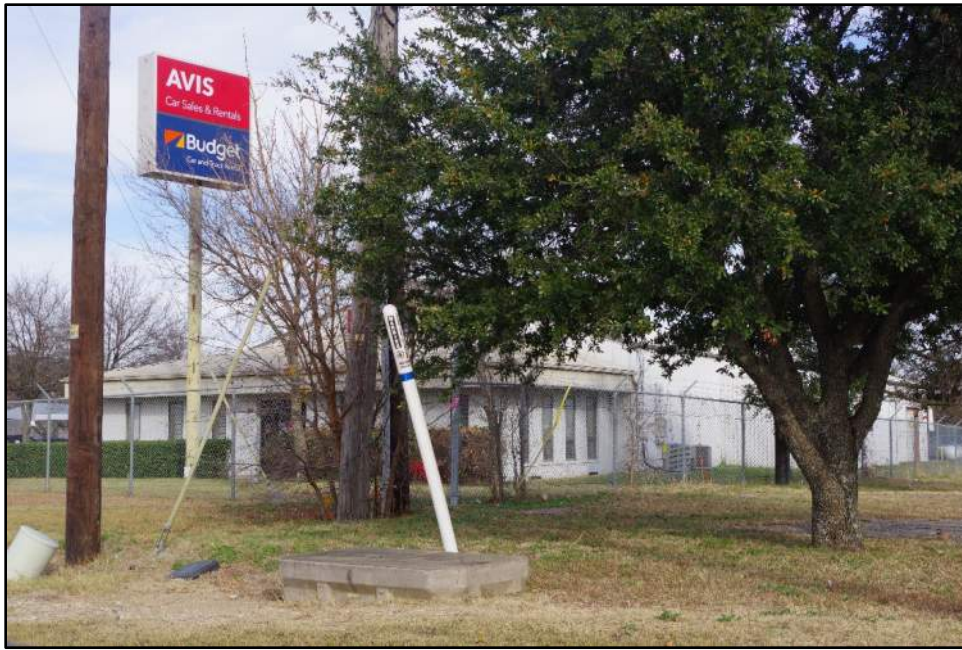
Photograph F-159: Obstructed view of Resource 33, camera facing northeast.

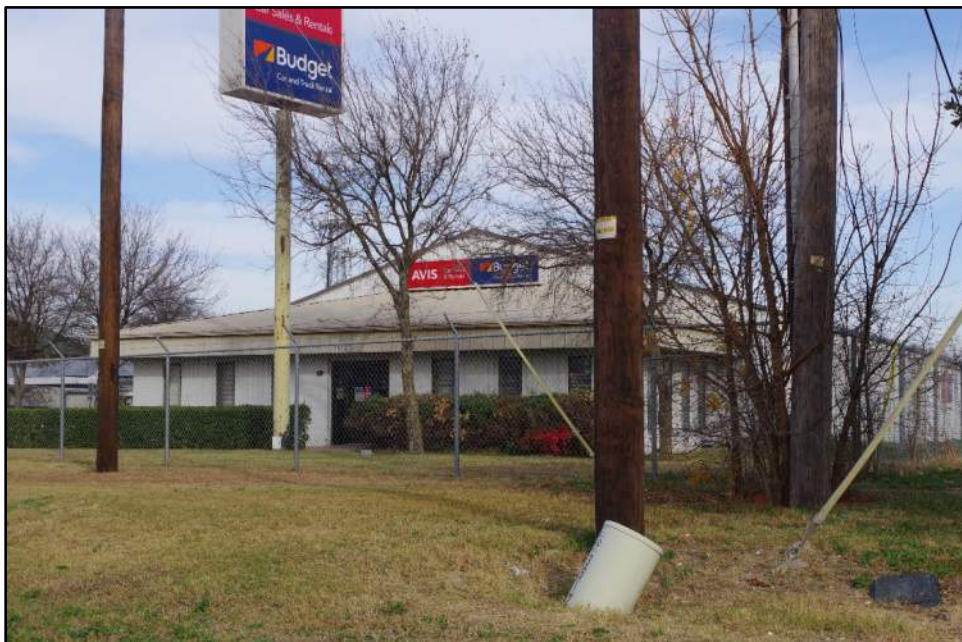
Photograph F-160: View of Resource 33, camera facing northeast.

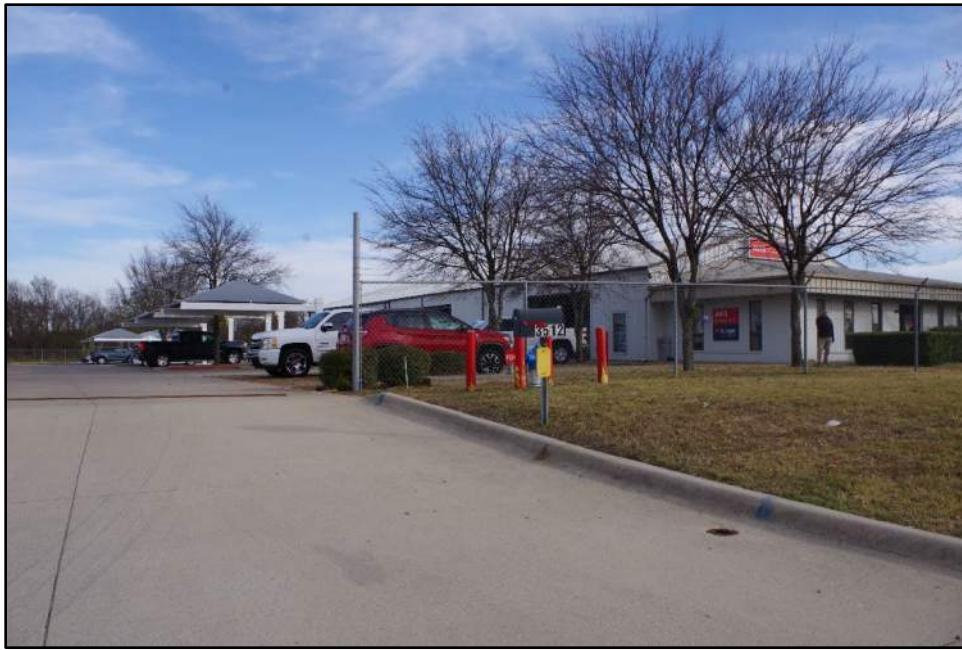
Photograph F-161: View of Resource 33, camera facing southeast.

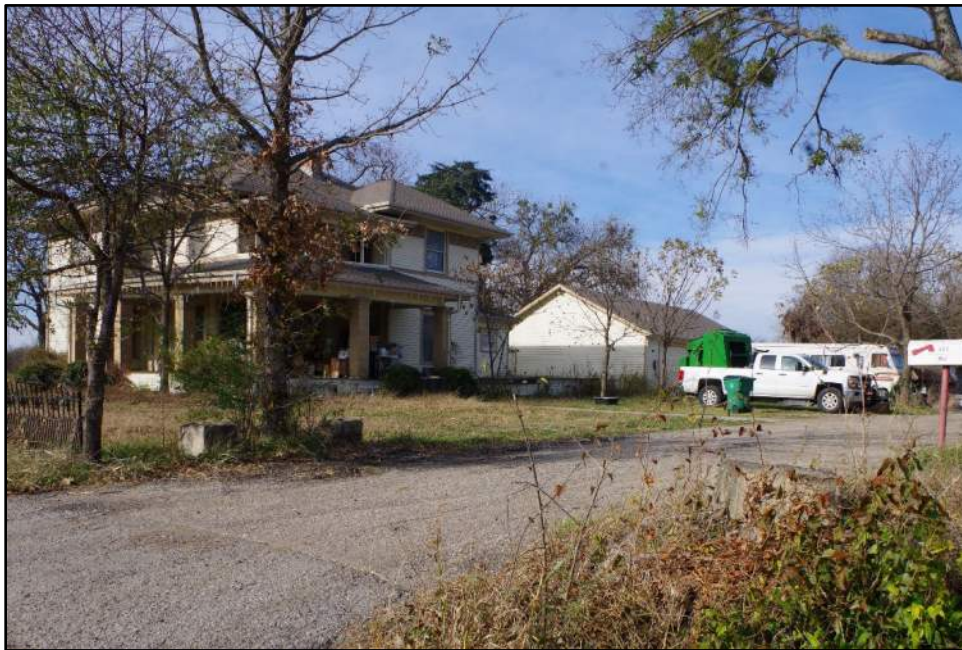
Photograph F-162: Overview of Resource 34, camera facing northwest.

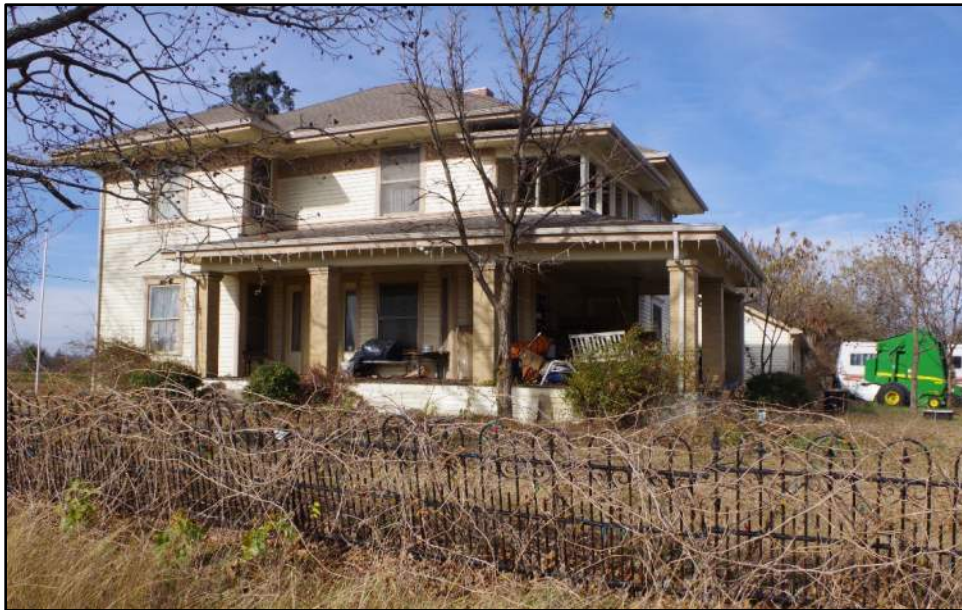
Photograph F-163: View of Resource 34a, camera facing north.

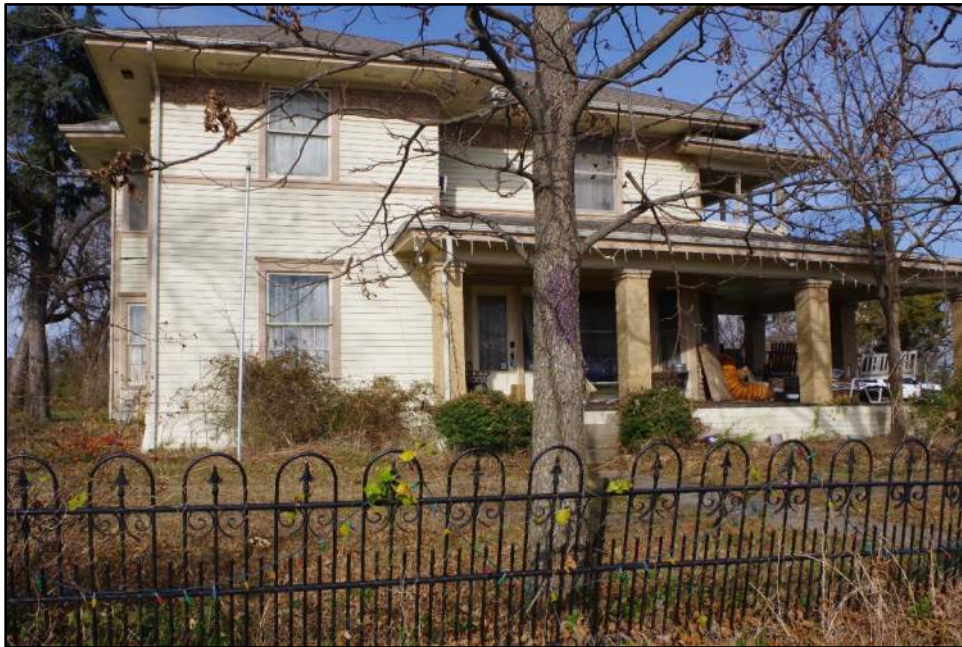
Photograph F-164: View of Resource 34a, camera facing north.

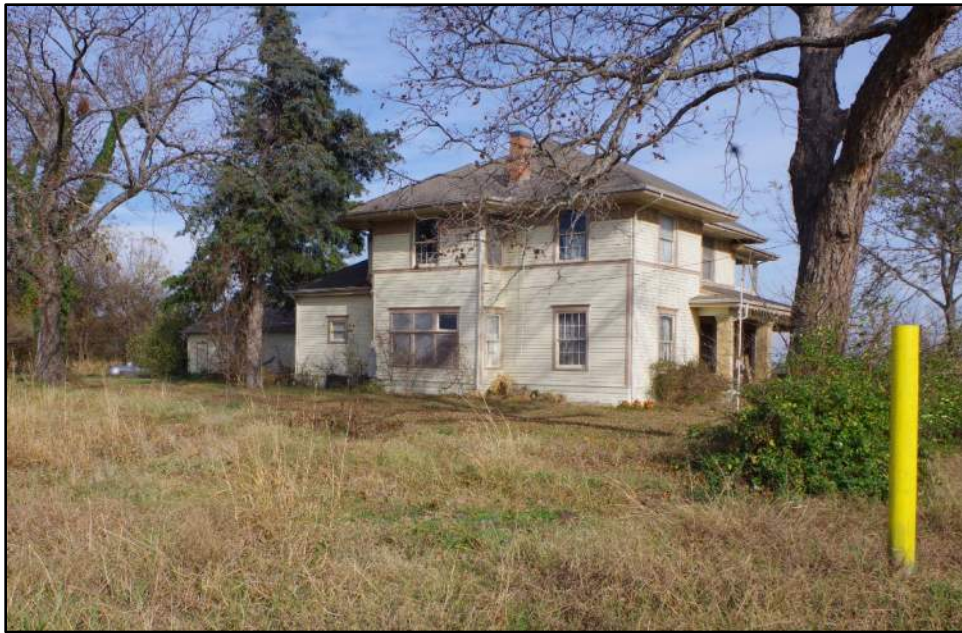
Photograph F-165: View of Resource 34a, camera facing northeast.

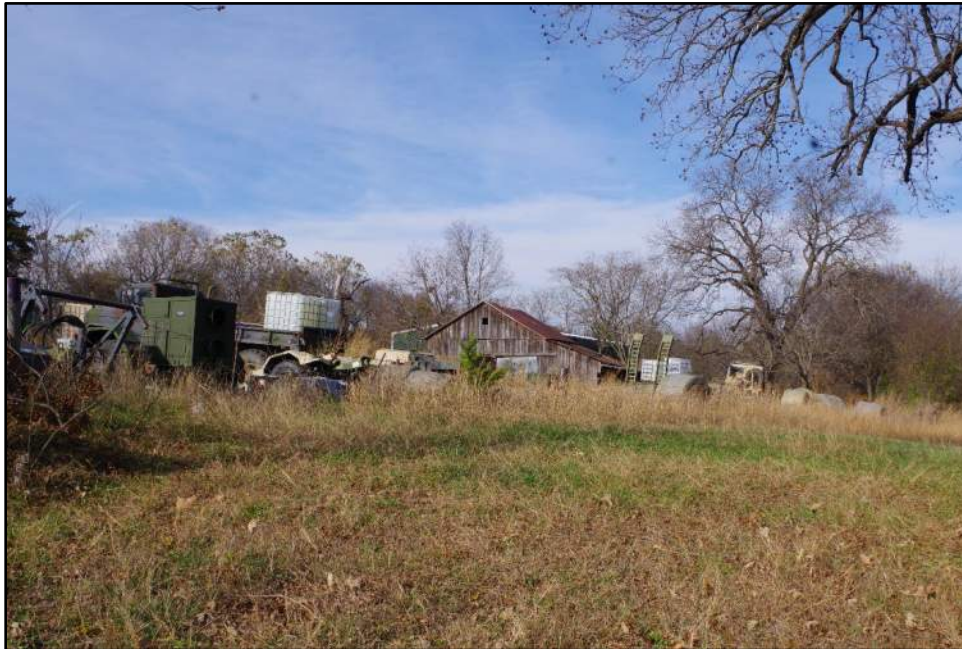
Photograph F-166: View of Resource 34b, camera facing north.

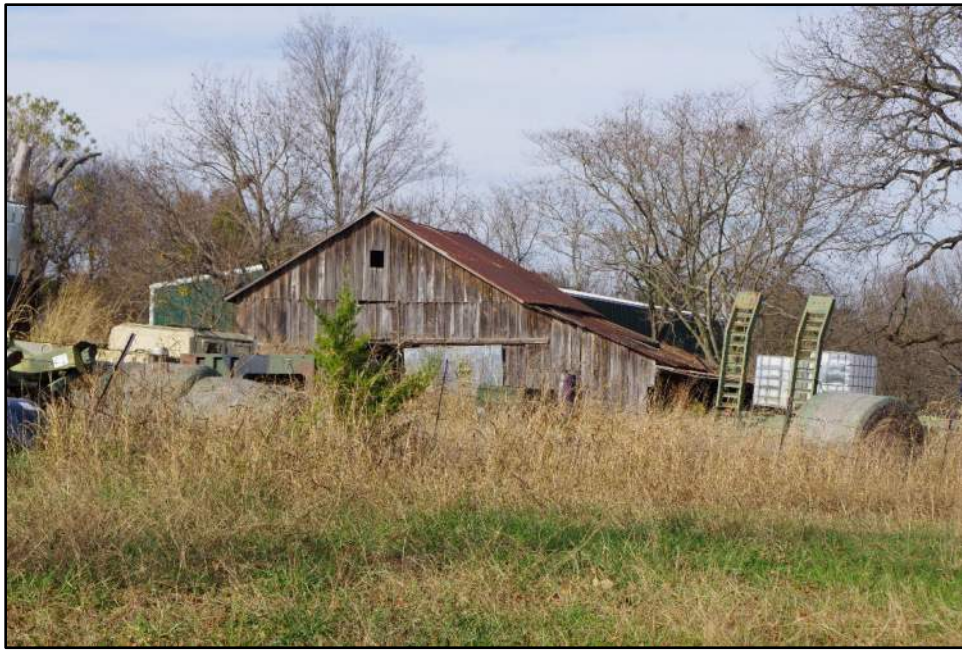
Photograph F-167: View of Resource 34b, camera facing north.

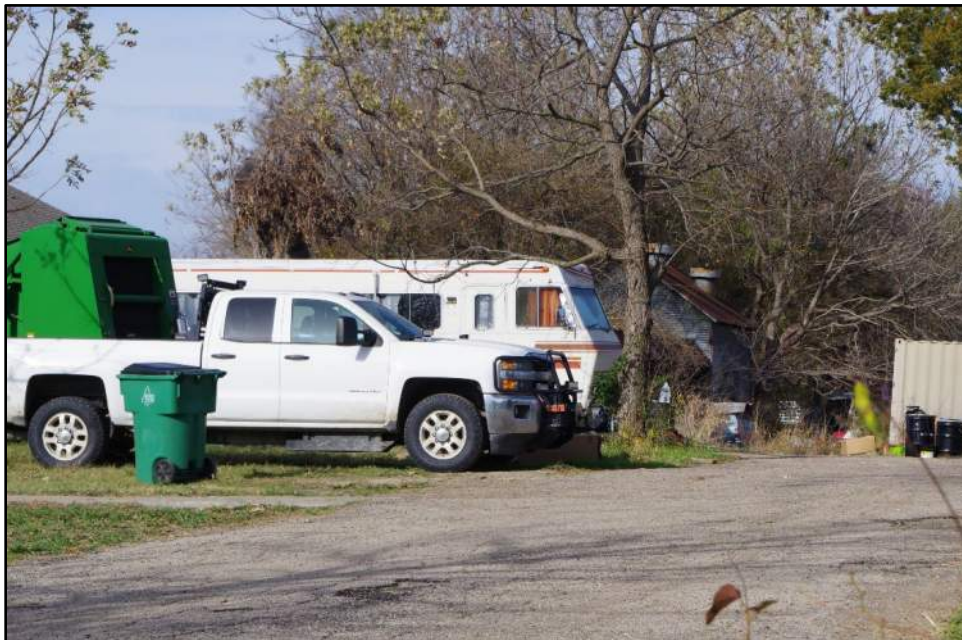
Photograph F-168: Obstructed view of Resource 34c, camera facing northwest.

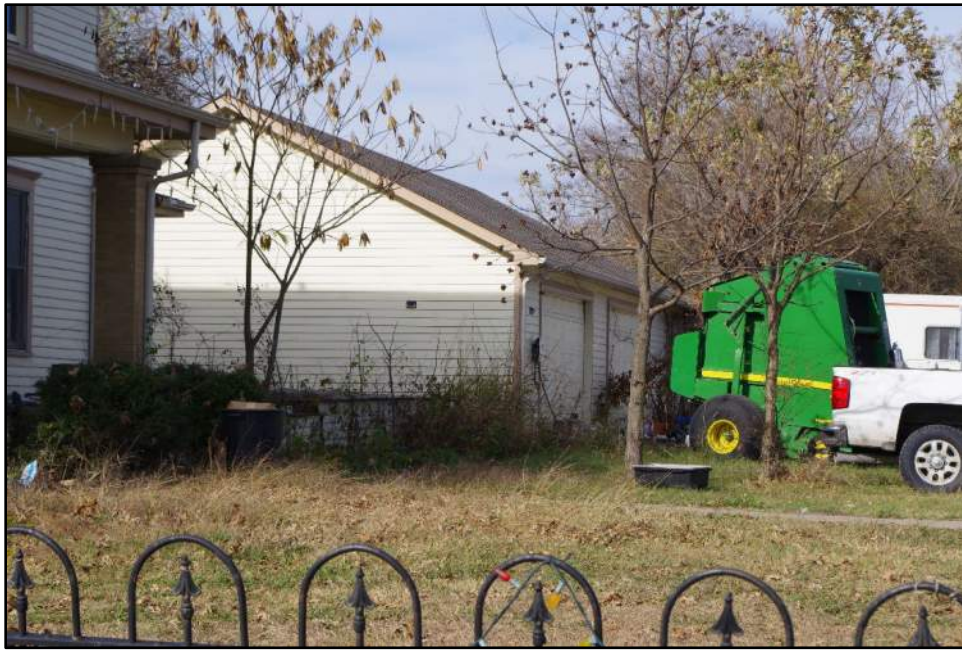
Photograph F-169: View of non-historic-age garage associated with Resource 34, camera facing north.

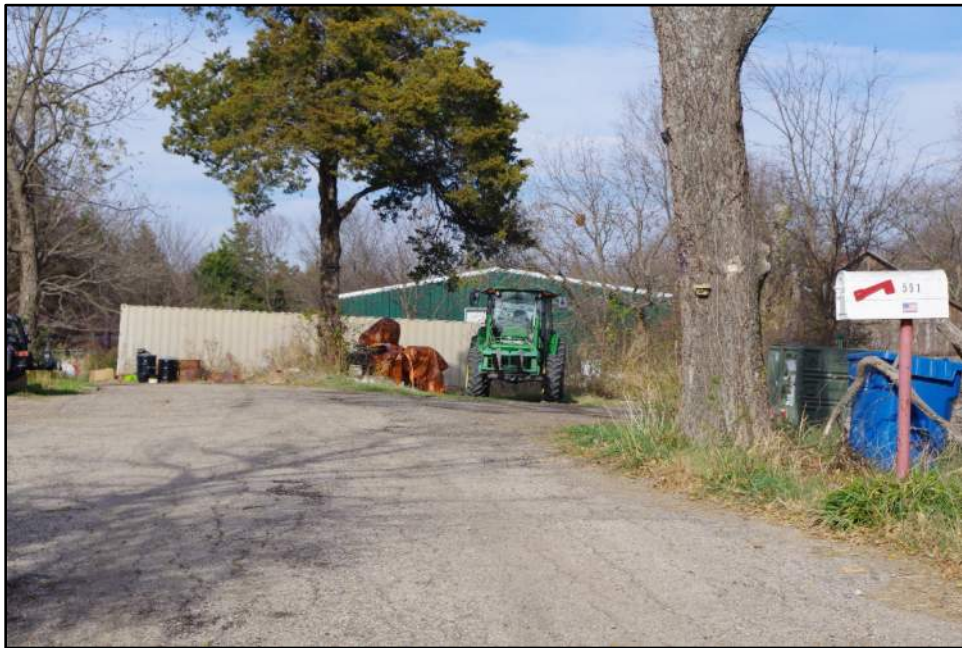
Photograph F-170: View of non-historic-age outbuilding associated with Resource 34, camera facing north.

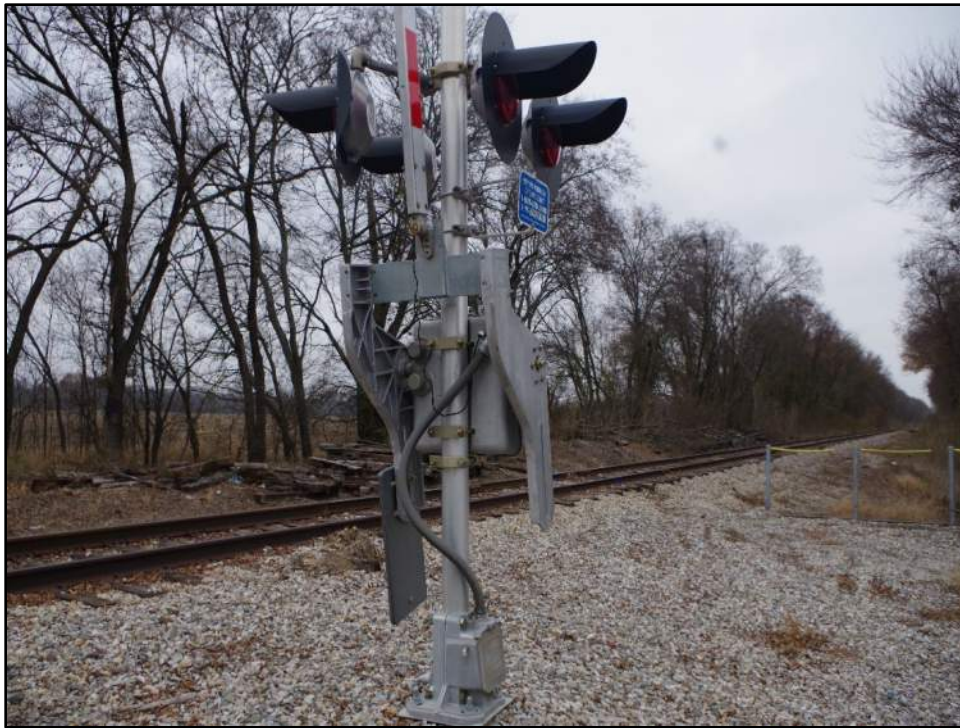
Photograph F-171: View of Resource 35a, camera facing north.

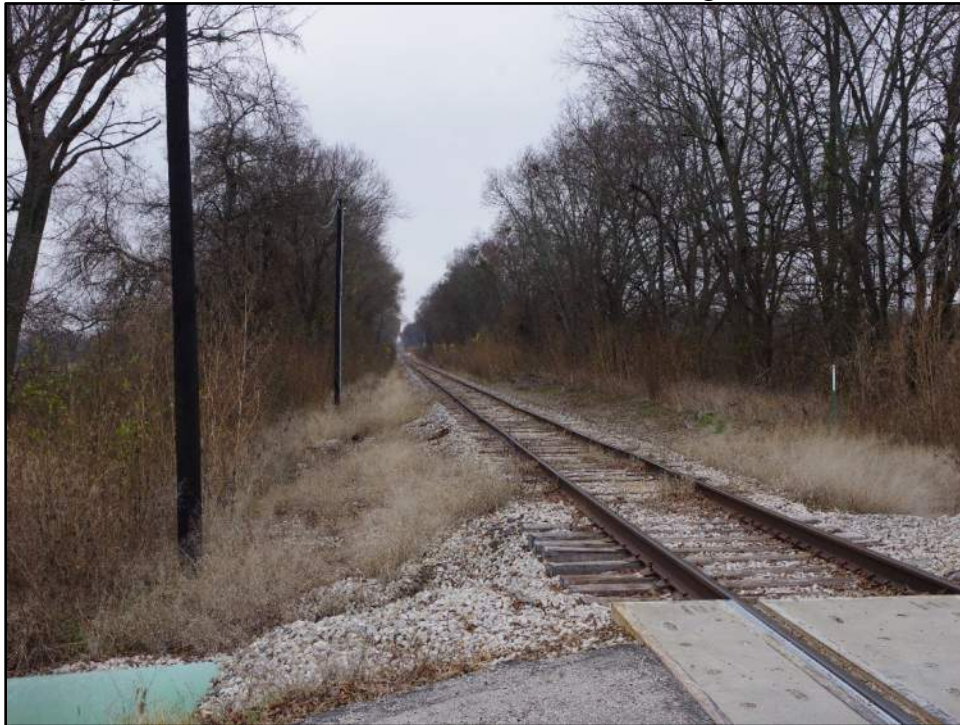
Photograph F-172: View of Resource 35a, camera facing south.

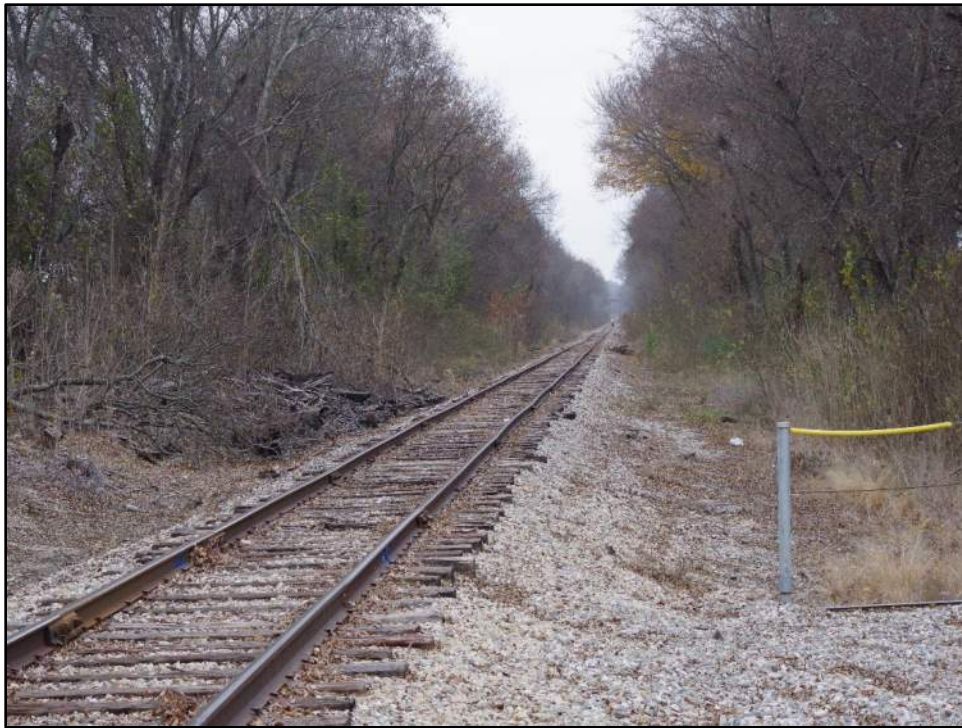
Photograph F-173: View of Resource 35a, camera facing north.

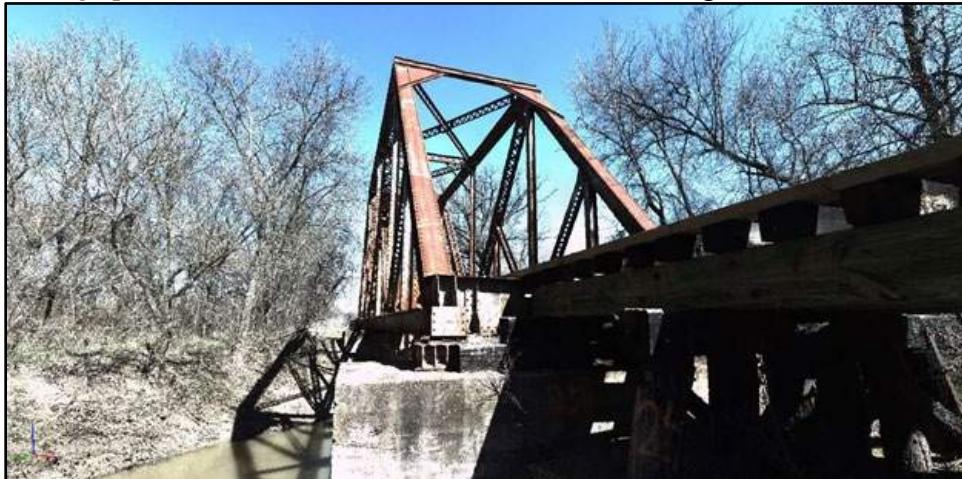
Photograph F-174: View of Resource 35b, camera facing north.

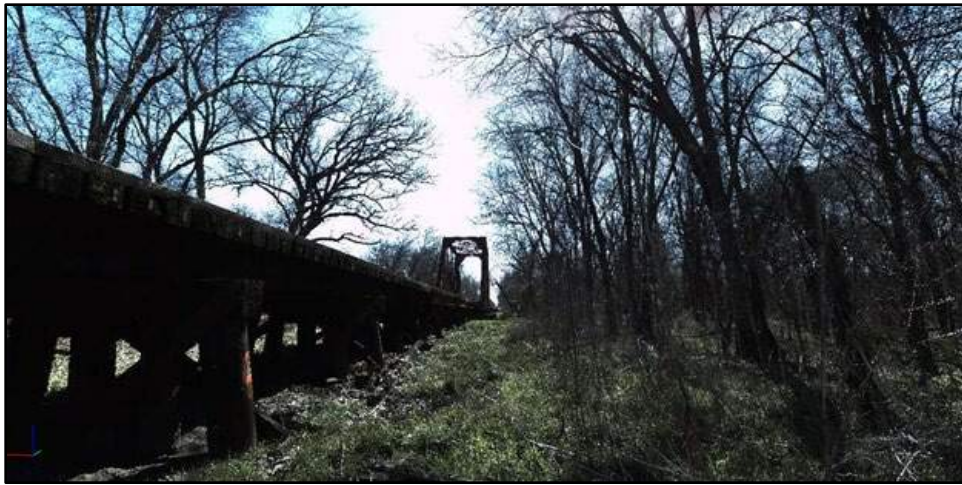
Photograph F-175: View of Resource 35b, camera facing south.

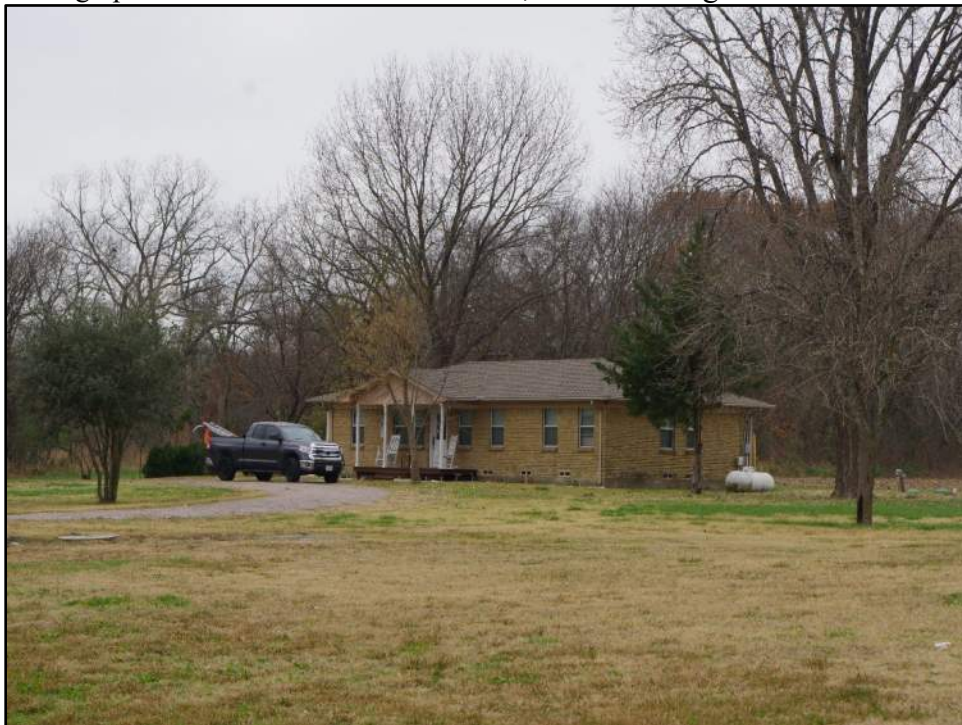
Photograph F-176: View of Resource 36, camera facing northwest.

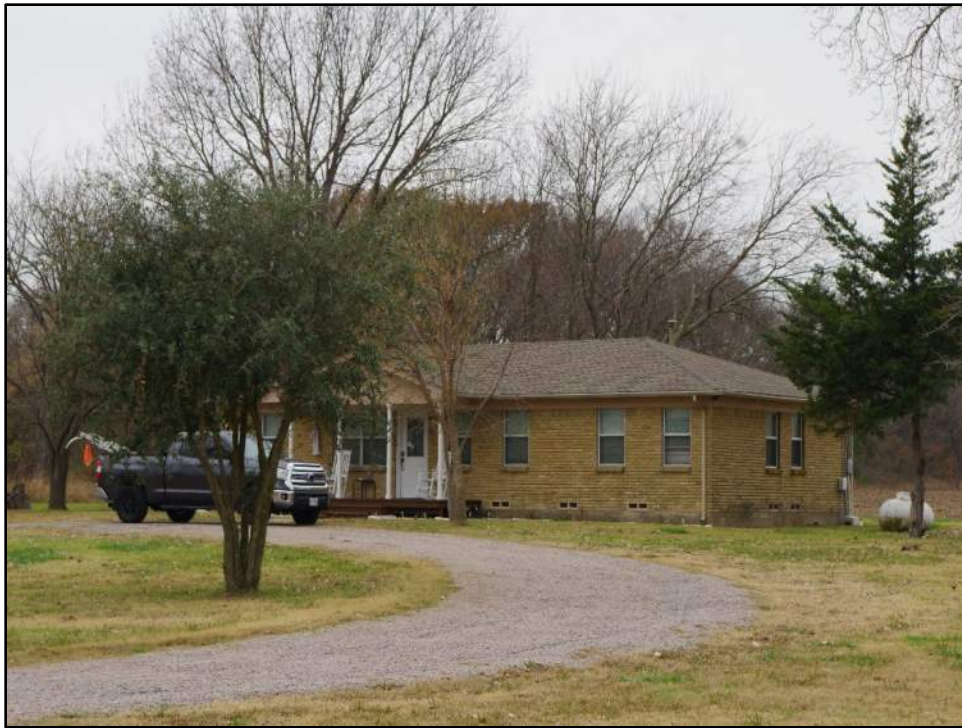
Photograph F-177: View of Resource 36, camera facing northwest.

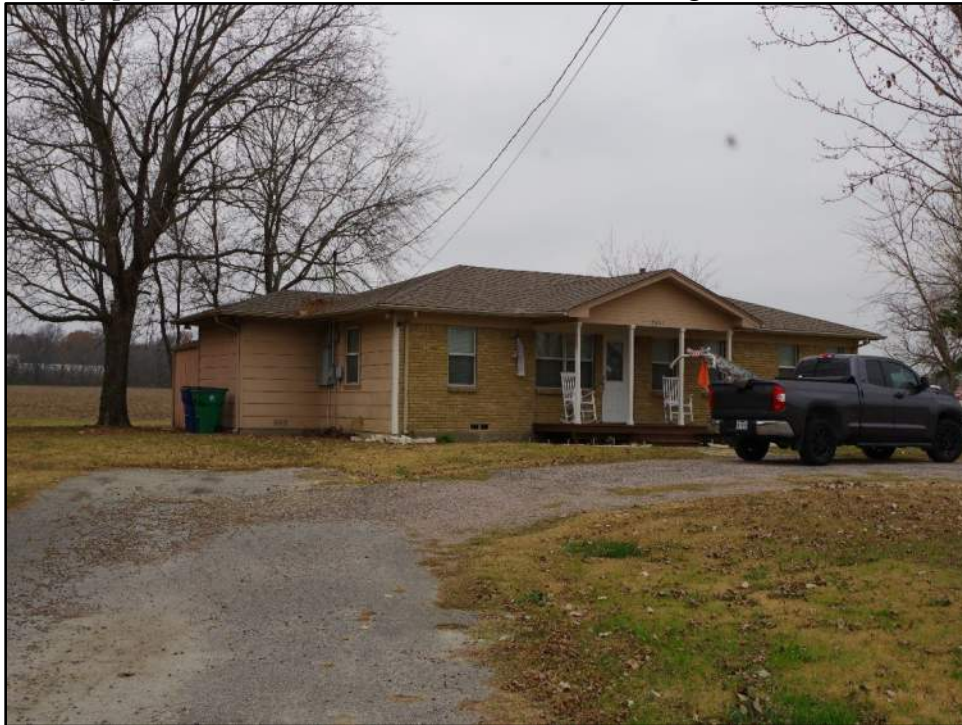
Photograph F-178: View of Resource 36, camera facing northeast.

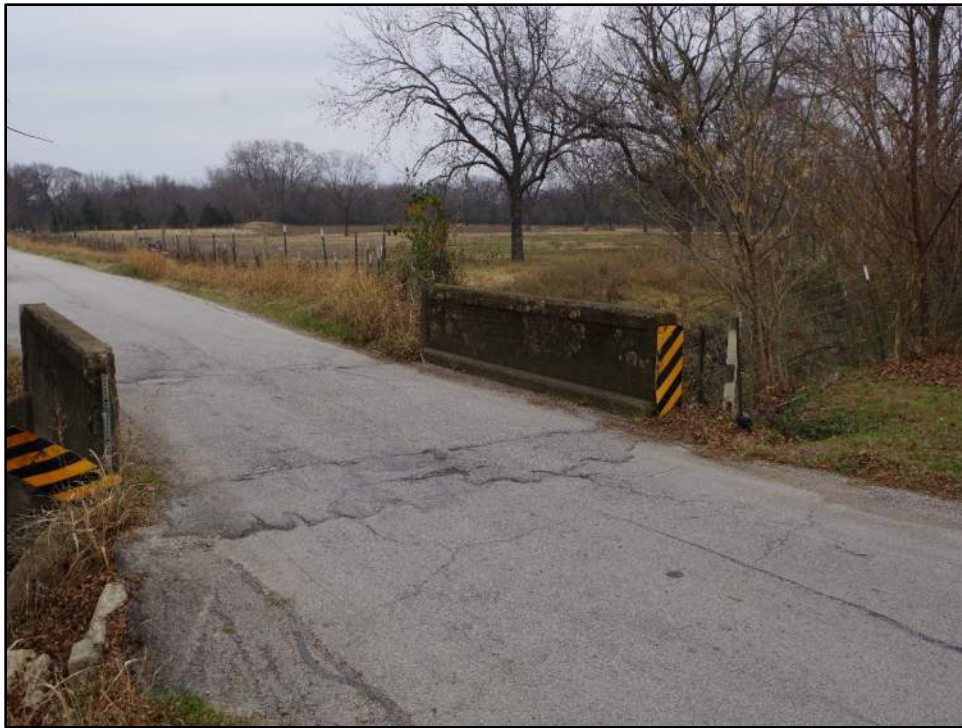
Photograph F-179: View of Resource 37, camera facing southwest.

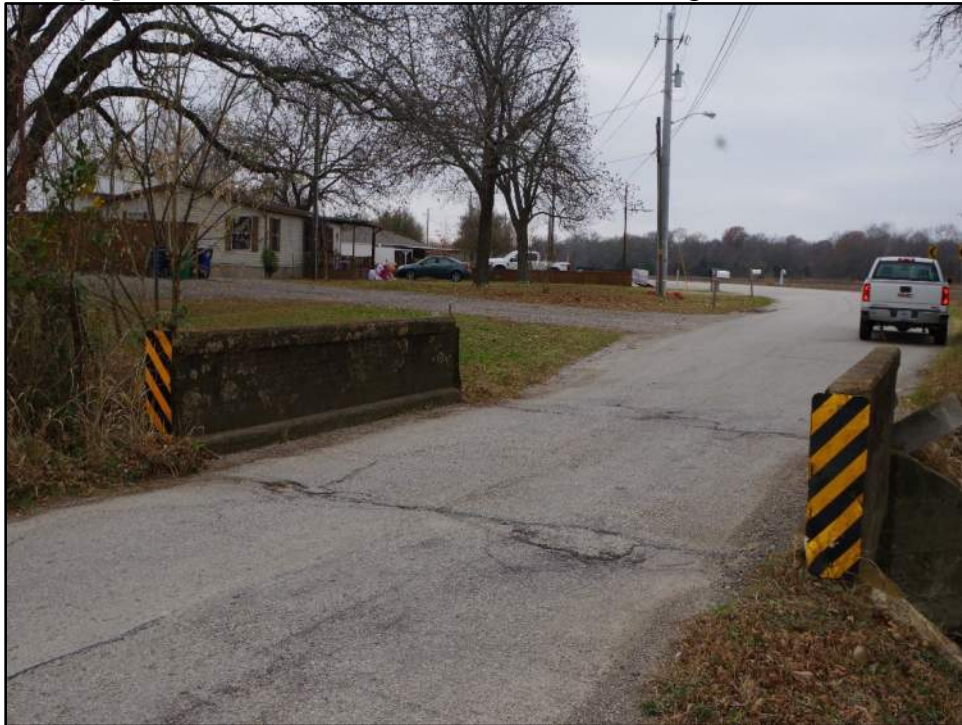
Photograph F-180: View of Resource 37, camera facing southeast.

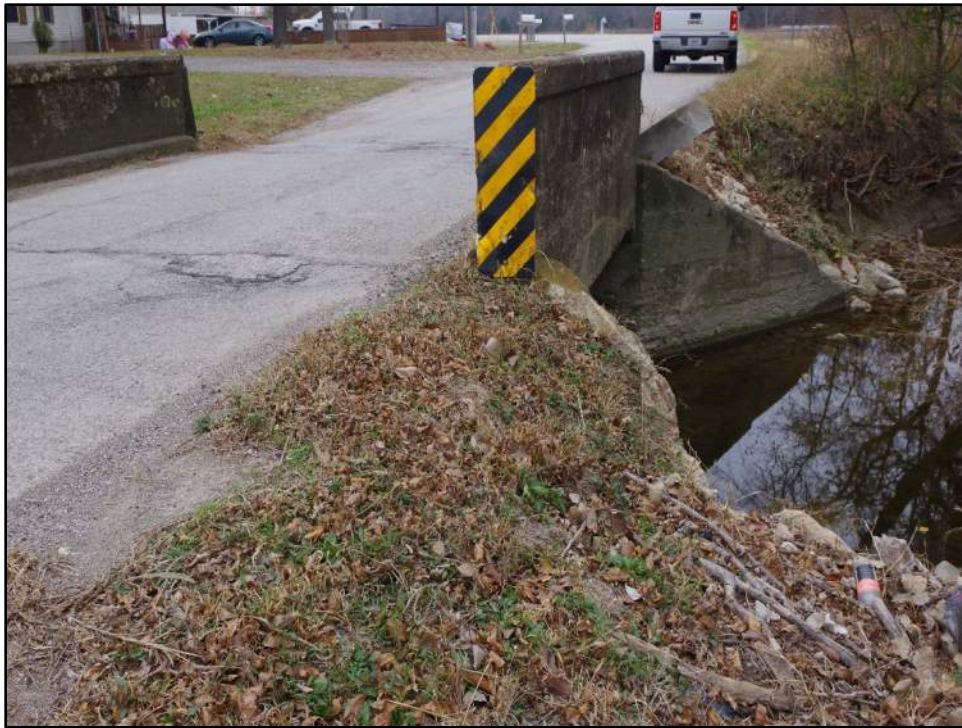
Photograph F-181: View of Resource 37, camera facing southeast.

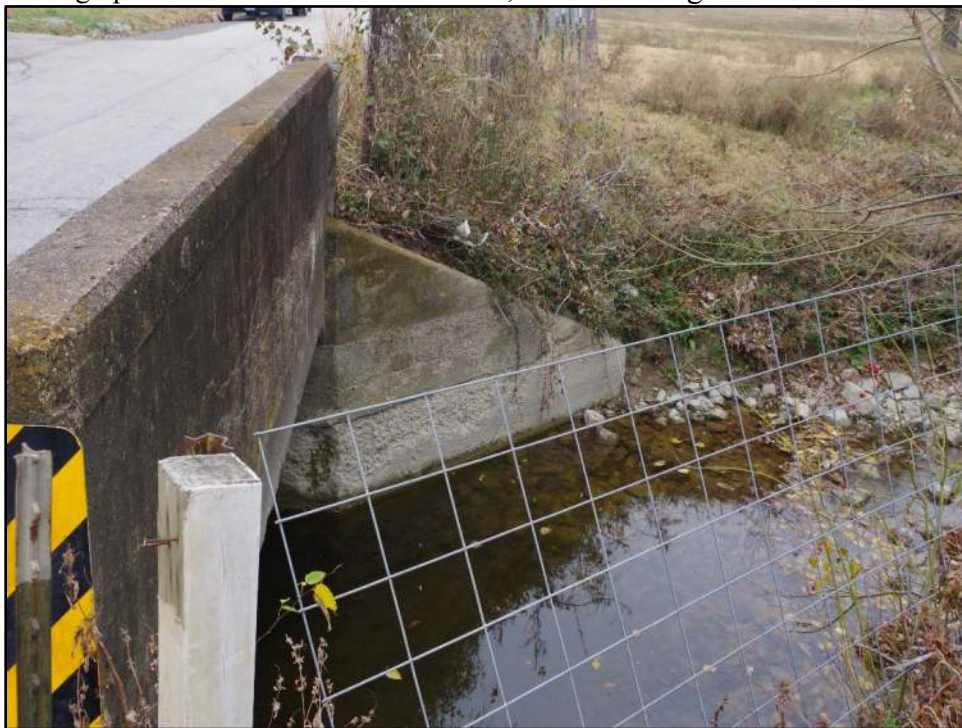
Photograph F-182: View of Resource 37, camera facing southeast.

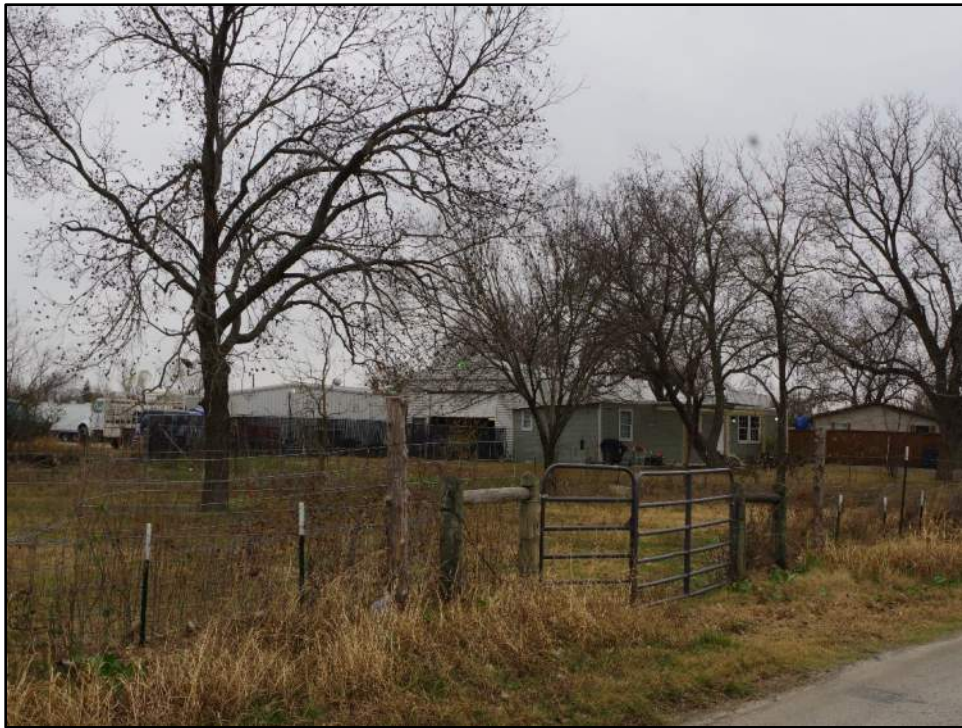
Photograph F-183: Overview of Resource 38, camera facing southeast.

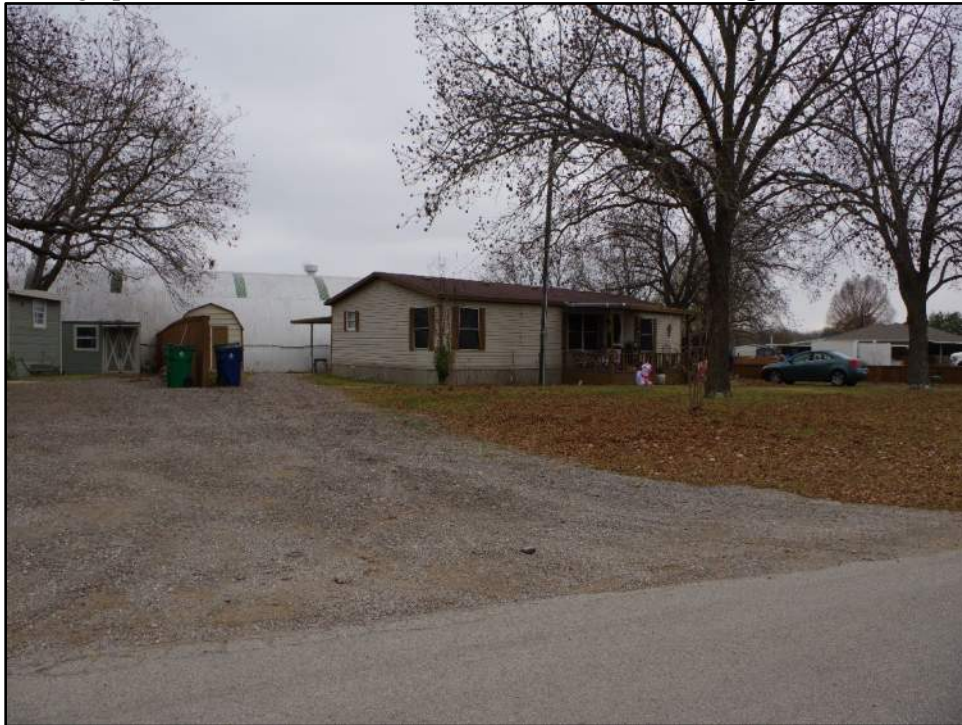
Photograph F-184: View of Resource 38a, camera facing east.

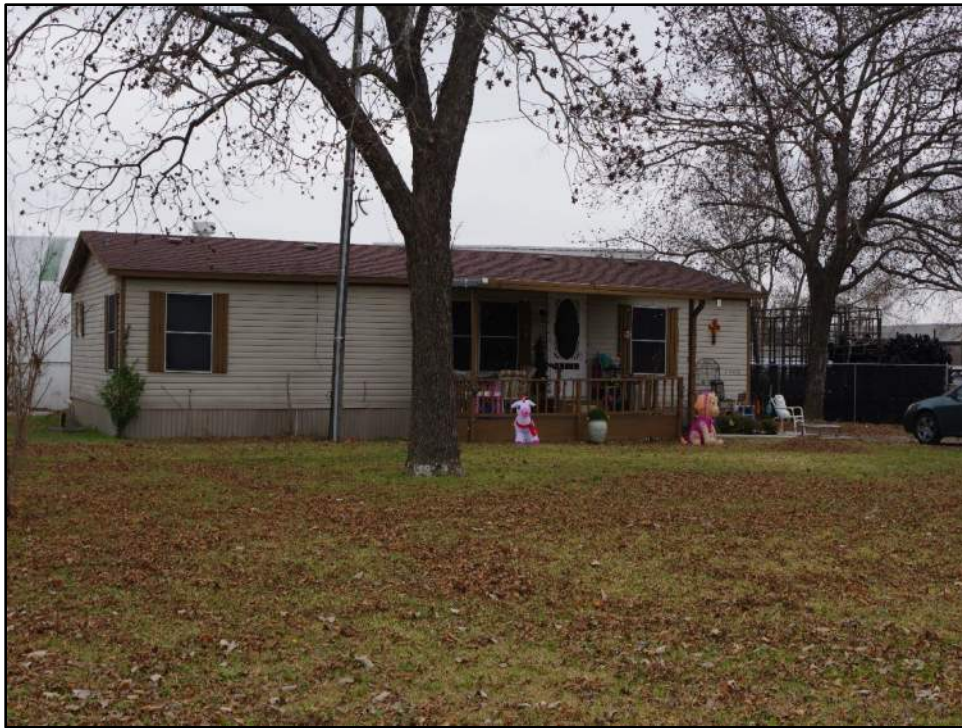
Photograph F-185: View of Resource 38a, camera facing east.

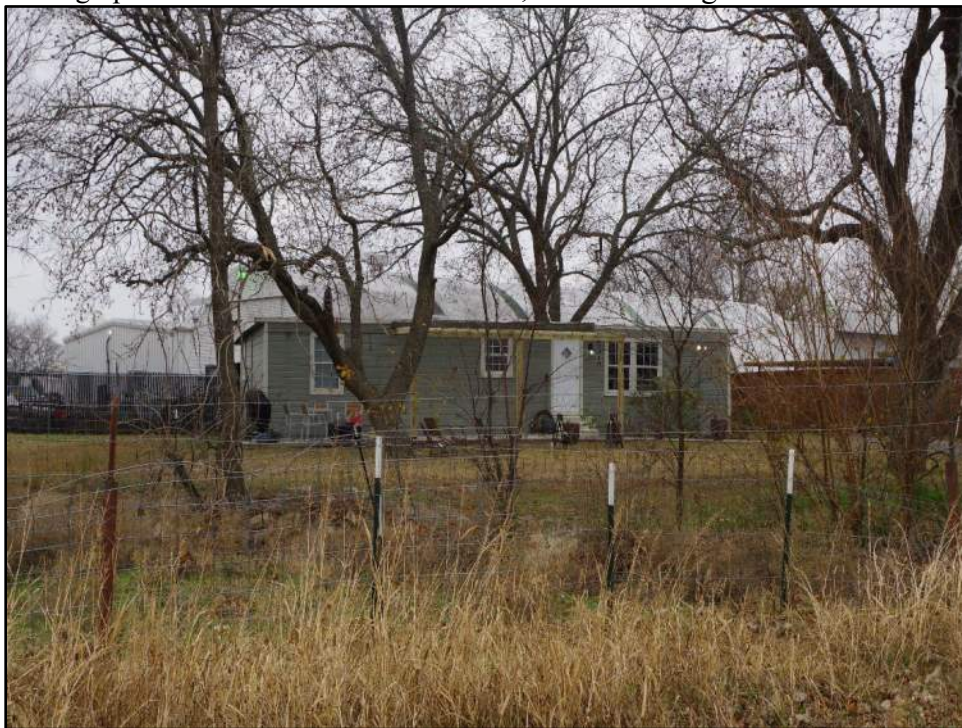
Photograph F-186: View of Resource 38b, camera facing southeast.
