APPENDIX L: Cultural Resources

APPENDIX L – CULTURAL RESOURCES – FEIS Preferred Alternative/Blue Alternative

US 380 MCKINNEY – Coit Road to FM 1827, Collin County CSJs 0135-02-065 and 0135-15-002; Dallas District

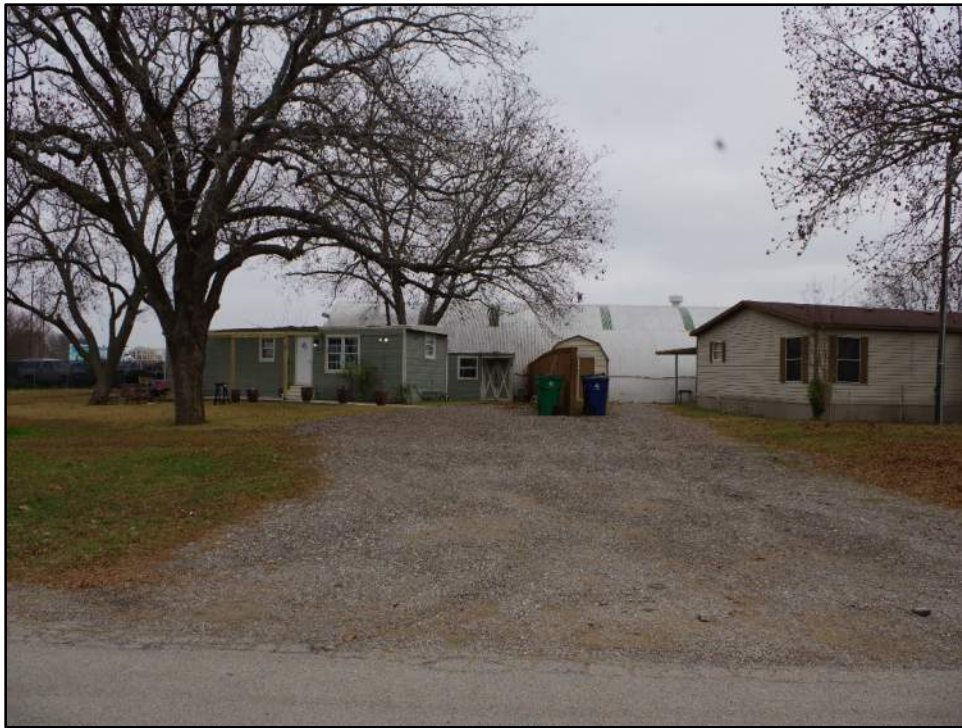
Photograph F-187: View of Resource 38b, camera facing east.

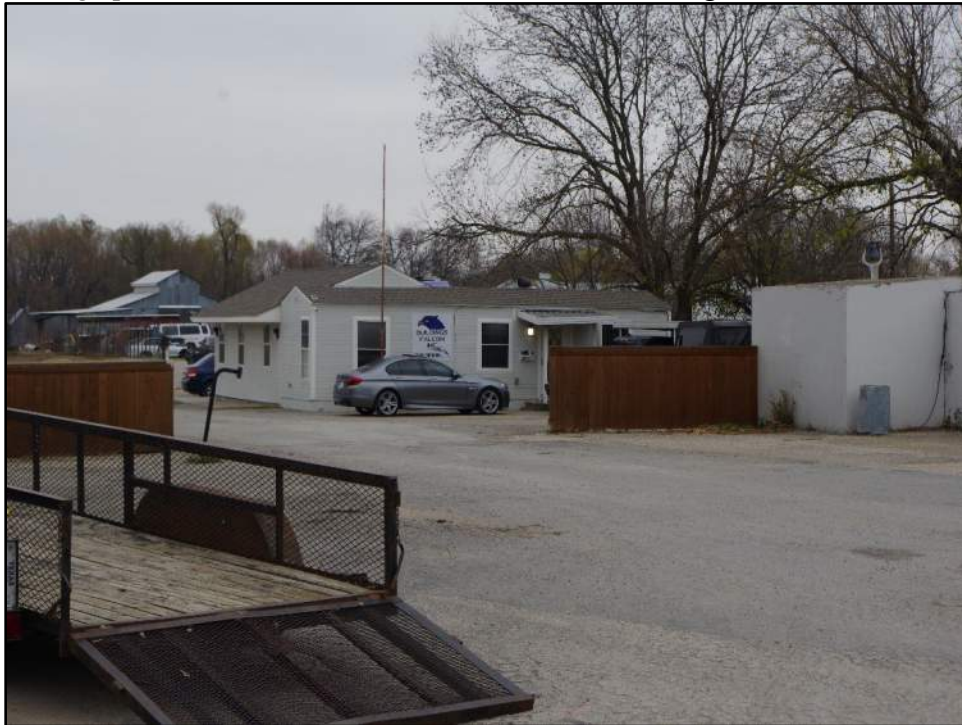
Photograph F-188: View of Resource 39a, camera facing southeast.

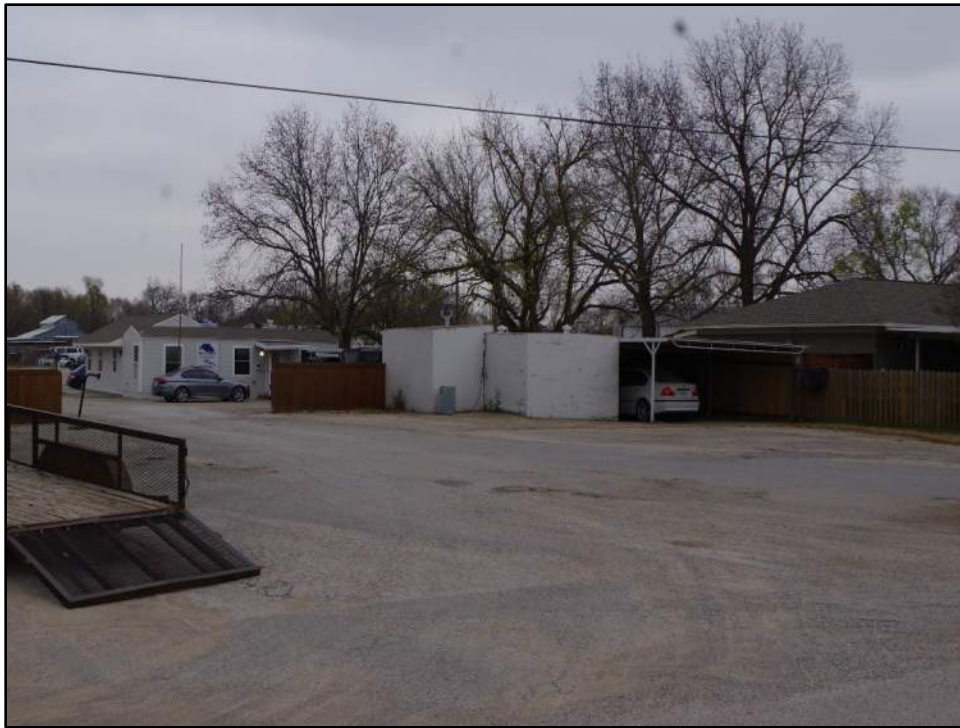
Photograph F-189: View of Resource 39a (rear) and Resource 39b (foreground), camera facing southeast.

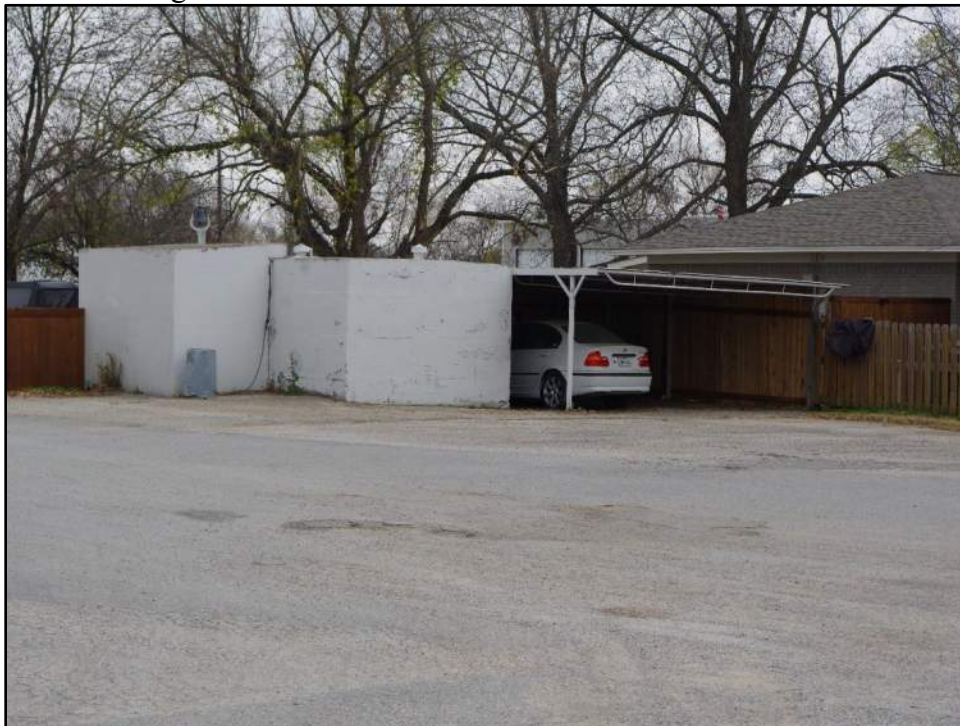
Photograph F-190: View of Resource 39b carport, camera facing southeast.

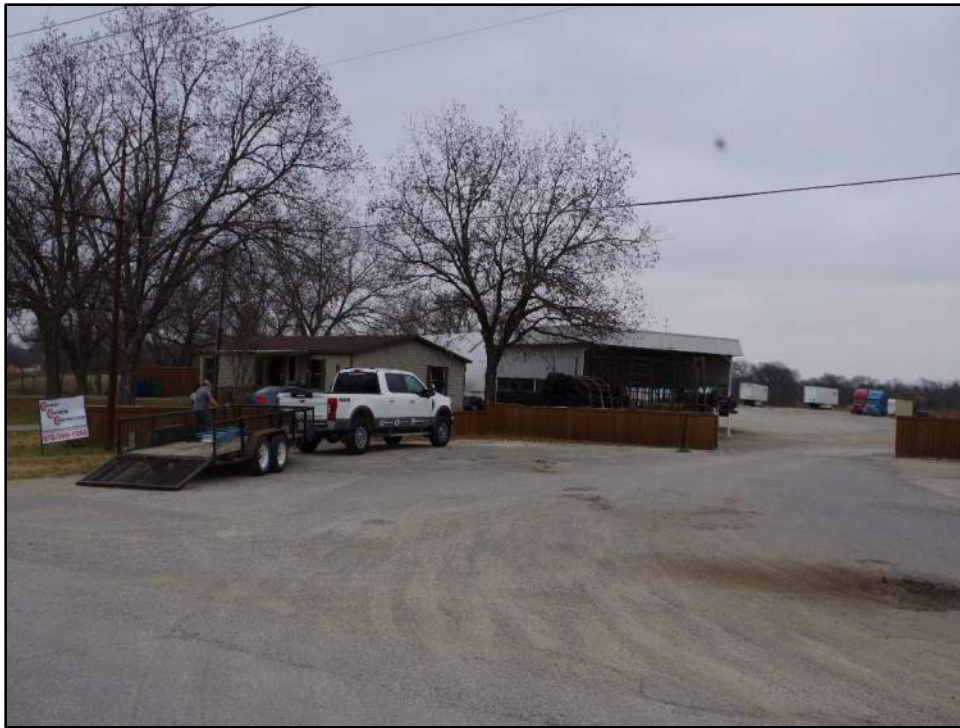
Photograph F-191: View of Resource 39c (right), camera facing northeast.

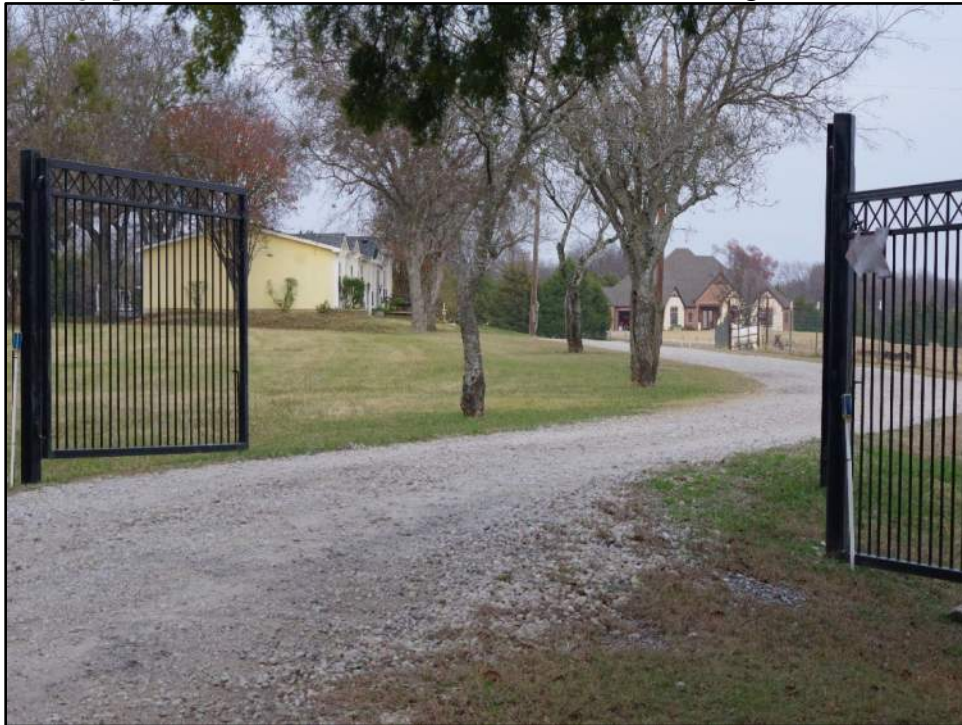
Photograph F-232: View of Resource 50a (left) and non-historic building (right), camera facing northeast.

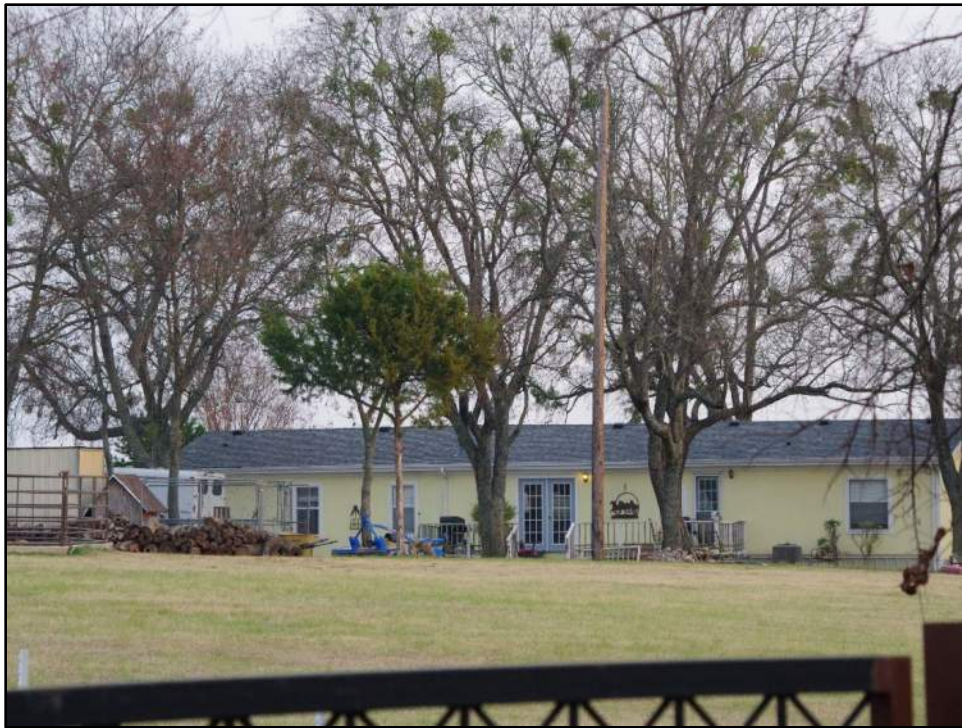
Photograph F-233: View of Resource 50a, camera facing southeast.

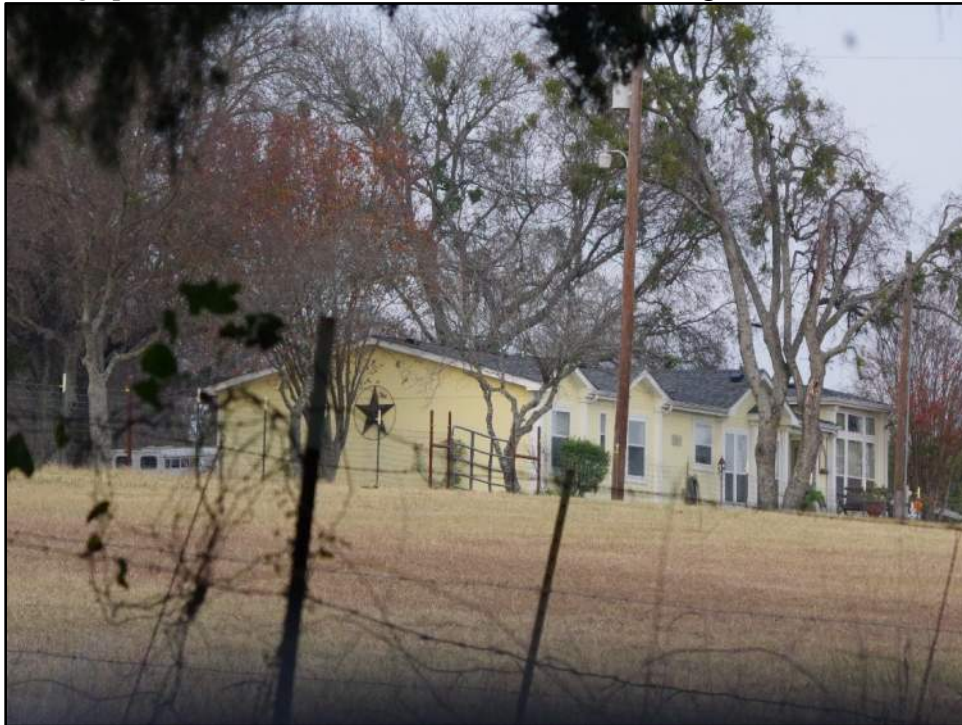
Photograph F-234: View of Resource 50a, camera facing northeast.

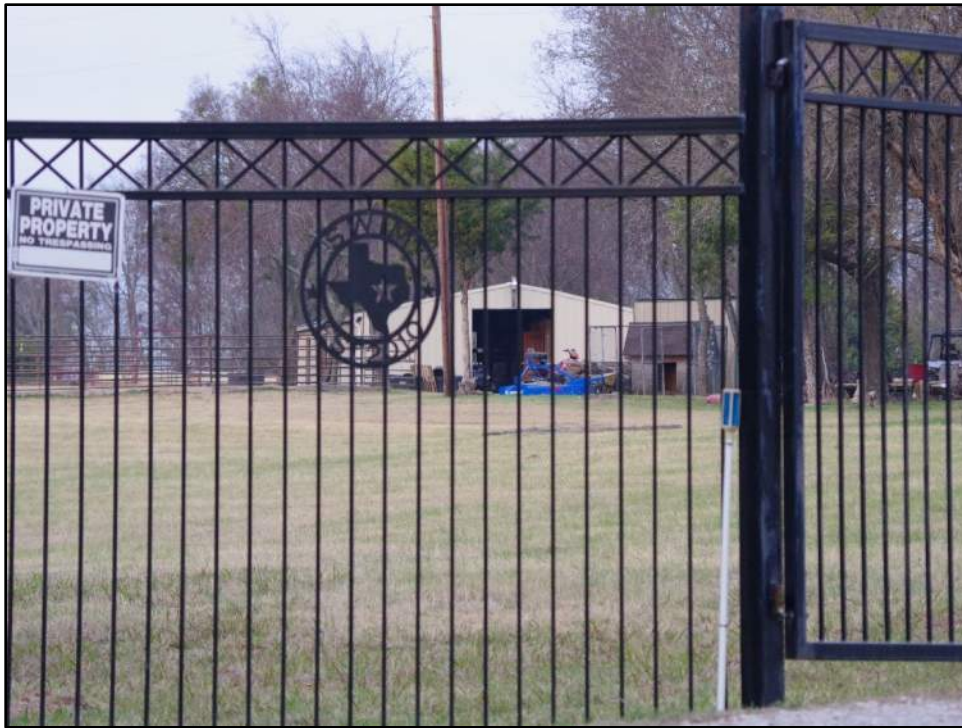
Photograph F-235: View of Resource 50b, camera facing northeast.

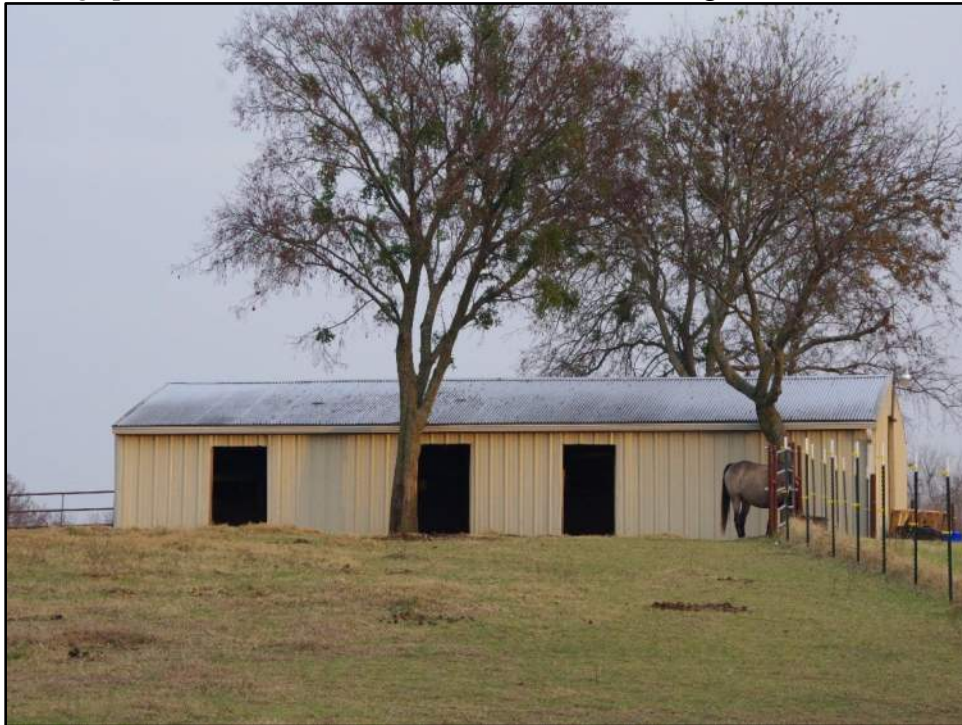
Photograph F-236: View of Resource 50b, camera facing northeast.

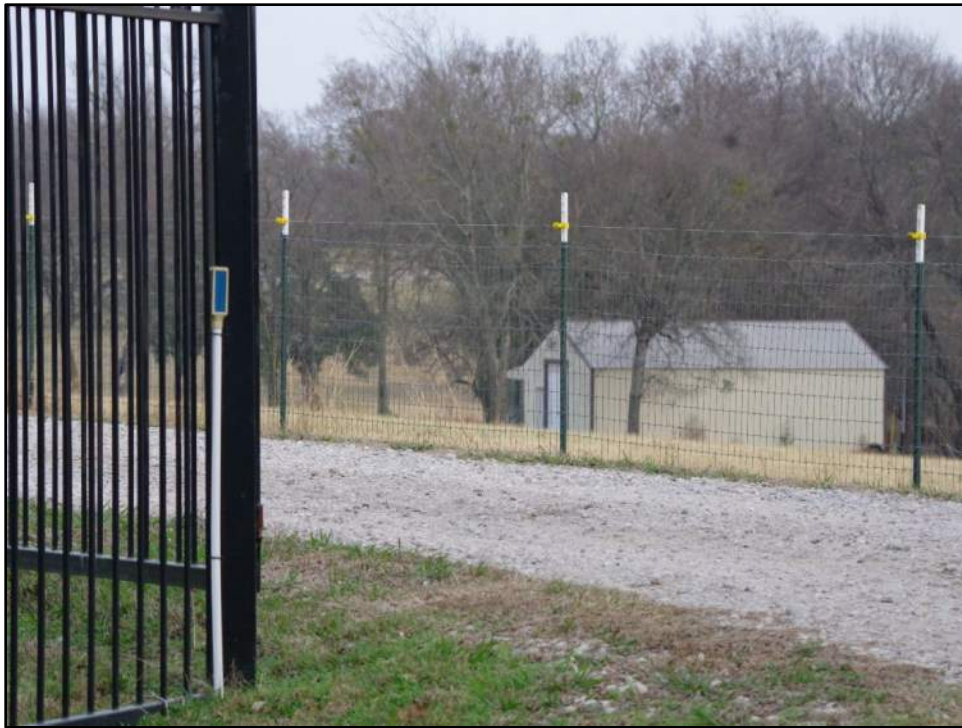
Photograph F-237: View of non-historic-age shed associated with Resource 50, camera facing southeast.

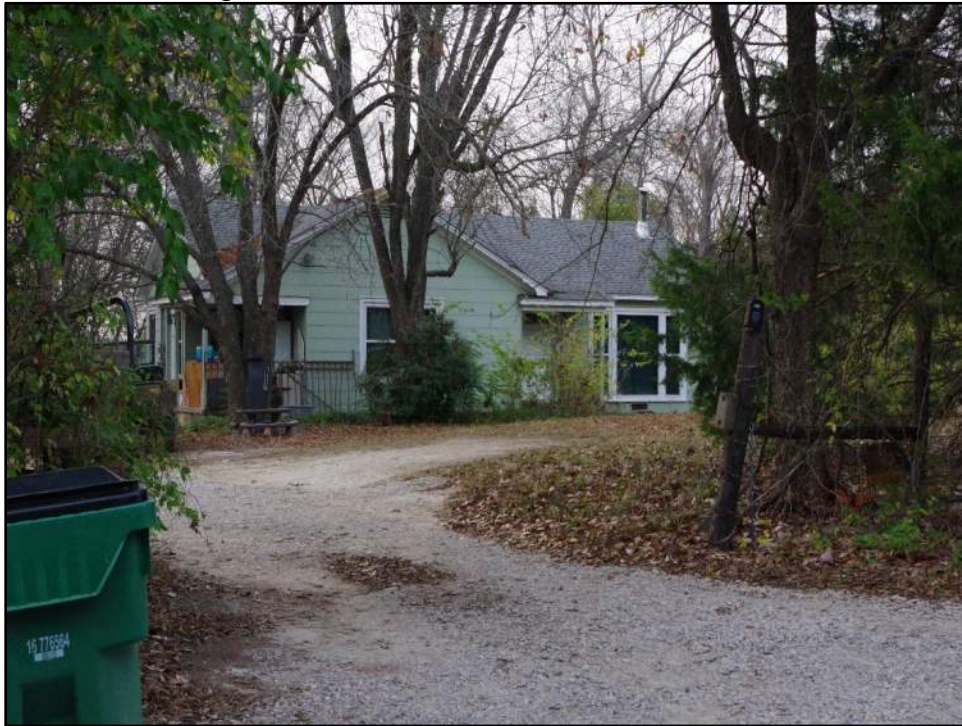
Photograph F-238: View of Resource 51a, camera facing west.

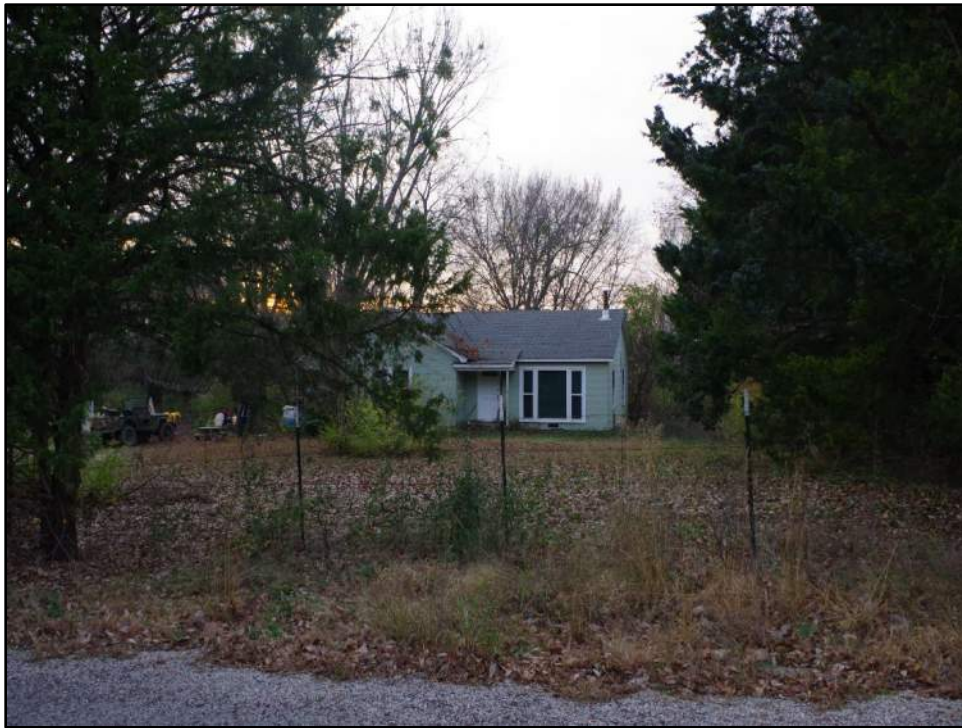
Photograph F-239: View of Resource 51a, camera facing southwest.

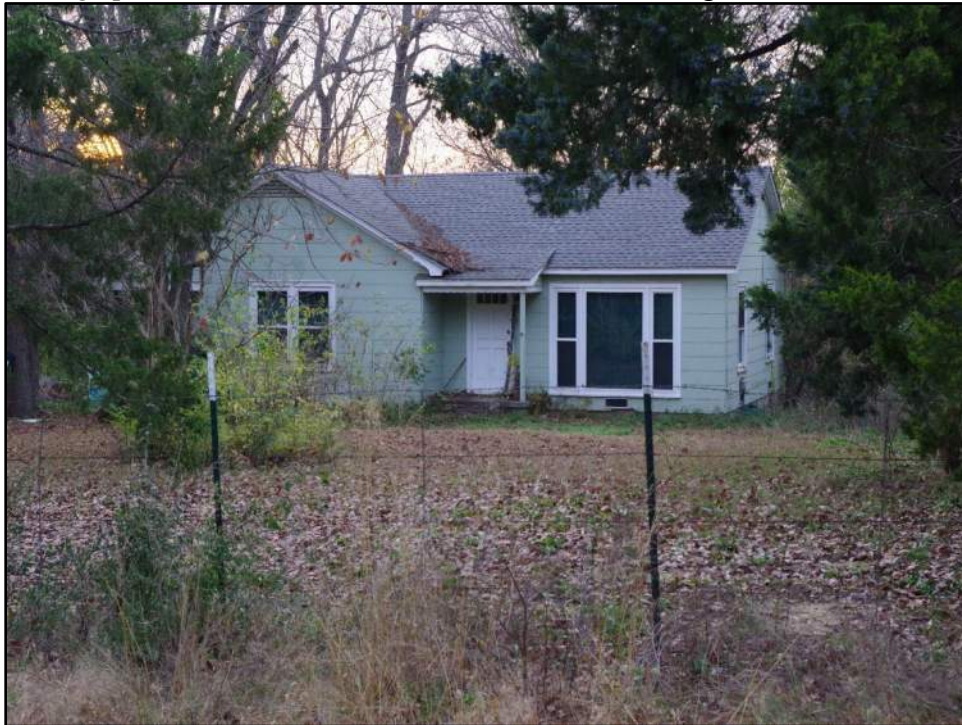
Photograph F-240: View of Resource 51a, camera facing west.

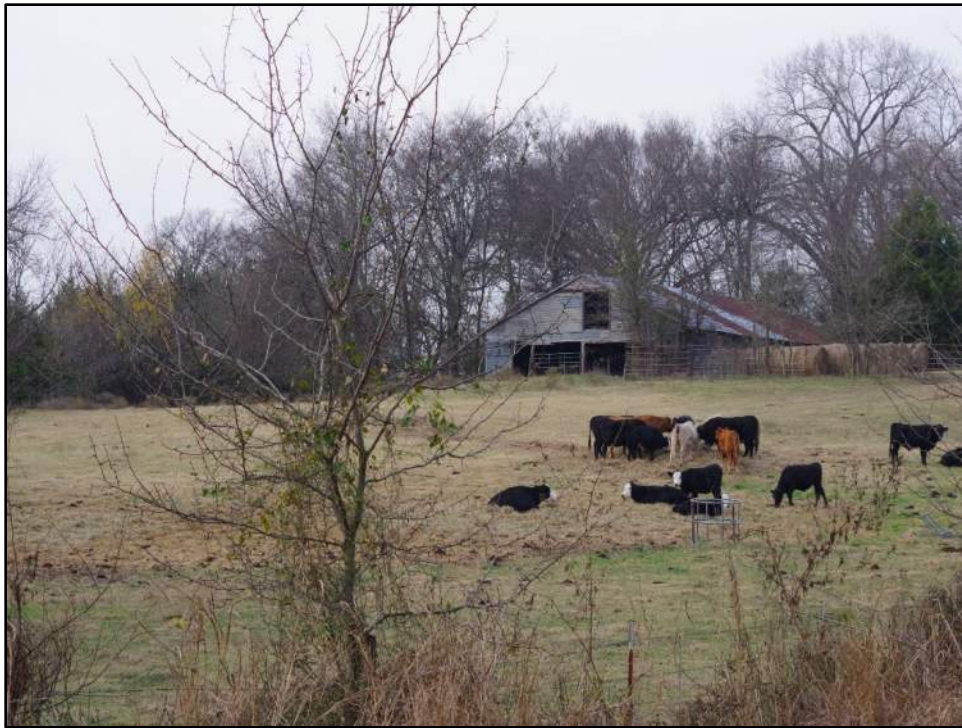
Photograph F-241: View of Resource 51b, camera facing north-northwest.

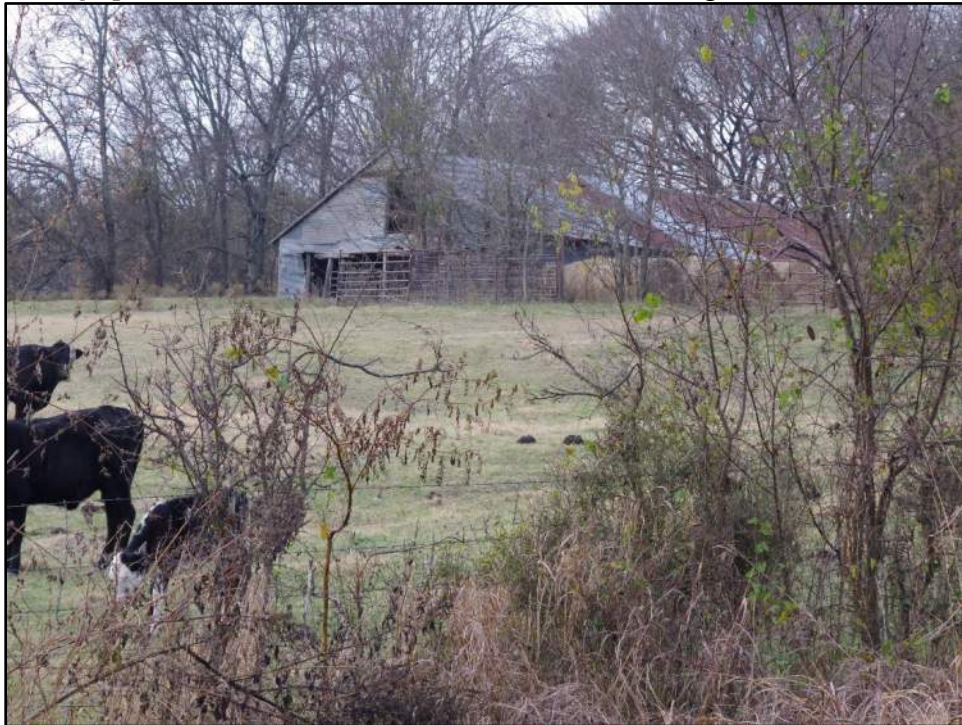
Photograph F-242: View of Resource 51b, camera facing northwest.

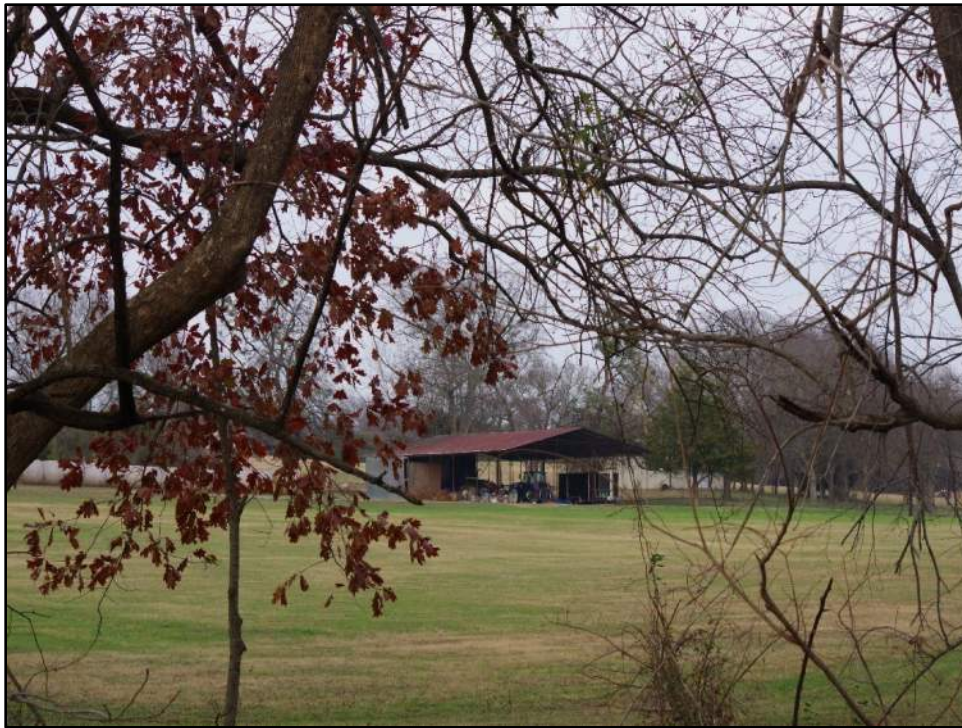
Photograph F-243: View of Resource 52 pole barn/open shed, camera facing northeast.

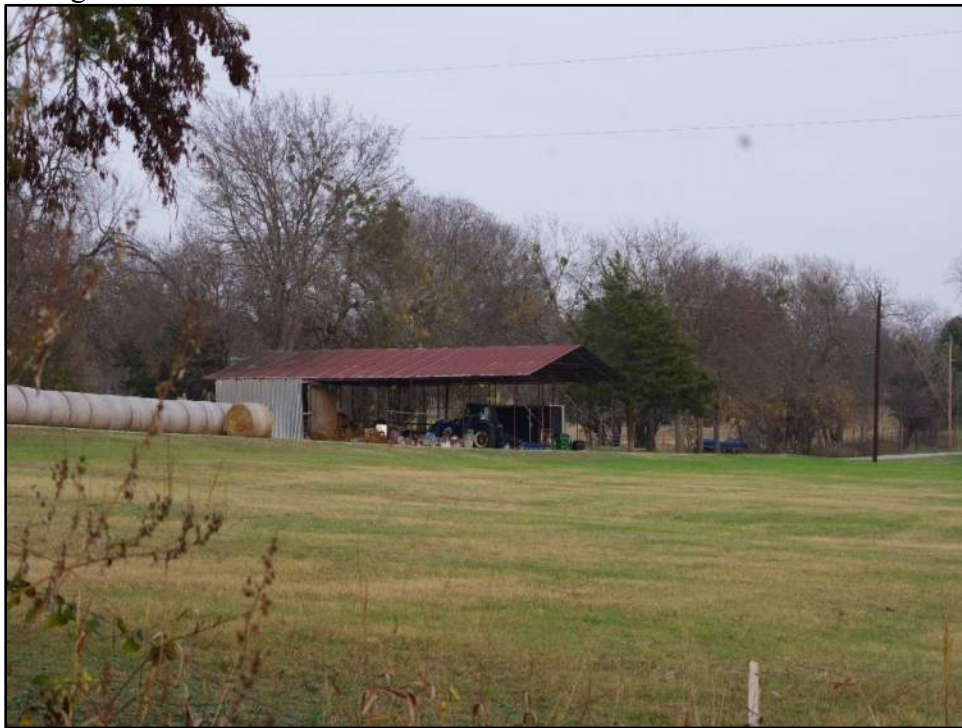
Photograph F-244: View of Resource 52, camera facing northeast.

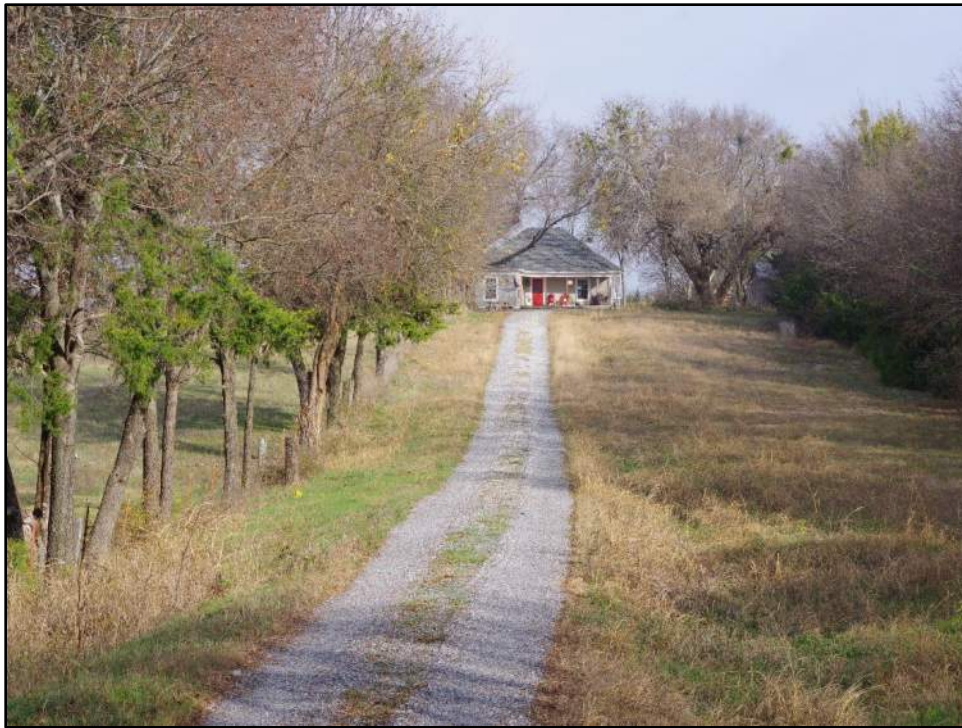
Photograph F-245: View of Resource 53a, camera facing north.

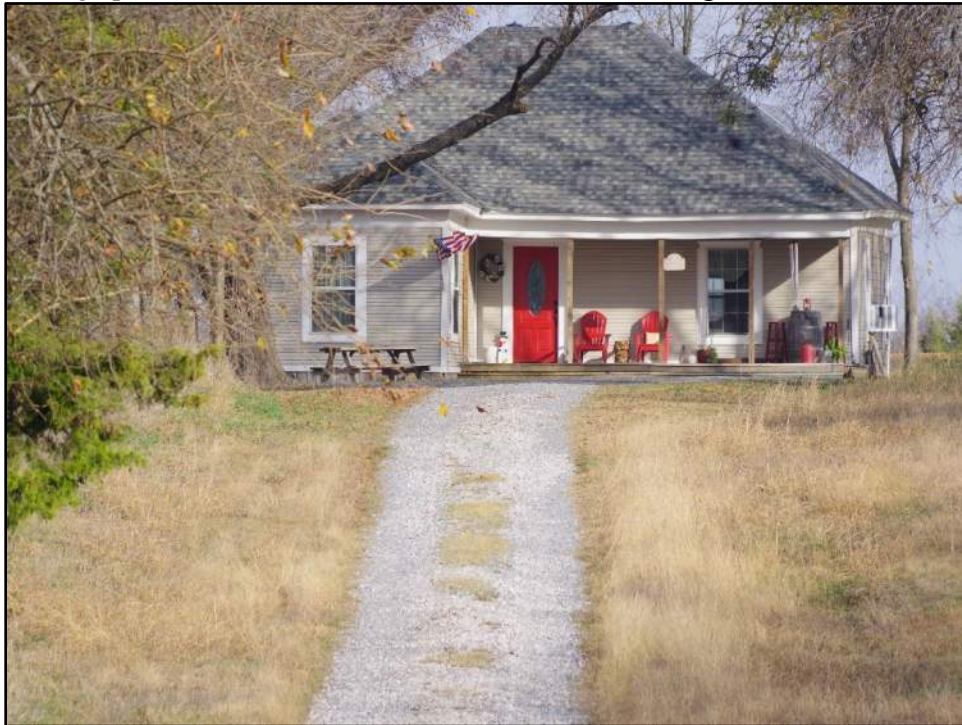
Photograph F-246: View of Resource 53a, camera facing north.

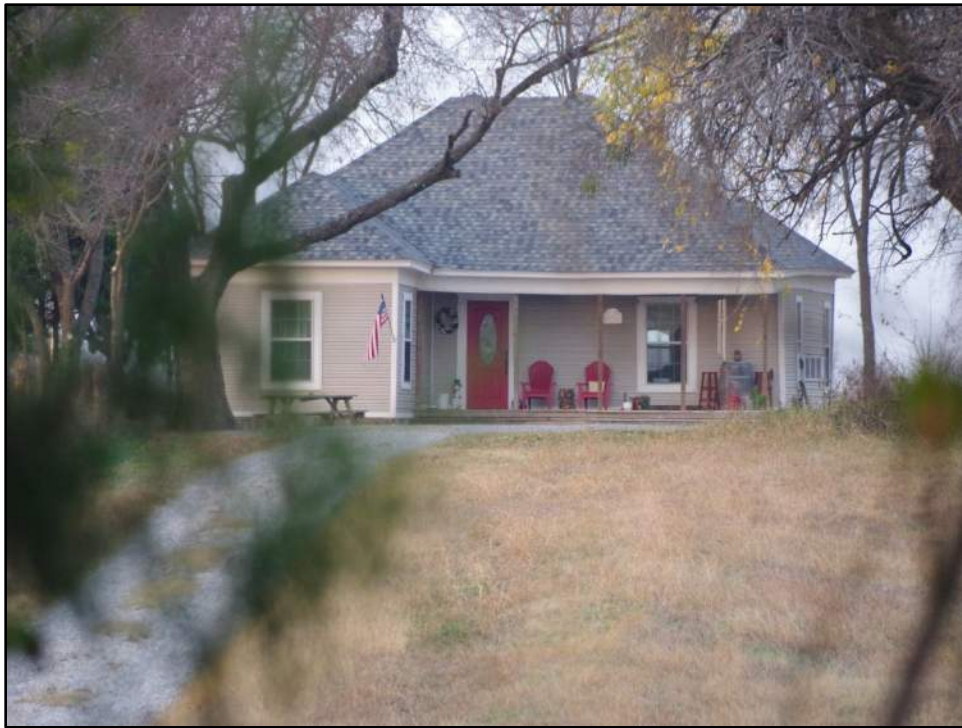
Photograph F-247: View of Resource 53a, camera facing north.

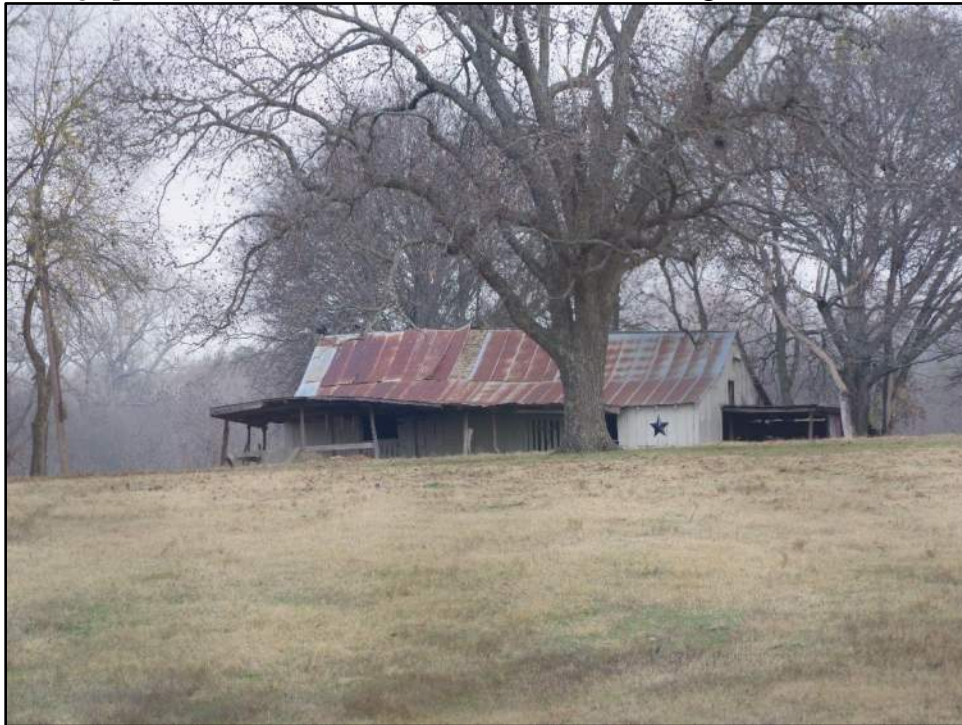
Photograph F-248: View of Resource 53b, camera facing north.

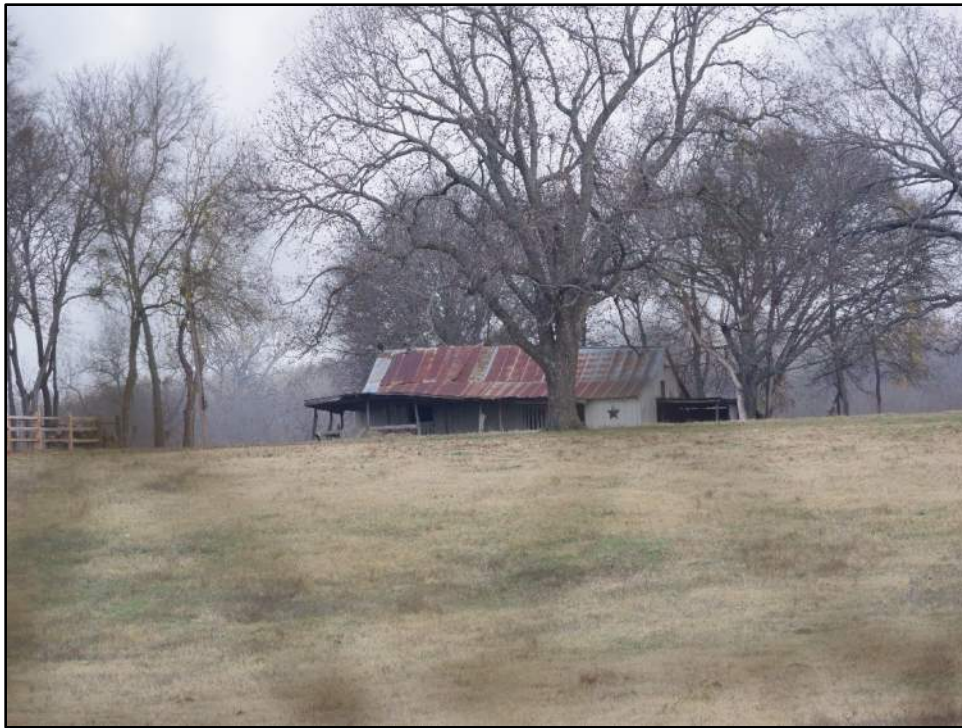
Photograph F-249: View of Resource 53b, camera facing north

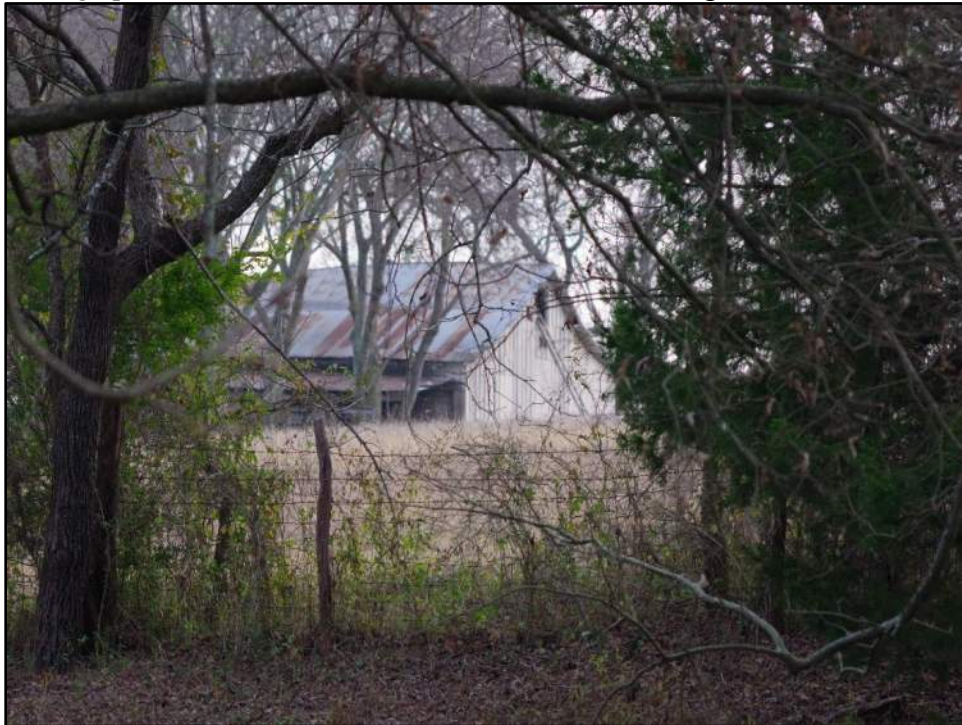
Photograph F-250: Obscured view of Resource 53b, camera facing southeast.

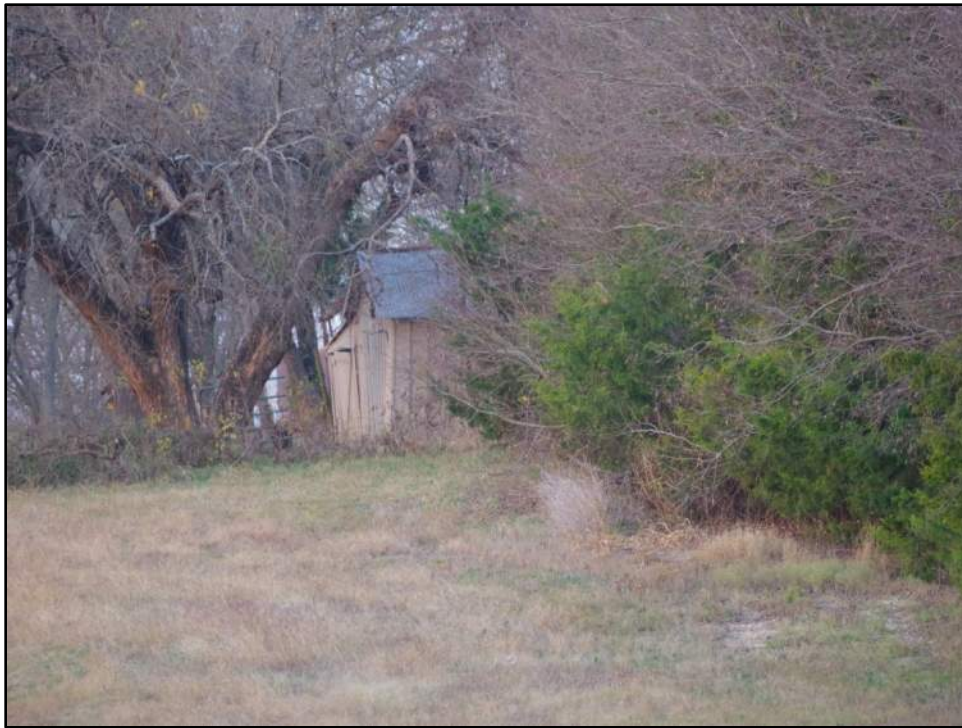
Photograph F-251: View of Resource 53c, camera facing northeast.

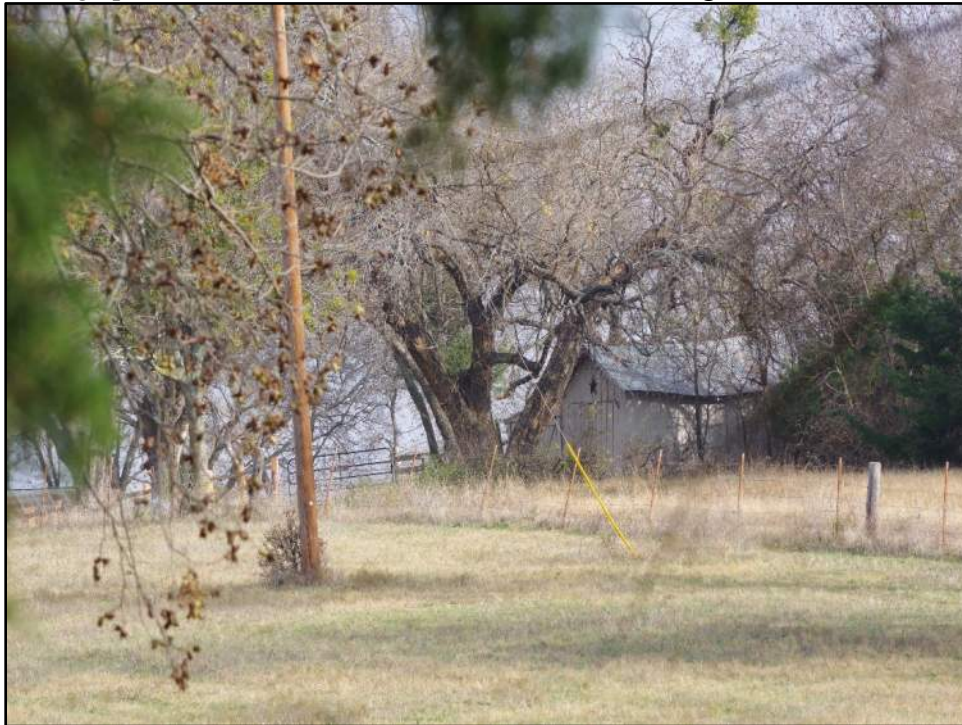
Photograph F-252: View of Resource 53c, camera facing north.

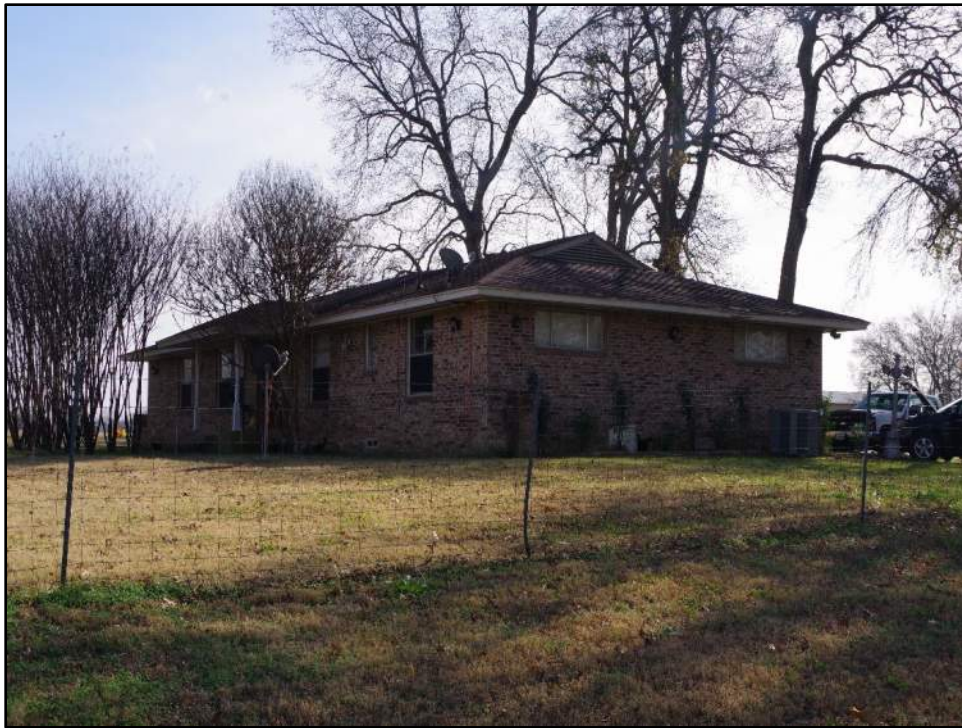
Photograph F-253: View of Resource 54a, camera facing southeast.

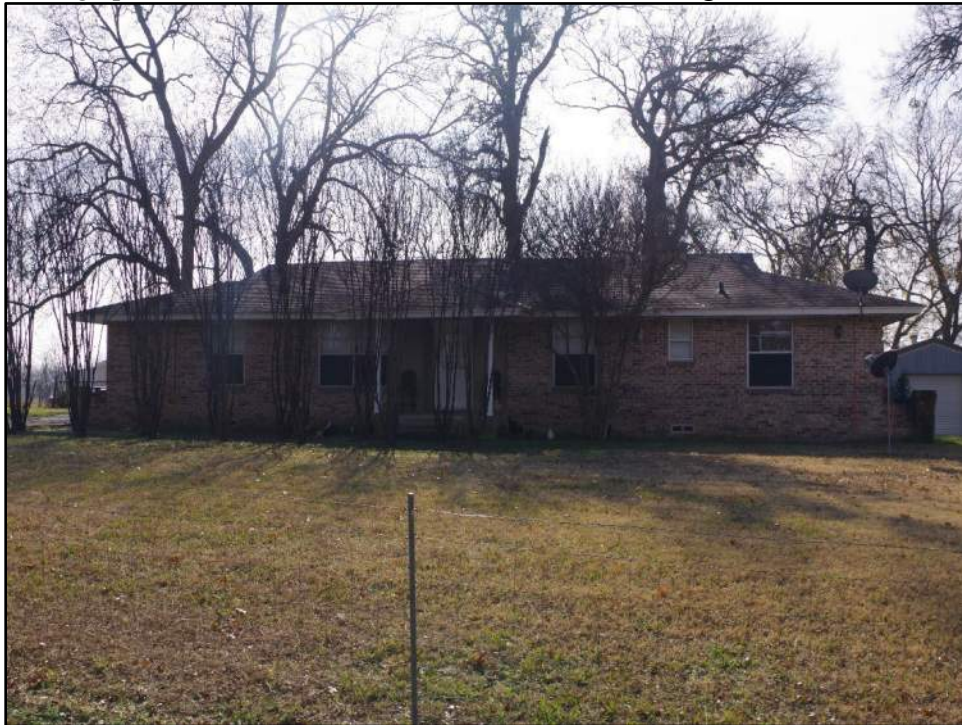
Photograph F-254: View of Resource 54a, camera facing south.

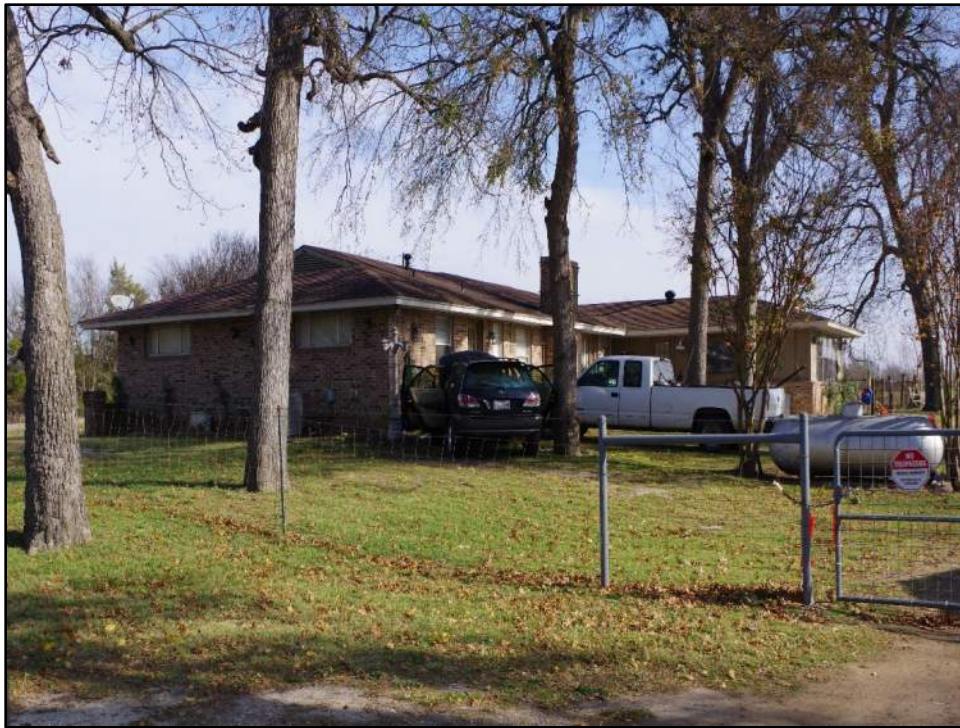
Photograph F-255: View of Resource 54a, camera facing northeast.

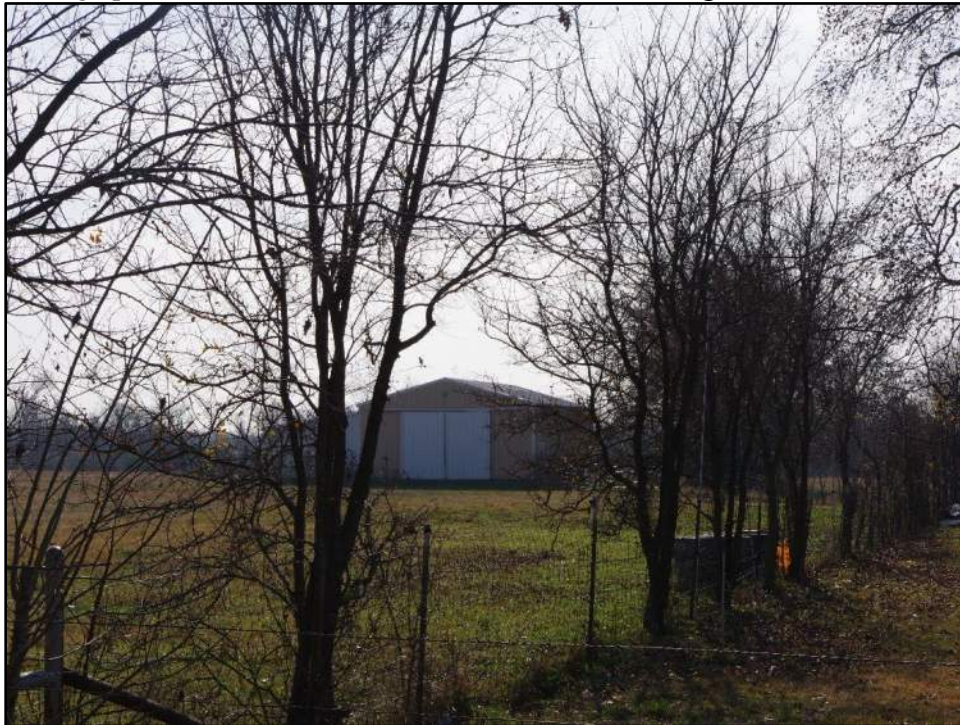
Photograph F-256: View of Resource 54b, camera facing south.

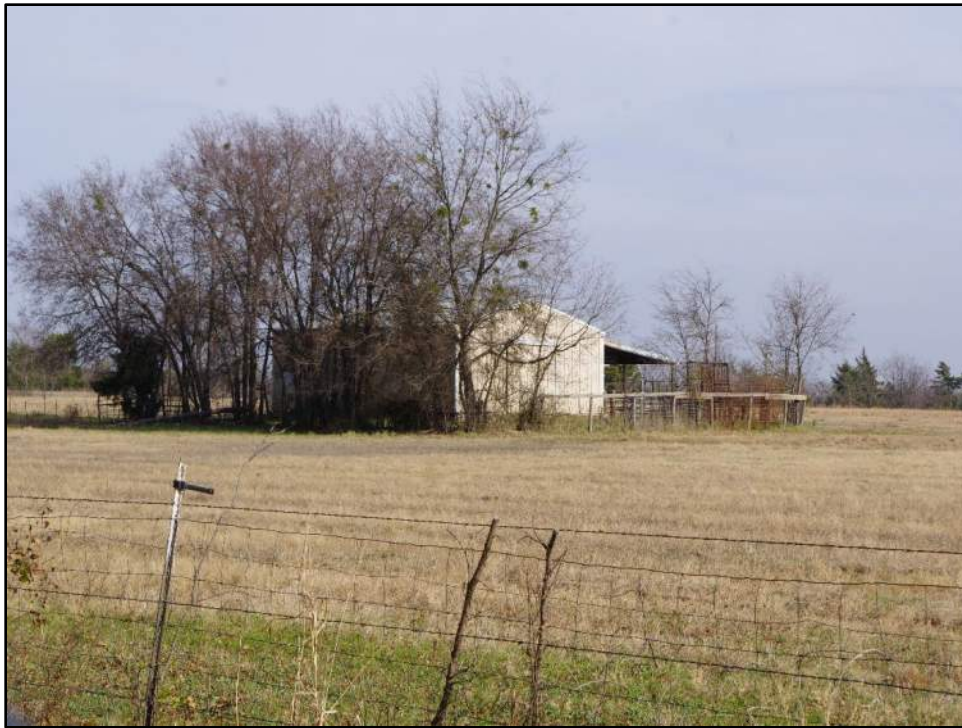
Photograph F-257: View of Resource 54b, camera facing northeast.

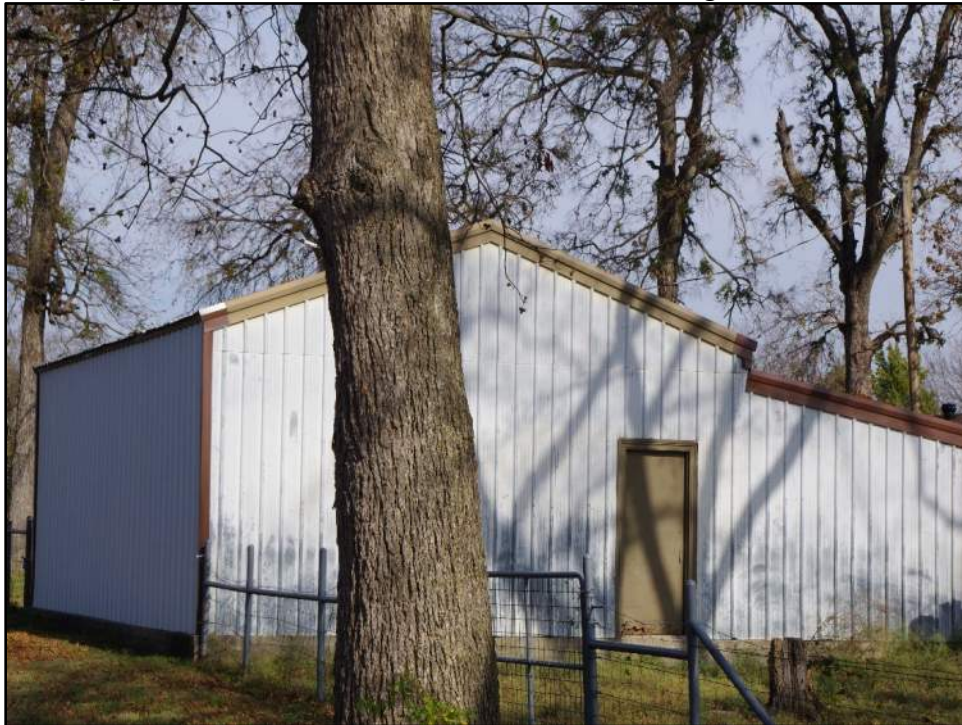
Photograph F-258: View of Resource 54c, camera facing north-northeast.
