APPENDIX L: Cultural Resources

APPENDIX L – CULTURAL RESOURCES – FEIS Preferred Alternative/Blue Alternative

US 380 MCKINNEY – Coit Road to FM 1827, Collin County CSJs 0135-02-065 and 0135-15-002; Dallas District

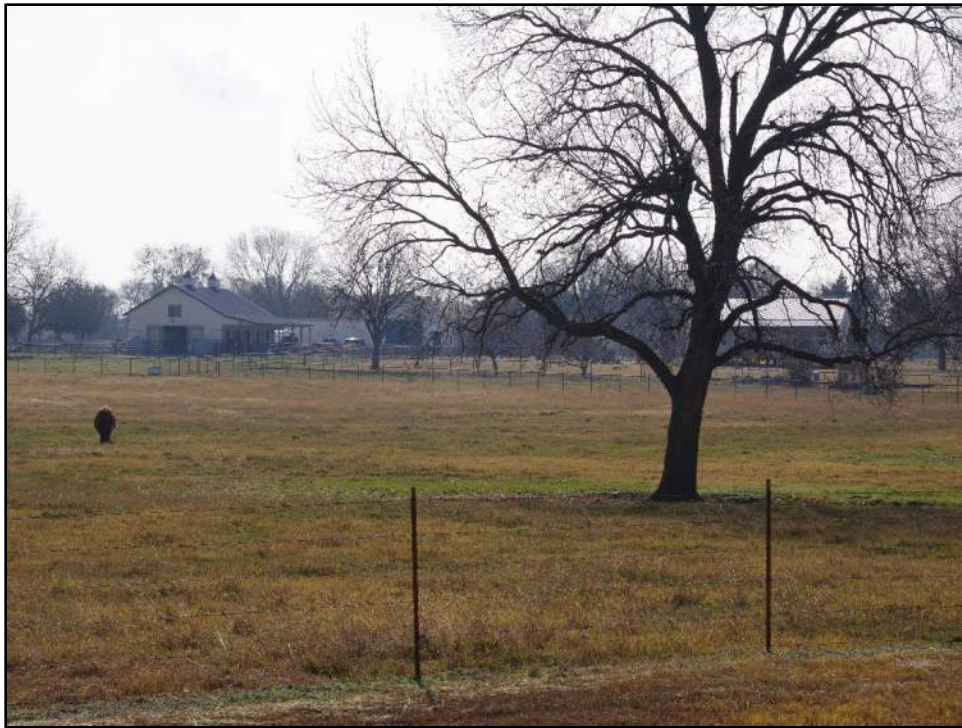
Photograph F-259: Overview of Resource 55, camera facing east.

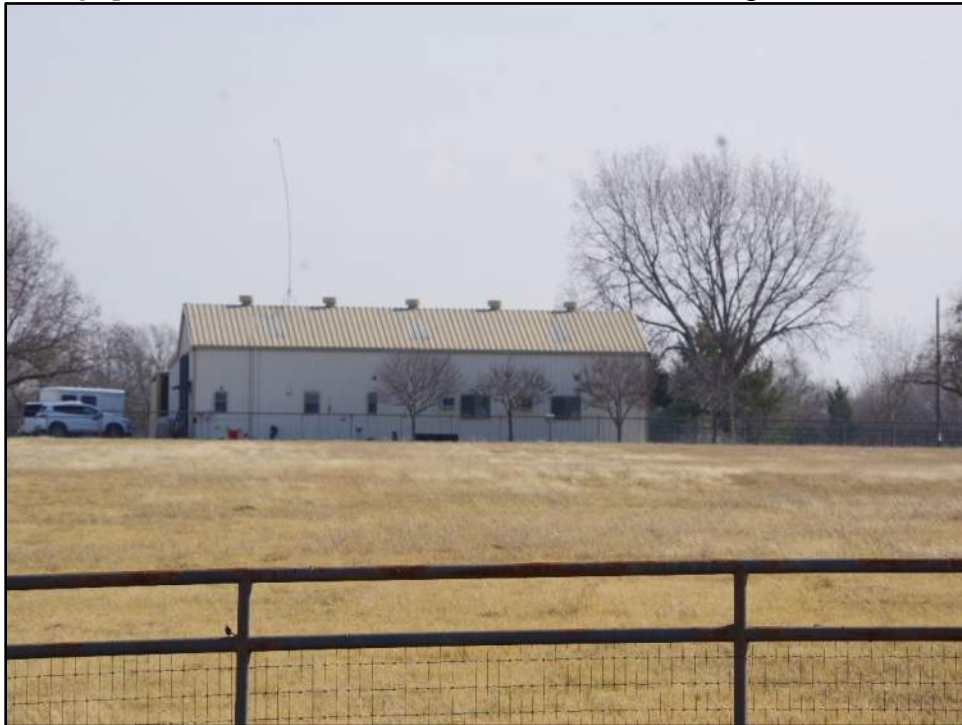
Photograph F-260: View of Resource 55a, camera facing east.

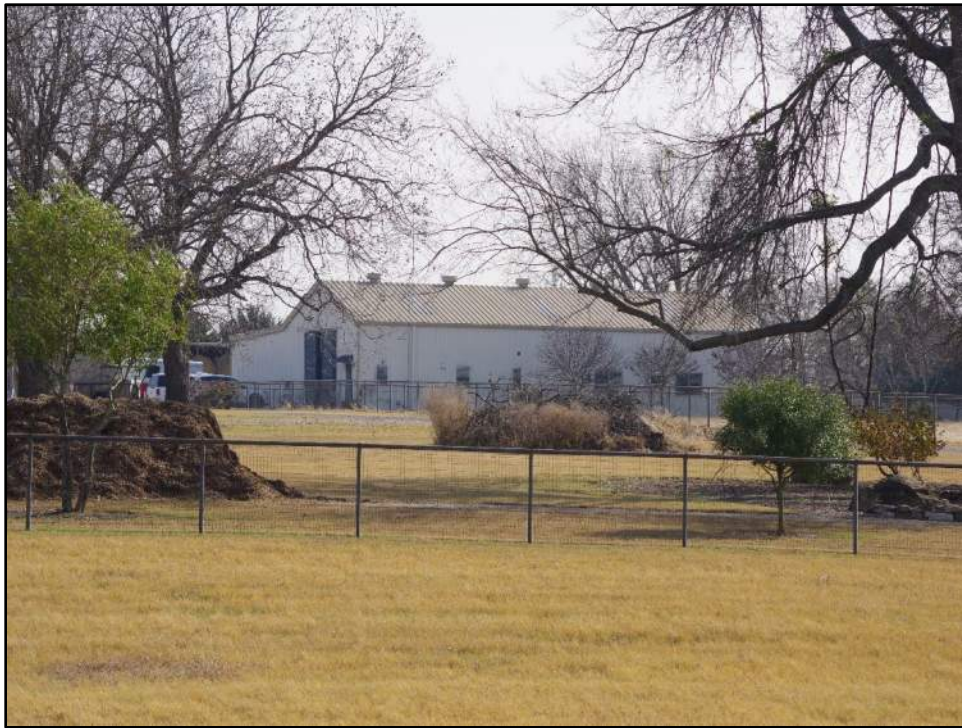
Photograph F-261: View of Resource 55a, camera facing east-southeast.

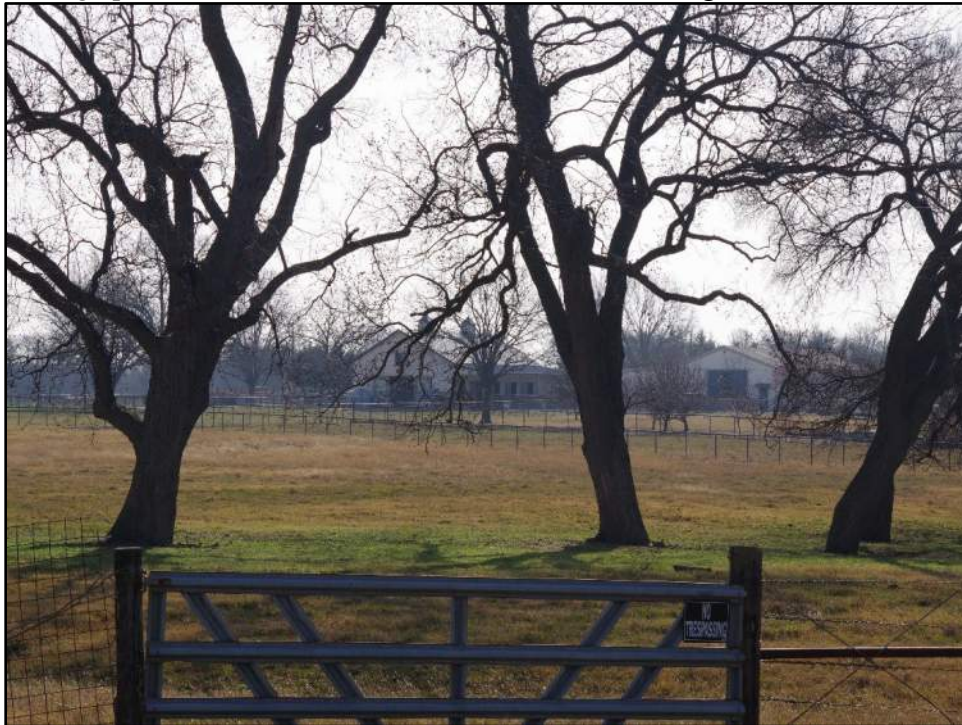
Photograph F-262: View of Resource 55a (right) and non-historic-age barn (left), camera facing east-southeast.

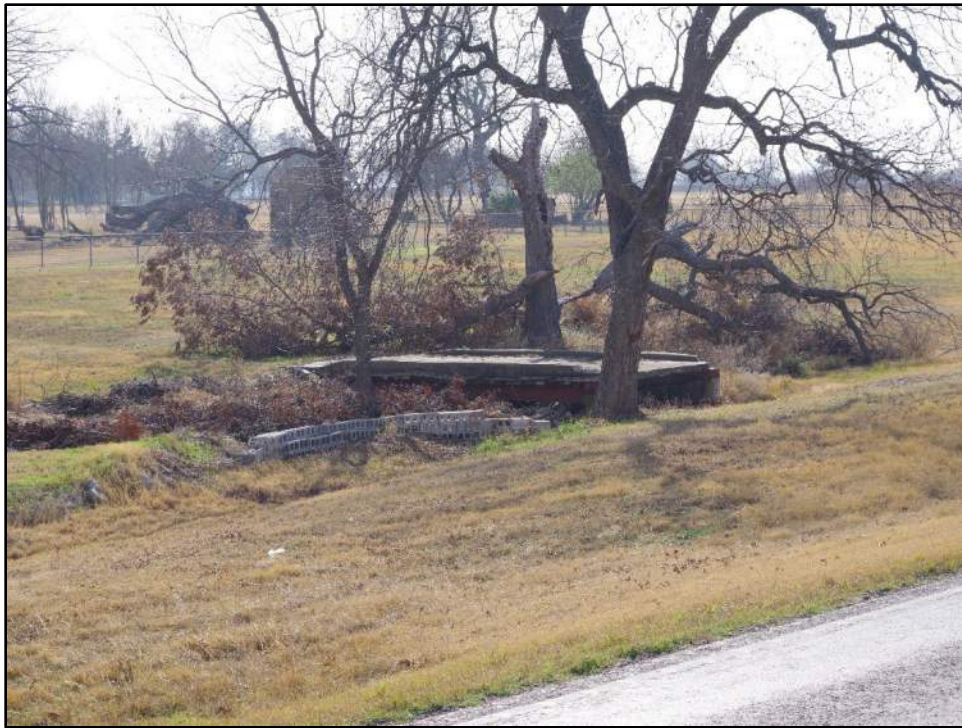
Photograph F-263: View of Resource 55b, camera facing southeast.

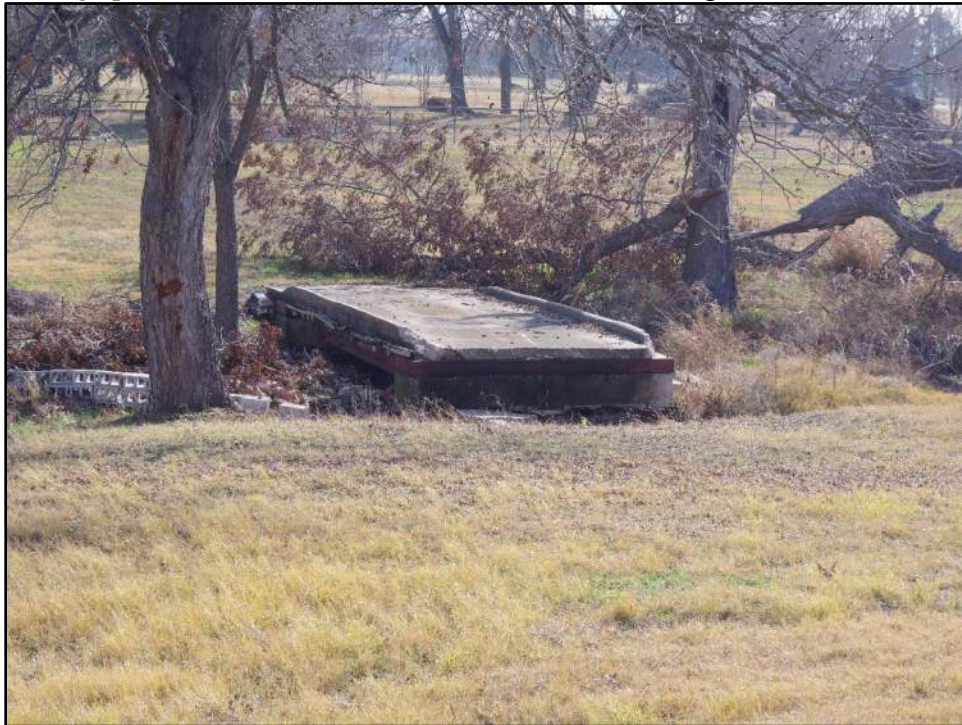
Photograph F-264: View of Resource 55b, camera facing east.

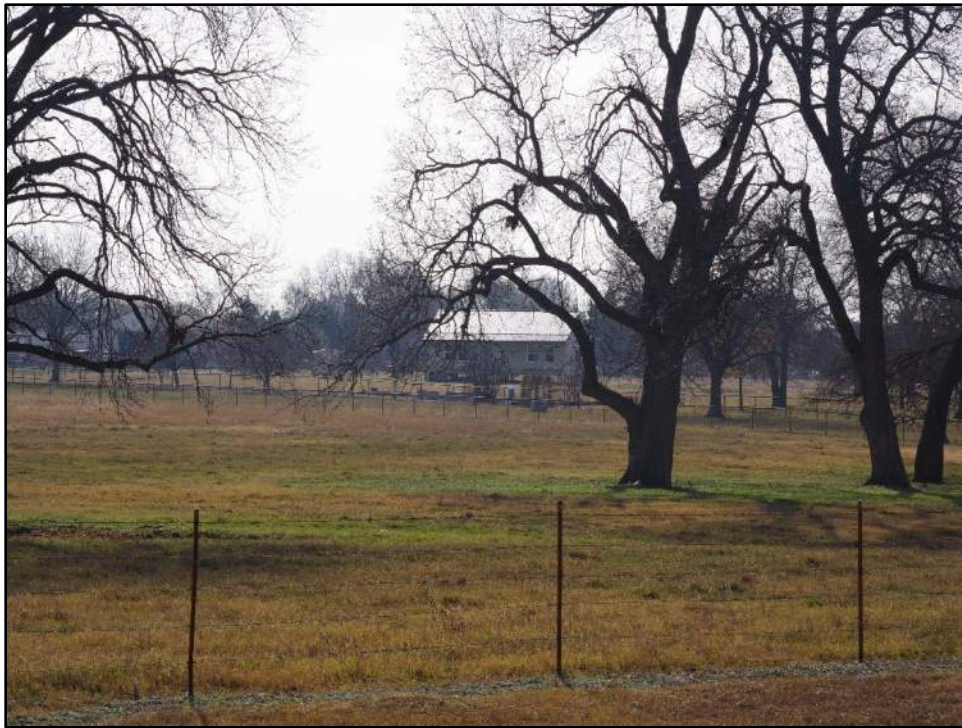
Photograph F-265: View of non-historic-age dwelling associated with Resource 55, camera facing southeast.

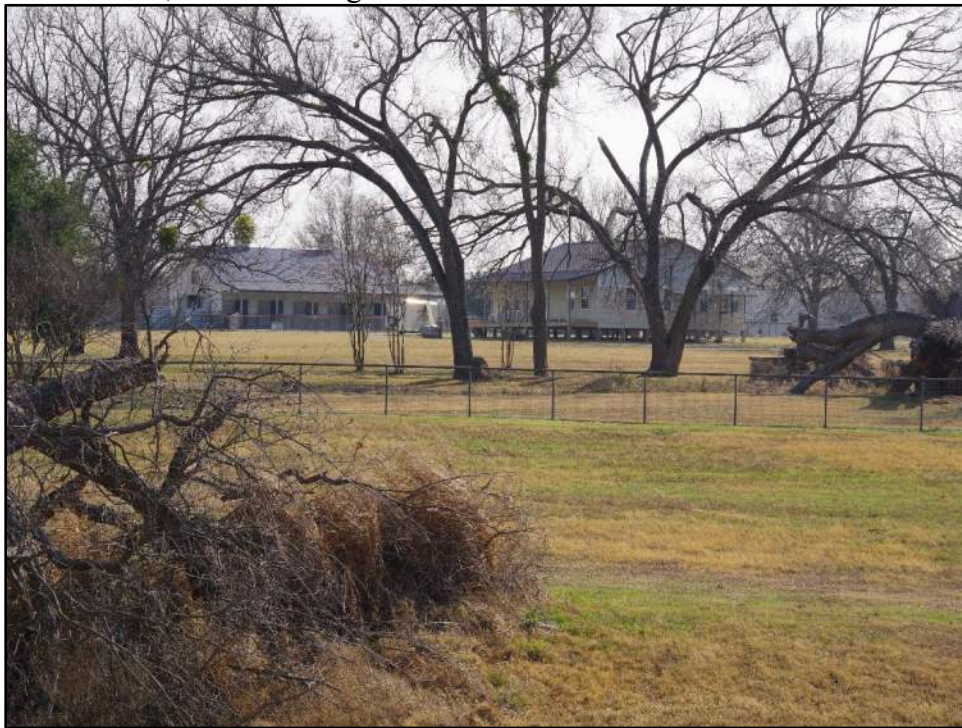
Photograph F-266: View of non-historic-age dwelling and outbuilding associated with Resource 55, camera facing east.

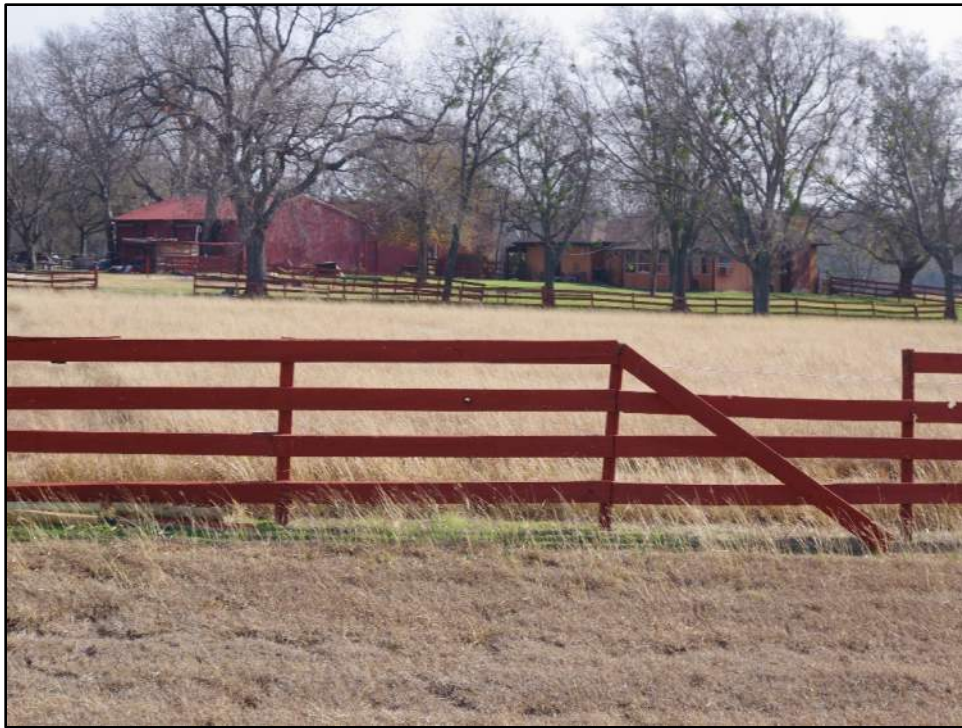
Photograph F-267: Overview of Resource 56, camera facing northeast.

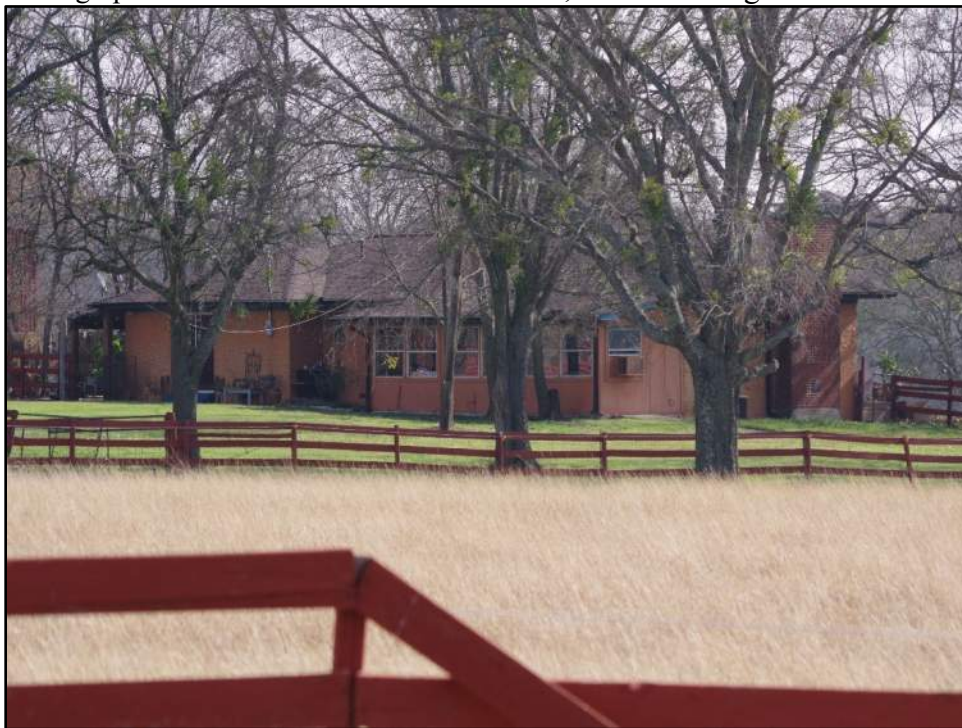
Photograph F-268: View of Resource 56a, camera facing southeast.

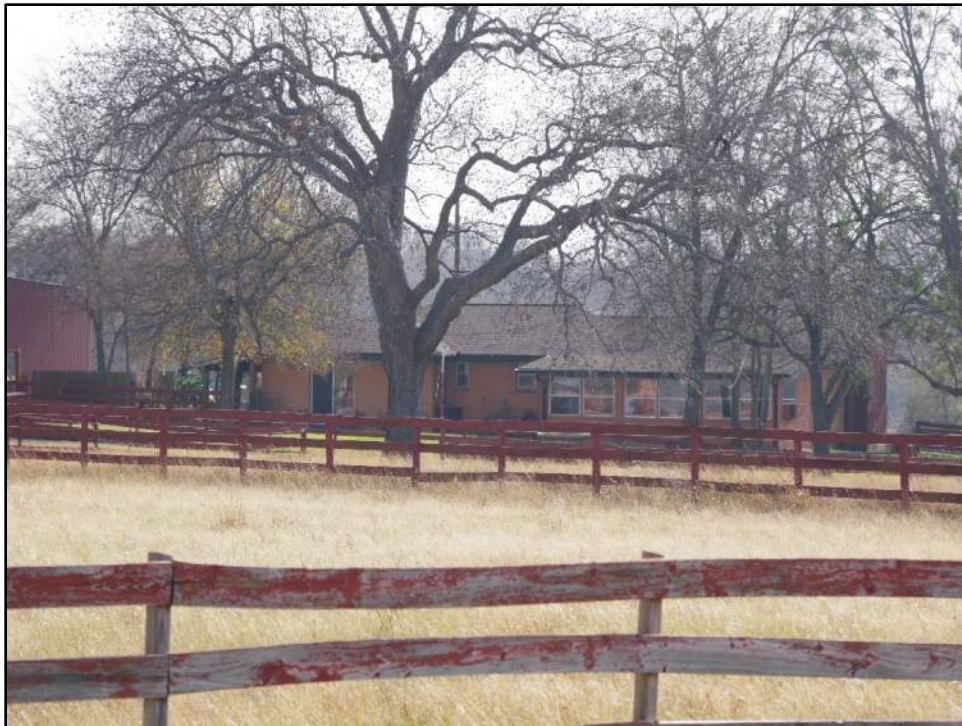
Photograph F-269: View of Resource 56a, camera facing east.

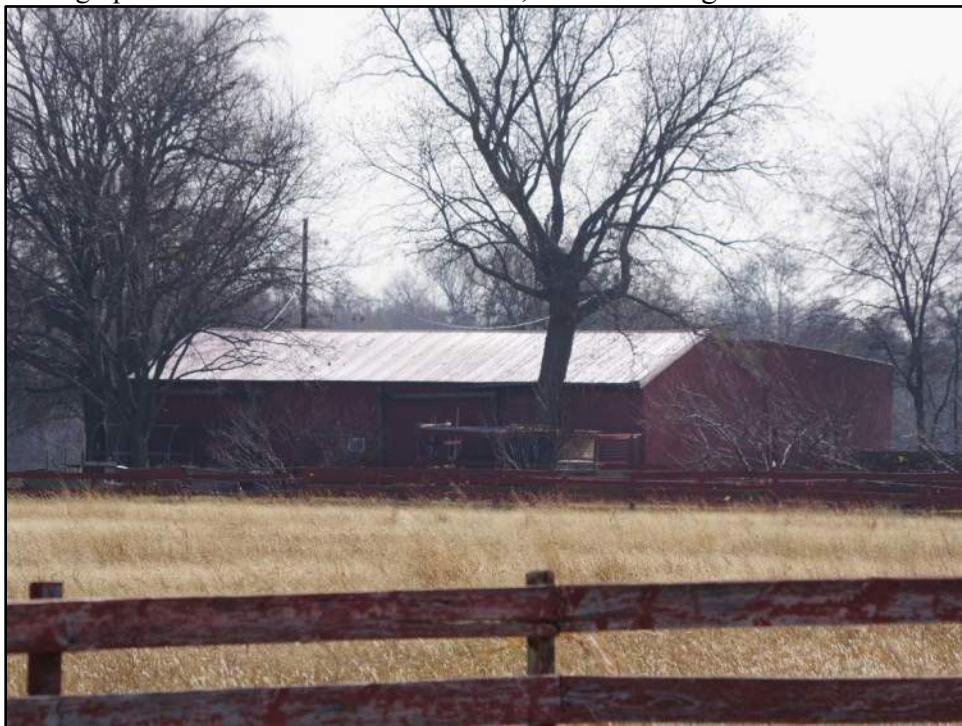
Photograph F-270: View of Resource 56b, camera facing southeast.

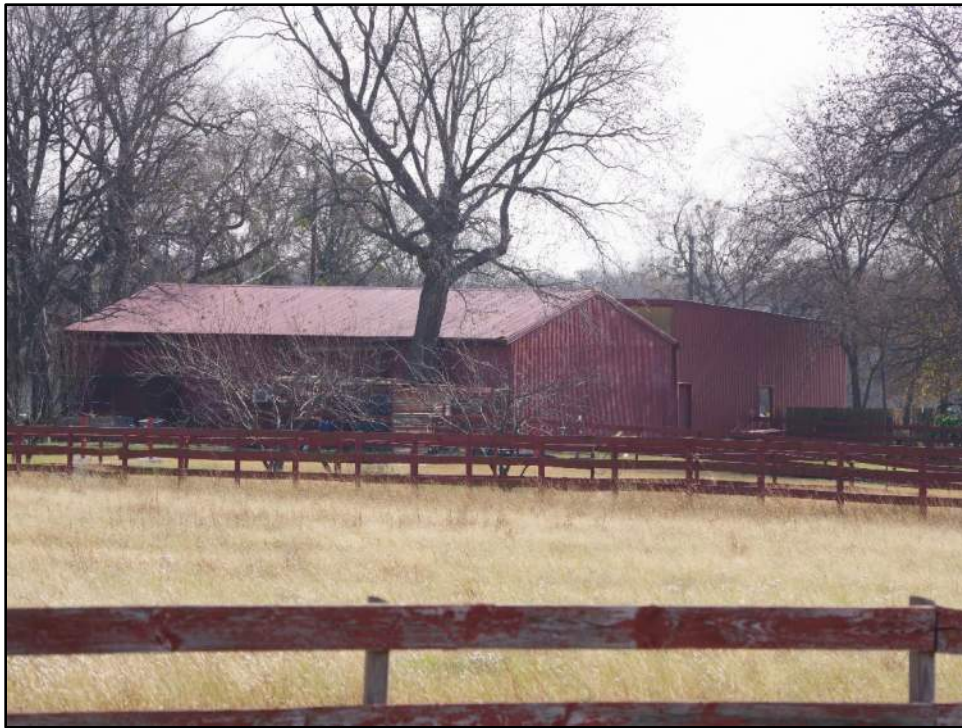
Photograph F-271: View of Resource 56b, camera facing northeast.

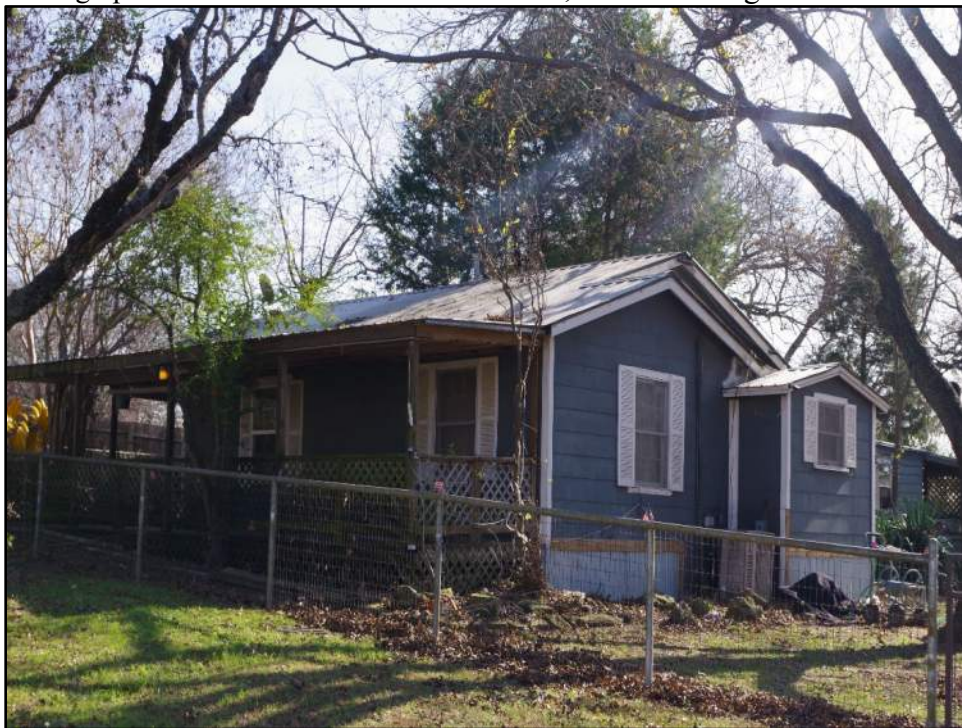
Photograph F-312: View of Resource 66, camera facing southeast.

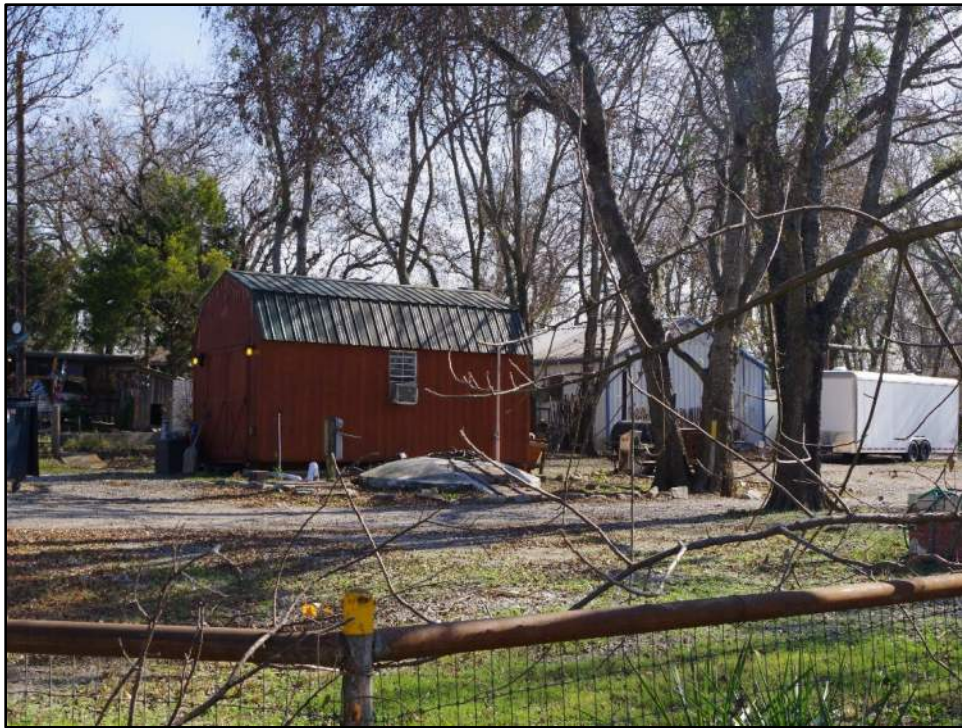
Photograph F-313: View of non-historic-age outbuildings associated with Resource 66, camera facing southeast.

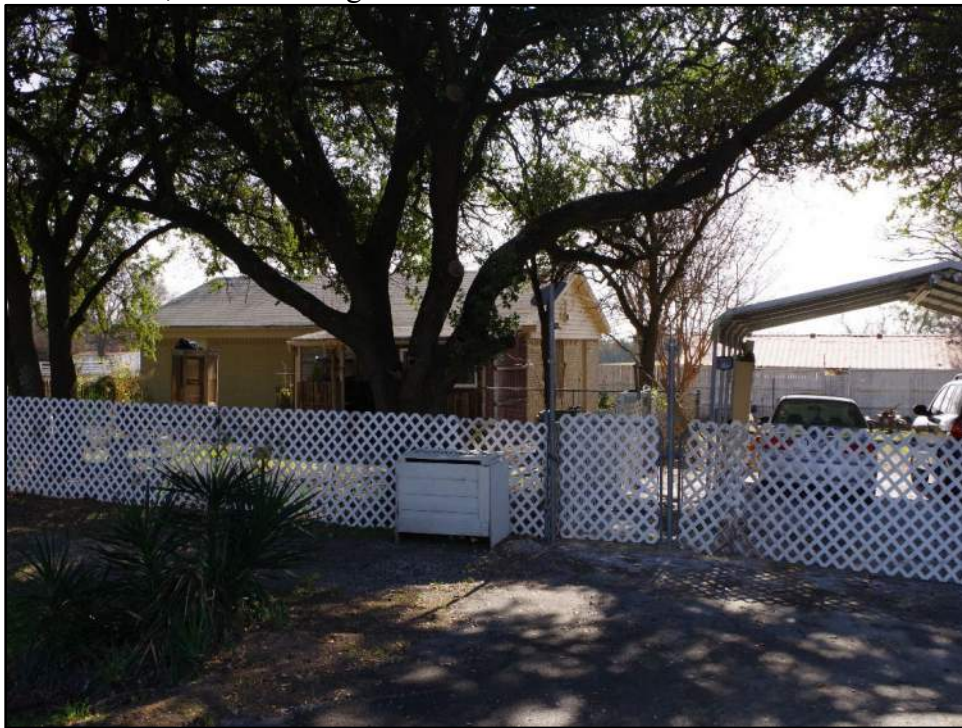
Photograph F-314: View of Resource 67, camera facing south.

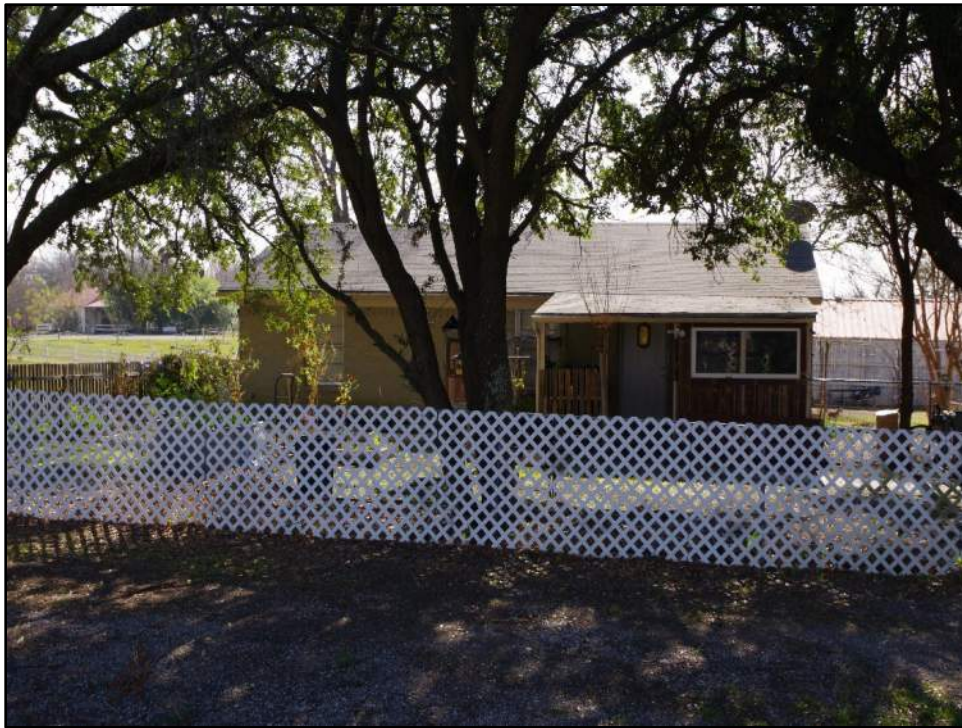
Photograph F-315: View of Resource 67a, camera facing south.

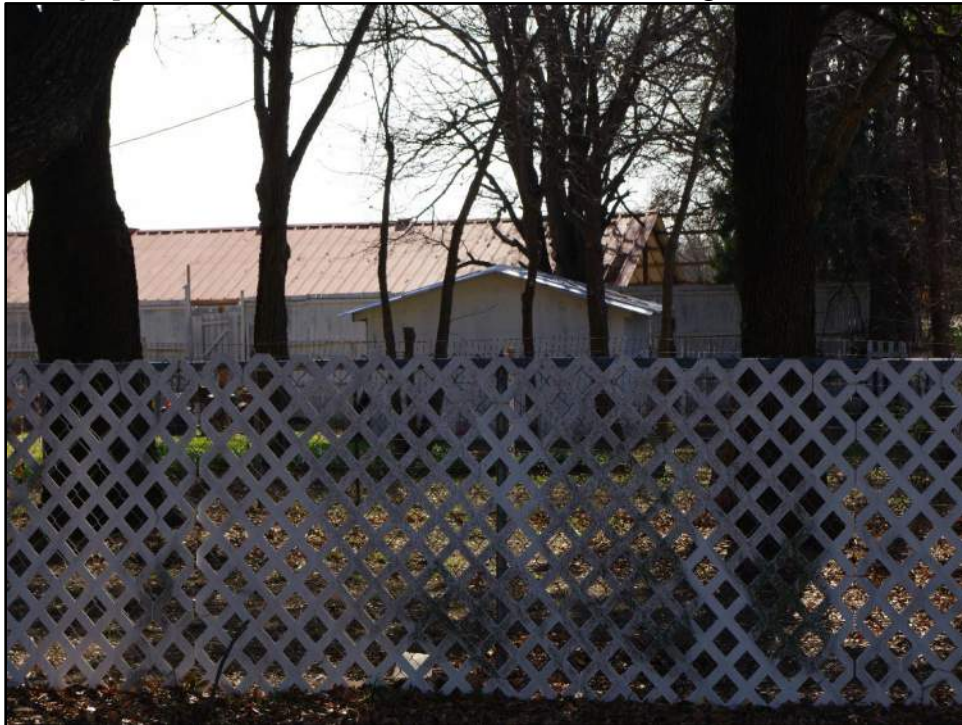
Photograph F-316: View of Resource 67b, camera facing south.

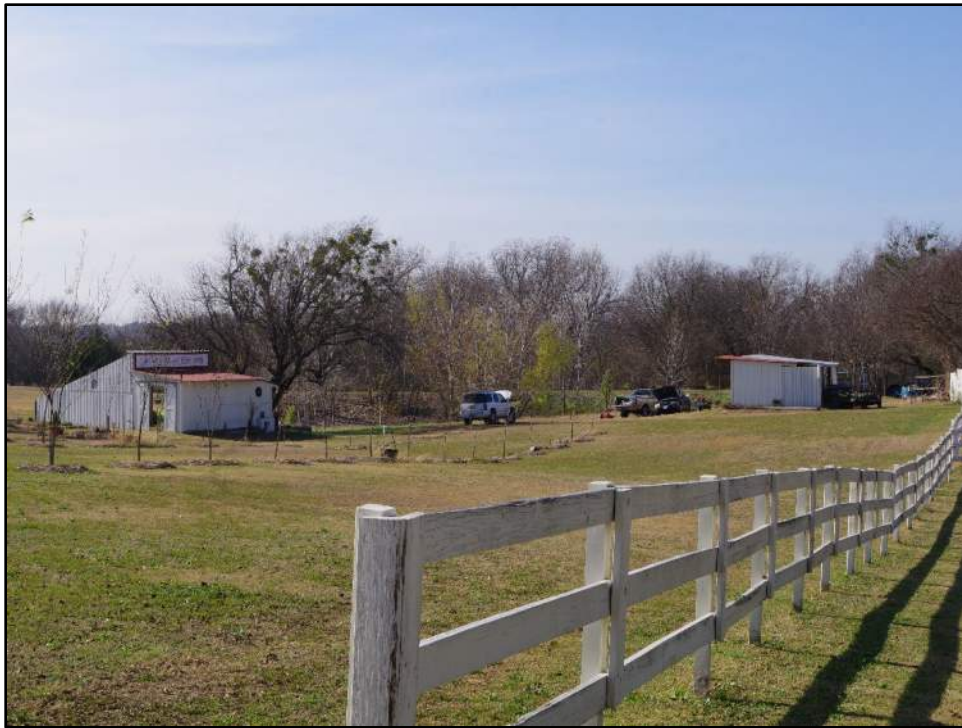
Photograph F-317: Overview of Resource 68, camera facing southwest.

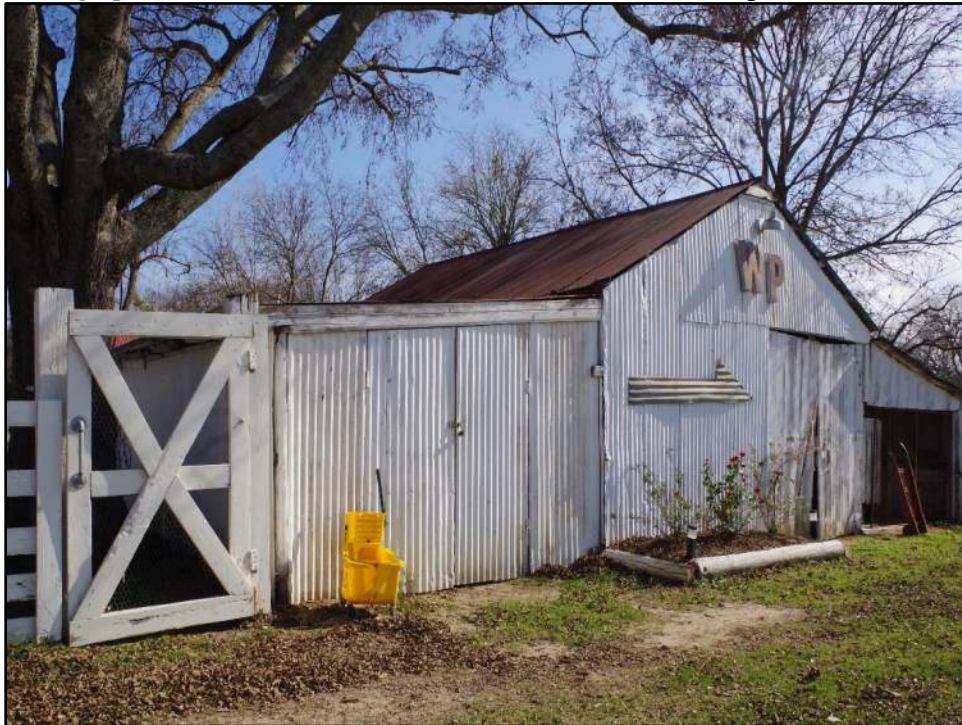
Photograph F-318: View of Resource 68a, camera facing southwest.

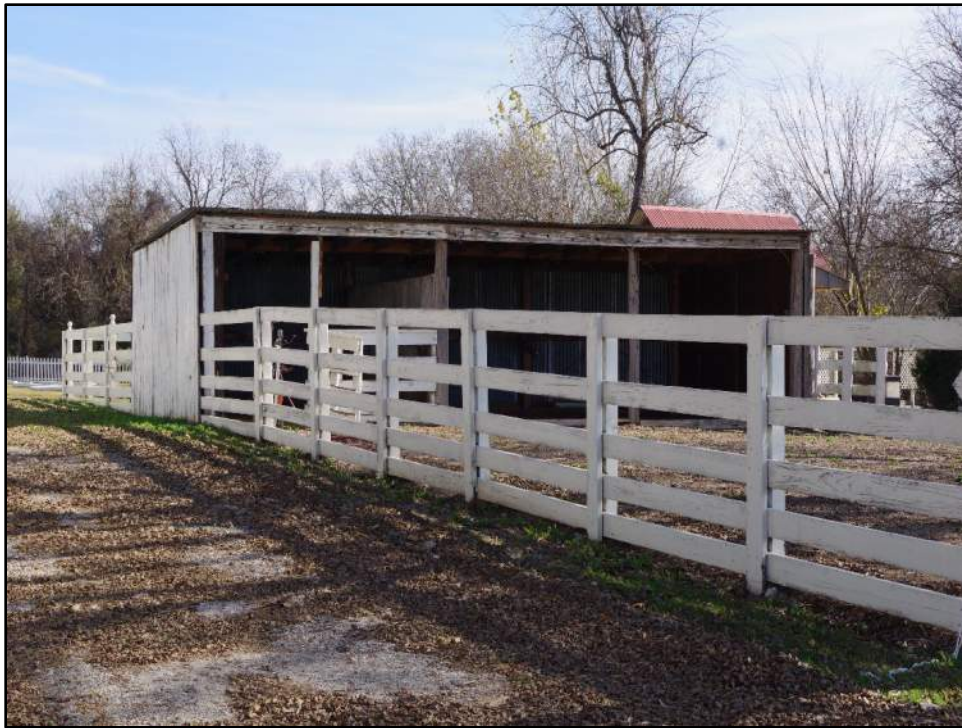
Photograph F-319: View of Resource 68b, camera facing south.

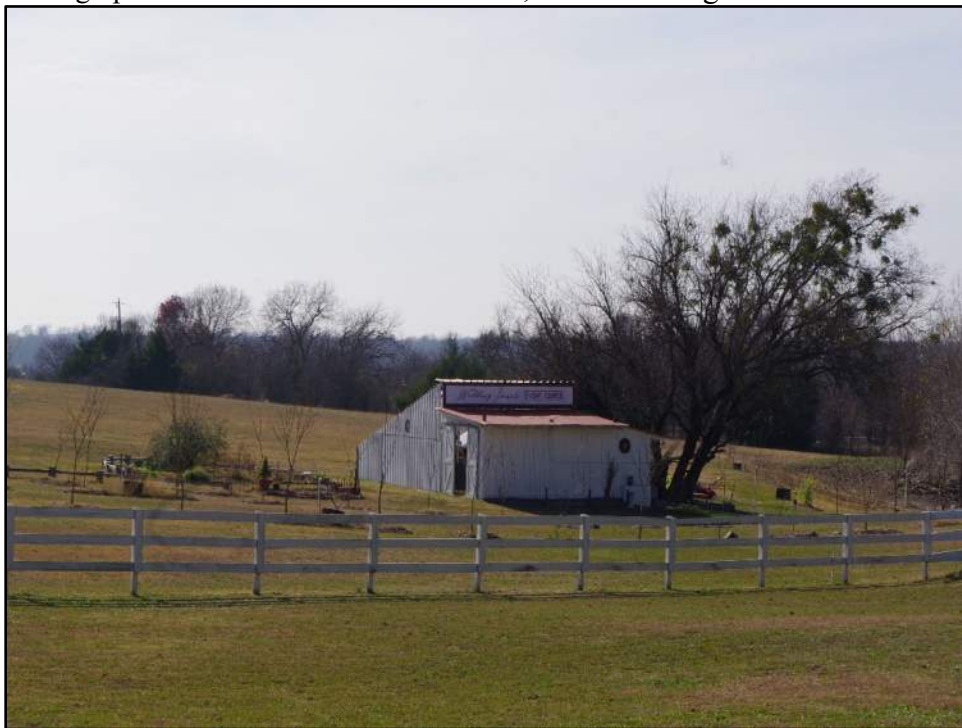
Photograph F-320: View of Resource 68c, camera facing southwest.

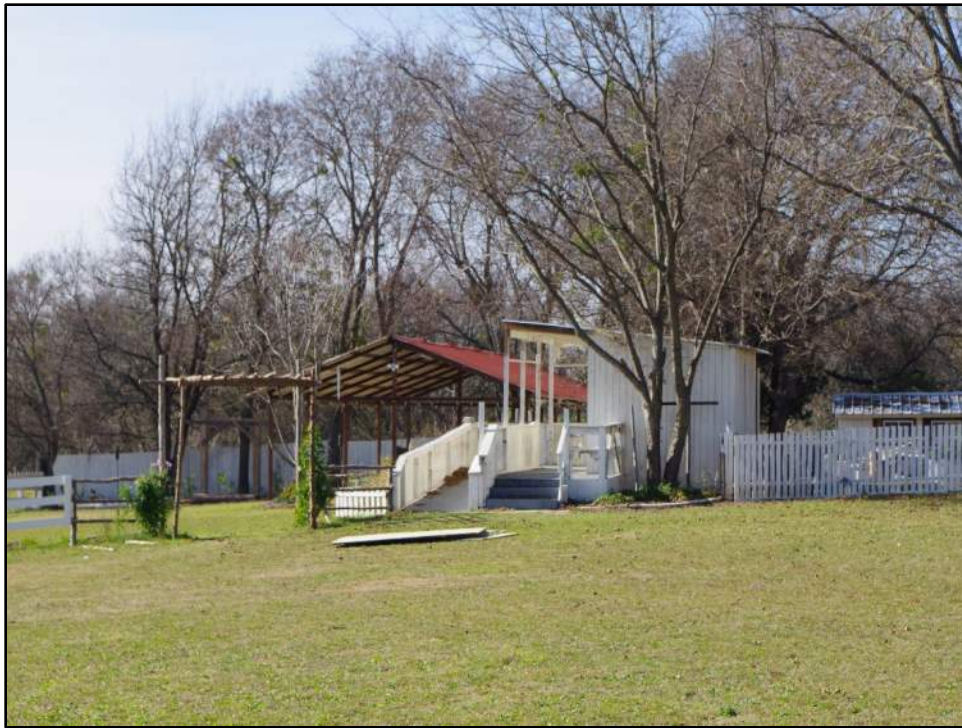
Photograph F-321: View of non-historic-age outbuilding associated with Resource 68, camera facing west.

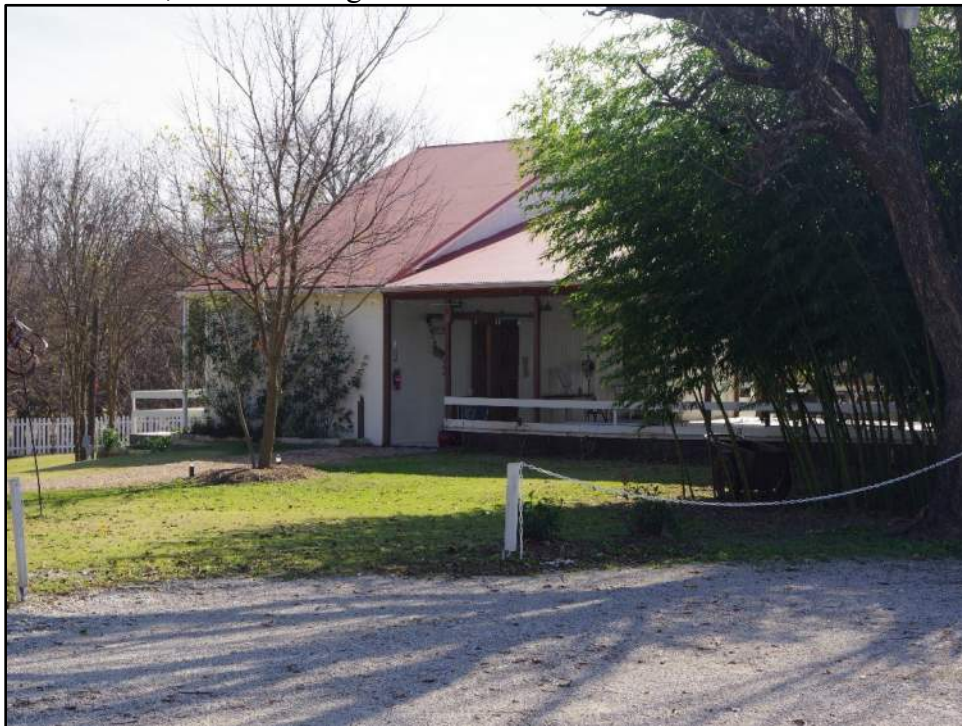
Photograph F-322: View of non-historic-age building associated with Resource 68, camera facing south.

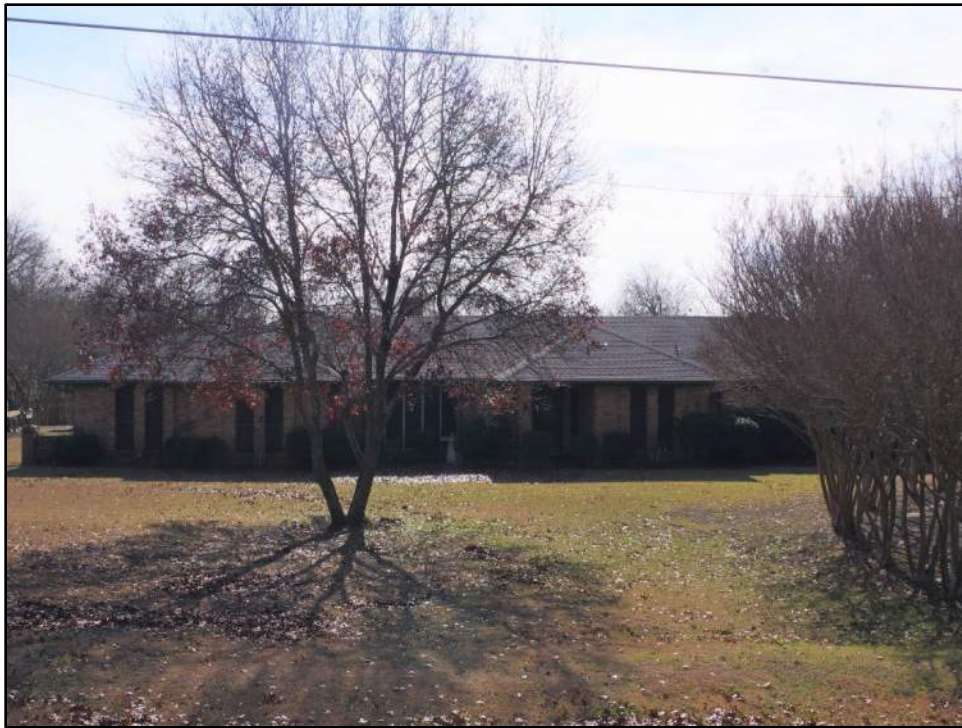
Photograph F-323: View of Resource 69, camera facing south.

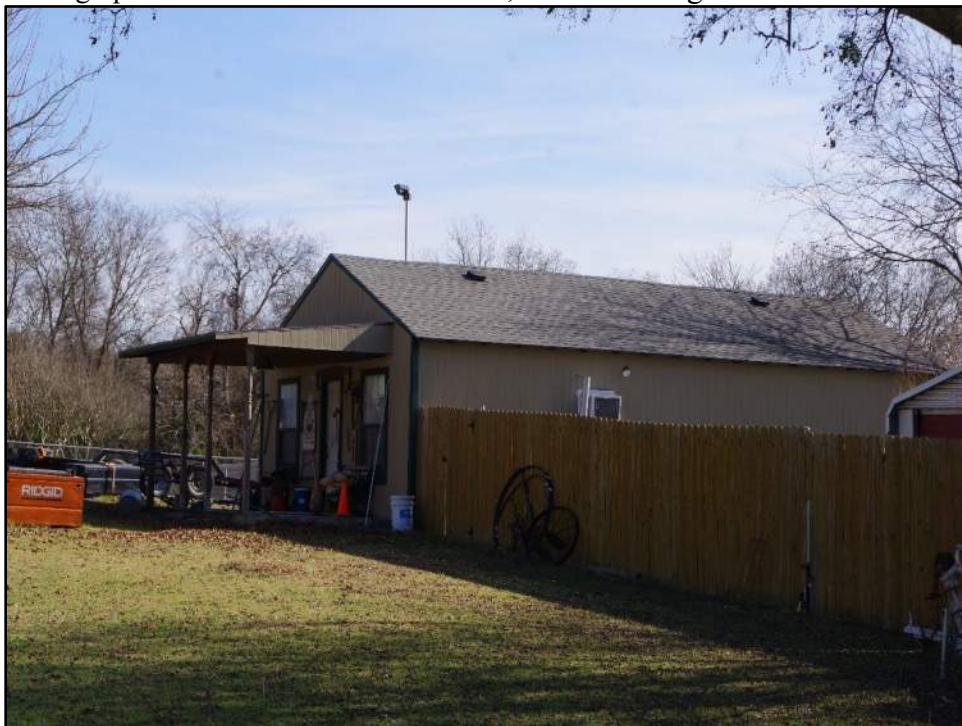
Photograph F-324: View of non-historic-age building associated with Resource 69, camera facing southeast.

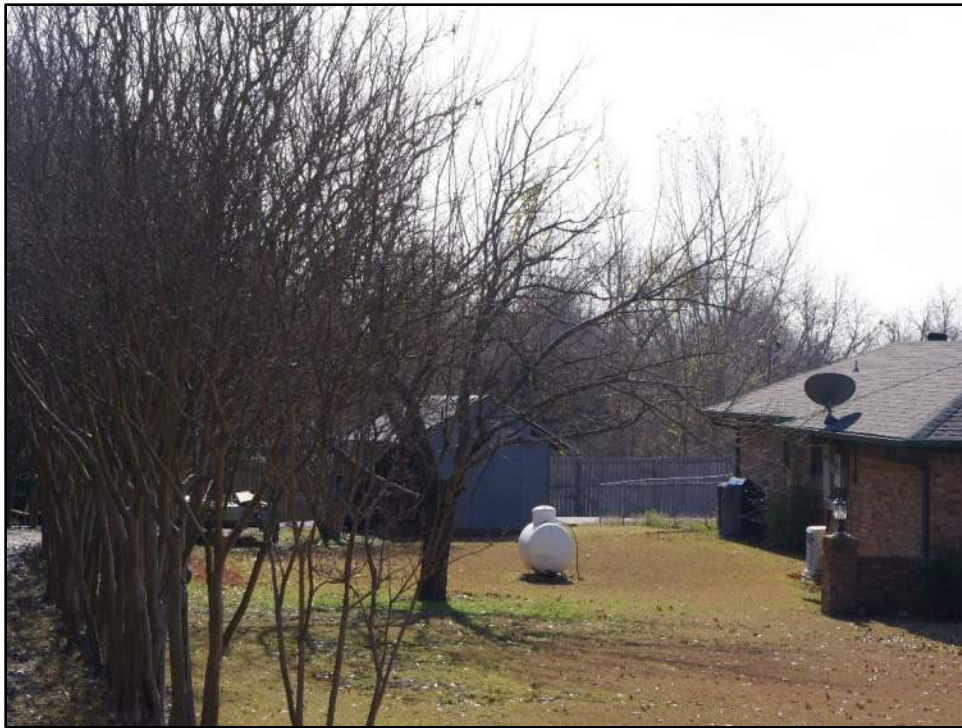
Photograph F-325: View of non-historic-age outbuilding association with Resource 69, camera facing south.

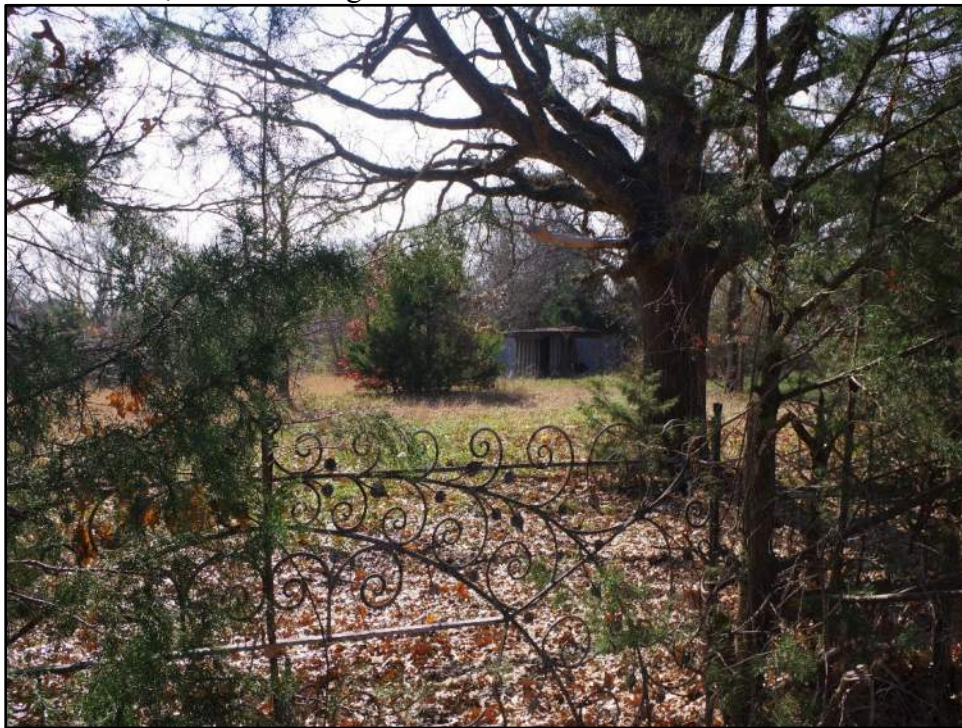
Photograph F-326: View of Resource 70, camera facing southwest.

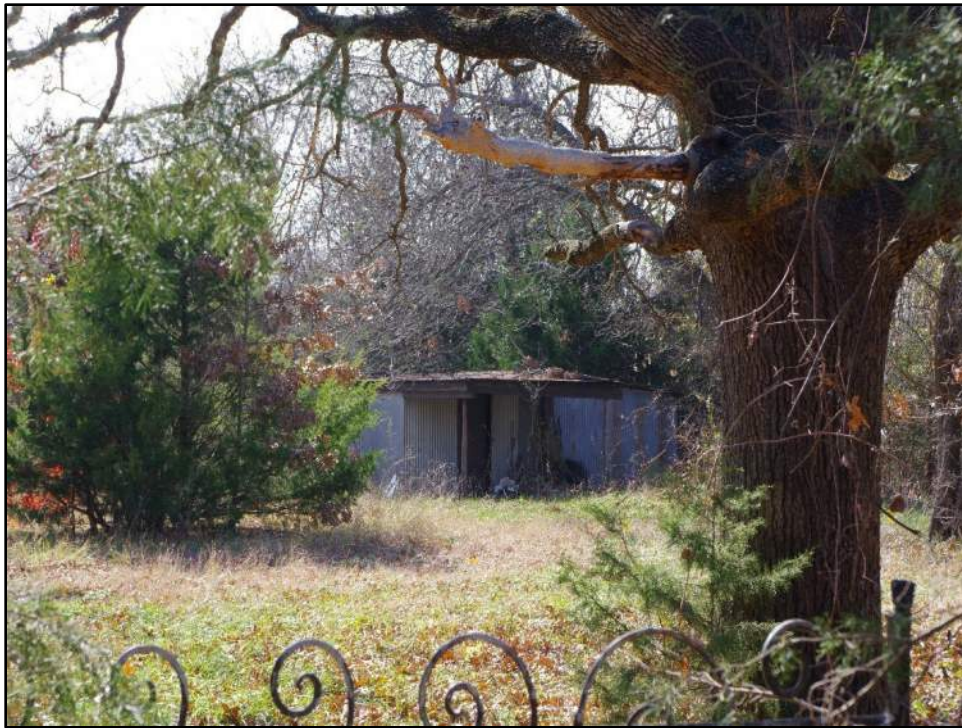
Photograph F-327: View of Resource 70, camera facing southwest.

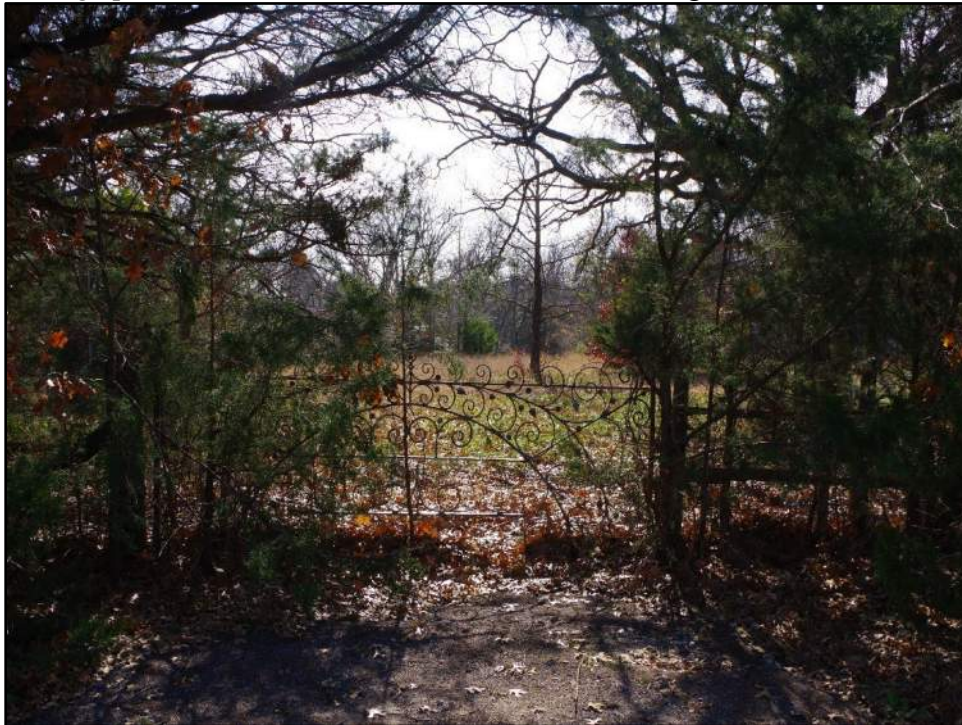
Photograph F-328: View of entrance gate of Resource 70, camera facing south.

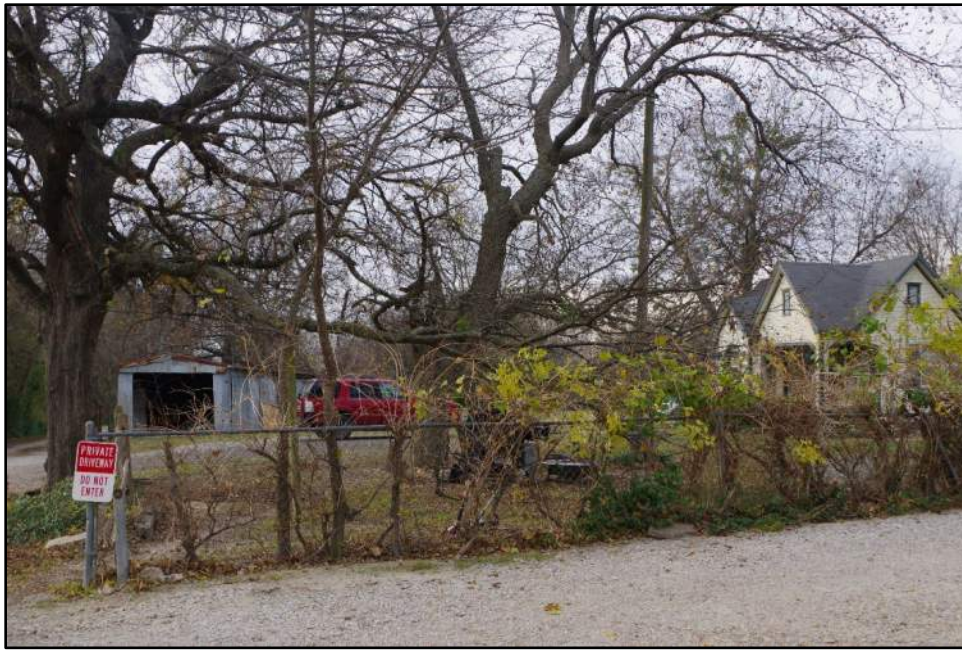
Photograph F-329: Overview of Resource 71, camera facing west.

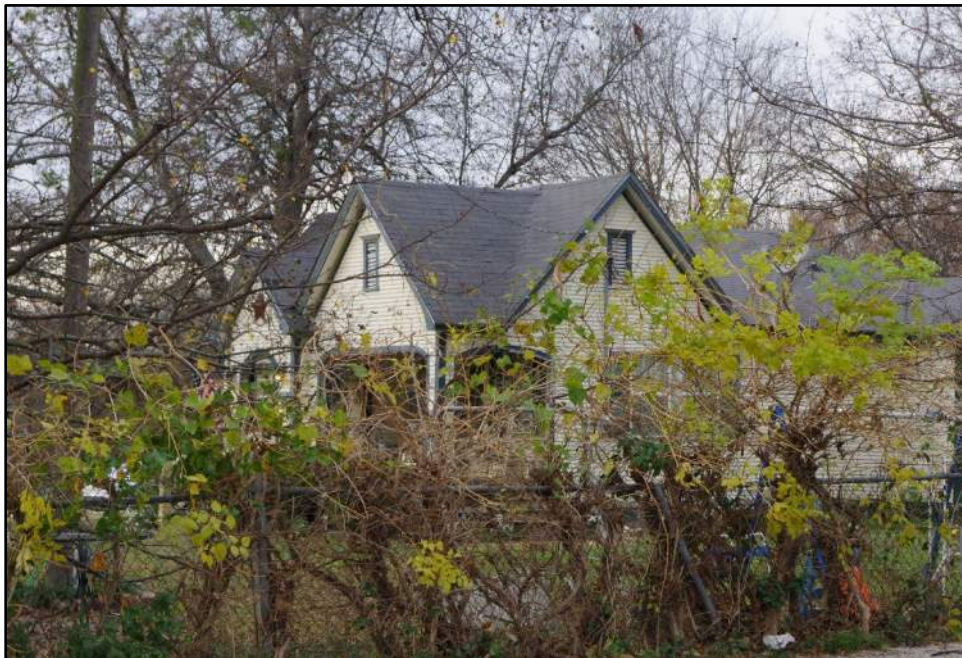
Photograph F-330: View of Resource 71a, camera facing northwest.
