APPENDIX L: Cultural Resources

APPENDIX L – CULTURAL RESOURCES – FEIS Preferred Alternative/Blue Alternative

US 380 MCKINNEY – Coit Road to FM 1827, Collin County CSJs 0135-02-065 and 0135-15-002; Dallas District

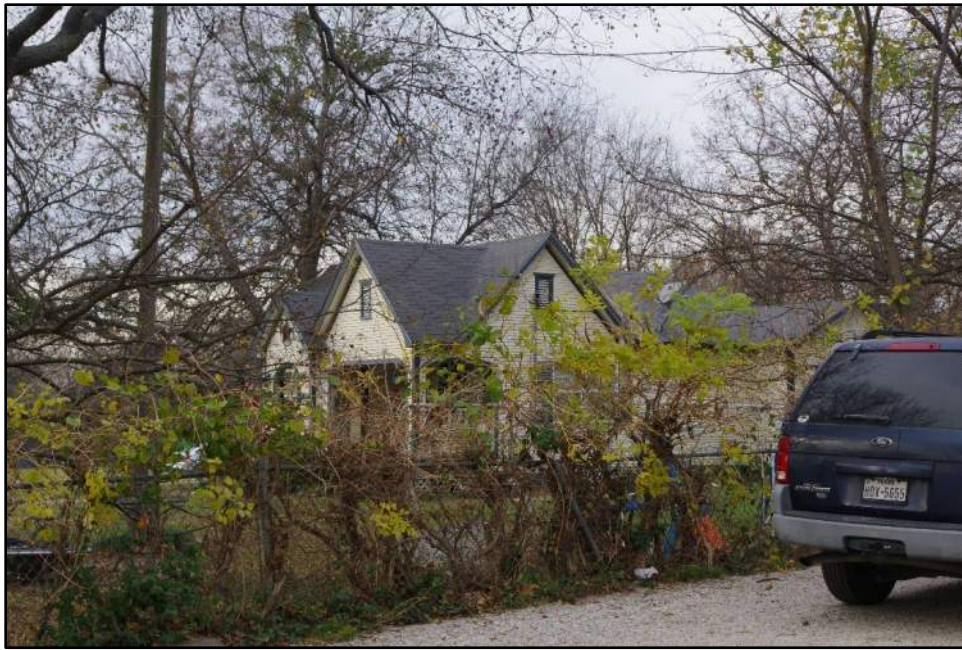
Photograph F-331: View of Resource 71a, camera facing northwest.

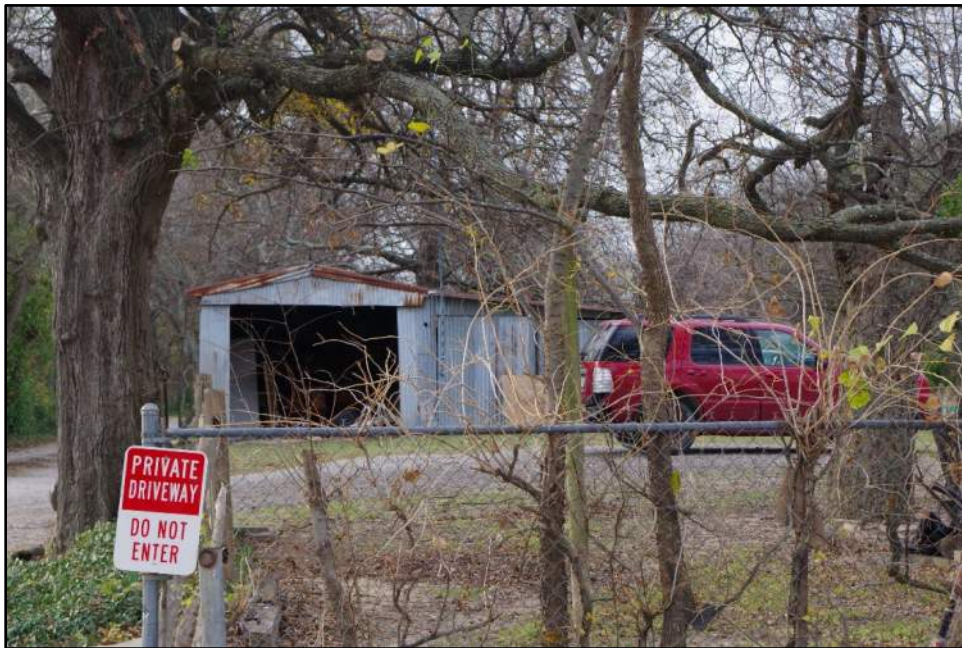
Photograph F-332: View of Resource 71b, camera facing west.

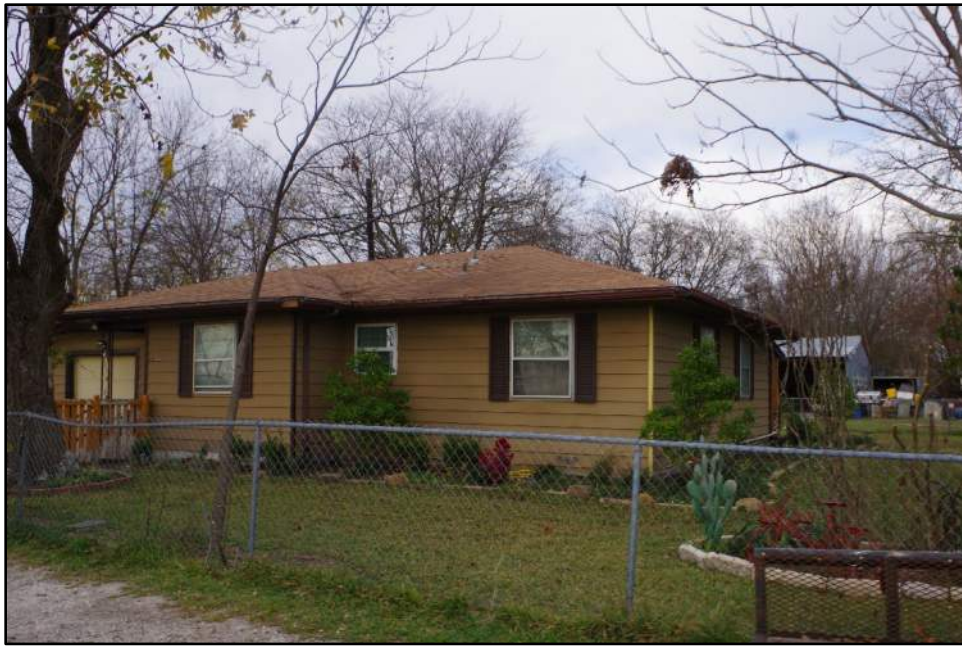
Photograph F-333: Overview of Resource 72, camera facing northwest.

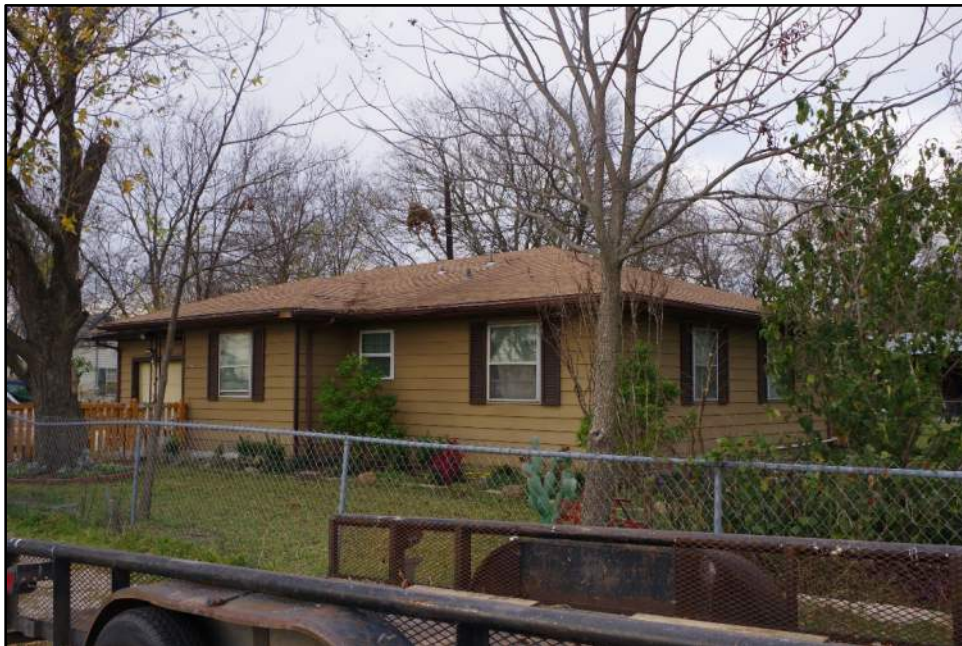
Photograph F-334: View of Resource 72a, camera facing northwest.

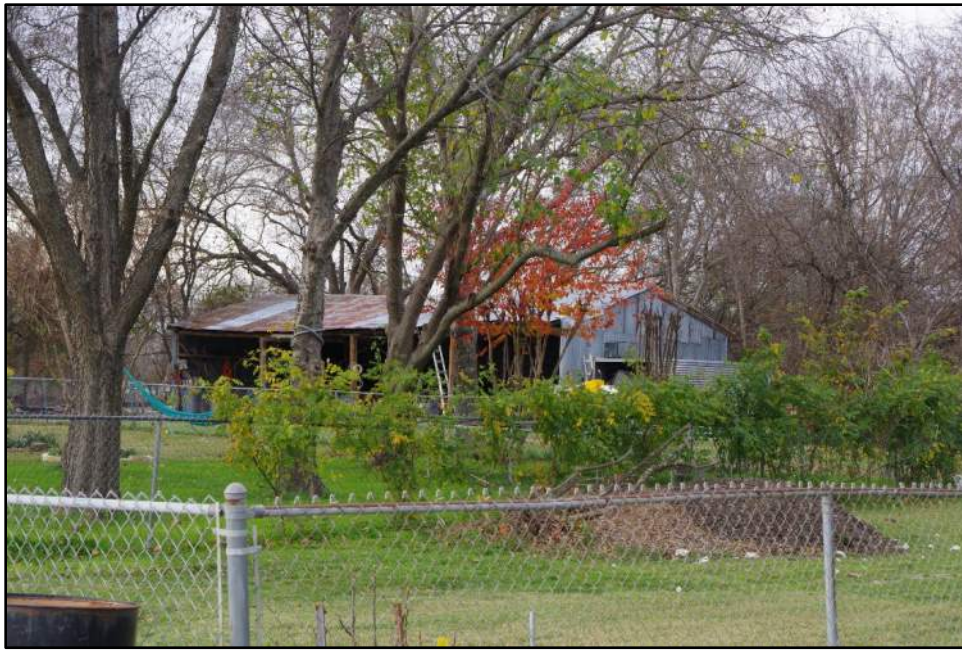
Photograph F-335: View of Resource 72b, camera facing northwest.

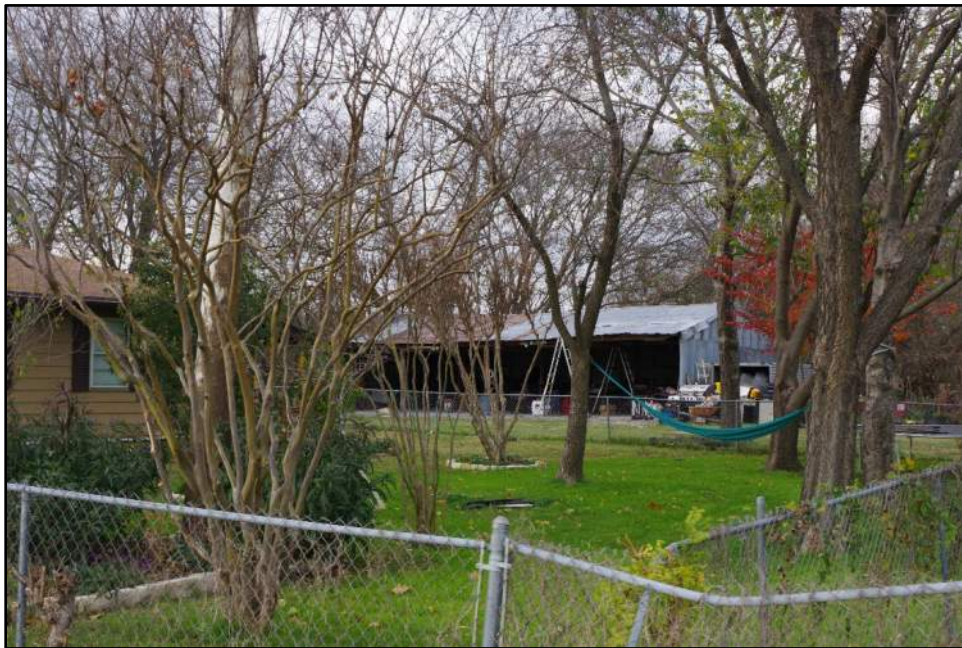
Photograph F-336: View of Resource 72b, camera facing northwest.

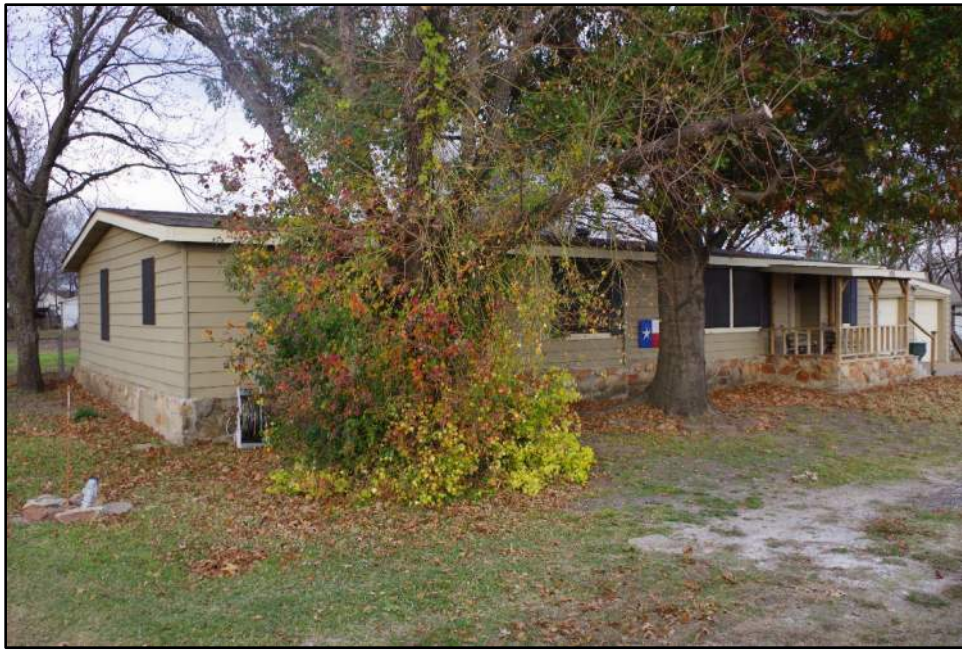
Photograph F-337: View of Resource 73, camera facing northeast.

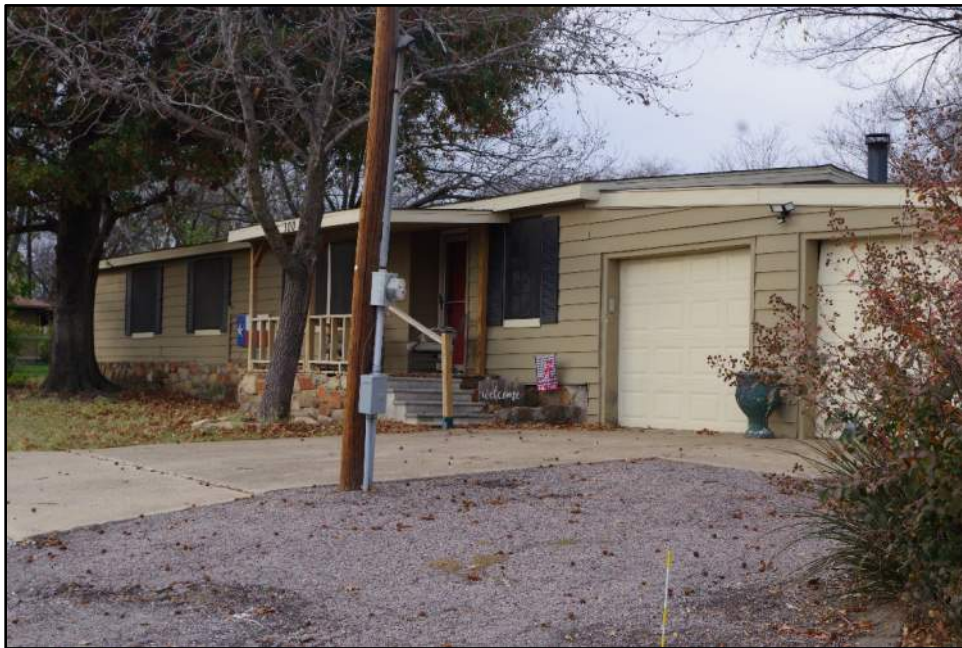
Photograph F-338: View of Resource 73, camera facing northwest.

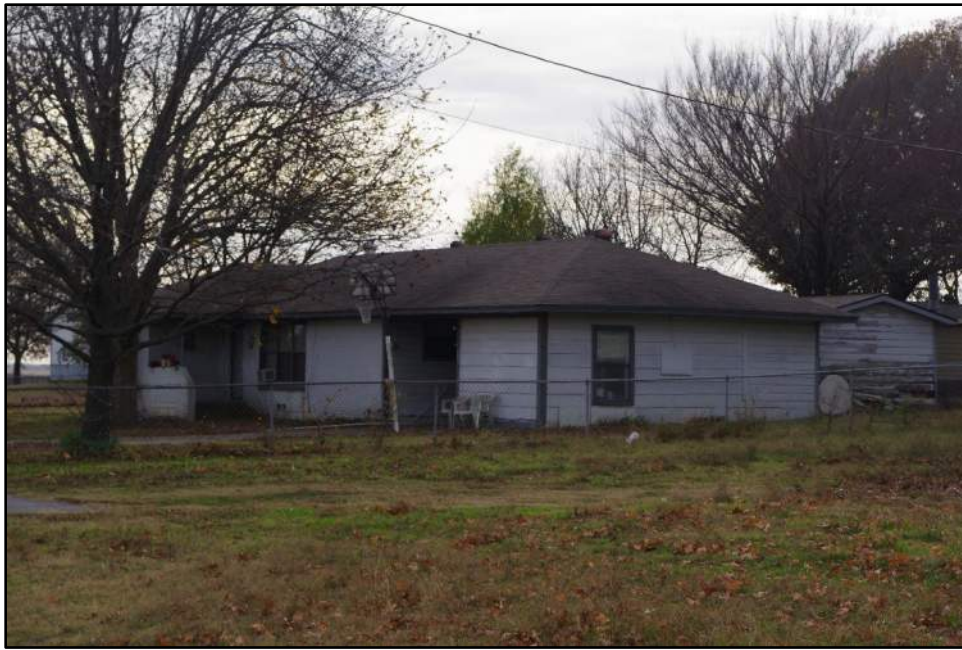
Photograph F-339: View of Resource 74, camera facing southwest.

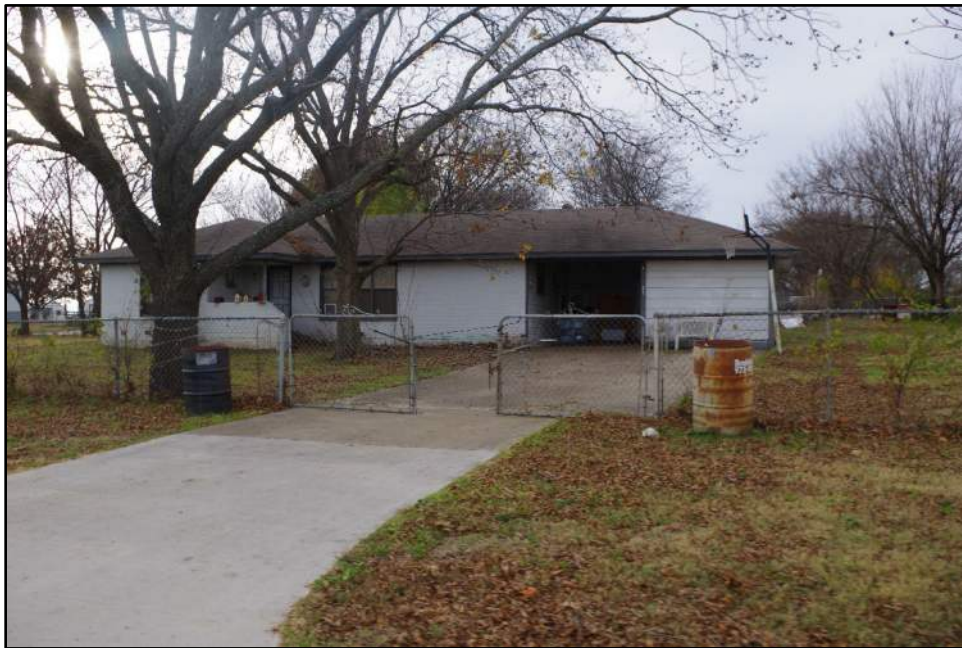
Photograph F-340: View of Resource 74, camera facing west.

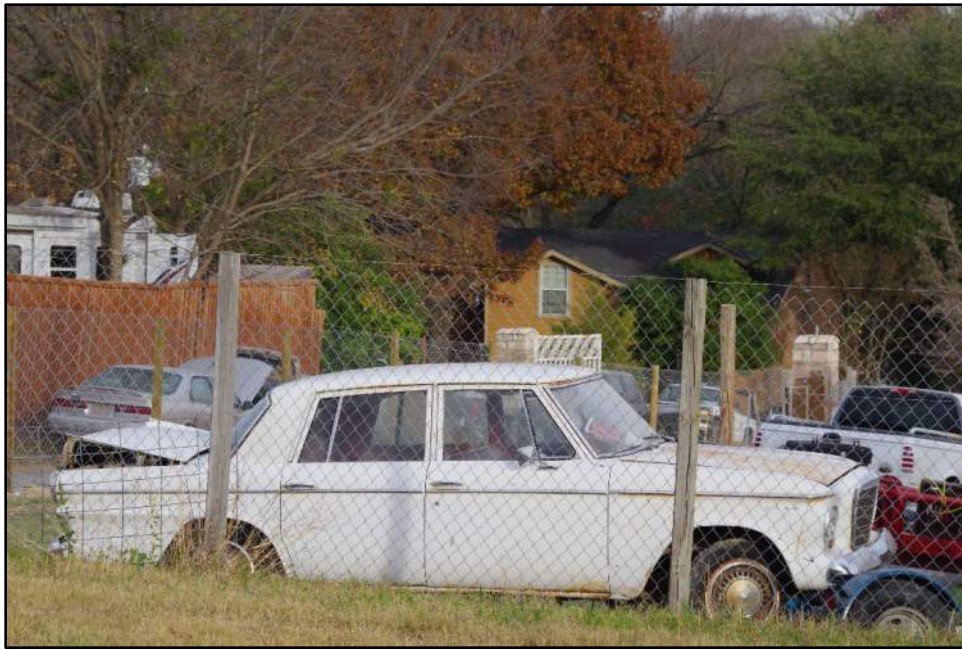
Photograph F-341: Obstructed view of Resource 75, camera facing east.

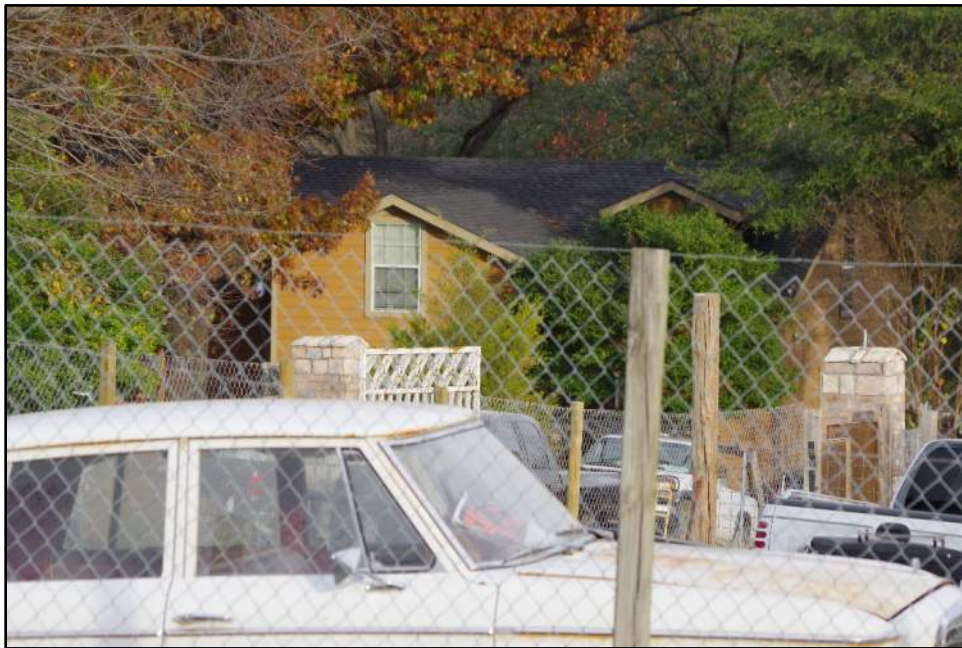
Photograph F-342: Obstructed view of Resource 75, camera facing east.

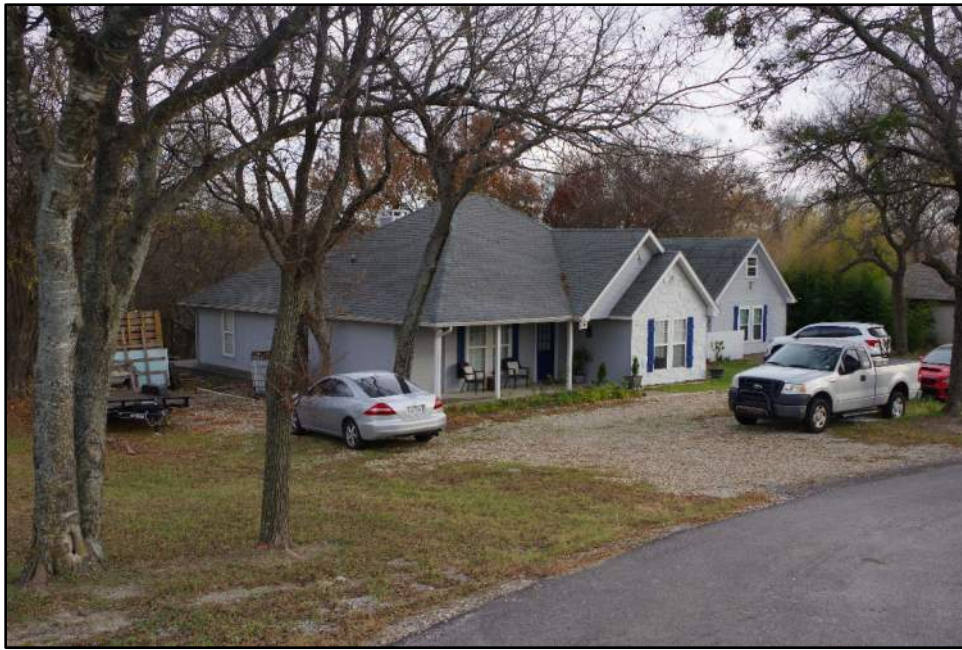
Photograph F-343: View of Resource 76, camera facing southeast.

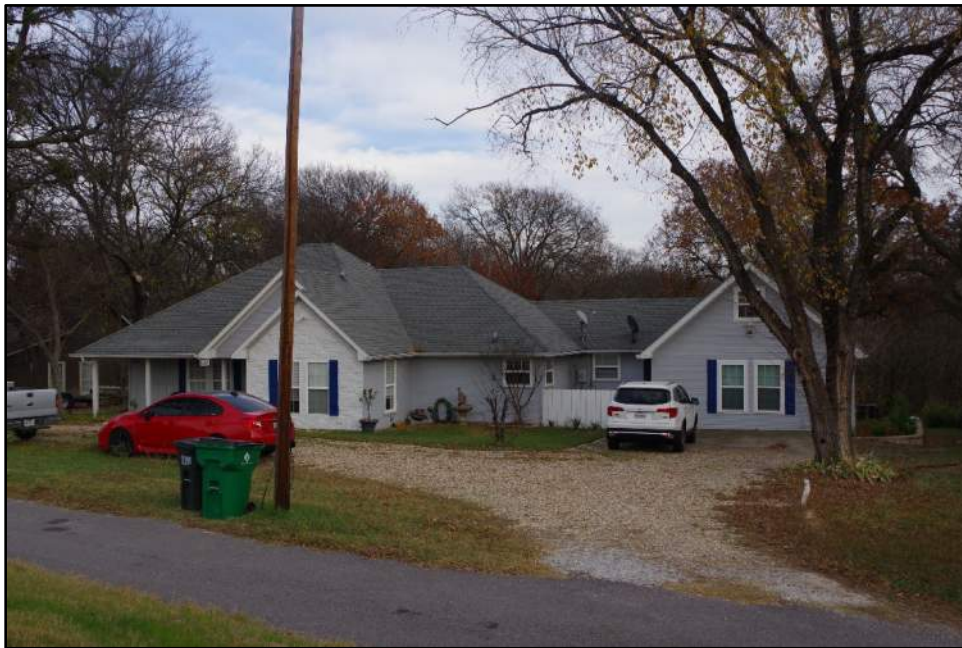
Photograph F-344: View of Resource 76, camera facing northeast.

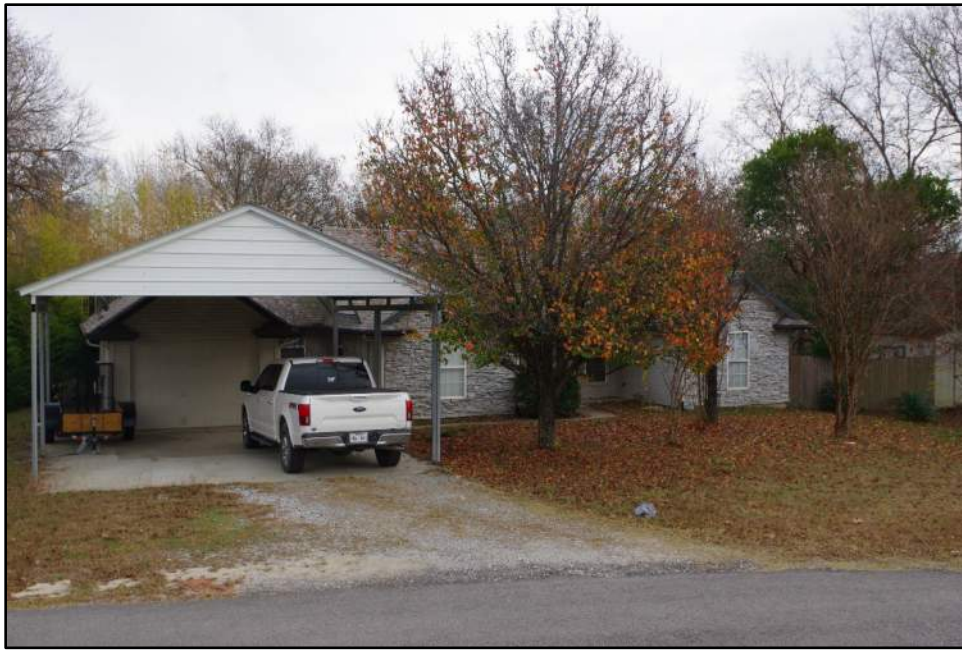
Photograph F-345: Overview of Resource 77, camera facing southeast.

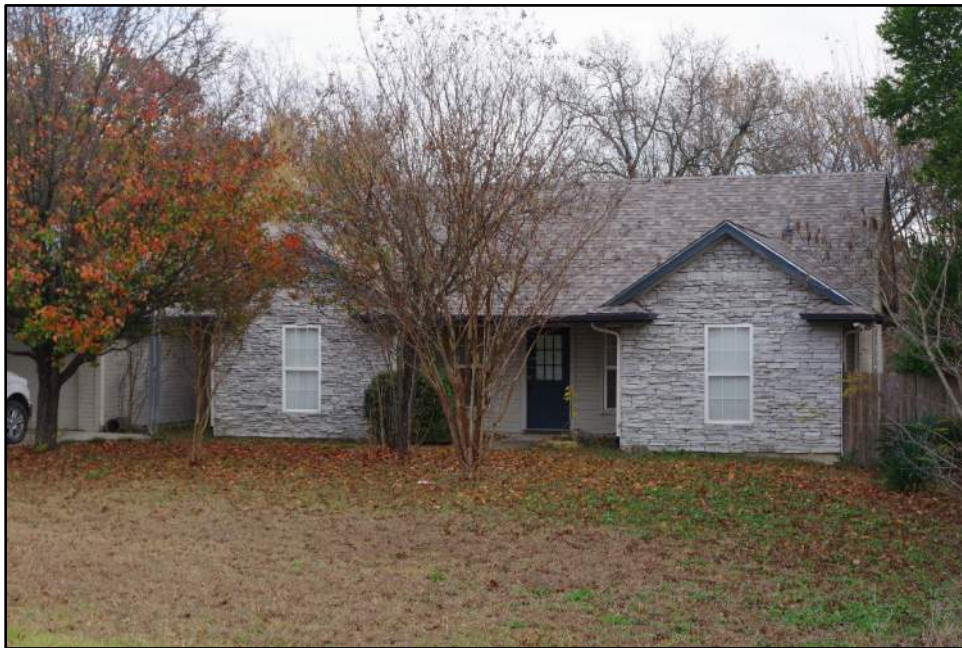
Photograph F-346: View of Resource 77, camera facing east.

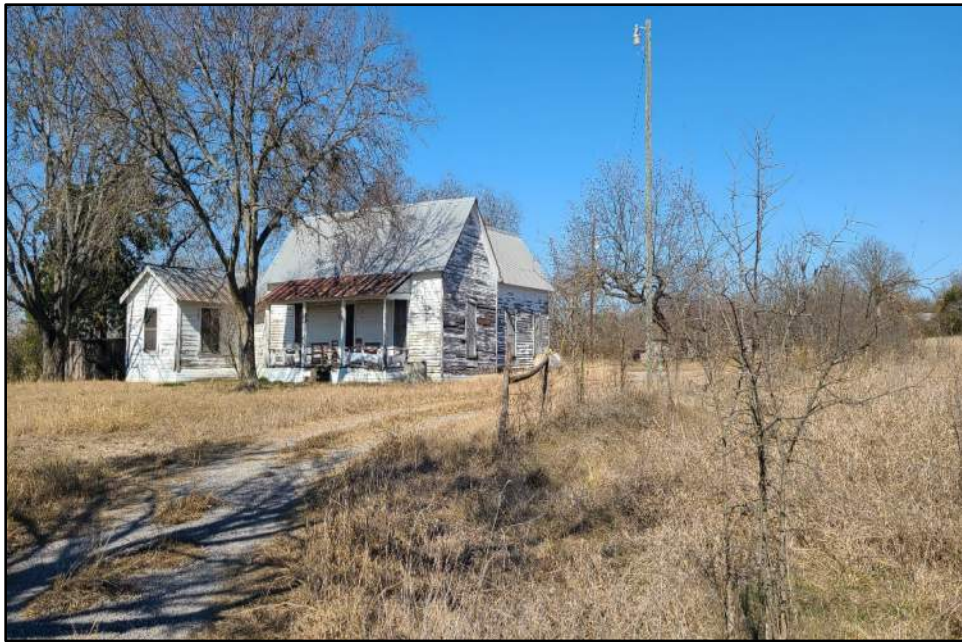
Photograph F-347: View of Resource 78a, camera facing northwest.

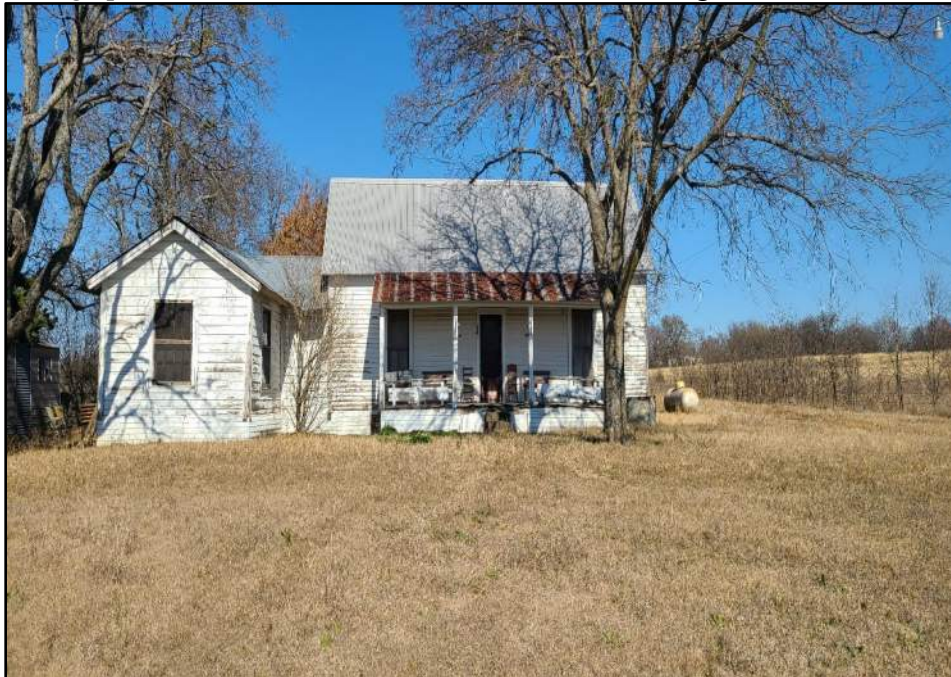
Photograph F-348: View of Resource 78a, camera facing north.

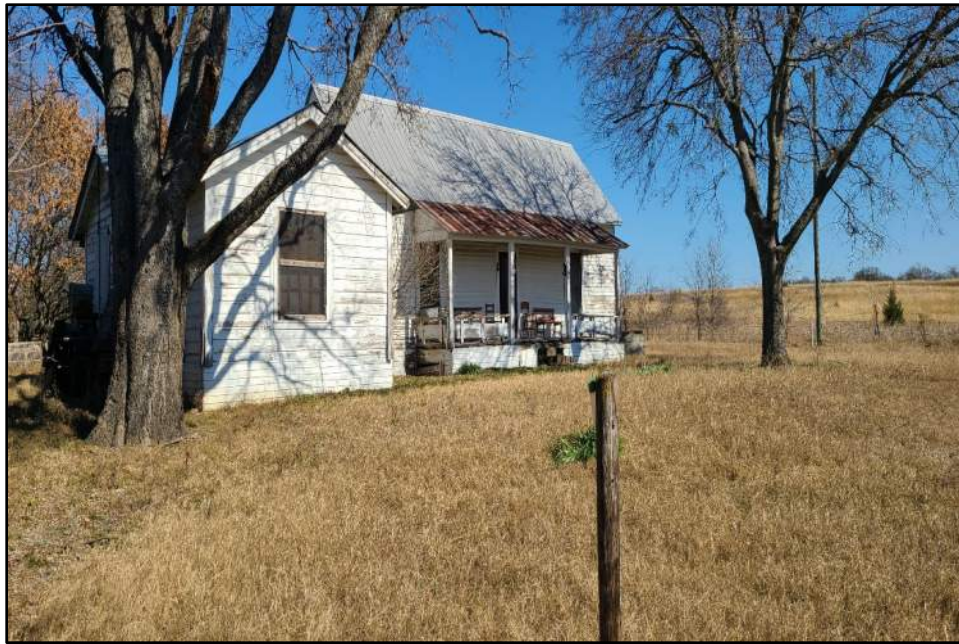
Photograph F-349: View of Resource 78a, camera facing northeast.

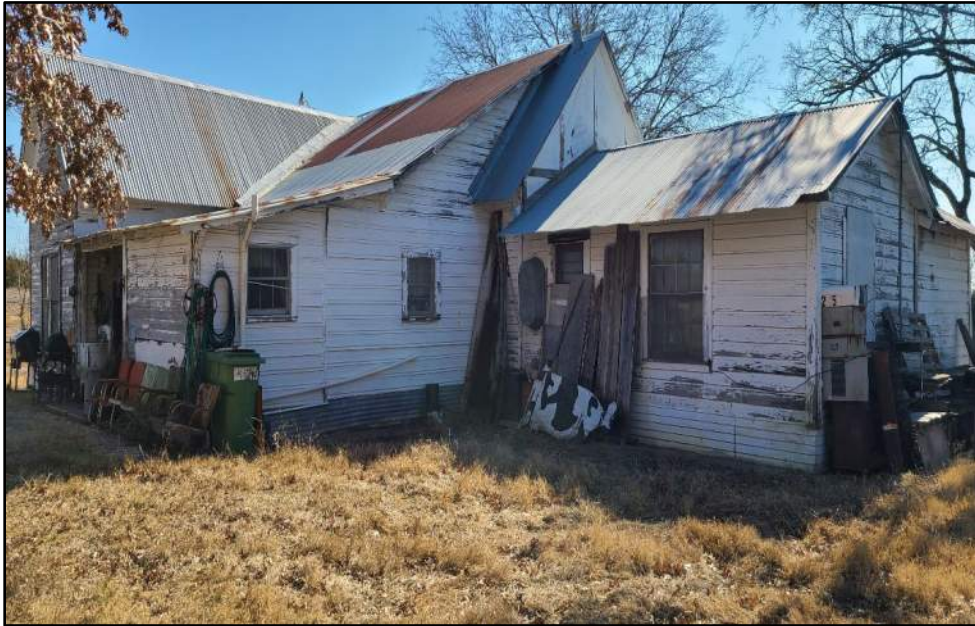
Photograph F-350: View of Resource 78a, camera facing southeast.

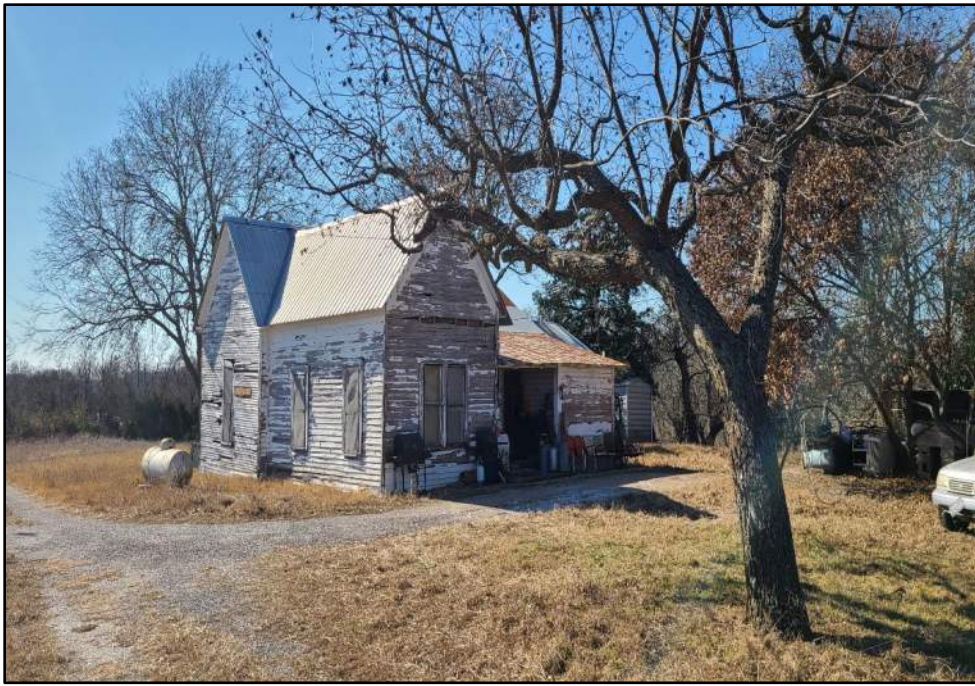
Photograph F-351: View of Resource 78a, camera facing southwest.

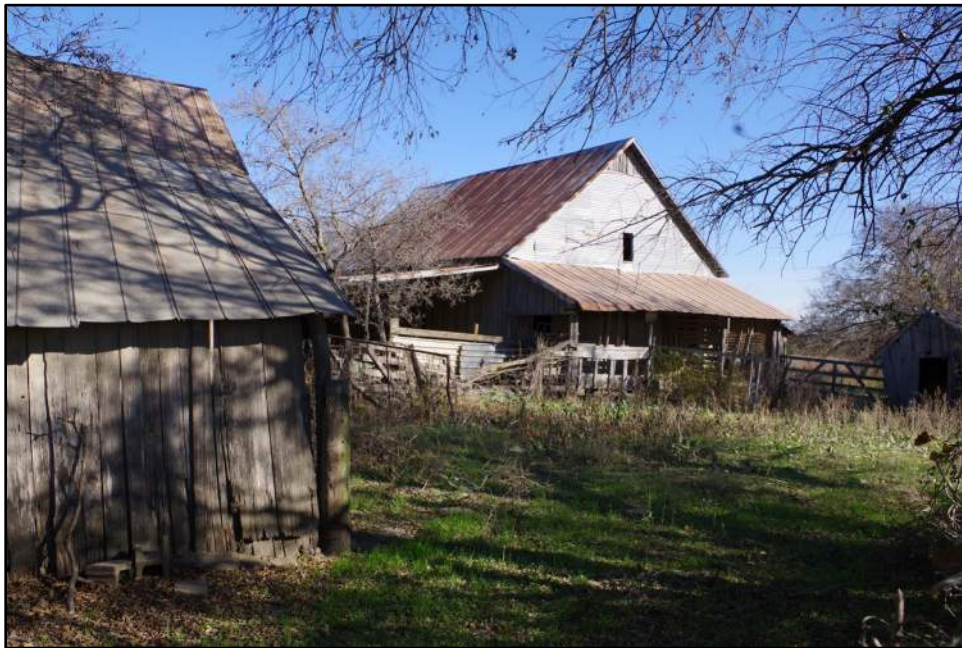
Photograph 10: View of former farmstead at 3734 County Road 164, camera facing northeast.

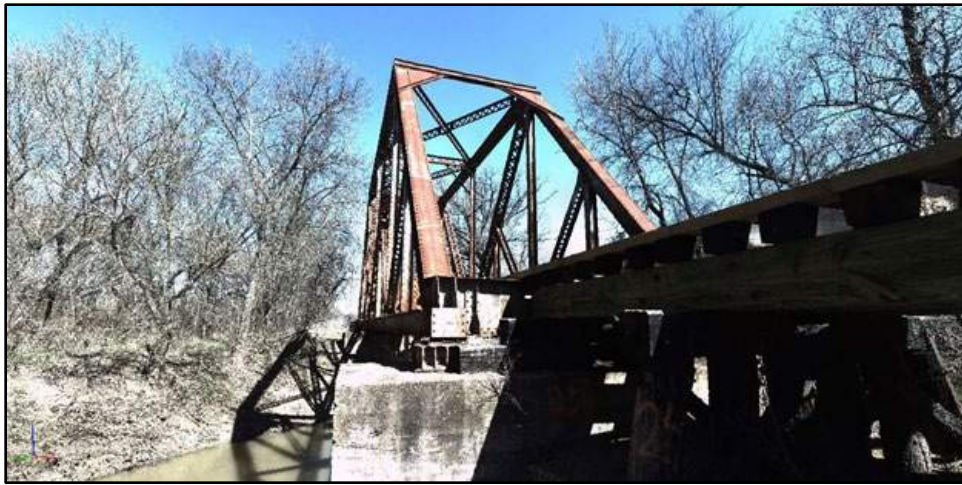
Photograph 15: Railroad Truss Bridge over East Fork Trinity River.

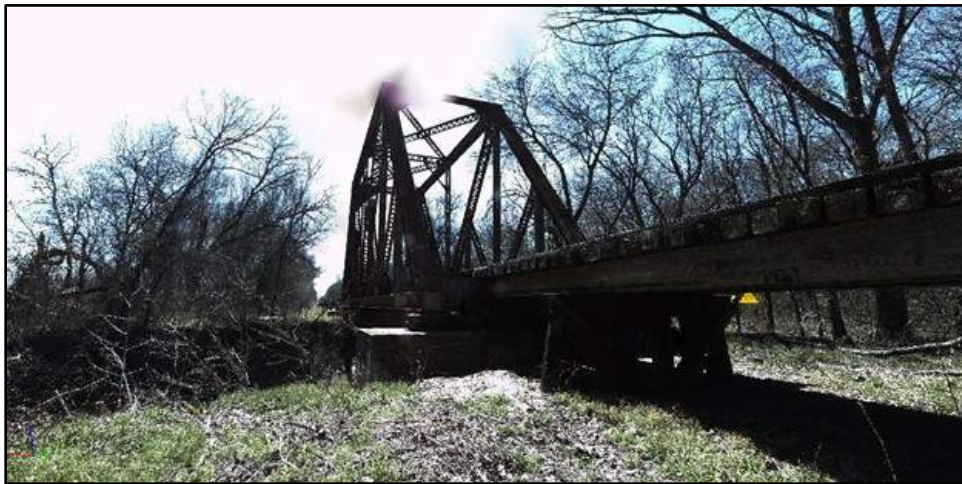
Photograph 16: Railroad Truss Bridge over East Fork Trinity River.

Regarding the truss railroad bridge (Photos 15 & 16 in the TxDot package). Possibly a relic of the Interurban railroad.

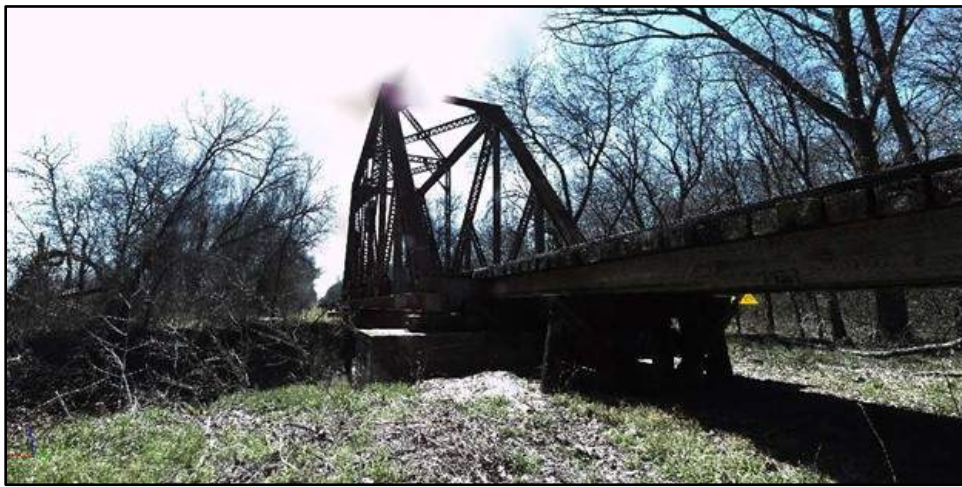
Photograph 16: Railroad Truss Bridge over East Fork Trinity River.

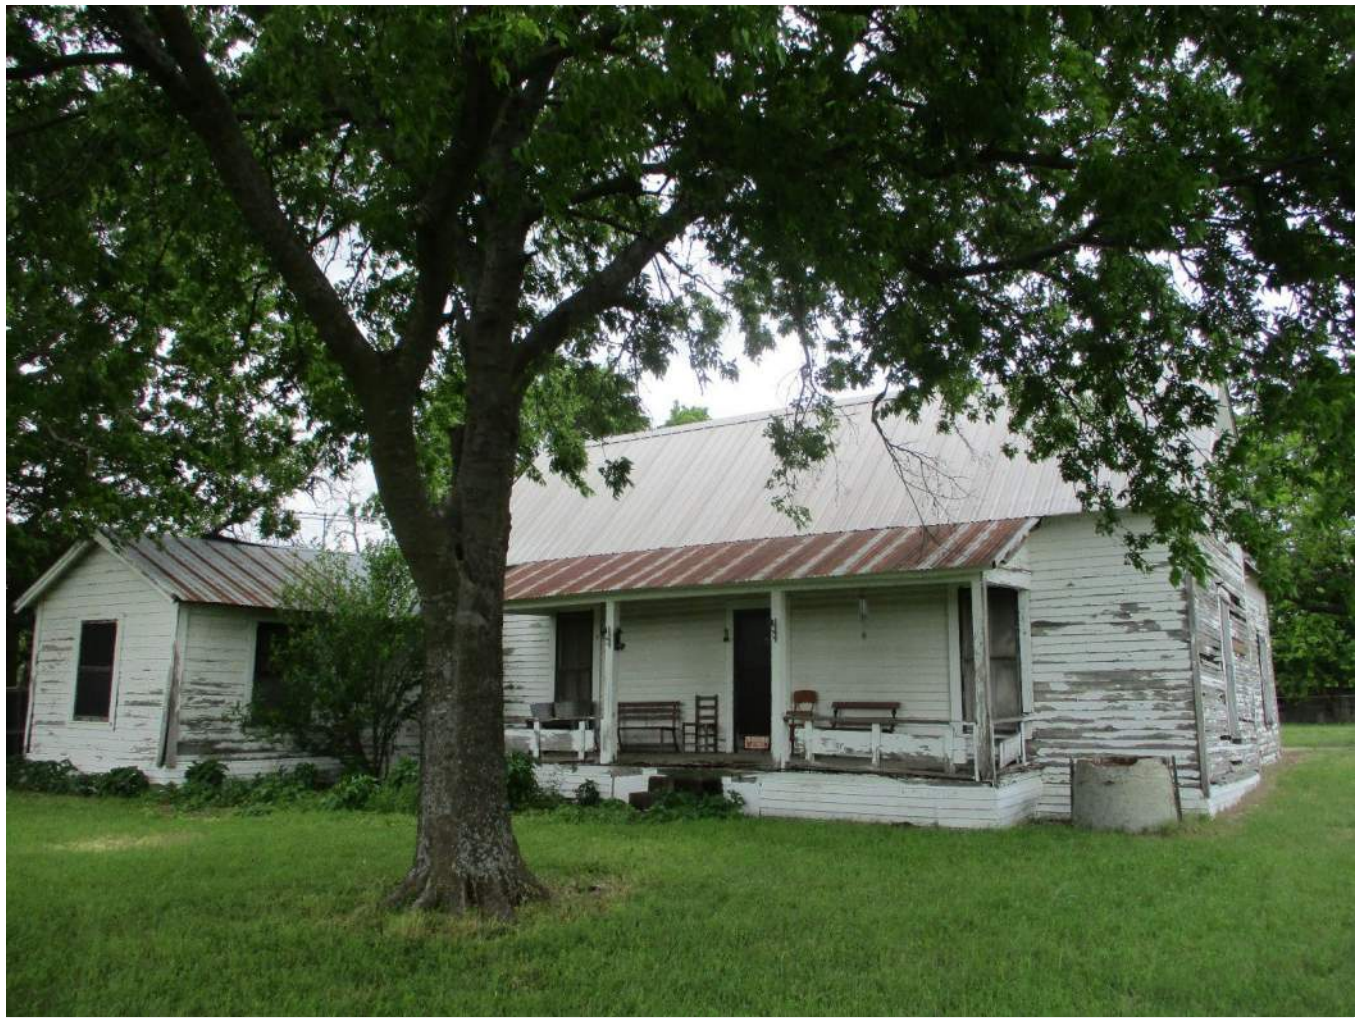
Resource 01a southern elevation, facing northwest.

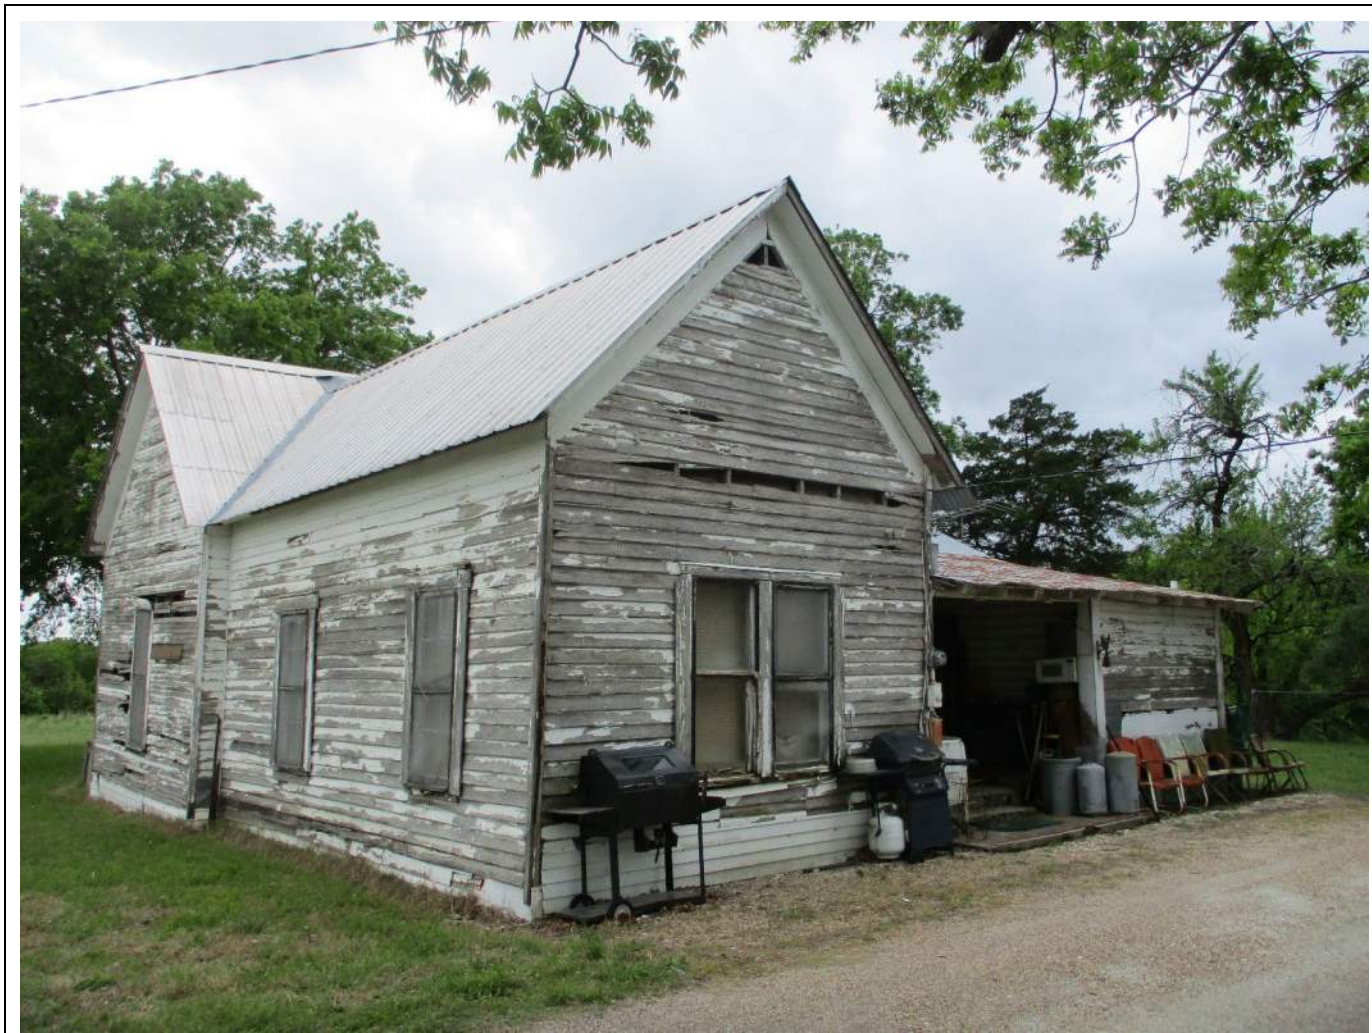
Resource 01a eastern elevation and northern ell, facing southwest.

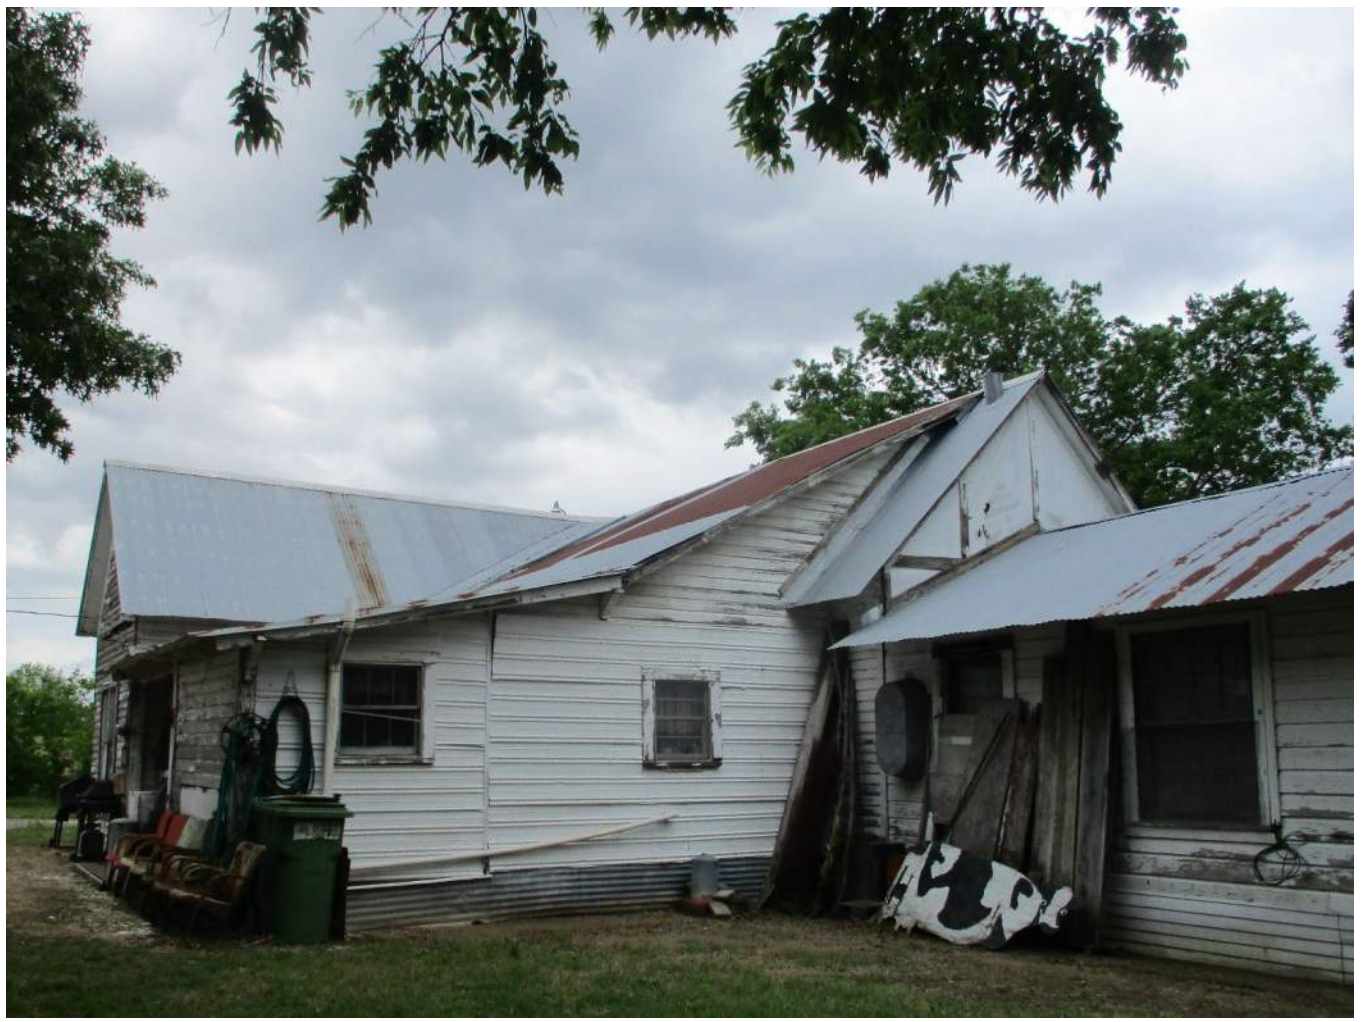
Resource 01a western elevation, facing southeast.

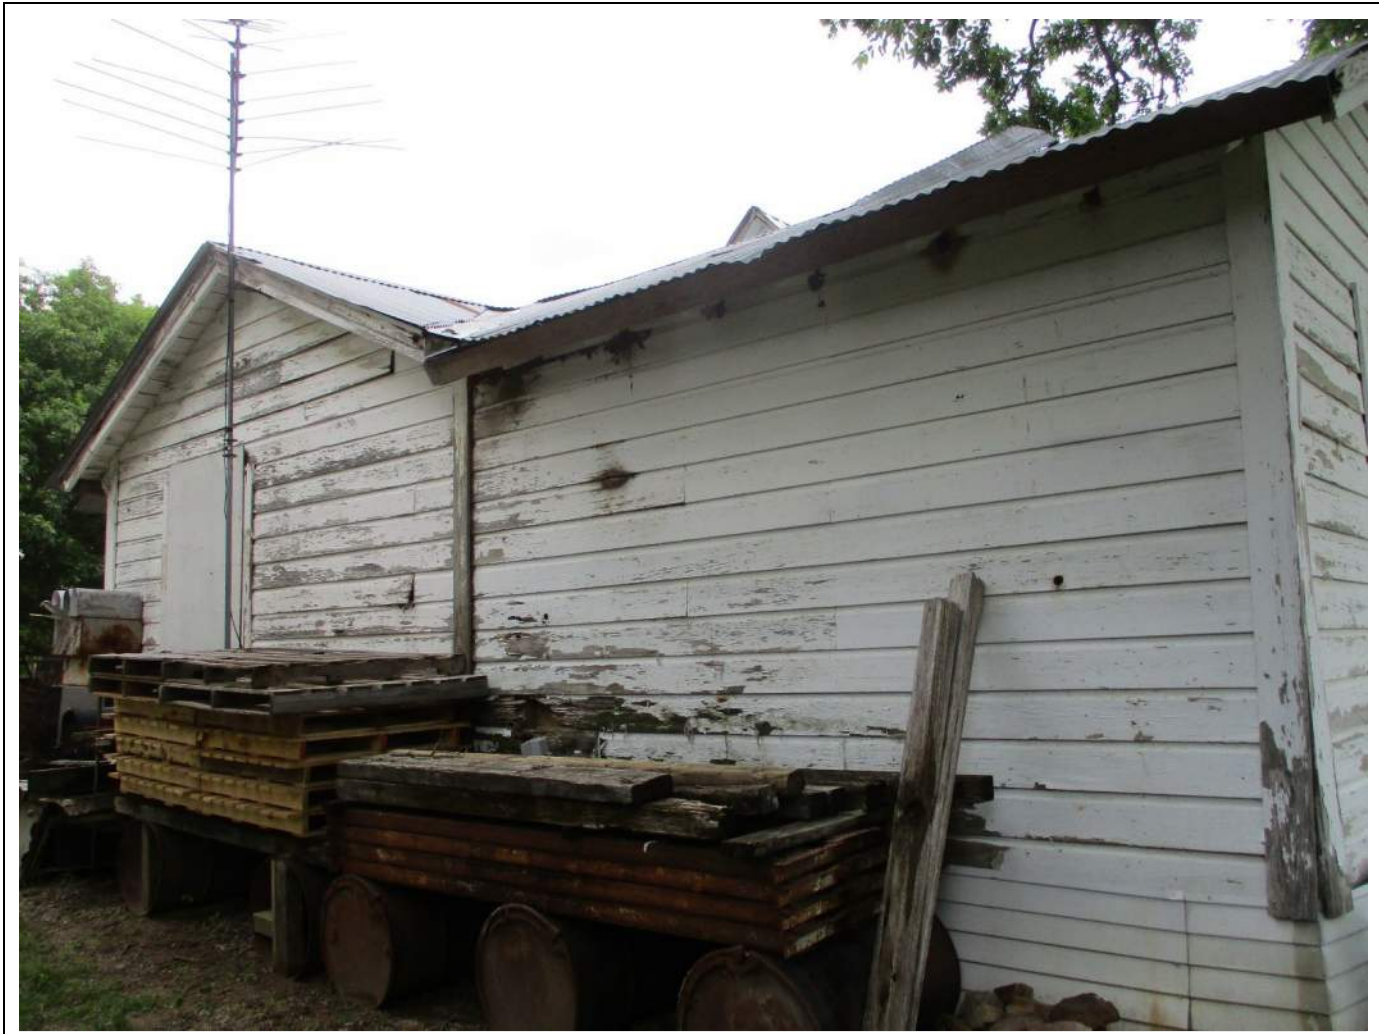
Resource 01a western addition elevation, facing southeast.

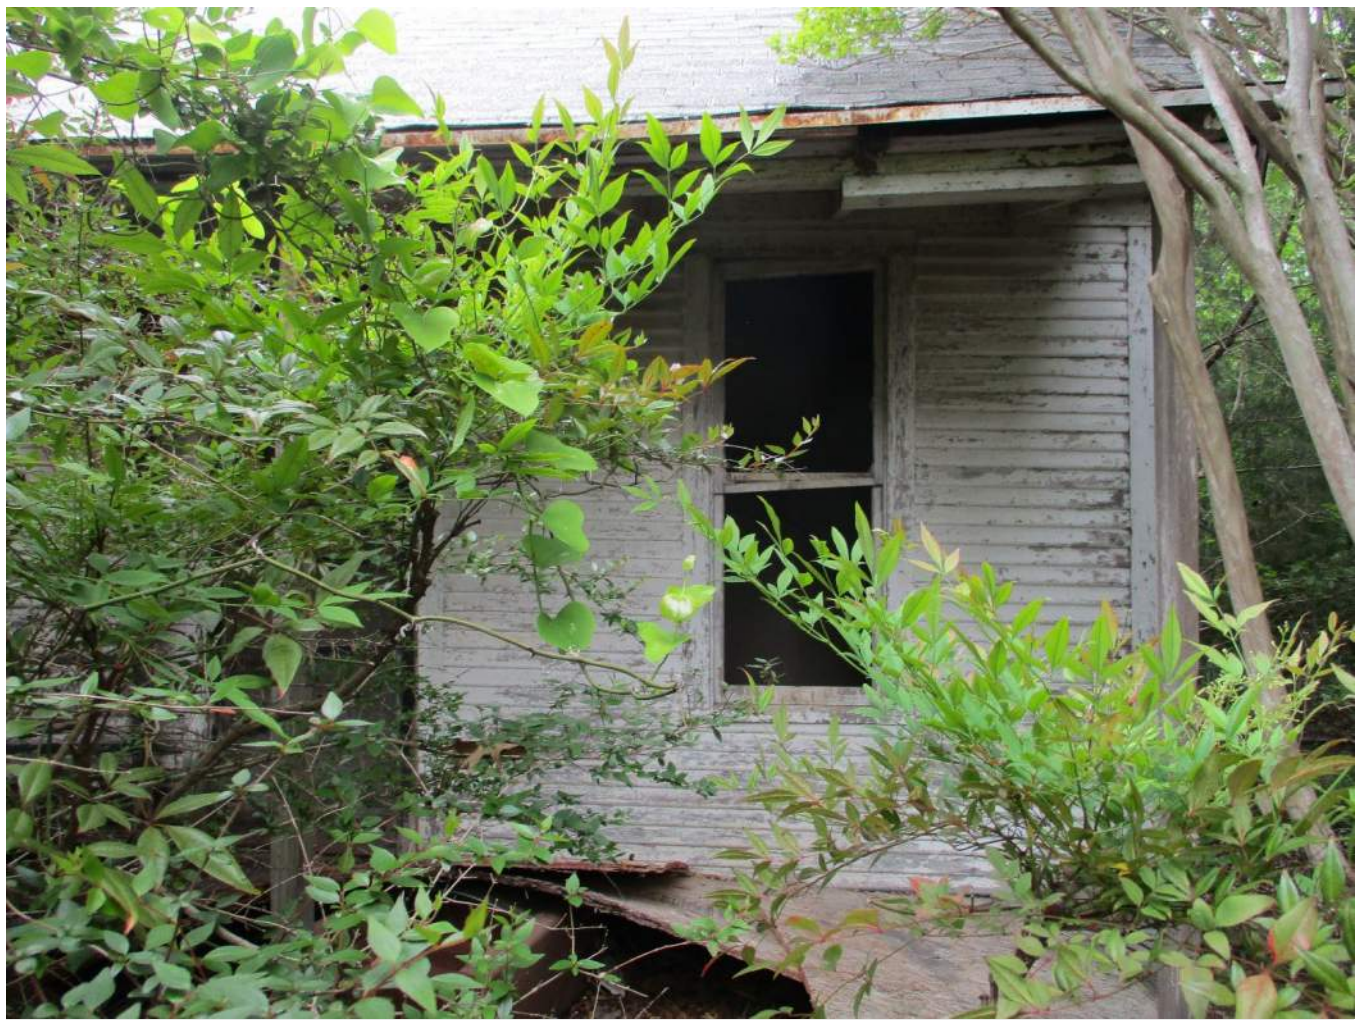
Resource 01b southern elevation, facing north.
