APPENDIX L: Cultural Resources

APPENDIX L – CULTURAL RESOURCES – FEIS Preferred Alternative/Blue Alternative

US 380 MCKINNEY – Coit Road to FM 1827, Collin County CSJs 0135-02-065 and 0135-15-002; Dallas District

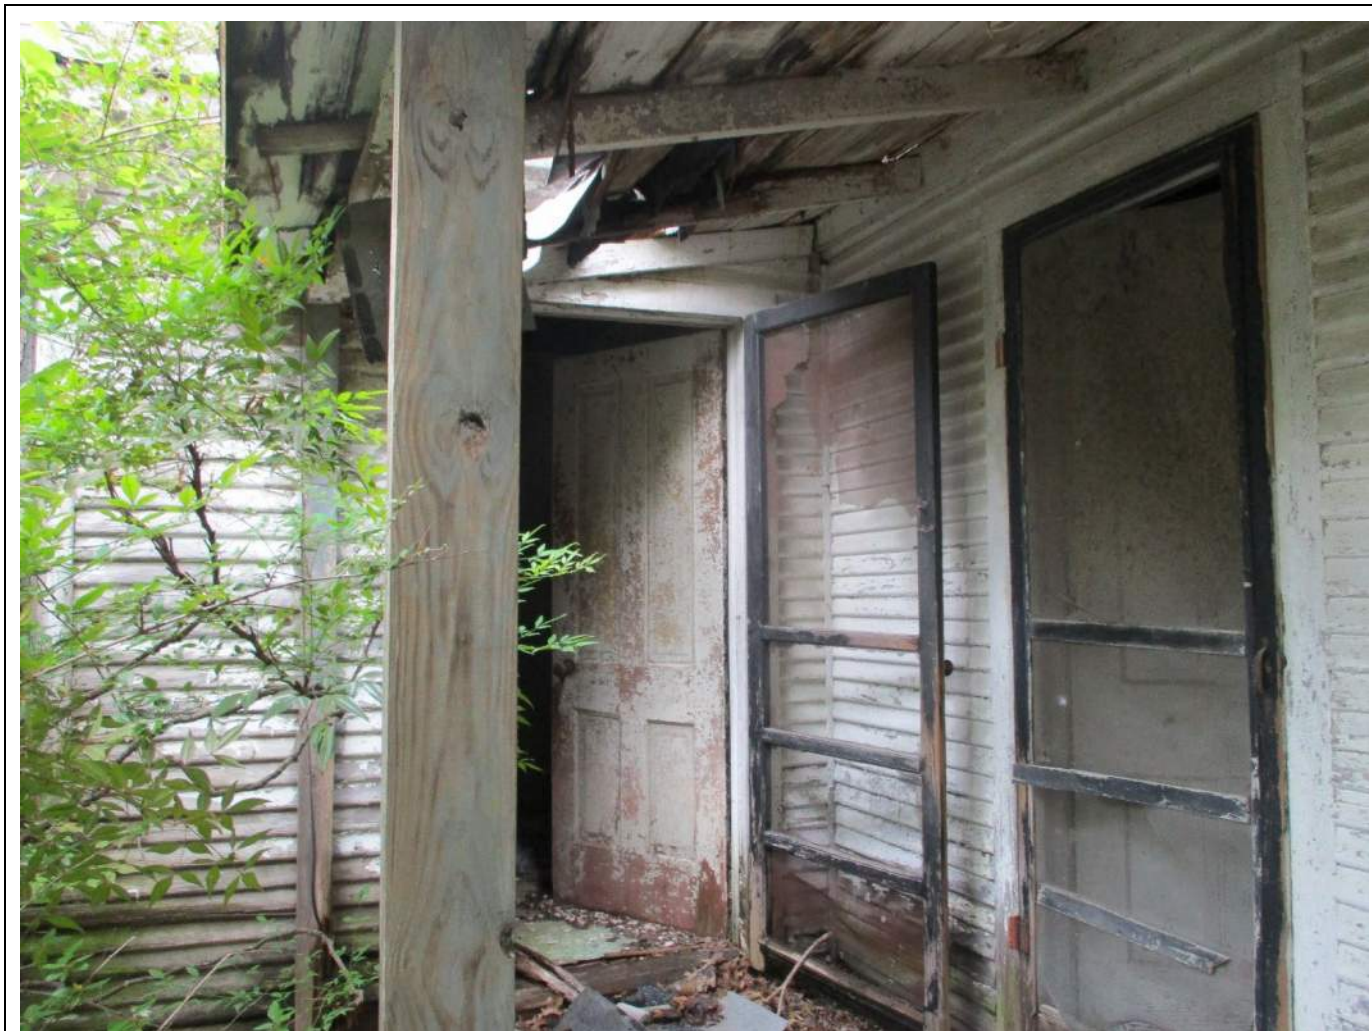
Resource 01b southern elevation and front ell, facing northwest.

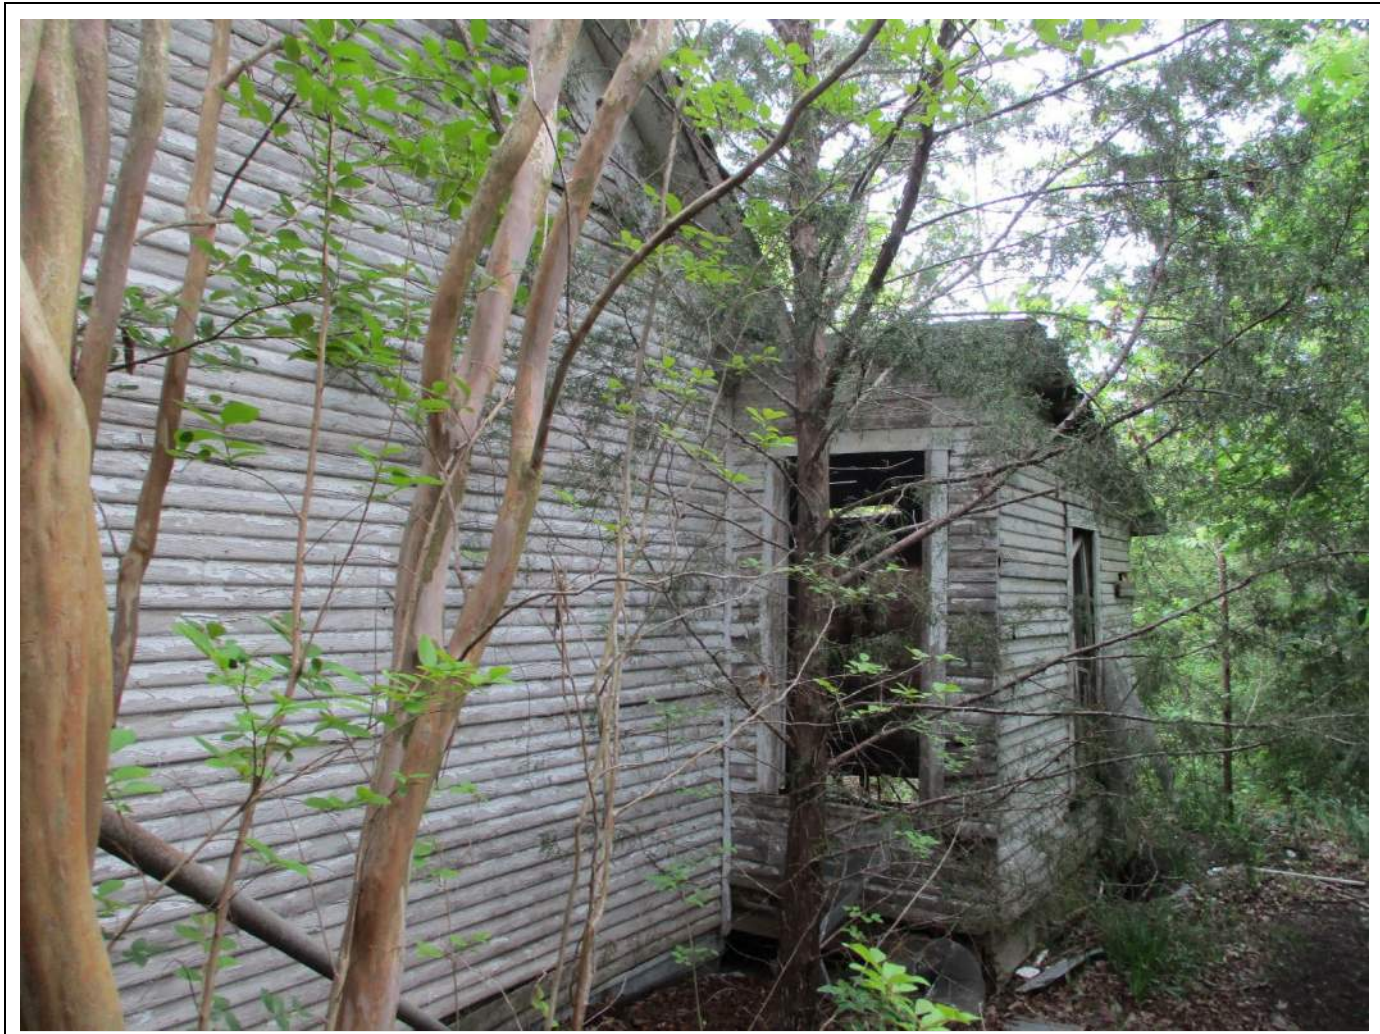
Resource 01b eastern elevation, facing northwest.

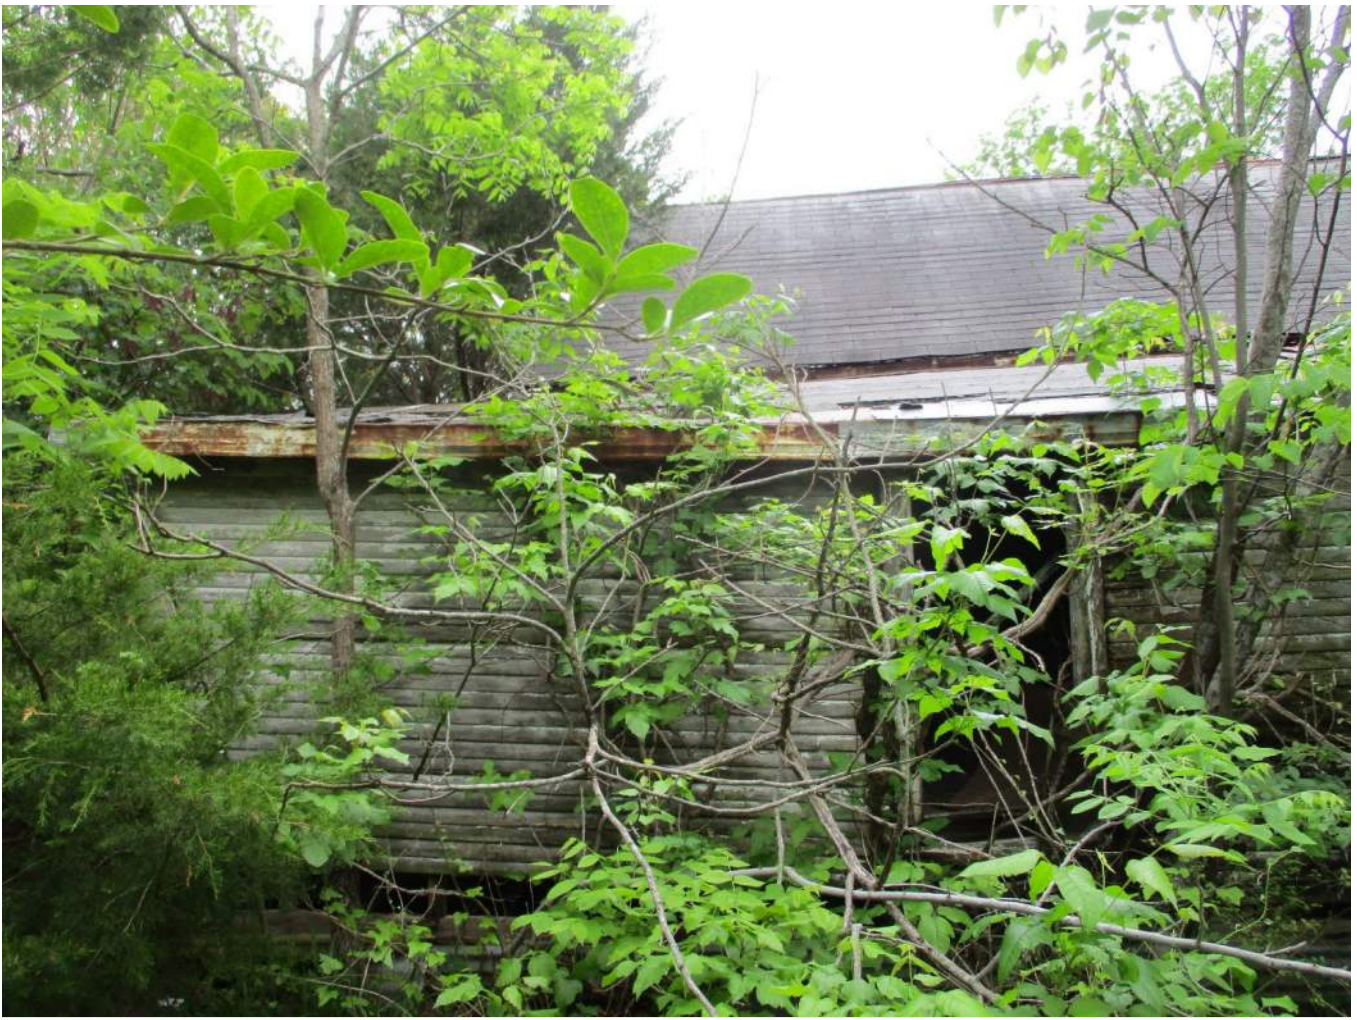
Resource 01b northern elevation, facing south.

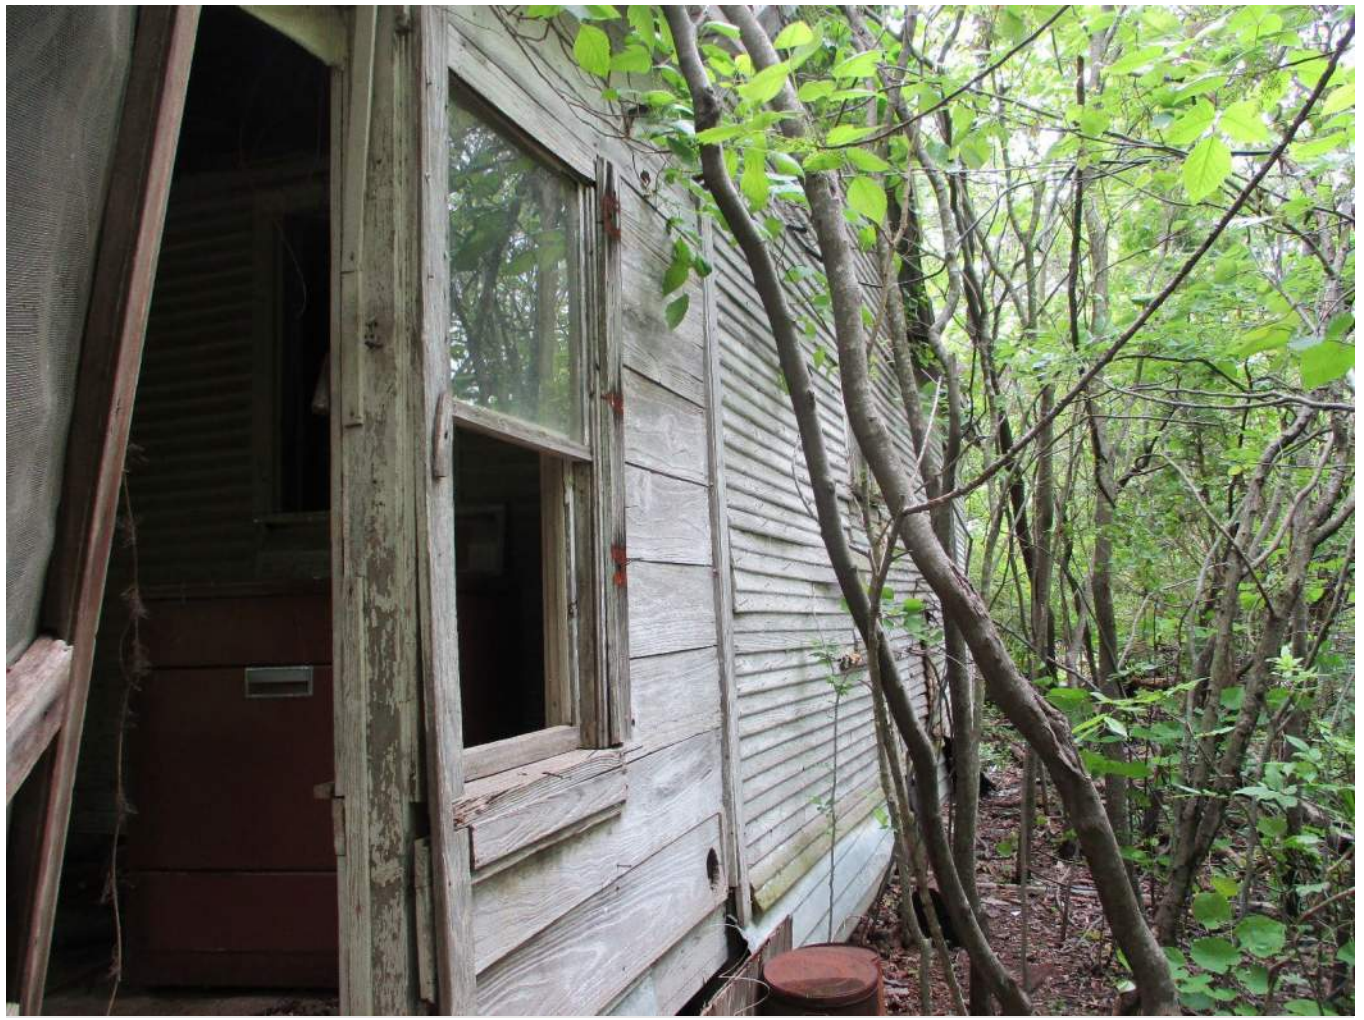
Resource 01b western elevation, facing south.
