Water Resources Technical Report

STATE HIGHWAY 5 (SH 5)

FROM SOUTH OF FARM-TO-MARKET ROAD
1378 TO SOUTH OF MELISSA ROAD

Date: December 2019

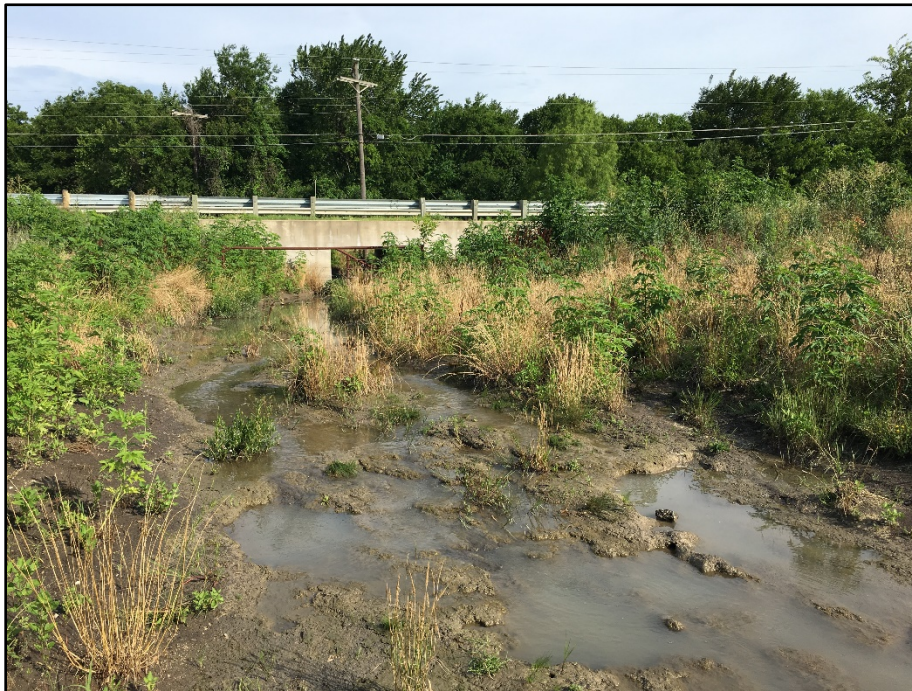
Photo 1: View looking northwest at crossing S-1 – Barksdale Creek from east of SH 5. Approximately 0.027 acre (243.33 linear feet) of permanent impacts is currently anticipated at the crossing due to proposed road widening.

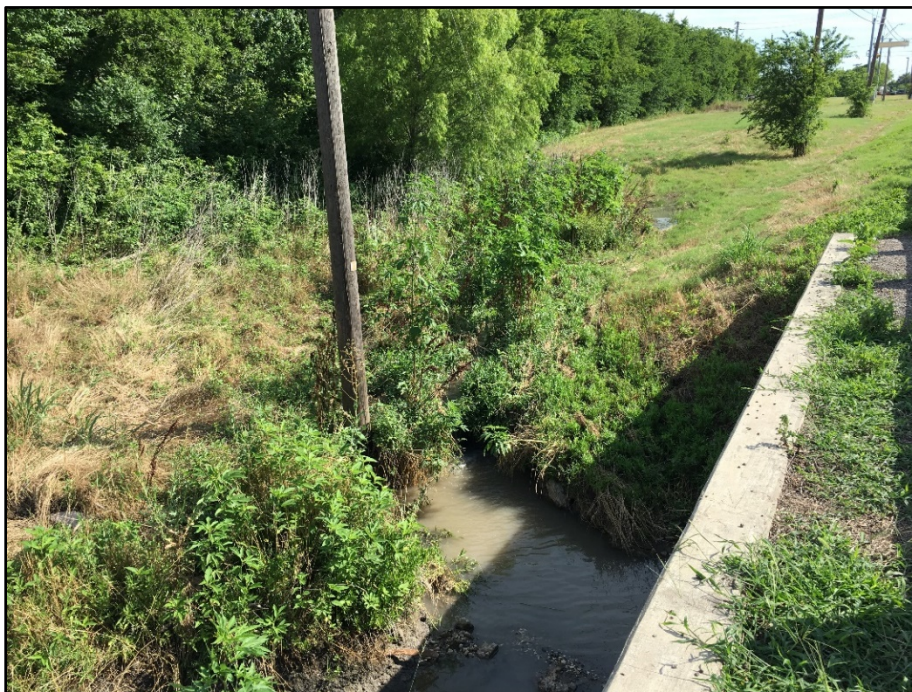
Photo 2: View looking north at crossing S-1 – Barksdale Creek from west of SH 5. Approximately 0.027 acre (243.33 linear feet) of permanent impacts is currently anticipated at the crossing due to proposed road widening.

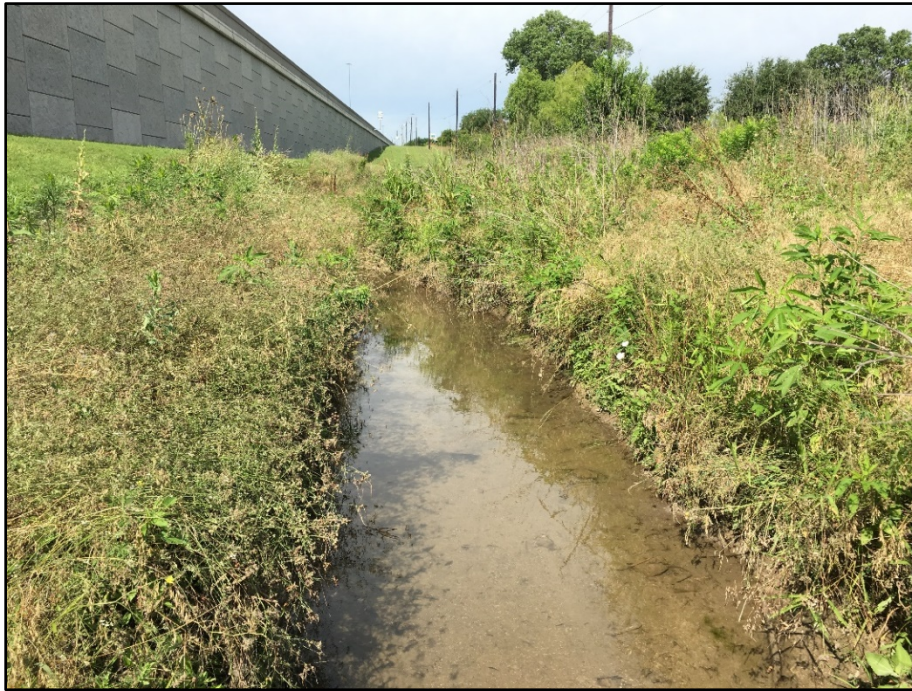
Photo 3: View looking southwest along crossing S-2a – tributary to Wilson Creek from north of Spur 399. Approximately 0.071 acre (628.3 linear feet) of permanent impacts is currently anticipated at the crossing due to proposed frontage road bridge construction.

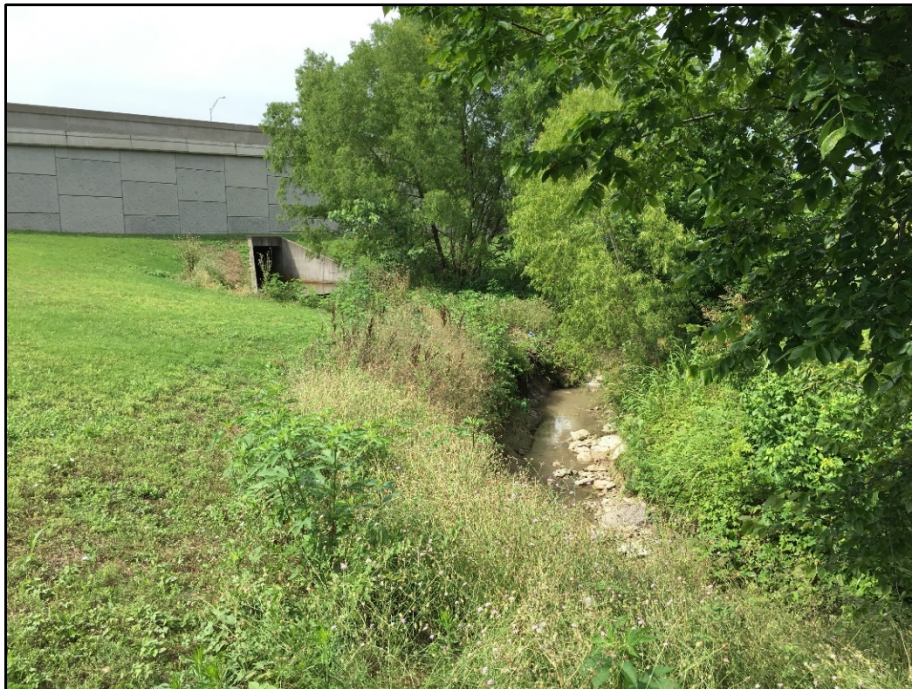
Photo 4: View looking south along crossing S-2a – tributary to Wilson Creek from north of Spur 399. Approximately 0.071 acre (628.3 linear feet) of permanent impacts is currently anticipated at the crossing due to proposed frontage road bridge construction.

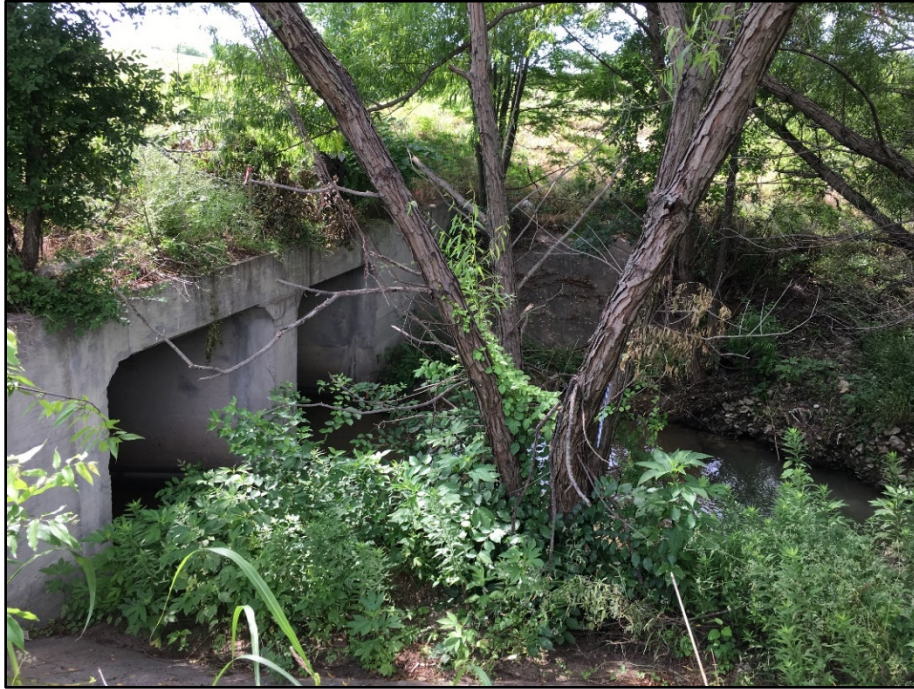
Photo 5: View looking east at crossing S-2a – tributary to Wilson Creek from northwest of the Spur 399 and SH 5 interchange. Approximately 0.071 acre (628.3 linear feet) of permanent impacts is currently anticipated at the crossing due to proposed frontage road construction and drainage improvements.

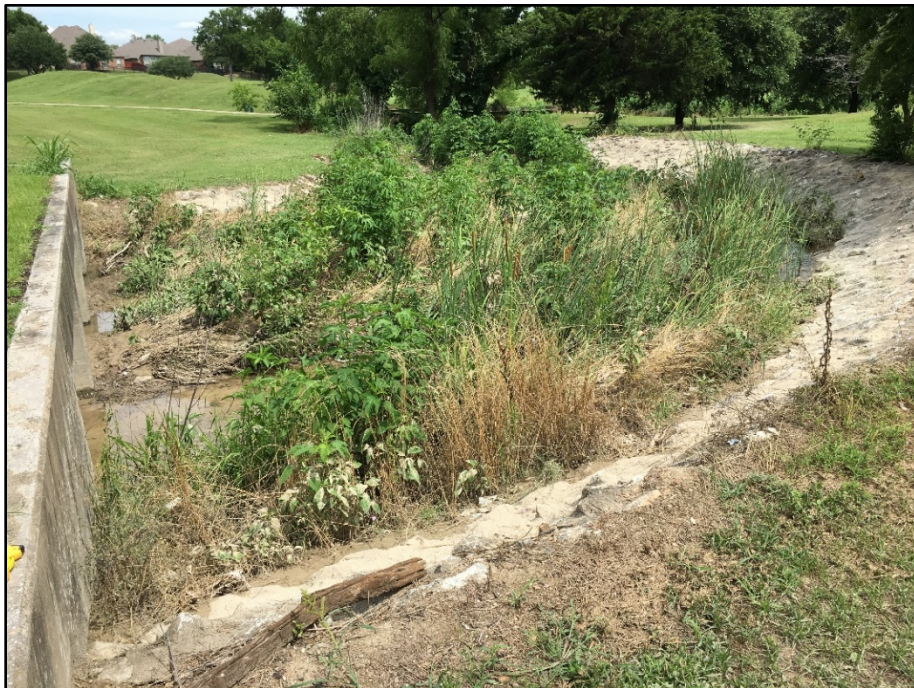
Photo 6: View looking north at crossing S-2b – tributary to Wilson Creek from northwest of the intersection of Stewart Road and SH 5. Approximately 0.042 acre (153.48 linear feet) of permanent impacts is currently anticipated at the crossing due to proposed frontage road construction.

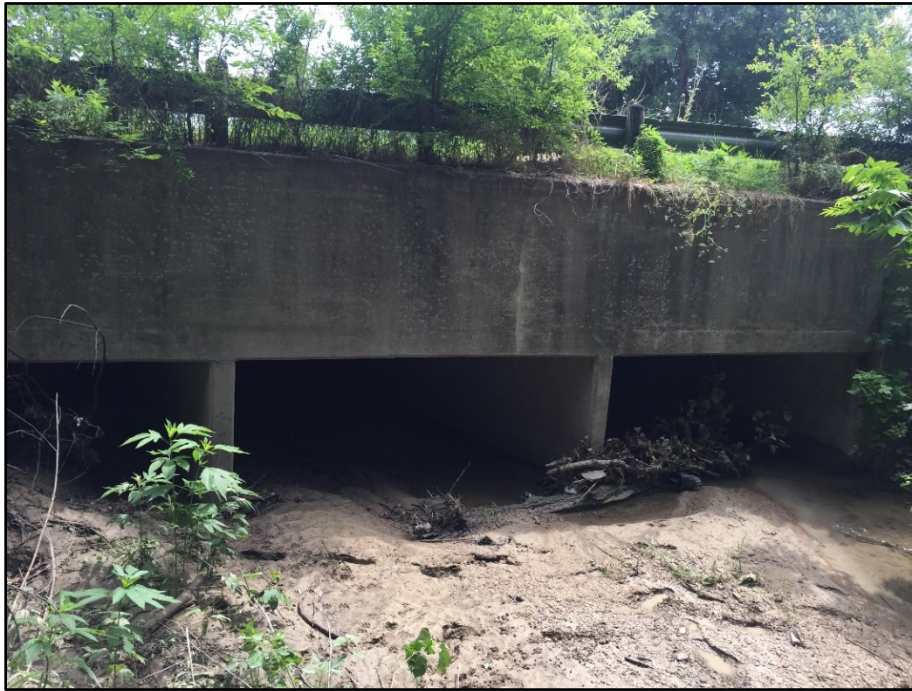
Photo 7: View looking northeast at crossing S-2b – tributary to Wilson Creek from northwest of the intersection of Stewart Road and SH 5. Approximately 0.042 acre (153.48 linear feet) of permanent impacts is currently anticipated at the crossing due to proposed frontage road construction.

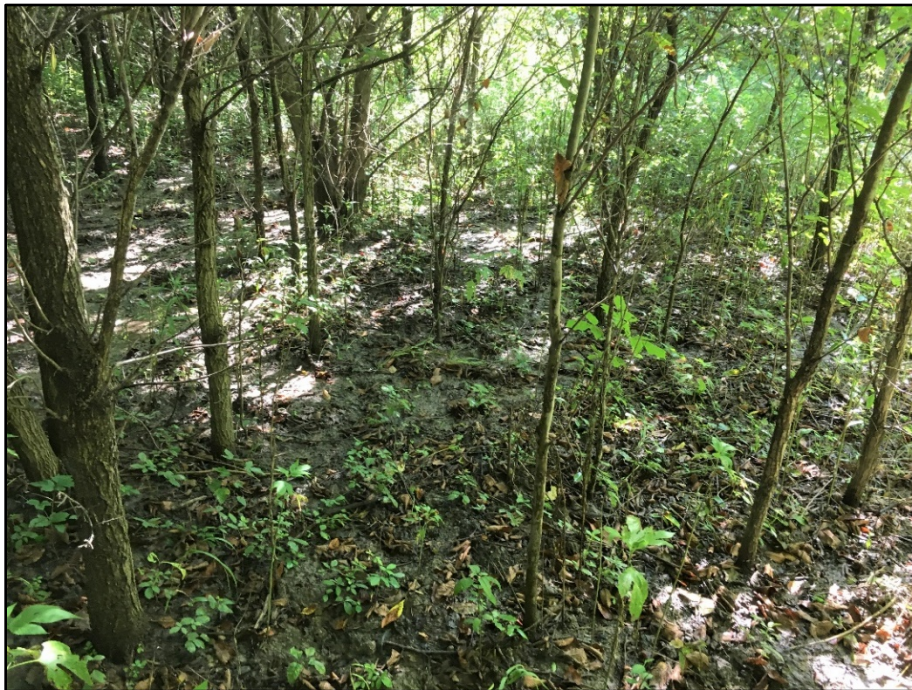
Photo 8: View looking north at Wetland Area 1 (sample point WL-1) from southeast of SH 5 and Wilson Creek. Approximately 0.154 acre of permanent impacts is currently anticipated in the wetland due to proposed frontage road construction.

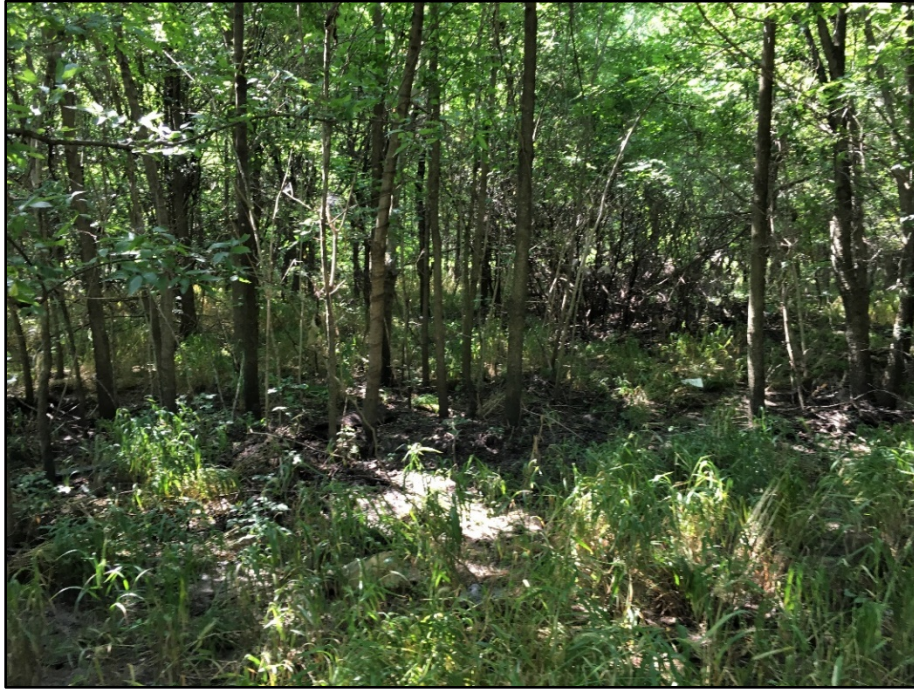
Photo 9: View looking north at Wetland Area 1 (sample point WL-2) from southeast of SH 5 and Wilson Creek. Approximately 0.154 acre of permanent impacts is currently anticipated in the wetland due to proposed frontage road construction.

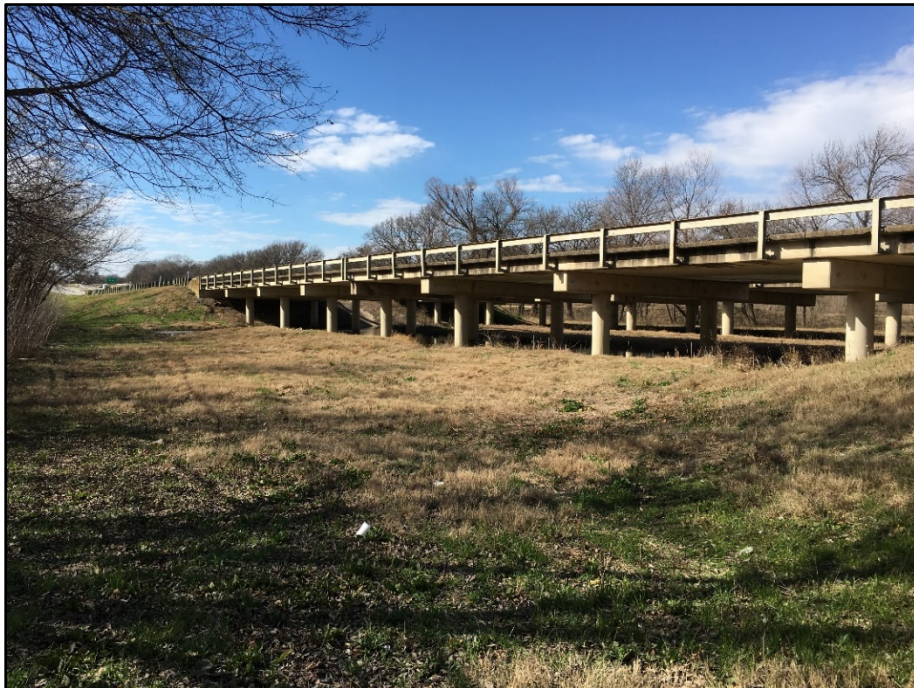
Photo 10: View looking west at Upland Area 1 (sample point UP-1) from southeast of SH 5 and Wilson Creek. Approximately 0.154 acre of permanent impacts is currently anticipated in the adjacent Wetland Area 1 (sample points WL-1/WL-2) due to proposed frontage road construction.

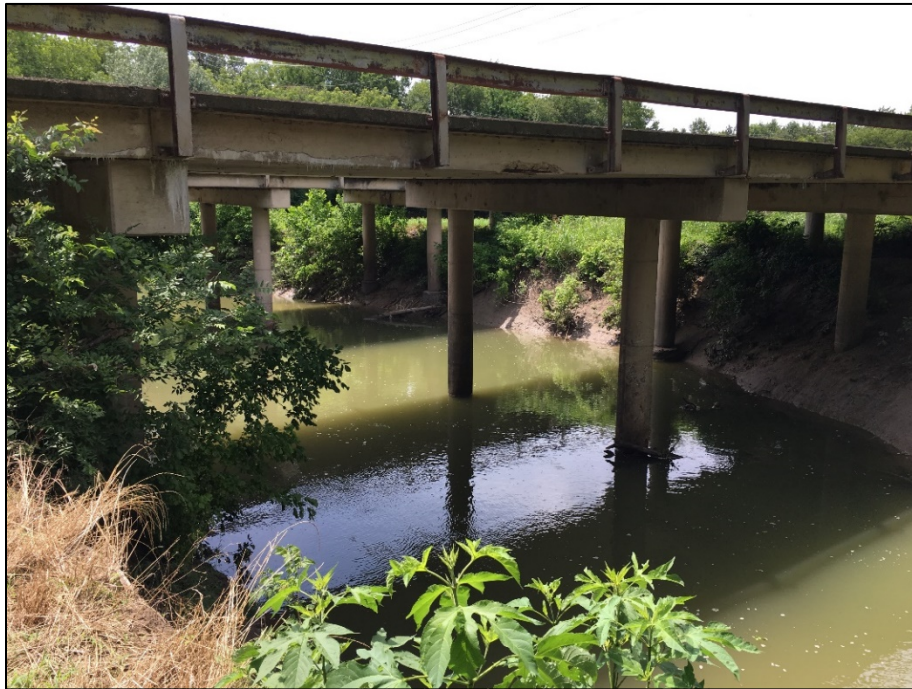
Photo 11: View looking south at crossing S-3 – Wilson Creek from northwest of the SH 5 mainlane bridges. Approximately 0.347 acre (265.3 linear feet) of permanent impacts is currently anticipated at the crossing due to proposed mainlane bridge expansion.

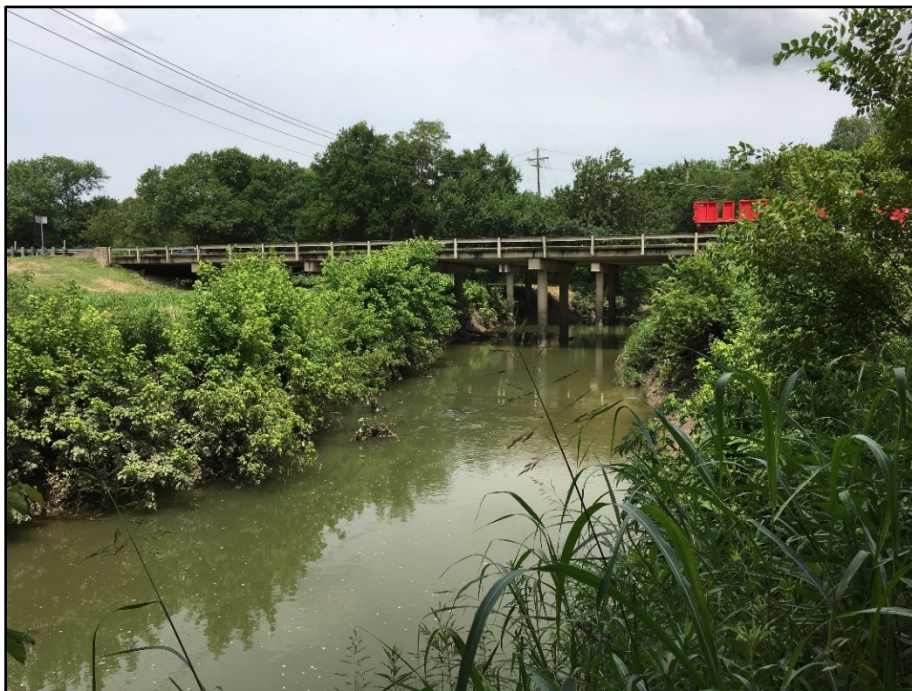
Photo 12: View looking west at crossing S-3 – Wilson Creek from southeast of the SH 5 mainlane bridges. Approximately 0.347 acre (265.3 linear feet) of permanent impacts is currently anticipated at the crossing due to proposed mainlane bridge expansion.

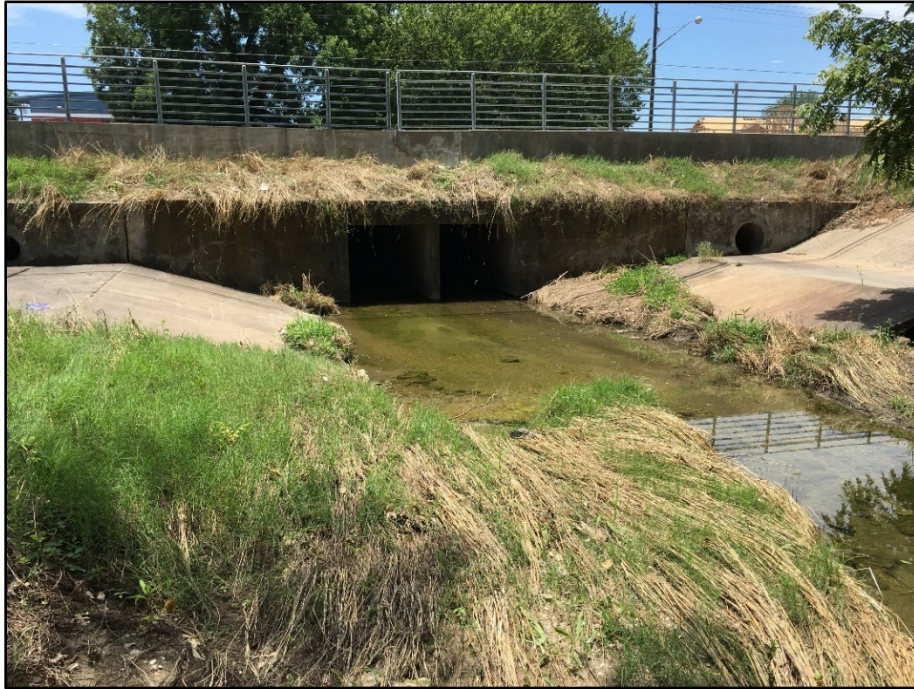
Photo 13: View looking west at crossing S-4 – tributary to East Fork Trinity River from east of SH 5. Approximately 0.028 acre (59.65 linear feet) of permanent impacts is currently anticipated at the crossing due to proposed road widening.

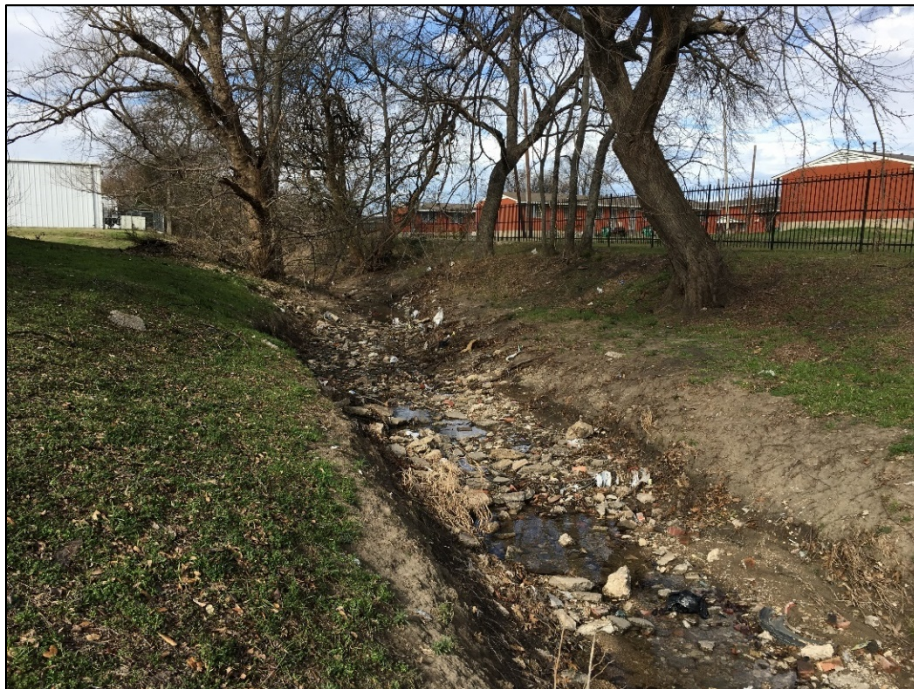
Photo 14: View looking west at crossing S-4 – tributary to East Fork Trinity River from west of SH 5. Approximately 0.028 acre (59.65 linear feet) of permanent impacts is currently anticipated at the crossing due to proposed road widening.

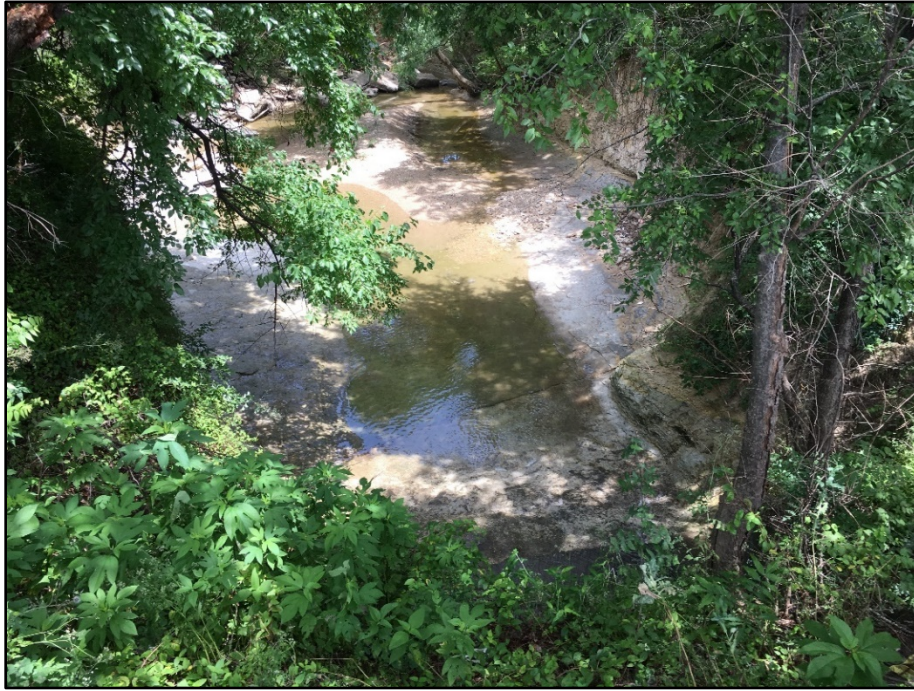
Photo 15: View looking east at crossing S-5 – tributary to East Fork Trinity River from east of SH 5. Approximately 0.068 acre (99.19 linear feet) of permanent impacts is currently anticipated at the crossing due to proposed road widening.

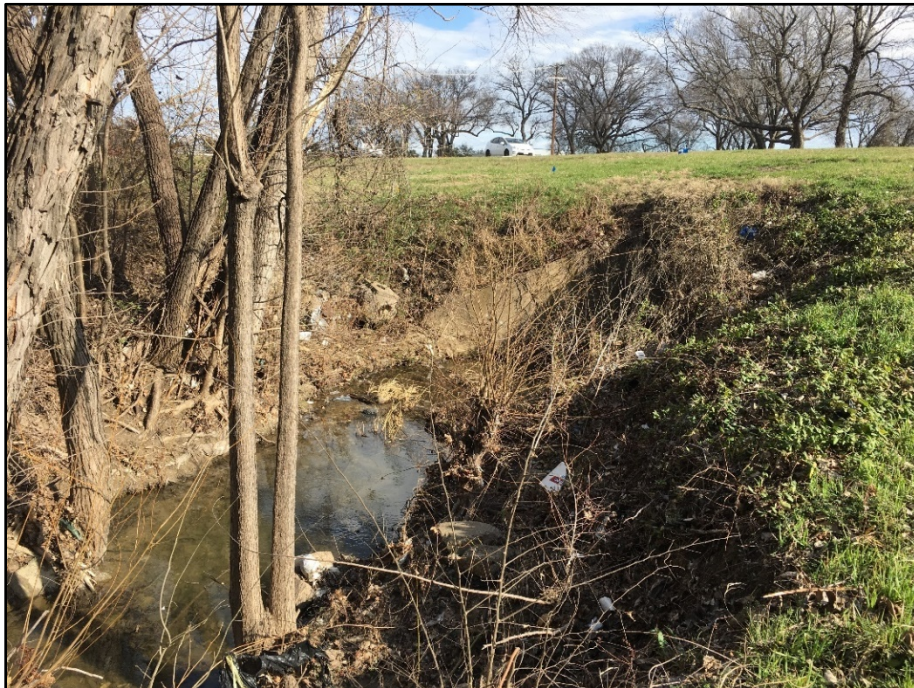
Photo 16: View looking northeast at crossing S-5 – tributary to East Fork Trinity River from west of SH 5. Approximately 0.068 acre (99.19 linear feet) of permanent impacts is currently anticipated at the crossing due to proposed road widening.

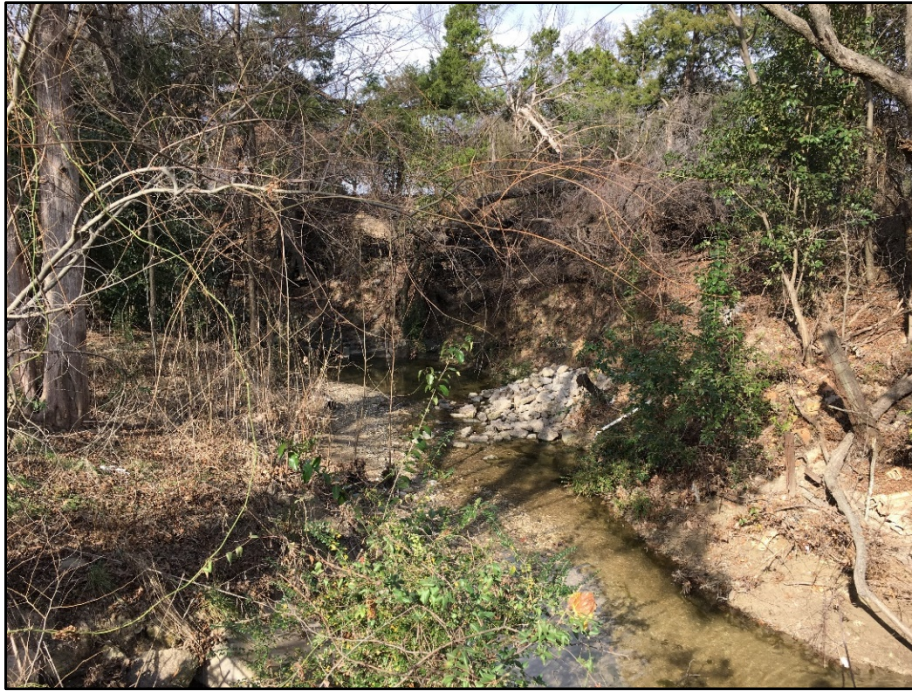
Photo 17: View looking west at crossing S-6 – tributary to East Fork Trinity River from west of SH 5. Approximately 0.094 acre (215.06 linear feet) of permanent impacts is currently anticipated at the crossing due to proposed road widening.

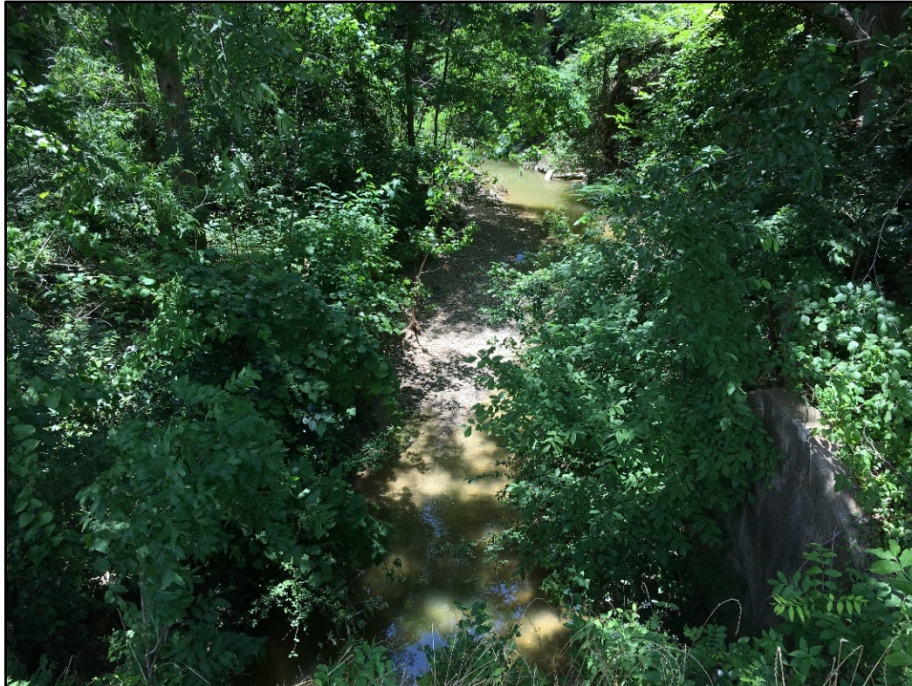
Photo 18: View looking east at crossing S-6 – tributary to East Fork Trinity River from east of SH 5. Approximately 0.094 acre (215.06 linear feet) of permanent impacts is currently anticipated at the crossing due to proposed road widening.

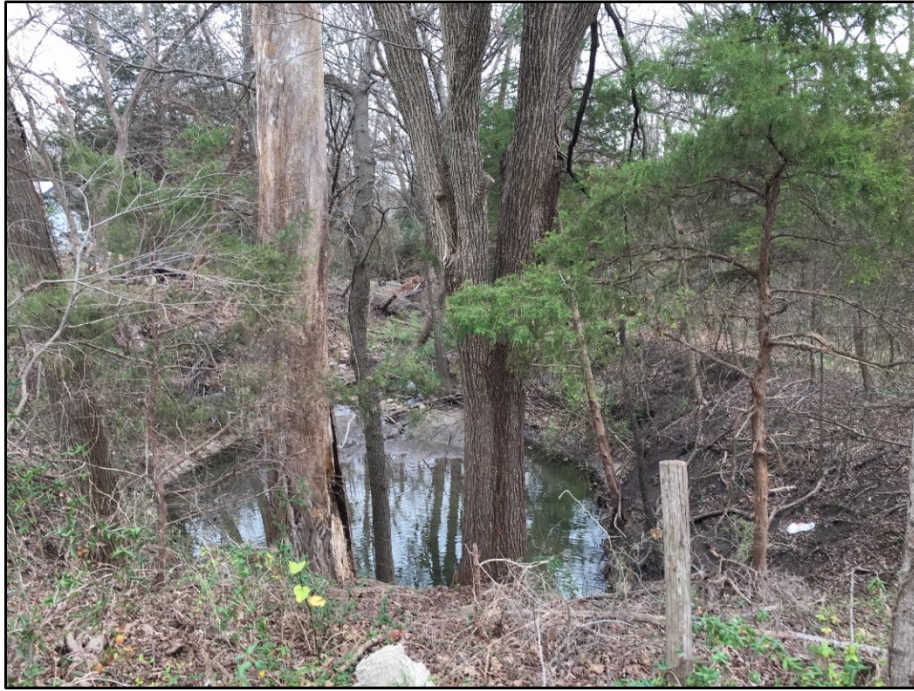
Photo 19: View looking east at crossing S-7 – tributary to East Fork Trinity River from east of SH 5. Approximately 0.074 acre (122.67 linear feet) of permanent impacts is currently anticipated at the crossing due to proposed road widening.

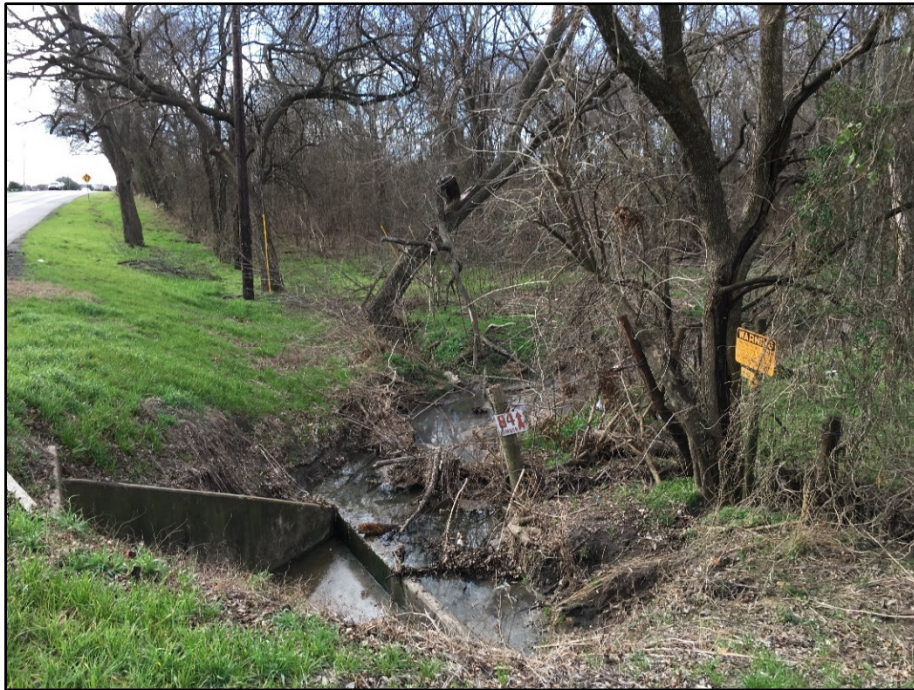
Photo 20: View looking south at crossing S-7 – tributary to East Fork Trinity River from west of SH 5. Approximately 0.074 acre (122.67 linear feet) of permanent impacts is currently anticipated at the crossing due to proposed road widening.

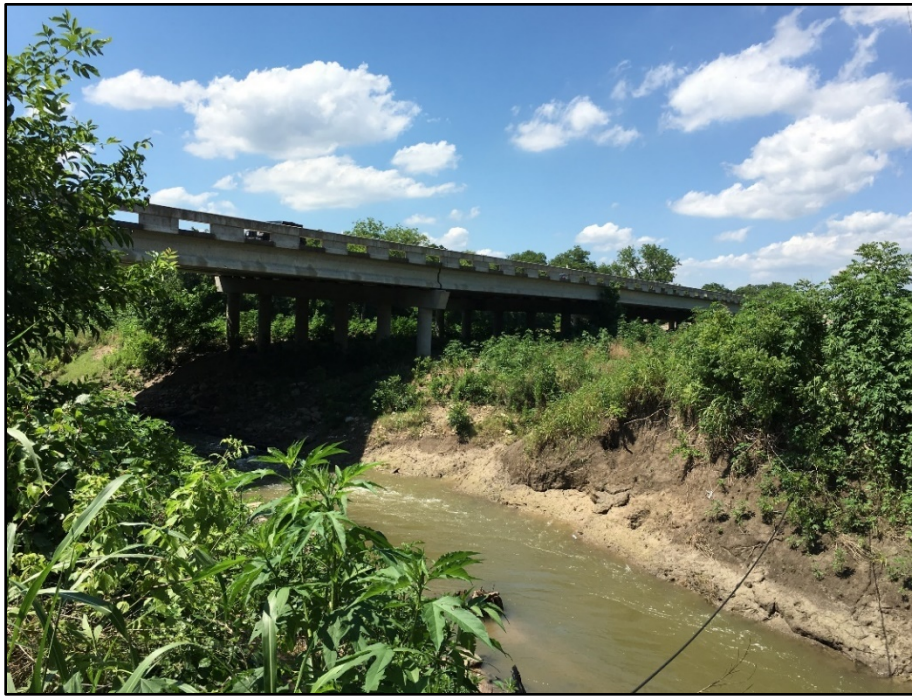
Photo 21: View looking north at crossing S-8 – East Fork Trinity River from southeast of the SH 5 mainlane bridge. Approximately 0.293 acre (303.14 linear feet) of permanent impacts is currently anticipated at the crossing due to proposed northbound mainlane bridge addition.

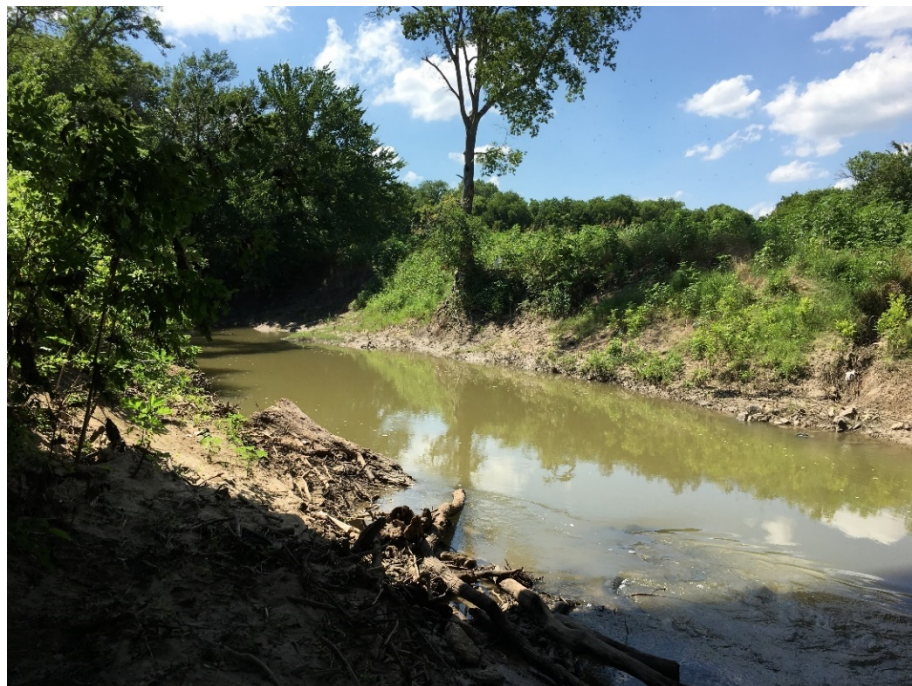
Photo 22: View looking northwest at crossing S-8 – East Fork Trinity River from northwest of the SH 5 mainlane bridge. Approximately 0.293 acre (303.14 linear feet) of permanent impacts is currently anticipated at the crossing due to proposed northbound mainlane bridge addition.

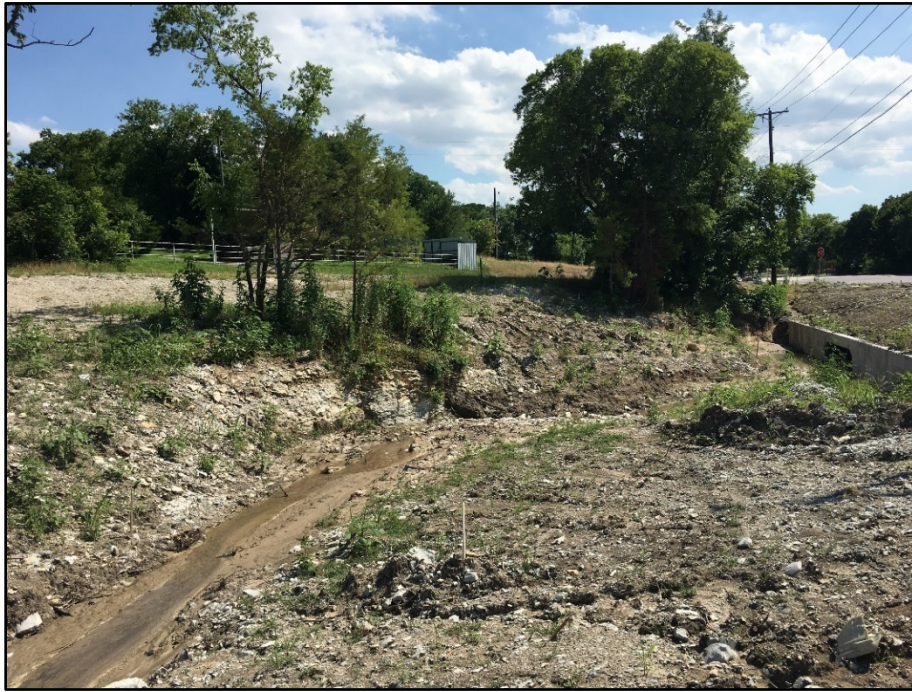
Photo 23: View looking southwest at crossing S-9 – tributary to East Fork Trinity River from east of SH 5. Approximately 0.077 acre (404.22 linear feet) of permanent impacts is currently anticipated at the crossing due to proposed road widening.

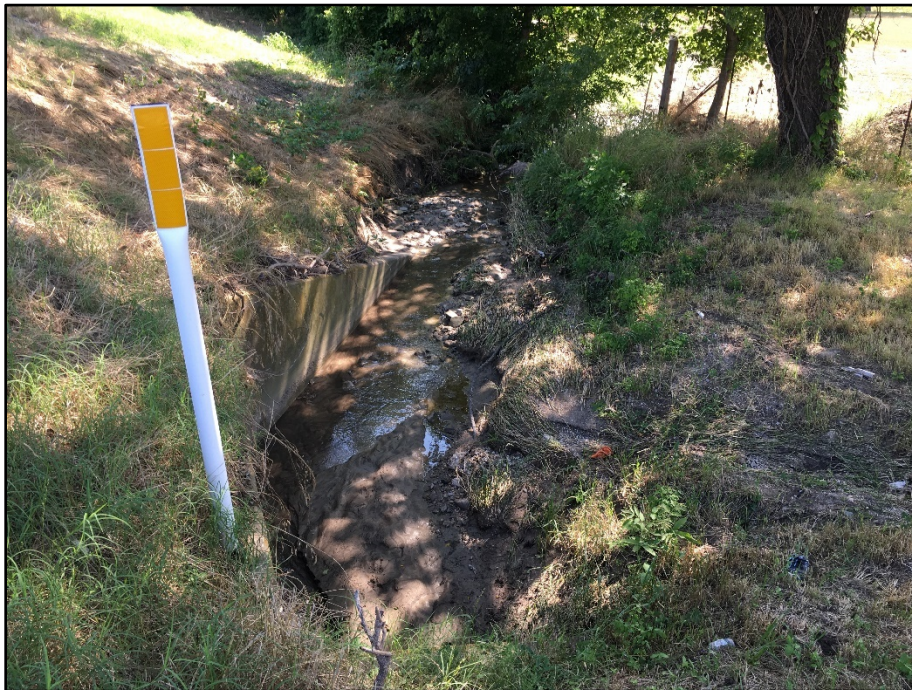
Photo 24: View looking southwest at crossing S-9 – tributary to East Fork Trinity River from west of SH 5. Approximately 0.077 acre (404.22 linear feet) of permanent impacts is currently anticipated at the crossing due to proposed road widening.
