IH 35W Frontage Roads Technical Reports

Air Quality Resources Technical Report

Interstate Highway (IH) 35W Frontage Roads

Control-Section-Job (CSJ) 0081-13-065

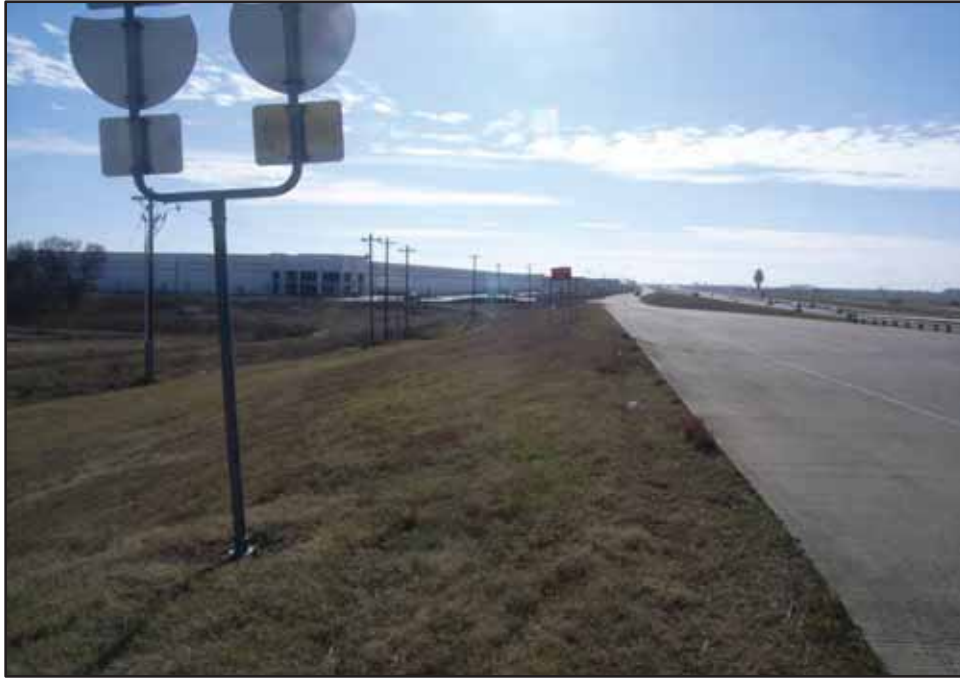
Photograph 1: View looking southwest along the IH 35W east ROW from near STA. 228+00. The TESCP/EMST Mapper classifies the mowed-maintained vegetation and portions of the roadway as Disturbed Prairie; however, they better fit the Urban classification. Date of photograph: 12/7/19.

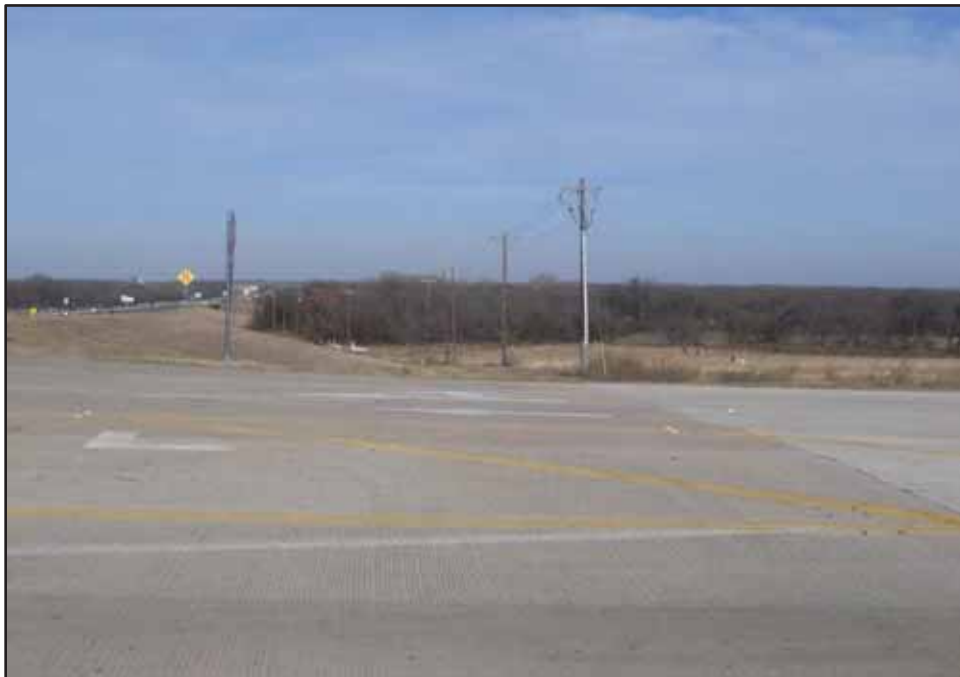
Photograph 2: View looking northeast across Dale Earnhardt Way and along the IH 35W east ROW from near STA. 228+00. The TESCP/EMST Mapper classifies the mowed-maintained vegetation and portions of the roadway as Disturbed Prairie and Tallgrass Prairie, Grassland; however, they better fit the Urban classification. Date of photograph: 12/7/19.

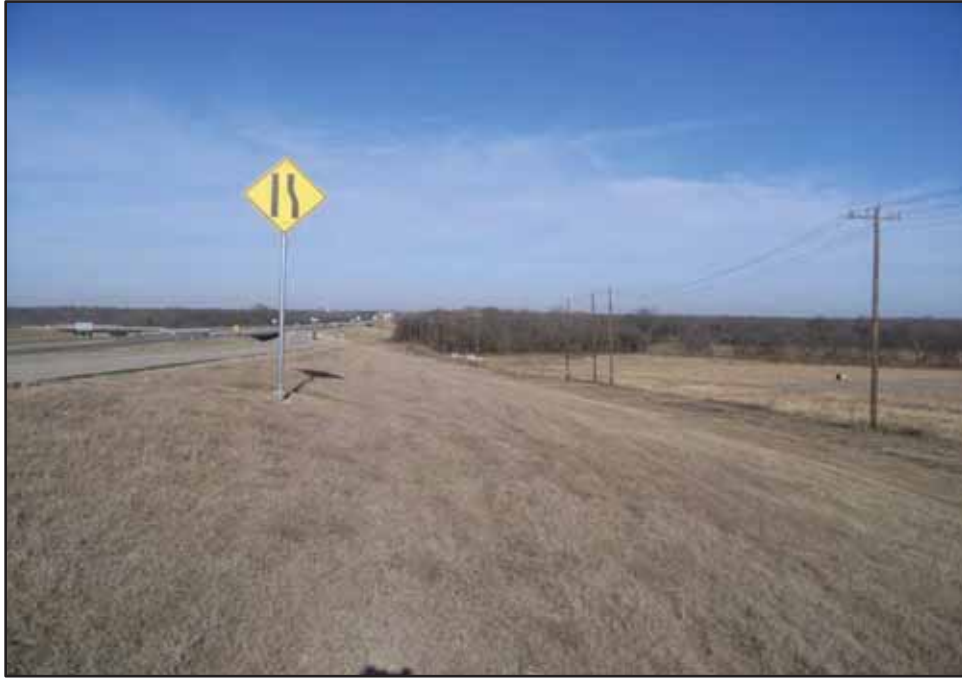
Photograph 3: View looking northeast from Dale Earnhardt Way along the IH 35W east ROW from near STA. 235+00. The TЕСP/EMST Mapper classifies the mowed-maintained vegetation as Disturbed Prairie; however, it better fits the Urban classification. Date of photograph: 12/7/19.

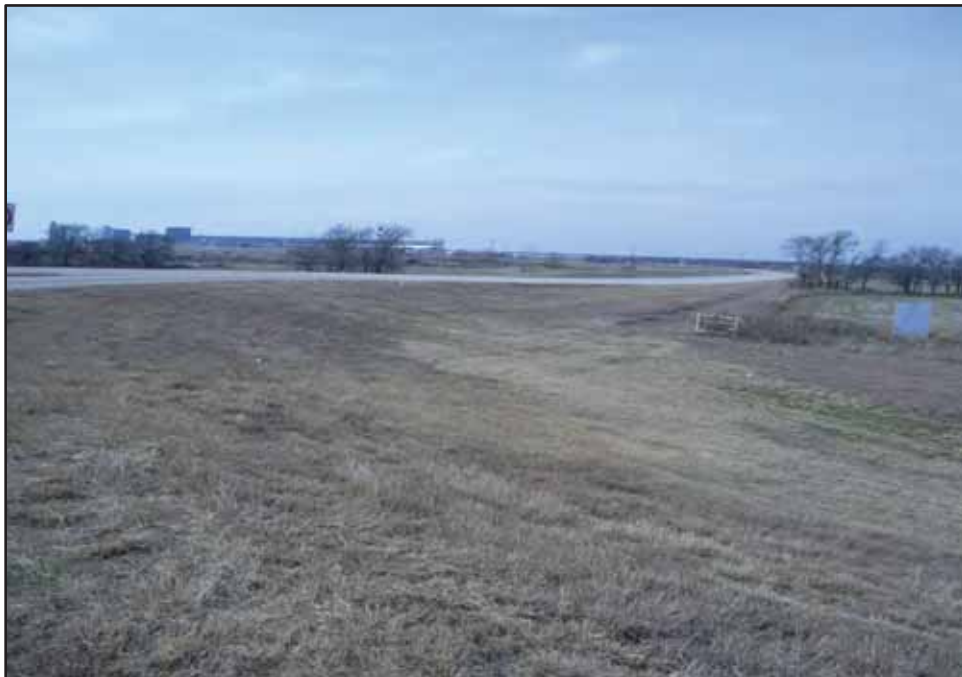
Photograph 4: View looking west towards Dale Earnhardt Way and IH 35W west ROW from near STA. 233+00. The TЕСP/EMST Mapper classifies the mowed-maintained vegetation and portions of the roadway as Tallgrass Prairie, Grassland; however, they better fit the Urban classification. Date of photograph: 12/7/19.

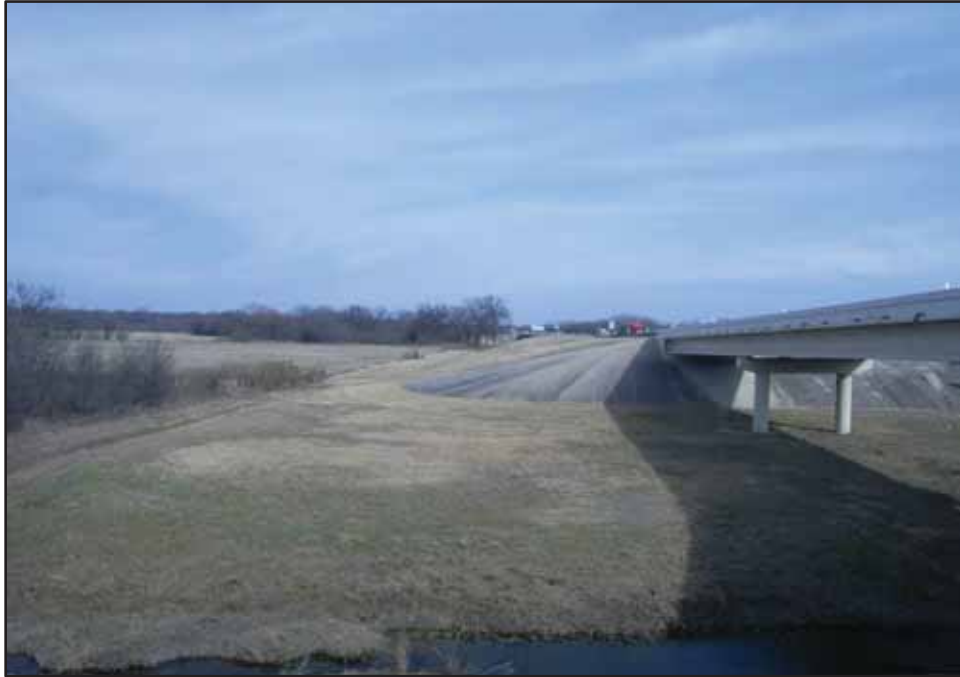
Photograph 5: View looking northeast across the Catherine Branch and floodplain from the bridge abutment of the southbound IH 35W mainlanes near STA. 240+00. The TЕСP/EMST Mapper classifies the mowed-maintained vegetation and stream as Riparian; however, the vegetation better fits the Urban classification. The stream better fits the Open Water classification. Date of photograph: 12/8/19.

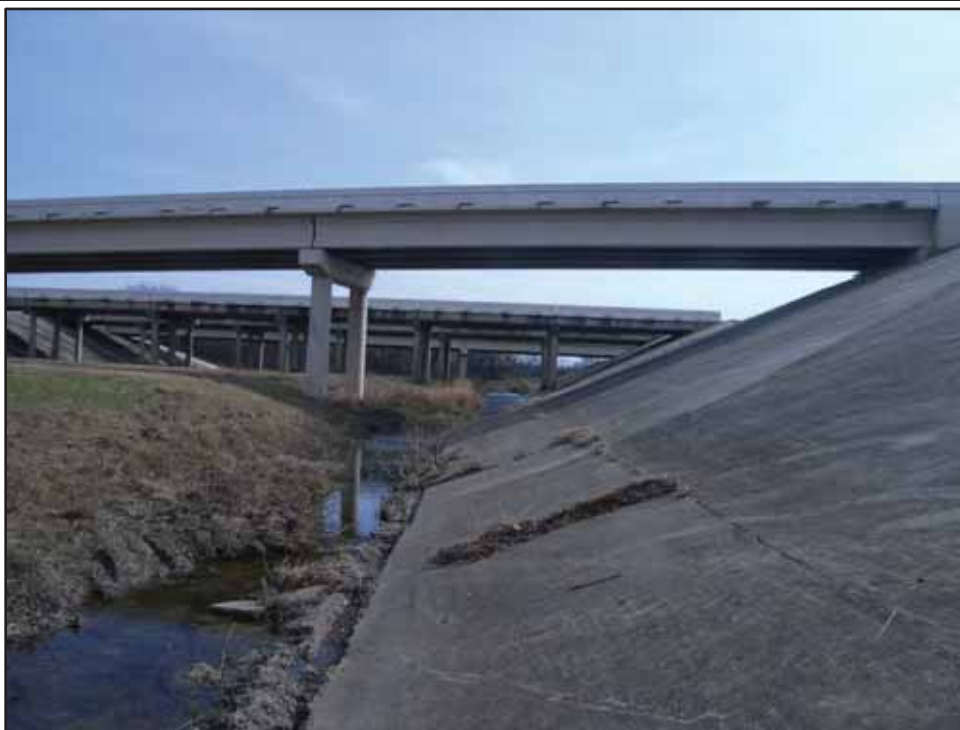
Photograph 6: View looking southeast along the Catherine Branch from the bridge abutment of the southbound IH 35W mainlanes near STA. 240+00. The TЕСP/EMST Mapper classifies this stream as Riparian; however, it better fits the Open Water classification. Date of photograph: 12/8/19.

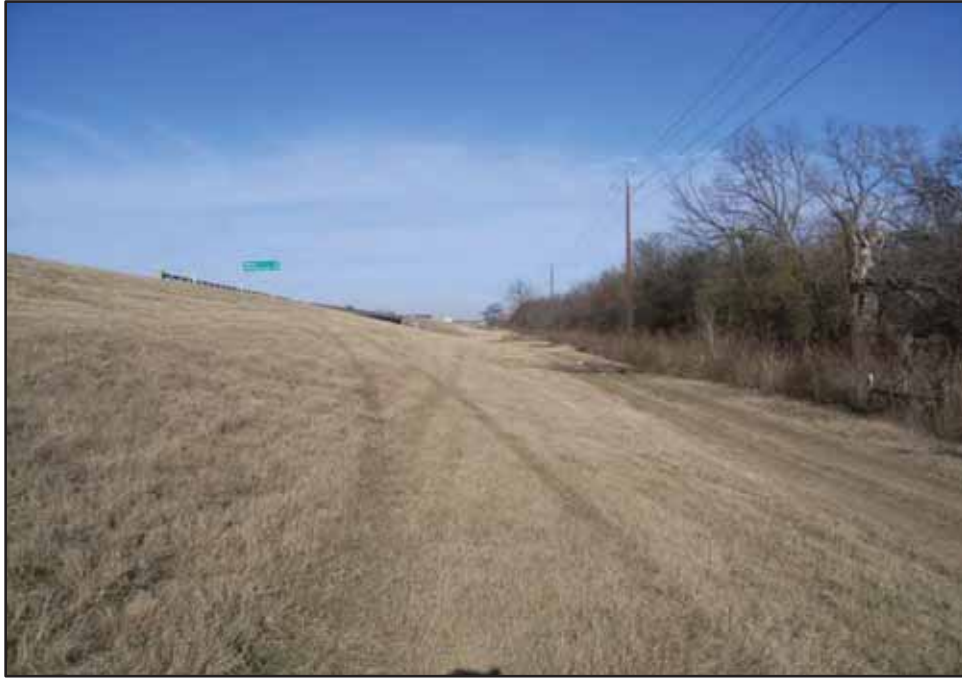
Photograph 7: View looking northeast along IH 35W east ROW from near STA. 249+00. The TЕСP/EMST Mapper classifies portions of the mowed-maintained vegetation as Riparian, and the woody vegetation as Riparian and Crosstimbers Woodland and Forest. The mowed-maintained vegetation better fits the Urban classification and the woody vegetation fits the Riparian classification. Date of photograph: 12/7/19.

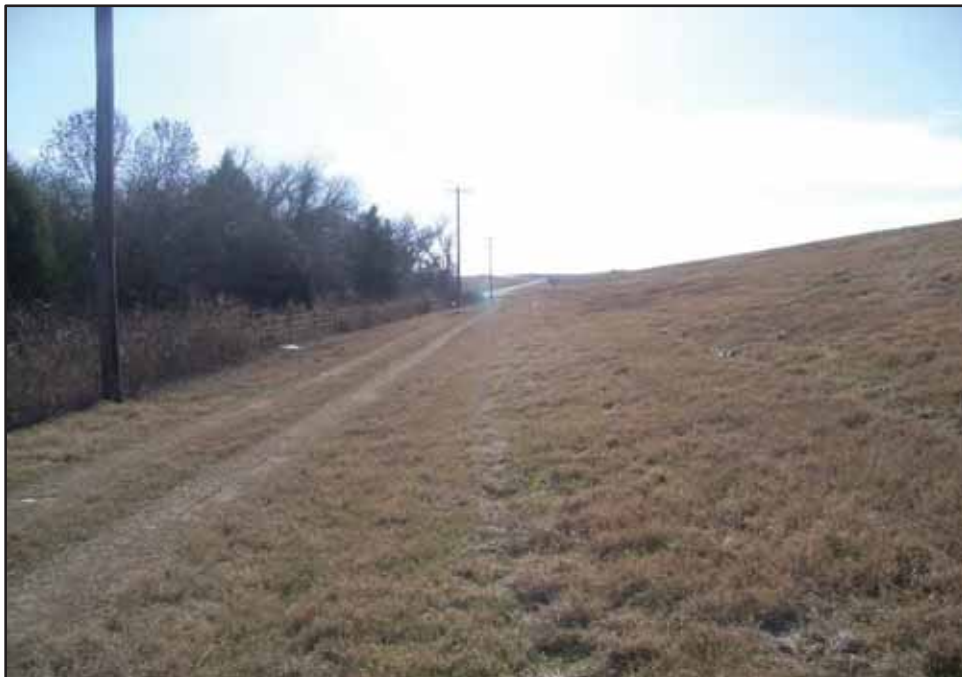
Photograph 8: View looking southwest along IH 35W east ROW from near STA. 249+00. The TЕСP/EMST Mapper classifies portions of the mowed-maintained vegetation and woody vegetation as Riparian. The mowed-maintained vegetation better fits the Urban classification and the woody vegetation fits the Riparian classification. Date of photograph: 12/7/19.

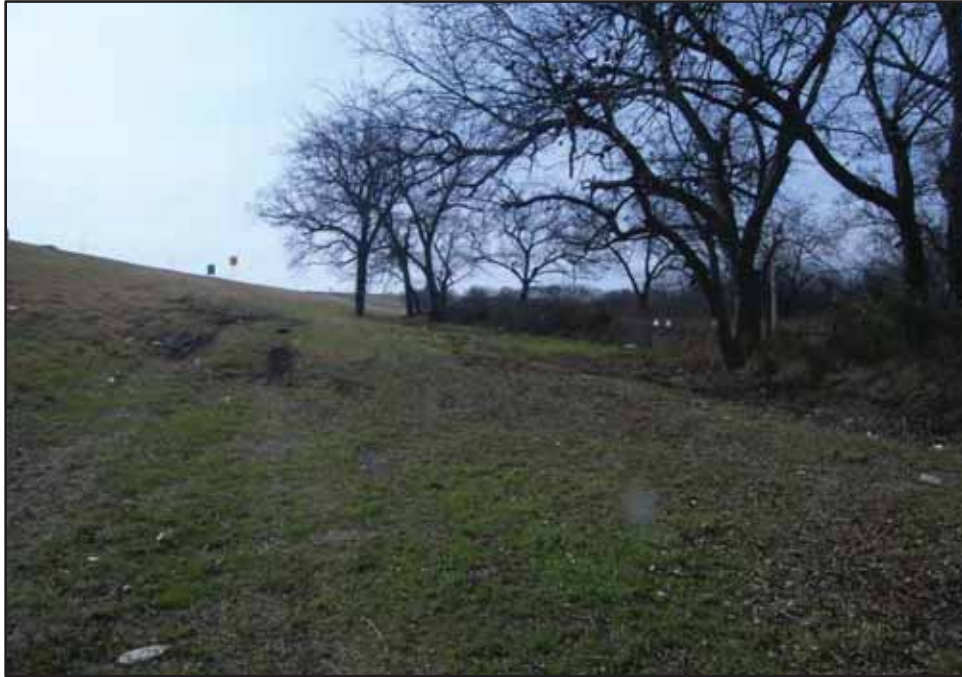
Photograph 9: View looking southwest along IH 35W west ROW from near STA. 252+00. The TЕСP/EMST Mapper classifies the mowed-maintained vegetation, woody, and other unmaintained vegetation as Riparian. The mowed-maintained vegetation better fits the Urban classification. The woody and other unmaintained vegetation fits the Riparian classification. A small portion of woody vegetation up slope fits the Edwards Savannah, Woodland, and Shrubland classification. Date of photograph: 12/7/19.

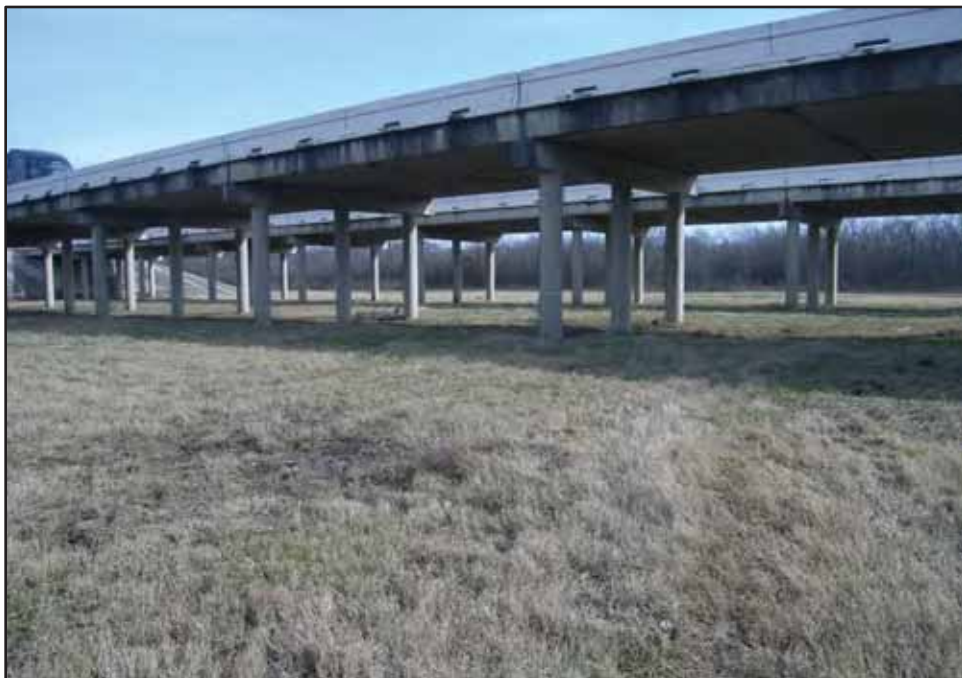
Photograph 10: View looking east from near the IH 35W west ROW line near STA. 253+00. The TЕСP/EMST Mapper classifies the mowed-maintained vegetation as Riparian; however, it better fits the Urban classification. Date of photograph: 12/8/19.

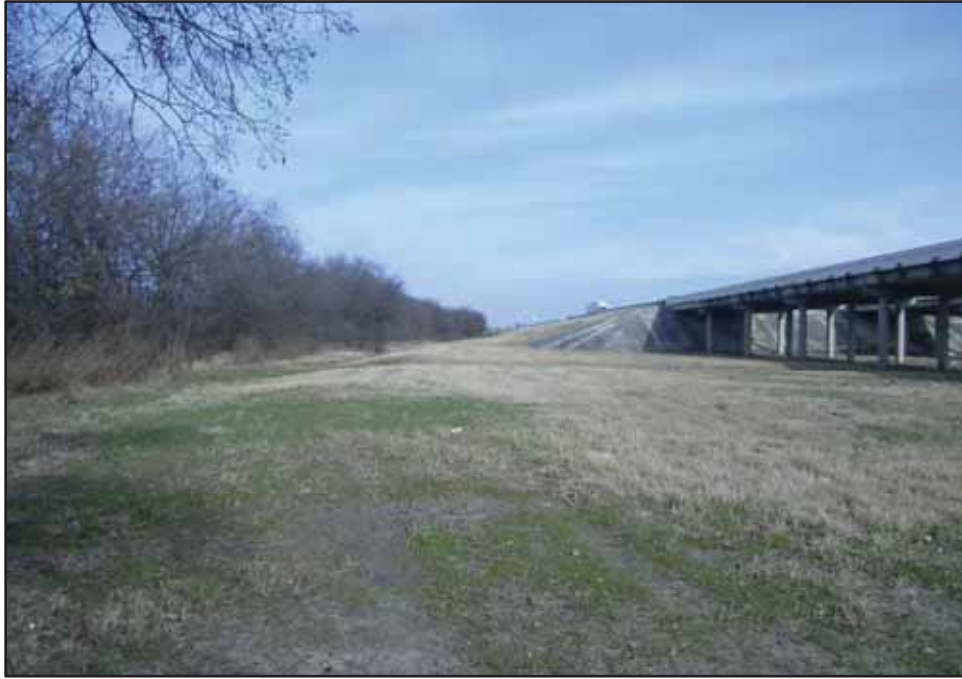
Photograph 11: View looking northeast along IH 35W west ROW from near STA. 253+00. The TЕСP/EMST Mapper classifies the mowed-maintained vegetation and woody vegetation as Riparian. The mowed-maintained vegetation better fits the Urban classification and the woody vegetation fits the Riparian classification. Date of photograph: 12/8/19.

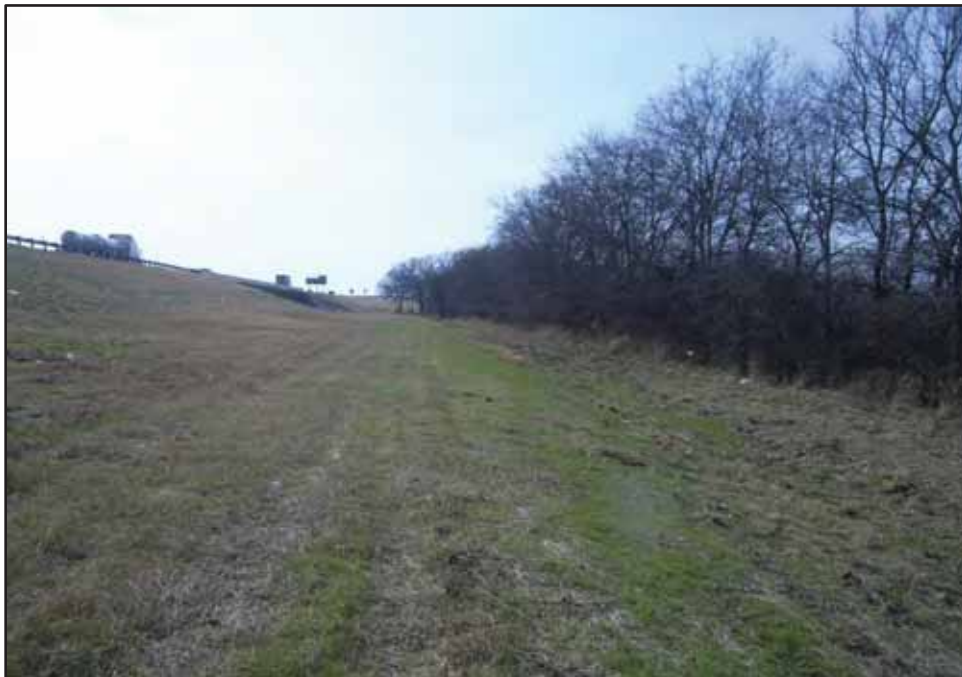
Photograph 12: View looking southwest along IH 35W west ROW from near STA. 262+00. The TЕСP/EMST Mapper classifies portions of the roadway, and the mowed-maintained vegetation and woody vegetation as Edwards Plateau Savannah, Woodland, and Shrubland, along with Riparian. The roadway and mowed-maintained vegetation better fit the Urban classification and the woody vegetation fits the Riparian classification. Date of photograph: 12/8/19.

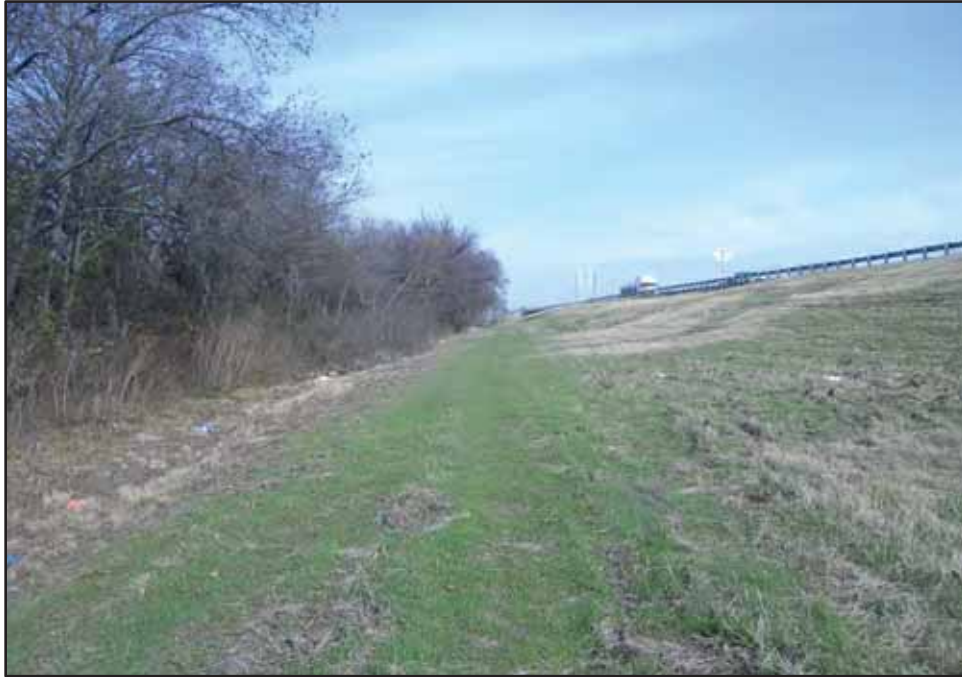
Photograph 13: View looking northeast along IH 35W west ROW from near STA. 262+00. The TЕСP/EMST Mapper classifies portions of the roadway, and the mowed-maintained vegetation and woody vegetation as Riparian. The roadway and mowed-maintained vegetation better fit the Urban classification and the woody vegetation fits the Riparian classification. Date of photograph: 12/8/19.

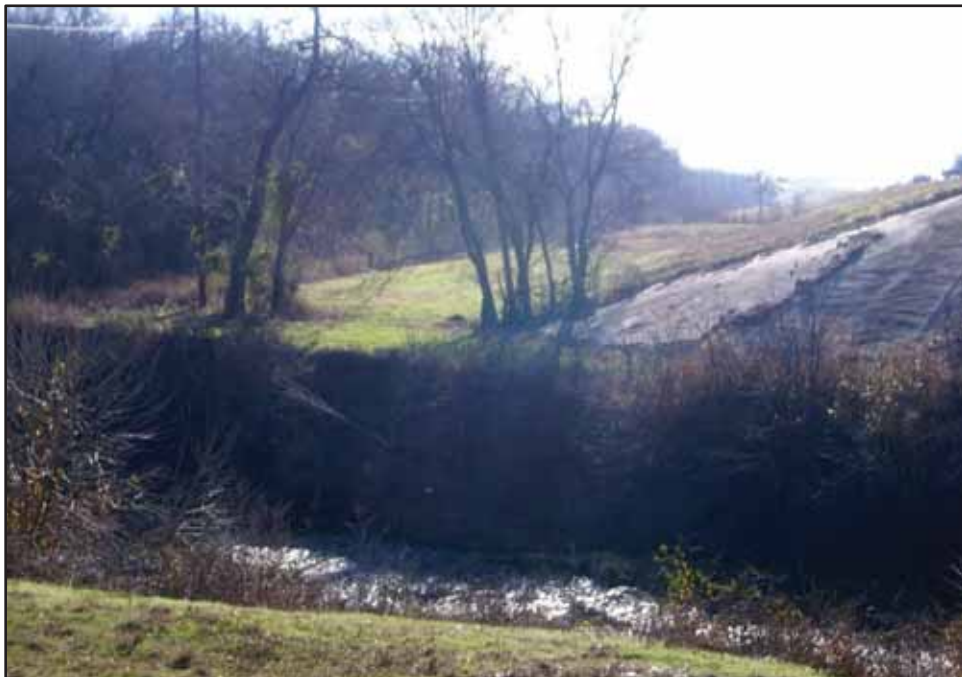
Photograph 14: View looking southwest across Denton Creek from the IH 35W east ROW from near STA. 276+80. The TЕСP/EMST Mapper classifies portions of the roadway, the mowed-maintained vegetation, and woody and unmaintained vegetation as Edwards Plateau Savannah, Woodland, and Shrubland, along with Riparian. The woody and unmaintained vegetation fit the Riparian classification. Denton Creek fits the Open Water classification. The mowed-maintained vegetation fits the Urban classification. Date of photograph: 12/7/19.

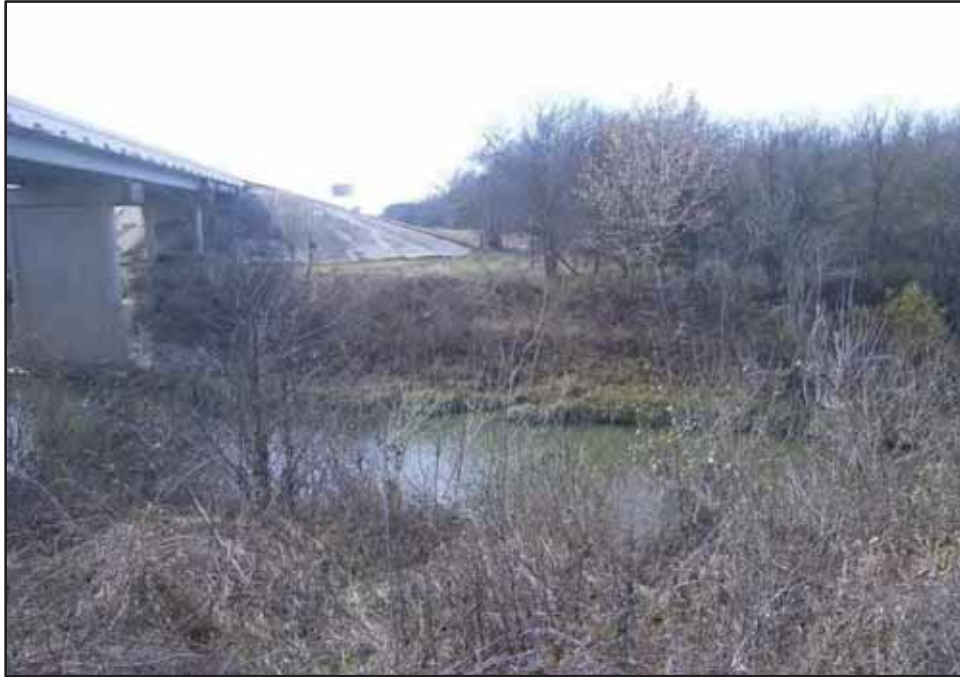
Photograph 15: View looking southwest across Denton Creek along the IH 35W west ROW near STA. 277+00. The TЕСP/EMST Mapper classifies portions of the roadway, and the mowed-maintained vegetation, and woody and unmaintained vegetation as Edwards Plateau Savannah, Woodland, and Shrubland, along with Riparian. The roadway and mowed-maintained vegetation better fit the Urban classification. The woody and unmaintained vegetation fit the Riparian classification. Denton Creek fits the Open Water classification. Date of photograph: 12/8/19.

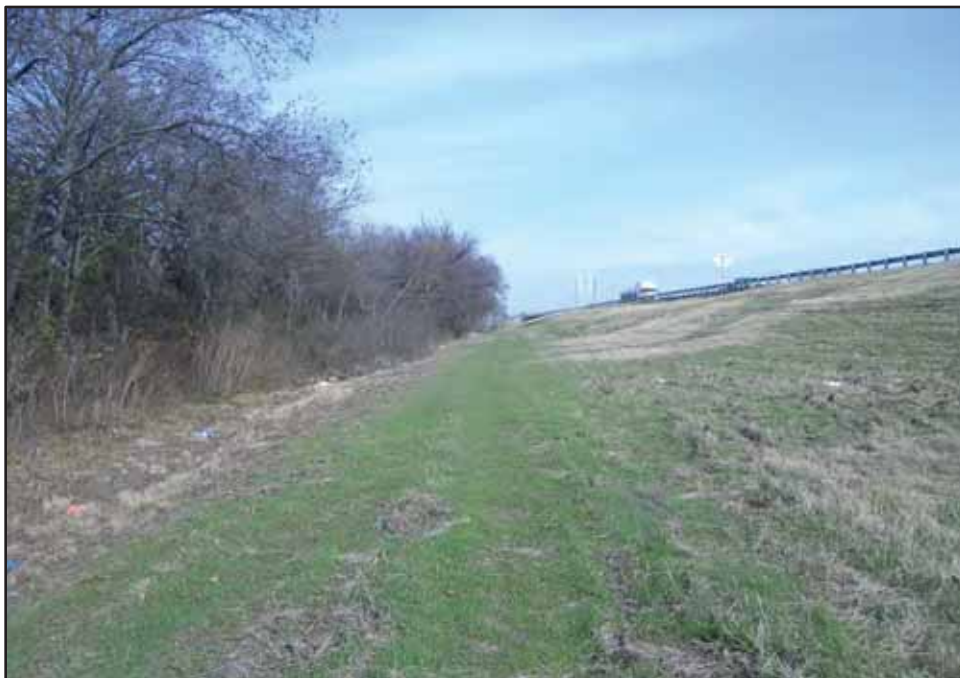
Photograph 16: View looking northeast along IH 35W west ROW from near STA. 280+00. The TЕСP/EMST Mapper classifies portions of the mowed-maintained vegetation, and woody and unmaintained vegetation as Crosstimbers Woodland and Forest, along with Disturbed Prairie. The mowed-maintained vegetation better fits the Urban classification. The woody and unmaintained vegetation fit the Crosstimbers Woodland and Forest classification. Date of photograph: 12/8/19.

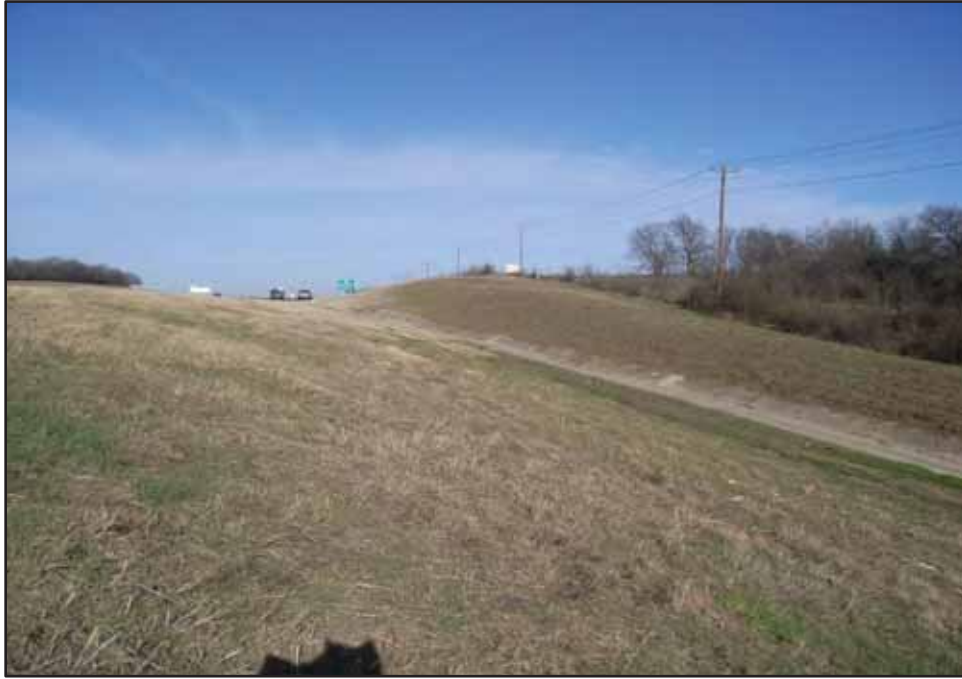
Photograph 17: View looking northeast along IH 35W east ROW from near STA. 280+00. The TЕСP/EMST Mapper classifies portions of the mowed-maintained vegetation, and woody and unmaintained vegetation as Tallgrass Prairie, Grassland. The mowed-maintained vegetation better fits the Urban classification. The woody and unmaintained vegetation fits the Crosstimbers Woodland and Forest, and Disturbed Prairie classifications. Date of photograph: 12/7/19.

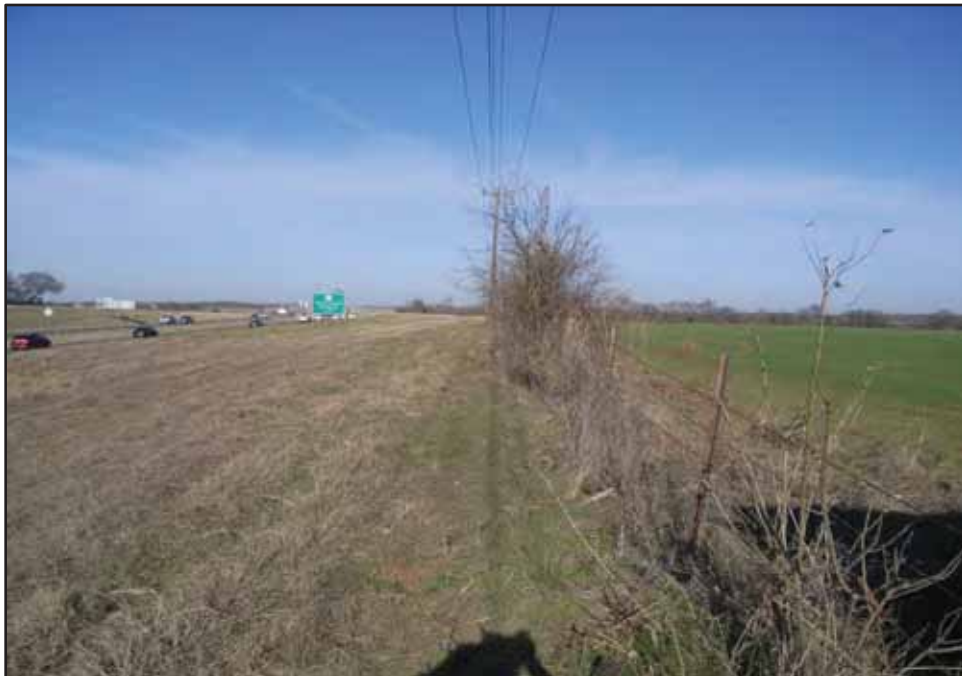
Photograph 18: View looking northeast along IH 35W east ROW from near STA. 283+00. The TЕСP/EMST Mapper classifies portions of the mowed-maintained vegetation as Agriculture and portions of the row crops at the right of the photo as Urban. The mowed-maintained vegetation better fits the Urban classification. Date of photograph: 12/7/19.

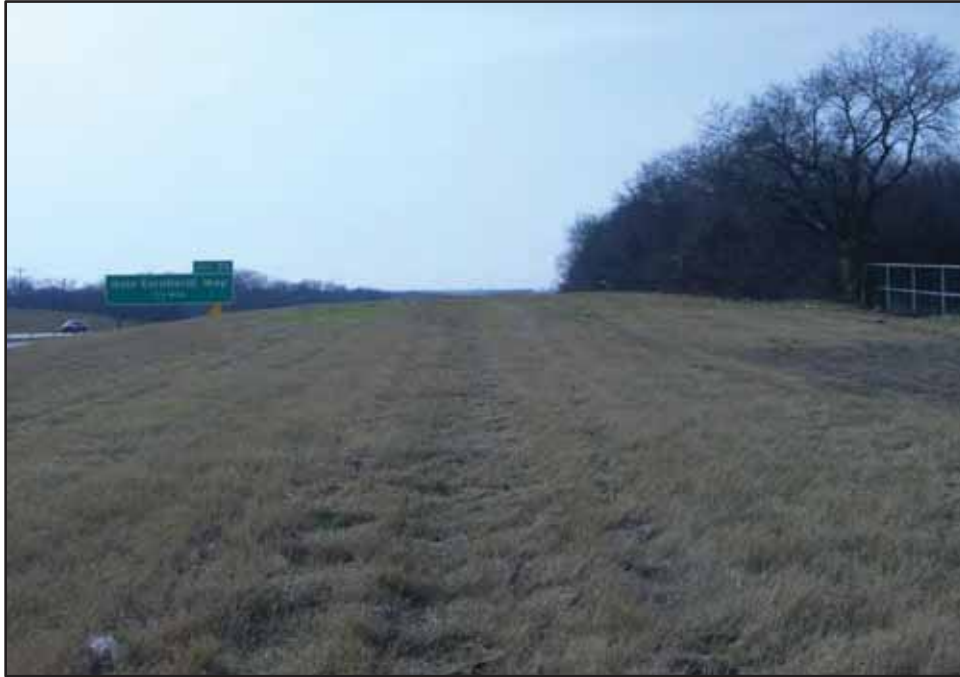
Photograph 19: View looking southwest along IH 35W west ROW from near STA. 290+00. The TЕСP/EMST Mapper classifies portions of the mowed-maintained vegetation, and the woody vegetation as Crosstimbers Woodland and Forest. The mowed-maintained vegetation better fits the Urban classification and the woody vegetation fits the Crosstimbers Woodland and Forest classification. Date of photograph: 12/8/19.

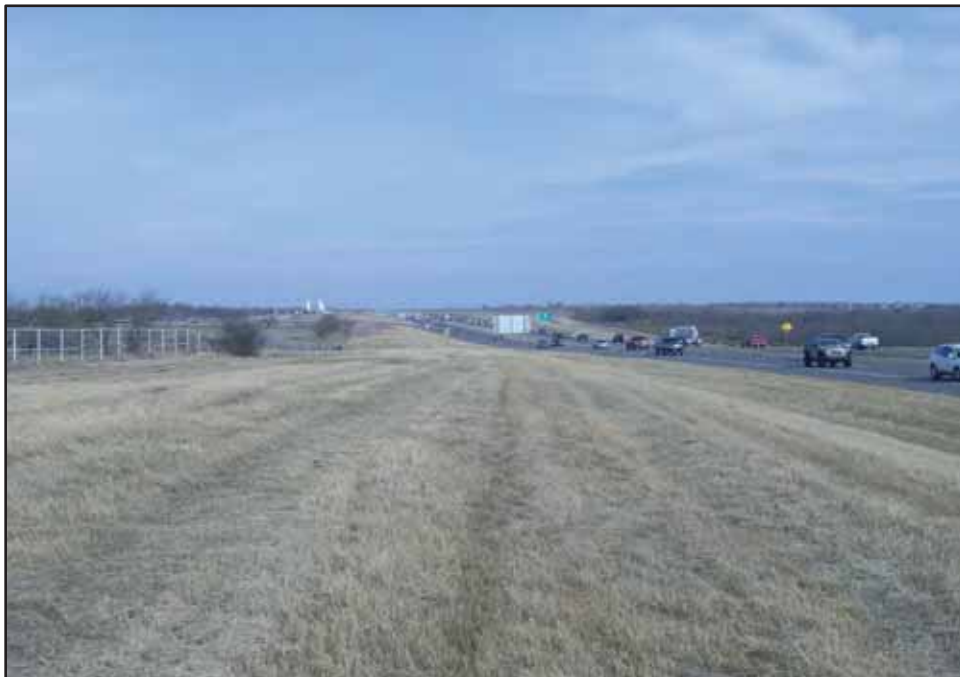
Photograph 20: View looking north-northeast along IH 35W west ROW from near STA. 290+00. The TЕСP/EMST Mapper classifies portions of the roadway and mowed-maintained vegetation as Tallgrass Prairie, Grassland. The roadway and mowed-maintained vegetation better fit the Urban classification. Date of photograph: 12/8/19.

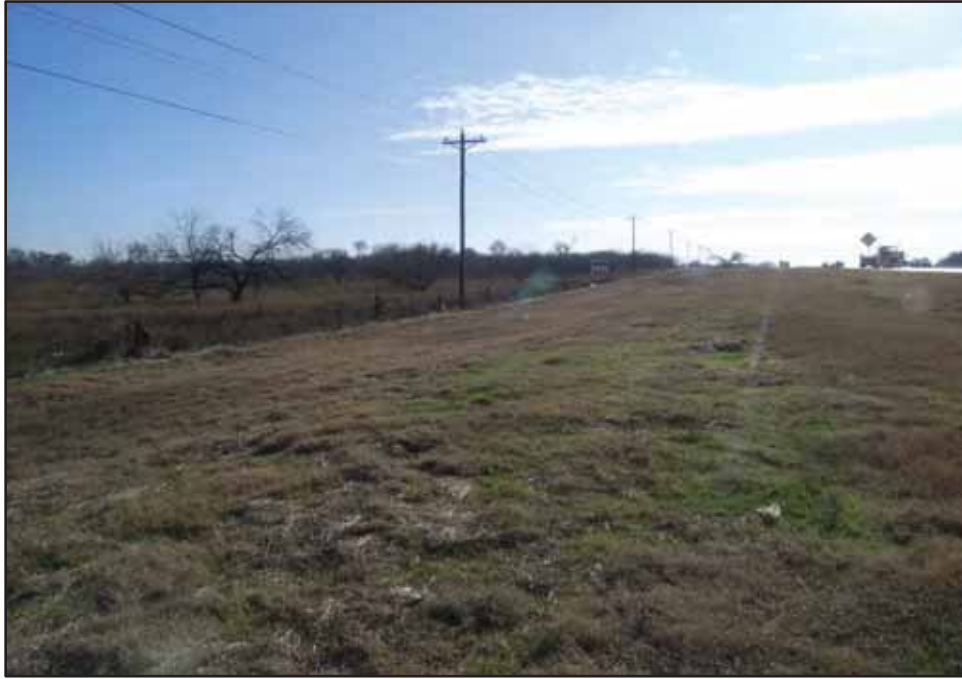
Photograph 21: View looking south-southeast along IH 35W east ROW from near STA. 299+00. The TESCP/EMST Mapper classifies portions of the roadway and mowed-maintained vegetation as Tallgrass Prairie, Grassland. The mowed-maintained vegetation better fits the Urban classification. The vegetation east of the fence line fits the Disturbed Prairie classification. Date of photograph: 12/8/19.

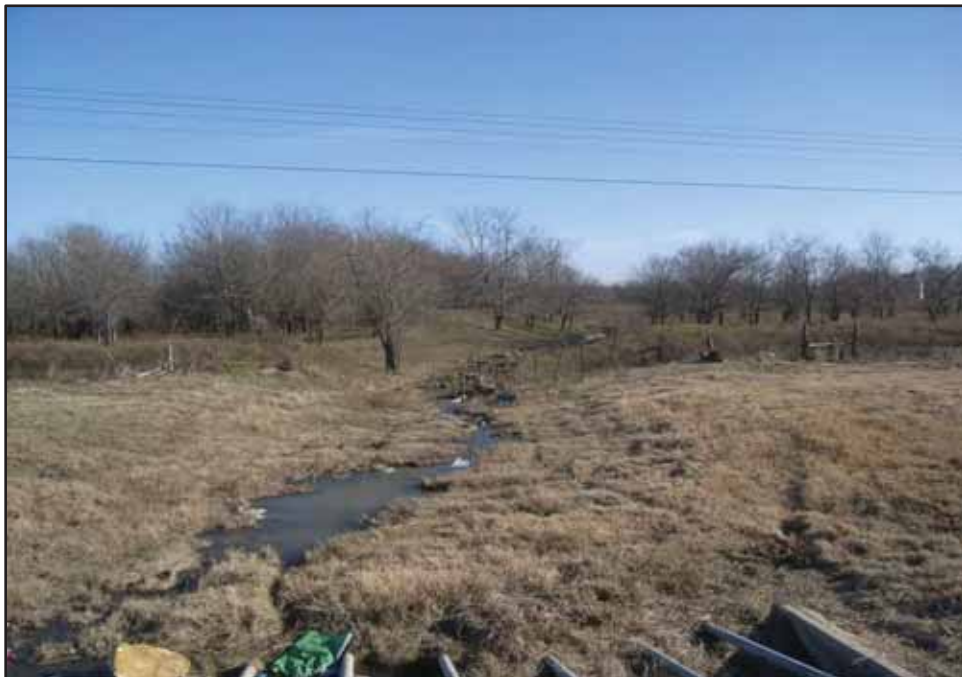
Photograph 22: View looking southeast along a tributary to Cleveland Branch on IH 35W east ROW from near STA. 301+50. The TESCP/EMST Mapper classifies the mowed-maintained vegetation and stream as Tallgrass Prairie, Grassland. The mowed-maintained vegetation better fits the Urban classification. The stream fits the Open Water classification. Disturbed Prairie is in the background. Date of photograph: 12/7/19.

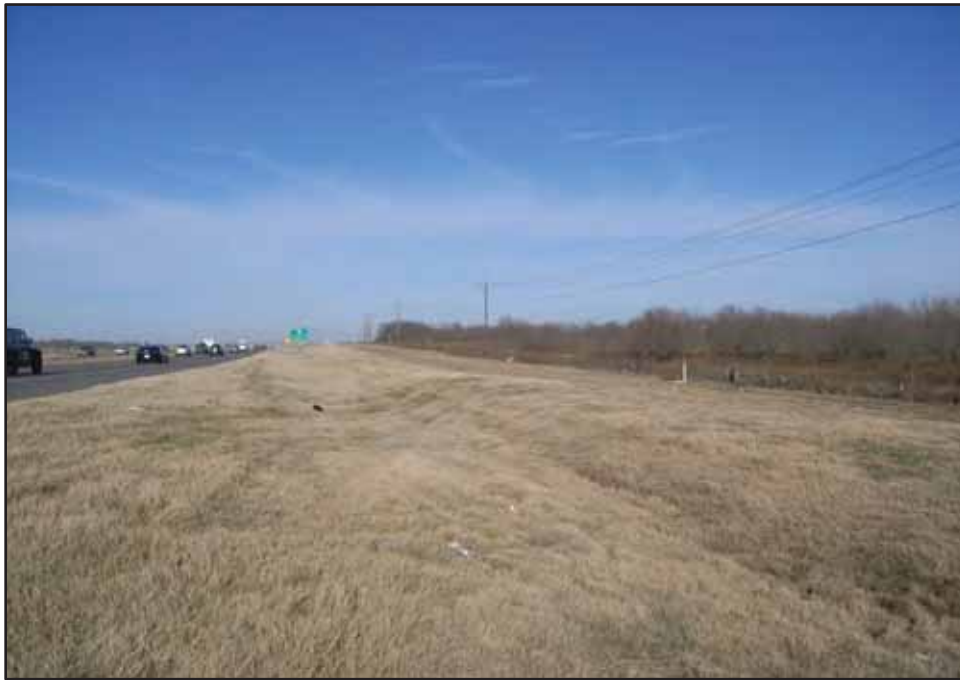
Photograph 23: View looking north-northeast along IH 35W east ROW from near STA. 301+50. The TЕСP/EMST Mapper classifies portions of the mowed-maintained vegetation and stream as Tallgrass Prairie, Grassland. The mowed-maintained vegetation better fits the Urban classification. Disturbed Prairie is east of the fence line. Date of photograph: 12/7/19.

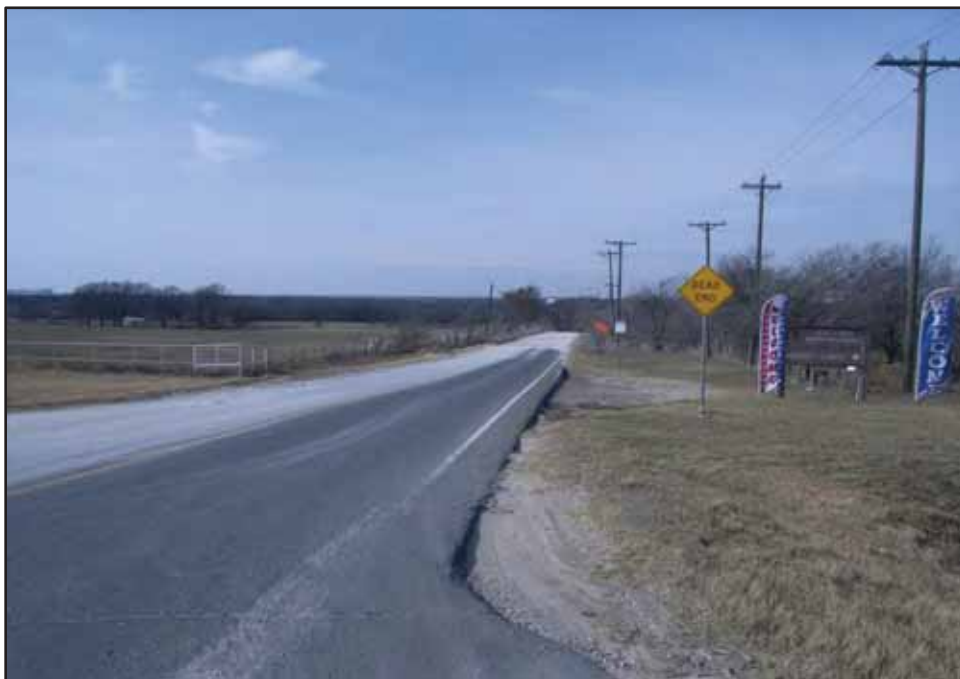
Photograph 24: View looking west along FM 1171/Cross Timbers Road at the intersection with the southbound IH 35W exit ramp near STA. 329+00. The TЕСP/EMST Mapper classifies portions of roadway and mowed-maintained vegetation as Crosstimbers Woodland and Forest. The roadway and mowed-maintained vegetation better fit the Urban classification. Date of photograph: 12/8/19.

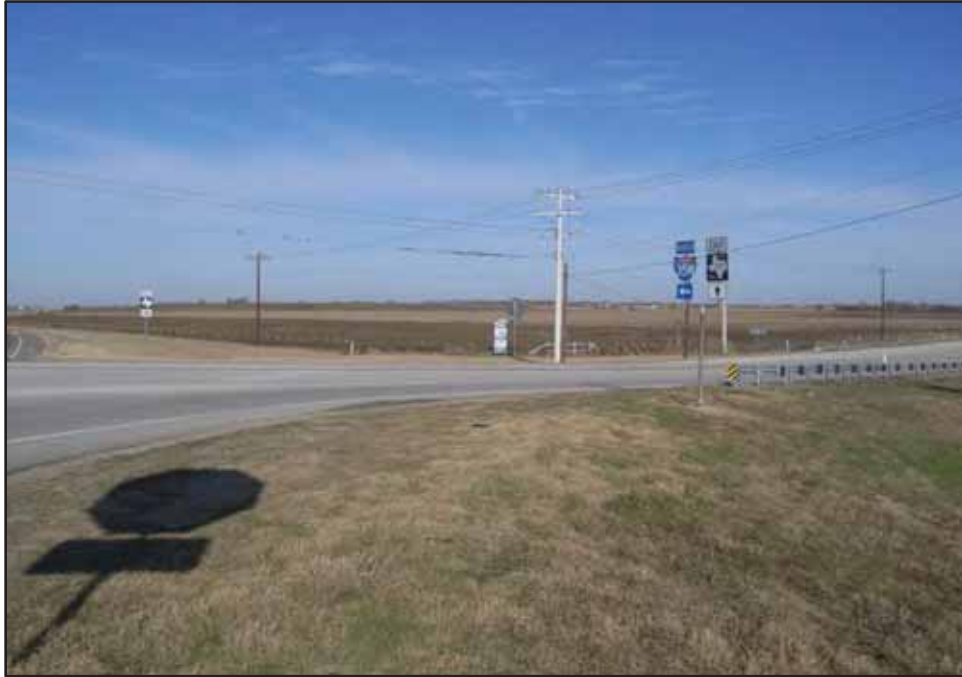
Photograph 25: View looking northeast from the intersection of FM 1171 and Cross Timbers Road at the northbound IH 35W entrance ramp near STA. 327+00. The TЕСP/EMST Mapper classifies portions of the mowed-maintained vegetation as Tallgrass Prairie, Grassland. The mowed-maintained vegetation better fits the Urban classification. Date of photograph: 12/7/19.

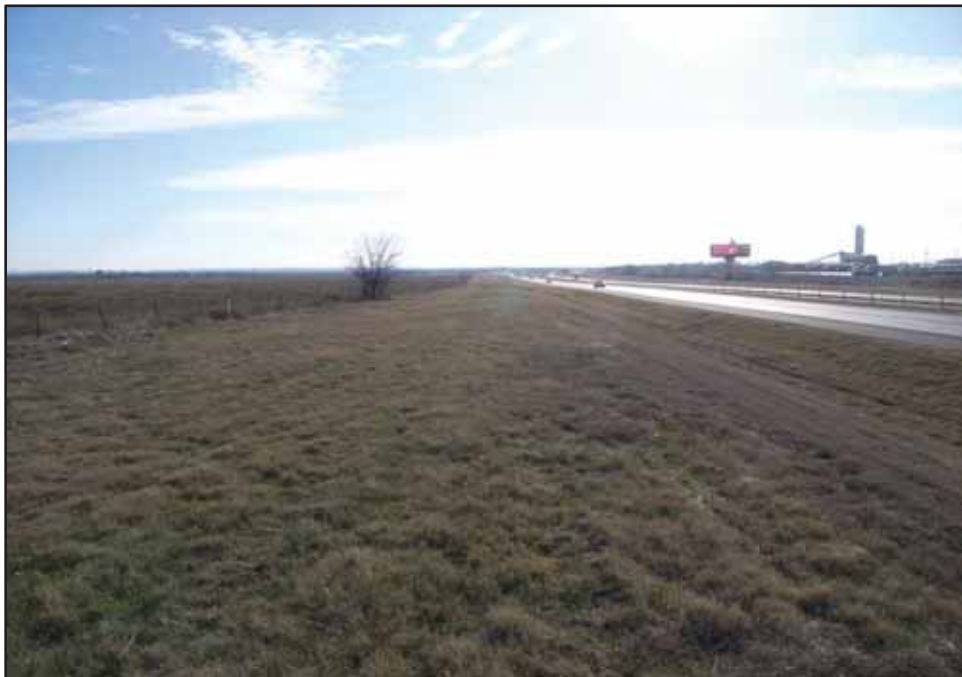
Photograph 24: View looking south-southwest along IH 35W east ROW from near STA. 357+00. The TЕСP/EMST Mapper classifies portions of the mowed-maintained vegetation as Tallgrass Prairie, Grassland, along with Riparian. The mowed-maintained vegetation better fits the Urban classification. Tallgrass Prairie, Grassland is east of the fence line. Date of photograph: 12/7/19.

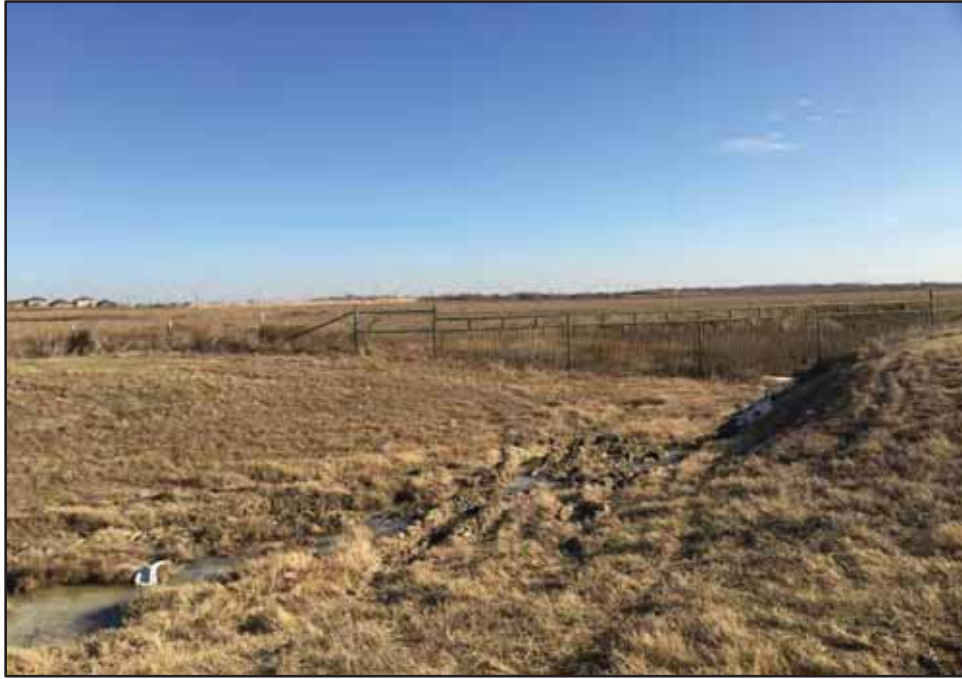
Photograph 27: View looking southeast along Cleveland Branch on east ROW near STA. 358+00. The TESCP/EMST Mapper classifies stream and the mowed-maintained vegetation as Riparian. The mowed-maintained vegetation better fits the Urban classification. The stream better fits the Open Water classification. Date of photograph: 12/7/19.

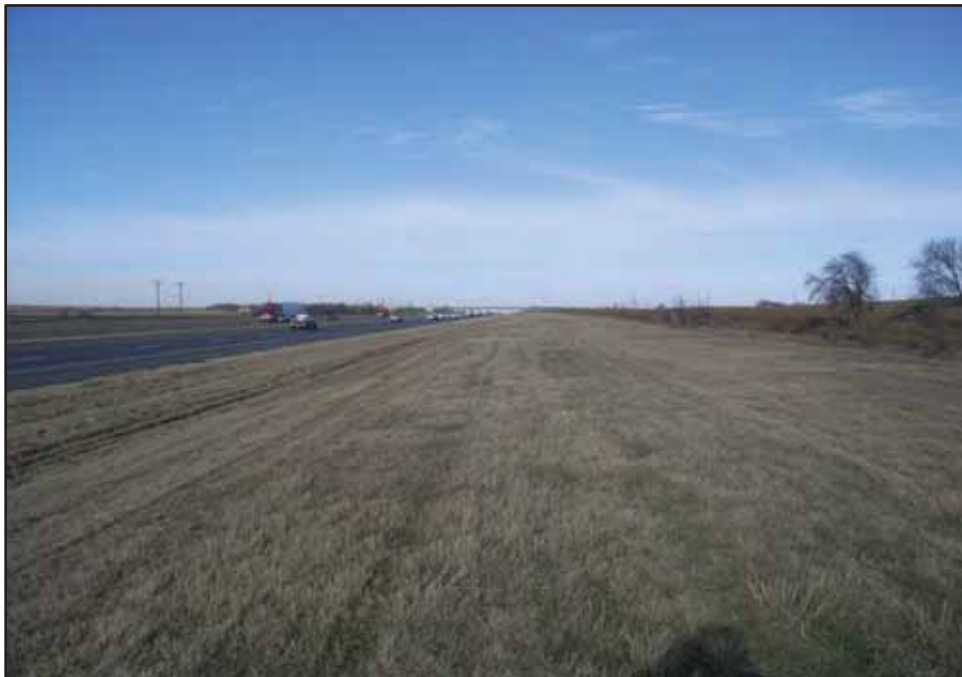
Photograph 25: View looking north-northeast along IH 35W east ROW near STA. 358+00. The TESCP/EMST Mapper classifies portions of the mowed-maintained vegetation as Tallgrass Prairie, Grassland. The mowed-maintained vegetation better fits the Urban classification. Tallgrass Prairie, Grassland is east of the fence line. Date of photograph: 12/7/19.

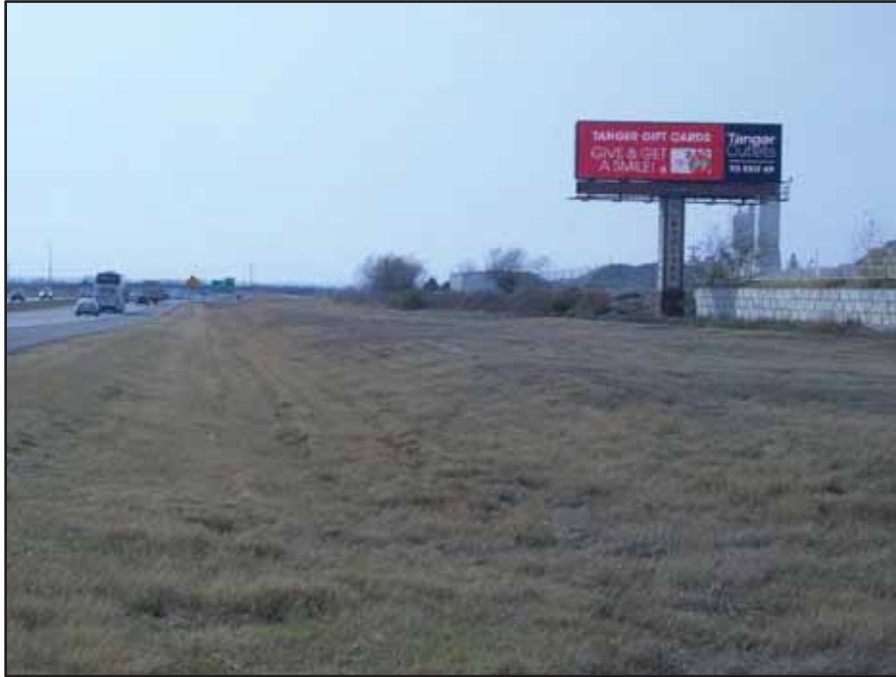
Photograph 29: View looking south-southwest along IH 35W west ROW near STA. 358+00. The TЕСP/EMST Mapper classifies portions of the mowed-maintained vegetation as Tallgrass Prairie, Grassland, along with Urban. The mowed-maintained vegetation better fits the Urban classification. Date of photograph: 12/7/19.

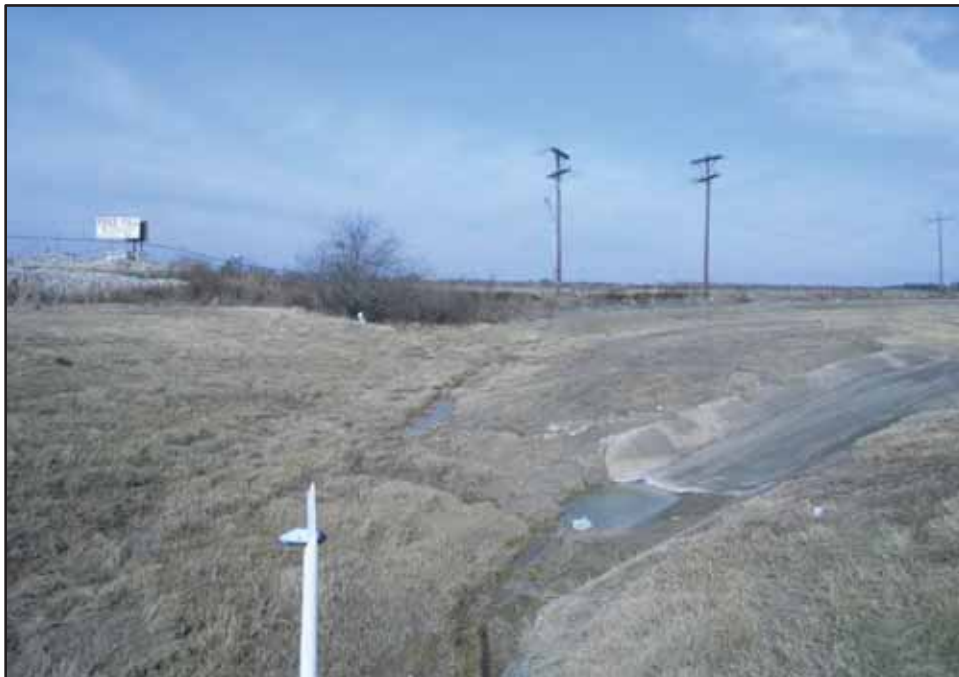
Photograph 30: View looking northwest along Cleveland Branch on the IH 35W west ROW near STA. 359+00. The TЕСP/EMST Mapper classifies the mowed-maintained vegetation, stream, and woody vegetation as Riparian and Tallgrass Prairie, Grassland. The mowed-maintained vegetation better fits the Urban classification and the woody vegetation fits the Disturbed Prairie classification. The stream better fits the Open Water classification. Date of photograph: 12/8/19
