IH 35W Frontage Roads Technical Reports

Air Quality Resources Technical Report

Interstate Highway (IH) 35W Frontage Roads

Control-Section-Job (CSJ) 0081-13-065

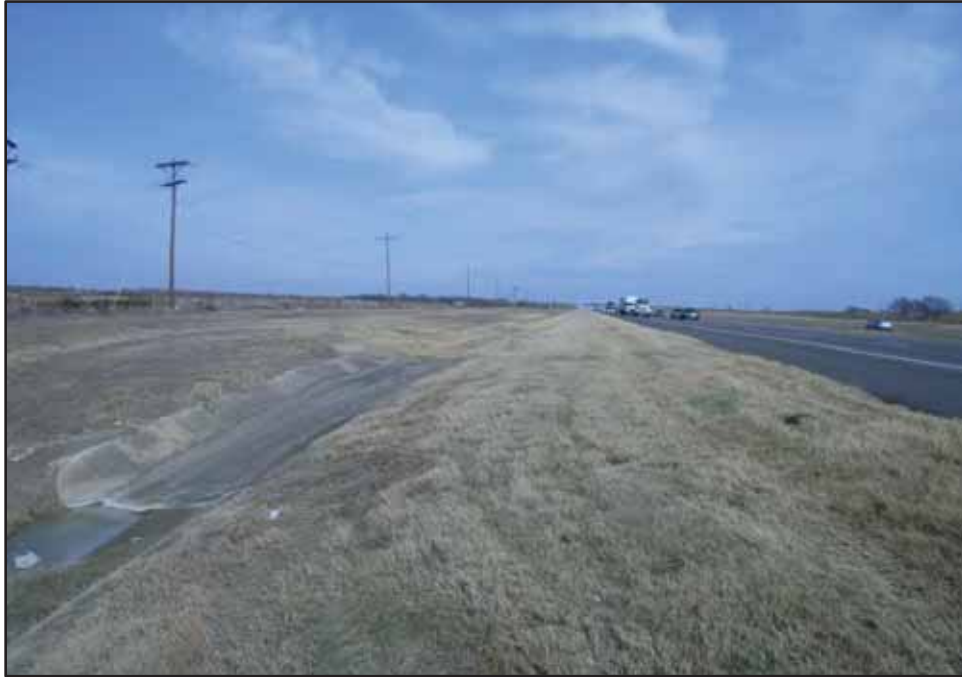
Photograph 31: View looking north-northeast along IH 35W west ROW near STA. 359+00. The TЕСP/EMST Mapper classifies portions of the roadway and mowed-maintained vegetation as Tallgrass Prairie, Grassland. The roadway and mowed-maintained vegetation better fit the Urban classification. Tallgrass Prairie, Grassland is west of the fence line. Date of photograph: 12/8/19

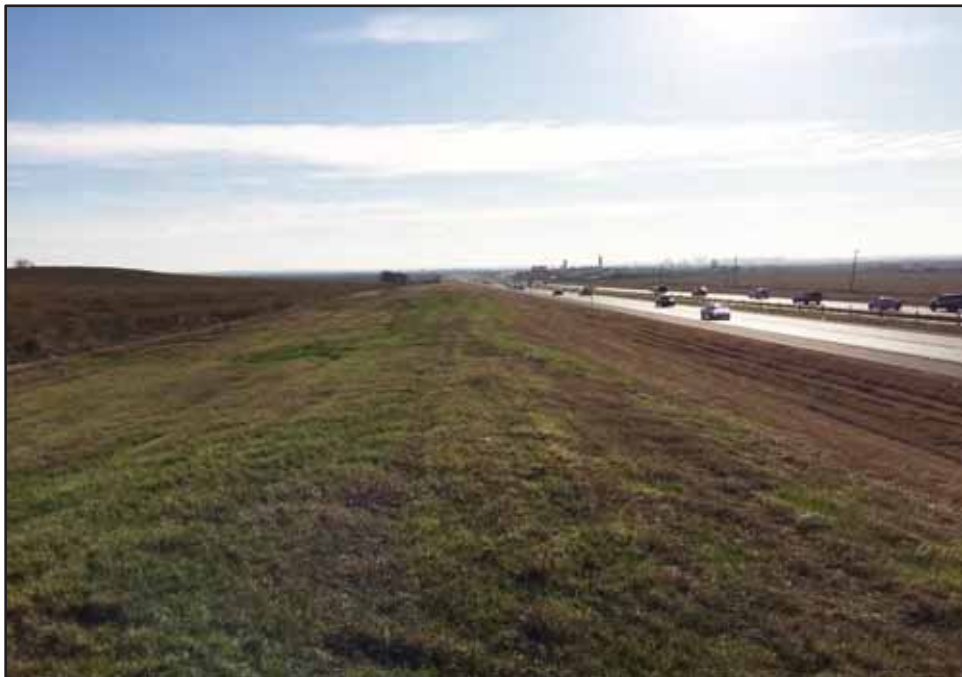
Photograph 32: View looking south-southwest along IH 35W east ROW from near STA. 380+00. The TЕСP/EMST Mapper classifies portions of the mowed-maintained vegetation as Tallgrass Prairie, Grassland. The mowed-maintained vegetation better fits the Urban classification. Tallgrass Prairie, Grassland is east of the fence line. Date of photograph: 12/7/19.

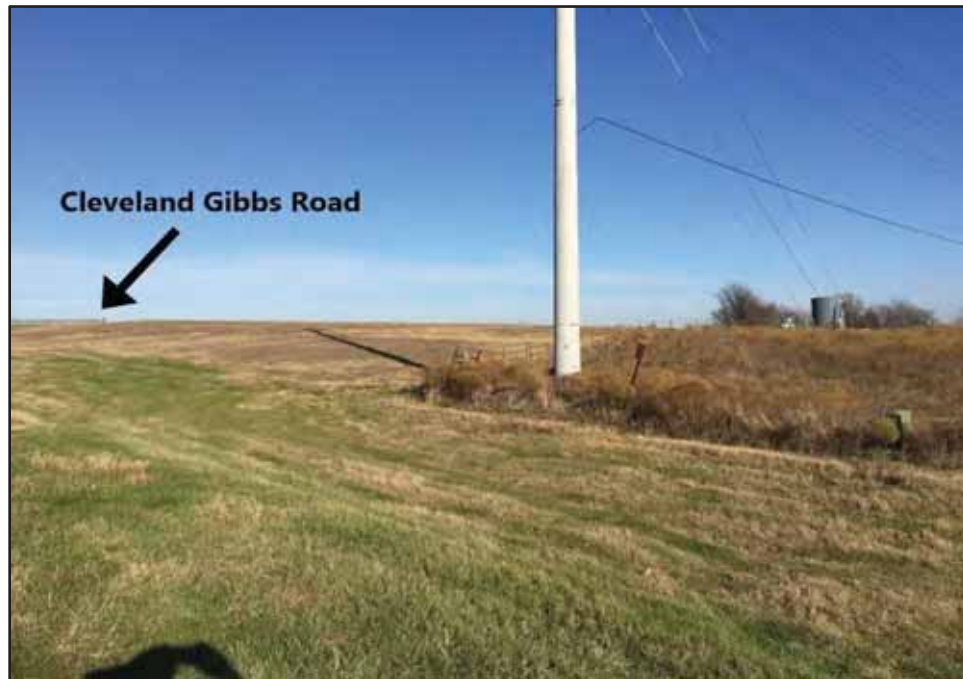
Photograph 33: View looking east towards Cleveland Gibbs Road from IH 35W east ROW near STA. 381+00. The TЕСP/EMST Mapper classifies portions of the mowed-maintained vegetation and Cleveland Gibbs Road as Edwards Plateau Savannah, Woodland, and Shrubland. The mowed-maintained vegetation and Cleveland Gibbs Road better fit the Urban classification. Date of photograph: 12/7/19.

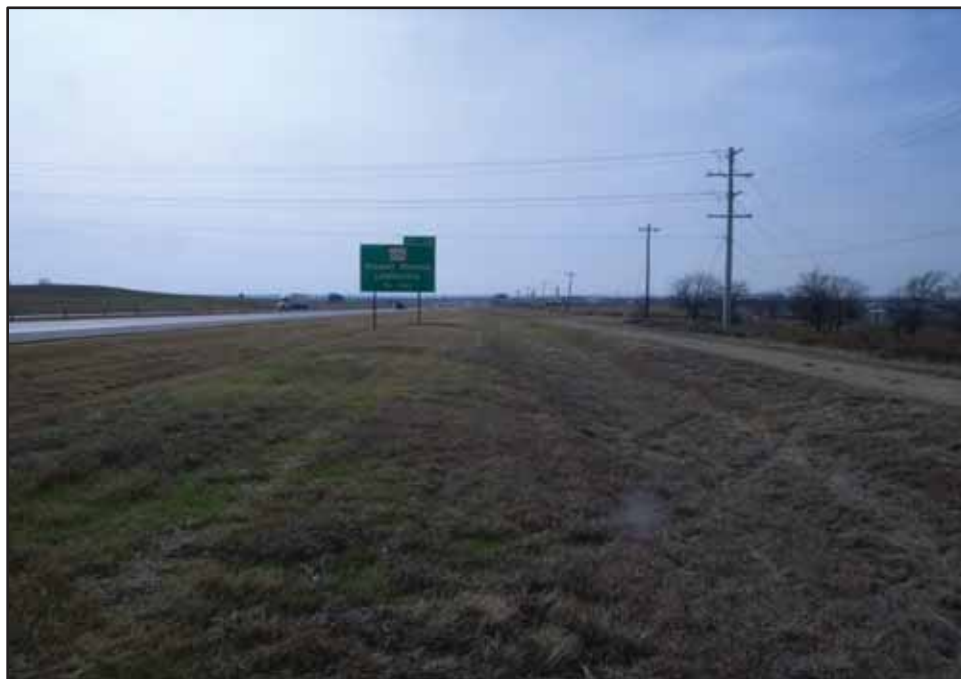
Photograph 34: View looking south-southwest along IH 35W west ROW from near STA. 386+00. The TЕСP/EMST Mapper classifies portions of the roadway and mowed-maintained vegetation as Tallgrass Prairie, Grassland. The roadway and mowed-maintained vegetation better fit the Urban classification. Disturbed Prairie is west of the fence line. Date of photograph: 12/8/19.

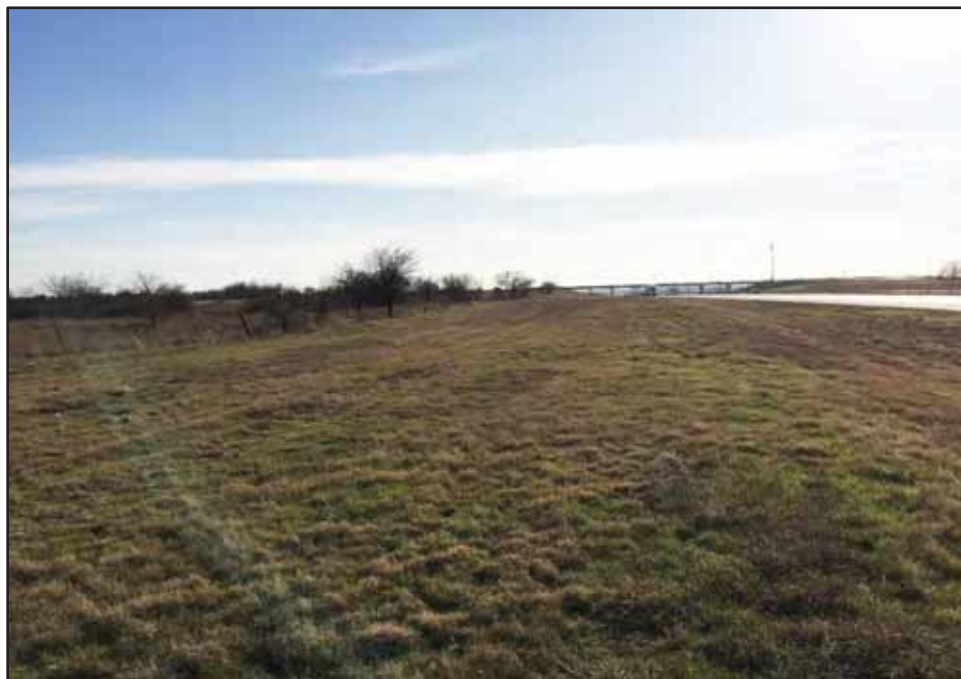
Photograph 36: View looking south-southeast along IH 35W east ROW from near STA. 393+00. The TESCP/EMST Mapper classifies portions of the mowed-maintained vegetation as Edwards Plateau Savannah, Woodland, and Shrubland. The mowed-maintained vegetation better fits the Urban classification. Disturbed Prairie is east of the fence line. Date of photograph: 12/7/19.

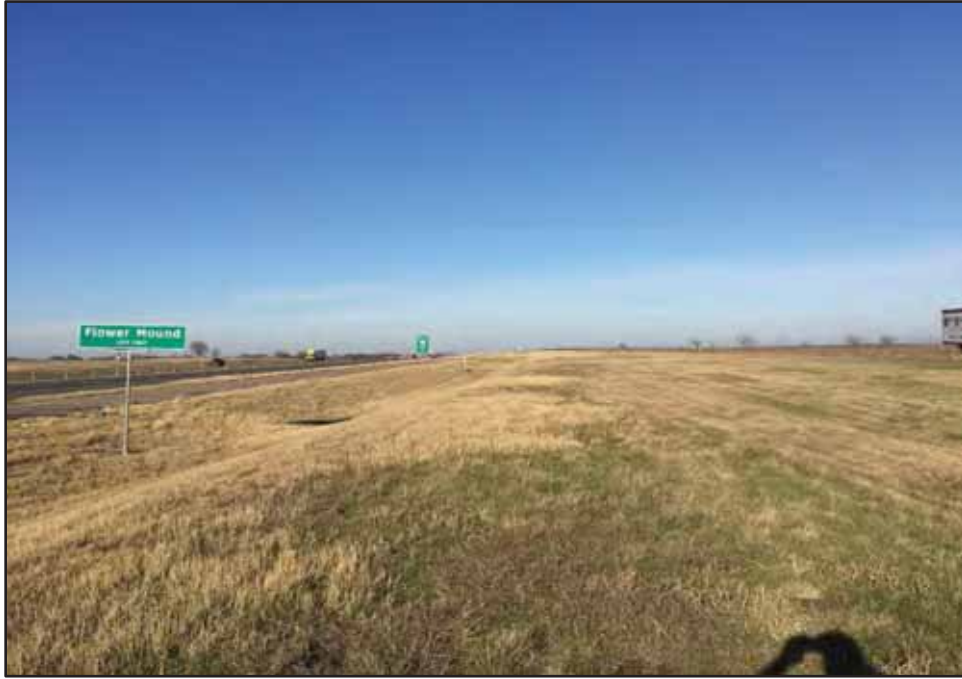
Photograph 37: View looking north-northeast along IH 35W east ROW from near STA. 393+00. The TESC/EMST Mapper classifies portions of the mowed-maintained vegetation as Edwards Plateau Savannah, Woodland, and Shrubland, along with Tallgrass Prairie, Grassland. The mowed-maintained vegetation better fits the Urban classification. Date of photograph: 12/7/19.

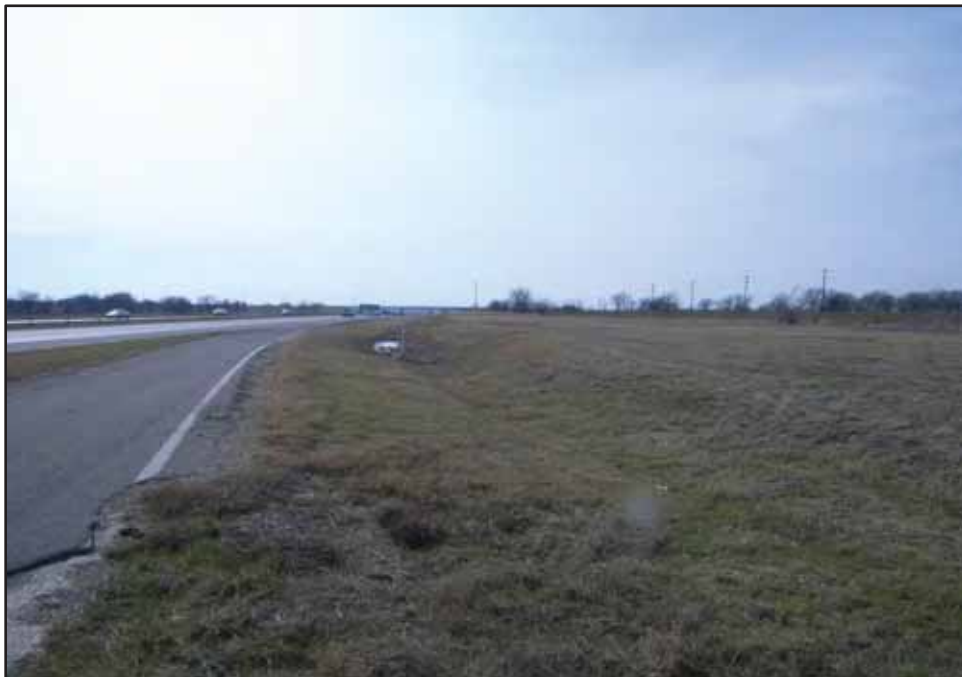
Photograph 38: View looking south-southwest along IH 35W west ROW from near STA. 405+00. The TESC/EMST Mapper classifies portions of the mowed-maintained vegetation as Edwards Plateau Savannah, Woodland, and Shrubland, along with Tallgrass Prairie, Grassland. The mowed-maintained vegetation better fits the Urban classification. Date of photograph: 12/8/19.

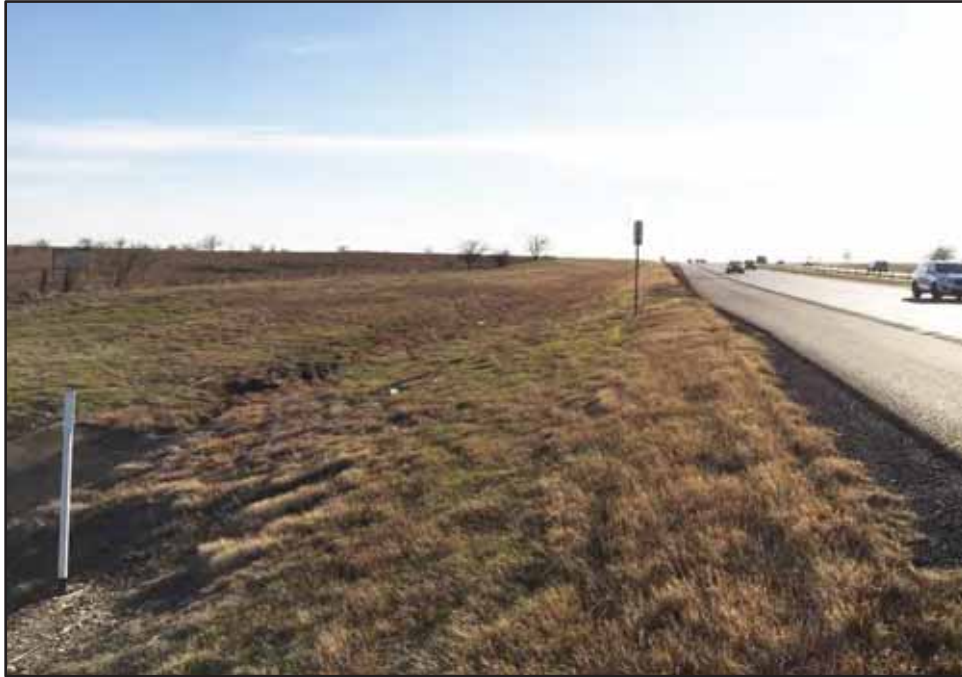
Photograph 39: View looking south-southwest along IH 35W east ROW from near STA. 427+00. The TЕСP/EMST Mapper classifies portions of the roadway and mowed-maintained vegetation as Tallgrass Prairie, Grassland. The mowed-maintained vegetation better fits the Urban classification. Tallgrass Prairie, Grassland is east of the fence line. Date of photograph: 12/7/19.

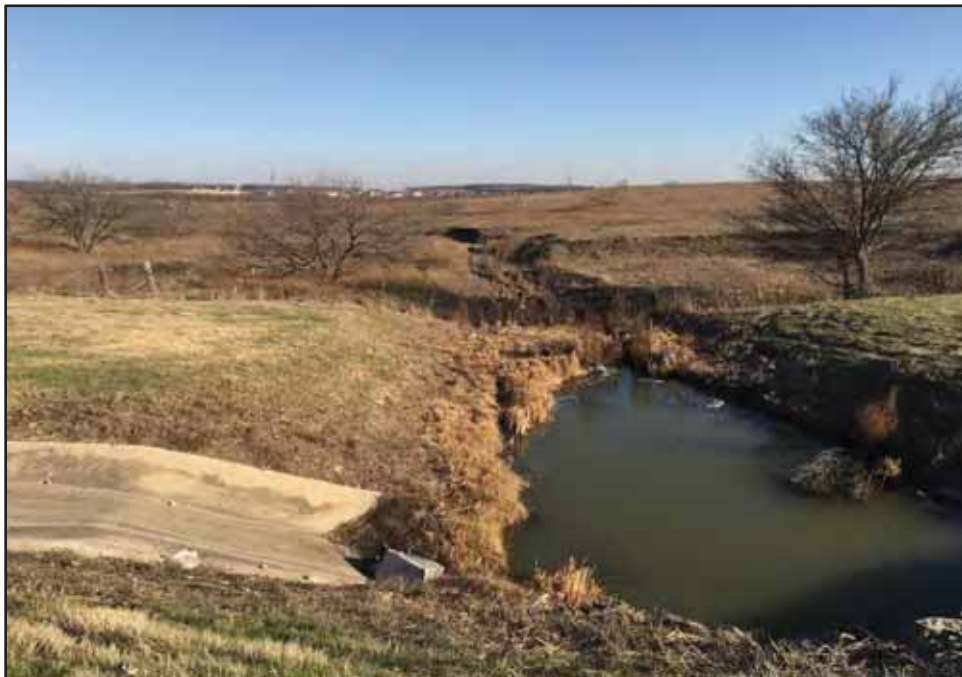
Photograph 40: View looking east-southeast towards a stream on IH 35W east ROW near STA. 427+00. The TЕСP/EMST Mapper classifies the tributary and surrounding mowed-maintained vegetation as Riparian. The mowed-maintained vegetation better fits the Urban classification. The stream fits the Open Water classification. Date of photograph: 12/7/19.

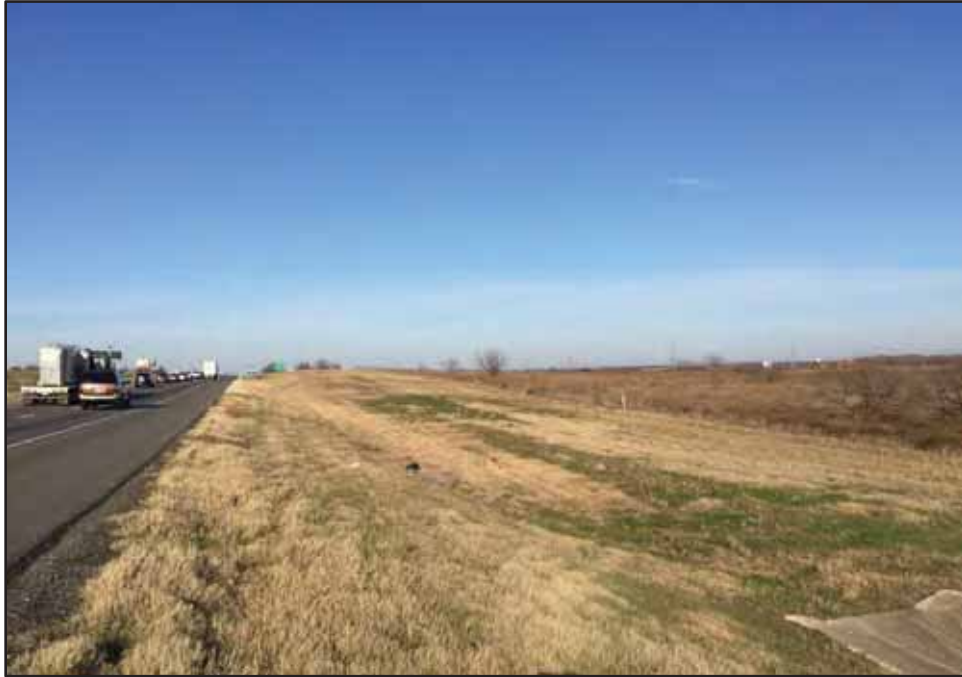
Photograph 41: View looking north-northeast along IH 35W east ROW from near STA. 427+00. The TESCP/EMST Mapper classifies portions of the mowed-maintained vegetation as Edwards Plateau Savannah, Woodland, and Shrubland, along with Tallgrass Prairie, Grassland. The mowed-maintained vegetation better fits the Urban classification. Tallgrass Prairie, Grassland is east of the fence line. Date of photograph: 12/7/19.

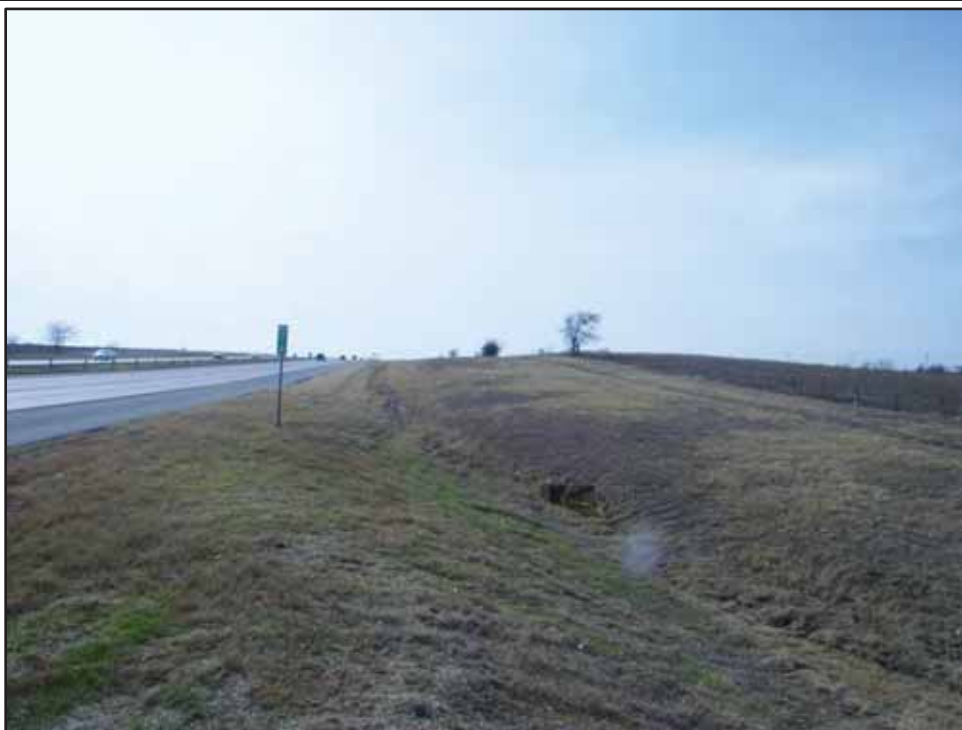
Photograph 42: View looking south-southwest along IH 35W west ROW from near STA. 428+00. The TESCP/EMST Mapper classifies portions of the mowed-maintained vegetation as Edwards Plateau Savannah, Woodland, and Shrubland. The mowed-maintained vegetation better fits the Urban classification. Date of photograph: 12/8/19.

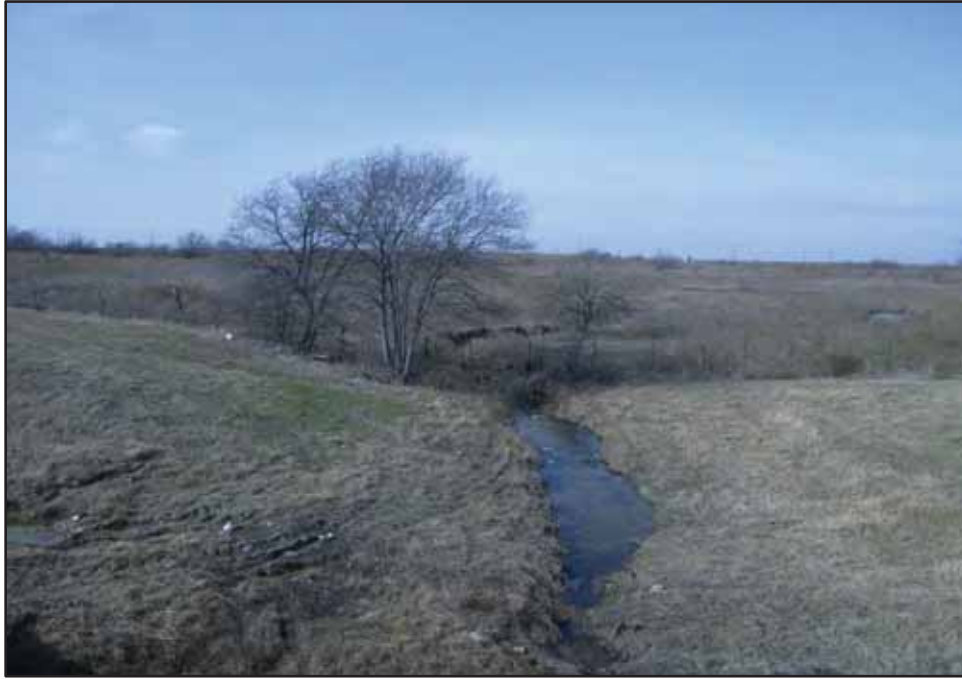
Photograph 43: View looking west-northwest towards a stream on IH 35W west ROW near STA. 428+00. The TЕСP/EMST Mapper classifies the stream and surrounding mowed-maintained vegetation as Riparian. The mowed-maintained vegetation better fits the Urban classification. The stream fits the Open Water classification. The wooded area fits the Disturbed Prairie classification. Date of photograph: 12/8/19.

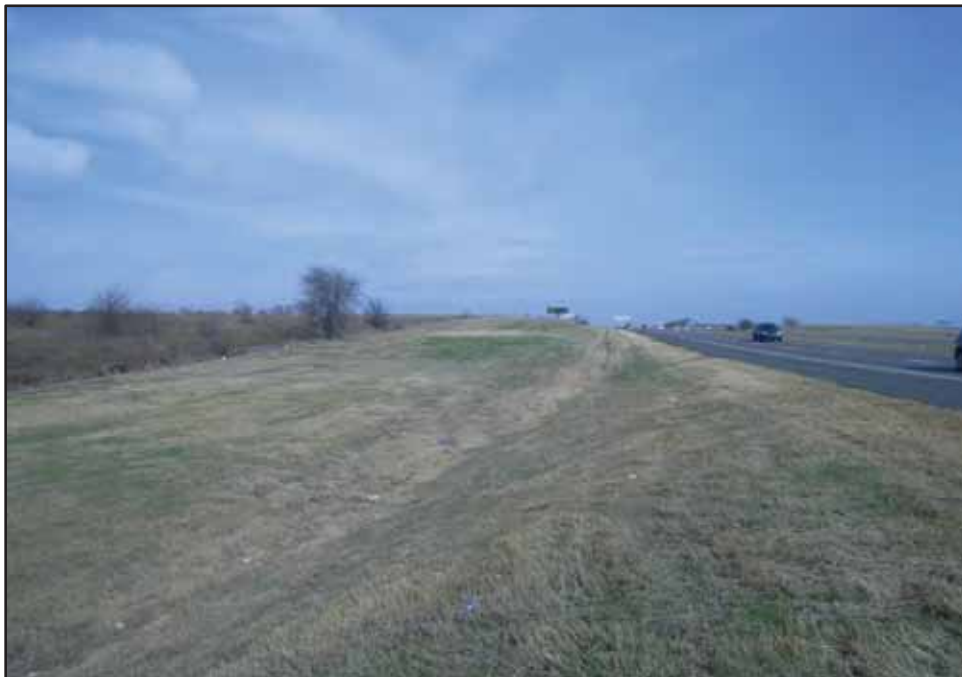
Photograph 44: View looking north-northeast along IH 35W west ROW near STA. 428+00. The TЕСP/EMST Mapper classifies the mowed-maintained vegetation as Edwards Plateau Savannah, Woodland, and Shrubland, along with Tallgrass Prairie, Grassland. The mowed-maintained vegetation better fits the Urban classification. The stream fits the Riparian classification. Date of photograph: 12/8/19.

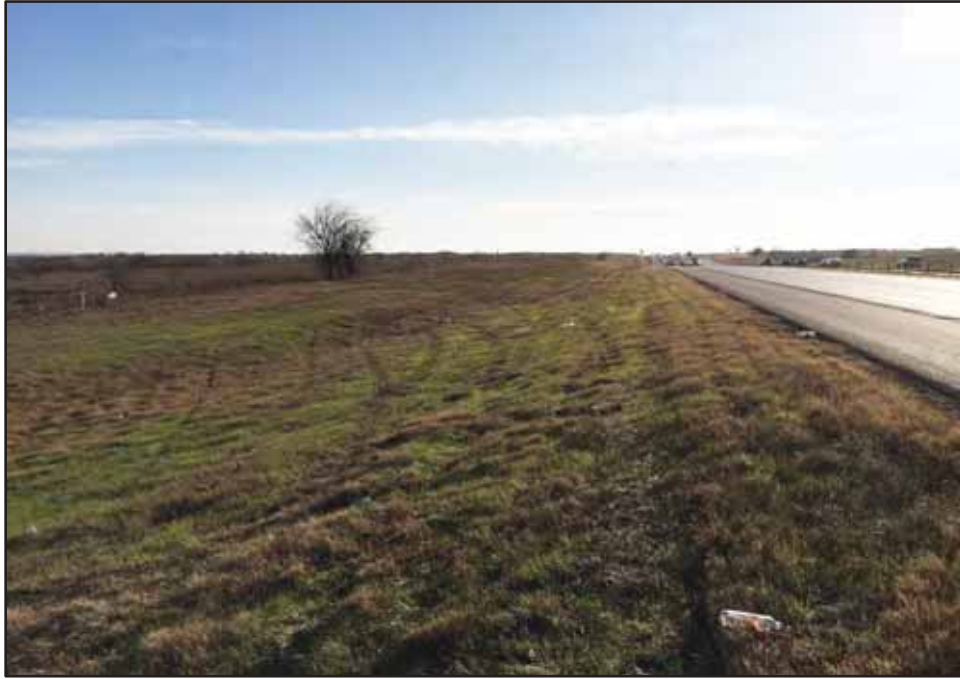
Photograph 45: View looking south-southwest along IH 35W east ROW from near STA. 441+00. The TЕСP/EMST Mapper classifies portions of the mowed-maintained vegetation as Edwards Plateau Savannah, Woodland, and Shrubland, along with Tallgrass Prairie, Grassland. The mowed-maintained vegetation better fits the Urban classification. Tallgrass Prairie, Grassland is east of the fence line. Date of photograph: 12/7/19.

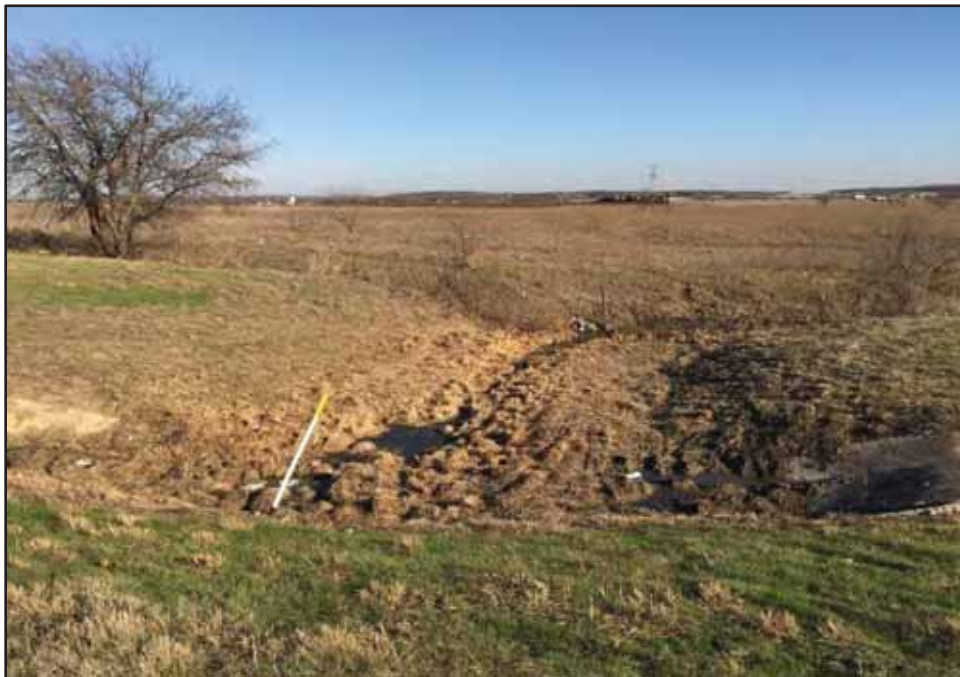
Photograph 46: View looking southeast towards a stream on IH 35W east ROW near STA. 441+00. The TЕСP/EMST Mapper classifies the stream and surrounding mowed-maintained vegetation as Riparian. The mowed-maintained vegetation better fits the Urban classification. The stream better fits the Open Water classification. Tallgrass Prairie, Grassland is in the background. Date of photograph: 12/7/19.

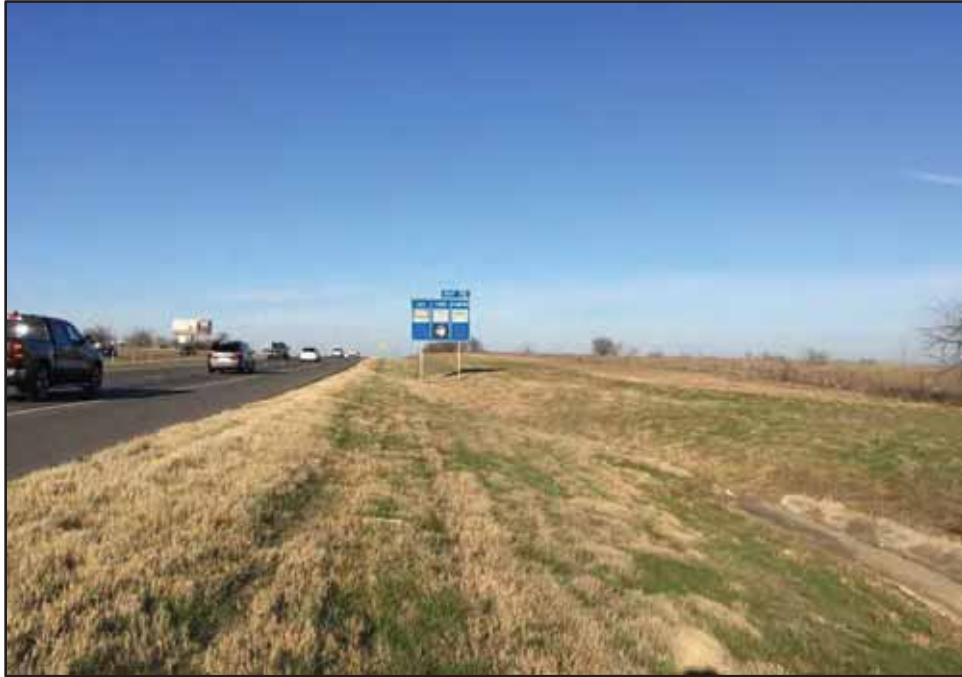
Photograph 47: View looking north-northeast along IH 35W east ROW near STA. 441+00. The TЕСP/EMST Mapper classifies the mowed-maintained vegetation as Edwards Plateau Savannah, Woodland, and Shrubland, along with Crosstimbers Woodland and Forest. The mowed-maintained vegetation better fits the Urban classification. Tallgrass Prairie, Grassland is east of the fence line. Date of photograph: 12/7/19.

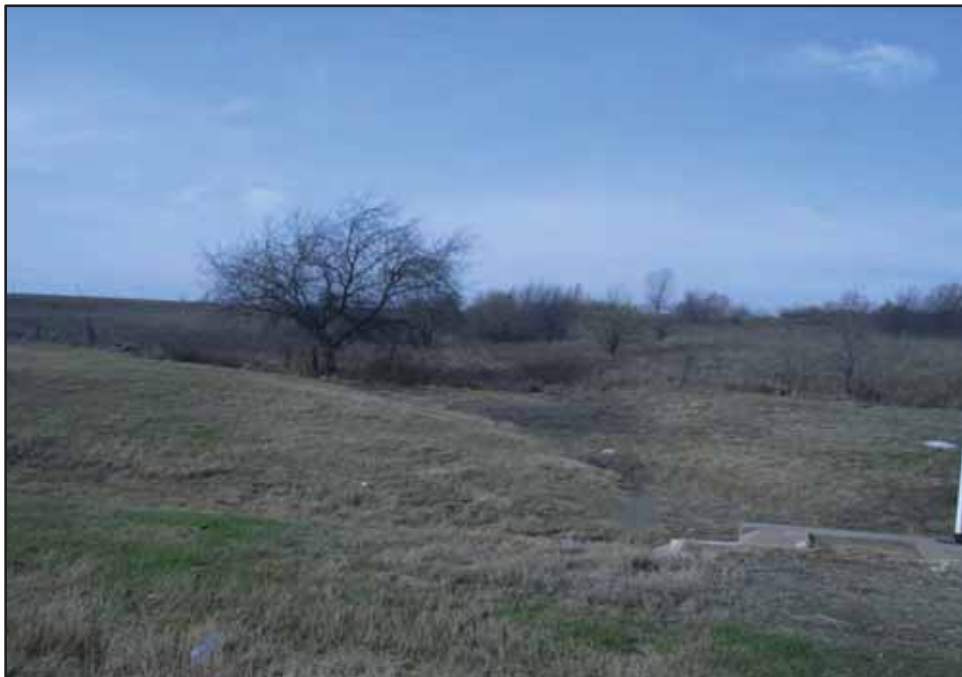
Photograph 48: View looking northwest towards a stream on IH 35W west ROW from near STA. 443+00. The TЕСP/EMST Mapper classifies the mowed-maintained vegetation and ephemeral stream as Riparian. The mowed-maintained vegetation and ephemeral stream better fit the Urban classification. Date of photograph: 12/8/19.

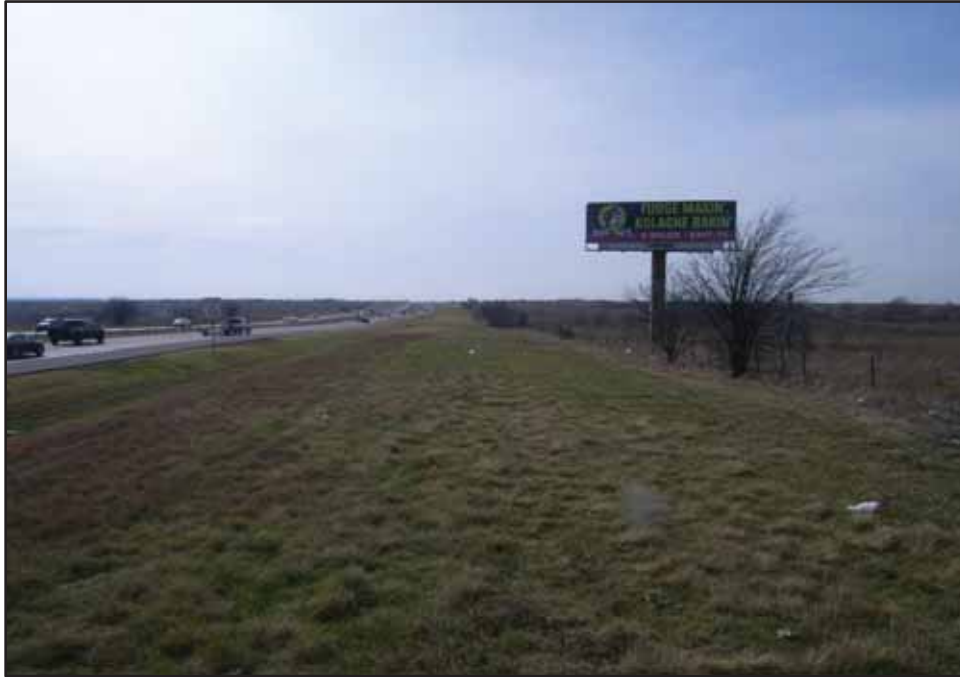
Photograph 49: View looking south-southwest along IH 35W west ROW from near STA. 452+00. The TЕСP/EMST Mapper classifies portions of the mowed-maintained vegetation as Crosstimbers Woodland and Forest. The mowed-maintained vegetation better fits the Urban classification. Tallgrass Prairie, Grassland is west of the fence line. Date of photograph: 12/8/19.

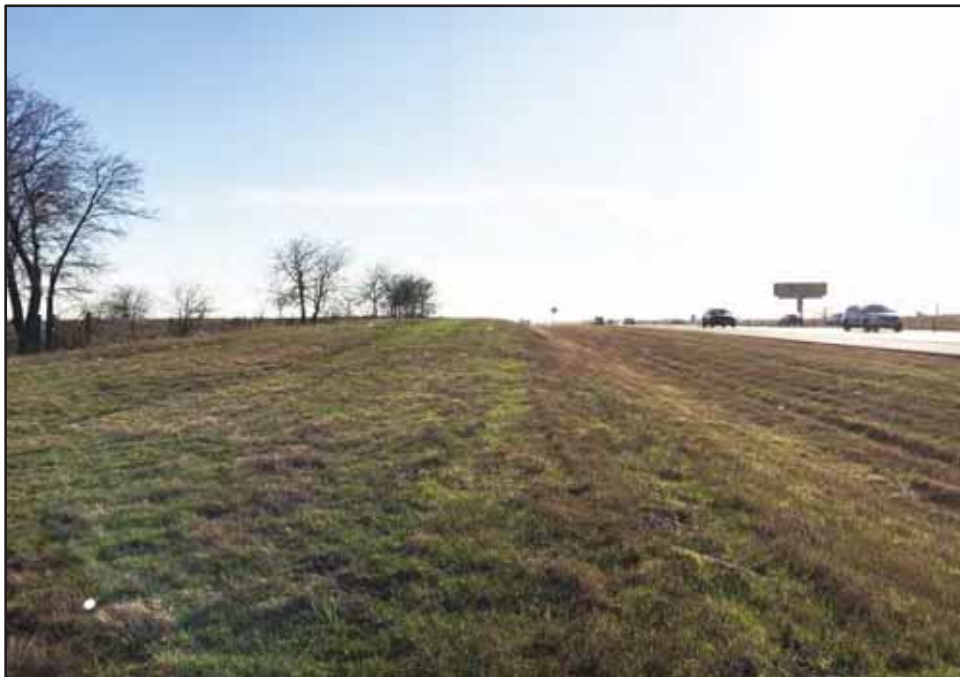
Photograph 50: View looking south-southwest along IH 35W east ROW from near STA. 459+00. The TЕСP/EMST Mapper classifies portions of the mowed-maintained vegetation as Edwards Plateau Savannah, Woodland, and Shrubland, along with Crosstimbers Woodland and Forest. The mowed-maintained vegetation better fits the Urban classification. Disturbed Prairie is east of the fence line. Date of photograph: 12/7/19.

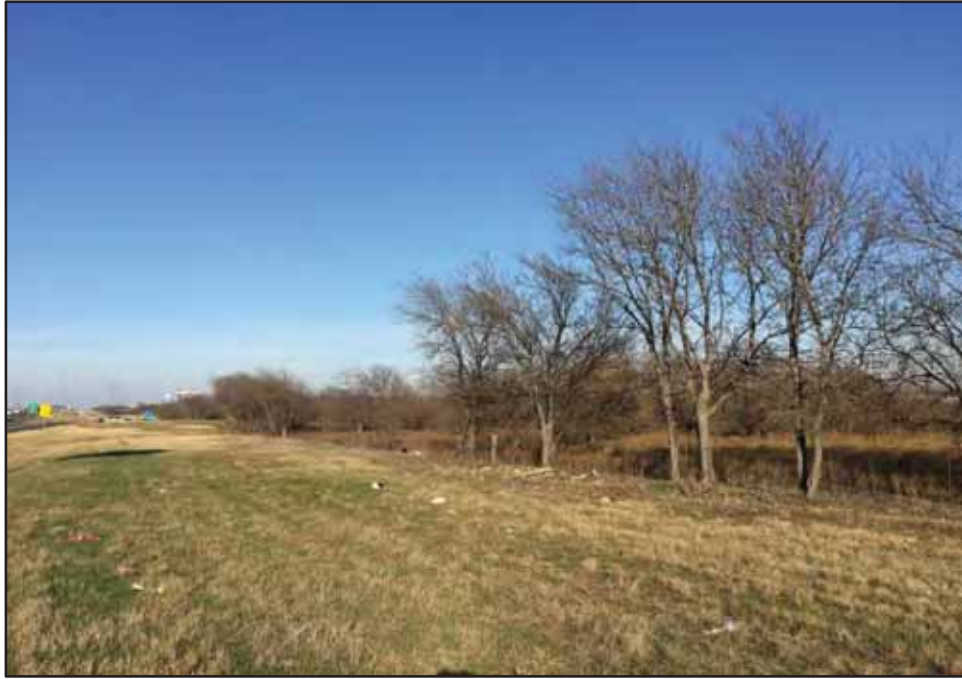
Photograph 51: View looking north-northeast along IH 35W east ROW from near STA. 459+00. The TЕСP/EMST Mapper classifies portions of the mowed-maintained vegetation as Tallgrass Prairie, Grassland. The mowed-maintained vegetation better fits the Urban classification. Disturbed Prairie is east of the fence line. Date of photograph: 12/7/19.

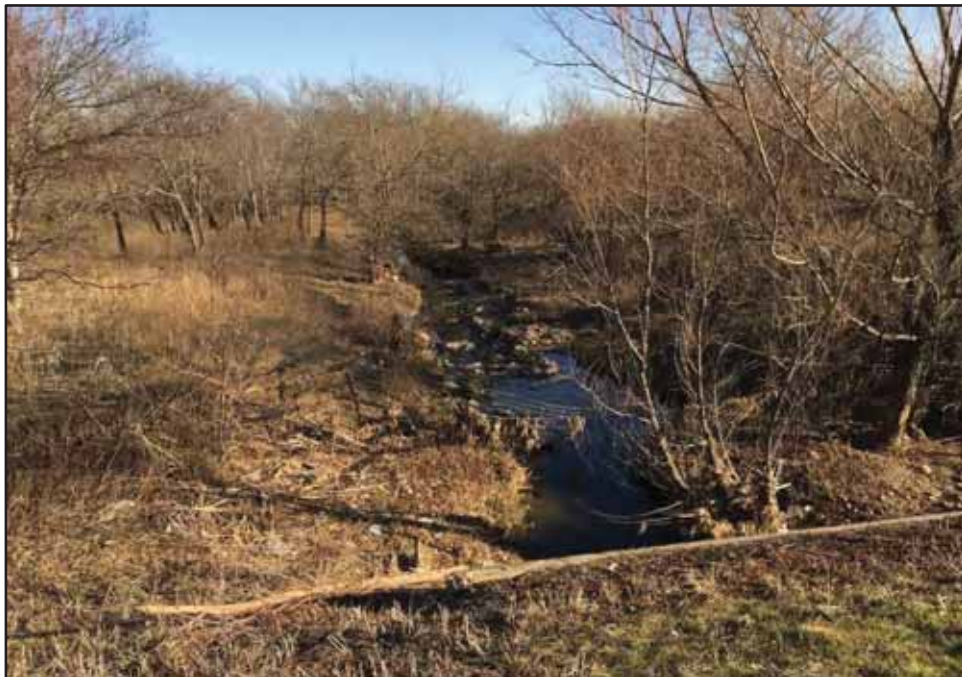
Photograph 52: View looking east-southeast towards a stream on IH 35W east ROW from near STA. 468+00. The TЕСP/EMST Mapper classifies this stream and adjacent vegetation as Urban; however, the vegetation better fits the Riparian classification and the stream better fits the Open Water classification. Date of photograph: 12/7/19.

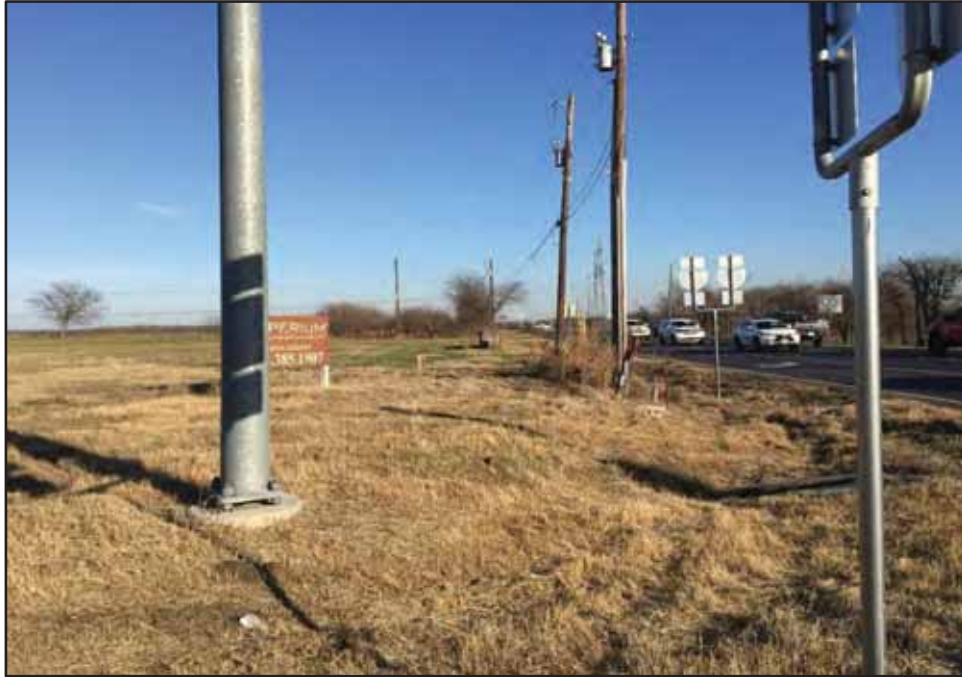
Photograph 53: View looking east from the intersection of FM 407 at the IH 35W northbound entrance ramp. The TЕСP/EMST Mapper classifies the mowed-maintained vegetation as Crosstimbers Woodland and Forest. The mowed-maintained vegetation better fits the Urban classification. Date of photograph: 12/7/19.

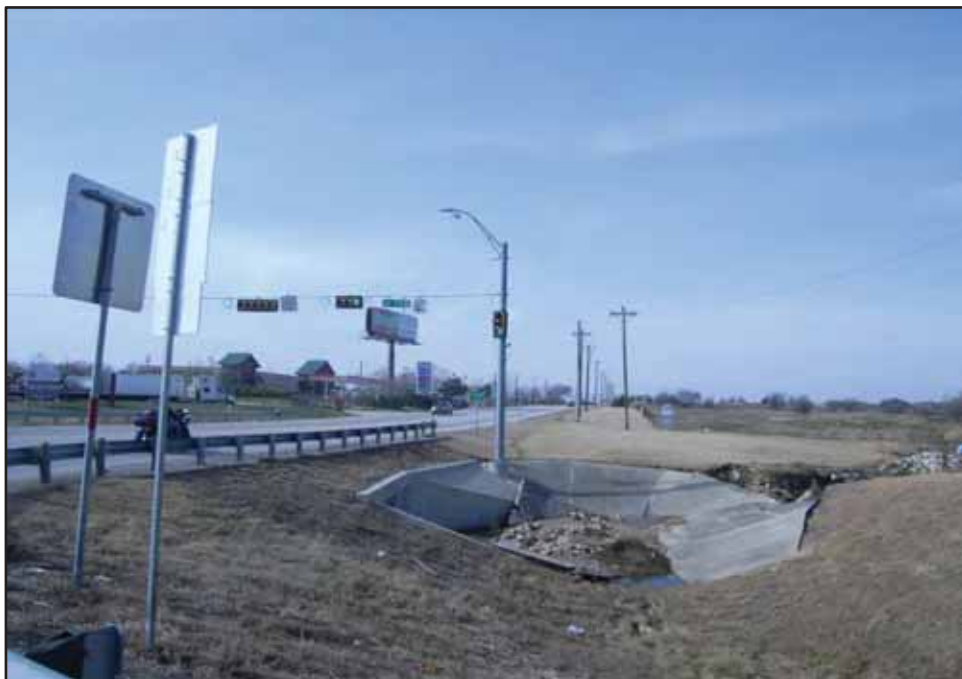
Photograph 54: View looking west-southwest from the intersection of FM 407 at the IH 35W southbound exit ramp. The TЕСP/EMST Mapper classifies portions of the roadway, mowed-maintained vegetation and stream as Crosstimbers Woodland and Forest, along with Tallgrass Prairie, Grassland. The mowed-maintained vegetation better fits the Urban classification. The stream better fits the Open Water classification. Date of photograph: 12/8/19.

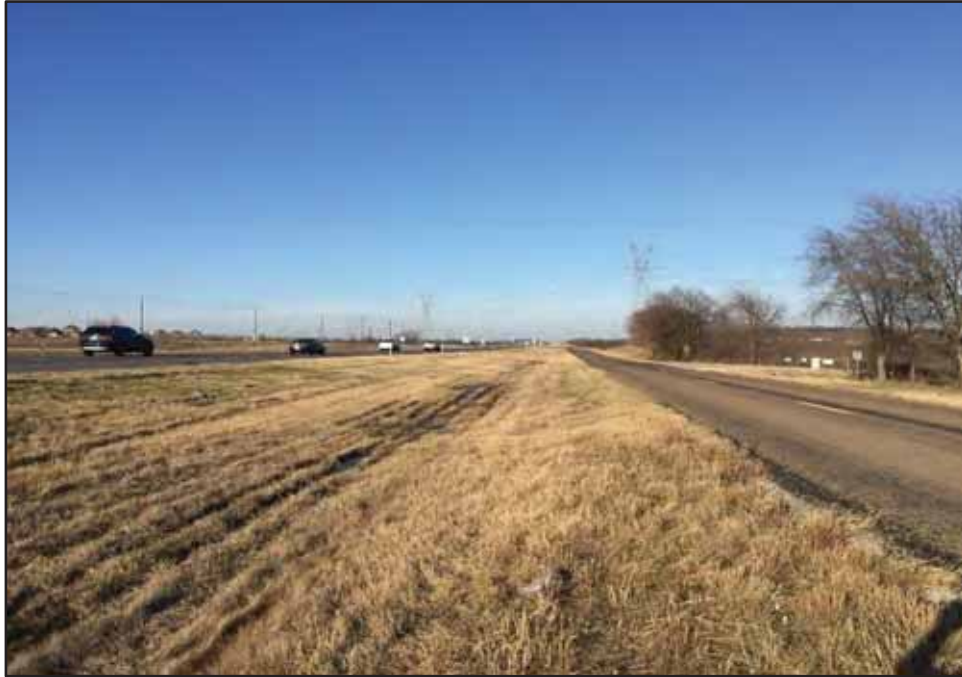
Photograph 55: View looking north-northeast along IH 35W east ROW near STA. 485+00. The TЕСP/EMST Mapper classifies portions of the mowed-maintained vegetation as Crosstimbers Woodland and Forest; however, it better fits the Urban classification. Disturbed Prairie is east of the fence line. Date of photograph: 12/7/19.

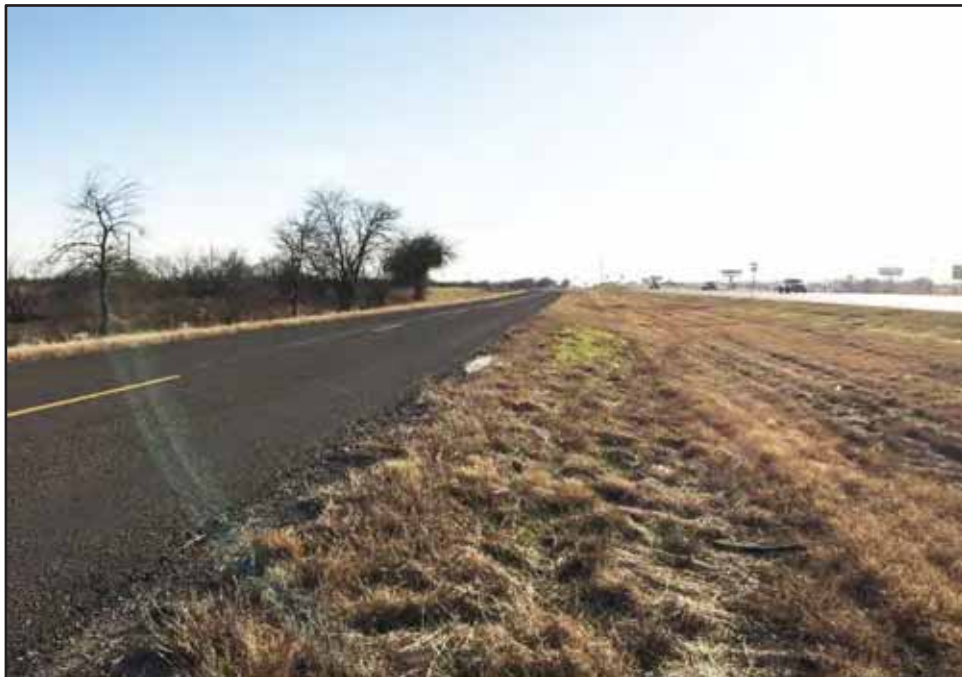
Photograph 56: View looking south-southwest along IH 35W east ROW near STA. 485+00. The TЕСP/EMST Mapper classifies portions of the mowed-maintained vegetation as Crosstimbers Woodland and Forest, along with Tallgrass Prairie, Grassland; however, it better fits the Urban classification. Disturbed Prairie is east of the fence line. Date of photograph: 12/7/19.

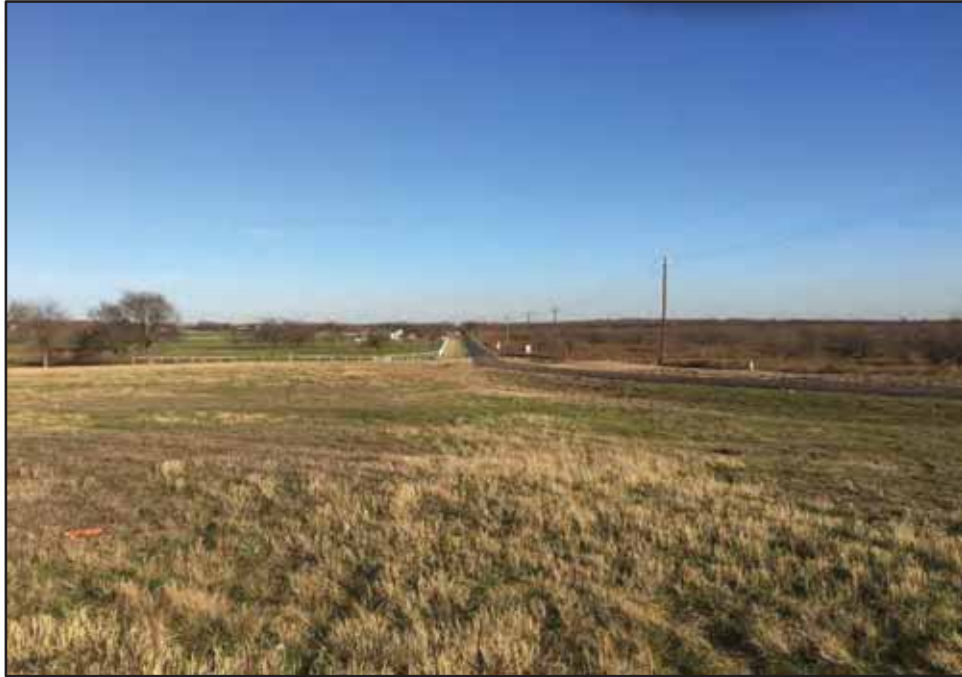
Photograph 57: View looking east towards Sam Davis Road from IH 35W east ROW near STA. 500+00. The TЕСP/EMST Mapper classifies portions of Sam Davis Road as Crosstimbers Woodland and Forest, along with Riparian. The roadway better fits the Urban classification. Date of photograph: 12/7/19.

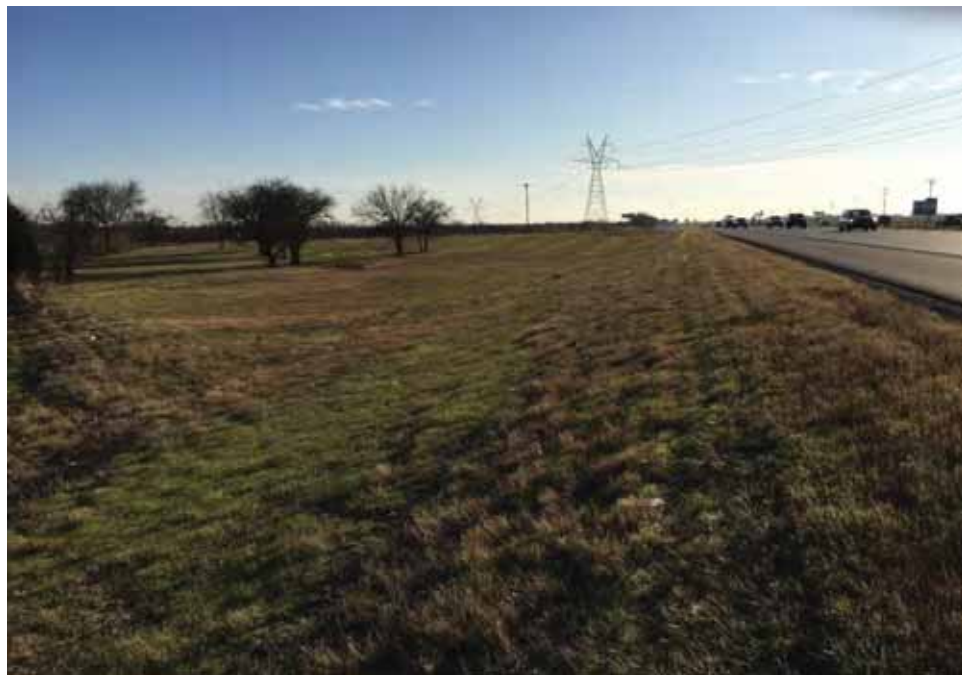
Photograph 58: View looking south-southwest along IH 35W east ROW from near STA. 506+00. The TЕСP/EMST Mapper classifies portions of the mowed-maintained vegetation as Crosstimbers Woodland and Forest, along with Riparian. The mowed-maintained vegetation better fits the Urban classification. Disturbed Prairie is east of the fence line. Date of photograph: 12/7/19.

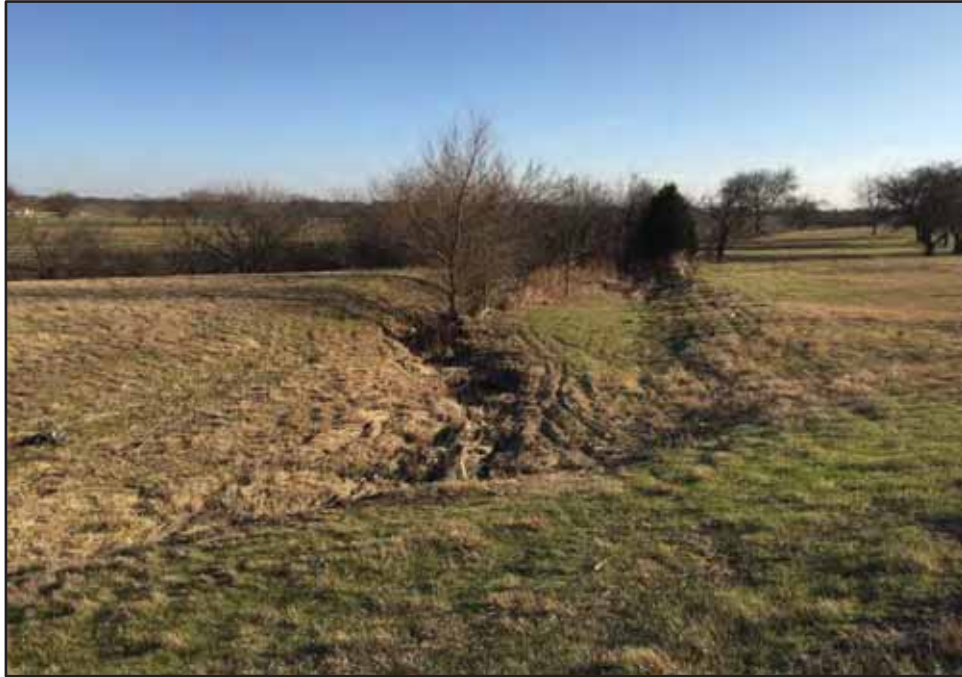
Photograph 59: View looking southeast towards a tributary to Graham Branch on IH 35W east ROW from near STA. 507+00. The TЕСP/EMST Mapper classifies this stream and mowed-maintained vegetation as Riparian. The mowed-maintained vegetation better fits the Urban classification and the stream fits the Open Water classification. Date of photograph: 12/7/19.

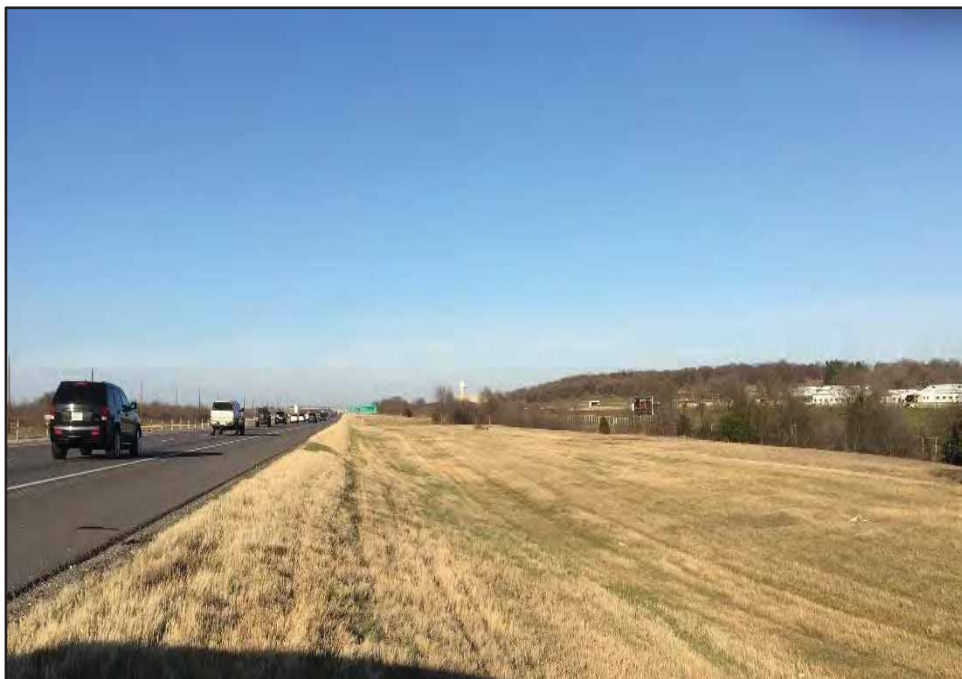
Photograph 60: View looking north-northeast along IH 35W east ROW near STA. 506+00. The TЕСP/EMST Mapper accurately classifies the mowed-maintained vegetation as Urban. Date of photograph: 12/7/19.

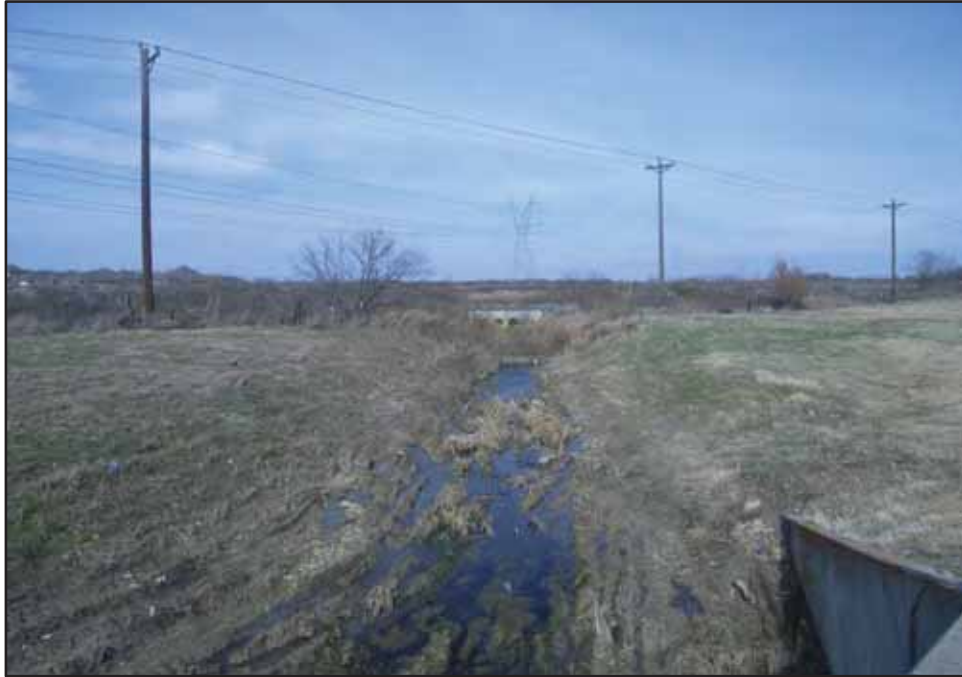
Photograph 61: View looking northwest towards a tributary to Graham Branch on IH 35W west ROW from near STA. 509+00. The TESCP/EMST Mapper classifies the roadway, stream and mowed-maintained vegetation as Riparian. The roadway and mowed-maintained vegetation better fit the Urban classification. The stream fits the Open Water classification. Disturbed Prairie is in the background. Date of photograph: 12/8/19.
