IH 35W Frontage Roads Technical Reports

Air Quality Resources Technical Report

Interstate Highway (IH) 35W Frontage Roads

Control-Section-Job (CSJ) 0081-13-065

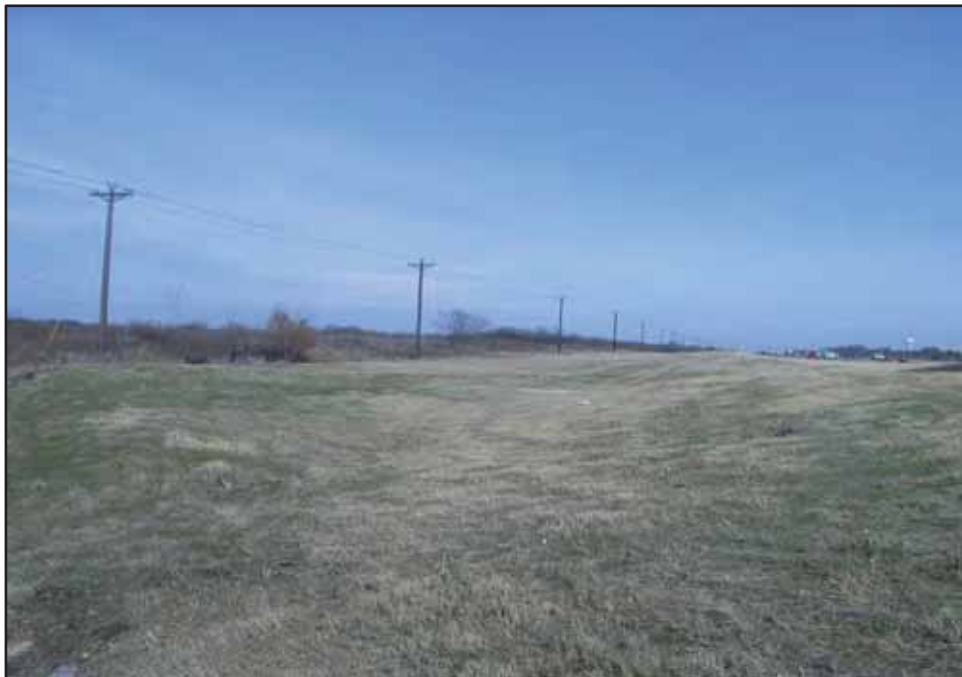
Photograph 62: View looking north-northeast along IH 35W west ROW near STA. 509+00. The TESCP/EMST Mapper classifies portions of the roadway and mowed-maintained vegetation as Crosstimbers Woodland and Forest, along with Tallgrass Prairie, Grassland. The roadway and mowed-maintained vegetation better fit the Urban classification. Date of photograph: 12/7/19.

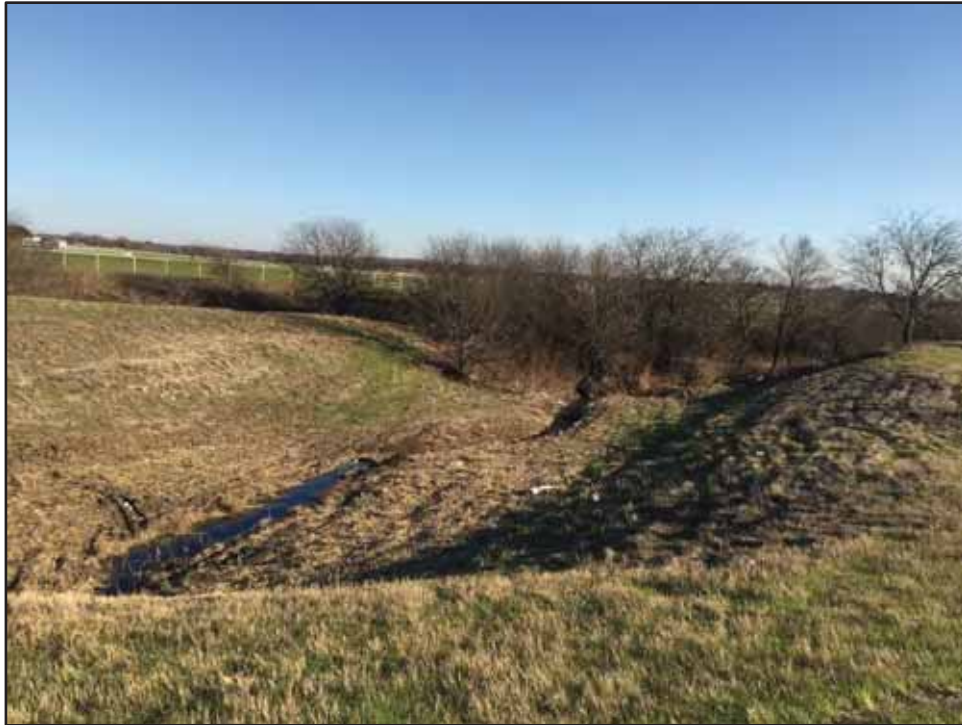
Photograph 63: View looking southeast towards Graham Branch on IH 35W east ROW from near STA. 518+50. The TЕСP/EMST Mapper classifies the stream as Urban; however, it better fits the Open Water classification. Date of photograph: 12/7/19.

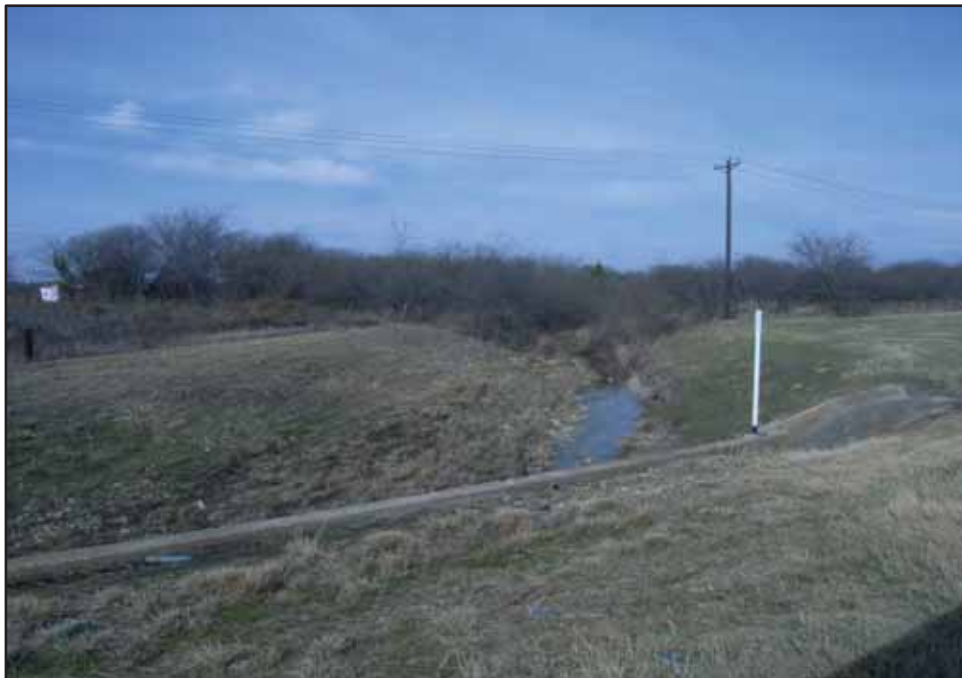
Photograph 64: View looking northwest towards Graham Branch on IH 35W west ROW from near STA. 520+00. The TЕСP/EMST Mapper classifies the stream and mowed-maintained vegetation as Riparian. The mowed-maintained vegetation better fits the Urban classification and the stream fits the Open Water classification. Date of photograph: 12/8/19.

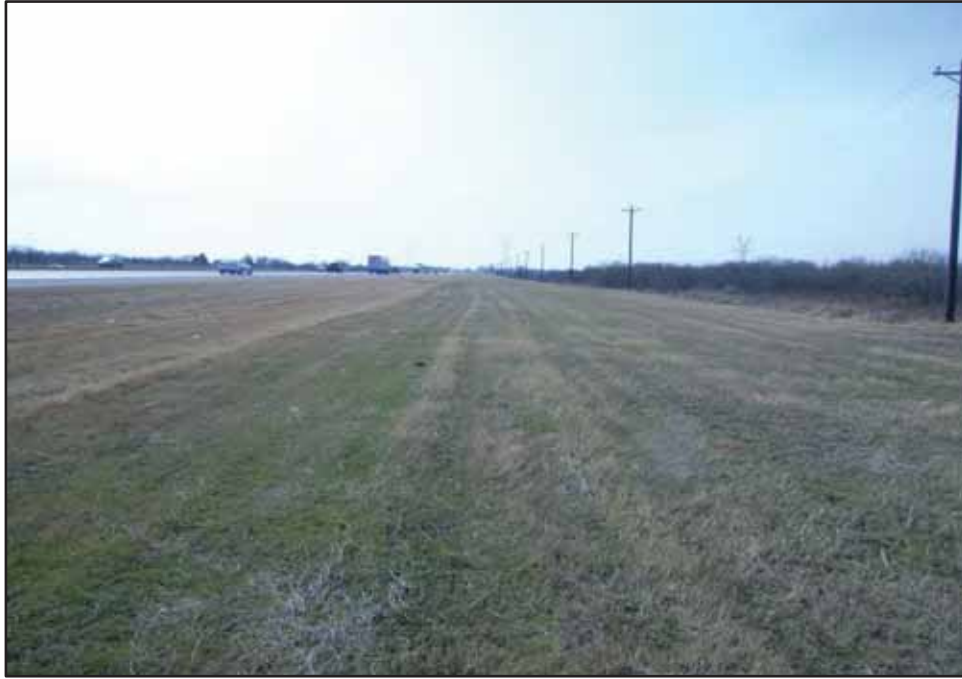
Photograph 65: View looking south-southwest along IH 35W west ROW from near STA. 530+00. The TЕСP/EMST Mapper classifies portions of the mowed-maintained vegetation as Crosstimbers Woodland and Forest, along with Tallgrass Prairie, Grassland. The mowed-maintained vegetation better fits the Urban classification. Disturbed Prairie is west of the fence line. Date of photograph: 12/8/19.

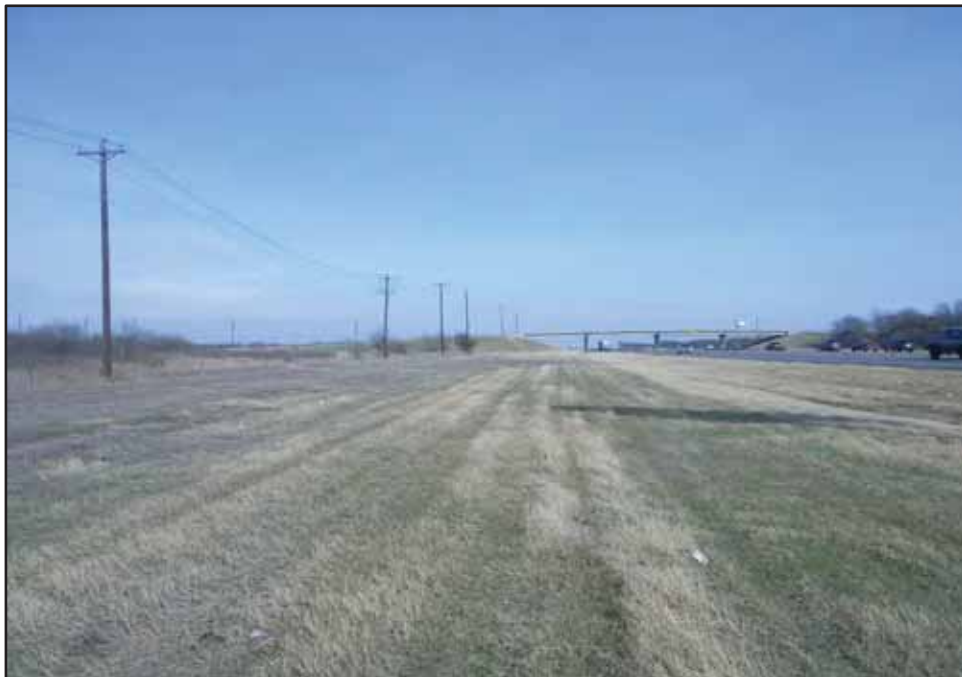
Photograph 66: View looking north-northeast along IH 35W west ROW from near STA. 530+00. The TЕСP/EMST Mapper classifies portions of the mowed-maintained vegetation as Crosstimbers Woodland and Forest, along with Tallgrass Prairie, Grassland. The mowed-maintained vegetation better fits the Urban classification. Disturbed Prairie is west of the fence line. Date of photograph: 12/8/19

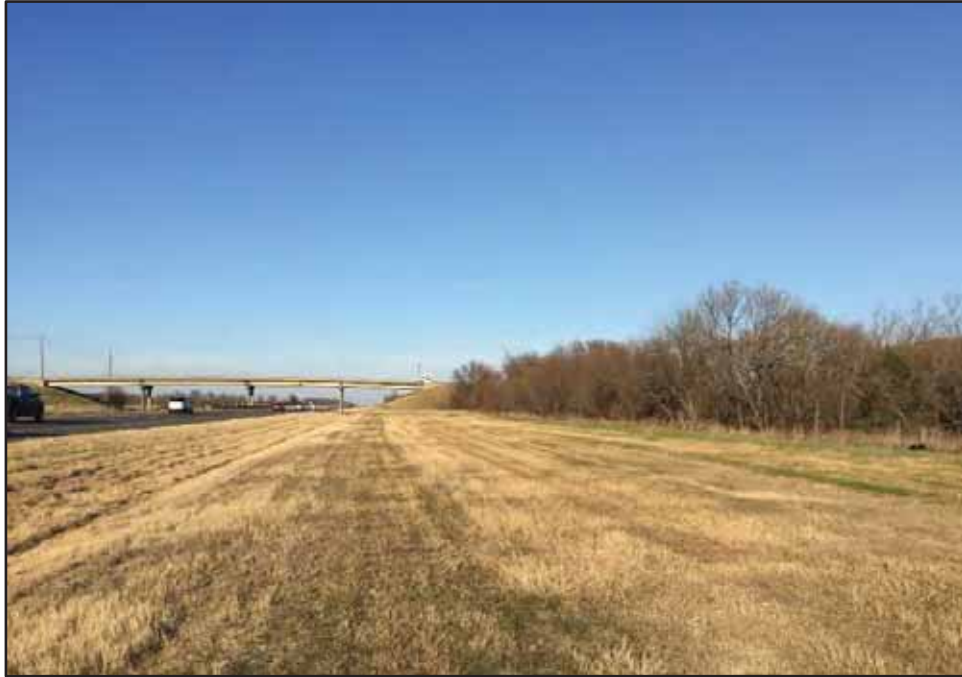
Photograph 67: View looking northeast along IH 35W east ROW from near STA. 535+00. The TЕСP/EMST Mapper classifies the mowed-maintained vegetation and woody vegetation as Urban. The woody vegetation better fits the Disturbed Prairie classification. Date of photograph: 12/7/19.

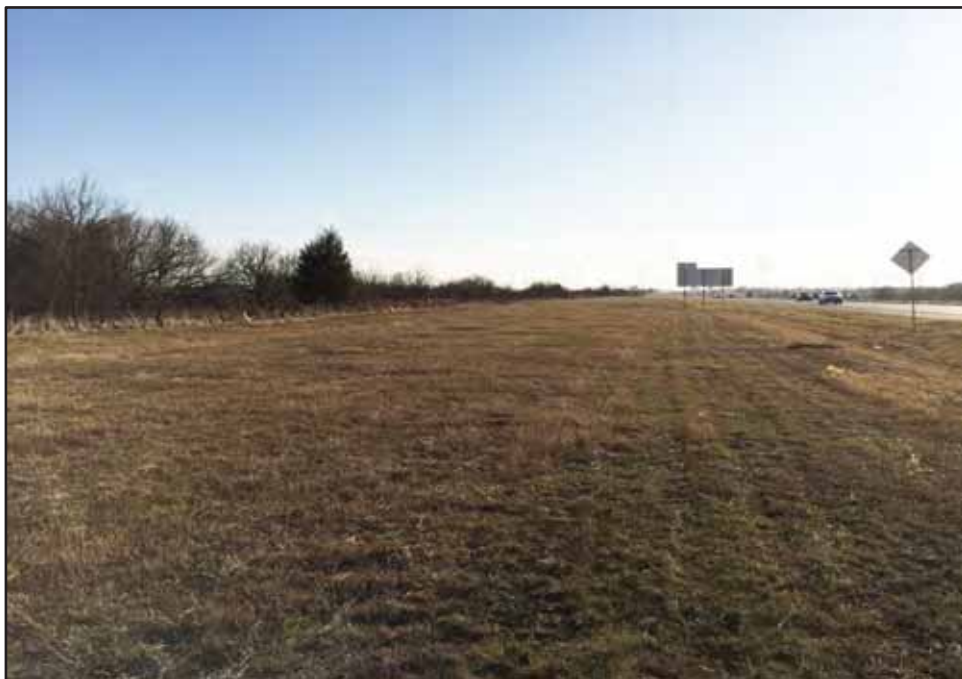
Photograph 68: View looking southwest along IH 35W east ROW from near STA. 535+00. The TЕСP/EMST Mapper classifies the mowed-maintained vegetation and woody vegetation as Urban. The woody vegetation better fits the Disturbed Prairie classification. Date of photograph: 12/7/19.

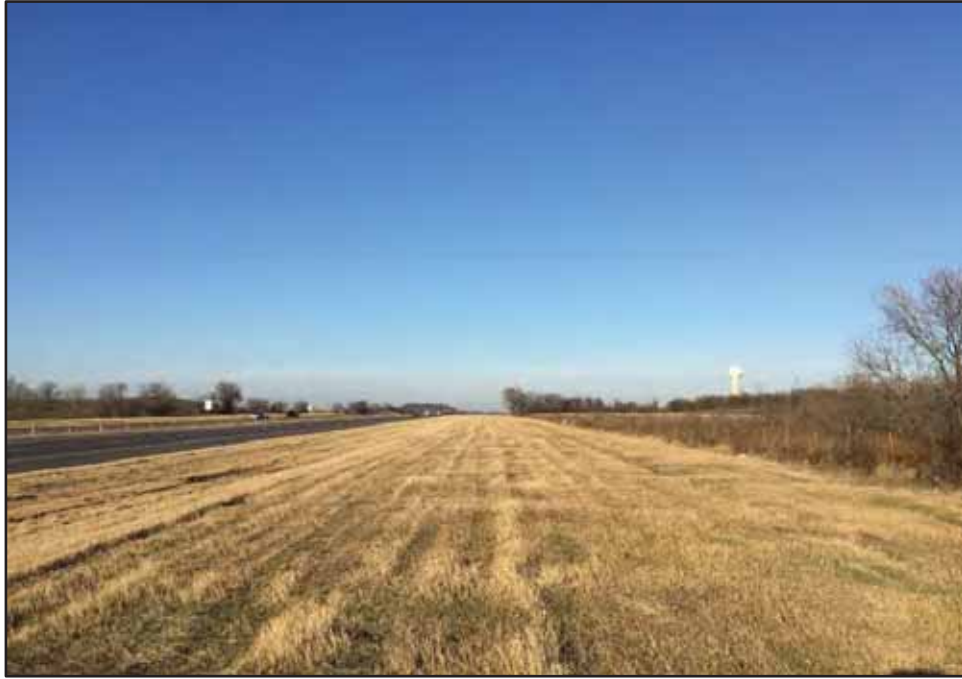
Photograph 69: View looking northeast along IH 35W east ROW from near STA. 548+00. The TЕСP/EMST Mapper classifies the mowed-maintained vegetation and woody vegetation as Riparian and Urban. The mowed-maintained vegetation better fits the Urban classification and the woody vegetation better fits the Disturbed Prairie classification. Date of photograph: 12/7/19.

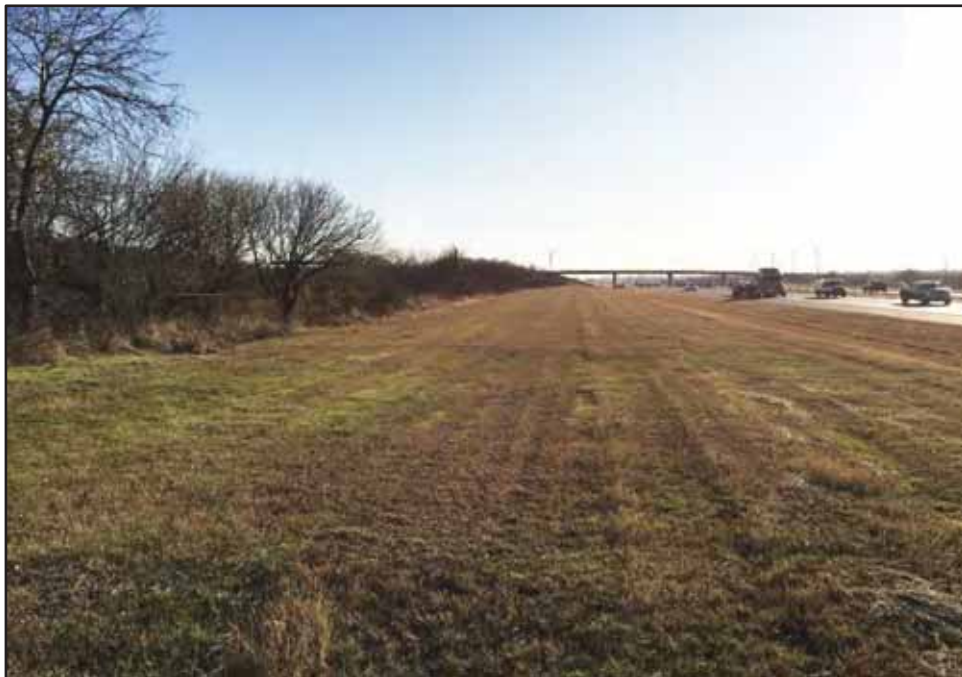
Photograph 70: View looking southwest along IH 35W east ROW near STA. 548+00. The TЕСP/EMST Mapper classifies the mowed-maintained vegetation and woody vegetation as Riparian and Urban. The mowed-maintained vegetation better fits the Urban classification and the woody vegetation better fits the Disturbed Prairie classification. Date of photograph: 12/7/19.

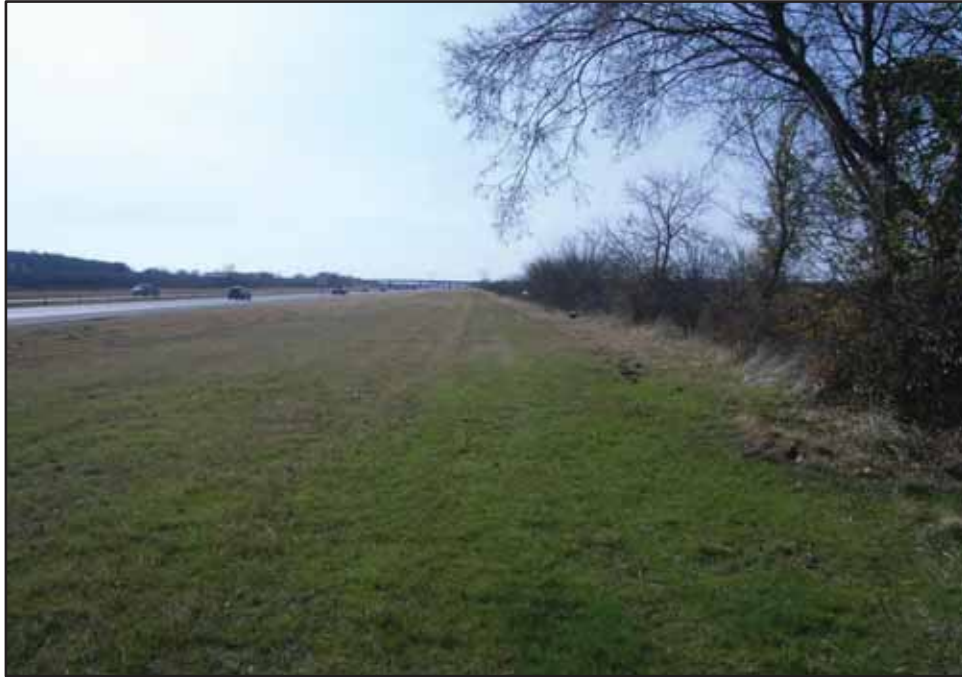
Photograph 71: View looking southwest along IH 35W west ROW near STA. 560+00. The TESCP/EMST Mapper classifies portions of the mowed-maintained vegetation and woody vegetation as Crosstimbers Woodland and Forest, along with Disturbed Prairie. The mowed-maintained vegetation better fits the Urban classification and the woody vegetation better fits the Disturbed Prairie classification. The fence line vegetation fits the Disturbed Prairie classification. Date of photograph: 12/8/19.

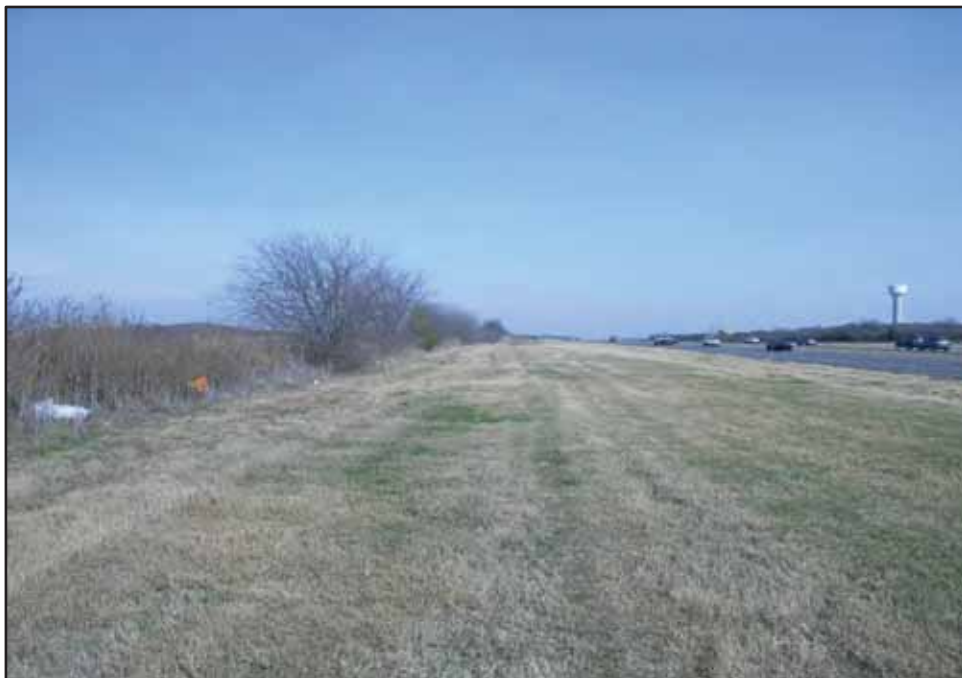
Photograph 72: View looking northeast along IH 35W west ROW near STA. 560+00. The TESCP/EMST Mapper classifies portions of the roadway, mowed-maintained vegetation, and woody vegetation as Agriculture, Crosstimbers Woodland and Forest, and Edwards Plateau Savannah, Woodland, and Shrubland. The roadway and mowed-maintained vegetation better fit the Urban classification. The woody vegetation fits the Disturbed Prairie classification. The land to the west-northwest of the fence line fits the Agriculture classification. Date of photograph: 12/8/19.

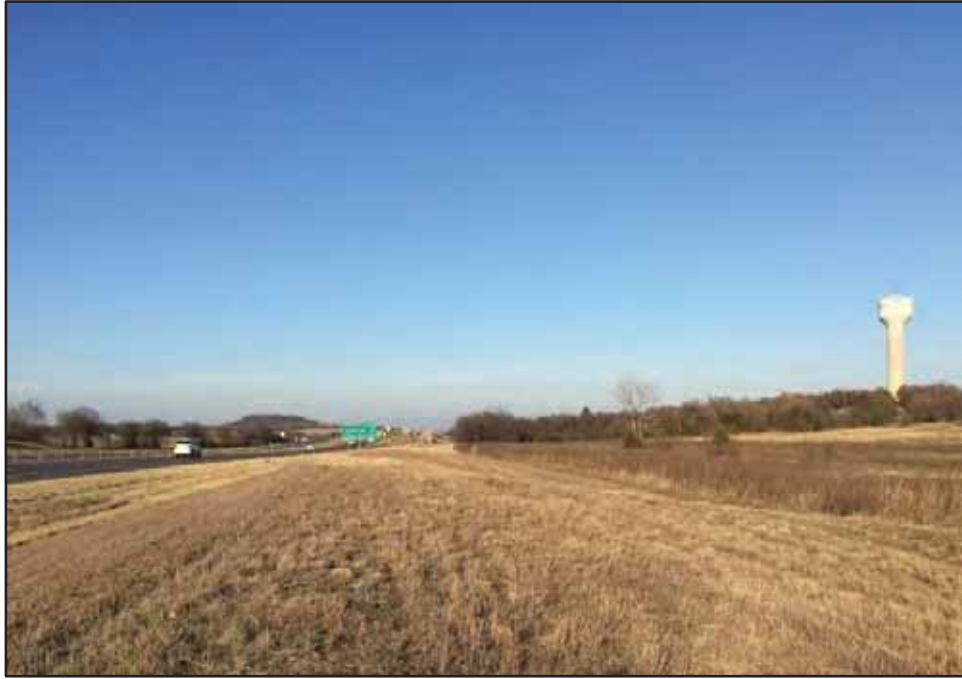
Photograph 73: View looking northeast along IH 35W east ROW near STA. 572+00. The TЕСP/EMST Mapper classifies portions of the roadway and mowed-maintained vegetation as Crosstimbers Woodland and Forest. The roadway and mowed-maintained vegetation better fit the Urban classification. The unmaintained herbaceous vegetation to the east fits the Tallgrass Prairie, Grassland classification. Date of photograph: 12/7/19.

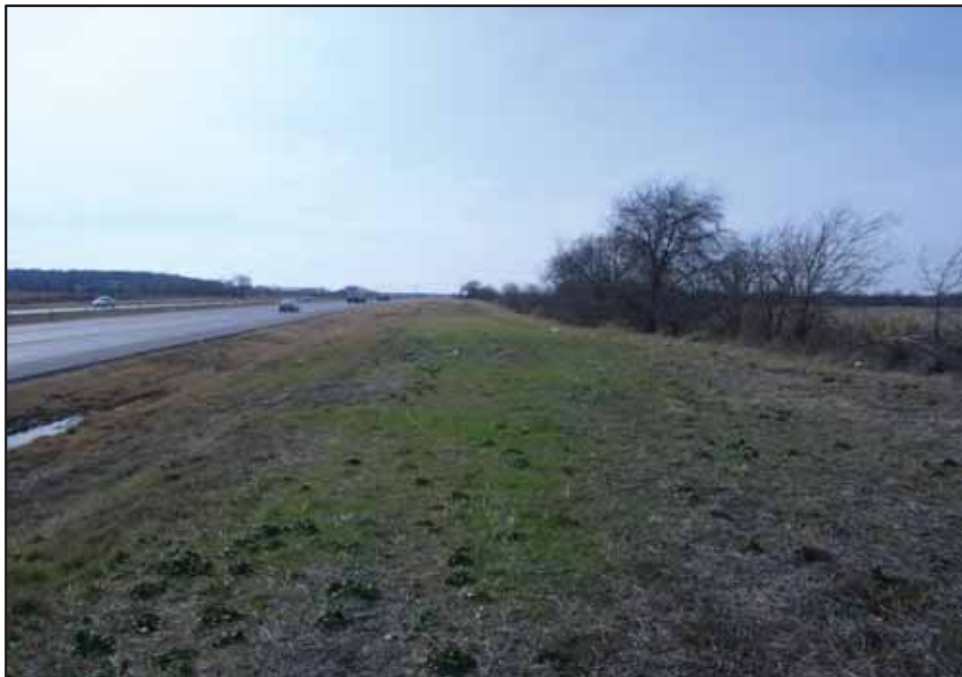
Photograph 74: View looking southwest along IH 35W west ROW from near STA. 585+00. The TЕСP/EMST Mapper classifies portions of the roadway and mowed-maintained vegetation as Crosstimbers Woodland and Forest. The roadway and mowed-maintained vegetation better fit the Urban classification. Date of photograph: 12/8/19.

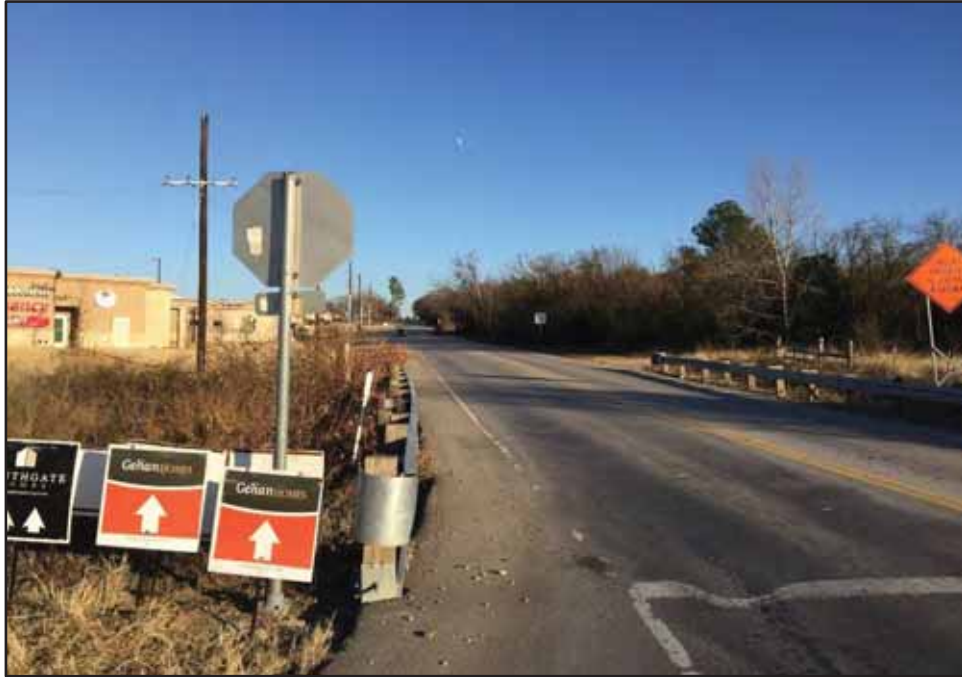
Photograph 75: View looking east along Crawford Road from the intersection of Crawford Road at the northbound IH 35W entrance ramp. The TЕСP/EMST Mapper classifies portions of Crawford Road as Crosstimbers Woodland and Forest. The roadway better fits the Urban classification. Date of photograph: 12/7/19.

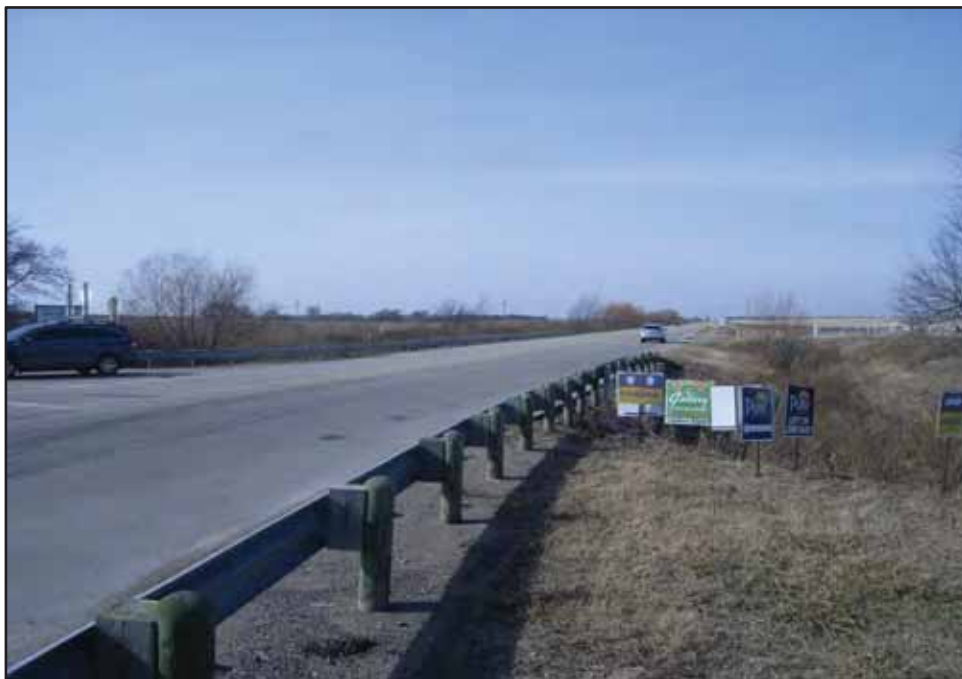
Photograph 76: View looking west along Robson Ranch Road from the intersection of Robson Ranch Road at the southbound IH 35W exit ramp. The TЕСP/EMST Mapper classifies portions of Robson Ranch as Crosstimbers Woodland and Forest. The roadway better fits the Urban classification. Date of photograph: 12/8/19.

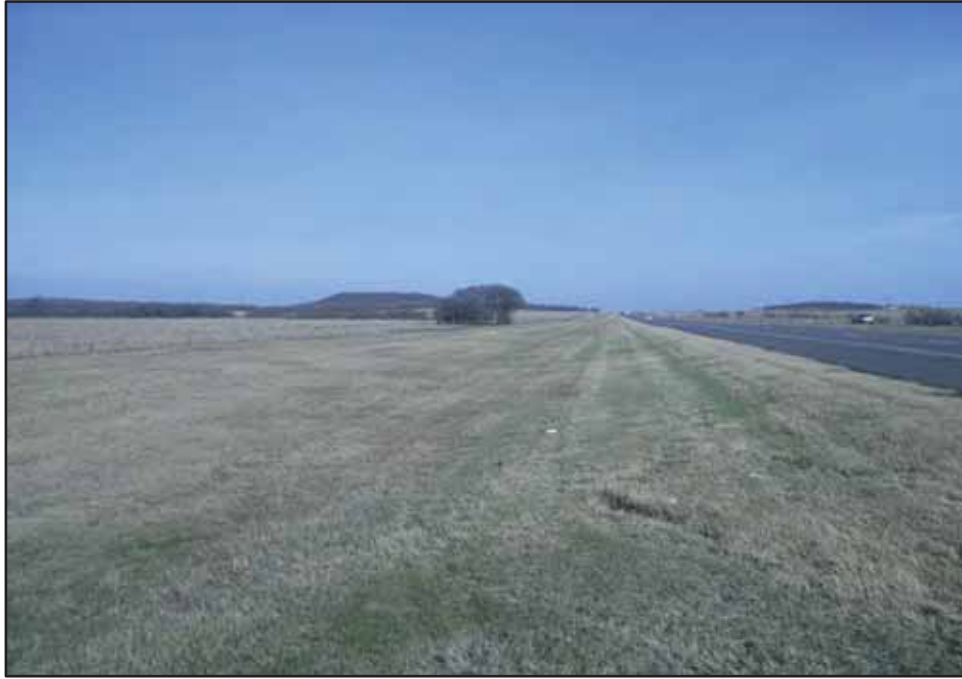
Photograph 77: View looking northeast along IH 35W west ROW from near STA. 603+00. The TЕСP/EMST Mapper classifies portions of the mowed-maintained vegetation Crosstimbers Woodland and Forest; however, it better fits the Urban classification. Date of photograph: 12/8/19.

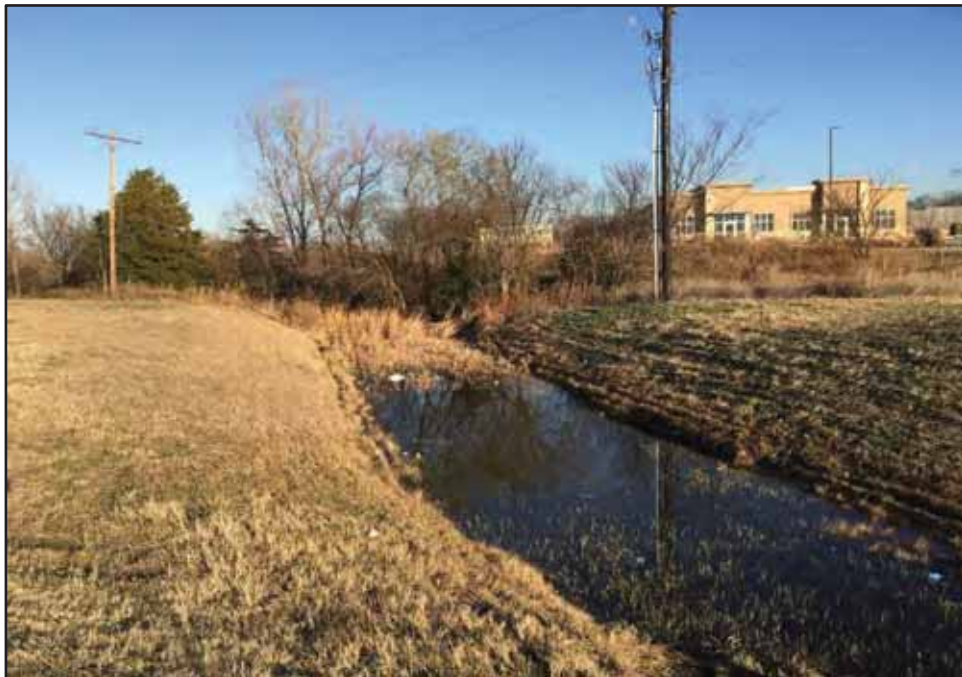
Photograph 78: View looking east-northeast towards a stream IH 35W east ROW from near STA. 602+00. The TЕСP/EMST Mapper classifies the mowed-maintained vegetation and stream as Urban. The stream better fits the Open Water classification. Disturbed Prairie is in the background. Date of photograph: 12/7/19.

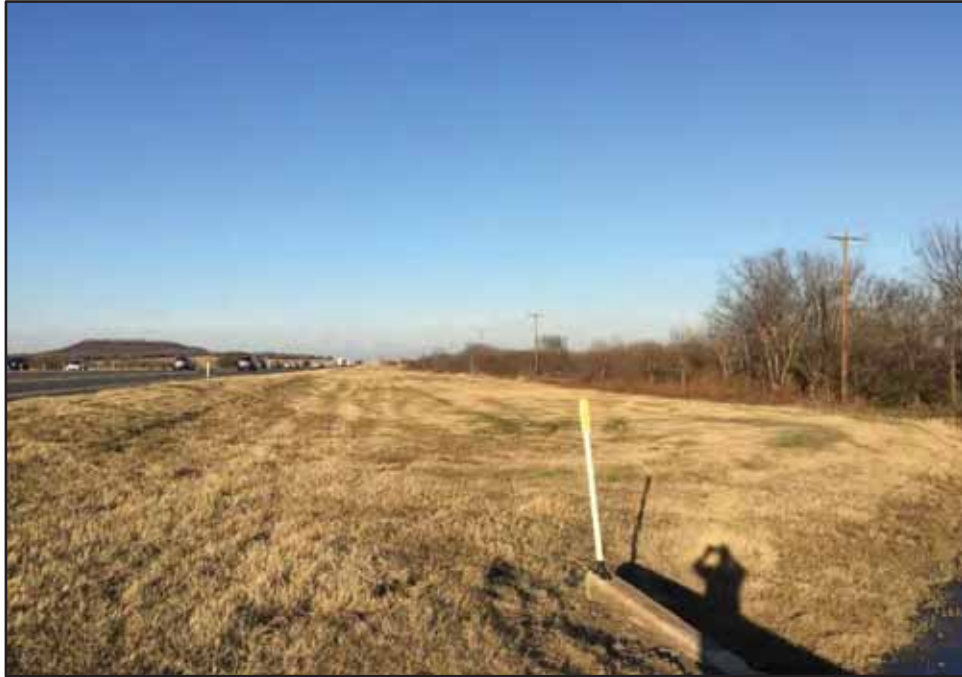
Photograph 79: View looking northeast along IH 35W east ROW from near STA. 605+00. The TЕСP/EMST Mapper classifies portions of the mowed-maintained vegetation as Crosstimbers Woodland and Forest. The mowed-maintained vegetation better fits the Urban classification. Disturbed Prairie is east of the fence line. Date of photograph: 12/7/19.

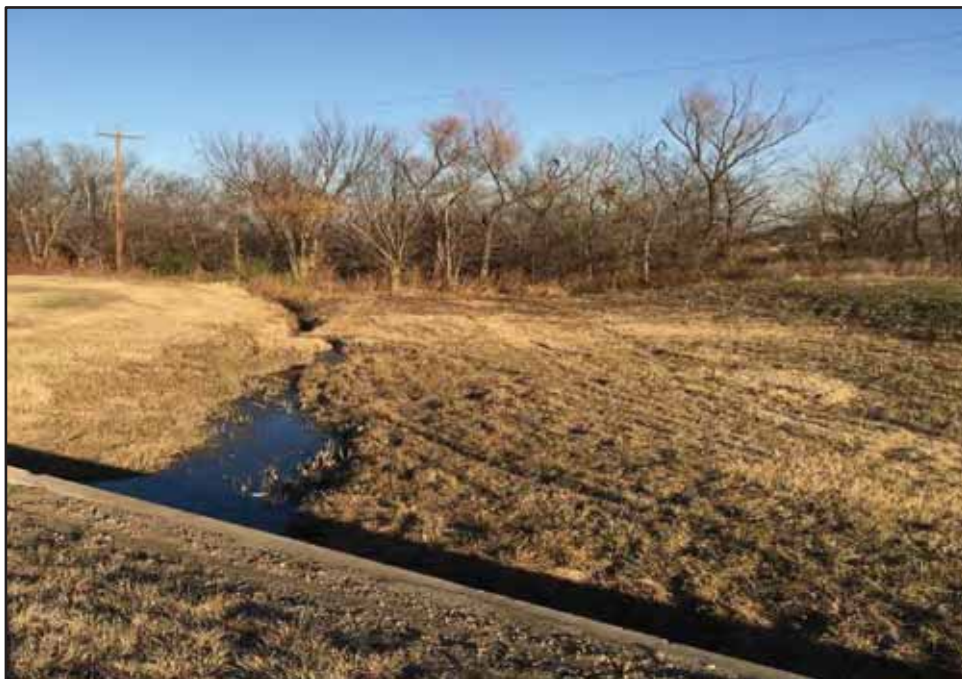
Photograph 80: View looking east-northeast towards a stream IH 35W east ROW from near STA. 605+00. The TЕСP/EMST Mapper classifies the mowed-maintained vegetation and stream as Cross Timbers Woodland and Forest, along with Urban. The mowed-maintained vegetation better fits the Urban classification and the stream fits the Open Water classification. Date of photograph: 12/7/19

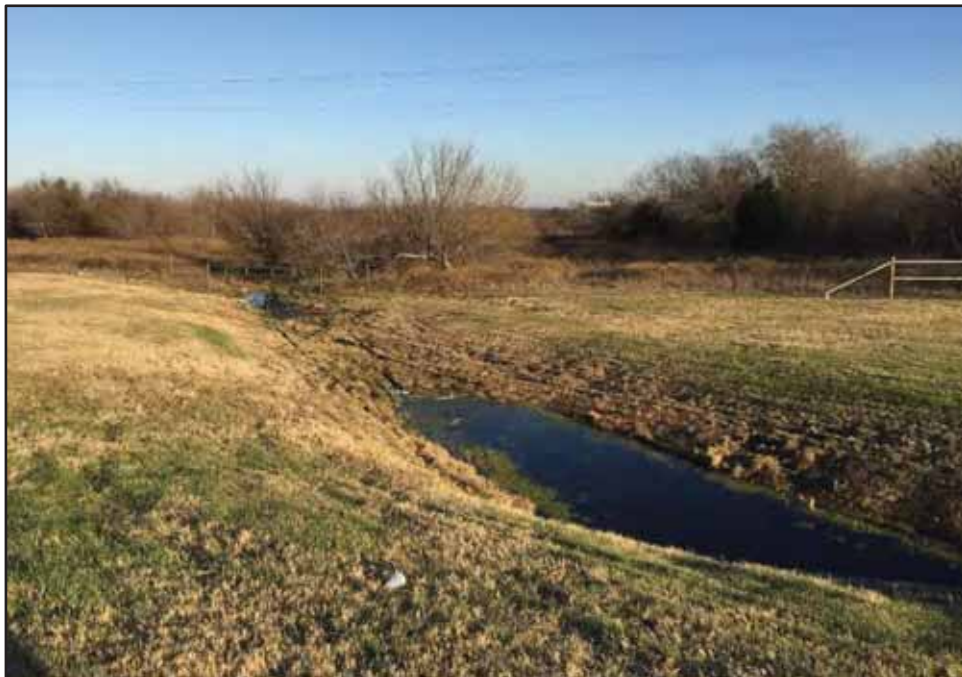
Photograph 82: View looking east-southeast towards a stream on IH 35W east ROW near STA. 618+00. The TЕСP/EMST Mapper classifies the mowed-maintained vegetation and stream as Urban. The mowed-maintained vegetation fits the Urban classification and the stream better fits the Open Water classification. Date of photograph: 12/7/19.

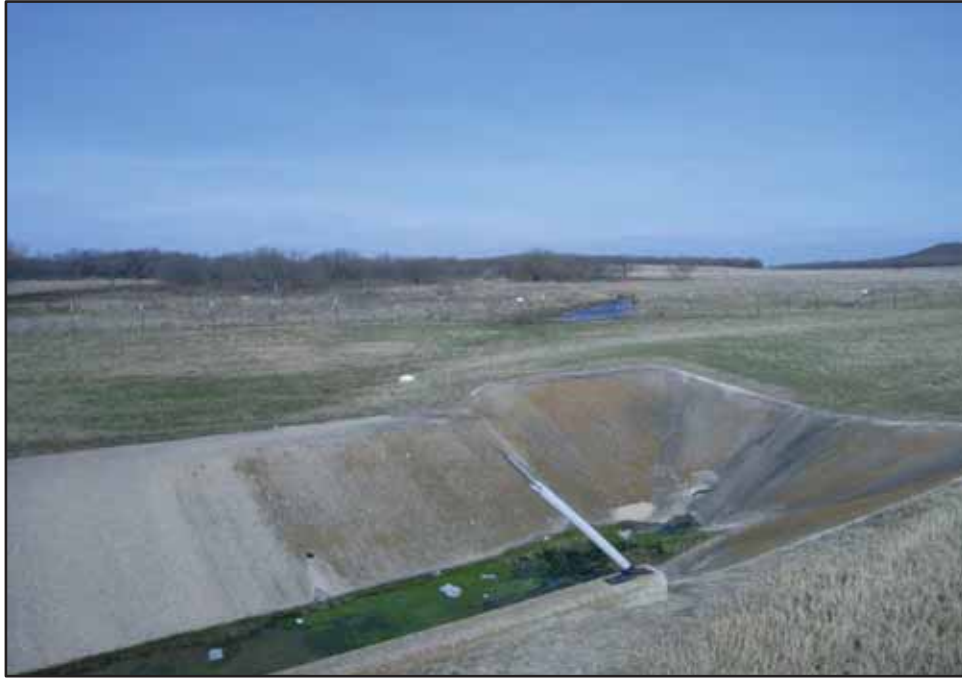
Photograph 83: View looking northwest along a stream on IH 35W west ROW near STA. 627+00. The TЕСP/EMST Mapper classifies this area as Crosstimbers Woodland and Forest, along with Riparian. The mowed-maintained vegetation better fits the Urban classification. The small area of water better fits the Open Water classification. Date of photograph: 12/8/19.

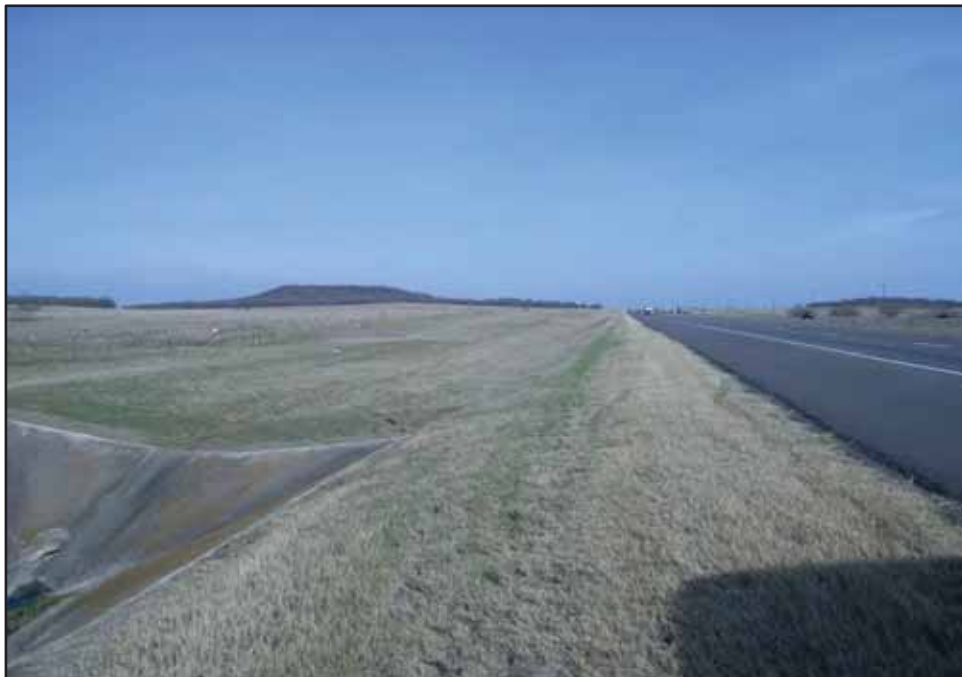
Photograph 84: View looking northeast along IH 35W west ROW near STA. 627+00. The TЕСP/EMST Mapper classifies the mowed-maintained vegetation as Crosstimbers Woodland and Forest, along with Riparian. The mowed-maintained vegetation better fits the Urban classification. Date of photograph: 12/8/19.

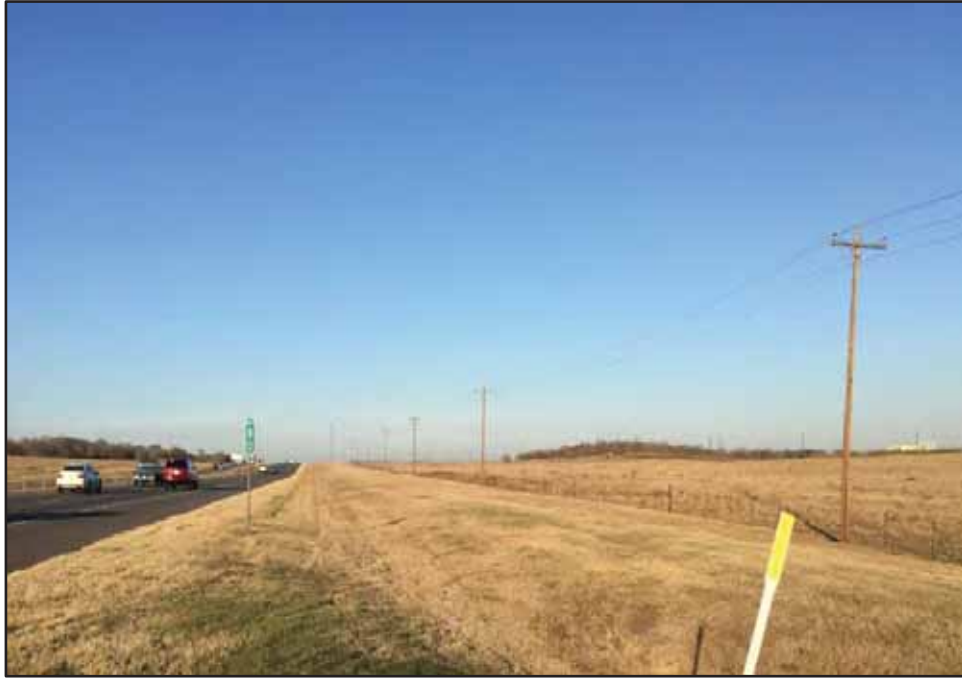
Photograph 85: View looking northeast along IH 35W east ROW near STA. 639+00. The TЕСP/EMST Mapper classifies portions of the mowed-maintained vegetation as Crosstimbers Woodland and Forest. The mowed-maintained vegetation better fits the Urban classification. The vegetation east of the fence line fits the Tallgrass Prairie, Grassland classification. Date of photograph: 12/7/19.

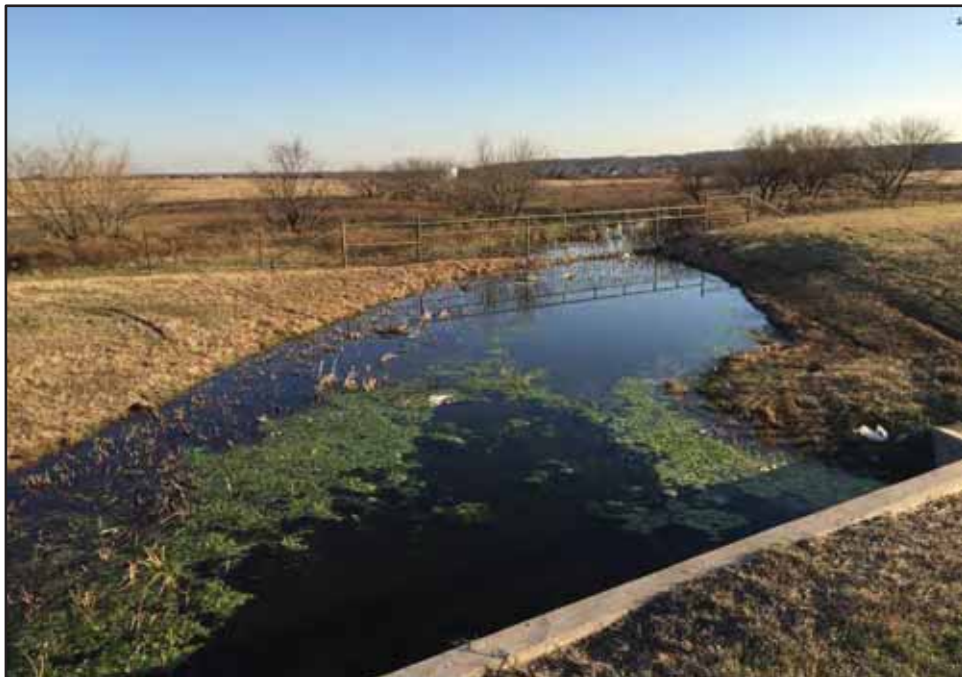
Photograph 86: View looking south-southeast towards a stream on IH 35W east ROW from near STA. 639+00. The TЕСP/EMST Mapper classifies the stream and mowed-maintained vegetation as Riparian. The mowed-maintained vegetation better fits the Urban classification and the stream fits the Open Water classification. Date of photograph: 12/7/19.

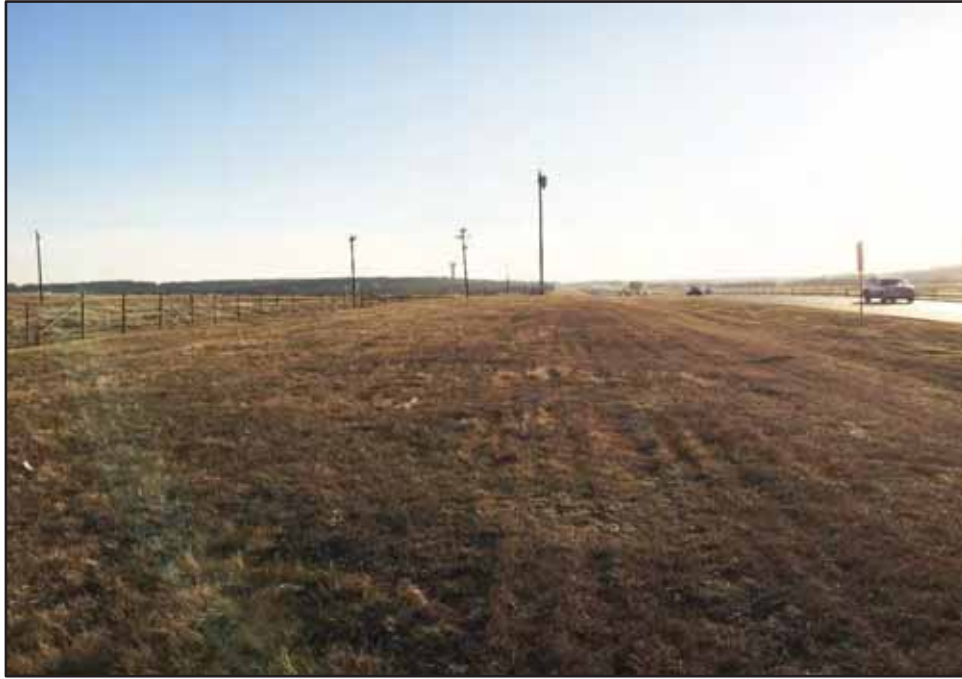
Photograph 87: View looking southwest along IH 35W east ROW from near STA. 660+00. The TЕСP/EMST Mapper classifies portions of the mowed-maintained vegetation as Crosstimbers Woodland and Forest. The mowed-maintained vegetation better fits the Urban classification. Tallgrass Prairie, Grassland is east of the fence line. Date of photograph: 12/7/19.

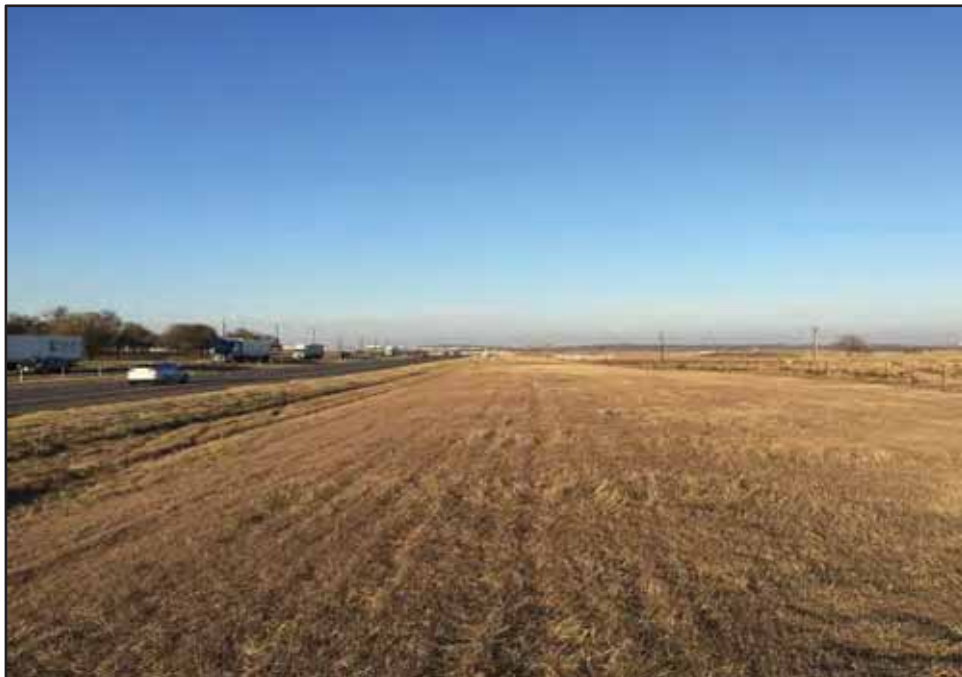
Photograph 88: View looking northeast along IH 35W east ROW from near STA. 660+00. The TЕСP/EMST Mapper classifies portions of the mowed-maintained vegetation as Crosstimbers Woodland and Forest, along with Tallgrass Prairie, Grassland. The mowed-maintained vegetation better fits the Urban classification. Tallgrass Prairie, Grassland is east of the fence line. Date of photograph: 12/7/19.

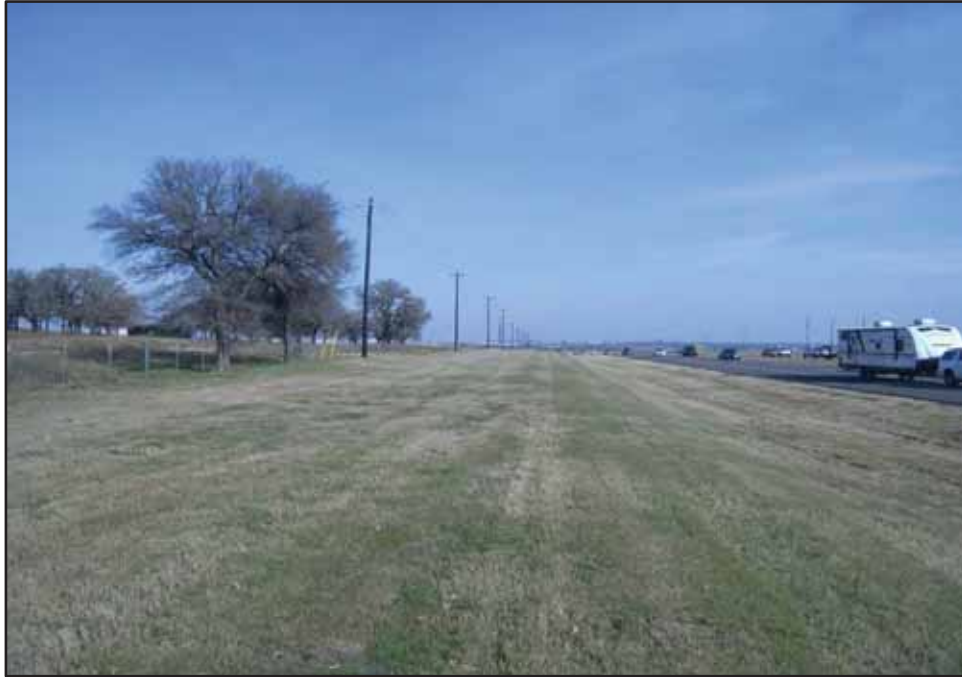
Photograph 89: View looking northeast along IH 35W west ROW from near STA. 667+00. The TЕСP/EMST Mapper classifies portions of the mowed-maintained vegetation as, along with Tallgrass Prairie, Grassland. The mowed-maintained vegetation better fits the Urban classification. The woody vegetation to the west of the fence line fits the Crosstimbers Woodland and Forest classification. Date of photograph: 12/8/19.

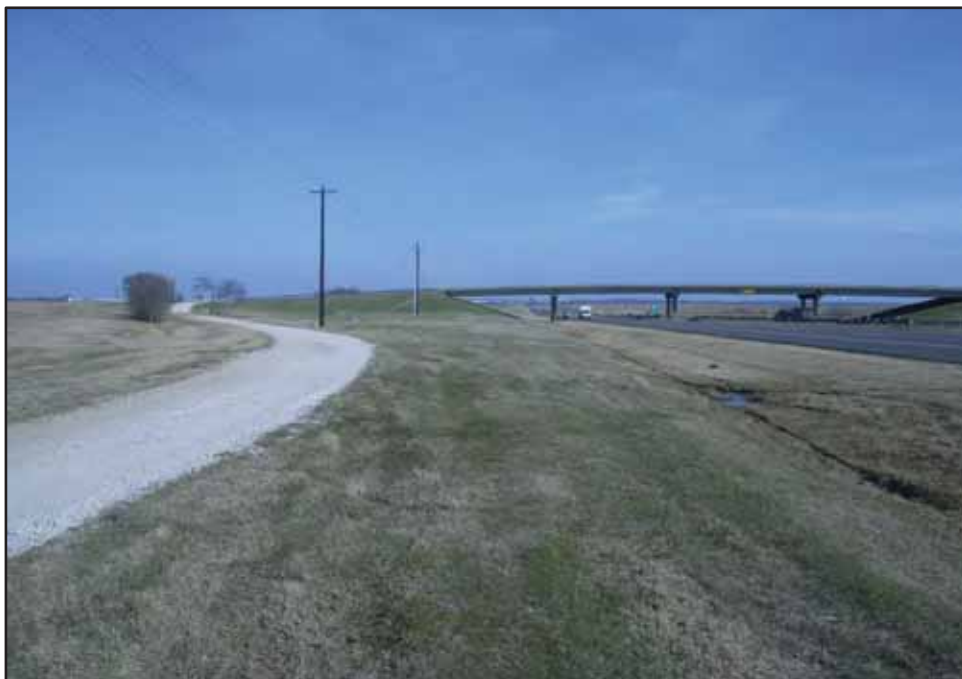
Photograph 90: View looking northeast along IH 35W west ROW from near STA. 683+00. The TЕСP/EMST Mapper classifies portions of the mowed-maintained vegetation as Tallgrass Prairie, Grassland; however, it better fits the Urban classification. Date of photograph: 12/8/19.

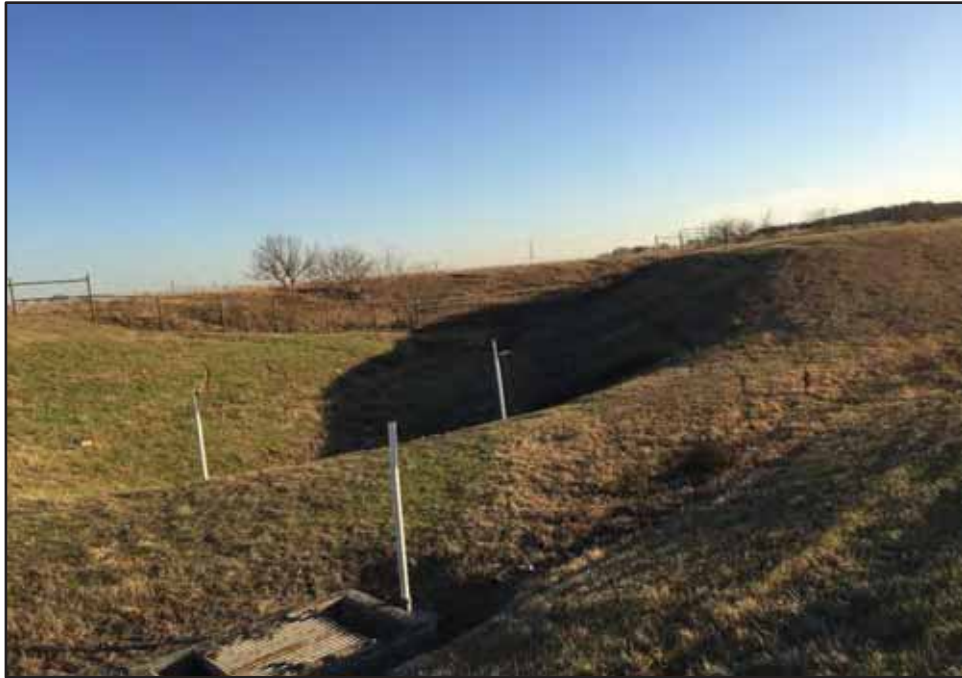
Photograph 91: View looking southeast toward a stream on IH 35W east ROW from near STA. 696+00. The TЕСP/EMST Mapper classifies this area as Tallgrass Prairie, Grassland. The mowed-maintained vegetation better fits the Urban classification. Date of photograph: 12/7/19.

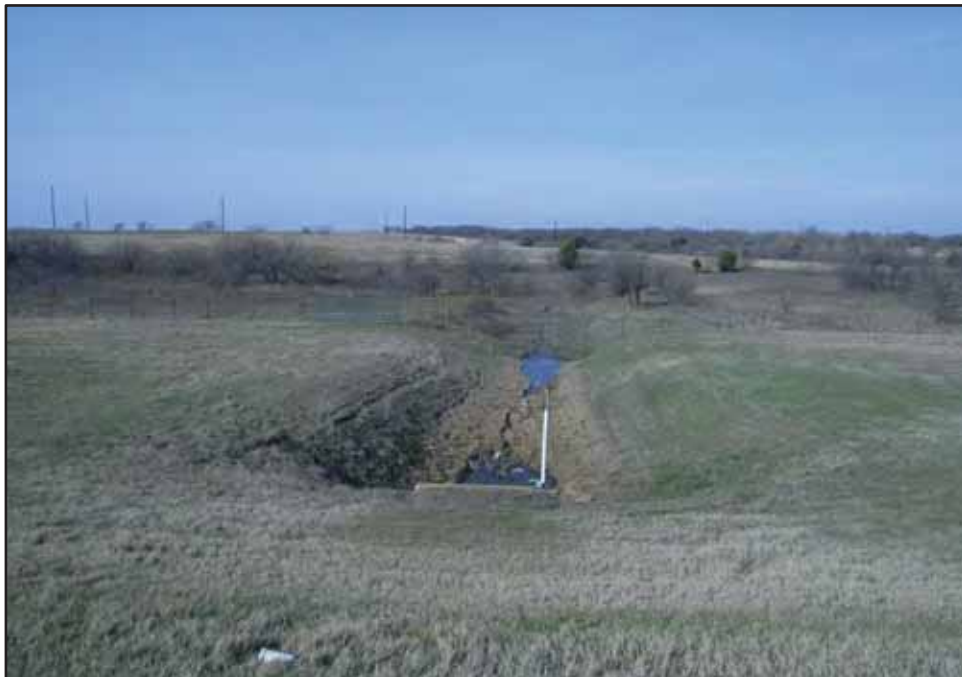
Photograph 92: View looking northwest toward a stream on IH 35W west ROW from near STA. 697+00. The TЕСP/EMST Mapper classifies this area as Riparian and Tallgrass Prairie, Grassland. The mowed-maintained vegetation better fits the Urban classification and the stream fits the Open Water classification. Disturbed Prairie is in the background. Date of photograph: 12/8/19.
