IH 35W Frontage Roads Technical Reports

Air Quality Resources Technical Report

Interstate Highway (IH) 35W Frontage Roads

Control-Section-Job (CSJ) 0081-13-065

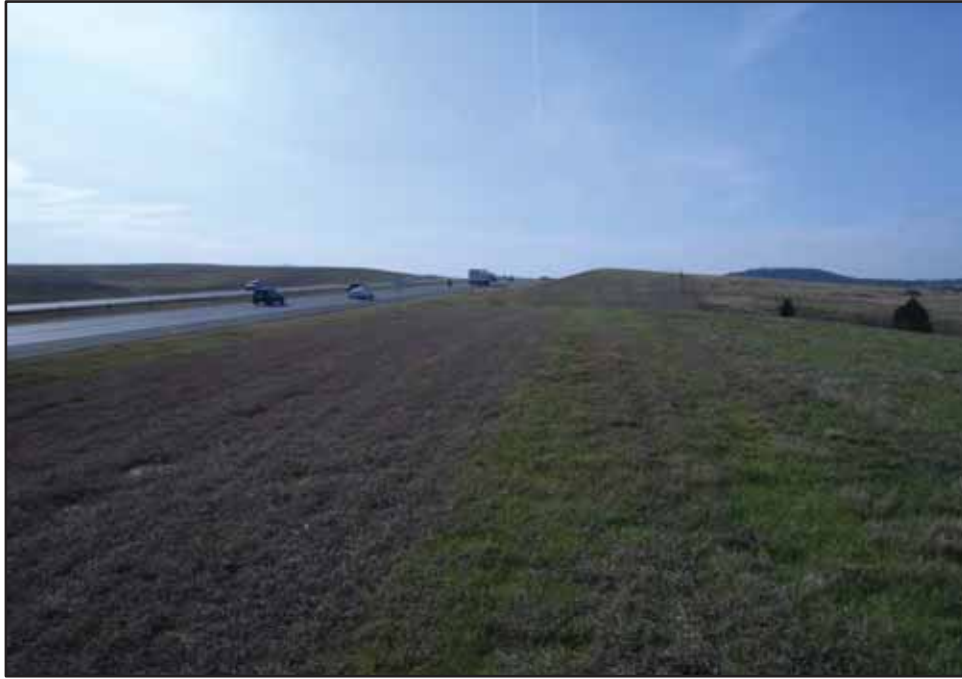
Photograph 93: View looking southwest along IH 35W west ROW from near STA. 733+00. The TЕСP/EMST Mapper classifies portions of the roadway and mowed-maintained vegetation as Tallgrass Prairie, Grassland. The mowed-maintained vegetation better fits the Urban classification. Disturbed Prairie is west of the fence line. Date of photograph: 12/8/19.

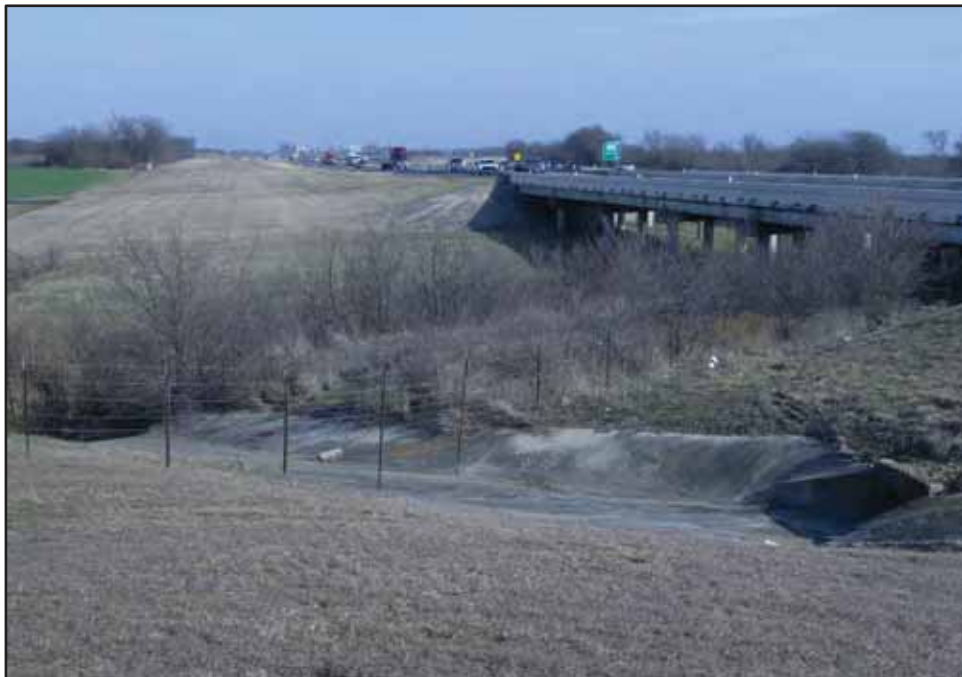
Photograph 94: View looking northeast across the Roark Branch from IH 35W west ROW from near STA. 734+00. The TЕСP/EMST Mapper classifies the stream, vegetation and mowed-maintained vegetation as Riparian. The mowed-maintained vegetation better fits the Urban classification. The other vegetation beyond the fence fits the Riparian classification. The stream better fits the Open Water classification. Date of photograph: 12/8/19.

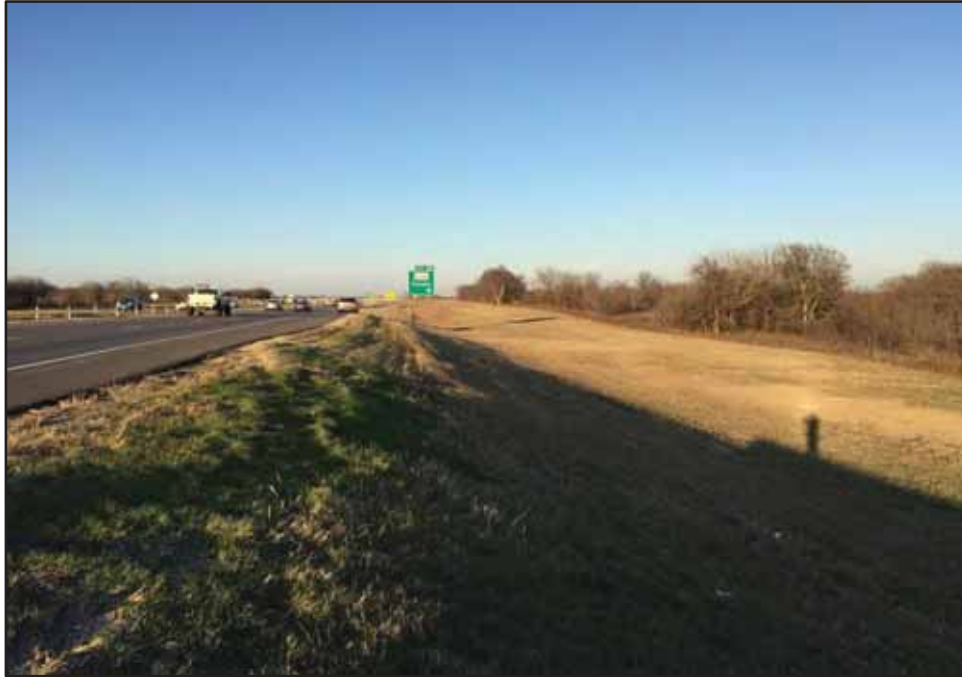
Photograph 95: View looking northeast along IH 35W east ROW from near STA. 738+00. The TESCP/EMST Mapper classifies portions of the roadway and mowed-maintained vegetation as Tallgrass Prairie, Grassland and Disturbed Prairie. The mowed-maintained vegetation better fits the Urban classification. The woody vegetation to the east of the fence line fits the Disturbed Prairie classification. Date of photograph: 12/7/19.

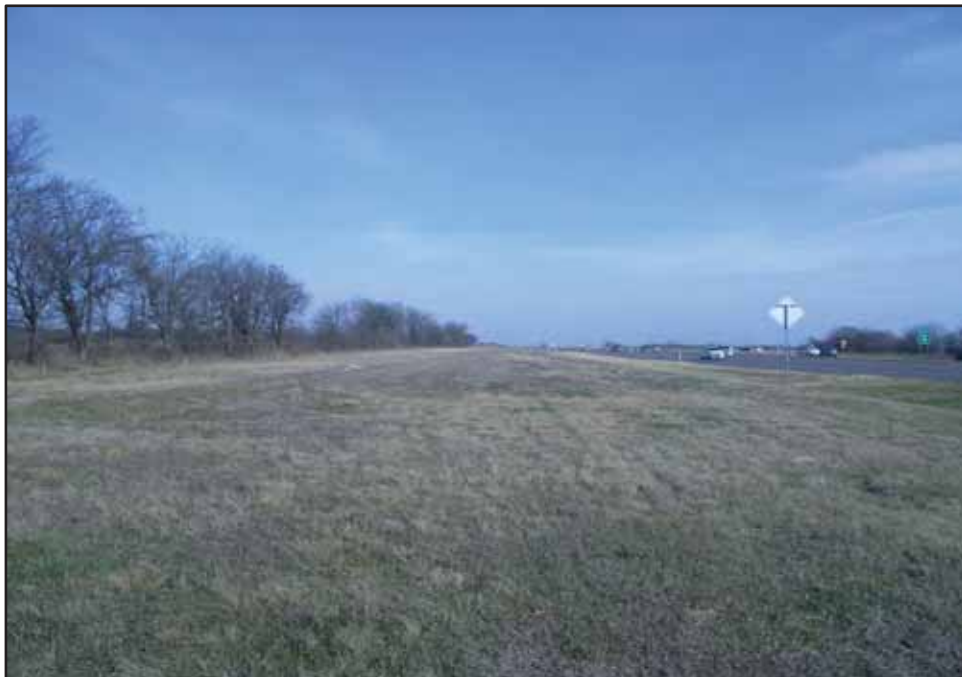
Photograph 96: View looking northeast along IH 35W west ROW from near STA. 743+00. The TESCP/EMST Mapper classifies portions of the mowed-maintained vegetation as Tallgrass Prairie, Grassland. The mowed-maintained vegetation better fits the Urban classification. The woody vegetation along the fence line fits the Disturbed Prairie classification. Date of photograph: 12/8/19.

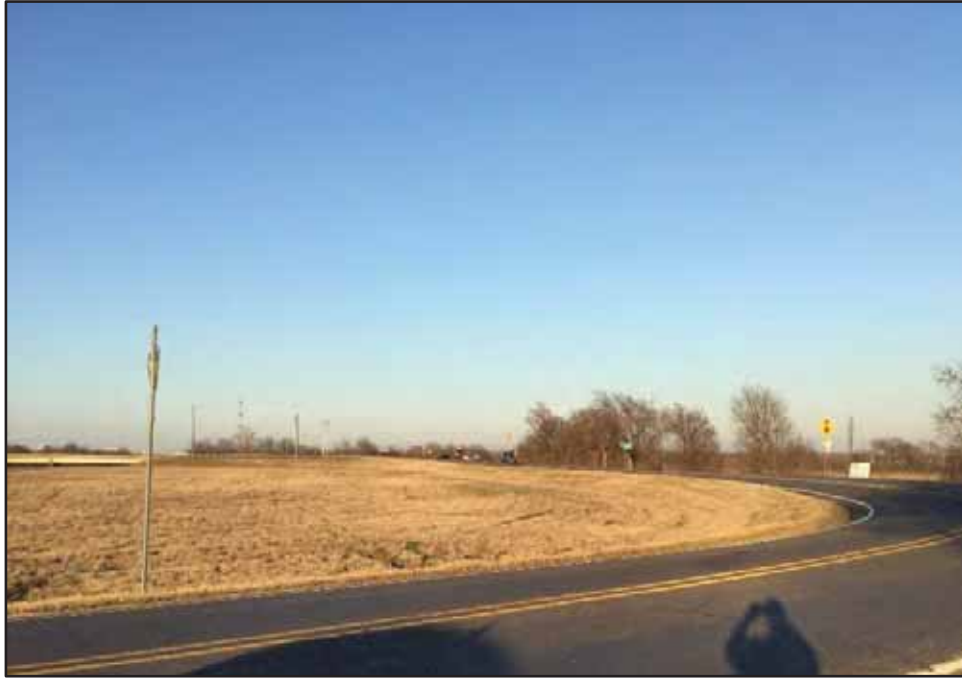
Photograph 97: View looking northeast across the FM 2499 interchange on the east side of IH 35W from near STA. 755+00. The TЕСP/EMST Mapper classifies portions of the roadway and mowed-maintained vegetation Agriculture and Tallgrass Prairie, Grassland. The roadway and mowed-maintained vegetation better fit the Urban classification. Date of photograph: 12/7/19

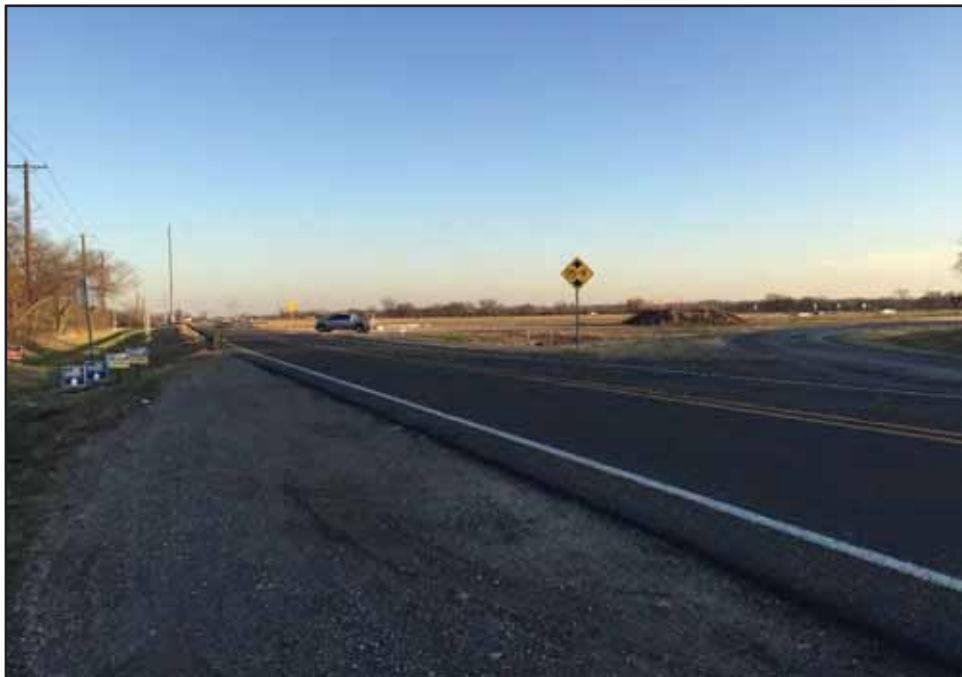
Photograph 98: View looking east-southeast across the FM 2449 interchange from the west side of IH 35W near STA 755+00. The TЕСP/EMST Mapper classifies portions of the roadway and mowed-maintained vegetation as Crosstimbers Woodland and Forest, along with Disturbed Prairie. The roadway and mowed-maintained vegetation better fit the Urban classification. Date of photograph: 12/8/19.

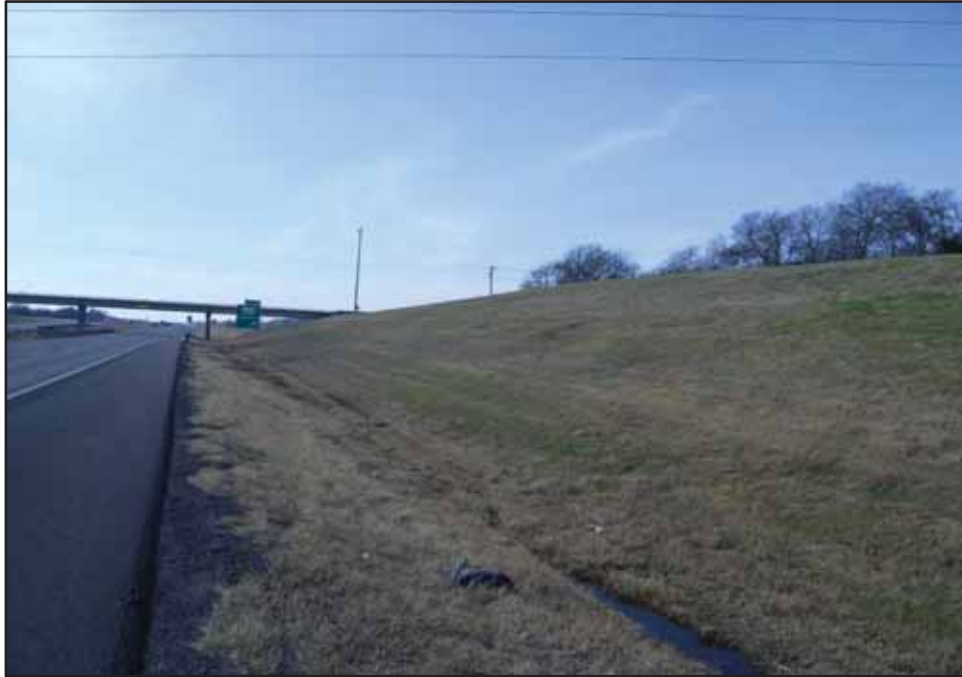
Photograph 99: View looking southwest along IH 35W west ROW from near STA. 767+00. The TЕСP/EMST Mapper classifies portions of the mowed-maintained vegetation as Tallgrass Prairie, Grassland, Crosstimbers Woodland, and Forest, and Disturbed Prairie. The mowed-maintained vegetation better fits the Urban classification. Date of photograph: 12/8/19.

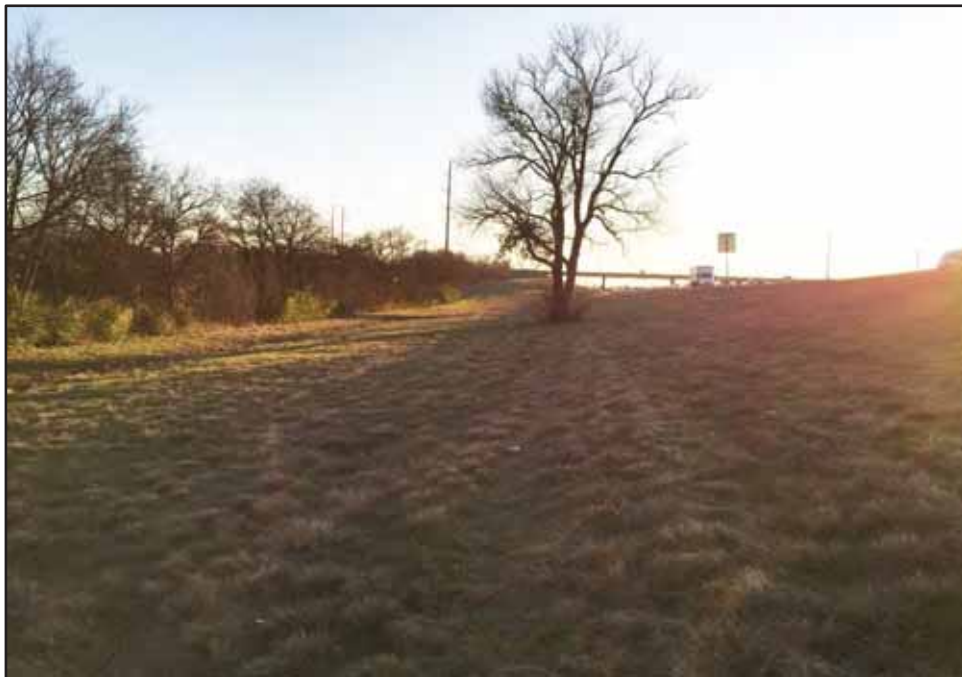
Photograph 100: View looking southwest along IH 35W east ROW from near STA. 767+00. The TЕСP/EMST Mapper classifies portions of the mowed-maintained vegetation as Disturbed Prairie. The mowed-maintained vegetation better fits the Urban classification. Disturbed Prairie is east of the fence line. Date of photograph: 12/8/19.

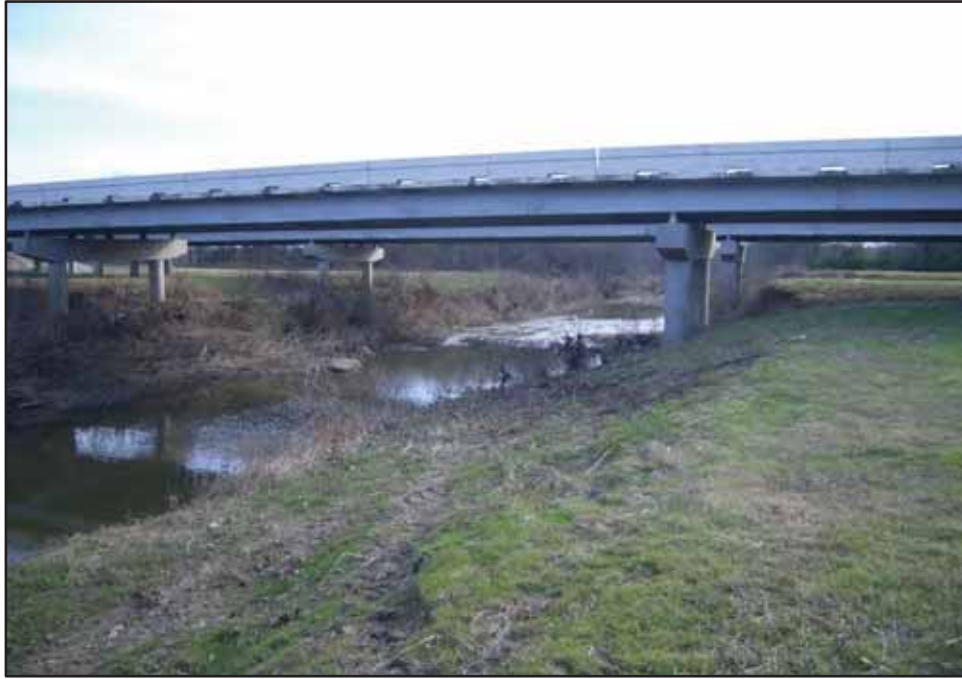
Photograph 101: View looking east towards Hickory Creek on the IH 35W west ROW near STA. 779+00. The TЕСP/EMST Mapper classifies the stream, unmaintained vegetation and mowed-maintained vegetation as Riparian. The mowed-maintained vegetation better fits the Urban classification and the stream better fits the Open Water classification. The unmaintained vegetation fits the Riparian classification. Date of photograph: 12/8/19.

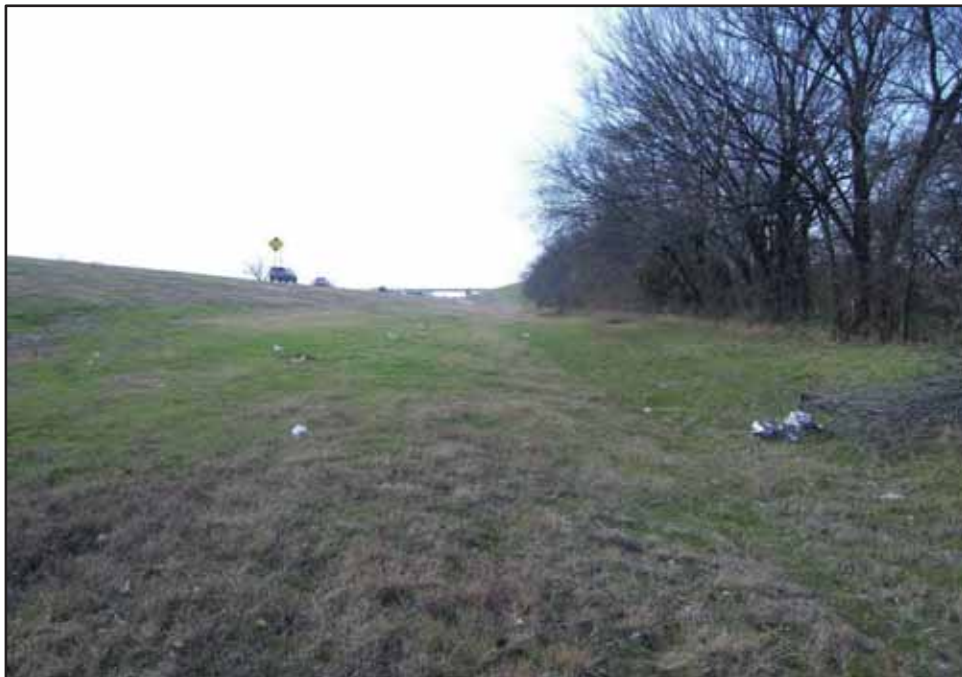
Photograph 102: View looking southwest along IH 35W west ROW near STA. 777+00. The TЕСP/EMST Mapper classifies portions of this area as Riparian. The mowed-maintained vegetation better fits the Urban classification. The woody vegetation fits the Riparian classification. Woody vegetation up slope fits the Crosstimbers Woodland, and Forest classification. Date of photograph: 12/7/19.

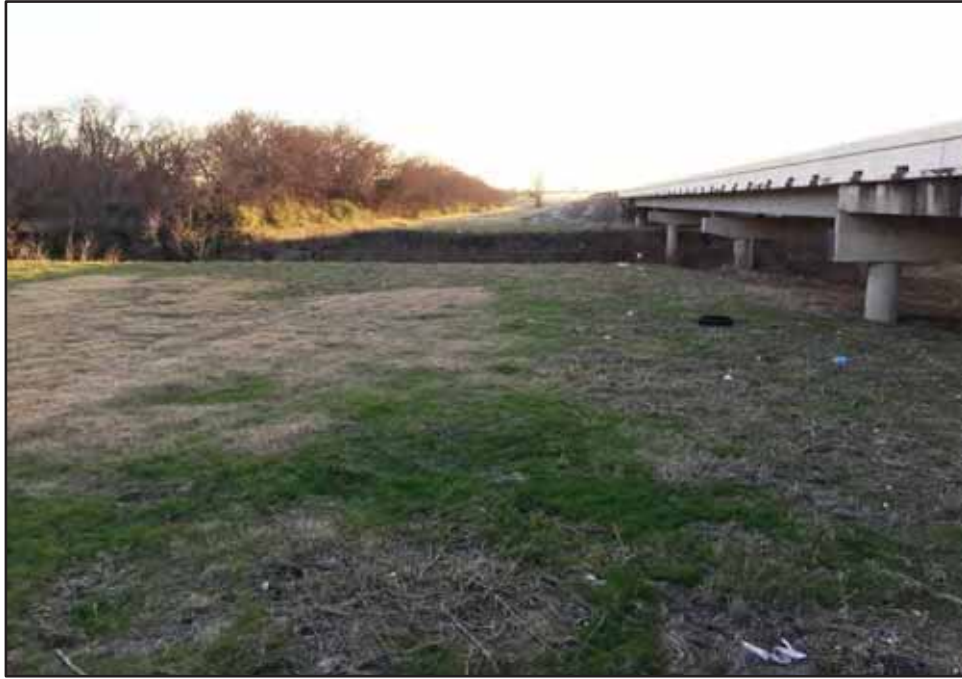
Photograph 103: View looking southeast towards Hickory Creek on IH 35W east ROW from near STA. 780+00. The TЕСP/EMST Mapper classifies this area as Riparian. The mowed-maintained vegetation better fits the Urban classification and the stream better fits the Open Water classification. The unmaintained vegetation fits the Riparian classification. Date of photograph: 12/7/19.

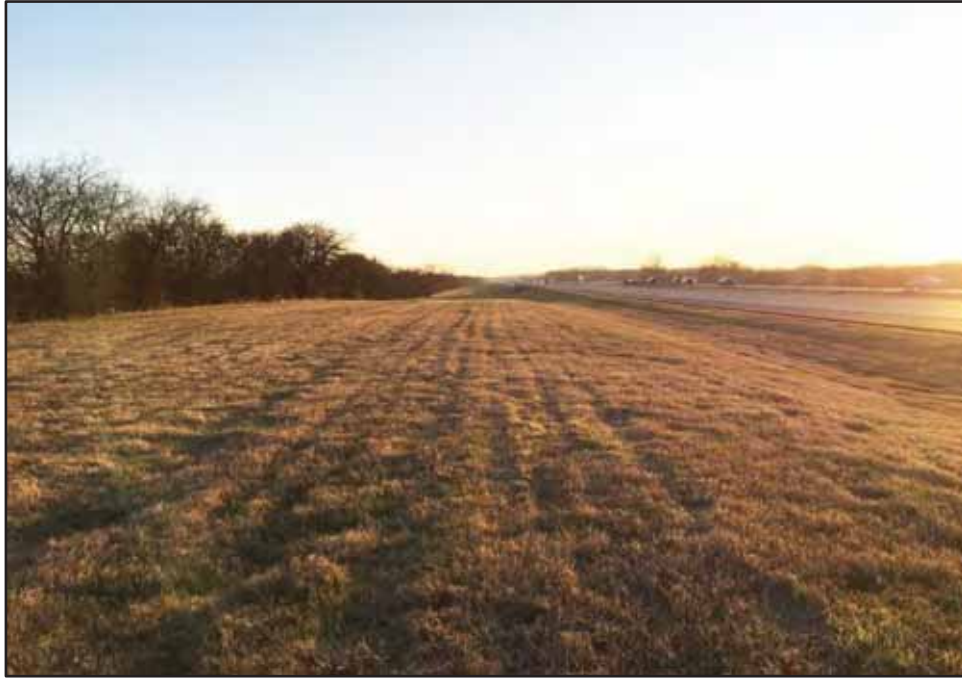
Photograph 105: View looking southwest along IH 35W east ROW from near STA. 815+00. The TESCP/EMST Mapper classifies this area as Riparian. The mowed-maintained vegetation better fits the Urban classification and the woody vegetation fits the Disturbed Prairie classification. Date of photograph: 12/7/19.

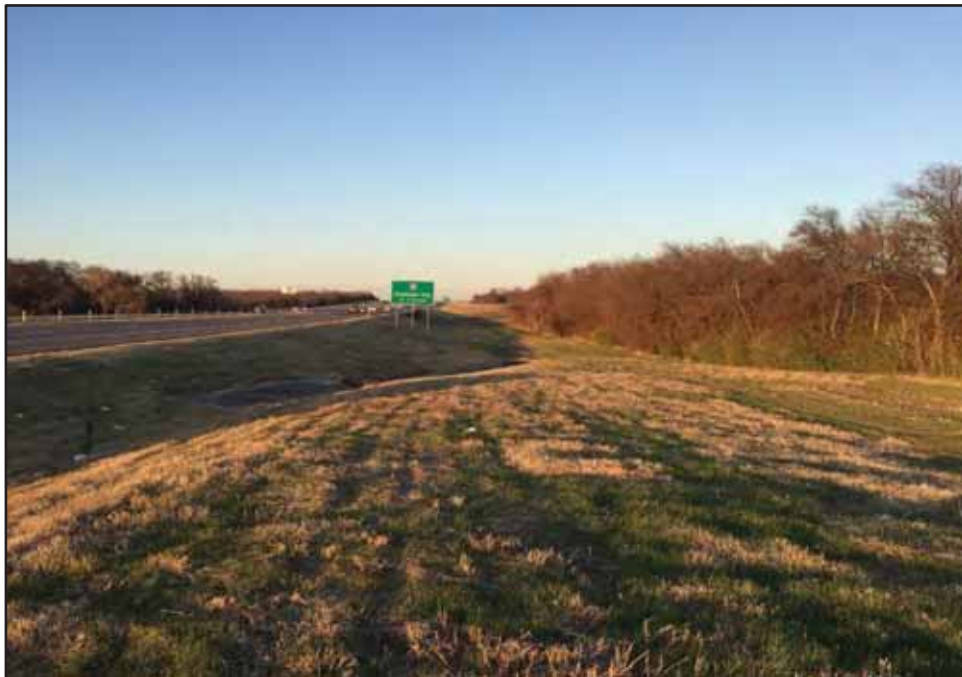
Photograph 106: View looking northeast along IH 35W east ROW from near STA. 815+00. The TESCP/EMST Mapper classifies this area as Riparian. The mowed-maintained vegetation better fits the Urban classification and the woody vegetation fits the Crosstimbers Woodland and Forest classification. Date of photograph: 12/7/19.

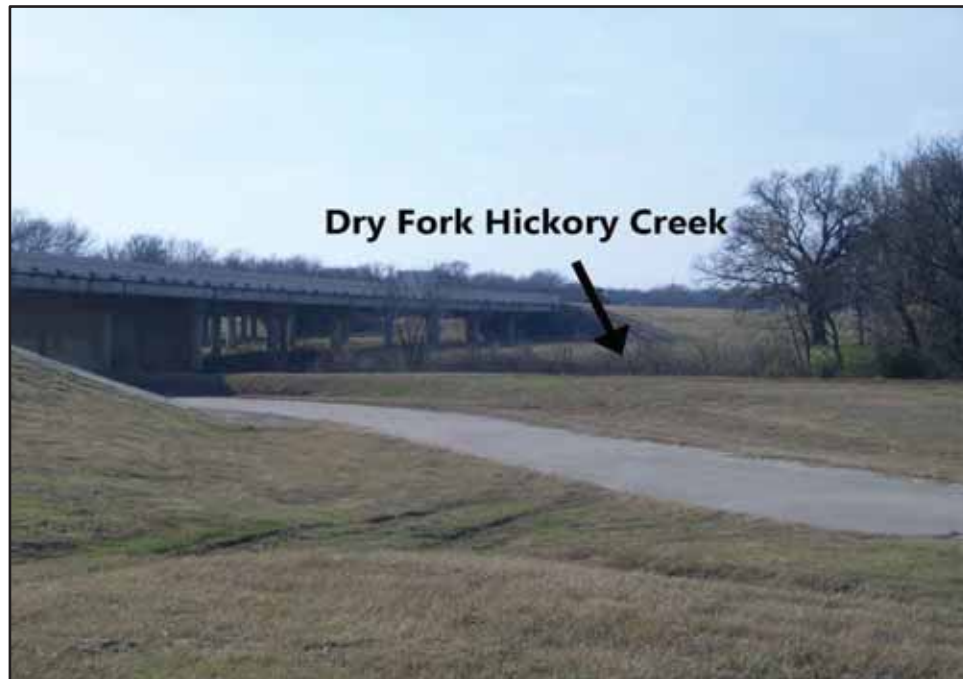
Photograph 107: View looking southeast across Corbin Road on IH 35W west ROW near STA. 821+00. The TЕСP/EMST Mapper classifies portions of the mowed-maintained vegetation as Riparian; however, it better fits the Urban classification. The stream better fits the Open Water classification. The woody vegetation adjacent to the stream fits the Riparian classification. Date of photograph: 12/8/19.

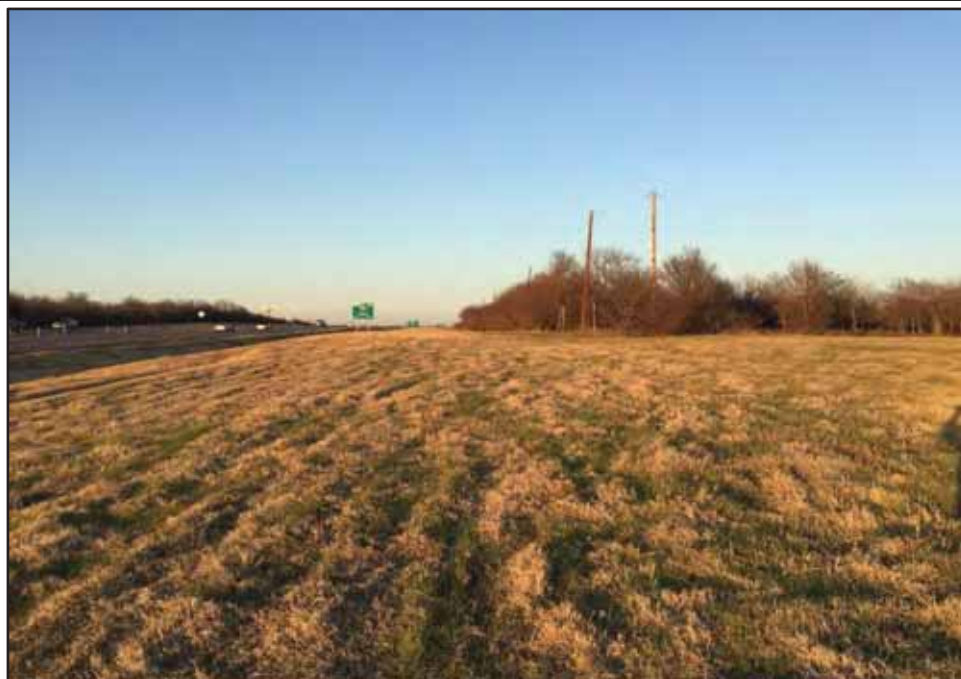
Photograph 108: View looking northeast along IH 35W east ROW from near STA. 825+00. The TЕСP/EMST Mapper classifies portions of the mowed-maintained vegetation as Crosstimbers Woodland and Forest. The mowed-maintained vegetation better fits the Urban classification and the woody vegetation fits the Crosstimbers Woodland and Forest classification. Date of photograph: 12/7/19.

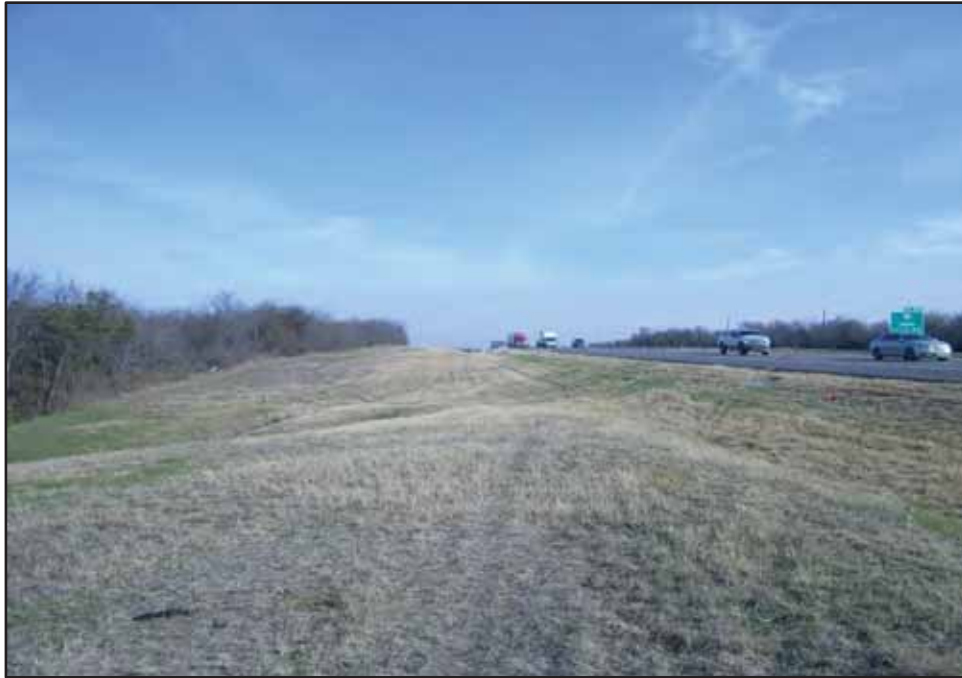
Photograph 109: View looking northeast along IH 35W west ROW from near STA. 827+00. The TЕСP/EMST Mapper classifies portions of the mowed-maintained vegetation as Crosstimbers Woodland and Forest, and Disturbed Prairie. The mowed-maintained vegetation better fits the Urban classification and the woody vegetation fits the Crosstimbers Woodland and Forest classification. Date of photograph: 12/8/19.

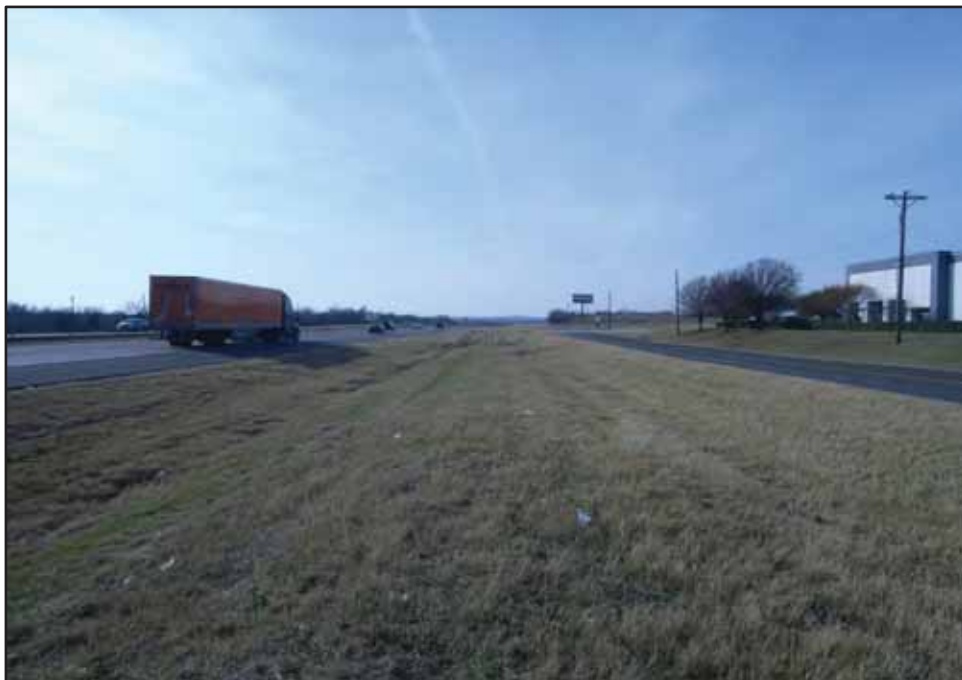
Photograph 110: View looking southwest along IH 35W west ROW from near STA. 847+00. The TЕСP/EMST Mapper classifies portions of the mowed-maintained vegetation as Crosstimbers Woodland and Forest, and Tallgrass Prairie, Grassland. The mowed-maintained vegetation better fits the Urban classification. Date of photograph: 12/8/19.

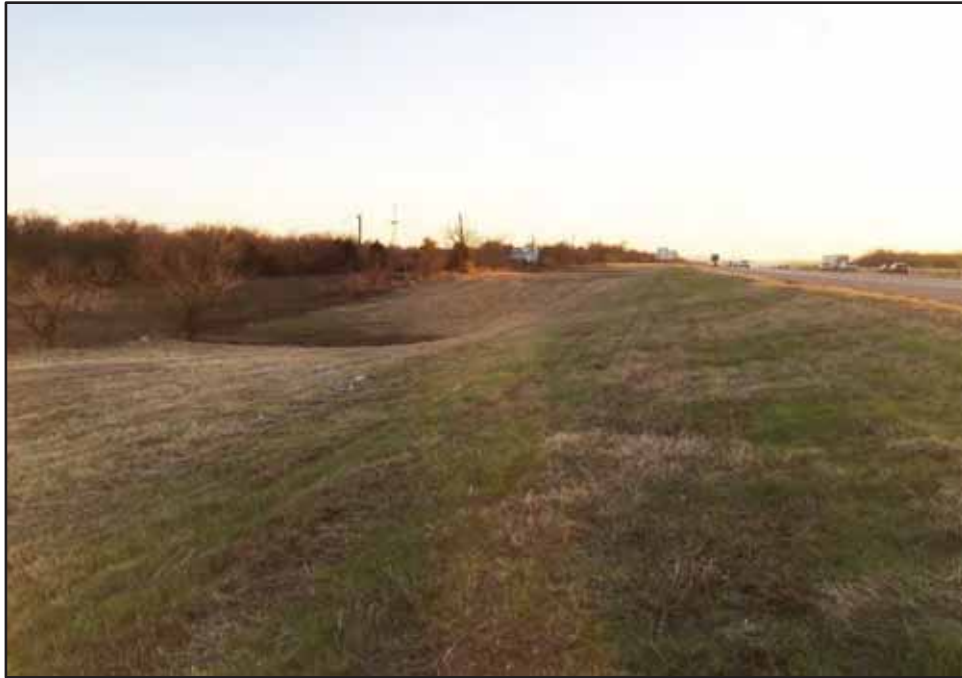
Photograph 111: View looking southwest along IH 35W east ROW from near STA. 860+00. The TЕСP/EMST Mapper classifies portions of the mowed-maintained vegetation as Tallgrass Prairie, Grassland. The mowed-maintained vegetation better fits the Urban classification. Disturbed Prairie is east of the fence line. Date of photograph: 12/7/19.

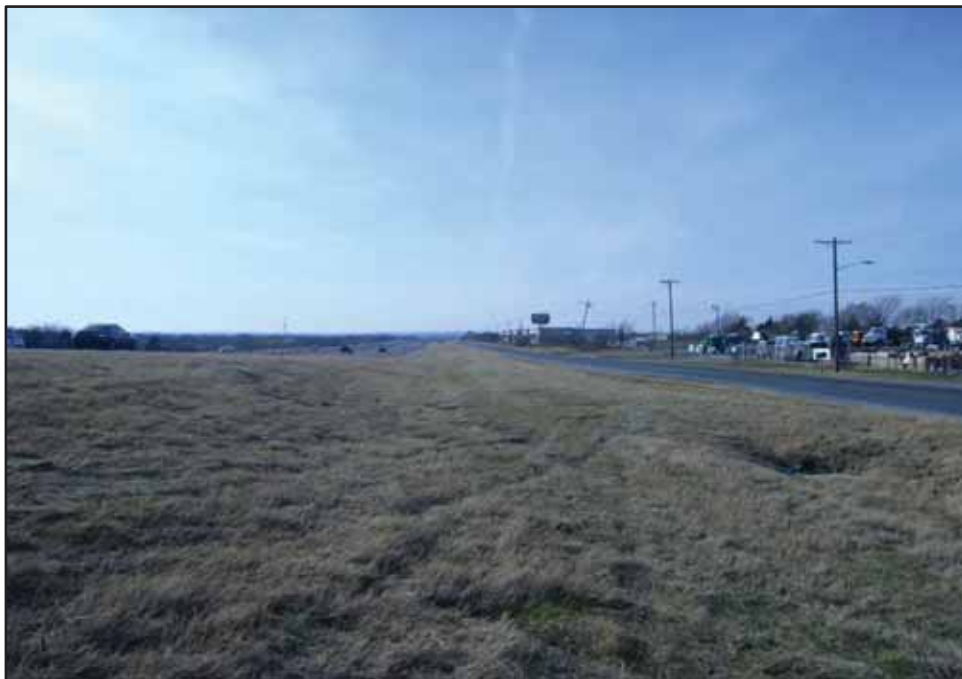
Photograph 112: View looking southwest along IH 35W west ROW from near STA. 874+00. The TЕСP/EMST Mapper accurately classifies this area as Urban. Date of photograph: 12/8/19.

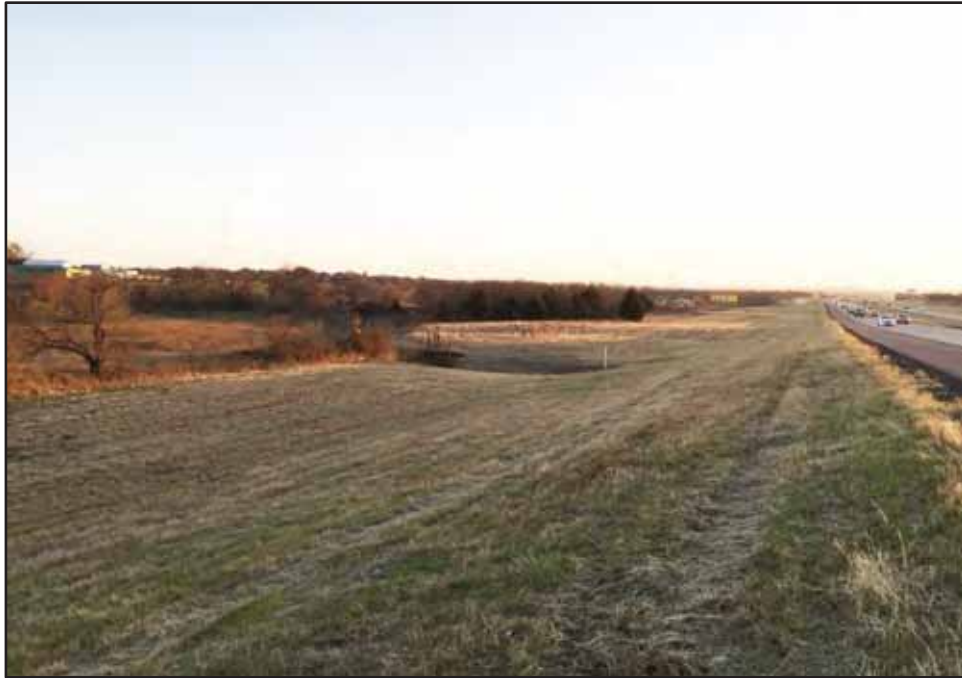
Photograph 113: View looking southwest along IH 35W west ROW from near STA. 874+00. The TЕСP/EMST Mapper classifies portions of the mowed-maintained vegetation as Disturbed Prairie. The mowed-maintained vegetation better fits the Urban classification. Date of photograph: 12/7/19.

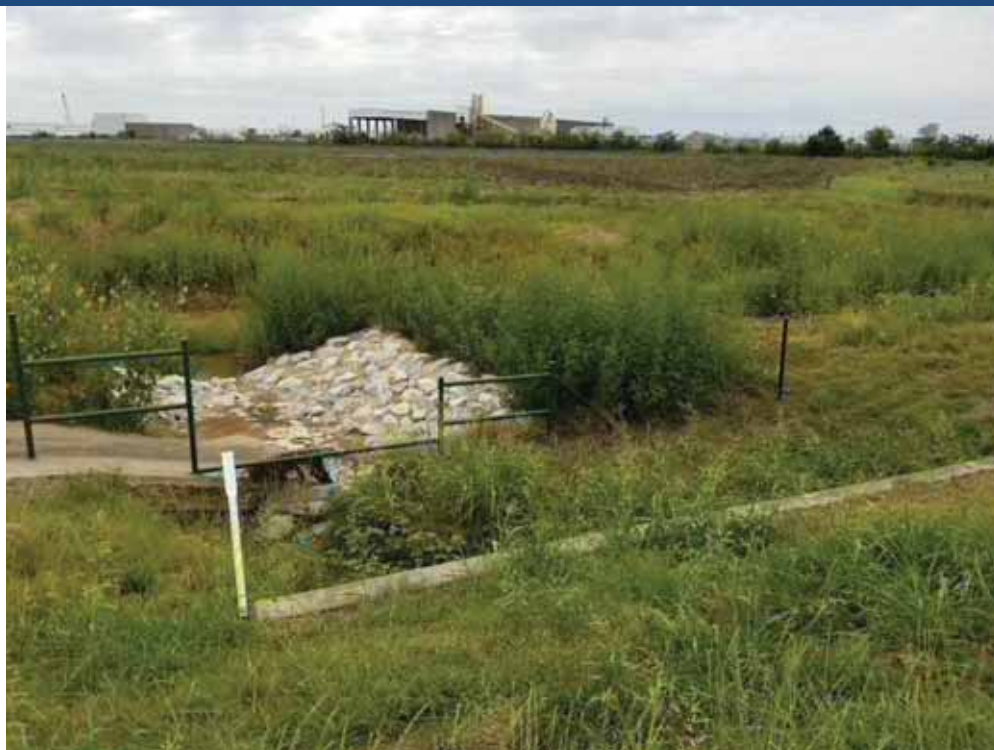
Photograph 1. Unnamed Tributary of Elizabeth Creek. Facing east from IH 35W

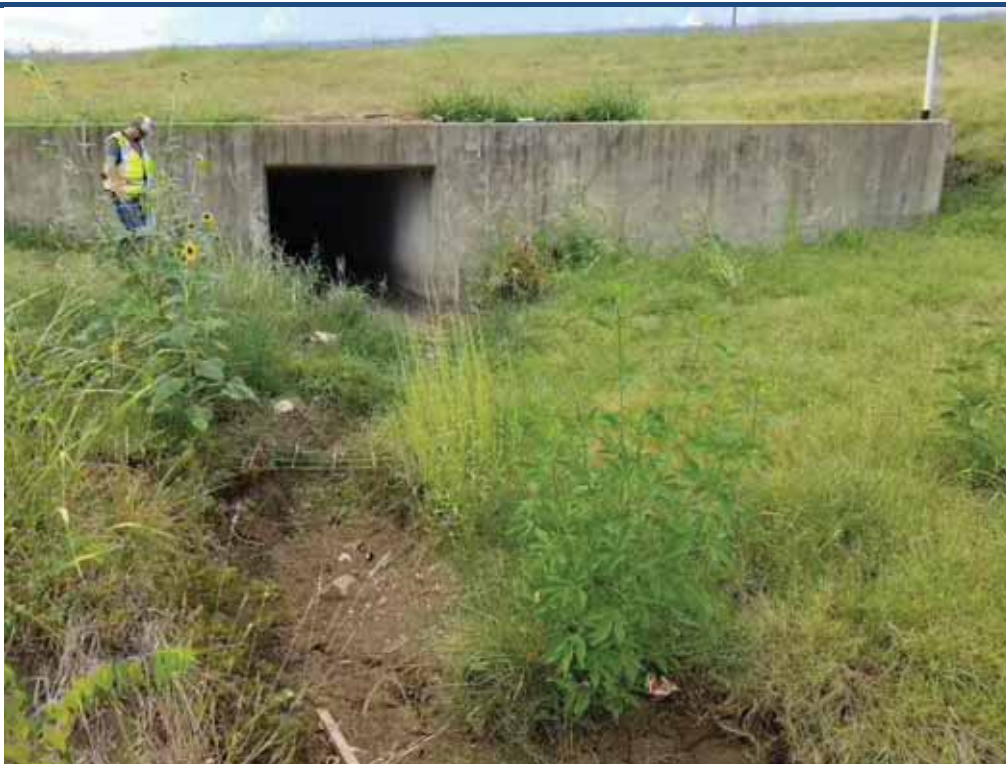
Photograph 2. Elizabeth Creek Tributary 2. Facing west toward IH 35W

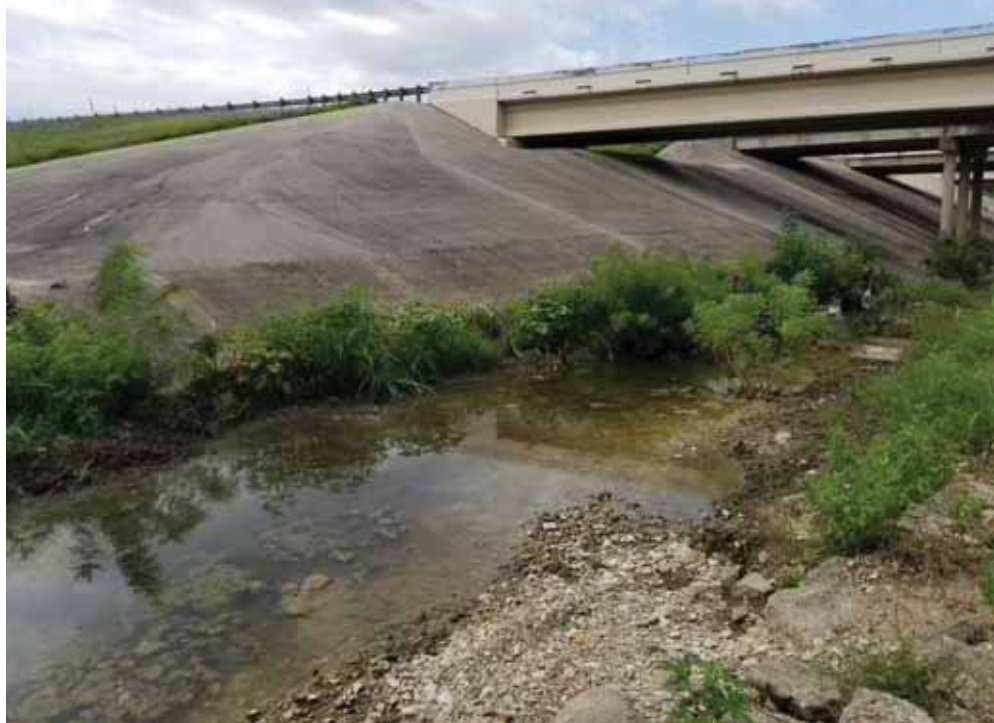
Photograph 3. Catherine Branch – Facing southwest toward IH 35W

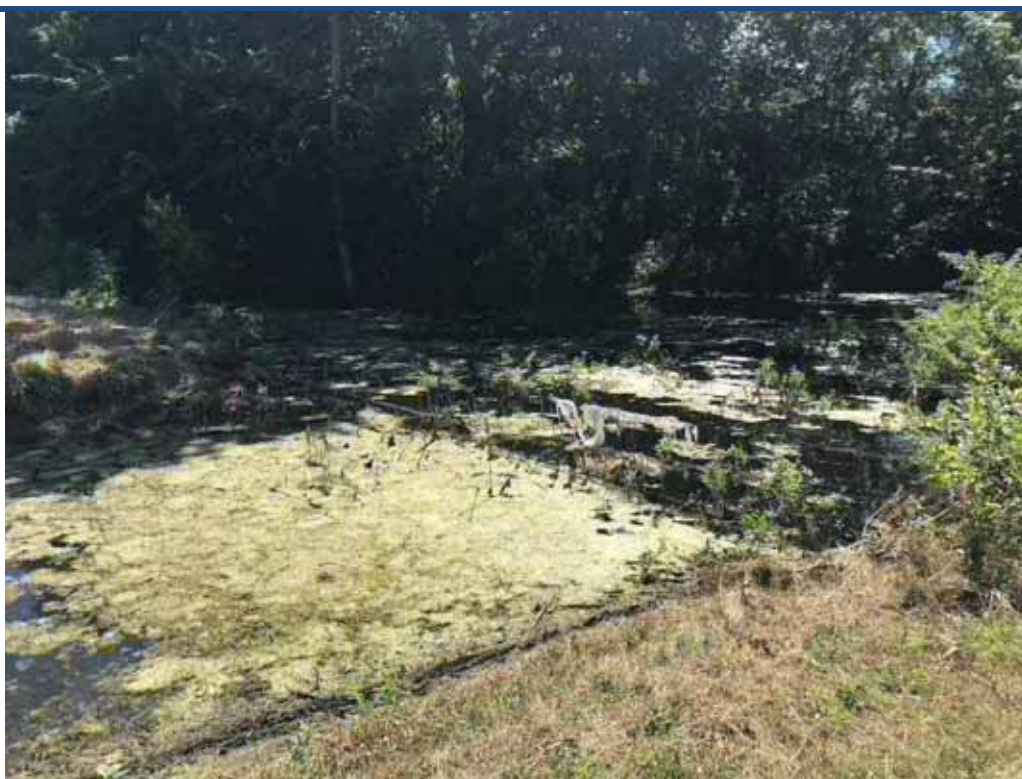
Photograph 4. Open Water 1 – Facing east from IH 35W

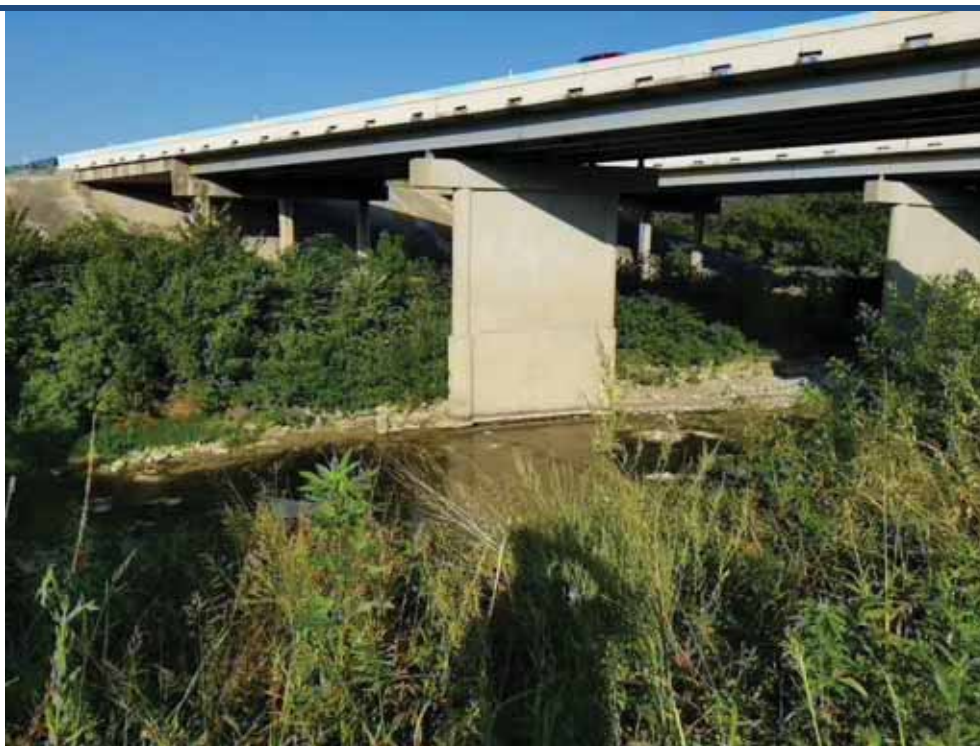
Photograph 5. Denton Creek Tributary 6 – Facing east from under IH 35W

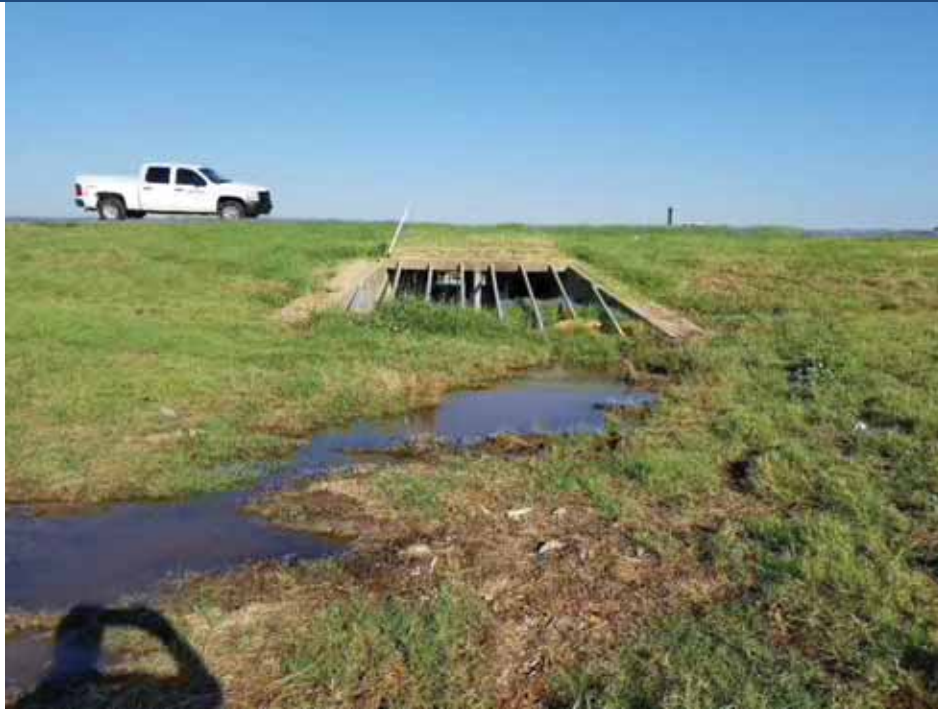
Photograph 6. Denton Creek – Facing southwest from just east of IH 35W

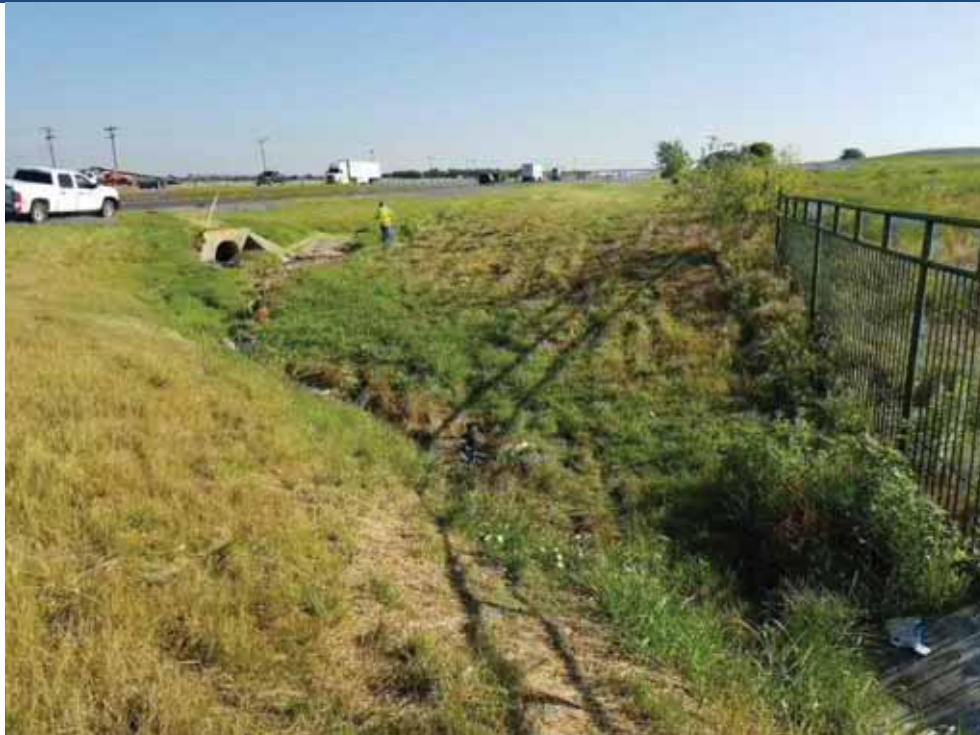
Photograph 7. Unnamed Tributary of Cleveland Branch - Facing west toward IH 35W

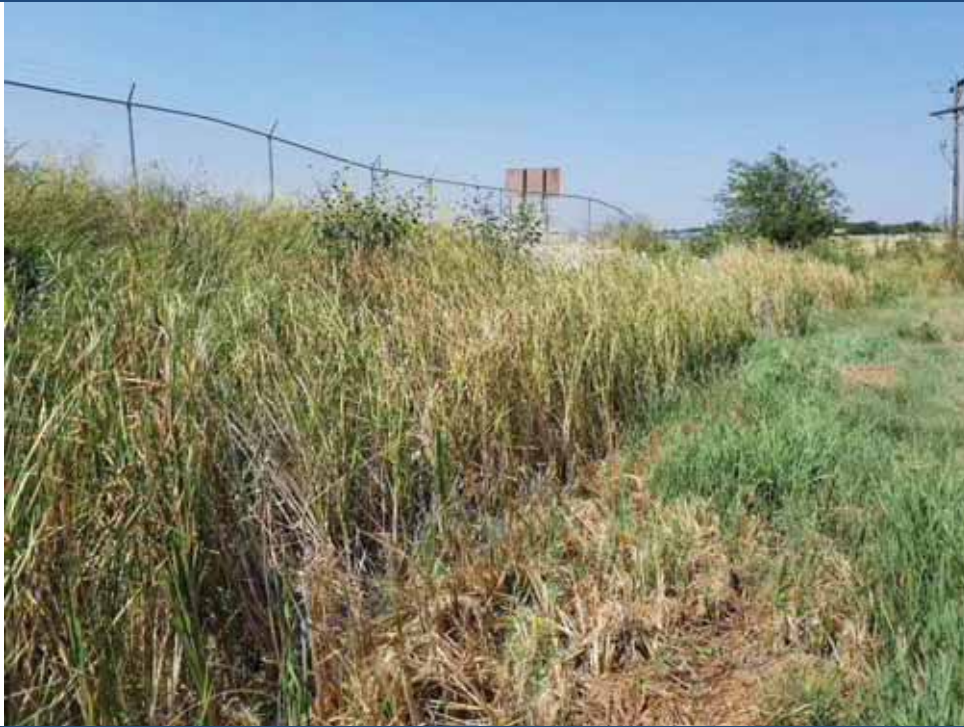
Photograph 8. Cleveland Branch – Facing north from NB IH 35W

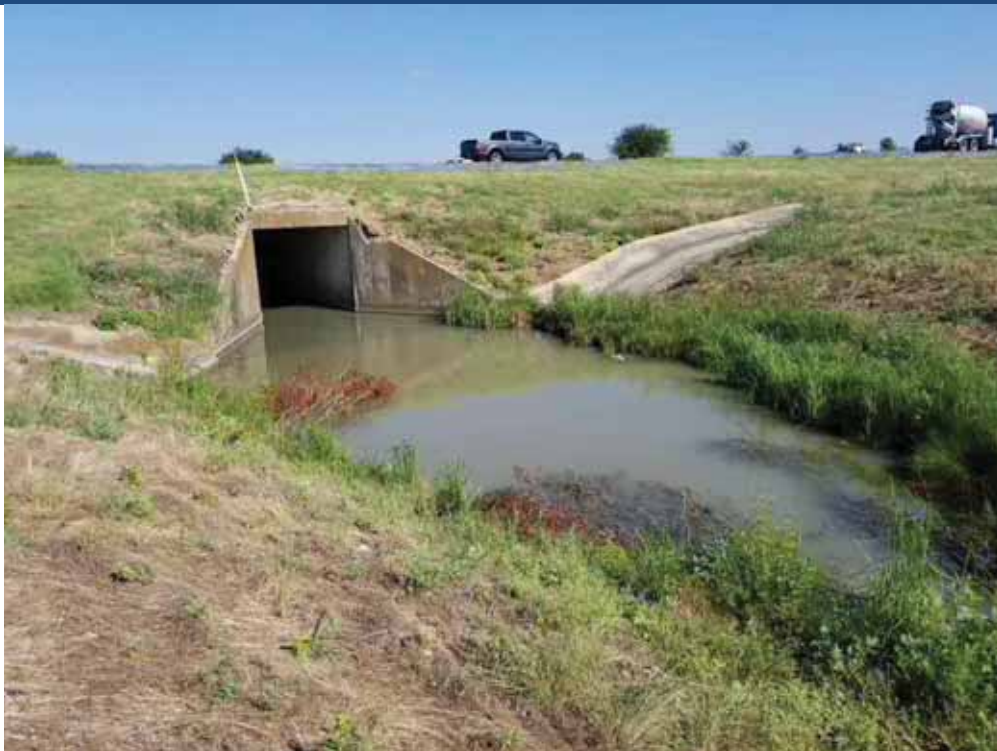
Photograph 9. Wetland 1 - Facing north from west of IH 35

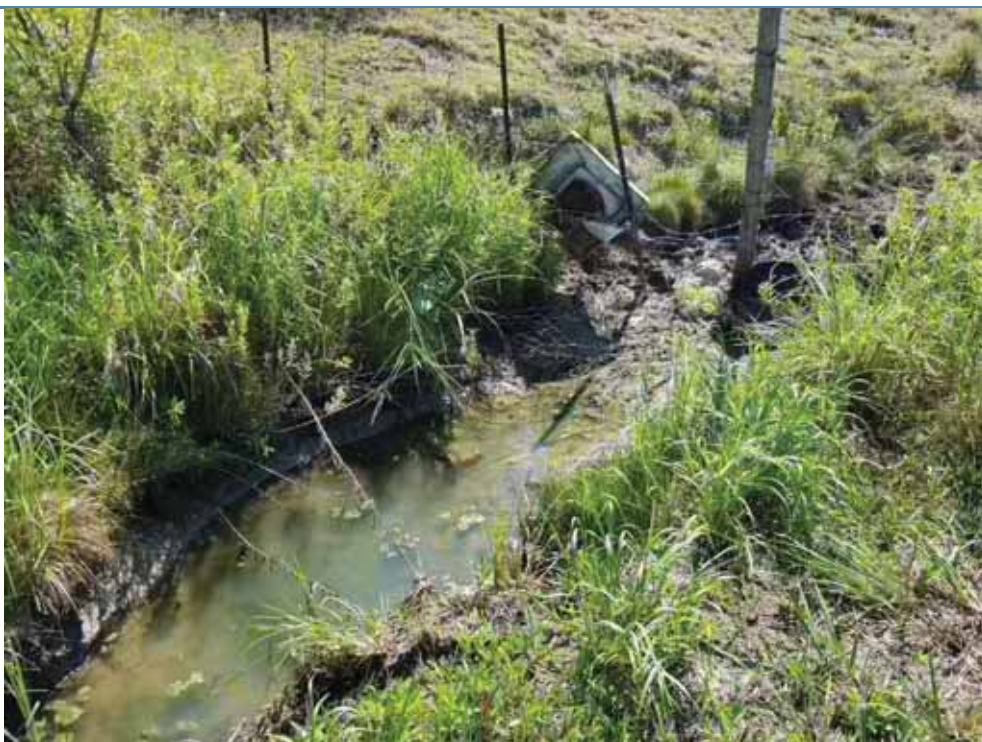
Photograph 11. Wetland 2 – Facing east from Graham Branch Tributary 10
