IH 35W Frontage Roads Technical Reports

Air Quality Resources Technical Report

Interstate Highway (IH) 35W Frontage Roads

Control-Section-Job (CSJ) 0081-13-065

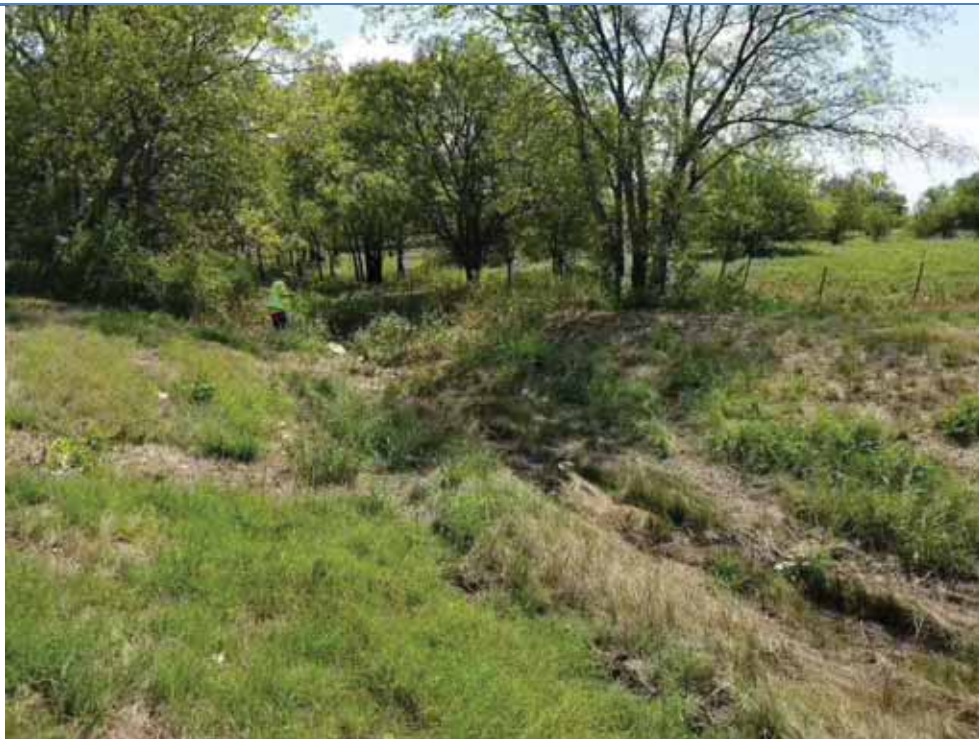
Photograph 13. Wetland 3 – Looking north across Graham Branch Trib 10.1, east of IH 35W

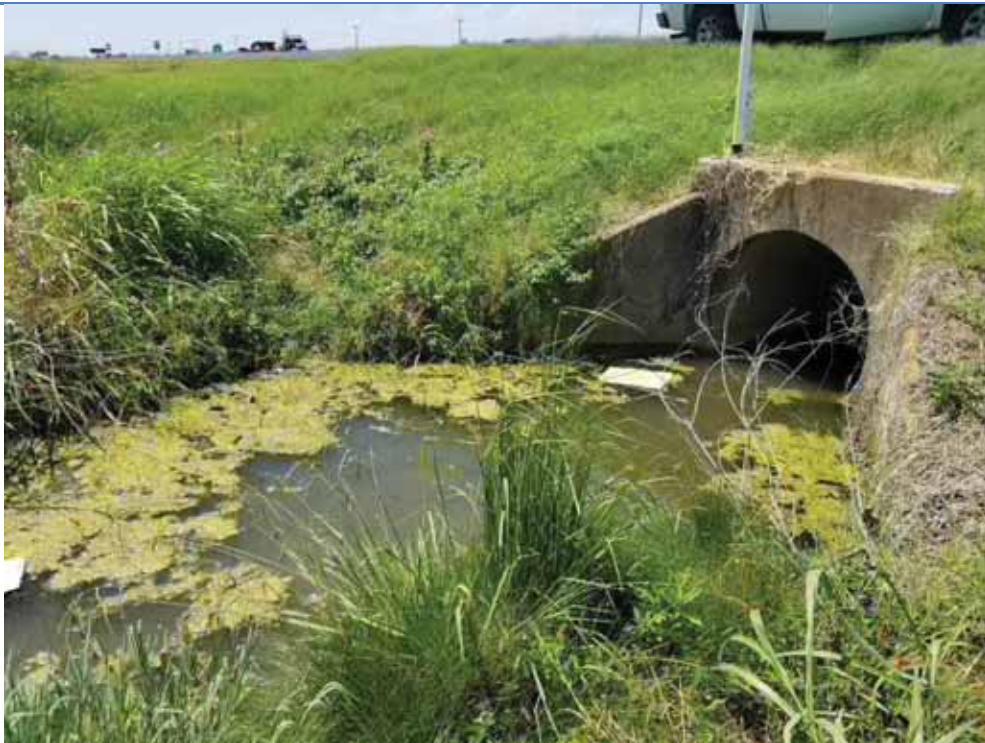
Photograph 17. Wetland 4 – Looking east from just west of Sam Davis Road

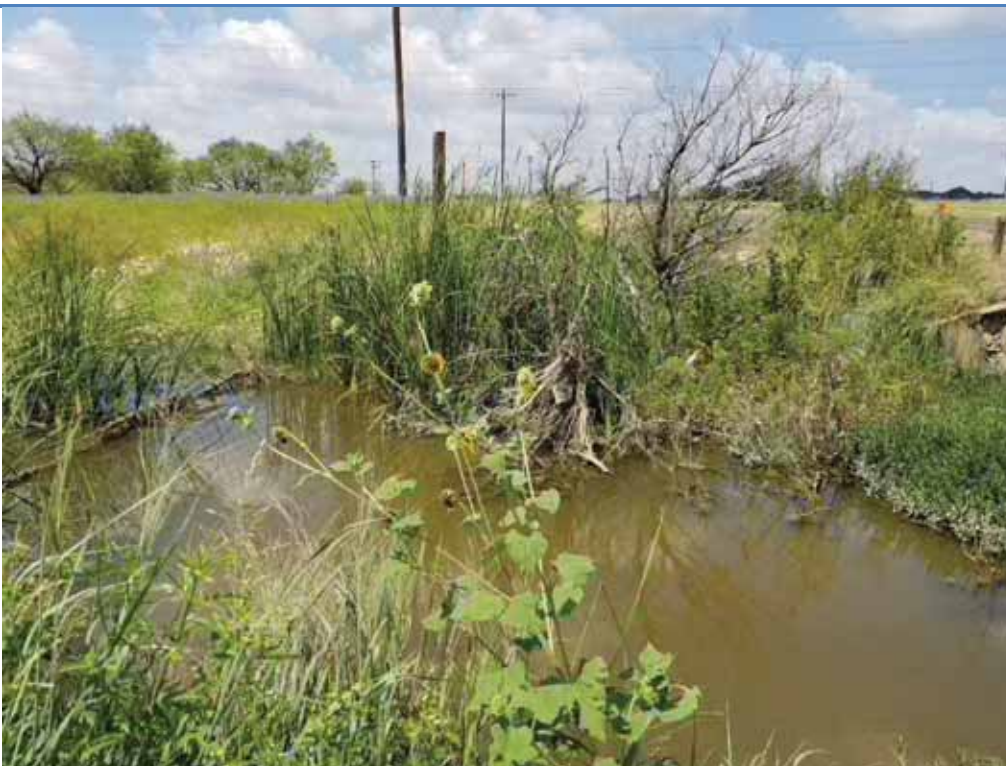
Photograph 19. Wetland 5 – Looking east from just west of Sam Davis Road

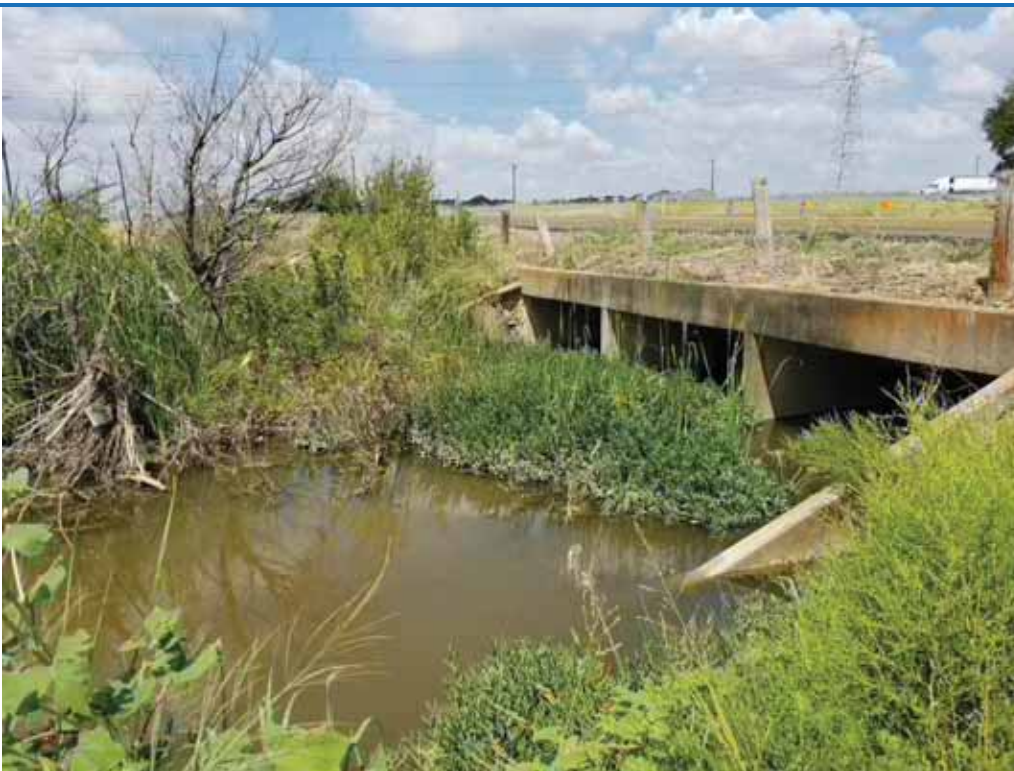
Photograph 21. Wetland 6 – Looking southwest from just north of Sam Davis Road

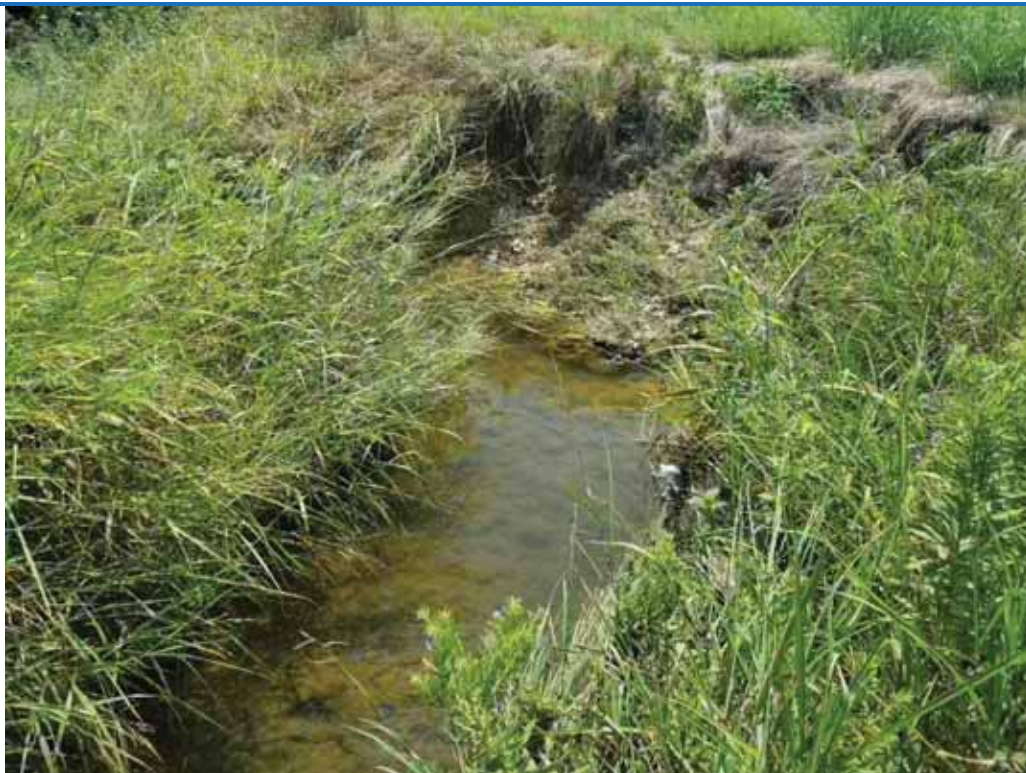
Photograph 22. Wetland 7 – Looking northwest from just south of Sam Davis Road

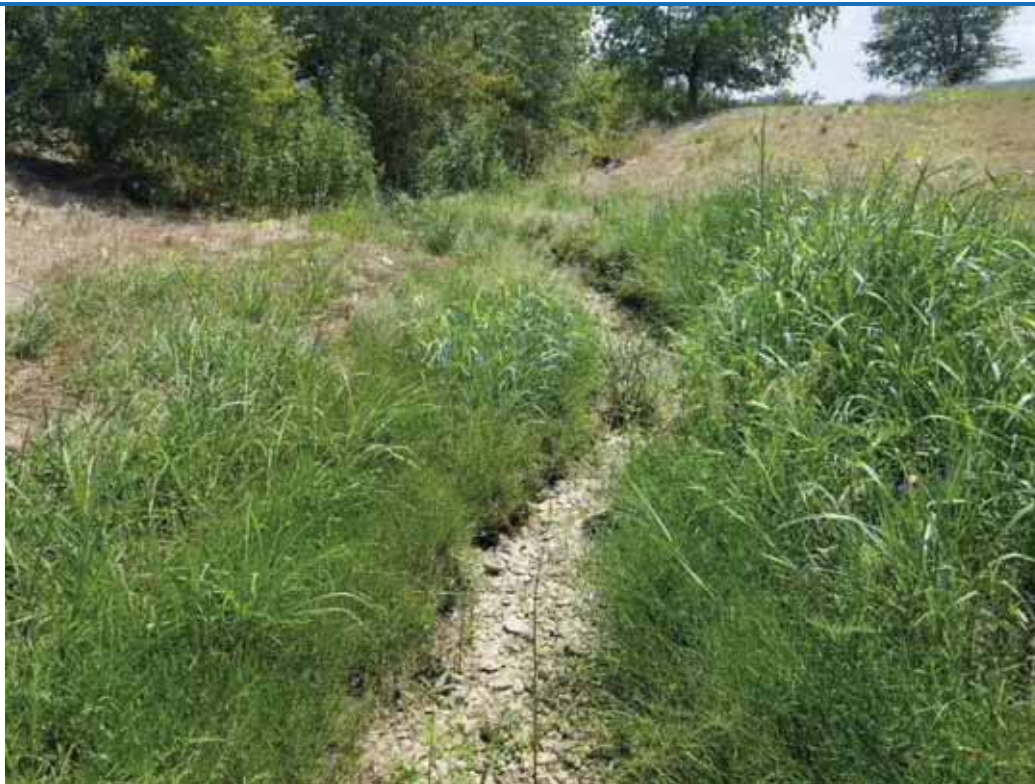
Photograph 24. Wetland 8 – Looking southeast toward IH 35

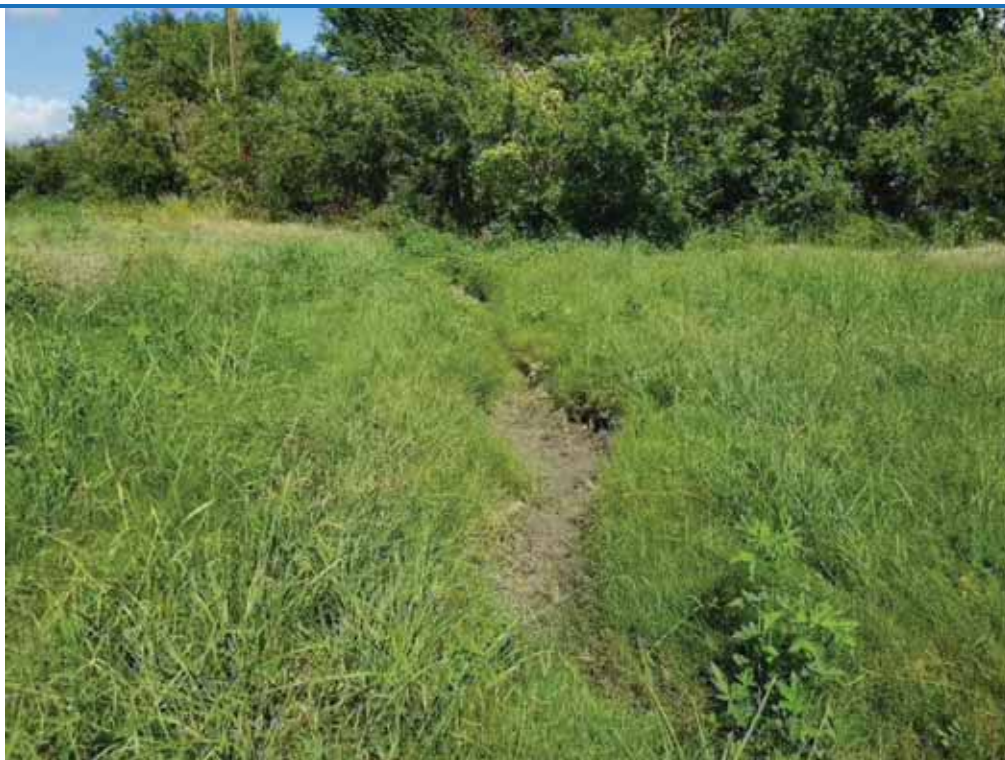
Photograph 27. Wetland 9 – Looking west toward IH 35W

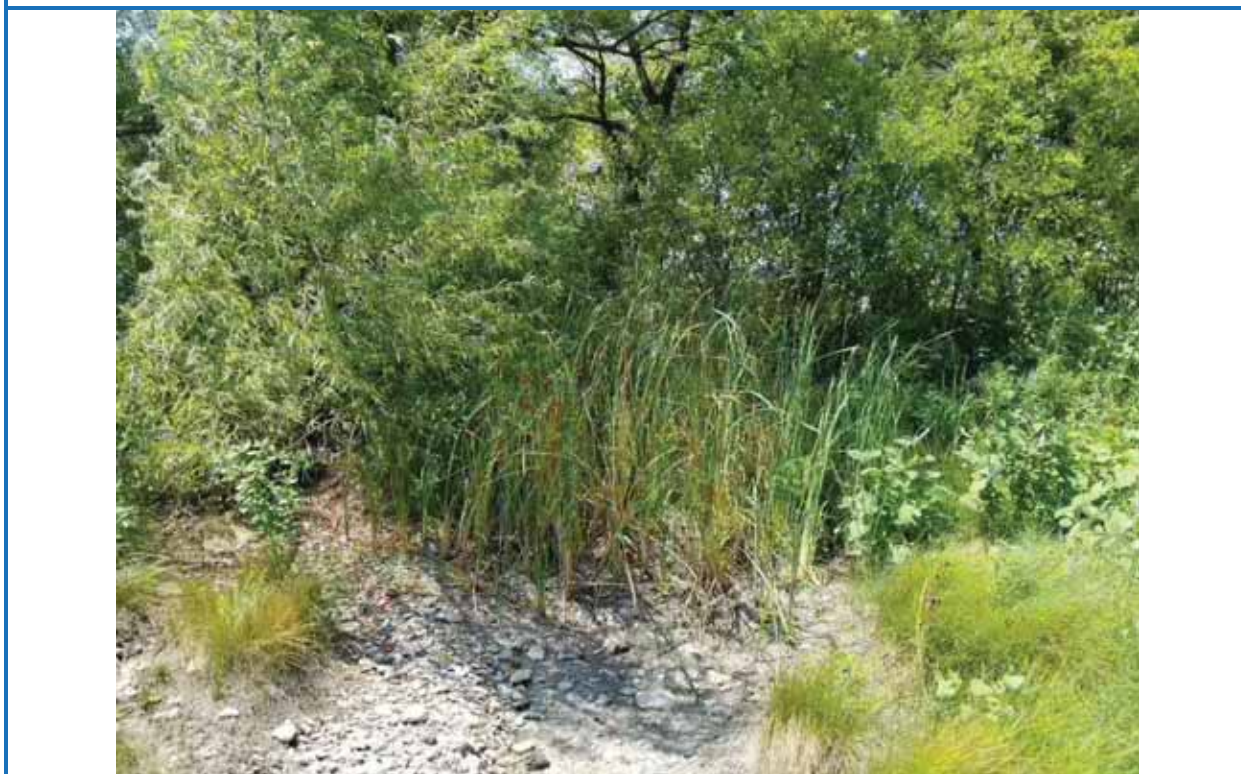
Photograph 29. Wetland 10 – Looking east toward IH 35W

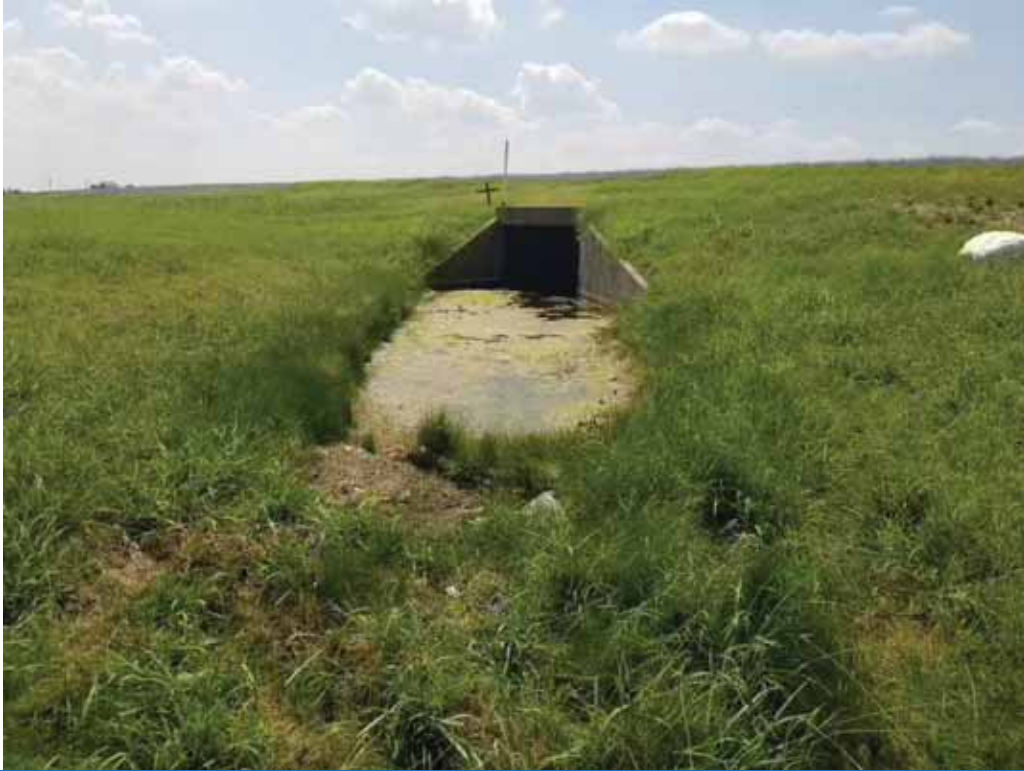
Photograph 30. Wetland 11 – Looking east from IH 35W

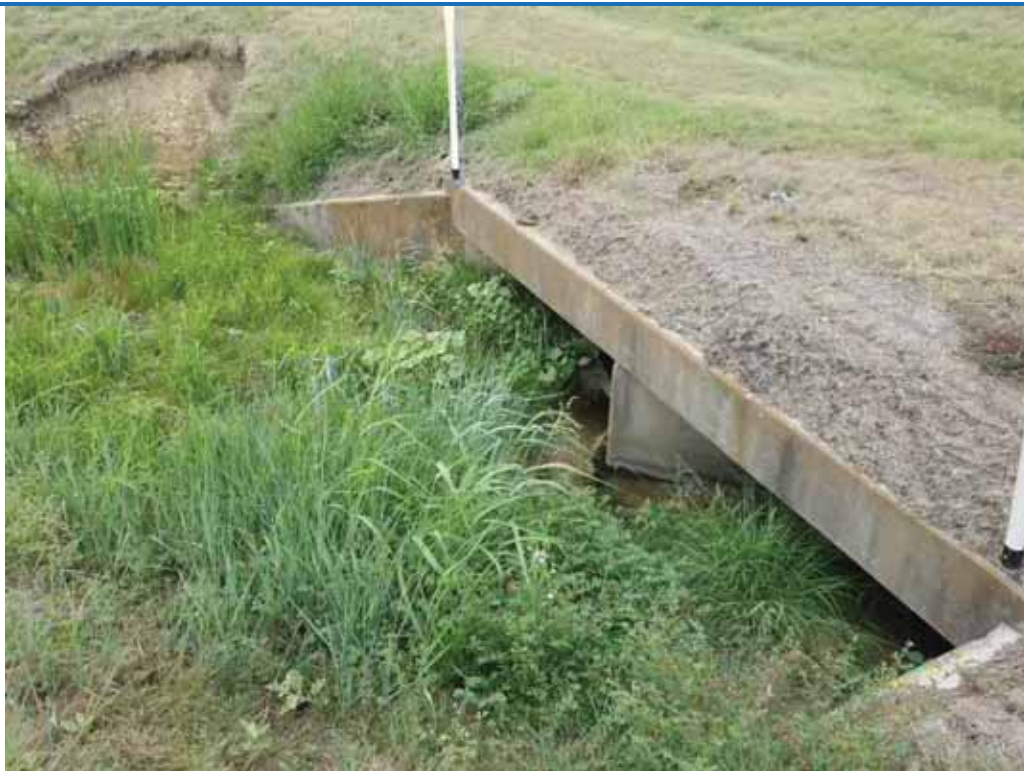
Photograph 34. Wetland 12 – Looking east from IH 35W
