## Report Version 6 Hazardous Materials Initial Site Assessment (ISA)

CSJ: 0261-01-041. US 67 at Lake Ridge Parkway

# TxDOT Hazardous Materials Initial Site Assessment (ISA) Report Project Information CSJ No:0261-01-041 City:Cedar Hill and Midlothian Zip Code:75104 and 76065 County:Dallas and Ellis HWY:US 67 Limits:From north of Shiloh Road to South of Mount Lebanon Road

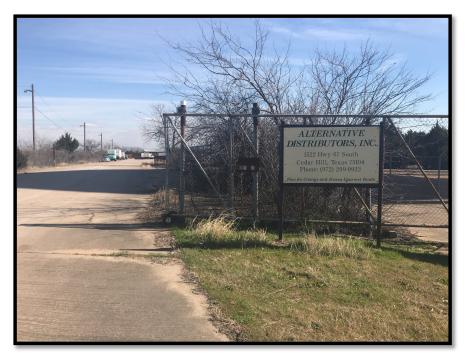
1. Map ID#1 is a Cement Plant Manufacturing Facility located at 1522 S. Highway 67. The facility has one AST that has been out of service since 1994 and no reported releases. The entrance is located adjacent to the ROW; however, the facility is set back approximately 290 feet from the ROW. This site is considered a low environmental risk.

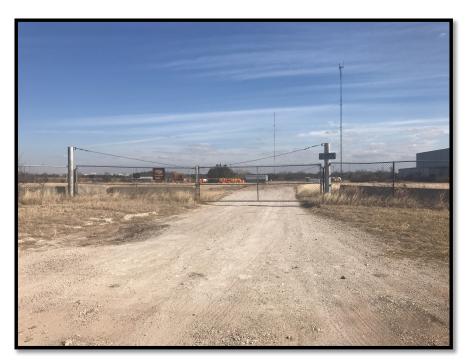
2. Map ID #2 is J D Abrams Inc, a construction yard, located at 2040 S Highway 67 within the proposed ROW. This site is considered a low environmental risk.

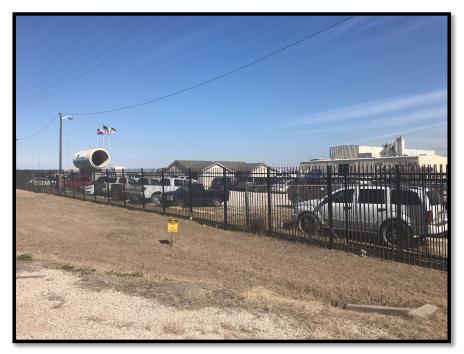
3. Map ID #3 is Hanson Pipe & Products Inc. located at 2138 S Highway 67. ROW acquisition is proposed from the northeast corner area of the property. The facility had two underground storage tanks removed in 1998 and one active and one inactive AST with no reported releases. This site is considered a low environmental risk.

Map ID 3 (Hanson Pipe & Products) is adjacent east of US 67 and ROW acquisition is proposed from this property at the northeast corner area. The facility records include four tanks. The site formerly used two underground tanks that were removed in 1998 and one aboveground tank out of use as of 1998. The remaining tank is one active 6,000-gallon diesel aboveground tank installed in 1998. No releases are reported for the facility. The current aboveground tank was not observed to be within proposed ROW. Based on regulatory information and site observations, this site is considered a low environmental risk.				
□Unresolved ☑Resolved □No Issue	Leaking Petroleum Storage Tanks (LPSTs) Concerns discovered during the database search: LPSTs are PSTs that have caused or are suspected to have caused a release of fuel or other petroleum substances to the environment.			
	□Yes ⊠No	Additional Research is needed or uncertain of impacts from one or more LPSTs. Request assistance from ENV.

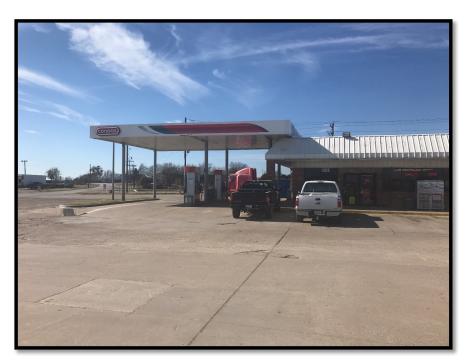
4. Map ID # 5 is Mini Mart is at 4741 N. Highway 67 approximately 760 feet south of the project limits. The facility has an LPST that was issued a final concurrence in 2001 and has four active USTs. Based on the distance from the ROW, and LPST final concurrence status, this site is not considered an environmental concern.
