# Archeological Survey Report

**Project Name:** Farm-to-Market (FM) 741 Road Widening

**Project Limits:** From US Highway (US) 175 to FM 548

**CSJ Number(s):** 1092-01-021

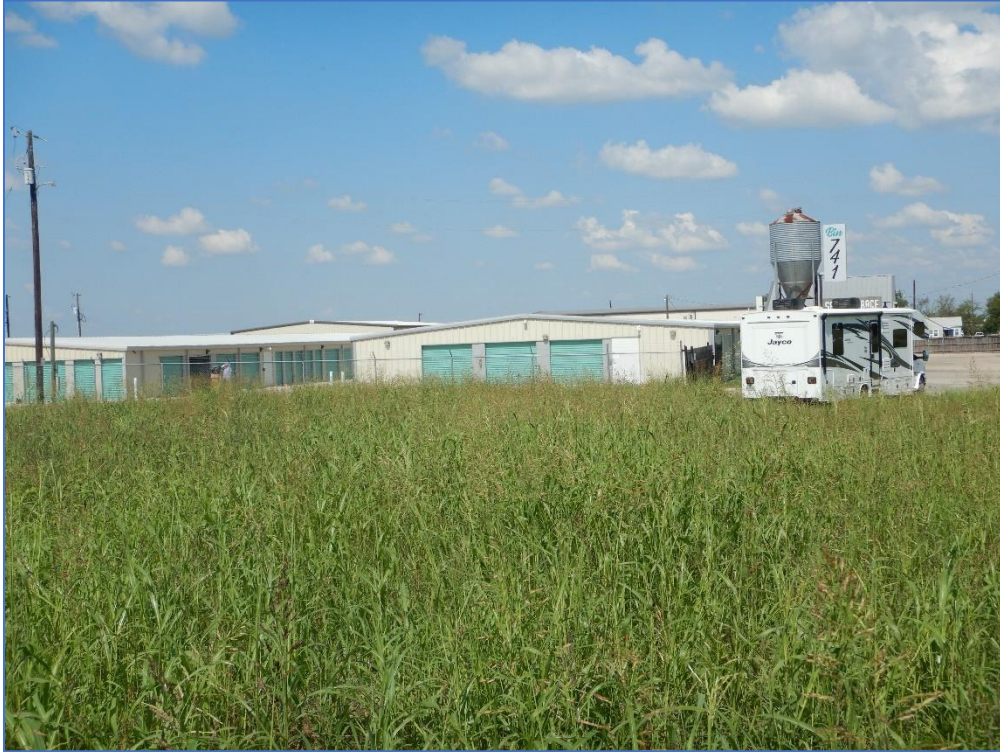
Photo 21. Disturbed parcel by Bin 741 Storage; view west.

Additionally, the parcel with disturbance from the Bin 741 storage facility was not shovel tested (**Photo 21**). No cultural material or features were observed on the surface or subsurface; **Attachment 9** contains full shovel test results.

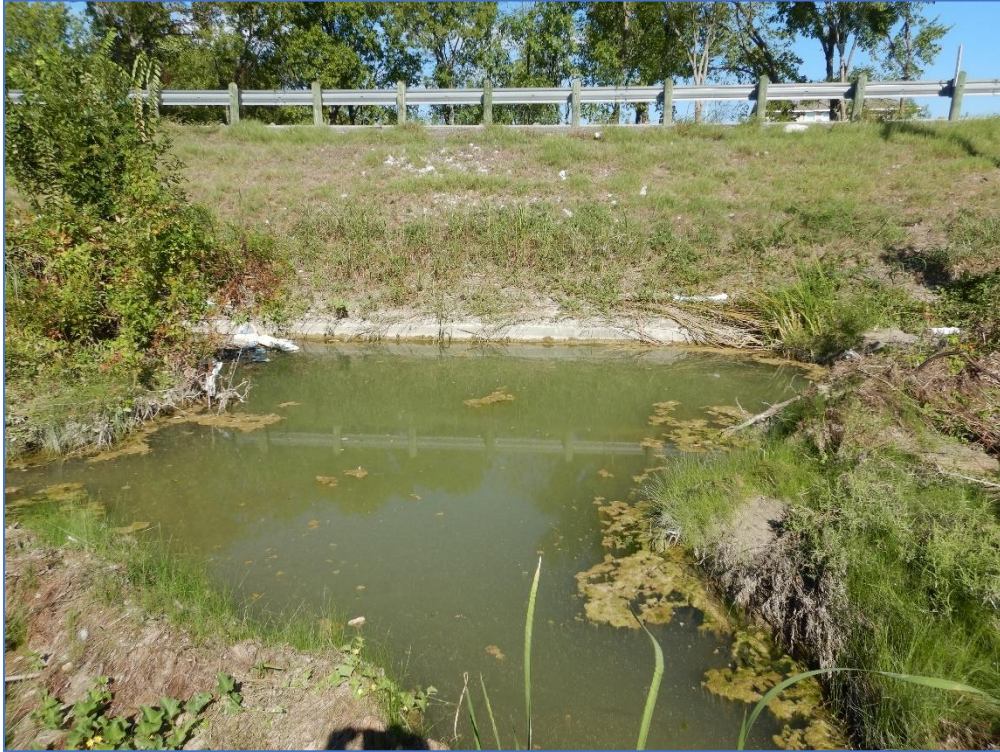
Photo 31. Channelized drainage on east side of FM 741 by Bronte Blvd; view northwest.

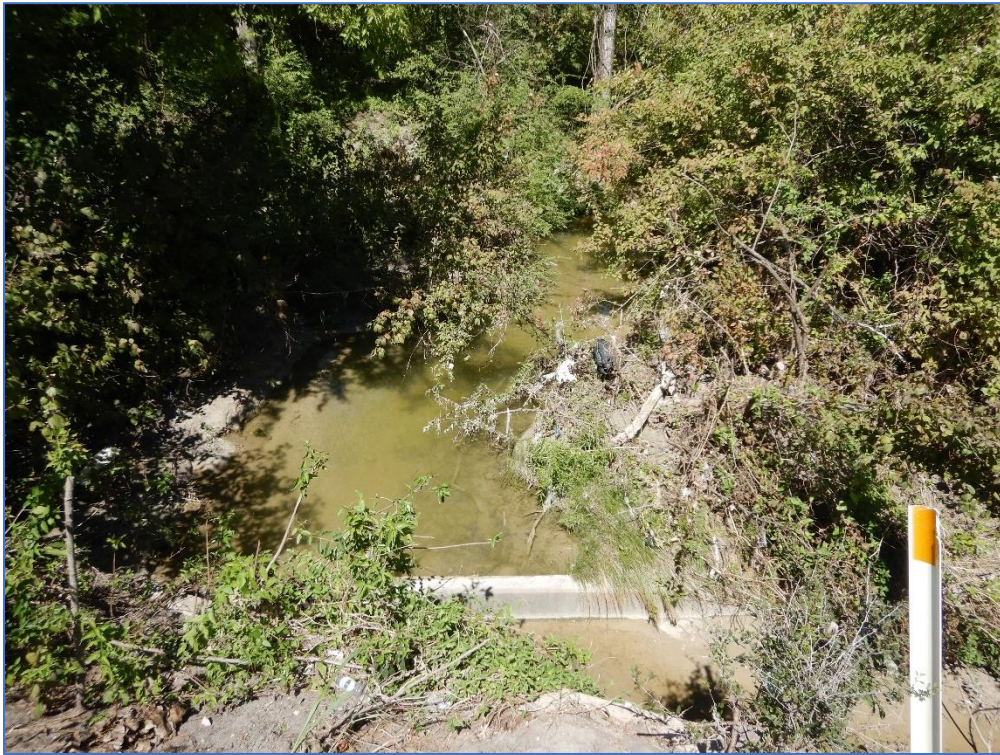
Photo 32. Channelized drainage on west side of FM 741 by Bronte Blvd; view northwest.

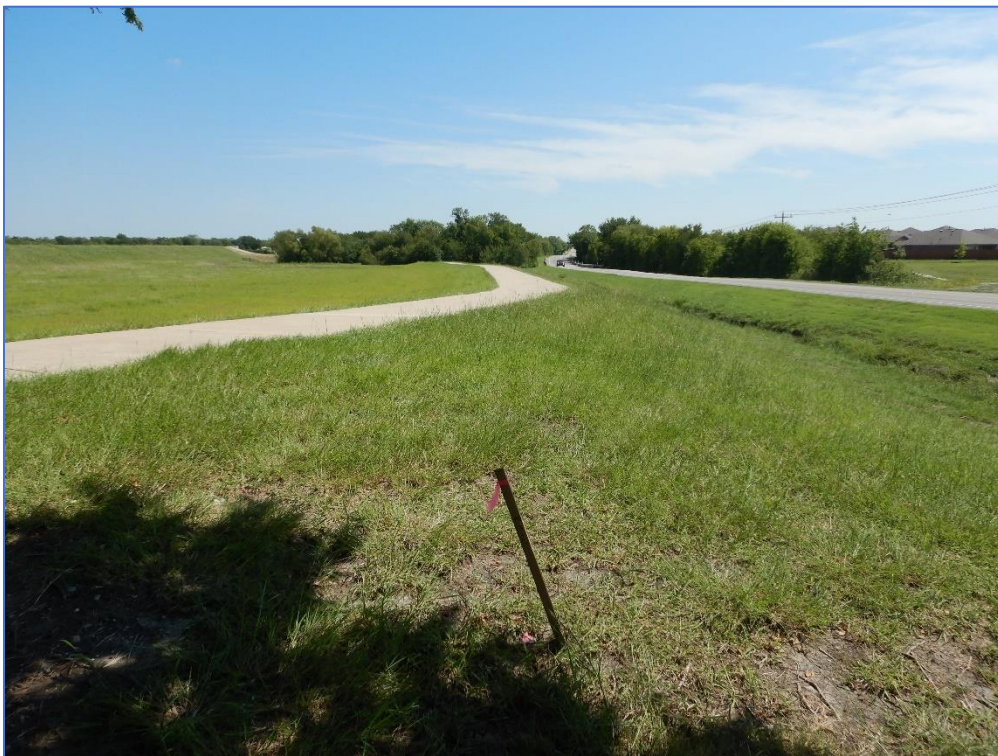
Photo 36. Disturbance from levees on north bank of drainage north of Griffin Lane; view southeast.

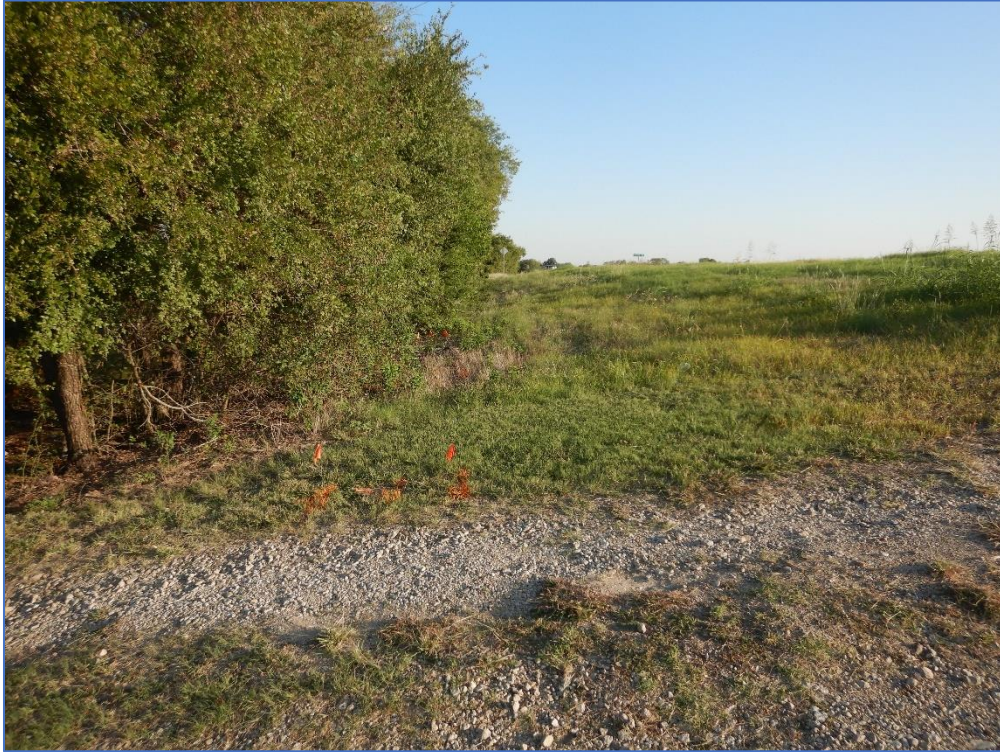
Photo 37. ROW prior to trenching showing the marked AT&T lines; view north.

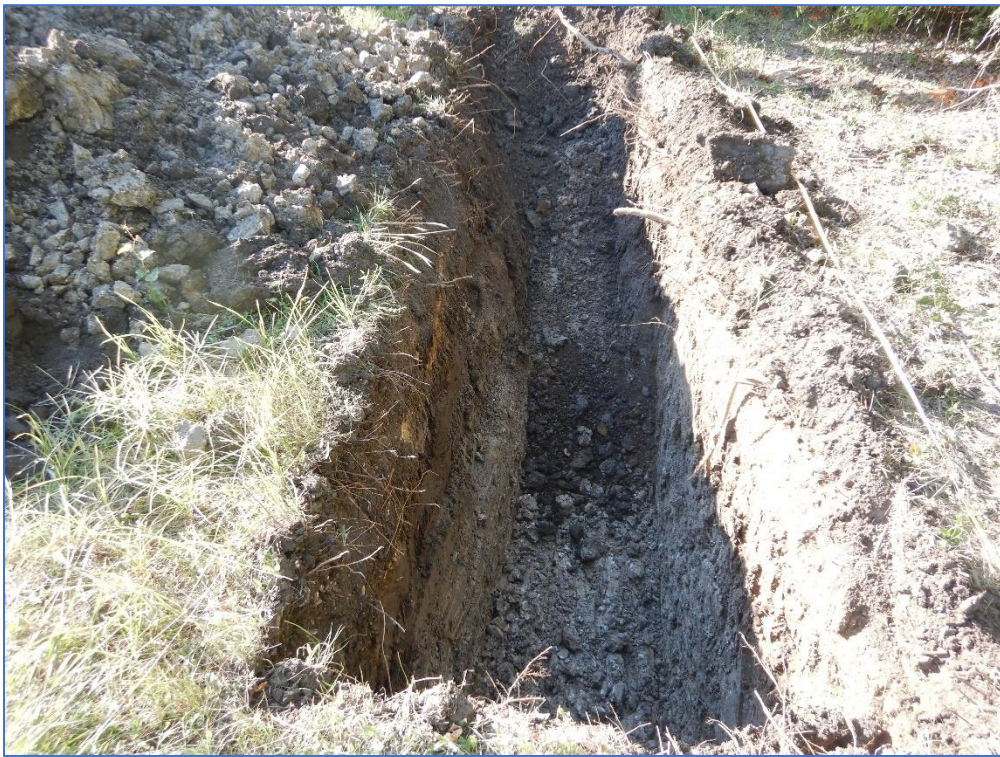
Photo 38. View of BT1 from the north end; view south.

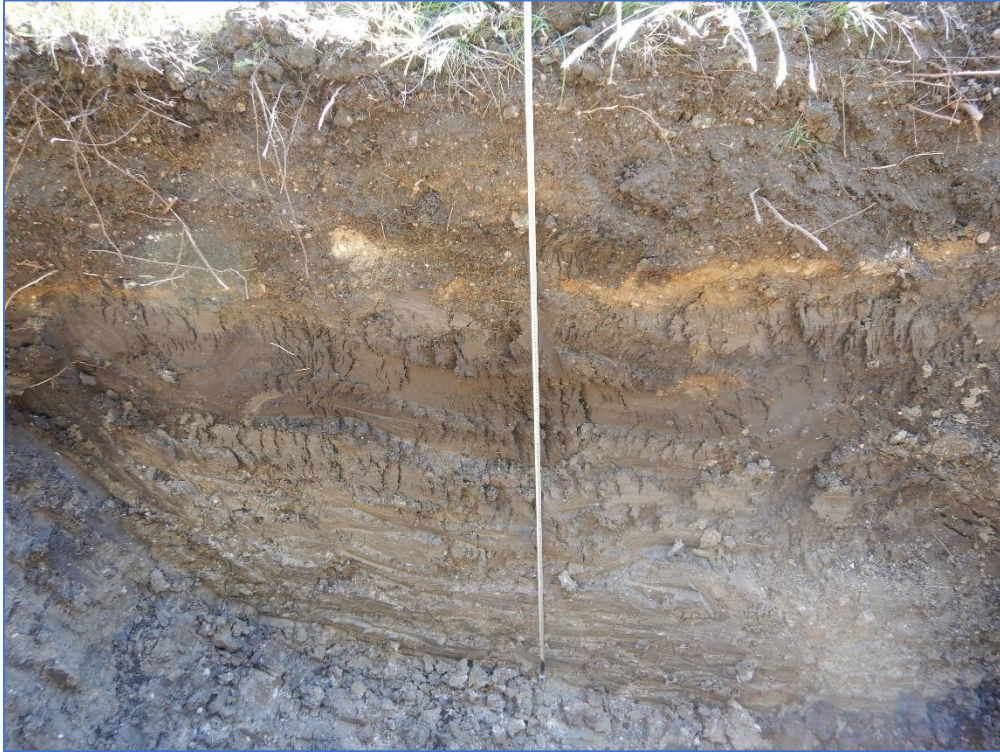
Photo 39. West wall profile of BT1 with scale; view west.

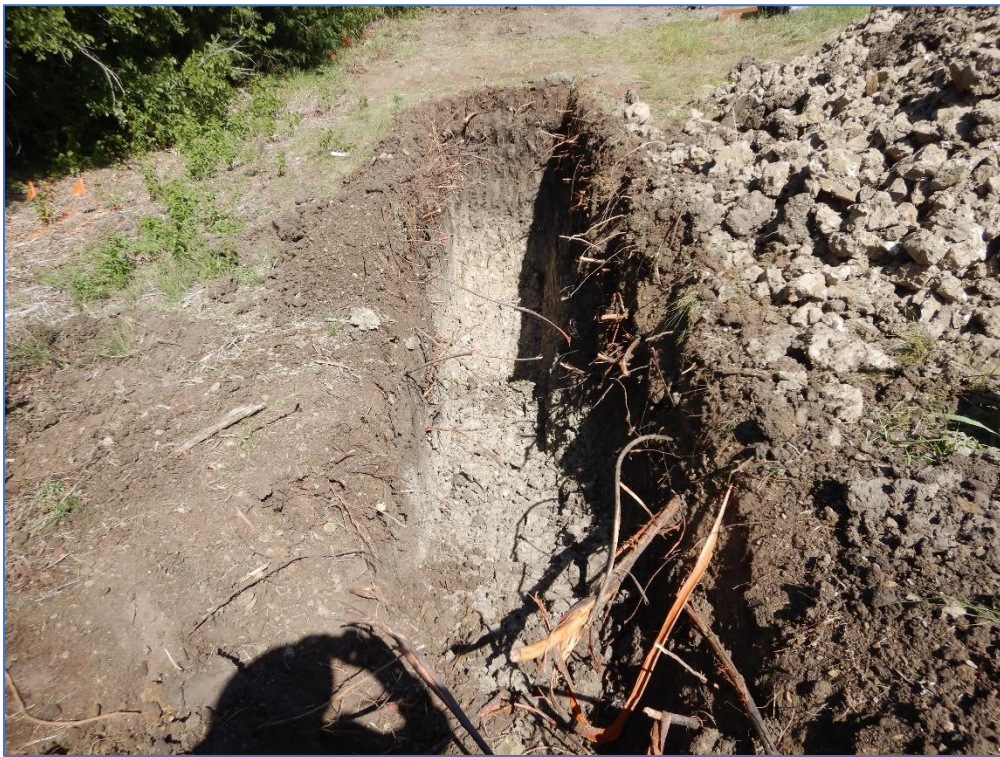
Photo 40. View of BT 2 from the south end; view north

BT2, measuring 1.4 meters (4.5 feet) wide and 7 meters (22.9 feet) long, was located approximately 10 meters (32.8 feet) from the south end of BT1. The trench did not have the same Zone 1 as observed in BT1 (**Photos 40 and 41**), and the transition into Zones 2, 3, 4, and 5 were more gradual compared to the zones in BT1. Zone 1 consisted of dark gray (7.5YR4/1) clay with gravels were from the surface to 35 centimeters. The underlying Zones 2 and 3 extending to 106 centimeters were very dark gray (7.5YR3/1) with calcium carbonate nodules present. Zones 4 and 5 consisted of gray (10YR6/1) clay mottled with yellowish brown (10YR5/6) clay and calcium carbonate and light brownish gray (10YR6/2) clay mottled with strong brown (7.5YR5/6) clay and calcium carbonate terminating at 210 centimeters. The trench was closer to the cemetery entrance and appeared less disturbed compared to BT1 where the slope for the construction of FM 741 was observed. See table in **Attachment 10** for complete trench descriptions.

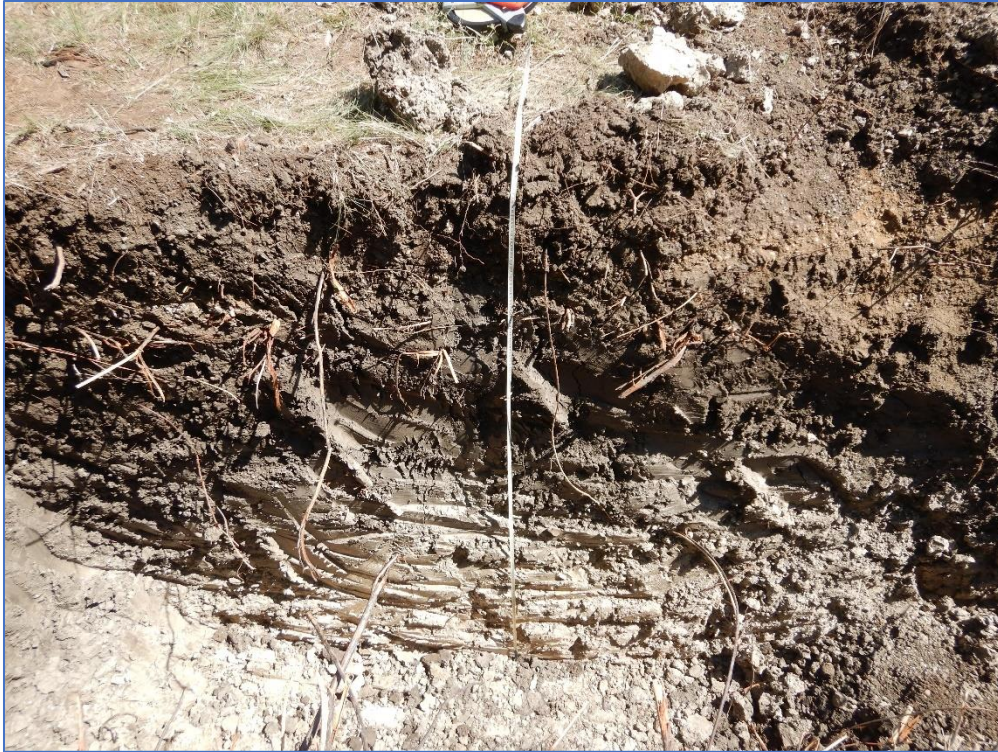
Photo 41. East wall profile of BT2 with scale; view east.

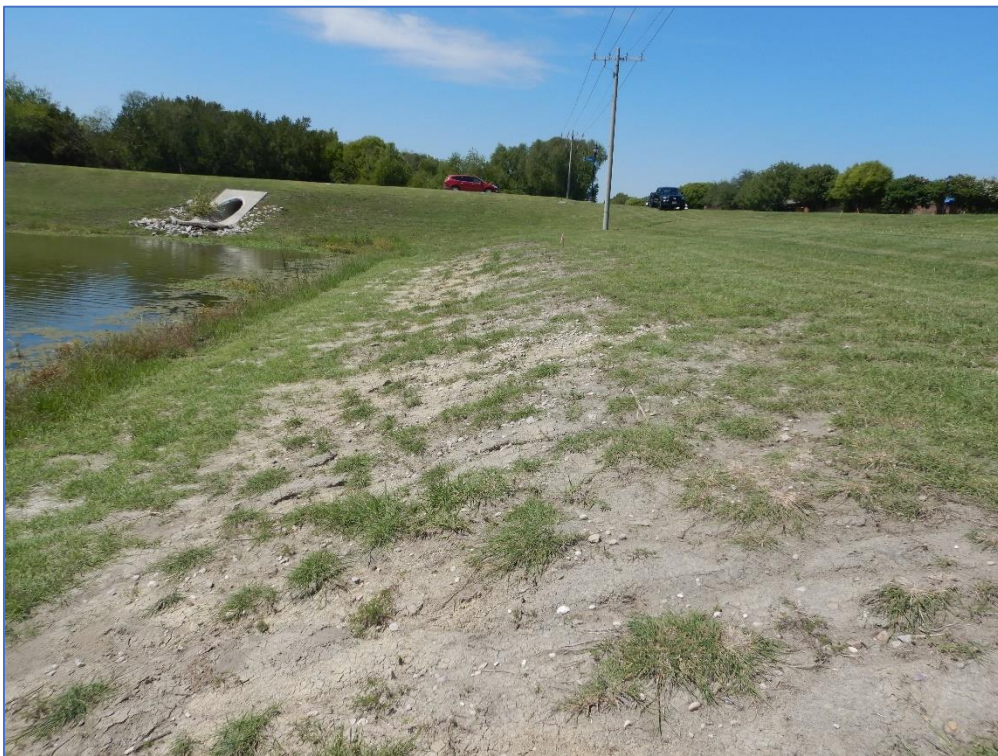
Photo 42. Site 41KF234 from the center of the site showing the eroded slope; view northwest.

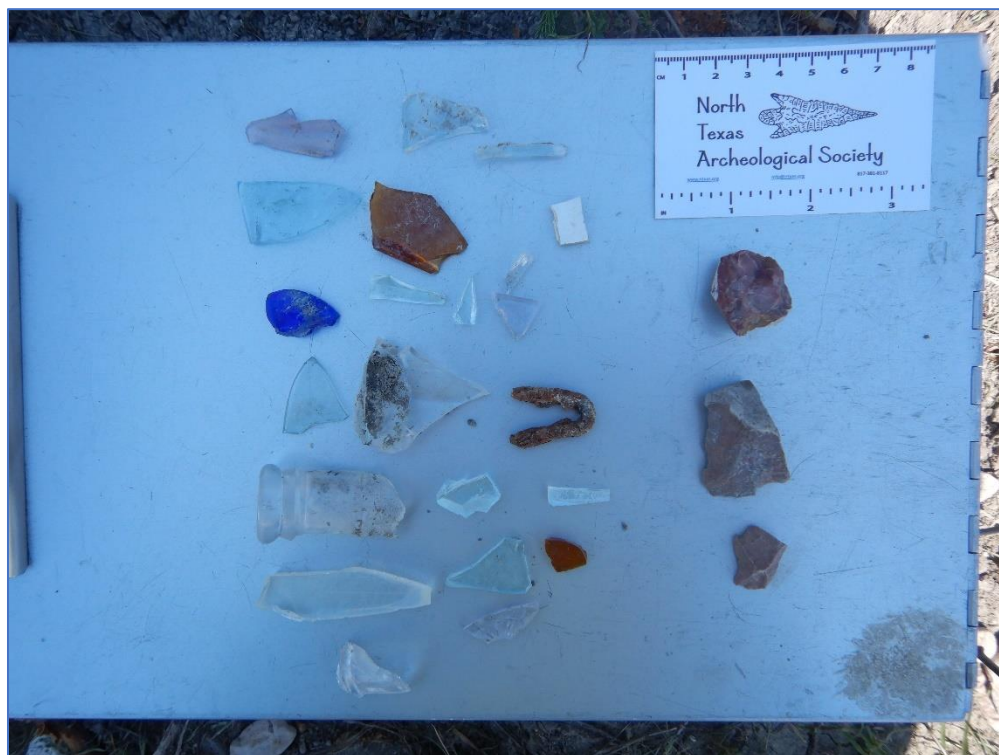
Photo 44. Artifacts on the surface at site 41KF234; view northeast and down.

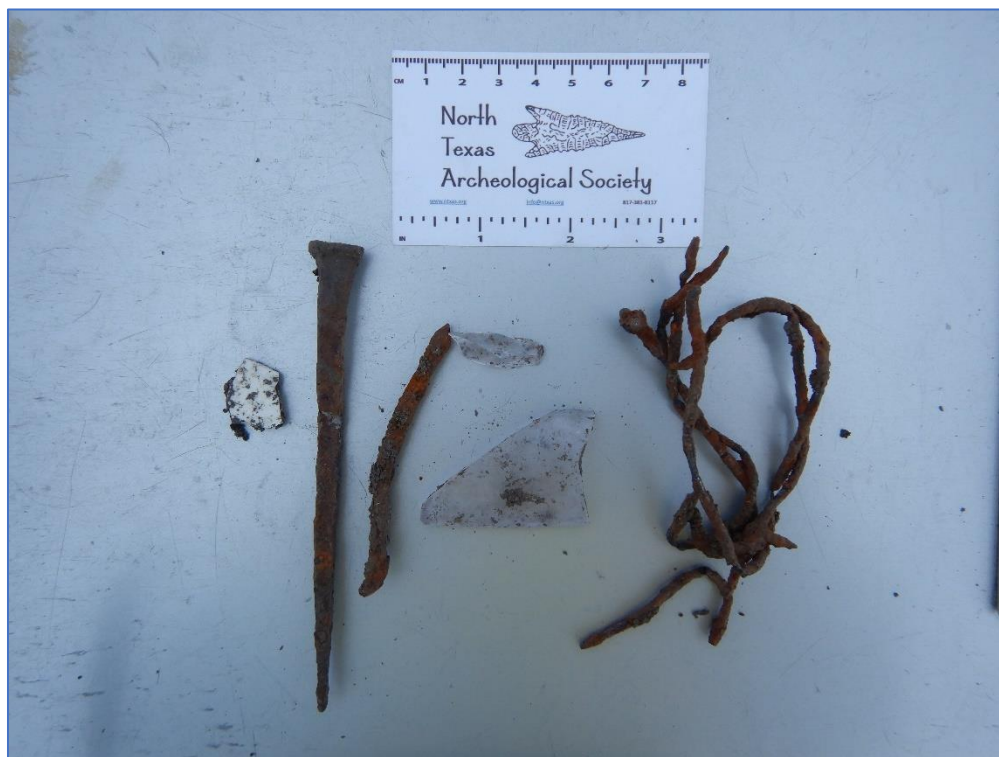
Photo 47. Artifacts uncovered in shovel test BL19 at site 41KF235; view north and down.

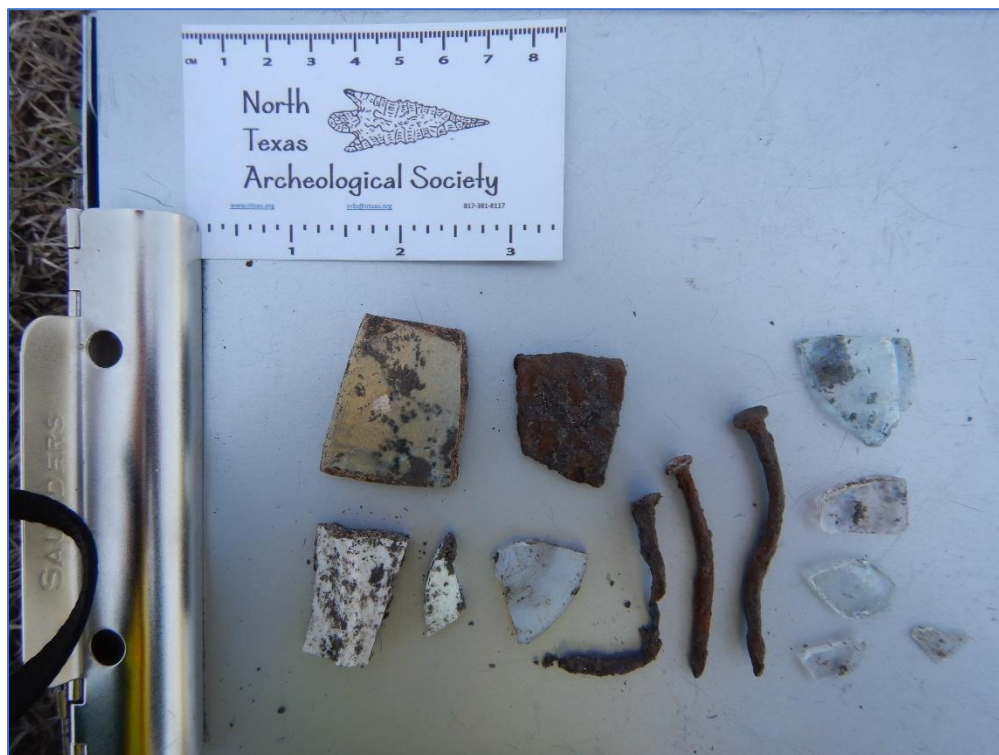
Photo 48. Artifacts uncovered in shovel test FS02-1 at 41KF235; view north and down.

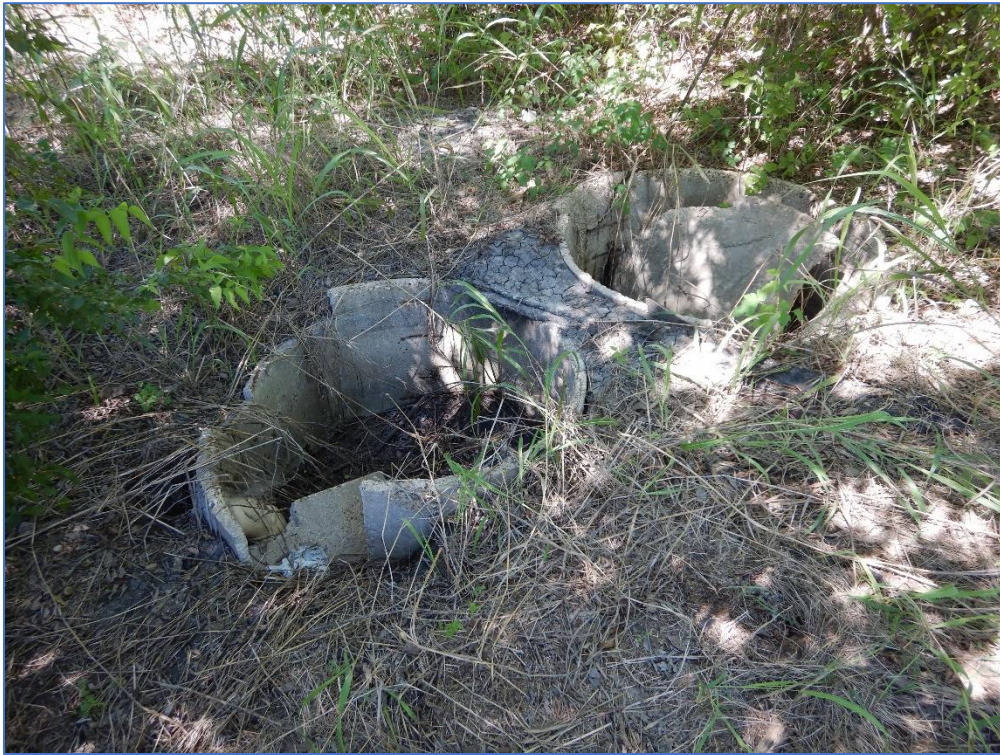
Photo 52. Concrete septic tanks at site 41KF236; view north.
