Waters of the U.S. Delineation Report-Draft

FM 2931 from US 380 to FM 428
(CSJ 2979-01-011)

Texas Department of Transportation, Dallas District
March 2022

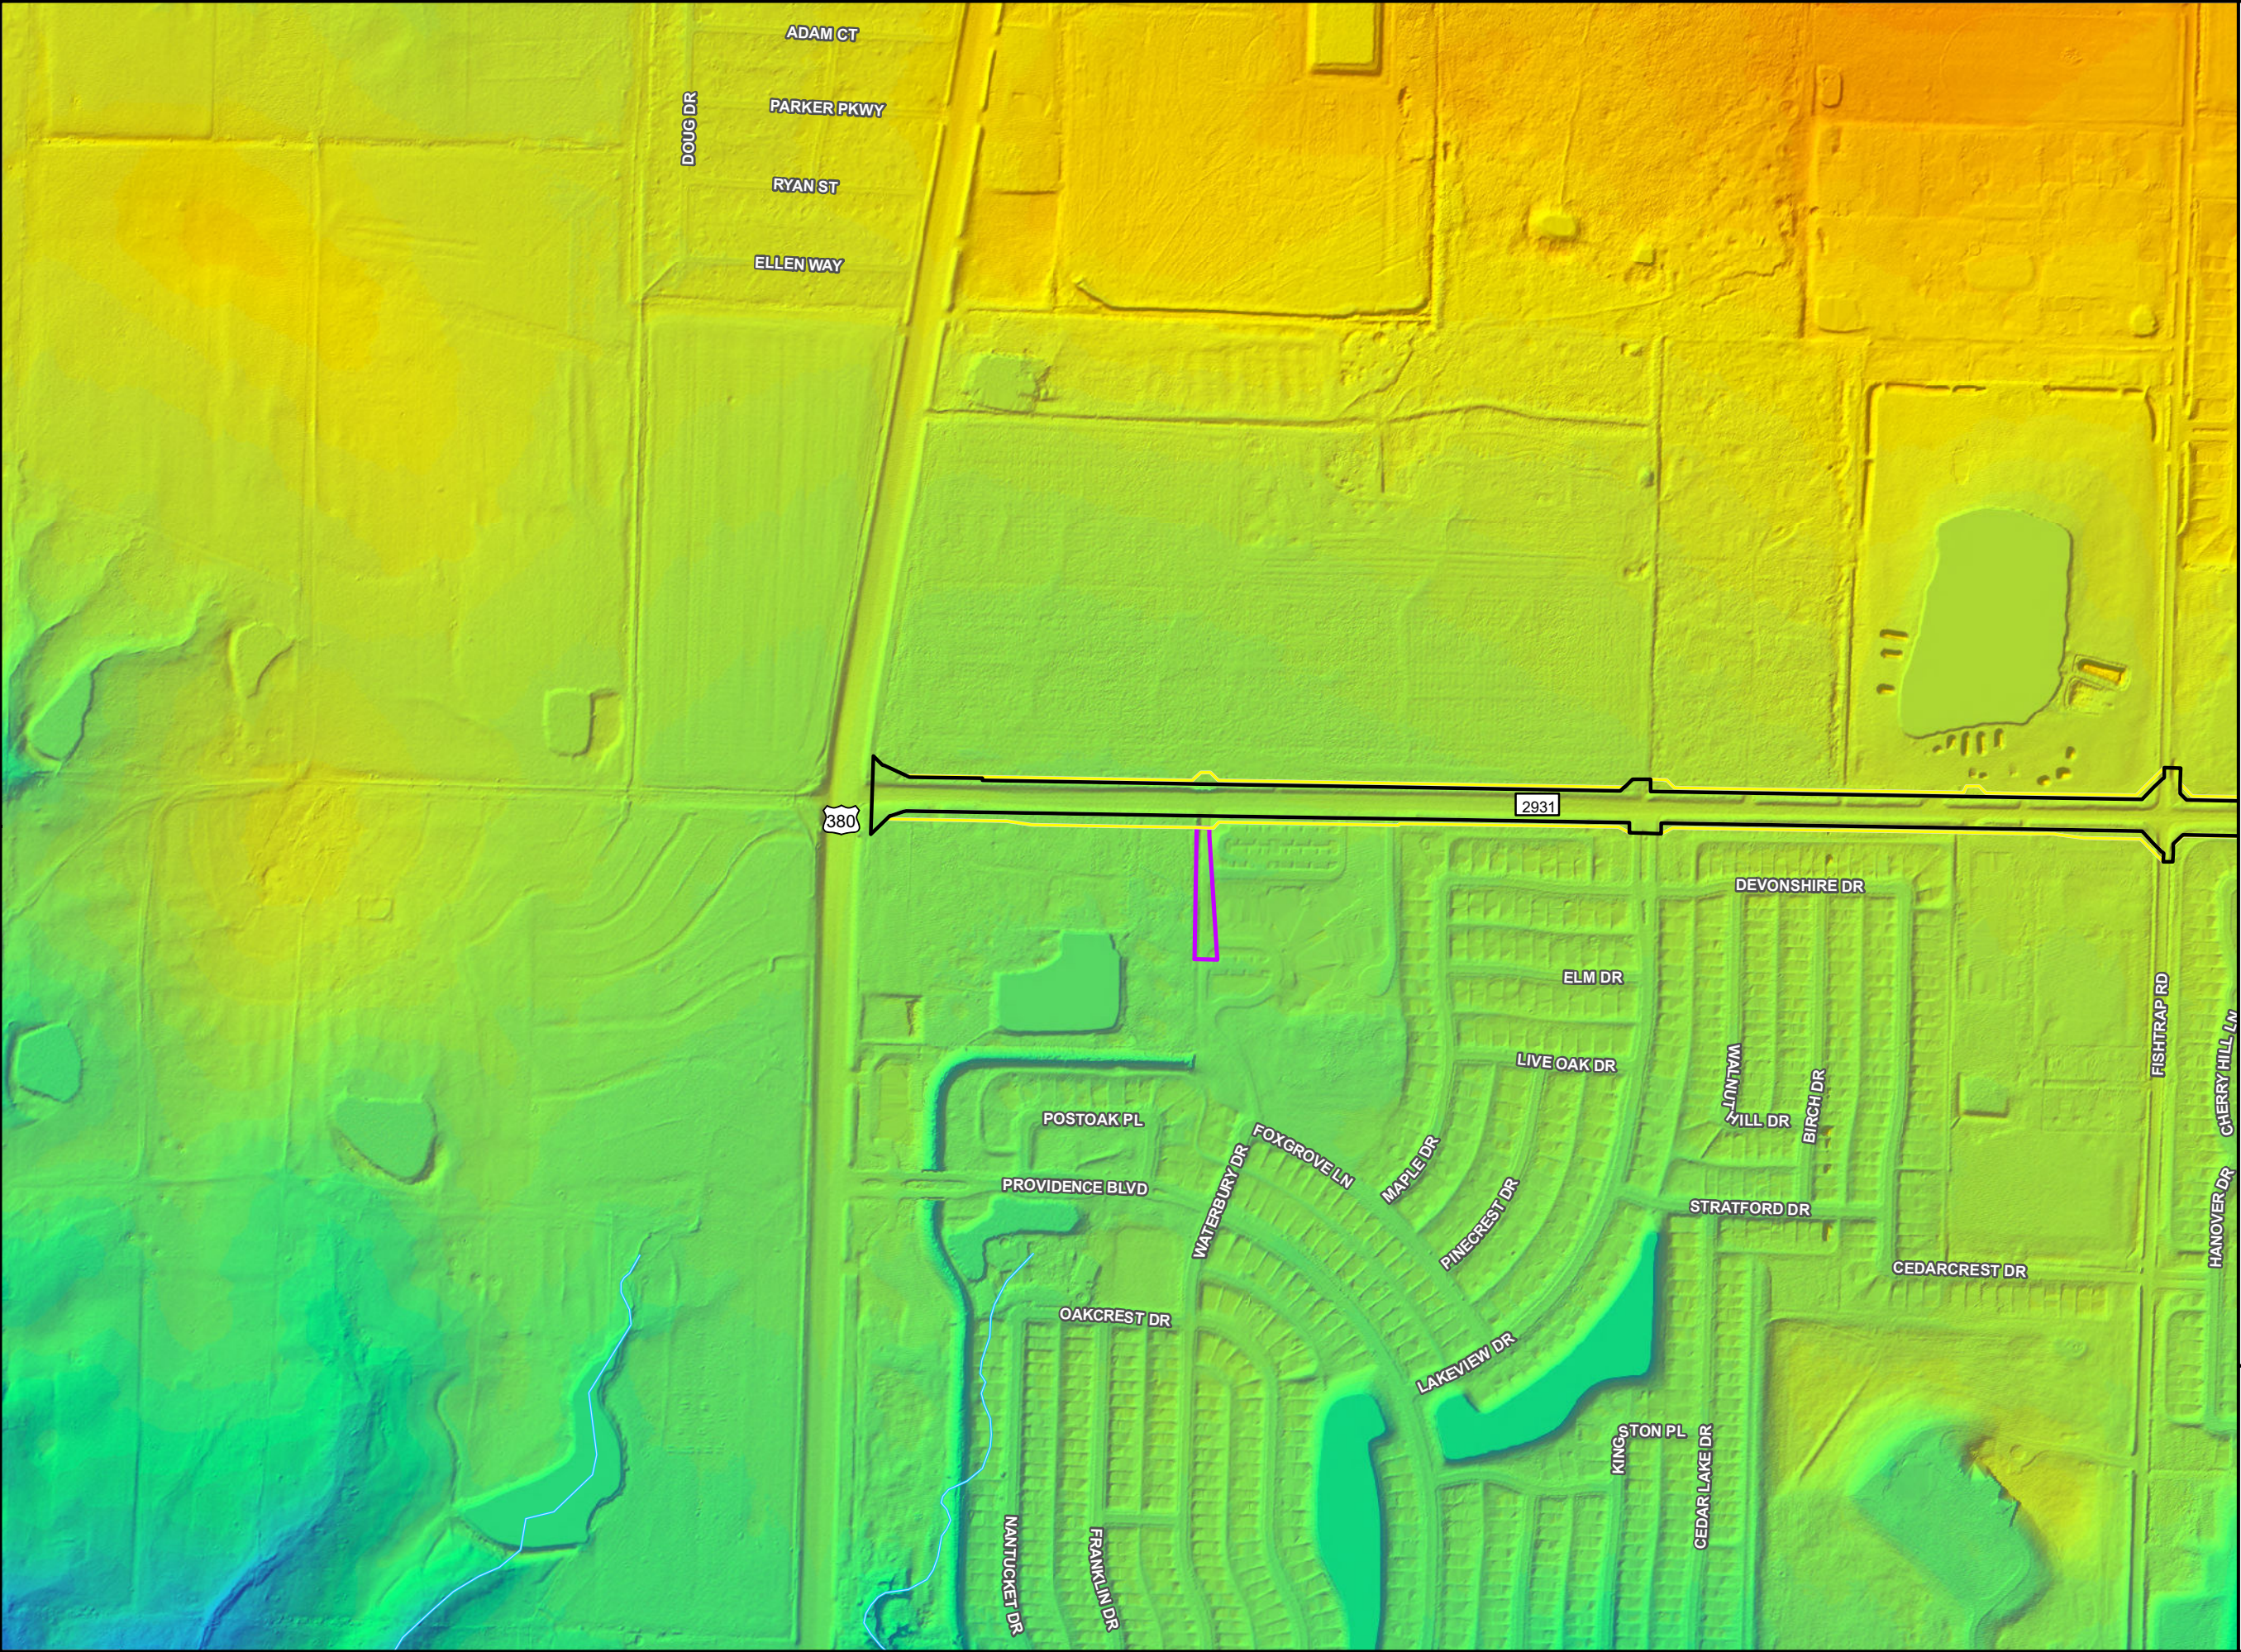
Figure 7-1

LiDAR

A review of LiDAR data indicated that the project area is sloping to the south-southeast with the highest elevations found in the northern end of the project near FM 428. Refer to **Figures 7-1** through **7-6** in **Attachment 1** for an illustration of LiDAR data within the project area.

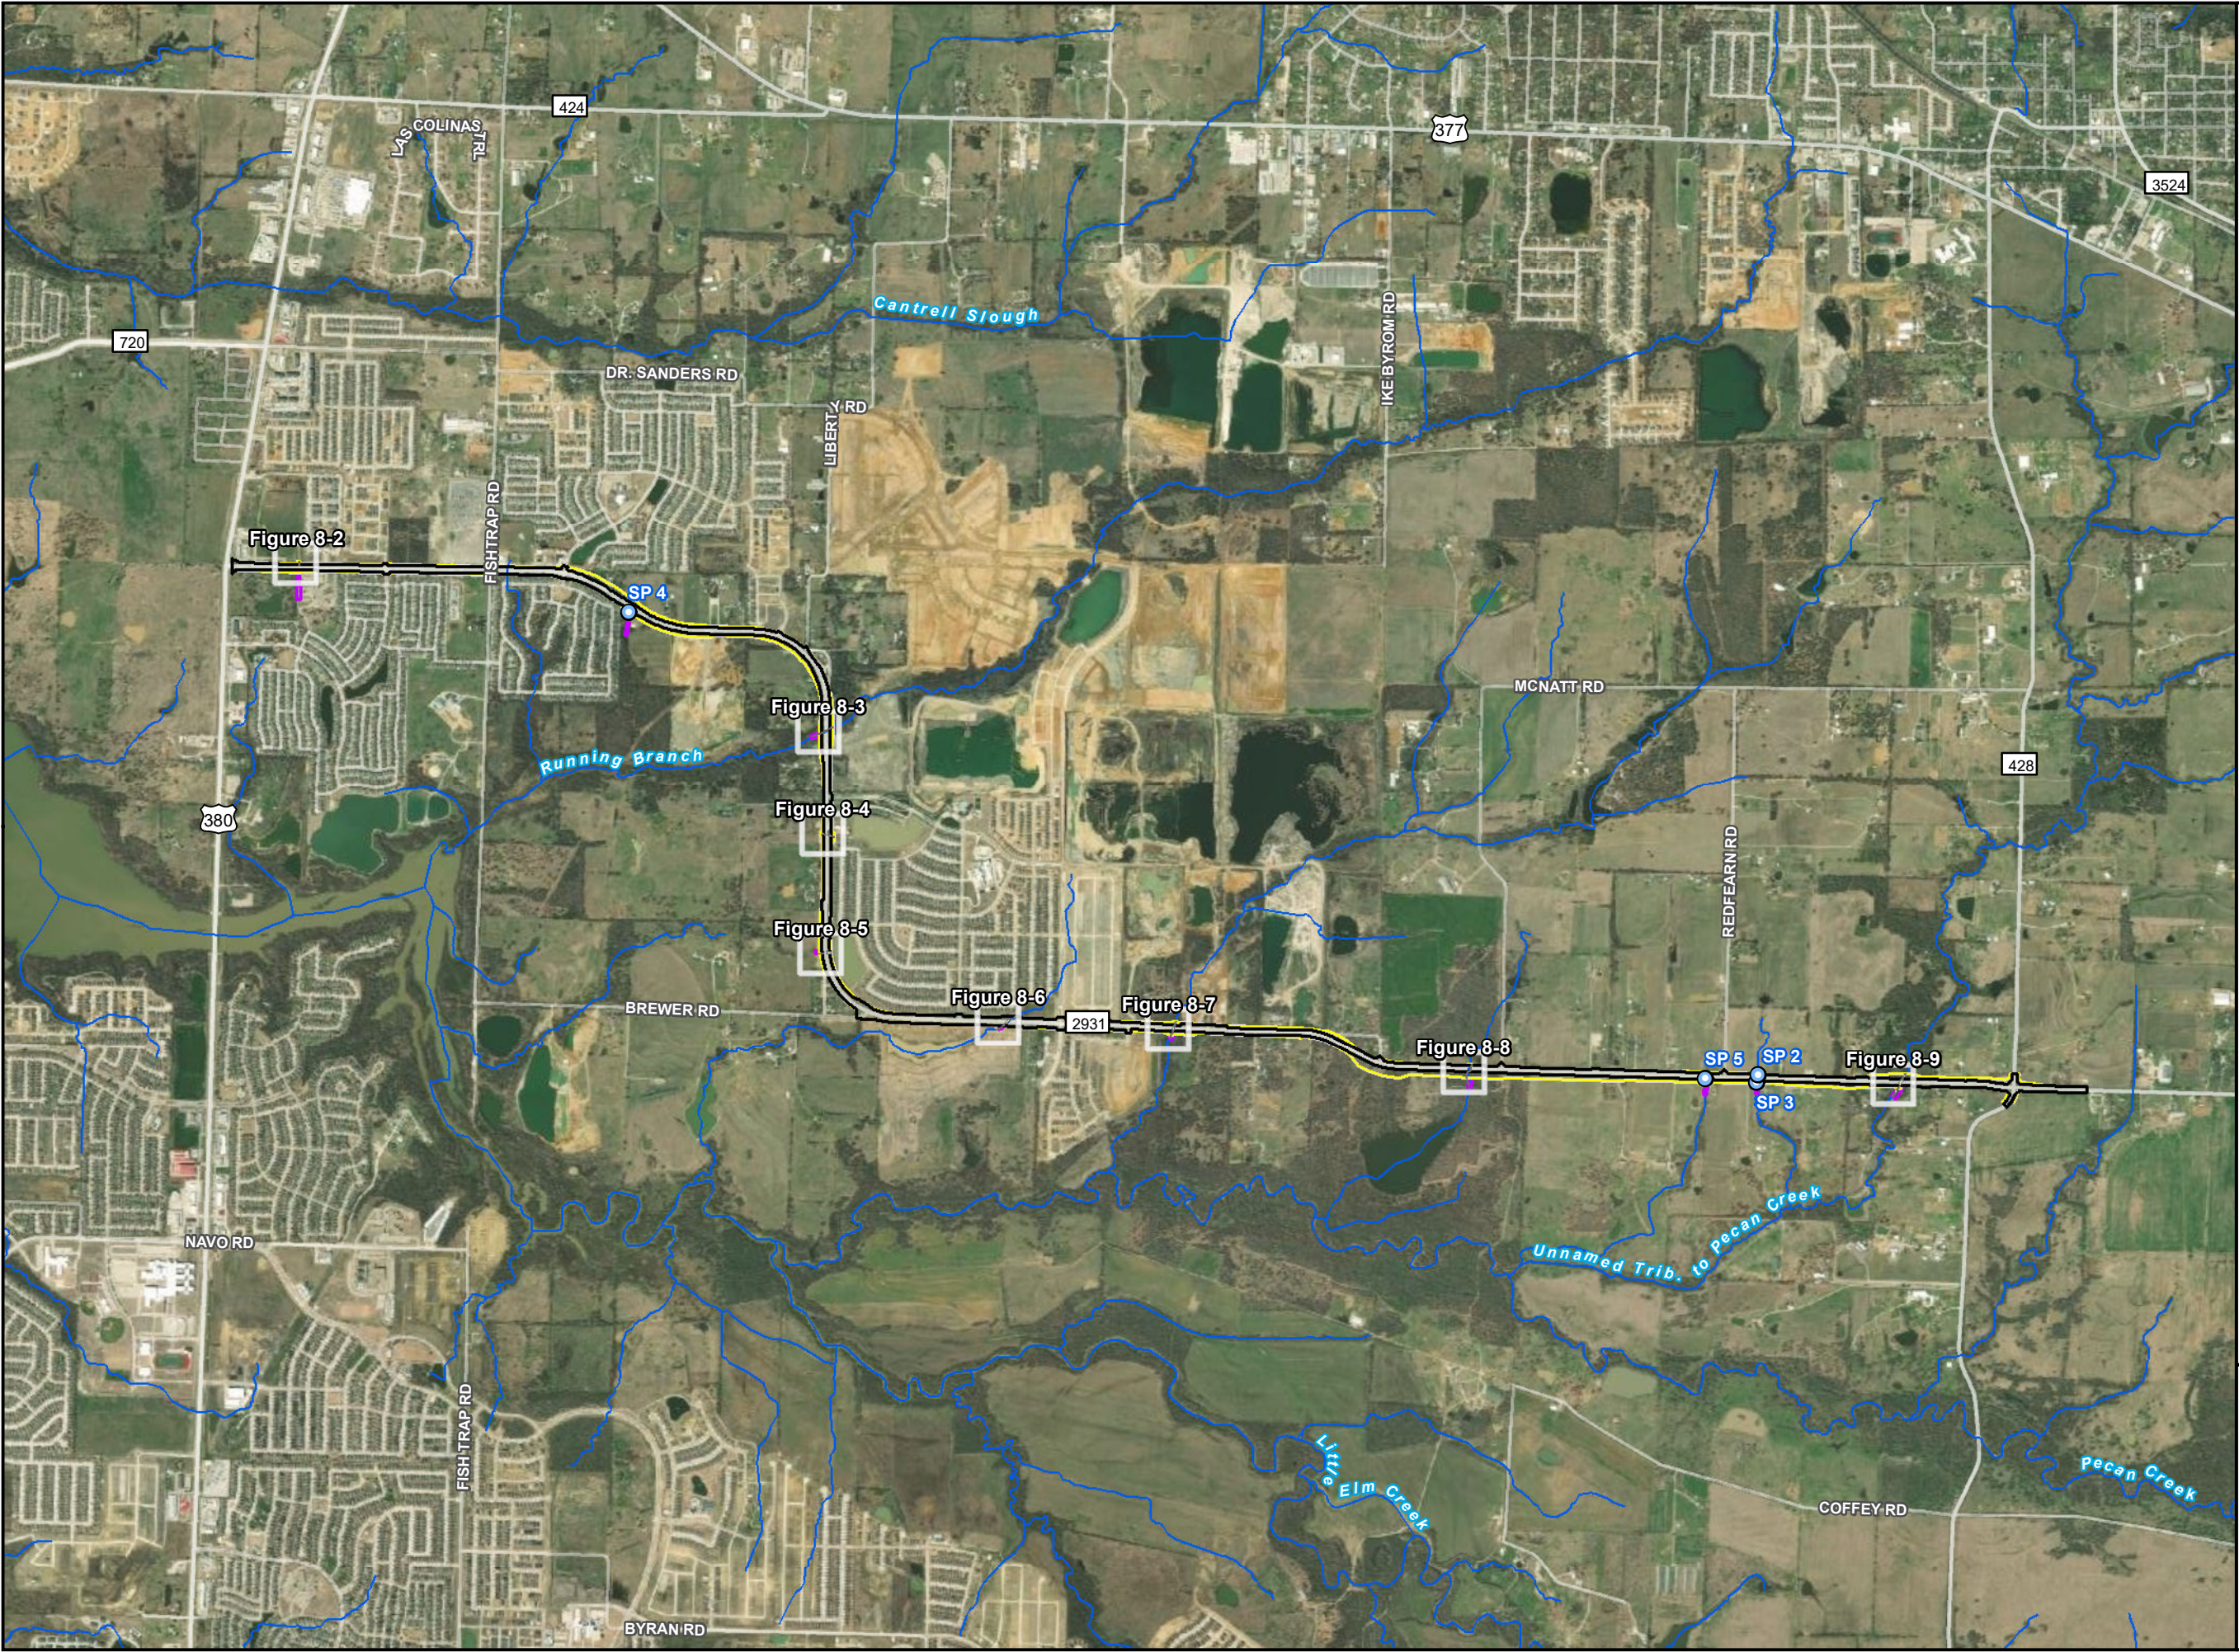
Figure 8-1

Waterbodies & Wetlands

The table below summarizes the waterbodies/wetlands identified within the project area. Refer to **Figures 8-1** through **8-9** in **Attachment 1** for a depiction of the boundaries of each waterbody/wetland feature, as well as the location within the project area where sample point data were collected. Refer to **Attachment 2 – Wetland Determination Data Forms**, for the completed wetland determination data forms for the project. Refer to **Attachment 4 – Site Photographs**, for one or more photographs of each waterbody/wetland feature observed within the project area.

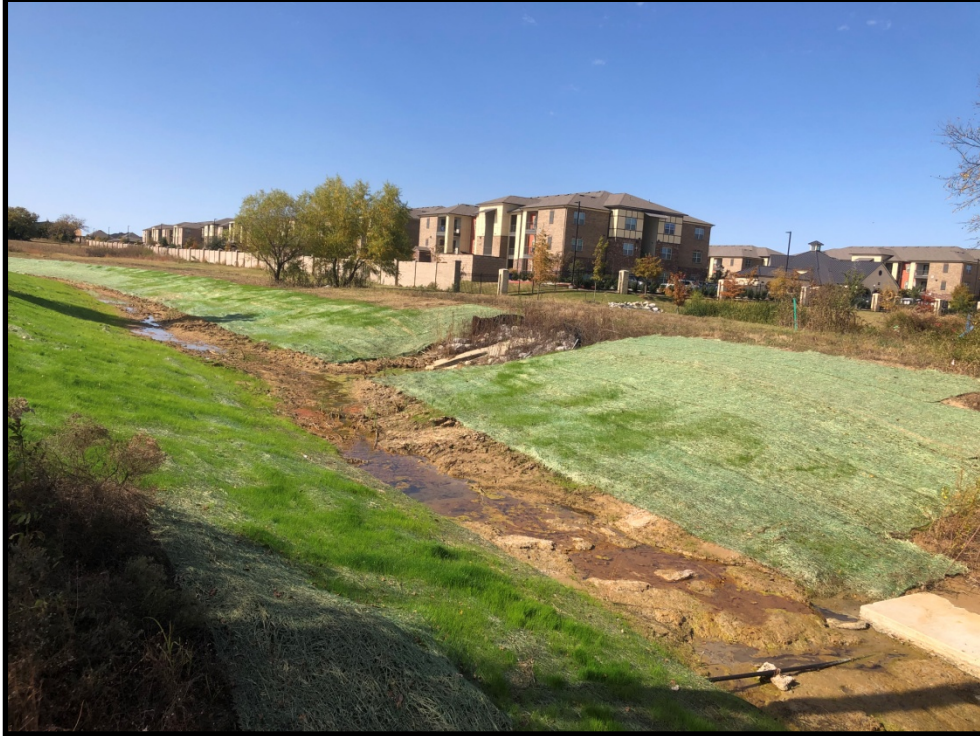
Photo 3: General view of DD-1, facing west. (November 10, 2020)

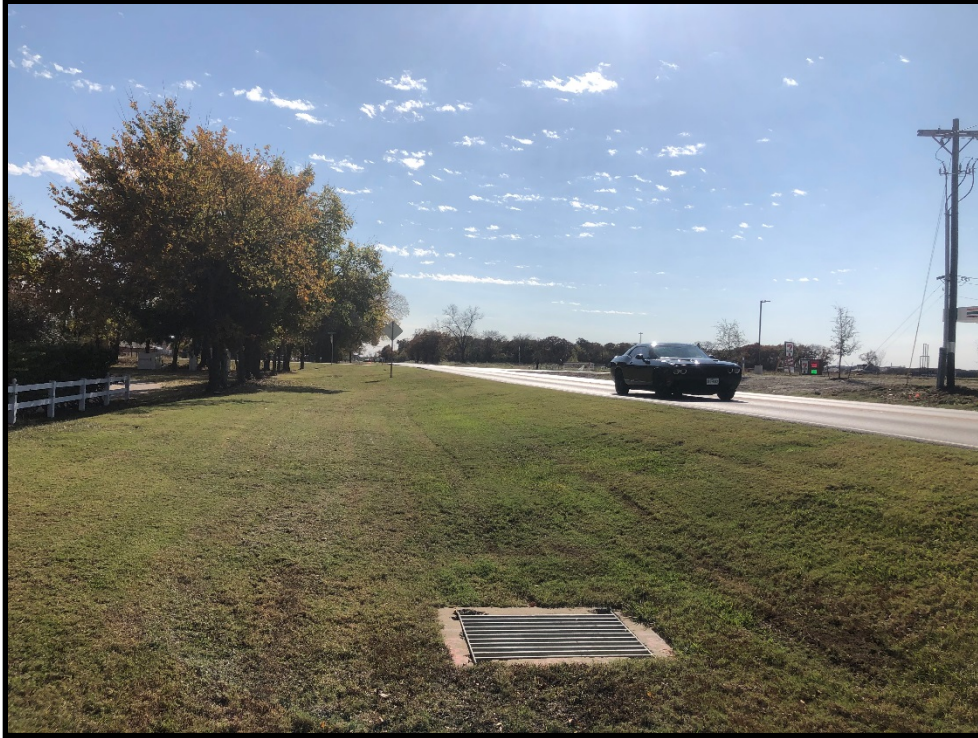
Photo 5: General view of the location where topographic maps indicate an unnamed tributary to Running Branch crosses FM 2931, facing south from the northbound lane. (November 10, 2020)

the project area. A storm sewer drain was noted in this location (see **Photo 5** in **Attachment 4**). Additionally, one unnamed tributary to Pecan Creek was identified as a swale with no discernable OHWM (see **Photo 30** in **Attachment 4**). The topography is rolling to strongly sloping with elevations between approximately 545 and 605 feet above mean sea level (AMSL) across the project area. Refer to **Figure 3** in **Attachment 1** for an illustration of topography in and surrounding the project area.

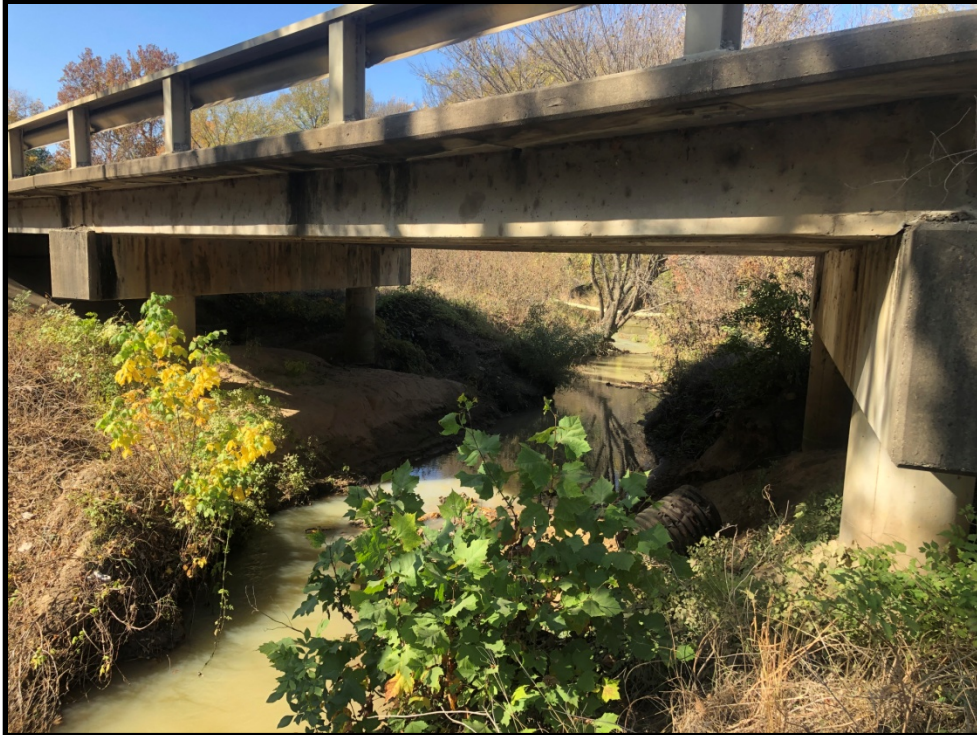
Photo 7: General view of Running Branch and bridge on the south and downstream side of FM 2931. Facing northwest. (November 10, 2020)

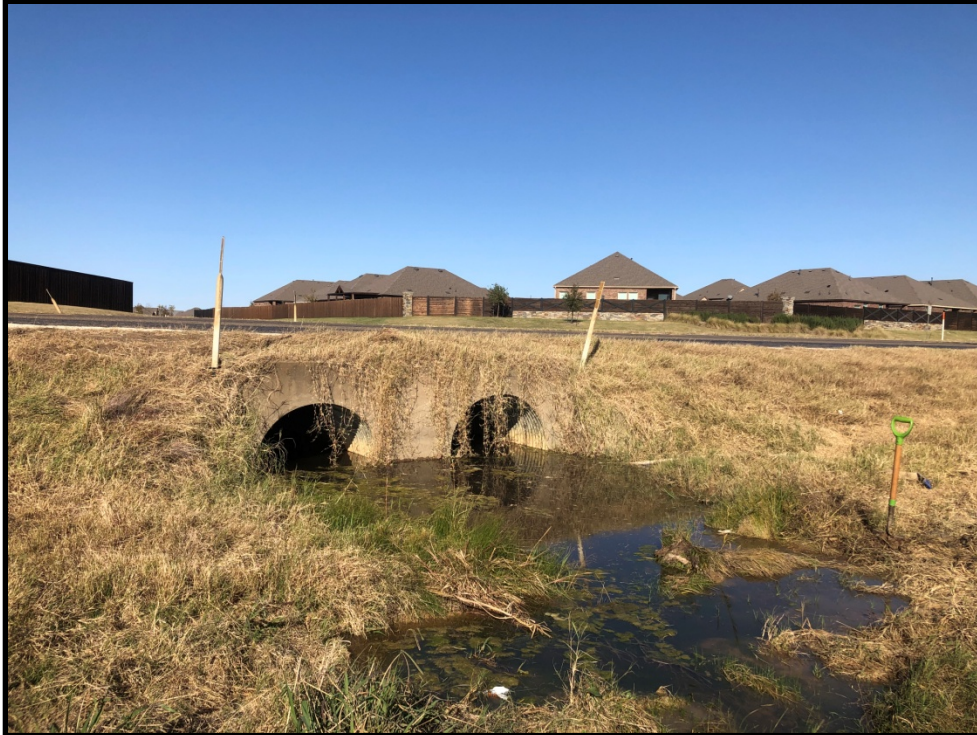
Photo 13: General view of W-2 (emergent wetland) and culvert on the south side of FM 2931. Facing north. (November 10, 2020)

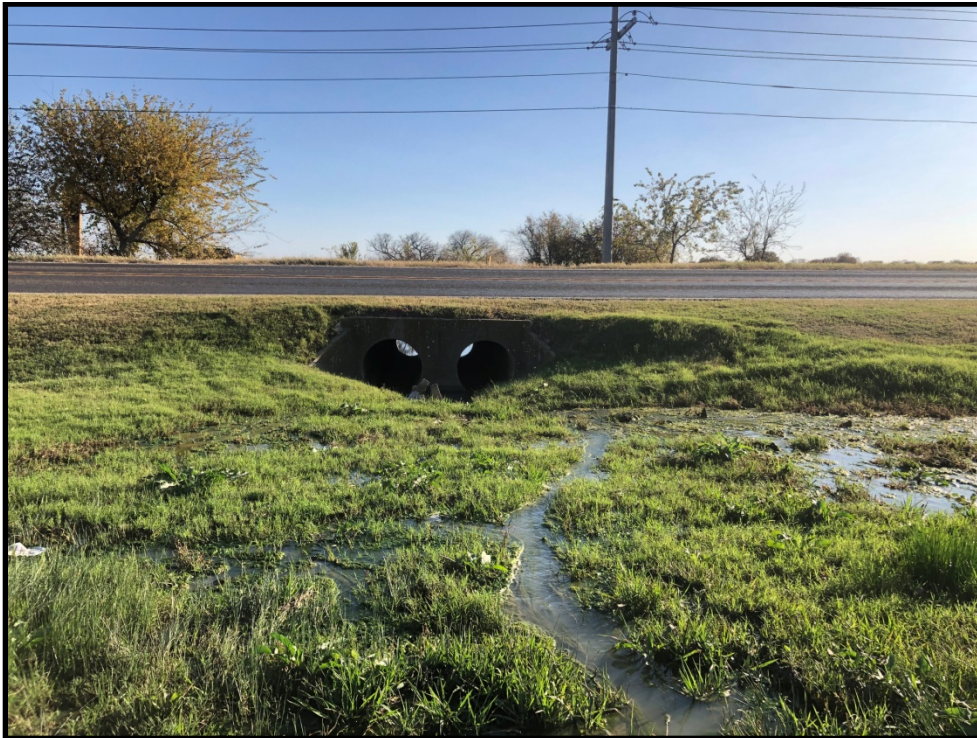
Photo 16: General view of W-3 (emergent wetland) within and abutting the channel of ES-1 (Unnamed Tributary to Little Elm Creek) on the north side of FM 2931. Facing south and downstream. (November 10, 2020)

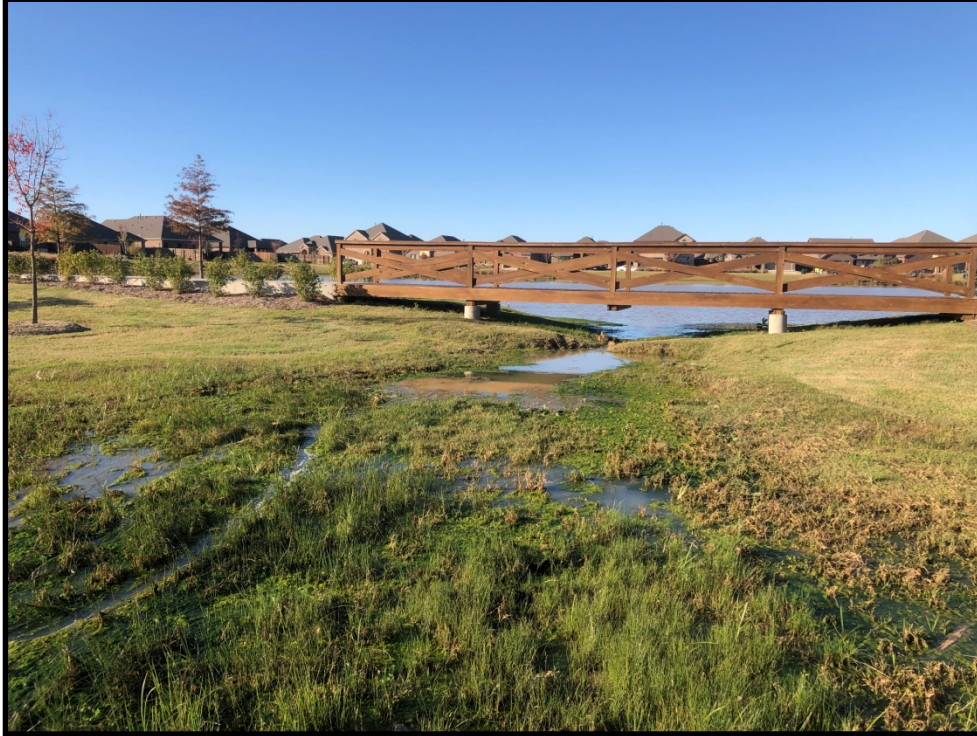
Photo 17: Additional view of W-3 (emergent wetland) within and abutting the channel of ES-1 (Unnamed Tributary to Little Elm Creek) on the north side of FM 2931. Facing north and upstream. (November 10, 2020)

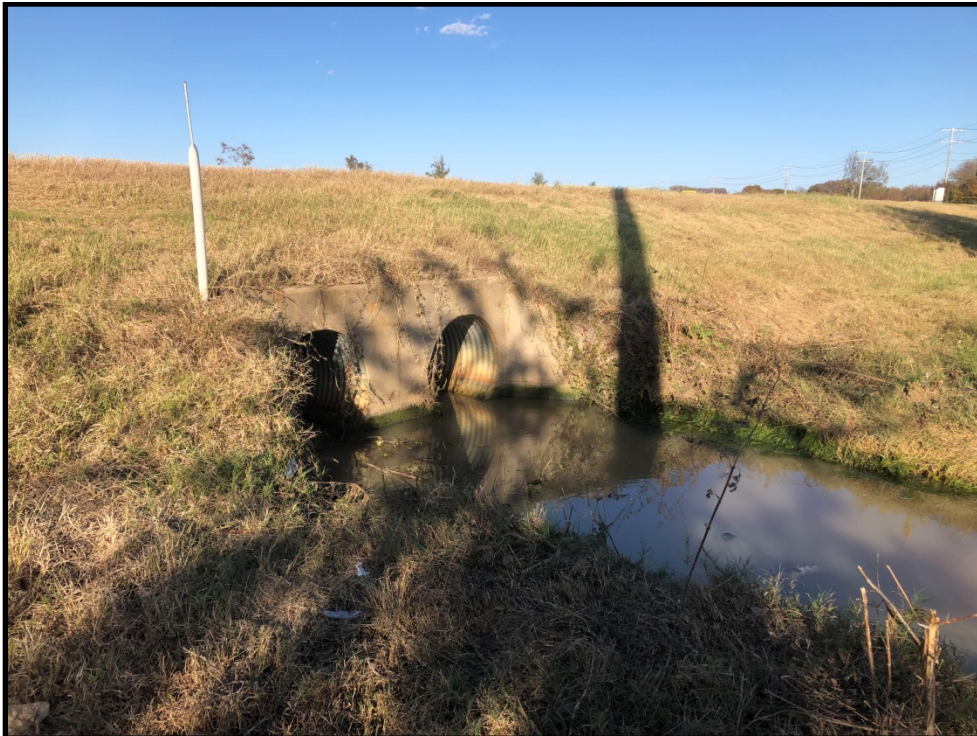
Photo 20: General view of ES-1 (Unnamed Tributary to Little Elm Creek) and culvert on the south and downstream side of FM 2931. Facing northeast. (November 10, 2020)

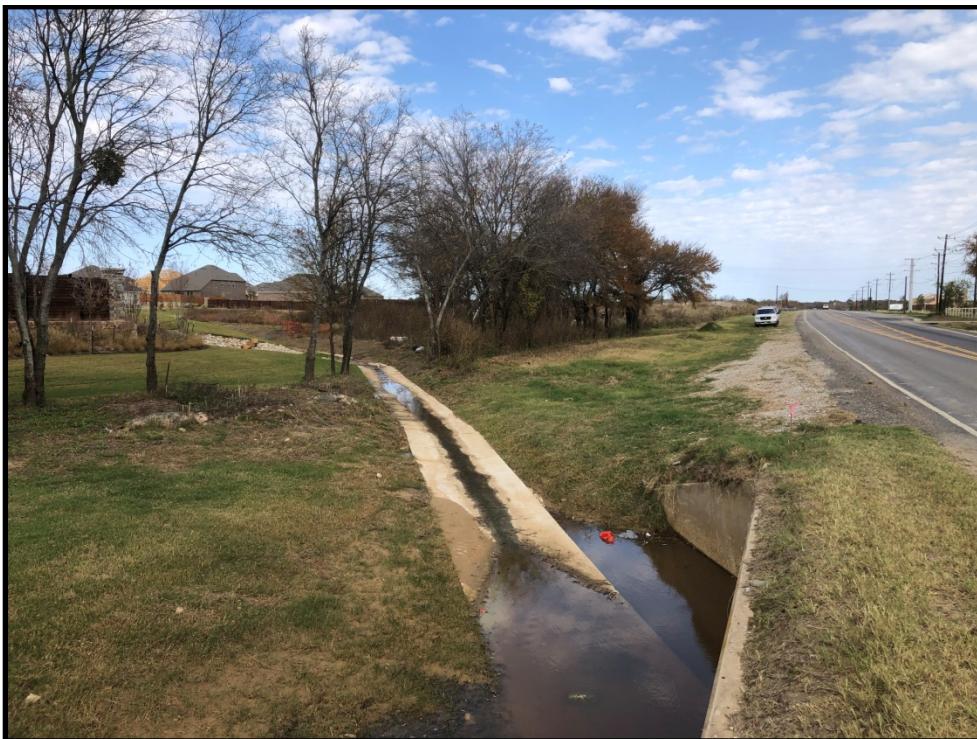
Photo 22: General view of concrete-lined channel portion of IS-1 (Unnamed Tributary to Pecan Creek) on the west side of FM 2931. Facing northwest and upstream. (November 10, 2020)

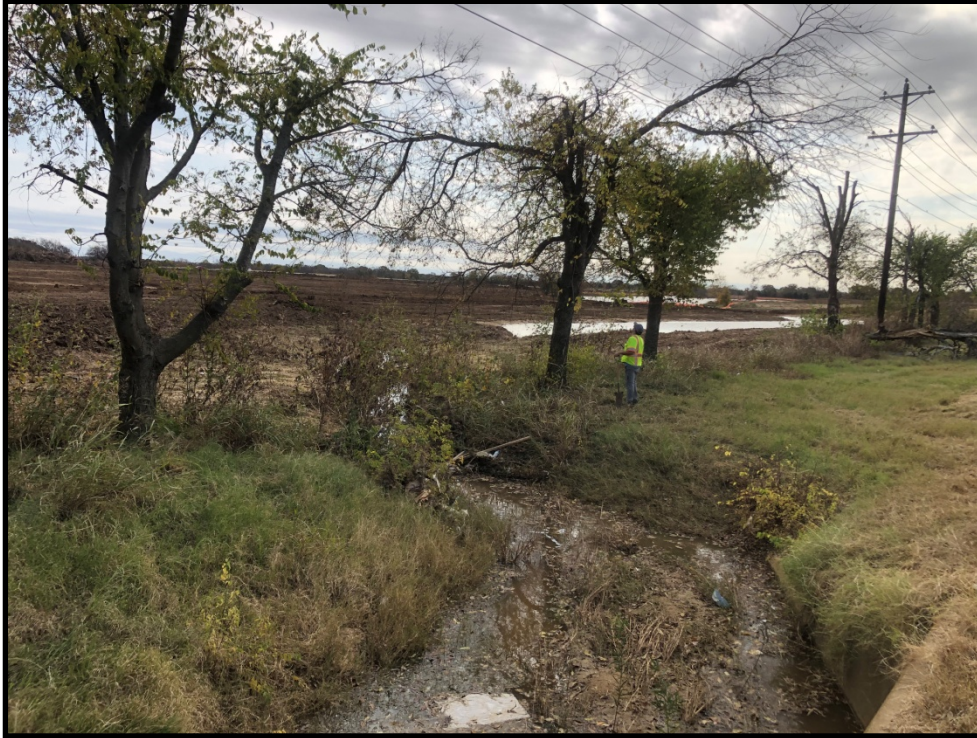
Photo 23: General view of IS-1 (Unnamed Tributary to Pecan Creek) on the east side of FM 2931. Facing southeast and downstream. (November 10, 2020)

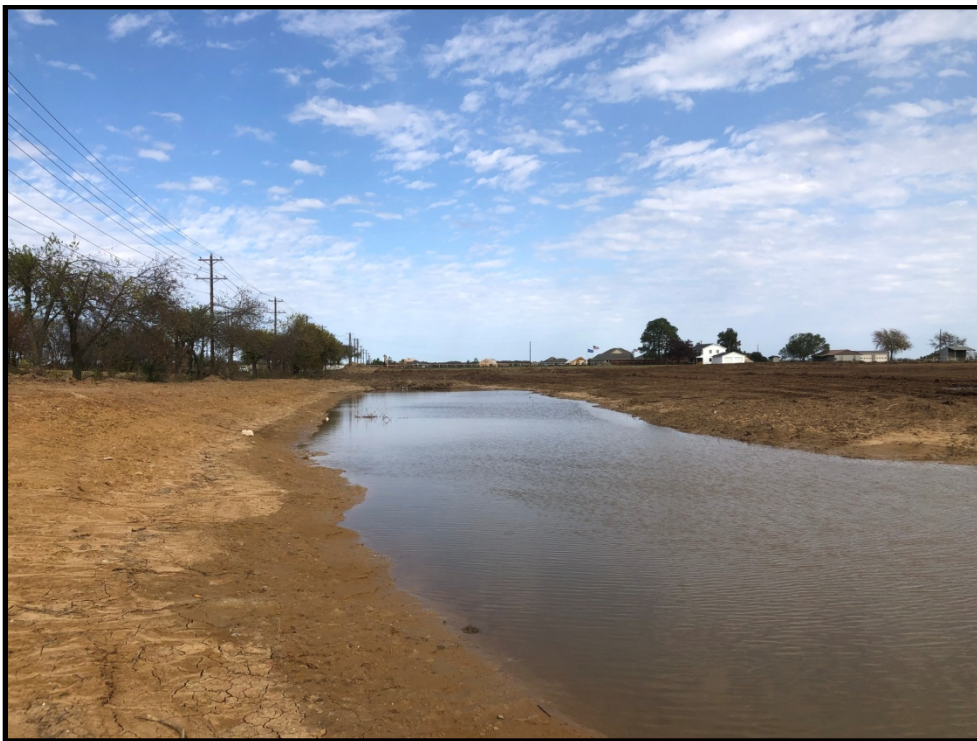
Photo 24: General view of OW-1 in the disturbed area on the east and downstream side of FM 2931. Facing north. (November 10, 2020)

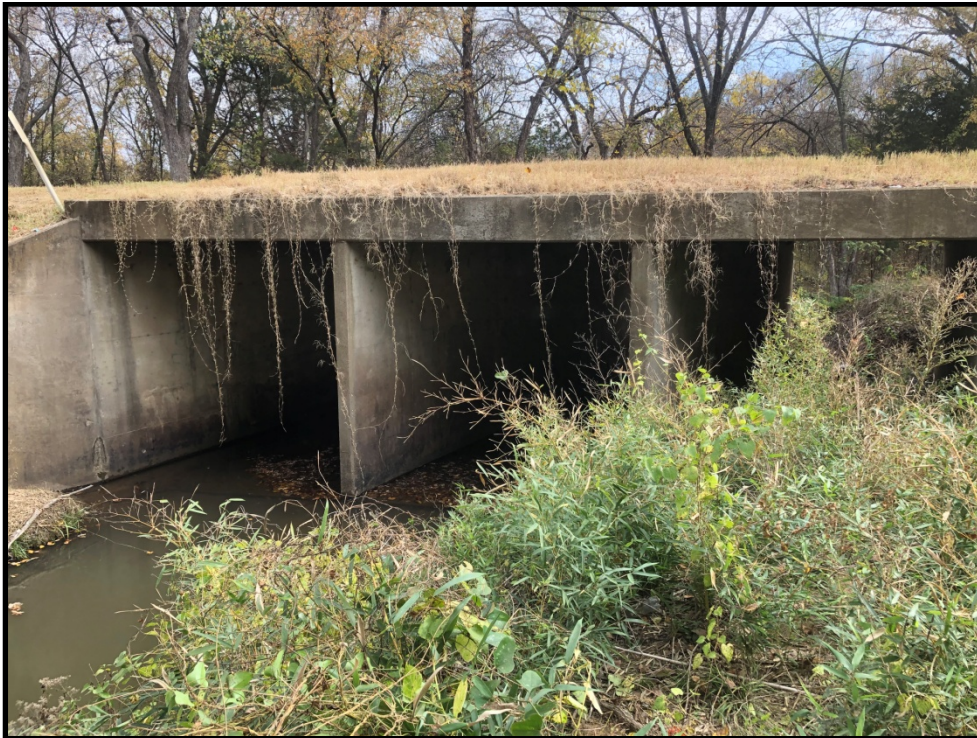
Photo 26: General view of IS-2 (Unnamed Tributary to Pecan Creek) and culvert on the west and upstream side of FM 2931. Facing east. (November 10, 2020)

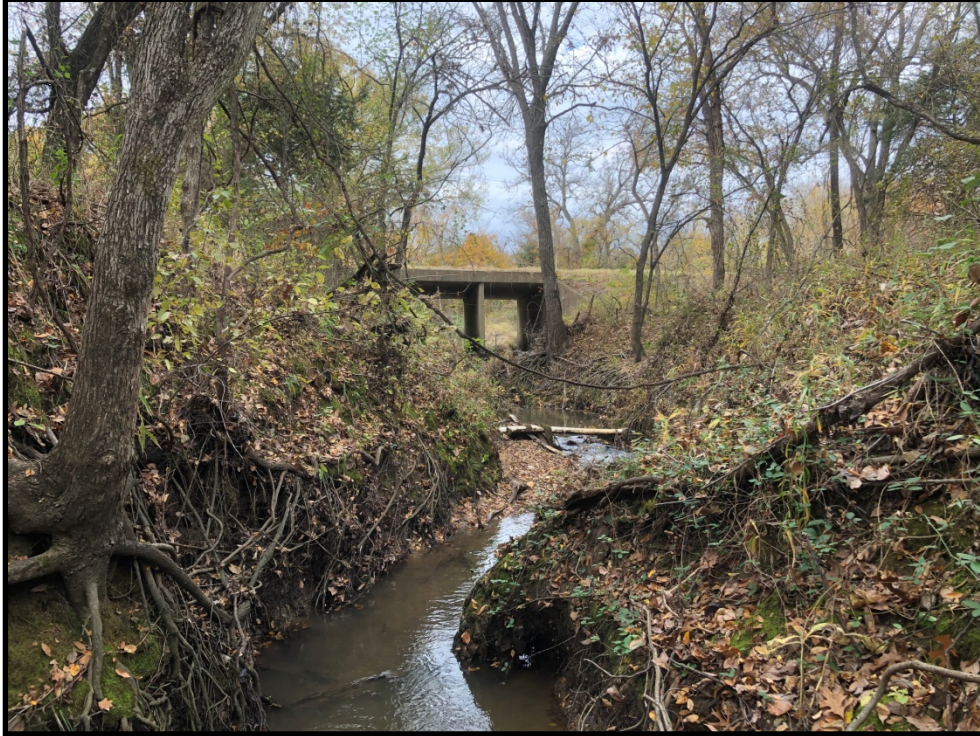
Photo 27: General view of IS-2 (Unnamed Tributary to Pecan Creek) on the east and downstream side of FM 2931. Facing west and upstream. (November 10, 2020)

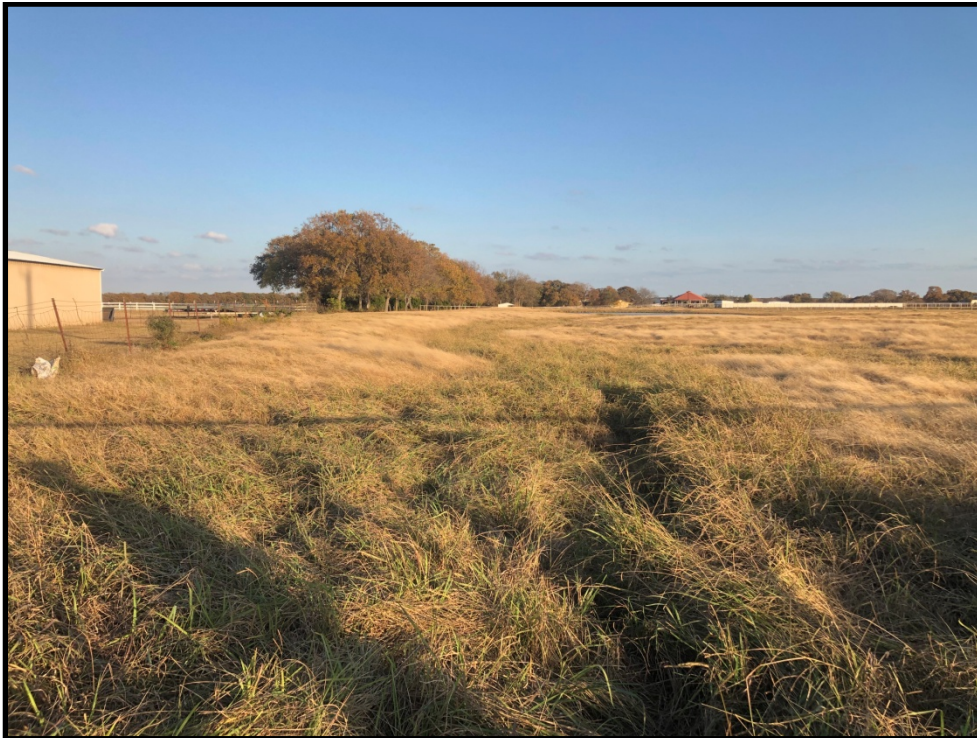
Photo 30: General view of swale at SP5 on the east side and downstream of FM 2931. Facing east. (November 9, 2020)

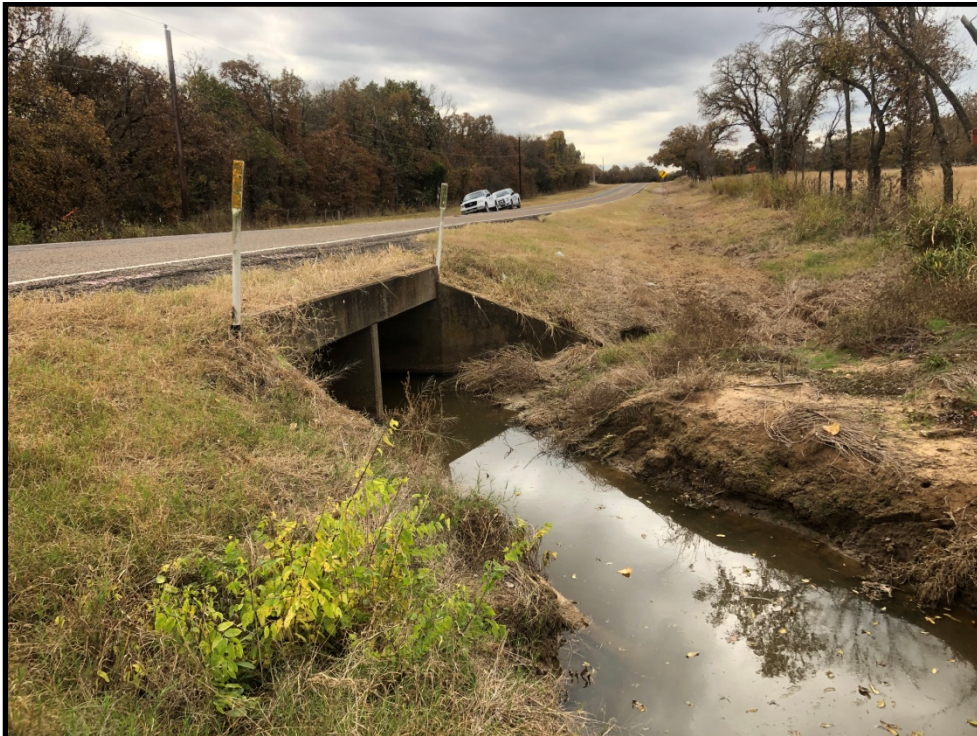
Photo 34: General view of IS-3 (Unnamed Tributary to Pecan Creek) and culvert on the west and upstream side of FM 2931. Facing southeast. (November 10, 2020)

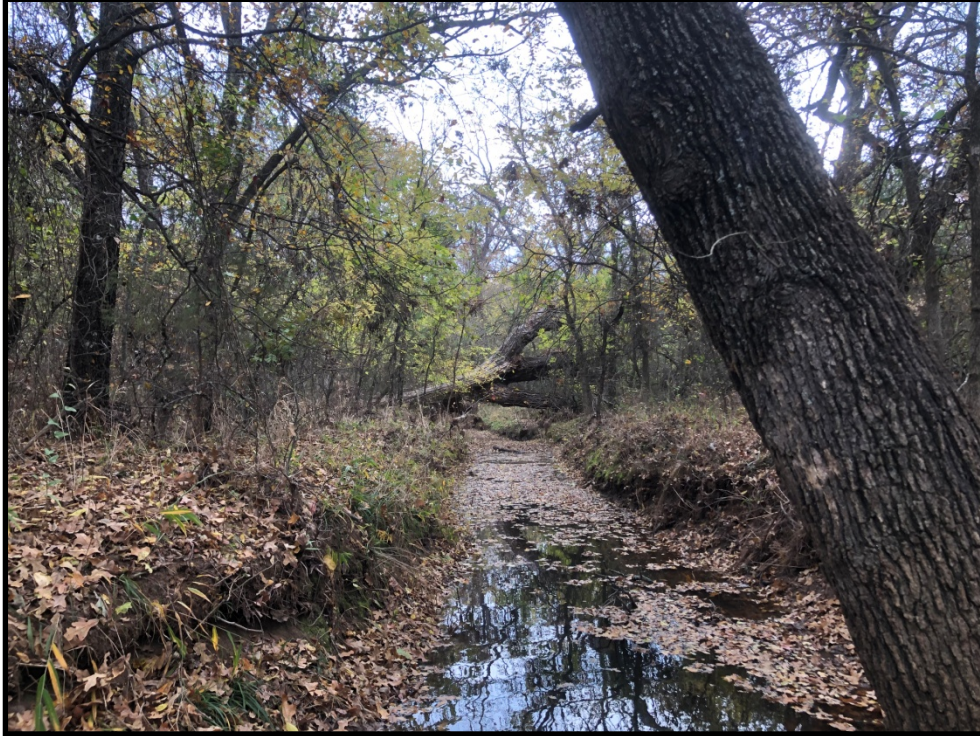
Photo 35: General view of IS-3 (Unnamed Tributary to Pecan Creek) on the west side of FM 2931. Facing east and downstream. (November 10, 2020)

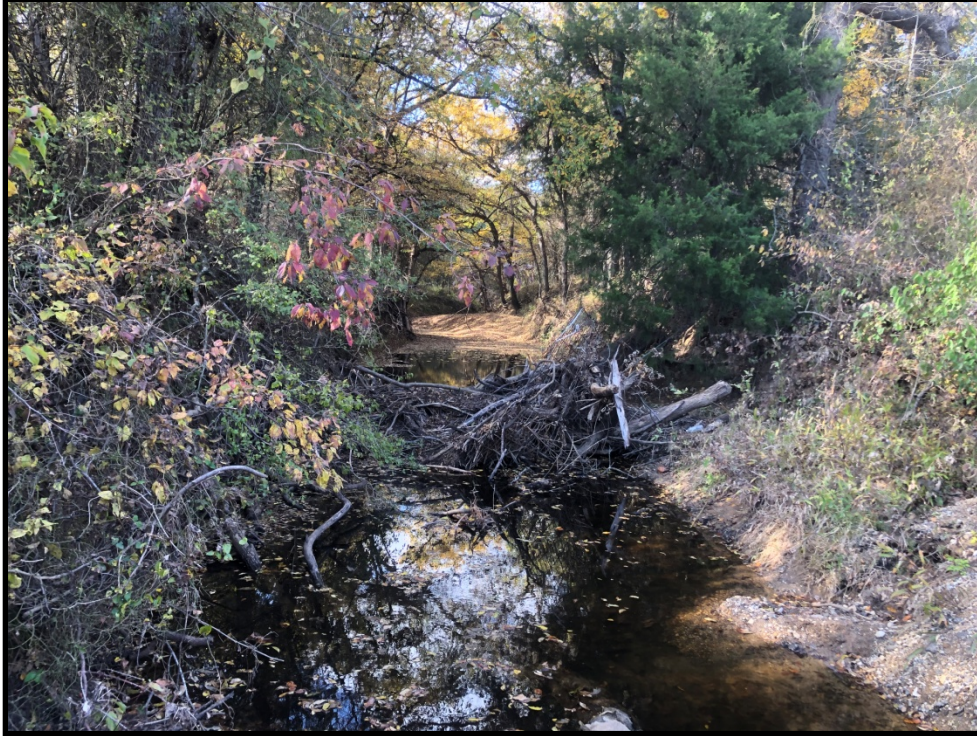
Photo 37: General view of PS-1 (Unnamed Tributary to Pecan Creek) on the west side of FM 2931. Facing west and upstream. (November 9, 2020)

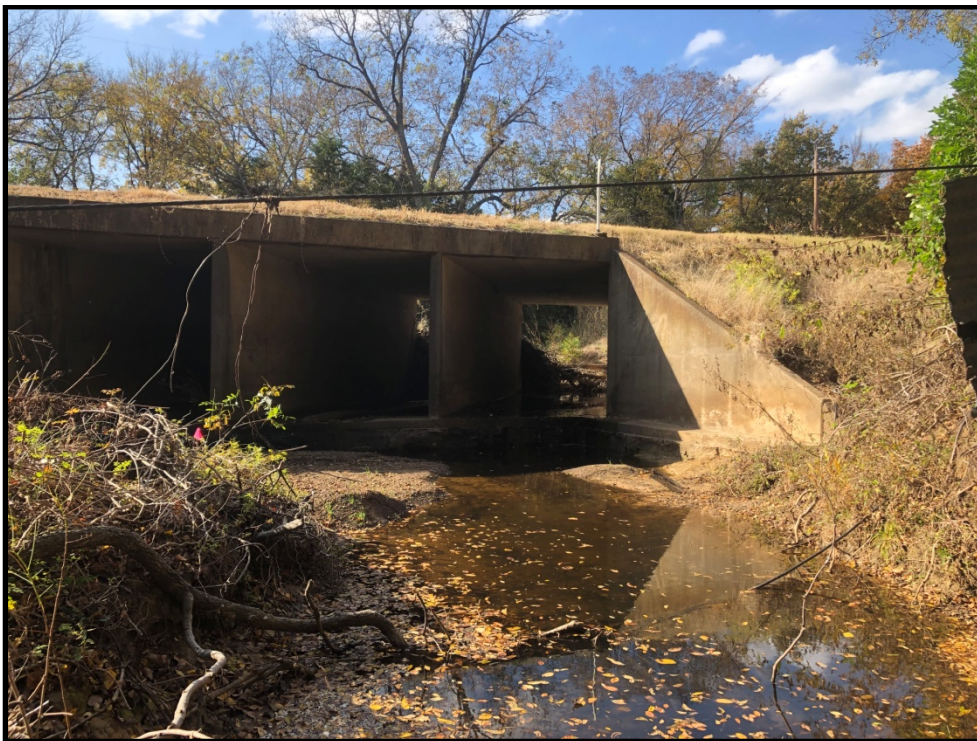
Photo 38: General view of PS-1 (Unnamed Tributary to Pecan Creek) and culvert on the east and downstream side of FM 2931. Facing west and upstream. (November 9, 2020)
