# ADDENDUM

24-MARCH-2022

## APPENDIX N – WATER RESOURCES – Proposed ROW Change

**SPUR 399 EXTENSION EIS - US 75 to US 380, Collin County  
CSJs 0364-04-051, 0047-05-058, and 0047-10-002; Dallas District**

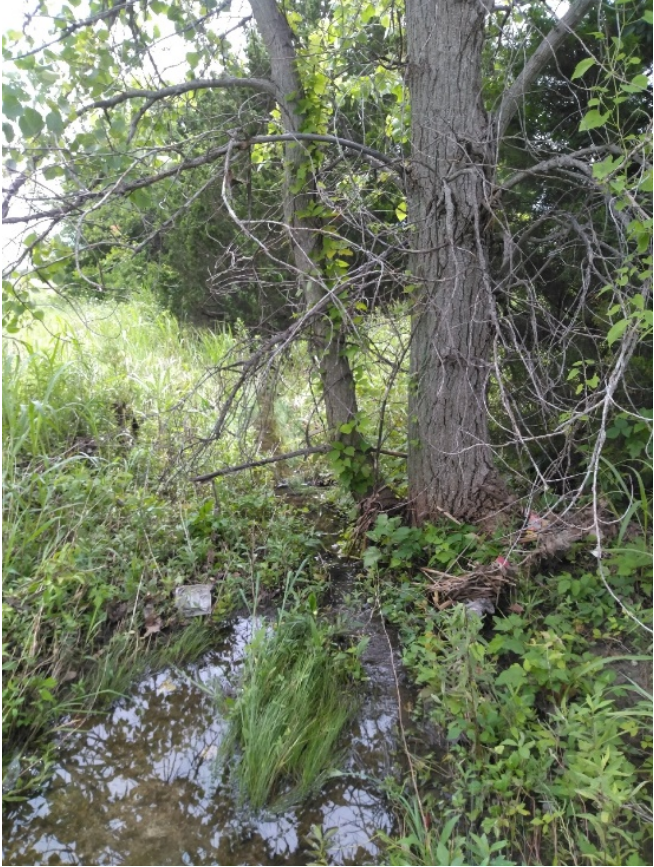
<p><b>Photo 1.</b>  Photograph of ephemeral stream <b>Water Feature 5</b> in the southwestern portion of the study area. Note that the water in the channel is in direct response to heavy rains and not an indicator of seasonal flow. Photo was taken June 8, 2021.</p>

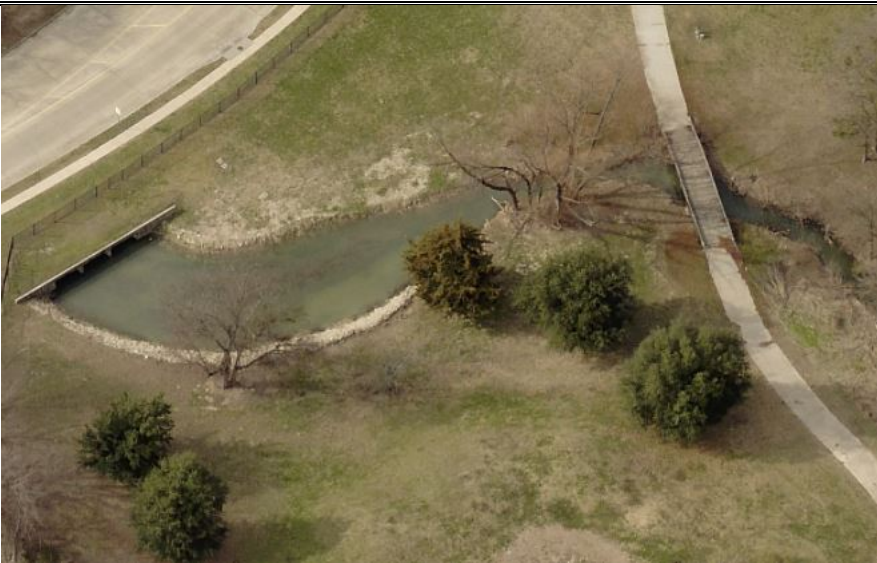
<p><b>Photo 2.</b>  Representative aerial photo (Pictometry 12/27/2019) of perennial stream <b>Water Feature 10A and 10B</b>. Note the armoring and manipulated nature of the stream and the maintained riparian area.</p>

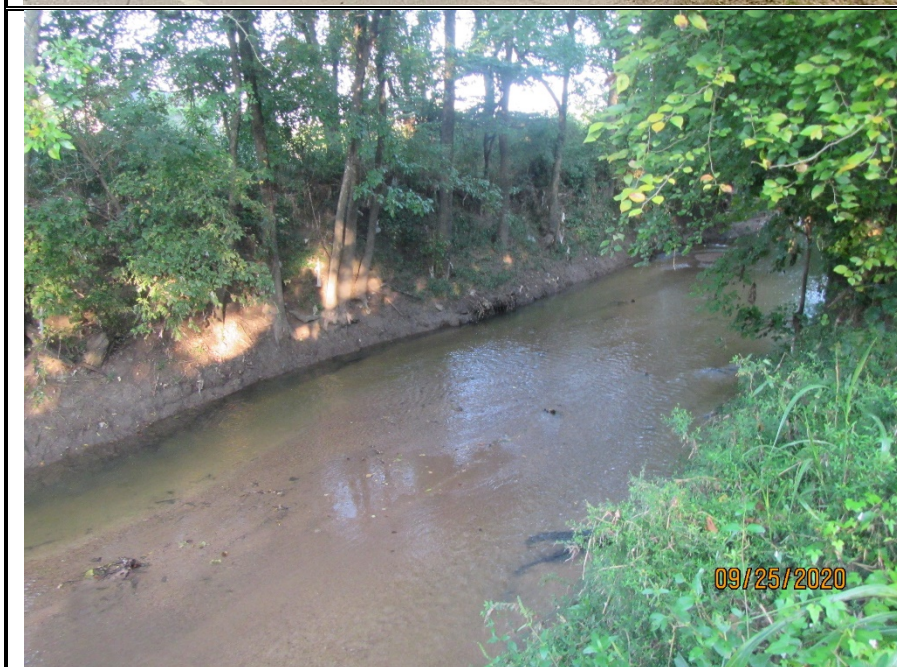
**Photo 4.**  
Representative photo of perennial stream **Water Feature 14**, Wilson Creek. **Water Feature 15** is an intermittent overflow channel of this stream. Note steep, vegetated banks, clay and silt substrate, and waterflow covering channel bottom. Photo was taken to the northwest on September 25, 2020.

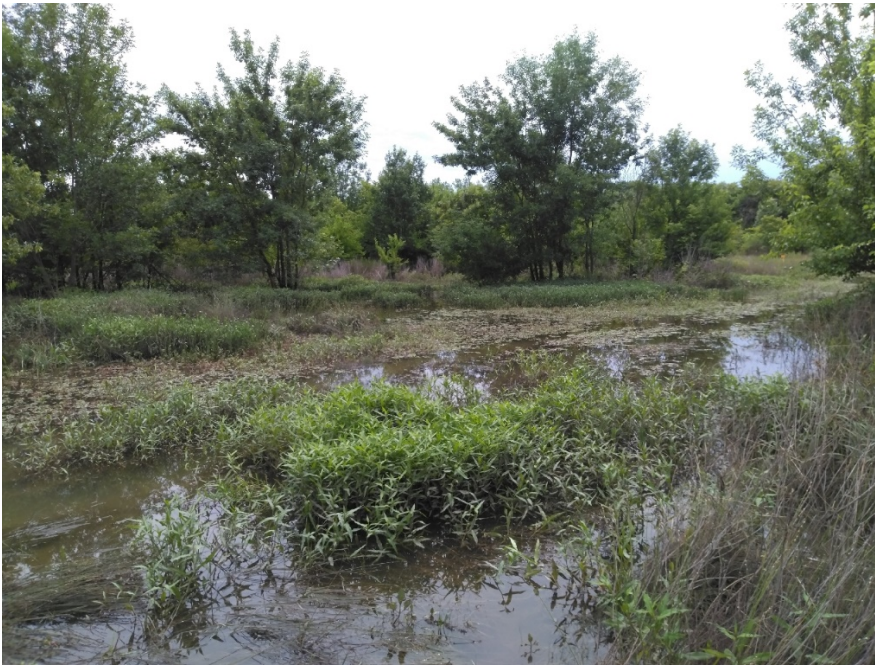
#### Photo 5.

Representative photo of **Water Feature 16** that abuts Forested Wetland **Water Feature 17** in the southwestern portion of the study area. **Water Feature 16** is a palustrine emergent wetland dominated by swamp smartweed (*Persicaria hydropiperoides*) and sparse green ash (*Fraxinus pennsylvanica*). Photo was taken to the north on June 8, 2021.

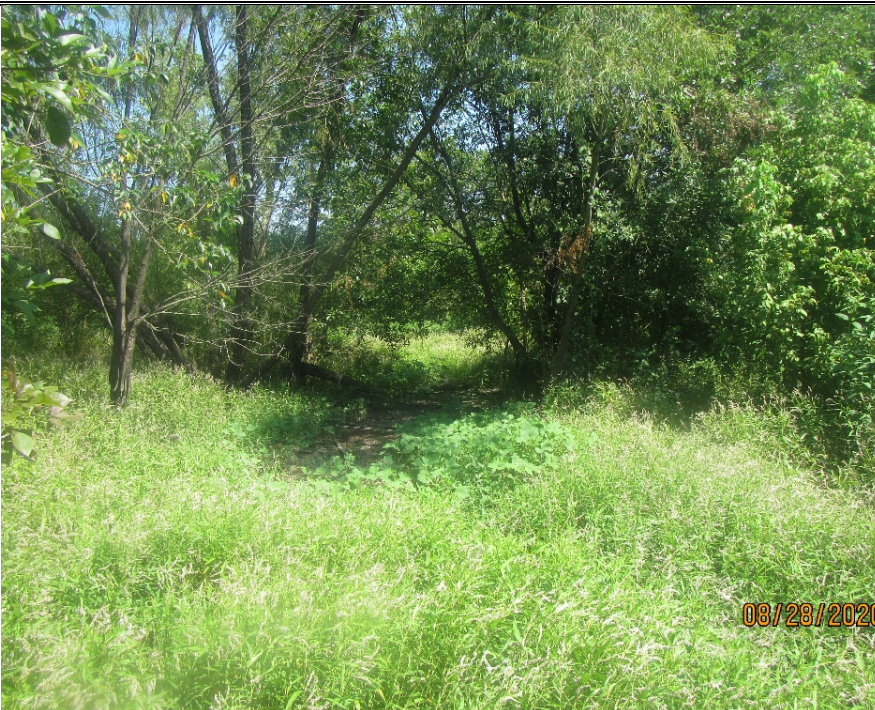
#### Photo 6.

Representative photo of **Water Feature 17** that abuts Emergent Wetland **Water Feature 16** in the southwestern portion of the study area. **Water Feature 17** is a palustrine forested wetland dominated by green ash, American elm (*Ulmus americana*), black willow (*Salix nigra*), and rice cut grass (*Leersia oryzoides*). Photo was taken to the south on August 28, 2020.

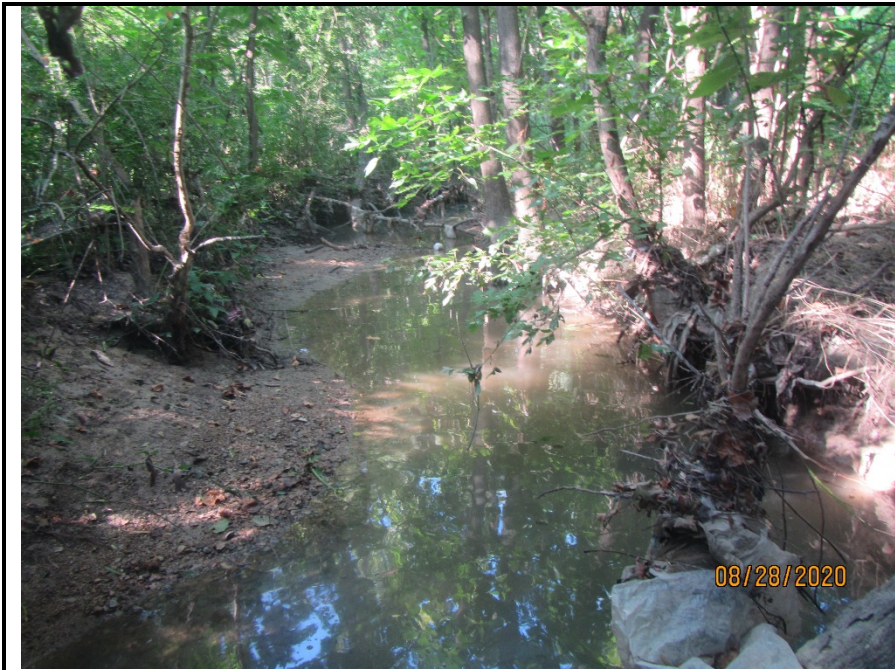
**Photo 7.**  
Photograph of  
intermittent stream  
**Water Feature 18**  
in the southwest  
portion of the study  
area. Photo was  
taken August 28,  
2020.

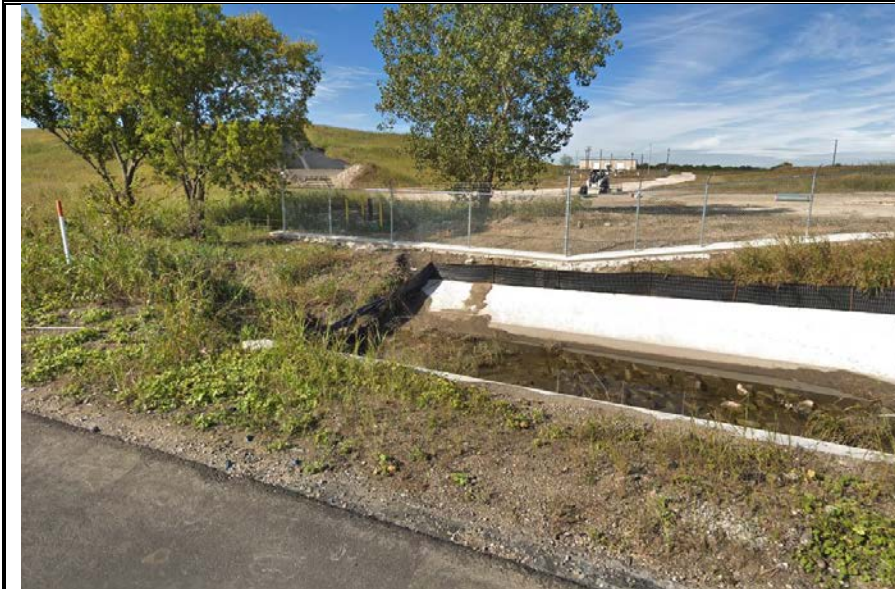
**Photo 8.**  
Representative  
photo of ephemeral  
stream **Water  
Feature 20** (Google  
Street View  
October 2018). This  
stream functions  
like a ditch (only  
flowing as water  
sheds off the  
roadway); however,  
this feature appears  
to be a realignment  
of a natural  
ephemeral stream  
channel.

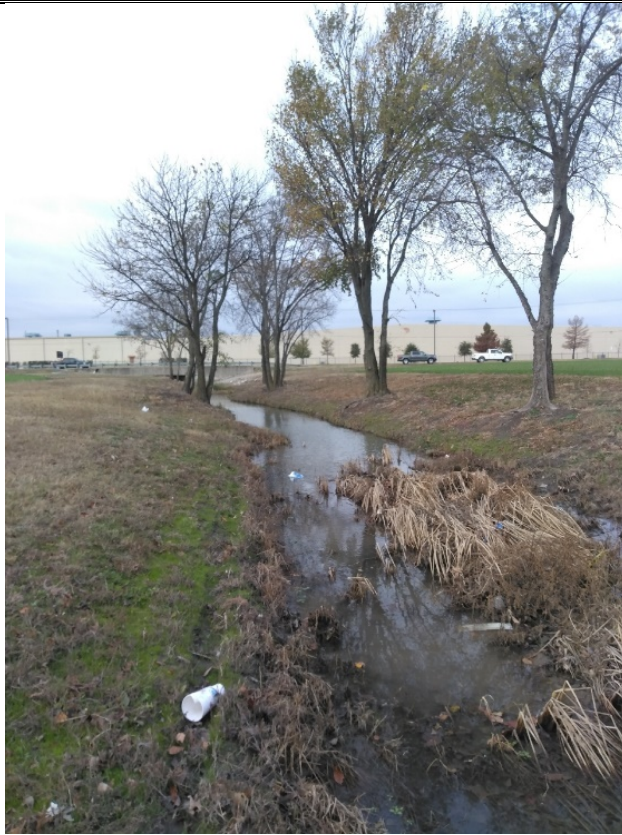
**Photo 9.**  
Representative photo of intermittent stream **Water Feature 21** in the western portion of the study area. Photo was taken to the west on December 3, 2020.

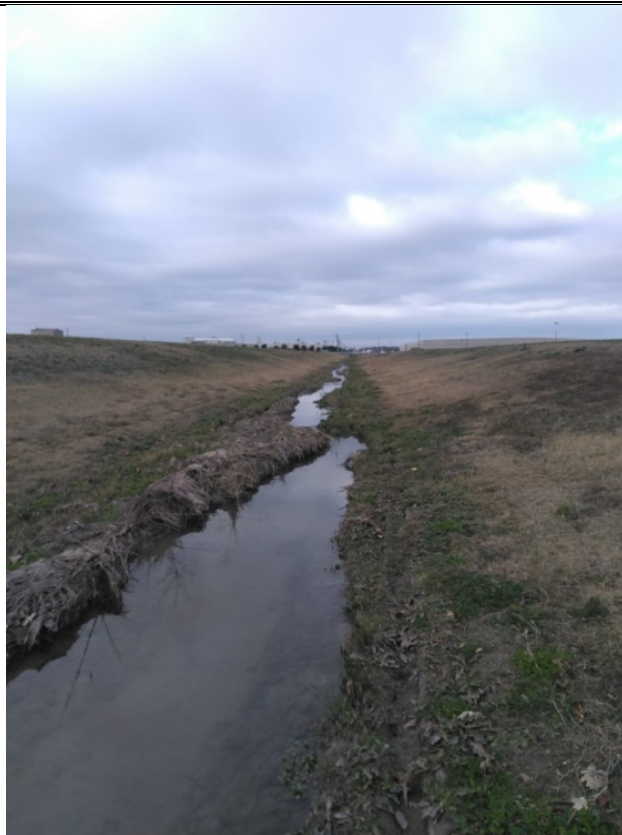
**Photo 10.**  
Representative photo of constructed ditch **Water Feature 23** in the western portion of the study area. Note the anthropogenic symmetry of the excavated ditch between developed areas. Ditch was not associated with a native stream channel. Photo was taken to the east of the study area on December 3, 2020.

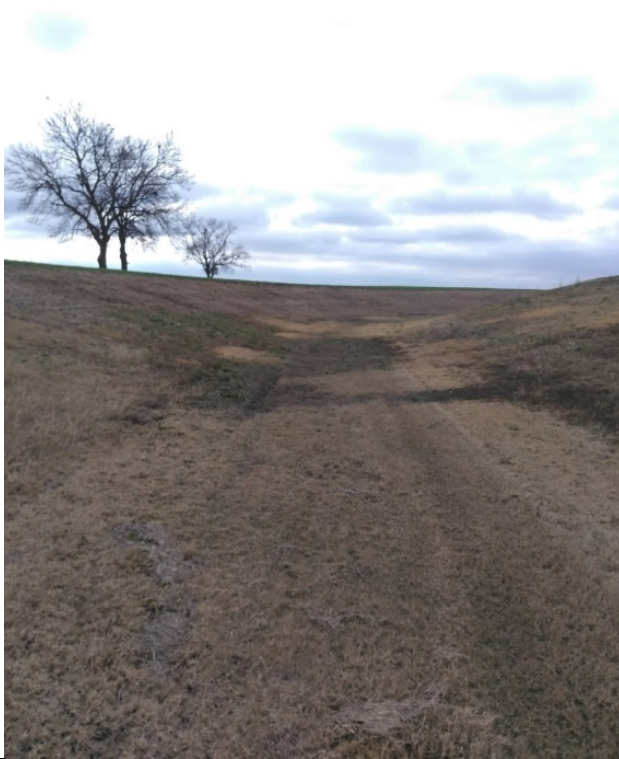
**Photo 11.**  
Photo of  
constructed swale  
**Water Feature 24**  
in the western  
portion of the study  
area. Photo was  
taken to the east of  
the study area on  
December 3, 2020.

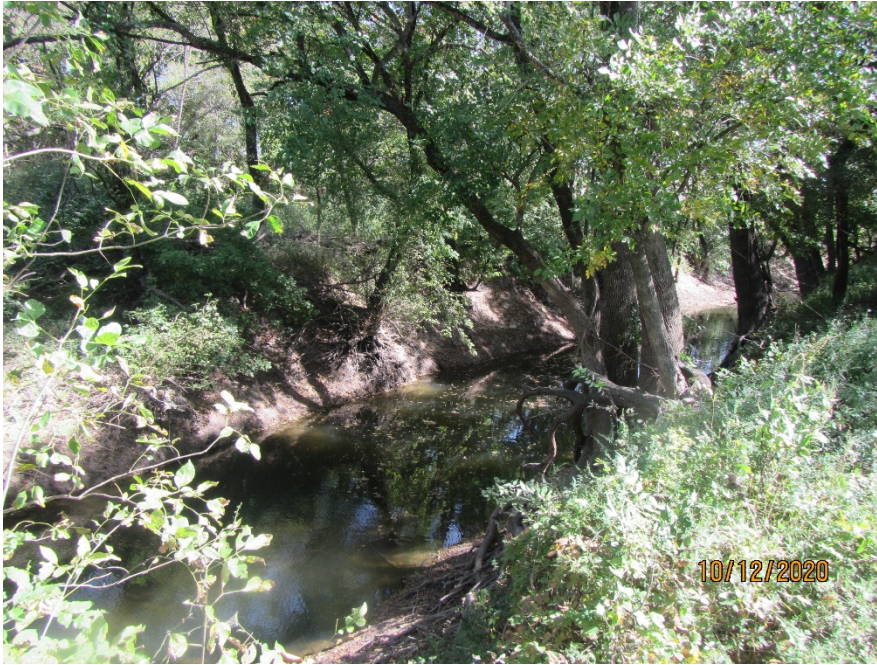
**Photo 12.**  
Representative  
photo of intermittent  
stream **Water  
Feature 25** in the  
northwest portion of  
the study area.  
Note that this photo  
was taken during  
the wet season;  
however, APT  
indicates incipient  
drought conditions  
at the time of the  
delineation. Normal  
conditions for this  
stream would  
include season flow  
and access to  
groundwater. Photo  
was taken to the  
west of the study  
area on December  
1, 2020.

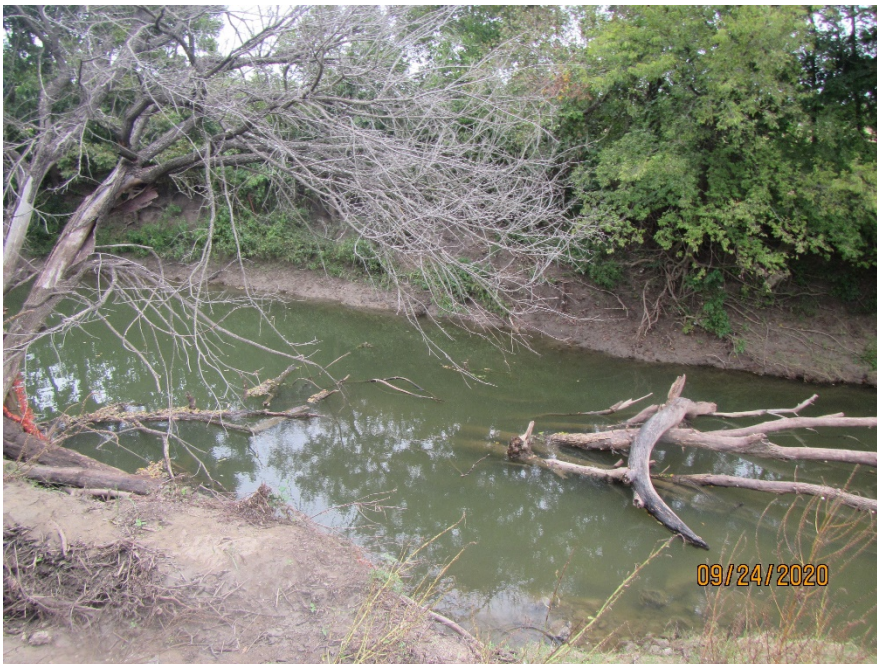
**Photo 14.**  
Representative photo of the East Fork Trinity River in the northwest portion of the study area. The East Fork makes up perennial streams **Water Feature 26, Water Feature 40, and Water Feature 79.** Note the turbulent water, large tree cover in riparian zone, and steep banks. Photo was taken on the **Water Feature 40** portion in the northwest side of the study area on September 24, 2020.

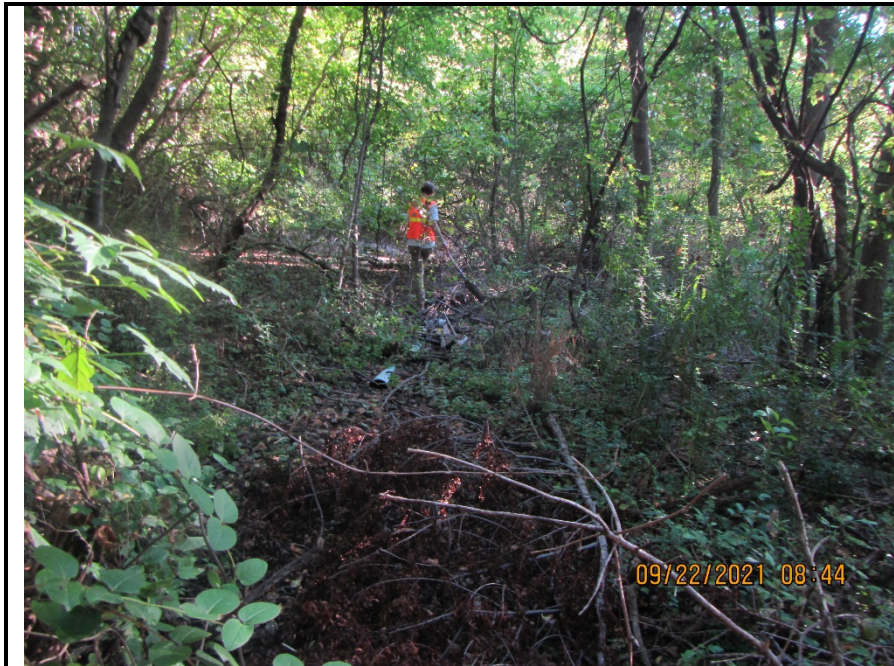
**Photo 15.**  
Photo of swale drainage features **Water Feature 28** and representative of swale drainage feature **Water Feature 31**. **Water Feature 28** and **Water Feature 31** are hydrologically connected to **Water Feature 29**, **Water Feature 32**, and **Water Feature 34**. Photo was taken on September 22, 2021.

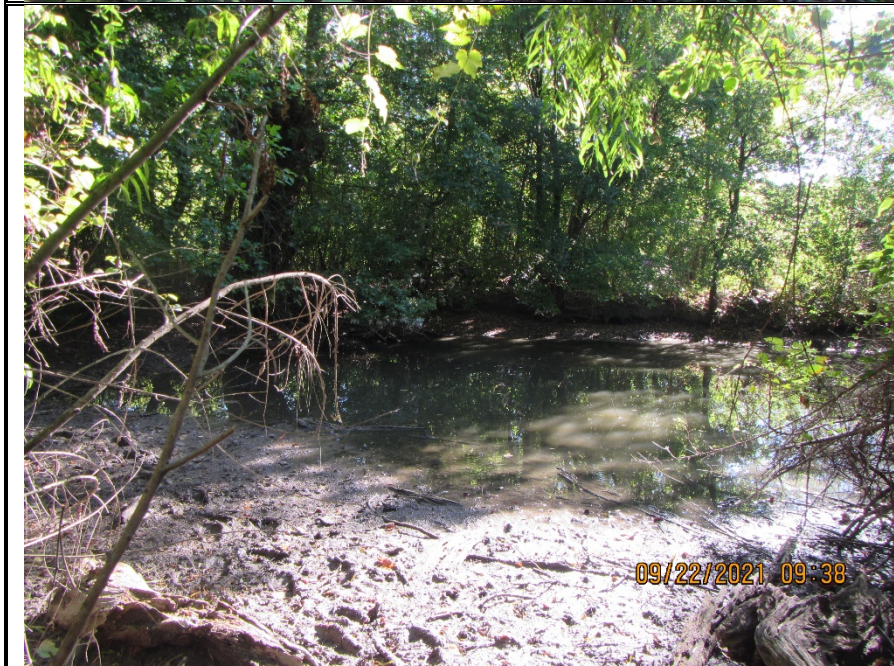
**Photo 16.**  
Photograph of upland pond **Water Feature 29**. Photo was taken September 22, 2021.

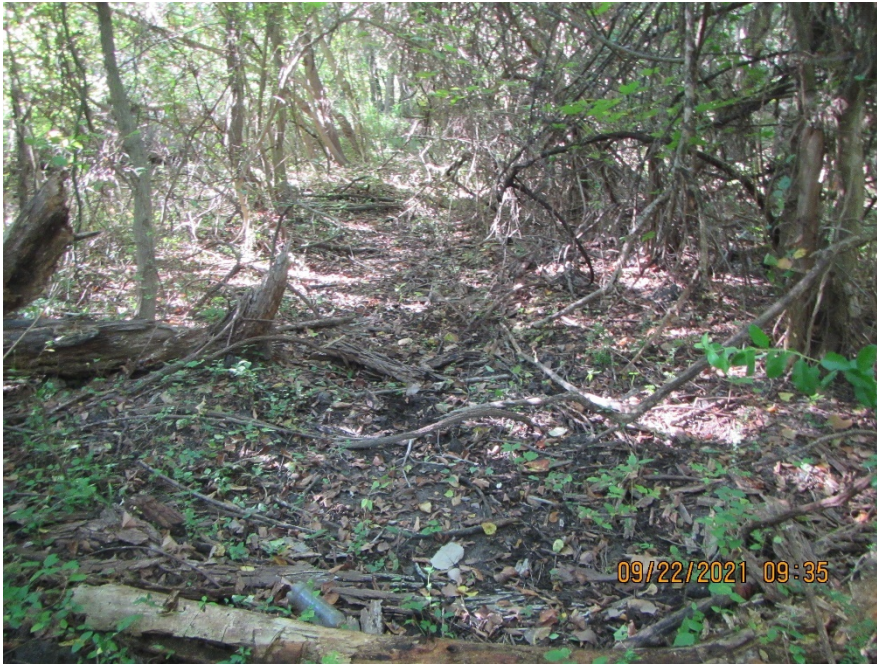
**Photo 17.**  
Representative photograph of ephemeral stream **Water Feature 30** in the northeast portion of the study area. Note the clear natural line impressed on the bank, the presence of litter/debris, and lack of surface water present within the defined channel. Riparian vegetation was dominated by sugar hackberry (*Celtis laevigata*), American elm, Virginia wild rye (*Elymus virginicus*), and narrow-leaf primrose-willow (*Ludwigia linearis*). Photo was taken on September 22, 2021.

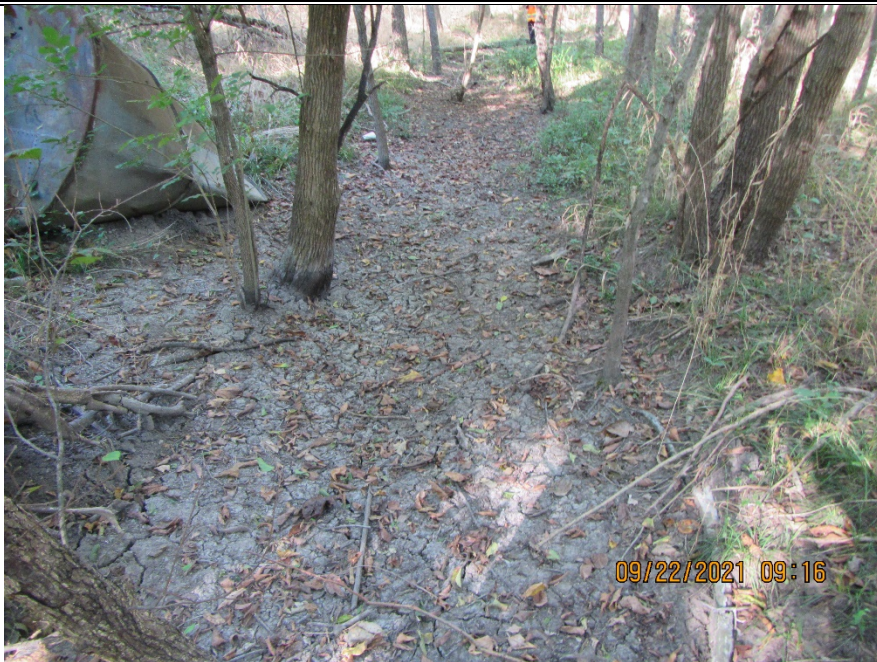
**Photo 18.**  
Representative photo of ephemeral stream **Water Feature 33** in the western portion of the study area. Note the lack of surface water and leaf litter/vegetation present within the hydrological flow path. Photo was taken September 22, 2021.

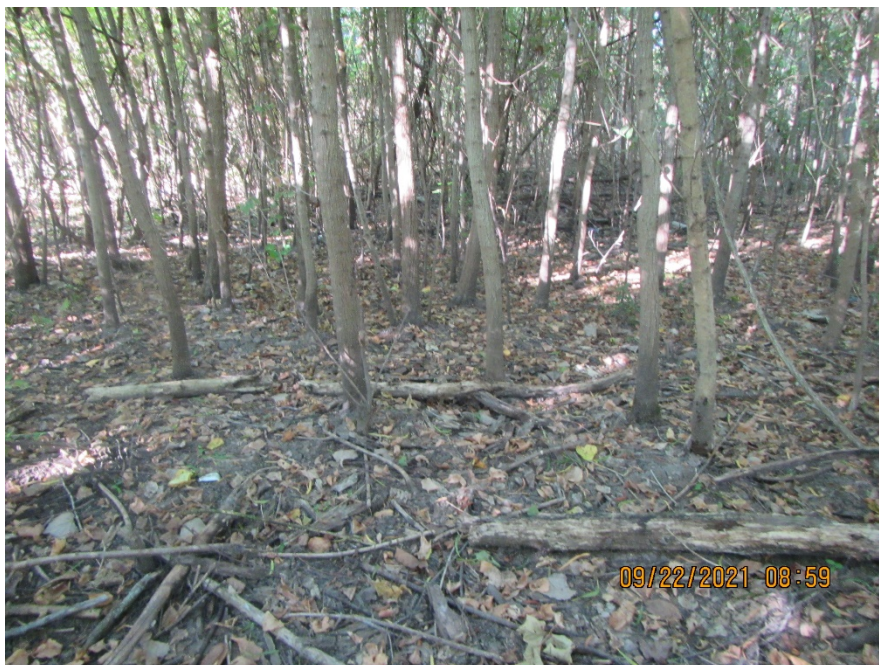
**Photo 19.**  
Representative photo of **Water Feature 32** in the eastern portion of the study area. **Water Feature 32** is a palustrine forested wetland dominated by mature black willow, as well as green ash, boxelder (*Acer negundo*), and sugar hackberry saplings. Note the water marks on trees and drift deposits. Photo was taken on September 22, 2021.

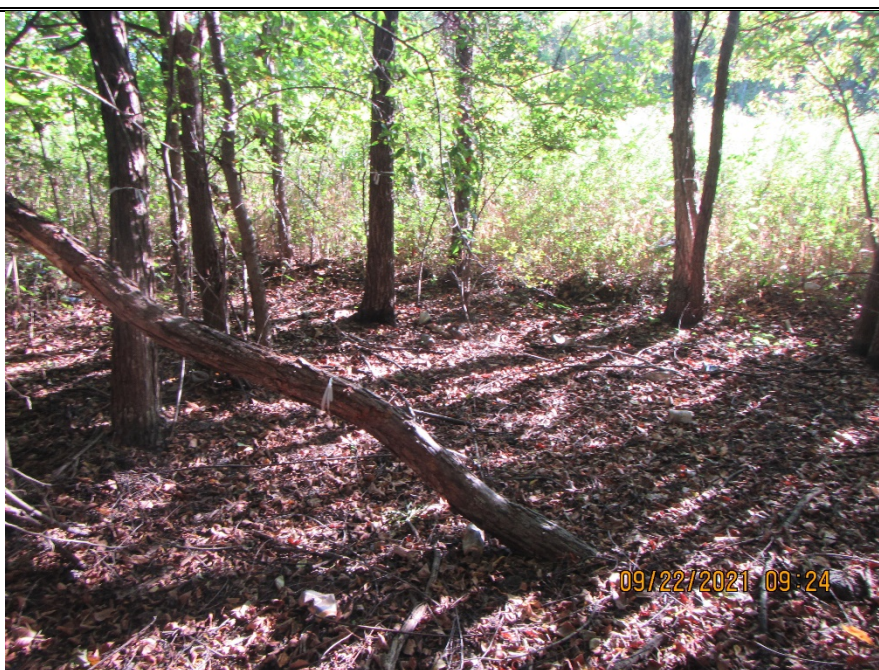
**Photo 20.**  
Representative photo of **Water Feature 34** in the eastern portion of the study area. **Water Feature 34** is a palustrine forested wetland dominated by black willow and American elm. Note the water marks on trees and sparsely vegetated concave surface. Photo was taken on September 22, 2021.

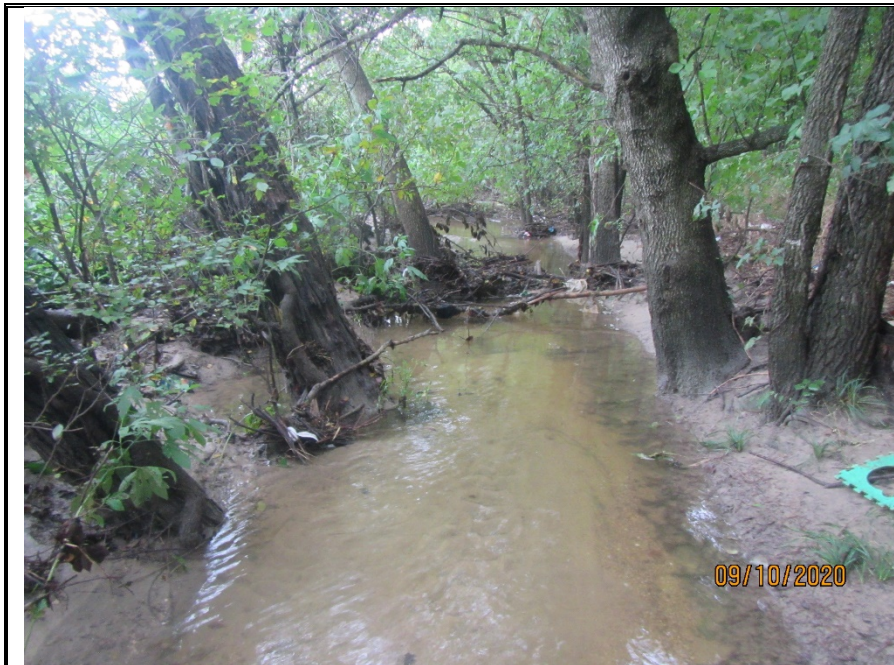
**Photo 21.**  
Representative photo of intermittent stream **Water Feature 36** in the northwest portion of the study area. Note the gradual stream banks, large tree cover, and flowing water covering a clay and silt stream bottom. Photo was taken looking into the study area from the west on September 10, 2020.

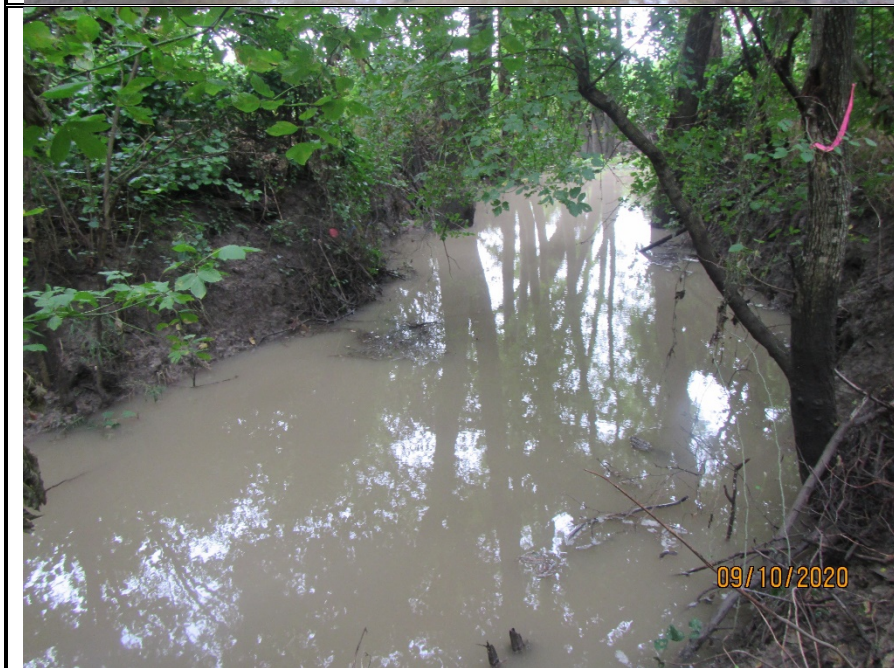
**Photo 22.**  
Representative photo of perennial stream **Water Feature 39** in the northwest portion of the study area. Note turbulent water and steep banks. Photo was taken looking to the northeast on September 10, 2020.

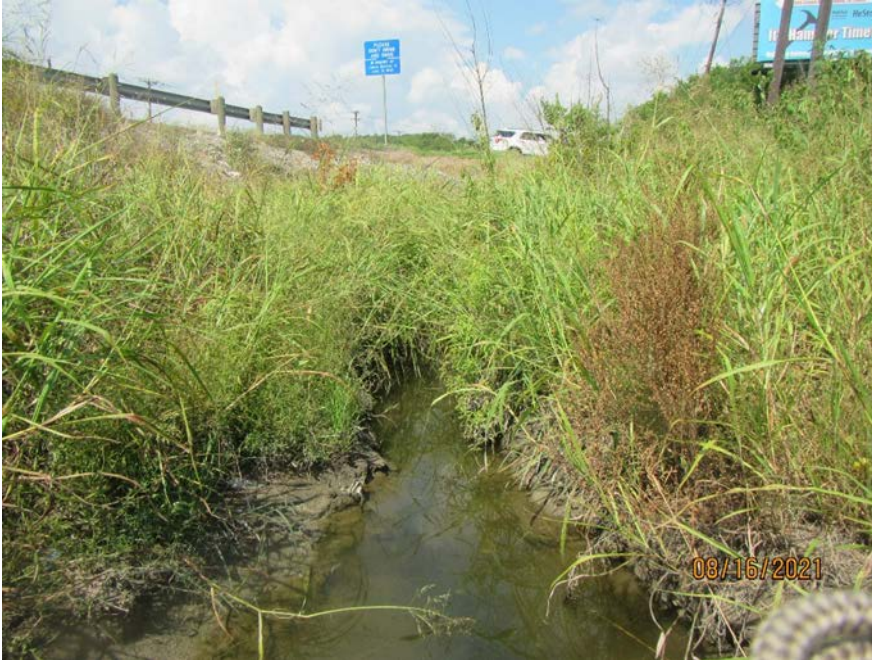
**Photo 23.**  
Photo of Intermittent Stream **Water Feature 41**. **Water Feature 41** was located in the northern portion of the study area north of US-380 and had artificially stabilized banks, overhanging vegetation, gravel bars, aquatic vegetation, and matted vegetation. Dominant vegetation included johnsongrass (*Sorghum halepense*), great ragweed (*Ambrosia trifida*), and black willow. Photo was taken on August 16, 2021.

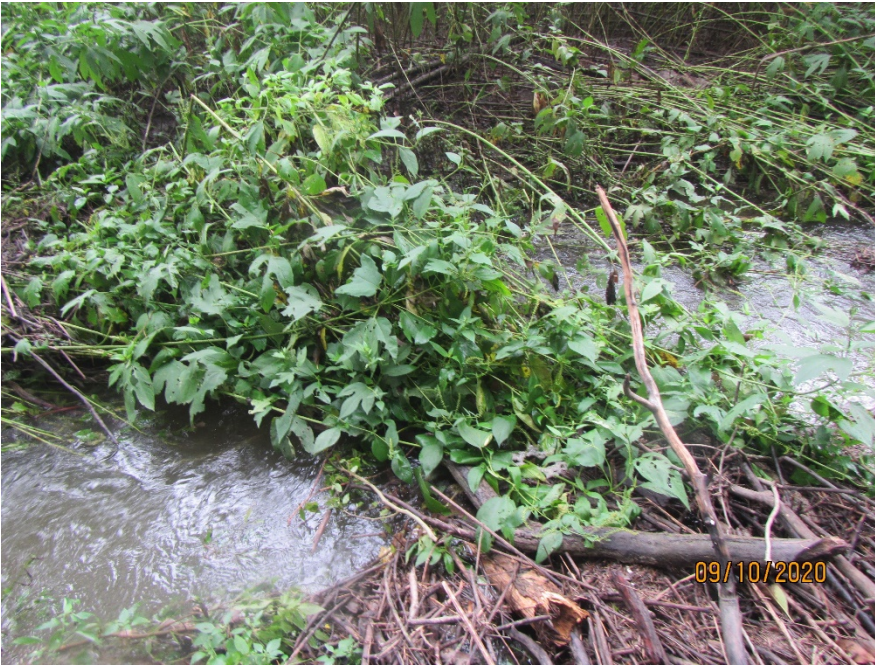
**Photo 24.**  
Representative photo of intermittent stream **Water Feature 47** in the northern portion of the study area. Photo was taken to the south on September 10, 2020.

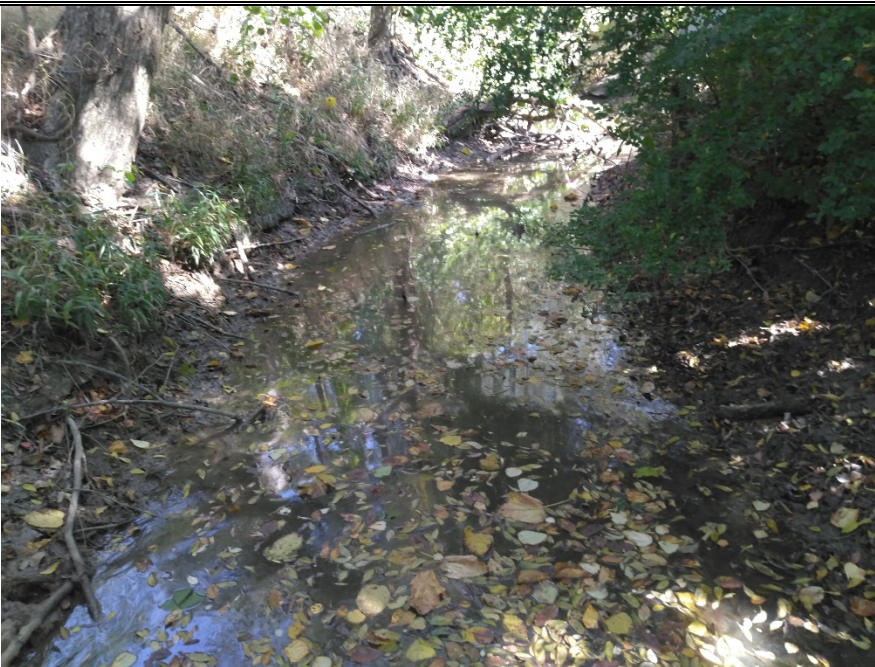
**Photo 25.** Photograph of ephemeral stream **Water Feature 49** in the northern portion of the study area. Note that the water in the channel is in direct response to heavy rains and not an indicator of seasonal flow. This photo is also representative of **Water Feature 12**. Photo was taken September 10, 2020 after a very heavy local rainfall event.

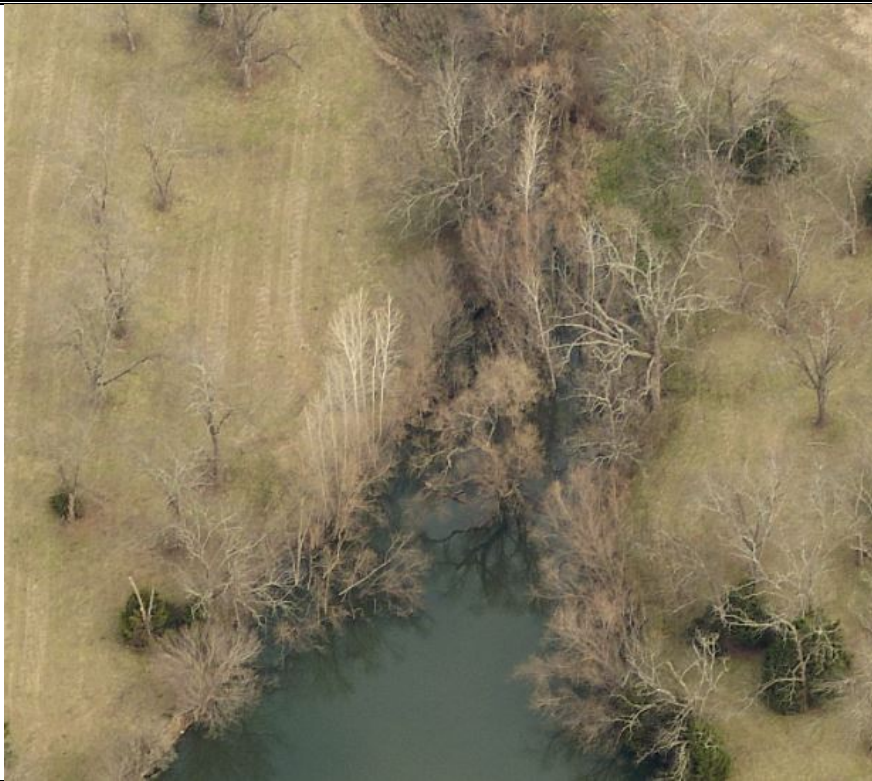
**Photo 26.** Representative photo of intermittent stream **Water Feature 51** in the northeastern portion of the study area. Photo was taken to the east on October 14, 2020.

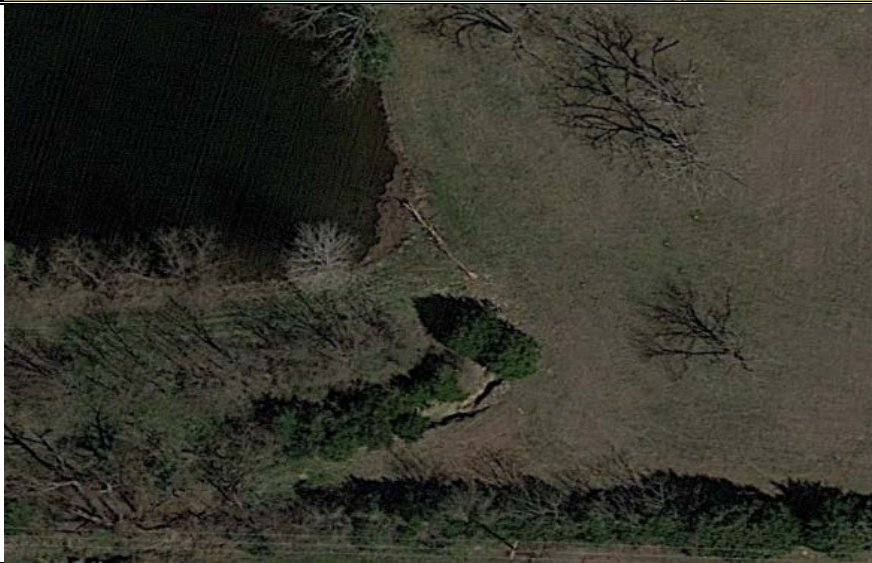
**Photo 27.**  
Representative  
aerial photo  
(Pictometry  
1/15/2019) of  
isolated forested  
wetland **Water  
Feature 53**, the  
lacustrine fringe  
associated with  
**Water Feature 54**.

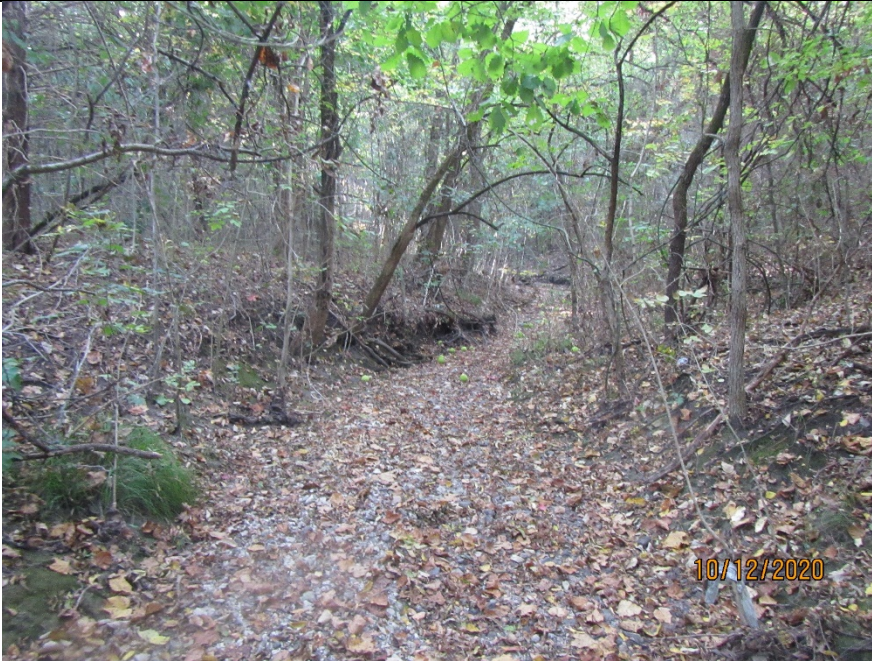
**Photo 28.**  
Photo of swale  
**Water Feature 55**  
in the southern  
portion of the study  
area. **Water  
Feature 55**  
connects **Water  
Feature 54** and  
**Water Feature 56**.  
Photo from Google  
Earth Aerial  
Imagery dated  
March 20, 2018.

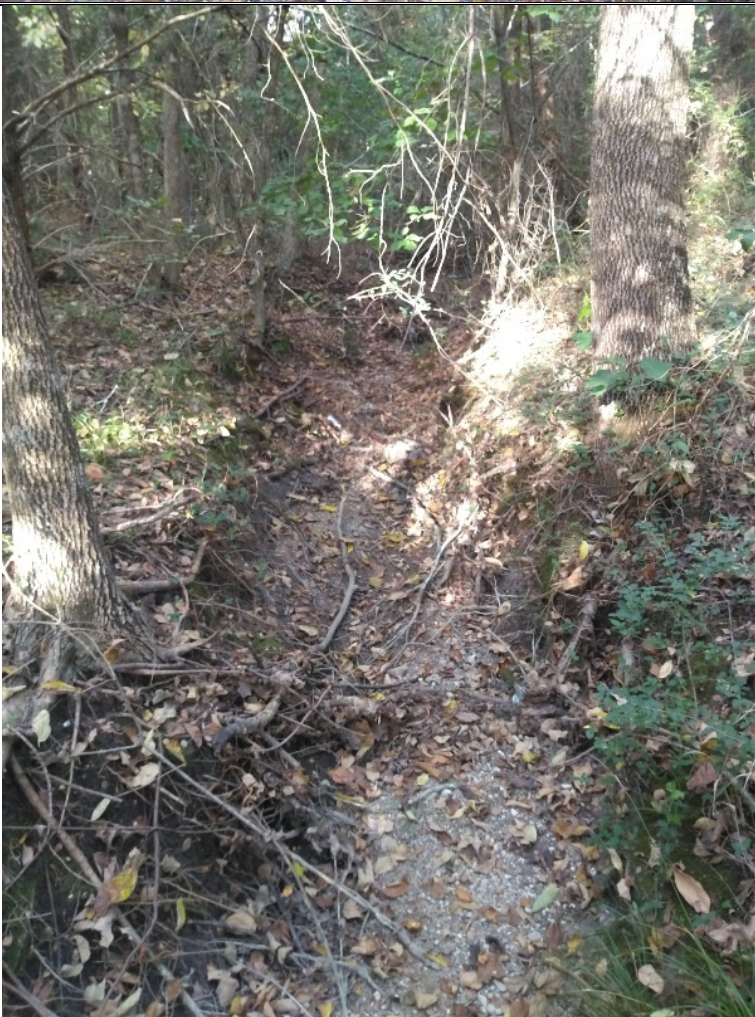
**Photo 29.**  
Representative photo of ephemeral stream **Water Feature 57** in the southeastern portion of the study area. Note the lack of surface water, leaf litter covering the channel, and cobble/gravel substrate. Photo was taken to the north on October 12, 2020.

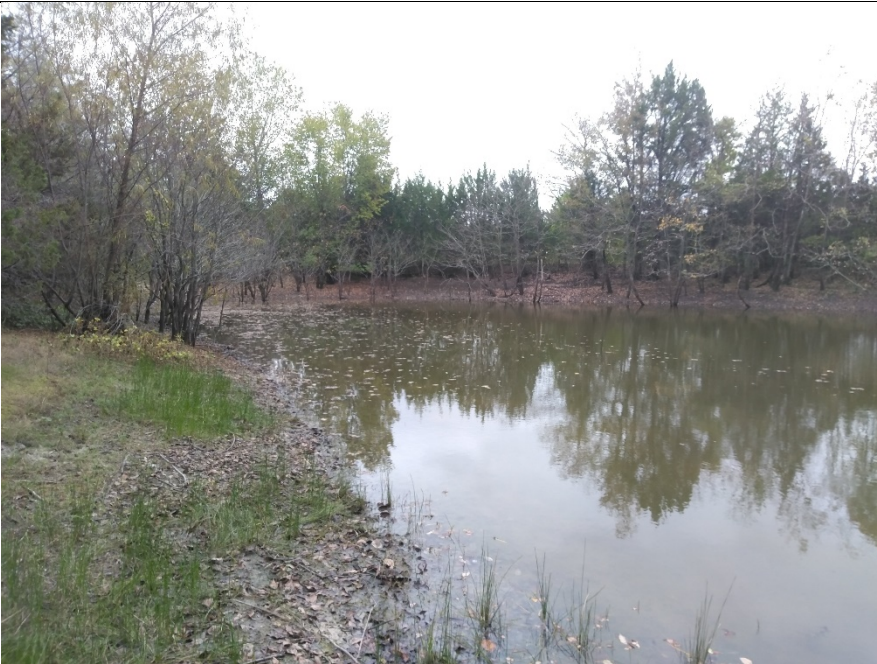
**Photo 30.**  
Representative photo of ephemeral stream **Water Feature 59** in the southeastern portion of the study area with lack of surface water or indicators of seasonal flow. Photo was taken to the east of the study area on October 12, 2020.

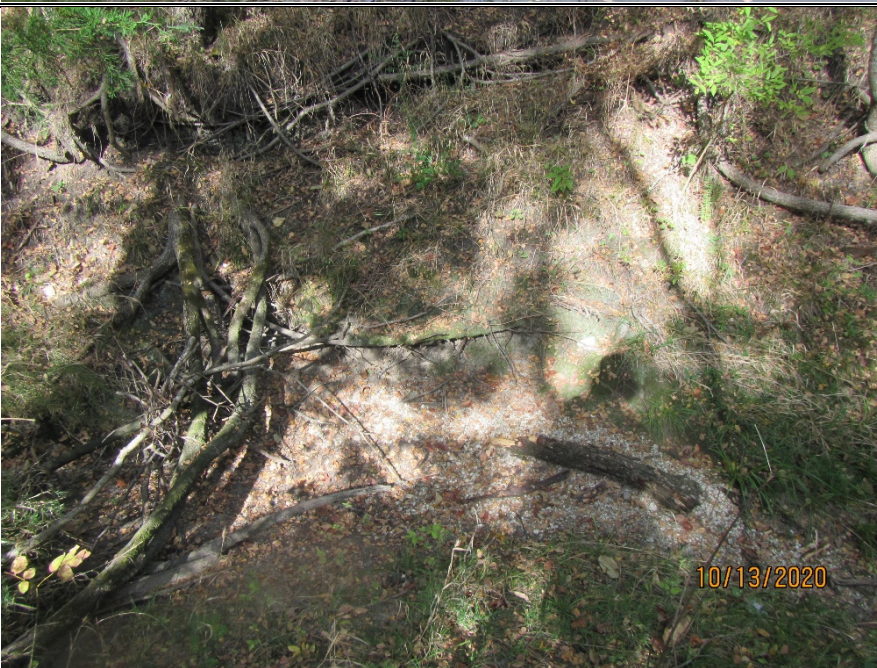
**Photo 31.**  
 Photograph of  
 upland pond **Water  
 Feature 61** and is  
 representative of  
 isolated pond  
**Water Feature 54.**  
 Photo was taken  
 October 15, 2020.

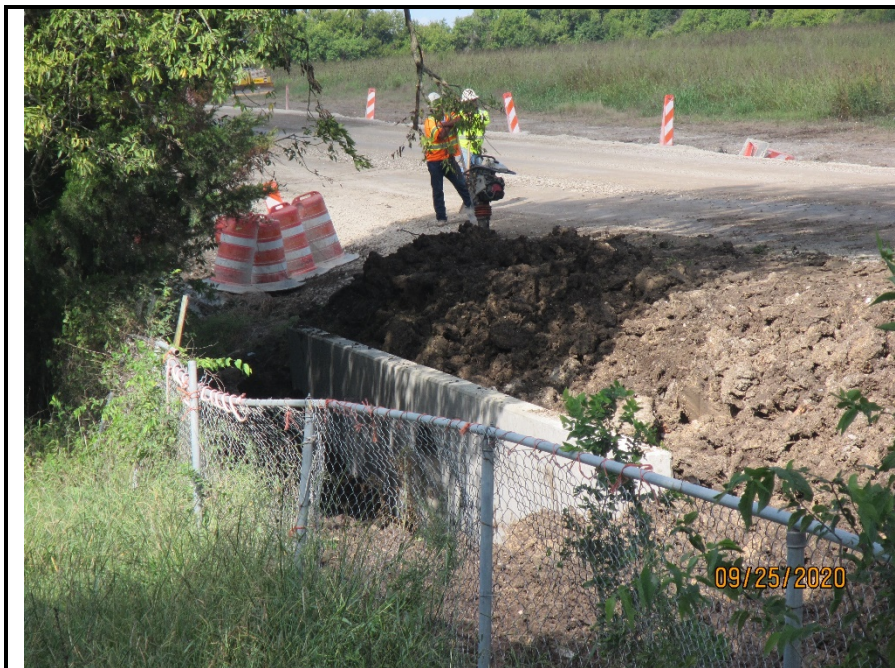
**Photo 32.**  
 Representative  
 photo of ephemeral  
 stream **Water  
 Feature 62** in the  
 eastern portion of  
 the study area. This  
 photo is also  
 representative of  
 the condition of  
**Water Feature 63,**  
 a small, ephemeral  
 tributary to **Water  
 Feature 62.** Both  
 lack indicators of  
 seasonal flow.  
 Photo was taken on  
 October 13, 2020.

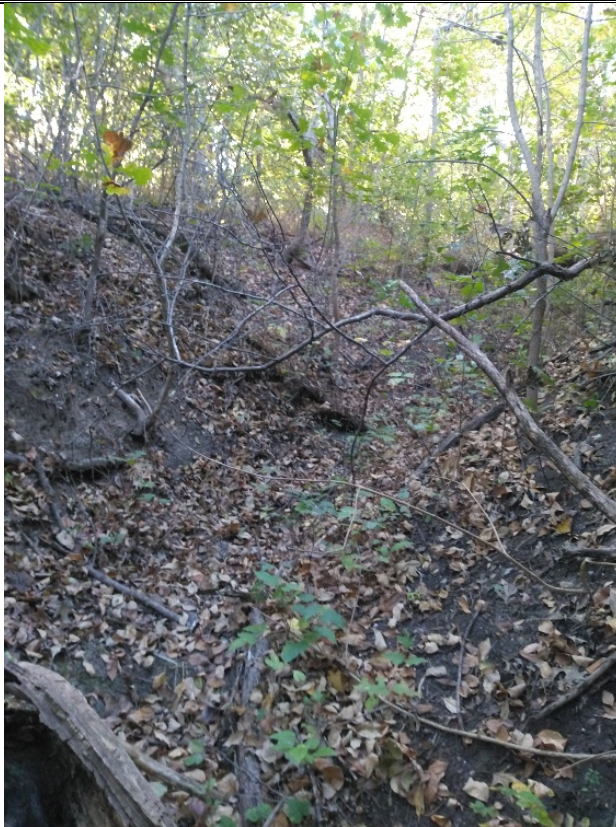
**Photo 35.**  
Representative photo of perennial stream **Water Feature 65** in the eastern portion of the study area. This stream has year-round access to ground water. Note the root stabilization along the banks. Photo was taken to the southwest on October 13, 2020.

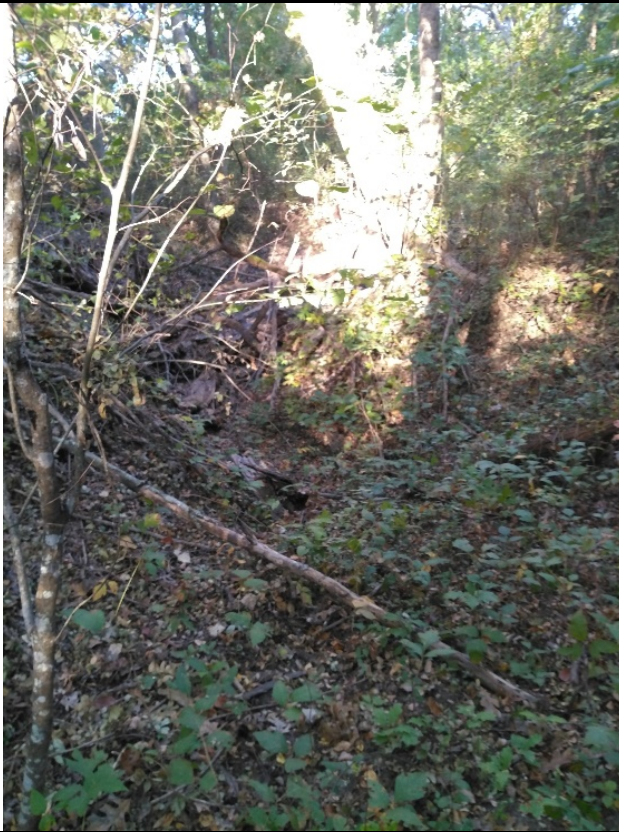
**Photo 36.**  
Representative photo of ephemeral stream **Water Feature 66** in the eastern portion of the study area. Note the defined, highly eroded channel, lack of surface water, and leaf litter/vegetation present within the hydrological flow path. Photo was taken October 13, 2020.

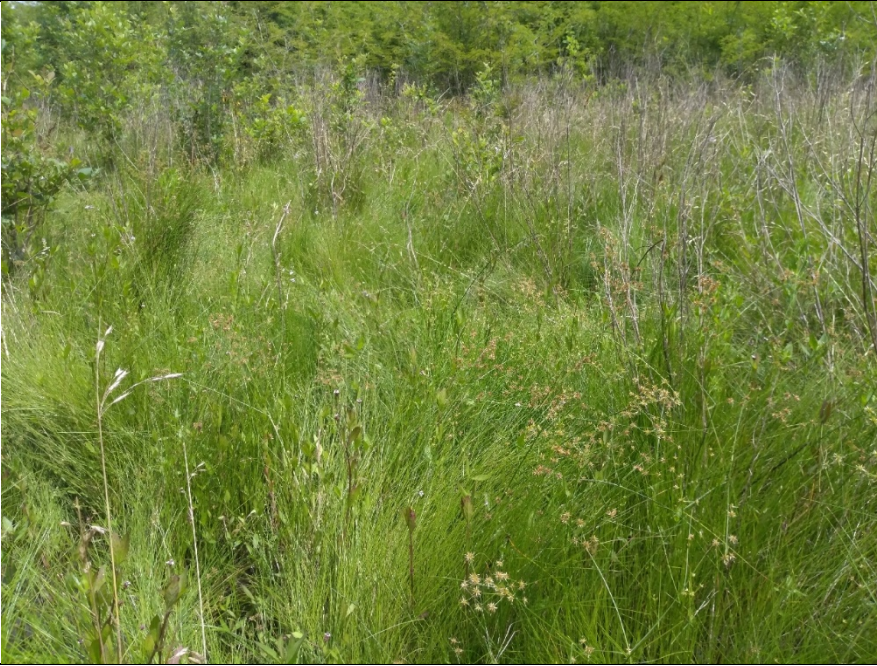
**Photo 38.**  
Photograph is of upland pond **Water Feature 68**. Photo was taken October 13, 2020.

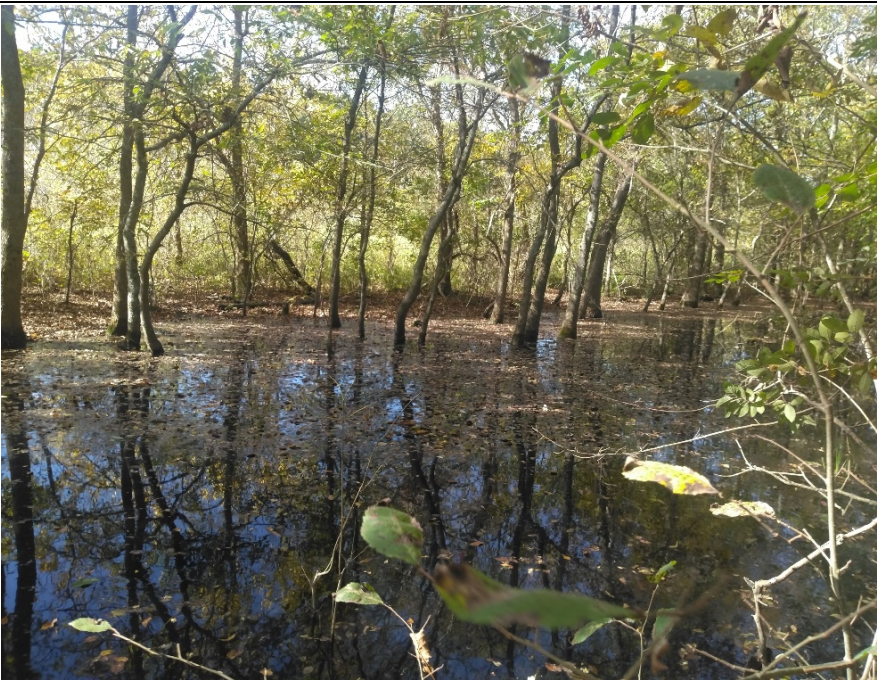
**Photo 39.**  
Representative photo of **Water Feature 69** in the eastern portion of the study area. **Water Feature 69** is a palustrine emergent wetland dominated by common spike-rush (*Eleocharis palustris*), Torrey's Rush (*Juncus torreyi*), and green ash saplings. Photo was taken on June 8, 2021.

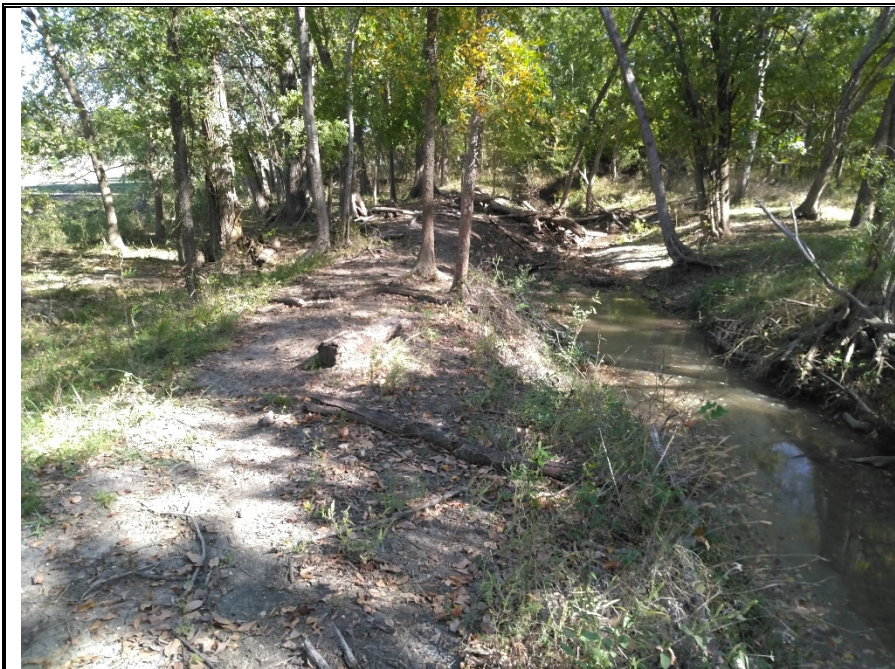
**Photo 40.**  
Representative photo of **Water Feature 70** in the eastern portion of the study area. **Water Feature 70** is a palustrine forested wetland dominated by sugar hackberry, green ash, sapling American elm, rice cut grass, and nodding wild rye (*Elymus canadensis*). Photo was taken to the east of the study area on October 13, 2020.
