# ADDENDUM

24-MARCH-2022

## APPENDIX N – WATER RESOURCES – Proposed ROW Change

**SPUR 399 EXTENSION EIS - US 75 to US 380, Collin County  
CSJs 0364-04-051, 0047-05-058, and 0047-10-002; Dallas District**

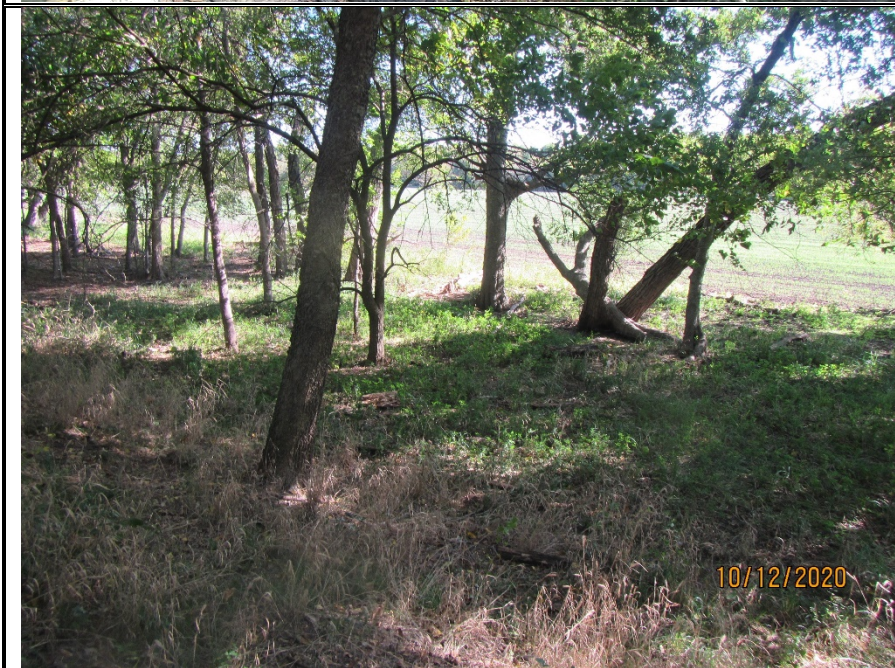
**Photo 41.**  
Representative photo of perennial stream **Water Feature 71** in the eastern portion of the study area. This stream has year-round access to groundwater; thus, it is perennial. Note the incised banks, cobble/gravel substrate, and root stabilization of the channel. Photo was taken to the east on October 12, 2020.

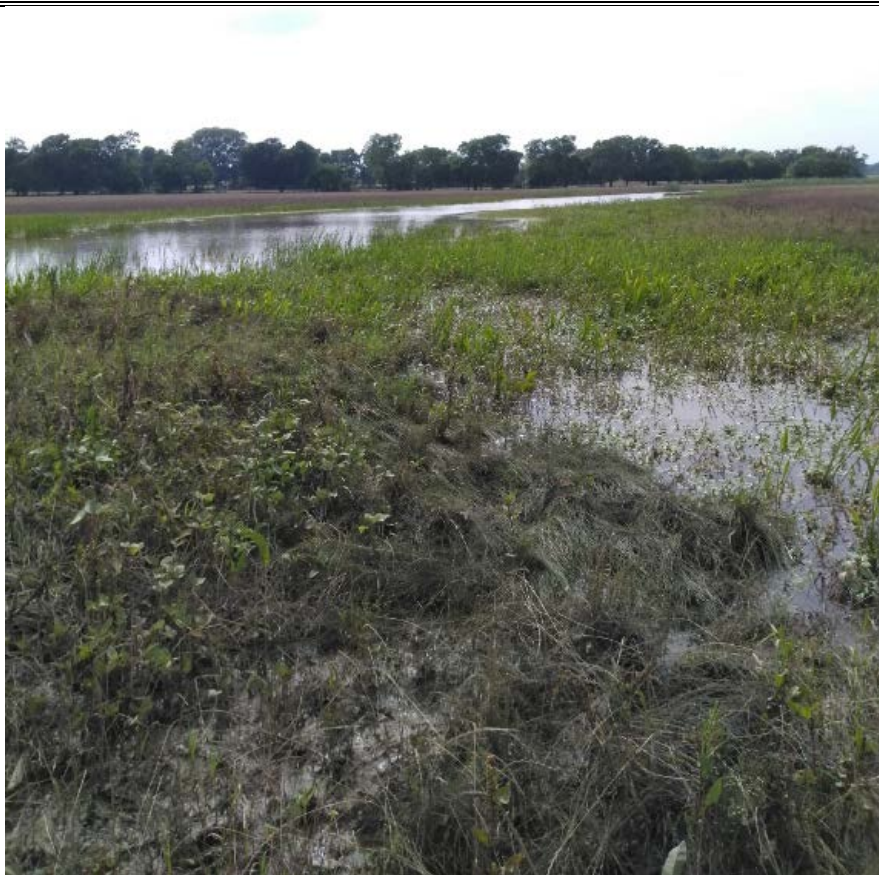
**Photo 45.**  
Representative photo of swale **Water Feature 76** in the eastern portion of the study area. Drainage through cultivated field is subject to regular migration, with no defined channel. Photo was taken to the south on October 12, 2020.

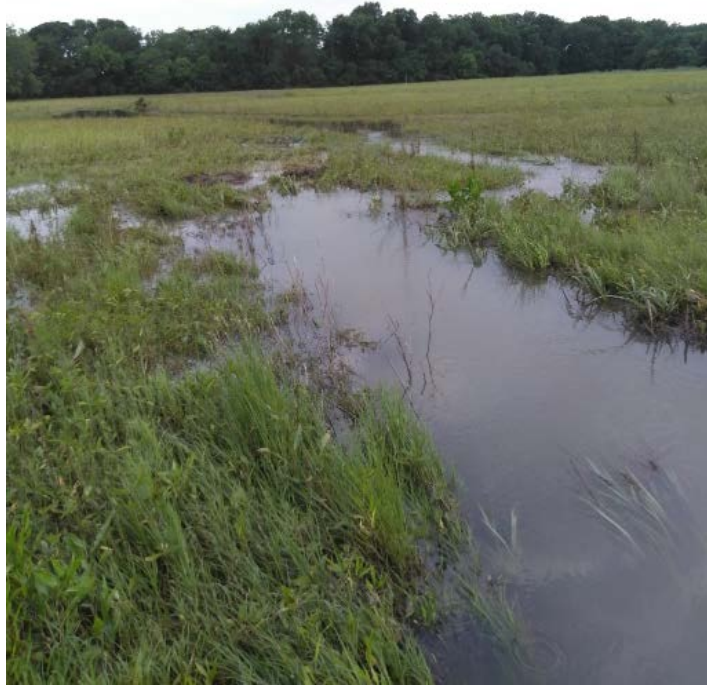
**Photo 48.**

Representative aerial photo (Pictometry 4/27/17) of intermittent stream **Water Feature 80** and swale **Water Feature 81**. Note the sharp shift from vegetated, pasture swale to channelized, water-filled stream channel. This is the result of a ditch constructed upstream that modified hydrology. Only channel scars (**Water Feature 81**, **Water Feature 82**, **Water Feature 83**, **Water Feature 84**, **Water Feature 85**, and **Water Feature 86**) remain.

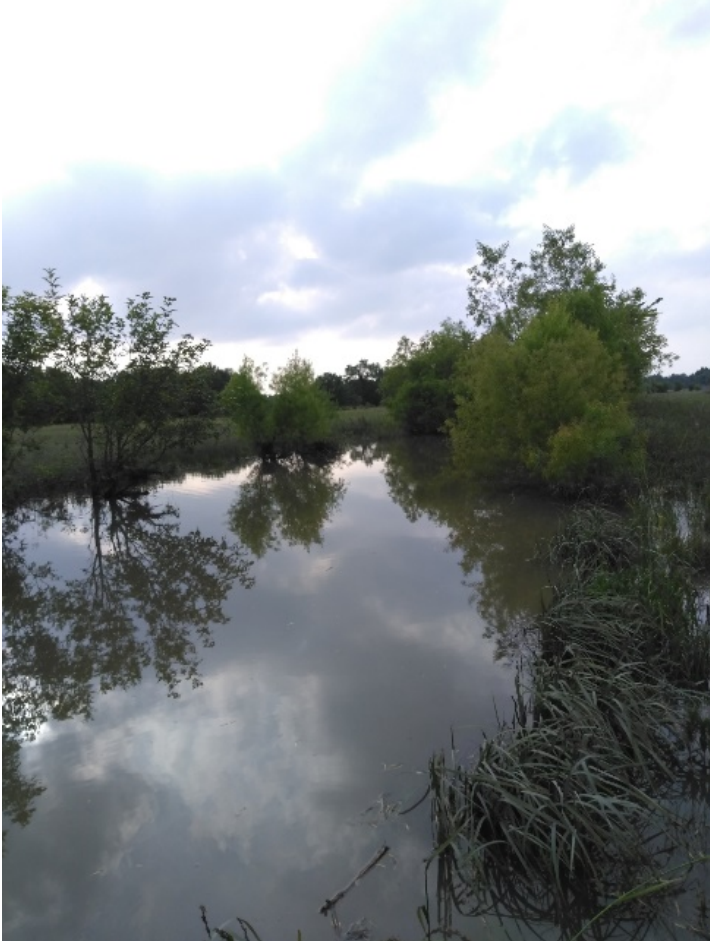
**Photo 49.** Photograph of swale **Water Feature 84** in the northeastern portion of the study area. Photograph is representative of swales **Water Feature 81, Water Feature 82, Water Feature 86, and Water Feature 90.** Note that the water in the swale is in direct response to heavy rains and not an indicator of seasonal flow. Photograph was taken on June 8, 2021 after an extremely heavy local rainfall event.

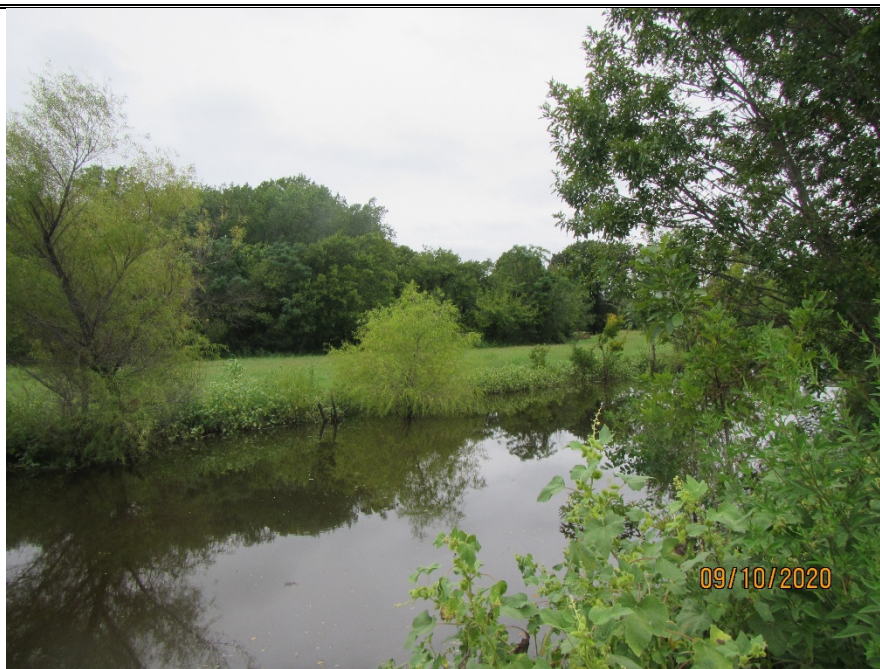
**Photo 50.** Photograph of on-channel pond **Water Feature 85** in the northeastern portion of the study area. Photo is also representative of on-channel pond **Water Feature 83,** which is part of the same former channel described on Photo 22. Also representative of **Water Feature 13** which is conditionally and visually like **Water Feature 85;** however, it is an oxbow of a natural channel migration rather than manmade. Photo was taken on June 8, 2021 after an extremely heavy local rainfall event.

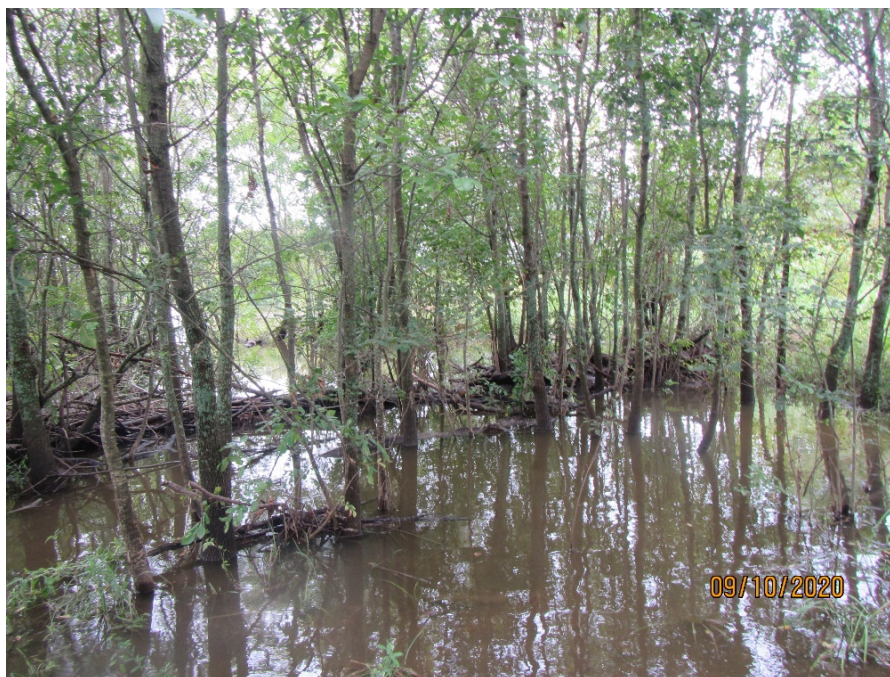
**Photo 51.**  
Representative photo of on-channel pond **Water Feature 87**. **Water Feature 87** abuts forested wetland **Water Feature 88** and is approximately 100 feet northeast of the East Fork Trinity River in the northeastern portion of the study area. Photo was taken to the east on September 10, 2020.

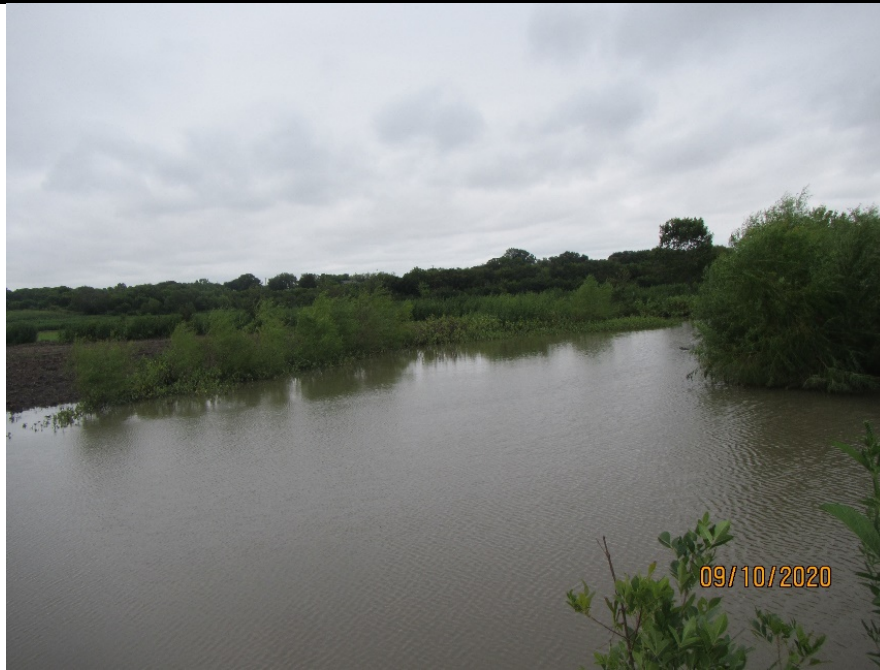
**Photo 52.**  
Representative photo of **Water Feature 88** in the northeastern portion of the study area. **Water Feature 88** is a palustrine forested wetland and is dominated by boxelder trees and saplings, green ash, rice cut grass, swamp smartweed, and rough cocklebur (*Xanthium strumarium*). Photo was taken to the north of the study area on September 10, 2020.

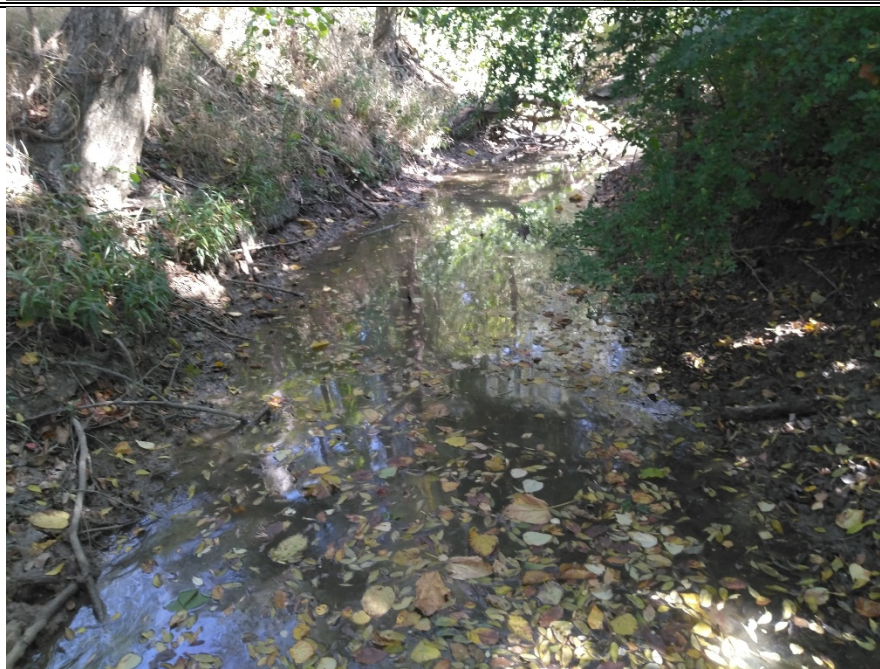
**Photo 53.**  
 Photograph is of on-channel pond **Water Feature 91** in the northeastern portion of the study area. Photo is representative of on-channel pond **Water Feature 89** and was taken September 9, 2020.

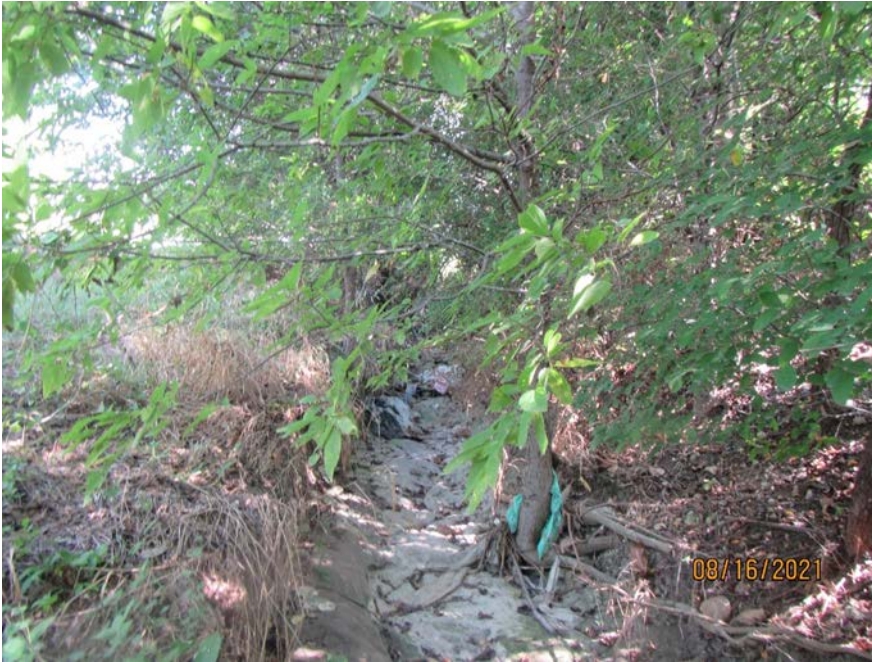
**Photo 54.**  
 Representative photo of intermittent stream **Water Feature 51** in the northeastern portion of the study area. Photo was taken to the east on October 14, 2020.

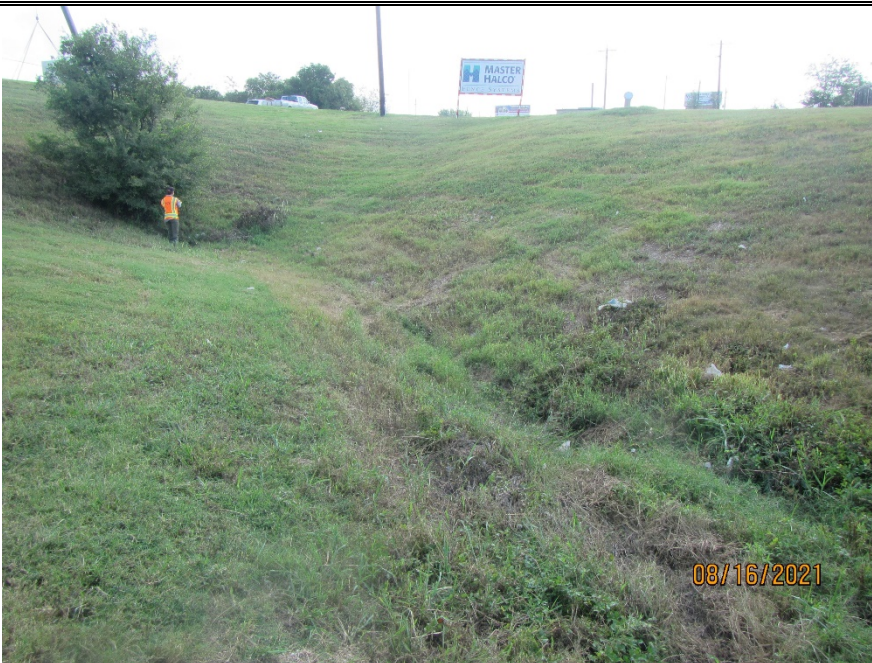
**Photo 55.**  
Photo of Ephemeral Stream **Water Feature 94**. **Water Feature 94** was located in the northern portion of the study area and receives runoff from US-380. Bedrock was visible and litter and debris was within the stream channel. Dominant vegetation included sugar hackberry, pecan (*Carya illinoensis*), and eastern poison ivy (*Toxicodendron radicans*). Photo was taken on August 16, 2021.

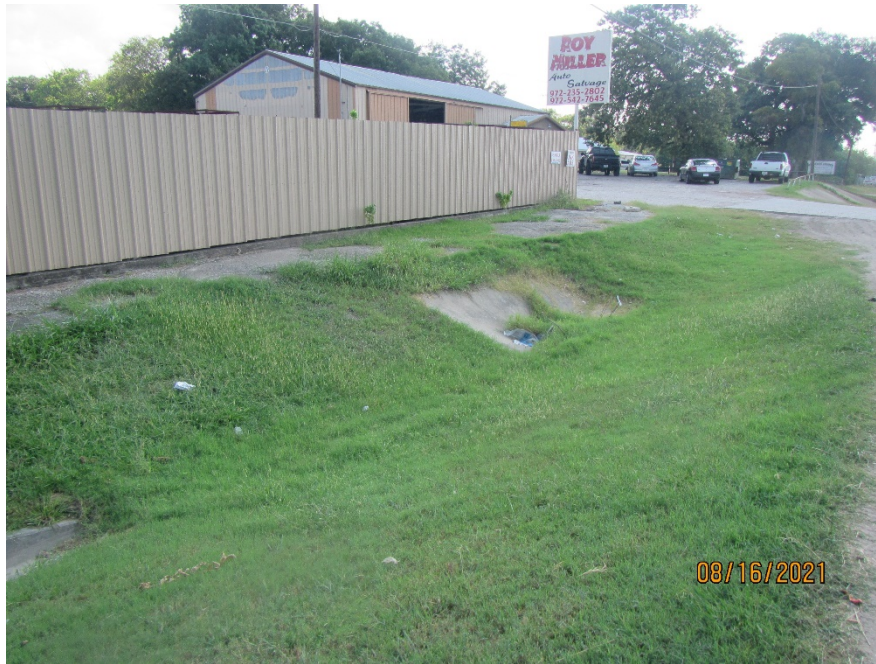
**Photo 56.**  
Photo of ditch drainage feature **Water Feature 95**. Dominant vegetation was bermudagrass (*Cynodon dactylon*) and Water Feature 95 drains southwest into Water Feature 94. Photo was taken on August 16, 2021.

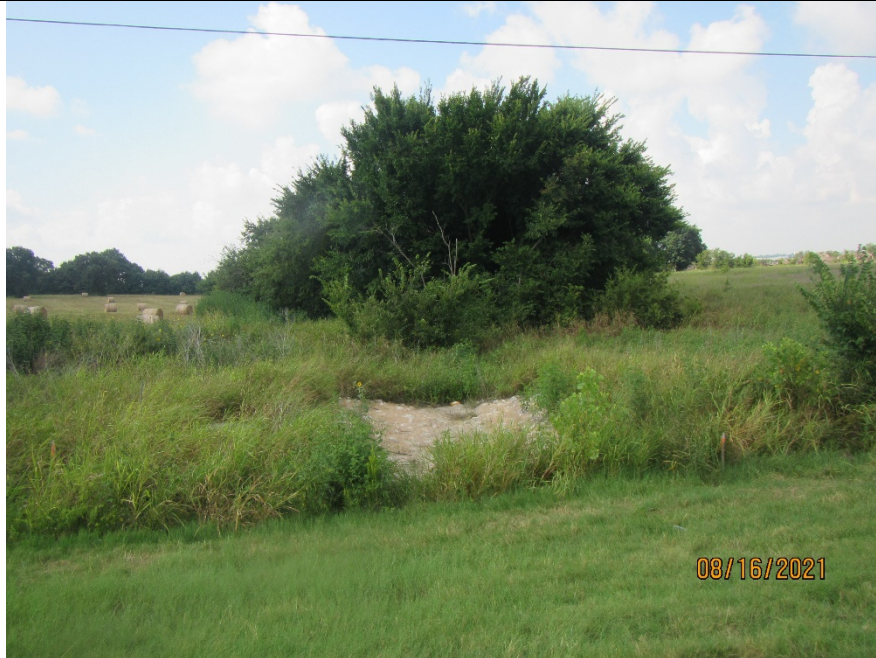
**Photo 57.**  
Photo of ditch drainage feature **Water Feature 102**. Representative photo of ditch drainage features adjacent to US 380, **Water Feature 96, Water Feature 97, Water Feature 98, Water Feature 101, Water Feature 103, Water Feature 105, and Water Feature 106**. Dominant vegetation was bermudagrass. Photo was taken on August 16, 2021.

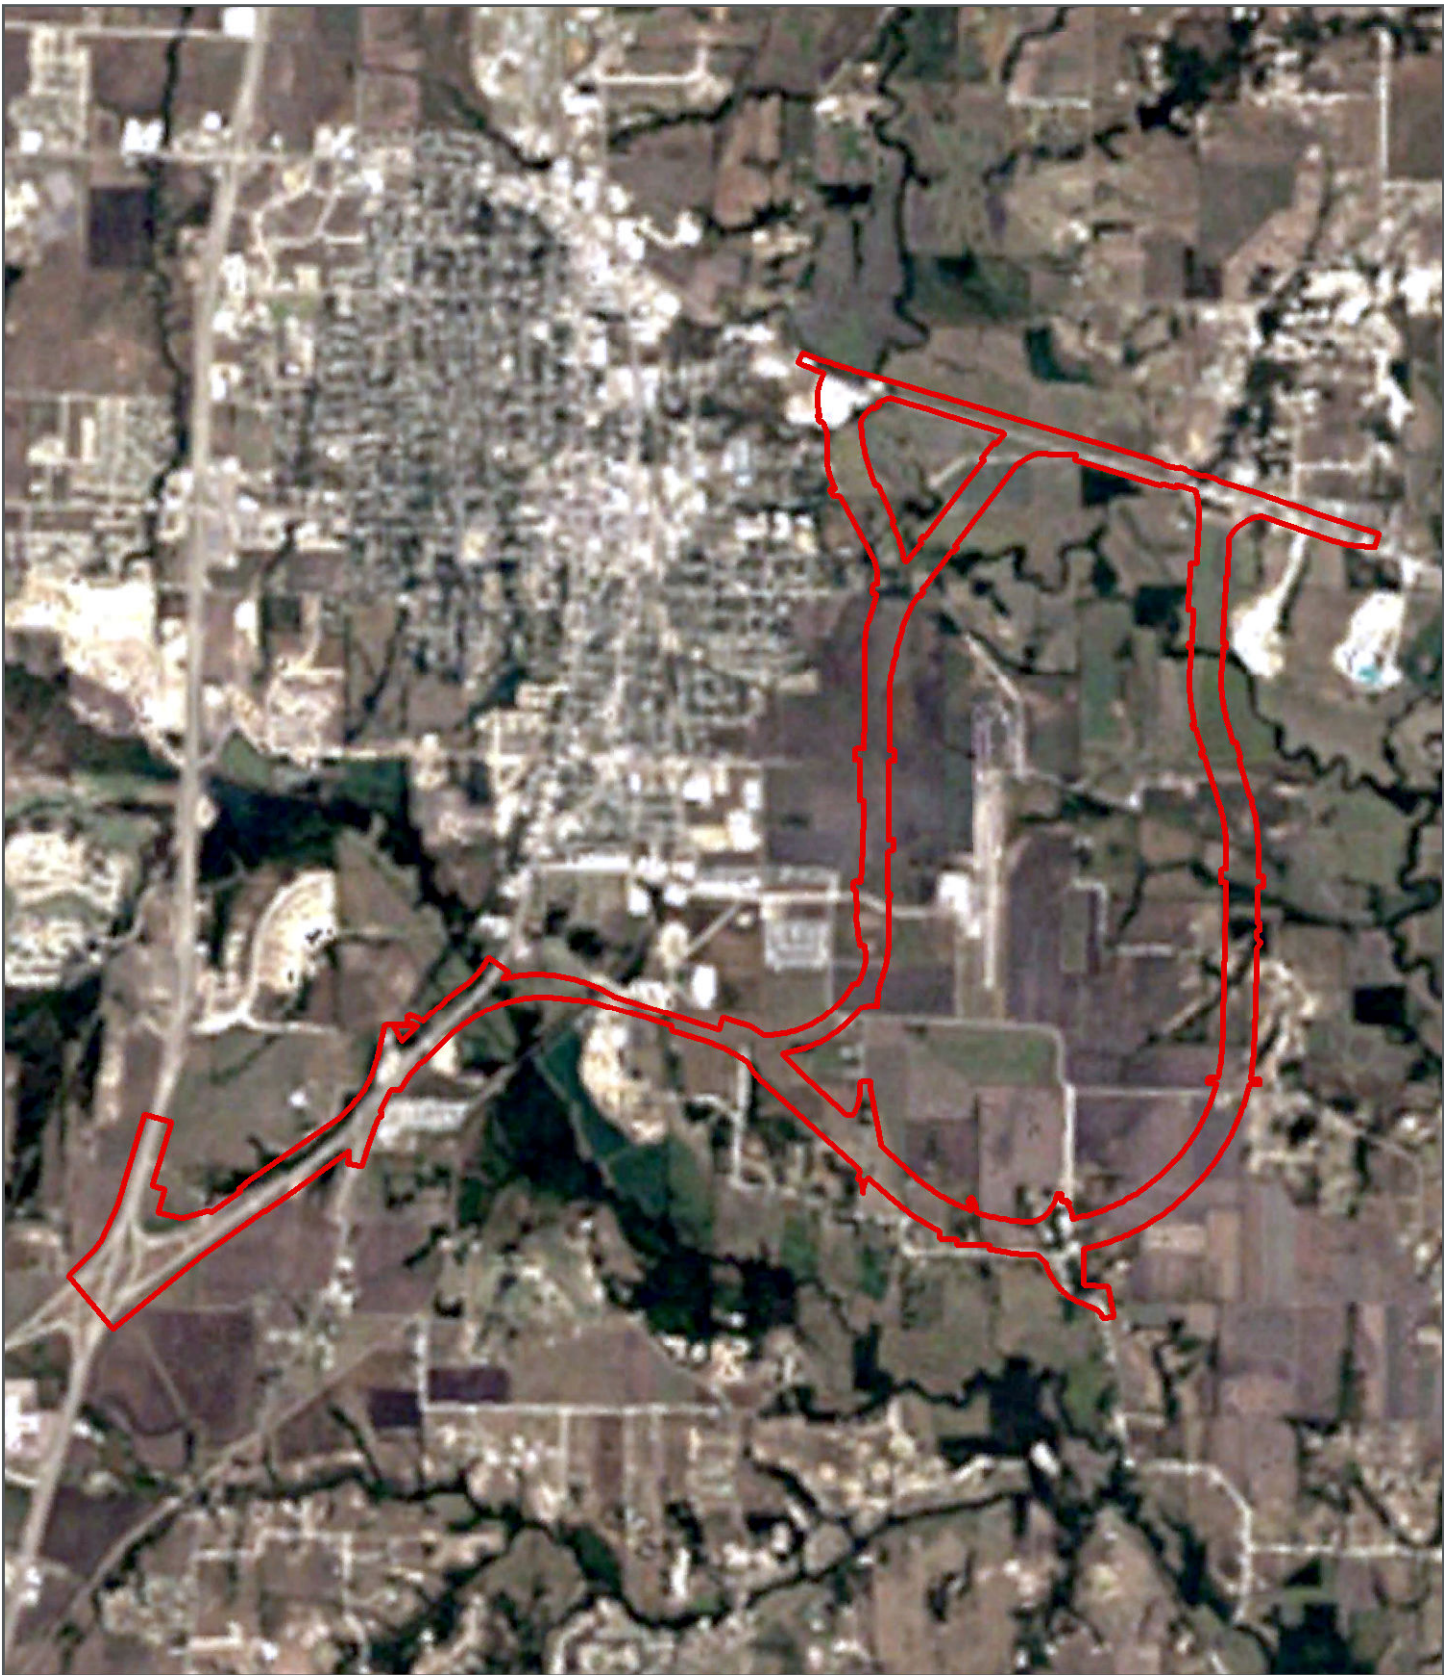
FIGURE 2

Attachment 1 – Figures contains numbered maps of the Project area. Figure 1 provides a vicinity map that depicts the location of the Project area. Figure 2 is an aerial overview map of the Project area. Figure 3 is a 7.5-minute series United States Geological Survey (USGS) topographic overview map. Figure 4 is an NWI map. Figure 5 is a Natural Resources Conservation Service (NRCS) soil unit map. Figure 6 is a Federal Emergency Management Agency (FEMA) 100-year floodplain map. Figure 7 is a TxDOT Contour map showing 2-foot contours of the Project area. Figure 8 is a series of Water Features maps depicting delineated water feature boundaries.

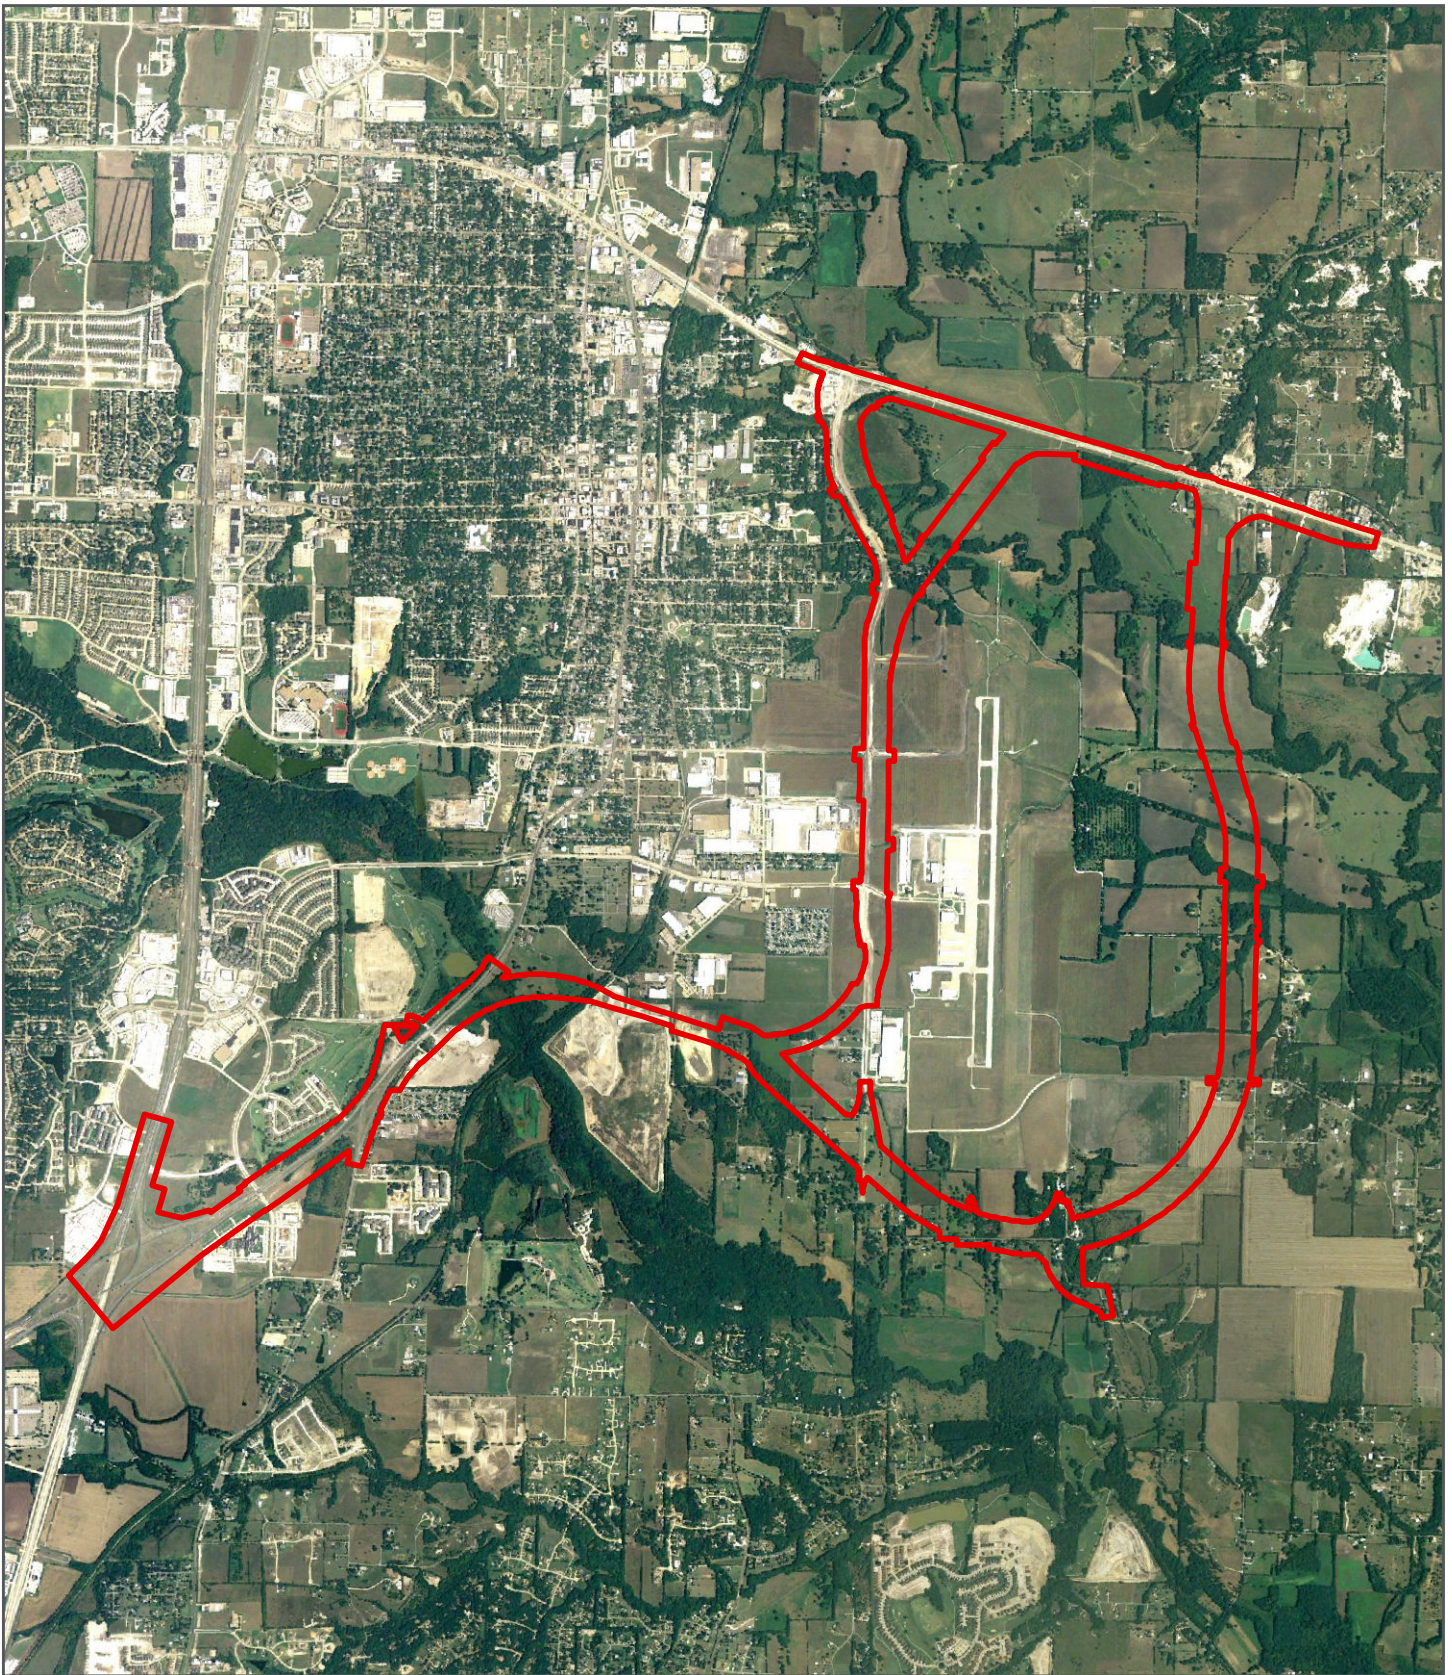
FIGURE 5

The table below summarizes the soil units represented within the Project area based on information collected from the Web Soil Survey database. Refer to Figure 5 in Attachment 1 for an illustration of the mapped soil units in and surrounding the Project area.
