APPENDIX N: Water Resources

Attachment 4 - Site Photographs

Representative Environmental Footprint Photographs
Water Features Delineation
TxDOT US 380

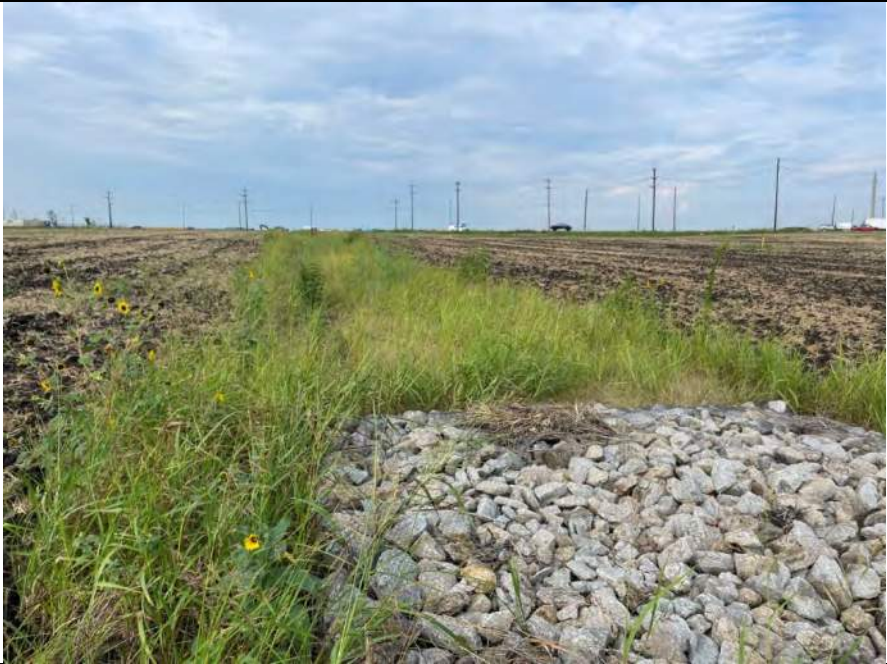
<p>Photo 1. Photo of Ditch Drainage Feature Water Feature 1. Water Feature 1 was constructed within an agricultural field to assist in draining. Note the anthropogenic symmetry and upland vegetation covering the entire channel. Photo taken to the southwest on August 17, 2021.</p>

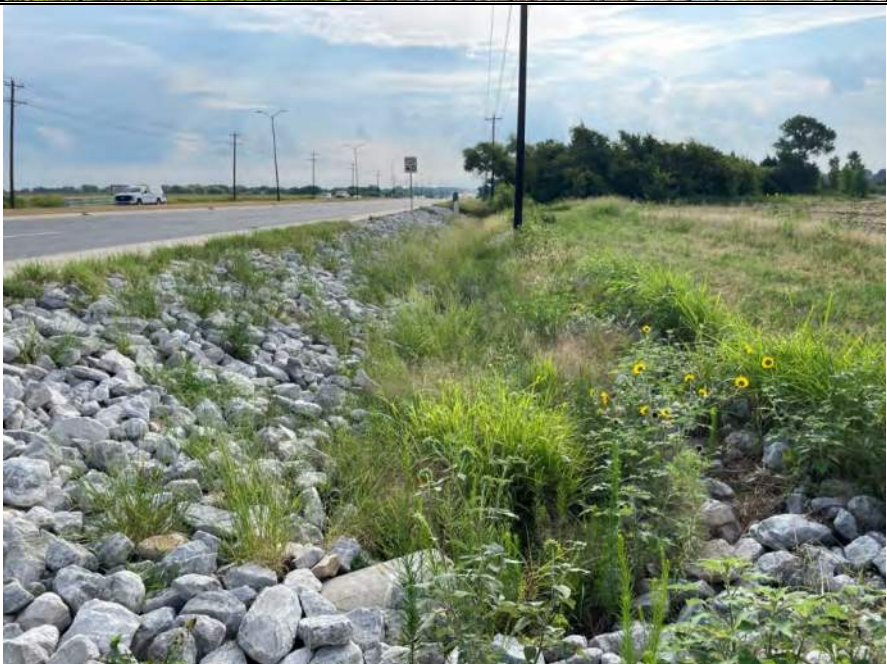
<p>Photo 2. Photo of Ditch Drainage Feature Water Feature 2. Water Feature 2 was constructed in uplands to assist in the rapid removal of water from US 380. Photo was taken to the east on August 17, 2021.</p>

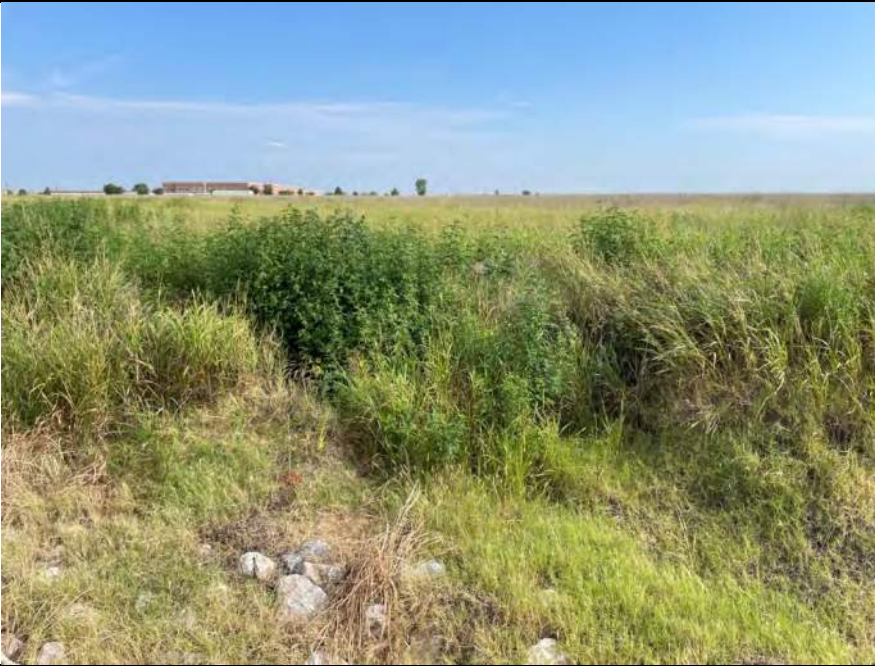
Photo 3.
Photo of Swale Drainage Feature **Water Feature 4** located in the western portion of the Environmental Footprint. Note the lack of an ordinary high-water mark (OHWM), hydrophytic vegetation, hydric soils, hydrological indicators, a stream bed, or banks within the area. Photo taken to the north on August 17, 2021.

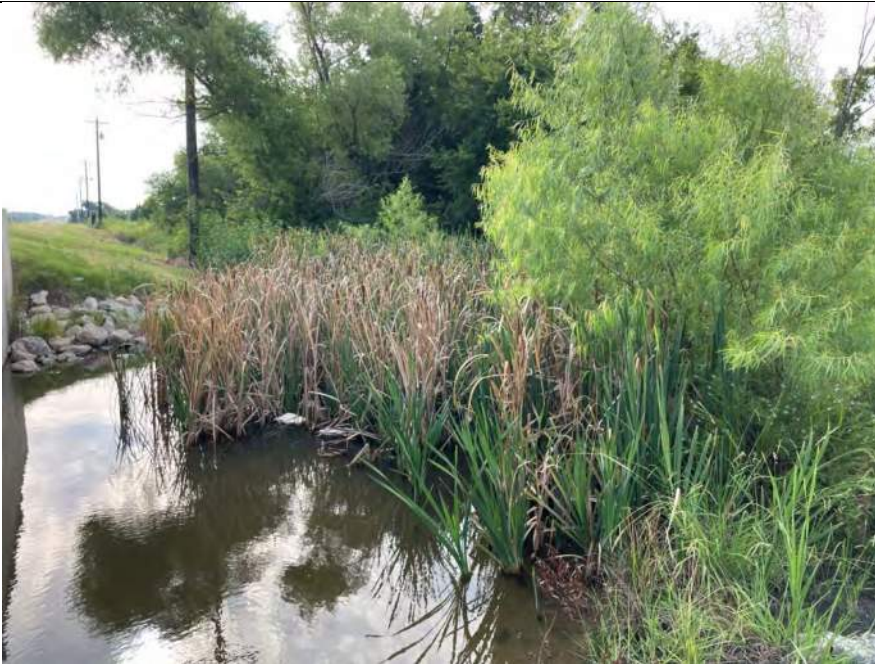
Photo 4.
Photo of Emergent Wetland **Water Feature 5** located in the western portion of the Environmental Footprint. Dominant vegetation included narrow-leaf cattail (*Typha angustifolia*) and black willow (*Salix nigra*). Intermittent Stream **Water Feature 6** flowed southeast through **Water Feature 5**. Photo was taken to the southeast on August 18, 2021.

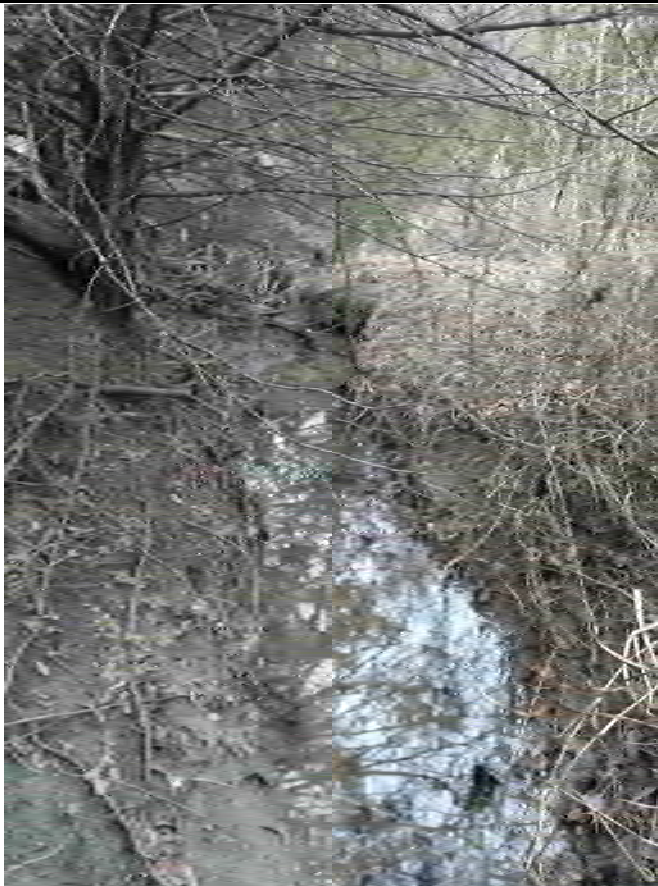
Photo 5.
Photo of Intermittent Stream **Water Feature 6** located in the western portion of the Environmental Footprint. **Water Feature 6** abuts **Water Feature 5** and flows to the southeast. Note the heavily wooded riparian zone and presence of flowing water within the channel. Photo was taken to the east on January 17, 2021.

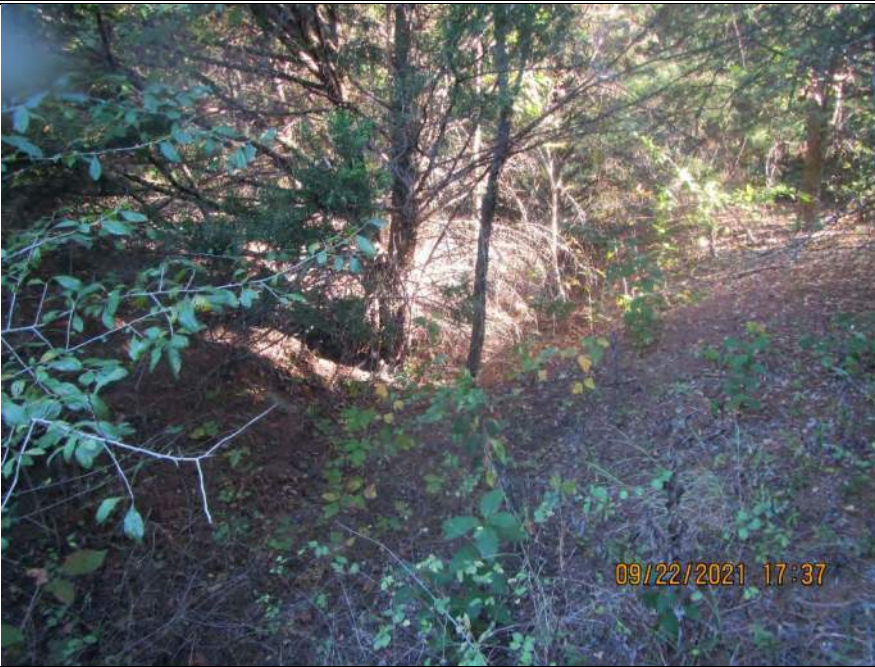
Photo 6.
Photo of Ephemeral Stream **Water Feature 7** located in the western portion of the Environmental Footprint. **Water Feature 7** flows south into **Water Feature 6**. Note the heavily wooded riparian zone, lack of water within the channel, and defined stream banks. Photo was taken to the south on September 22, 2021.

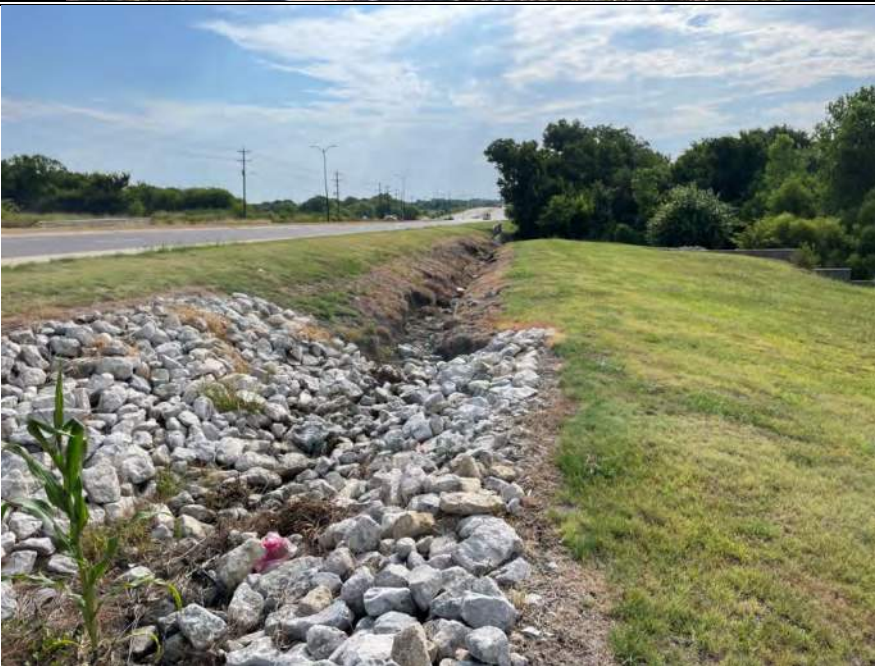
Photo 8.
Photo of Ditch Drainage Feature **Water Feature 10** located in the western portion of the Environmental Footprint. **Water Feature 10** was constructed in uplands and drained east into **Water Feature 11**. Photo was taken to the east on August 17, 2021.

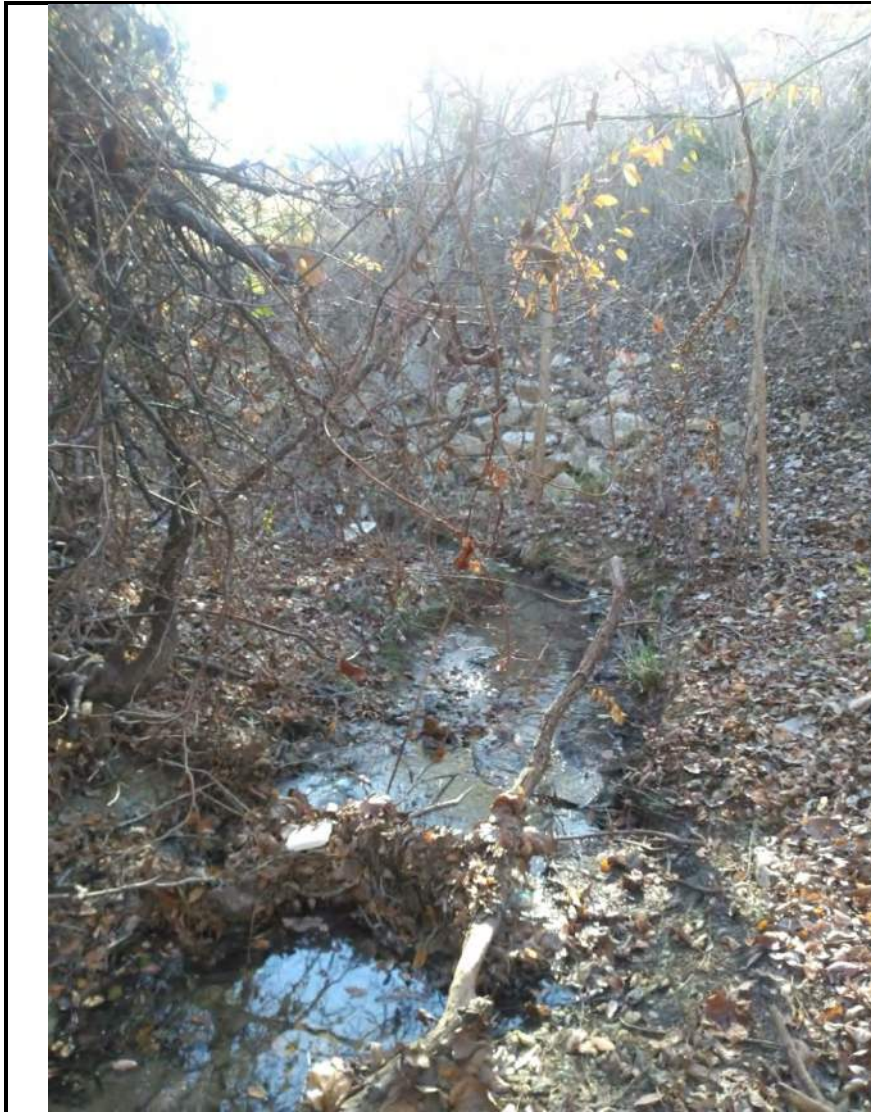
Photo 9.
Photo of Intermittent Stream **Water Feature 11** located in the western portion of the Environmental Footprint. Note the root bound edges, clear water, riffle-pool sequences, heavily wooded riparian zone, and gravel/cobble substrate. Photo is representative of **Water Feature 287**. Photo was taken to the west December 1, 2020.

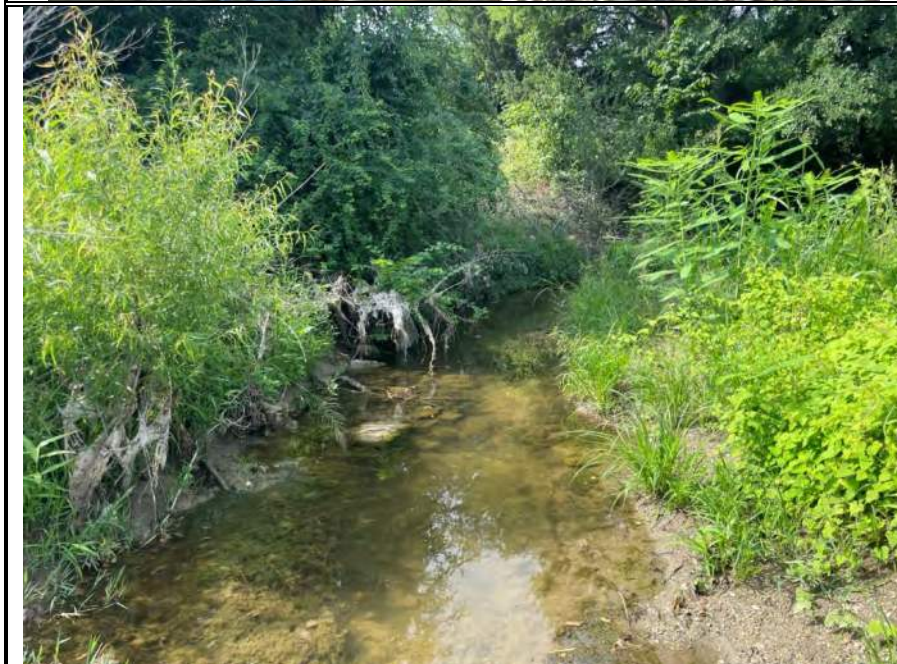
Photo 10.
Photo of Perennial Stream **Water Feature 16**, also known as Rutherford Branch, located in the western portion of the Environmental Footprint. Note the exposed bed rock and deep clear pools of water. **Water Feature 16** is hydrologically influenced by ground water. Photo was taken to the north on August 17, 2021.

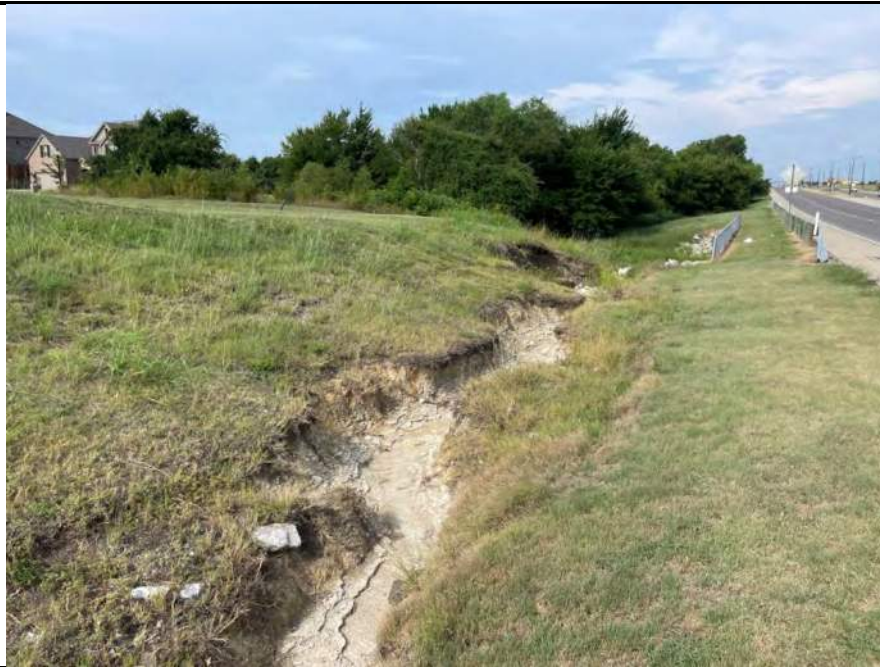
Photo 11.
Photo of Ditch Drainage Feature **Water Feature 22** in the western portion of the Environmental Footprint. Photo is representative of Ditch Drainage Feature **Water Feature 23**. Note the erosion and adjacency to US 380. Photo was taken to the west on August 17, 2021.

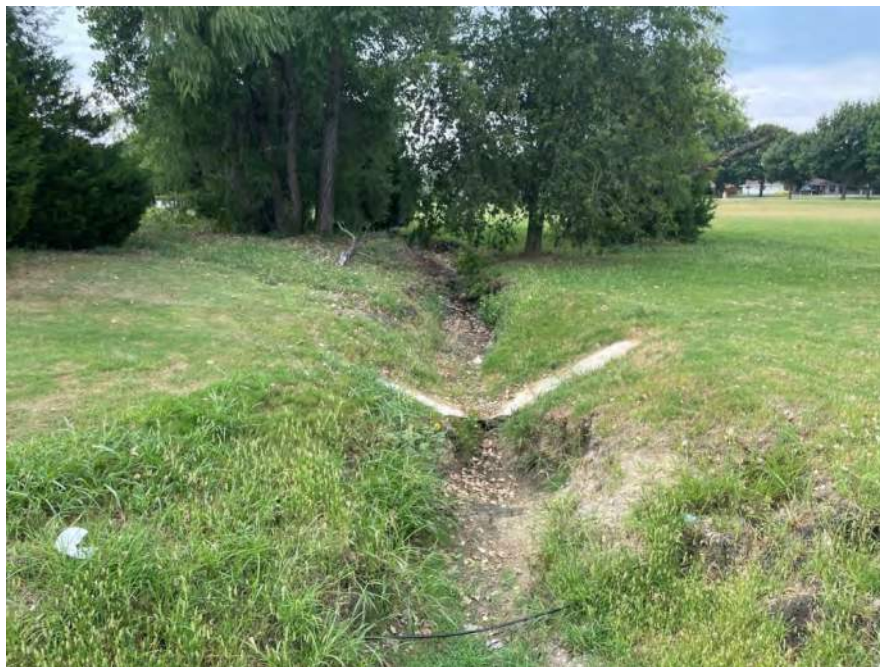
Photo 12.
Photo of Ephemeral Stream **Water Feature 25** located in the western portion of the Environmental Footprint. Note the lack of water within the defined channel and eroded banks. Dominant riparian vegetation was bermudagrass. Photo was taken to the south on August 17, 2021.

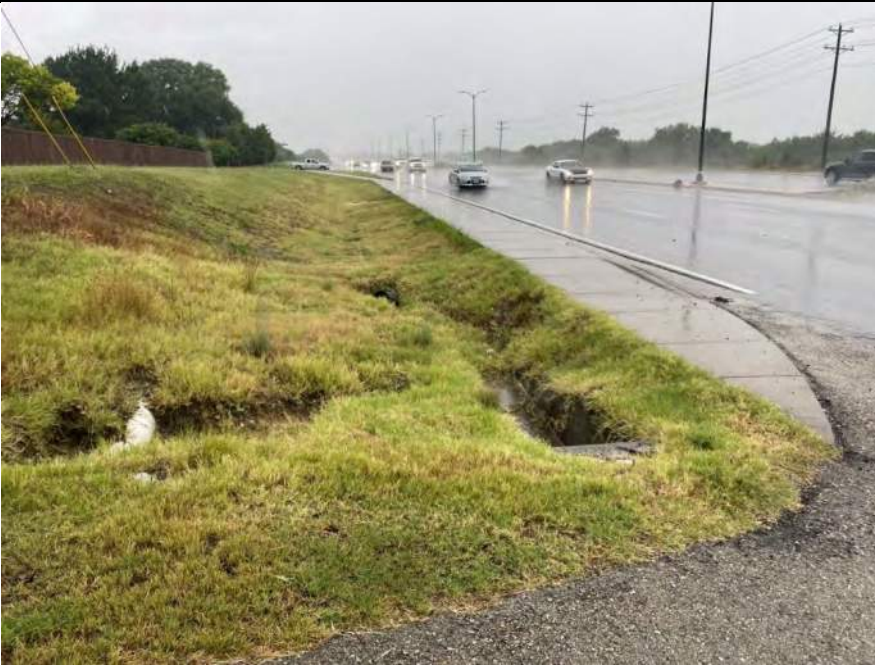
Photo 13.
Photo of Ditch Drainage Feature **Water Feature 27** in the western portion of the Environmental Footprint adjacent to US 380. **Water Feature 27** was constructed in uplands and contained a section of scour. Photo taken to the west on August 17, 2021. Photo is representative of Ditch Drainage Features **Water Feature 9, 28, 34, 36, 38, 39, 40, 41, 42, 43, 47, 48, 55, 56, 57, 60, 67, 68, 73, 74, 86, 90, 93, 95, 96, 324, and 326.**

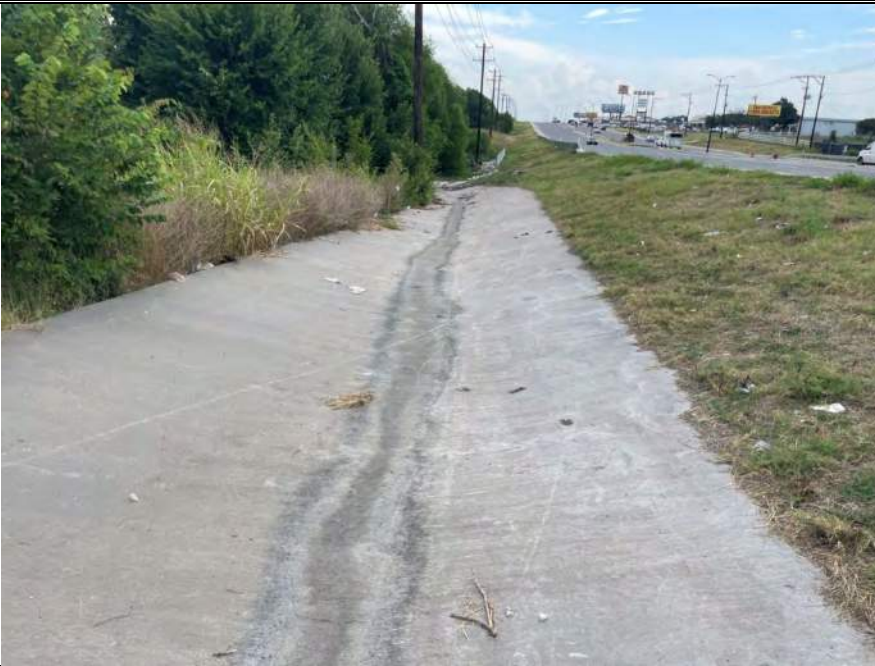
Photo 14.
Photo of Ditch Drainage Feature **Water Feature 29** located in the western portion of the Environmental Footprint adjacent to US 380. **Water Feature 29** was lined with concrete to prevent erosion. Photo was taken to the east on August 17, 2021. Photo is representative of Ditch Drainage Features **Water Feature 44, 49, and 75.**

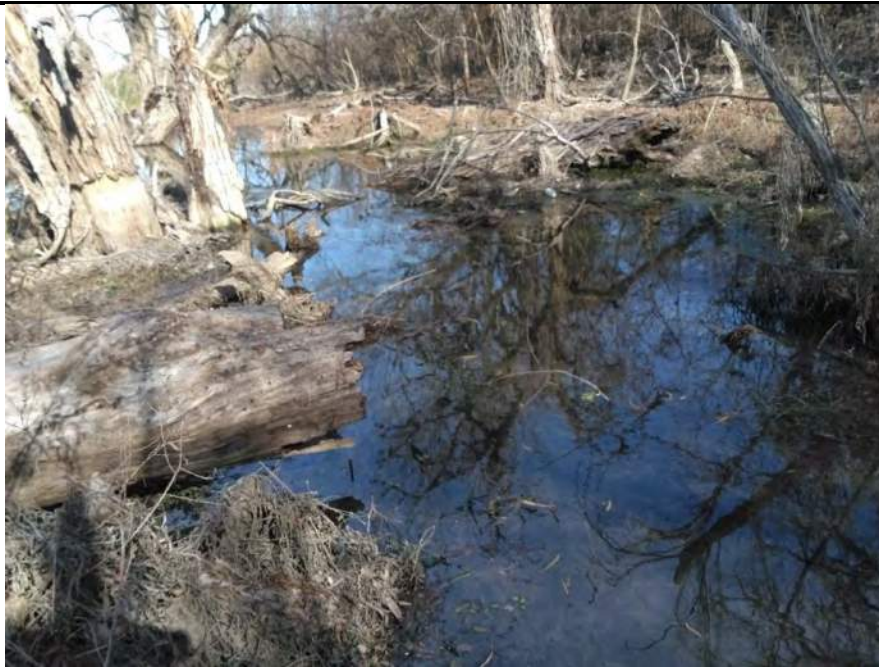
Photo 15.
Photo of Perennial Stream **Water Feature 31** located in the western portion of the Environmental Footprint. Note the inundation from downstream impoundment, wrack line, and dead terrestrial vegetation. **Water Feature 31** abuts **Water Feature 32** and flows into **Water Feature 33**. Photo was taken to the north on December 22, 2020.

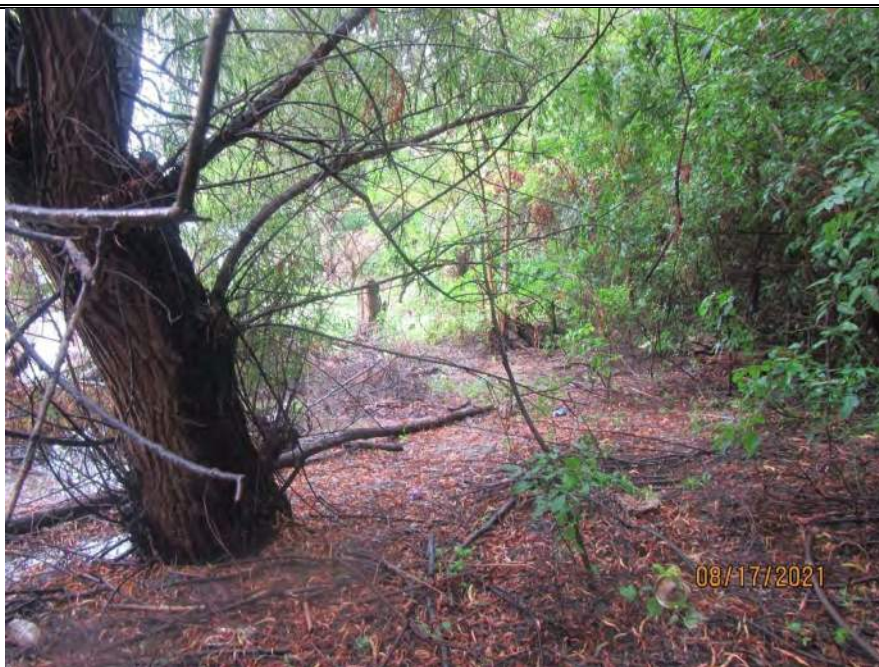
Photo 16.
Photo of Forested Wetland **Water Feature 32** located in the western portion of the Environmental Footprint. Dominant vegetation included black willow and green ash (*Fraxinus pennsylvanica*). **Water Feature 32** abuts Emergent Wetland **Water Feature 33** and Perennial Stream **Water Feature 31**. Photo was taken to the north on August 17, 2021.

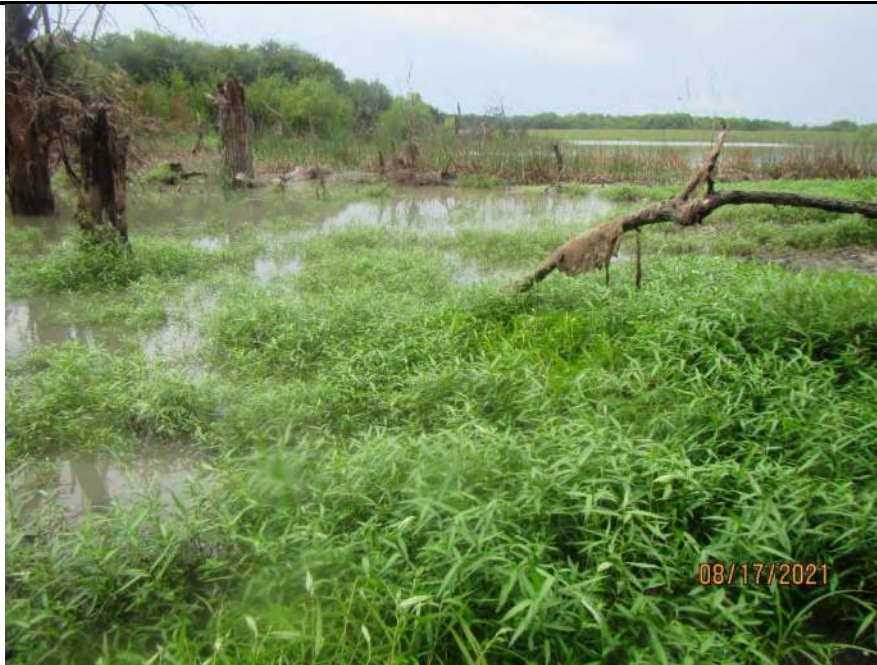
Photo 17. Photo of Emergent Wetland **Water Feature 33** located in the western portion of the Environmental Footprint. Dominant vegetation included swamp smartweed (*Persicaria hydropiperoides*). **Water Feature 33** abuts On-Channel Pond **Water Feature 124** and Forested Wetland **Water Feature 32** and is hydrologically connected to Perennial Stream **Water Feature 31**, Perennial Stream **Water Feature 37**, and Forested Wetland **Water Feature 125**. Photo was taken to the northwest on August 17, 2021.

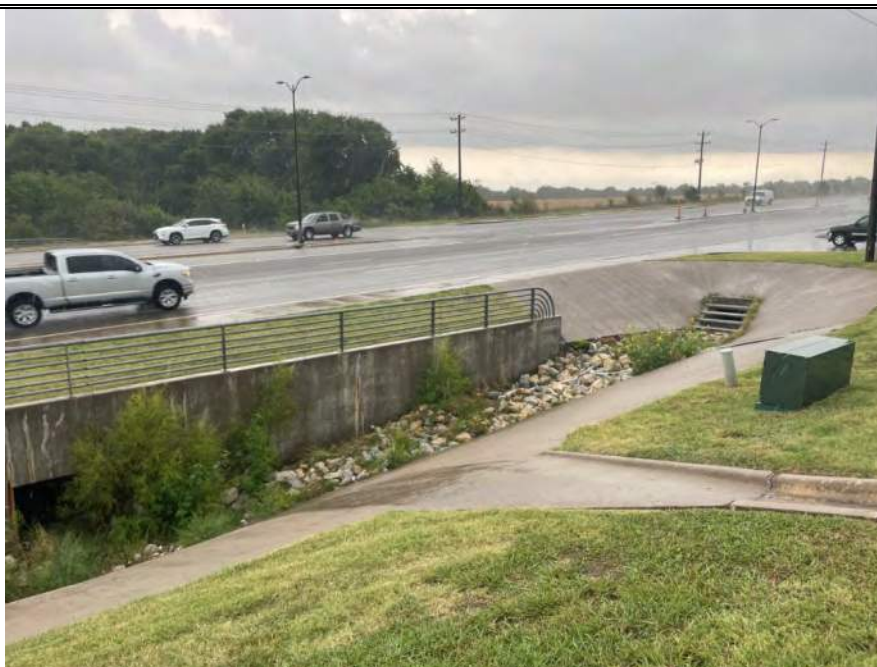
Photo 18. Photo of Ditch Drainage **Water Feature 35** located in the western portion of the Environmental Footprint adjacent to US 380. **Water Feature 35** had riprap to control erosion. **Water Feature 35** flowed north through a box culvert into **Water Feature 37**. Photo taken to the northeast on August 17, 2021.

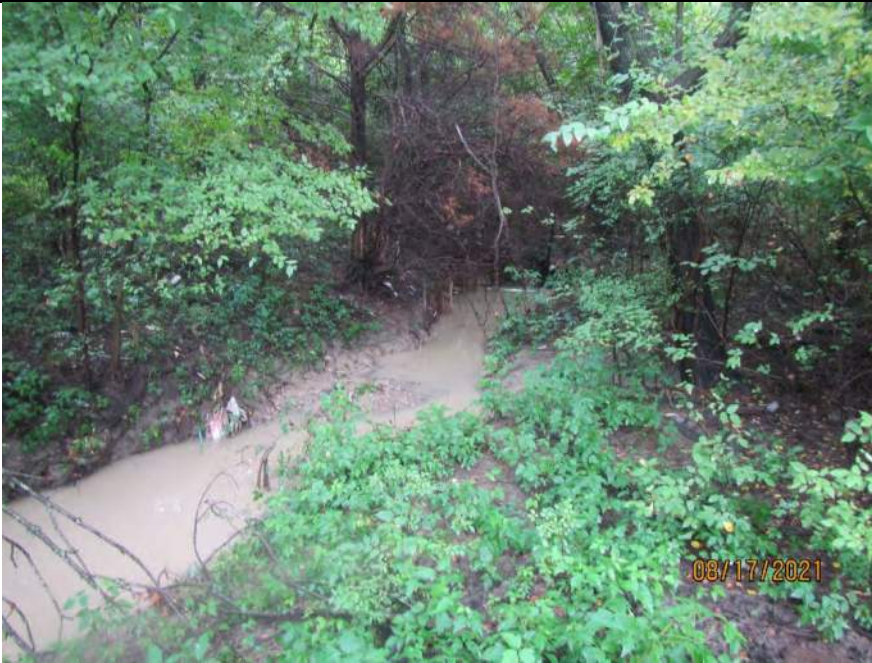
Photo 19.
Photo of Perennial Stream **Water Feature 37** located in the western portion of the Environmental Footprint. Note the incised banks and inundation from downstream impoundment. Photo was taken to the west on December 22, 2020.

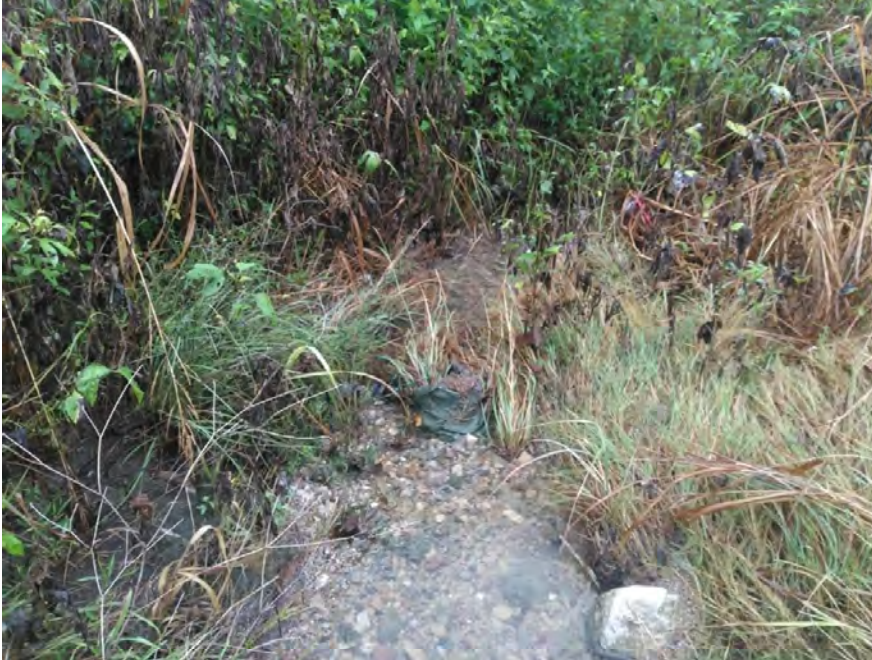
Photo 20.
Photo of Ephemeral Stream **Water Feature 45** located in the western portion of the Environmental Footprint. **Water Feature 45** was inundated during the delineation due to recent precipitation. Note the bank stabilization by vegetation. Dominant riparian vegetation included American elm, johnsongrass, and great ragweed. Photo was taken to the north on August 18, 2021.

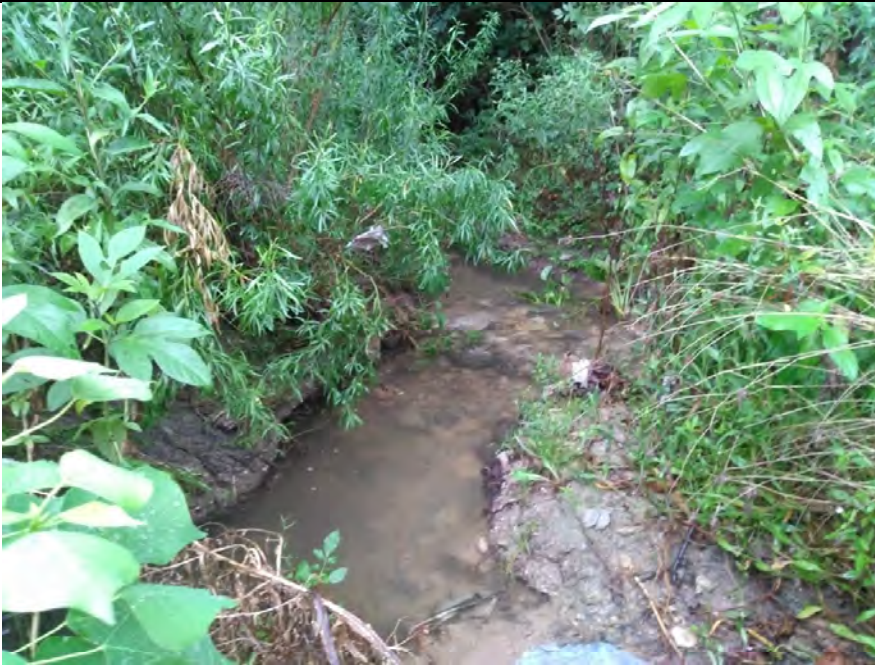
Photo 21.
Photo of Intermittent Stream **Water Feature 51** located in the western portion of the Environmental Footprint. Note the overhanging vegetation, riffle-pool sequences, gravel/cobble substrate, and debris within stream channel. Dominant riparian vegetation included American elm, johnsongrass, and great ragweed. Photo was taken to the north on August 18, 2021.

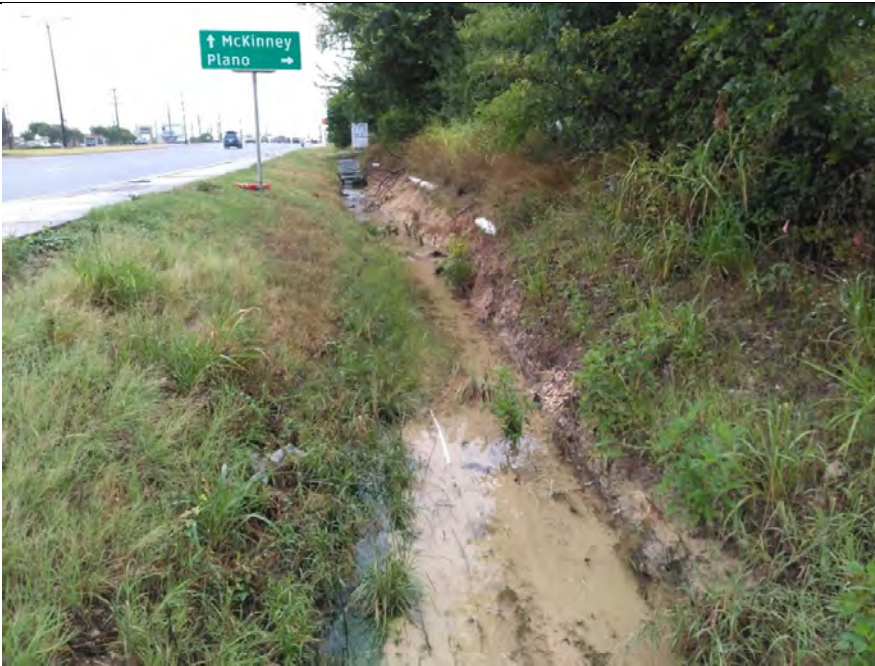
Photo 22.
Photo of Ditch Drainage Feature **Water Feature 54**, located in the western portion of the Environmental Footprint adjacent to US 380. **Water Feature 54** was constructed in uplands and experienced high flow during the delineation. Photo was taken to the east on August 18, 2021.

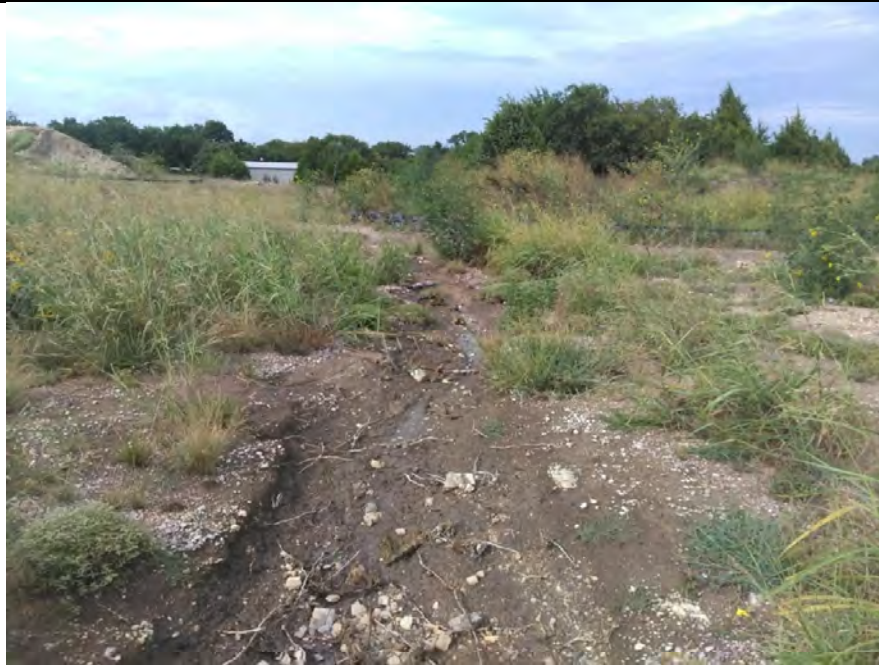
Photo 23. Photo of Ephemeral Stream Water Feature 58 located adjacent to US 380 in the western portion of the Environmental Footprint. **Water Feature 58** flows north and receives hydrology from precipitation and runoff from US 380. Dominant riparian vegetation included bermudagrass, johnsongrass, and common sunflower (*Helianthus annuus*). Photo was taken to the north on August 18, 2021.

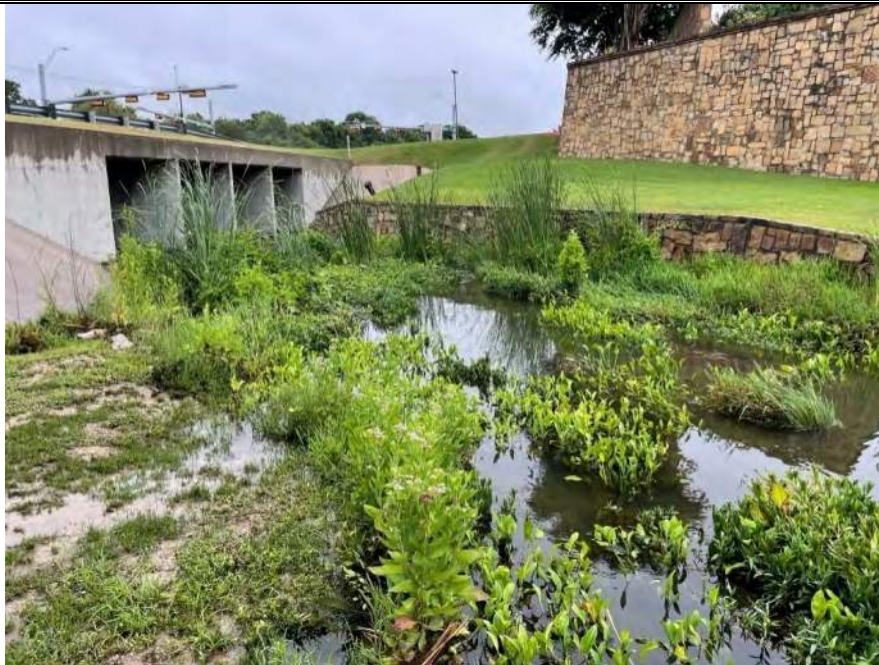
Photo 24. Photo of Emergent Wetland **Water Feature 61** located in the western portion of the Environmental Footprint. Dominant vegetation included broad-leaf cattail (*Typha latifolia*) and common spike-rush (*Eleocharis palustris*). **Water Feature 61** abuts Perennial Stream **Water Feature 62**. Photo was taken to the northeast on December 22, 2020.

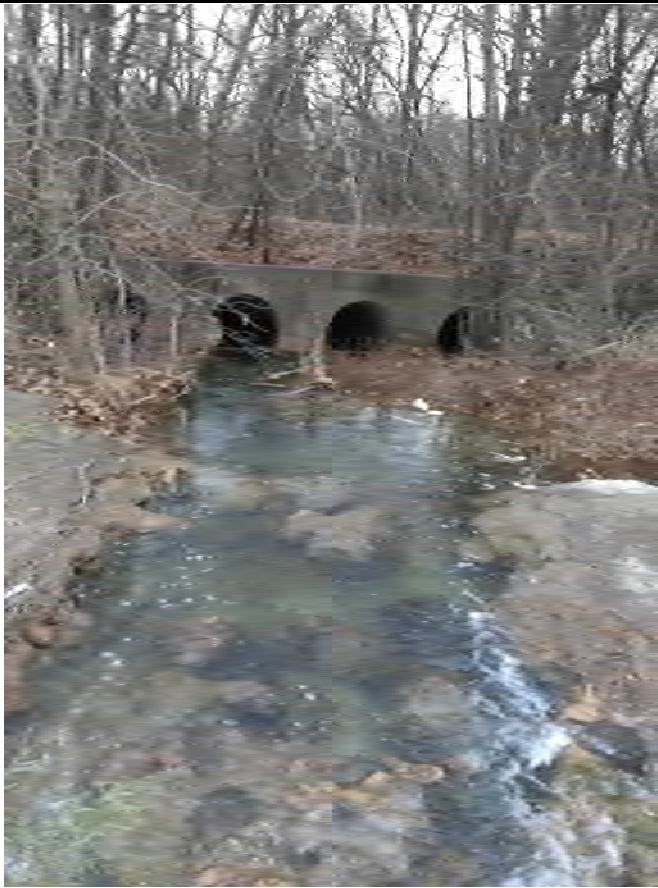
Photo 25.
Photo of Perennial Stream **Water Feature 62** located in the western portion of the Environmental Footprint. **Water Feature 62** abuts **Water Feature 61** and flows north into Pond **Water Feature 63**. **Water Feature 62** receives hydrology from precipitation and groundwater. Note the bedrock/cobble substrate, clear water, riffle-pool sequences, and heavily wooded riparian zone. Photo was taken to the north on January 19, 2021.

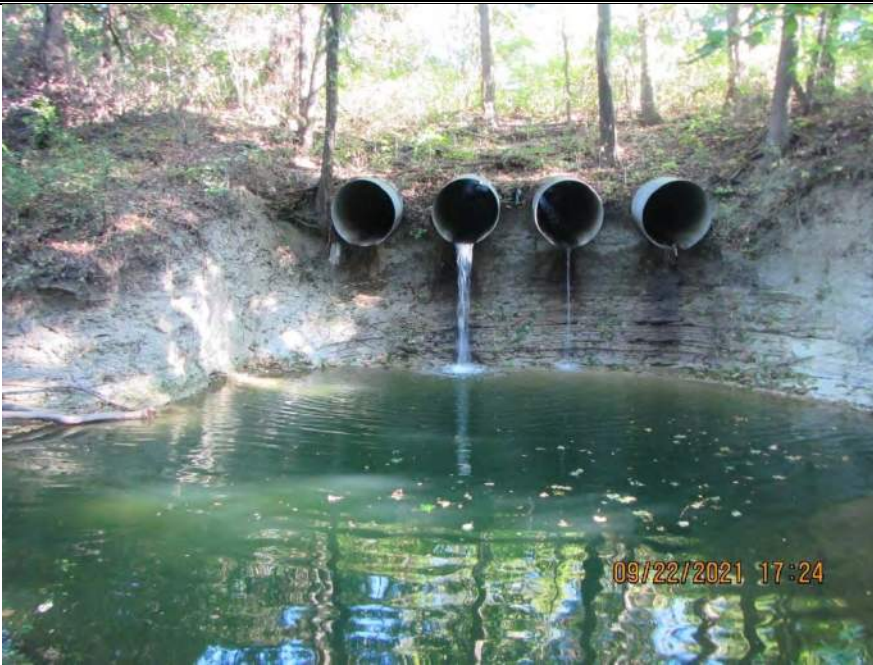
Photo 26.
Photo of Pond **Water Feature 63** located in the western portion of the Environmental Footprint. **Water Feature 63** is hydrologically connected to **Water Feature 62** and **65**. Photo taken to the south on September 22, 2021.

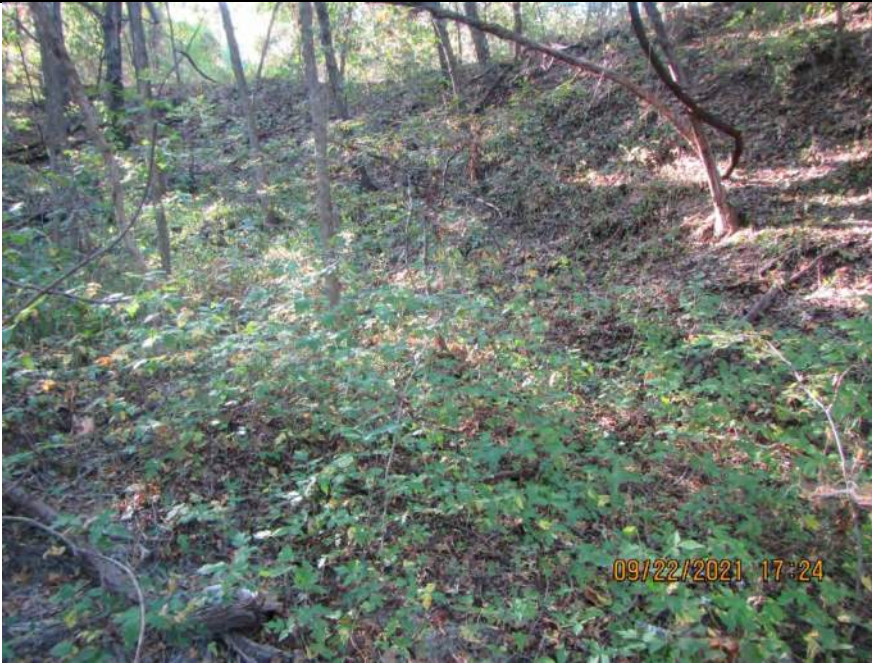
Photo 27.
 Photo of Swale
 Drainage Feature
Water Feature 64
 located in the
 western portion of
 the Environmental
 Footprint. **Water
 Feature 64**
 provides overland
 flow to **Water
 Feature 63**. Photo
 was taken to the
 west on September
 22, 2021.

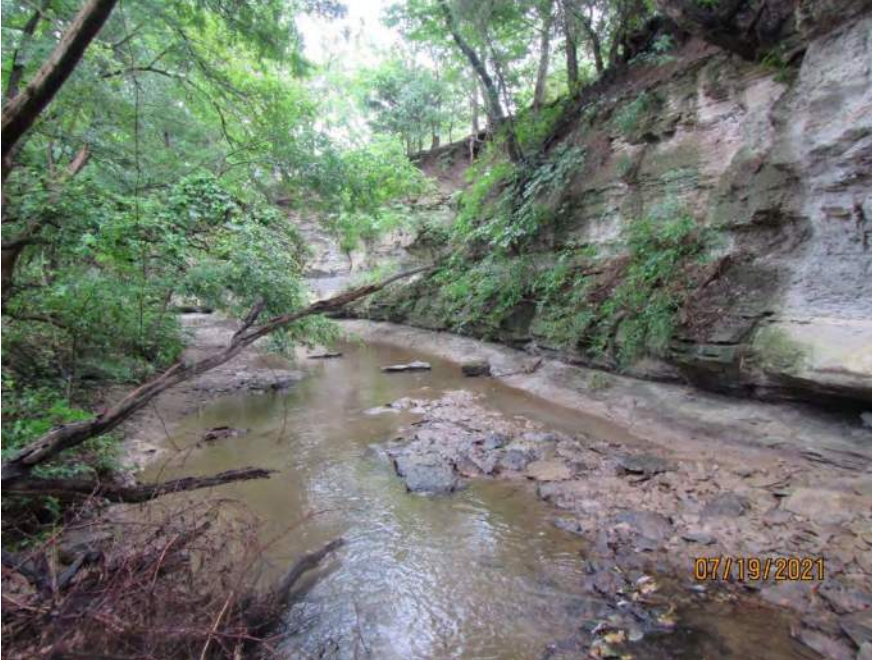
Photo 28.
 Photo of Perennial
 Stream **Water
 Feature 65** located
 in the western
 portion of the
 Environmental
 Footprint. **Water
 Feature 65**
 receives hydrology
 from precipitation,
Water Feature 63,
 and groundwater.
 Note the
 channelized nature,
 erosion through
 limestone bedrock,
 heavily wooded
 riparian zone,
 overhanging
 vegetation, and
 riffle-pool
 sequences. Photo
 was taken to the
 east on July 19,
 2021.

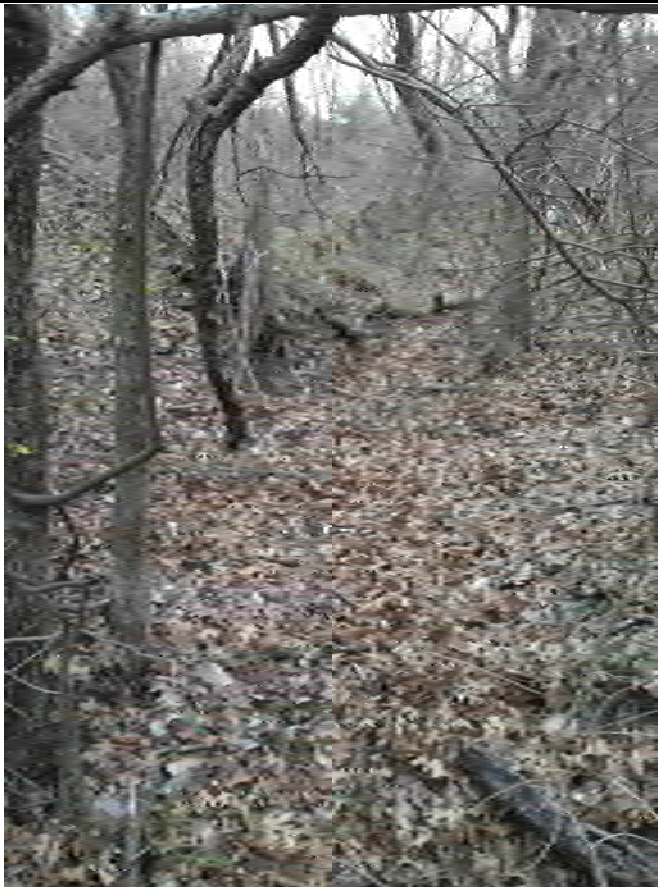
Photo 29.
Photo of Ephemeral Stream **Water Feature 66** located in the western portion of the Environmental Footprint. Note the lack of water, freshly fallen leaves, destroyed vegetation, and large trees providing bank stabilization. Dominant vegetation included bur oak (*Quercus macrocarpa*), Shumard oak (*Quercus shumardii*), and chinkapin oak (*Quercus muehlenbergii*). Photo was taken to the northeast on January 19, 2021.

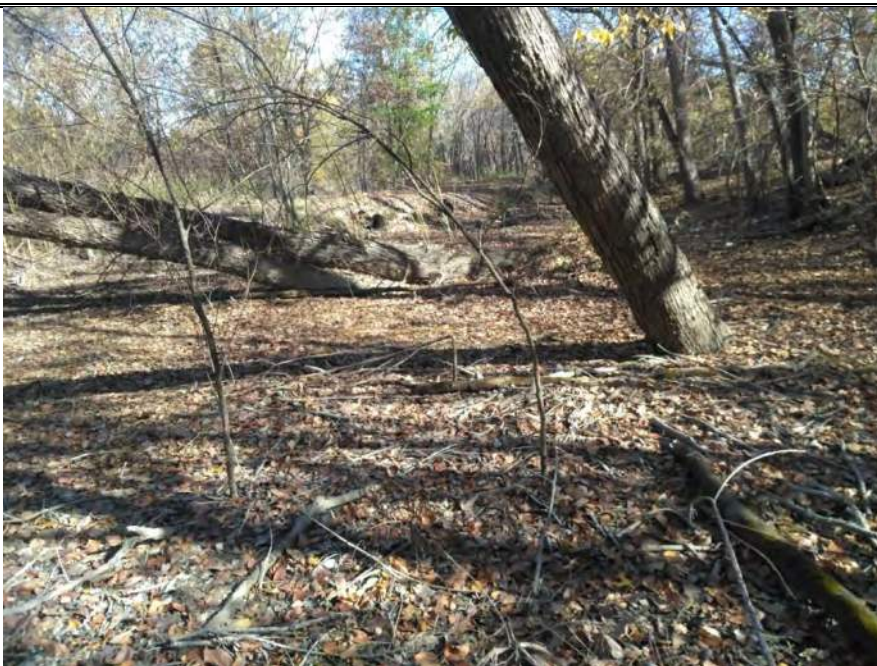
Photo 30.
Photo of Forested Wetland **Water Feature 69** located in the western portion of the Environmental Footprint. Dominant vegetation included black willow. **Water Feature 69** is hydrologically connected to Ephemeral Stream **Water Feature 70** outside of the Environmental Footprint. Photo was taken to the north on November 11, 2021.

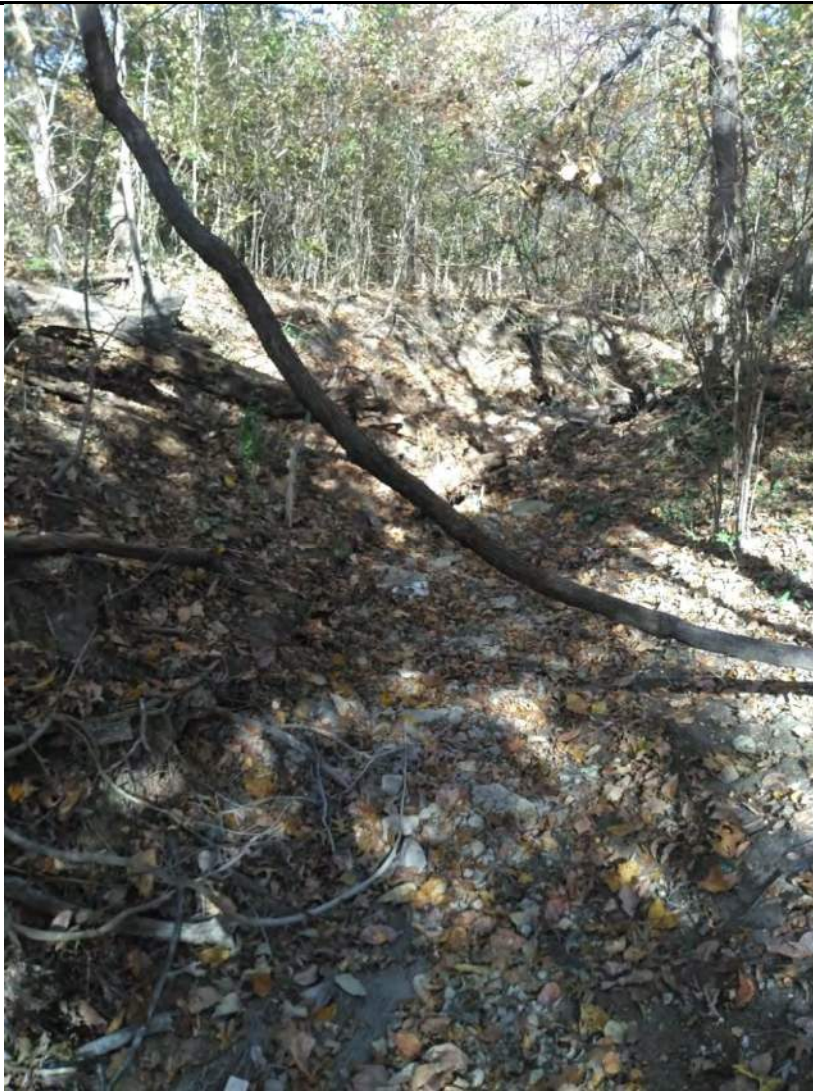
Photo 31.
Photo of Ephemeral Stream **Water Feature 70** located in the western portion of the Environmental Footprint. **Water Feature 70** flows north into **Water Feature 69**. Note the gravel substrate, lack of water within the channel, and vegetation stabilizing the banks. Photo was taken to the north on November 9, 2020.

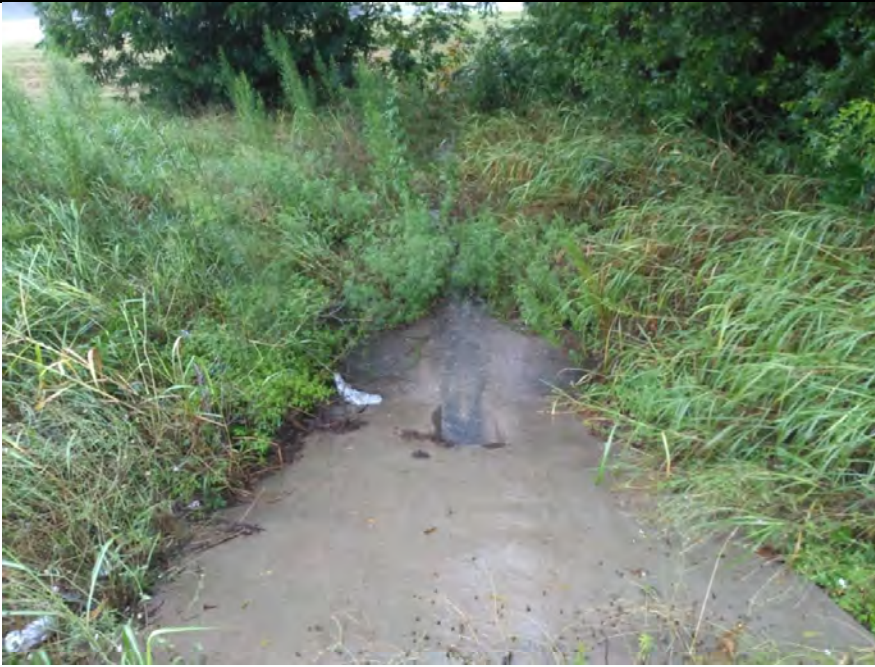
Photo 32.
Photo of Swale
Drainage Feature
Water Feature 71
located in the
western portion of
the Environmental
Footprint. Photo
representative of
Swale Drainage
Feature **Water
Feature 348.**
Water Feature 71
received its
hydrology from the
runoff of adjacent
parking lots fed
underground
through a culvert.
Note the lack of an
OHWM,
hydrophytic
vegetation, hydric
soils, hydrological
indicators, stream
bed, or banks
within the area.
Photo was taken to
the south on
August 18, 2021,
after a heavy
rainfall event.

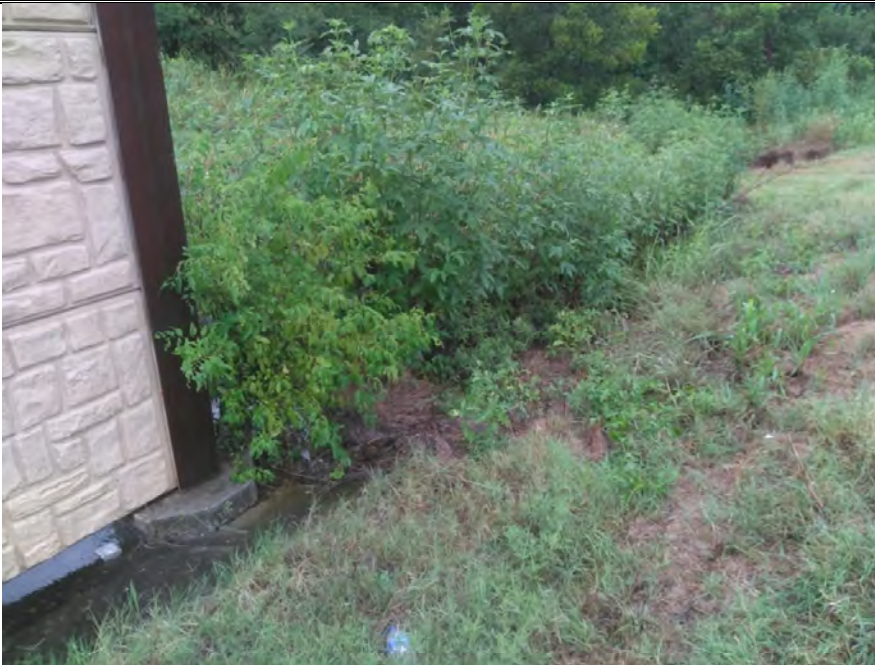
Photo 33.
Photo of Swale
Drainage Feature
Water Feature 72
in the western
portion of the
Environmental
Footprint. Note the
lack of an ordinary
high-water mark, a
stream bed/banks,
or wetland
characteristics.
Photo was taken to
the west on August
18, 2021, after a
heavy rainfall
event.
