APPENDIX N: Water Resources

Attachment 4 - Site Photographs

Representative Environmental Footprint Photographs
Water Features Delineation
TxDOT US 380

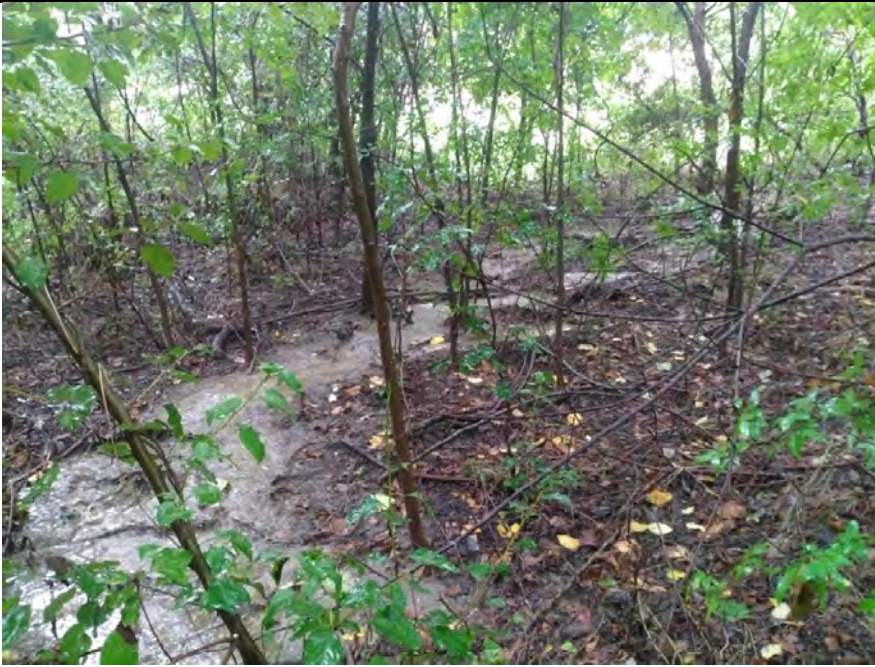
Photo 34. Photo of Swale Drainage Feature **Water Feature 77** in the western portion of the Environmental Footprint. Photo is representative of Ditch Drainage Feature **Water Feature 83**. Note the lack of an OHWM, hydrophytic vegetation, hydric soils, hydrological indicators, a stream bed, or banks within the area. Photo was taken to the east on August 18, 2021, after a heavy localized precipitation event.

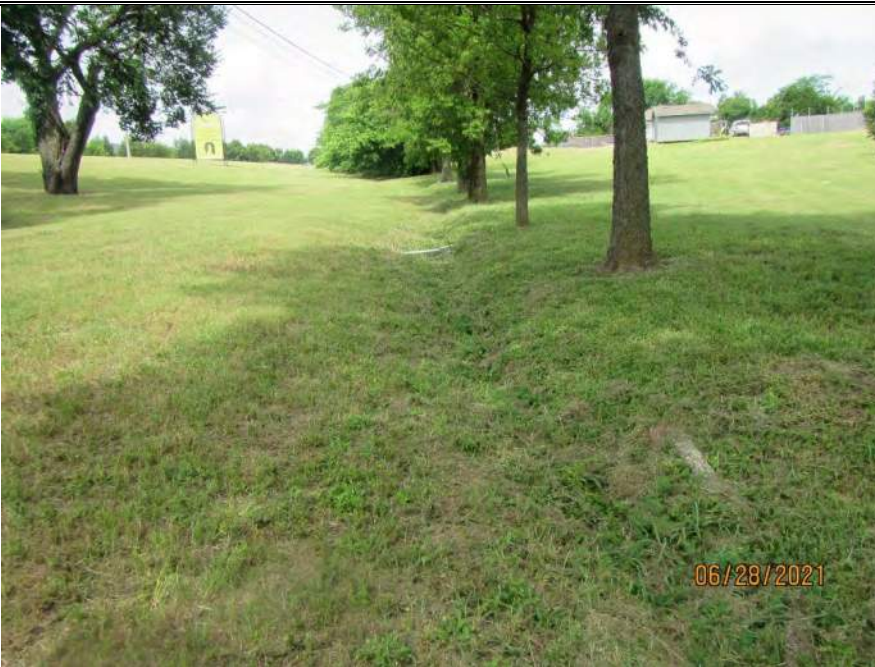
Photo 35. Photo of Swale Drainage Feature **Water Feature 78** in the western portion of the Environmental Footprint. Photo is representative of Swale Drainage Feature **Water Feature 76**. **Water Feature 78** received its hydrology from **Water Feature 73** and US 380. Note the lack of an ordinary Note the lack of an OHWM, hydrophytic vegetation, hydric soils, hydrological indicators, stream bed, or banks within the area. Photo was taken to the west on June 28, 2021.

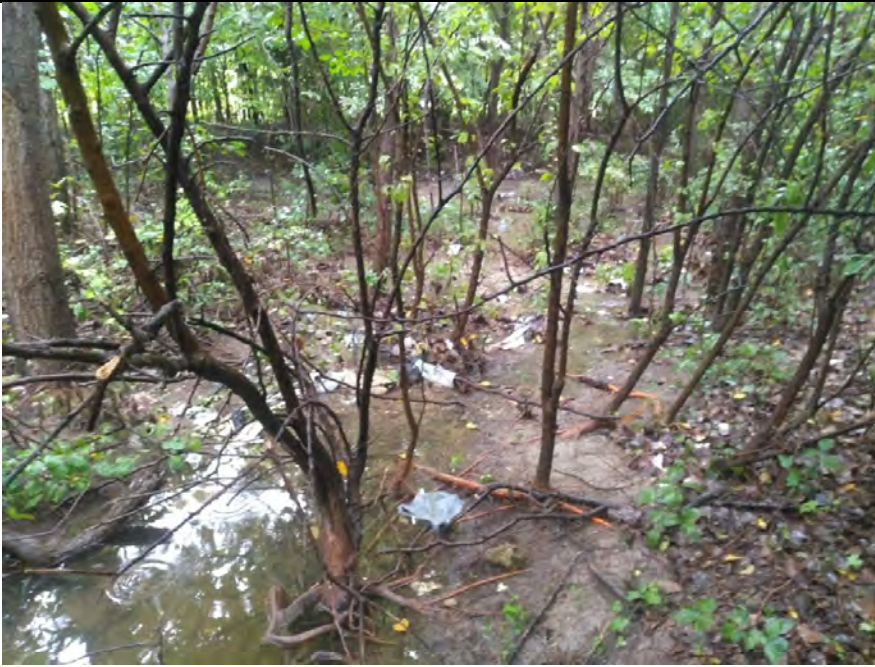
Photo 36.
Photo of Ephemeral Stream **Water Feature 79** located in the western portion of the Environmental Footprint. **Water Feature 79** receives hydrology from the underground drainage network of an adjacent subdivision and flows north into **Water Feature 80**. Note the shallow stream channel and water flow due to recent precipitation. Photog was taken to the northeast on August 18, 2021.

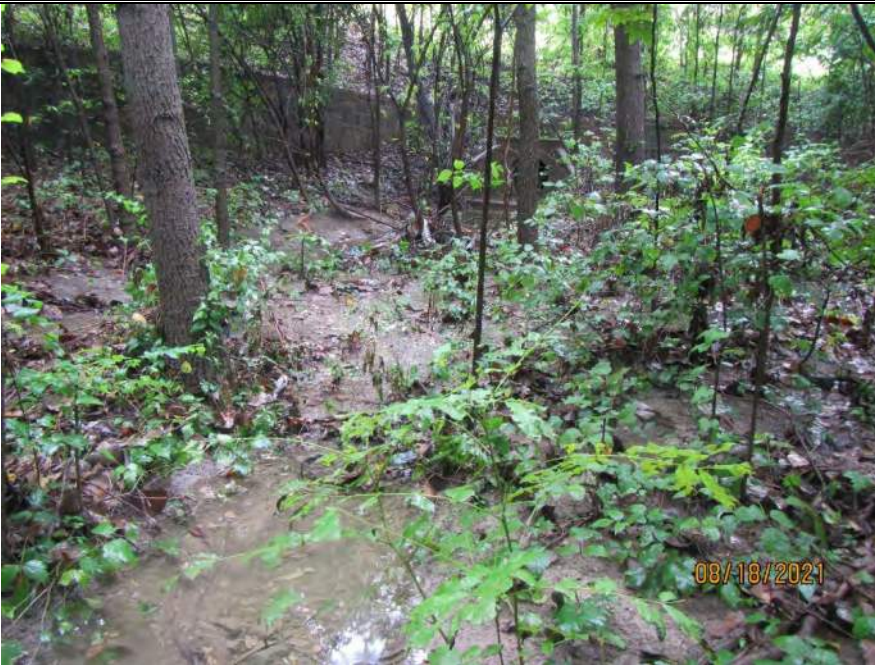
Photo 37.
Photo of Forested Wetland **Water Feature 80** located in the western portion of the Environmental Footprint. Dominant vegetation included American elm (*Ulmus americana*). **Water Feature 80** is influenced by culverts and concrete barriers. Photo was taken to the east on August 18, 2021.

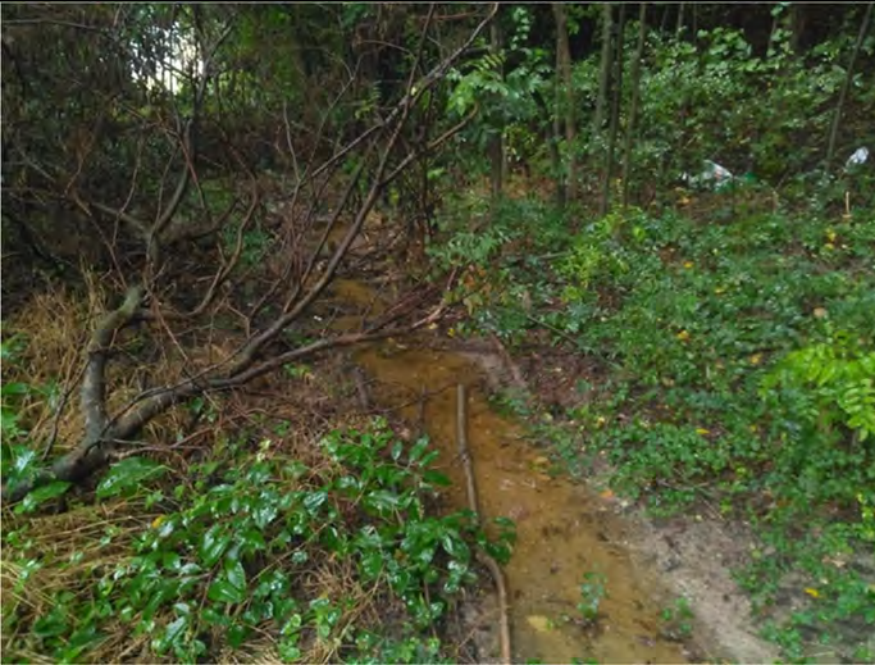
Photo 38.
Photo of Swale
Drainage Feature
Water Feature 81
in the western
portion of the
Environmental
Footprint. **Water
Feature 81**
received its
hydrology from the
roadside ditch
Water Feature 74.
Note the water
within feature due
to heavy ongoing
precipitation. Photo
was taken to the
west on August 18,
2021, after a heavy
precipitation event.

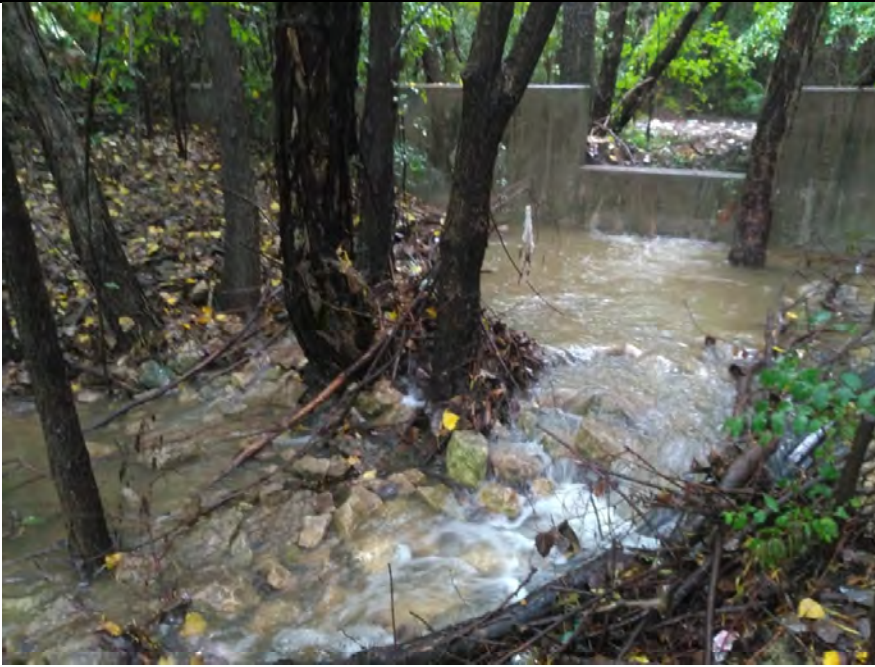
Photo 39.
Photo of Ephemeral
Stream **Water
Feature 82** in the
western portion of
the Environmental
Footprint. **Water
Feature 82** flowed
south into **Water
Feature 80.** Note
the shallow defined
channel and lack of
surface water. The
riparian vegetation
was dominated by
American elm and
pecan. Photo was
taken to the north
on August 18,
2021.

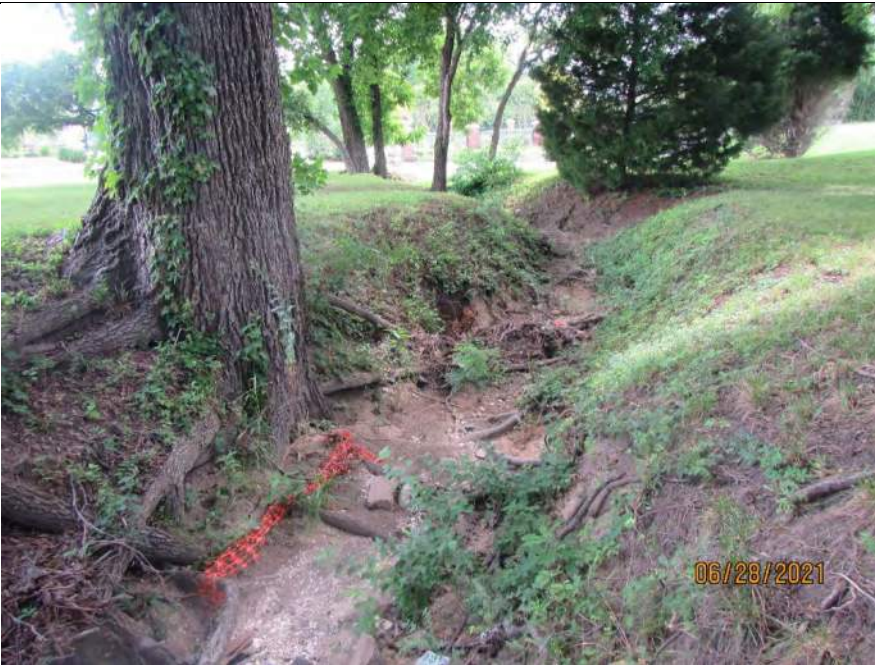
Photo 40. Photo of Ephemeral Stream **Water Feature 84** located in the western portion of the Environmental Footprint. The southern end of **Water Feature 84** was a stormwater control structure connected to **Water Feature 80**. Recent precipitation caused heavy water flow through **Water Feature 84**. The riparian vegetation was dominated by American elm and pecan (*Carya illinoensis*). Photo was taken to the south on August 18, 2021.

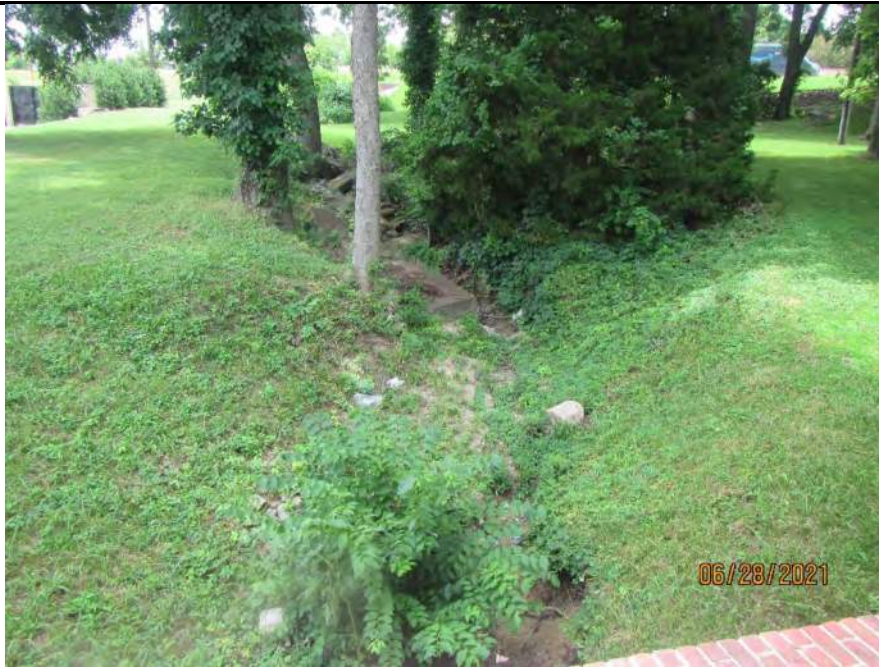
Photo 42.
Photo of Ephemeral Streams **Water Feature 88** and representative of Ephemeral Stream **Water Feature 87** located in the western portion of the Environmental Footprint. Note the defined channel, lack of surface water within stream bed, and concrete blocks within channel to prevent erosion. Riparian vegetation was dominated by bermudagrass, American elm, Shumard oak, and eastern red-cedar. Photo was taken to the southwest on June 28, 2021.

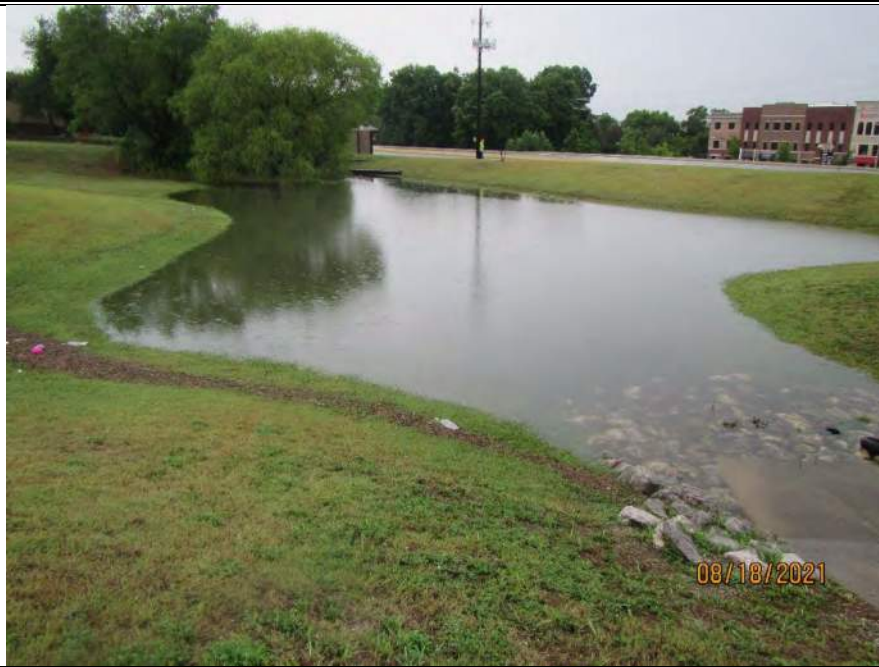
Photo 43.
Photo of Upland Pond **Water Feature 91** located in the western portion of the Environmental Footprint. **Water Feature 91** is an anthropogenically made stormwater retention pond and discharges to **Water Feature 89**. Photo taken to the west on August 18, 2021.

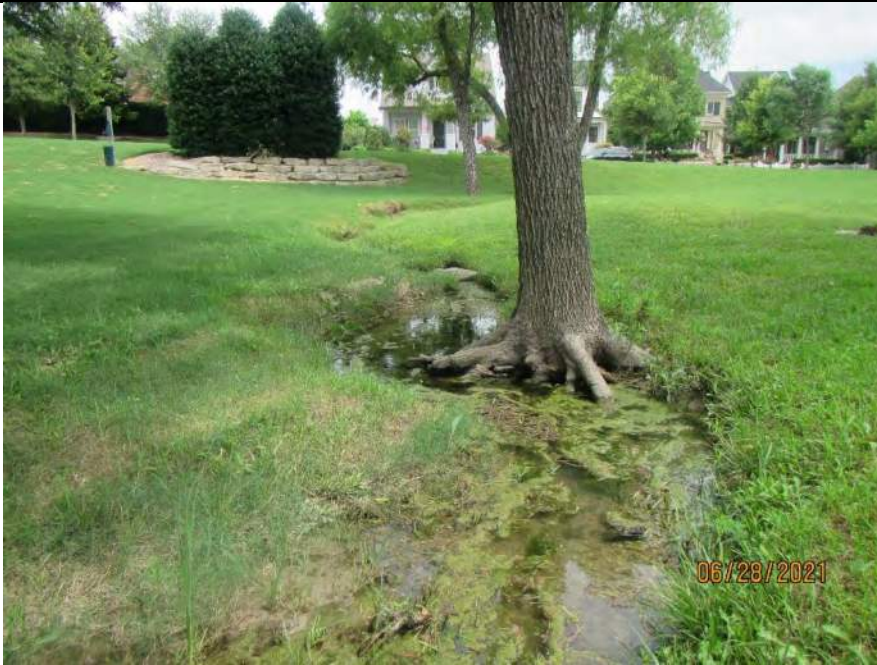
Photo 44.
Photo of Intermittent Stream **Water Feature 92** in the western portion of the Environmental Footprint. Note the pools of clear water, root balls, and bank stabilization from sod forming grasses. Riparian vegetation was dominated by bermudagrass, American elm, Shumard oak, and eastern red-cedar. Photo was taken to the northeast on June 28, 2021.

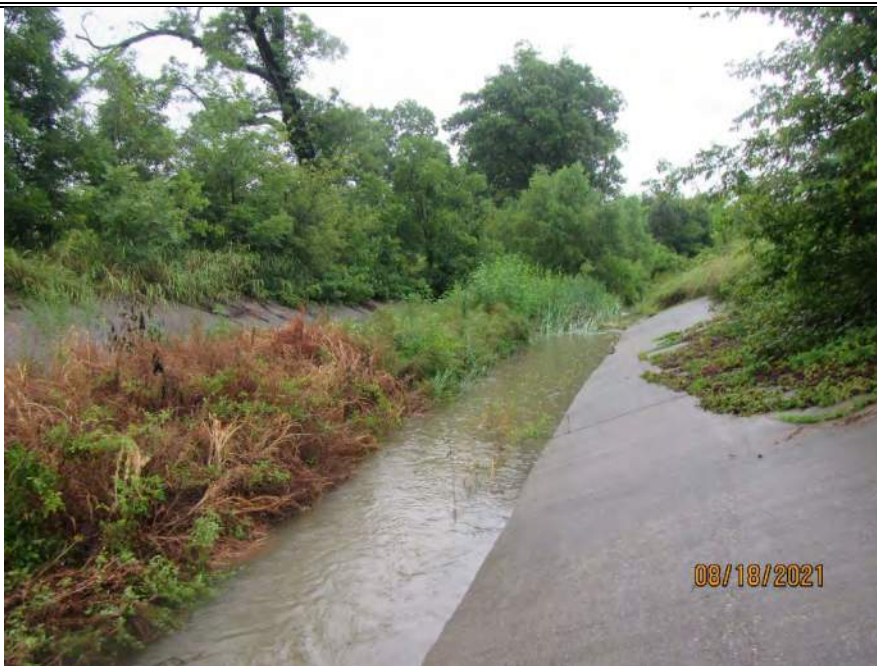
Photo 45.
Photo of Intermittent Stream **Water Feature 94.** **Water Feature 94** has a seasonal connection to groundwater. Riparian vegetation was dominated by black willow, eastern red-cedar, fringed greenbrier and great ragweed. Photo was taken to the northeast on August 18, 2021.

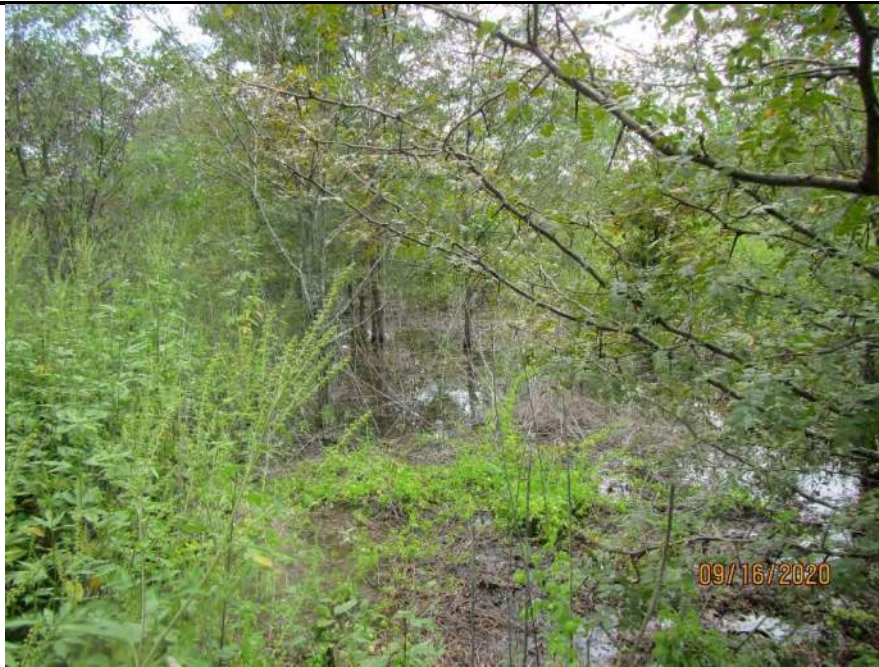
Photo 46.
Photo of Forested Wetland **Water Feature 99** located in the western portion of the Environmental Footprint. Dominant vegetation included American elm, cedar elm (*Ulmus crassifolia*), black willow, and marsh-elder. **Water Feature 99** is an impoundment influenced by beaver activity that was saturated. Photo was taken to the south on September 16, 2020.

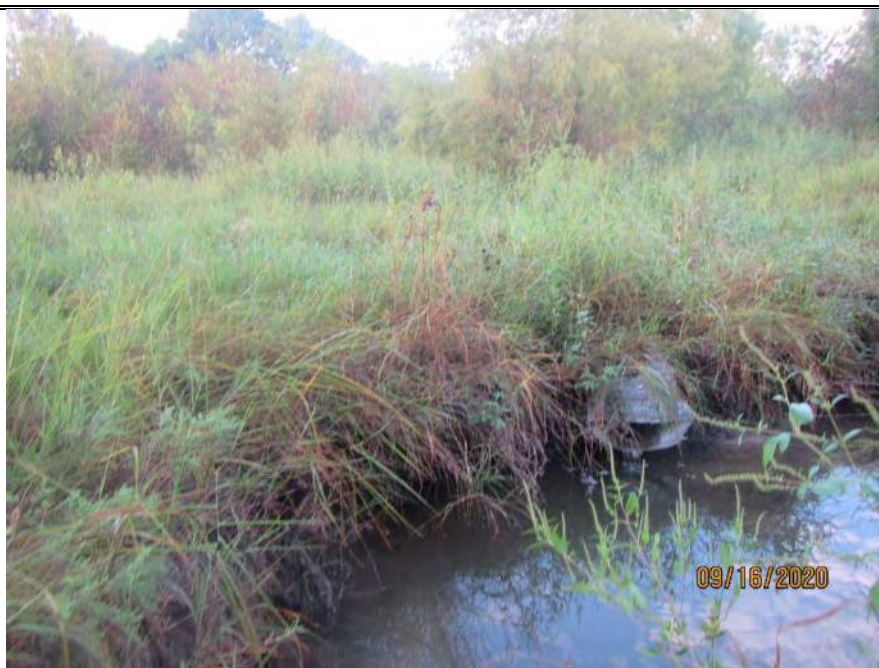
Photo 47.
Photo of Intermittent Stream **Water Feature 100** located in the western portion of the Environmental Footprint. Note the defined channel. Dominant vegetation included fringed green brier, cedar elm, eastern poison ivy, and American elm. **Water Feature 100** receives flow from **Water Feature 99** and flows into **Water Feature 101**. Photo taken to the northeast on September 16, 2020.

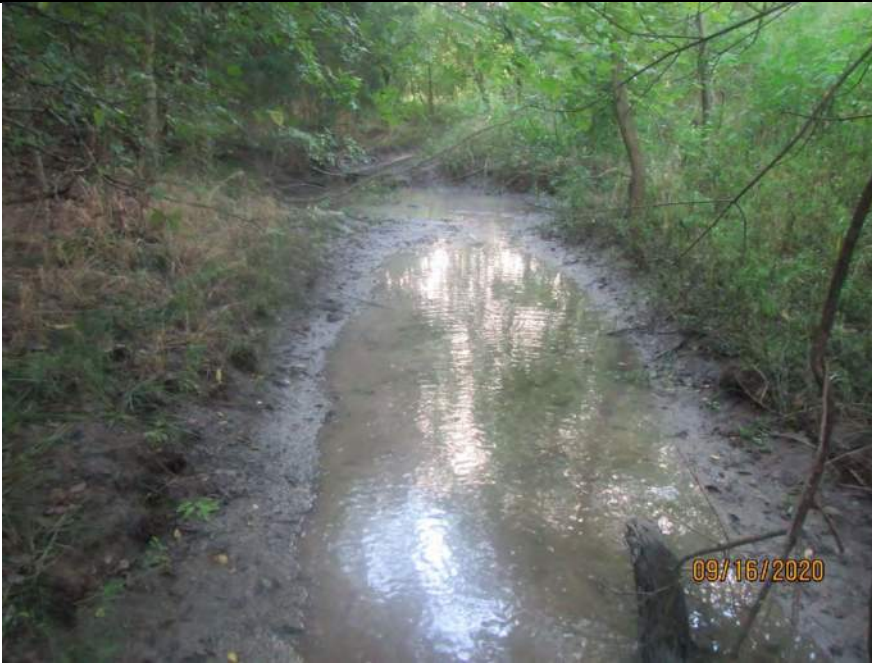
Photo 48.
Photo of Intermittent Stream **Water Feature 101** located in the western portion of the Environmental Footprint. Note the defined channel and destruction of terrestrial vegetation within stream. Dominant vegetation included fringed green brier, cedar elm, eastern poison ivy, and American elm. **Water Feature 101** receives flow from **Water Feature 104** and **Water Feature 100** and flows into **Water Feature 105**. Photo taken to the east on September 16, 2020.

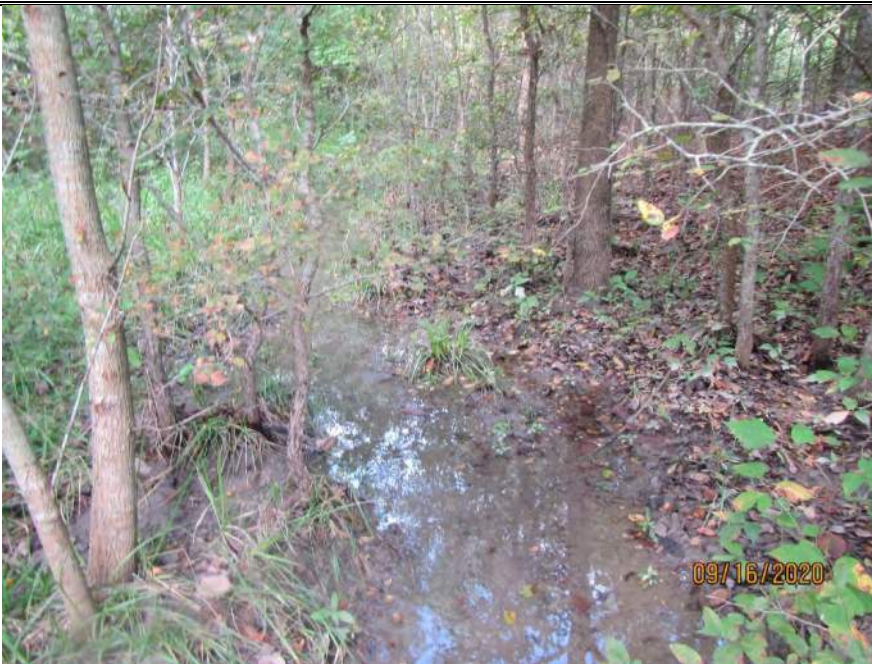
Photo 49.
Photo of Ephemeral Stream **Water Feature 102** located in the western portion of the Environmental Footprint. Dominant vegetation included fringed green brier, cedar elm, eastern poison ivy, and American elm. Water is flowing due to recent precipitation. Photo taken to the east on September 16, 2020.

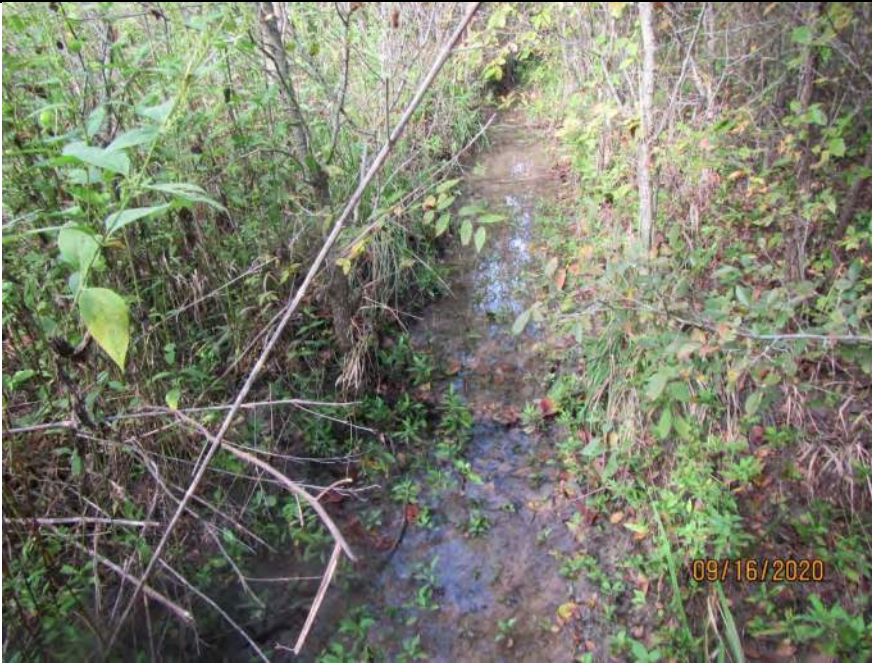
Photo 50.
Photo of Intermittent Stream **Water Feature 104** located in the western portion of the Environmental Footprint. Note the defined channel and wrack line within stream. Dominant vegetation included fringed green brier, cedar elm, eastern poison ivy, and American elm. **Water Feature 104** receives flow from **Water Feature 102** and flows into **Water Feature 105**. Photo taken to the east on September 16, 2020.

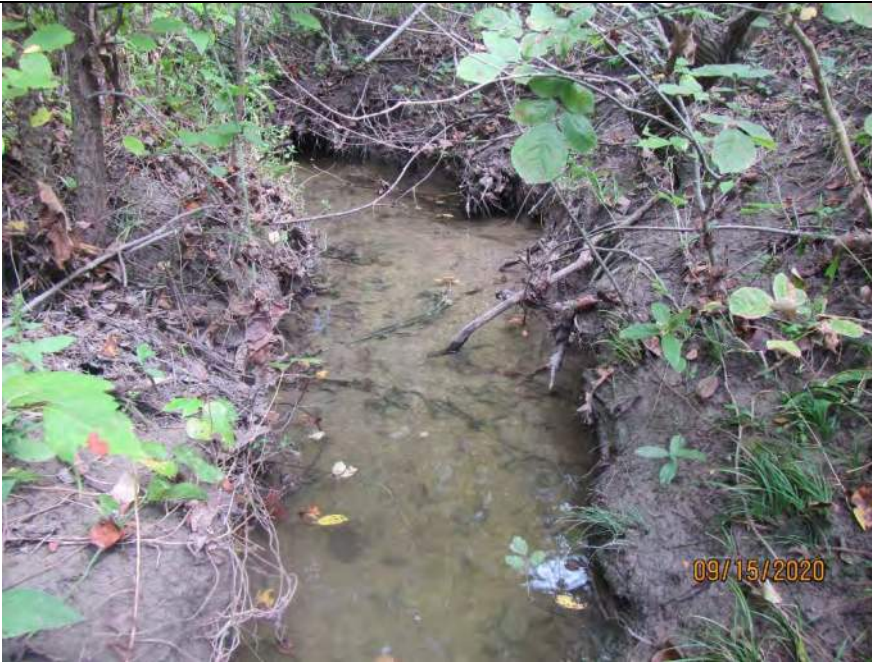
Photo 51.
Photo of Intermittent Stream **Water Feature 105** located in the western portion of the Environmental Footprint. Note the scoured banks and destruction of terrestrial vegetation. Dominant vegetation included eastern poison ivy, sugar-berry, and American elm. Photo taken to the east on September 15, 2020.

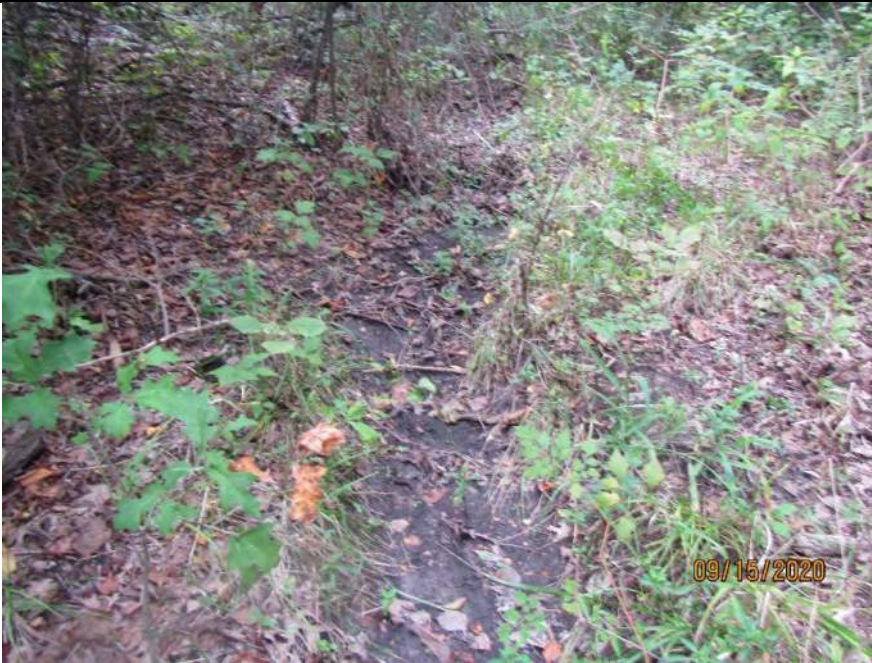
Photo 52.
Photo of Ephemeral Stream **Water Feature 107** located within the western portion of the Environmental Footprint. **Water Feature 107** had overhanging vegetation, leaf litter disturbed, and matted vegetation. Dominant vegetation included eastern poison ivy (*Toxicodendron radicans*), trumpet creeper (*Campsis radicans*), and sugar-berry. Photo was taken to the north on September 15, 2020.

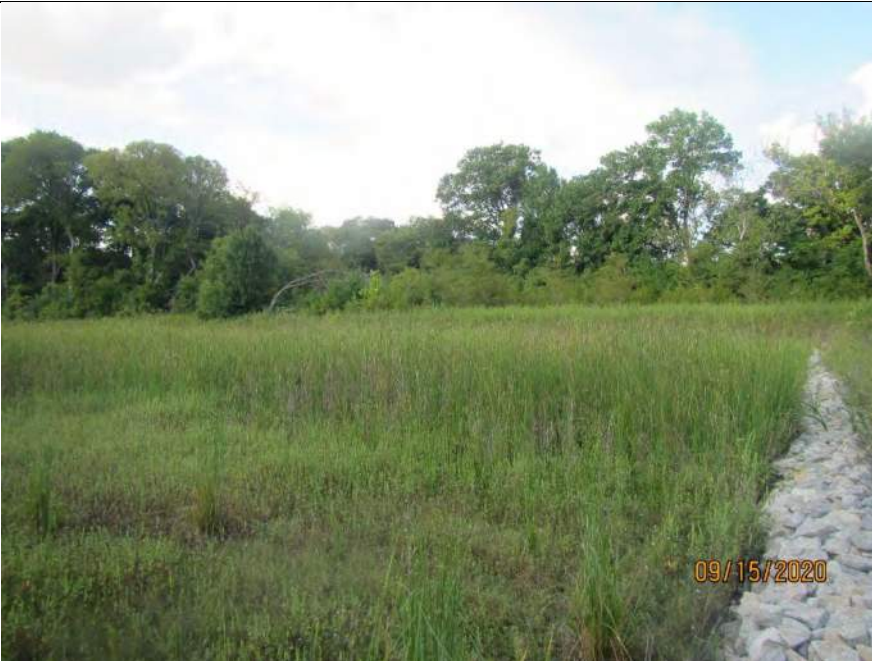
Photo 53.
Photo of Emergent Wetland **Water Feature 109** located in the western portion of the Environmental Footprint. Dominant vegetation included blunt spike-rush (*Eleocharis obtusa*) and annual marsh-elder (*Iva annua*). **Water Feature 109** is adjacent to Perennial Stream **Water Feature 110** (Wilson Creek). Photo was taken to the southwest on September 15, 2020.

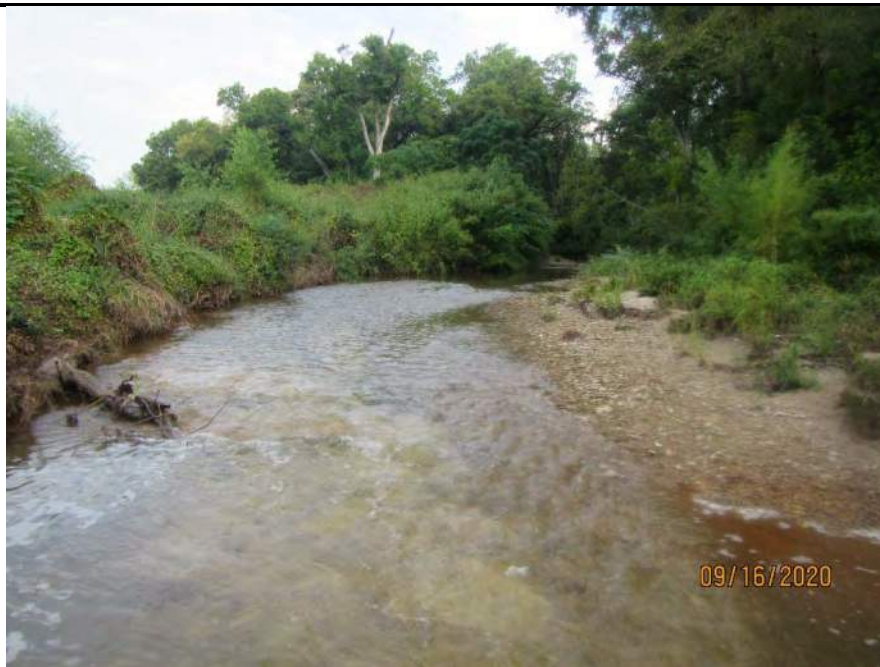
Photo 54.
Photo of Perennial Stream **Water Feature 110** also known as Wilson Creek. Note the high amount of erosion to bedrock, gravel/cobble substrate, aquatic macrophytes, riffle-pool sequences, and clear water. Riparian vegetation was dominated by boxelder (*Acer negundo*), American elm, green ash, and eastern poison ivy. Photo taken to the southeast on September 16, 2020.

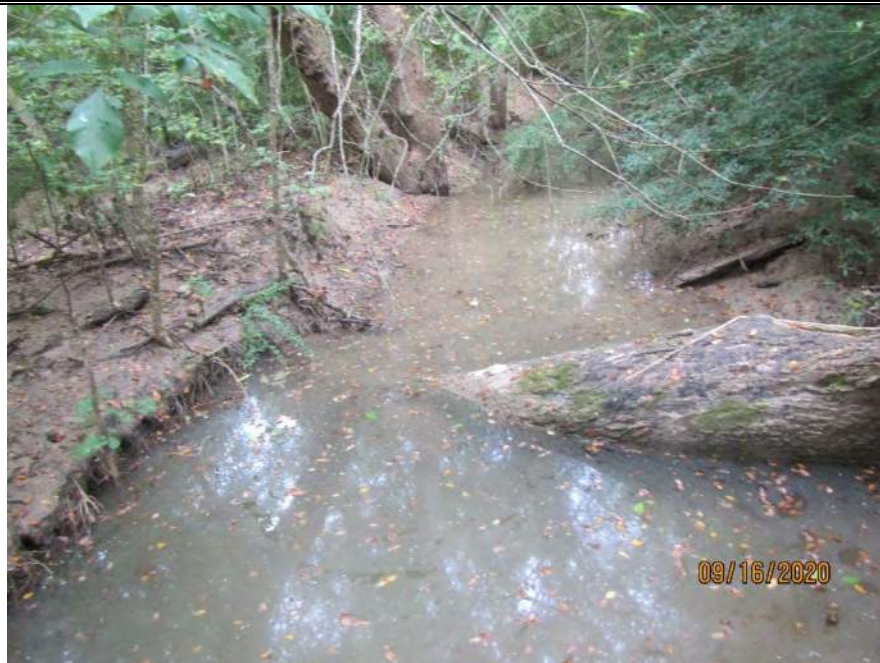
Photo 55.
Photo of Intermittent Stream **Water Feature 113** located in the western portion of the Environmental Footprint. **Water Feature 113** had overhanging vegetation with turbid pools of water. Dominant vegetation included green ash, yaupon (*Ilex vomitoria*), and Bois d'arc. Photo was taken to the southeast on September 16, 2020.

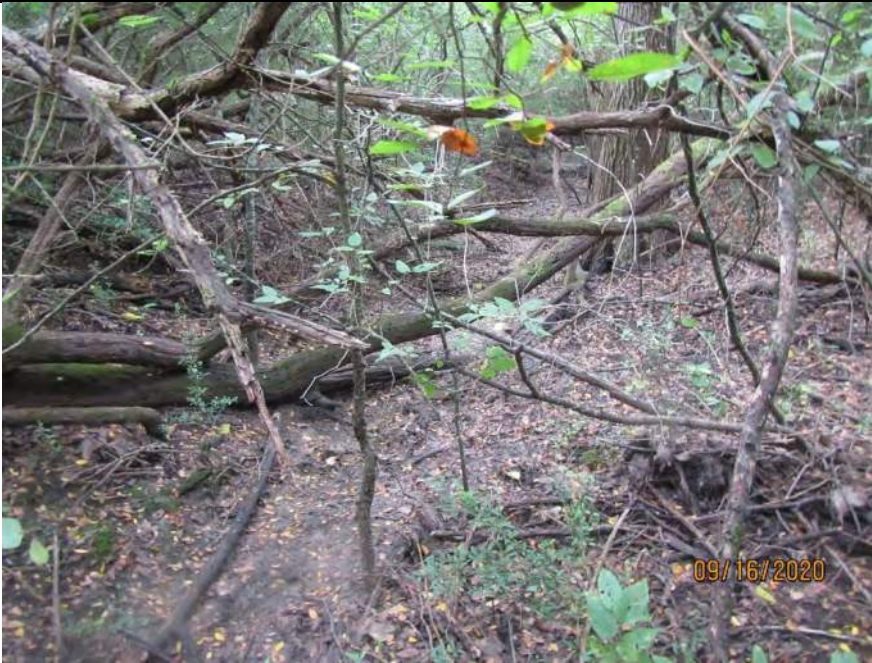
Photo 56.
Photo of Ephemeral Stream **Water Feature 114** located in the western portion of the Environmental Footprint. **Water Feature 114** flows east into **Water Feature 113**. **Water Feature 114** had a wrack line, destruction of terrestrial vegetation, and litter and debris. Dominant vegetation included green ash, yaupon, and Bois d'arc. Photo was taken to the east on September 16, 2020.

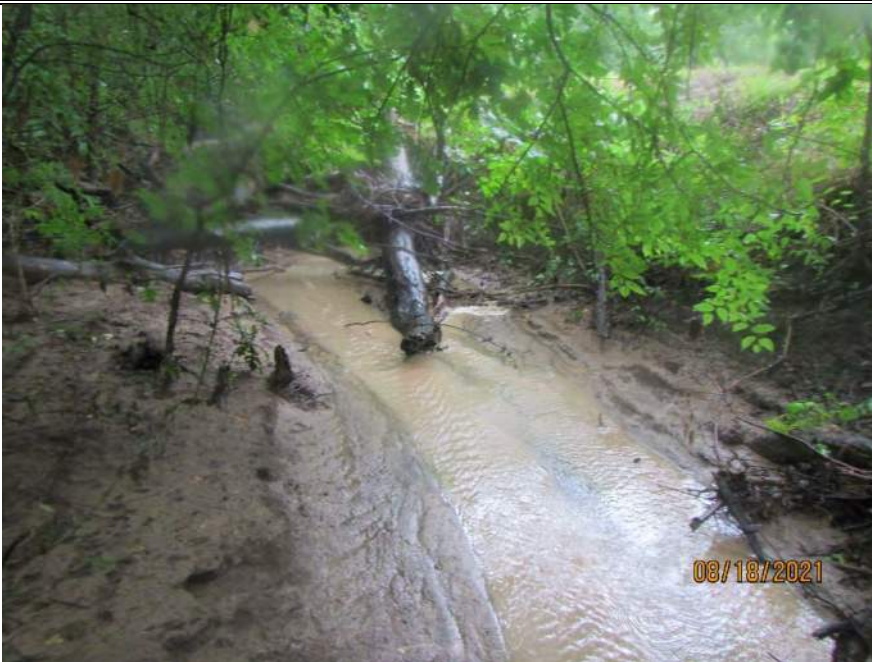
Photo 57.
Photo of Ephemeral Stream **Water Feature 115** located in the northern portion of the Environmental Footprint. **Water Feature 115** flows south into **Water Feature 113** and contained water due to current precipitation during delineation. Dominant riparian vegetation included Chinese privet (*Ligustrum sinense*), Carolina false buckthorn (*Frangula caroliniana*), and American elm. Photo was taken to the south on August 18, 2021.

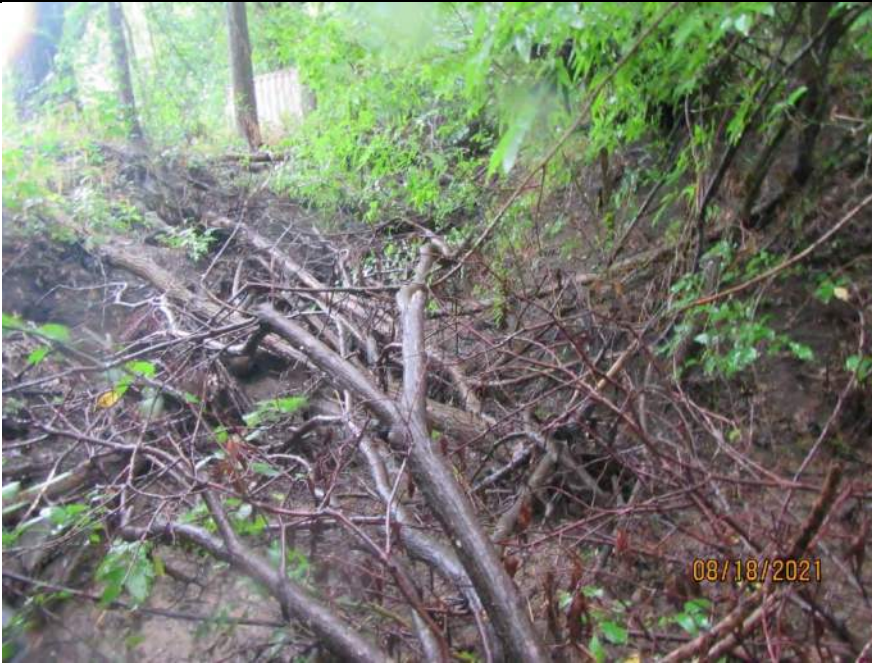
Photo 58.
 Photo of Erosion Gully Drainage Feature **Water Feature 117** in the western portion of the Environmental Footprint. Photo is representative of Erosion Gully Drainage Feature **Water Feature 116**. Note the lack of an OHWM, hydrophytic vegetation, hydric soils, hydrological indicators, a stream bed or banks within the area. Photo was taken to the northwest on August 18, 2021.

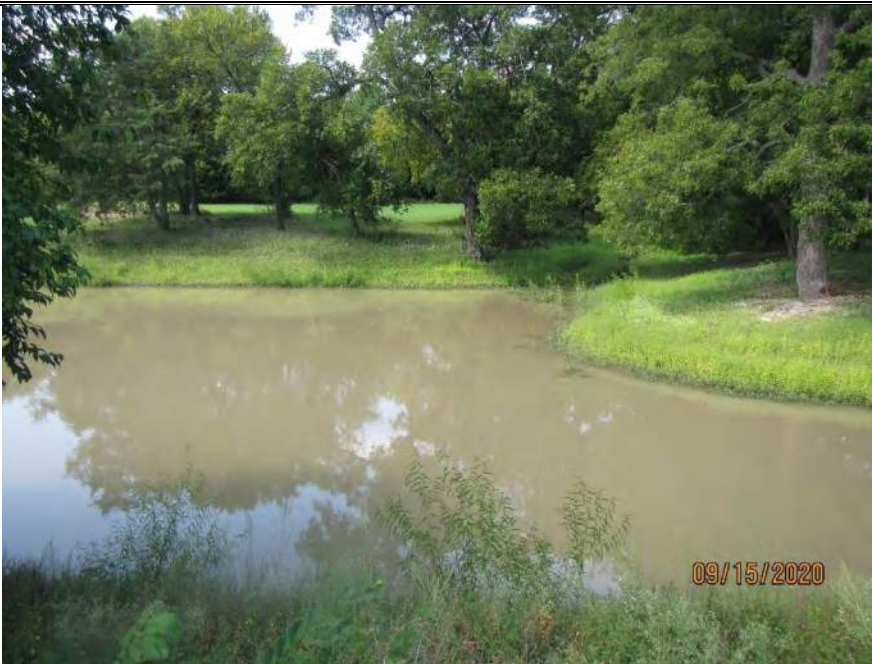
Photo 59.
 Photo of Pond **Water Feature 118** located in the western portion of the Environmental Footprint. **Water Feature 118** is hydrologically connected to **Water Feature 119**. Photo taken to the west on September 15, 2020.

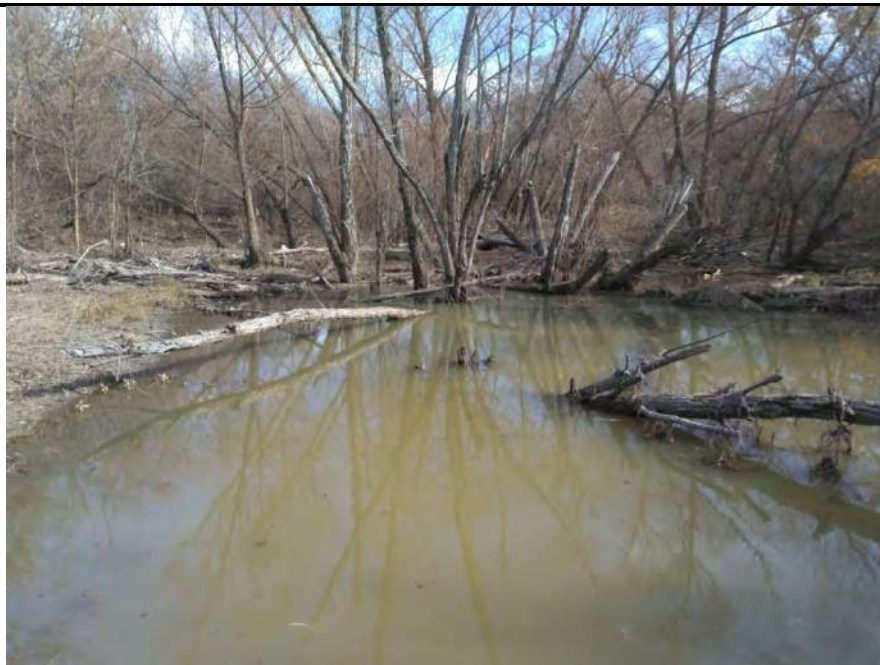
Photo 62.
Photo of Forested Wetland **Water Feature 125** located in the western portion of the Environmental Footprint. Dominant vegetation included black willow and swamp smartweed. **Water Feature 125** abuts Perennial Stream **Water Feature 37** and is hydrologically connected to **Water Feature 33**. Photo was taken to the east on December 22, 2020.

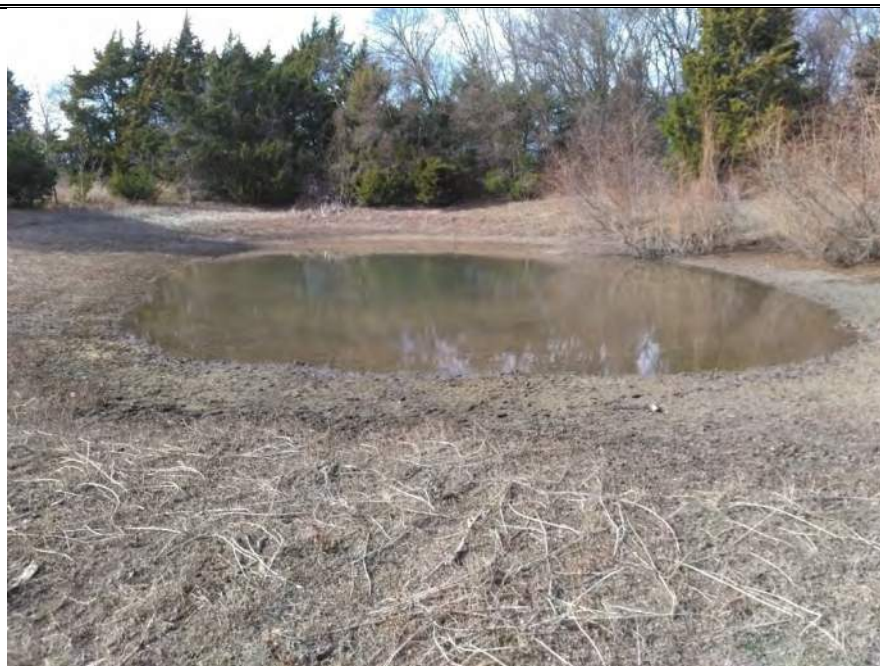
Photo 63.
Photo of Pond **Water Feature 126** located in the western portion of the Environmental Footprint. **Water Feature 126** likely had groundwater influence and overflows into **Water Feature 127** to the northwest. Photo taken to the northwest on December 22, 2020.

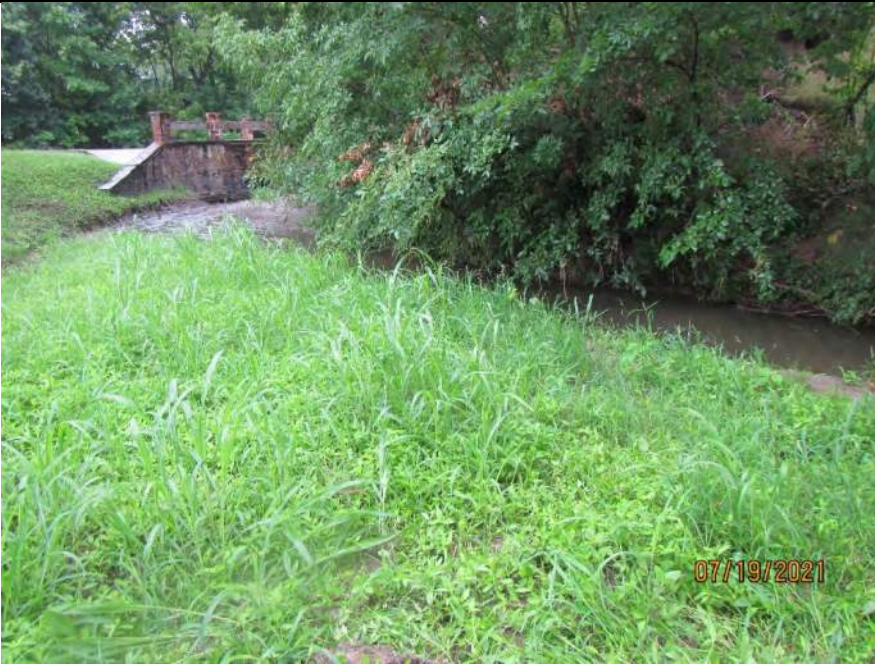
Photo 65.
Photo of Emergent Wetland **Water Feature 137** located in the northwestern portion of the Environmental Footprint. Dominant vegetation included northern frogfruit (*Phyla lanceolata*), johnsongrass (*Sorghum halepense*), and jungle rice (*Echinochloa colona*). **Water Feature 137** abuts Perennial Streams **Water Feature 136** and **138** (braided Rutherford Branch channels hydrologically connected to **Water Feature 142**). Photo was taken to the north on July 19, 2021.

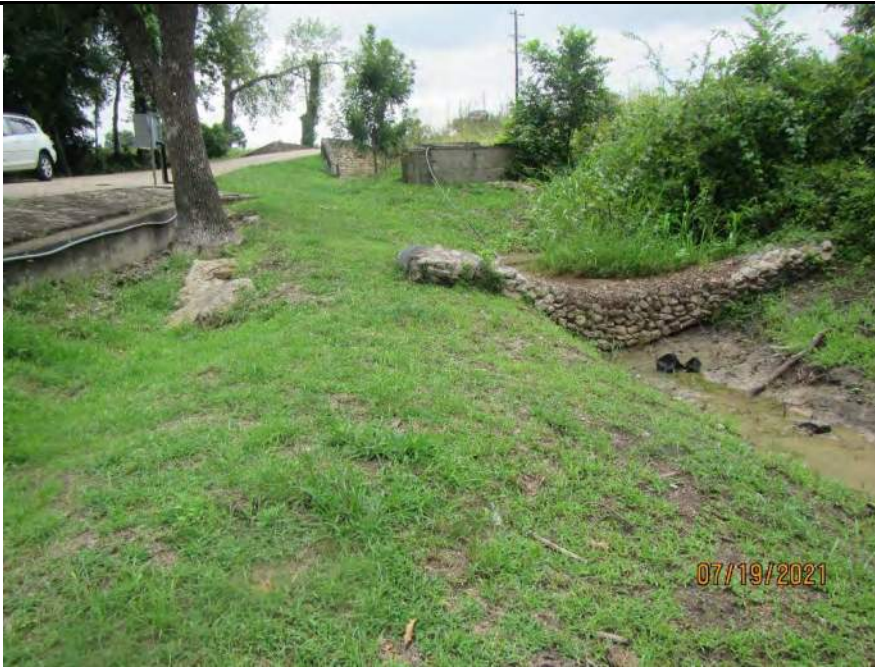
Photo 66.
Photo of Ephemeral Stream **Water Feature 139** located in the western portion of the Environmental Footprint. **Water Feature 139** receives roadway runoff and flows northeast into **Water Feature 140**. Note the erosion control structure in place and matted vegetation. Dominant riparian vegetation included bermudagrass, johnsongrass, and Chinese privet. Photo was taken to the southwest on July 19, 2021.

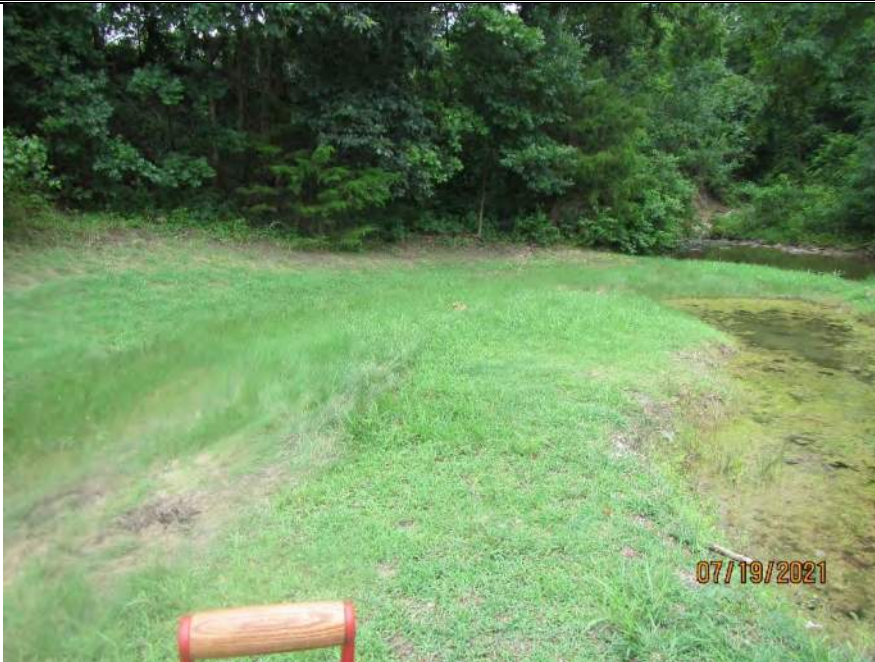
Photo 67.
Photo of Emergent Wetland **Water Feature 140** located in the northwestern portion of the Environmental Footprint. Dominant vegetation included common spike-rush and bermudagrass (*Cynodon dactylon*). **Water Feature 140** abuts Perennial Stream **Water Feature 142** (Rutherford Branch). Photo taken to the northeast on July 19, 2021.

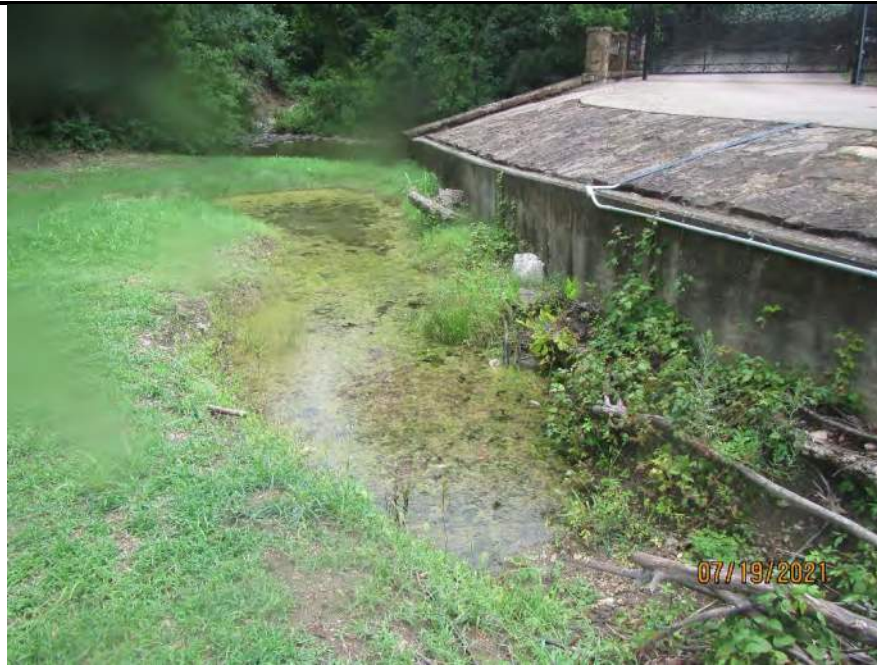
Photo 68.
Photo of Upland
Pond **Water
Feature 141**
located in the
western portion of
the Environmental
Footprint. **Water
Feature 141** was
excavated and
adjacent to **Water
Feature 140, 139,**
and **142.** Photo
taken to the east on
July 19, 2021.

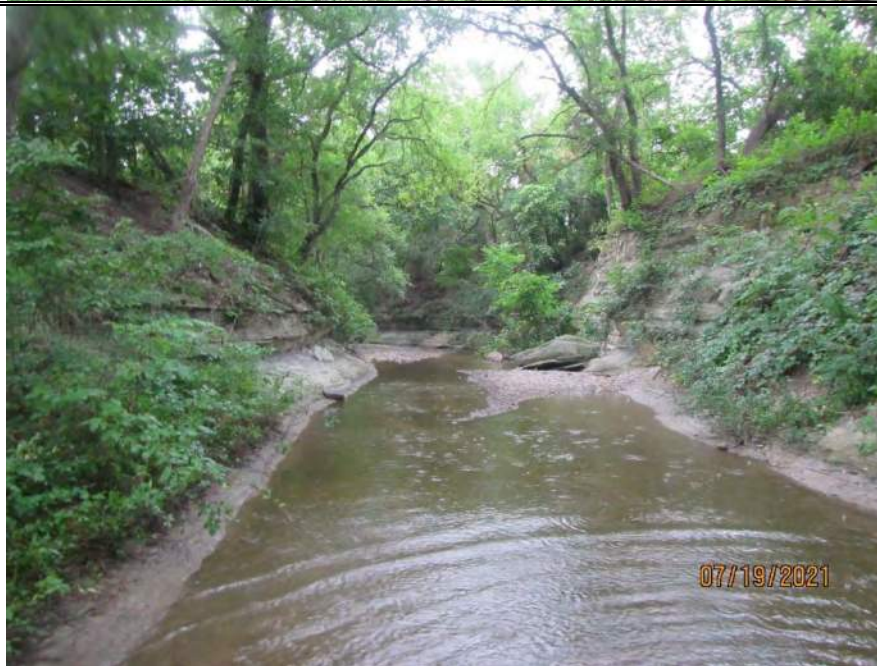
Photo 69.
Photo of Perennial
Stream **Water
Feature 142** also
known as
Rutherford Branch,
and located in the
western portion of
the Environmental
Footprint. Photo
representative of
Perennial Streams
Water Feature 136
and **138** (other
sections of
Rutherford Branch).
Note the clear
water and riffle-pool
sequences. The
heavily wooded
riparian zone was
dominated by
pecan and green
ash. **Water Feature
136** and **138** are
braided around
Water Feature 137
and flow north.
Photo was taken to
the northeast on
July 19, 2021.

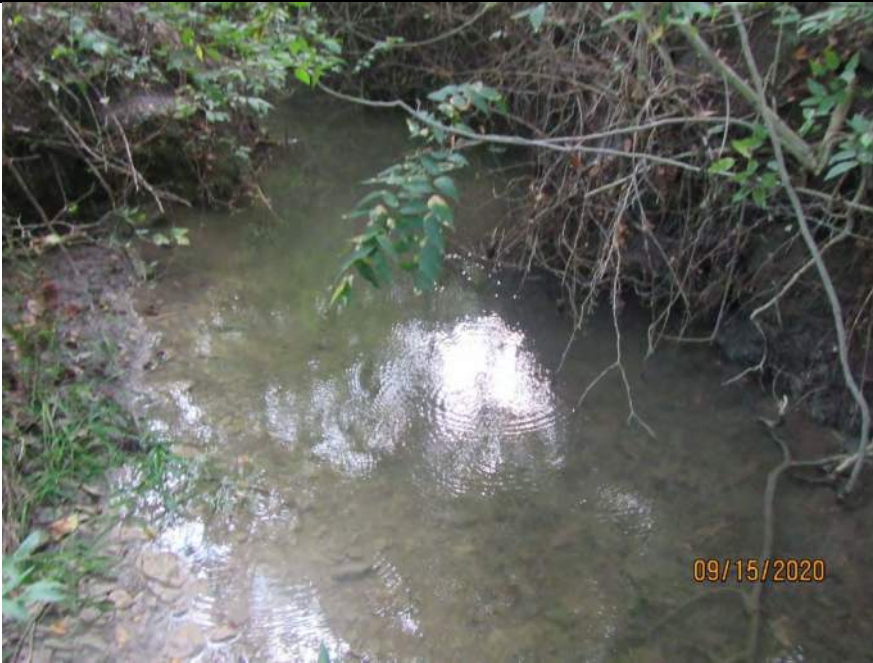
Photo 70.
 Photo of Intermittent Stream **Water Feature 148** located in the northern portion of the Environmental Footprint. **Water Feature 148** had overhanging vegetation and gravel bars. Dominant vegetation included Chinese privet, perennial ragweed (*Ambrosia psilostachya*), and cedar elm. Photo was taken to the northeast on September 15, 2020.
