APPENDIX N: Water Resources

Attachment 4 - Site Photographs

Representative Environmental Footprint Photographs
Water Features Delineation
TxDOT US 380

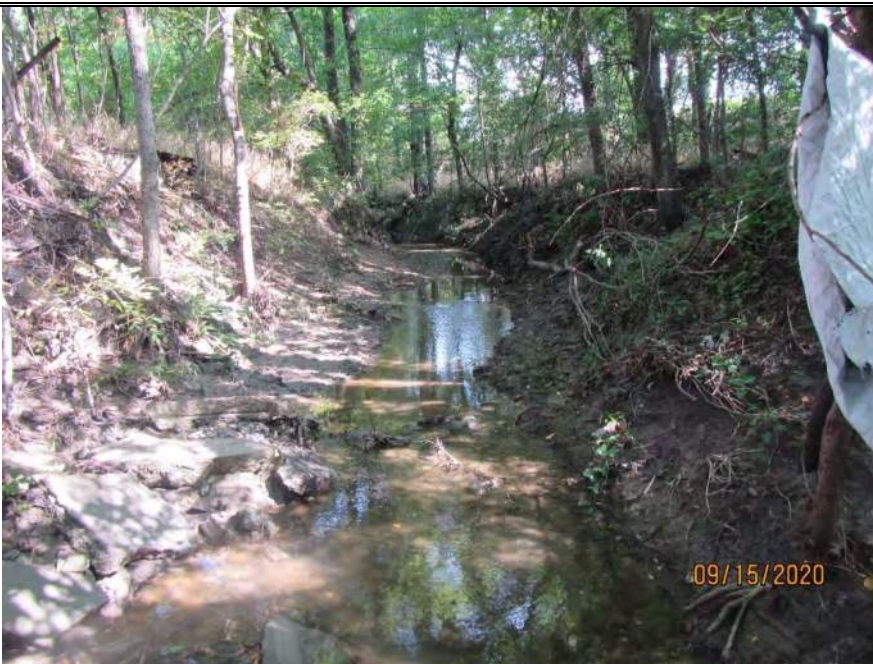
Photo 71.
 Photo of Intermittent Stream **Water Feature 158**, known as Franklin Branch, located in the northern section of the Environmental Footprint. Note overhanging vegetation, a deep channel, and litter/debris within the channel. Dominant vegetation included boxelder, American elm, and pecan. Photo was taken to the north on September 15, 2020.

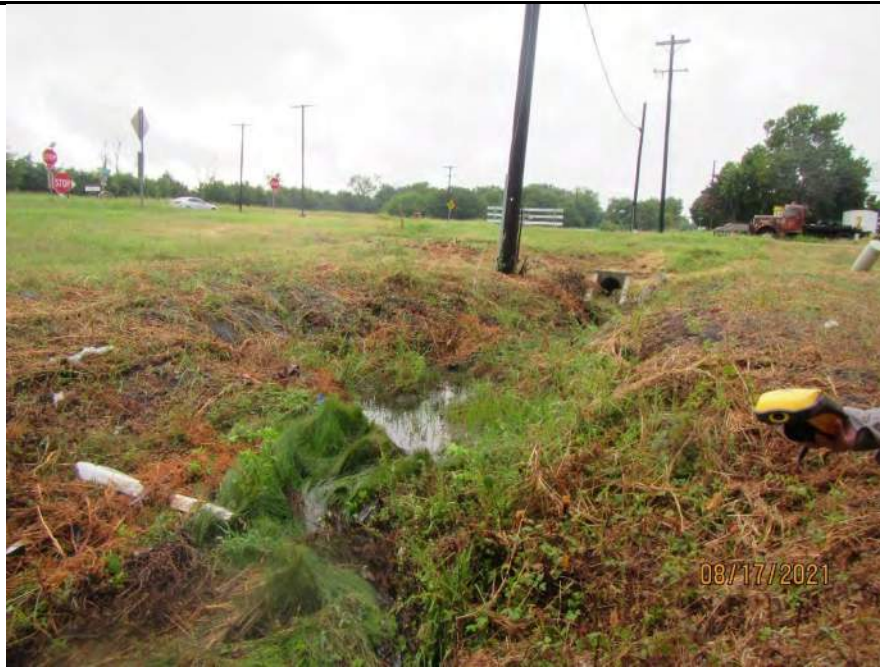
Photo 72.
Photo of Ditch
Drainage Feature
Water Feature 159
in the central
portion of the
Environmental
Footprint. **Water
Feature 159** was
constructed in
uplands to aid in
the draining of
stormwater from
adjacent roads.
Note the
anthropogenic
symmetry of the
channel. Photo
taken on August
17, 2021.

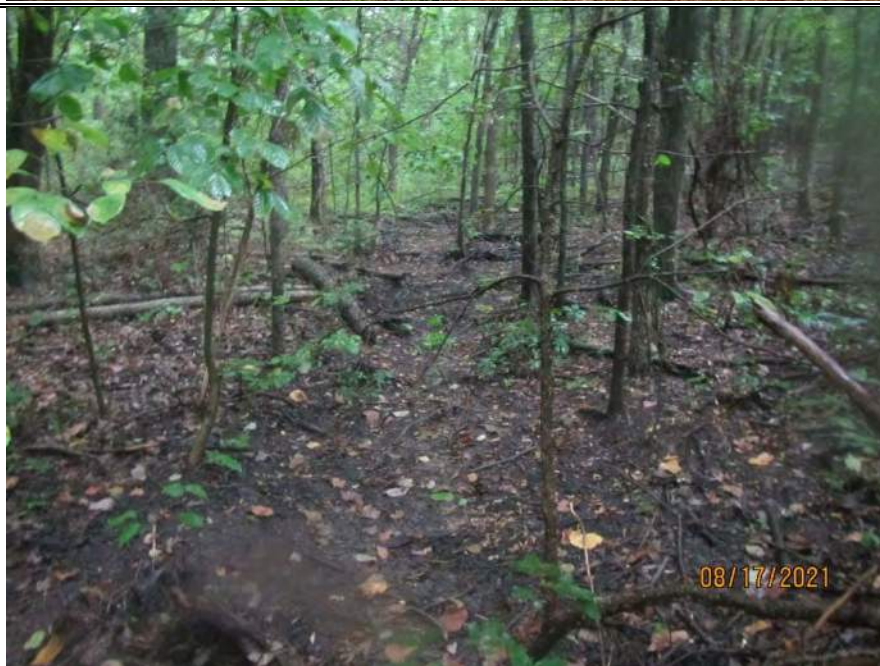
Photo 73.
Photo of Swale
Drainage Feature
Water Feature 169
in the central
portion of the
Environmental
Footprint. **Water
Feature 169** flowed
into **Water Feature
140**. Note the lack
of an OHWM,
hydrophytic
vegetation, hydric
soils, hydrological
indicators, or a
stream bed and
banks within the
area. Photo was
taken to the
northwest on
August 17, 2021.

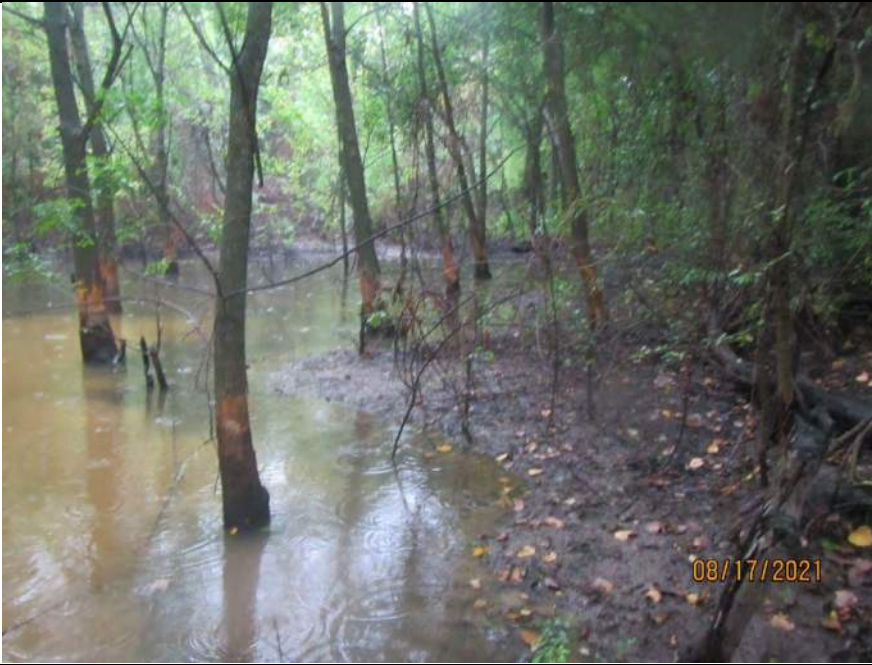
Photo 74.
Photo of Forested Wetland **Water Feature 170** located in the north central portion of the Environmental Footprint. Dominant vegetation included green ash, black willow, and eastern cottonwood (*Populus deltoides*). Photo was taken to the west on August 17, 2021.

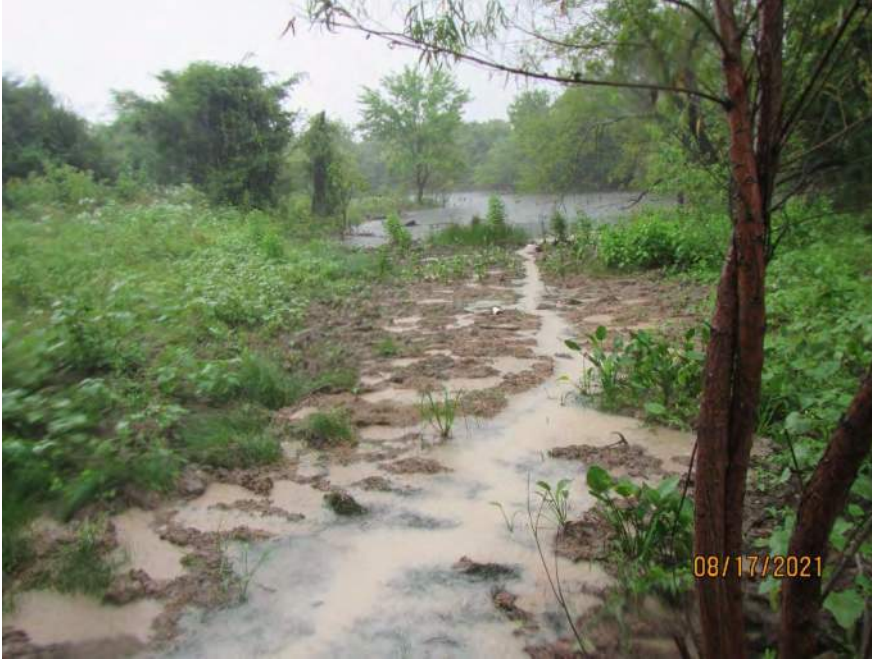
Photo 75.
Photo of Emergent Wetland **Water Feature 171** located in the north central portion of the Environmental Footprint. Dominant vegetation included common spike-rush, rough cocklebur (*Xanthium strumarium*) and bull-tongue arrowhead (*Sagittaria lancifolia*). Photo was taken to the east on August 17, 2021.

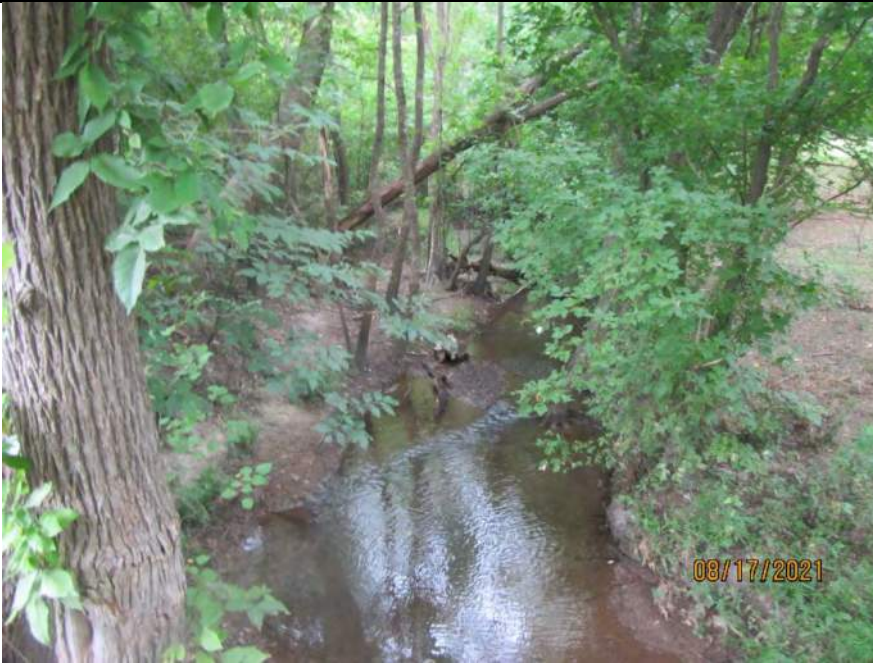
Photo 78.
Photo of Intermittent Stream **Water Feature 175** located in the north central portion of the Environmental Footprint. **Water Feature 175** flowed north into **Water Feature 176** and had overhanging vegetation, gravel bars, and a deep channel. Dominant vegetation included American elm, eastern poison ivy, and boxelder. Photo was taken to the south on August 17, 2021.

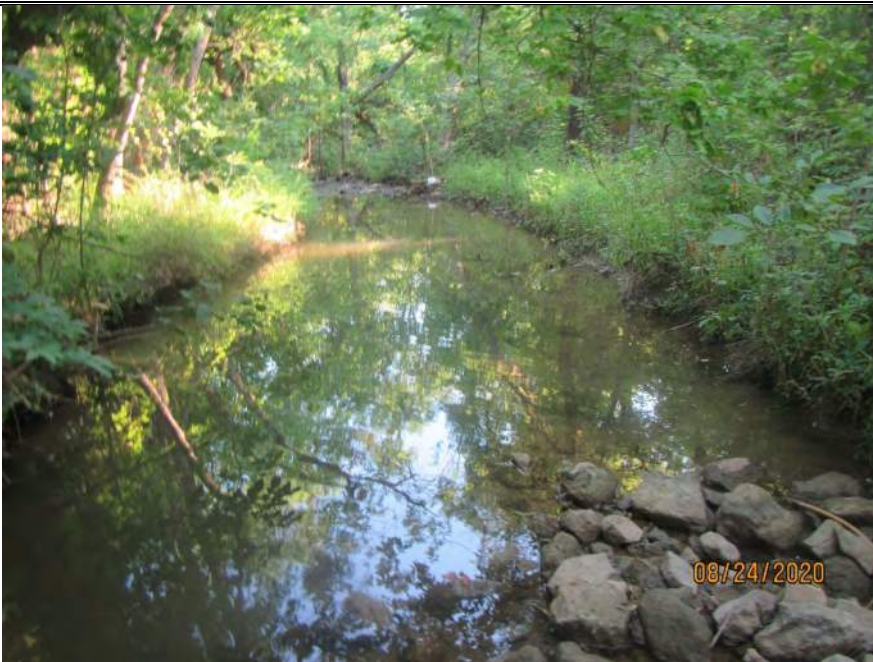
Photo 79.
Photo of Perennial Stream **Water Feature 176** located in the northern portion of the Environmental Footprint. **Water Feature 176** had overhanging vegetation, gravel bars, and a deep channel. Dominant vegetation included black willow, American elm, and Bois d'arc. Photo was taken to the north on August 24, 2020.

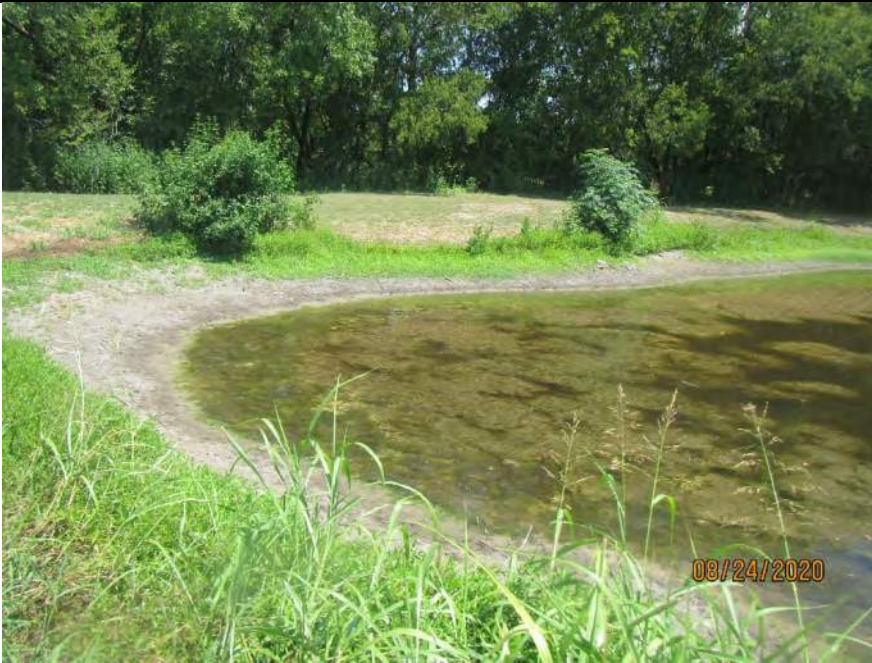
Photo 80.
 Photo of Upland
 Pond **Water**
Feature 177
 located in the
 western portion of
 the Environmental
 Footprint **Water**
Feature 177 was
 excavated and
 adjacent to **Water**
Feature 179. Photo
 taken to the east on
 August 24, 2020.

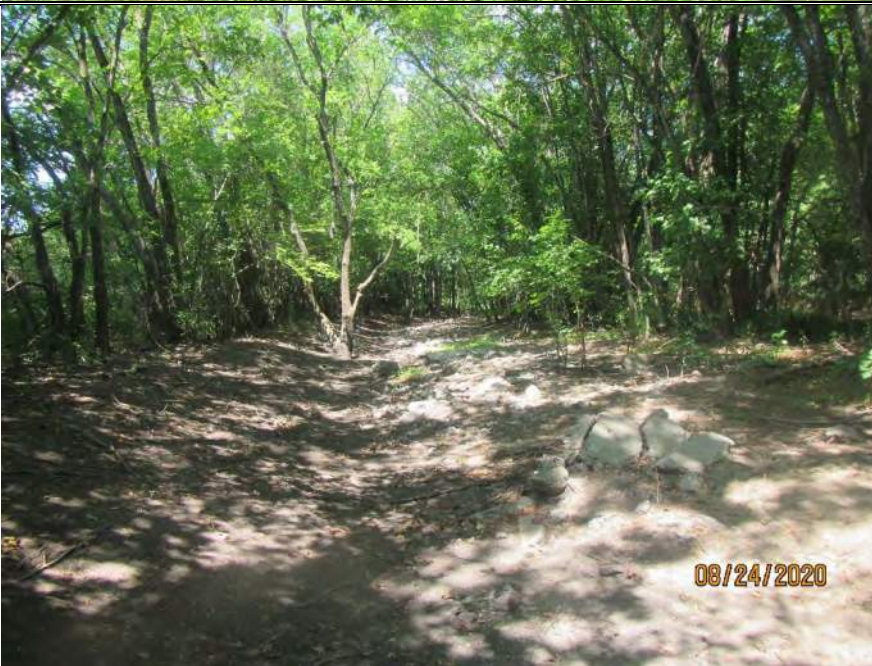
Photo 81.
 Photo of Forested
 Wetland **Water**
Feature 178
 located in the north
 central portion of
 the Environmental
 Footprint. Dominant
 vegetation included
 green ash and
 American elm.
 Photo was taken to
 the northwest on
 August 24, 2020.

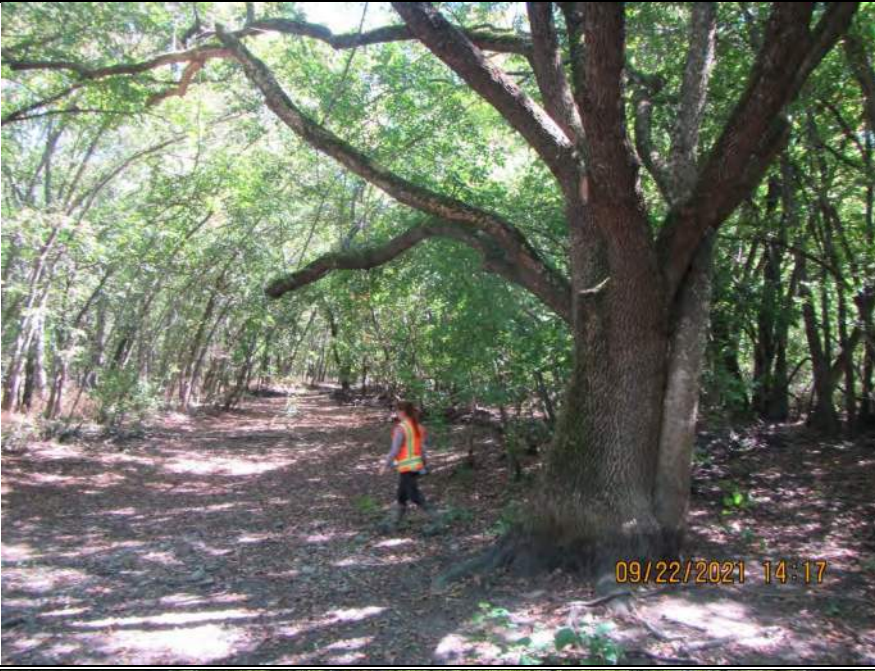
Photo 82.
 Photo of Forested
 Wetland **Water**
Feature 179
 located in the north
 central portion of
 the Environmental
 Footprint. Dominant
 vegetation included
 green ash and
 American elm.
 Photo was taken to
 the southeast on
 September 22,
 2021.

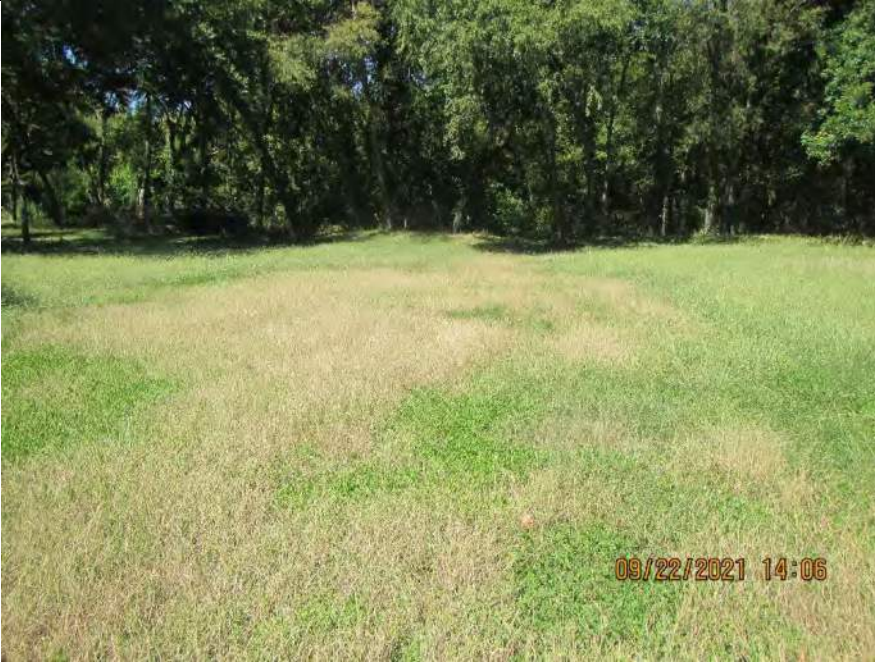
Photo 83.
 Photo of Emergent
 Wetland **Water**
Feature 180
 located in the north
 central portion of
 the Environmental
 Footprint. Dominant
 vegetation included
 blunt spike-rush
 and common spike-
 rush. Photo was
 taken to the north
 on September 22,
 2021.

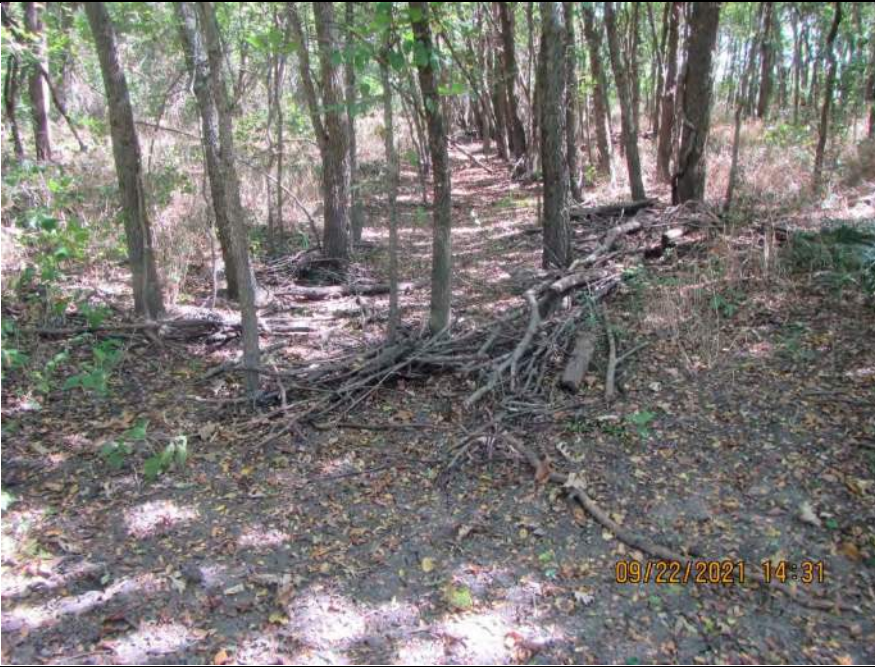
Photo 84.
Photo of Swale
Drainage Feature
Water Feature 181
in the central
portion of the
Environmental
Footprint. Note the
lack of an OHWM,
hydrophytic
vegetation, hydric
soils, a stream bed,
or banks within the
area. Photo was
taken to the
northwest on
September 22,
2021.

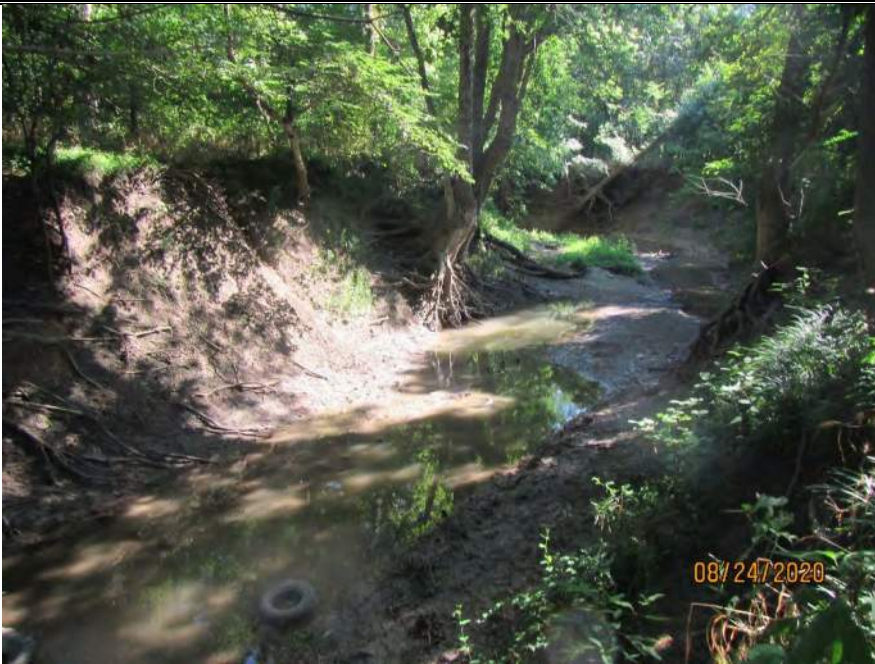
Photo 85.
Photo of Perennial
Stream **Water
Feature 182** and
representative of
Water Feature 192
and **227**, known as
Honey Creek, and
is located in the
northern section of
the Environmental
Footprint. **Water
Feature 182** had
overhanging
vegetation, deep
channels, gravel
bars, and large litter
and debris within
the channel.
Dominant
vegetation included
green ash,
American elm, and
pecan. Photo taken
to the north on
August 24, 2020.

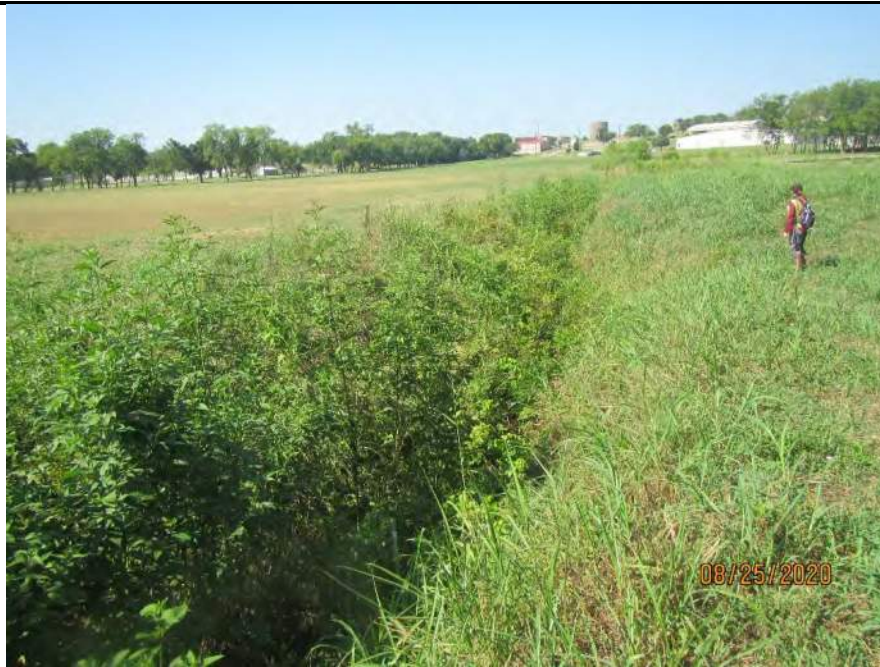
Photo 86.
Photo of Ditch
Drainage Feature
Water Feature 183
in the central
portion of the
Environmental
Footprint. **Water
Feature 183** was
constructed within
an agricultural field
to assist in draining.
Note the
anthropogenic
symmetry and
upland vegetation
covering the entire
channel. Photo
taken to the
southwest on
August 25, 2020.

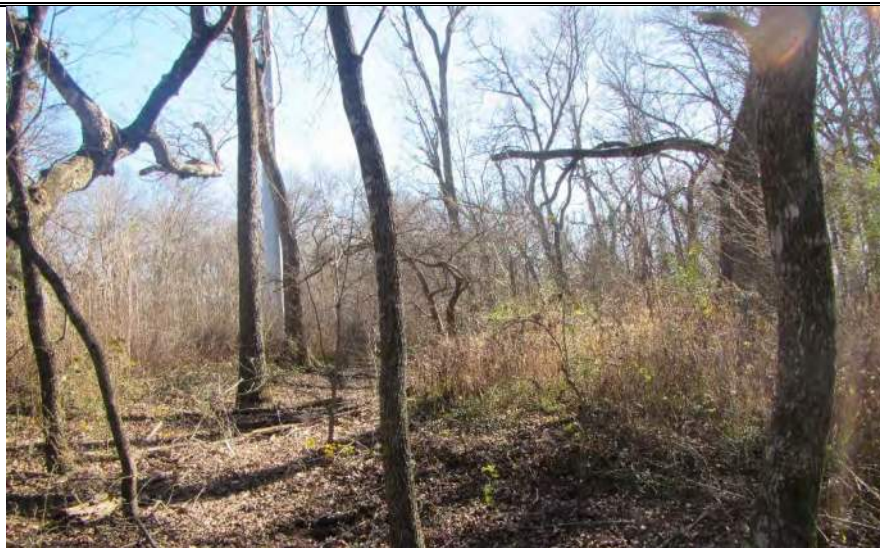
Photo 87.
Photo of Swale
Drainage Feature
Water Feature 184
and **186** in the
central portion of
the Environmental
Footprint. Note the
lack of an OHWM
or a bed and banks.
Photo was taken to
the north on
January 7, 2020.

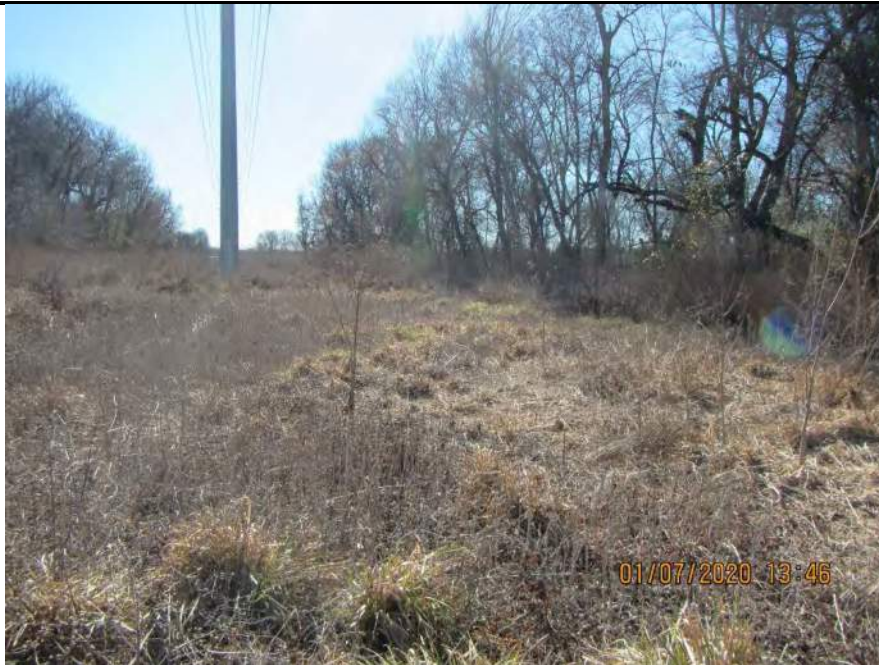
Photo 88.
Photo of Emergent Wetland **Water Feature 185** located in the north central portion of the Environmental Footprint. Dominant vegetation included fox sedge (*Carex vulpinoidea*), rough cocklebur, and northern water plantain (*Alisma triviale*). **Water Feature 185** is adjacent to Perennial Stream **Water Feature 182** (Honey Creek). Photo was taken to the north on January 7, 2020.

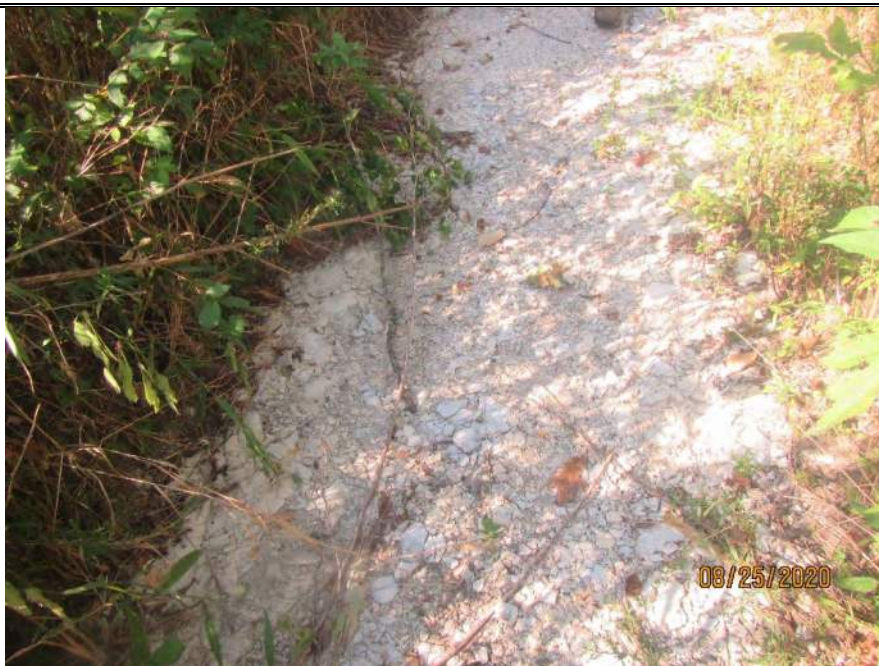
Photo 89.
Photo of Ephemeral Stream **Water Feature 187** located in the central portion of the Environmental Footprint. Note the lack of water within the channel and gravel substrate. Photo was taken to the southwest on August 25, 2020.

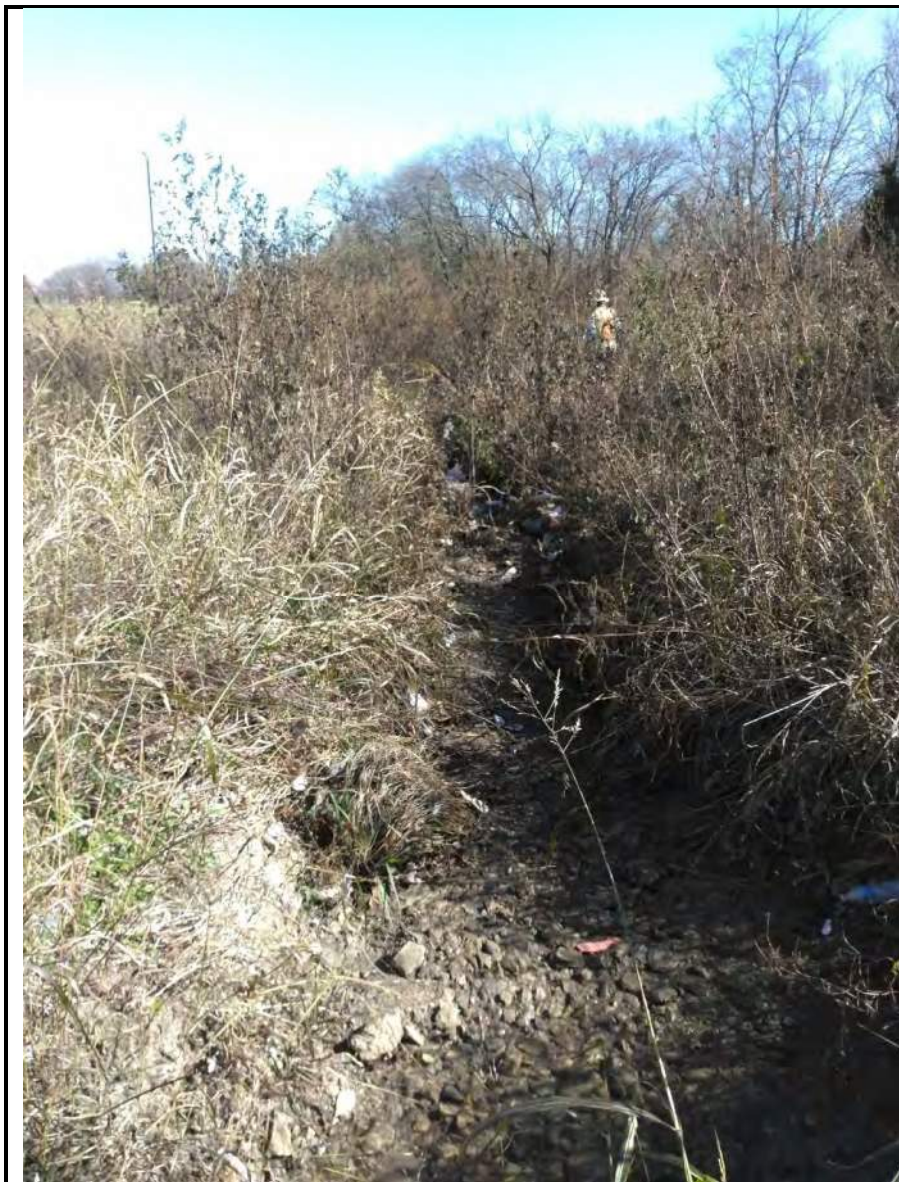
Photo 90.
Photo of Ephemeral Stream **Water Feature 189** located in the northern portion of the Environmental Footprint. Note the overhanging vegetation, matted vegetation, and a wrack line. Dominant vegetation included black locust (*Robinia pseudoacacia*), large barnyard grass (*Echinochloa crus-galli*), and johnsongrass. Photo taken to the east on December 1, 2020.

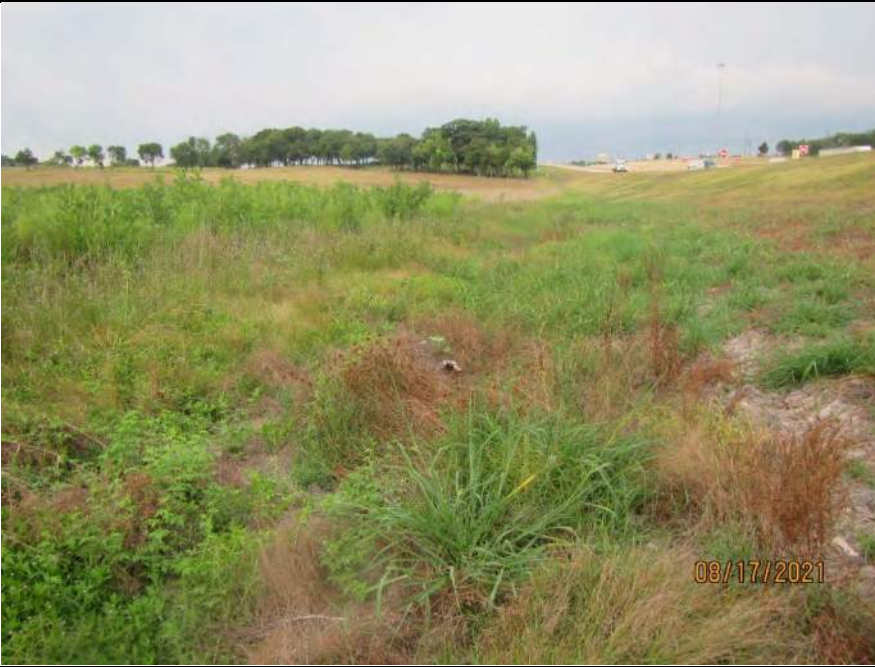
Photo 91.
 Photo of Emergent Wetland **Water Feature 190** located adjacent to US 75 in the north central portion of the Environmental Footprint. Dominant vegetation included rough cocklebur and northern frogfruit. Photo was taken to the southwest on August 17, 2021.

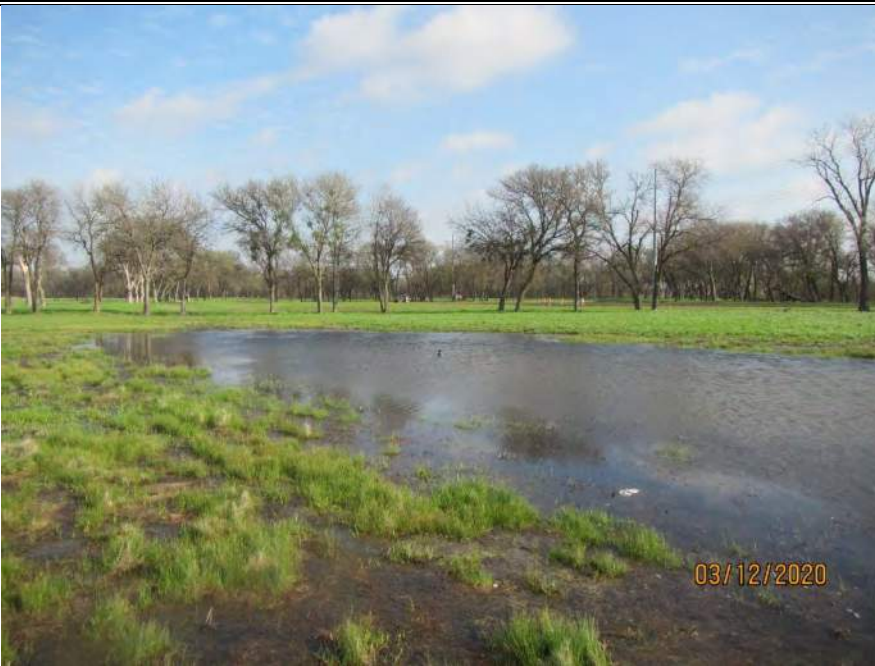
Photo 92.
 Photo of Emergent Wetland **Water Feature 191** located adjacent to US 75 in the north central portion of the Environmental Footprint. Dominant vegetation included blunt spike-rush and common spike-rush. Note the presence of surface water due to recent precipitation. Photo was taken to the north on March 12, 2020.

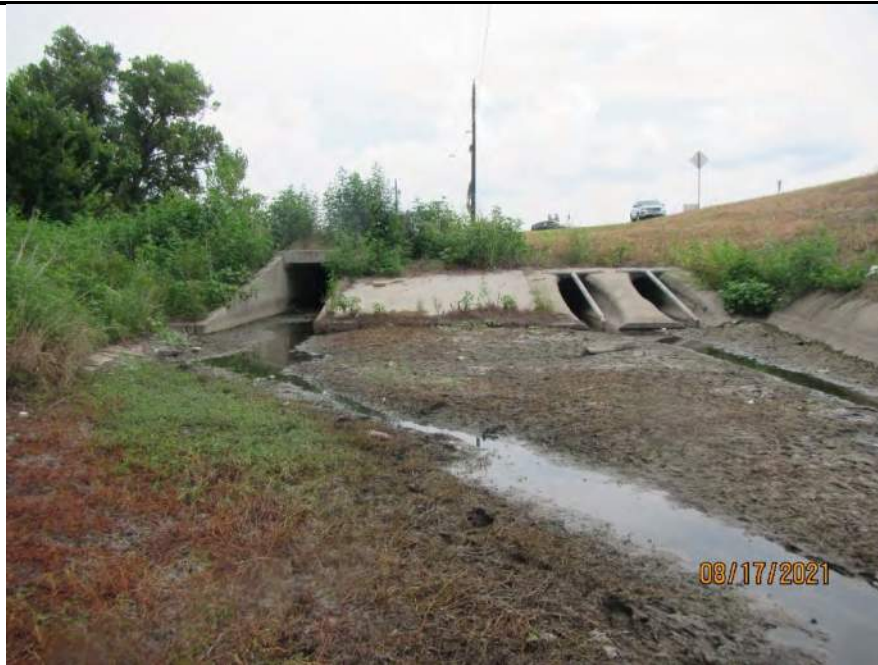
Photo 93.
Photo of Emergent Wetland **Water Feature 194** located in the north central portion of the Environmental Footprint. Dominant vegetation included swamp smartweed and broad-leaf cattail. **Water Feature 194** is within a constructed stormwater runoff area adjacent to US 75. Photo was taken to the northeast on August 17, 2021.

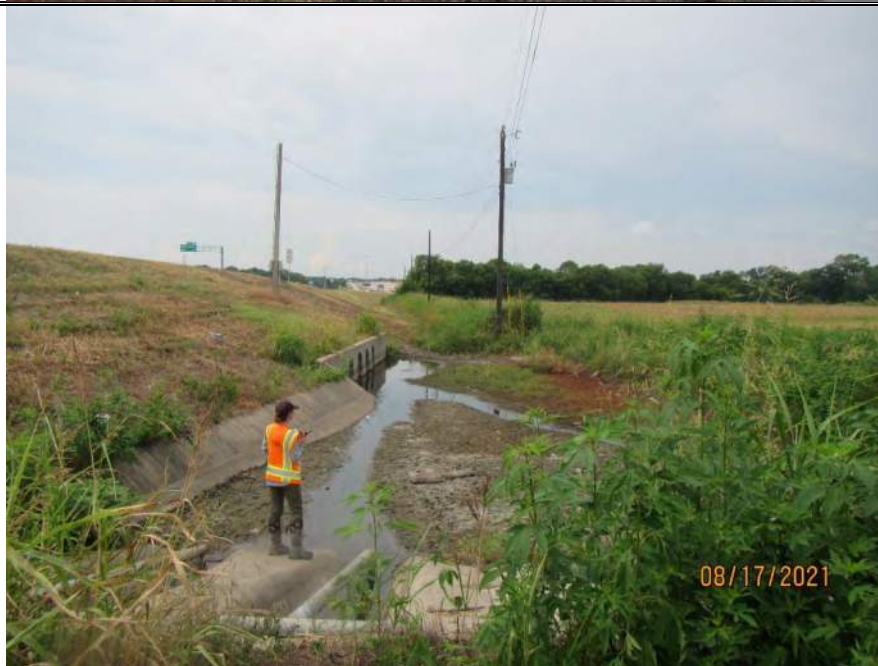
Photo 94.
Photo of Swale Drainage Feature **Water Feature 195** in the foreground of the photo. Ditch Drainage Feature **Water Feature 193** in the background. These features were located within the central portion of the Environmental Footprint. Note how these features aided in the draining of stormwater from adjacent US 75. Photo was taken August 17, 2021.

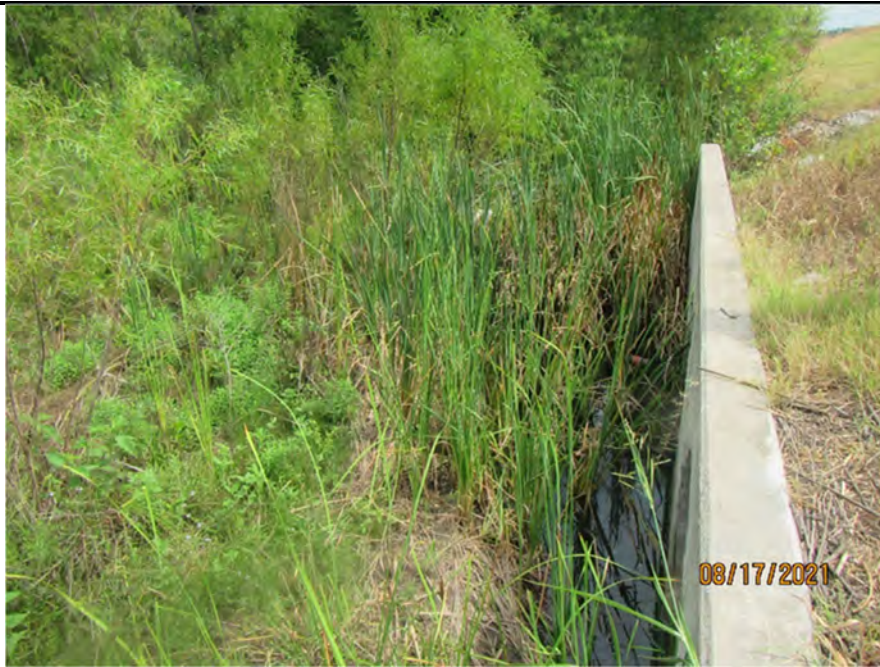
Photo 95.
Photo of Intermittent Stream **Water Feature 196** located in the central portion of the Environmental Footprint. Note how the hydrophytic vegetation was only present within the ordinary high-water mark of **Water Feature 196** due to sedimentation at the culvert. Photo was taken to the northeast on August 17, 2021.

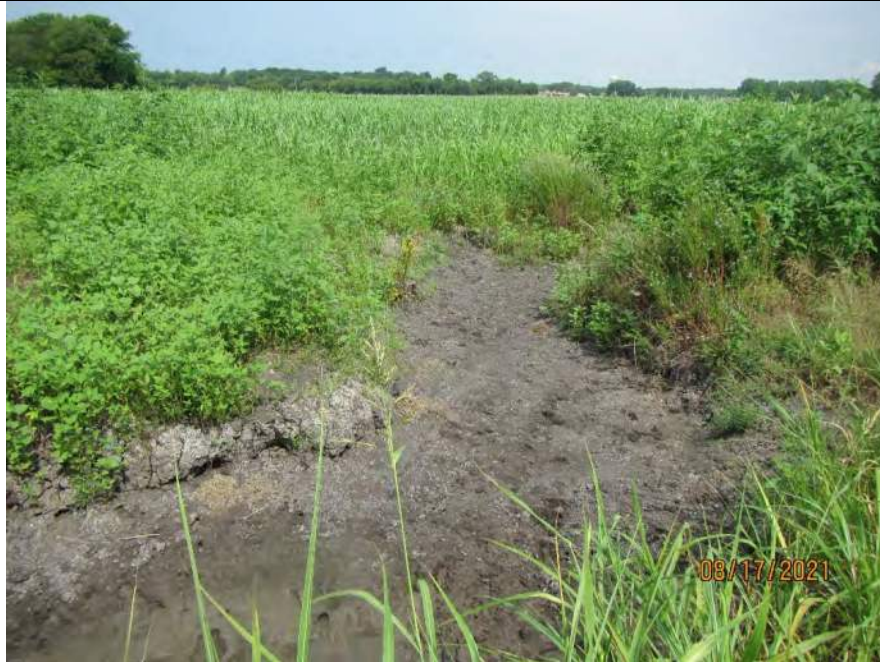
Photo 96.
Photo of Ephemeral Stream **Water Feature 199** located in the central portion of the Environmental Footprint. Note the defined channel and lack of surface water. Riparian vegetation was dominated by johnsongrass and annual marsh-elder. Photo was taken to the northwest on August 17, 2021.

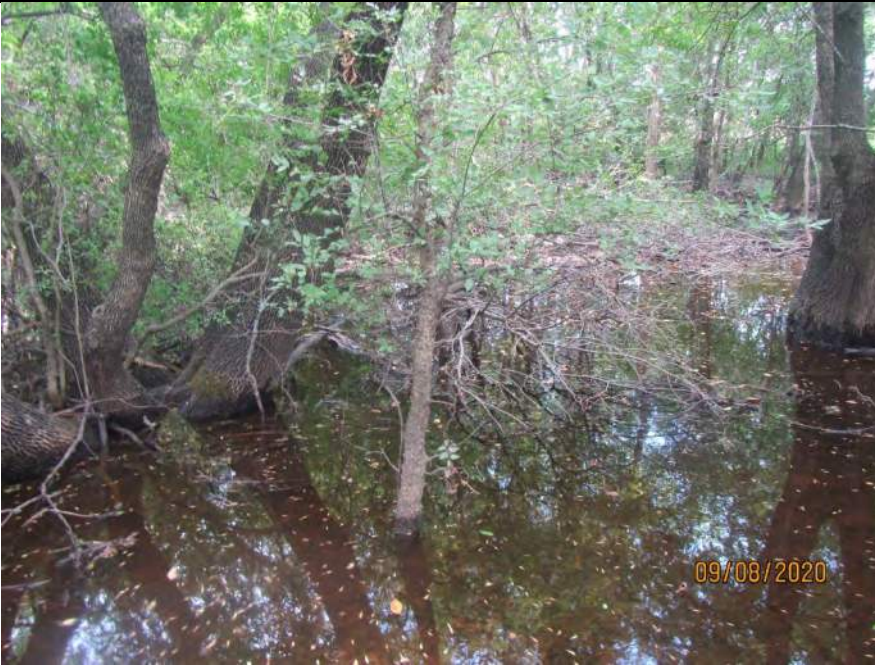
Photo 97.
Photo of Forested Wetland **Water Feature 200** located adjacent to US 75 in the north central portion of the Environmental Footprint. Dominant vegetation included green ash and sugar-berry (*Celtis laevigata*). Photo was taken to the west on September 8, 2020.

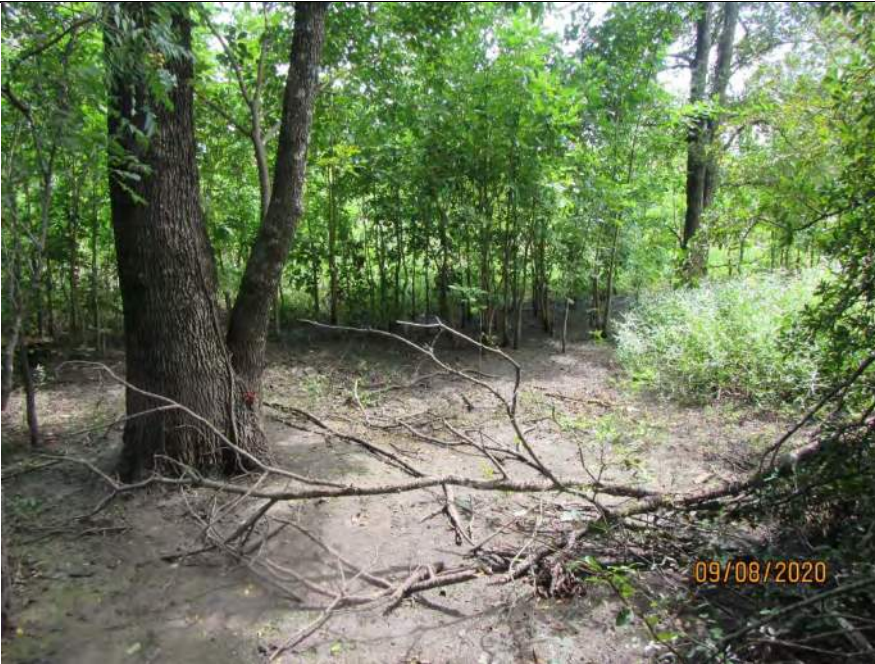
Photo 98.
Photo of Forested Wetland **Water Feature 201** located adjacent to US 75 in the north central portion of the Environmental Footprint. Dominated vegetation included green ash and sugar-berry. **Water Feature 201** abuts **Water Feature 202** and is hydrologically connected to Intermittent Stream **Water Feature 204** and Perennial Stream **Water Feature 205** (East Fork Trinity River). Photo was taken to the north on September 8, 2020.

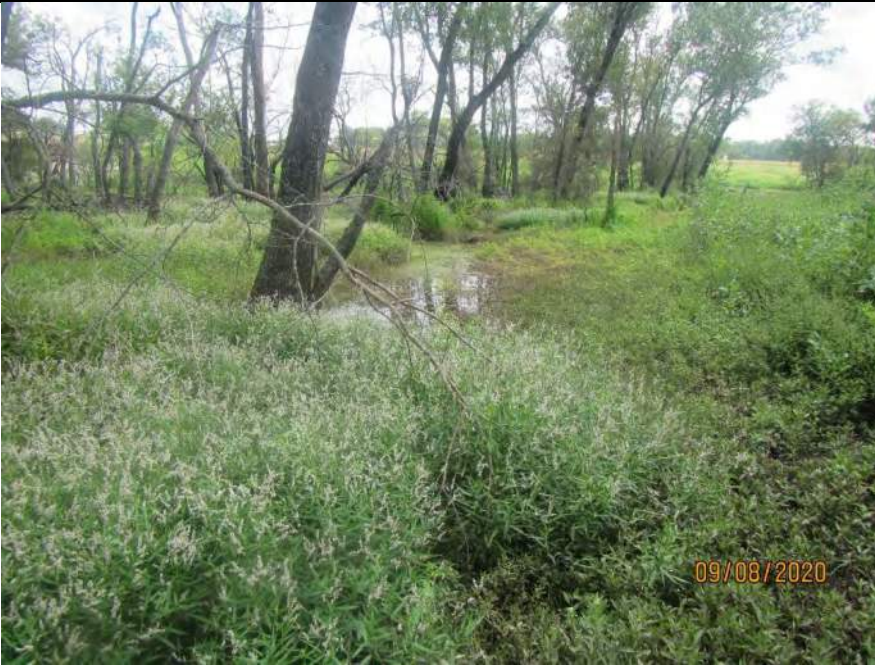
Photo 99.
Photo of Forested Wetland **Water Feature 202** located adjacent to US 75 in the north central portion of the Environmental Footprint. Dominant vegetation included green ash, swamp smartweed, and creeping water primrose (*Ludwigia peploides*). **Water Feature 202** abuts **Water Feature 201** and is hydrologically connected to Intermittent Stream **Water Feature 204** and Perennial Stream **Water Feature 205** (East Fork Trinity River). Photo was taken to the north on September 8, 2020.

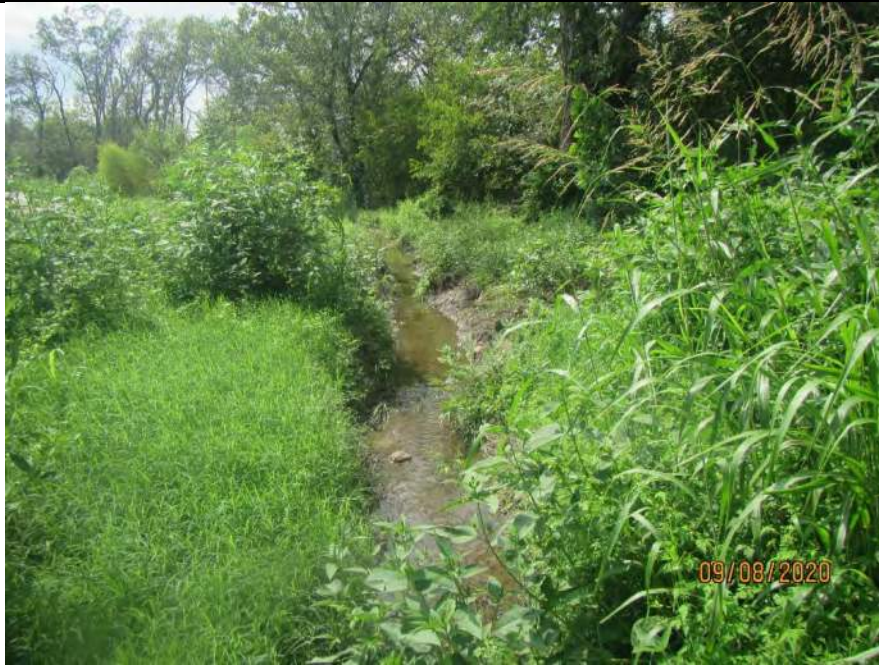
Photo 100.
Photo of
Intermittent Stream
Water Feature 204
located in the
central portion of
the Environmental
Footprint. **Water
Feature 204** is
hydrologically
connected to **Water
Feature 201** and
202 and flows
northeast into
**Water Feature
205. Water
Feature 204** has
groundwater
influence, silt
substrate, and
vegetated banks
dominated by great
ragweed,
johnsongrass,
bermudagrass,
pecan, and green
ash. Photo was
taken to the west
on September 8,
2020.

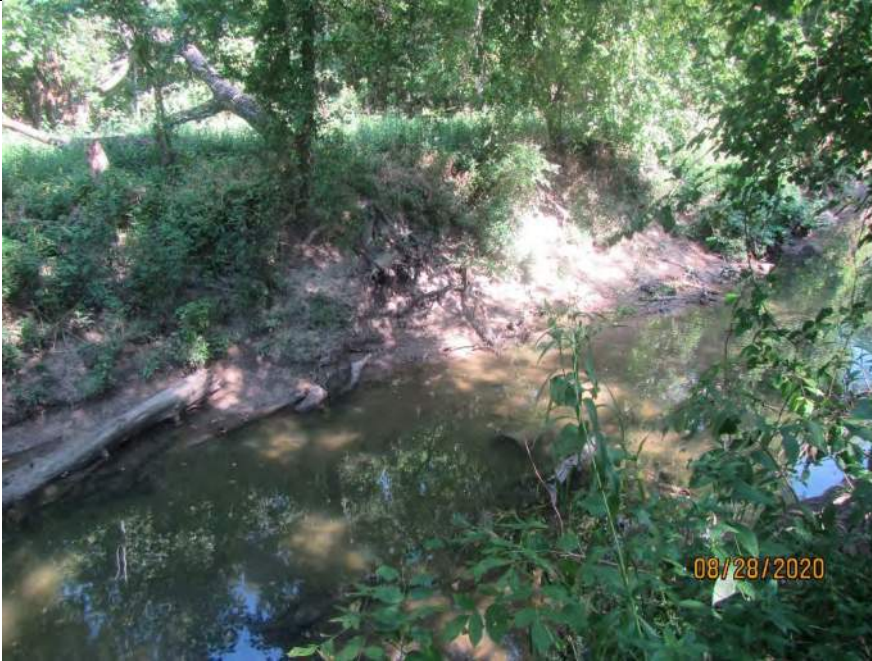
Photo 101. Photo of Perennial Stream **Water Feature 205** known as the East Fork Trinity River, located in the northern portion of the Environmental Footprint. Photo also representative of other reaches of the East Fork Trinity River, **Water Features 231, 234, 235, 236, 273, and 358.** Water Feature **205** had incised banks with scour, shelving, overhanging vegetation, and deep pools. Dominant vegetation included pecan, green ash, Bois d'arc, and sugar-berry. Photo was taken to the north on August 28, 2020.

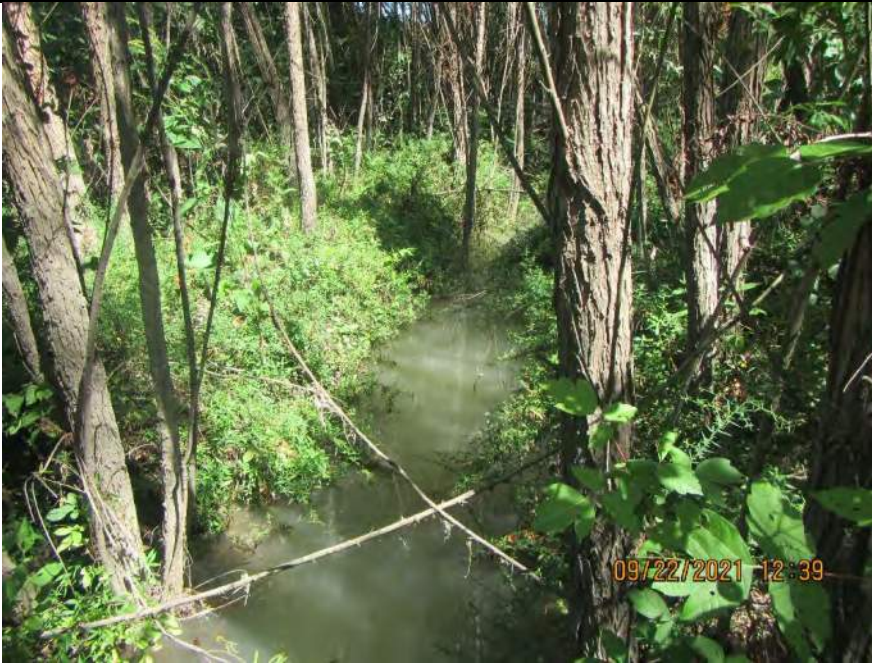
Photo 102.
Photo of Intermittent Stream **Water Feature 206** located in the central portion of the Environmental Footprint. **Water Feature 206** receives flow from **Water Feature 207** and flows southwest into **Water Feature 205** (East Fork Trinity River). Wooded riparian area dominated by black willow. Beaver activity influenced hydrology of **Water Feature 206** and **Water Feature 207**. Photo was taken to the northeast on September 22, 2021.

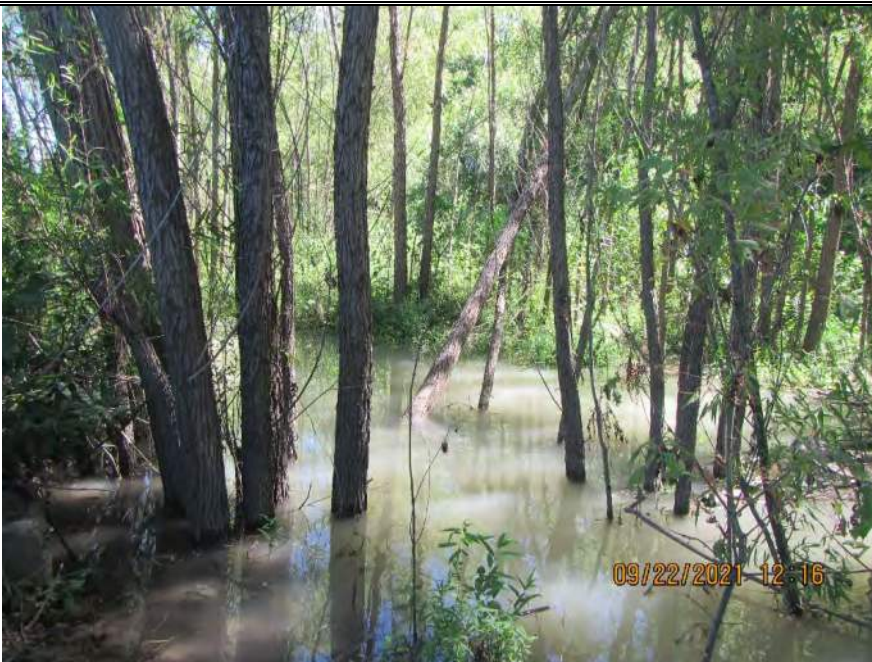
Photo 103.
Photo of Forested Wetland **Water Feature 207** located adjacent to US 75 in the north central portion of the Environmental Footprint. Dominant vegetation included black willow. **Water Feature 207** is hydrologically connected to Intermittent Stream **Water Feature 206** and Perennial Stream **Water Feature 205** (East Fork Trinity River). Photo was taken to the northeast on September 22, 2021.

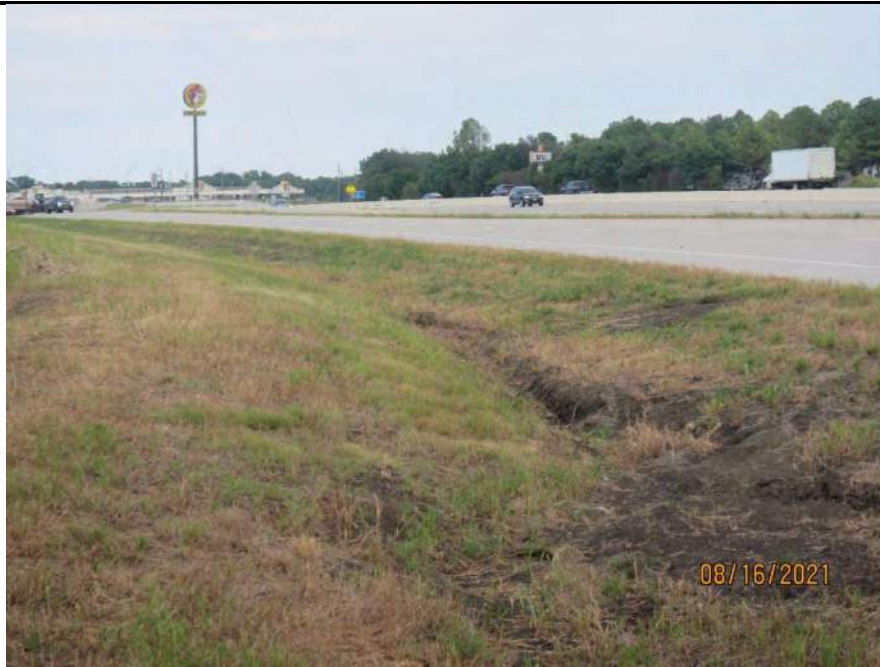
Photo 104. Representative photo of Ditch Drainage Features **Water Features 208, 210, 211, 213, and 217** in the north central portion of the Environmental Footprint. These roadside ditches were constructed in uplands around the US 75 and SH 121 interchange to aid in the rapid removal of stormwater runoff from highways. Photo taken August 16, 2021.

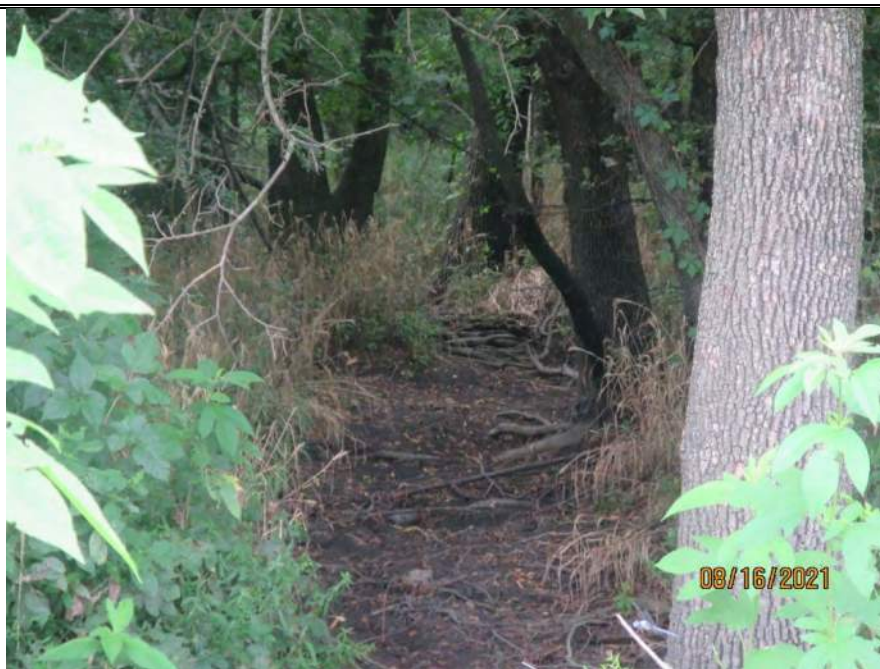
Photo 105. Photo of Ephemeral Stream **Water Feature 209** located in the central portion of the Environmental Footprint. Note the defined channel and lack of surface water. Riparian vegetation was dominated by bermudagrass, johnsongrass, and green ash. Photo was taken to the west on August 16, 2021.
