APPENDIX N: Water Resources

Attachment 4 - Site Photographs

Representative Environmental Footprint Photographs
Water Features Delineation
TxDOT US 380

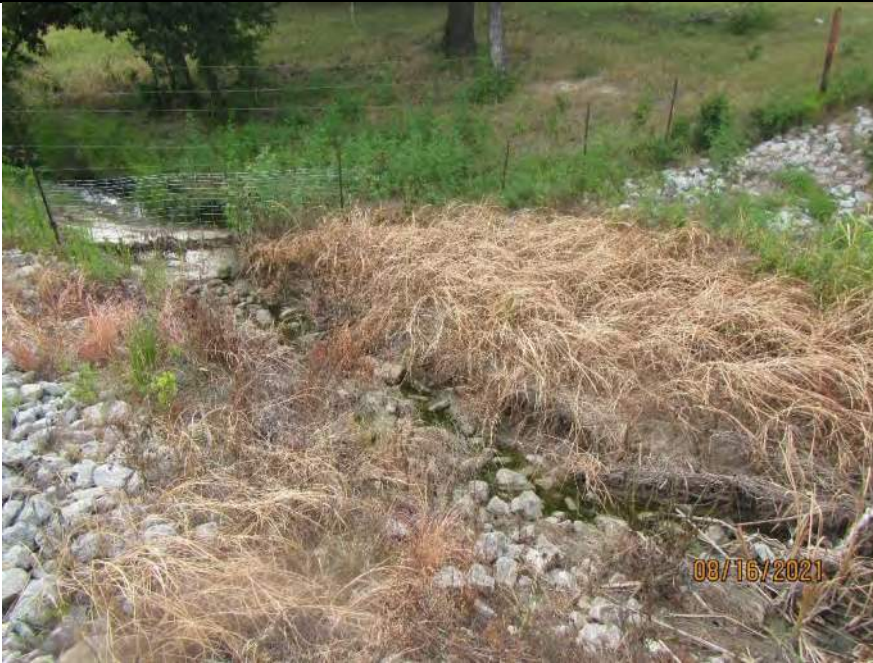
Photo 106.
Photo of Intermittent Stream **Water Feature 212** located within the northern portion of the Environmental Footprint. **Water Feature 212** had overhanging vegetation, matted vegetation, and oil or organic sheens in the water within the stream channel. Dominant vegetation included narrow-leaf cattail, black willow, and common persimmon (*Diospyros virginiana*). Photo was taken to the west on August 16, 2021.

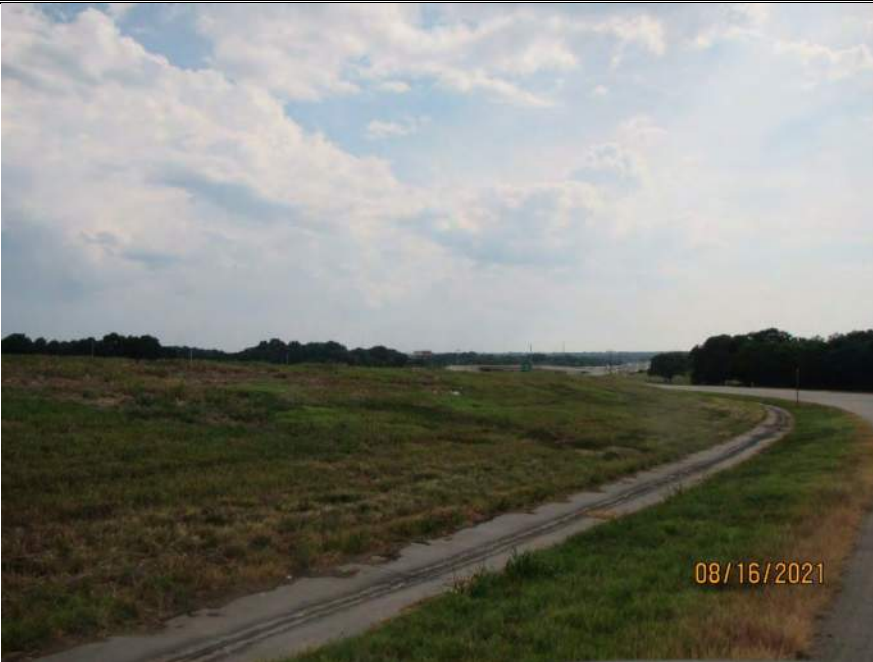
Photo 107.
Photo of Ditch Drainage Feature **Water Feature 214** in the central portion of the Environmental Footprint. **Water Feature 214** is a concrete lined ditch and was constructed in uplands around the US 75 and SH 121 interchange to aid in the rapid removal of stormwater runoff from highways. Photo taken August 16, 2021.

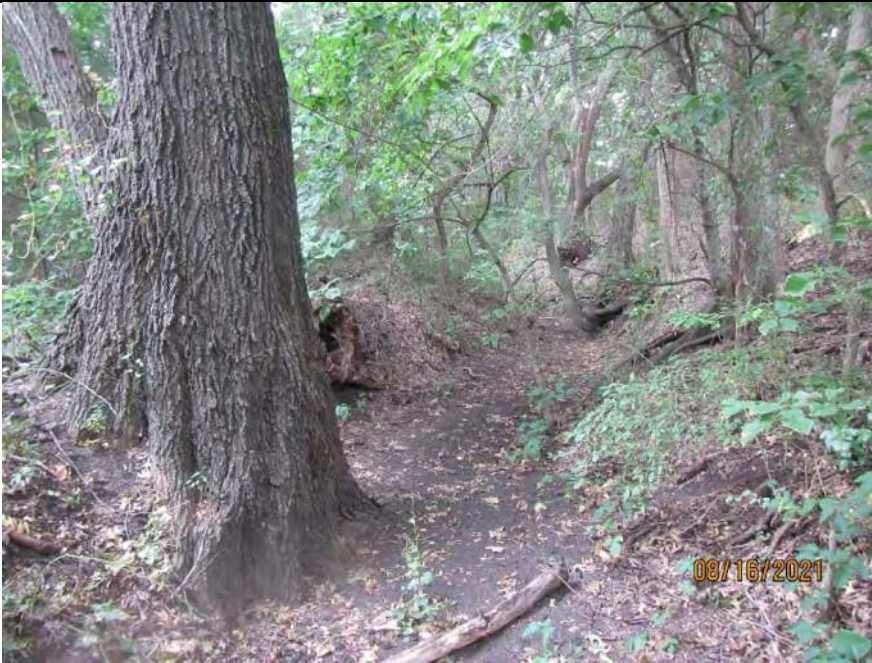
Photo 108.
Photo of Ephemeral Stream **Water Feature 215** located in the eastern portion of the Environmental Footprint. **Water Feature 215** had leaf litter disturbed and overhanging vegetation. Dominant vegetation included pecan, sugar-berry, and green ash. Photo was taken to the east on August 16, 2021.

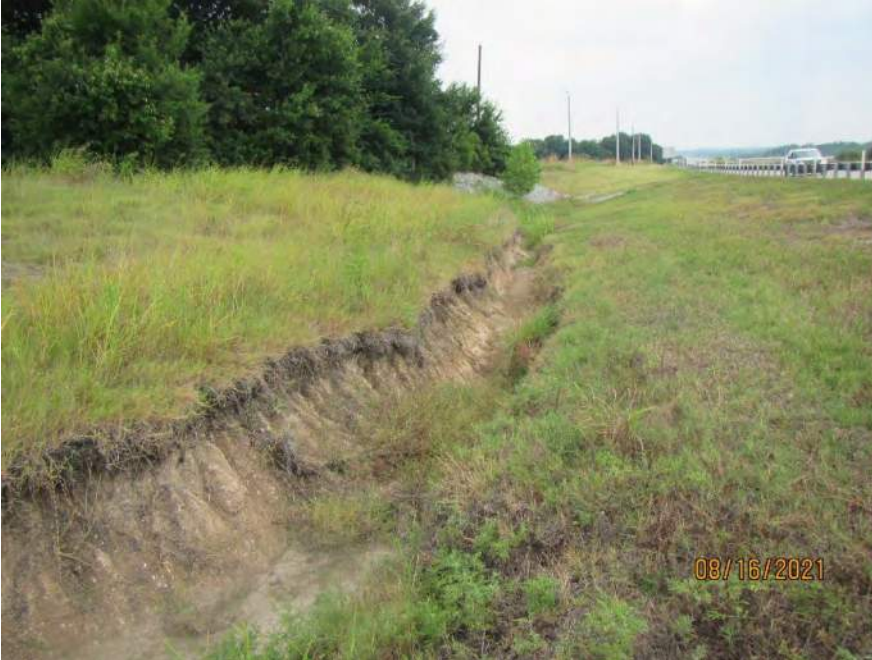
Photo 109.
Photo of Ditch Drainage Feature- **Water Feature 216** in the central portion of the Environmental Footprint. **Water Feature 216** was constructed in uplands to aid in the removal of stormwater runoff from US 75. Note the presence of erosion here. Photo was taken to the west on August 16, 2021.

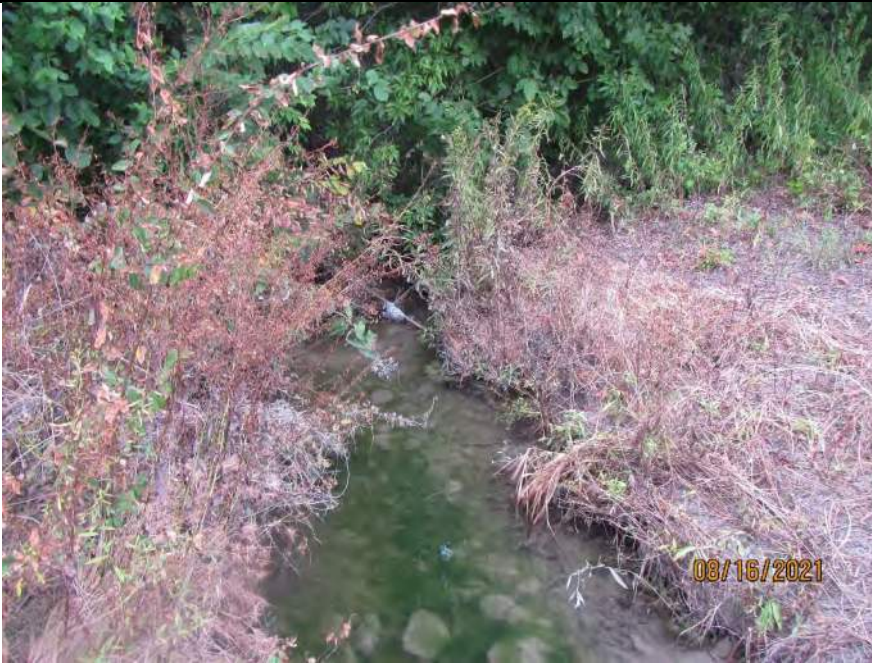
Photo 110.
Photo of Intermittent Stream **Water Feature 218** located in the northern portion of the Environmental Footprint. **Water Feature 218** had overhanging vegetation, deep pools within the channel, and matted vegetation. **Water Feature 218** is located adjacent to **Water Feature 219**. Dominant vegetation included eastern red-cedar, cedar elm, and American elm. Photo was taken to the west on August 16, 2021.

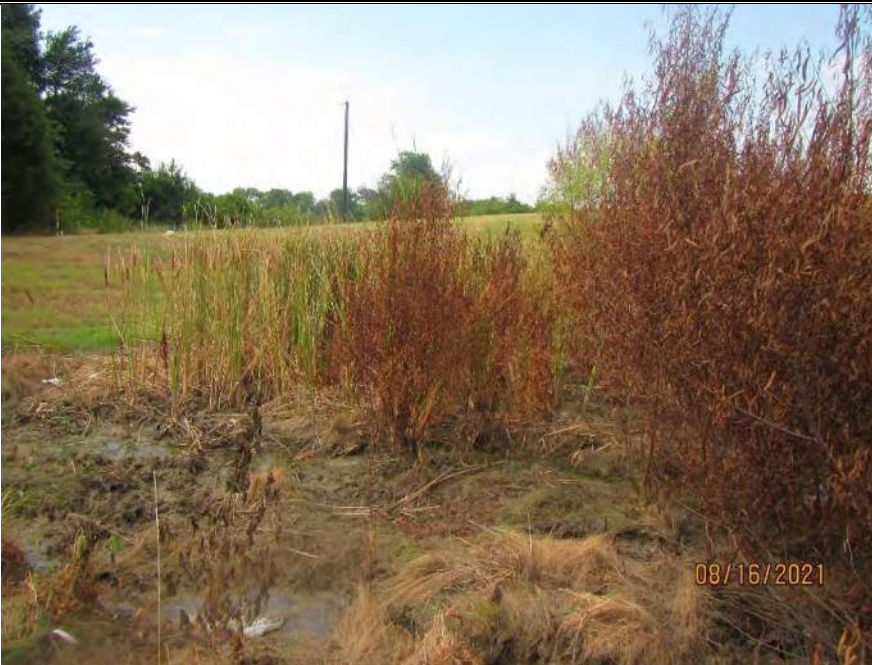
Photo 111.
Photo of Emergent Wetland **Water Feature 219** located in the north central portion of the Environmental Footprint. Dominant vegetation included common spike-rush and broad-leaf cattail. **Water Feature 219** is hydrologically connected to Intermittent Stream **Water Feature 218**. Photo was taken to the north on August 16, 2021.

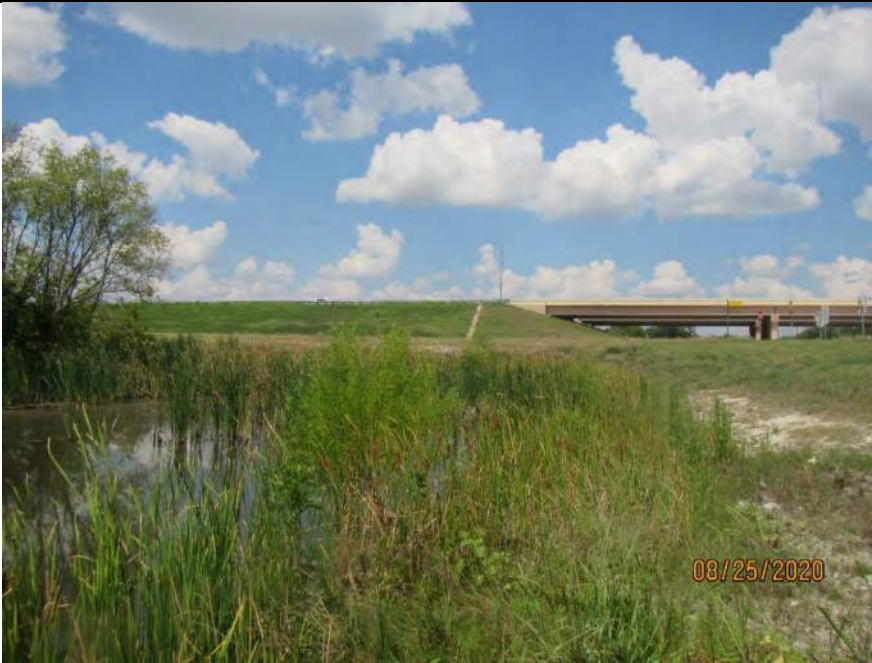
Photo 112.
Photo of Emergent Wetland **Water Feature 221** located adjacent to US 75 in the north central portion of the Environmental Footprint. Dominant vegetation included narrow-leaf cattail, bermudagrass, and black willow. **Water Feature 221** is hydrologically connected to **Water Feature 222**. Photo was taken to the north on August 25, 2020.

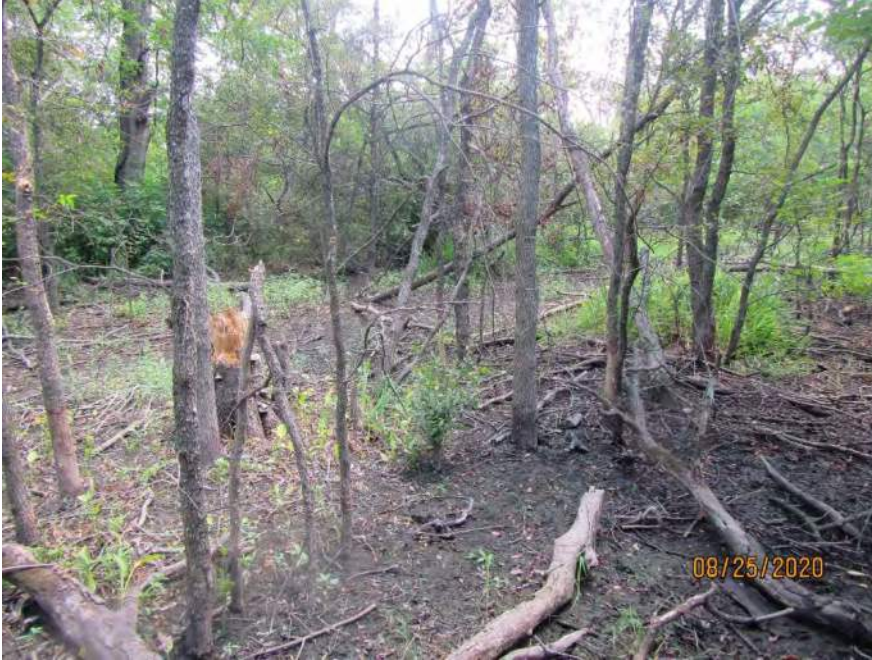
Photo 113.
Photo of Forested Wetland **Water Feature 222** located adjacent to US 75 in the north central portion of the Environmental Footprint. Dominant vegetation included black willow, American elm, green ash, bull-tongue arrowhead, and love-in-a-puff (*Cardiospermum halicacabum*). **Water Feature 222** is hydrologically connected to **Water Feature 221**. Photo was taken to the north on August 25, 2020.

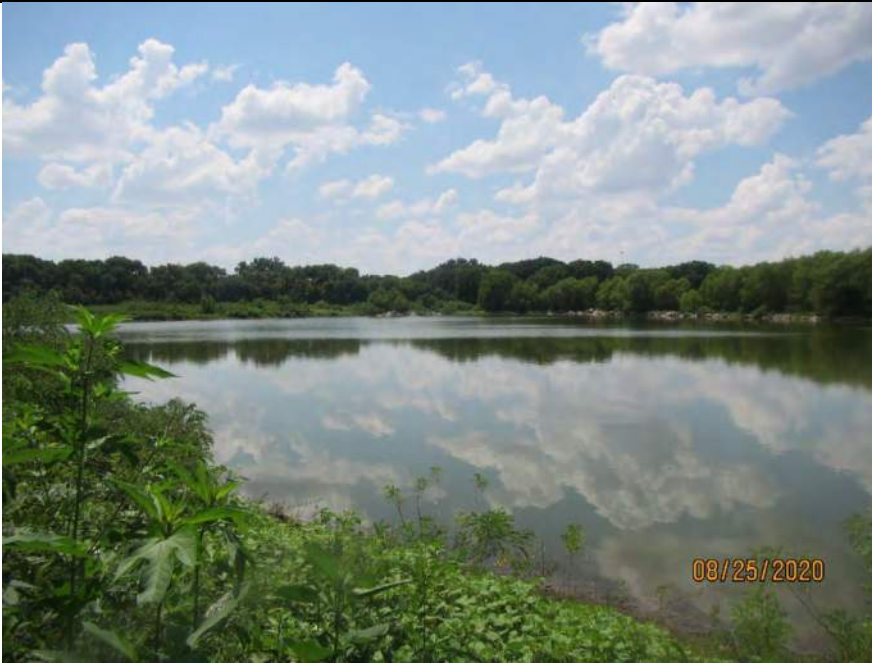
Photo 114.
 Photo of Upland
 Pond **Water
 Feature 223**
 located in the
 central northern
 portion of the
 Environmental
 Footprint. **Water
 Feature 223** was
 excavated near
Water Feature 222
 and **224**. Photo
 taken to the west
 on August 25,
 2020.

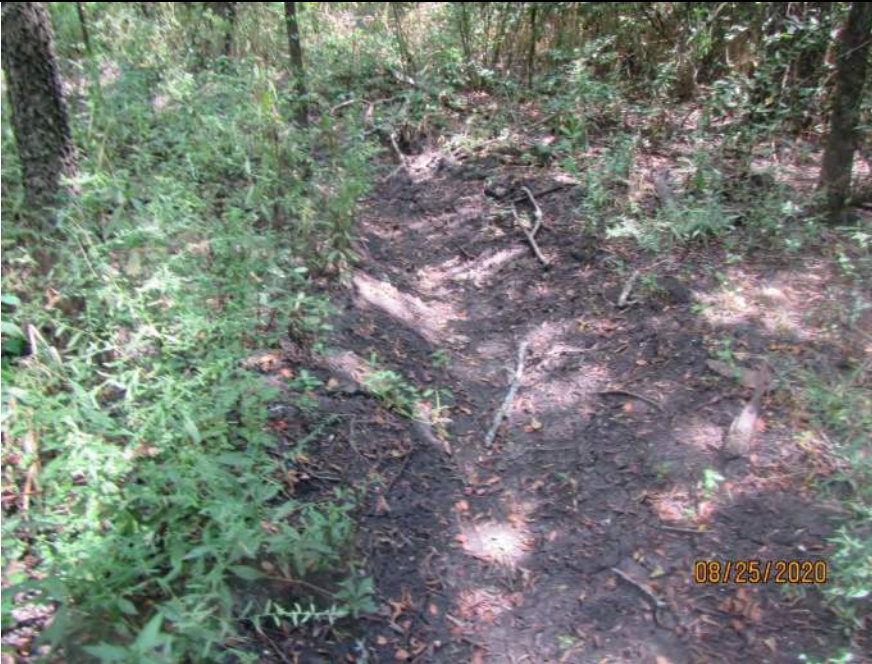
Photo 115.
 Photo of Ephemeral
 Stream **Water
 Feature 224** in the
 central portion of
 the Environmental
 Footprint. **Water
 Feature 224** flows
 into **Water Feature
 222**. Note the
 defined stream
 bed/banks, lack of
 water within the
 channel, and
 heavily wooded
 riparian area
 dominated by green
 ash and sugar-
 berry. Beaver
 activity influenced
 hydrology. Photo
 was taken to the
 west on August 25,
 2020.

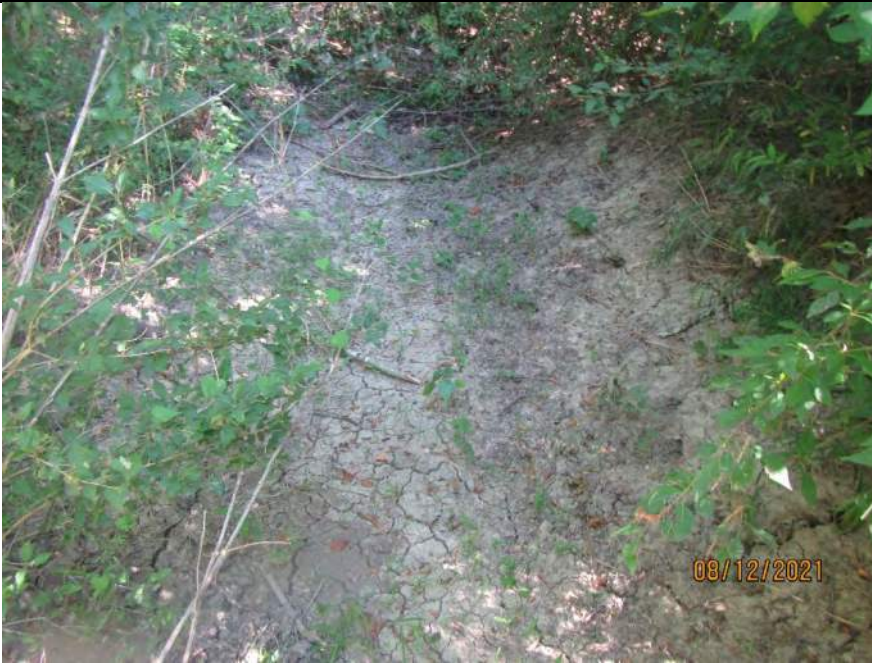
Photo 116. Photo of Ephemeral Stream **Water Feature 232** located in the northern portion of the Environmental Footprint. **Water Feature 232** had matted vegetation and destruction of terrestrial vegetation. Dominant vegetation included sugar-berry, boxelder, and great ragweed. Photo taken to the southeast on August 12, 2021.

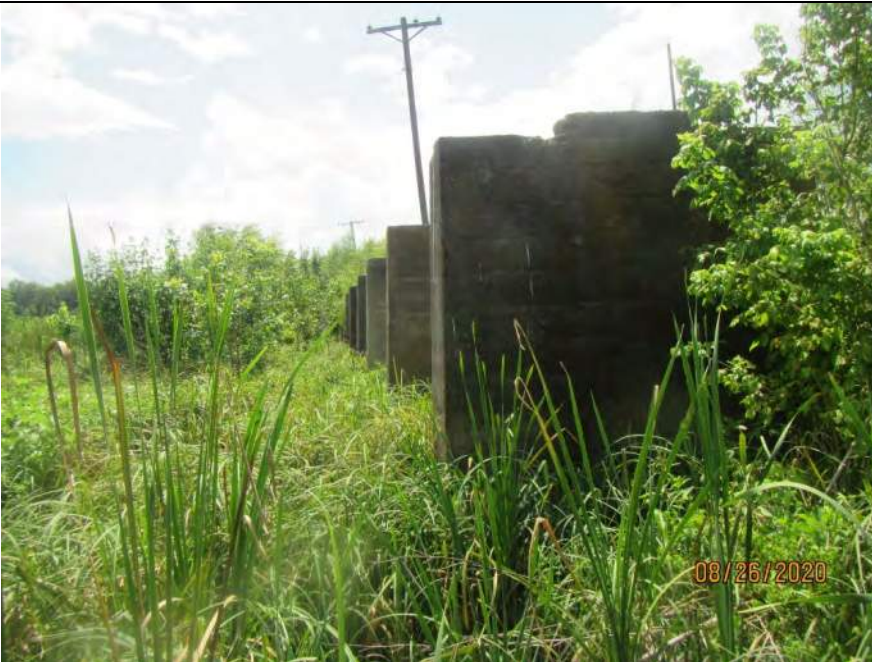
Photo 117. Photo of Emergent Wetland **Water Feature 288** and is representative of **289** located in the eastern portion of the Environmental Footprint. Dominant vegetation included northern frogfruit, rice cut grass, swamp smartweed, and narrow-leaf cattail. **Water Feature 233** and **288** about **Water Feature 289** and are located within an old railroad path (old bridge piers pictured). **Water Feature 233** and **288** receive overflow from Perennial Stream **Water Feature 235** (East Fork Trinity River). Photo was taken to the south on August 26, 2020.

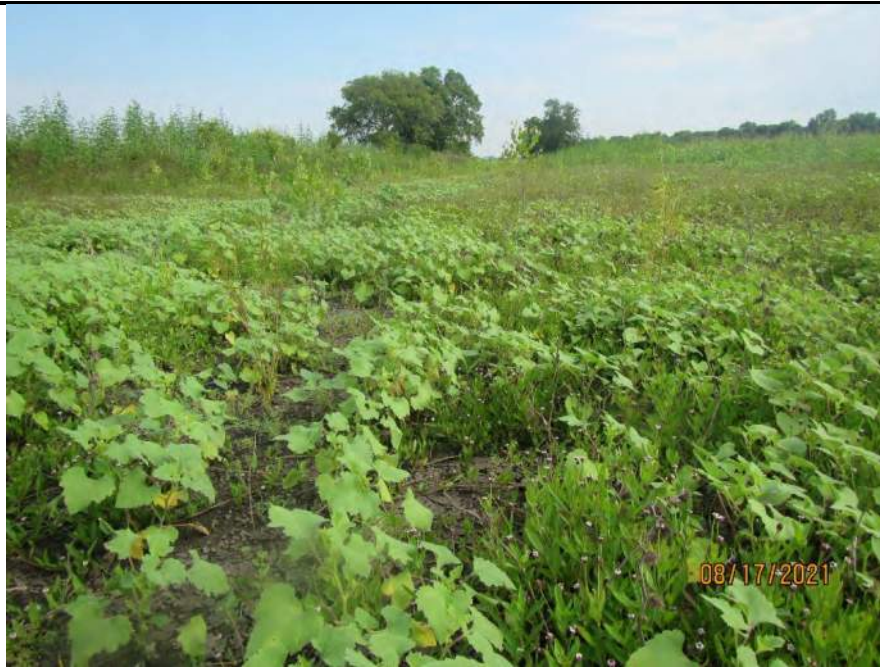
Photo 118.
Photo of Emergent Wetland **Water Feature 237** in the eastern portion of the Environmental Footprint. Dominant vegetation included northern frogfruit and rough cocklebur. Photo was taken to the north on August 17, 2021.

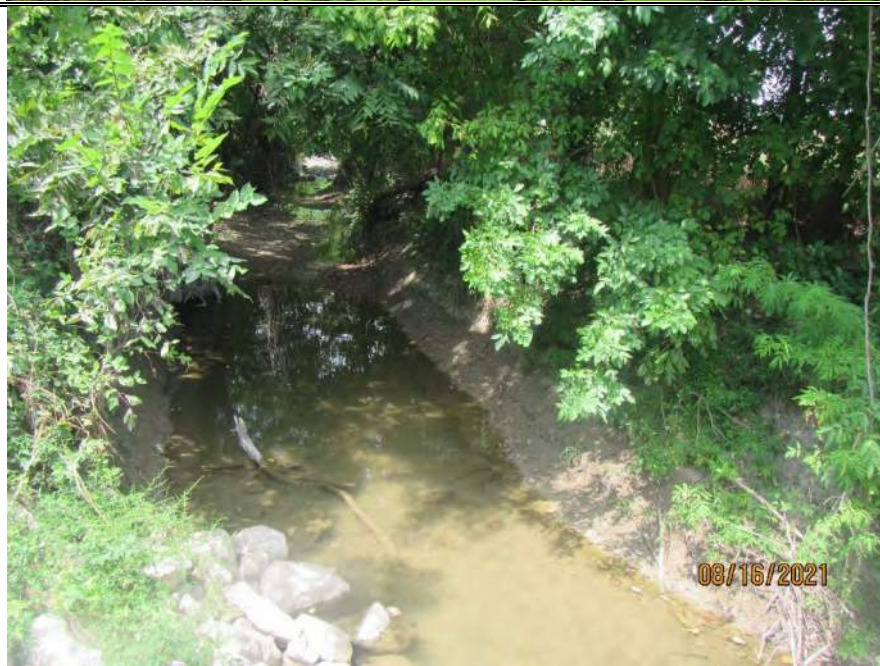
Photo 119.
Photo of Perennial Stream **Water Feature 242** also known as Powerhouse Creek, located in the eastern portion of the Environmental Footprint. **Water Feature 242** had deep channels with shelving, wrack lines, and gravel bars. Dominant vegetation included American elm, pecan, and boxelder. Photo was taken to the west on August 16, 2021.

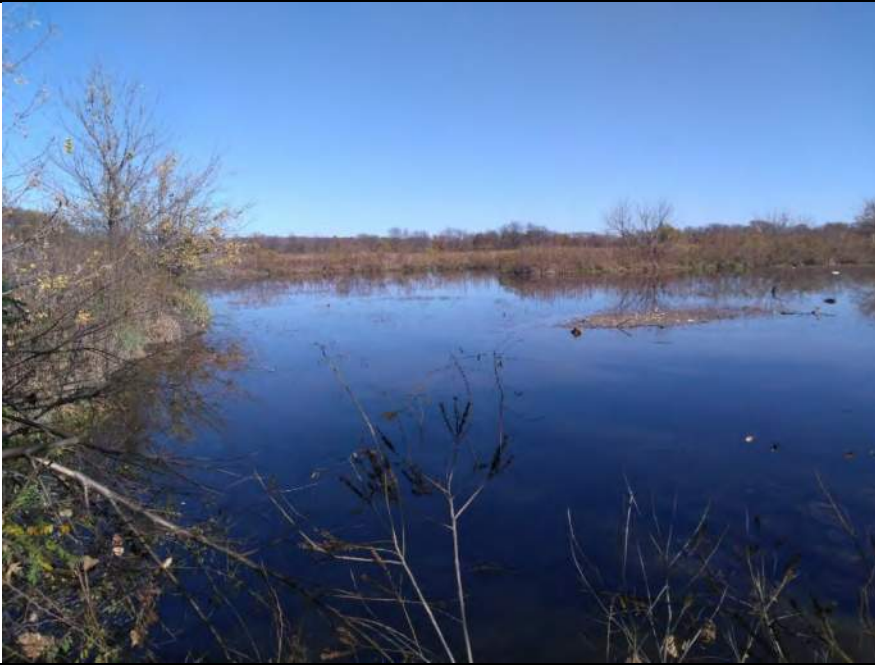
Photo 120.
Photo of On-Channel Pond **Water Feature 258** located in the eastern portion of the Environmental Footprint. **Water Feature 258** was excavated and is hydrologically connected to **Water Feature 259, 261, 262, 269, 271,** and the East Fork Trinity River, **Water Feature 273.** Photo taken to the north on November 11, 2020.

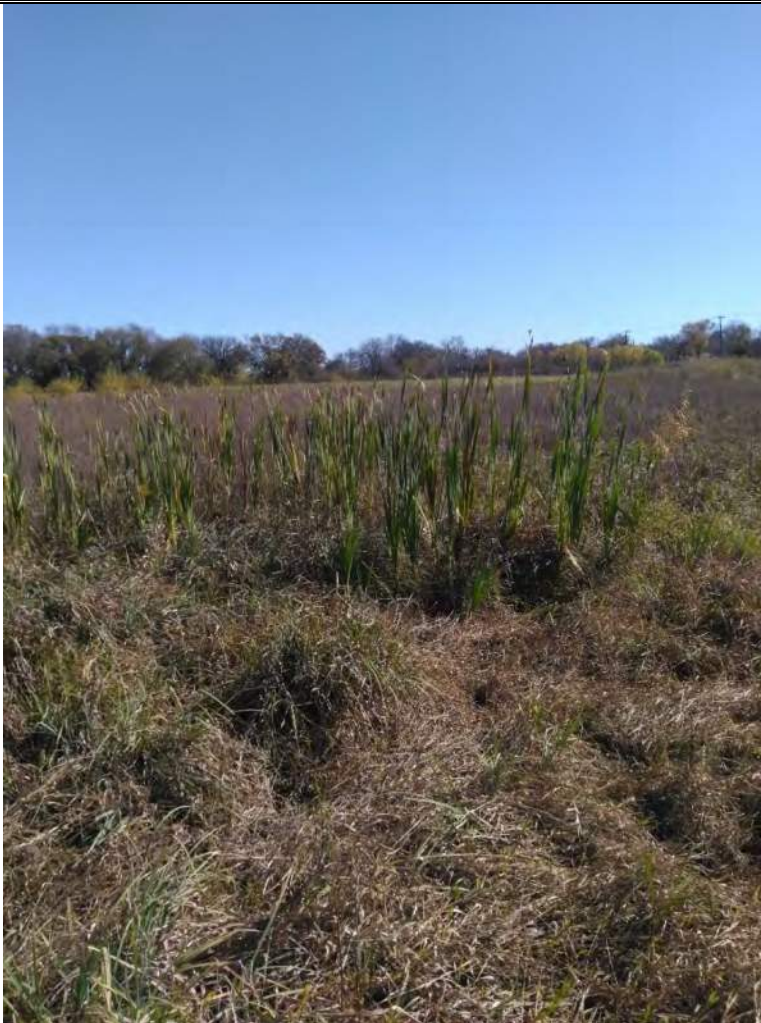
Photo 121.
Photo of Emergent Wetland **Water Feature 259** located in the eastern portion of the Environmental Footprint. Dominant vegetation included rice cut grass (*Leersia oryzoides*) and broad-leaf cattail. **Water Feature 259** is hydrologically connected to Stream **Water Feature 262.** Photo was taken to the east on November 9, 2020.

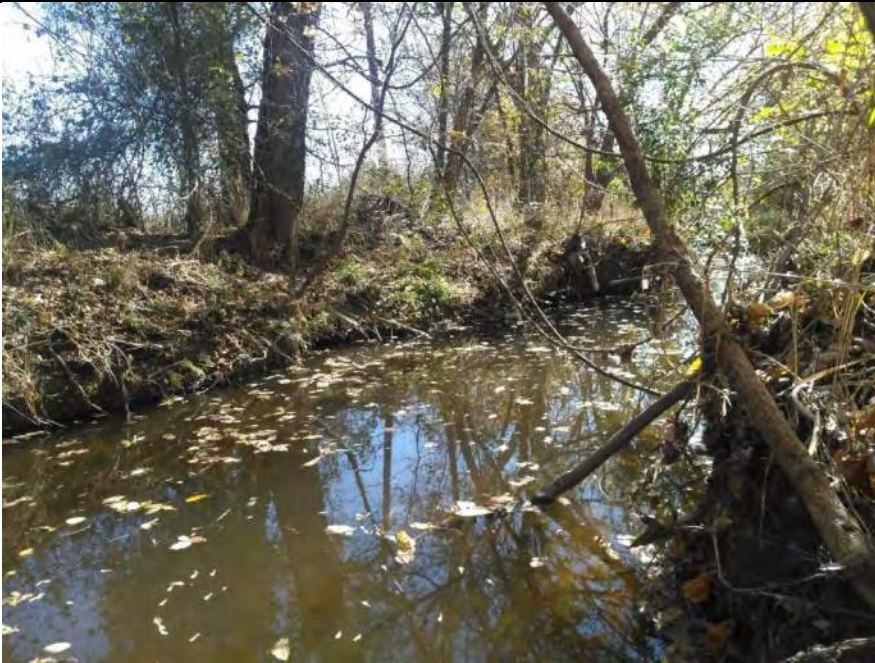
Photo 122.
Photo of Perennial Stream **Water Feature 261** located in the eastern portion of the Environmental Footprint. **Water Feature 261** had overhanging vegetation, a deep channel, and a wrack line. Dominant vegetation included great ragweed, sugar-berry, an American elm. Photo was taken to the southeast on November 11, 2020.

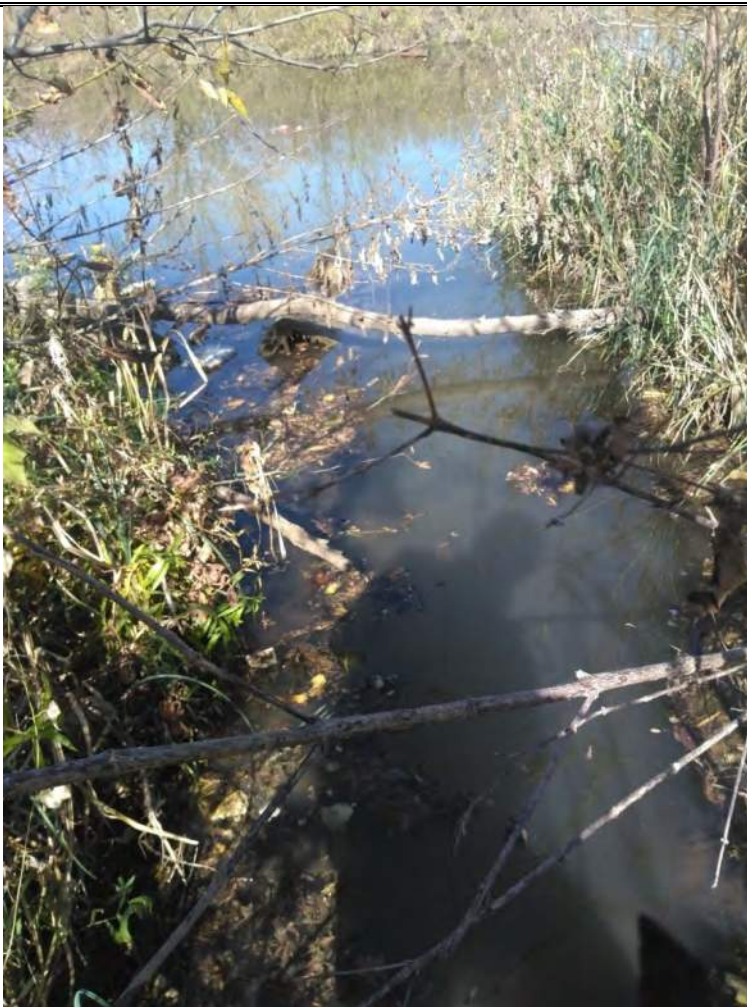
Photo 123.
Photo of perennial Stream **Water Feature 262** located in the eastern portion of the Environmental Footprint. **Water Feature 269** was hydrologically connected to **Water Feature 259** and **261**. **Water Feature 262** had wrack lines, shelving, and disturbed leaf litter. Dominant vegetation included rice cut grass, eastern poison ivy, and boxelder. Photo was taken to the south on November 11, 2020.

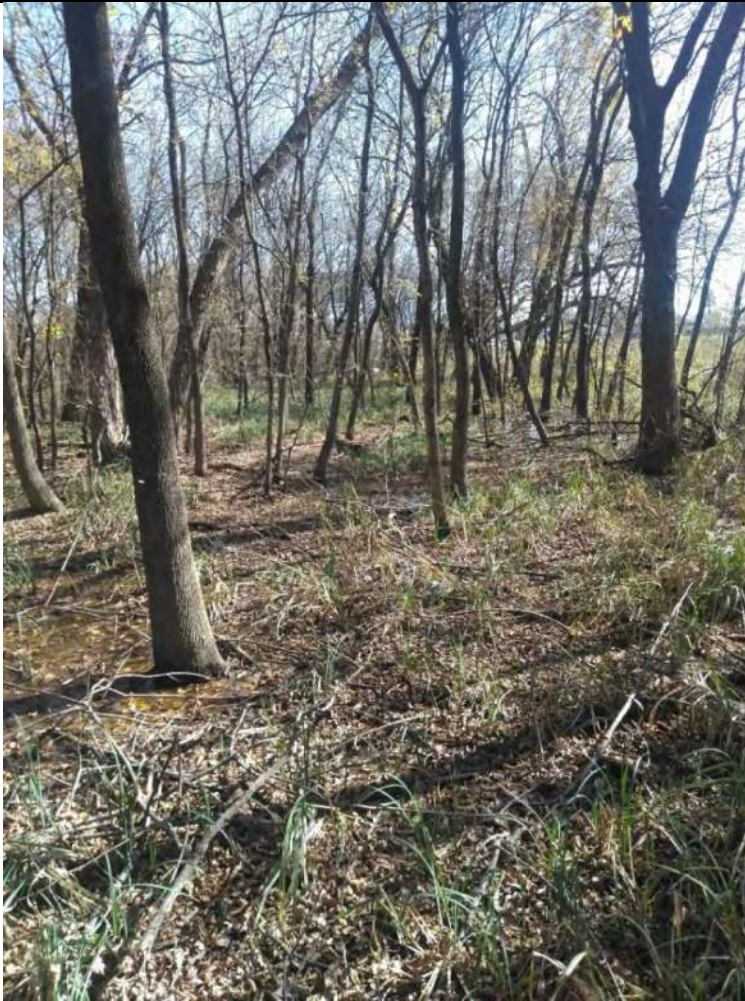
Photo 124.
Photo of Forested Wetland **Water Feature 264** located adjacent to US 380 in the eastern portion of the Environmental Footprint. Dominant vegetation included American elm, green ash, and rice cut grass. Photo was taken to the east on November 9, 2020.

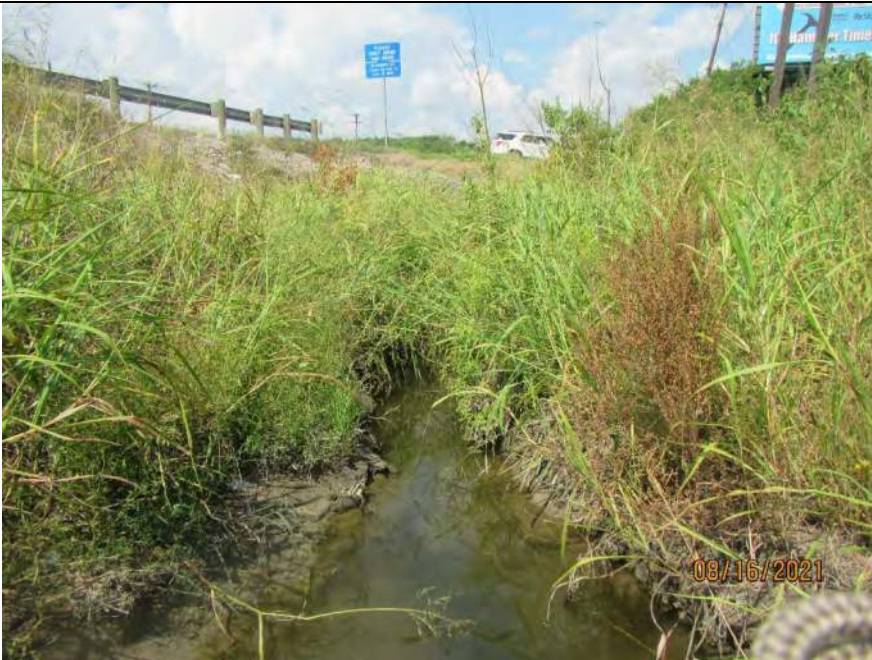
Photo 125.
Photo of Intermittent Stream **Water Feature 269** located in the eastern portion of the Environmental Footprint north of US 380. **Water Feature 269** had artificially stabilized banks, overhanging vegetation, gravel bars, aquatic vegetation, and matted vegetation. Dominant vegetation included johnsongrass, great ragweed, and black willow. Photo was taken to the west on August 16, 2021.

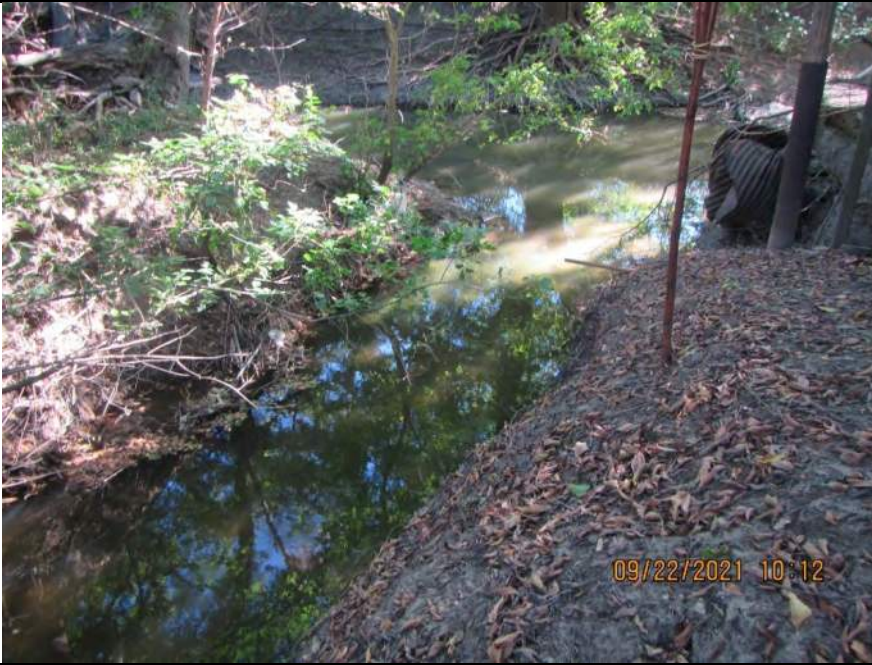
Photo 126.
Photo of Intermittent Stream **Water Feature 271** located within the eastern portion of the Environmental Footprint. **Water Feature 271** was hydrologically connected to Perennial Stream **Water Feature 273**, the East Fork Trinity River. Photo was taken to the east on September 22, 2021.

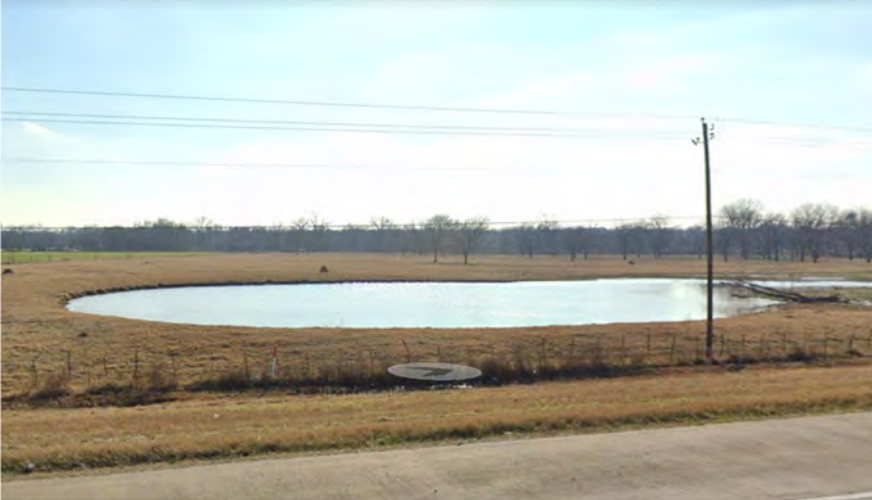
Photo 127.
Photo of Upland Pond **Water Feature 275** located in the eastern portion of the Environmental Footprint. **Water Feature 275** is isolated from **Water Feature 273**, the East Fork Trinity River, by a roadway constructed between 2004 and 2008. Photo is from Google Maps Roadway Viewer.

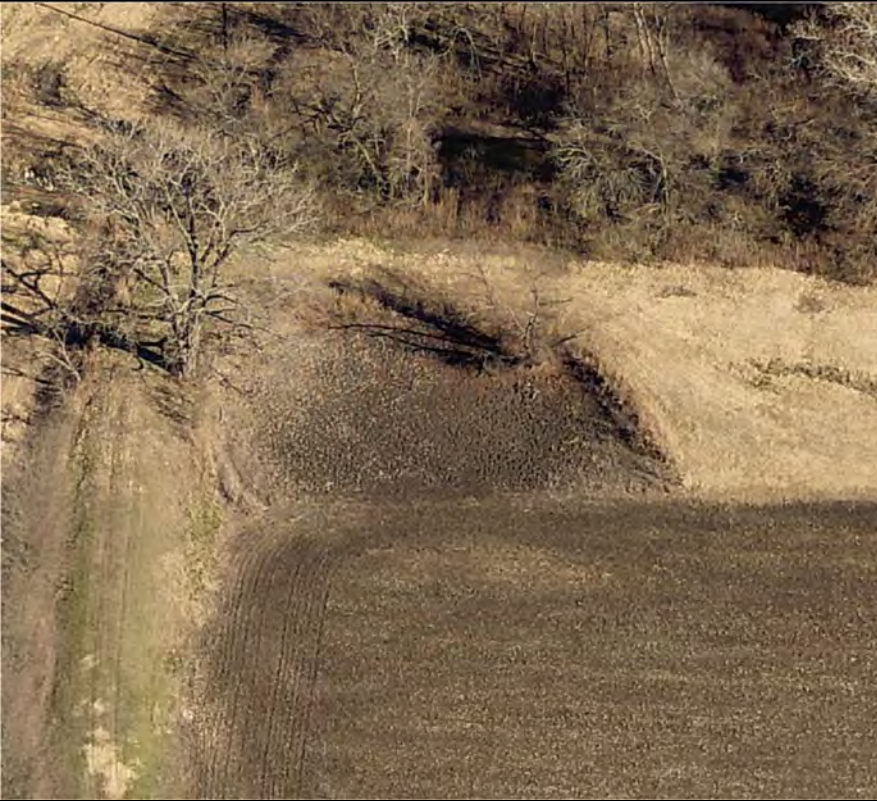
Photo 128.
Photo of Upland
Pond **Water**
Feature 281
located in the
eastern portion of
the Environmental
Footprint. **Water**
Feature 218 was
isolated from **Water**
Feature 283 from
an
anthropogenically
created berm to the
east. Photo was
taken from
EagleConnect
Pictometry Viewer,
December 17,
2020.

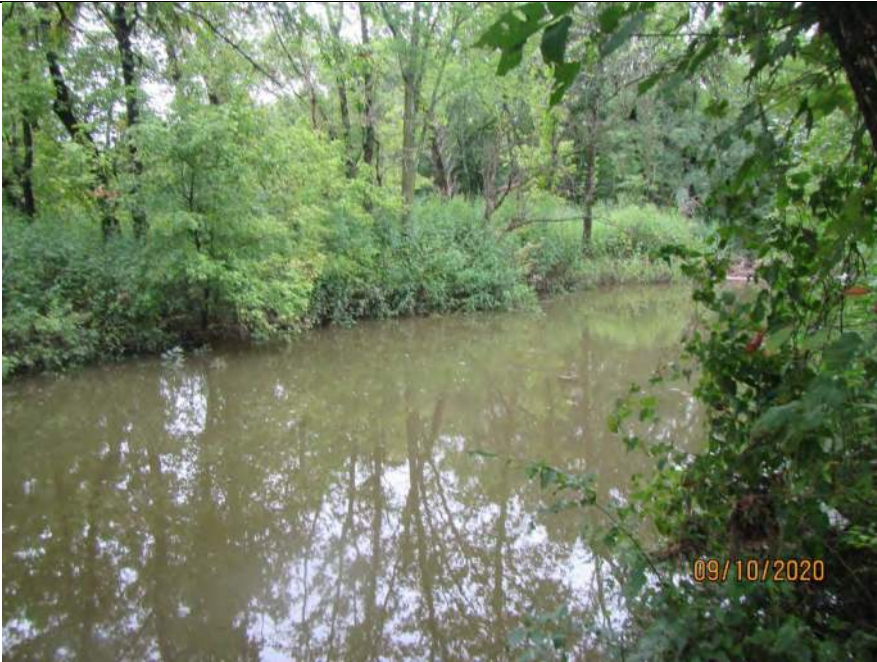
Photo 129.
Photo of
Intermittent Stream
Water Feature 283
located in the
eastern portion of
the Environmental
Footprint. **Water**
Feature 283 had
overhanging
vegetation,
destruction of
terrestrial
vegetation, and
scour along banks.
Dominant
vegetation included
bur oak, green ash,
and Bois d'arc.
Photo taken to the
north on September
10, 2020.

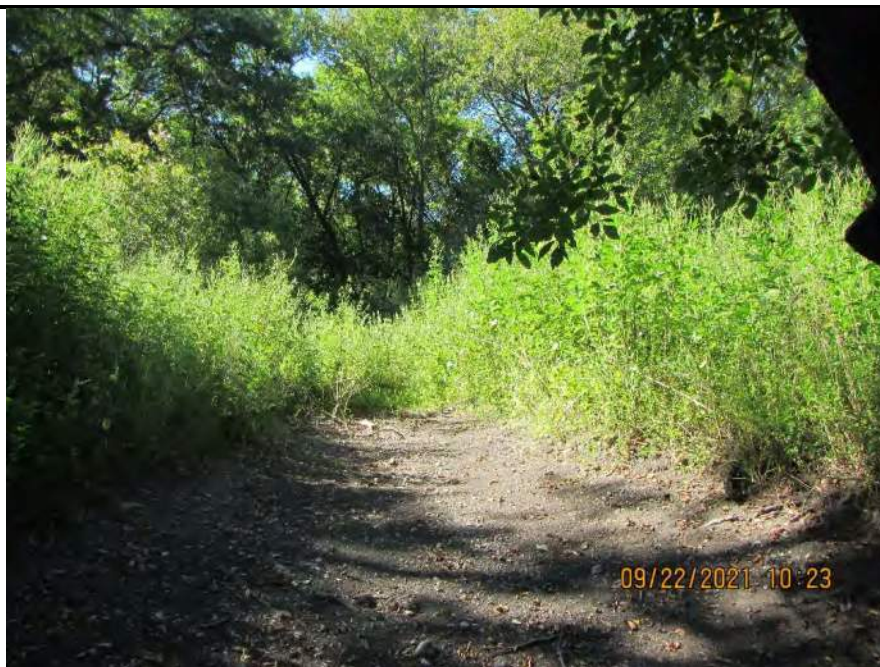
Photo 130.
Photo of Ephemeral Stream **Water Feature 285** located in the eastern portion of the Environmental Footprint. Note the destruction of terrestrial vegetation, bed/banks, and lack of surface water within the defined channel. Riparian vegetation consisted of great ragweed, Bois d'arc, green ash, and American elm. Photo was taken to the south on September 22, 2021.

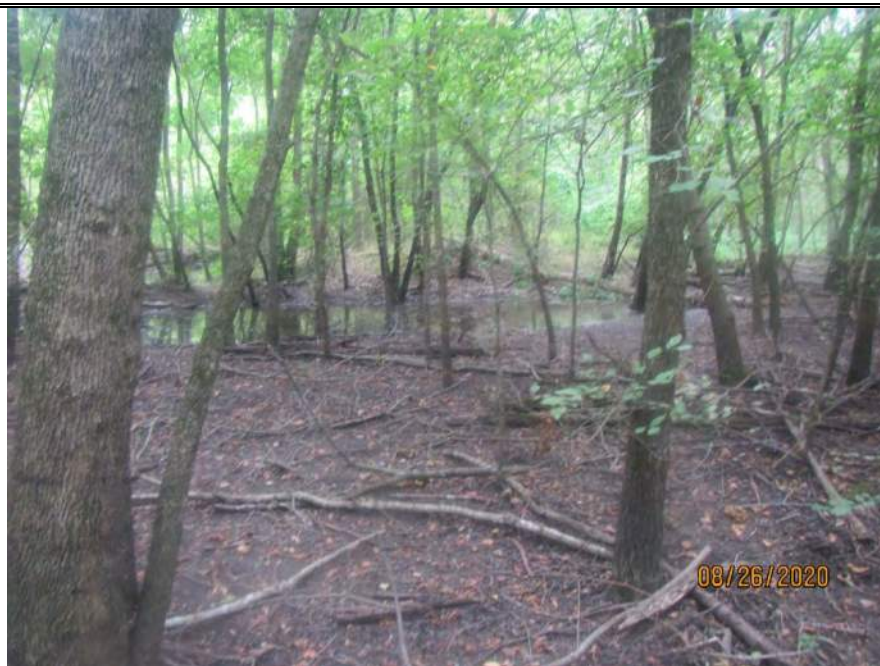
Photo 131.
Photo of Forested Wetland **Water Feature 286** located in the eastern portion of the Environmental Footprint. Dominant vegetation was American elm. **Water Feature 286** is hydrologically connected to **Water Feature 233, 288, 289, and 290** through **Water Feature 287**. Photo was taken to the north on August 26, 2020.

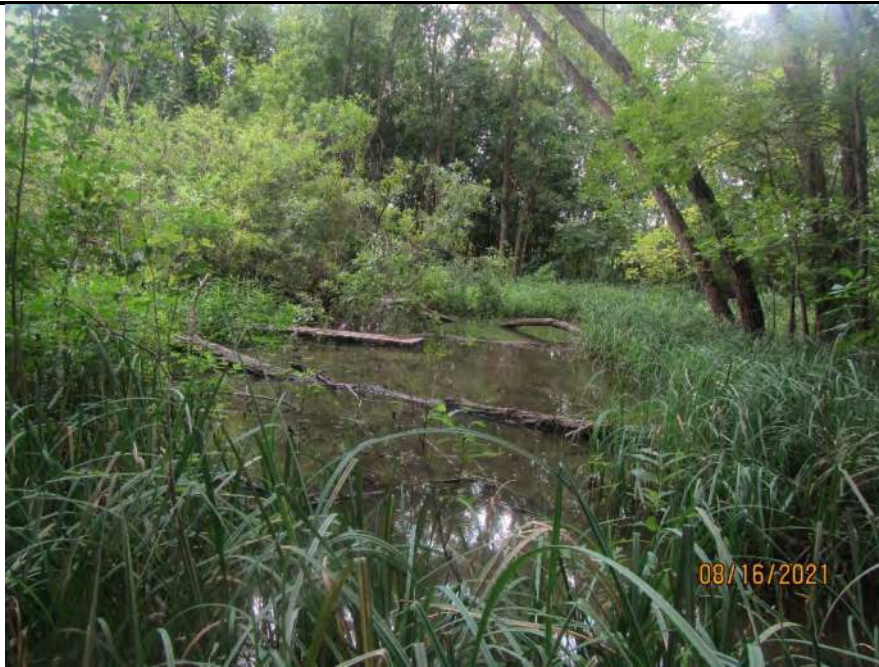
Photo 132.
Photo of Forested Wetland **Water Feature 289** located in the eastern portion of the Environmental Footprint. Dominant vegetation included American elm, green ash, black willow, and marsh-millet (*Zizaniopsis miliacea*). **Water Feature 289** abuts **Water Feature 288, 290, and 233**. **Water Feature 289** receives overflow from Perennial Stream **Water Feature 235** (East Fork Trinity River). Photo was taken to the north on August 16, 2021.

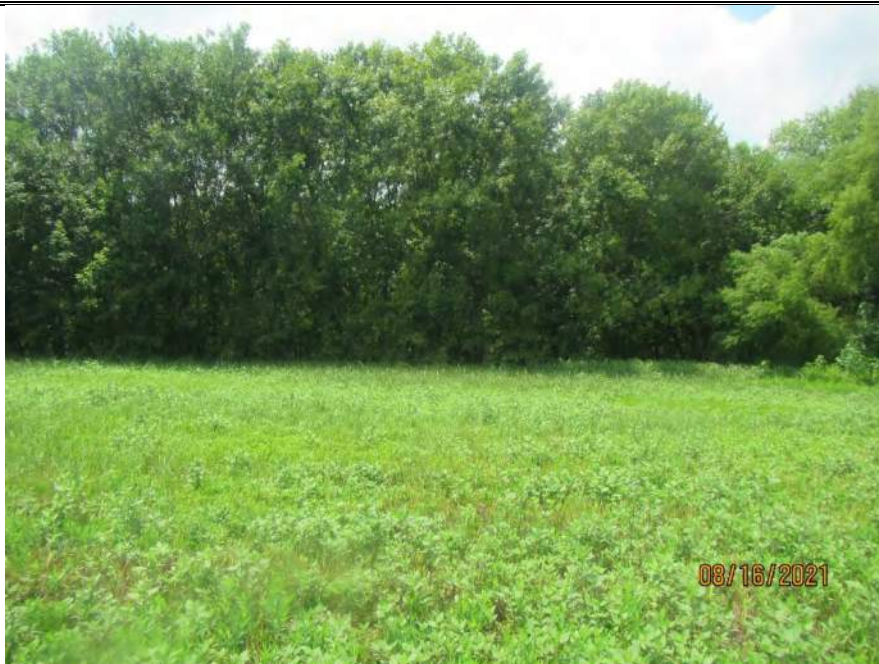
Photo 133.
Photo of Emergent Wetland **Water Feature 290** located in the eastern portion of the Environmental Footprint. Dominant vegetation included northern frogfruit, annual marsh-elder, and green ash saplings. **Water Feature 290** abuts **Water Feature 289** and receives overflow from Perennial Stream **Water Feature 235** (East Fork Trinity River). Photo was taken to the west on August 16, 2021.

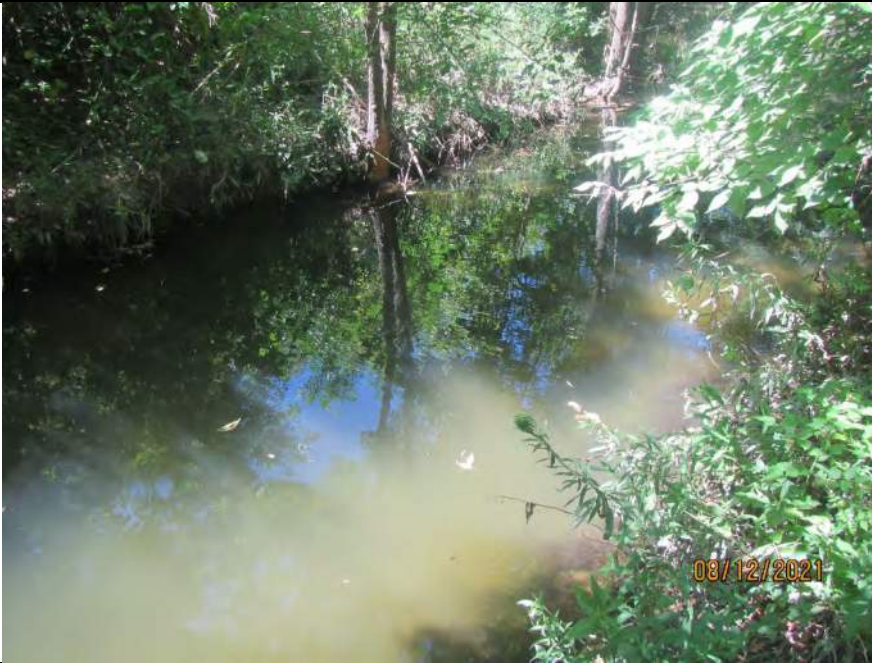
Photo 134.
 Photo of Perennial Stream **Water Feature 291** located in the eastern portion of the Environmental Footprint. **Water Feature 291** had overhanging vegetation, a deep channel, and matted vegetation. Dominant vegetation included rice cut grass, green ash, and love-in-a-puff. Photo was taken to the south on August 12, 2021.

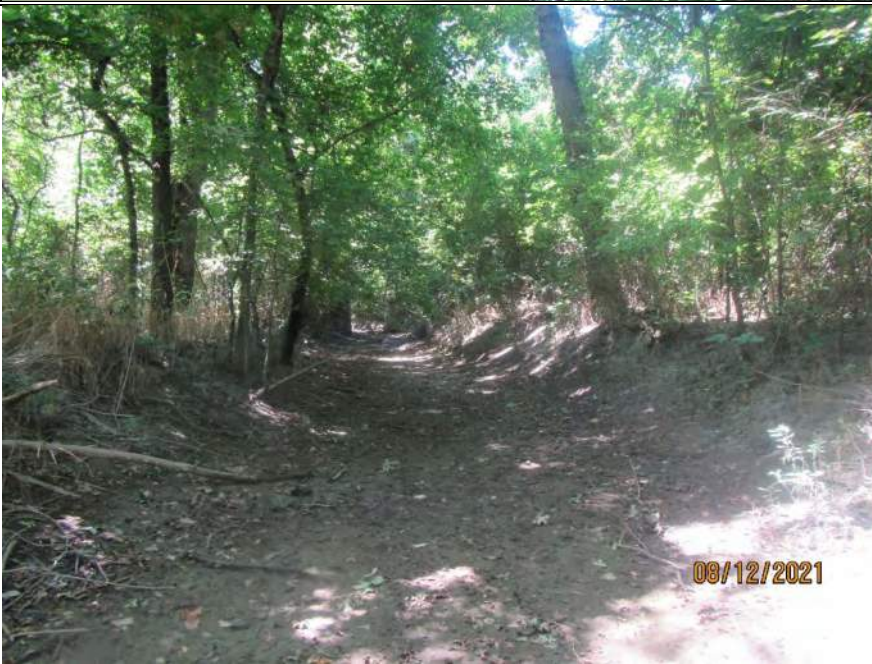
Photo 135.
 Photo of Intermittent Stream **Water Feature 293** known as Clemons Creek, located in the eastern portion of the Environmental Footprint. **Water Feature 293** had sediment deposition, matted vegetation, and litter/debris within the stream channel. Hydrology was likely impacted upstream from construction of the North Texas Municipal Water District Water Line. Dominant vegetation included boxelder, black willow, and American elm. Photo was taken to the north on August 12, 2021.

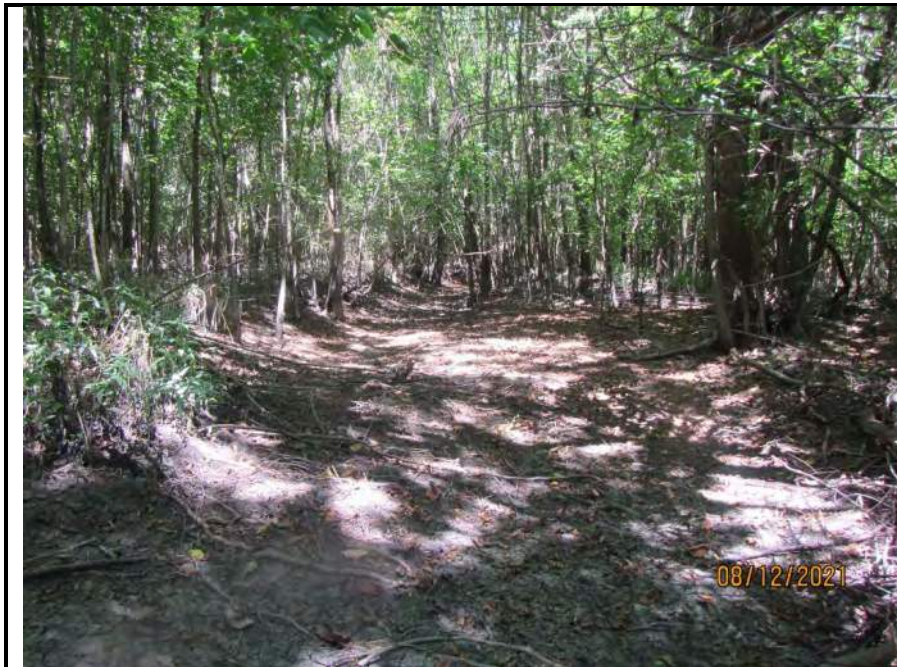
Photo 136.
Photo of Forested Wetland **Water Feature 297** located in the eastern portion of the Environmental Footprint. Dominant vegetation included American elm, black willow, and green ash saplings. **Water Feature 297** was linear and likely an old stream channel. Photo was taken to the northwest on August 12, 2021.

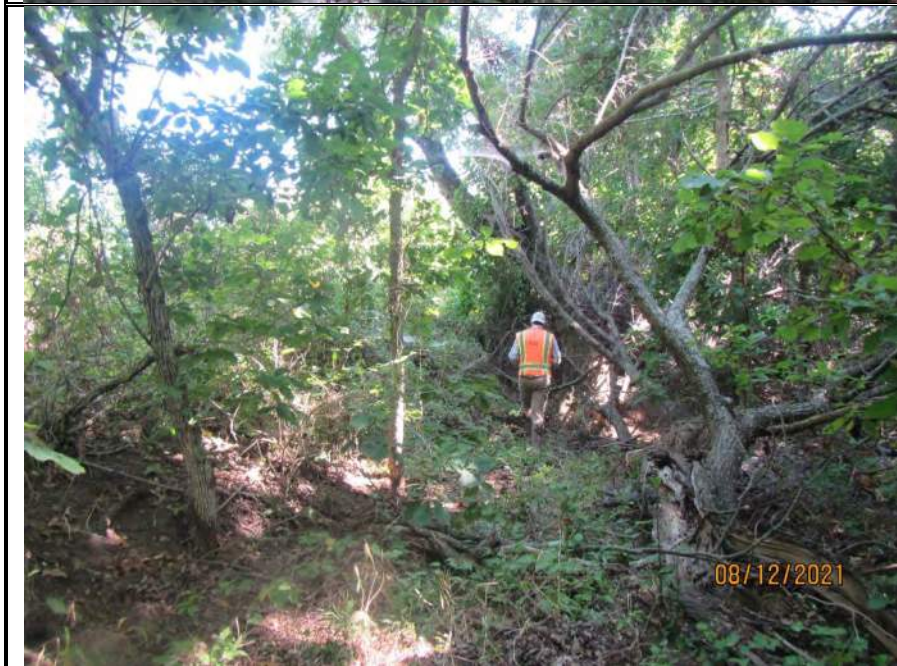
Photo 137.
Photo of Ephemeral Stream **Water Feature 304** located in the eastern portion of the Environmental Footprint. **Water Feature 304** was linear and likely an old stream channel adjacent to County Road 338. Photo was taken to the south on August 12, 2021.

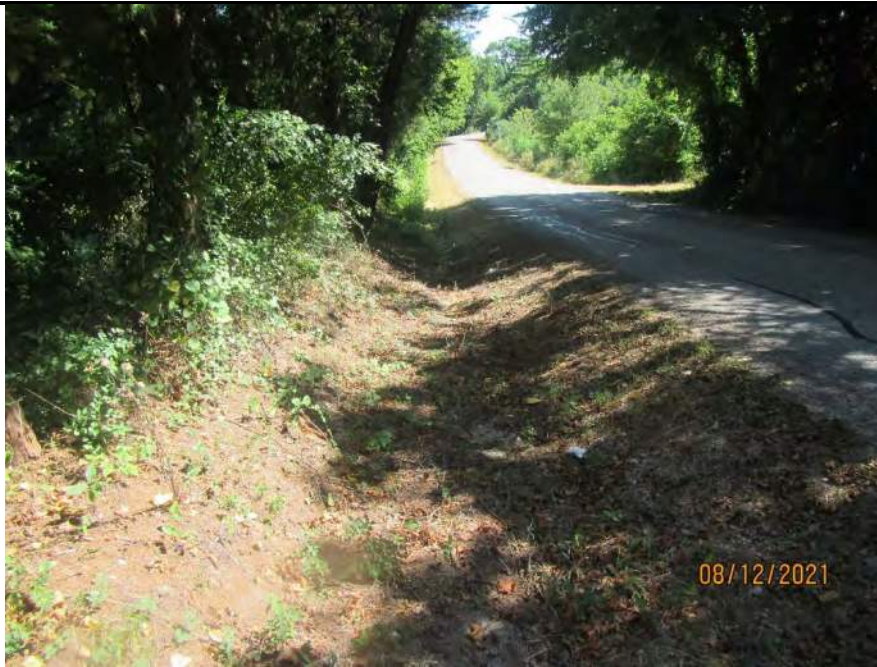
Photo 138.
Photo of Ditch
Drainage Feature
Water Feature 308
in the eastern
portion of the
Environmental
Footprint. **Water
Feature 308** was
constructed in
uplands to aid in
the removal of
stormwater runoff
from the adjacent
road. Note the
upland vegetation
in the hydrological
flow path, as well
as the lack of a
stream bed or
banks. Photo is
also representative
of **Water Feature
303** and **306** and
was taken August
12, 2021.
