APPENDIX N: Water Resources

Attachment 4 - Site Photographs

Representative Environmental Footprint Photographs
Water Features Delineation
TxDOT US 380

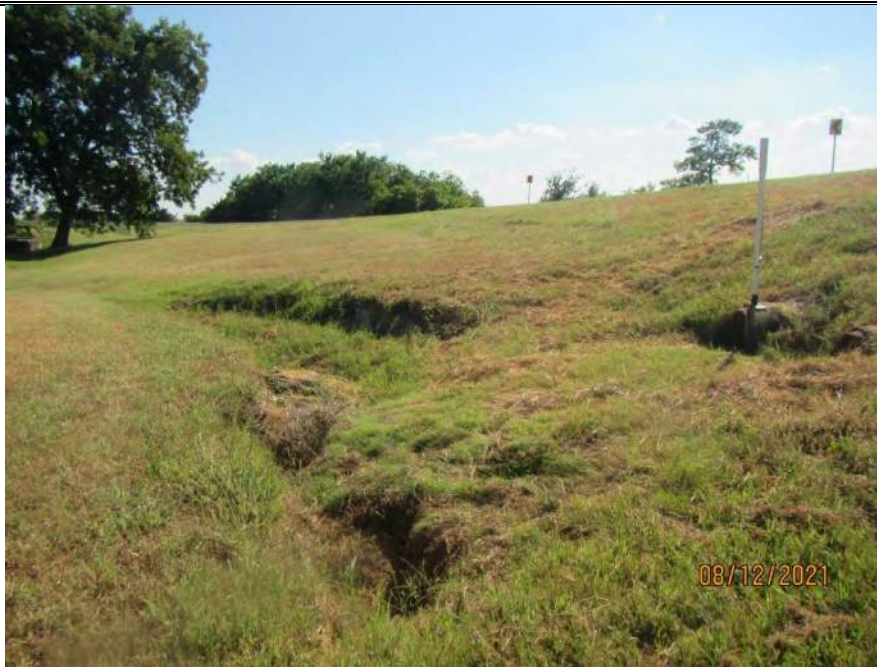
Photo 139.
Photo of Swale
Drainage Feature
Water Feature 314
in the eastern
portion of the
Environmental
Footprint. Note the
lack of an OHWM,
hydrophytic
vegetation, hydric
soils, hydrological
indicators, a stream
bed, or banks.
Photo is
representative of
Water Feature 316
and was taken to
the southwest on
August 12, 2021.

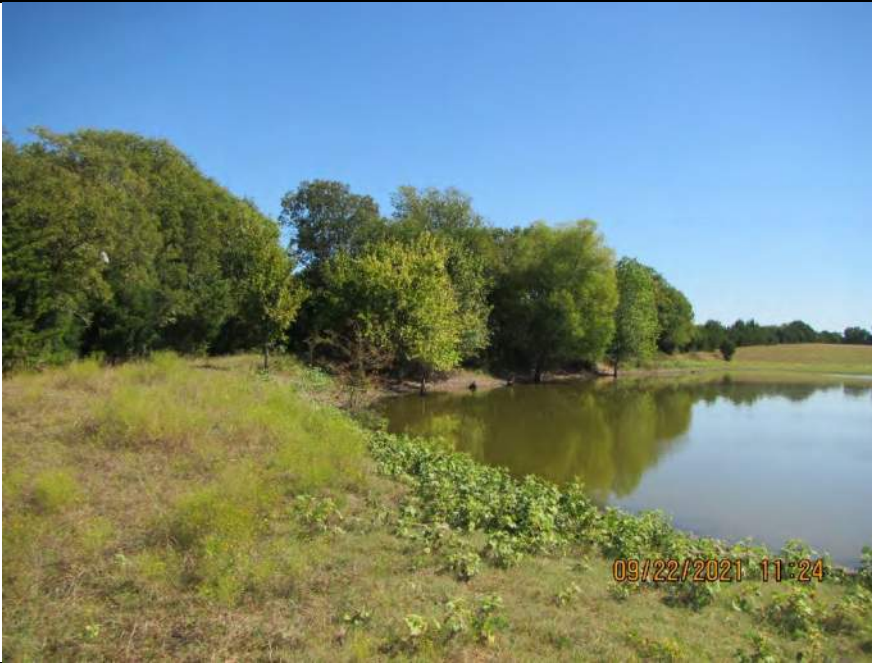
Photo 140.
Photo of Upland Pond **Water Feature 321** located in the eastern portion of the Environmental Footprint. **Water Feature 321** is isolated from **Water Feature 319*** and **320*** to the north by an anthropogenically created berm. Photo was taken to the east on September 22, 2021.

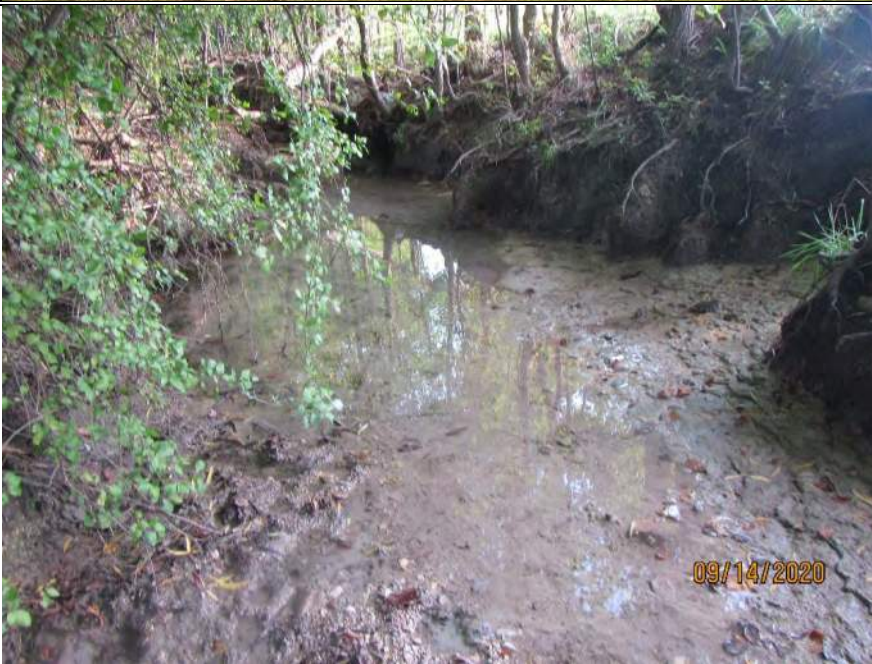
Photo 141.
Photo of Intermittent Stream **Water Feature 322** located in the eastern portion of the Environmental Footprint. **Water Feature 322** had deep channels, litter/debris within the channel, and matted vegetation. **Water Feature 322** received hydrology from seasonal high groundwater table, runoff from adjacent roadway, and precipitation. Dominant vegetation included common boneset (*Eupatorium perfoliatum*) and sugar-berry. Photo was taken to the east on September 14, 2020.

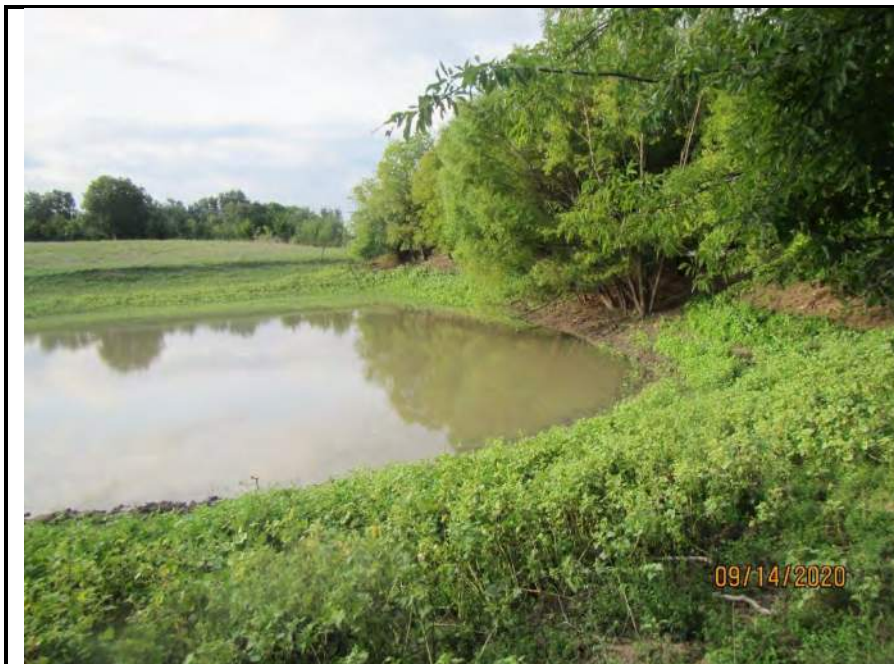
Photo 142.
Photo of Upland
Pond **Water
Feature 325**
located in the
eastern portion of
the Environmental
Footprint. Photo is
representative of
**Water Feature
332, 341, and 371.**
Photo was taken to
the south on
September 14,
2020.

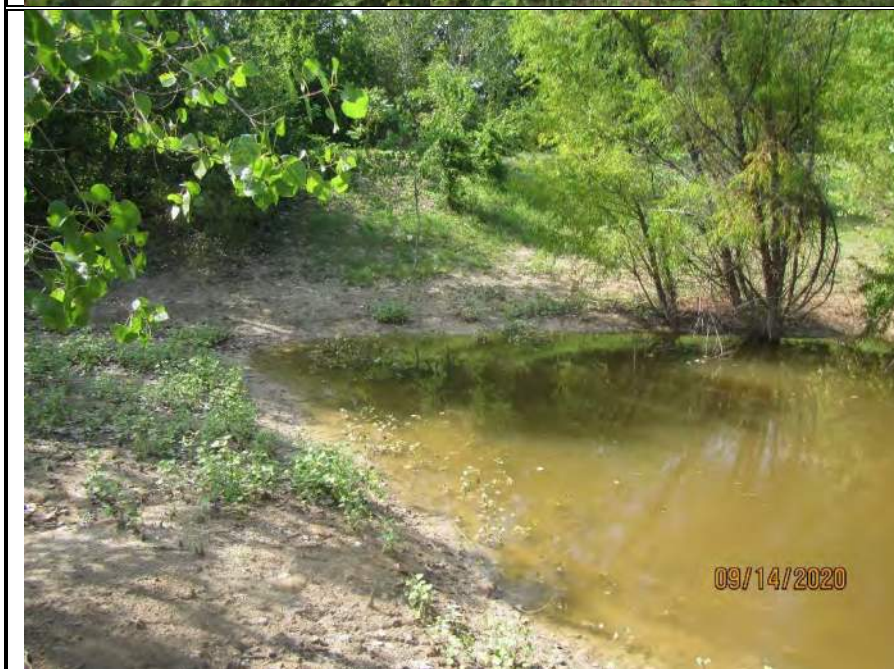
Photo 143.
Photo of Upland
Pond **Water
Feature 327**
located in the
eastern portion of
the Environmental
Footprint. Photo
was taken to the
west on September
14, 2020.

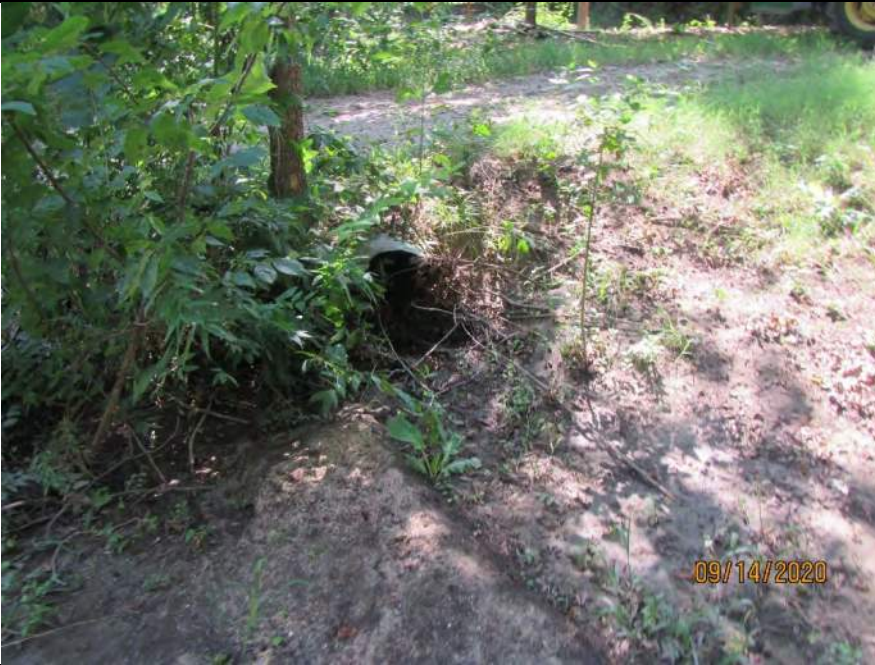
Photo 144.
Photo of Swale
Drainage Feature
Water Feature 328
in the eastern
portion of the
Environmental
Footprint. Note the
lack of an OHWM,
hydrophytic
vegetation, hydric
soils, hydrological
indicators, a stream
bed, or banks.
Photo was taken
September 14,
2020.

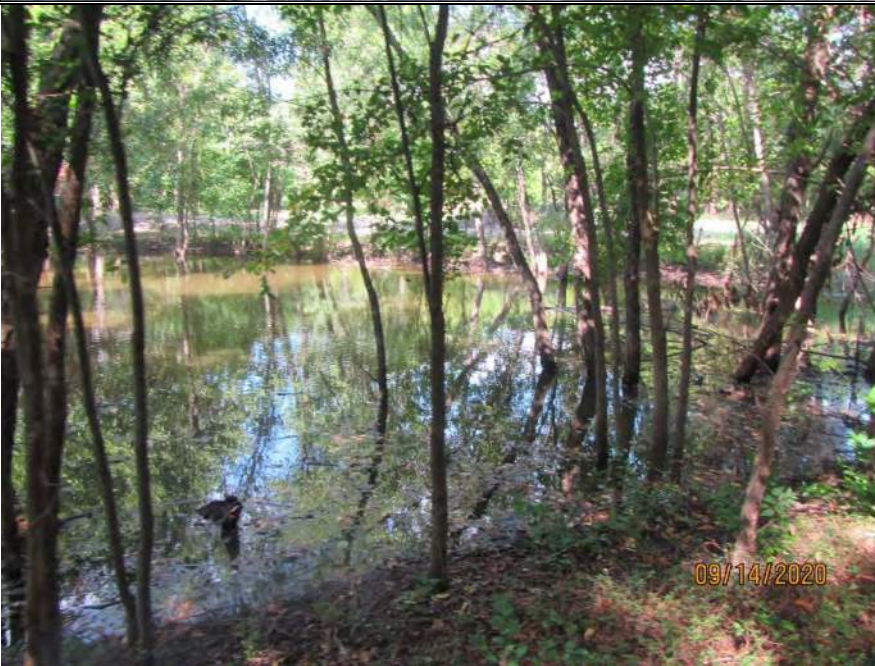
Photo 145.
Photo of Isolated
Forested Wetland
Water Feature 329
located in the
eastern portion of
the Environmental
Footprint. Dominant
vegetation included
American elm,
green ash, black
willow, and Bois
d'arc (*Maclura
pomifera*). **Water
Feature 329** abuts
Upland Pond **Water
Feature 332**. Photo
was taken to the
southwest on
September 14,
2020.

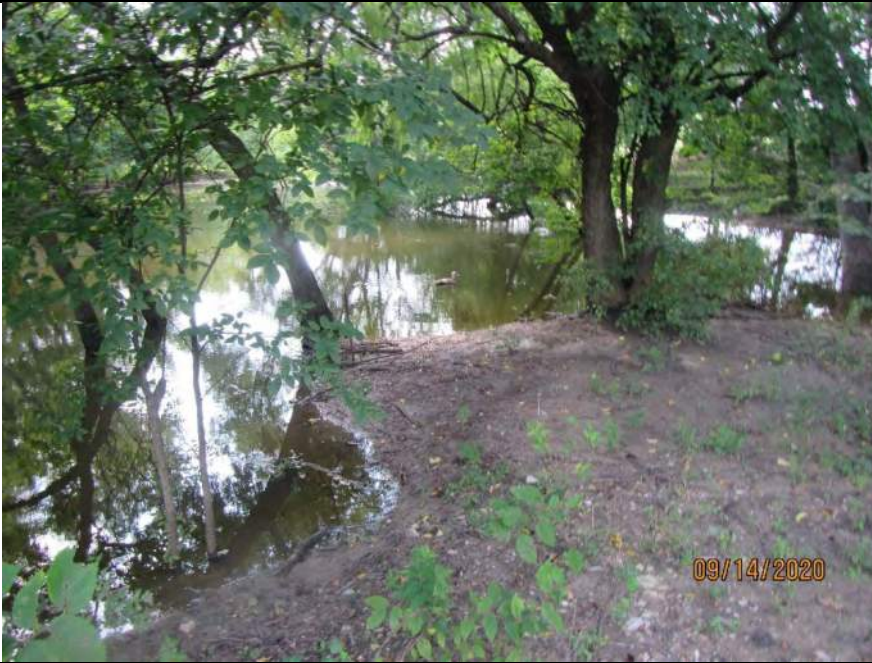
Photo 146.
Photo of Upland Pond **Water Feature 330** located in the eastern portion of the Environmental Footprint. **Water Feature 330** was created in uplands in 1968 and is adjacent to **Water Feature 329**. Photo was taken to the southwest on September 14, 2020.

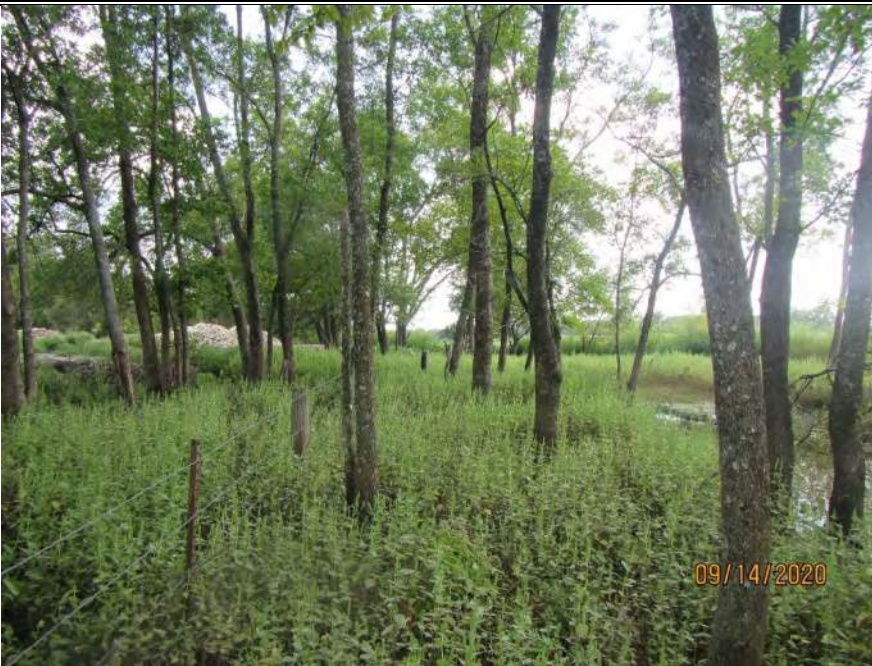
Photo 147.
Photo of Forested Wetland **Water Feature 333** located in the eastern portion of the Environmental Footprint. Dominant vegetation included green ash and sugar-berry. **Water Feature 333** abuts Emergent Wetland **Water Feature 334** and receives flow from Intermittent Stream **Water Feature 335**. Photo was taken to the southwest on September 14, 2020.

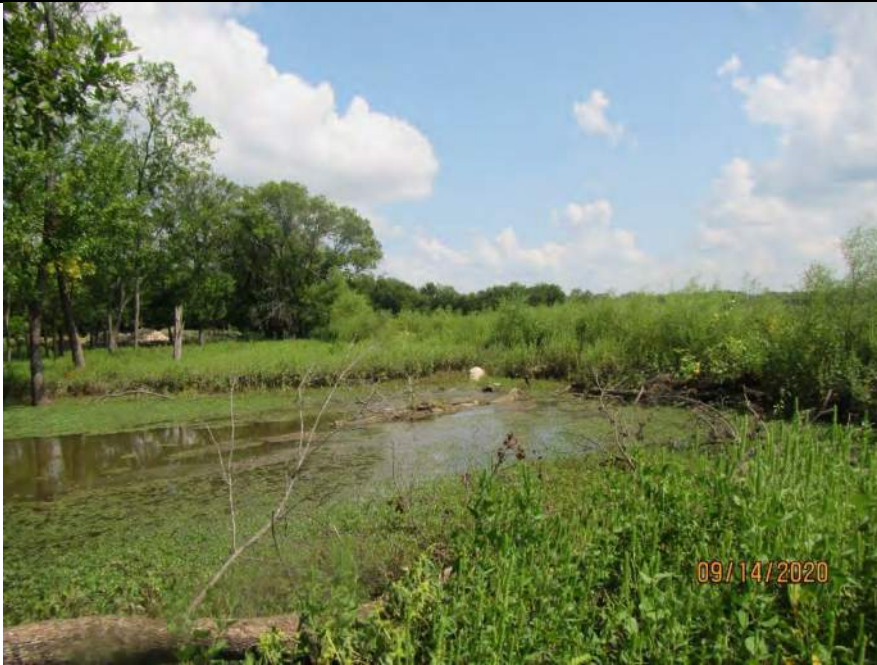
Photo 148.
Photo of Emergent Wetland **Water Feature 334** located in the eastern portion of the Environmental Footprint. Dominant vegetation included annual marsh-elder and longleaf wood oats (*Chasmanthium sessiliflorum*). **Water Feature 339** abuts Forested Wetland **Water Feature 333** and Intermittent Stream **Water Feature 335**. Photo was taken to the south on September 14, 2020.

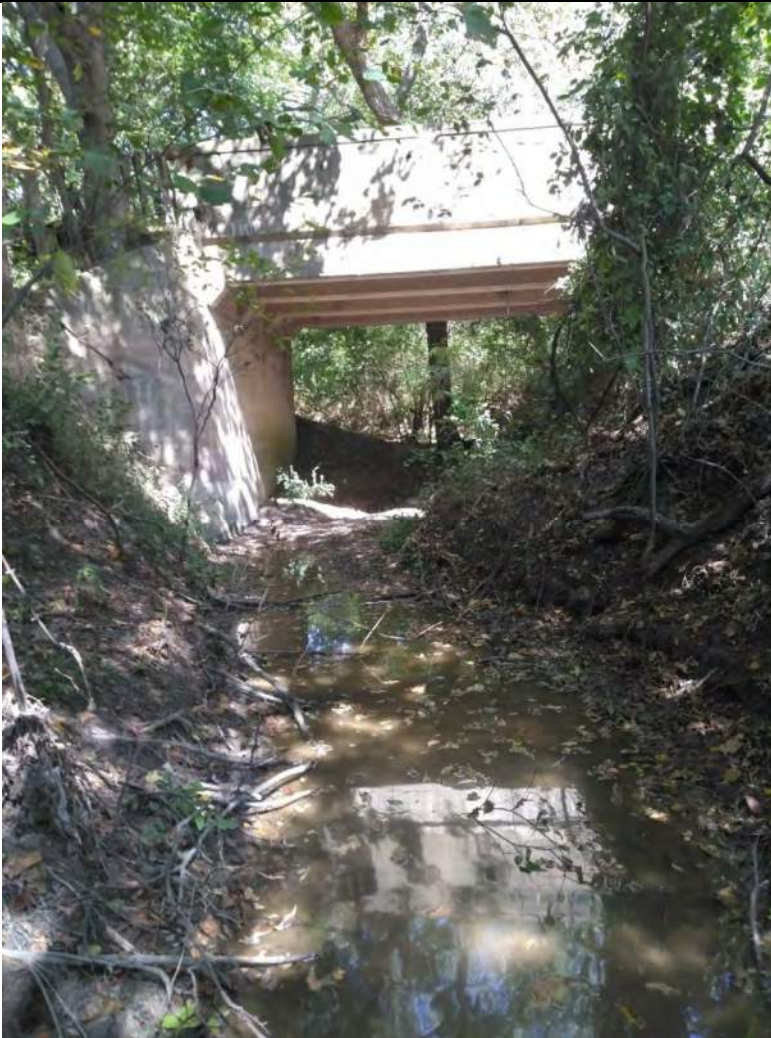
Photo 150.
Photo of Intermittent Stream **Water Feature 337** located within the eastern portion of the Environmental Footprint. **Water Feature 337** had destruction of terrestrial vegetation, overhanging and matted vegetation, and a portion of stream channel reinforced by concrete. Dominant vegetation included southern catalpa (*Catalpa bignonioides*), American elm, and green ash. Photo was taken to the northeast on September 14, 2020.

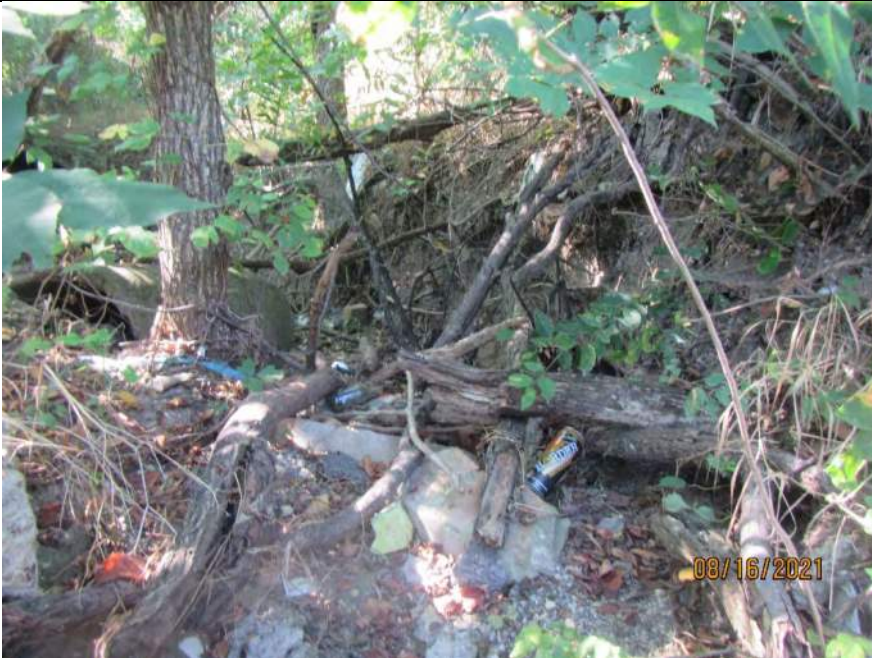
Photo 151.
Photo of Ephemeral Stream **Water Feature 338** located in the eastern portion of the Environmental Footprint. **Water Feature 338** received hydrology from precipitation and runoff. Dominant vegetation included American elm, green ash, and sugar-berry. Photo was taken to the east on August 16, 2021.

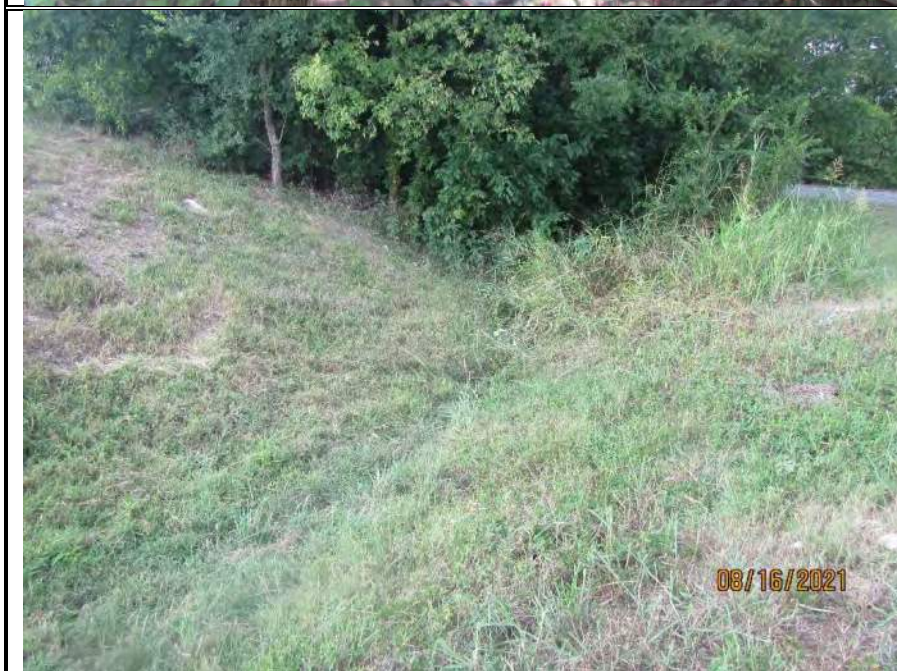
Photo 153.
Photo of Swale Drainage Feature **Water Feature 343** in the eastern portion of the Environmental Footprint. Note the lack of an OHWM, hydrophytic vegetation, hydric soils, hydrological indicators, a stream bed, or banks. Photo taken on August 16, 2021.

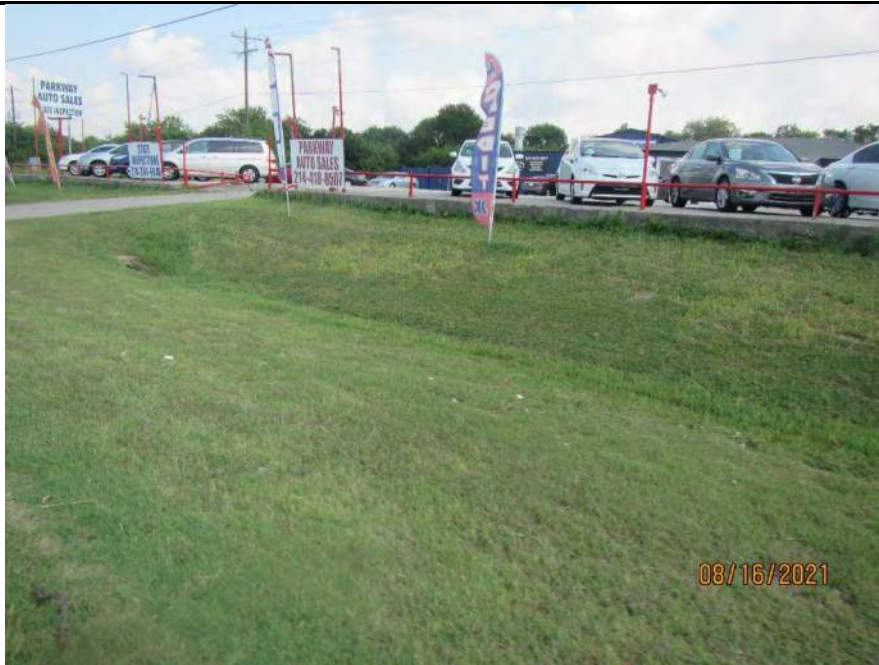
Photo 154. Photo of Ditch Drainage Feature **Water Feature 345** in the eastern portion of the Environmental Footprint. **Water Feature 345** was constructed in uplands to aid in the removal of stormwater from US 380. Note the upland vegetation throughout flow path, lack of a stream bed or banks, and adjacency to US 380. Photo is also representative of **Water Feature 344, 349, 350, and 352**. Photo was taken to the north on August 16, 2021.

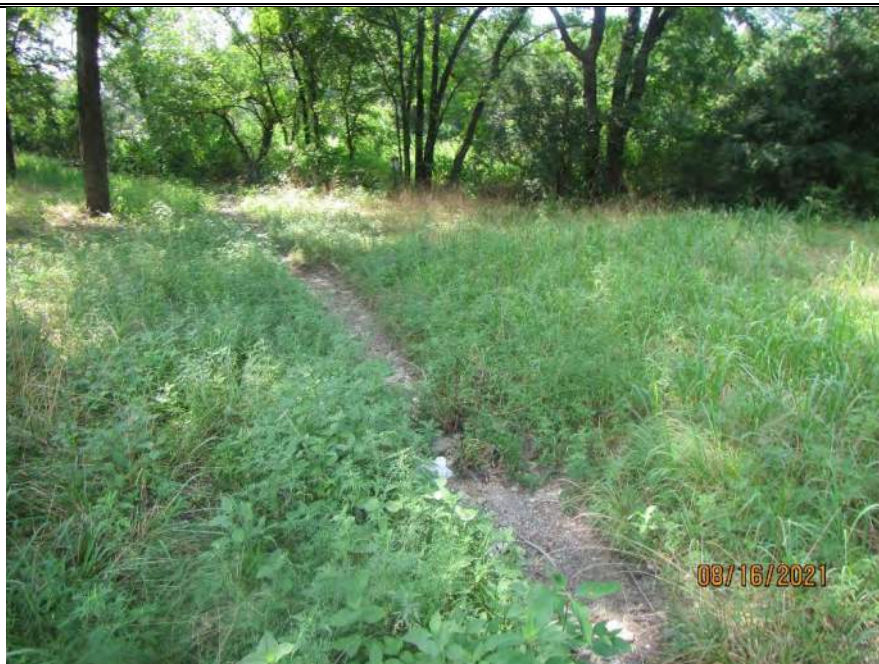
Photo 155. Photo of Ephemeral Stream **Water Feature 351** located in the eastern portion of the Environmental Footprint. **Water Feature 351** had destroyed vegetation and litter/debris within the stream channel. Dominant vegetation included tall false rye grass (*Schedonorus arundinaceus*), johnsongrass, and cedar elm. Photo taken to the south on August 16, 2021.

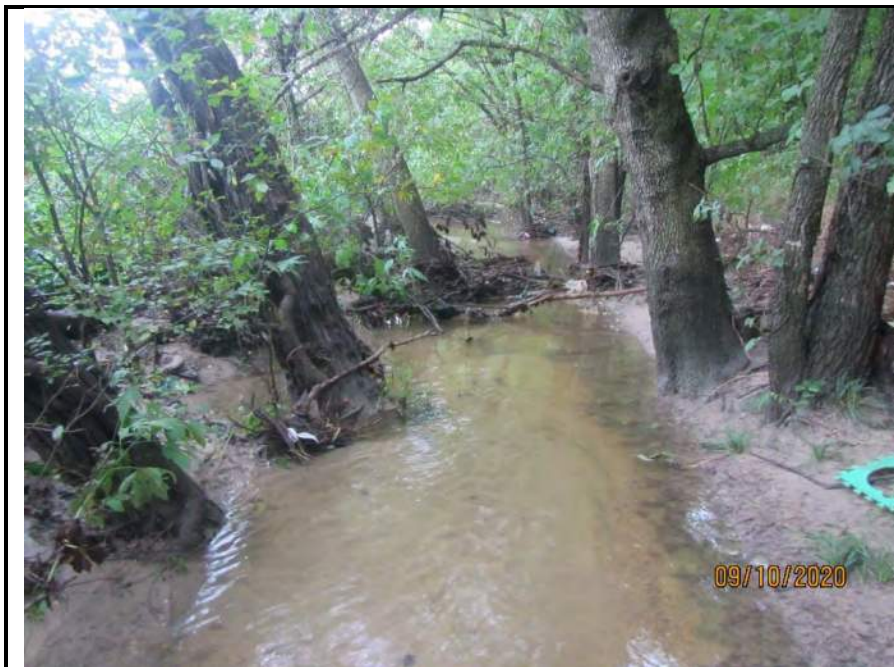
Photo 156. Photo of Intermittent Stream **Water Feature 354** in the northwest portion of the Environmental Footprint. Note the gradual stream banks, large tree cover, and flowing water covering a clay and silt stream bottom. Photo was taken to the west on September 10, 2020.

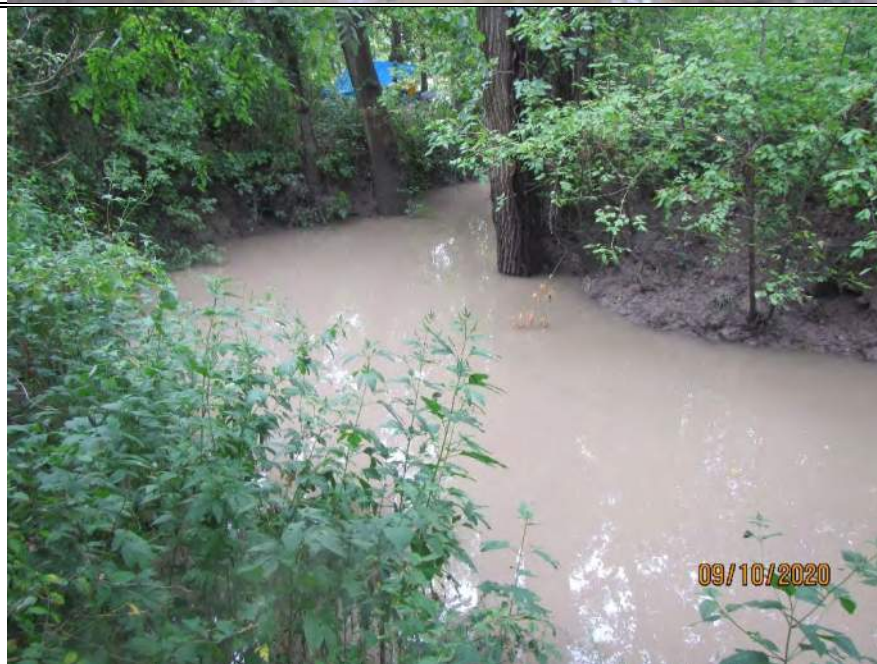
Photo 157. Photo of Perennial Stream **Water Feature 356**, located within the eastern portion of the Environmental Footprint. **Water Feature 356** had overhanging vegetation, a deep channel, and destruction of terrestrial vegetation, and was hydrologically connected to Perennial Stream **Water Feature 273**, the East Fork Trinity River. Dominant vegetation included Bois d'arc, fringed greenbrier, and black willow. Photo was taken to the northeast on September 10, 2020.

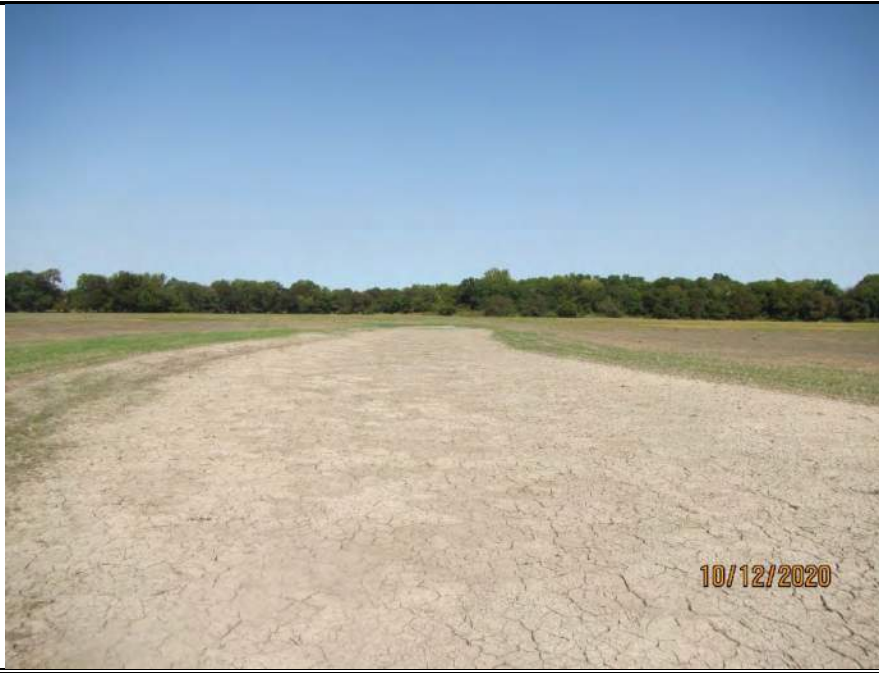
Photo 158.
Photo of Swale
Drainage Feature
Water Feature 357
located in the
eastern portion of
the Environmental
Footprint. Drainage
through cultivated
field is subject to
regular migration,
with no defined
channel. Photo was
taken to the north
on October 12,
2020.

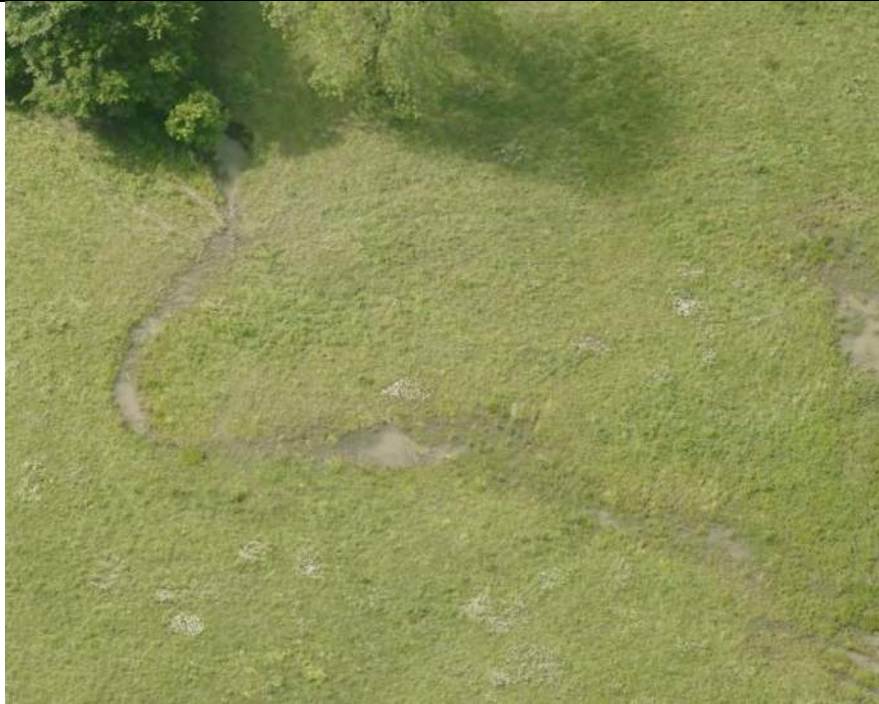
Photo 159.
Representative
aerial photo
(Pictometry
4/27/17) of
Intermittent Stream
Water Feature 359
and Water Feature
360. Note the sharp
shift from
vegetated, pasture
swale to
channelized, water-
filled stream
channel. This is the
result of ditches
constructed
upstream that cut
off the native
channel.

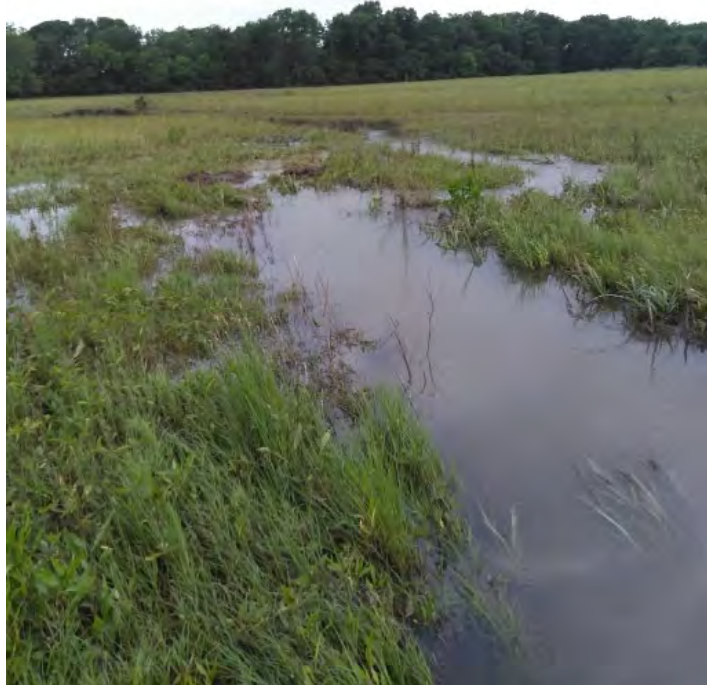
Photo 160.
Photo of Swale
Drainage Feature
Water Feature 363
located in the
eastern portion of
the Environmental
Footprint. Photo is
representative of
Swales Drainage
Feature **Water**
Feature 369, 365,
360, and 361. Note
that the water in the
swale is in direct
response to heavy
rains and not an
indicator of
seasonal flow.
Photo was taken to
the south on June
8, 2021 after a
heavy local rainfall
event.

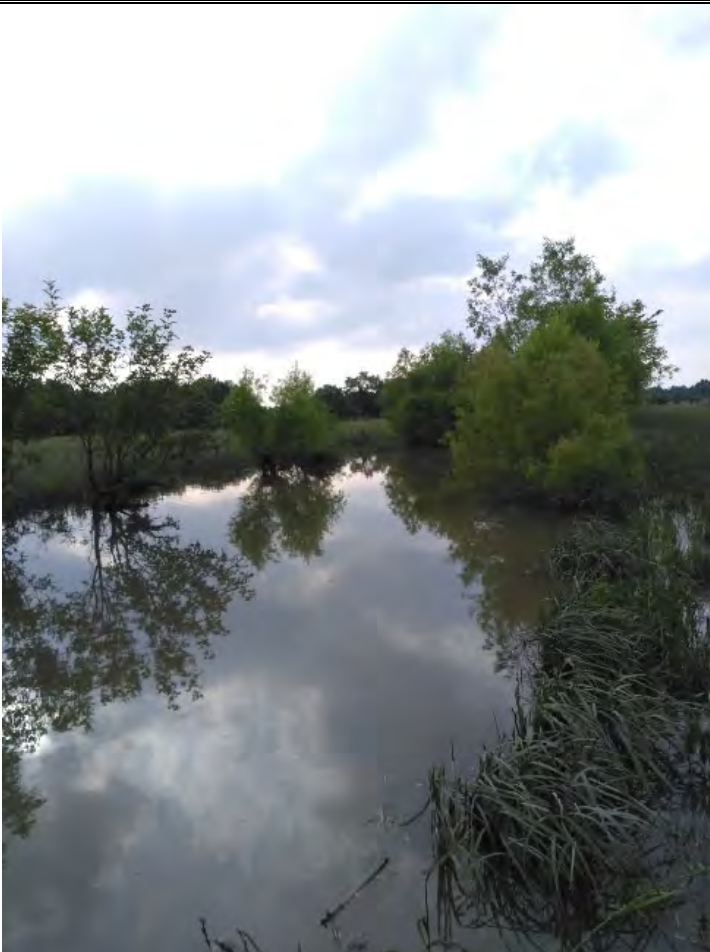
Photo 161.
Photo of On-
Channel Pond
Water Feature 364
located in the
eastern portion of
the Environmental
Footprint. Photo is
also representative
of on-channel pond
Water Feature
362. Photo was
taken to the south
on June 8, 2021
after a heavy local
rainfall event.

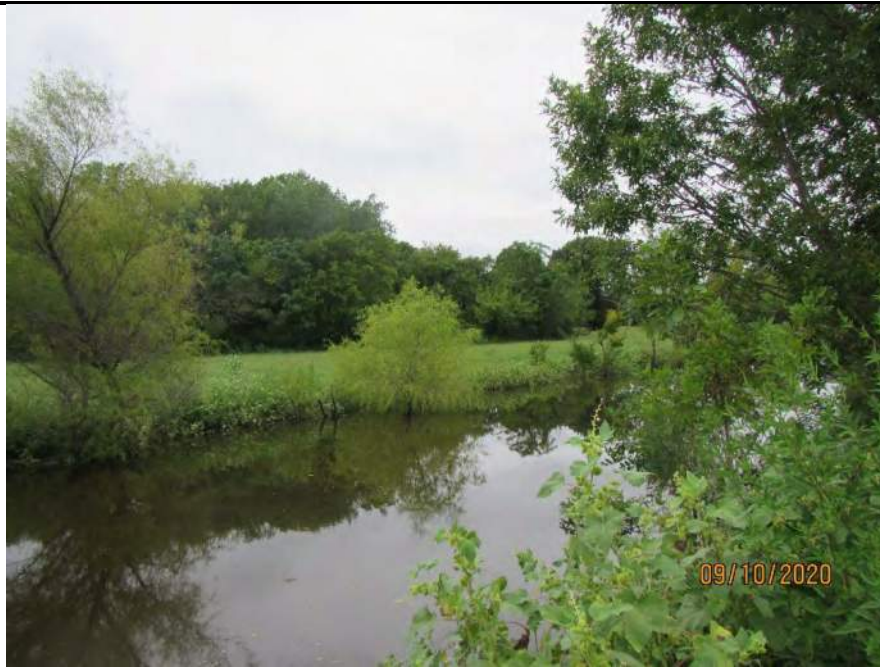
Photo 162.
Photo of On-Channel Pond **Water Feature 366** located in the eastern portion of the Environmental Footprint. **Water Feature 366** abuts **Water Feature 367** and is approximately 100 feet northeast of the East Fork Trinity River. Photo was taken to the east on September 10, 2020.

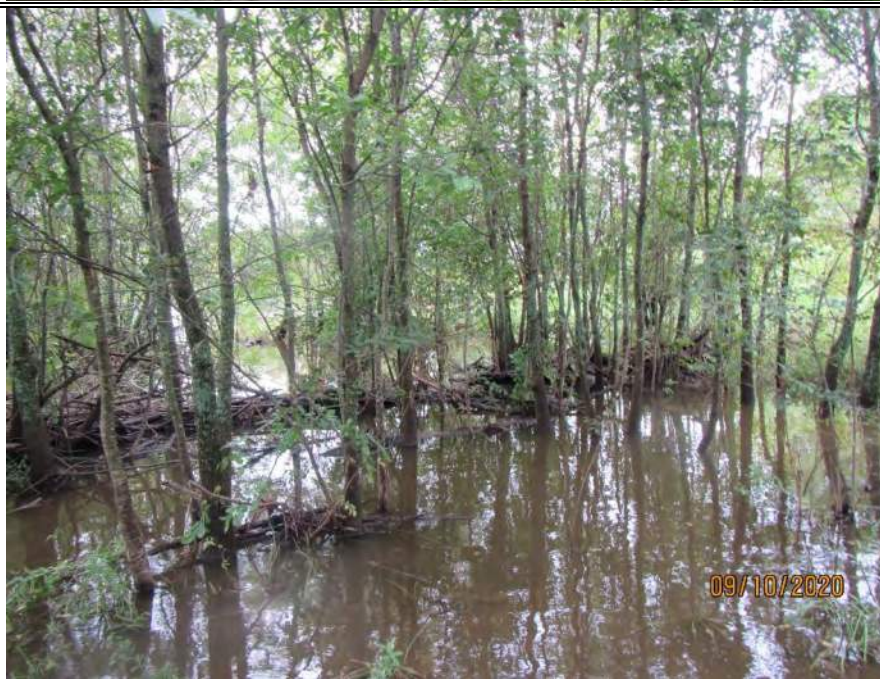
Photo 163.
Photo of Forested Wetland **Water Feature 367** in the northeastern portion of the Environmental Footprint. **Water Feature 367** is a palustrine forested wetland and is dominated by boxelder trees and saplings, green ash, rice cut grass, swamp smartweed, and rough cocklebur. Photo was taken to the north on September 10, 2020.

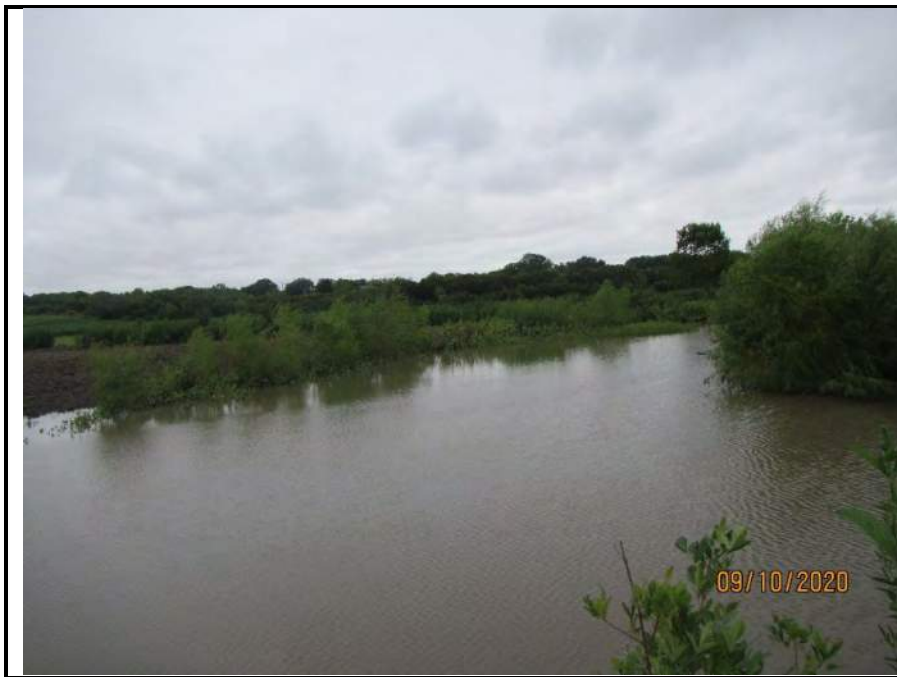
Photo 164.
Photo of On-Channel Pond
Water Feature 370
located in the
eastern portion of
the Environmental
Footprint. Photo is
representative of
On-Channel Pond
Water Feature
368. Photo was
taken to the south
on September 10,
2020.
