Interim Report for Archeological Survey

Loop 9, Segment A from US 67 to IH 35E,
Dallas and Ellis Counties, Dallas District
CSJ: 2964-10-006

April 2020

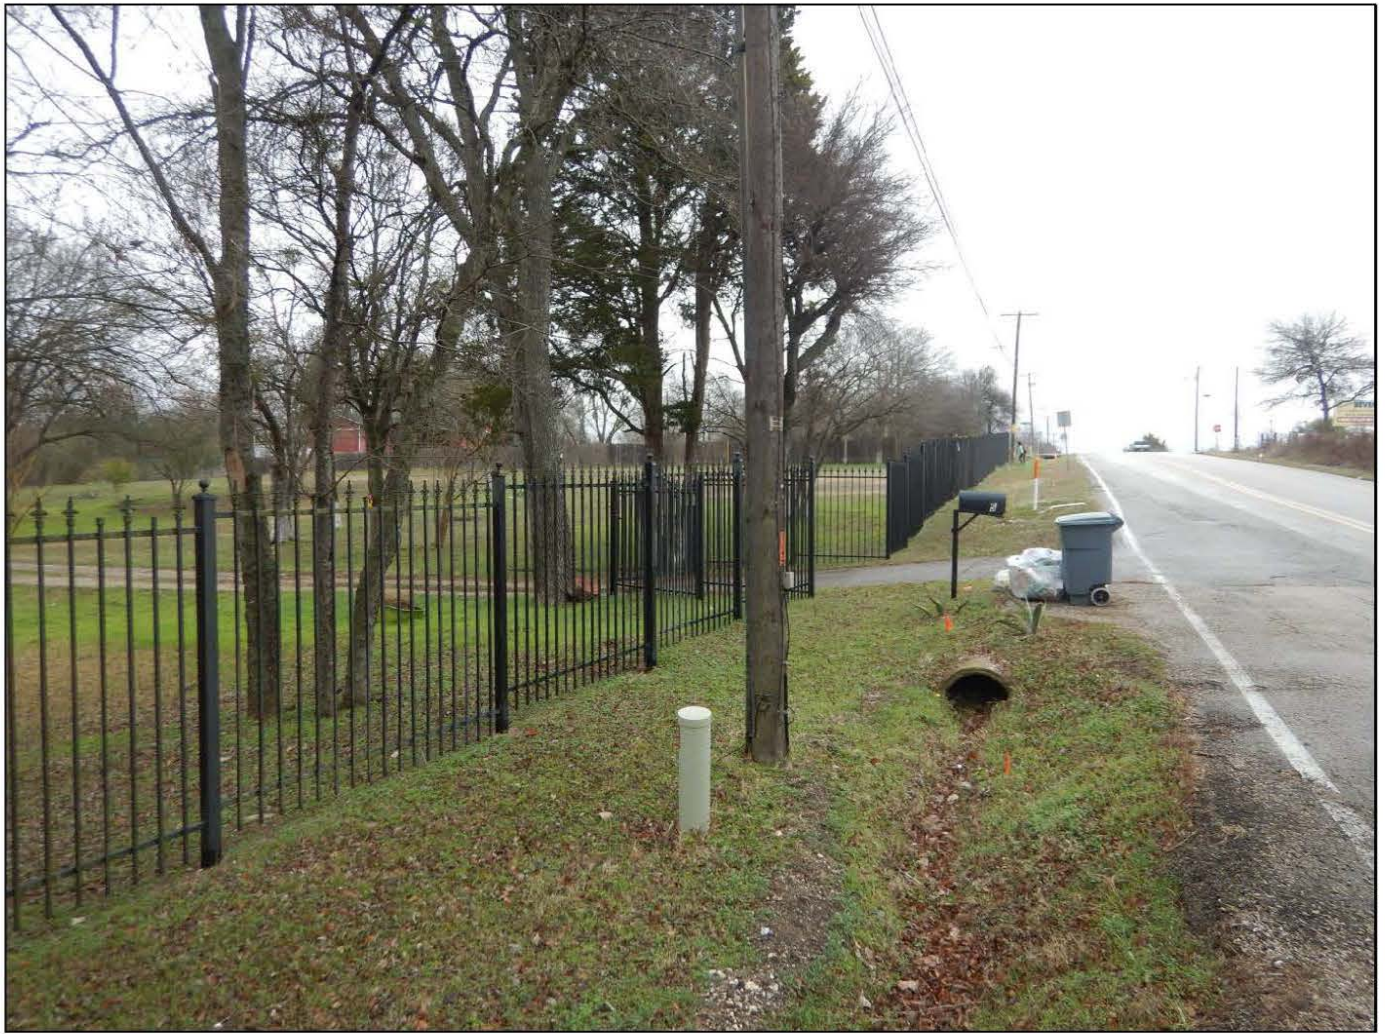
Figure 14. Disturbances including terraforming, drainage ditches, and utility lines identified throughout the APE.

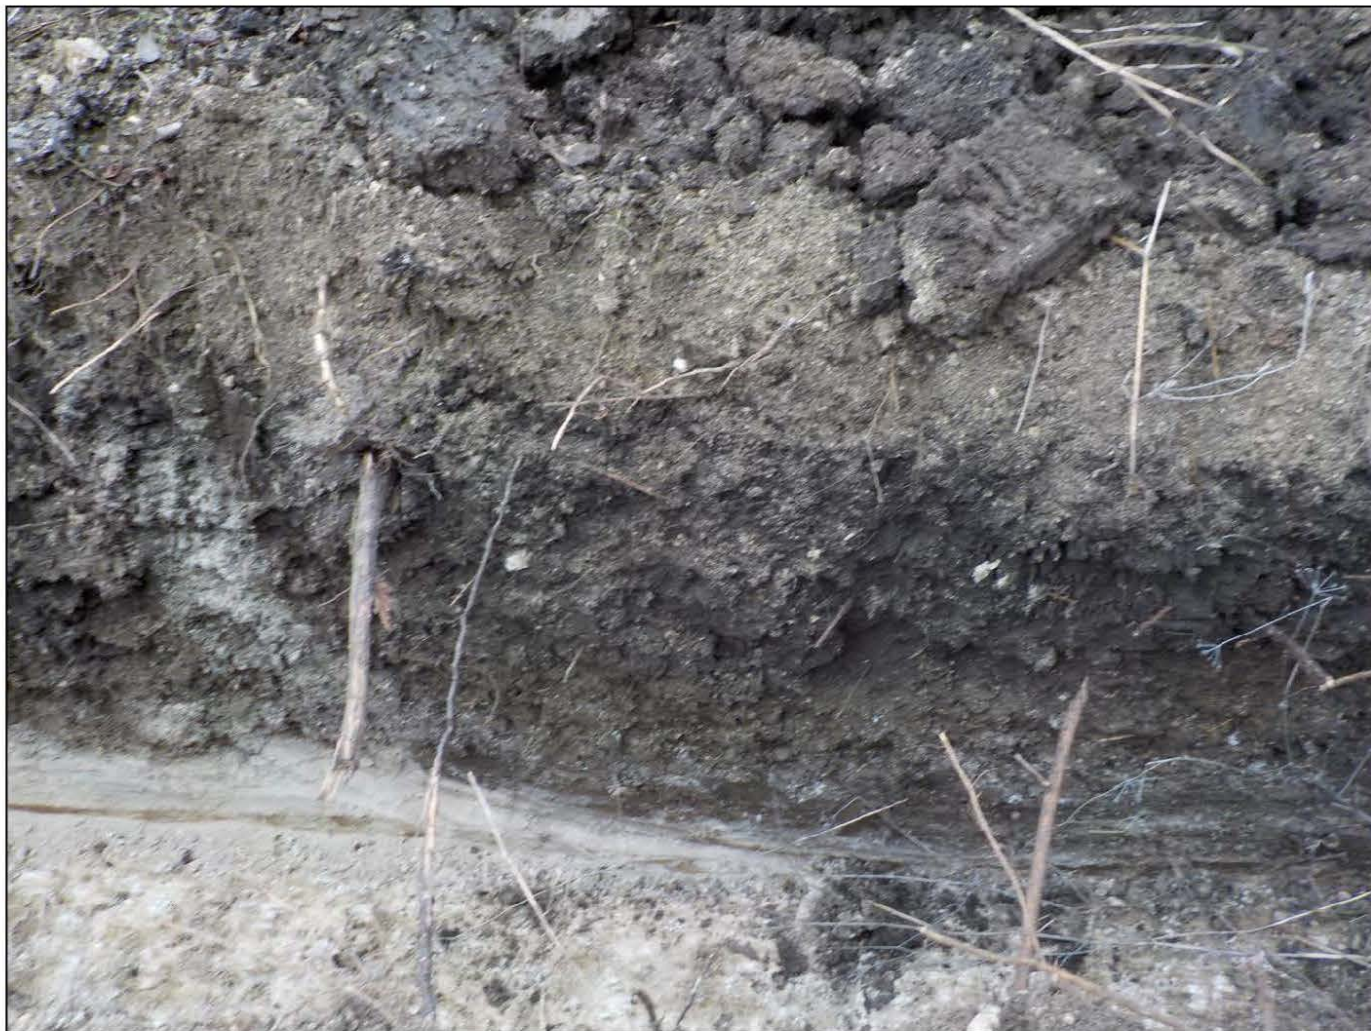
Figure 15. Profile of BHT03, facing north.

Backhoe Trench 03—BHT03 was placed approximately 41 meters west of an offshoot of Little Creek on the tree line of a terrace in Parcel 228. Vegetation consists of tree litter, scrub brush, and juniper trees. Soils in the trench included four stratified levels. Strat I consisted of a 10YR 5/3 silt with caliche gravels. Strat II consisted of a 10YR 3/4 sterile clay with large roots. Strat III consisted of a 10YR 4/2 clay with degraded limestone and small roots. Strat IV consisted of a 10YR 6/3 basal clay with heavy inclusions of limestone. The trench reached a maximum depth of 125 cmbs and no archeological material was observed (**Figure 8d and 15**).

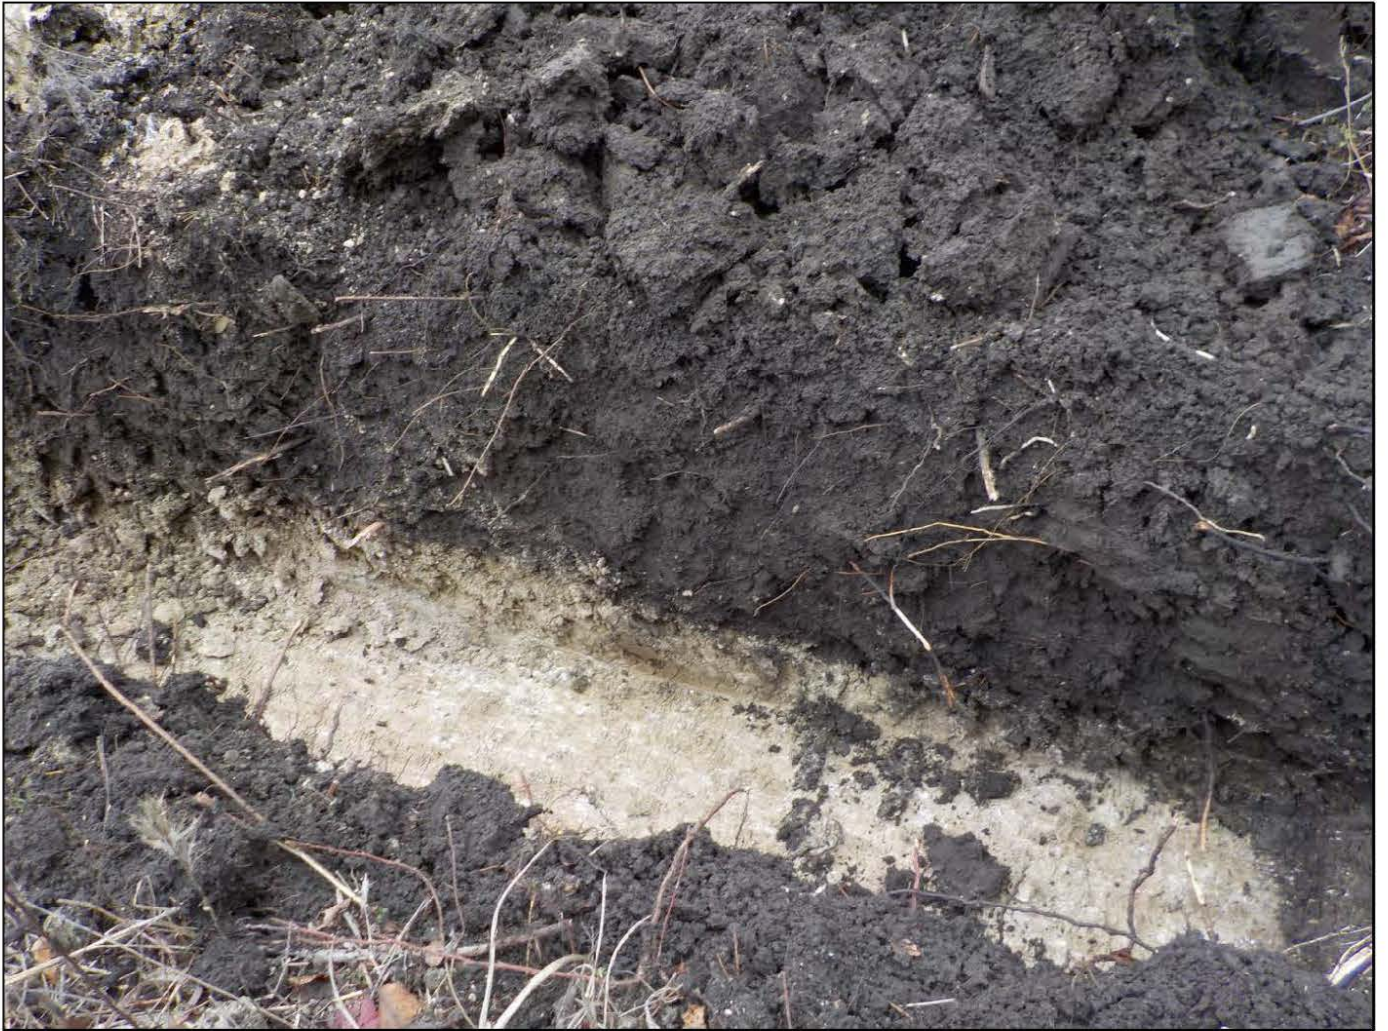
Figure 16. Profile of BHT04, facing north.

Backhoe Trench 04—BHT04 was placed approximately 5 meters west of an offshoot of Little Creek on the tree line of a terrace in Parcel 228. The vegetation consists of tall and short grasses, tree litter, scrub and juniper. Soils in the trench included two stratified levels. Strat I consisted of a 10YR 3/2 sticky clay full of roots and rootlets. Strat II consisted of a 10YR 6/3 basal clay with heavy limestone inclusions. The trench reached a maximum depth of 100 cmbs and no archeological material was observed (**Figure 8d and 16**).

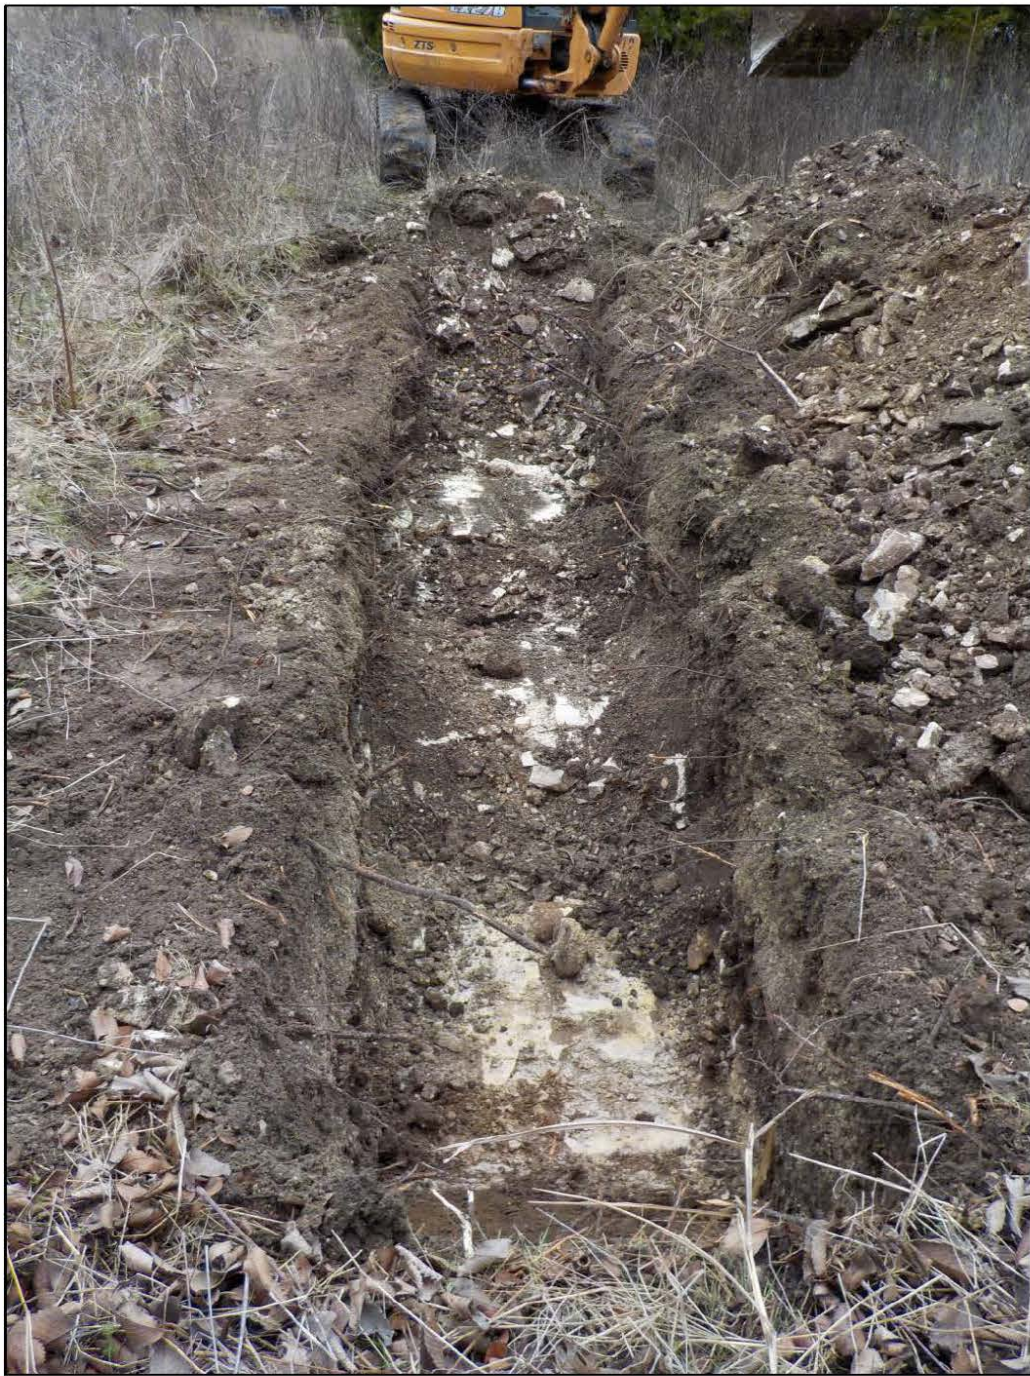
Figure 17. Shallow bedrock identified within BHT05, facing north.

Backhoe Trench 05—BHT05 was placed approximately 46 meters north of Little Creek in the tree line of a toe slope in Parcel 45. Vegetation consists of tree litter, scrub brush, and juniper trees. Soils in the trench included three stratified levels. Strat I consisted of a 10YR 5/3 mottled silt with rootlets and modern flood debris. Strat II consisted of a 10YR 4/2 clay with degraded bedrock. Strat III consisted of bedrock. The trench reached a maximum depth of 70 cmbs, and no archaeological material was observed (**Figure 8c and 17**).

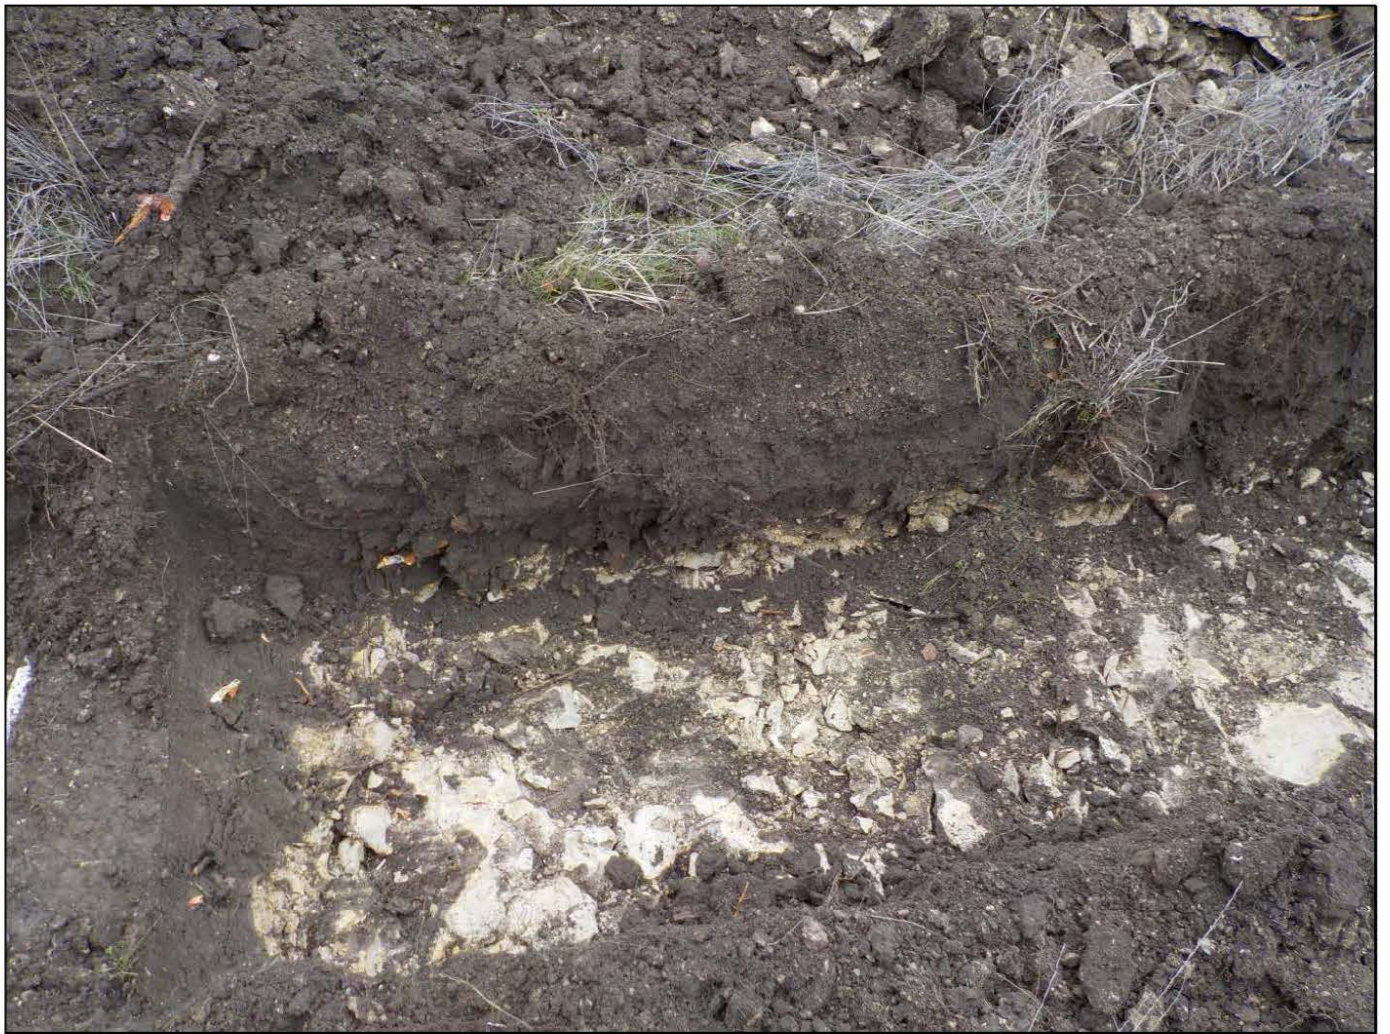
Figure 18. Profile of BHT06, facing west.

Backhoe Trench 06—BHT06 was placed approximately 31 meters south of an offshoot of Little Creek on an open terrace in Parcel 106. Vegetation consists of tall and short grasses. Soils in the trench included two stratified levels. Strat I consisted of a 10YR 4/2 clay loam with degraded bedrock. Strat II consisted of bedrock. The trench reached a maximum depth of 40 cmbs and no archeological material was observed (**Figure 8b and 18**).

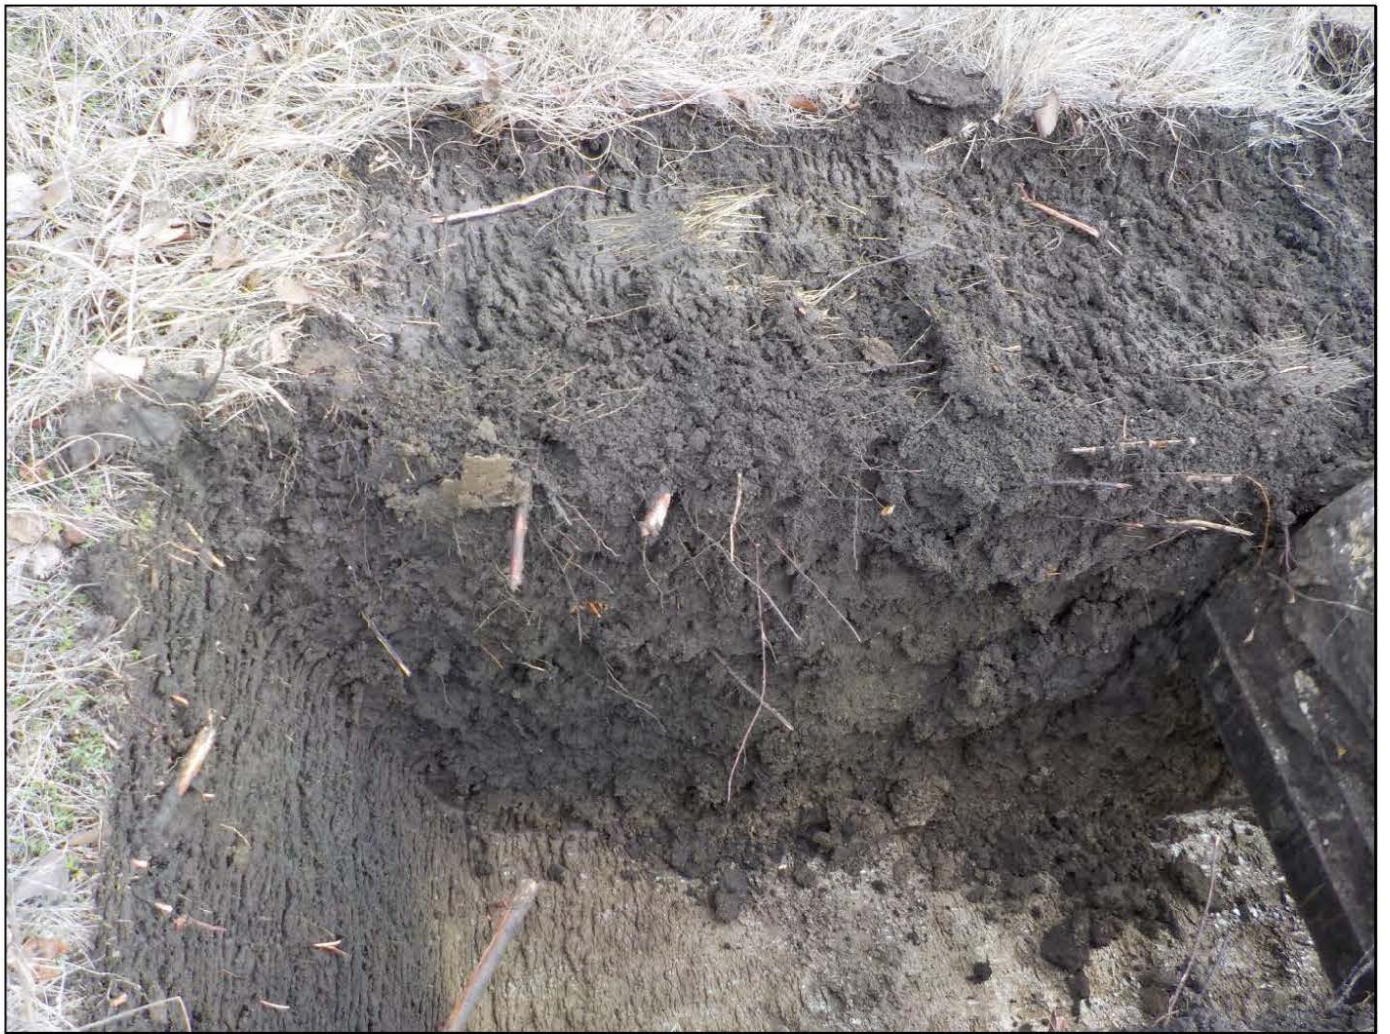
Figure 19. Profile of BHT07, facing east.

Backhoe Trench 07—BHT07 was placed approximately 52 meters north of an offshoot of Little Creek on the tree line of a terrace in Parcel 67. Vegetation consists of tall grasses, tree litter, cedar and juniper trees. Soils in the trench included three stratified levels. Strat I consisted of a 10YR 3/2 clay with cedar roots. Strat II consisted of a 10YR 4/3 clay. Strat III consisted of a 10YR 5/2 basal clay with degraded bedrock. The trench reached a maximum depth of 115 cmbs and no archeological material was observed (**Figure 8b** and **19**).

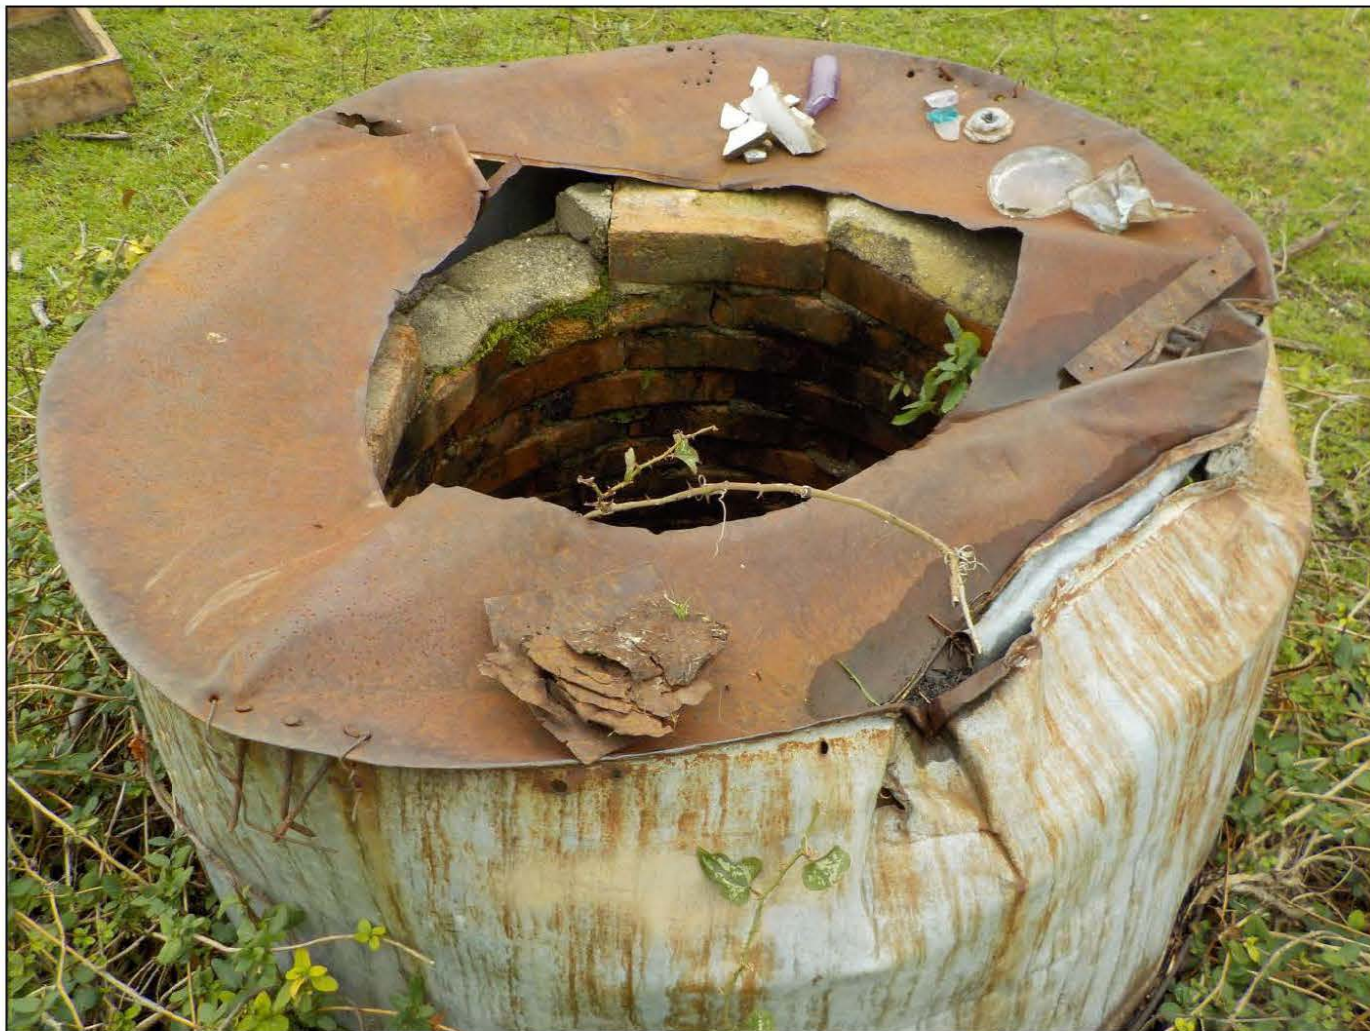
Figure 21. Cistern and artifacts identified within site 41DL556.

Due to the lack of intact archeological deposits or structures associated with notable persons, place, or event, site 41DL556 is recommended as not eligible for listing in the National Register of Historic Places (NRHP) or as a State Antiquities Landmark (SAL) within the new ROW. As such, no further work is recommended prior to construction.

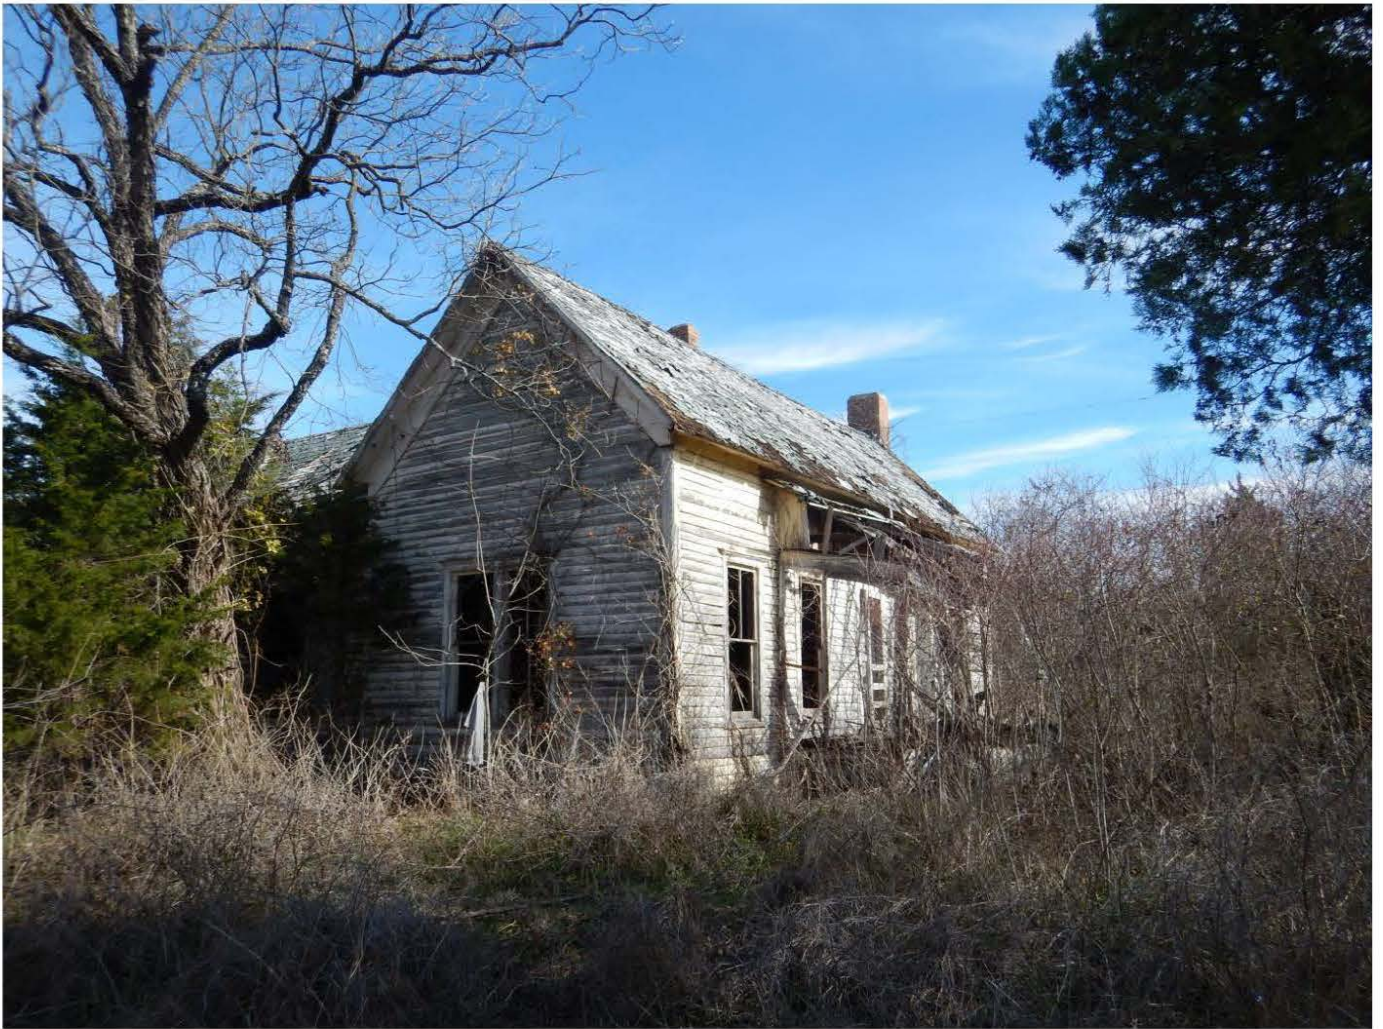
The main structure of the house measures 35 feet by 16 feet, with the addition measuring 24 feet by 13 feet (**Figure 29**). The roof has collapsed in the northwestern portion of the house subsequently destroying portions of the outer wall. Scattered debris was noted surrounding the house consisting of lumber, wire nails, shingles, and other miscellaneous construction debris (**Figure 30**). The house is covered in horizontal siding and one addition to the house has been added, and at least one renovation. The house is surrounded by a chain link fence with heavy overgrowth and vegetation consisting of vines, various hardwood trees, and scrub brush. The main house has two chimneys, with the original chimney and fireplace covered up from renovations to the house. The second chimney connects to a fireplace with a gas starter, likely added during the same renovation. The addition to the house includes a kitchen and an eating area, with appliances still located within the home dating approximately to the 1970's or 1980's. Various house goods and clothing were left within the house, and a newspaper dating to 1978 (**Figure 31**). Other miscellaneous artifacts were noted outside of the house including a deteriorating cowboy boot and broken Corning ware.

Figure 29. House structure located within site 41DL557.

Due to the lack of intact archeological deposits or structures associated with notable persons, place, or event, site 41DL557 is recommended as not eligible for listing in the National Register of Historic Places (NRHP) or as a State Antiquities Landmark (SAL) within the APE. As such, no further work is recommended prior to construction.

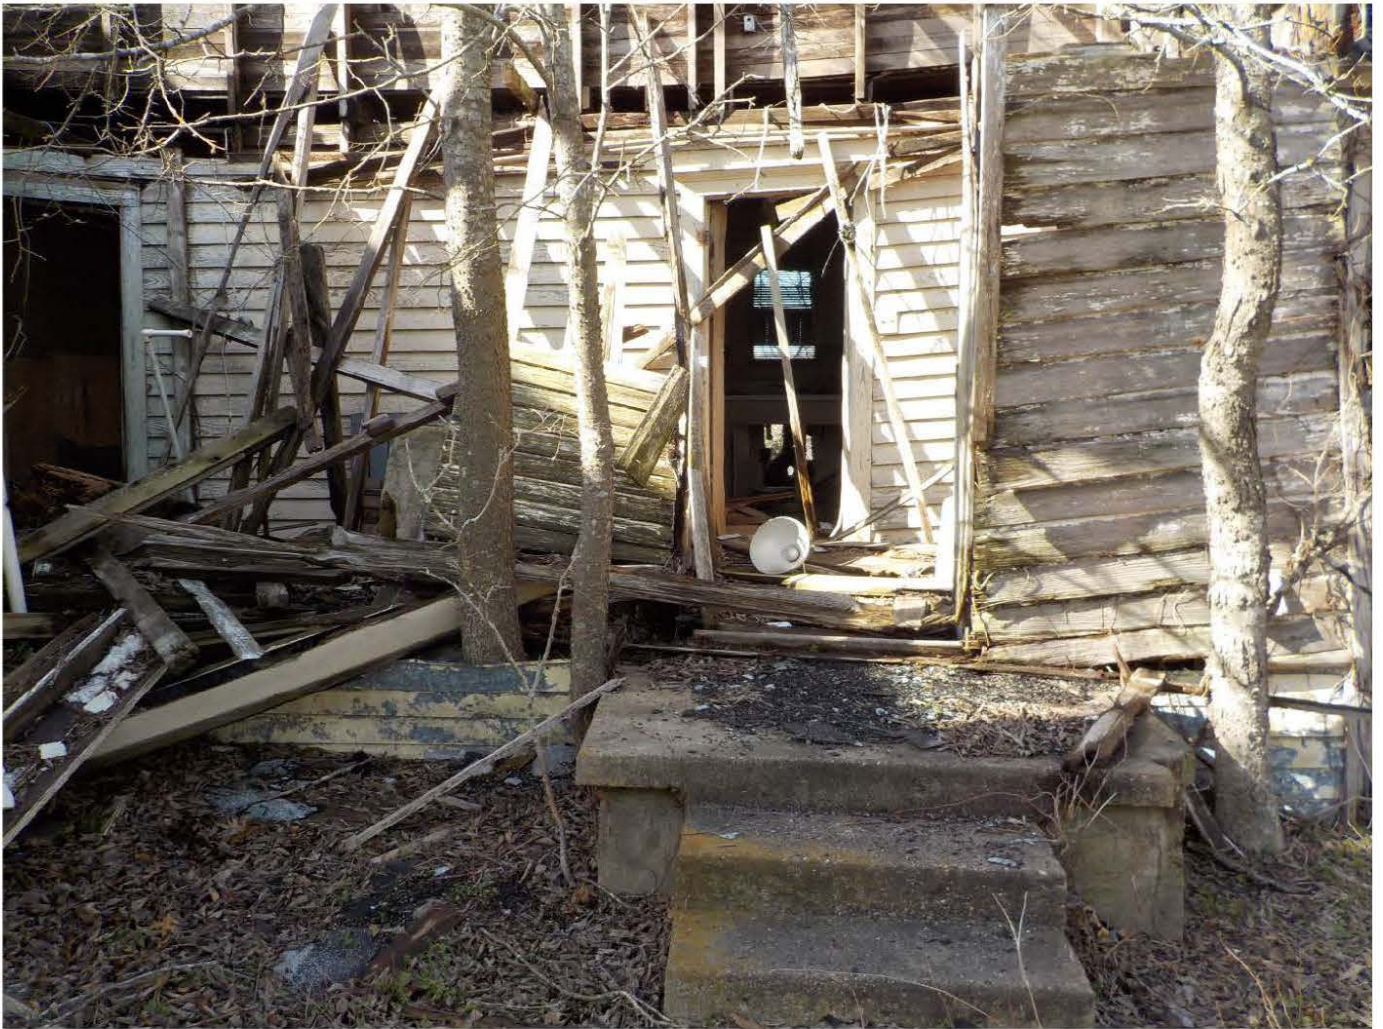
Figure 30. Debris associated with the house structure within site 41DL557.

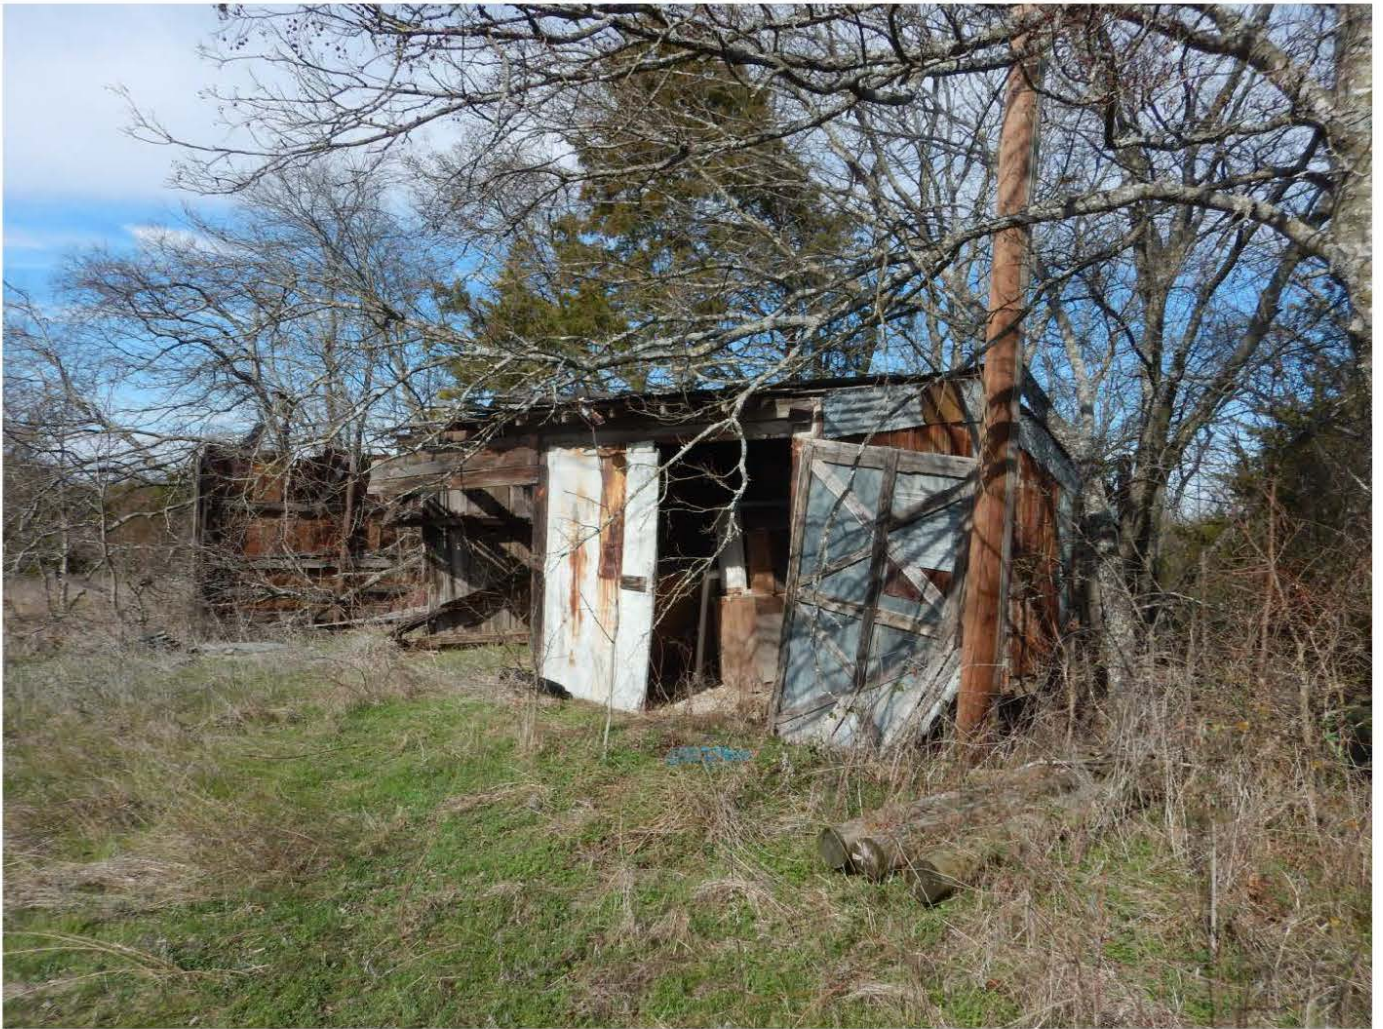
Figure 32. Outbuilding located northwest of the house within site 41DL557.

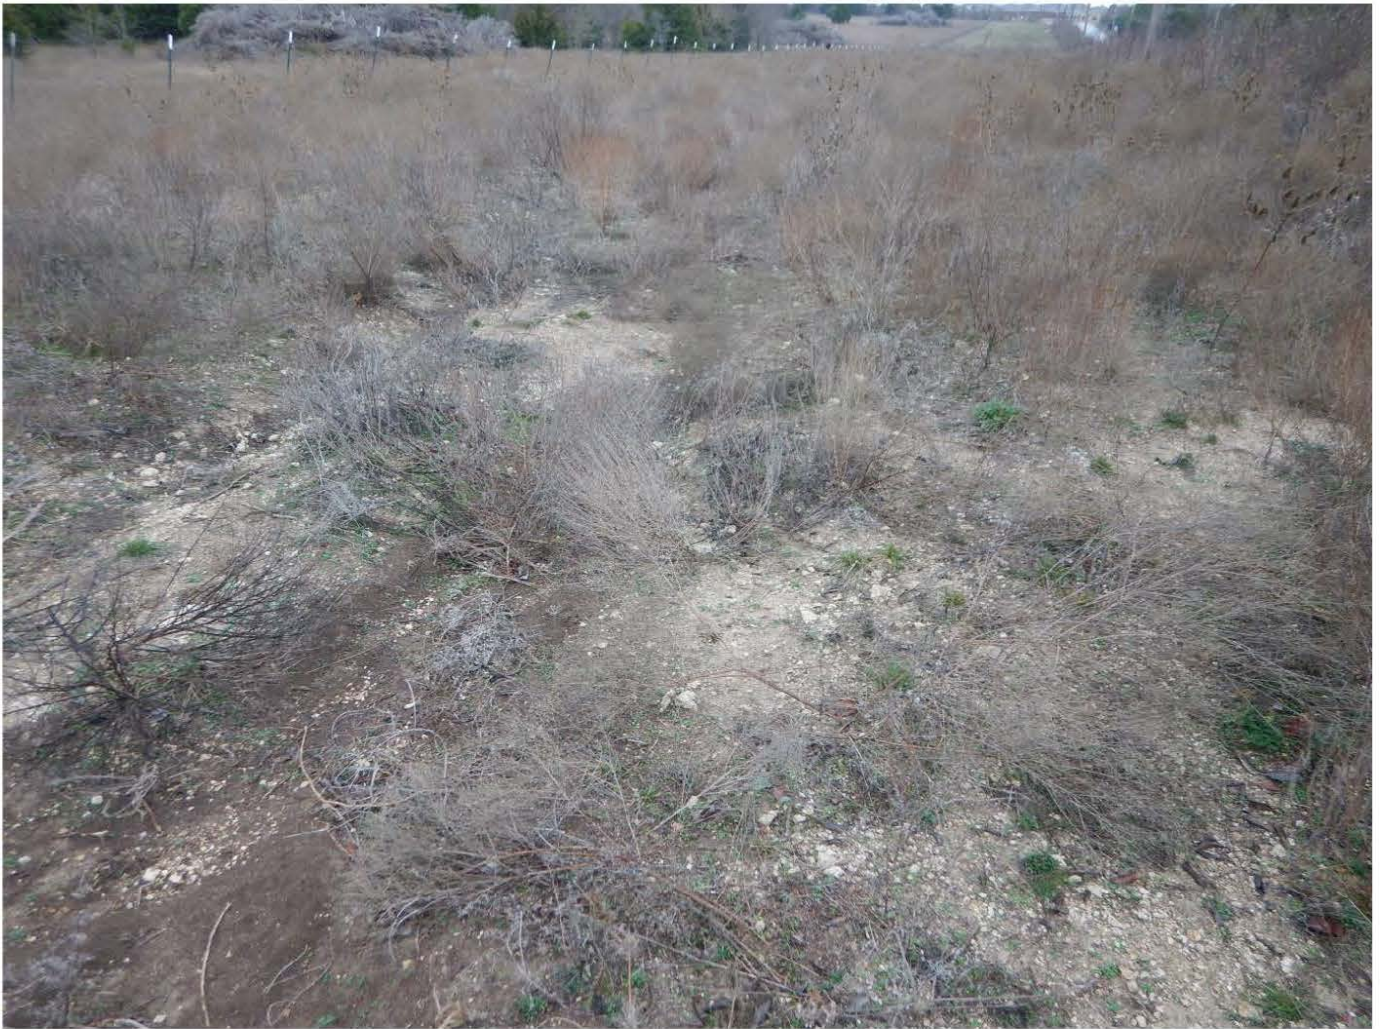
Figure 36. Exhibiting disturbed soils and exposure of bedrock.

The remaining properties within the APE without current ROE that do not require further survey were visually inspected from the current ROW for historical features or archeological potential. Additionally, recommendations of no survey for these properties were based on observations of heavy disturbances as seen from the ROW and include: residential or commercial development construction for roads, utility line installations, and terraforming for the installation of ditches; heavy disturbances from repeated agricultural practices disrupting the potential for intact archeological deposits; and lastly, disturbed soils and surface exposures of bedrock (**Figures 36**).
