United States Highway (US) 377 Technical Reports

United States Highway (US) 377

From: North of Business (BUS) 377E

To: US 380

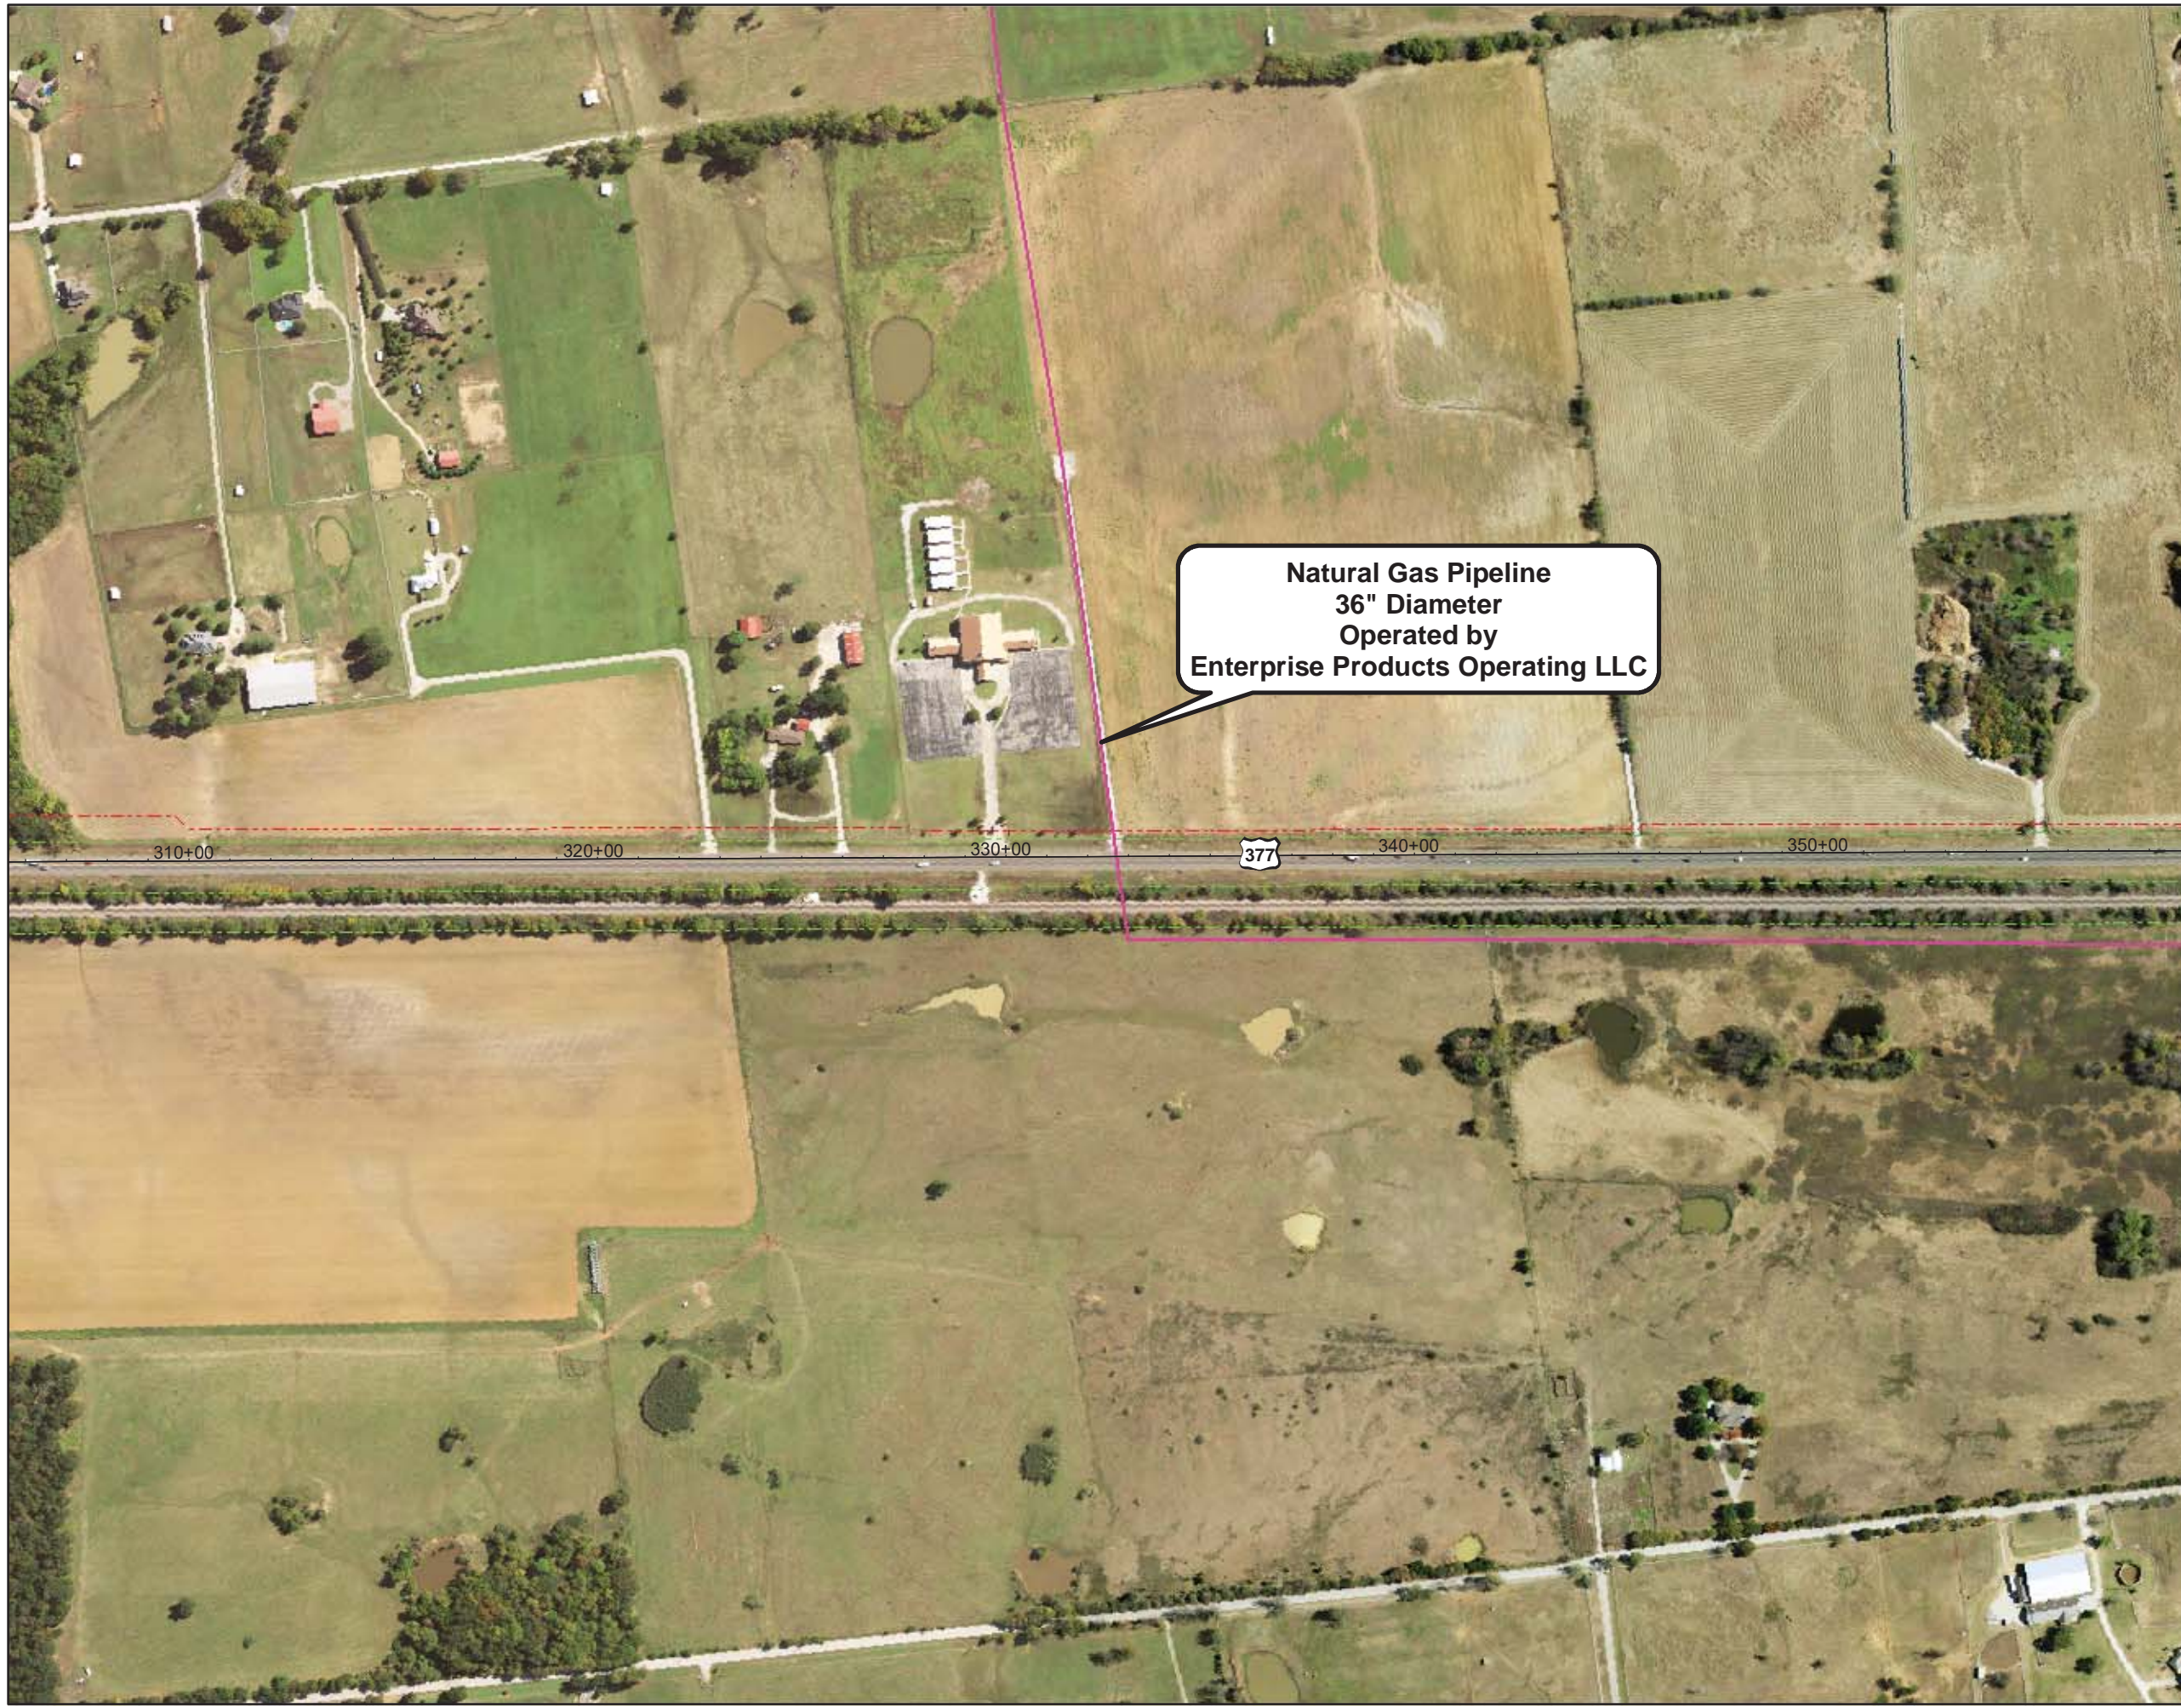
Page 6 of 16

Natural Gas Pipeline
36" Diameter
Operated by
Enterprise Products Operating LLC

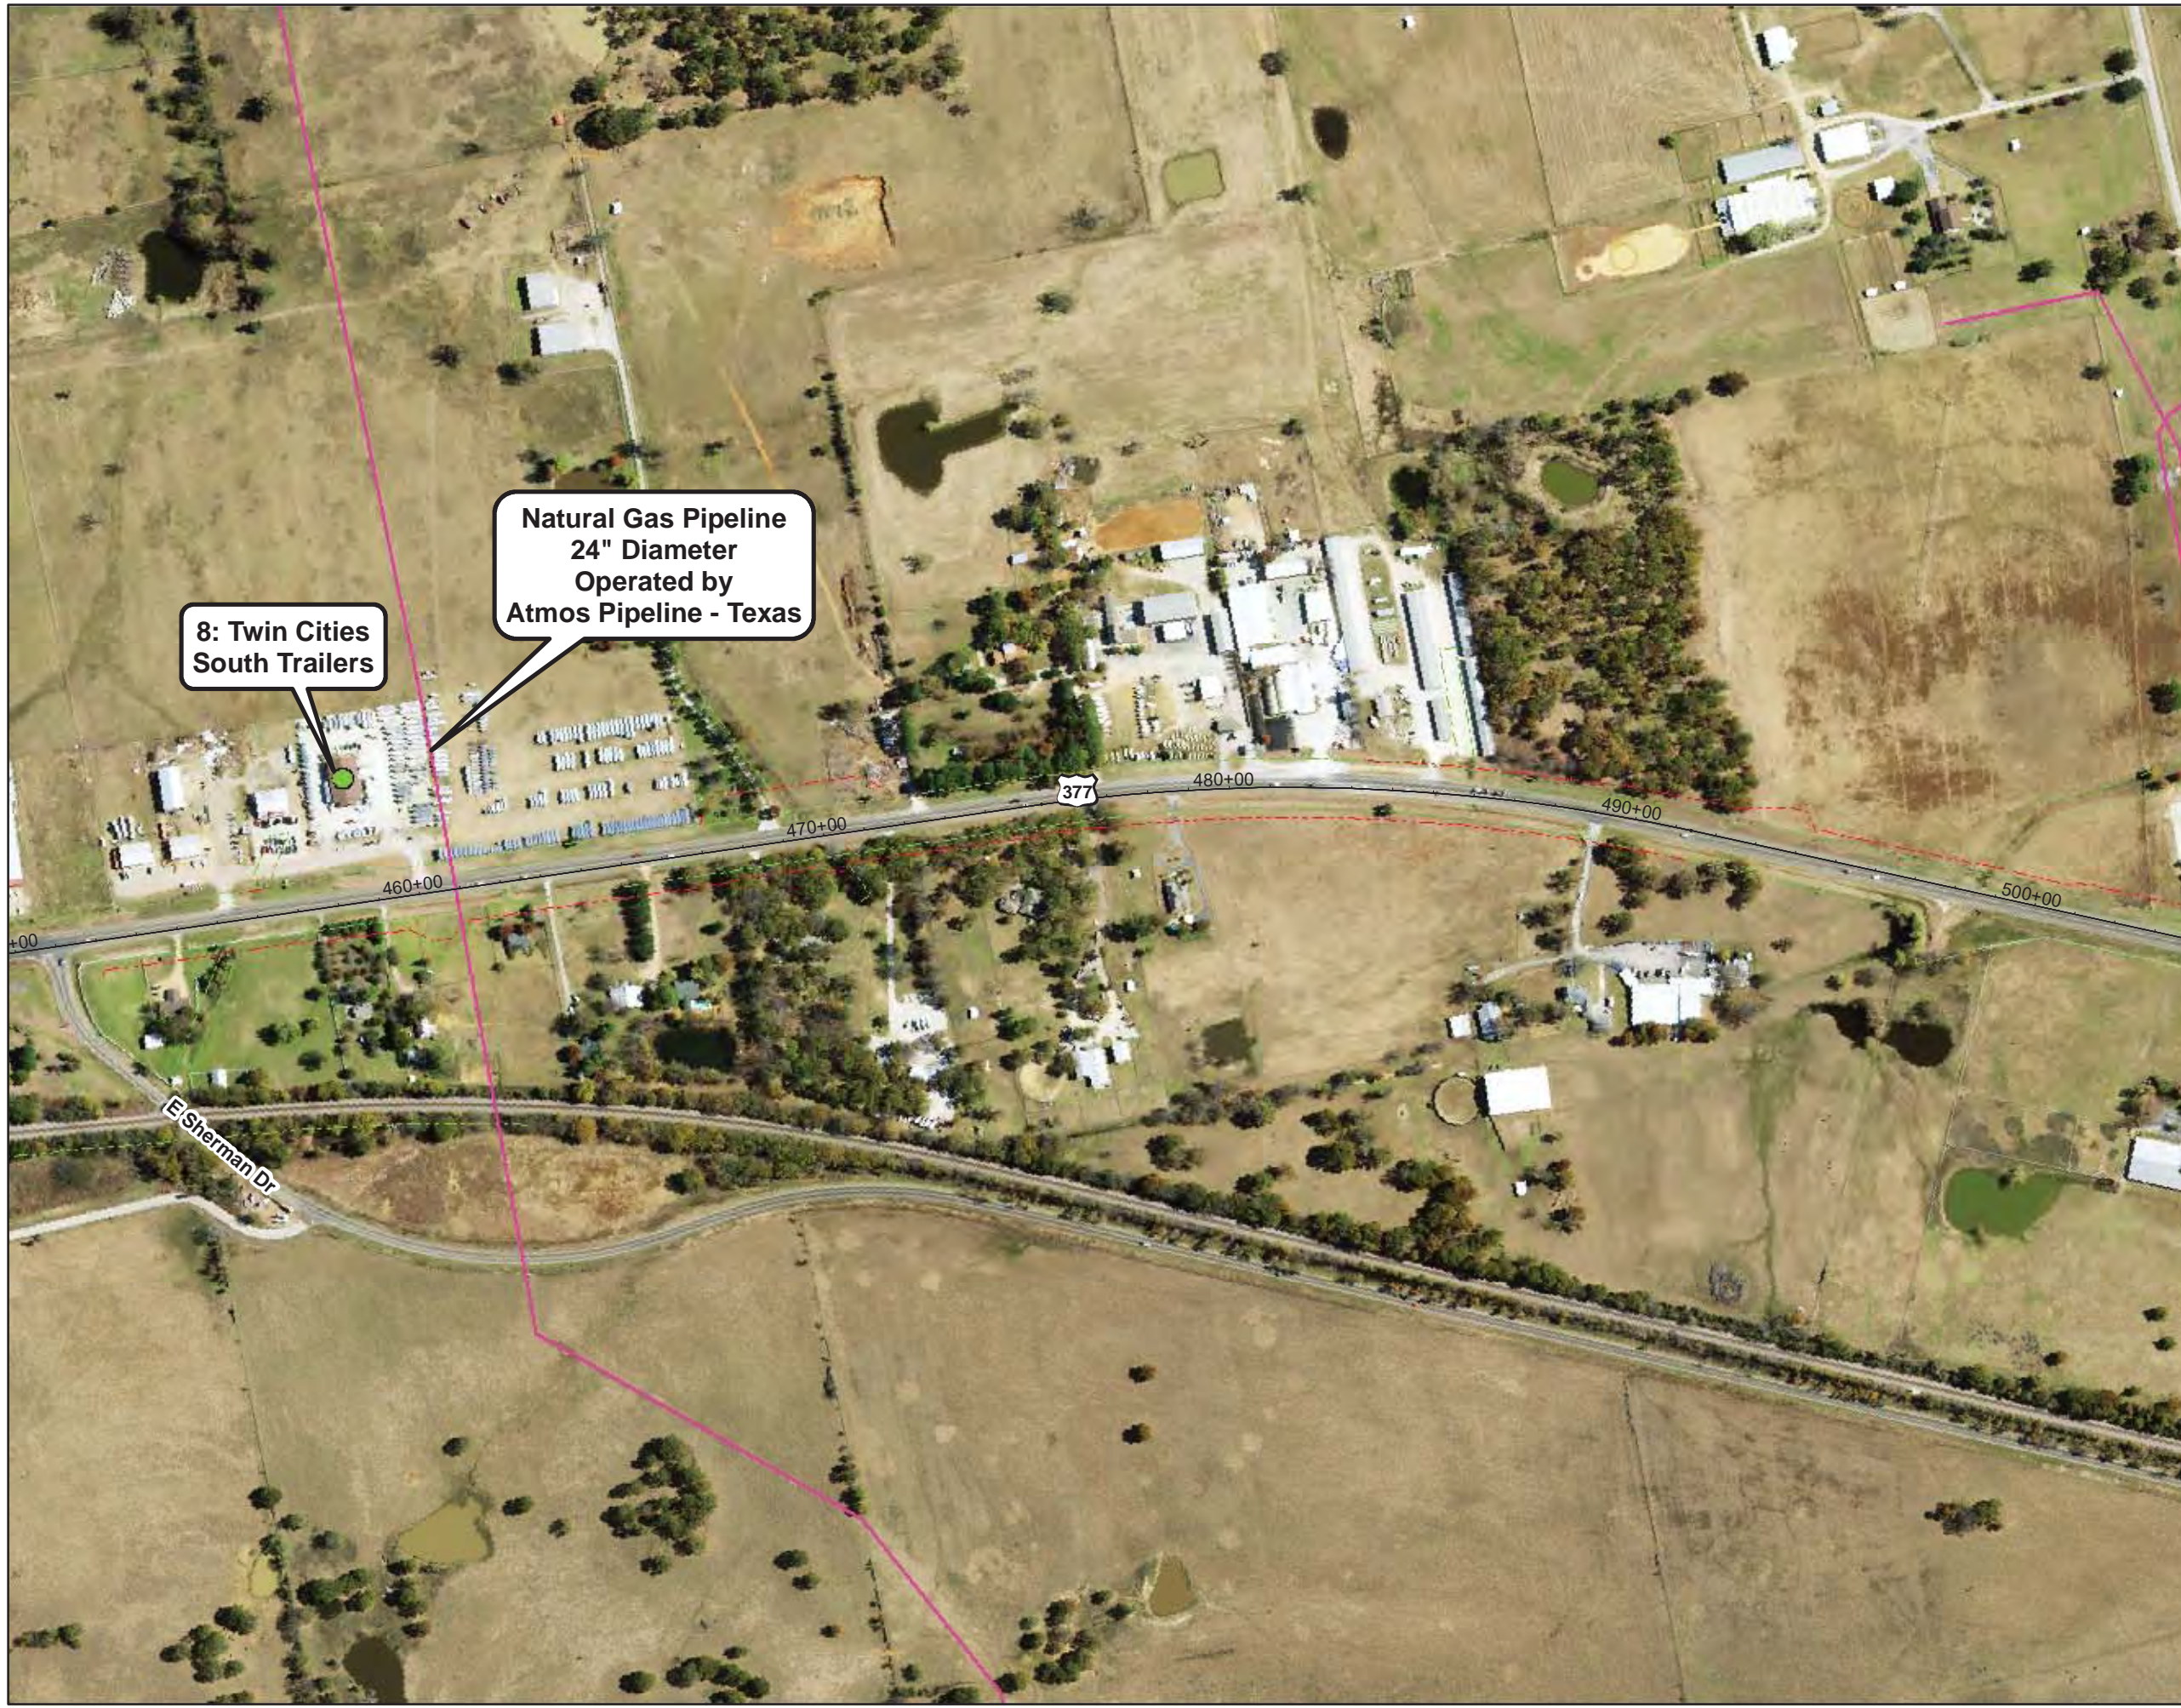
Page 9 of 16

8: Twin Cities South Trailers

Natural Gas Pipeline
24" Diameter
Operated by
Atmos Pipeline - Texas

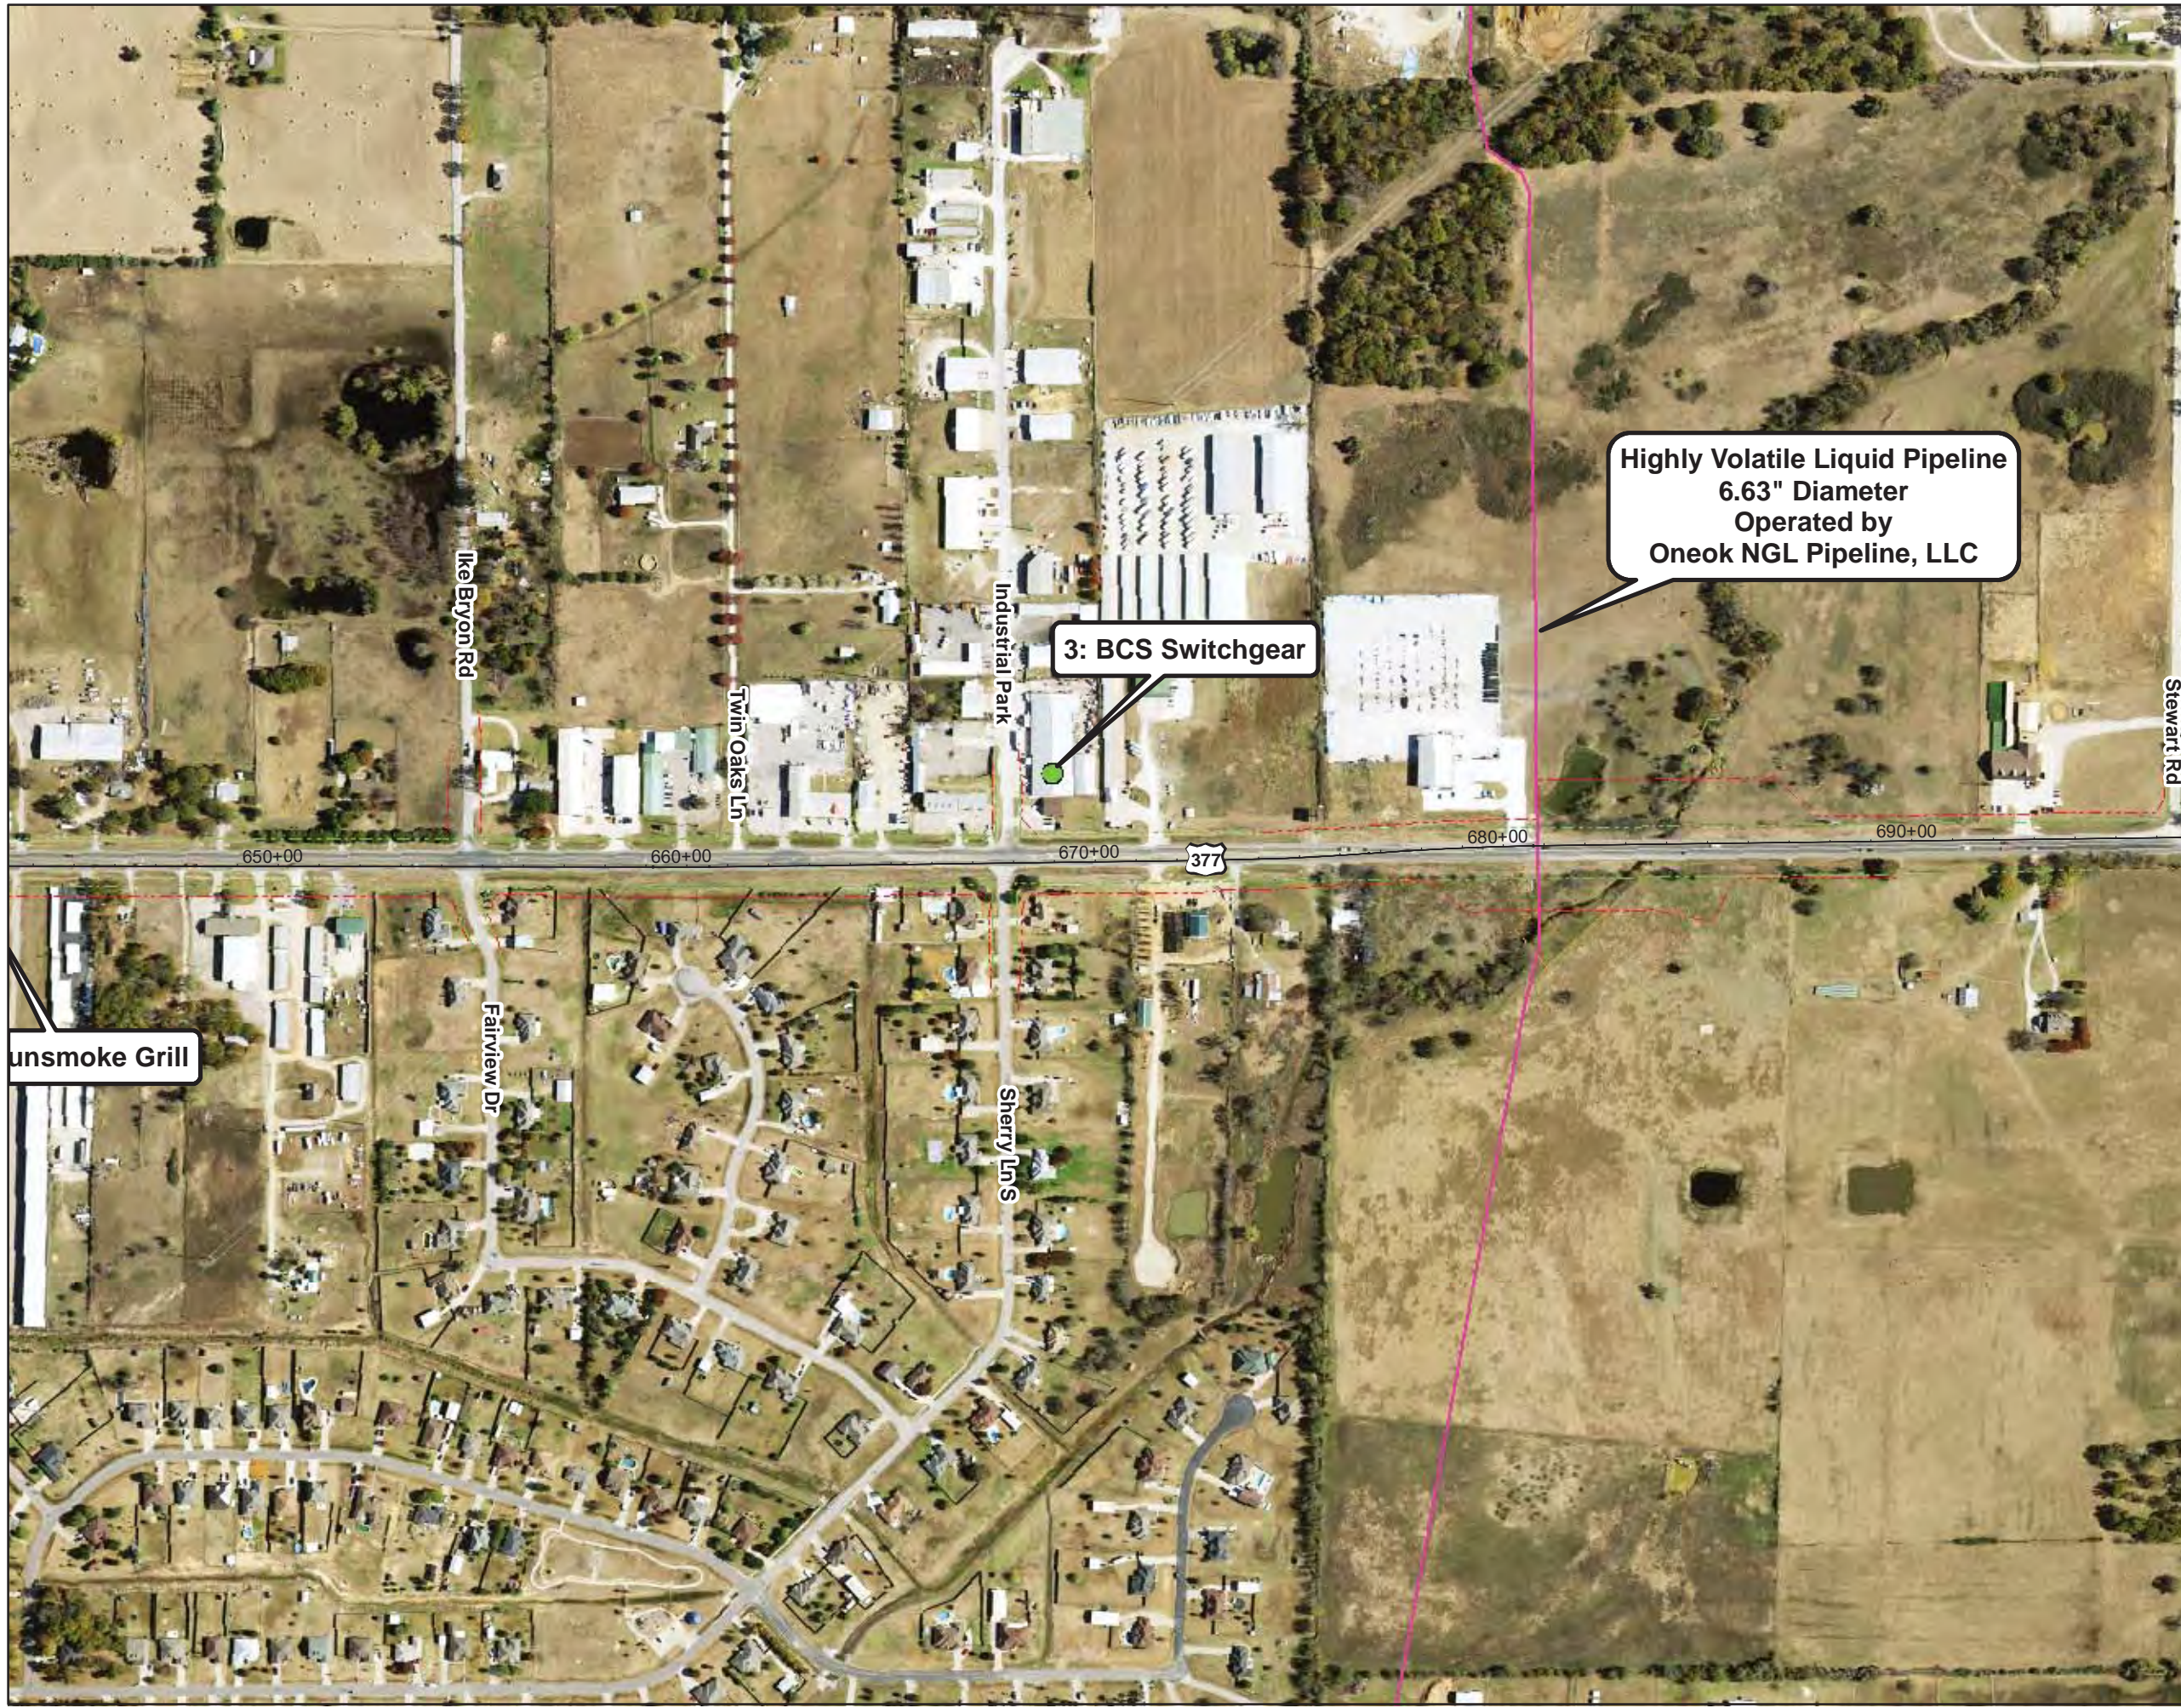
Page 13 of 16

Highly Volatile Liquid Pipeline
6.63" Diameter
Operated by
Oneok NGL Pipeline, LLC

3: BCS Switchgear
