Hazardous Materials Initial Site Assessment (ISA)

May 1, 2020

District: Dallas

CSJ No: 1059-01-047 & 1059-02-002	City: Krum, Denton	Zip Code: 76249, 76207	County: Denton
HWY: FM 1173	Limits: From FM 156 to Interstate Highway (IH) 35

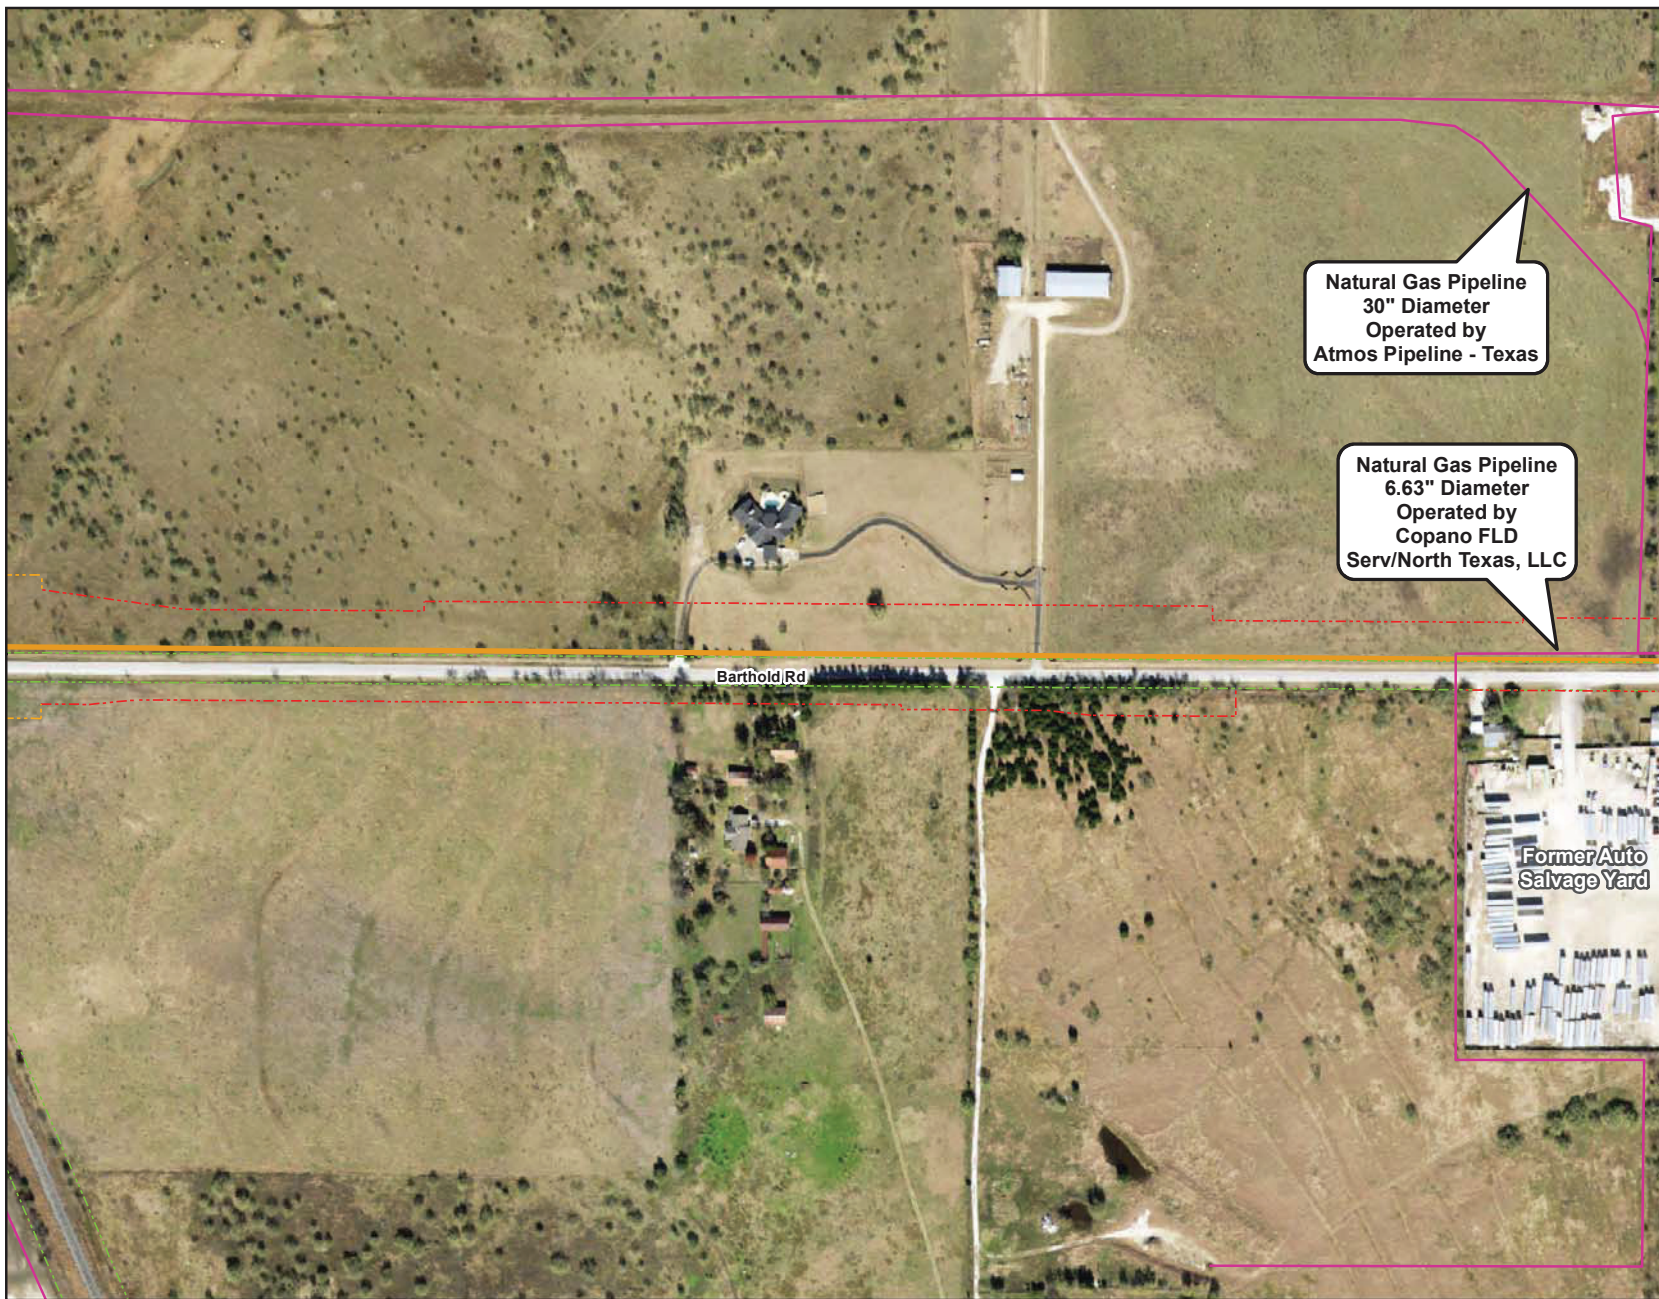
Hazardous Materials Site Map Farm-to-Market (FM) 1173

9. Eagleridge Operating, LLC 6.63-inch diameter North Denton natural gas, gathering line approximately 22.9 feet north of Barthold Road in Denton, TX. This pipeline is parallel to the existing FM 1173, and within the proposed ROW for widening of FM 1173, beginning at STA 280+50 to the end of the project limits. Status is "in service" (see the Hazardous Materials Sites Map - Page 6 and 7).

10. Atmos Pipeline - Texas 30-inch diameter WN natural gas, transmission line approximately 44.1 feet north of Barthold Road in Denton, TX. This pipeline is parallel to the existing FM 1173, beginning at STA 280+75 to the end of the project limits. Status is "in service" (see the Hazardous Materials Sites Map - Page 6 and 7).

Natural Gas Pipeline
30" Diameter
Operated by
Atmos Pipeline - Texas

Natural Gas Pipeline
6.63" Diameter
Operated by
Copano FLD
Serv/North Texas, LLC

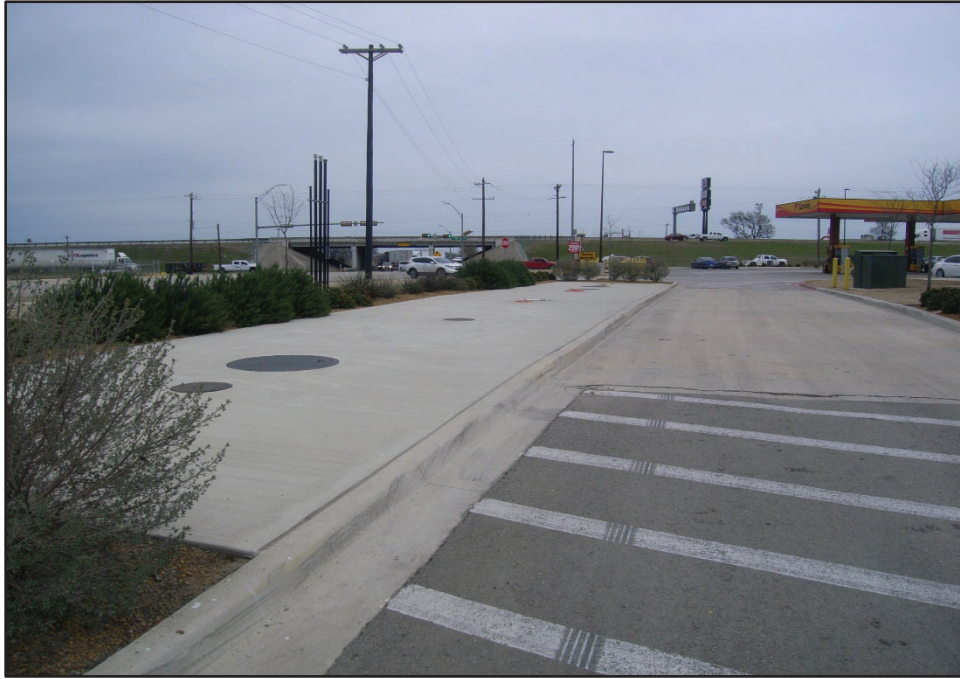
Photograph 1: View looking southeast from the parking lot of Loves Truck Stop at approximate STA 290+00 towards a tank hold at Love Truck Stop site at 6421 N IH 35, Denton, TX 76207 (Map ID 1). Proposed ROW would be acquired from this site. Date of photograph: 3/3/20.

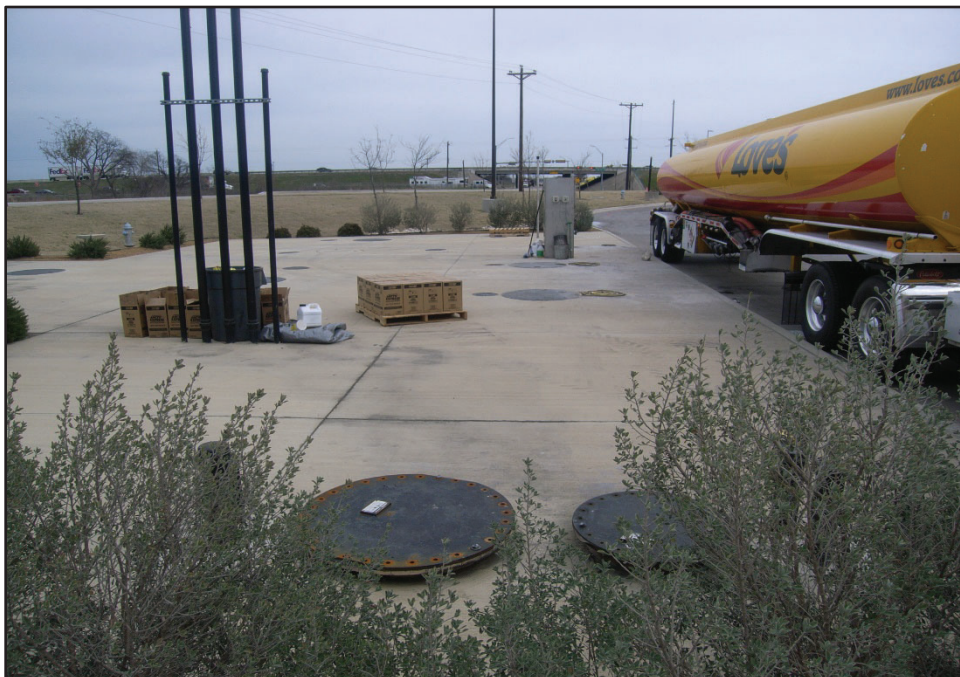
Photograph 2: View looking east from the western driveway of Loves Truck Stop at approximate STA 288+00 towards a tank hold at Love Truck Stop site at 6421 N IH 35, Denton, TX 76207 (Map ID 1). Proposed ROW would be acquired from this site. Date of photograph: 3/3/20.

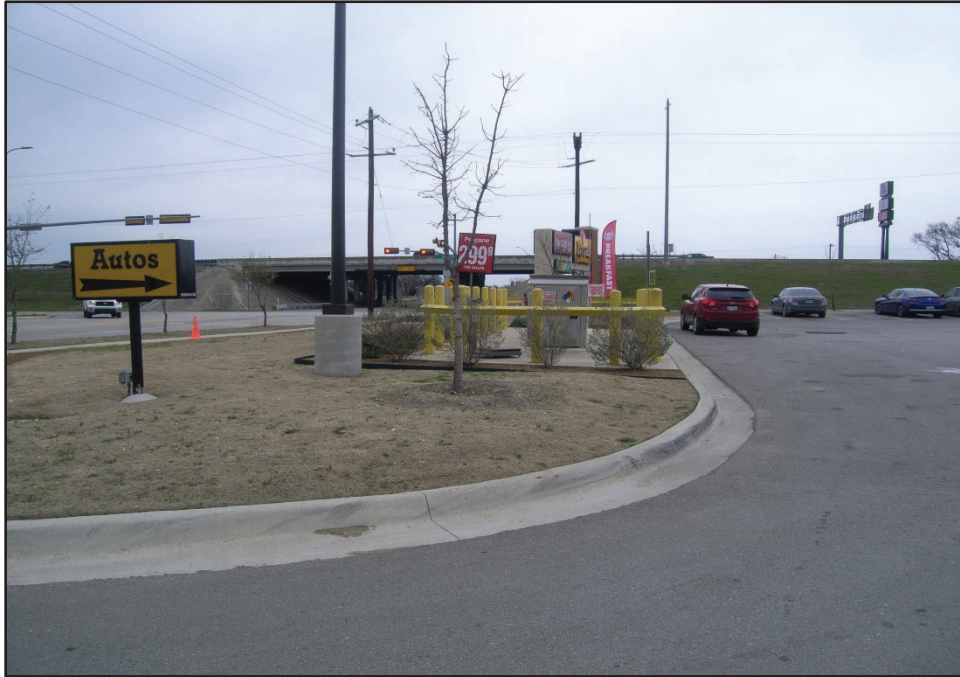
Photograph 3: View looking east from the eastern driveway of Loves Truck Stop at approximate STA 290+00 towards a propane storage tank at Love Truck Stop site at 6421 N IH 35, Denton, TX 76207 (Map ID 1). Proposed ROW would be acquired from this site. Date of photograph: 3/3/20.

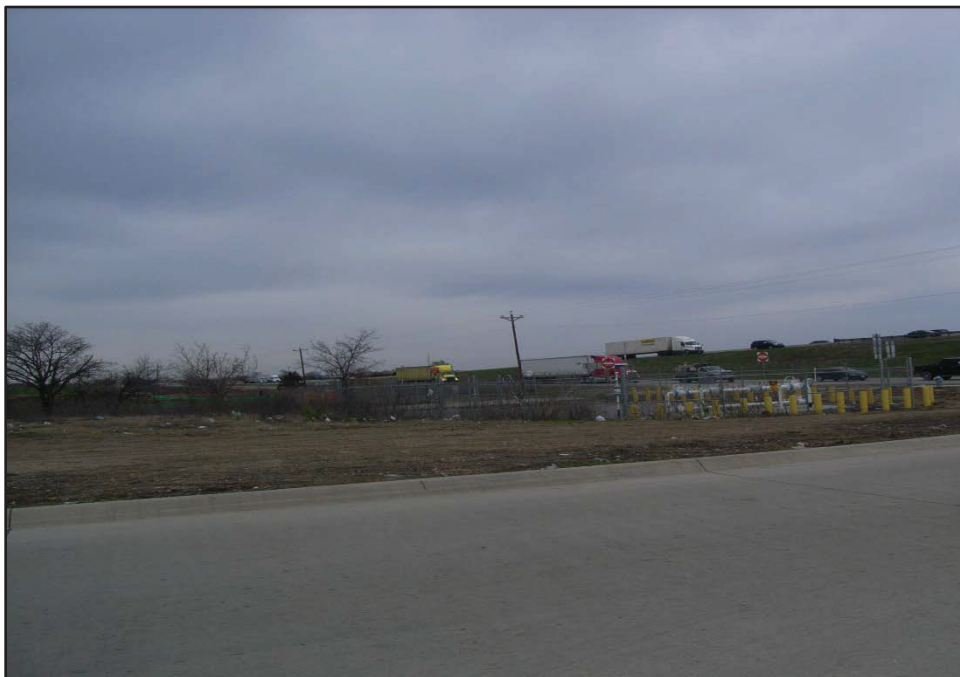
Photograph 4: View looking northeast from the parking lot of Loves Truck Stop at approximate STA 290+00 towards a gas pipeline approximately 96.5 feet north of the Love Truck Stop site at 6421 N IH 35, Denton, TX 76207. Proposed ROW would be acquired from the property the pipeline is on. Date of photograph: 3/3/20.

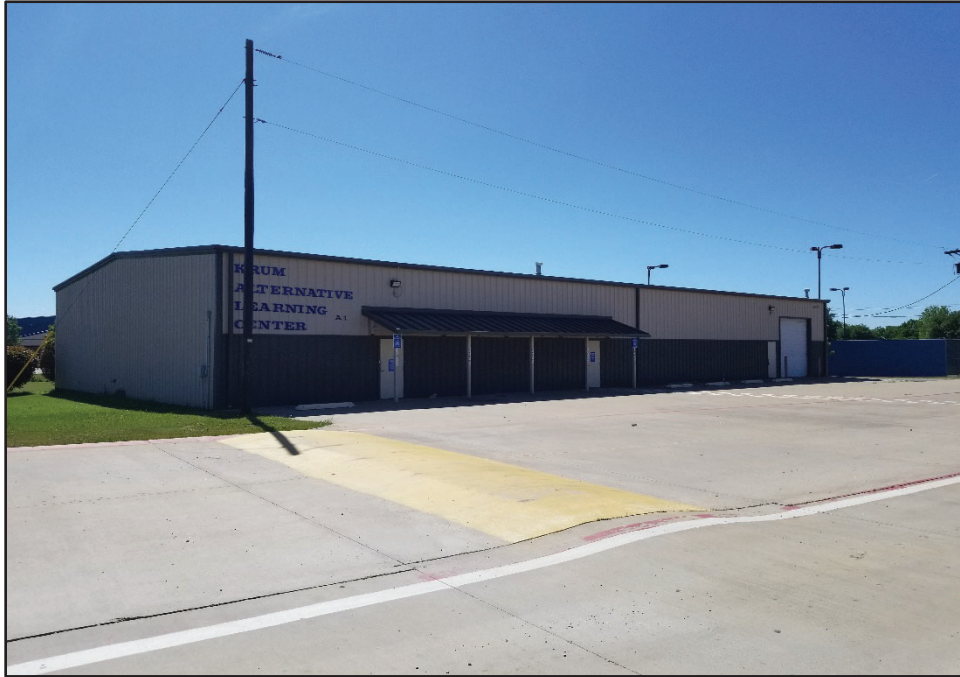
Photograph 5: View looking east from Bobcat Boulevard at approximate STA 138+00 towards the former PST facility that is now Krum ISD at 1200 Bobcat Boulevard, Krum, TX 76249 (Map ID 4). No proposed ROW would be acquired from this site. Date of photograph: 4/30/20.

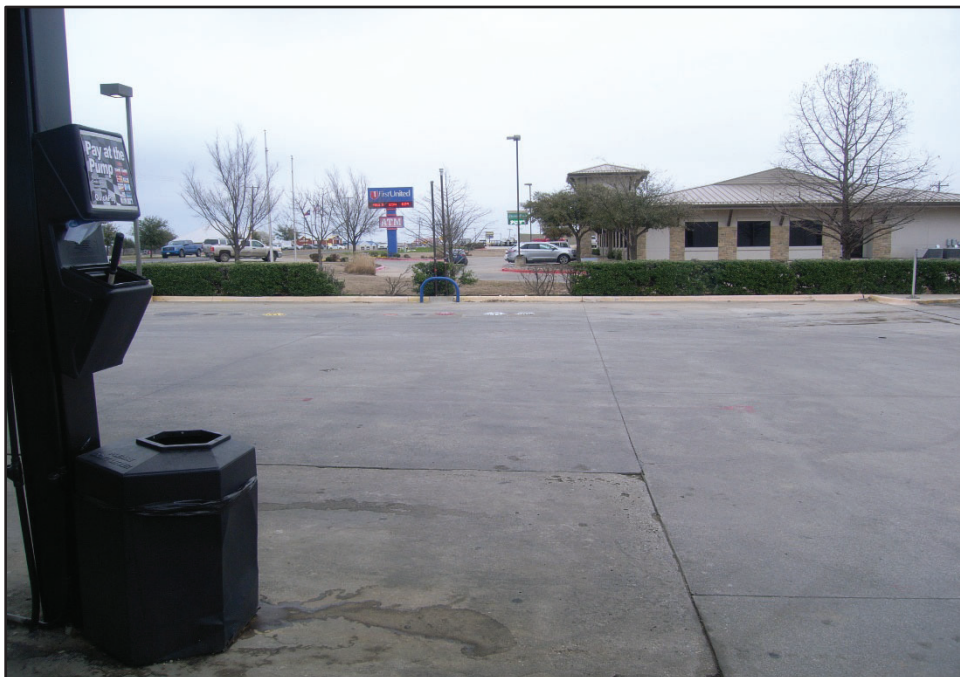
6	Krum Quick Track 920 E. McCart Street Krum, TX 76249 (Current facility) Photo: 6	Adjacent S	ERNSTX PST	The facility is an active gas station. PST information was not reported in the database. According to the TCEQ Central Registry, the facility utilizes one single-wall, composite, 40,000-gallon split diesel/gasoline underground PST installed in 2002. The tank hold is approx. 45 feet south-southeast of existing ROW. No releases have been reported for the facility. The site received a Notice of Violation on 8-20-18 for failure to protect the underground metallic components from corrosion. The status is reported as resolved. In 2008, an emergency response incident was reported. The incident is reported as a spill of gasoline possibly from someone fueling their car. It is reported that kitty litter was placed on the spill. No ROW would be acquired from this site. Proposed work activity adjacent to this facility includes widening FM 1173 with addition of a sidewalk and a drainage easement on the west side of the facility. Based on the absence of	Low

Photograph 6: View looking east northeast from the parking lot of Quick Track at approximate STA 143+00 towards the tank hold at the Quick Track site at 920 E McCart Street, Krum, TX 76249 (Map ID 6). No ROW would be acquired from this site. Date of photograph: 3/3/20.

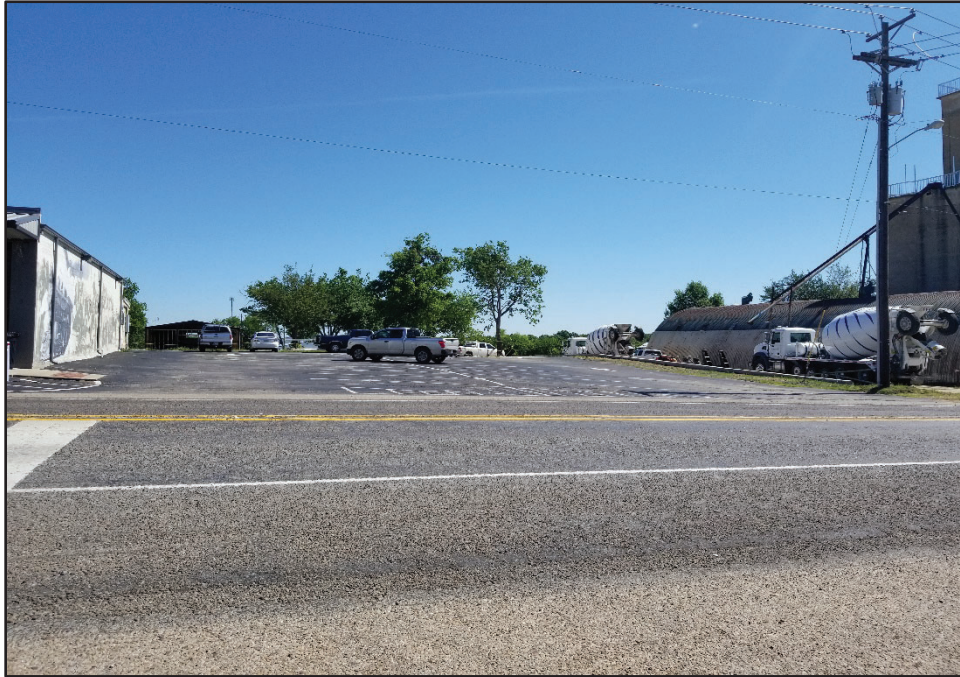
Photograph 7: View looking north from the ROW of FM 1173 at approximate STA 106+50 towards the Krum City Hall parking lot at 102 W. McCart Street, Krum, TX 76249 (Map IDs 7 & 18). No ROW would be acquired from this site. Date of photograph: 4/30/20.

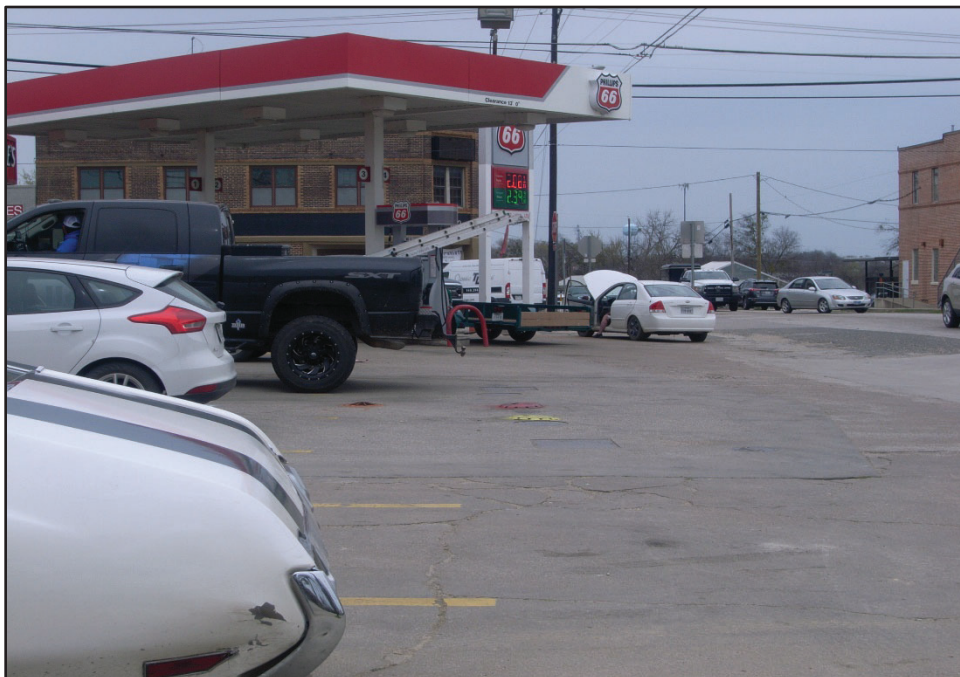
Photograph 8: View looking northeast from the parking lot of Johnny Joes 4 at approximate STA 15+00 on FM 156 (S. 1st Street) towards the tank hold at Johnny Joes 4 site at 100 S. 1st Street, Krum, TX 76249 (Map ID 9). No ROW would be acquired from this site. Date of photograph: 3/3/20.

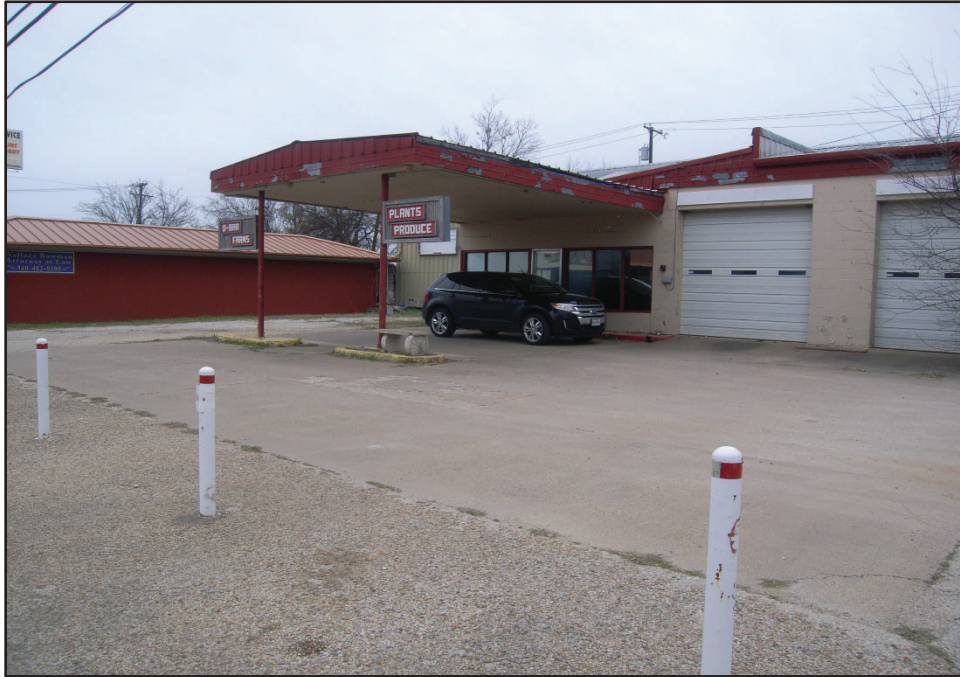
Photograph 9: View looking south from the ROW of FM 1173 at approximate STA 105+00 towards the D-Bar Farms at 129 W McCart Street, Krum, TX 76249 (Map ID 16). No ROW would be acquired from this site. Date of photograph: 3/3/20.

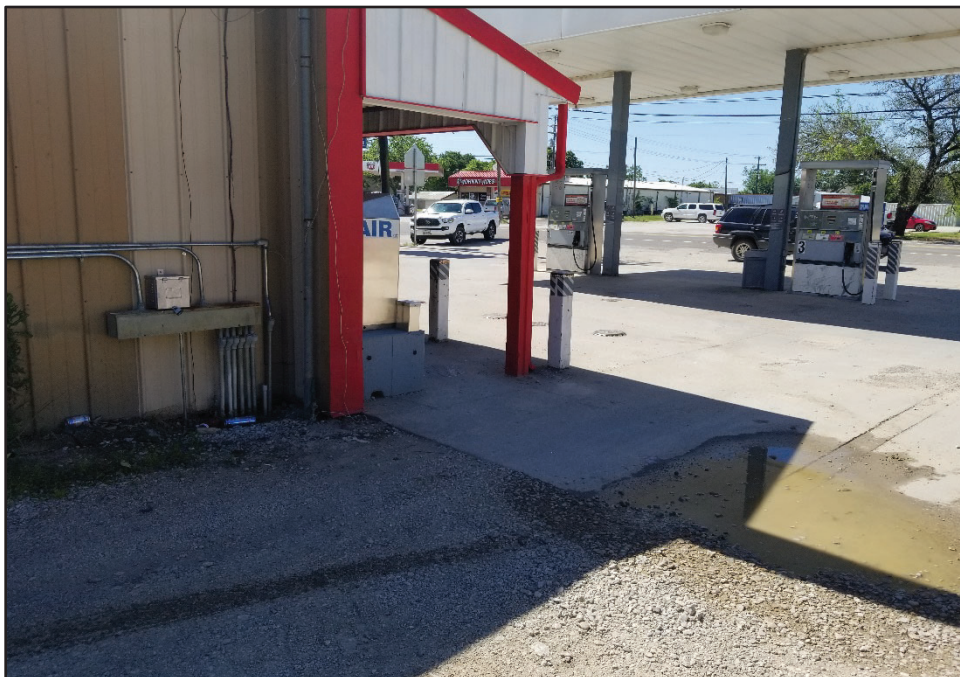
5	Outback Market 210 W. McCart Street Krum, TX 76249 (Current facility) Photo: 10	Adjacent N	PST	The facility is an active gas station. PST information was not reported in the database report. According to the TCEQ Central Registry, the facility utilizes three 4,000-gallon gasoline underground PSTs. The tanks were installed in 1982. No releases have been reported, however, a Commissioner's Enforcement Order was issued in 2013 for failing to monitor the USTs for releases. The tank hold is approx. 55 ft. northwest of the project existing ROW. The facility is adjacent north to the beginning project limits. No ROW acquisition is proposed from this property. Review of the schematic shows possible repaving of FM 1173 adjacent to this facility with no additional work activity shown. Based on no ROW acquisition and proposed work activity, this facility is considered a low environmental risk to the project.	Low

Photograph 10: View looking southeast from the parking lot of Outback Market at approximate STA 100+00 towards the tank hold at Outback Market at 210 W. McCart Street, Krum, TX 76249 (Map ID 5). No ROW would be acquired from this site. Date of photograph: 4/30/20.

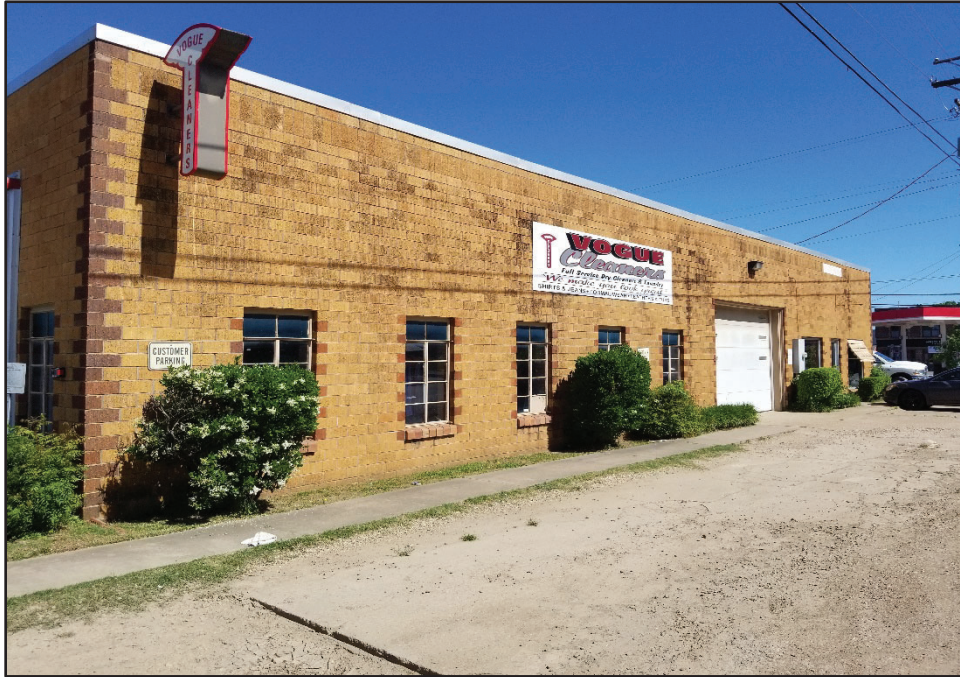
DCR: One drycleaner that performs on-site cleaning is adjacent to the project. This site is discussed in the attached Hazardous Materials Project Impact Evaluation.

Photograph 11: View looking north from the existing ROW on FM 156 (S. 1st Street) at approximate STA 13+00 towards Vogue Cleaners at 110 S. 1st Street, Krum, TX 76249 (Map ID 10). No ROW would be acquired from this site. Date of photograph: 4/30/20.
