Appendix I – Historical Resources Survey Report

MEMO

District: Dallas
County: Dallas, Ellis
CSJ#: 2964-10-006
Highway: SL 9, Segment A
Project Limits: US 67 to IH 34
Let Date: December 2023

SUBJECT: Internal review under the Section 106 Programmatic Agreement (Section 106 PA) among the Texas Department of Transportation, Texas State Historic Preservation Officer, Advisory Council on Historic Preservation, and Federal Highway Administration; and the Memorandum of Understanding (MOU) between the Texas Historical Commission and the Texas Department of Transportation

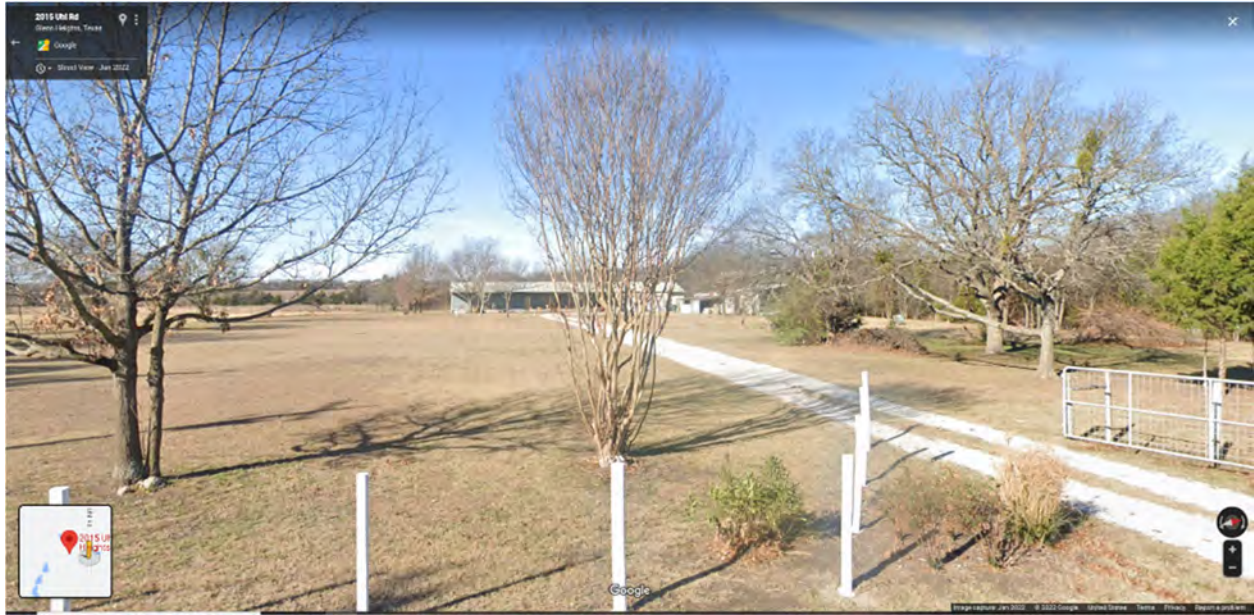
Figure 1. Overview of 2015 Uhl Road, facing northwest. Google Street View

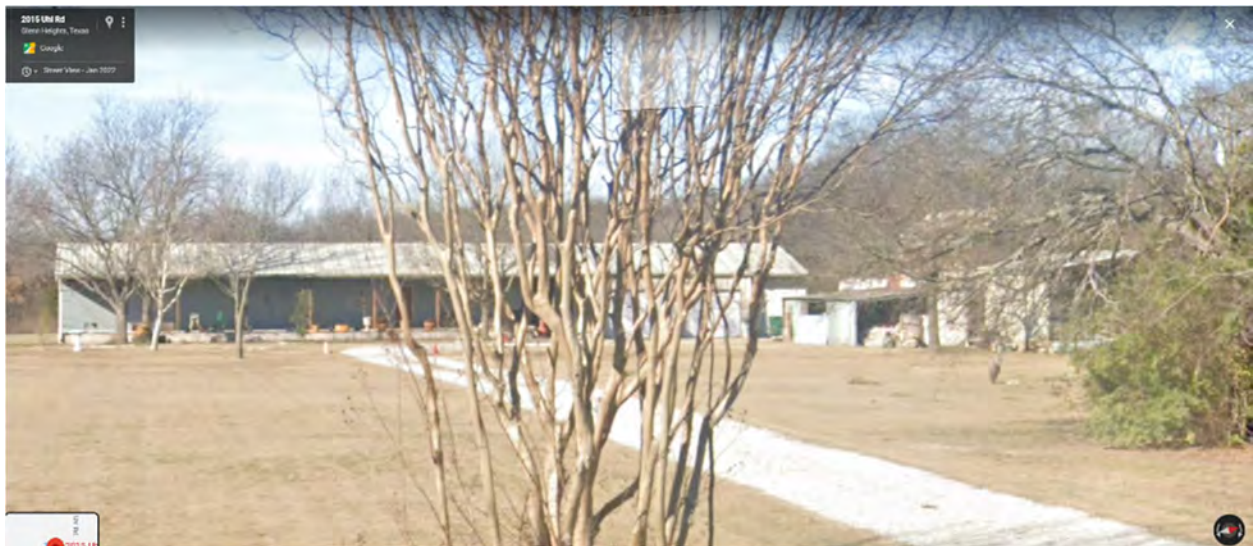
Figure 2. View of the residence at 2015 Uhl Road, facing northwest. Dallas CAD classifies the residence as a mobile home. The two-car garage unit addition is visible through the tree branches. Outbuildings are visible to the right of the home. Google Street View

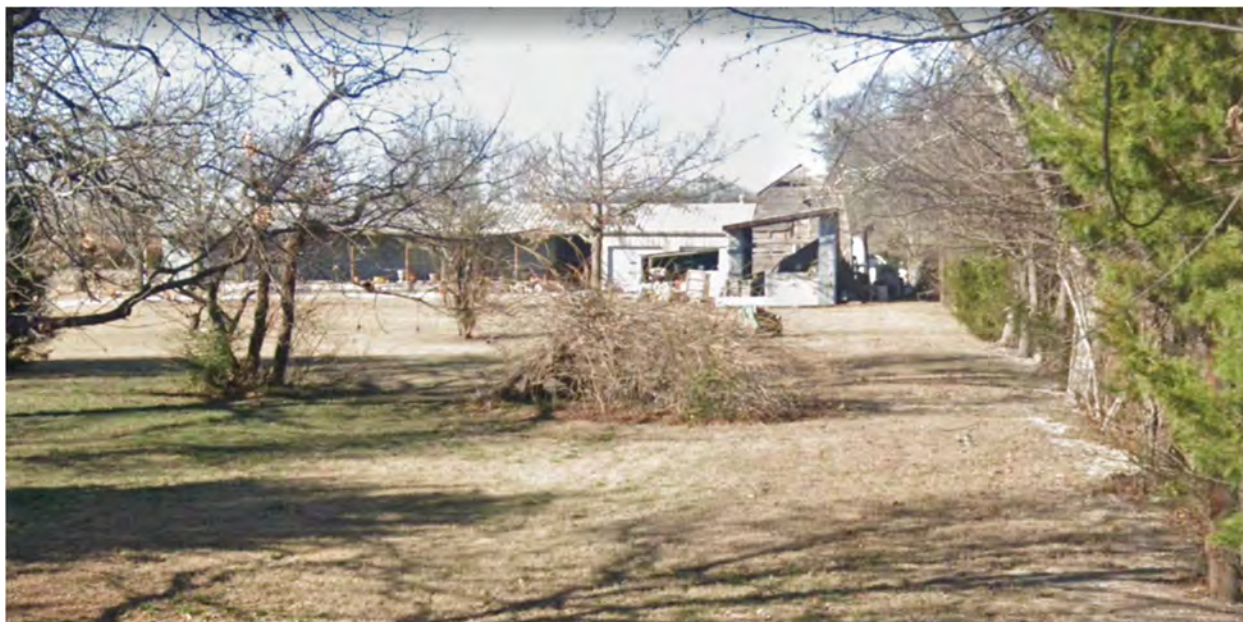
Figure 3. View of 2015 Uhl Road, facing southwest. A covered, open-air storage shed and the gable end of the barn are visible on the right. Google Street View

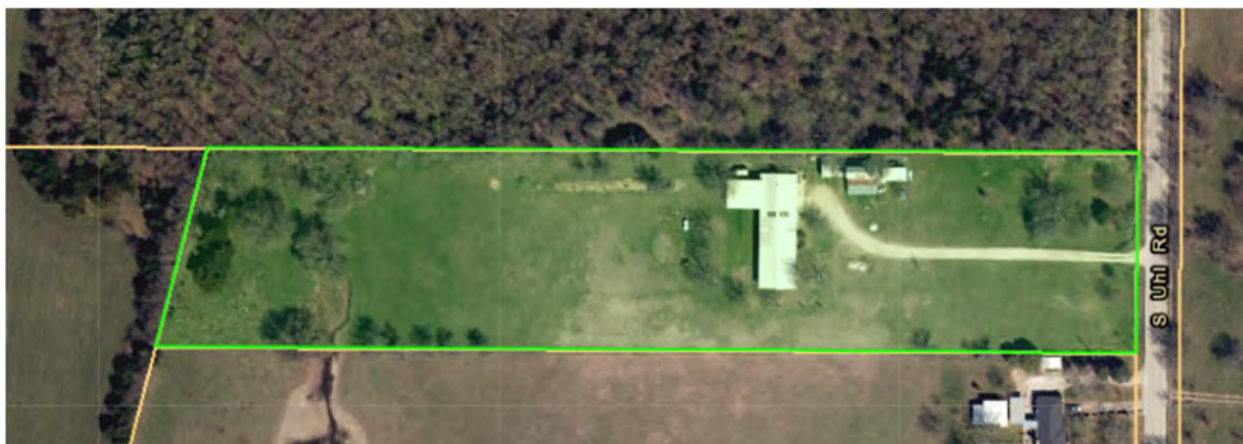
Figure 4. Aerial view of 2015 Uhl Drive with parcel outlines. Buildings are set back from the road. The residence is oriented north-south and has a rear addition. Outbuildings are northeast of the home. Dallas CAD

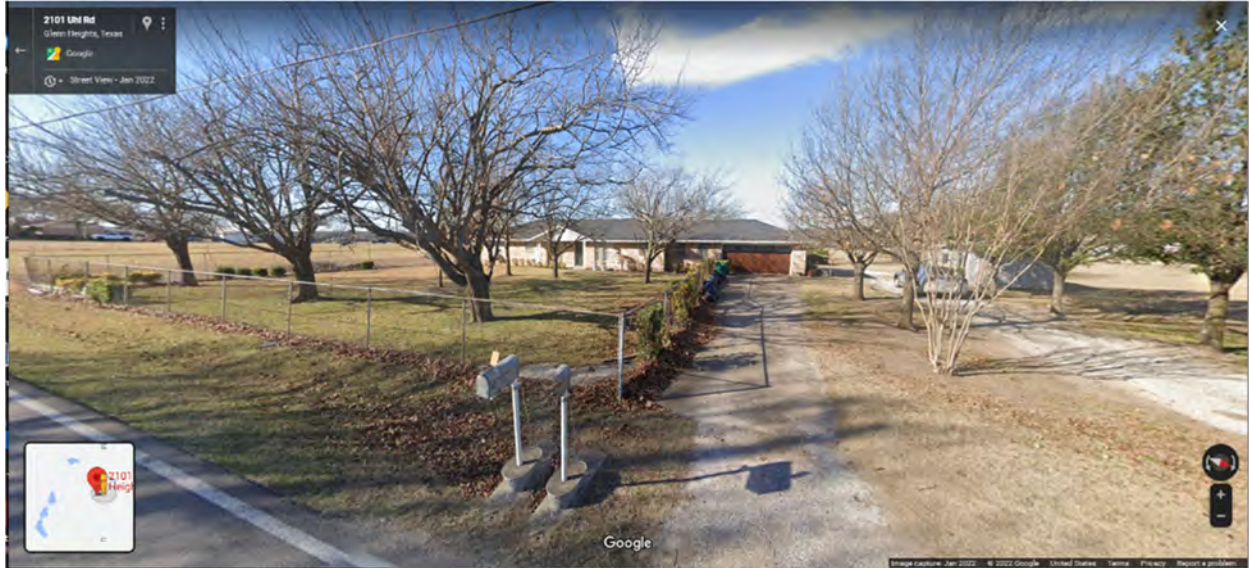
Figure 5. Overview of 2101 Uhl Road, facing southwest. Google Street View

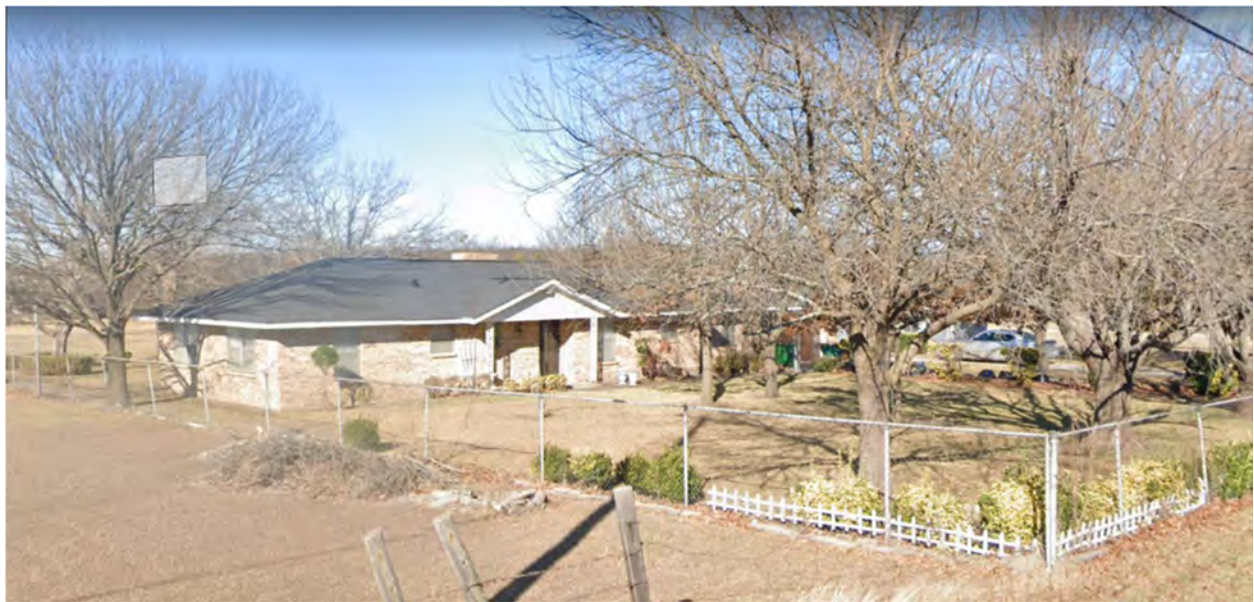
Figure 6. View of the residence at 2101 Uhl Road, facing northwest. Google Street View

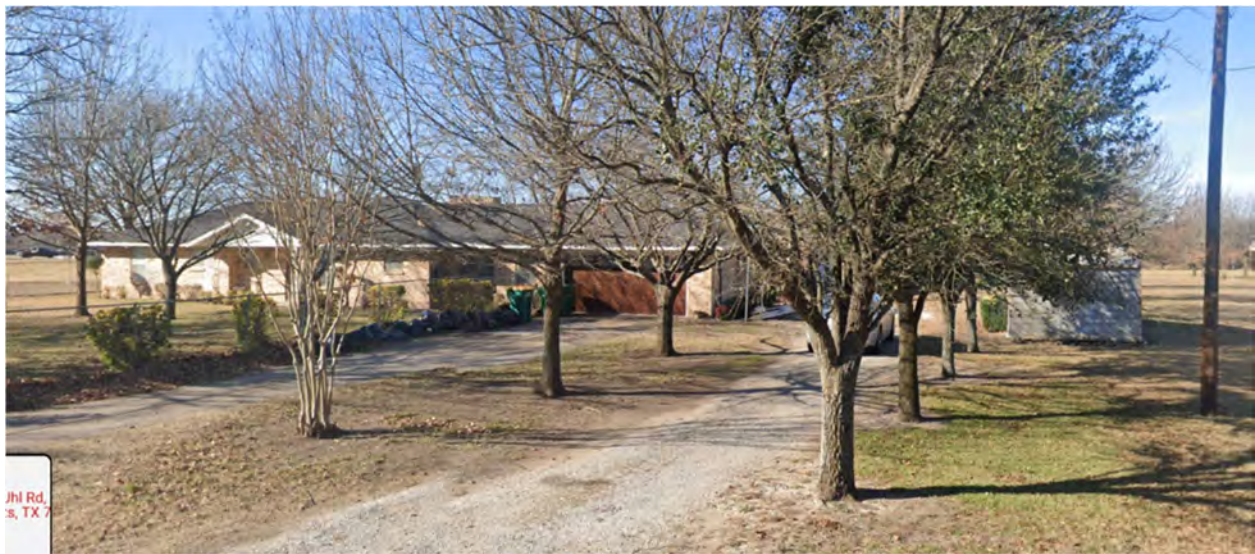
Figure 7. View of the residence at 2101 Uhl Road, facing southwest. Google Street View

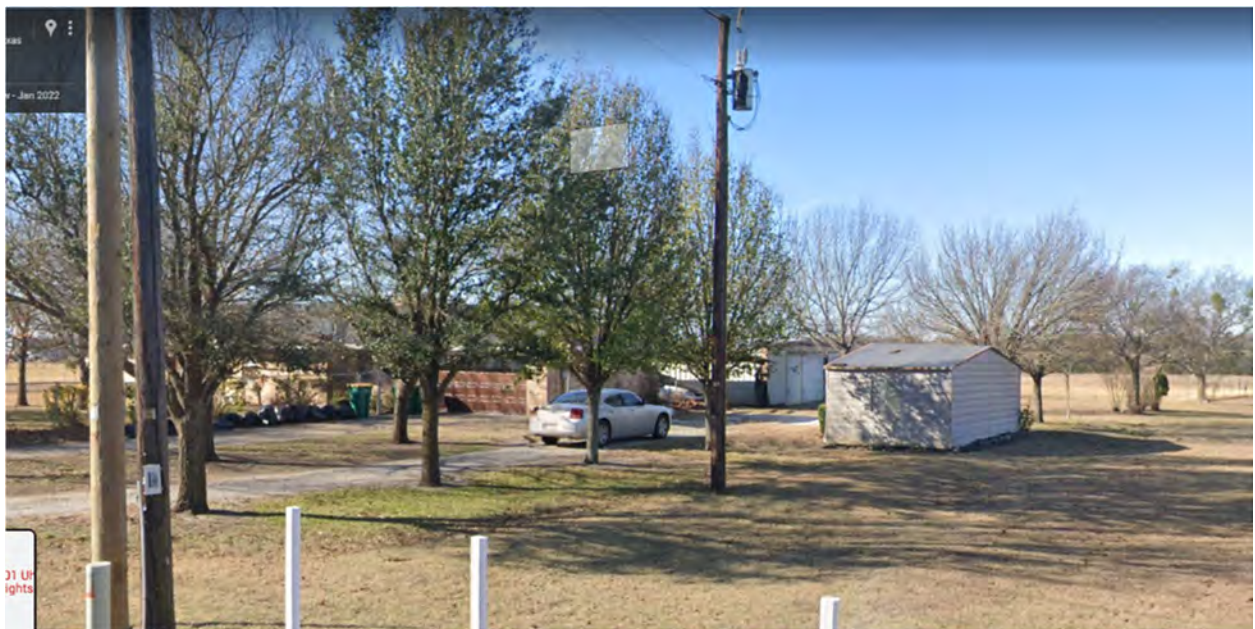
Figure 8. View of 2101 Uhl Road, facing southwest, with metal outbuildings visible on the right. Google Street View

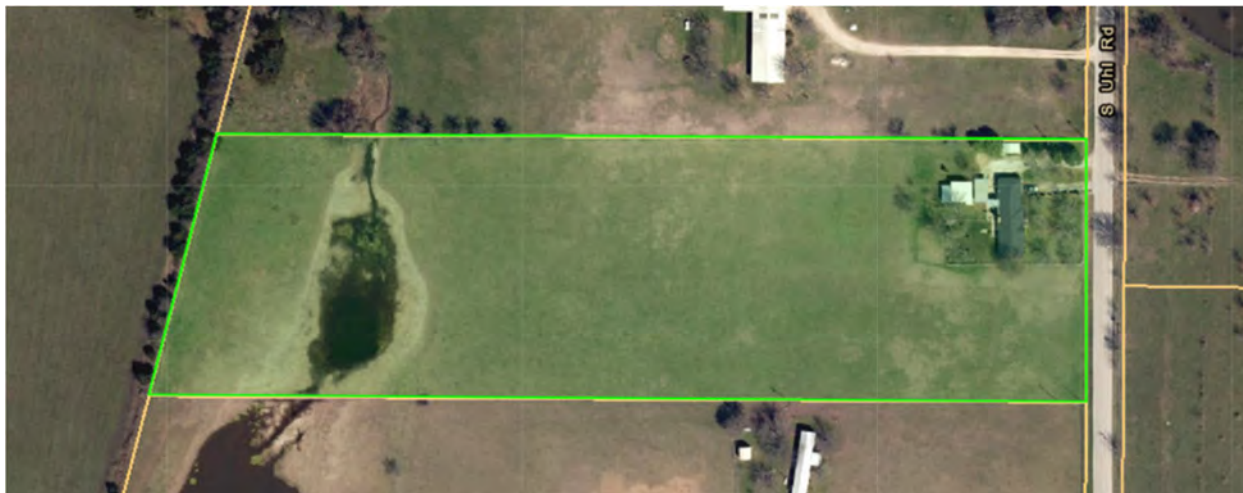
Figure 9. Aerial overview of 2101 Uhl Road with parcel outlines. Buildings are clustered in the northeast corner of the parcel. *Dallas CAD*

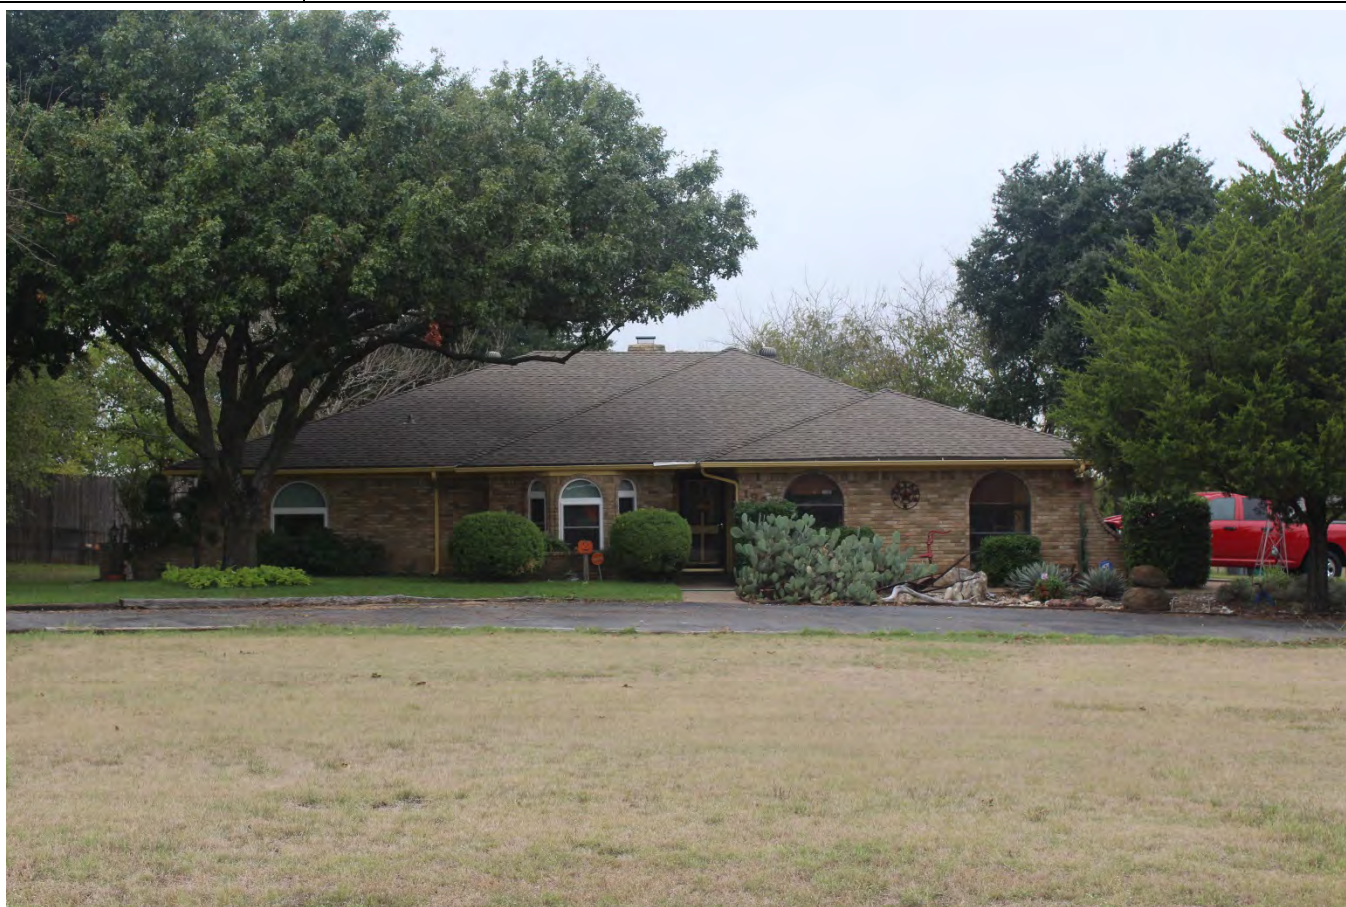
Camera facing west.

| NRHP Eligibility: | Not Eligible |
| Integrity/Comments: | Ranch style house with multiple hip roofs, brick siding, a recessed entry, a bay window, and replacement arched windows. Two brick half walls extend from the northeast and southeast corners of the house. |

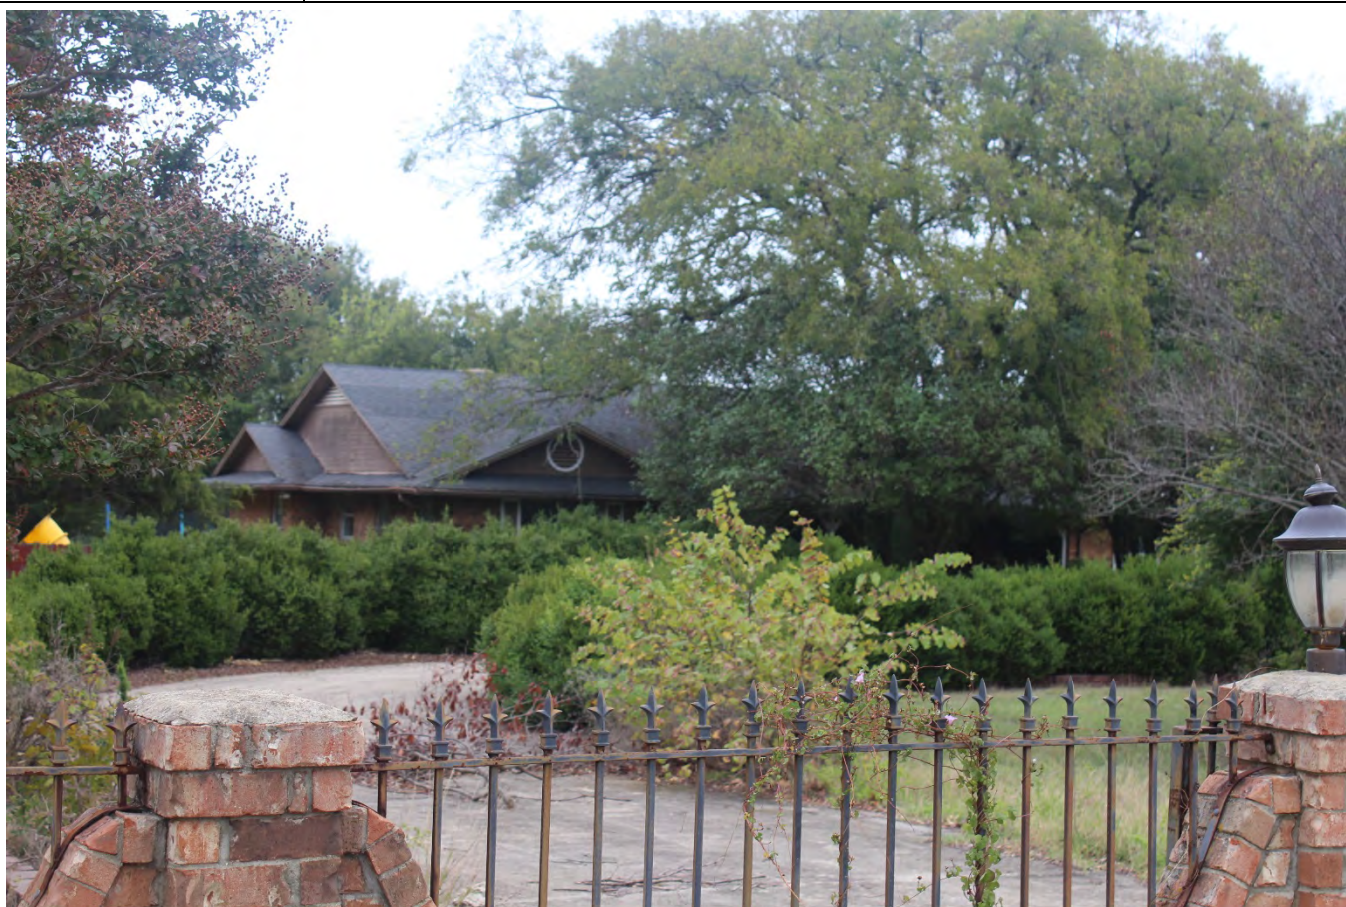
Camera facing southeast.

| NRHP Eligibility: | Not Eligible |
| Integrity/Comments: | Ranch style house with cross-gable roof, generous eaves, horizontal wood siding on gable ends, brick siding, and replacement windows. A modern addition of a garage extends from the rear (southwest) corner of the house. |

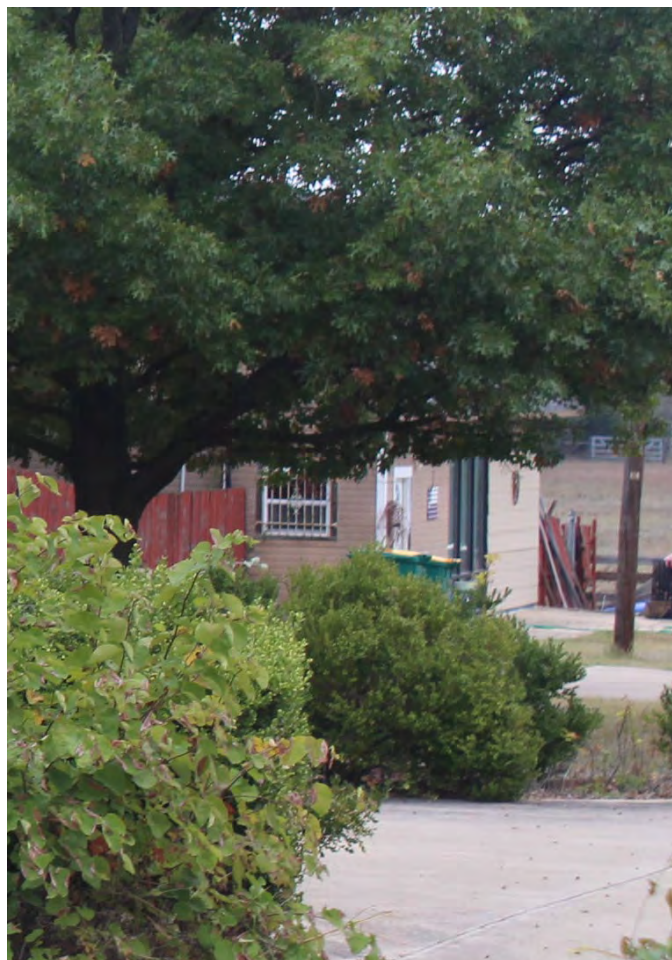
Camera facing northeast.

| NRHP Eligibility: | Not Eligible |
| Integrity/Comments: | Resource 02b is a shed with a gambrel roof, horizontal vinyl siding, and replacement windows. |

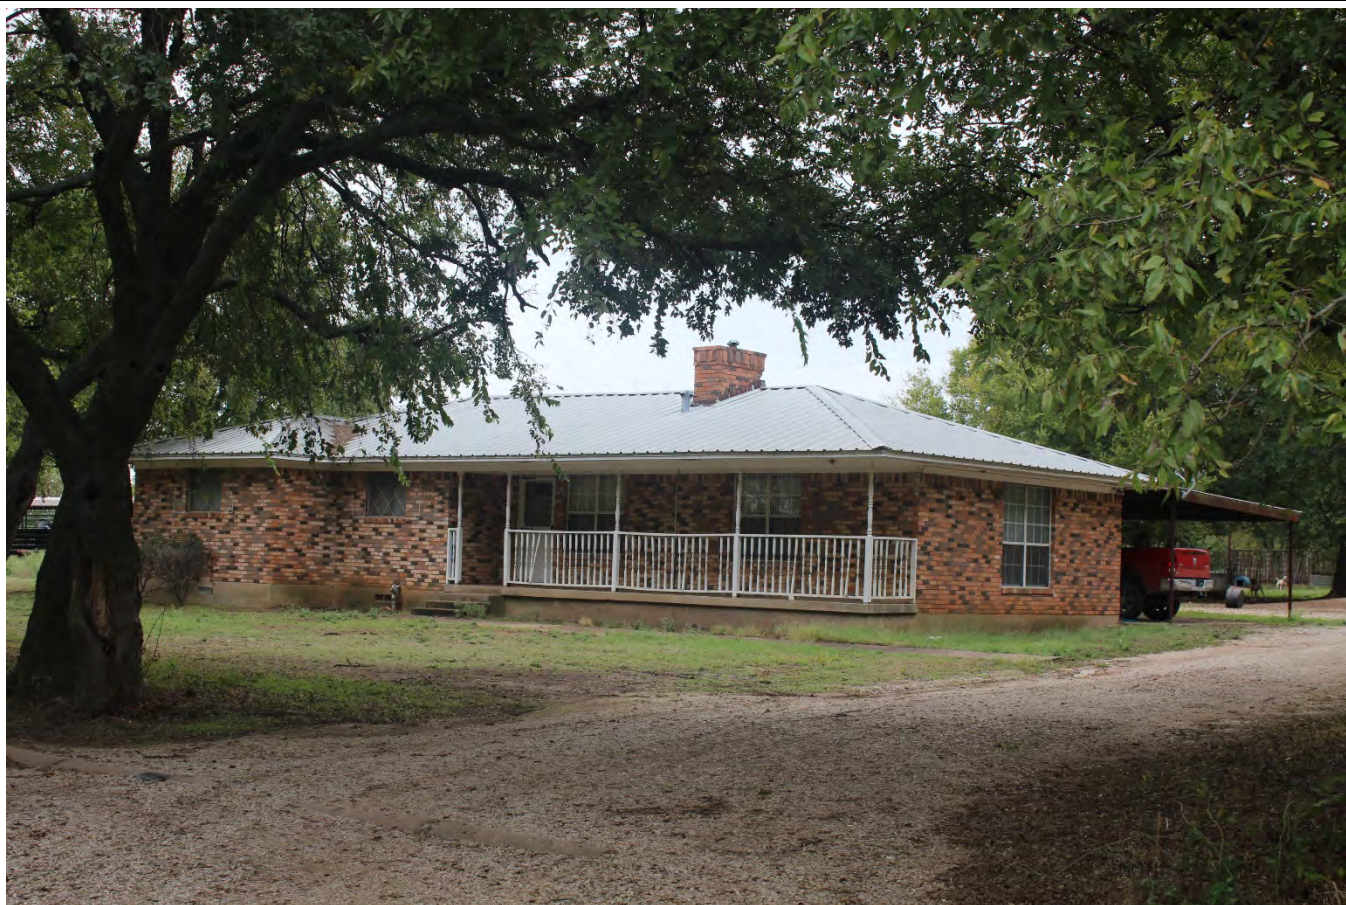
Camera facing southwest

Most houses have chimneys, and while most are located on the rear slope of the roof (see **Resource Nos. 25, 27, and 34**), **Resource No. 02** has a straddle ridge chimney, while **Resource Nos. 05a and 57** feature an exposed chimney located on the front façade. Attached garages are a frequent occurrence in the project area and are usually located on a side façade (see **Resource Nos. 30a and 35**). Most surveyed Ranch style houses are single story, but a few feature two story additions. Modern additions are a common feature among resources in the project area, as noted in **Resource No. 15a**, which has a two-story addition and **Resource No. 04**, which has a second-story addition completed with a Victorian-influence turret and trim.

| NRHP Eligibility: | Not Eligible |
| Integrity/Comments: | Ranch style house with shallow-pitch, replacement metal hip roof, polychrome brick siding, a partial-width porch, original diamond plated windows, replacement sash windows, and a straddle ridge chimney. A carport extends from the rear (west) façade. |

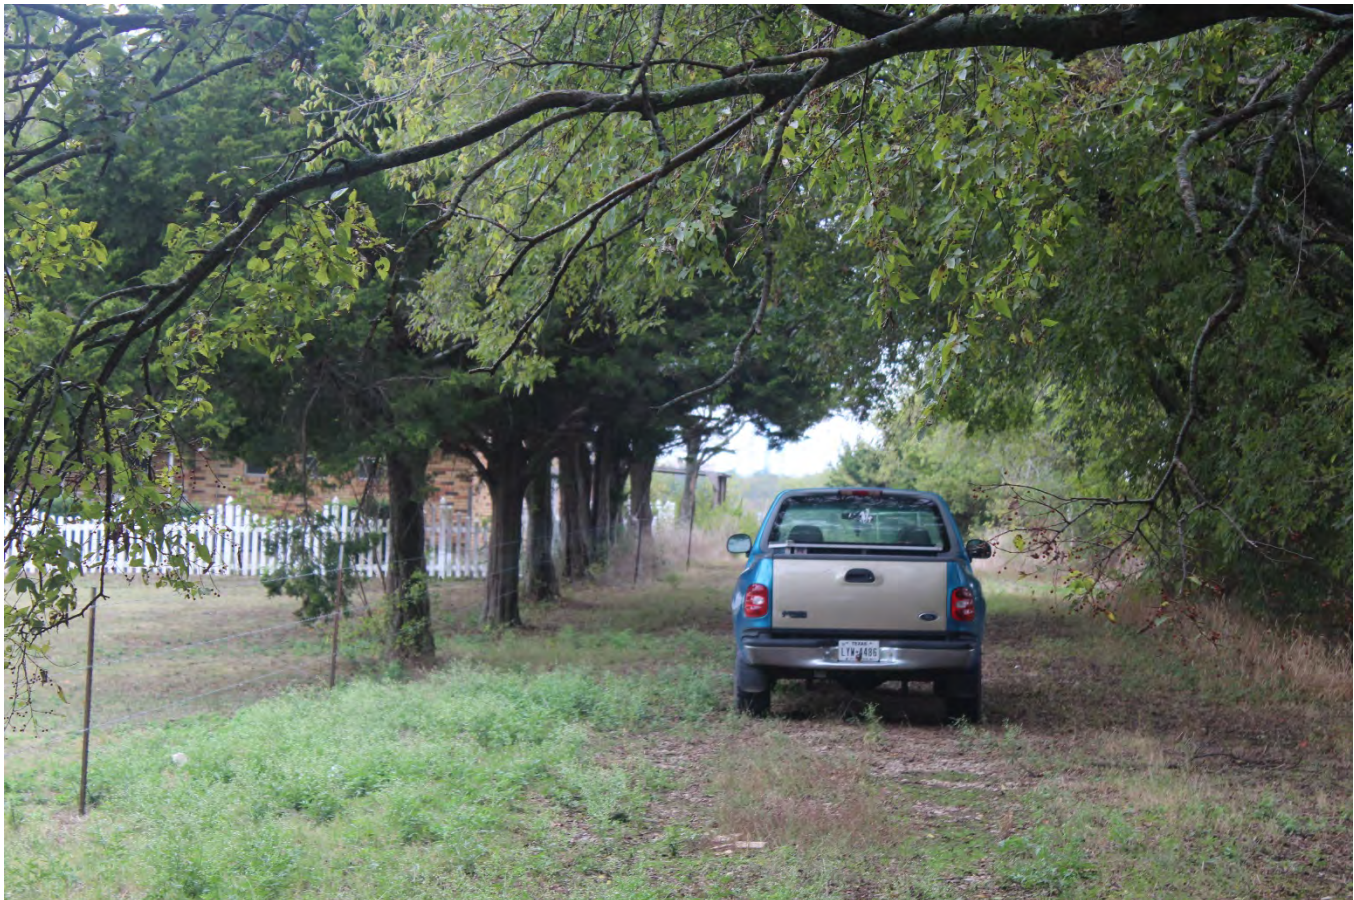
Camera facing south.

| NRHP Eligibility: | Not Eligible |
| Integrity/Comments: | Modern carport. |

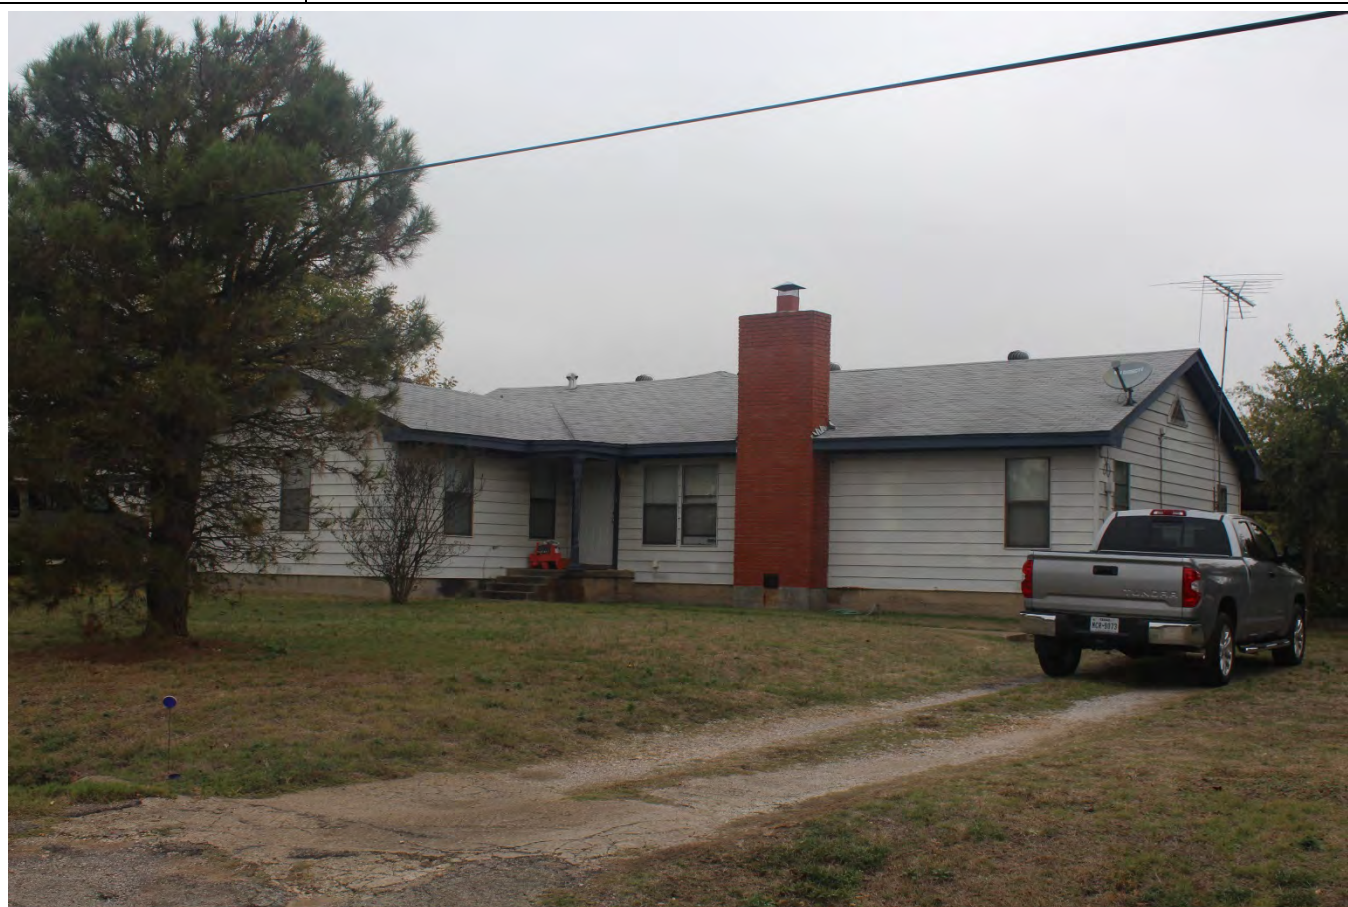
Camera facing northwest.

| NRHP Eligibility: | Not Eligible |
| Integrity/Comments: | Ranch style house with cross-gable roof, horizontal vinyl siding, a stoop, replacement windows, and an exterior chimney. |

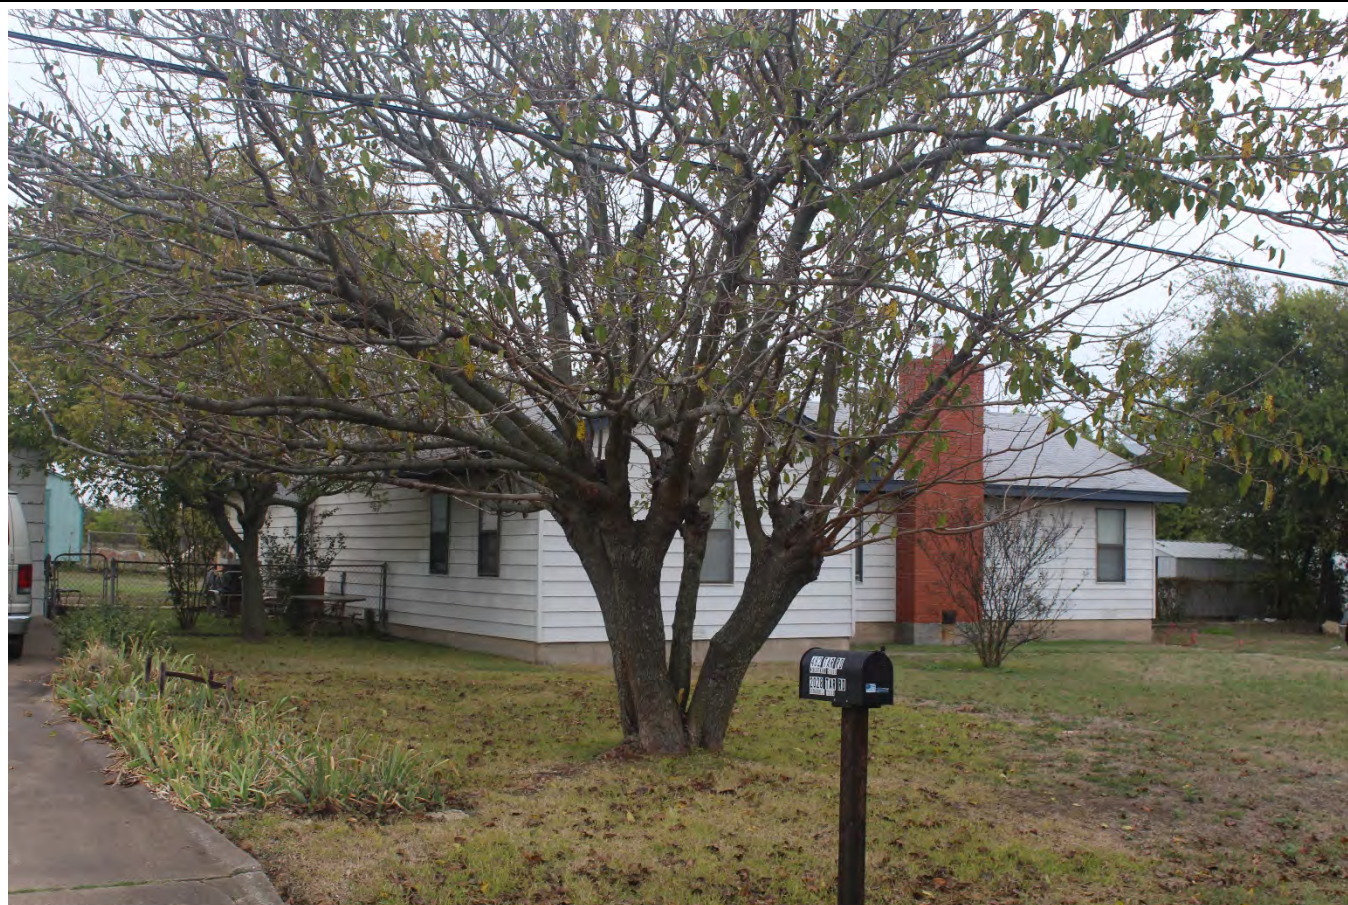
Camera facing

| NRHP Eligibility: | Not Eligible |
| Integrity/Comments: | Ranch style house with cross-gable roof, horizontal vinyl siding, a stoop, replacement windows, and an exterior chimney. |

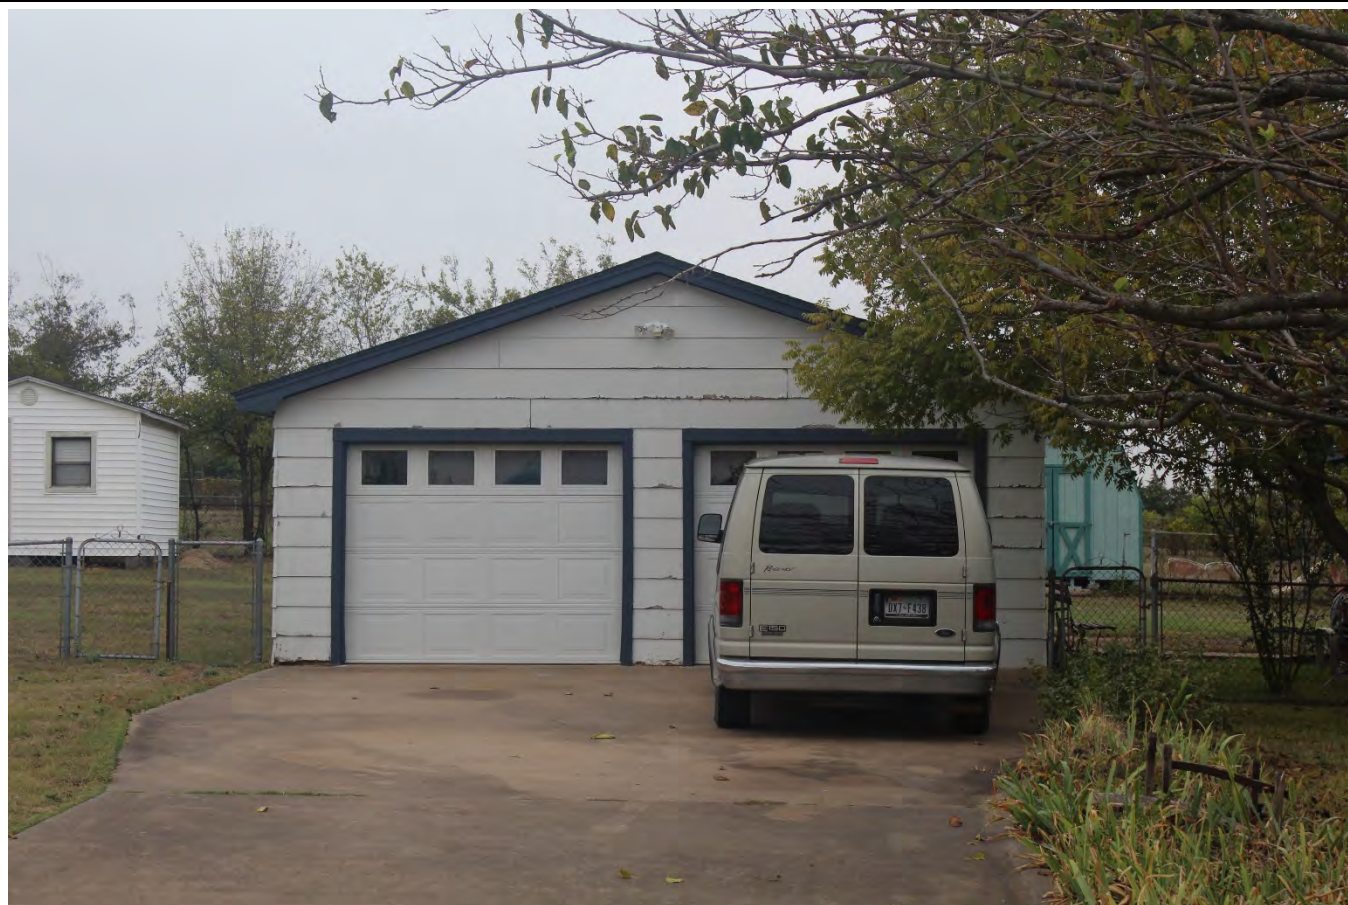
Camera facing north.

| NRHP Eligibility: | Not Eligible |
| Integrity/Comments: | Resource 05b is a garage with a front-gable roof, horizontal vinyl siding, and replacement sliding bay doors. |

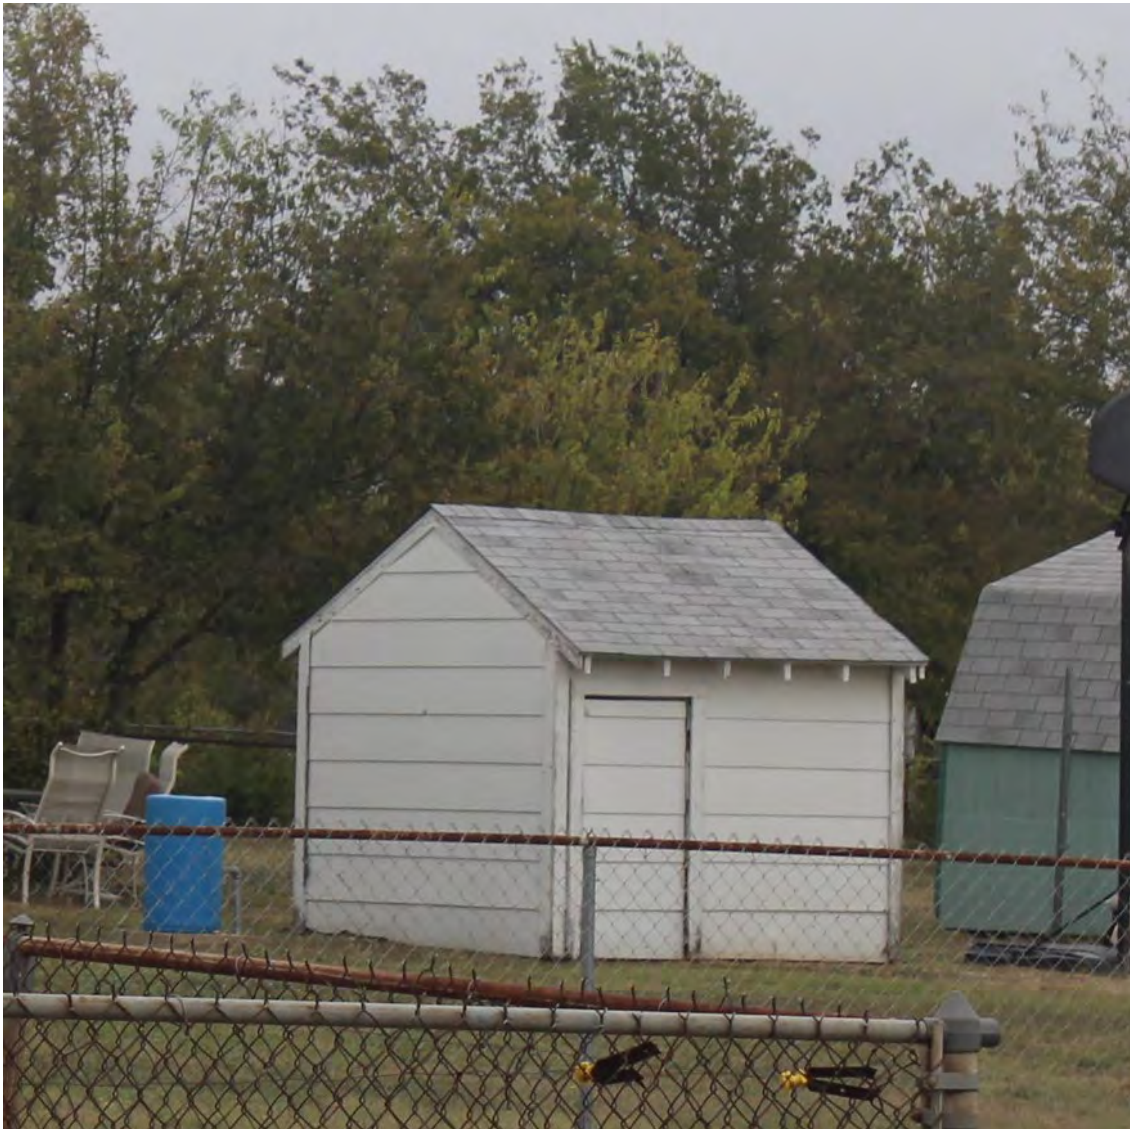
Camera facing northeast.

| NRHP Eligibility: | Not Eligible |
| Integrity/Comments: | Resource 05c is a shed with a side-gable roof, exposed rafter tails, and horizontal wood siding. |
