Interim Report for Intensive Archeological Investigations

Proposed US 67 Interchange at Lake Ridge Parkway, Dallas and Ellis Counties, Dallas District CSJ 0261-01-041

November 2020

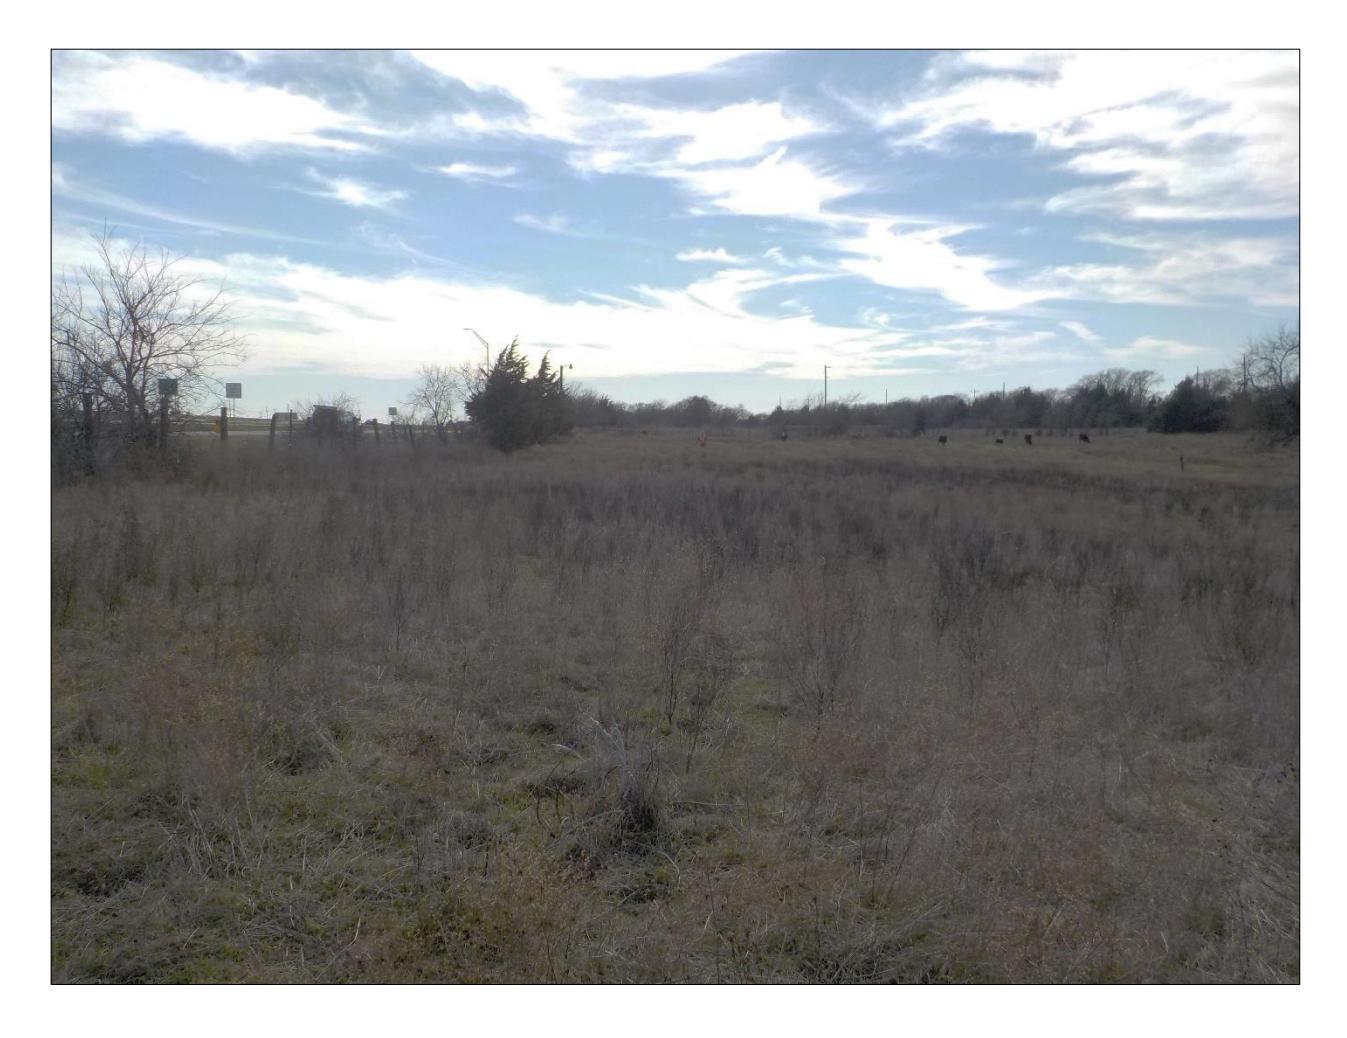
Figure 5: Example of Typical Visibility within the Project Area.

Survey Area Description: The project consists of open pastures over moderately sloping hills, as well as developed commercial areas. Due to the variety of grasses in the APE, ground visibility was anywhere from 0–20 percent (**Figure 5**) with localized areas having approximately 75 percent visibility, where surface bedrock precluded the need for shovel testing. Portions of the APE on both the east and west sides of US 67, were heavily disturbed by roadway construction. These areas were terraformed, with manmade ditches and utilities running along the road.

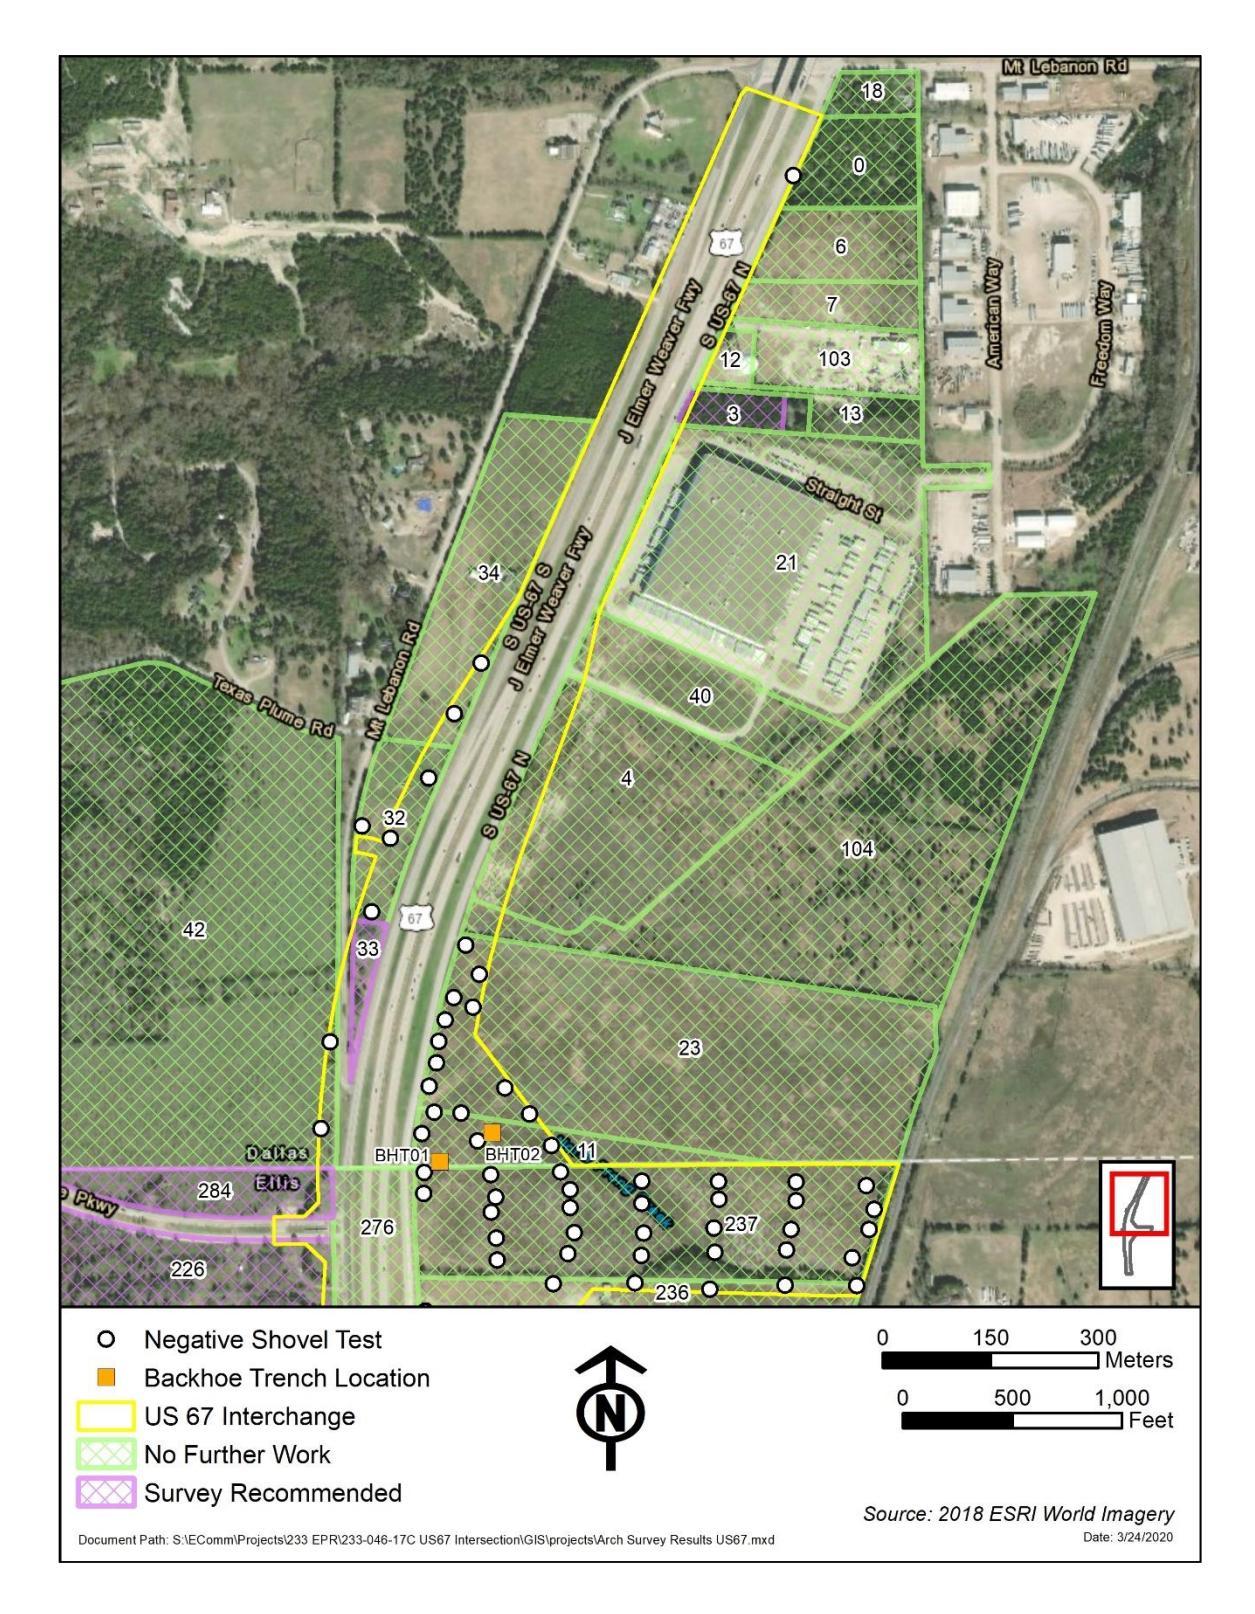
Figure 6a: Survey Results of the Northern Portion of the Project Area.

Shovel Testing Results: Shovel testing was performed following and/or exceeding CTA standards with a shovel test performed every 100 meters with the exception of areas with high visibility, or that had been disturbed. Archeologists excavated a total of 68 shovel tests (Figures 6a and 6b; Appendix A). No shovel tests were positive for cultural material. There was one typical soil profile throughout the APE. The soil profile consisted of a dark greyish brown (10YR 4/2) silty clay with limestone inclusions, overlying limestone bedrock.

Backhoe Trench Results: All mechanical trenching was performed within parcel 11, as it was the only place within the project area with potential for deeply buried intact archeological deposits, for which ROE was granted. AmaTerra staff excavated two backhoe trenches within the APE (Figure 6a; Appendix B). The first trench was placed on the western side of North Prong Creek within 175 meters of the creek. The second trench was also placed on the western side of North Prong Creek, 95 meters from the creek. No cultural material was discovered in either of the backhoe trenches.

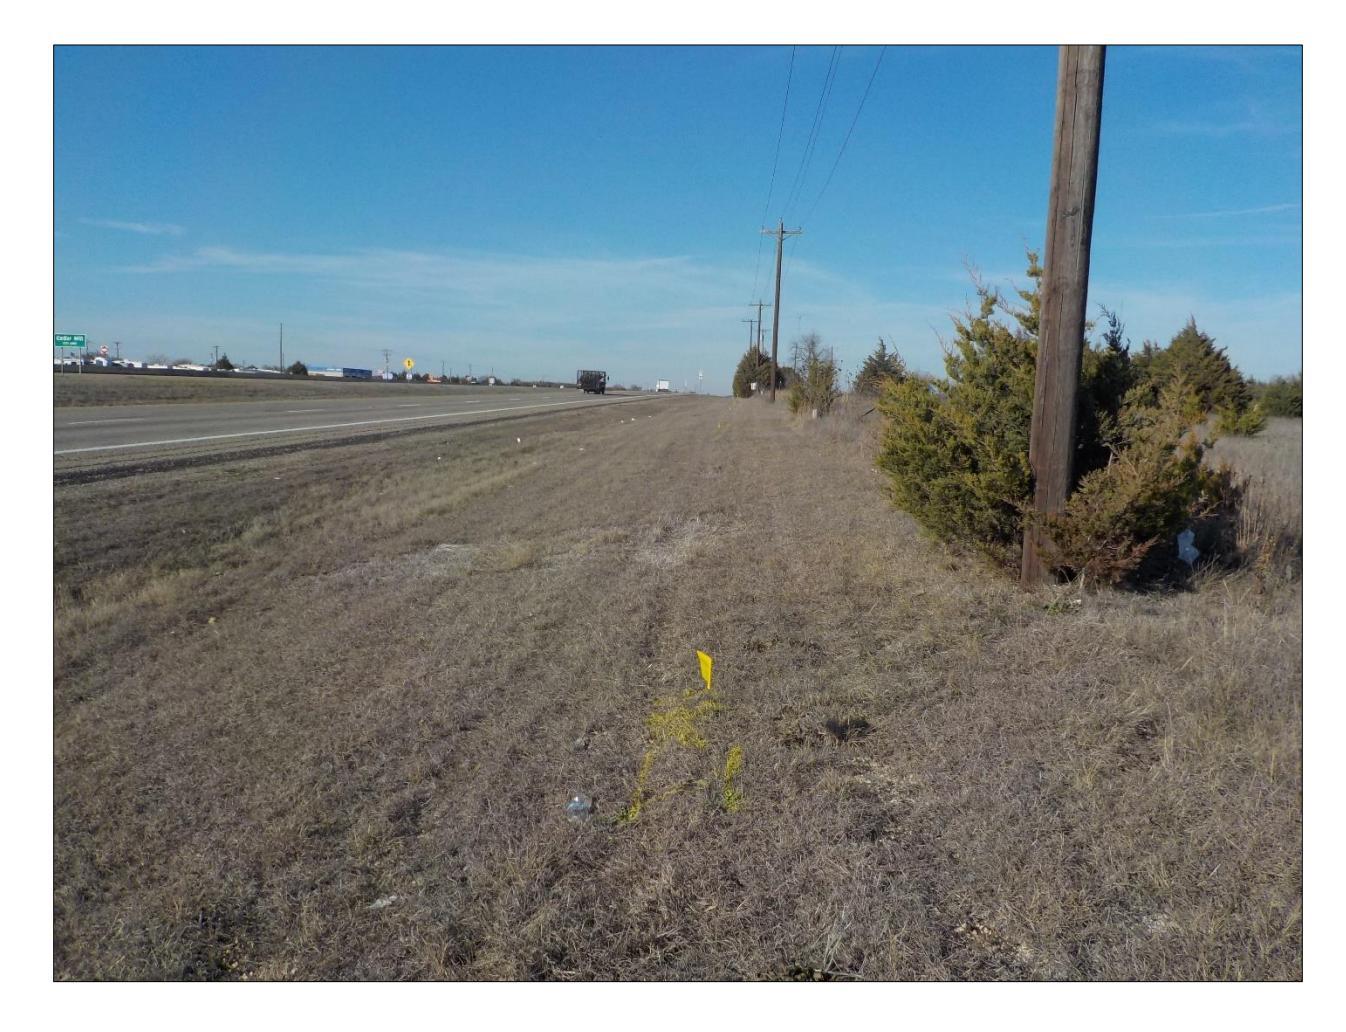
Figure 7: Utility Disturbance for Parcel 235.

Several parcels with ROE (12, 18, 103, and 235) were pedestrian surveyed only due to evidence of past disturbances. Utility lines run throughout parcels 18 and 235, negating and preventing any subsurface testing (**Figure 7**). Parcel 12 has been disturbed by the construction of a water tower as well as underground utilities, negating the need for shovel testing (**Figure 8**). A concrete driveway was present on the surface across Parcel 103 (**Figure 9**). Based on the amount of terraforming and subsurface disturbance associated with these areas, it was determined that the was little to no potential for intact cultural deposits to be located in these areas.

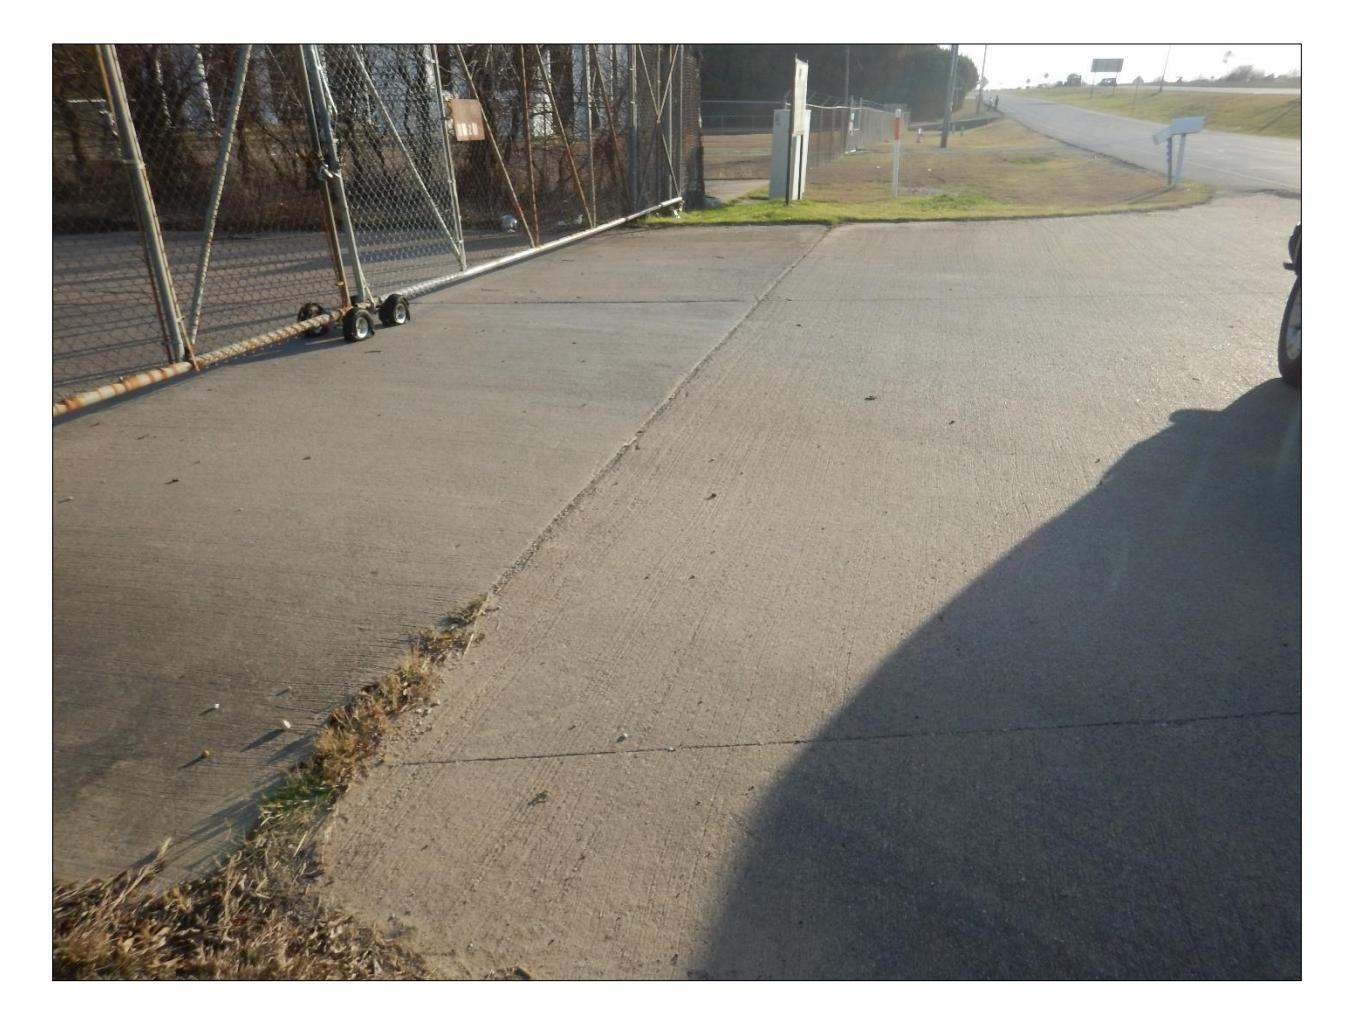
Figure 9: Driveway in Parcel 103.

Several types of disturbance were observed during the survey (see **Figures 7** to **9**, and **Appendix A**). Shovel tests located in areas of prairie or pasture have lively been subjected to disturbance caused by plowing, grazing, or mowing. Areas where mulch was found overlying topsoil may have been disturbed by landscaping activity. Disturbance from commercial developments, utilities, and roadway construction are present, and it is likely that activities related to the construction and normal use/maintenance of these features has disturbed sediments. Shovel tests were placed in proximity to disturbed areas to confirm that the areas affected have low potential for the preservation of archeological materials and this is supported by the lack of artifacts recovered during the shovel testing survey.

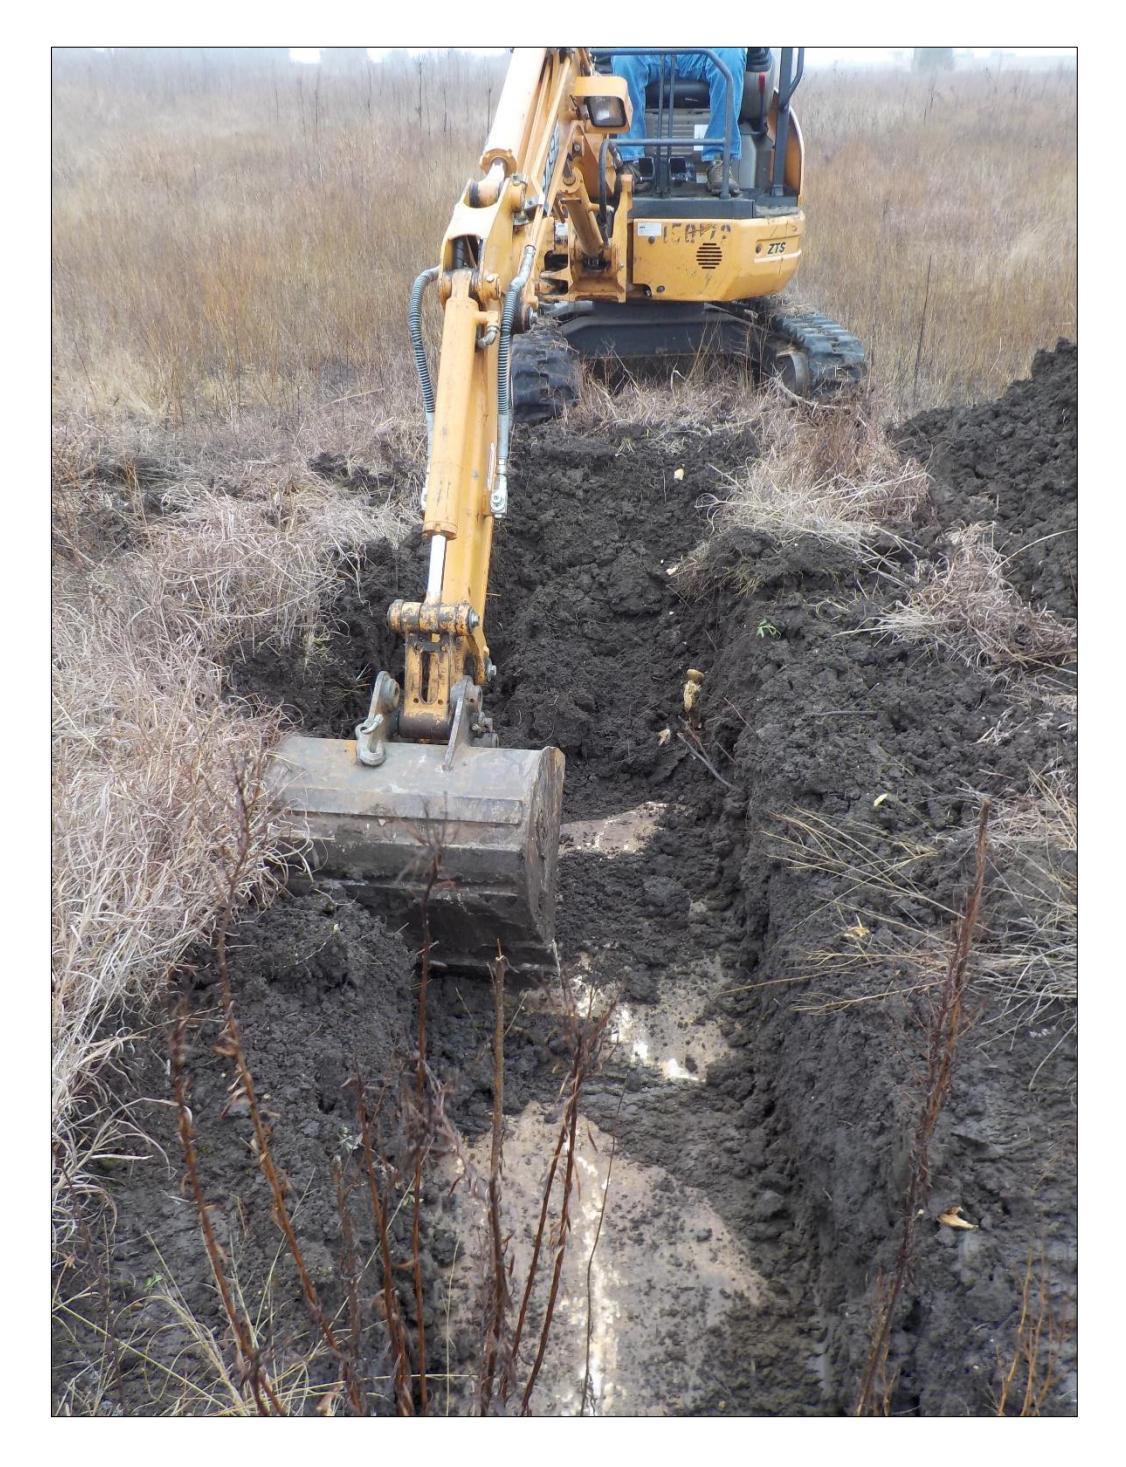
Figure 10: BHT01 Overview.

Backhoe Trench 01—BHT01 was placed approximately 175 meters west of North Prong Creek on a densely vegetated lowland. The vegetation consists of tall and short grasses. Soils in the trench included three stratified levels. Stratum I consisted of a 10YR 2/1 clay full of roots and rootlets. Stratum II consisted of a 10YR 3/2 clay. Stratum III consisted of smooth bedrock across the entire trench. The trench reached a maximum depth of 60 cmbs and no cultural material was observed (**Figure 10**).

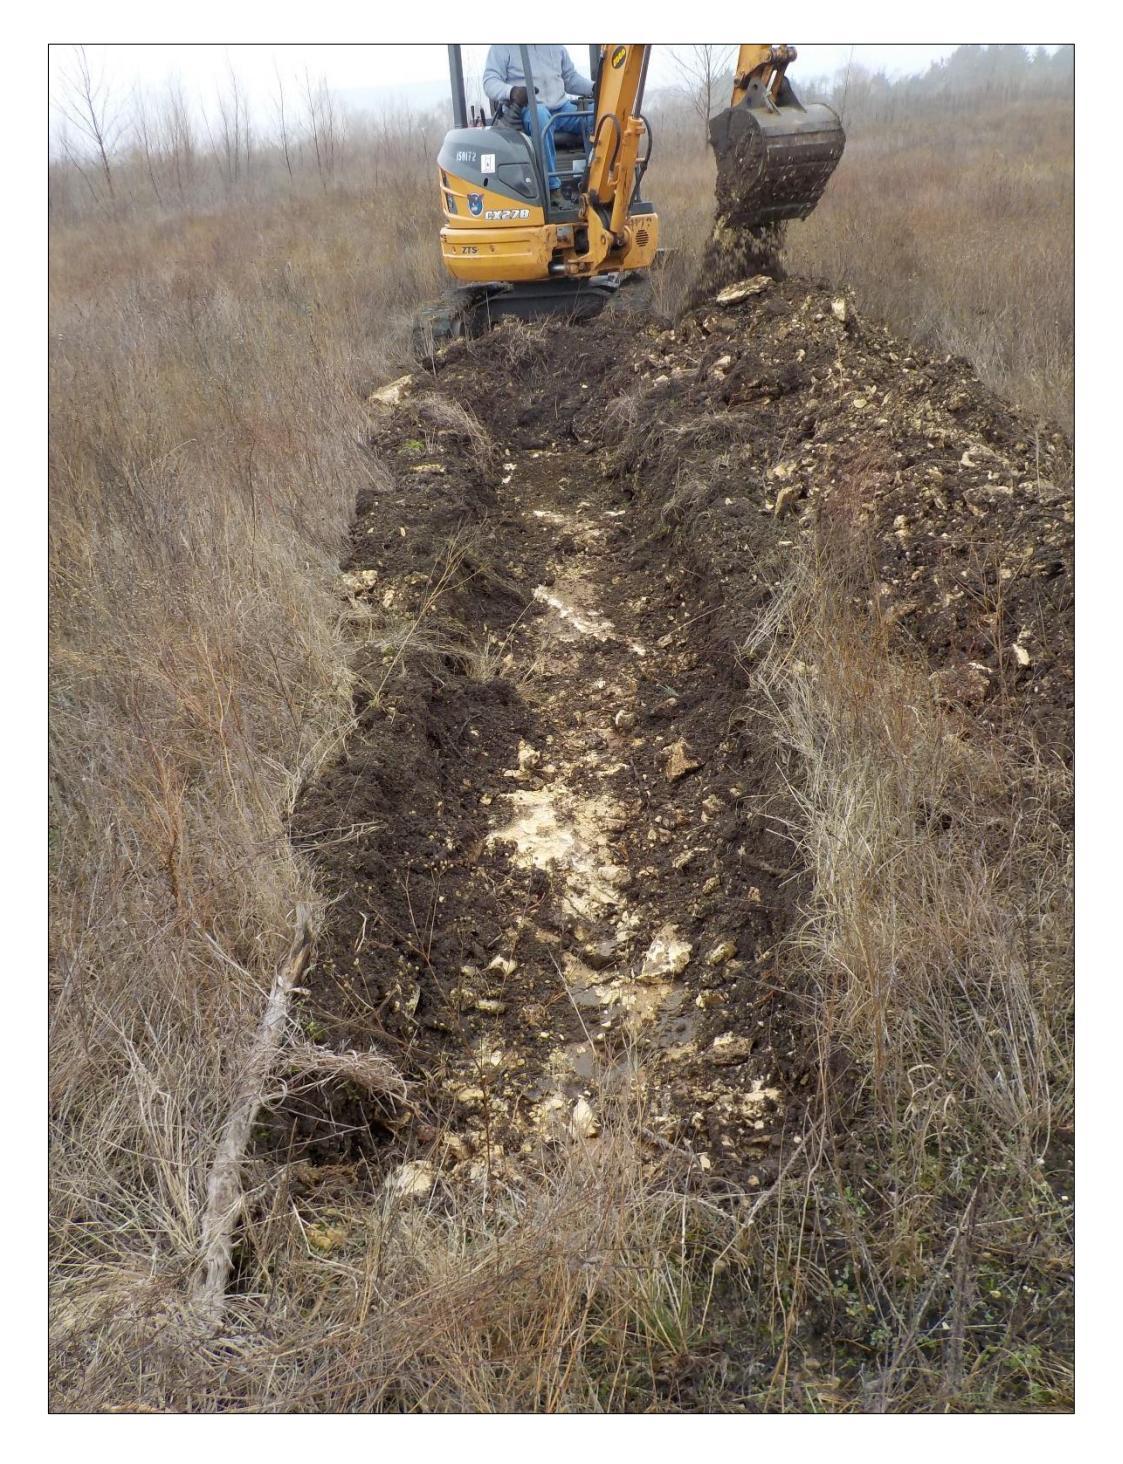
Figure 11: BHT02 Overview.

Backhoe Trench 02—BHT02 was placed approximately 95 meters northwest of North Prong Creek on a densely vegetated lowland. The vegetation consists of tall and short grasses. Soils in the trench included two stratified levels. Stratum I consisted of a 10YR 3/2 clay full of roots and degraded bedrock. Stratum II consisted of a limestone bedrock. The trench reached a maximum depth of 25 cmbs and no cultural material was observed (**Figure 11**).

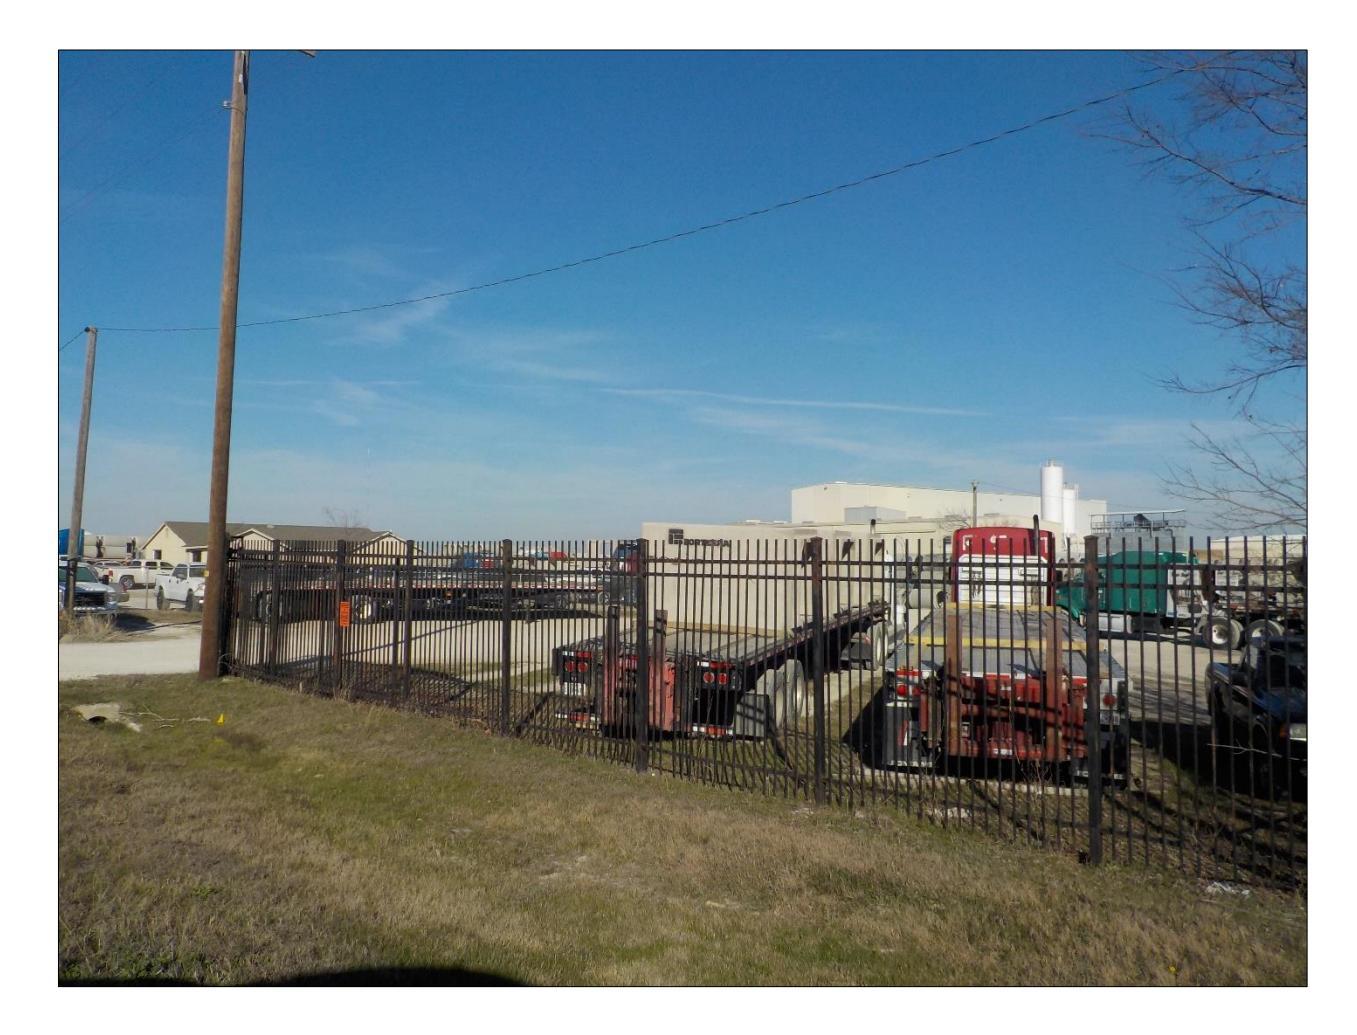
Figure 12: Disturbances for Parcel 238.

- Presence of commercial parking lots: Parcel 238 (Figure 12)
- Presence of driveway and terraforming: Parcel 13
- Surface bedrock present: Parcels 4, 40 and 104 (Figure 13)
- Presence of buried utilities and terraforming: Parcels 6 and 7 (Figure 14)
- Extensive evidence of buried utilities: Parcel 21 (Figure 15)

Further work is recommended for six undisturbed parcels for which ROE was not granted at the time of survey, including 3, 33, 226, 227, 284, and 286. Survey is recommended due to the potential for intact cultural remains within the APE. No further work is recommended for the existing ROW and the 12 parcels that were surveyed, including 0, 11, 12, 18, 23, 32, 34, 42, 103, 235, 236, and 237. Additionally, no further work is recommended for the eight parcels for which access was not granted that have been subjected to significant disturbance and are thus unlikely to have preserved cultural resources (Parcels 4, 6, 7, 13, 21, 40, 104, and 238).
